Cubert Vicarage – western outhouse, Cornwall
Archaeological Watching Brief

Cornwall Archaeological Unit

Report No: 2016R016

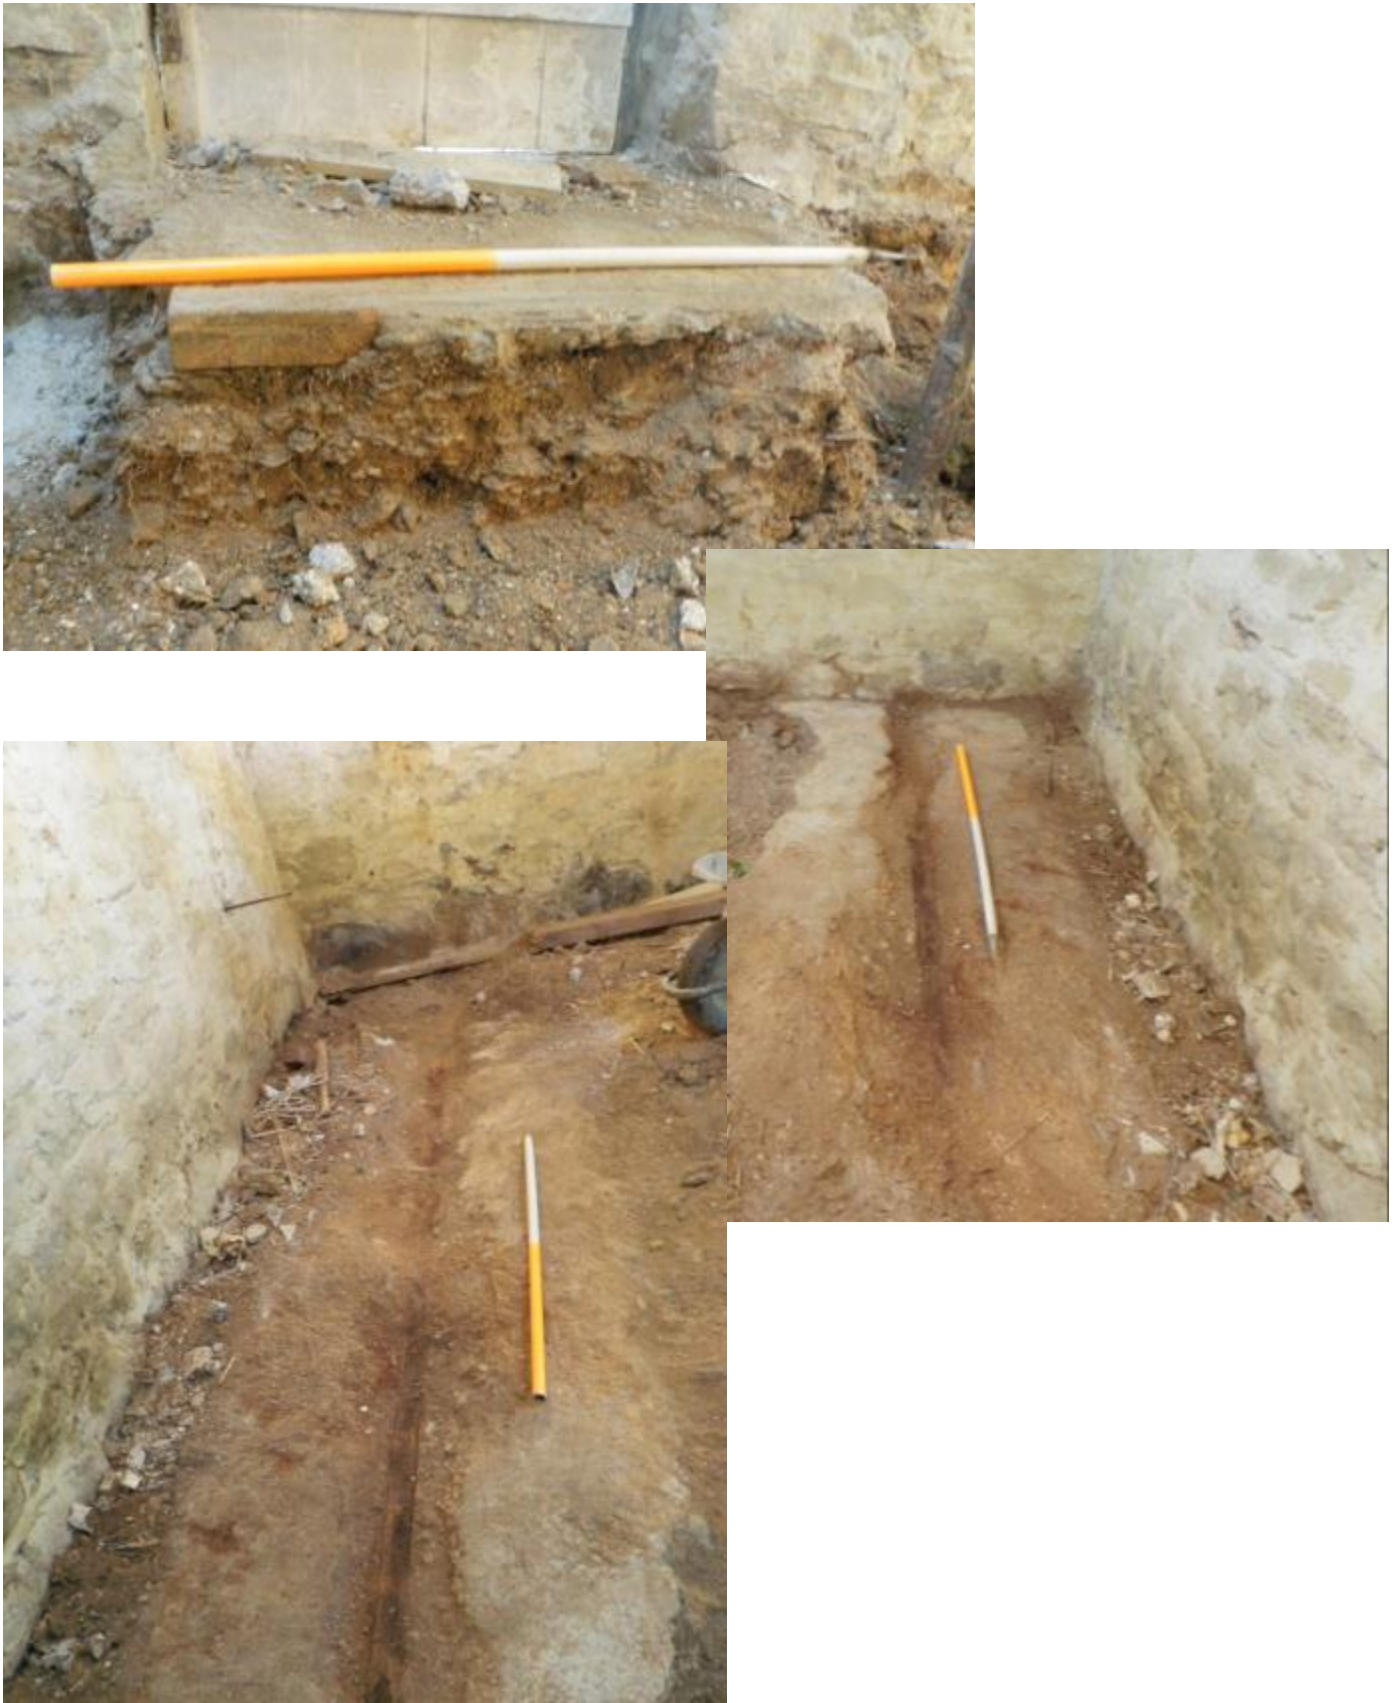
Fig 4 Top – Showing the brick defined door entrance in the southern wall. Above and left – looking south and north along the two westernmost timber joists. Note the overlying remnant wooden floor in the north-western corner of the room.

Prior to the start of the watching brief, the failed floor of closely spaced wooden floorboards had been removed. Only a single board was left *in situ*, clinging to the northern wall in the north-western corner of the room (see lower Fig 4 and upper and middle Fig 5). The floorboards ran approximately east to west, supported by north to south running timber joists. The joists were located within hand cut slots, which had been cut into lower compacted floor surface (1), at approximate 0.4m-0.5m intervals. Their former positions are marked on Figure 3, and their appearance recorded photographically (middle and lower Fig 4).

The compacted surface identified beneath the failed floor boards consisted of ash, lime, clay, sand, crushed quartz and burnt killas (mudstone). It averaged 0.05-0.08m thick, increasing to 0.15m in some places. Its lower surface directly overlay patchy remnant layer (3), and parts of exposed bedrock (7) and clay (4). The upper surface of the made floor was smooth and fine grained, consisting of what appeared to be an upper wash of lime-treated clay (possibly mixed with ash). The result was a resilient, cheap to produce, entirely locally sourced floor, traditionally termed an 'earth' floor. This type of floor surface, if kept dry, can have a long life, and has the advantage of being easily repairable. A single patch of repair was noted in the south-western corner, suggesting a possible ongoing problem with damp. In addition a red brick surround was incorporated around the southern doorway. The bricks appeared to have been cut through (1) and then re-sealed by well disguised repairs to the flooring (upper Fig 4). This brick threshold has now been removed.

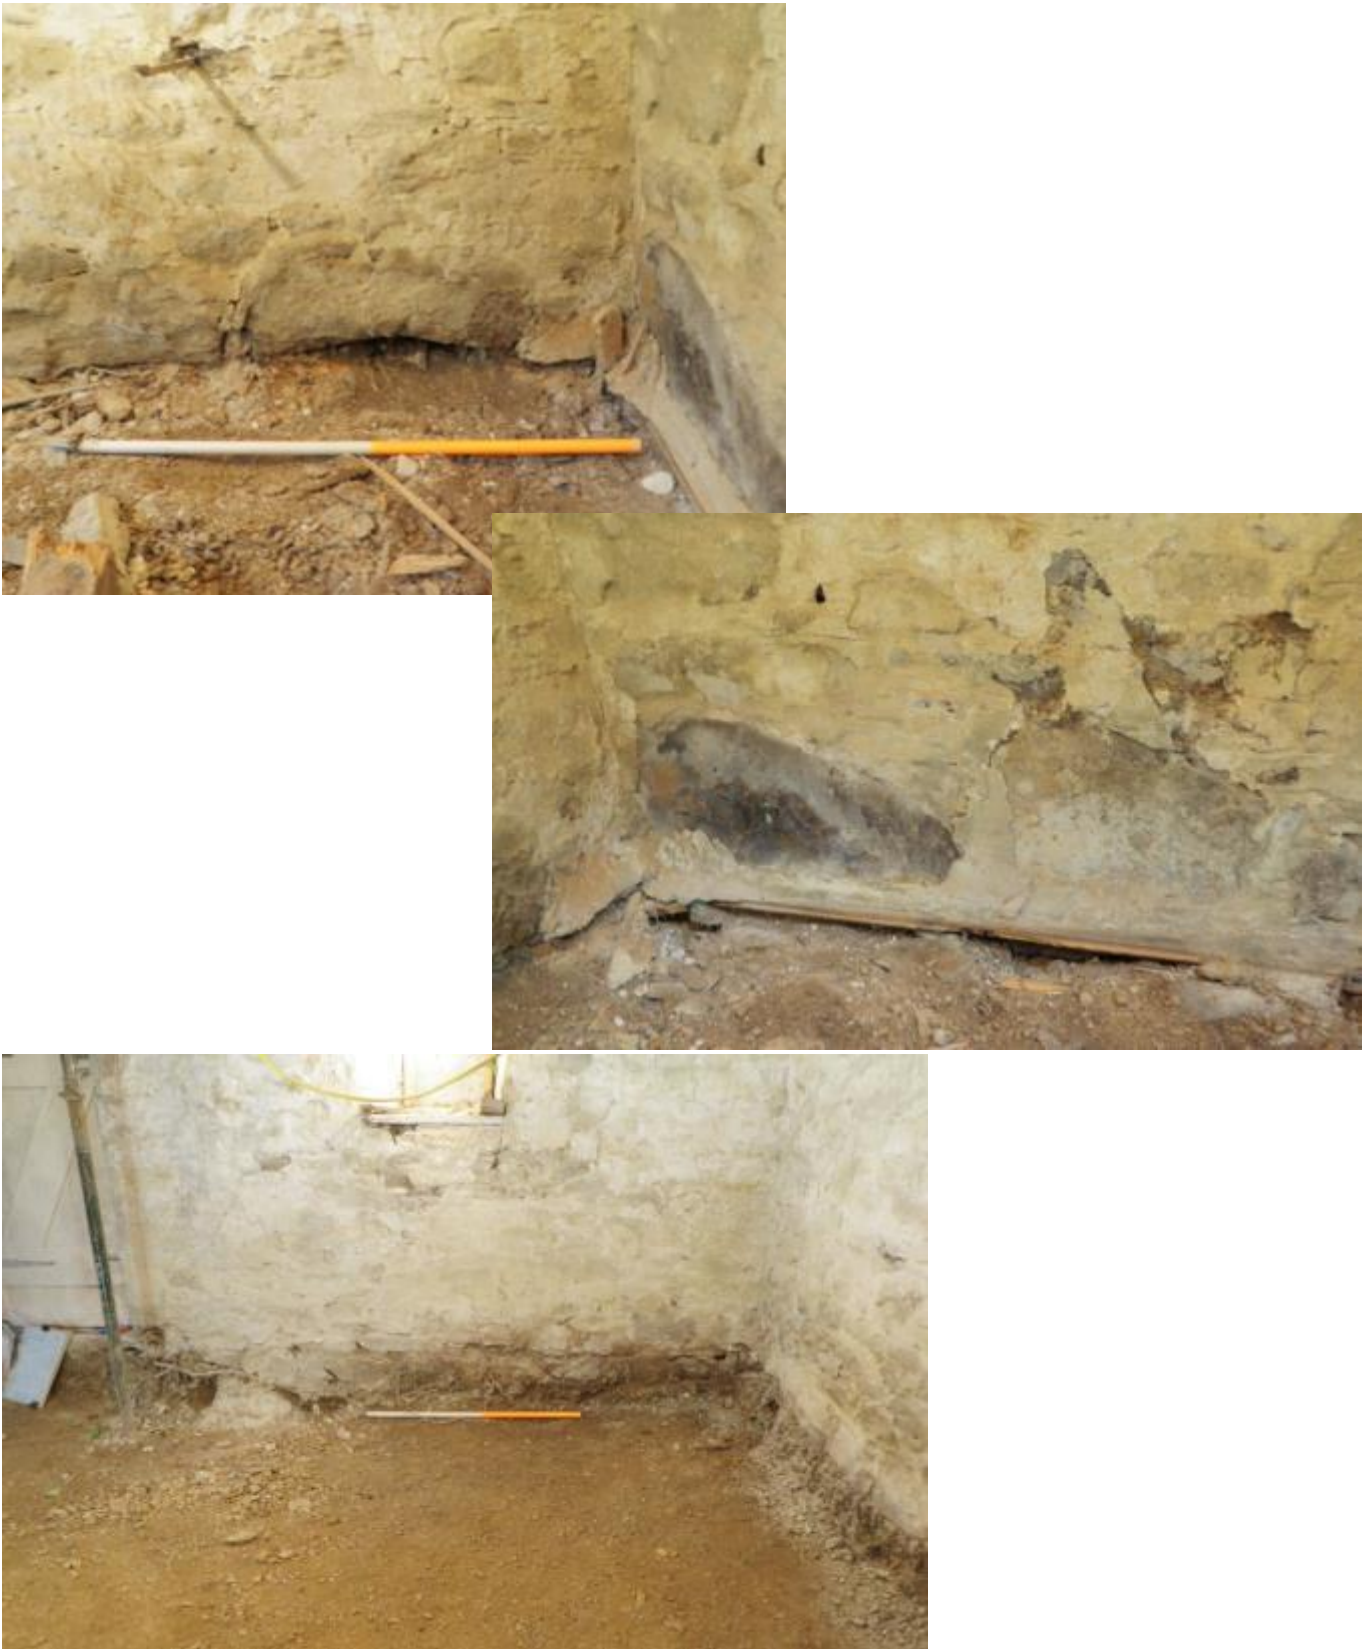
Fig 5 Top – Looking west at the notably large foundation stones supporting the wall in the north western corner of the room. Middle – looking north towards the remnant wooden flooring, showing loose animal disturbance beneath it. Bottom – looking south towards the former trial pit, showing the probable pillar-base stone.

Associated with this deposit was a large basal stone forming part of the foundation for the southern wall. Its position and size suggests that it could have been an original pillar-base, supporting the cob-built upper floor referred to in historic documentation (Parkes 2015, 10). It was partly seen in the original trial pit, but more fully exposed during the watching brief. It can be seen to the left of the scale in lower Figure 5, and is marked on Figure 3. The stone lies at what would have been the foot of the gable end shown in middle Figure 7.

Wall foundations, where revealed by the removal of the 0.3m depth of ground level, were minimal. Large stone blocks located along the base of the north-western corner of the wall (see Fig 5 top and middle) were visible in the lowest external course of walling. All of these larger stones had been deliberately placed; none were *in-situ* blocks of bedrock.

Contexts (2) and (5) did appear to extend beneath the walling (see above). Context (2) probably extended beneath the wall as animal tunnelling. Very loose fill was noted along parts of the remnant wood floor (middle Fig 5), while context (5) may represent pre-wall surface erosion in the form of a scoop, possibly associated with the building's use as an open sided structure (see above).

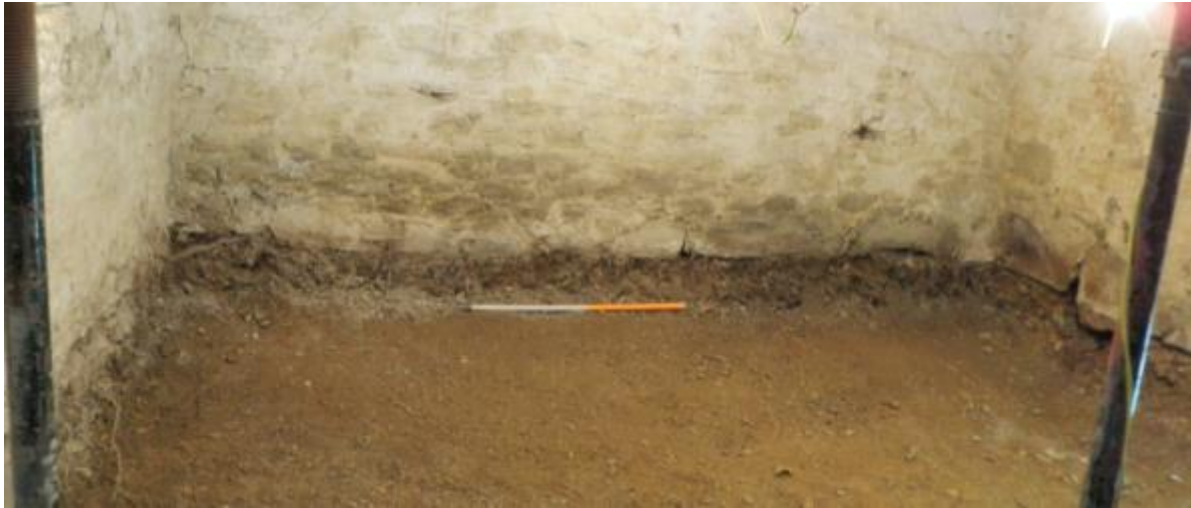
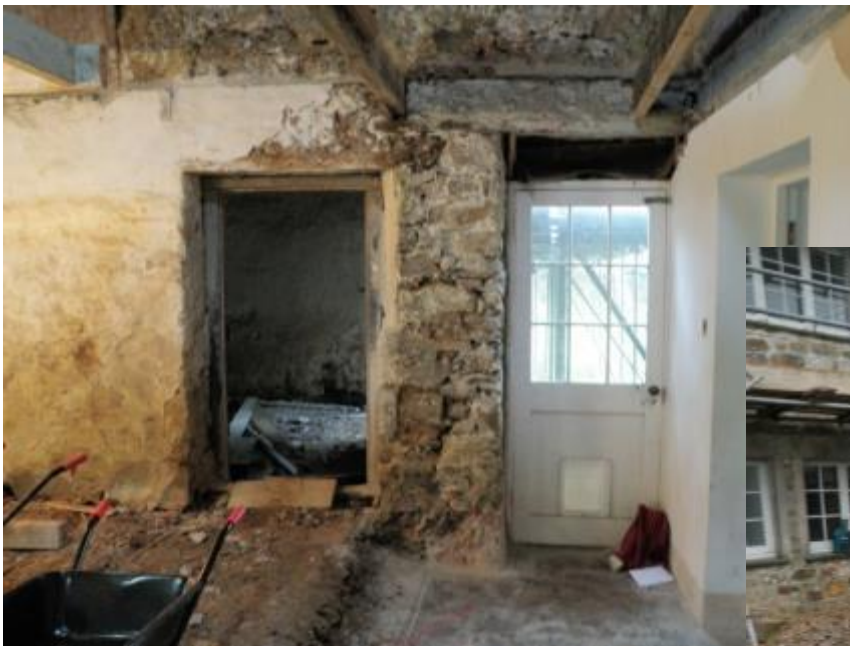
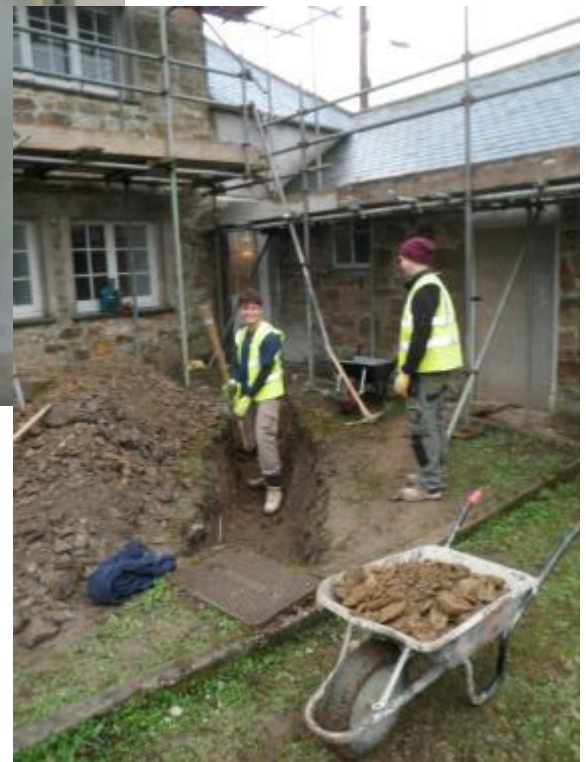
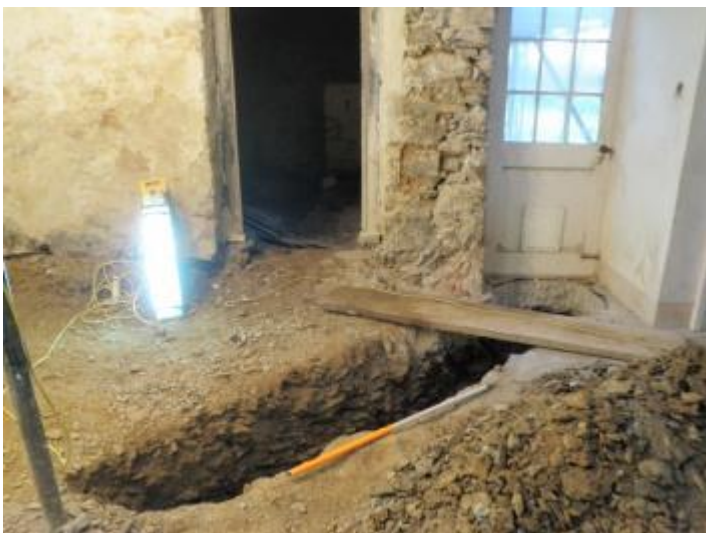
Fig 6 Top – Looking west across the excavated floor level showing the western wall base. Note the roots extending in from outside. Middle – Looking north in to the former stable showing the exposed wall masonry and concrete flooring prior to the trench excavation. Above left- the internal excavated pipe trench. Above right – the excavation of the external trench in progress.

In the damper south-western corner of the building, this redeposited fill retained its former pale orange-brown colour. In this corner, and along the southern edge of the wall plant roots have encroached from outside.

The trench extended from the centre of the building north-eastwards, running beneath the north-eastern outside door. It joined the already excavated external length of trench (middle Fig 6), which linked in to the main house drainage system (lower Fig 6). The concrete floor surface associated with the demolished concrete partition walling in the eastern side of the building was removed along the line of the trench (see Fig 3).

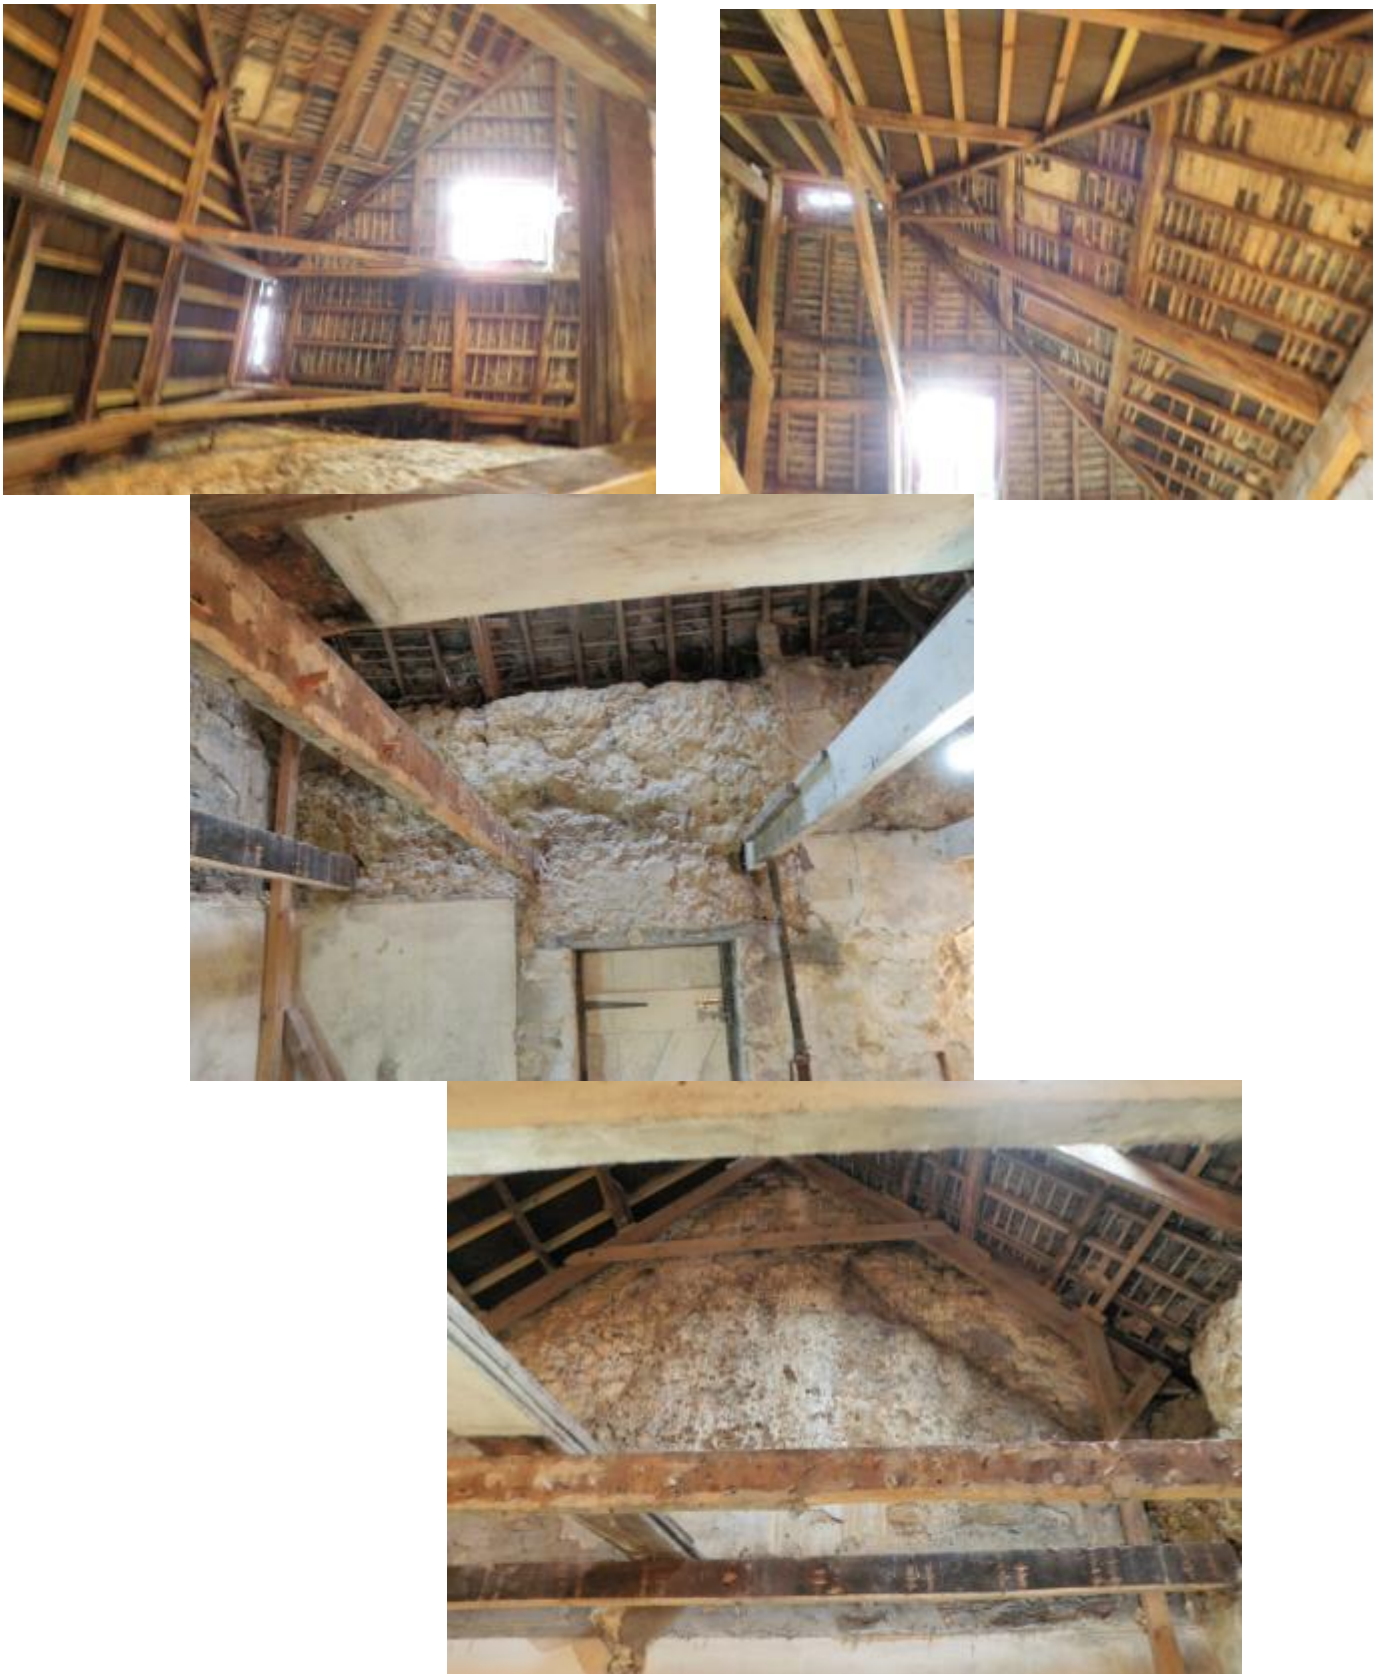
Fig 7 Top left and right - Looking at the exposed roof timbers, showing frequent phases of repair. Middle - View of the south wall showing phasing within the exposed cob walling, a former roof line and the later ceiling supports cutting in to it. Right - looking east at the exposed cob walling against the stone vicarage wall (clearly showing an earlier lower roof line).

Fossilised within the eastern part of the southern wall was a cob walled gable end reflecting a small roof space above a probable single roomed ground floor (see middle photograph Fig 7). This photograph also shows the extension upwards of cornice stones, reflecting phases of re-modelling (discussed fully in Parkes 2015).

A higher and more substantial roof line was visible in the eastern wall, against the main vicarage building (see lower photograph, Fig 7). This again was visible as a cob built gable end, and reflected a more substantial structure with a notably larger attic or first floor space, plus a change in the roof alignment from north to south to east to west.

The roof, at the time this record was made, was clearly in need of substantial repair. Internally it showed many patched slate and timber support repairs and alterations (see upper two photographs of Fig 7). It also represents the last and highest of the roofs at this end of the vicarage. Internally, changes in the roofing can be summarised as a series of structural enlargements, extending both out to the west and upwards. Externally the leaky state of the outhouse roof was not easily identifiable (see lower middle Fig 6, which clearly shows the outhouse as having a different roofline to both the taller main vicarage and the slightly shorter, differently aligned stable block).
