Leaden Well, Restormel Manor, Cornwall
Archaeological assessment

Report No: 2016R003

Client	Geraint Richards, Duchy of Cornwall
Report Number	2016R003
Date	April 2016
Status	Final
Report author(s)	Cathy Parkes
Checked by	Andy Jones
Approved by	Andrew Young

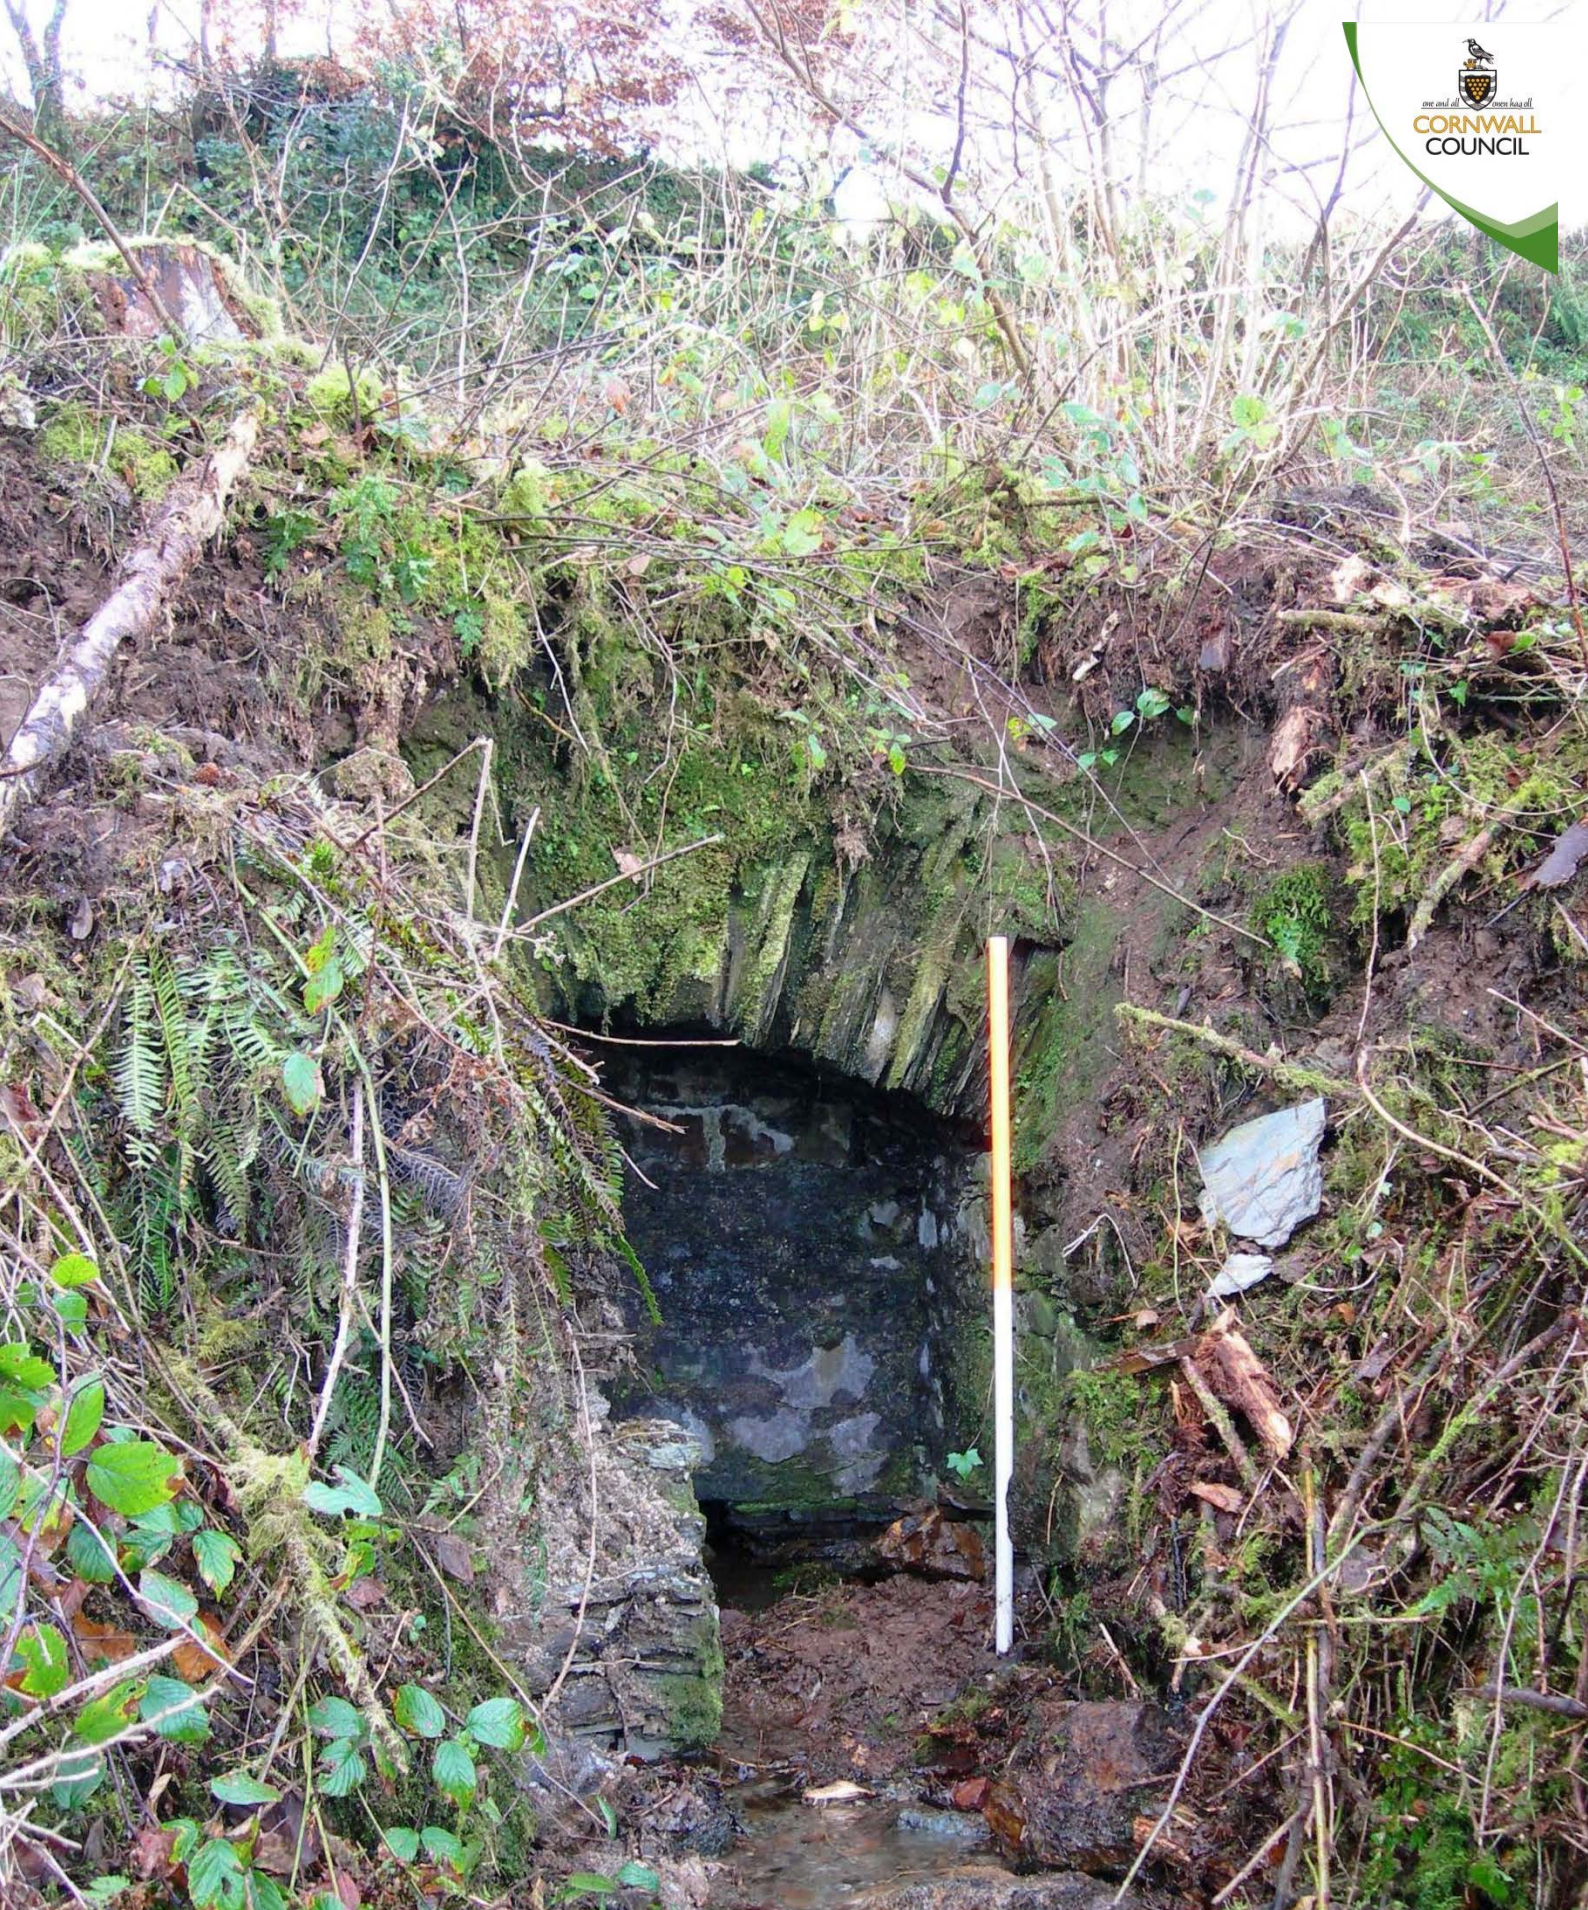
Cover illustration:

The opening of the well house from the front, north-east side (1m scale)

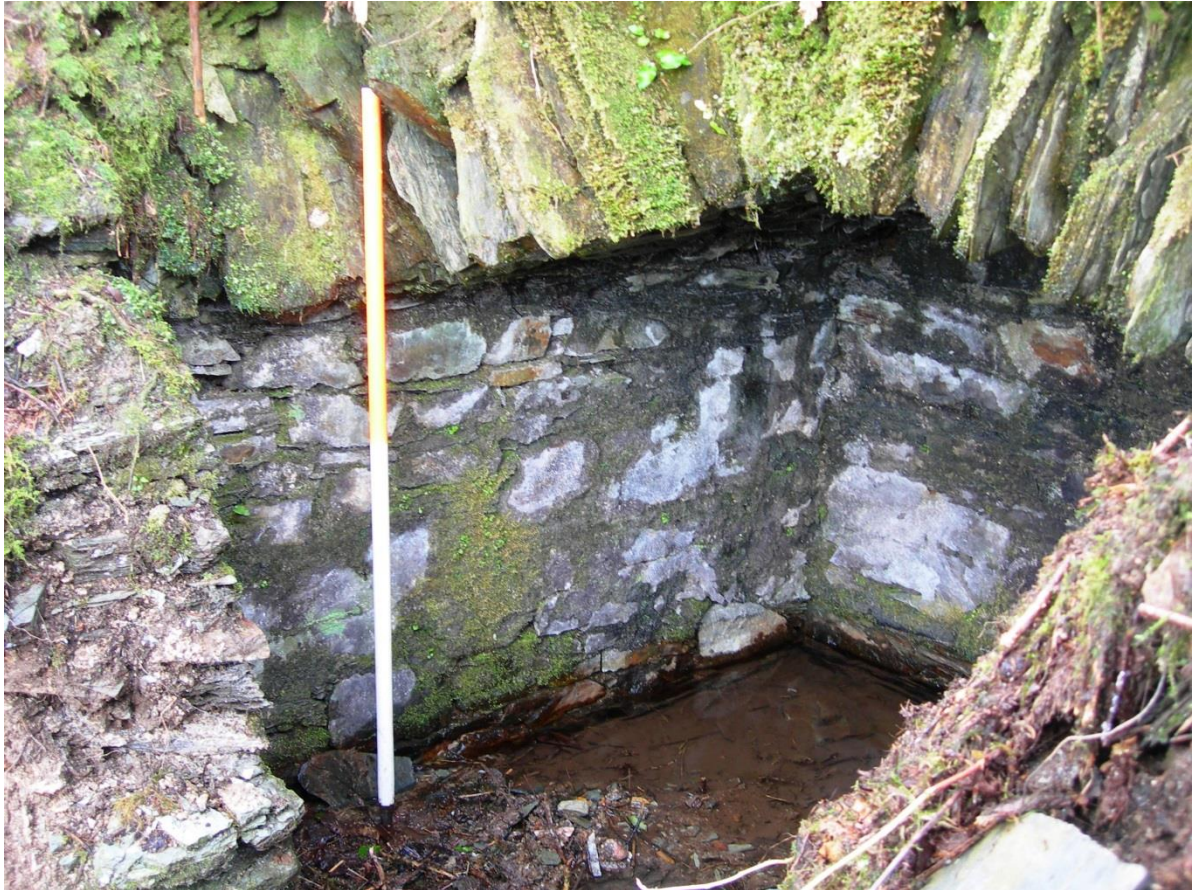
Fig 3 South-east corner of the well, from the doorway. This shows the roughly coursed, mortared stone of the interior, the vaulted roof, and collapse in the doorway (on the left)

The walls of the well house and its stone-vaulted roof are constructed in lime-mortared, roughly coursed slatey stone (Fig 3). Inside, the chamber is 1.33m by 1.55m across and the vaulted roof stands up to 1.2m high above the gravel-filled basin. As it is full of mud, stones and gravel, the depth of the well basin and the existence of any associated features (for example steps, or the exit from the basin of a pipe or culvert) are unknown, though may survive beneath the gravel.

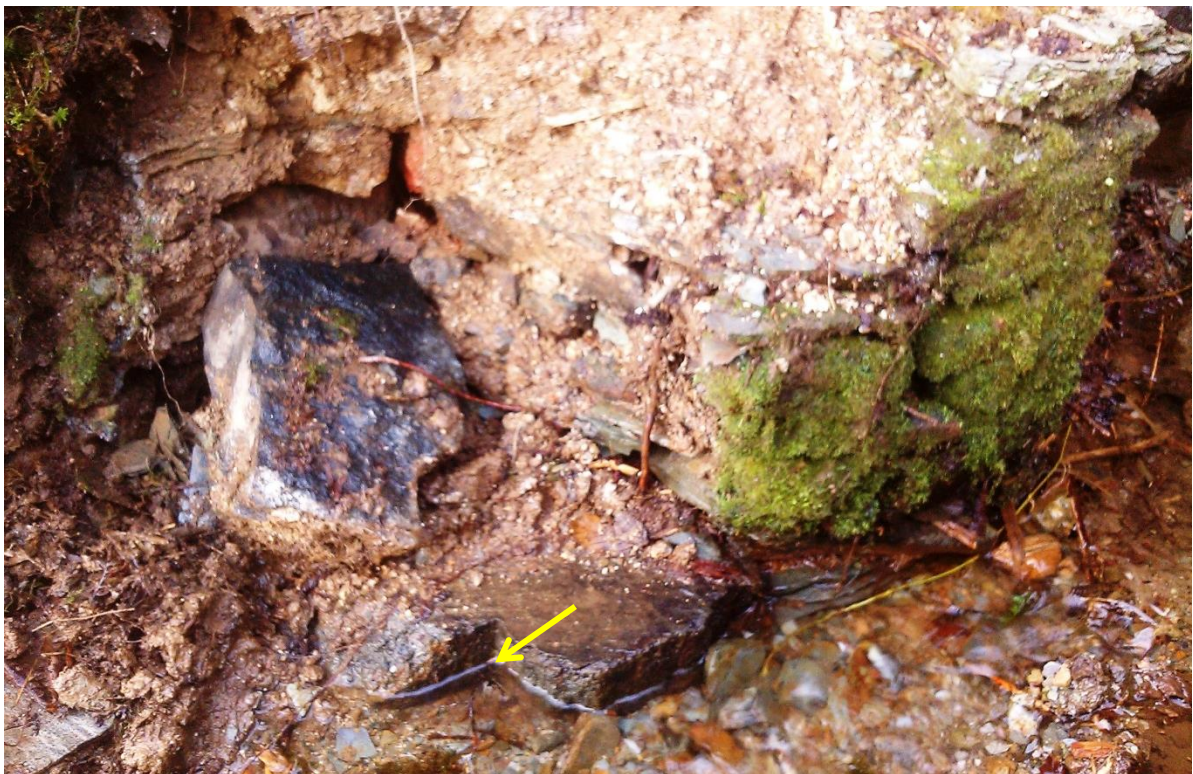
Fig 4 South-east side of the doorway showing a stone at the entrance, rebated for a door, and above it, collapsed stonework

The walling at the entrance is crumbly and ruined, and the outermost arch of the vaulted roof has fallen, though the structure is otherwise in reasonable condition.

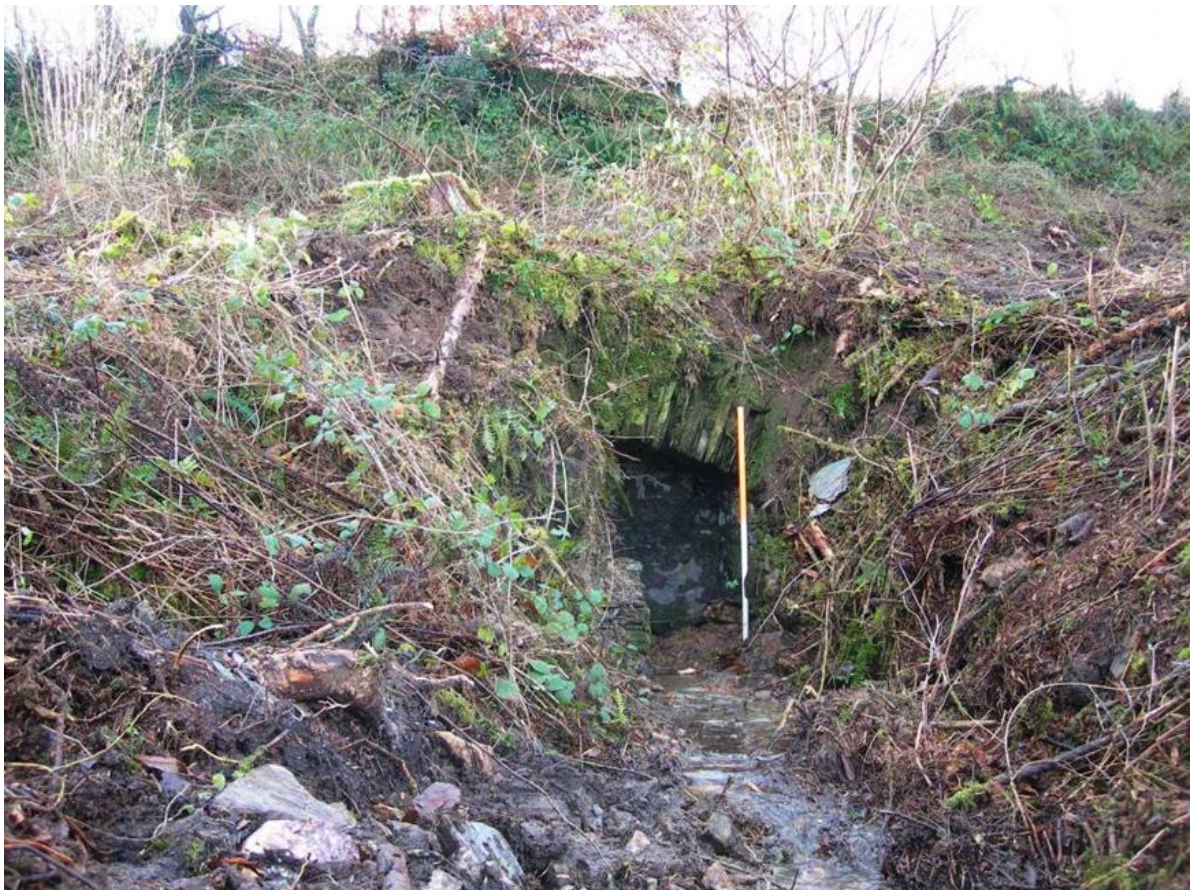
Fig 5 Well from the north-east, with field lynchet and boundary bank beyond (1m scale)

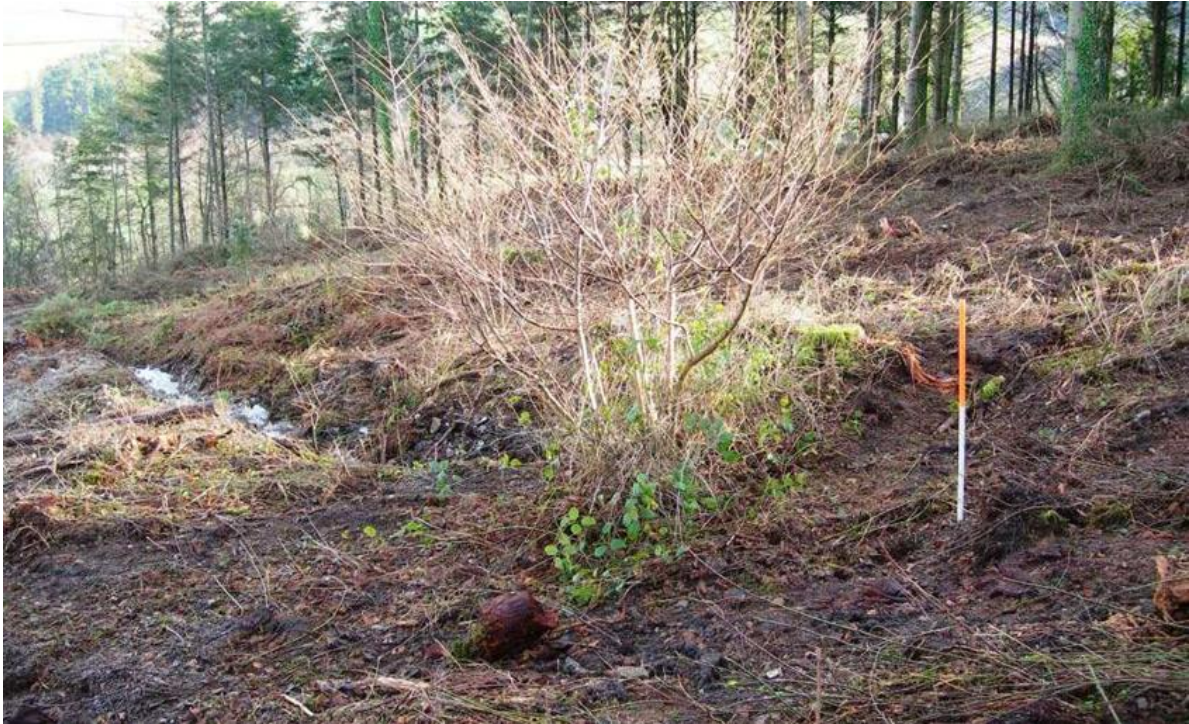
Fig 6 View over the well house from its rear (marked by the 1m scale) above the Fowey Valley. The castle spur, at a lower level, lies further down the valley (to the right)

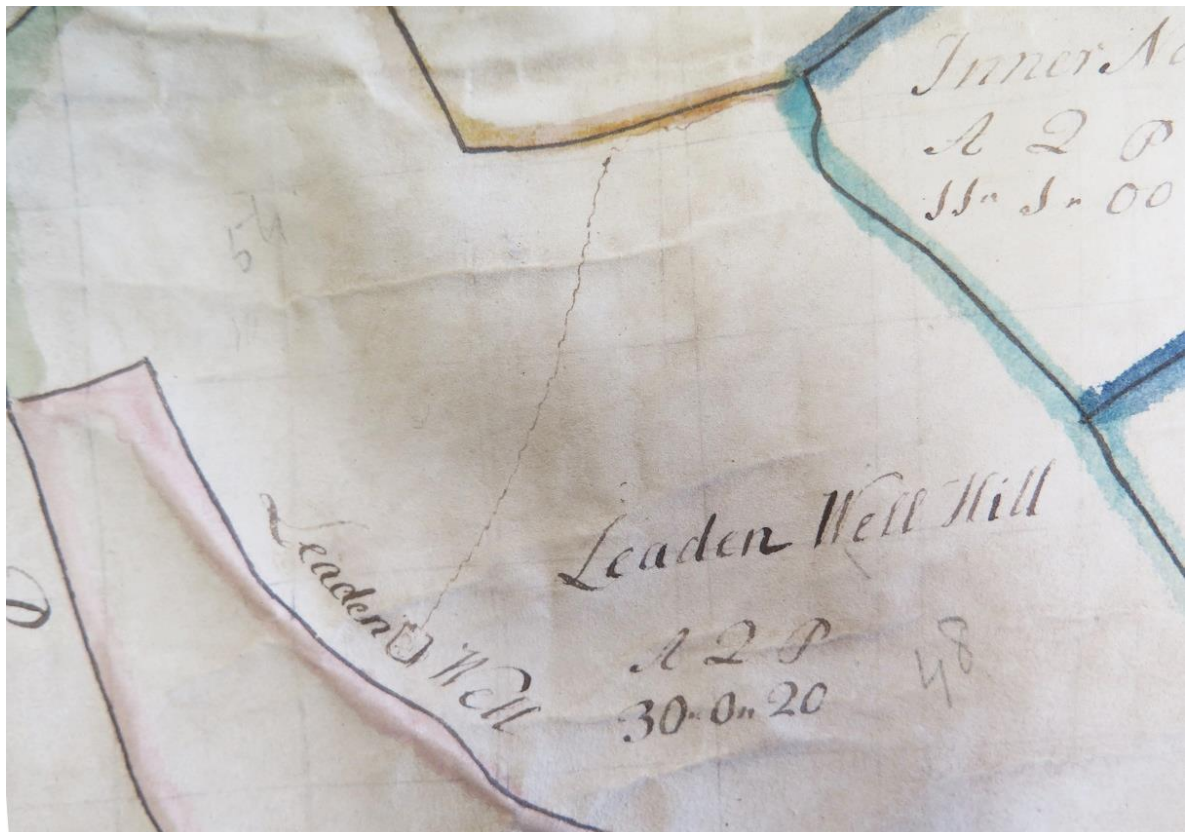
In the mid-18th century, as recorded in an estate map of 1755, the area in which the well lies was a field named Leaden Well Hill: this was part of the post-medieval field system of the consolidated 'barton' type, laid out at Restormel when the vast deer park surrounding the castle was no longer required. The 1755 map records the well by name, and depicts the well house, showing its rectangular plan with a stream issuing from its front, north-east side (Fig 7).

Fig 7 Detail of the Leaden Well as it appears on a map made in 1755, before the planting of the area, showing the well house with the stream issuing from it (Reproduced courtesy of Cornwall Record Office; reference CRO ME/2393)

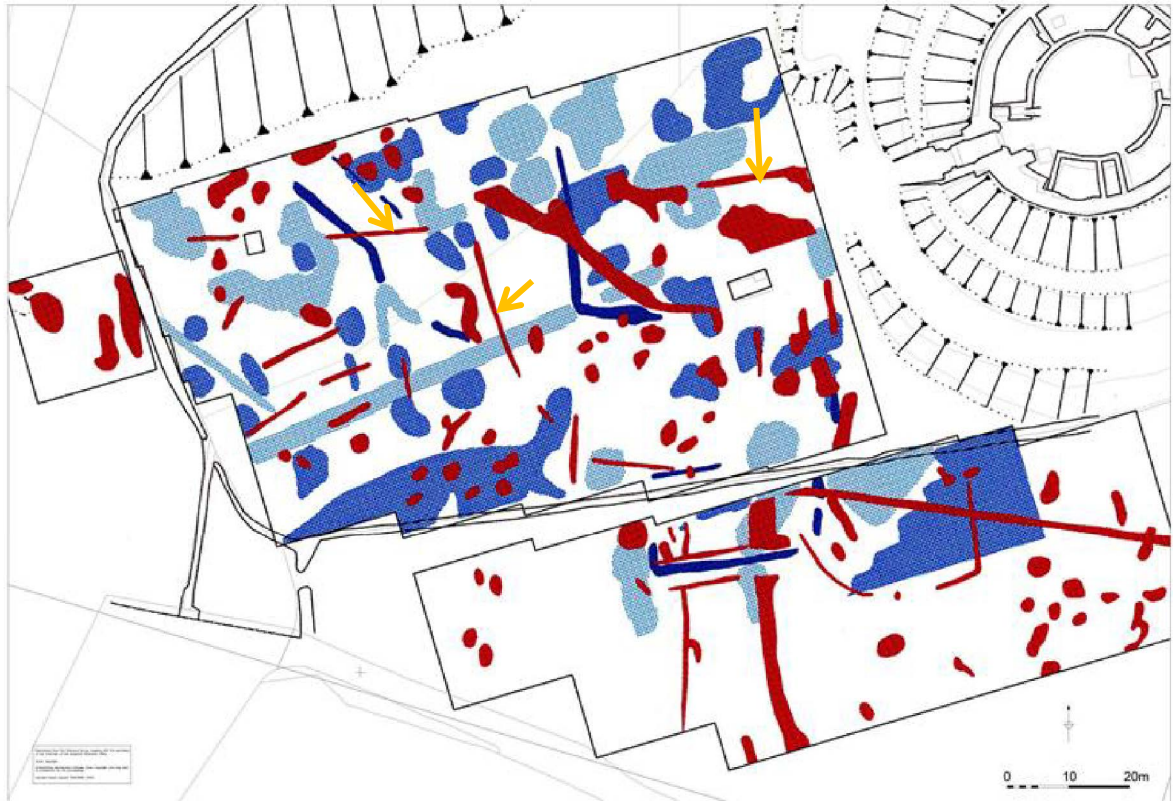
The identification of the well as the water source implied by the reference of 1337 is consistent with the observation in an early account of the castle that 'Water was conveyed thither, by a conduit, from the higher ground adjoining' (Carew 1602, 138R). Buried linear anomalies in the castle bailey recorded during a magnetometer survey (GSB 1994) may potentially mark the course of the water pipe or 'conduit' and a branch leading off from it (Taylor, Johns *et al*, forthcoming; and see Fig 8 below).

Fig 8 Geophysical survey of the bailey of Restormel Castle, showing the likely lines of potential lead water pipes (indicated with orange arrows) (after Geophysical Services of Bradford 1994: from Taylor, Johns, et al forthcoming, Fig 5)

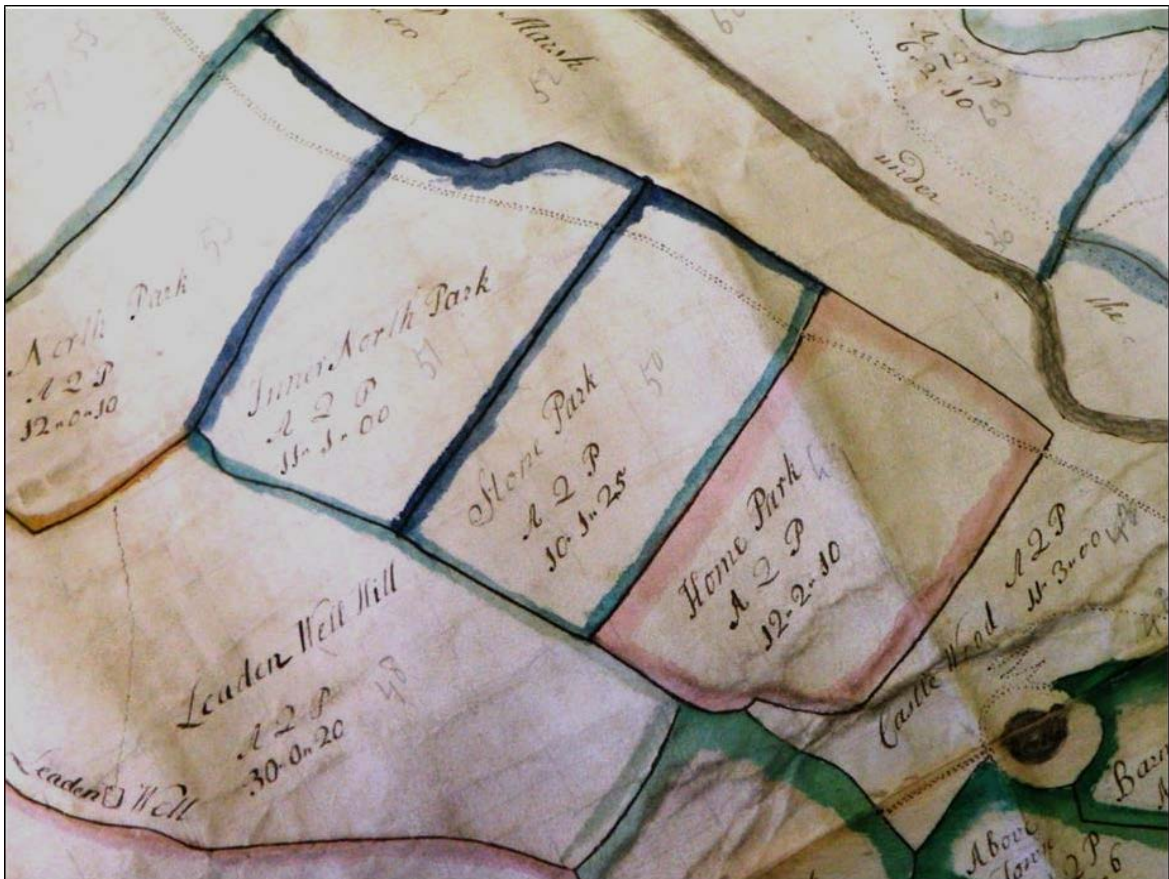
Fig 9 Well and landscape in 1755 (courtesy Cornwall Record Office; ref CRO ME/2393)

The dried-up course of the old stream continues from below the slanting forestry track, to end at a linear platform running across its line at the base of the steepest slopes, beyond which it was probably levelled during tree planting (the associated drainage works having taken the water underground). The 1755 map shows the well water flowing on from here to White Marsh in the valley bottom (Fig 9; the wavy line marking the stream runs by the north-west side of the field named Inner North Park).

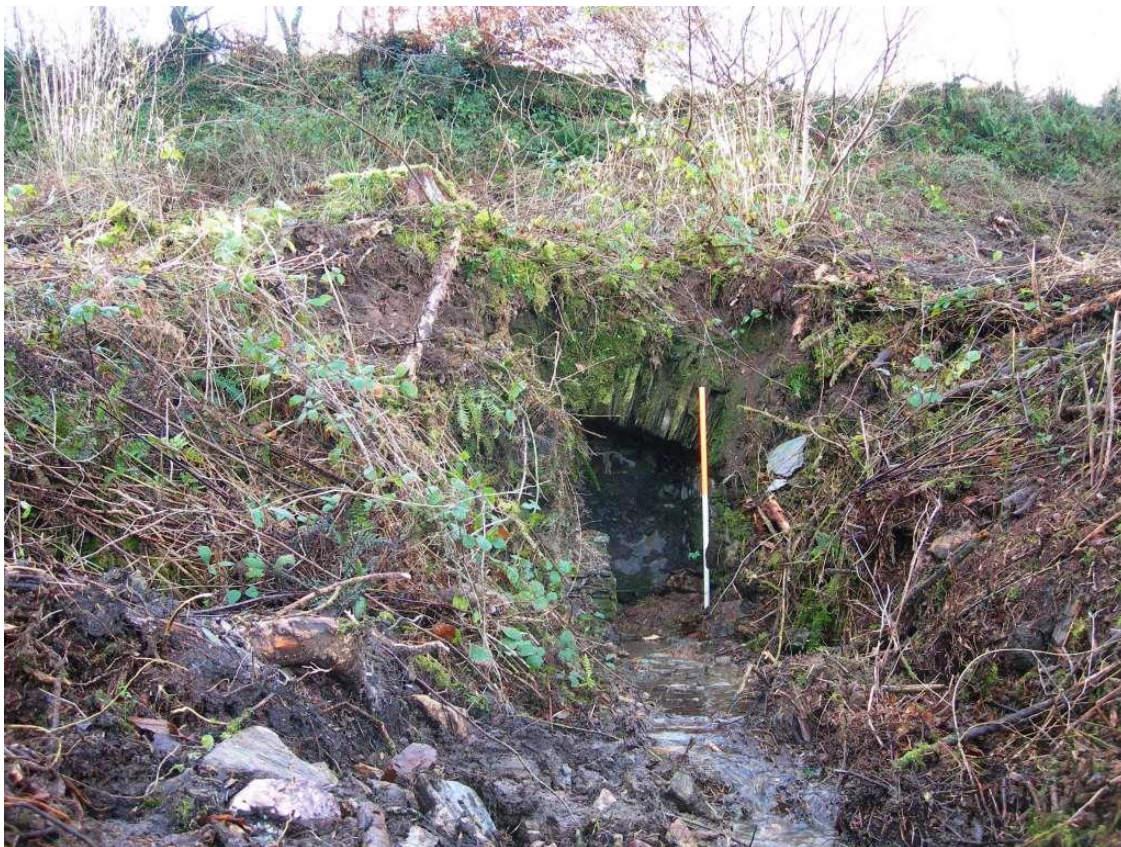
The Leaden Well of Restormel Manor supplied water to Restormel Castle in the later medieval period, as indicated by place-name and documentary evidence (Section 6). It lies in an area wooded since the later 19th century when Restormel was leased by the Robartes of the neighbouring estate of Lanhydrock, appearing as mixed woodland on the OS map of 1881 (Fig 14). The plantation has been regenerated in several phases of forestry work, the most recent of which led to the rediscovery of the well. The site is quite close to, but separate from, the field boundary to the south west on the shoulder of the slope; its rear side is around 13.8m from the stone-faced earth boundary bank, and 8m from the base of the associated massive lynchet - an earthwork running along the slope, resulting from plough sculpting on the boundary in the deep past, potentially both before and after the area served as part of the castle's deer park (Fig 12).

Fig 12 Well from the north- east, with field lynchet and boundary bank beyond (1m scale)

The surface of the ground covering the well house is c0.5m above the top of the vaulted roof (Figs 12, 18). This ground is higher than that of the surroundings particularly to the west, though it does not form a well-defined mound. It has been shaped by tree growth and felling, having a hazel growing on its south west side, a substantial tree stump on the east, and tracking and scraping by forestry machinery movements.

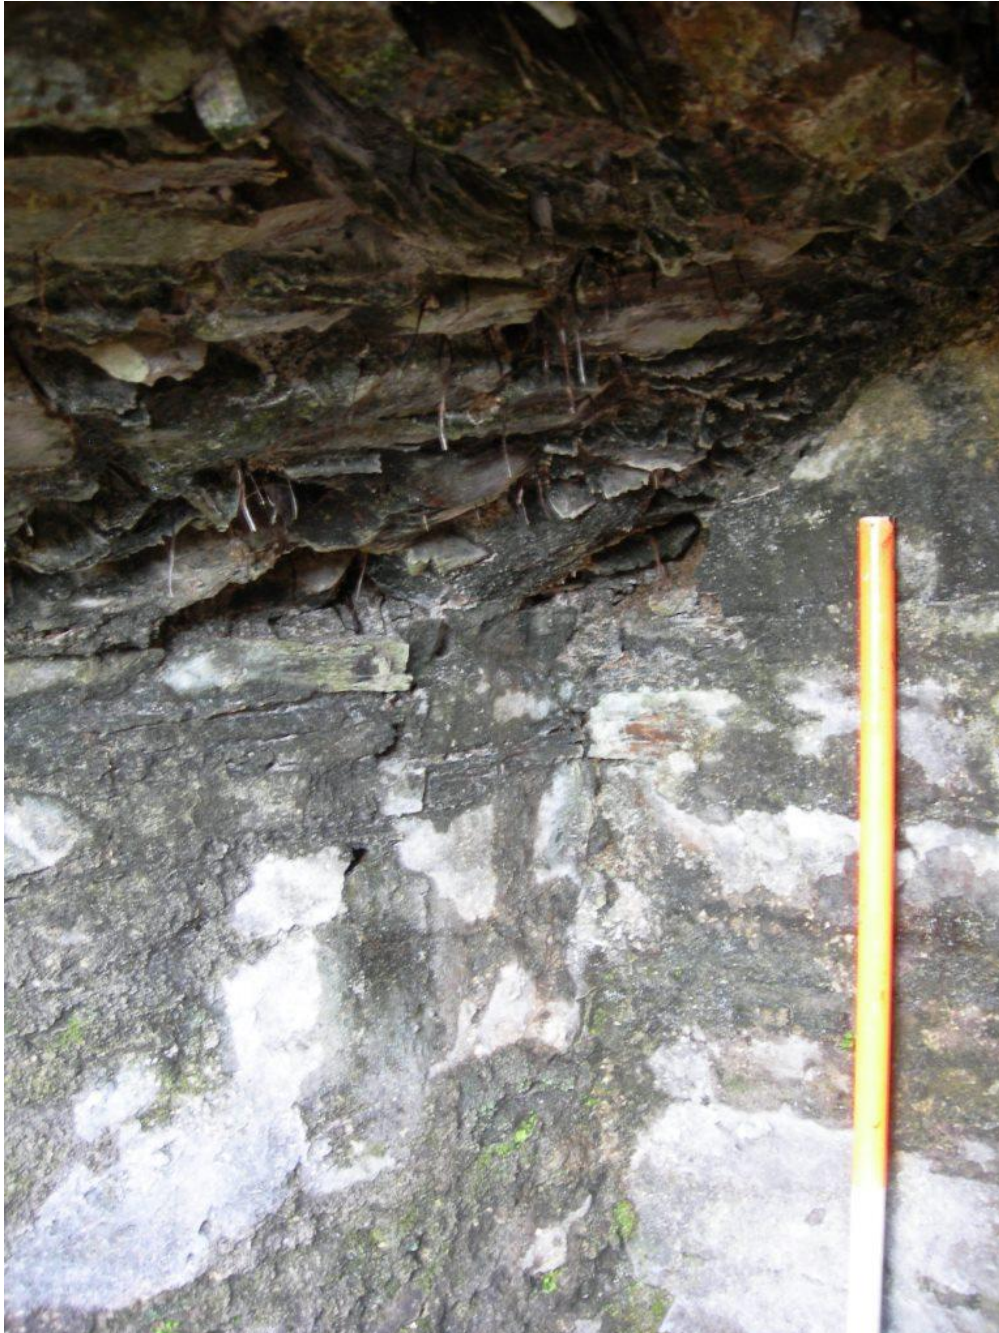
Walls have facing of laid local slatey stones mostly of similar size, c0.2m long by 0.1m high, with some thinner triggering stones, and lime mortar, in neat rough courses; the exposure of the top of the front wall reveals that its core fabric is clayey sub-soil. The roof is vaulted with slate in lime mortar, using irregular slabs selected for size or perhaps roughly trimmed, rather than cut or dressed voussoirs. These slabs are 0.3m to 0.4m high, 2cm-4cm wide, and some 0.3m long north-east to south-west so that, from front to back, the chamber is covered by a series of 5 or more interlinked arches each 0.3m thick (Figs 13, 17).

Fig 13 South corner of the well house, with its rear wall rising to the right with the arch of the vaulted roof of rough slate slabs (scale divisions are 0.5m)

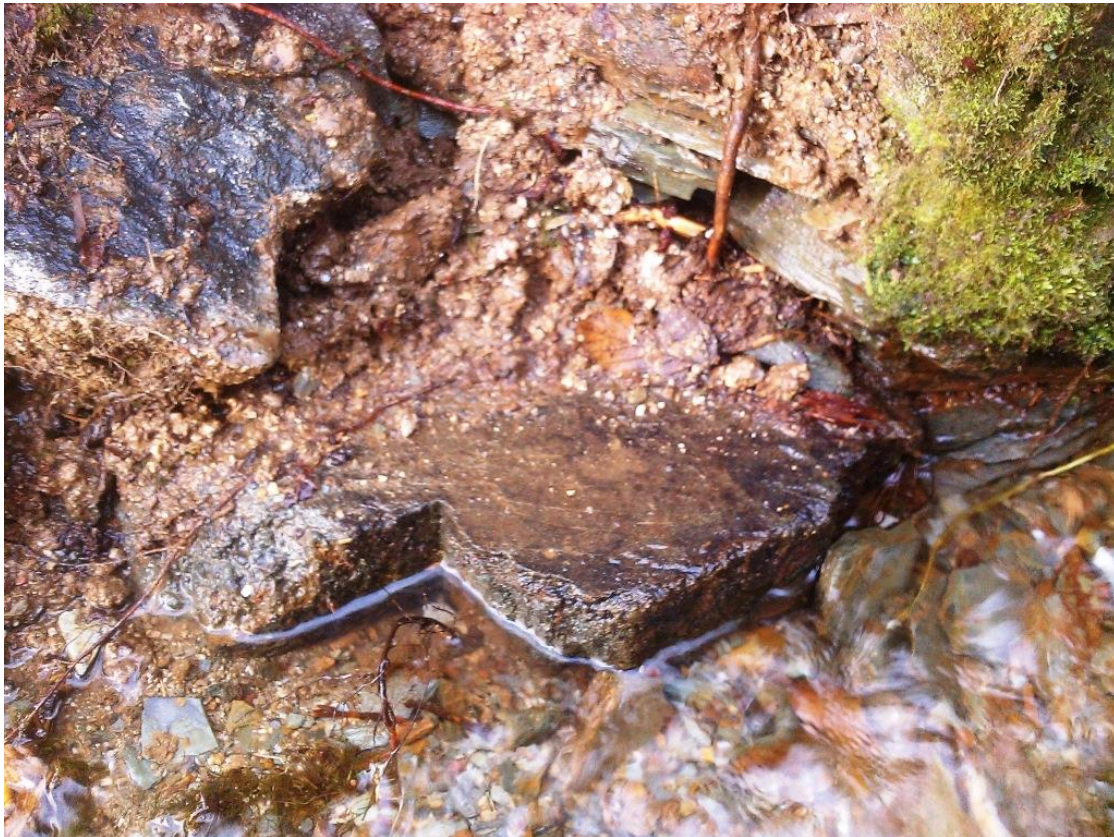
Returning to the better-defined side of the front opening, this has indications of an architectural finish for the lost door (Fig 14). A darker stone with a cut surface showing chisel marks appears to be a worked freestone laid in the frame of the doorway in such a way that it forms part of a rebate 8cm wide to take the edge of a door closing against it from the outside, 0.55m out from the chamber (so roughly in the middle of the apparent original thickness of the wall).

Fig 14 Detail of the lower part of the south east side of the doorway, looking south

The top of the worked stone with evidence of the rebate protrudes from the present stony and silty ground surface in the opening to the well which may be choking the lower part of a deeper doorway, along with any steps leading down inside it. A displaced piece of granite from the structure, 0.4m long and 0.2m wide and protruding 0.1m from the mud, lies on the opposite, north-west side of the stream opening. This is not evidently a worked stone from the door arch or other architectural feature, but it is not possible to determine its character from the portion visible which may be its back.

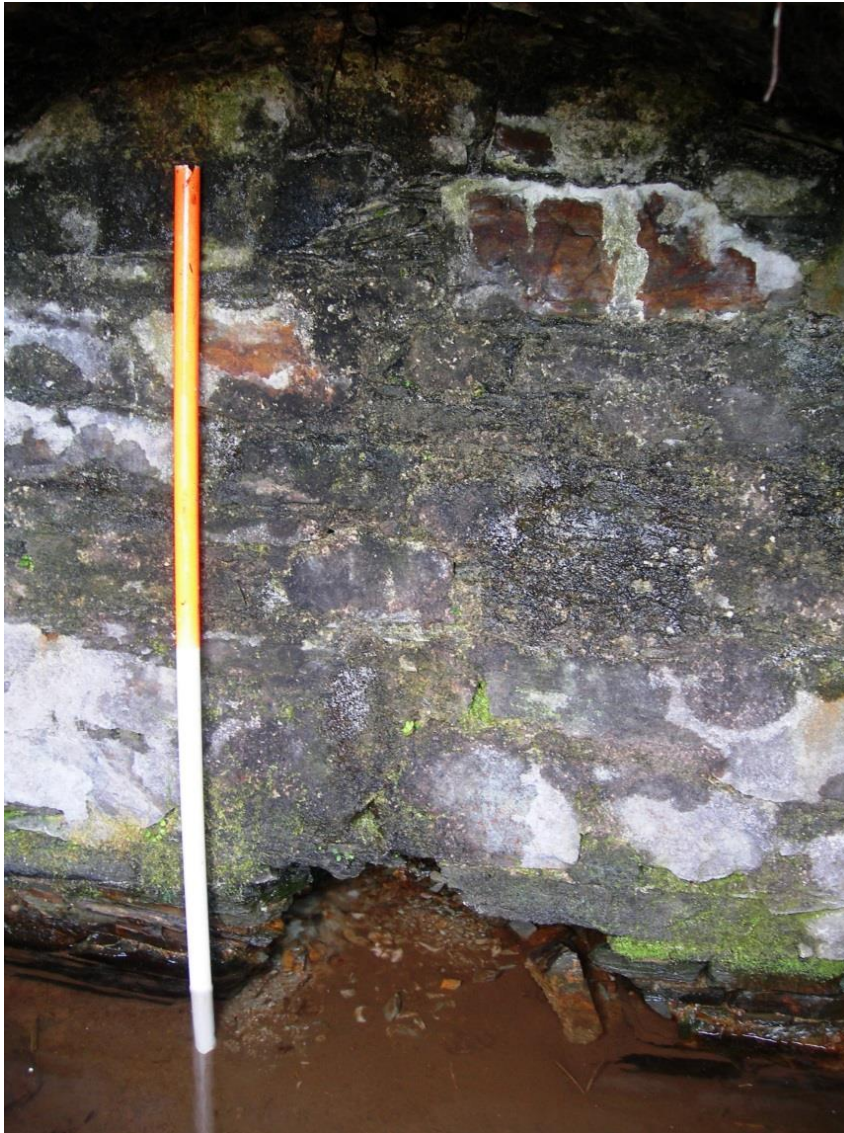
Within the well chamber, the silt and tumble from the front wall, filling the interior below the water level, obscure the base of the walls and any features there such as steps descending from the door. The walls other than the front one are generally near intact. However, some facing slabs in the tops of the walls have slipped forward (Fig 13), and at the rear of the chamber, to the right (north-west) of centre, a dozen or more have fallen away around the present water level leaving an irregular hole (Fig 15). This may be the result of damage from water flow/tree growth above the well (no roots are visible in the hole). The area which has lost its facing is 0.57m wide and rises

to 0.29m high above the gravelly fill, and extends at least 0.5m back into the wall fabric.

Fig 15 Rear wall inside the well house, with damage to stonework in its centre (1m scale)

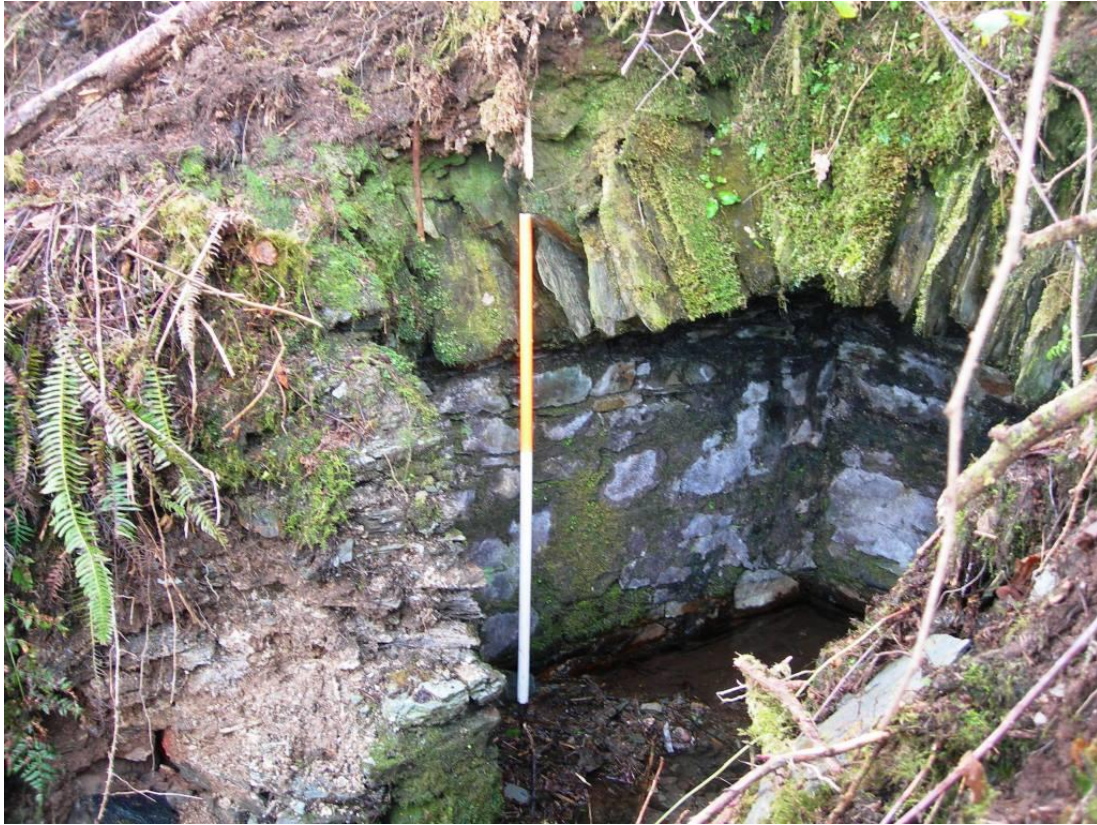
As already mentioned, the front of the well house has partly fallen, and the roof is in an unstable condition, at risk of collapse (Fig 16). The damage is worst in the front right (north) corner of the house, so that, of the 5 or so slate slab arches one behind the other forming the vault spanning the chamber, only the innermost (south-western) 3 are intact on the right hand side (north-west), while 4 remain left of the doorway, and all survive only above the 0.2m furthest to the left (south-east).

At either side of the front of the well house, where the vaulting has fallen, one can see how its slabs continue into the ground above the side walls of the chamber (Figs 16, 17).

Fig 16 Well house from the north, showing decay of front wall and loss of roof above

- **Repair and reconstruction of the well house** should be considered to address the demonstrable high risk of further collapse, which could result in loss of the roof. This would require archaeological work to inform restoration, ensure the protection of the site and appropriate treatment and recording of any new discoveries (see comment on this in Section 9.2, below).

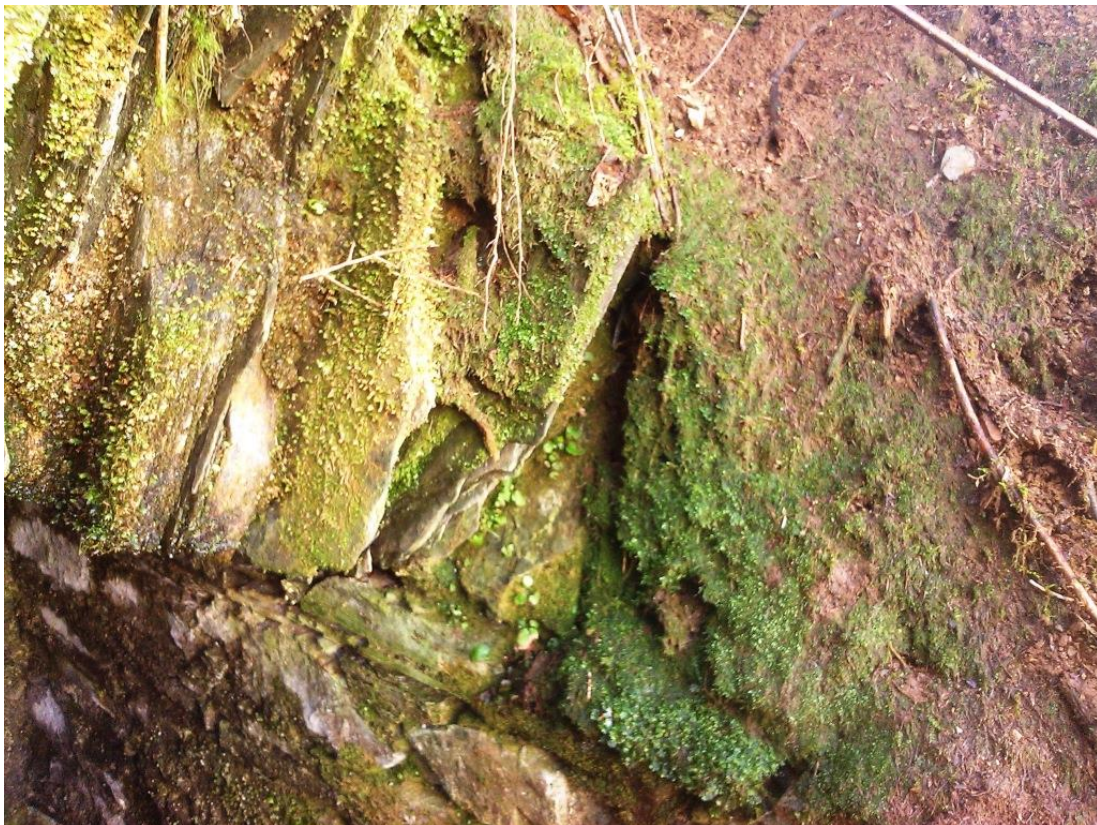
Fig 17 Outer part of the surviving roofing on the north-west side of the well house, with remains of the collapsed vaulting in front (the mossier slabs, right of photo)

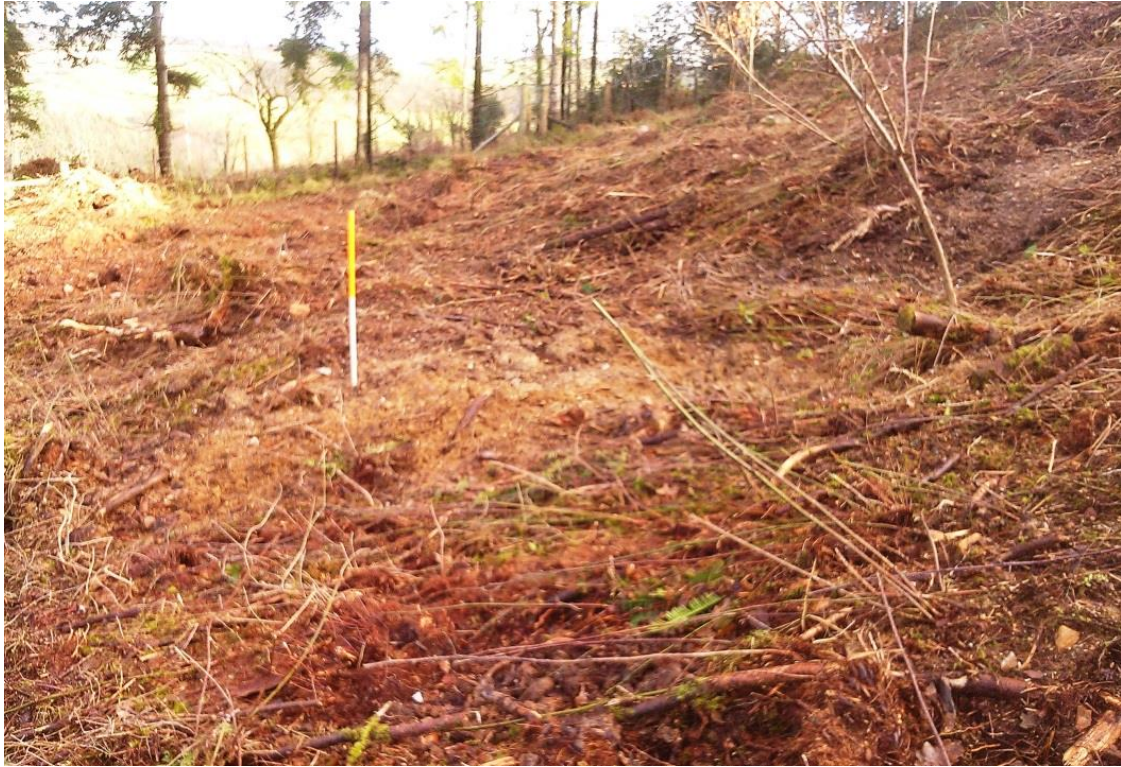
As mentioned above, at the lower end of the surviving dried-up stream course, where the very steep slope in front of the well becomes more moderate, is a platform running on a line close to the contour, 2m or more in width and levelled c0.7m into the slope. This earthwork curves around the slope to the east, from just west of the stream course (Fig 18). It runs across a mine on an iron lode, on a passage left between two deep openworks (the lower of the two gaps visible in Fig 2). Its general course might suggest it represents the line of the conduit. However, it is probably part of the mine's transport system of branching cart track and tramway, recorded east of the openwork, on the 1839 map (Fig 10). It is likely to be a route left through the mine to allow for access to the outer, west side of the deep openworks. Further, historical evidence for the course of the lead pipe which gave the well its name is included in Section 6, above.

Fig 18 Dry stream course from the well (by the sapling, right) overlain by a linear platform running east across the line of the openworks by the trees beyond

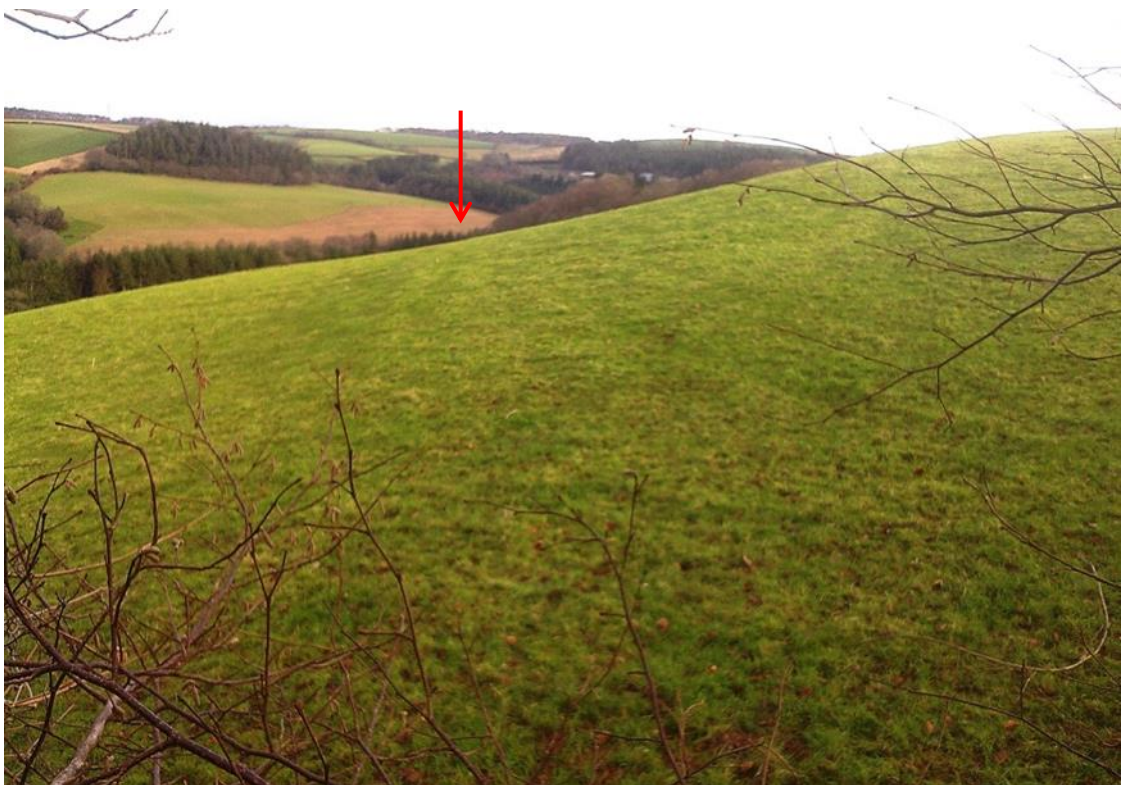
Fig 19 A slight earthwork on the castle side of Leadenhill Wood (centre) marks a more easterly part of the linear feature overlying the stream course, probably a mine track
