Castle Minor, Tintagel, Cornwall

Historic building record

Report No: 2017R045

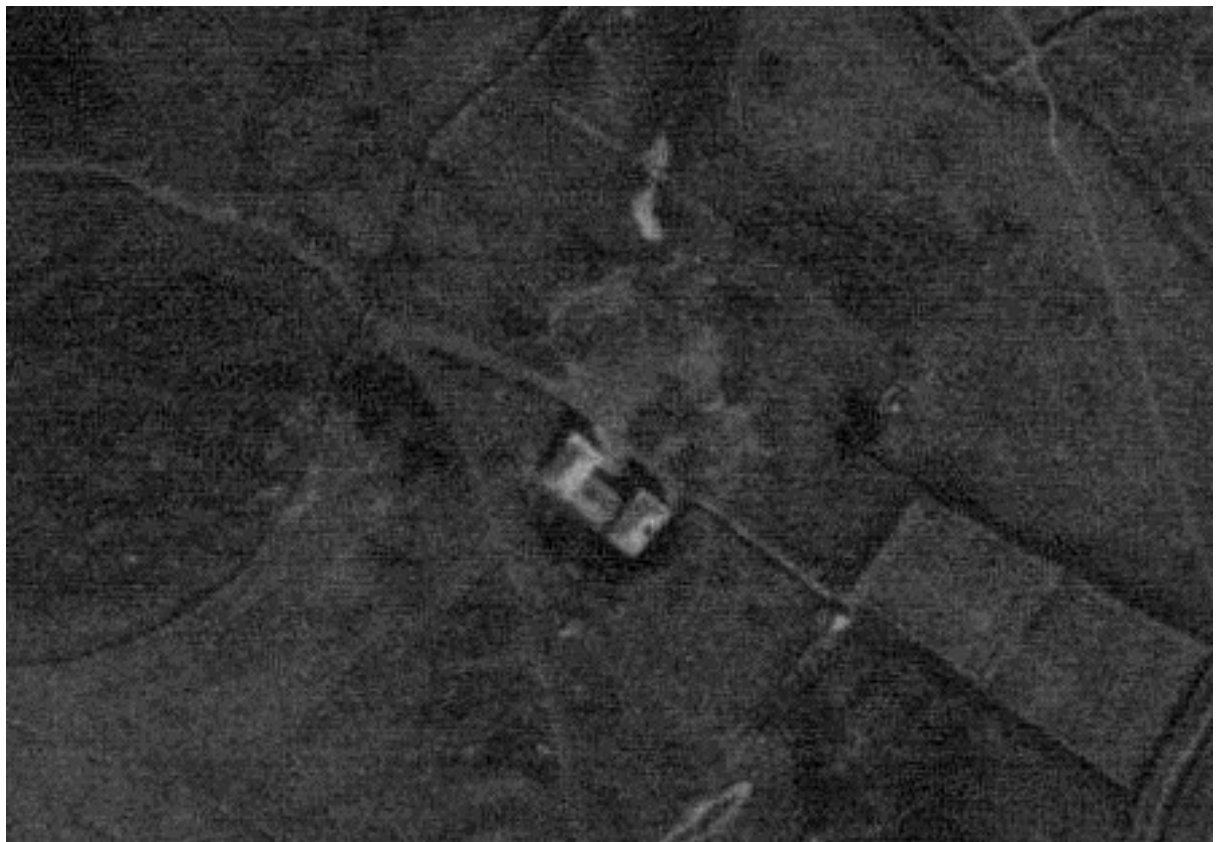
Fig 4 1946 aerial photograph (reproduced with permission by Cornwall Council).

The house is shown on the 1946 RAF aerial photograph (Fig 4). The aerial photograph shows a similar footprint to that shown in 1907 but with a single chimney on the western side of the building, suggesting that the domestic quarters at this date were still restricted to the south-east half of the building. At this time it may have still provided electricity to the Castle Hotel, however, both the 1907s OS map and 1946 aerial photograph do not record any transmission lines leading from the house to the hotel.

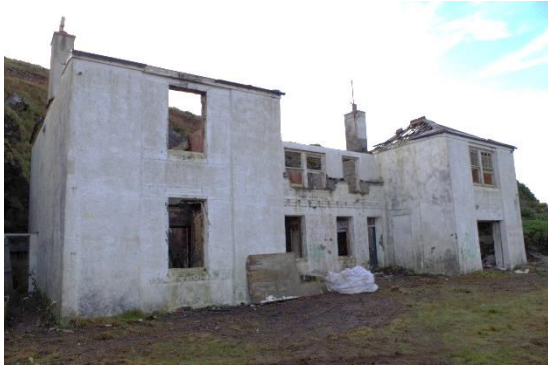
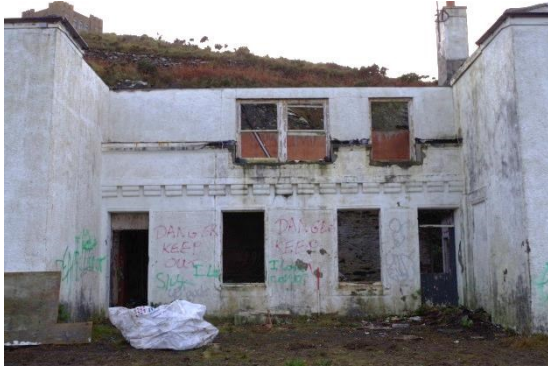
(Figs 5-6)

The north elevation of the central range clearly demonstrated a major phase of alteration to the building when the first floor was added.

The openings on the ground floor were original with ovolo-moulded render around the jambs and lintels and sloping sills to the window openings. Above the ground floor openings was an original dentil moulded stringcourse, above which was the remains of a crenellated wall-top, constructed as part of the original design but altered by the insertion of the later walling and window openings to create a first floor when this part of the building was converted for domestic use. This later, inserted wall at first floor level was set back to the rear edge of the crenellations. Within it a wide window opening was located centrally and another window opening positioned to the west of it between the window and door openings below. The first floor windows themselves appear to have been imitations of the wooden horned sash windows in the original parts of the building. These had irregular sashes with a 6-pane upper sash and a 9-pane lower one.

The north elevation of the east wing, had two rectangular window openings positioned centrally above one another to the ground and first floor. Each opening had similar mouldings to those in the central range at ground floor level, with extended incised design to the sills and lintels, giving extra adornment to the original caretaker's domestic wing.

The north elevation of the west wing, had two, wide, centrally-placed openings, both approximately 2.4m wide, one at ground floor level and the other at first floor level. The ground floor opening was a double door opening and the first floor opening of the same width was filled by a pair of wooden sash windows, the upper sashes surviving with six-panes each. These windows are likely to be a later insertion, perhaps dating to the conversion of the engine room to become part of the house. The frontage of the west wing is less ornamented than the east wing; however, the window opening had a lintel with a central incised moulding. This opening may have been taller to allow machinery to be easily brought into the building.

Fig 5 North elevation (frontage).

Fig 6 North elevation (frontage centre).

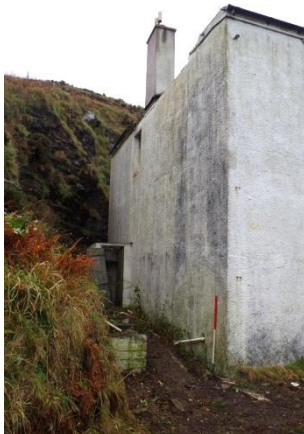
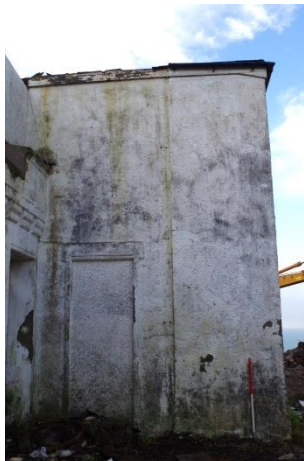
(Figs 7-8)

The east elevation of the east wing had a later WC lean-to added to the southern half. The later chimney was centrally placed and to the south of it was a narrow rectangular original window opening.

The east elevation of the west wing had a single blocked original door opening at ground floor level to the south.

Fig 7 East elevation (east wing).

Fig 8 East elevation (west wing).

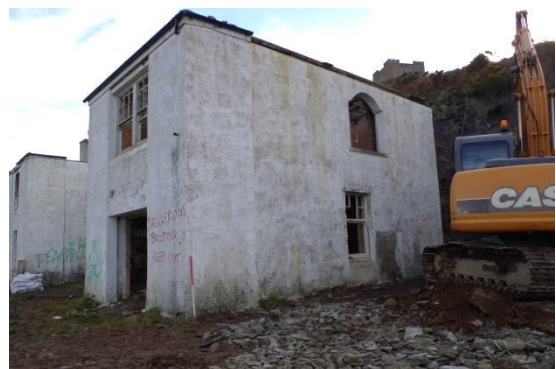
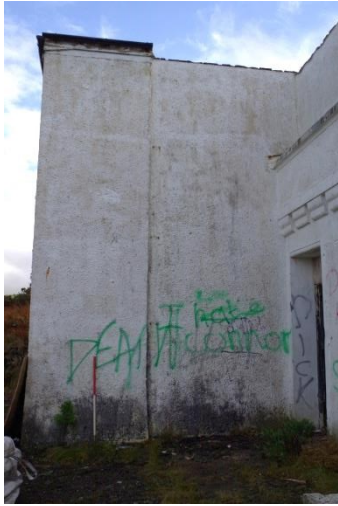
(Figs 12-13)

The west elevation of the west wing had two openings; a centrally placed window opening at ground floor level and a wide, blocked opening in the southern half of the elevation at first floor level. This wide, blocked opening had a modern window inserted in its northern half but is originally likely to have been used for electricity transmission from the generator to external pylons. The ground floor window opening is original and has similar detailing and ornamentation to the windows found on the north elevation of the central range and east wing. The inserted first floor opening was roughly square with a moulded concrete lintel and concrete sill.

Fig 12 West elevation (west wing).

Fig 13 West elevation (east wing).

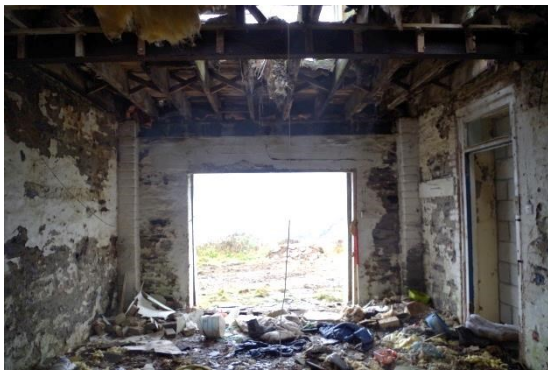
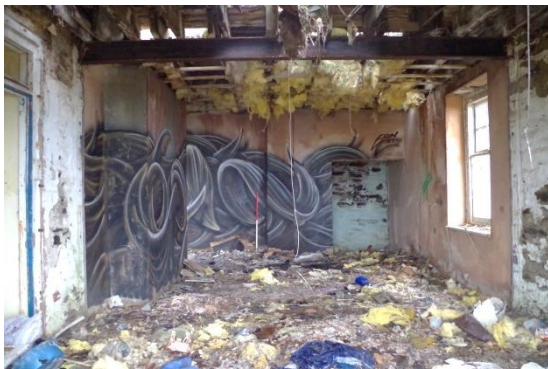
(Figs 14-15)

This is likely to be the original engine room. An original double door opening in the north wall indicates access for machinery. There was an original window opening in the west wall and in the east wall an original single door opening survived with internal woodwork, including a glass light panel above the timber door frame. This doorway had been blocked on its external side by a single concrete block-built wall. The partition between rooms 1 and 2 was a later, inserted concrete block-built wall and chimney breast and a later, modern staircase leading to the first floor was located against the south wall probably in the location of an earlier staircase.

The walls of the northern half of the room were cement wash over slate rubble walls, whereas the southern half of the room had a gypsum plaster finish. This suggests that the northern end of the wing had been converted to a garage at a later date and the southern part perhaps into a utility room; the division for a partition wall marked by a steel beam at ceiling height. Other later alterations included the insertion of a concrete block-built chimney which divided the original L-shaped into two. To the right of chimney a doorway led into room 2. The floor surface in this room was concrete (probably a more recent insertion).

Fig 14 Room 1 looking N.

Fig 15 Room 1 looking S.

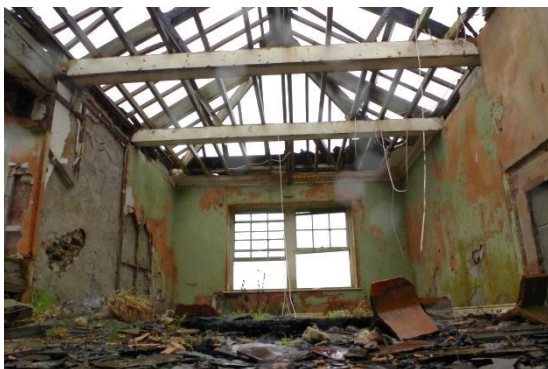
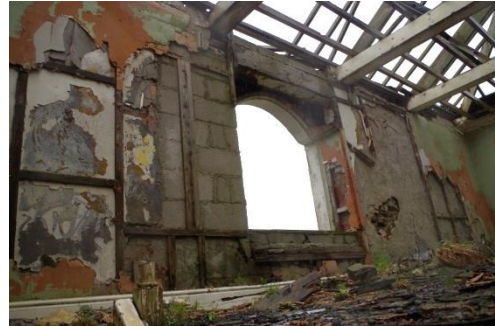
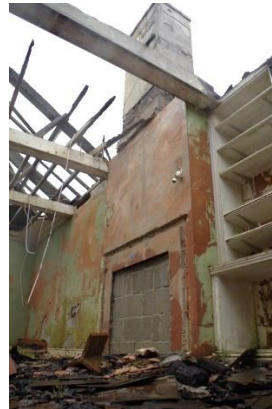
(Figs 16-18)

At first floor the west wing formed a single large rectangular bedroom with timber floorboards. Located off-centre on the east wall was an inserted, later fireplace, blocked at a later phase with concrete blockwork. To the right (south) of the chimney were later, inserted wooden shelves.

The damage from the fire had revealed original, large square section ceiling joists and simple lap-jointed and nailed roof trusses.

Internally, the structure of the west window revealed that the original window opening was much larger (approximately 2.4m wide) but had been partially infilled on its southern side with concrete blockwork to form a narrower opening approximately 1.65m wide. The original jambs were brick-built. The opening was topped by a square-section concrete lintel.

Fig 16 Room 1a looking N.

Fig 17 Room 1a blocked opening in W wall.

Fig 18 Room 1a inserted chimney breast in E wall.

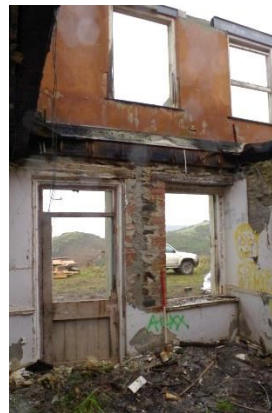
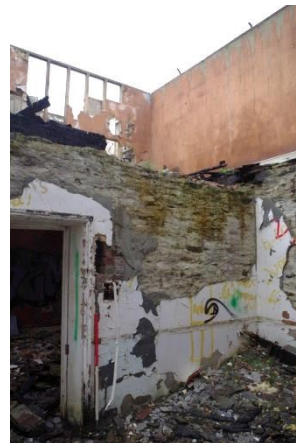
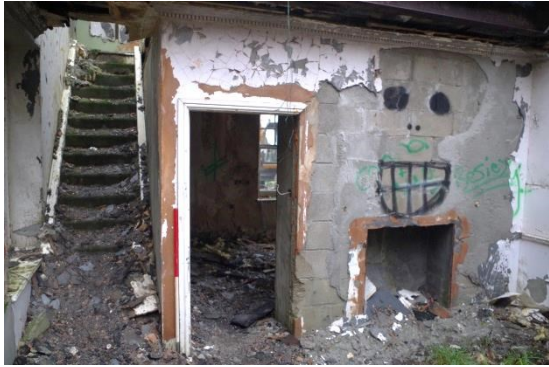
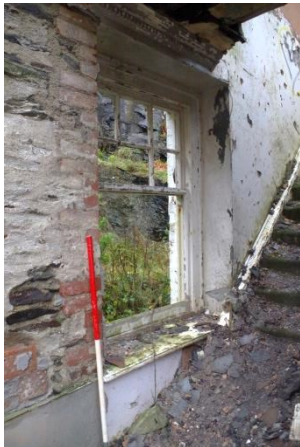
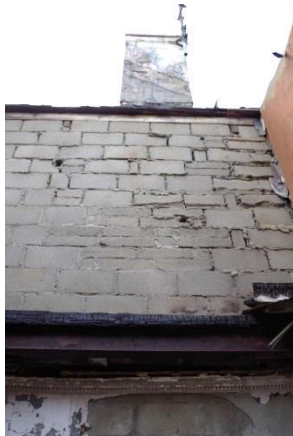
(Figs 19-23)

Room 2 was probably originally part of room 1. It too had a concrete floor surface. The west wall comprised an inserted concrete block-built fireplace with steel work above to support the inserted wall above. In the north wall the original door opening led outside and in the east wall an original door opening led into the east wing. The staircase up to room 1a was accessed from the south-west corner of the room.

Fig 19 Room 2 looking N.

Fig 20 Room 2 looking SE.

Fig 21 Room 2 looking W.

Fig 22 Room 2 window in S wall.

Fig 23 Room 2 concrete block W wall and chimney.

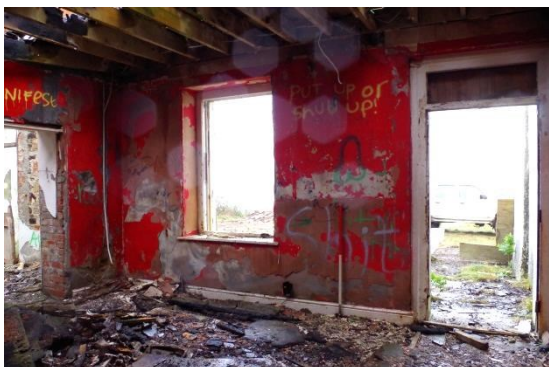
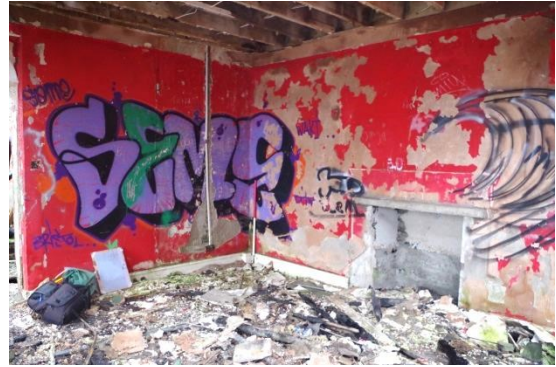
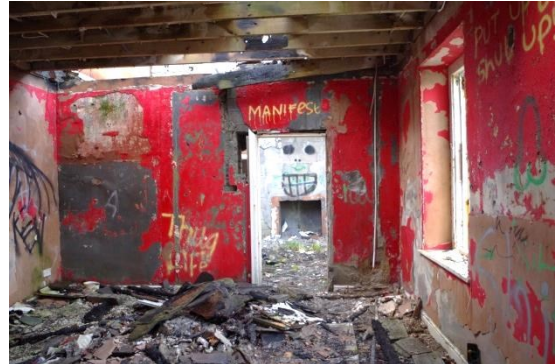
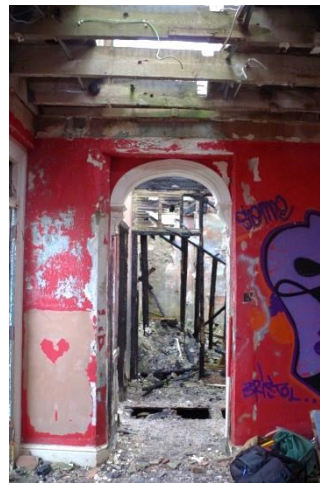
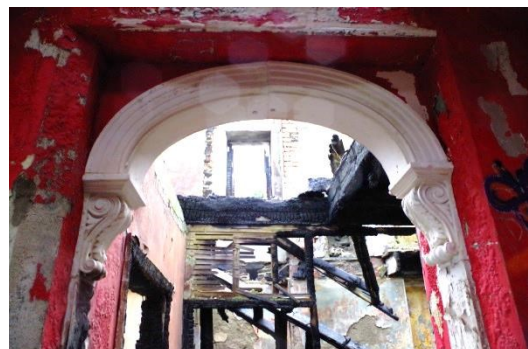
(Figs 24-28)

Room 3 was likely to have been a caretaker's office/workshop and tool store. The room retained its original window and door openings. In the south/rear wall was a later, inserted, fireplace with a concrete lintel, inserted into a blocked window opening. In the east wall leading into the east wing was the original arched doorway leading to the caretaker's lodgings which occupied the entire east wing. The door frame had an original ornate, corbelled moulding.

Fig 24 Room 3 looking N.

Fig 25 Room 3 looking SE.

Fig 26 Room 3 looking W.

Fig 27 Room 3 looking E, door to east wing.

Fig 28 Room 3 detail of corbelled arched entrance to east wing (caretaker's cottage).

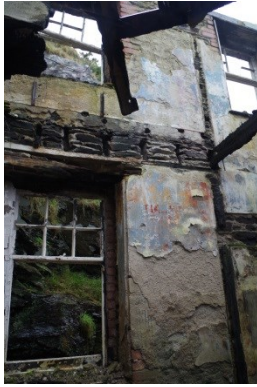
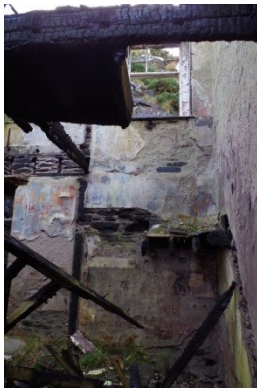
(Figs 29-31)

This was the original kitchen for the caretaker's accommodation but was presumably converted to a parlour with the change in room 5 (the original parlour) to the later kitchen. Positioned midway on its eastern wall was an original chimney stack and fireplace, blocked prior to 1946. In the rear wall was an original window opening.

The stairwell was divided from room 4 by a stud, lathe and plaster wall. Although mostly destroyed by the fire, the shadow of the timber staircase and half landing were visible in the line of plaster preserved on the walls.

Fig 29 Room 4 looking S.

Fig 30 Room 4 looking S to location of former staircase.

Fig 31 Room 4 looking E to fireplaces on ground and first floor.

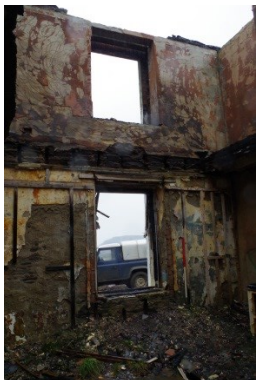
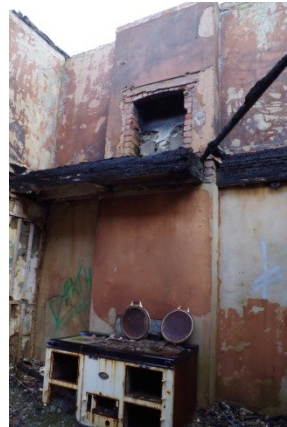
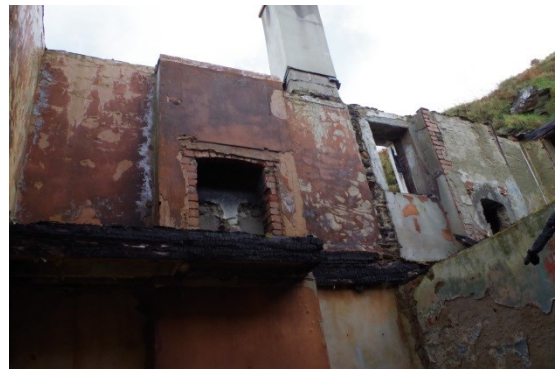
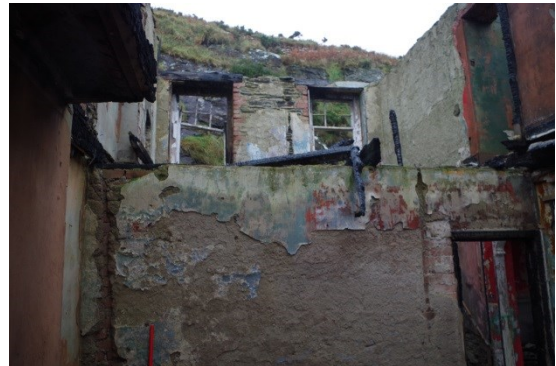
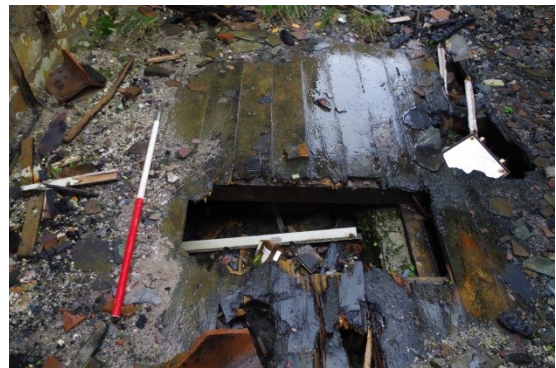
(Figs 32-35)

Located at the front of the west wing this large square shaped room was originally the parlour for the caretaker's domestic accommodation but later converted into a kitchen. The room was lit by an original window opening to the front. On the east wall was the original brick-built chimney and fireplace, the latter blocked with a large inserted Rayburn.

The first floor of the east wing was divided into two halves by a timber stud wall to form two bedrooms as part of the original domestic accommodation for the caretaker. The larger of the bedrooms was to the front of the building and lit by a window opening in the front wall. Surviving in the eastern wall of both bedrooms were the two original chimney stacks with each rising vertically from the ground floor. Positioned centrally within each stack were two fireplaces, both formed by brick-built jambs and arches. Modern cement render around the fireplace in the smaller (southern) bedroom suggested it had been narrowed or altered at a later date, but presumably prior to

The small (southern) bedroom had a rectangular window opening to the right of the later chimney stack. This window was assumed to have been original, to add extra light the room. In the rear wall of the small bedroom was a window opening with a further original window opening lighting the stair well half-landing.

Fig 32 Room 5 looking N.

Fig 33 Room 5 looking E.

Fig 34 Room 5 and 4 first floor looking E.

Fig 35 Room 5 looking S.

Fig 36 Room 5 looking N.
