St Clare, Penzance, Cornwall – proposed Health Centre Heritage Impact Assessment

Report No: 2016R025

Heritage Impact Assessment

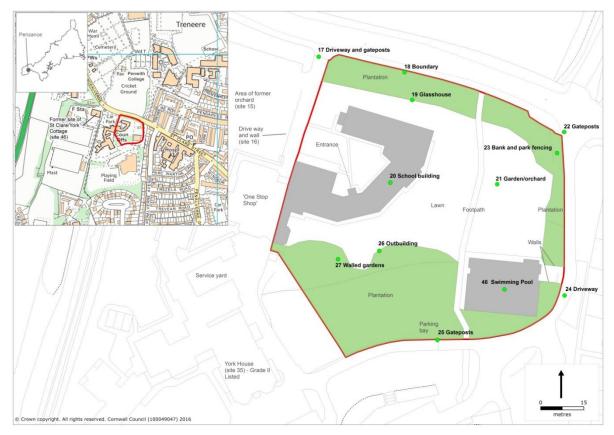
Fig 1 Site location. Shown with the boundary of the assessment area (in red) and the sites identified by Sturgess (2015).

The assessment area covers 0.8 ha of land and is located within Cornwall Council's 'St Clare's Offices' land holding which includes The Council's 'One Stop Shop' and local offices (Fig 1). The broader holding includes York House, a Grade II Listed Building (Designation ID 1210312). This was formerly the site of West Cornwall School for Girls but from 1974 to 2009, the offices of Penwith District Council.

The assessment area is currently used as part of Cornwall Council's St Clare's offices with a large part of it occupied by the Quadrangle Building (site **20**; Figs 1, 6, 7, 8 and 9).

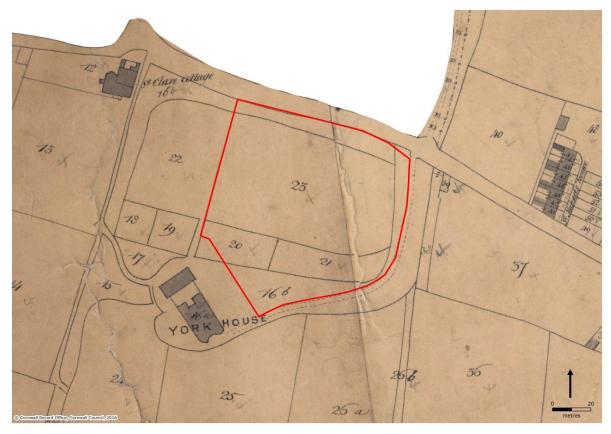
Fig 2 c1840 Tithe Survey (Cornwall Records Office TM/179). Assessment area approximate.

The *c*1840 Tithe map recorded York House (site 35) with its gardens (sites **18**, **21**, **23**, **27**) (Fig 2). The main entrance drive at this date led to the house from the north-east (site **24**).

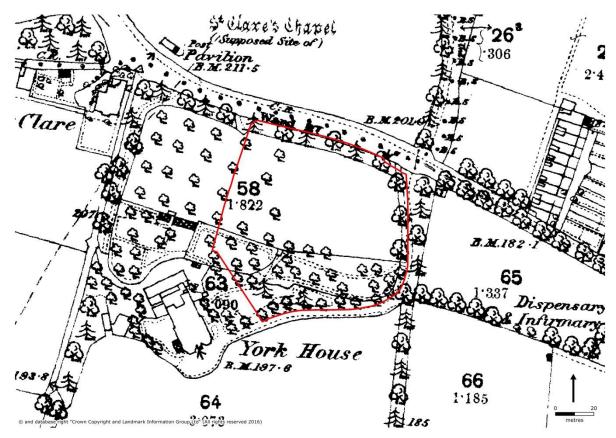
Fig 3 Second Edition Ordnance Survey 25 Inch Map, c1880.

The *c*1880 OS map of recorded the landscape of the assessment area in considerable detail (Fig 3). It shows the encircling shelterbelt bounded by boundaries **18** and **23** and a surviving part of the walled gardens (**27**). The western side of the assessment area formed part of a larger orchard (site 15; see Fig 1 for location) and the eastern side, a lawn or garden (site **21**). A small rectangular outbuilding is also recorded (site **26**).

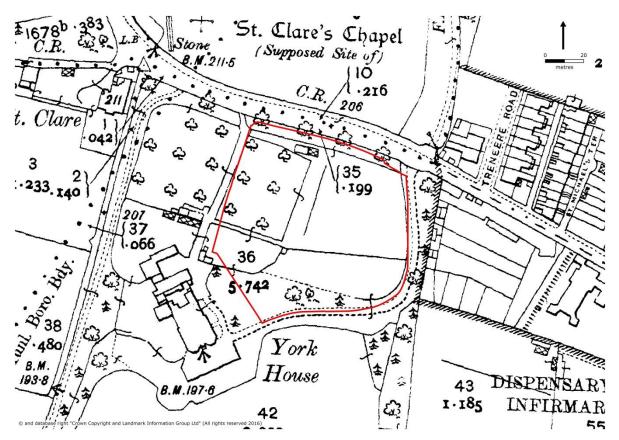
Fig 4 Second Edition Ordnance Survey 25 Inch Map, c1907.

The Second Edition OS map of *c*1907 records a number of changes to the assessment area (Fig 4). A range of buildings were added to the north side of York House creating a new open service yard (all part of site 35), and a new service drive (sites **16** and **17**) was cut through the walled gardens and orchard to the north of it. The gardens within the assessment area were again revised: the orchard created in *c*1880 was enclosed and a greenhouse and shed (site **19**) added to the north.

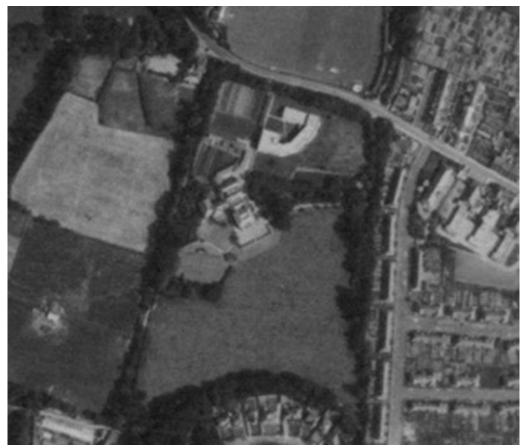
Fig 5 RAF vertical photograph, 1946 (held by Cornwall Council)

The 1946 RAF aerial photograph shows the newly completed Quadrangle Building (site **20**). The garden outbuildings (sites **19**, **26**) had been removed and the garden boundaries revised (sites **21**, **27**) (Fig 5).

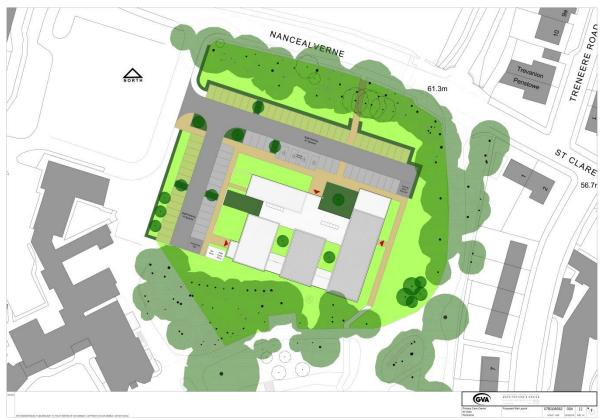
Fig 16 Proposed site layout - 07B308582 004 (dated to 02/09/2015).

The following assessment is based upon the proposed development presented in the proposed site layout and elevations (Figs 16-18 inclusive). The footprint of the development largely fits within the existing shelterbelts to preserve much of the presently found trees and ornamental landscaping.

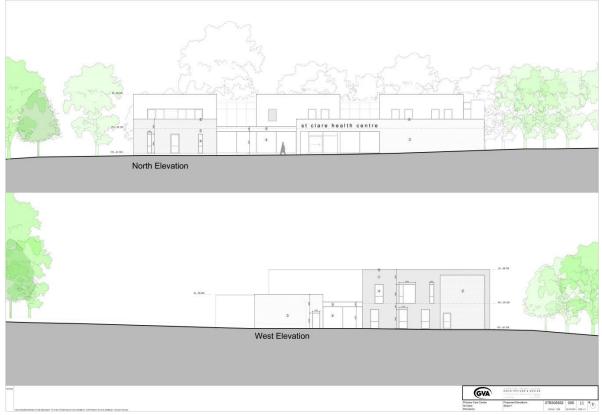
Fig 17 Proposed North and West Elevations - 07B308582 008 (dated to 02/03/2016).

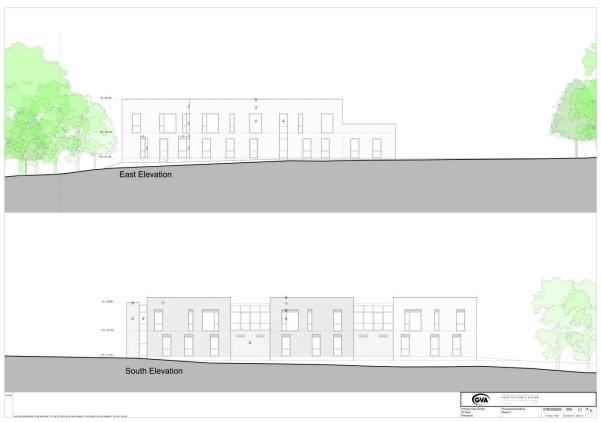
Fig 18 Proposed East and South Elevations - 07B308582 009 (dated to 02/03/2016).
