Chysauster, Gulval and Carn Euny, Sancreed, Penzance, Cornwall
Archaeological watching briefs during replacement of interpretation

Archaeological Watching brief during replacement of interpretation

Client	English Heritage
Report Number	2016R047
Date	25 August 2016
Status	Final
Report author	Adam Sharpe BA MCIfA
Checked by	Dr Andy Jones MCIfA
Approved by	Andrew Young MCIfA

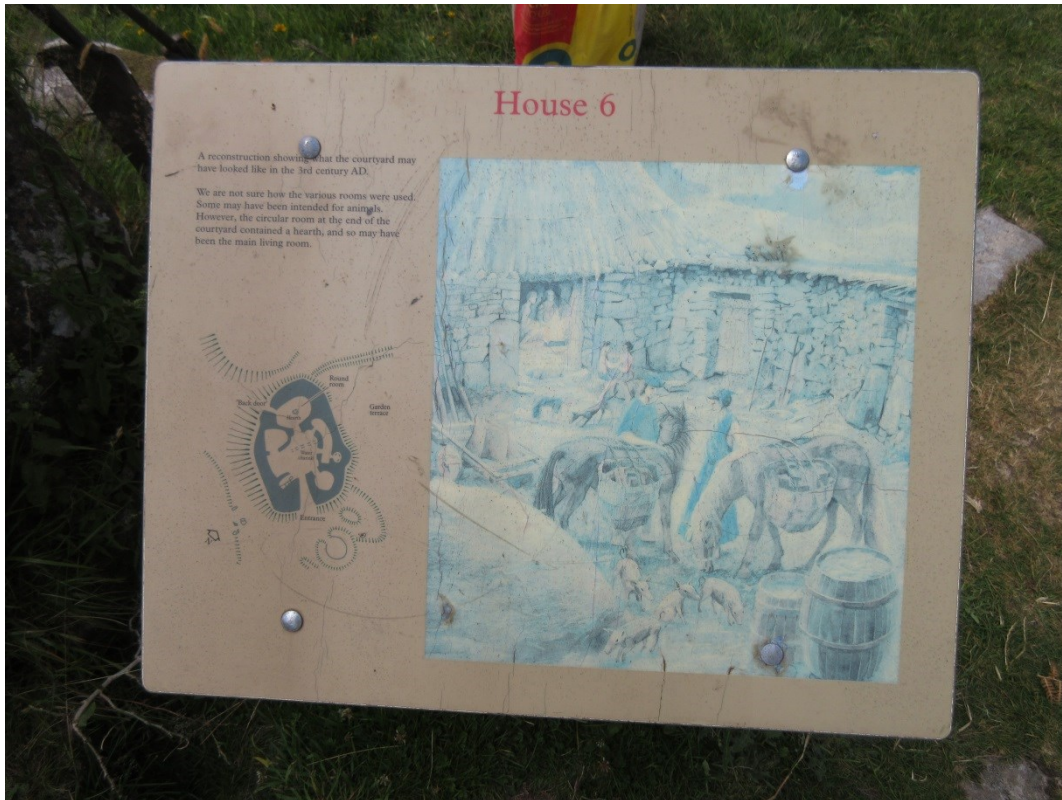
Fig 10. One of the existing faded interpretation panels at Chysauster requiring replacement, in this instance in House 6.

This panel replaces an original within the interior of House 6 interpreting its appearance during the Romano-British period of occupation.

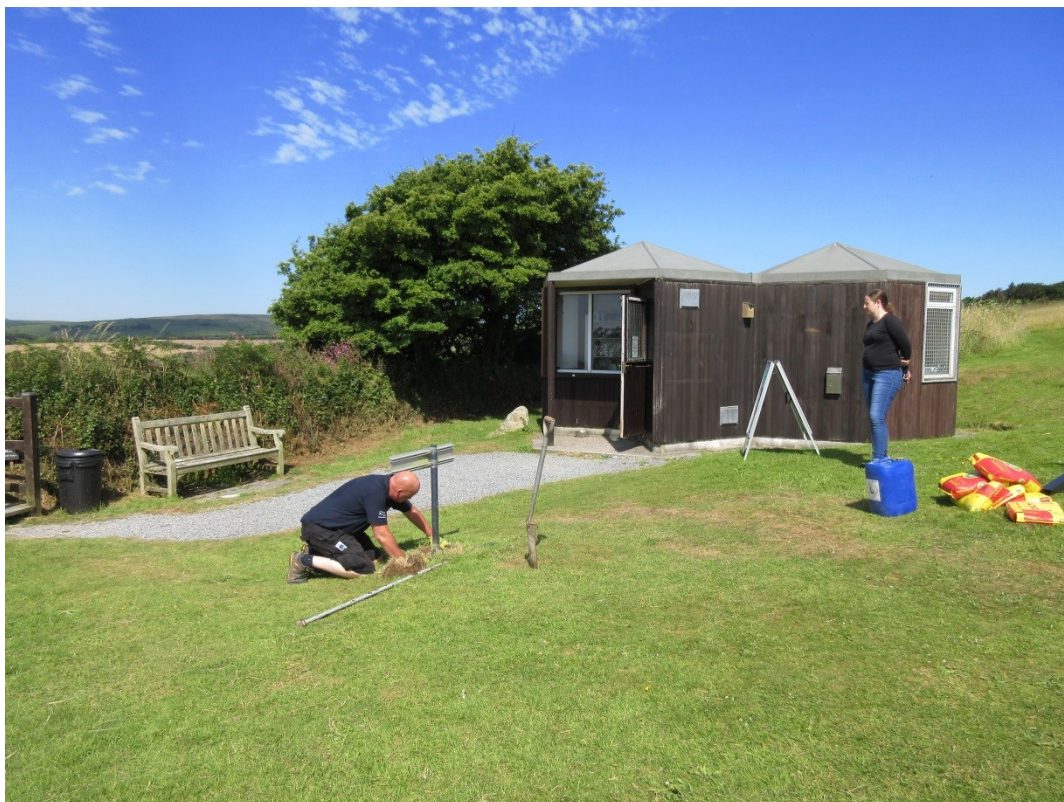
Fig 11. Hand excavating to remove the original Operational Sign 1 near the Chysauster ticket hut.

Two existing post-mounted signs at the lower end of the site directing visitors to the ticket office and the fogou were removed and replaced with a new double-sided sign on a single post. Whilst the sign to the fogou had simply been driven into the ground, the ticket office sign had been set into a 300mm x 300mm x 400mm deep mass of concrete overlain by turf and 100mm of the dry sandy loam which forms the topsoil across much of the site. The concrete was broken out by hand and the post for the new sign was set in the original socket, together with all of the original broken concrete and some additional Postcrete. The topsoil and turf were reinstated.

The topsoil at this point was found to be in excess of 400mm deep. No artefacts were recovered from the excavation.

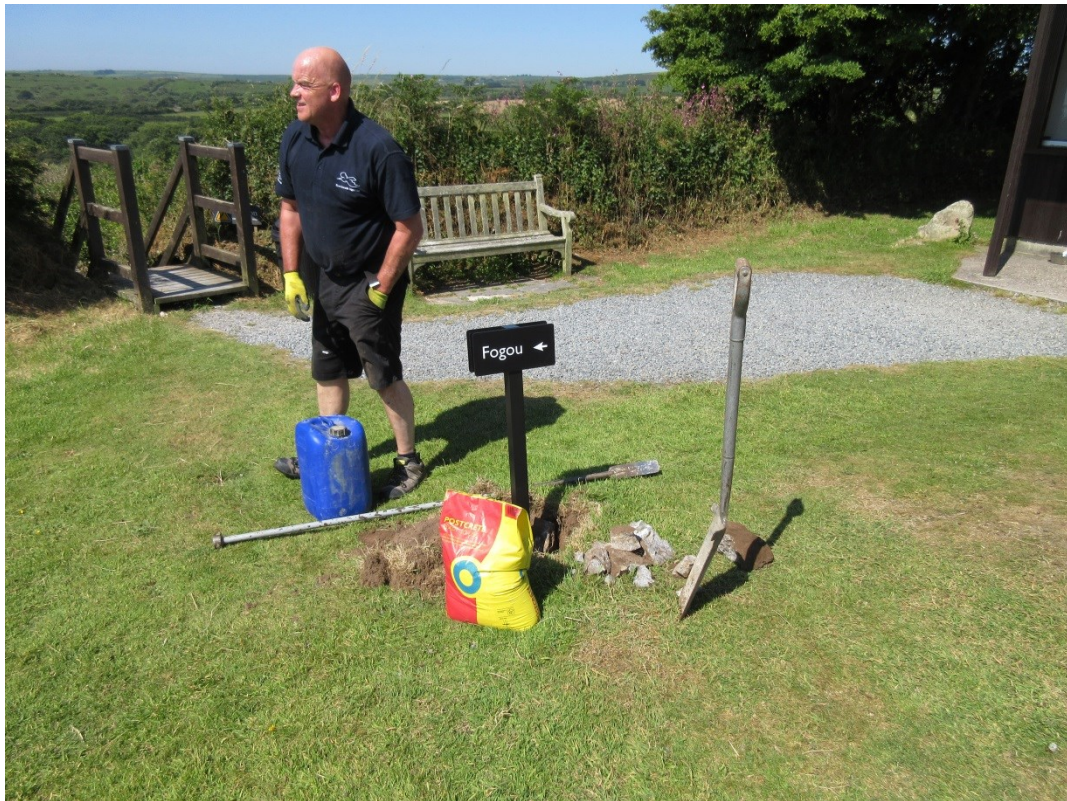
Fig 12. The replacement Operational Sign installed adjacent to the Chysauster ticket hut.

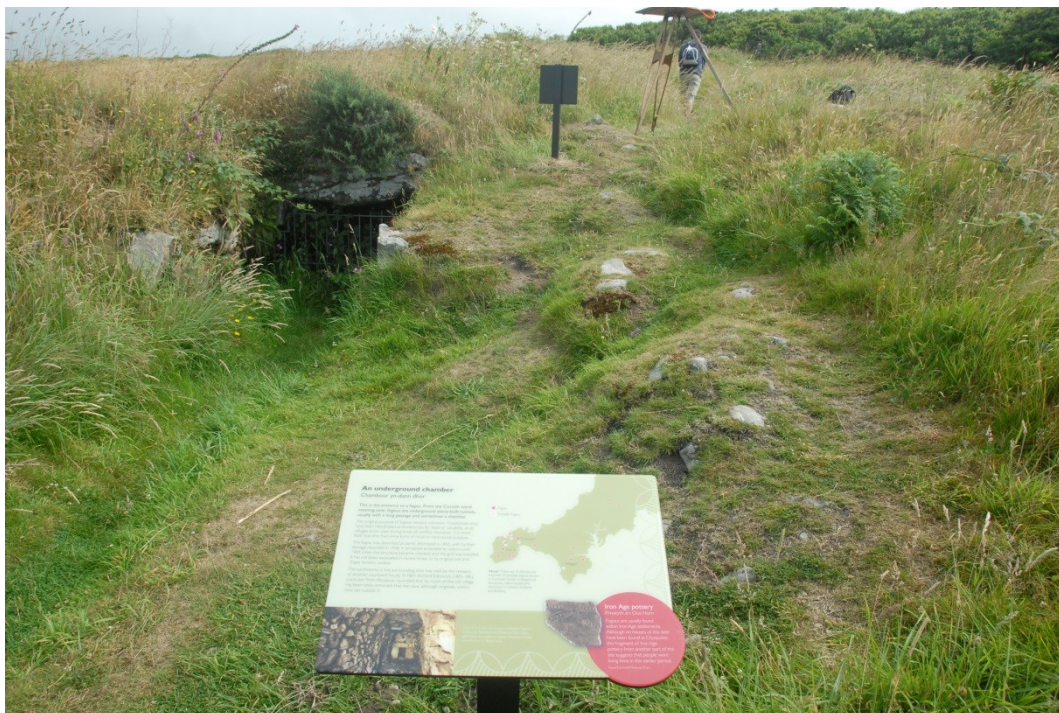
Fig 13. The new Panel 2 and (background) Operational Sign 2 adjacent to the entrance to the fogou at Chysauster.

A 200mm x 200mm post socket was hand excavated to a depth of 600mm on the eastern side of the path leading to the fogou. The turf covered very dry, friable mid-brown sandy topsoil. Small stone inclusions were found from 200mm below surface, whilst larger tabular pieces of granite were encountered below 500mm. The post for the new sign was set in a mixture of stone, soil and Postcrete and the turf was reinstated.

The topsoil was found to be in excess of 600mm deep at this point, though was notably more stony in its lower section. No artefacts were recovered from the excavation.

The existing 'Dangerous Drop' sign just to the north of the entrance to the fogou was replaced.

The post for the original sign had not been set in concrete. A circular posthole 200mm in diameter was hand excavated to a depth of 600mm once the original post and sign had been removed. Loose dry sandy topsoil was found to a depth of 500mm; below this, small stones were encountered. The new post was set in a mixture of excavated material and Postcrete and the turf was replaced.

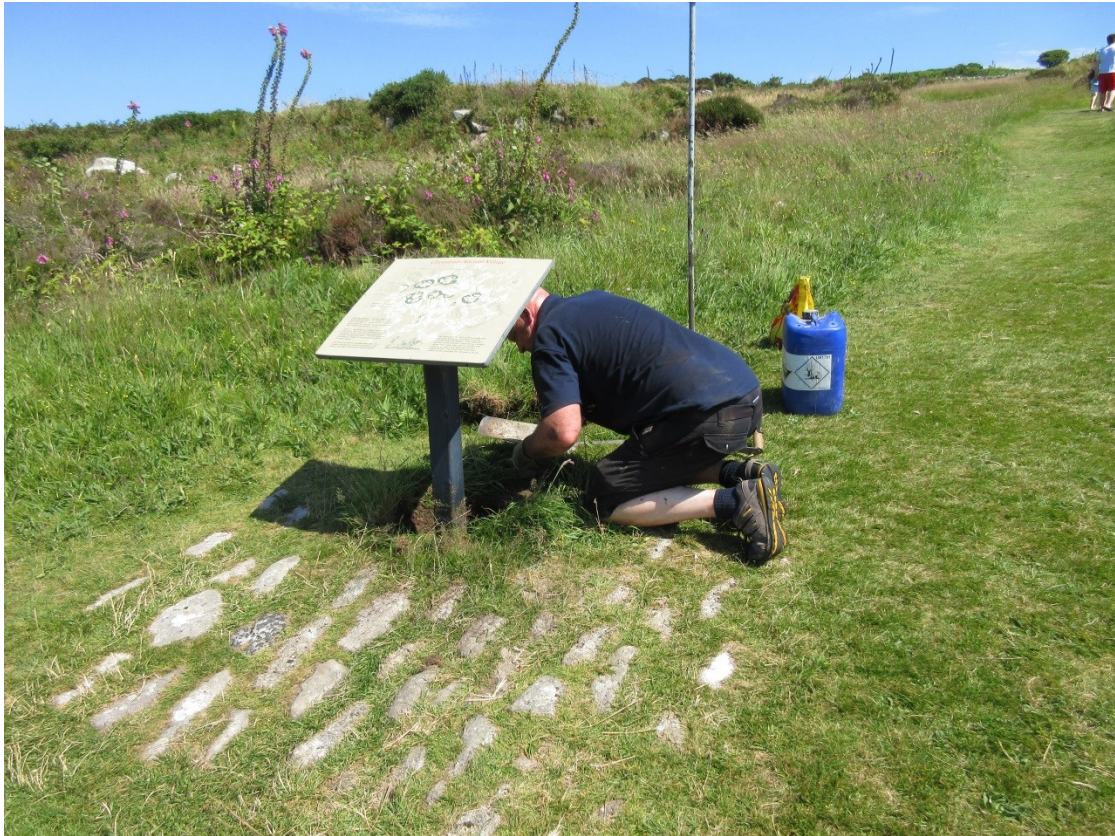
Fig 14 Excavating the original mount for Panel 3 at Chysauster.

This panel replaced an existing example adjacent to the path leading into the area of courtyard houses, and was sited to the south-west of House 7. The new panel depicts the layout of a typical courtyard house.

The original post had been set into a block of mass concrete measuring approximately 300mm x 300mm x 500mm deep which incorporated some pieces of granite. Most of this was broken out by hand; the sides of the excavation were formed of topsoil throughout. The new post was set into the lower section of the original concrete socket, the hole was backfilled with broken concrete, stone, soil and Postcrete and the turf was removed.

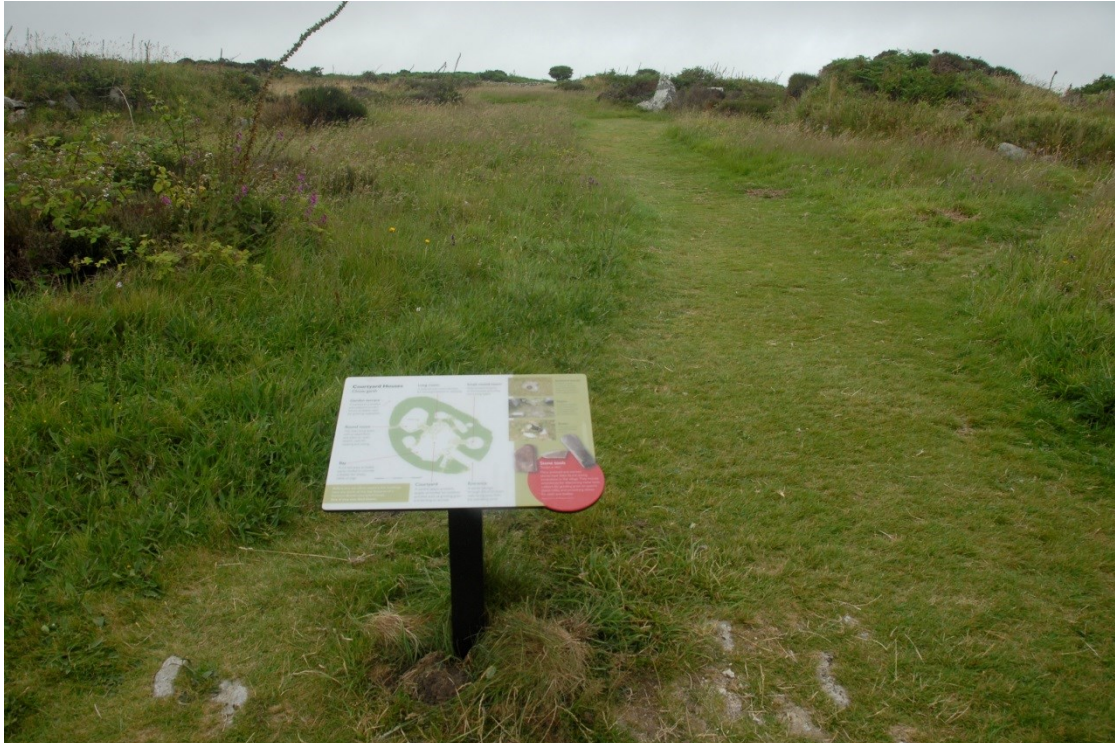
Fig 15. The replacement Panel 3 to the south of the Chysauster courtyard house settlement.

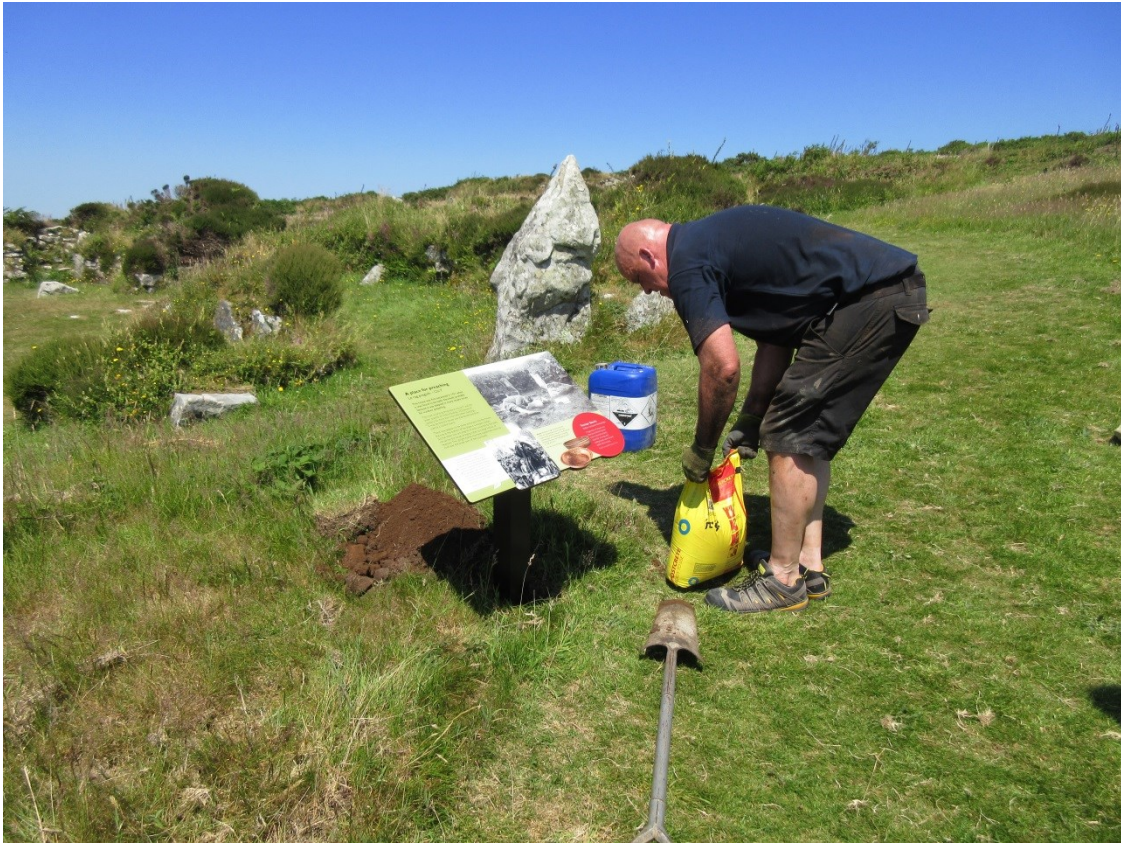
Fig 16. Installing new Panel 4 adjacent to House 7 at Chysauster.

A socket measuring 250mm in diameter was hand excavated once the turf had been removed. Fine mid-brown sandy topsoil was found to a depth of to 150mm; below this depth the topsoil incorporated numerous small pieces of granite. The hole was terminated at 600mm from surface at the interface between the topsoil and the notably more orange rab (subsoil). The post for the sign was set in a mixture of stone, soil and Postcrete and the turf was reinstated.

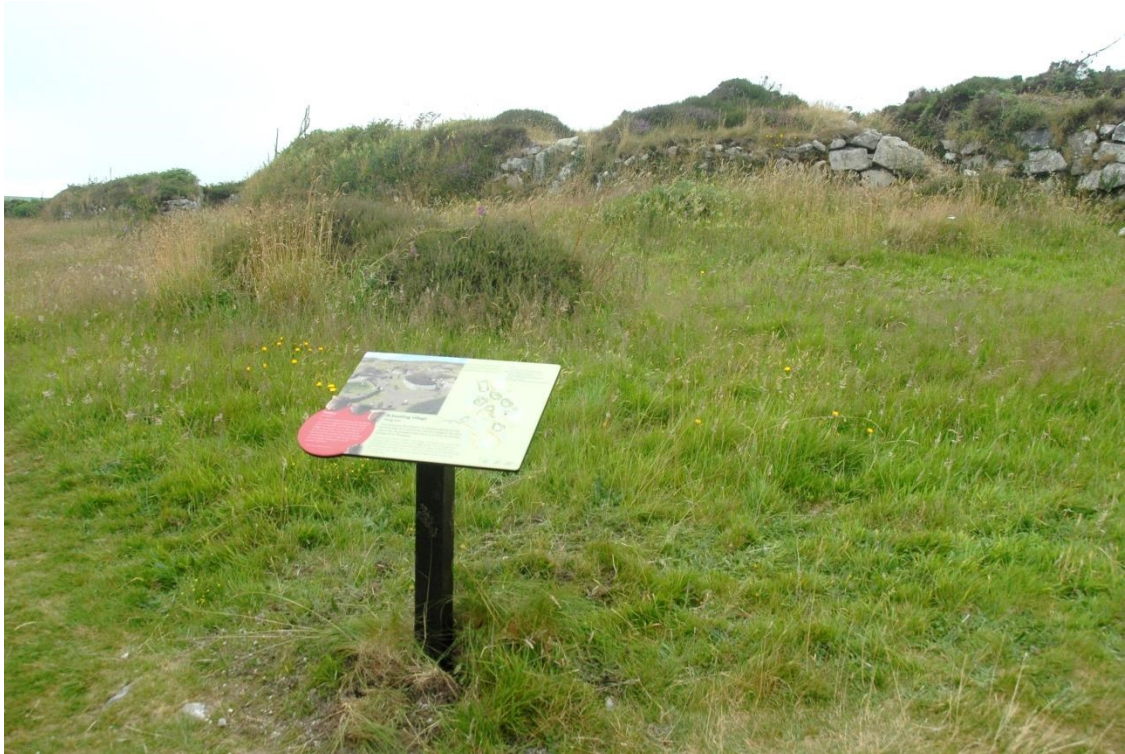
Fig 18. New Panel 5 installed just to the south of House 6 at Chysauster.

This interpretation panel replaces that formerly set to the south-east of House 6, and carries a depiction of the view from this location during the period when the courtyard house settlement was occupied.

The post for the original sign was found to be set within a 350mm x 350mm x 500mm mass of concrete covered by a small amount of topsoil and turf. The majority of the concrete was broken out by hand to a depth of 500mm from surface. Below this depth the concrete incorporated large stones which proved difficult to remove and were thus left in place. As a result the post for the new sign was shortened slightly so that

the sign could be set at the optimal reading height. The sides of the excavation consisted of slightly stony mid-brown sandy soil for the full depth exposed during the works. The new post was set into the remains of the original socket and the excavation was backfilled with a mixture of stone, broken concrete, soil and Postcrete, following which the turf was reinstated.

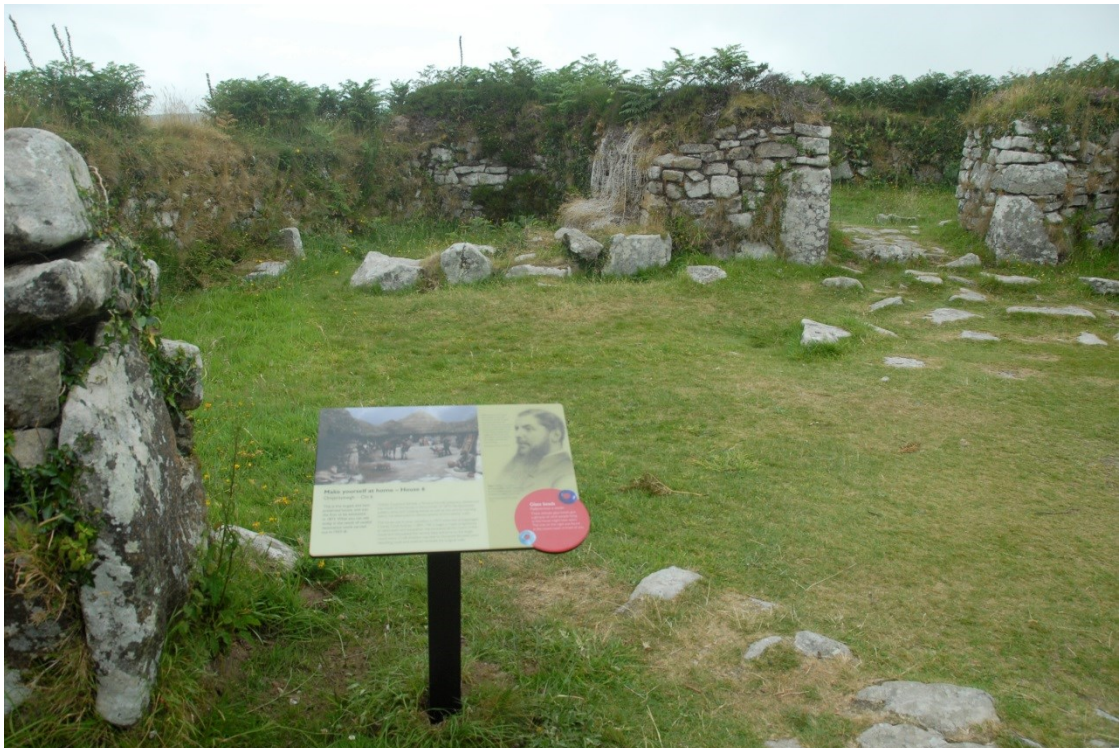
Fig 19. New Panel 6 installed inside House 6 at Chysauster, replacing that shown in Fig 10.

Following de-turfing and the excavation of 150mm of dry, slightly pinkish sandy topsoil, the upper surface of a mass of concrete measuring 350mm x 350mm was revealed. This was broken out to a depth of 580mm. The sides of the original excavation were composed of topsoil to a depth of 450mm from surface, below which it had been cut through orange rab (subsoil). Whilst the concrete had incorporated pieces of fist-sized granite the sides of the excavation were relatively stone-free. The excavation was backfilled with broken concrete, stone, soil and Postcrete and the turf was reinstated.

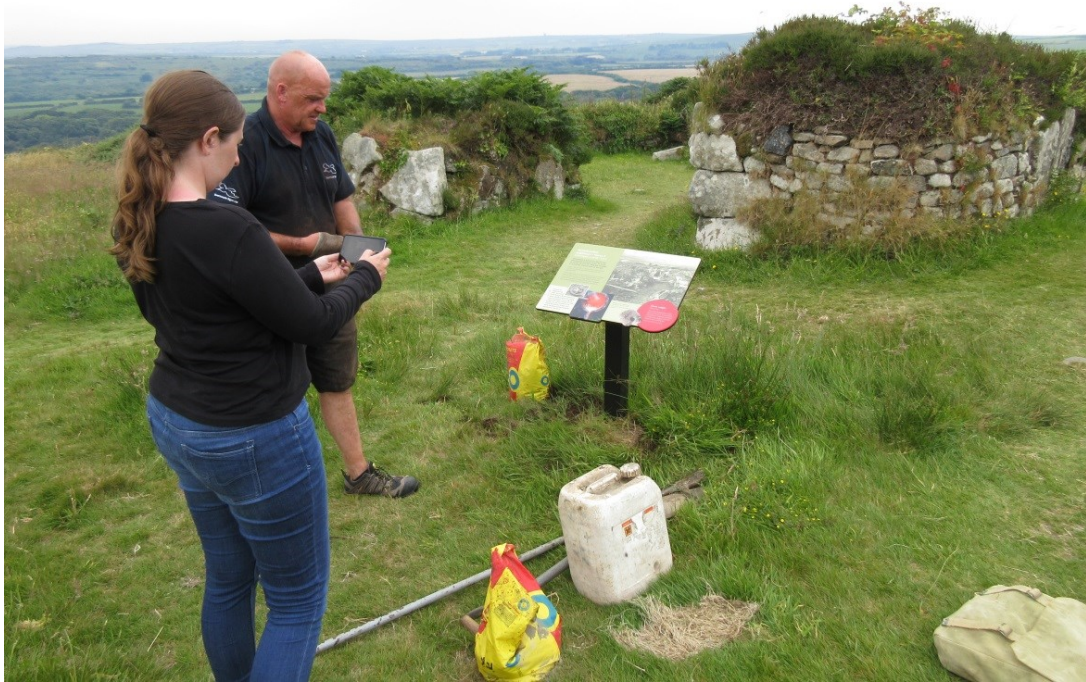
Fig 20. Completion of the installation of new Panel 7 adjacent to Houses 3a and 3b at Chysauster.

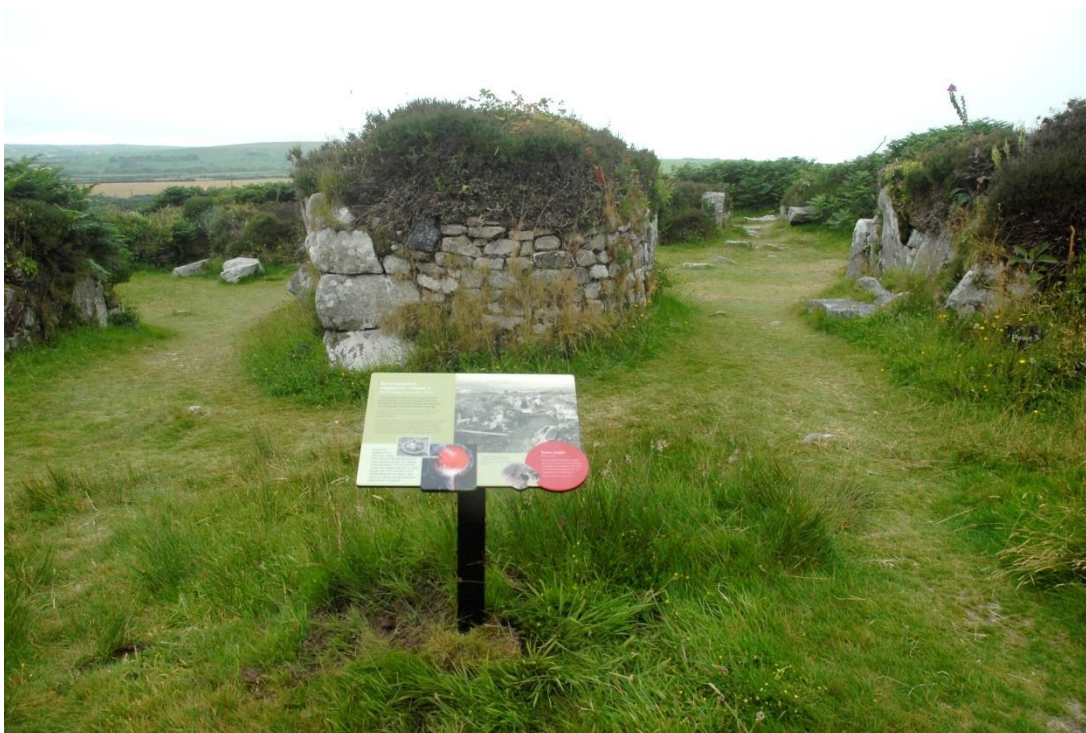
Fig 21. New Panel 7 installed at the entrance to Houses 3a/3b at Chysauster.

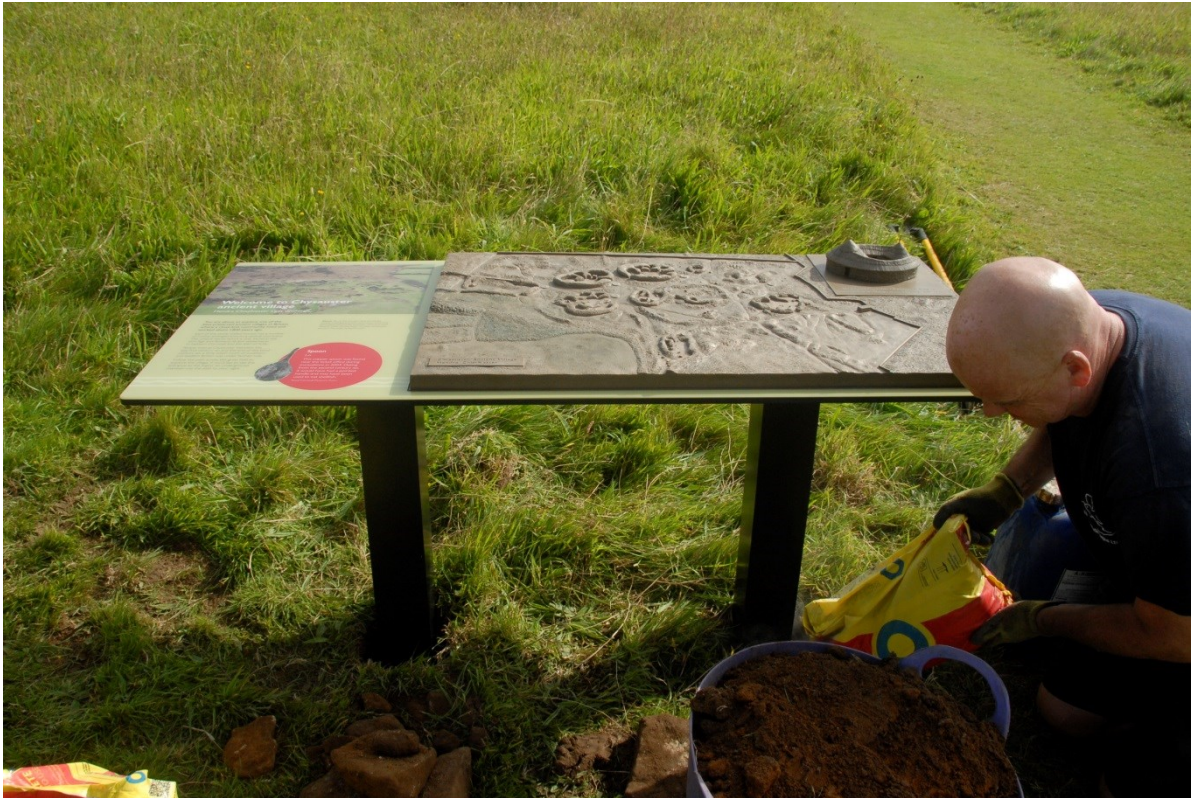
Fig 22. Concreting in the legs for new Interpretation Panel 1 near the ticket hut at Chysauster. This panel incorporates a 3D plan of the site derived from the 2016 Historic England survey.

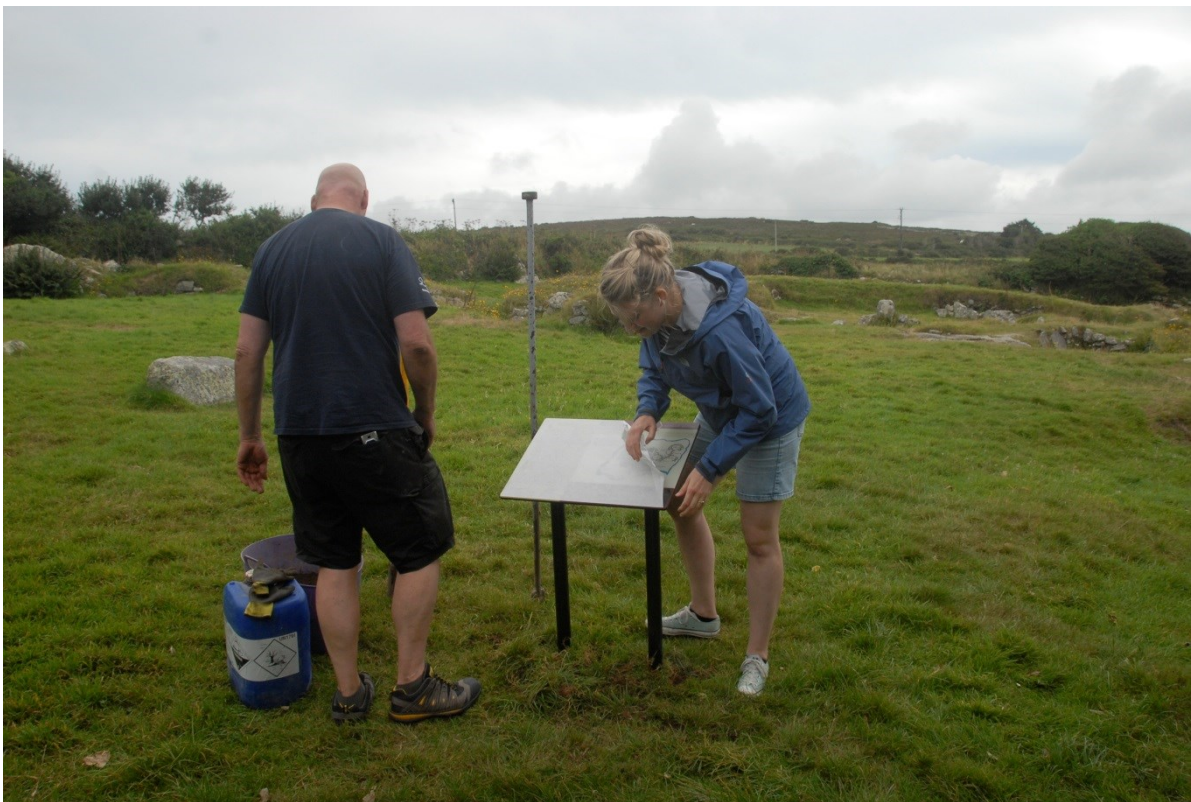
Fig 23. Removing the protective film from new Panel 1 at Carn Euny. The right hand posthole in this view produced a sherd of Iron Age pottery.

The legs for the new interpretation panel were Postcreted into place and the turf was replaced.

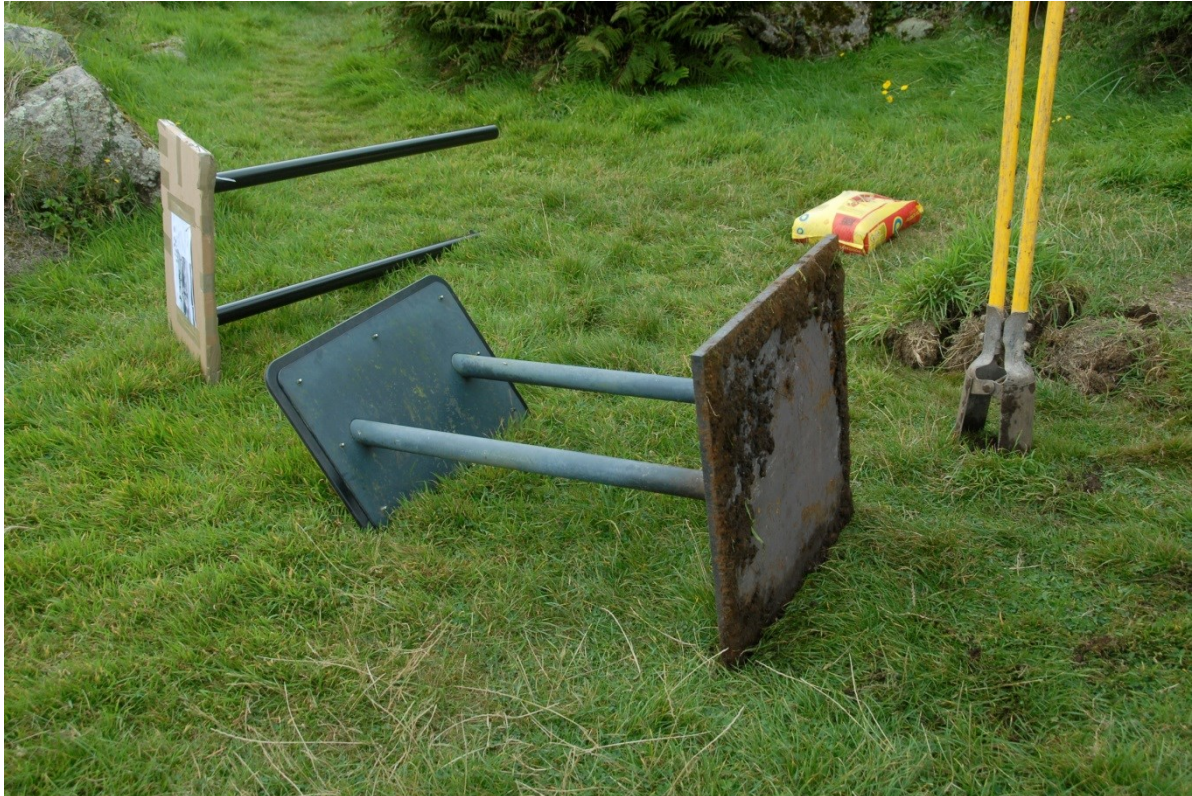
An existing interpretation panel adjacent to the north-eastern quadrant of House 1 was replaced. On examination, the legs for the original panel were found to be supported on a 500mm x 400mm x 25mm thick steel plate set at around 75mm below the existing ground surface. It had been proposed that the new interpretation panel would be set on twin posts set into the ground. The first posthole was excavated to 300mm from surface through topsoil, though below this depth the ground became significantly stonier. The hole was eventually terminated at 400mm from surface. The second hole became very stony at 200mm from surface, and at this point it was decided to re-utilise the original sheet steel mount. The old sign was removed from this and, following some shortening of the new panel's legs, the new replacement interpretation panel was installed in the original excavation.

Fig 24. The original Interpretation Panel 2 at Carn Euny following its removal, showing the heavy steel plate which had anchored it into the ground.

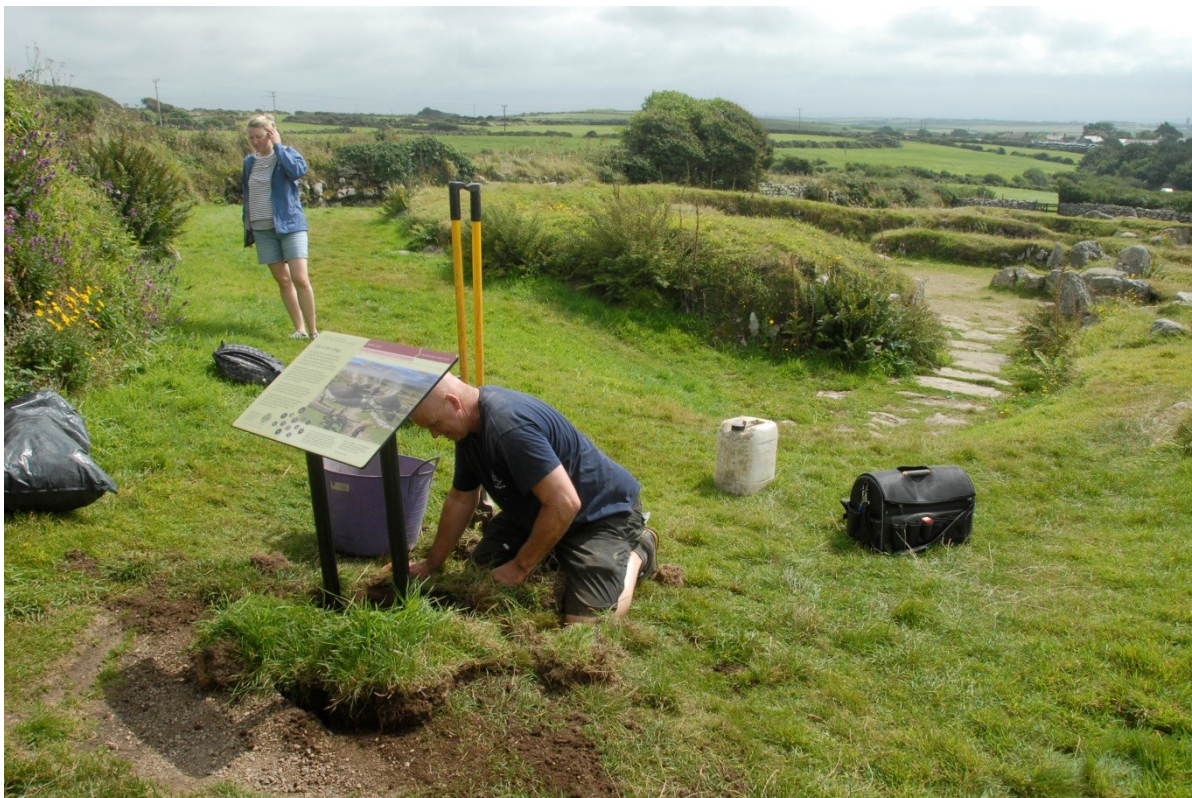
Fig 25. Replacing the turf at the site of Panel 2 at Carn Euny. The new interpretation panel was mounted on the original shallowly-buried baseplate rather than being set into postholes.

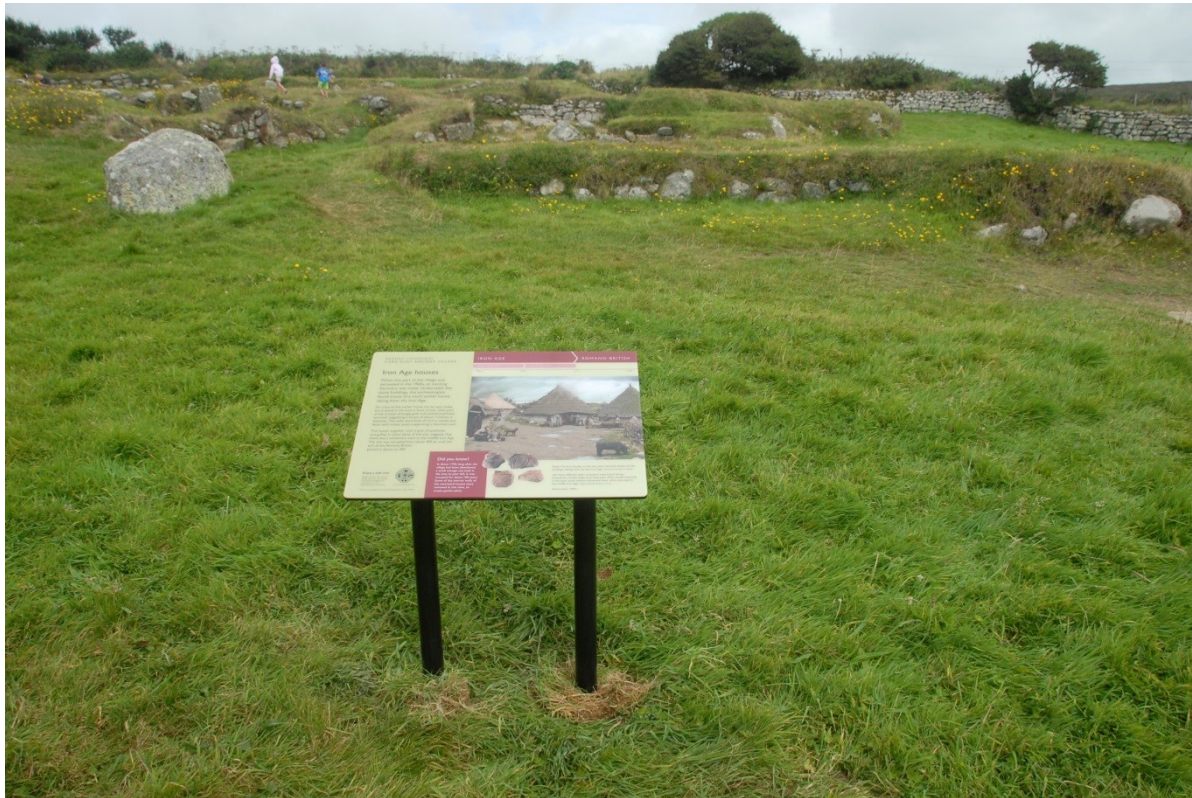
Fig 26. Panel 3 at Carn Euny following its installation.

Two postholes 200mm in diameter were hand-excavated to 500mm deep through topsoil to 400mm from surface, rab being encountered below this depth. The panel's legs were Postcreted into place and the turf was replaced.
