Higher Bochym and Carn Kennack buildings, Lizard, Cornwall
Photographic recording

Cornwall Archaeological Unit

Report No: 2016R058

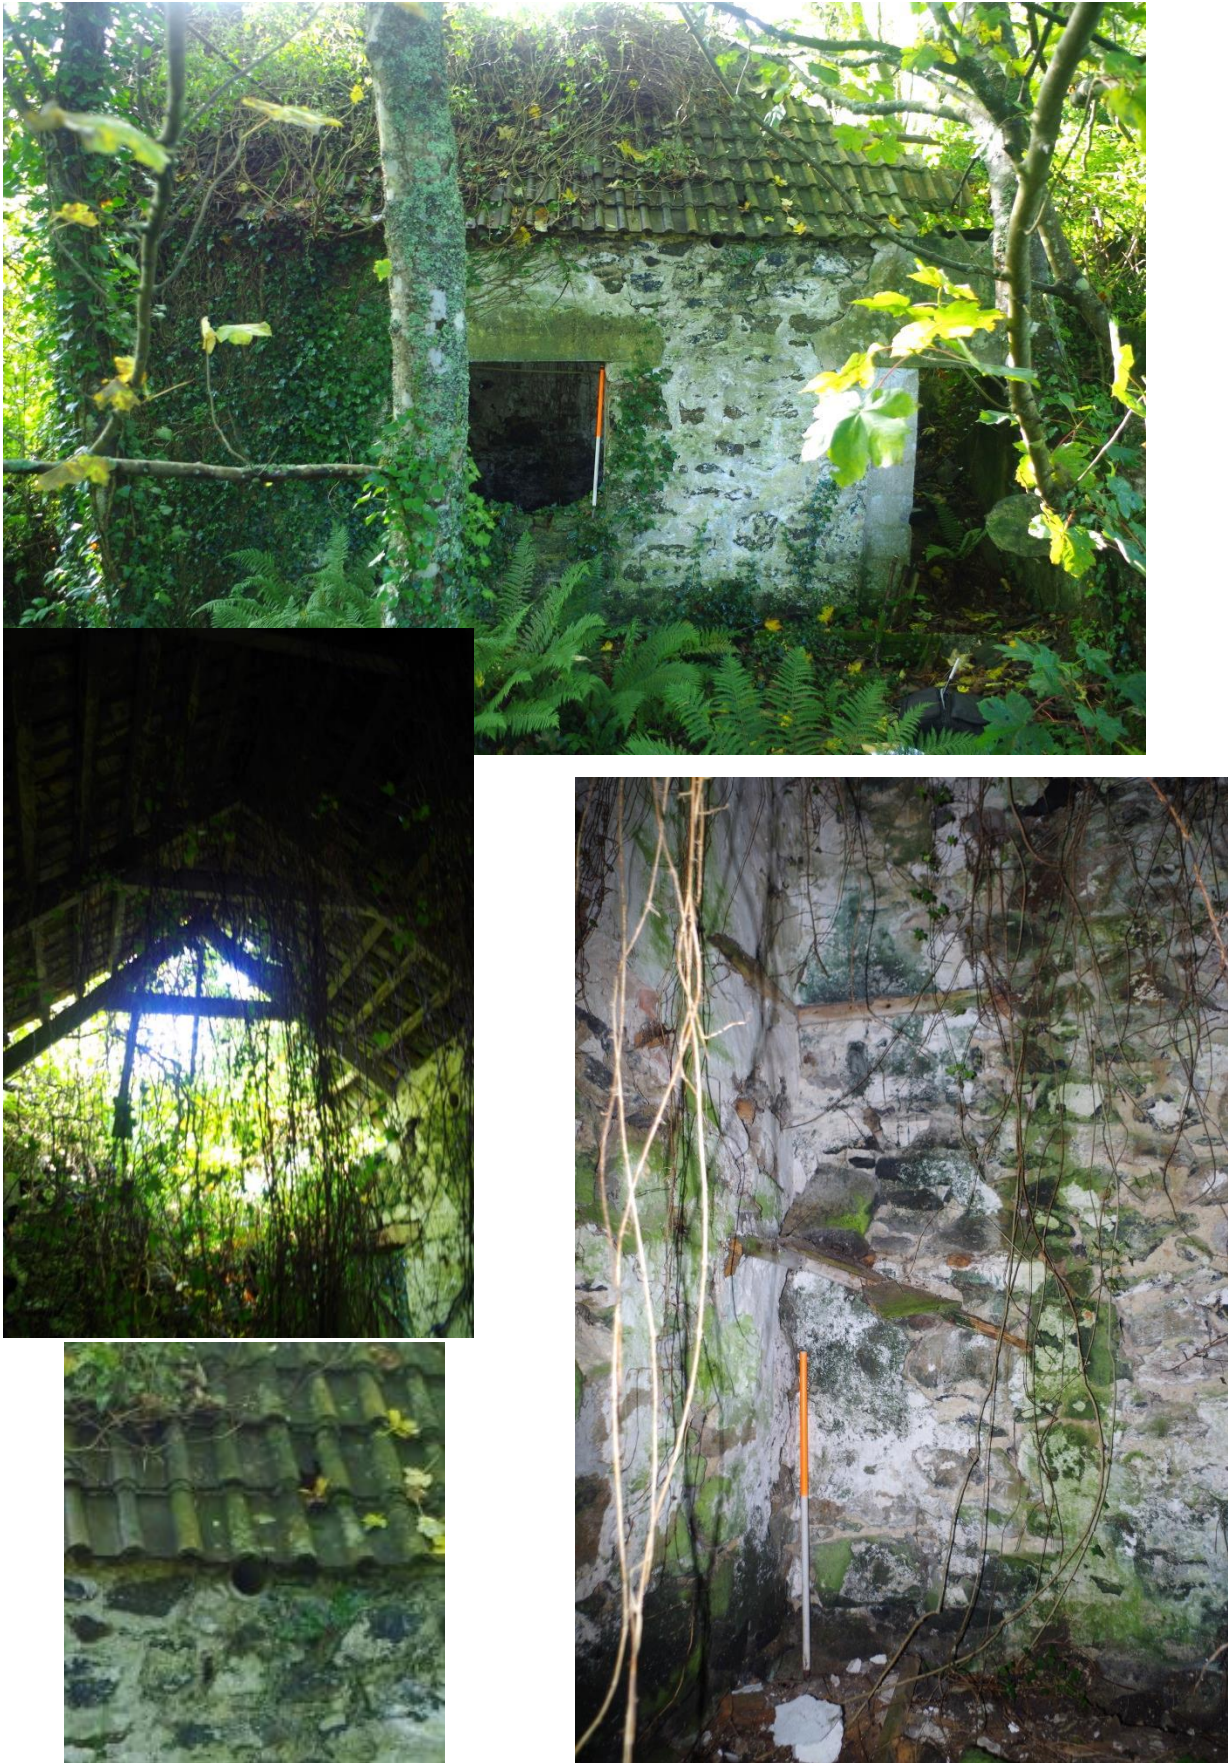
Fig 5 Higher Bochym, top – looking south at building B; middle left - looking west from inside building B showing remnant roof; bottom left – close up of one of the aeration holes; bottom right - the south-east corner showing remnant shelving in building B.

Building B was largely extant at the time of recording. It was a tall extension, which still retained approximately three quarters of its red ridge tiled roof (Fig 5, upper), plus timber door and window lintels (Fig 6 top left and bottom). There was no associated chimney or fireplace. The internal wall faces did not show any clear evidence for a first floor, despite the presence of a small high window (in excess of 2m above ground level) visible in the fully extant eastern gable end. The internal eastern corner of the gable wall showed remnant timber, probable shelf, fittings (Fig 5, bottom right). The upper external part of this gable wall included some red brick build, while external and internal walls showed remnant white coloured paint and/or render.

Along both long sides, close to the roof level, were three approximate 15cm diameter air holes formed by ceramic piping, which served as aeration for the structure. These were visible internally and externally – Figure 5, bottom left, and left hand side of the front cover photograph. These, the lack of obvious first floor flooring and the presence of two rope pulleys visible on the main horizontal roof timbers (see Fig 6, top right) might indicate that this building was constructed and used as a drying room associated with the 1907 mapped use as a laundry.

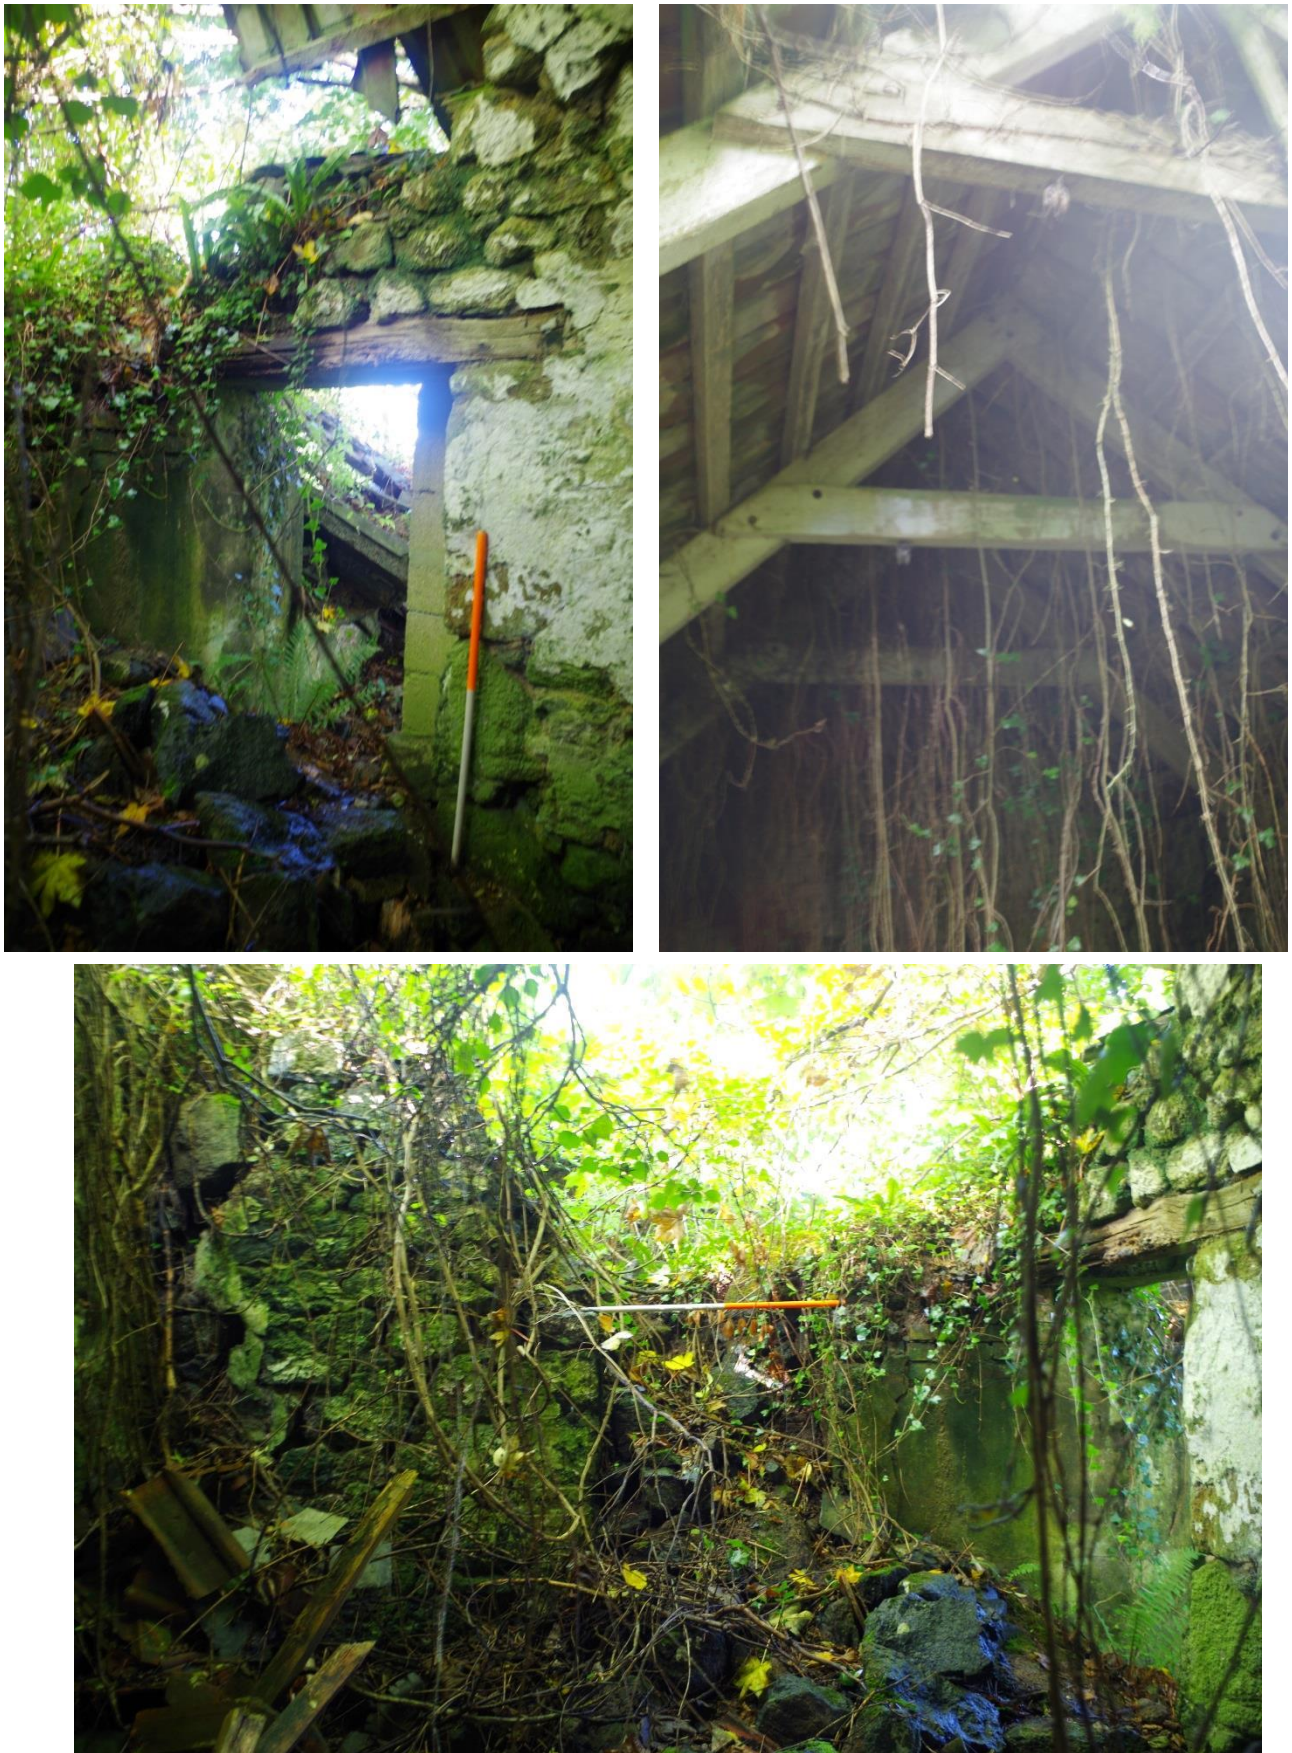
Fig 6 Higher Bochym, top left – internal north-west corner of building B showing doorway and building A outside; top right – remnant roofing with two surviving rope pulleys; bottom – looking west inside building B showing doorway blocked with collapsed building A.

The western gable end had largely fallen (Fig 6, bottom), probably as a result of instability caused by the fall of building A. Although much of the internal ground floor was clear of rubble, substantial burrowing and a lack of visible floor stone or concrete, might suggest an original earthen or timbered floor. It would seem unlikely that stone slabs had been lifted and removed since so much other good quality stone is still available on site.

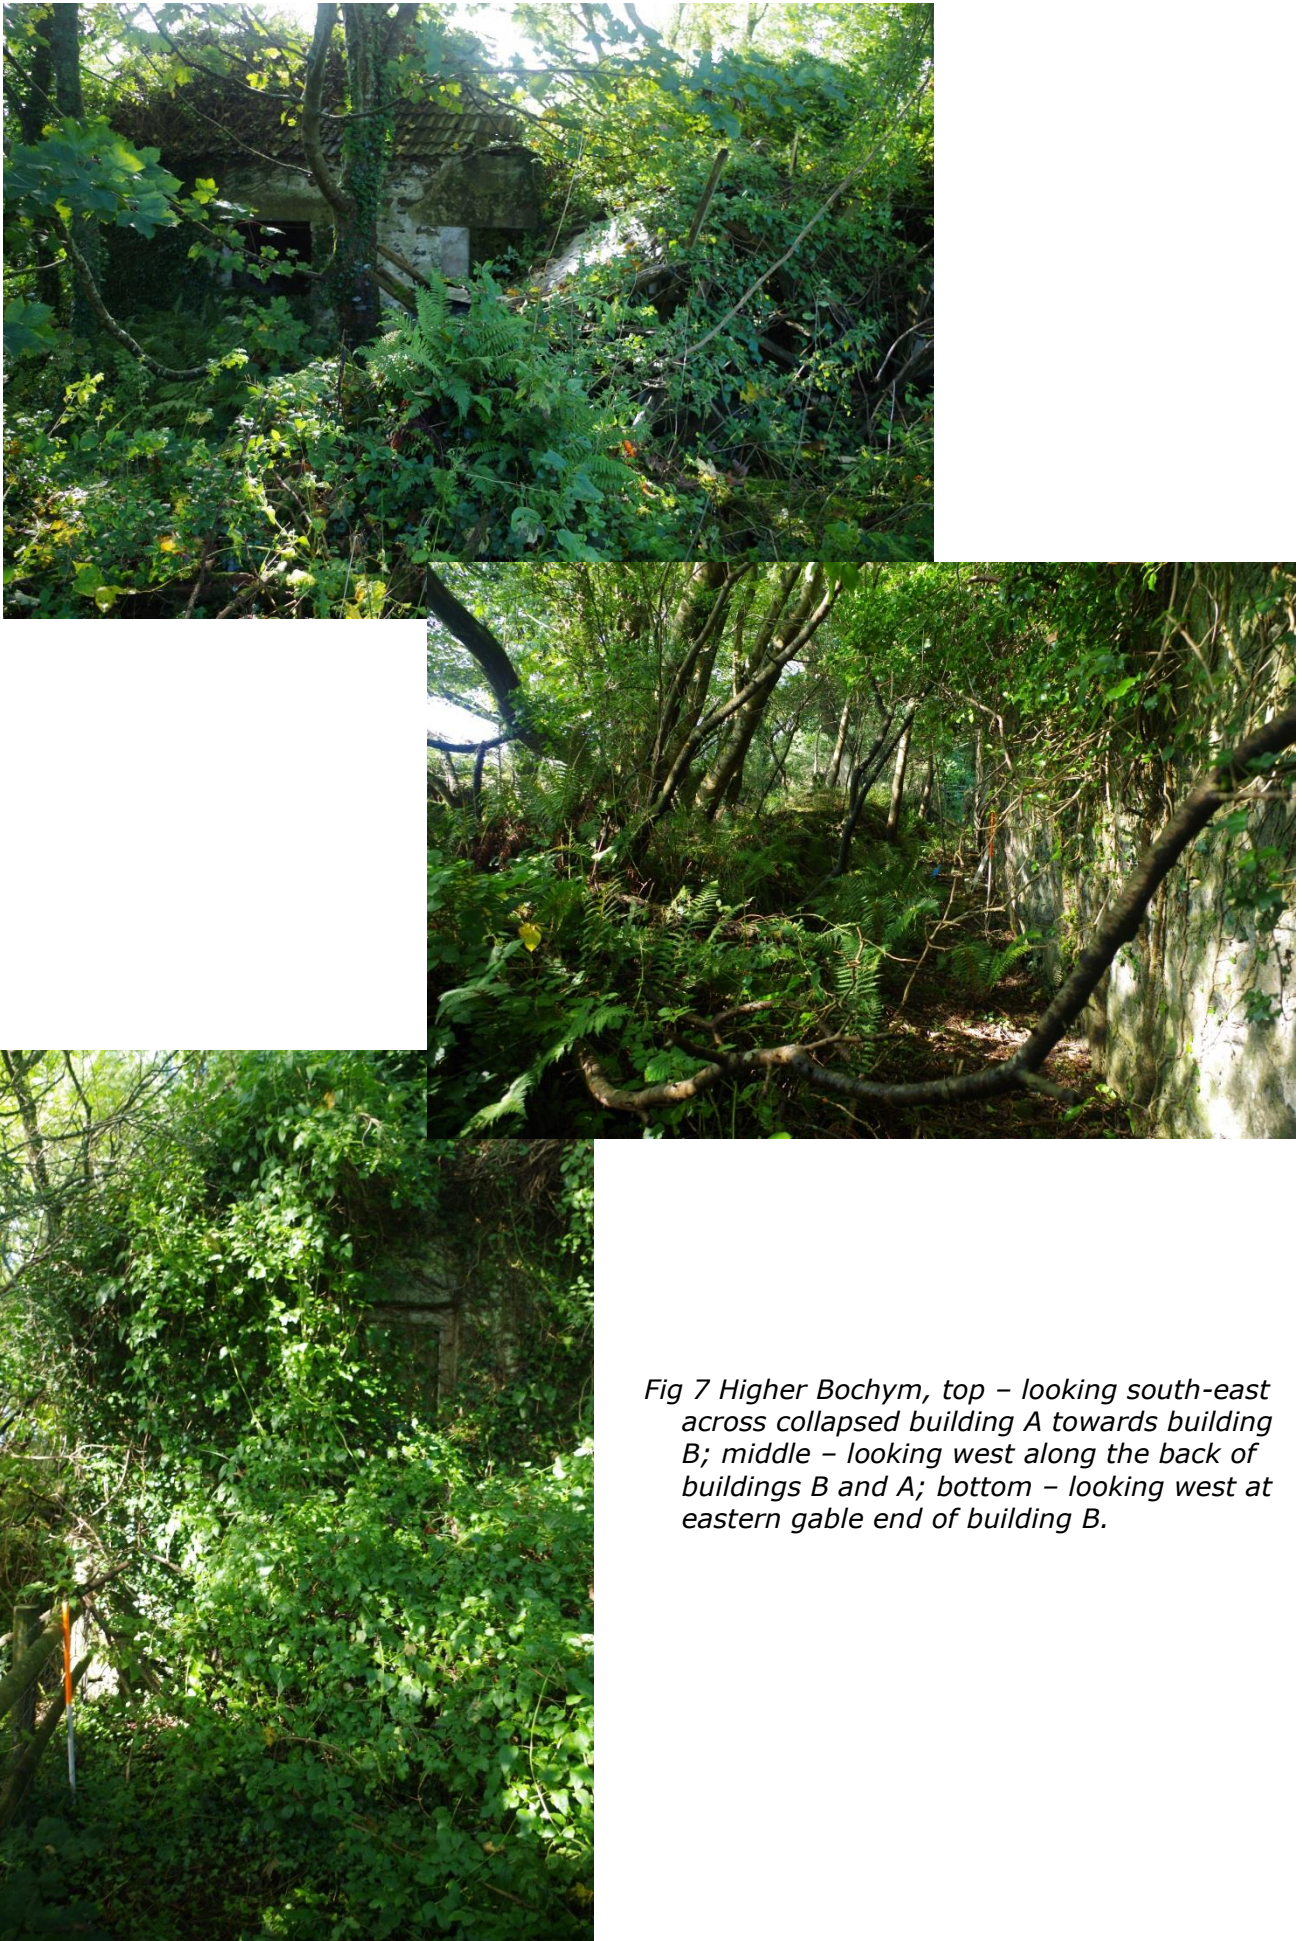
Fig 7 Higher Bochym, top – looking south-east across collapsed building A towards building B; middle – looking west along the back of buildings B and A; bottom – looking west at eastern gable end of building B.

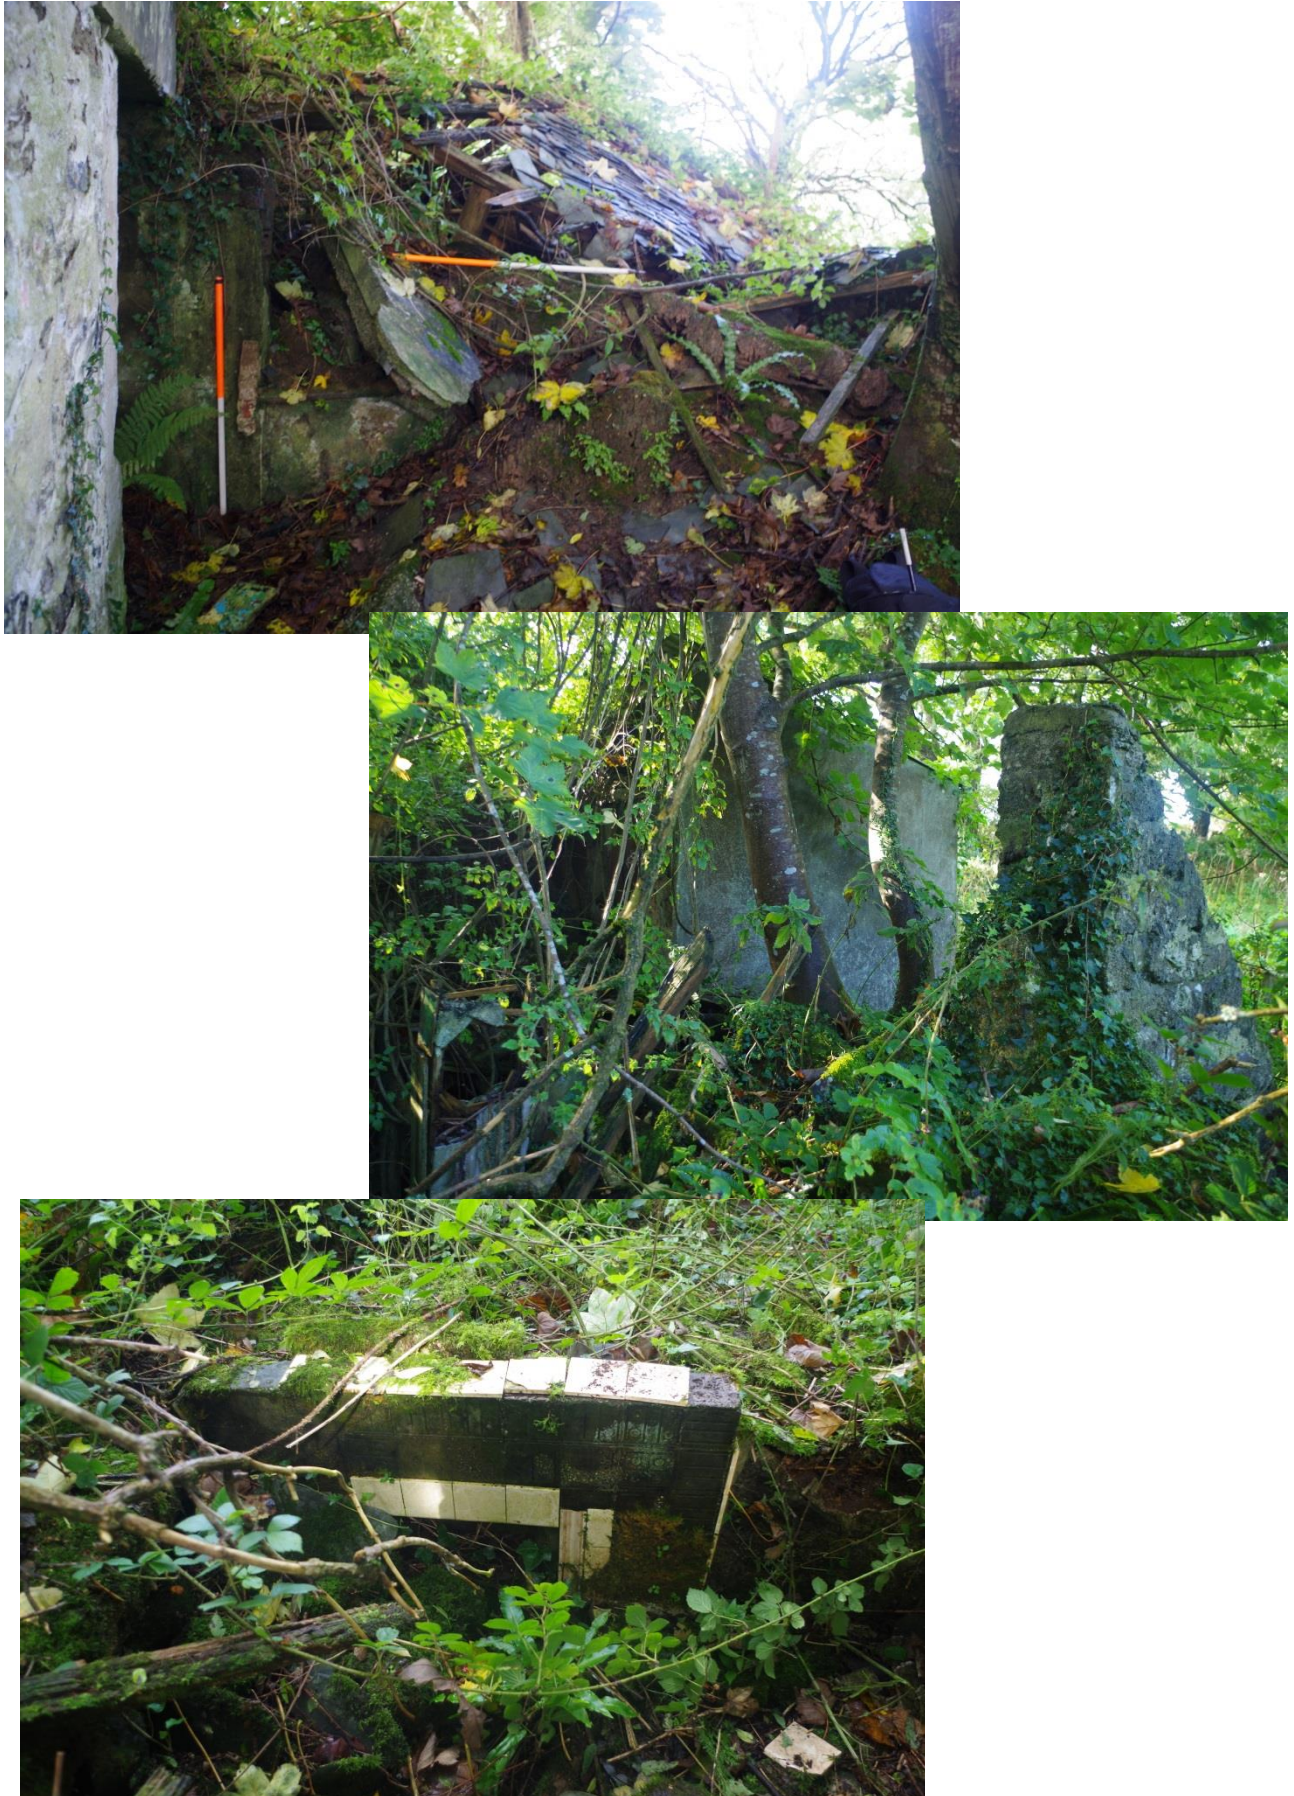
Fig 8 Higher Bochym, top – looking west at north-western corner of building A; middle - looking south along external western wall of building a showing buttress?; bottom – looking north at internal northern gable end of building A showing remnant fire place with ceramic cream tiles and fallen chimney stack beyond.

Externally a single, angular stone wall was recorded (Fig 8, middle), which probably acted as a buttress to support the western side of the building. It appeared to be a later build than the main western wall, and given its short length and angle is most unlikely to represent a remnant, un-mapped lean-to extension.

Located centrally within this larger ground floor rooms northern wall was the remains of a small cream coloured, ceramic, tiled fire place (Fig 8, bottom). The chimney had collapsed north and was visible as a heap of over grown rubble beyond the building footprint. Both rooms were full of collapsed roofing timbers and many complete slates. One large chunk of the fallen roof still had its slates in place (see Fig 8, top).

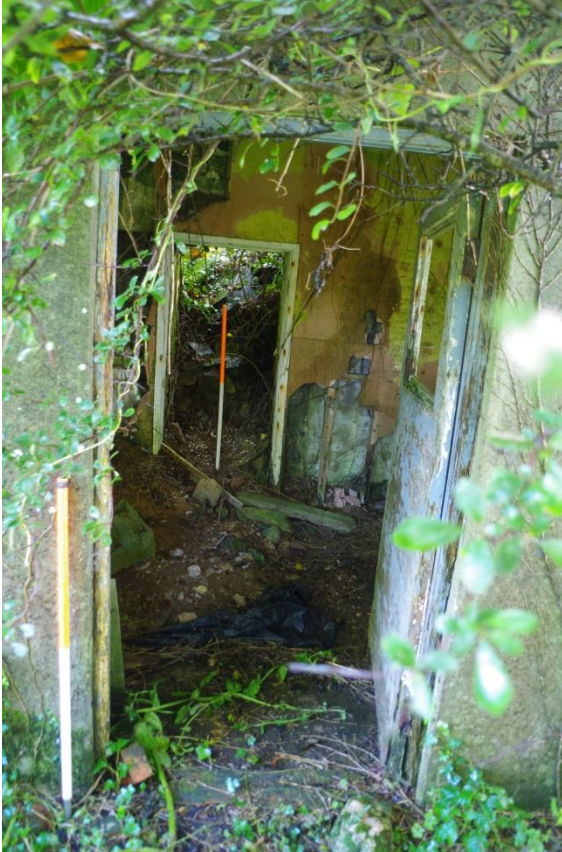
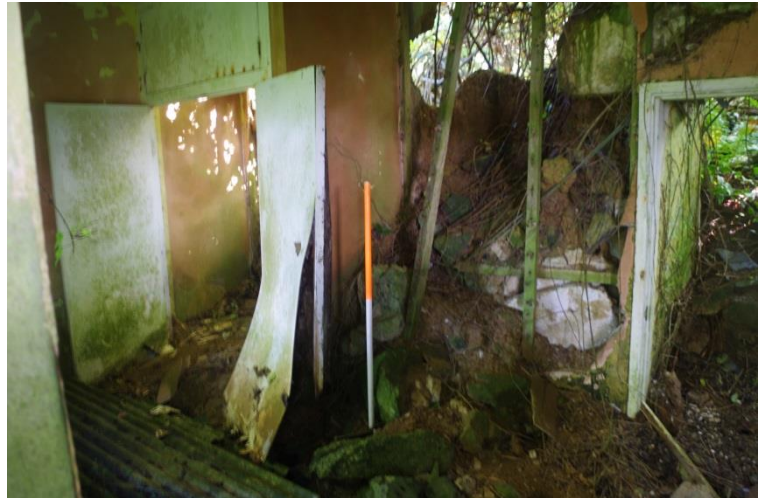
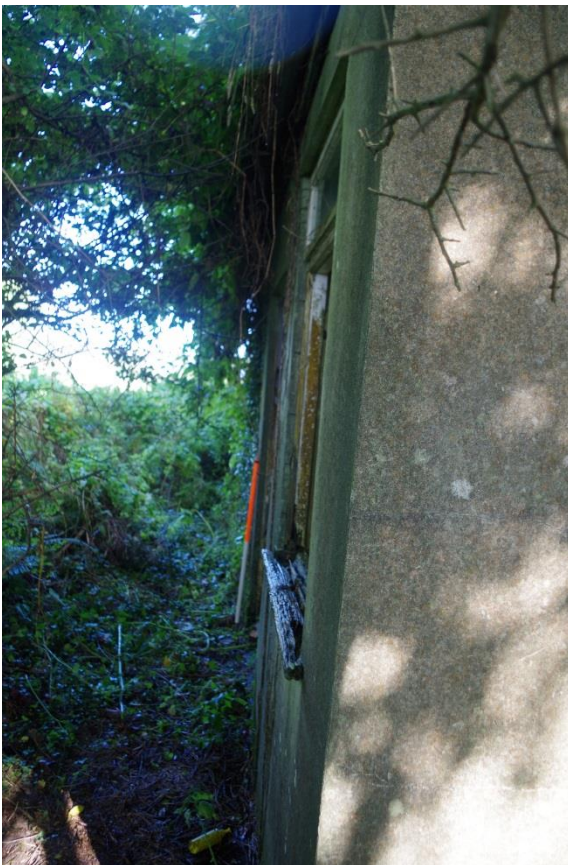
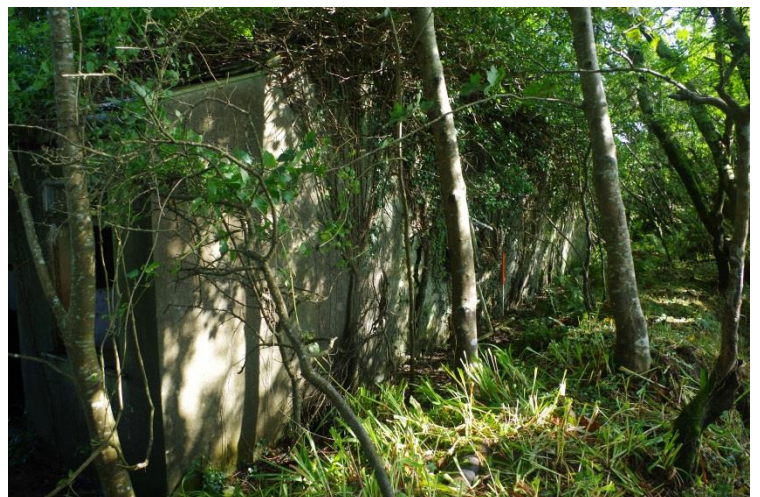
Fig 9 Higher Bochym, top left looking east through building C into building A's overgrown collapse (beyond furthest red and white scale); top right – looking at internal north-east corner of building C; bottom left – looking north along external western wall of building C; bottom right – looking north-east at external north-eastern corner of building C and back southern gable end of building A.

Building C was the latest phase of building at Higher Bochym. It was a breeze-block lean-to construction (Fig 9, bottom left and right), running along the western side of building A (separate from the buttress-like walling mentioned above, and positioned to its north – see Fig 4). The floor was concrete, and at the time of recording a pile of asbestos roof sheeting was piled in the north-western corner of the building.

The collapse of building A had resulted in much of the eastern side of this building being open to piled rubble and daylight (Fig 9, top right). Daylight, for example was clearly visible through the large double-doored cupboard in the north-eastern internal corner of building C. Figure 9 (top left) looks through building C in to overgrown building A.

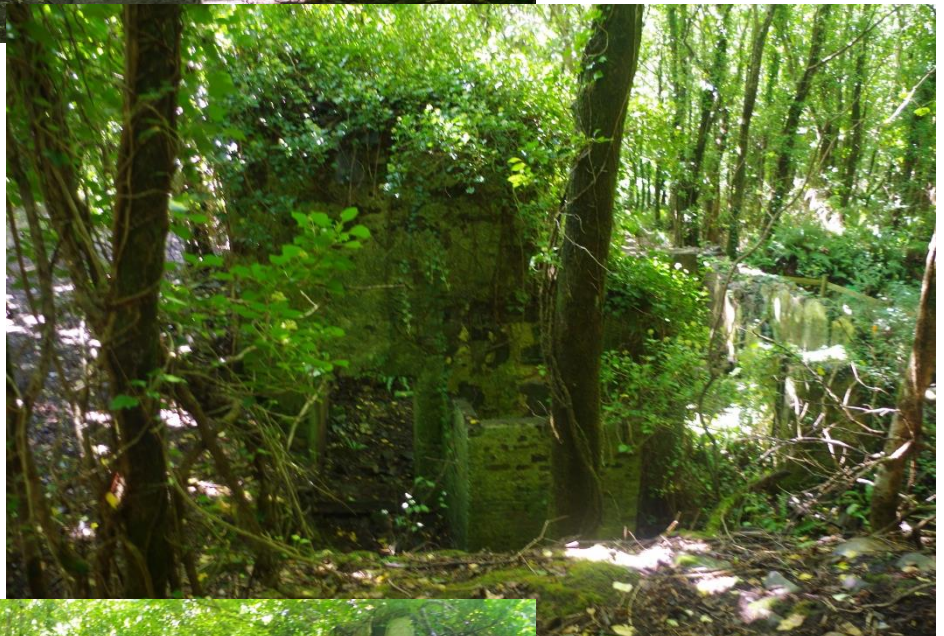
Fig 11 Carn Kennack, top - looking south-east along the public footpath towards the building; middle - looking down and north-west across the site; bottom - looking east-south-east at the north-western corner of the building.

(bottom) shows the whole building from just beyond its north-western external corner, and clearly shows the window and door frame positions as dark, vertically running insets. At the lower north-western corner, a very large cut stone block supported the corner of the wall. It had two closely spaced drill holes (Fig 14, bottom). A further loose stone nearby also had a drill mark. As with the window sill referred to above, the narrow drill marks imply a late 19th century date.

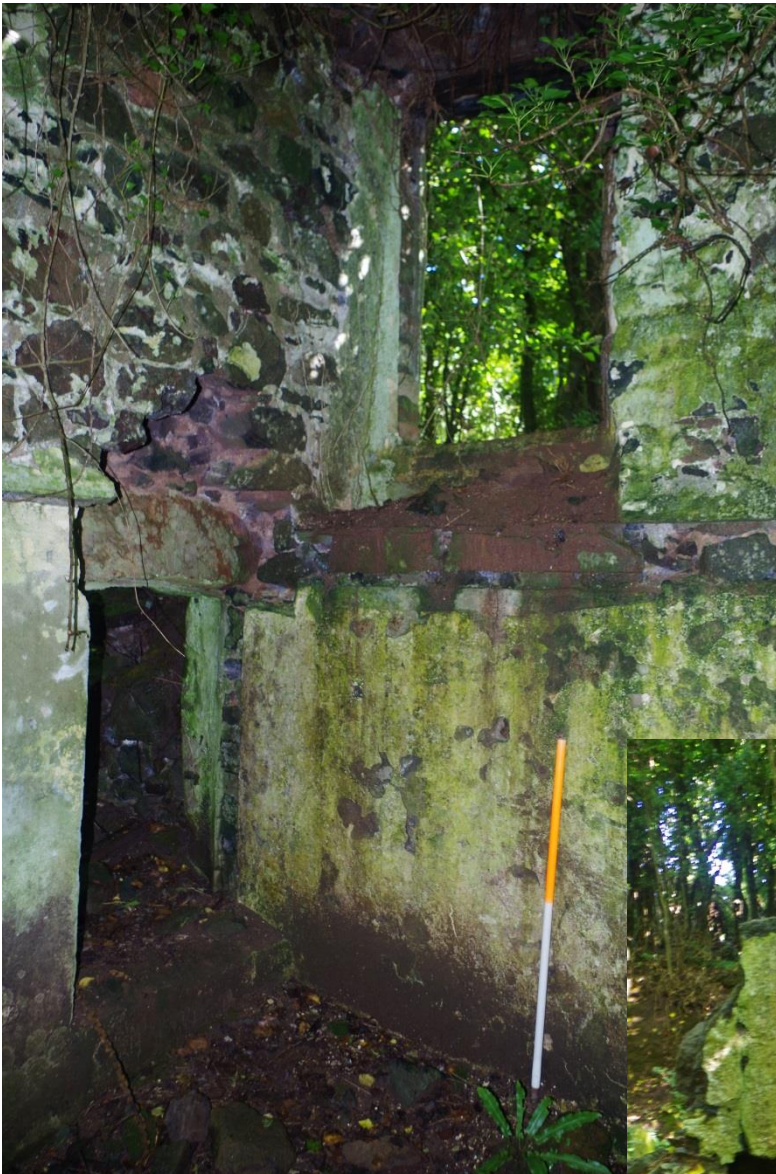
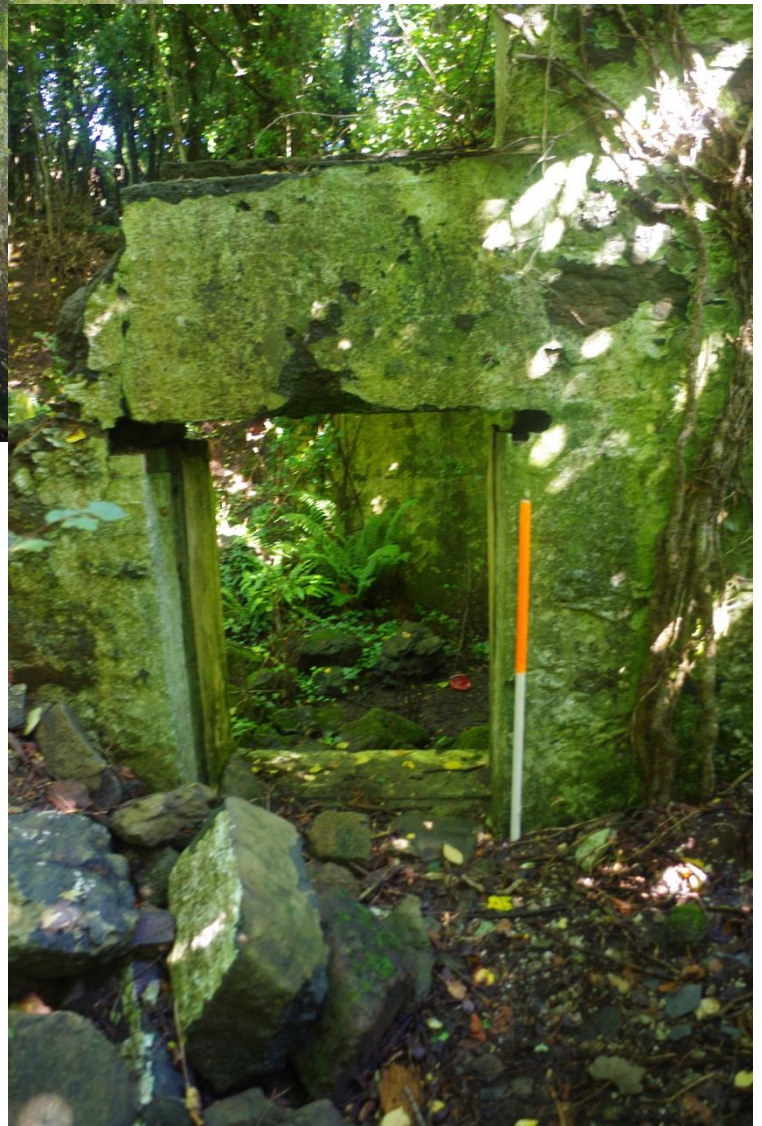
Fig 12 Carn Kennack, top – looking in to the internal south-eastern corner showing a low doorway and a large upper floor window; right – looking north-east in to the building. Note the rotted out timber lintel, upper window and heap of external wall tumble.

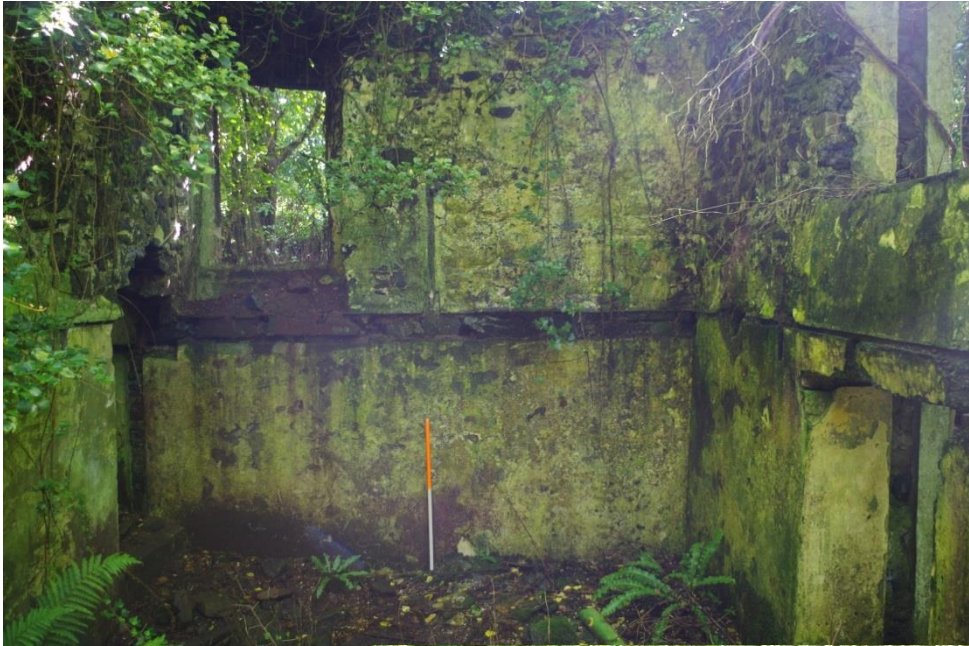
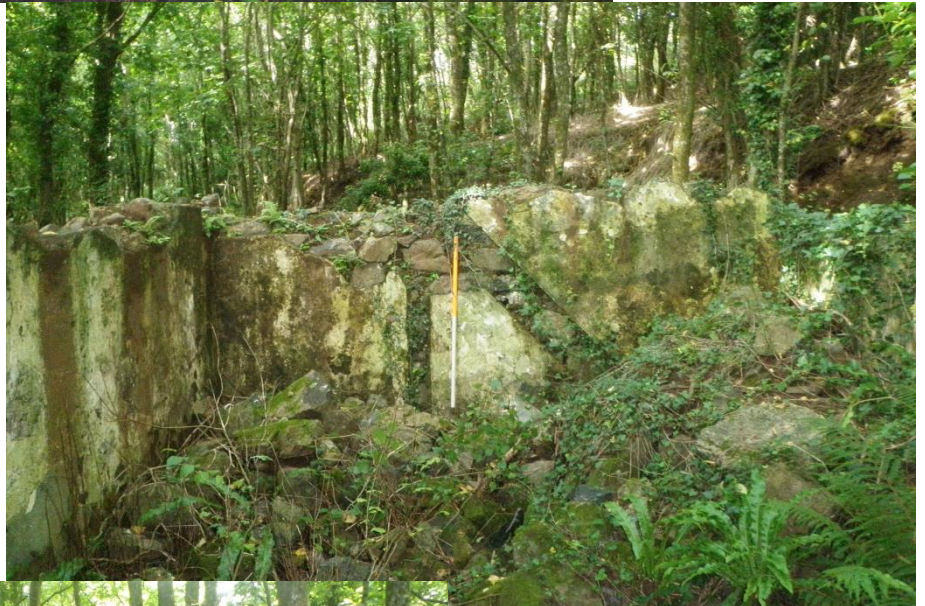
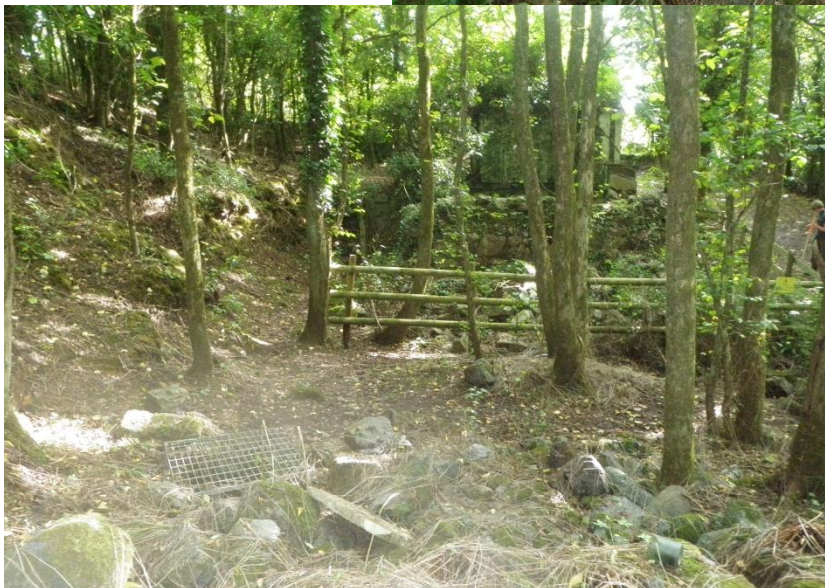
Fig 13 Carn Kennack, top – showing the internal south-eastern half of the building; middle – showing the internal north-western half of the building, note the impressions shown in the render; bottom – overlooking the whole building from the north-west, note the gridded well cover in the foreground.

The northern wall showed the position of several former internal features which appeared to represent wall fixtures – possibly for machinery? (Fig 13, middle). The 0.15 and 0.3m wide, 0.025m deep marks were defined by thick white render. As the photograph shows, the ground floor level was not visible, and it is possible that further associated detail exists below ground. The remains of a window sill were visible from outside at the top of the wall. It showed small drill marks typical of the late 19th century. None of the upper floor remained.

The western wall increased in height from north to south. The highest part survived because of the more massive stonework associated with an upper floor window over a ground floor large window or small door. This lower opening had a 1.25m height, but the base of it appeared close (within 0.3m) to the internal ground surface (Fig 12, bottom – note the rotted out external timber lintel, Fig 13, top, right side). Figure 11

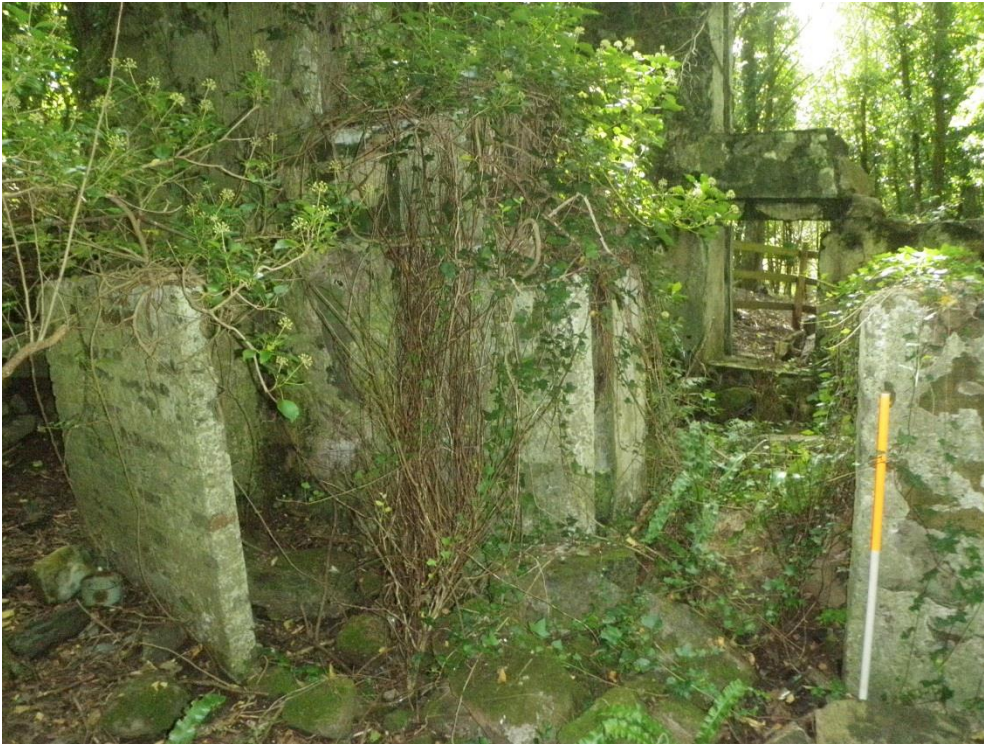
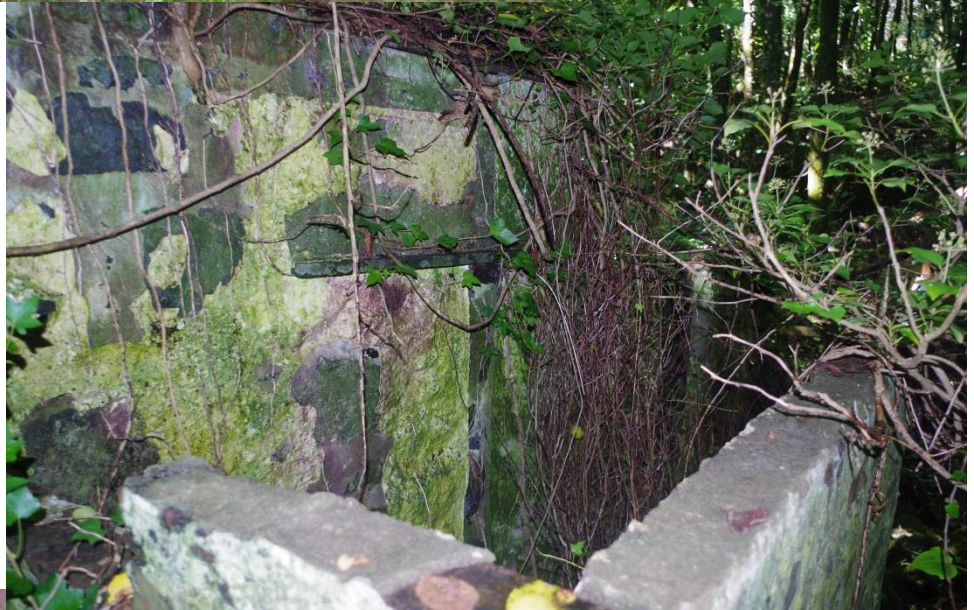
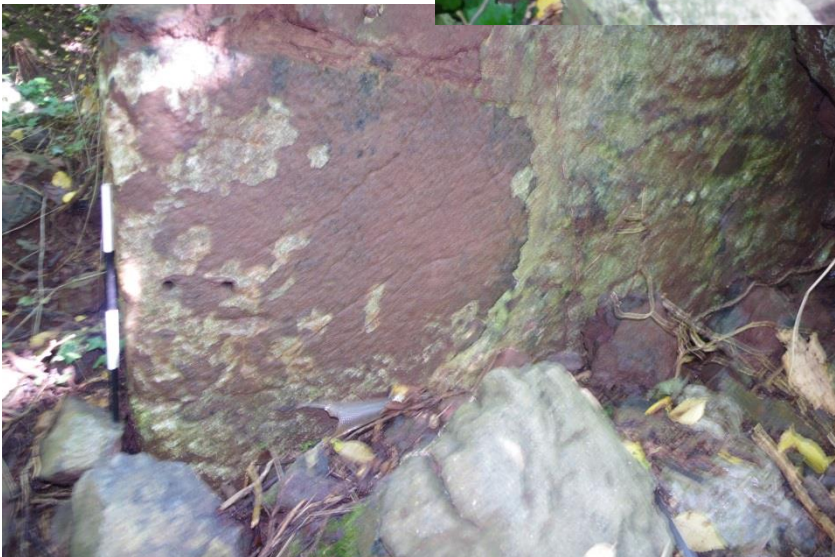
Fig 14 Carn Kennack, top – looking south-west through the building showing the brick extension to the left; middle – alterations visible in the walling above the brick extension; bottom – close-up of the external north-western corner of the building showing a very large cut stone with drill marks.

Between the ground floor door and large window, was an externally attached brick-built extension. The roof and door were missing and there was no internally visible plumbing or fixtures. However, a horizontally positioned slate built in to the main east wall could be seen (Fig 14, middle). This did not show internally and appeared un-related to roofing associated with the extension. This small extension may have functioned as a small store as opposed to an outside loo (which is what it initially looked like).
