Caerhays Castle, Cornwall: Investigation and Conservation of the Battery Arch, Kennels and Walled Garden

Report No: 2016R065

Client	Caerhays Castle estate
Report Number	2016R065
Date	October 2016
Status	Final
Report author	Nigel Thomas BA MCIfA (on behalf of CAU)
Checked by	Jo Sturgess
Approved by	Andy Jones

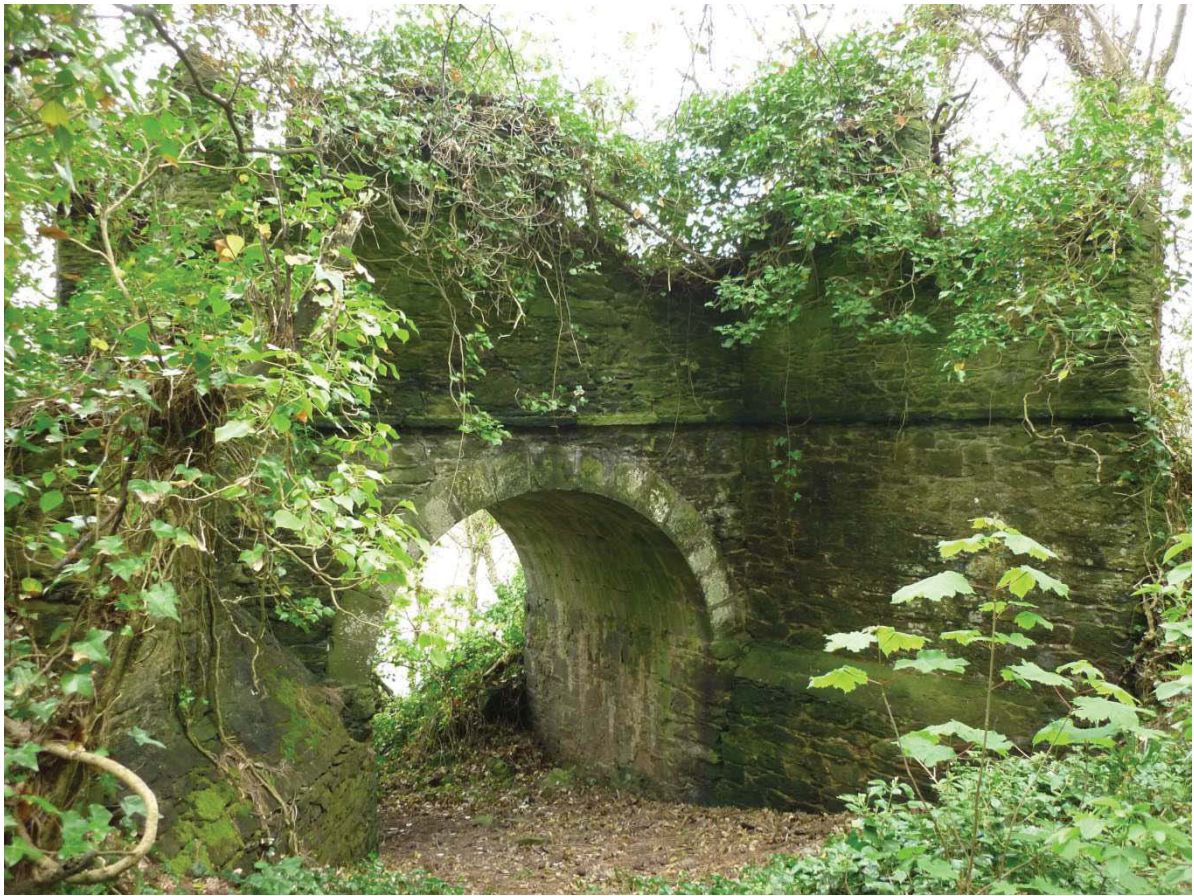
Figure 13 A view of the heavily overgrown and ruinous Battery Arch in 2014.

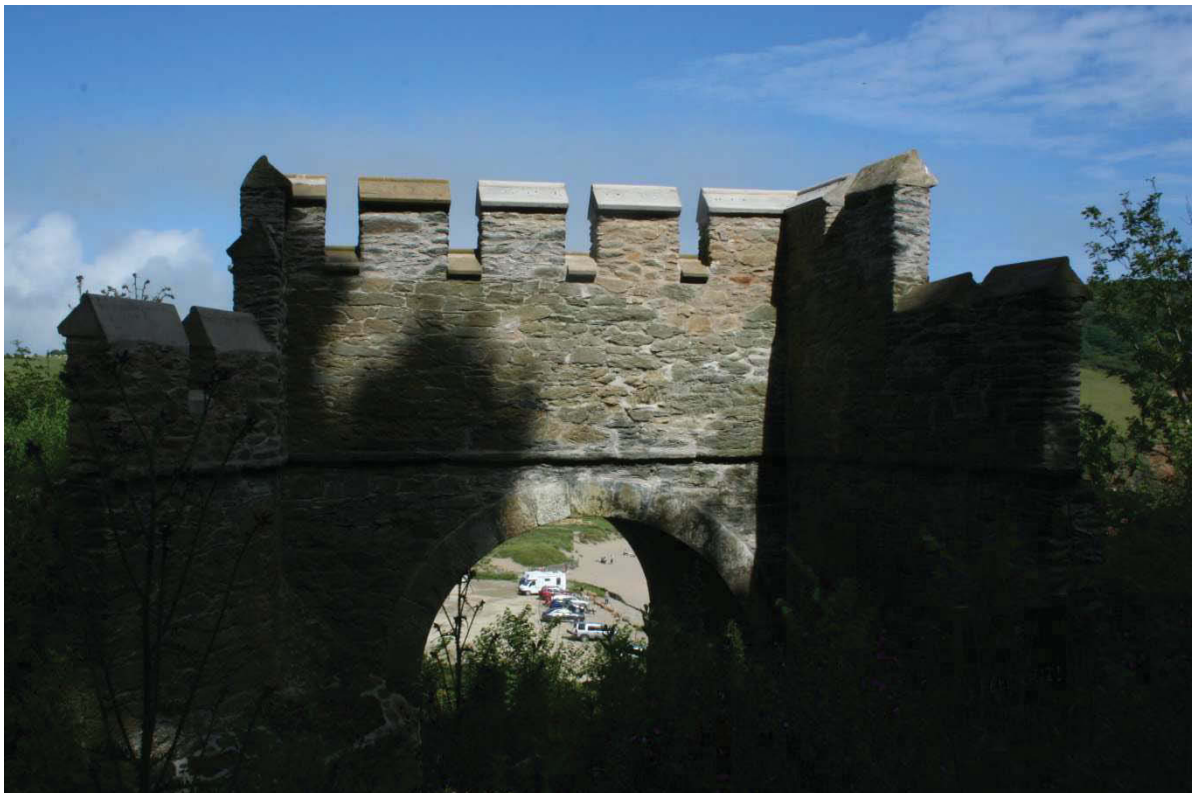
Figure 14 A similar view, after renovation works, in June 2016.

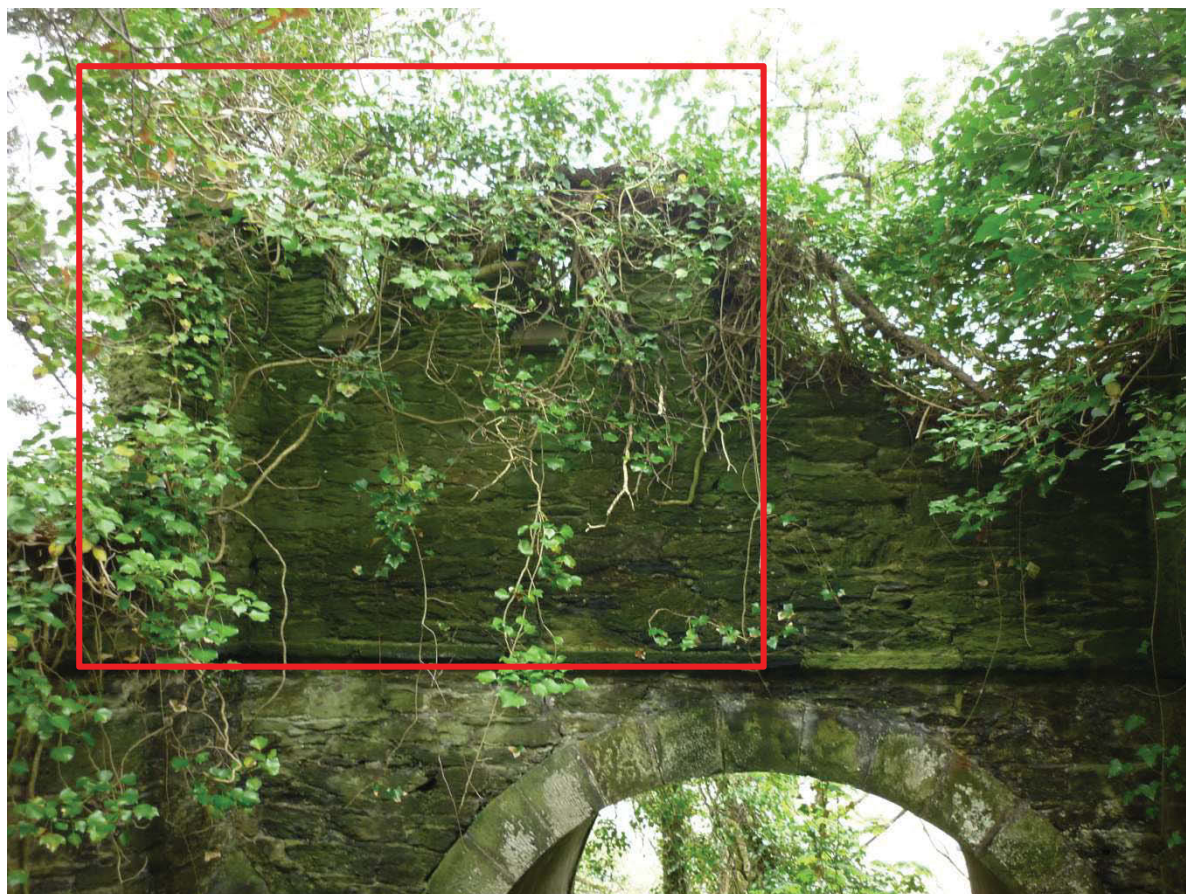
Figure 15 The overgrown and decayed parapet masonry in 2014.

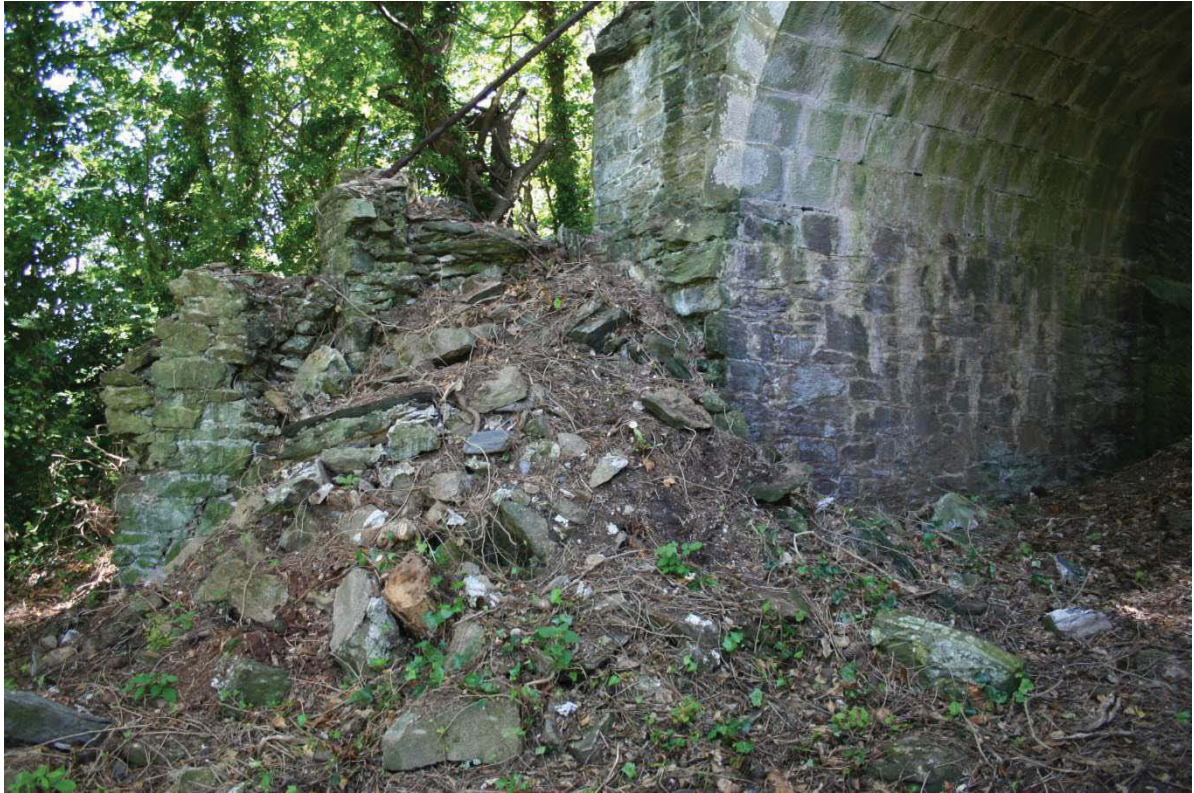
*Figure 19 Collapsed masonry covering the southeast flanking wall.
The remains of the stair turret are also visible (centre, top).*

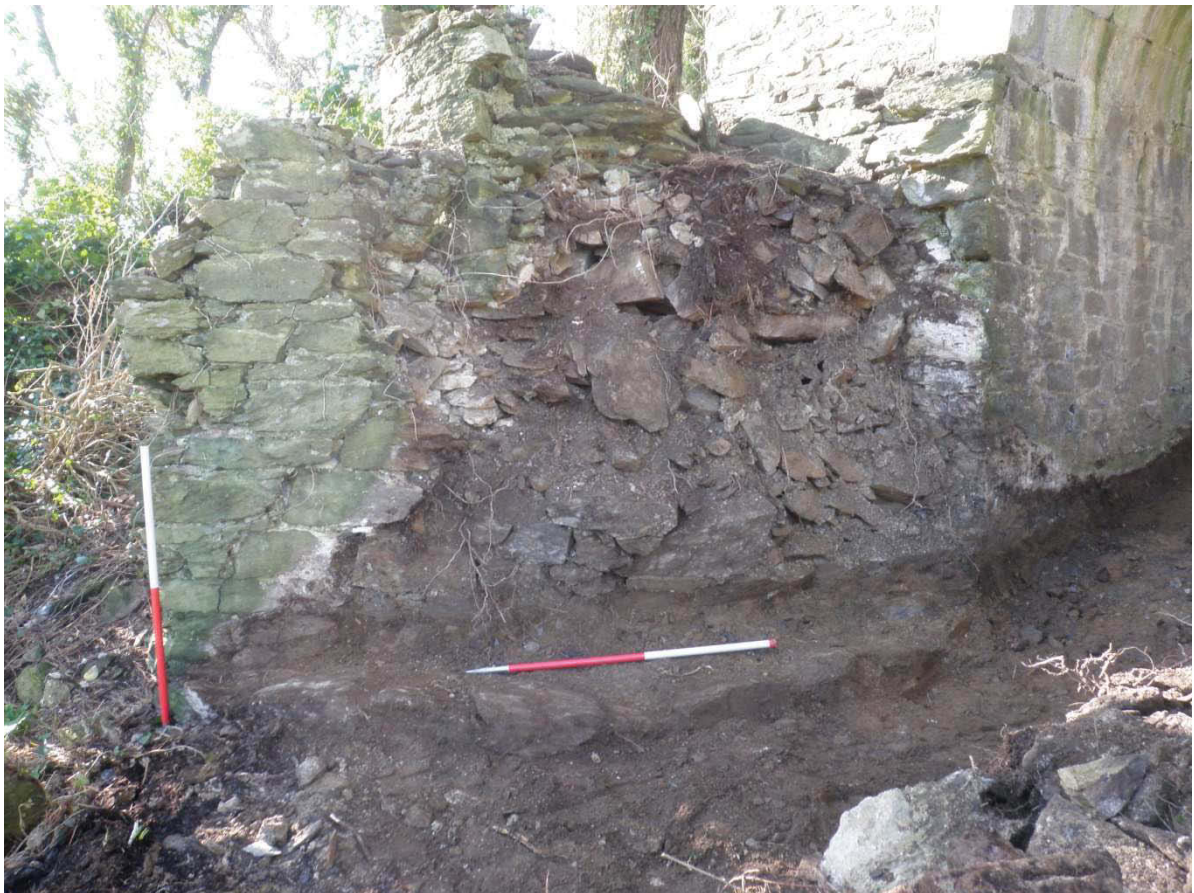
Figure 20 Removal of fallen masonry revealed a kerb at the foot of the wall.

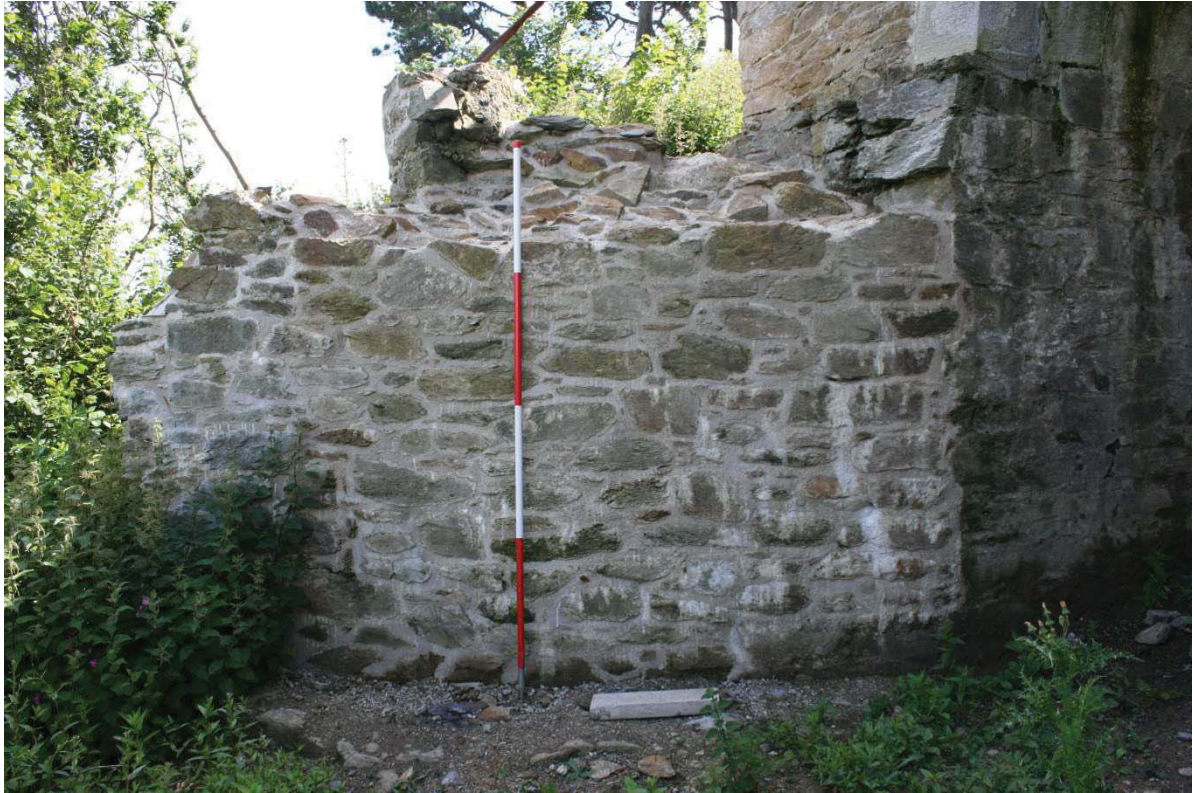
Figure 21 A similar view after rebuild of the tumbled wall face.

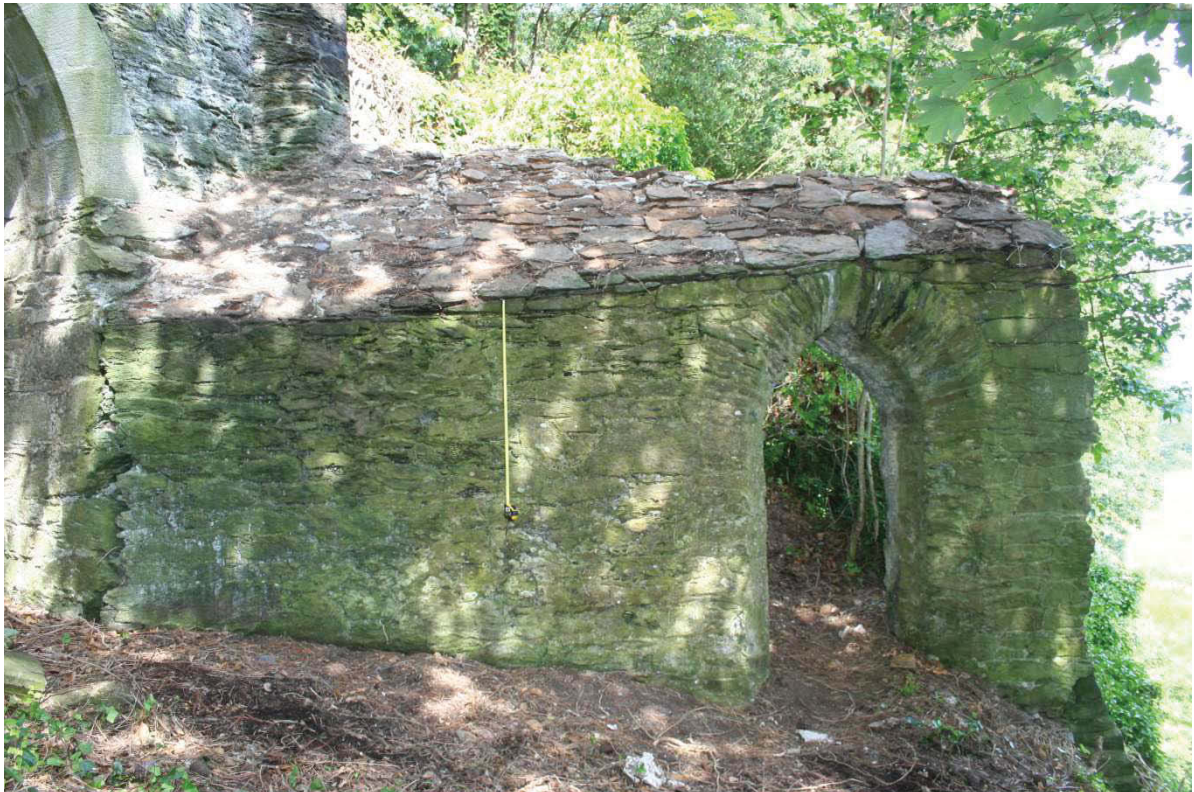
Figure 22 The north east wall prior to renovation.

The Gothic archway once linked a footpath from the Castle to Battery Arch. This access was removed when the Great Cut was created circa 1858.

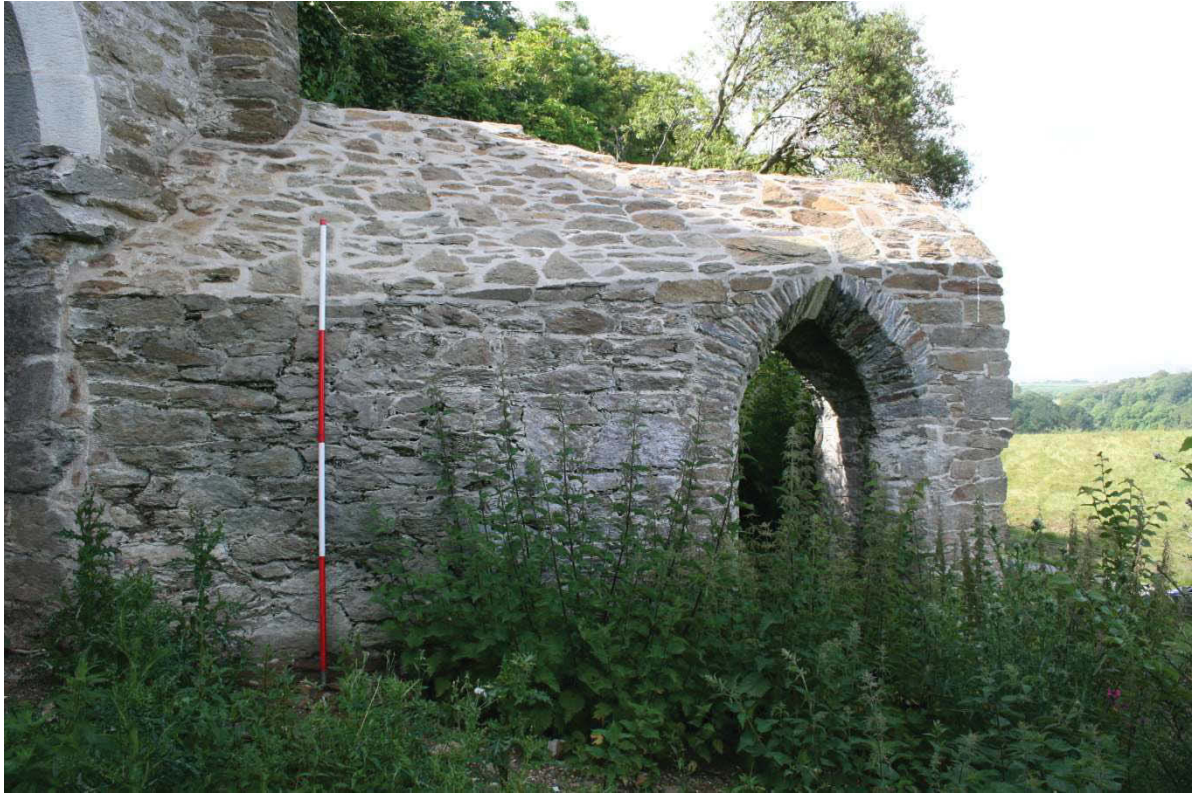
Figure 23 A similar view after completion of re-pointing works.

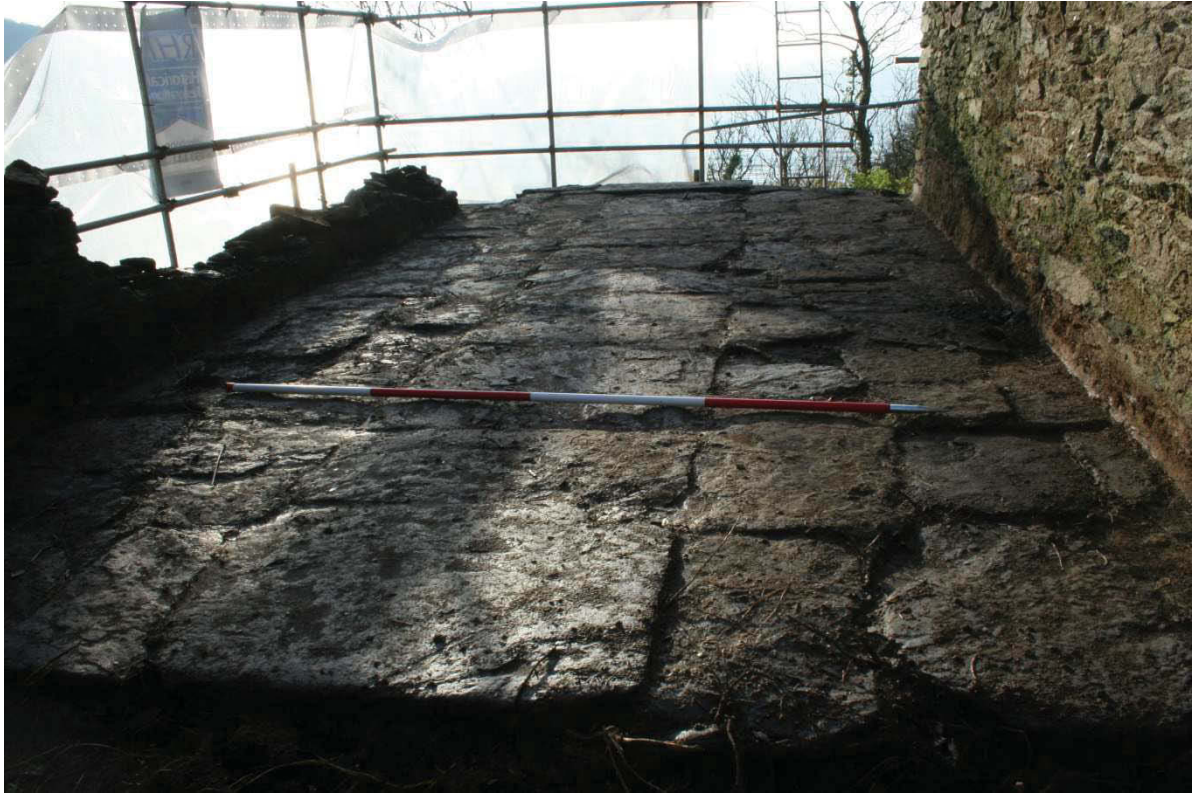
Figure 25 Removal of soil from the platform revealed surviving flagstones.

Removal of the debris revealed the original slate flagstone paving of the platform, remarkably well preserved although some of the stones had decayed where disturbed by roots (Fig 25). The central line of flagstones comprised neat squared paviments but less regular stones had been used nearer the edges (Fig 35). At the southeastern corner of the platform the top of the original access steps was exposed (Fig 26). There were also traces of a mortar line existing on the flagstones on the south side, indicating this side had also once been enclosed by a masonry parapet. This feature had completely disappeared, only traceable as tumble on the south side of the structure.

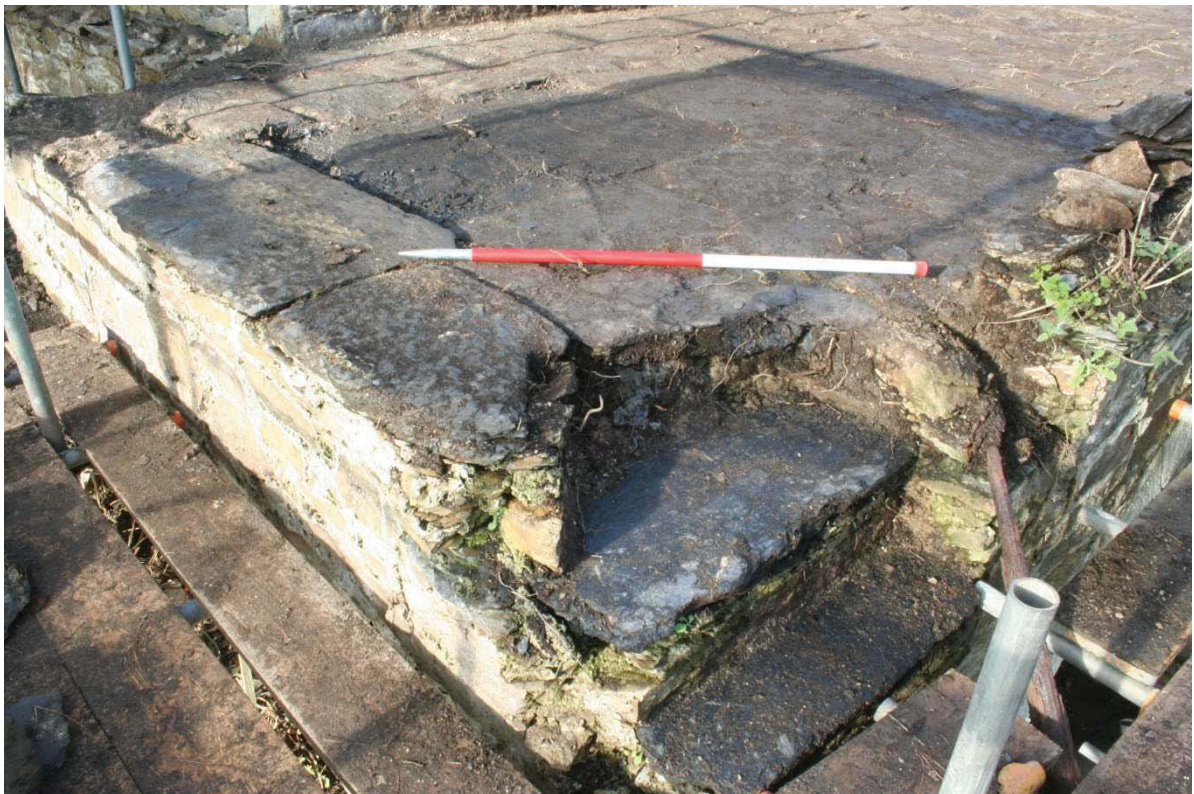
Figure 26 At the south east corner of the platform the top of the original access steps was revealed.

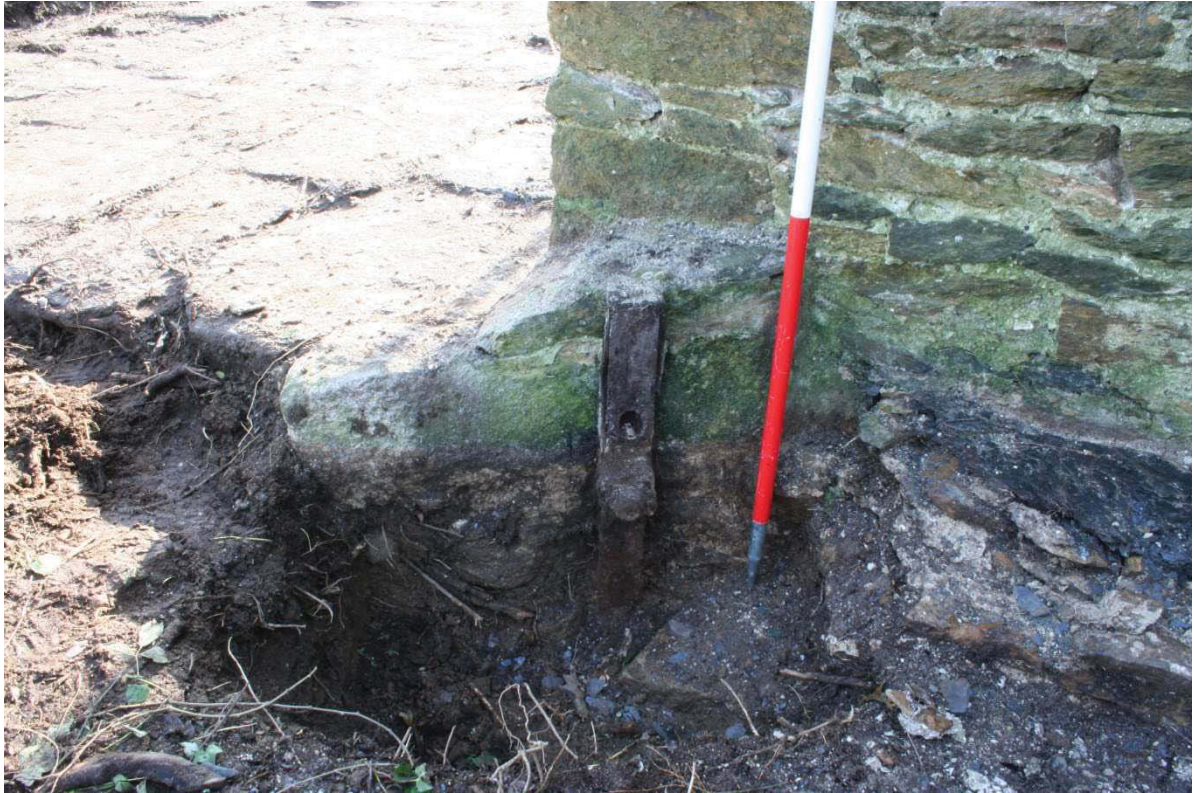
Figure 27 An iron tie-bar running diagonally across the structure, beneath the flagstone paving.

This feature was added as a bracing to try and prevent movement of the stair turret at the south east corner of the platform. A granite block has been added behind the bar. Addition of the tie bar would have involved lifting and replacement of part of the flagstone floor.

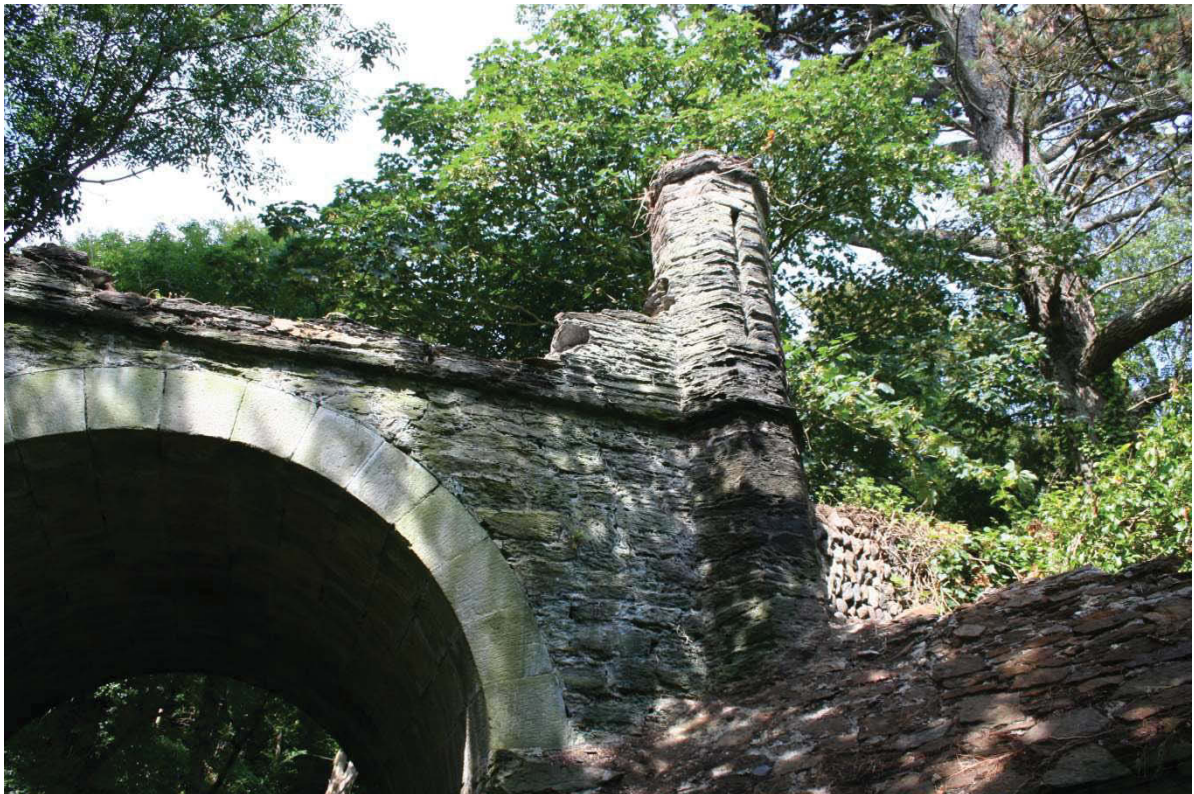
Figure 28 View of the decorative pinnacle and remains of the eastern parapet.

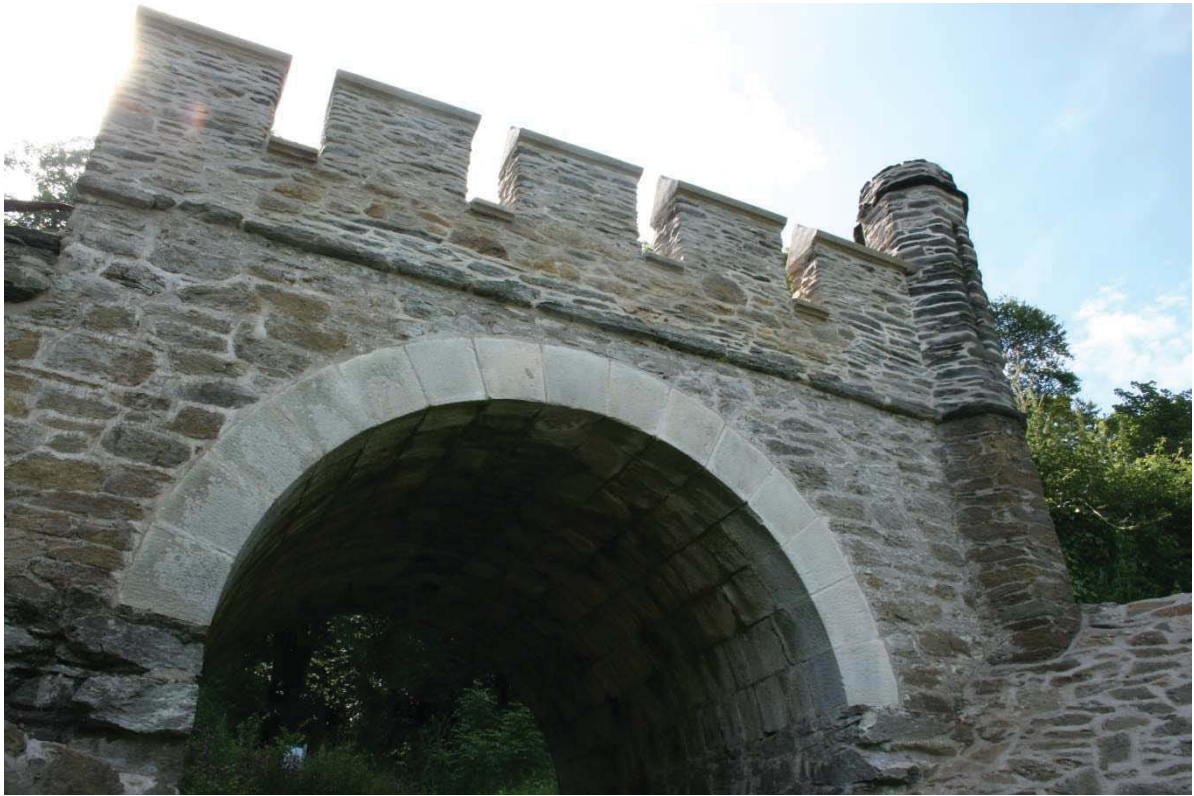
Figure 29 A similar view after replacement of the parapet.

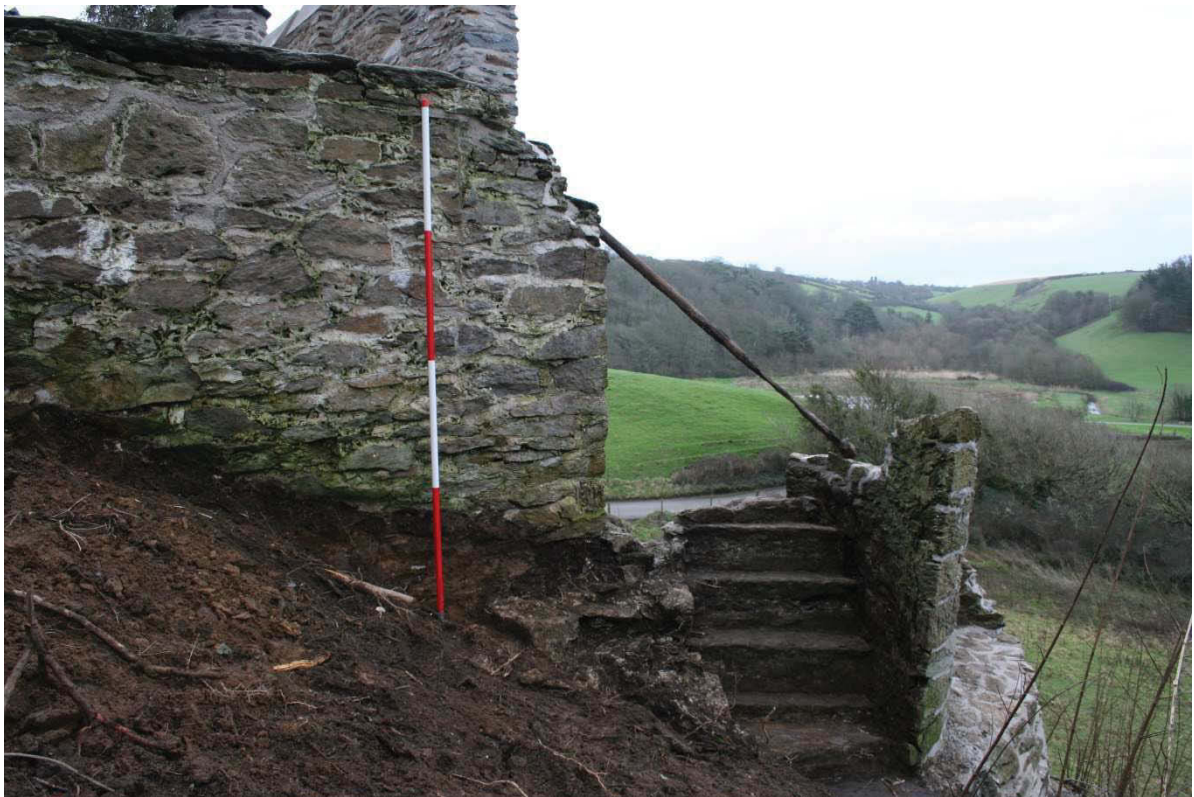
Figure 30 The south side after re-exposure of the base of the stair turret.
The drooped remains of the secondary tie-bar can be seen above.

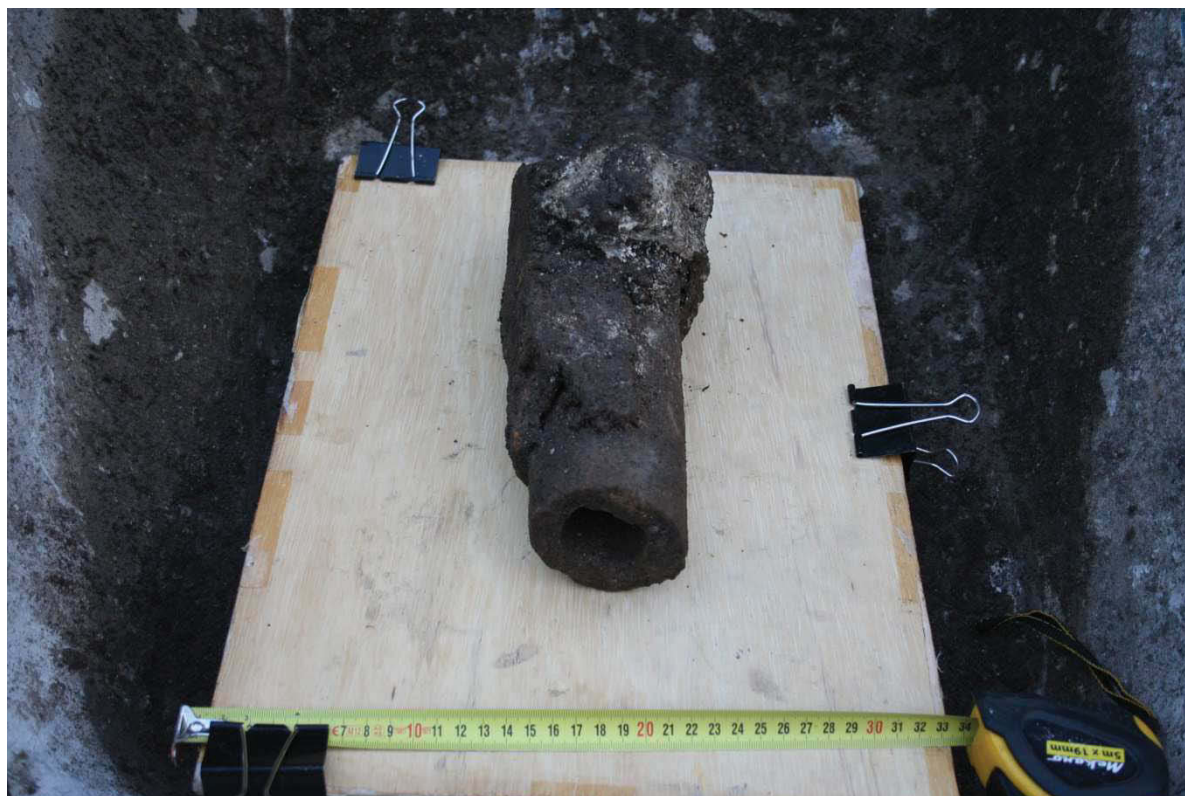
Figure 31 A fragment of a gargoyle, probably from the stair turret roof.

There was no surviving indication of any drainage arrangements for the platform, although the paving slightly sloped downward from west to east. As the base of the eastern parapet was solid, no drainage outlets were provided, although it is possible that a gargoyle type outlet was provided close to the stair turret. A fragment of a gargoyle, made from moulded cement-based mortar, was found by the contractors around the base of the arch (Fig 31).

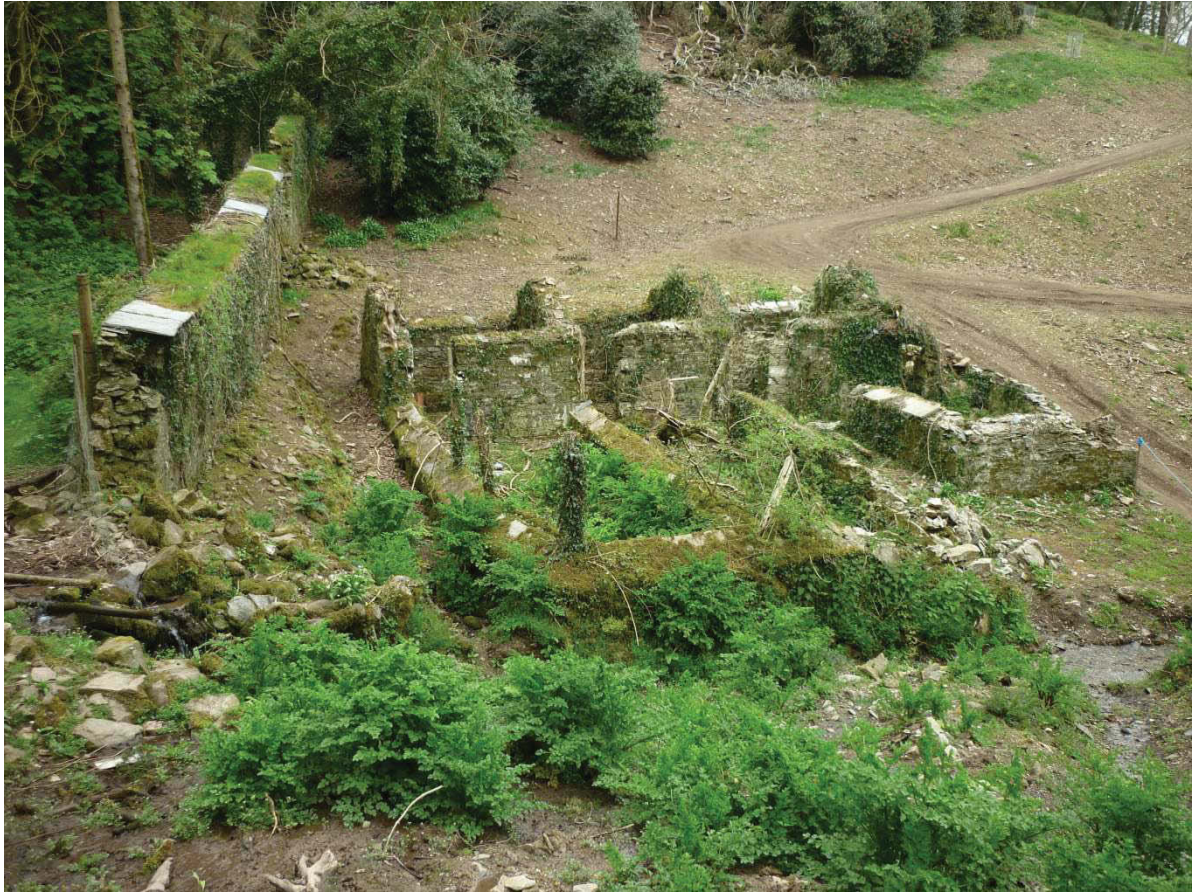
Figure 48 The derelict and partially overgrown kennels in 2014.

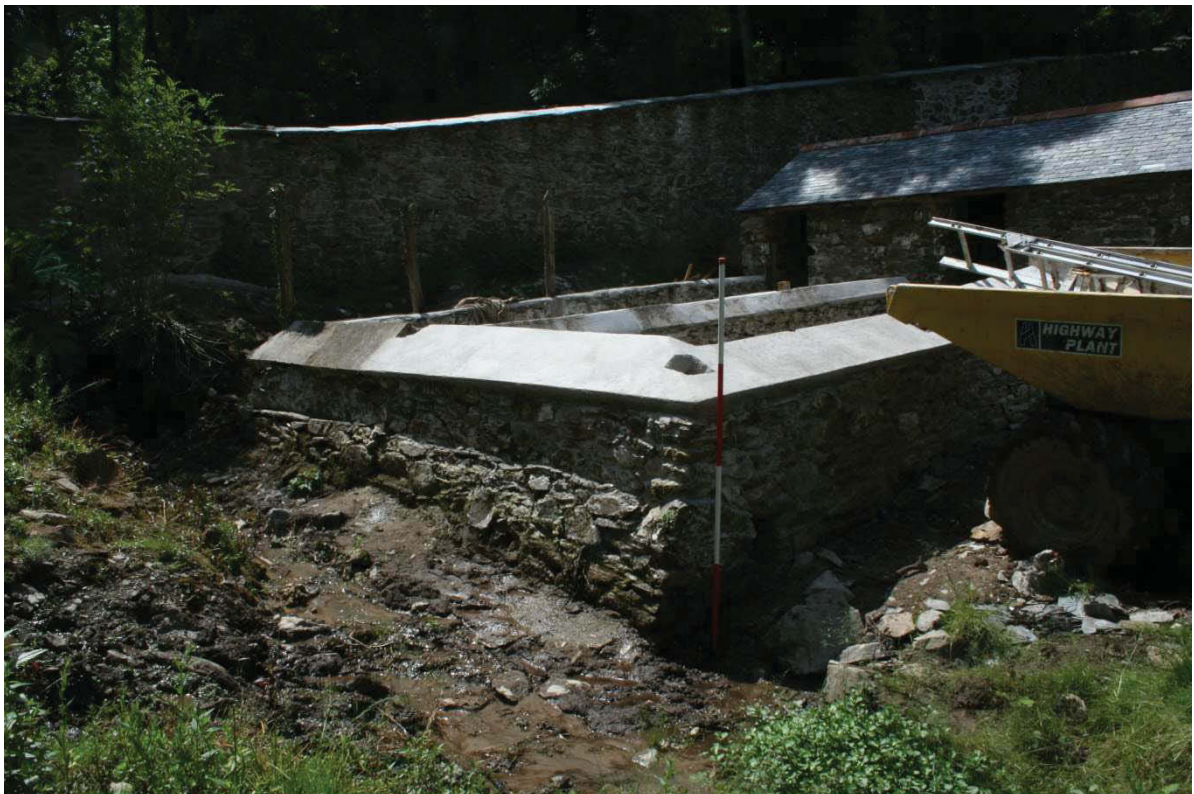
Figure 53 Vegetation clearance and renovation works revealed that the southern wall has a battered foundation above the line of the adjoining stream.

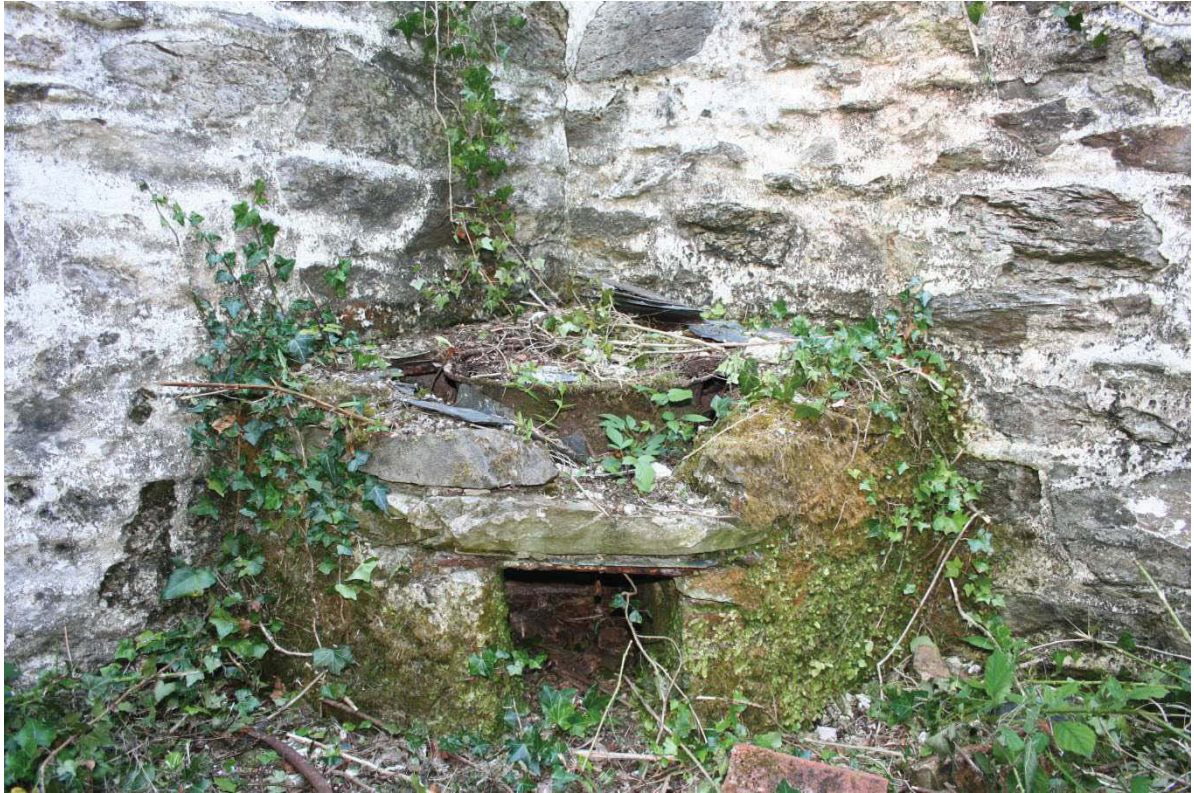
Figure 54 A derelict (but intact) cast-iron boiler, within the feed house.

Bricks in the foreground are from the collapsed chimney stack on the gable wall (out of shot, above right).

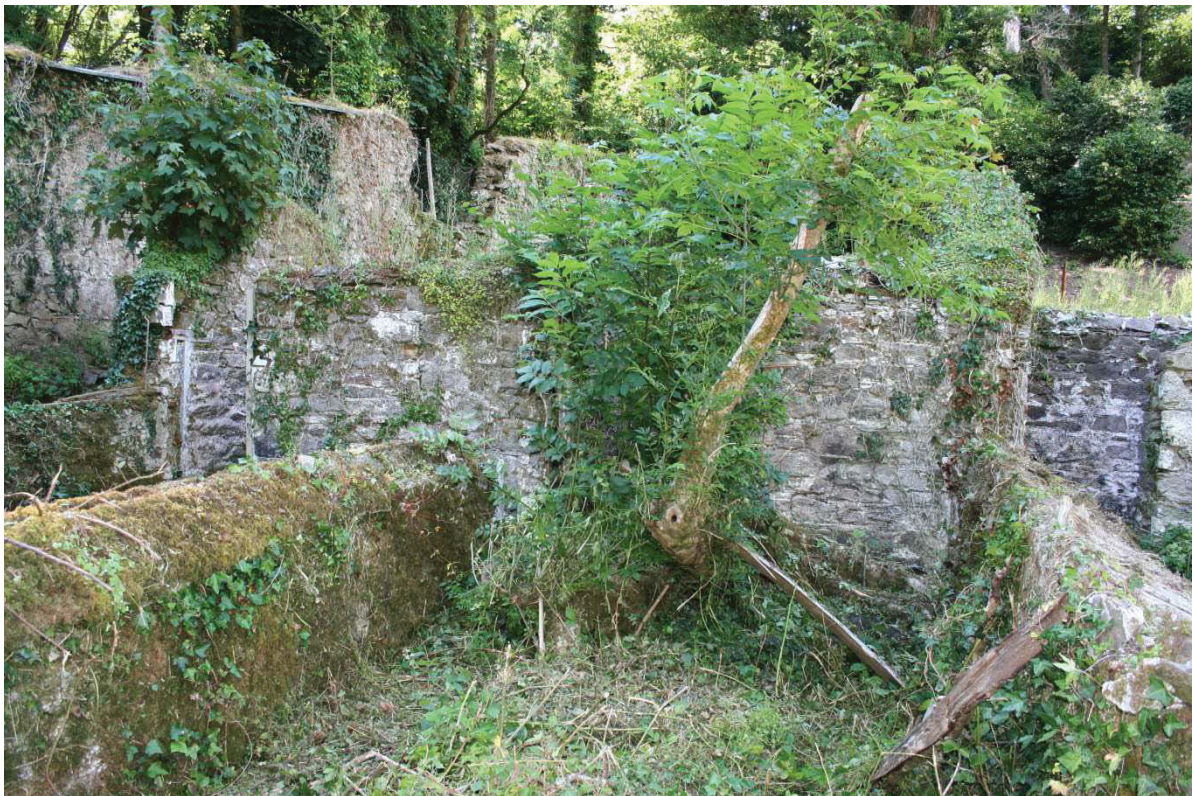
Figure 55 Damaging tree growth on the gable wall (left) and in the centre yard.

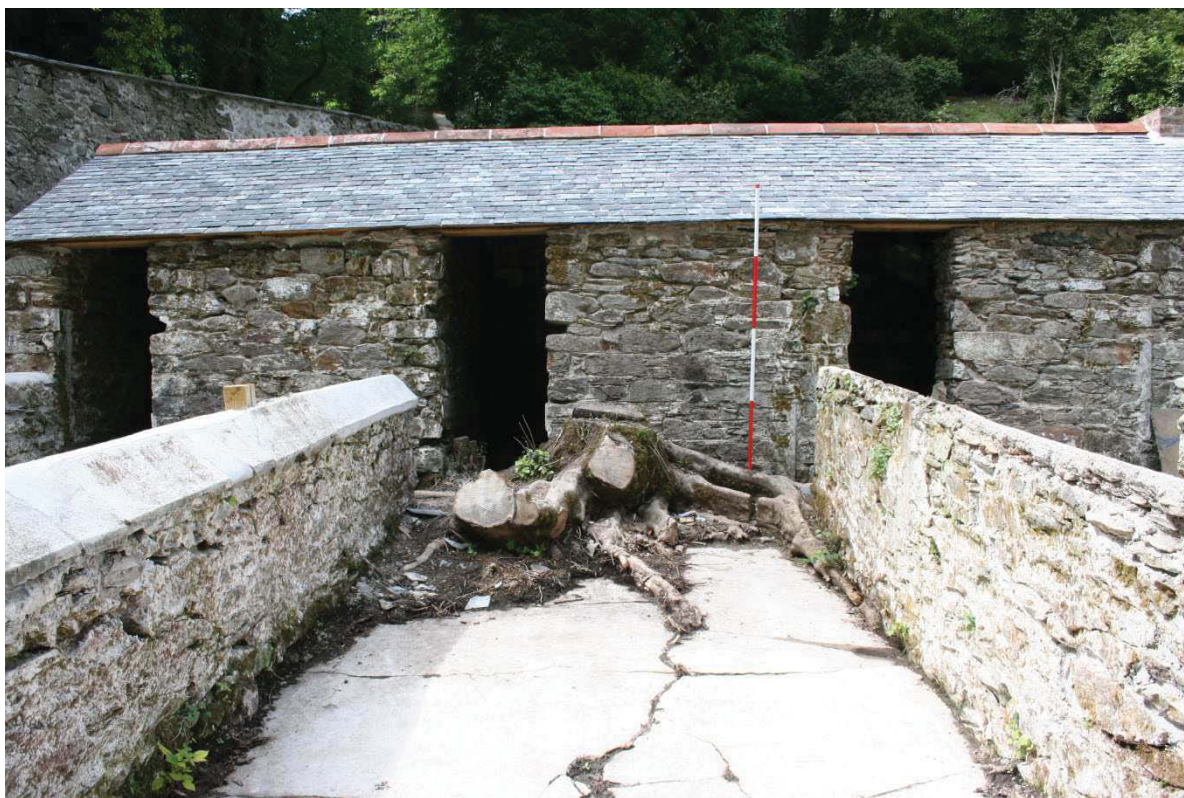
Figure 56 A similar view in June 2016.

The sprawling tree stump has roots penetrating the concrete yard surface.

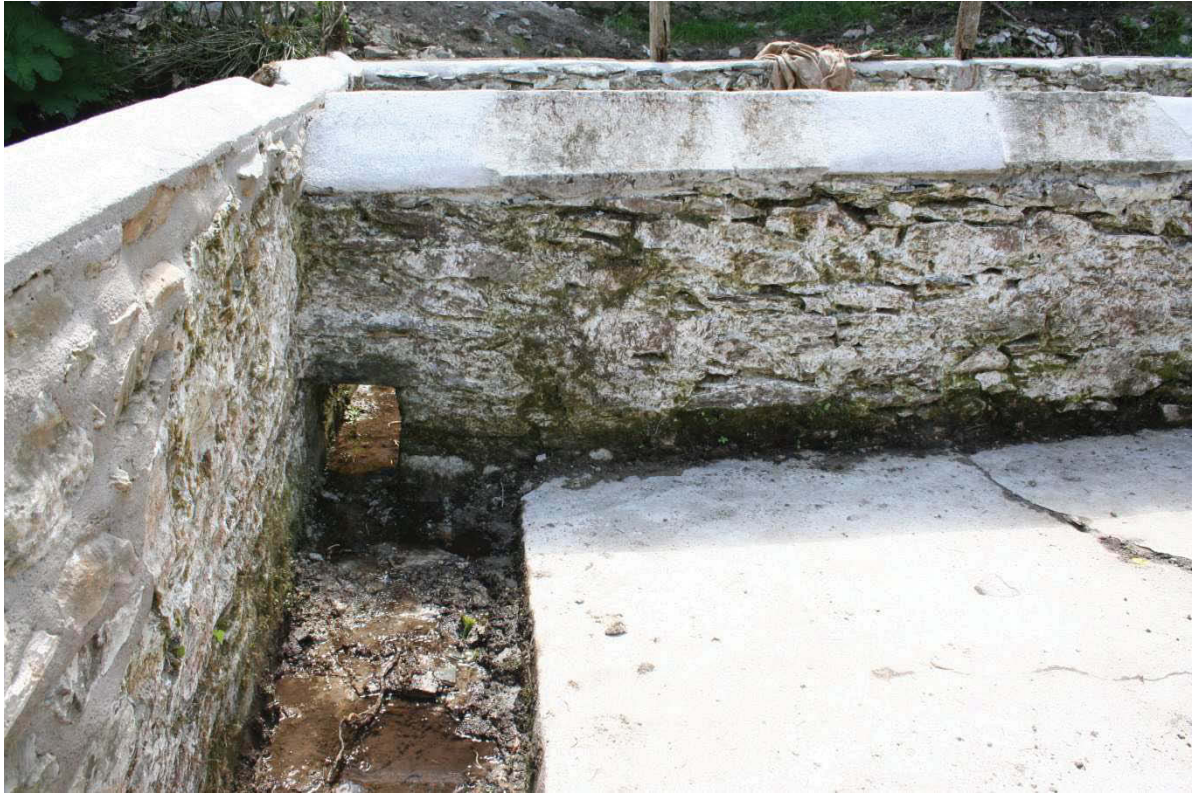
Figure 58 Culvert beneath wall to allow diverted stream through kennel yards.

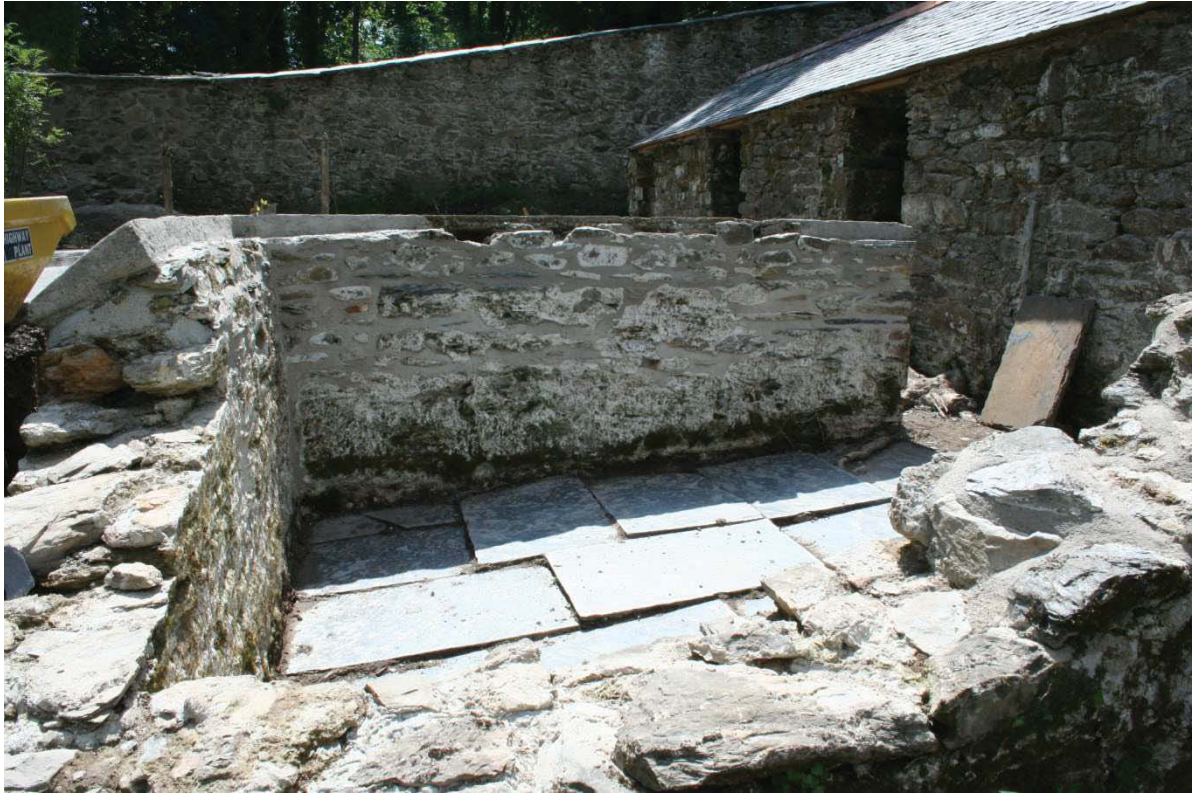
Figure 60 Removal of vegetation and soil debris in 2016 exposed a fine flagstone floor.
