Caerhays Castle, Cornwall: Investigation and Conservation of the Battery Arch, Kennels and Walled Garden

Report No: 2016R065

Client	Caerhays Castle estate
Report Number	2016R065
Date	October 2016
Status	Final
Report author	Nigel Thomas BA MCIfA (on behalf of CAU)
Checked by	Jo Sturgess
Approved by	Andy Jones

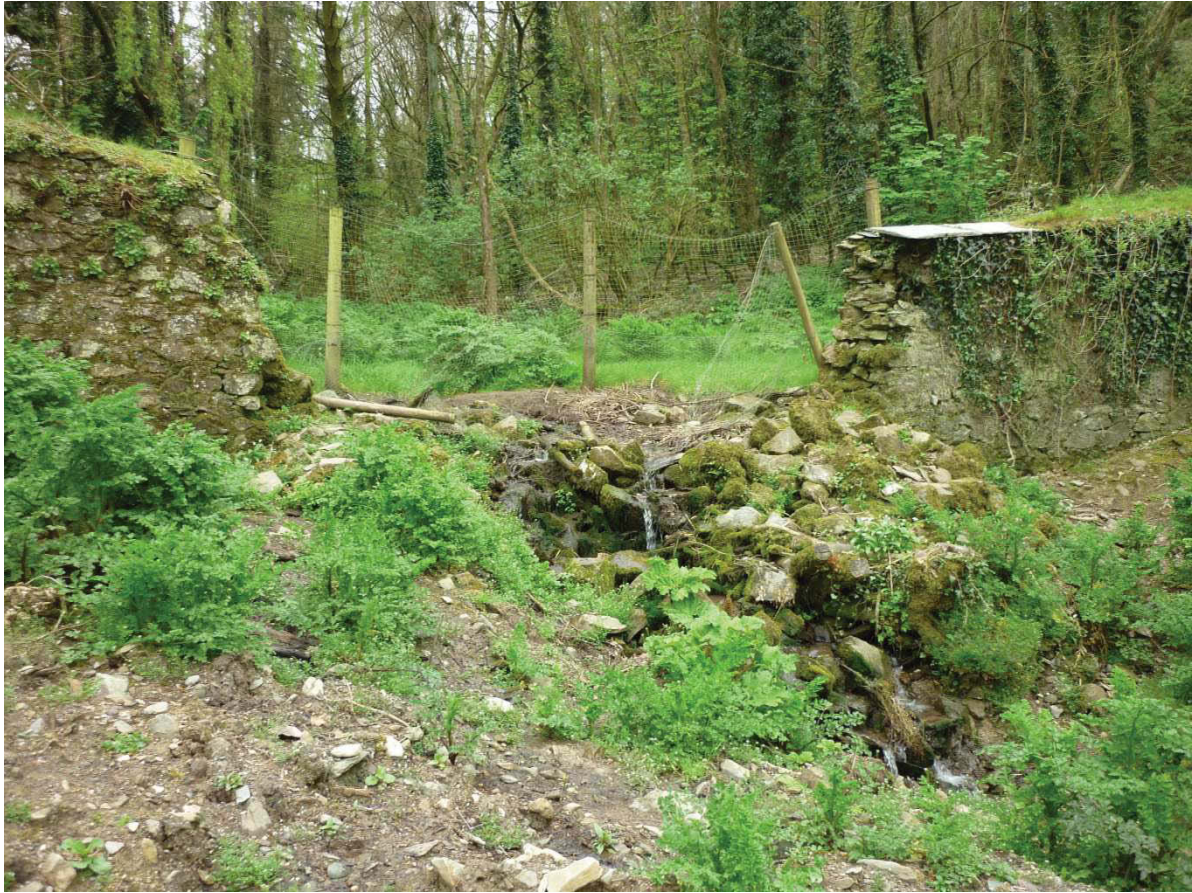
Figure 66 NE wall, showing collapsed lower middle part where stream has breached through.

- Rebuild breaches. Large breach/collapsed area beside kennels needed archaeological investigation to find original stream outflow (Figs 66-71).
- Replace copings.

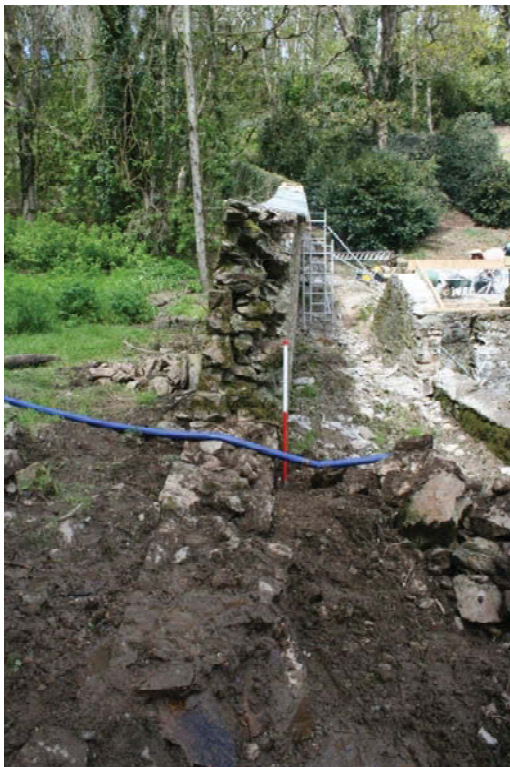
Figure 67 NE wall: Careful clearance of collapsed debris revealed the original wall foundation.

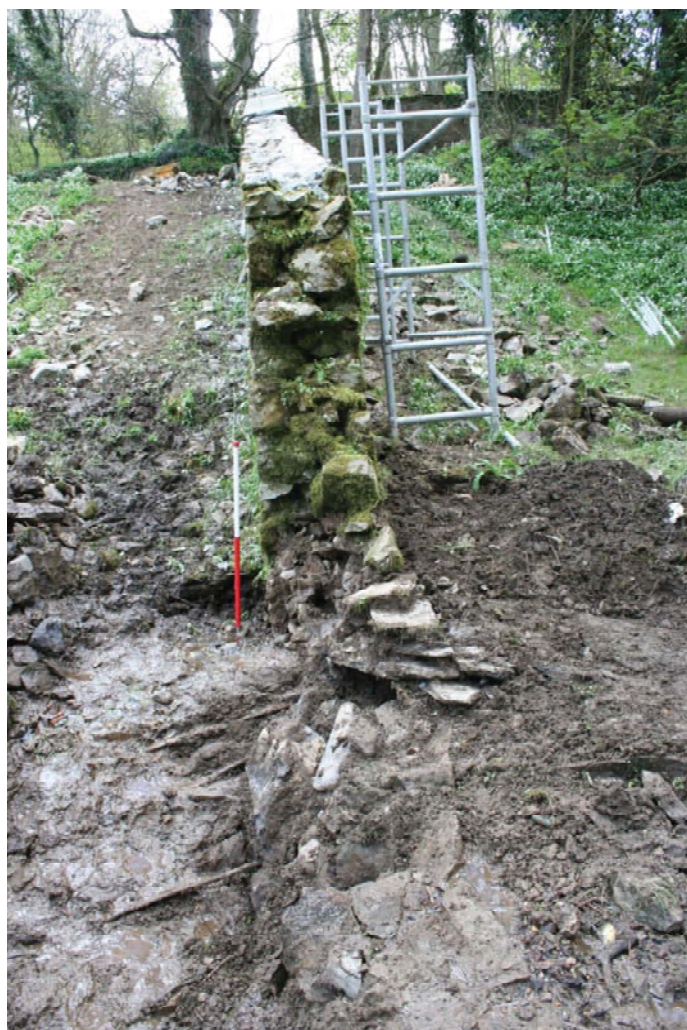
Figure 68 NE wall: Distorted foundation over blocked stream outlet.

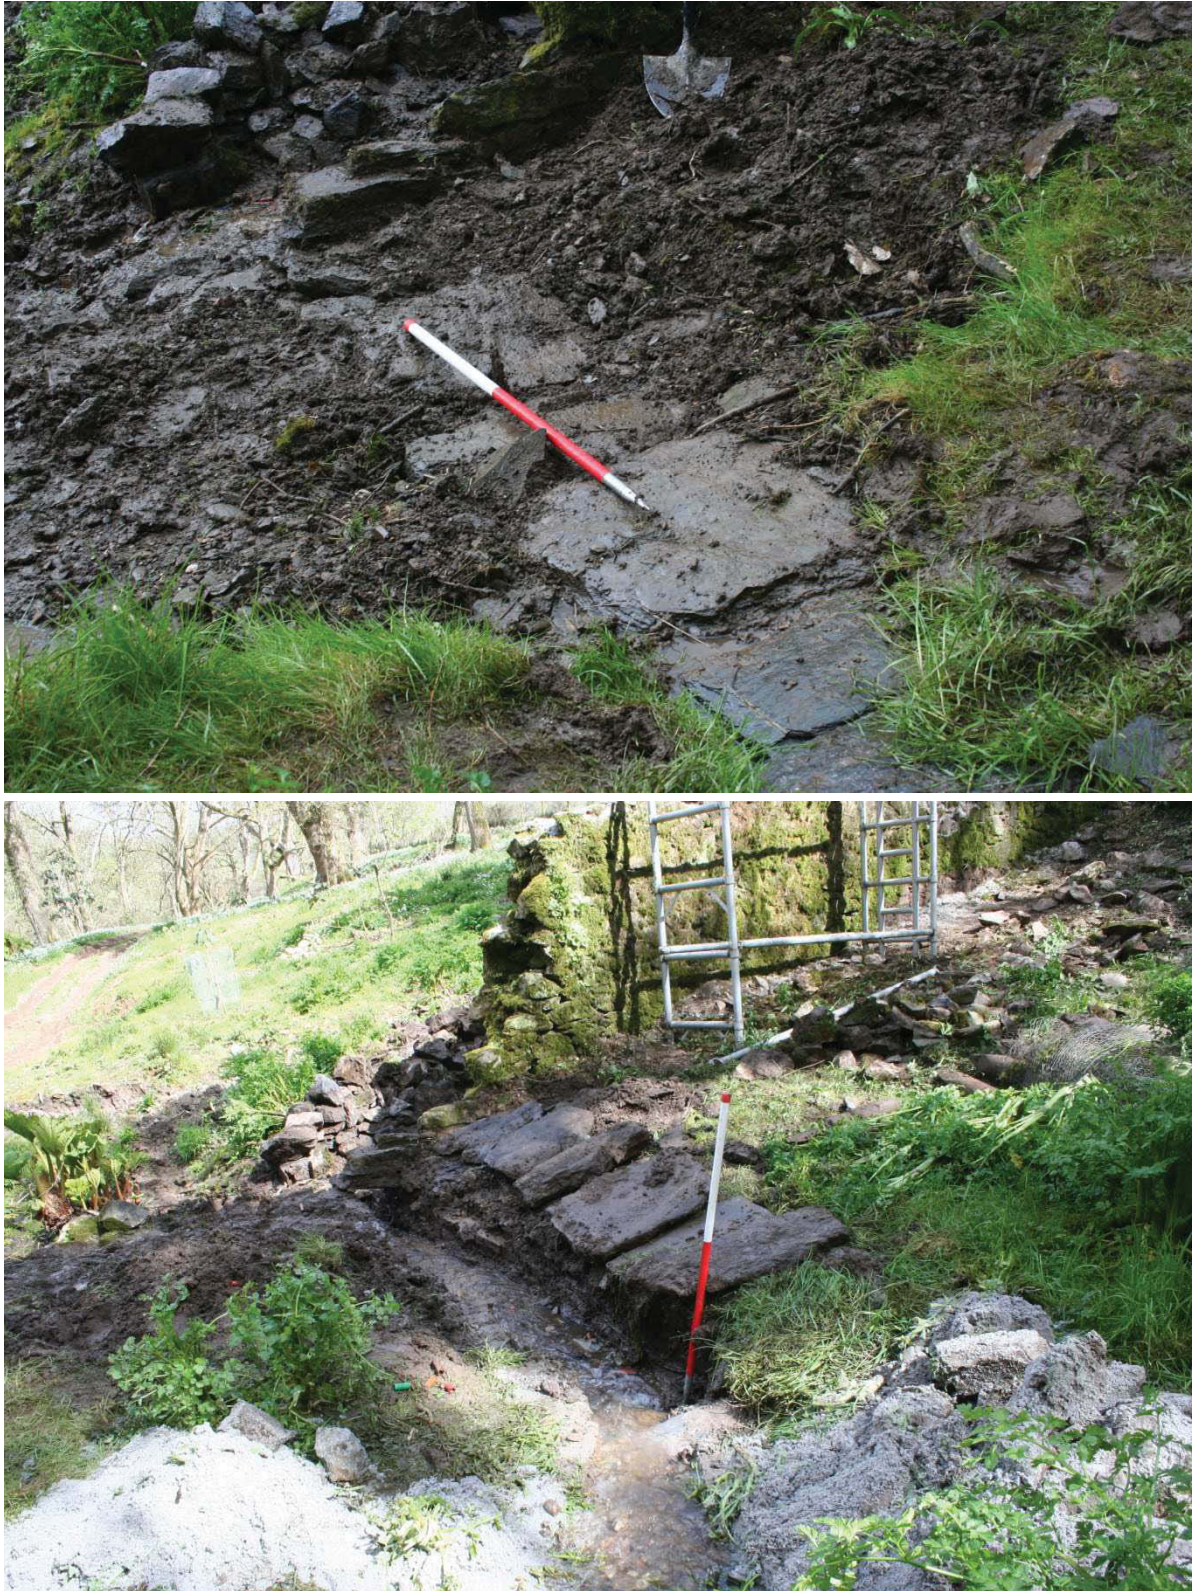
Figure 69 NE wall: Two views showing the original culverted stream course (above: slate capstones still in place; below: after temporary removal of the capstones and clearance of blocking debris).

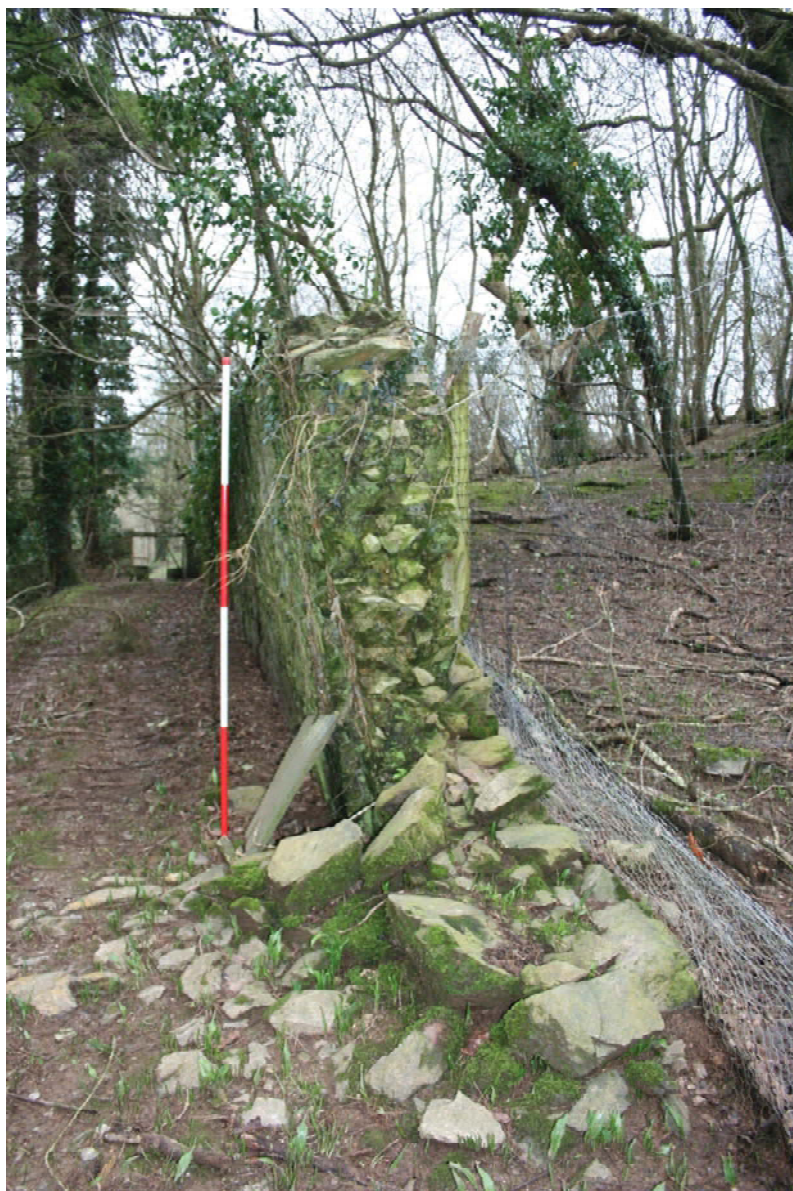
Figure 75 SE wall: severely leaning and collapsed part.

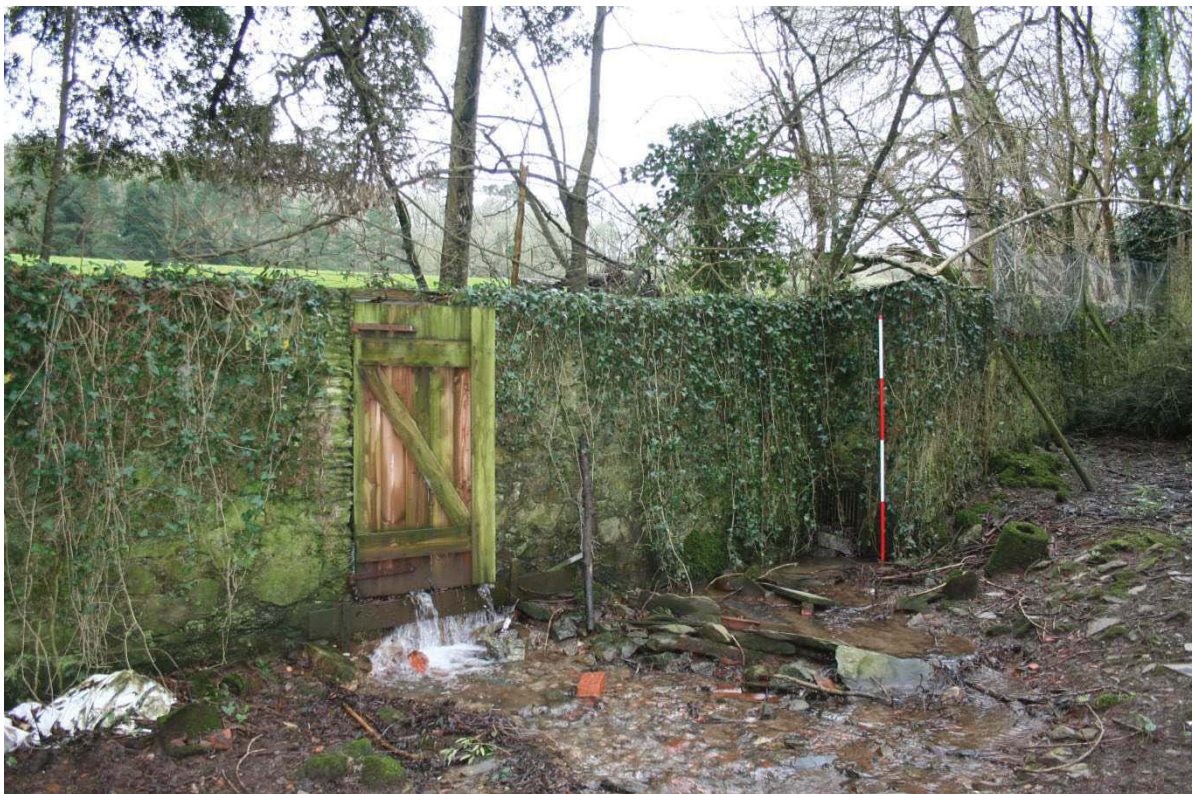
Figure 77 SE wall: Blockage of a culvert within the dogleg section (left of scale pole) has forced the stream to enter the garden beneath a pedestrian gateway.

- Maintenance: Monitor and keep stream culverts clear of debris, as blockages will cause flooding and damage to garden walls.
- Study estate records to find references to this garden, planting schemes, etc.
- Trace, survey and clear out original course of culverted stream through the garden. Re-route stream in original course so as to cause less damage to neighbouring parts of the garden.
- Trace and survey original paths and any other internal features.
- Clear debris from and survey the remains of the greenhouses.

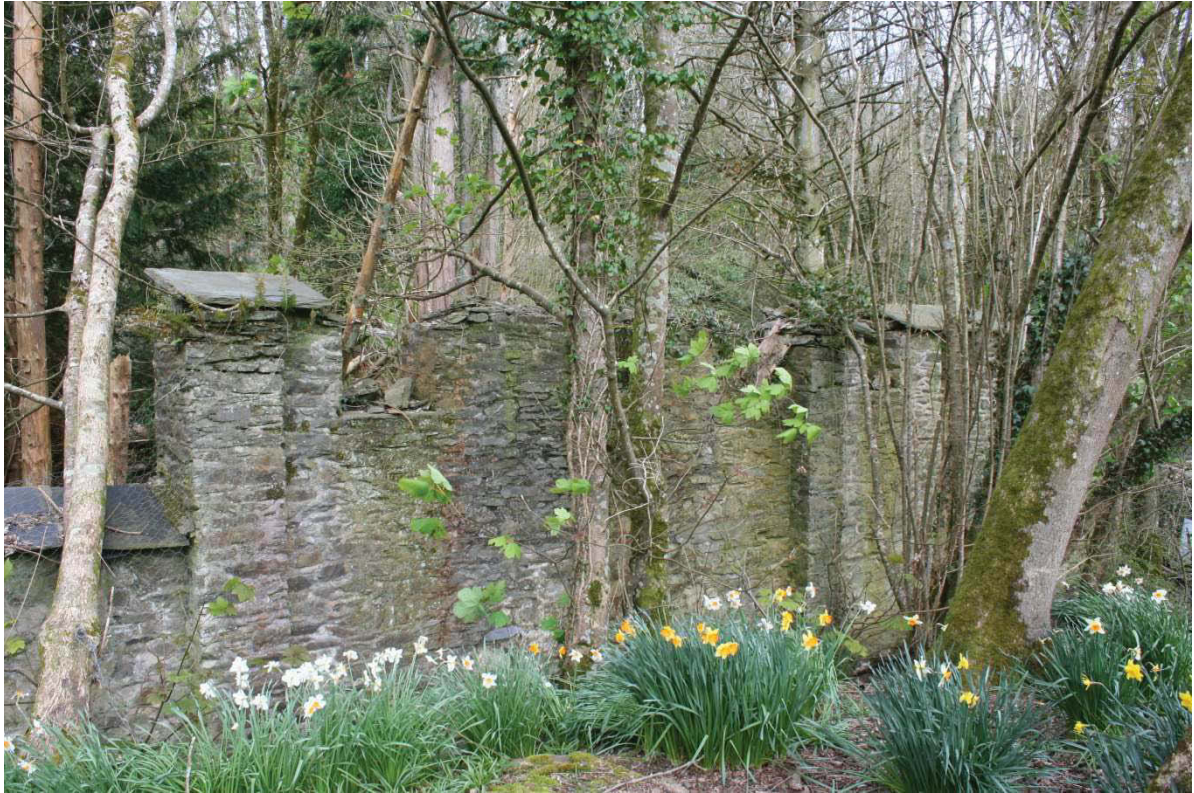
Figure 78 Remains of the lower lean-to greenhouse: the apparently crenelated wall top is the site of the top ventilators.

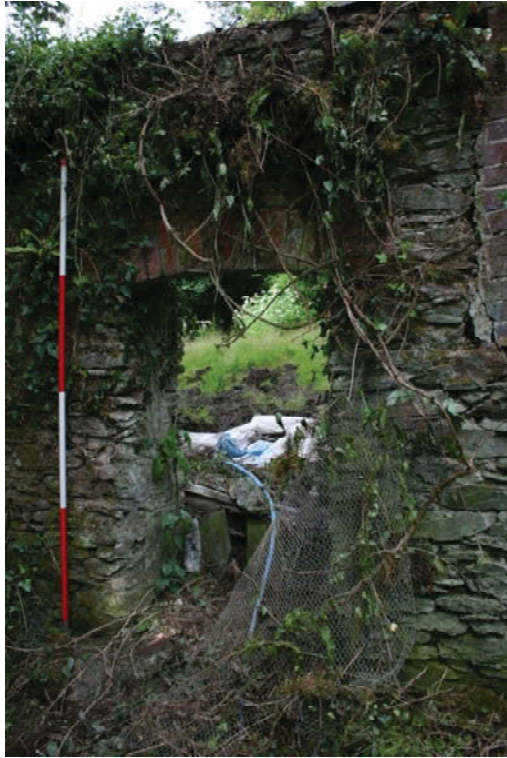
Figure 82 A brick-arched pedestrian gateway at the SW end.

This doorway was created as a breach through the original garden wall, and probably replaced an earlier opening at the south west corner.

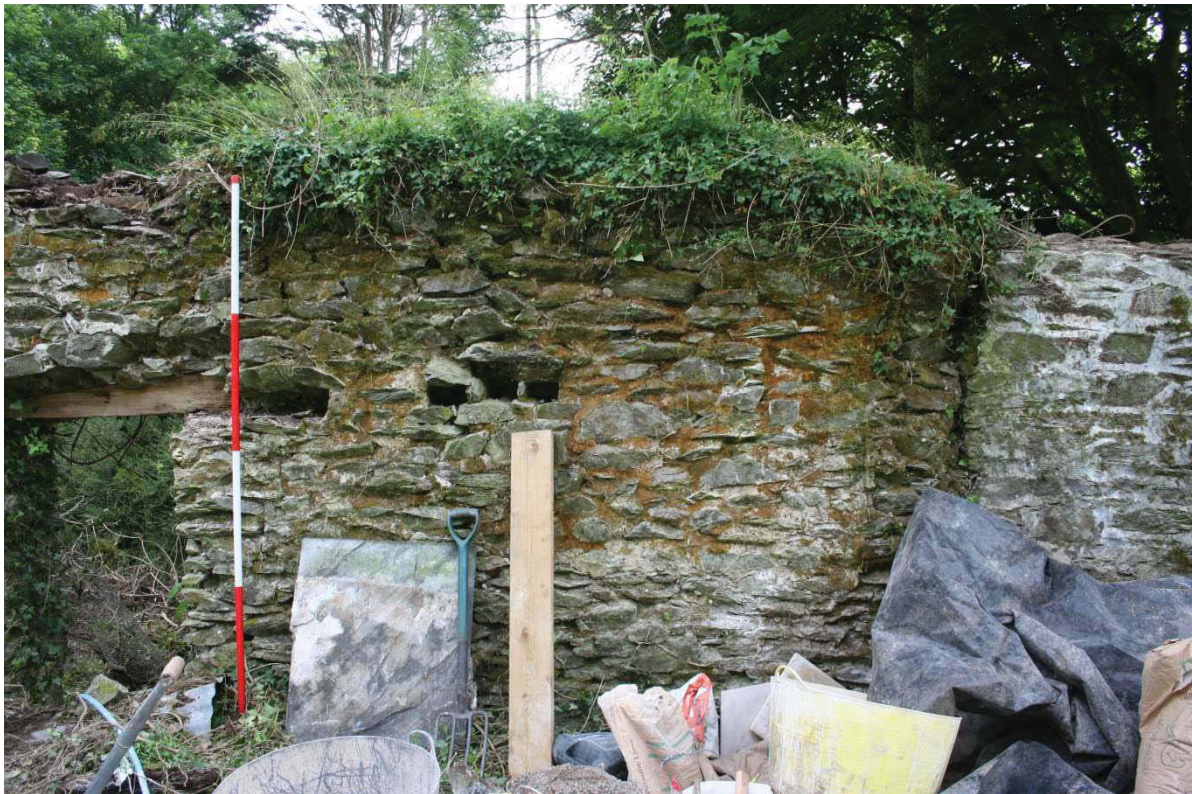
Figure 83 The same doorway, viewed from the exterior.

Lintel sockets (centre) and a wall return (towards the right) indicate the site of an external shed, mapped here in the 1870s. The wall (extreme right) is a later rebuild.

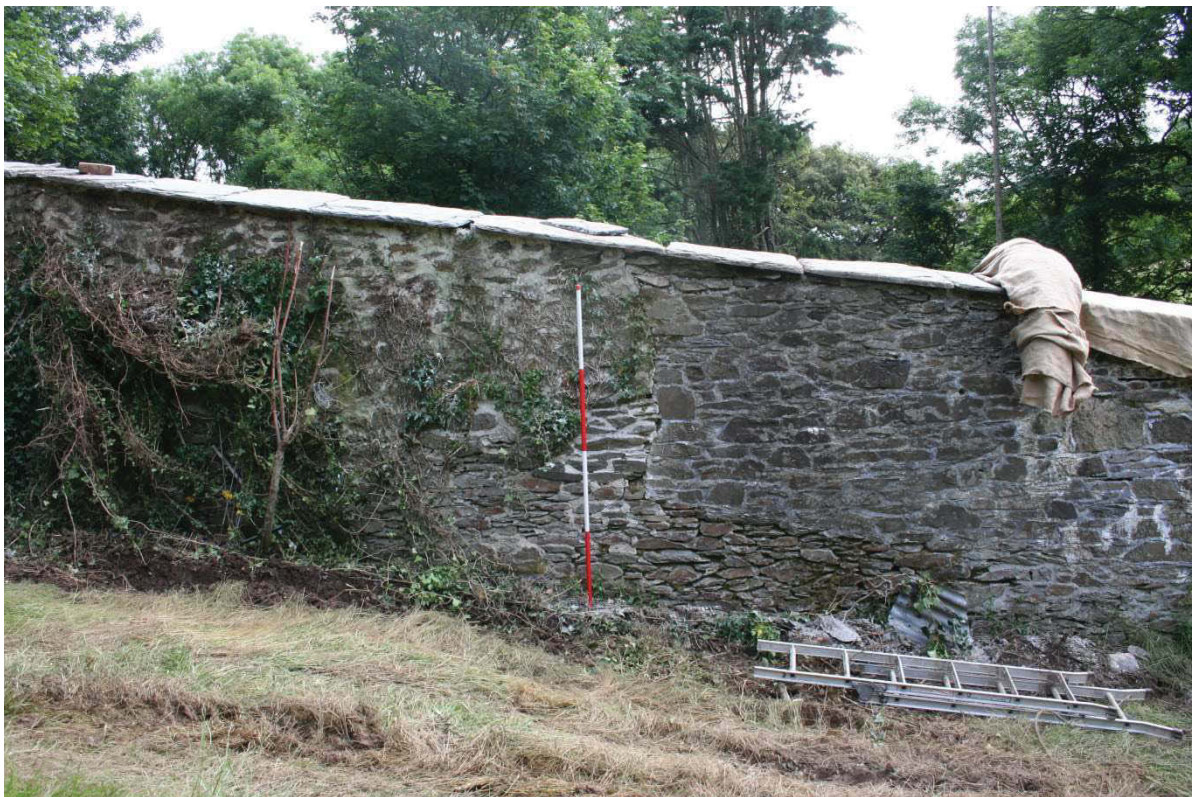
Figure 87 SW wall of the garden, viewed from the exterior, during renovation work.

Three build phases are visible, comprising the original stone base, a 19th century stone rebuild of the upper wall (left) and a 20th century stone rebuild to the right of the scale pole.

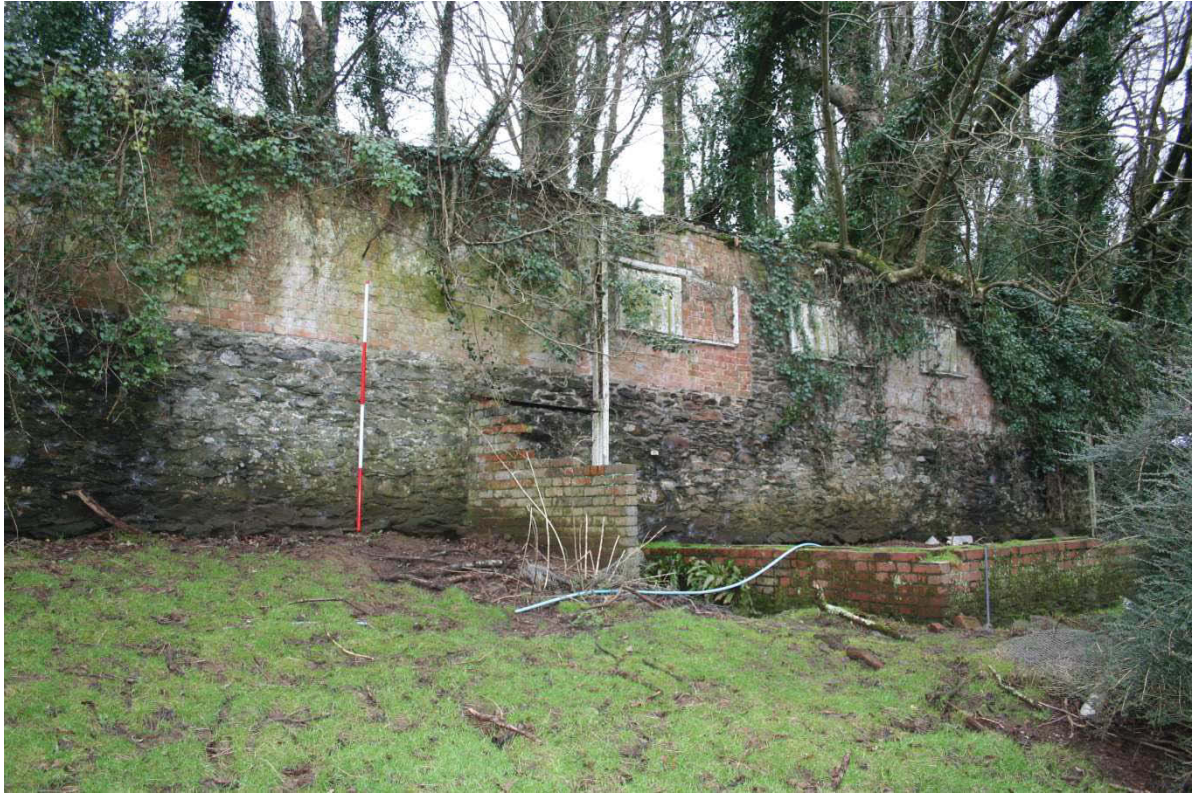
Figure 88 The NW wall and foundations of the upper greenhouse.

There are substantial remains of the upper greenhouse, comprising a brick-built foundation wall (surviving to its fully built height) enclosing an area 12.4m long and 3.7m wide. At the east end is a single doorway with an external concrete step. There are a few traces of its original wooden framework that supported the glazing and there is a large amount of broken window glass littering the site.

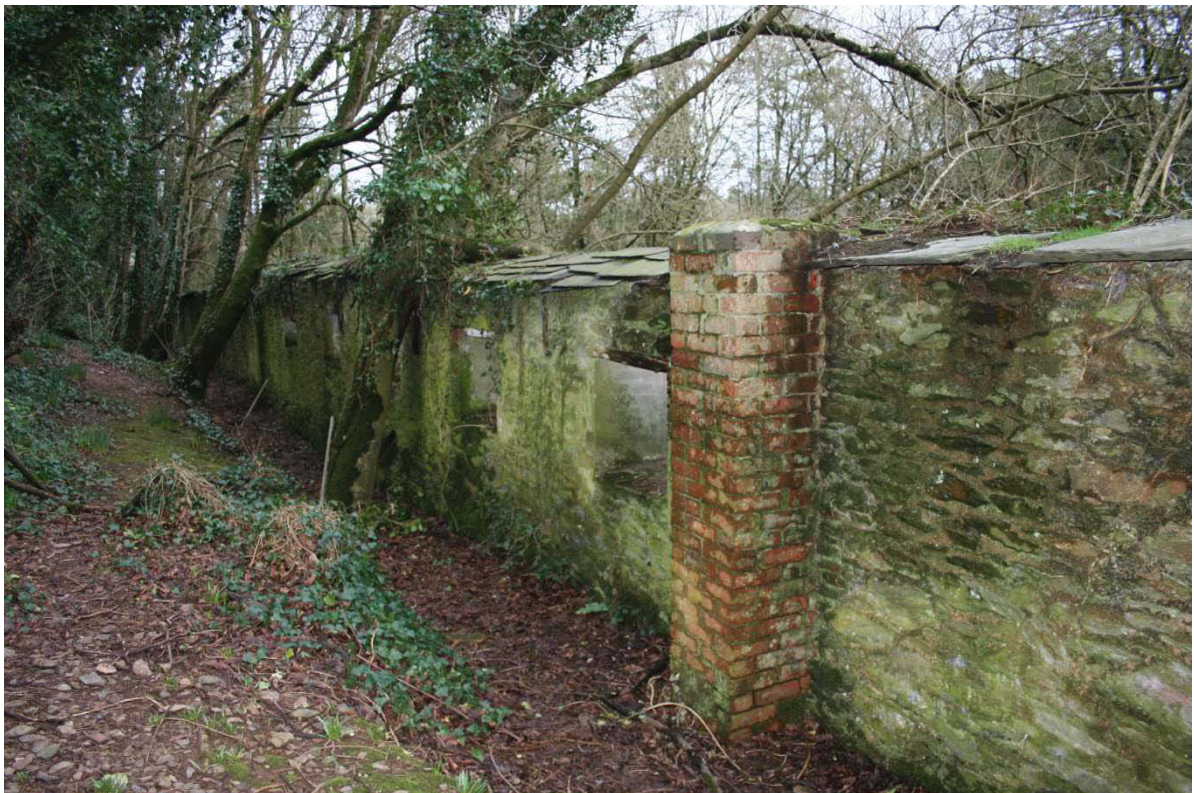
Figure 89 Brick chimney stack from the upper greenhouse boiler, added as an external buttress.

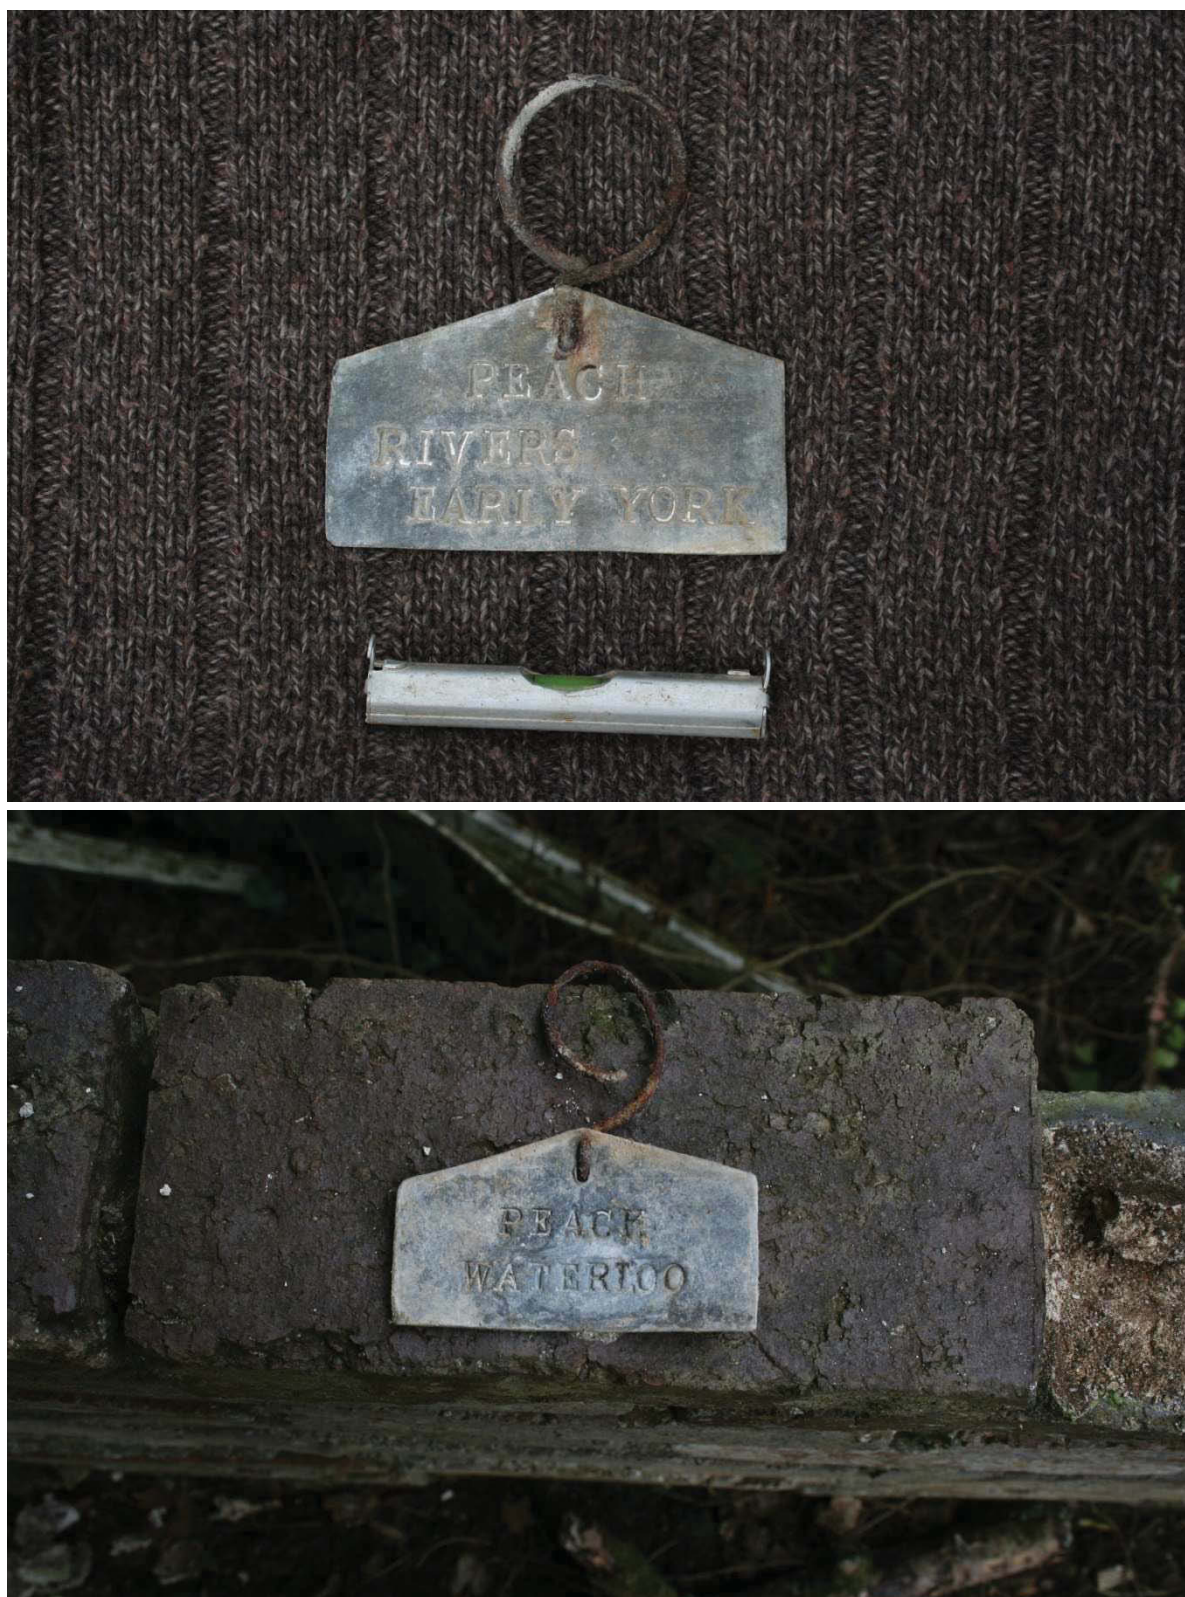
Figure 92 Surviving lead plant labels, found attached to the upper greenhouse wall.

The upper greenhouse will have benefited from its sunny location at the top of the walled garden. Lead plant tags were found attached to the wall, indicating that varieties of peaches were once grown here.

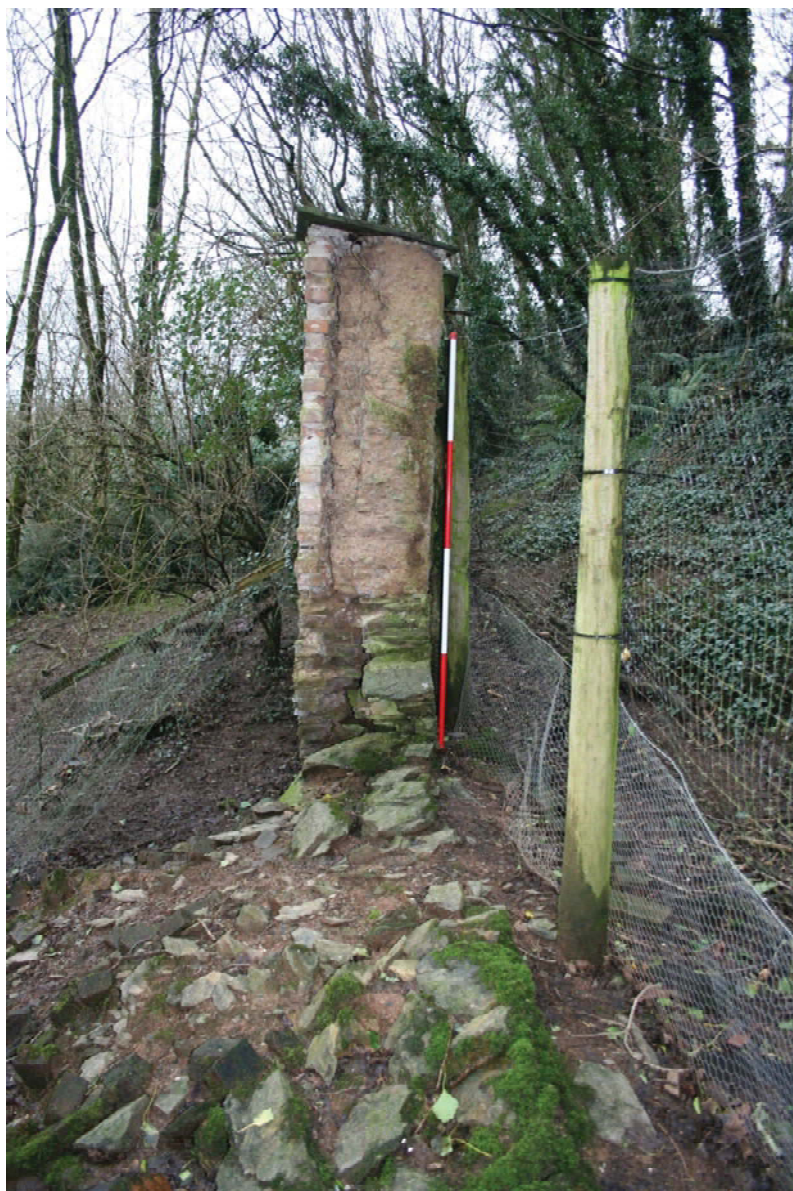
Figure 93 Collapsed part of the NW wall, showing its original construction detail.

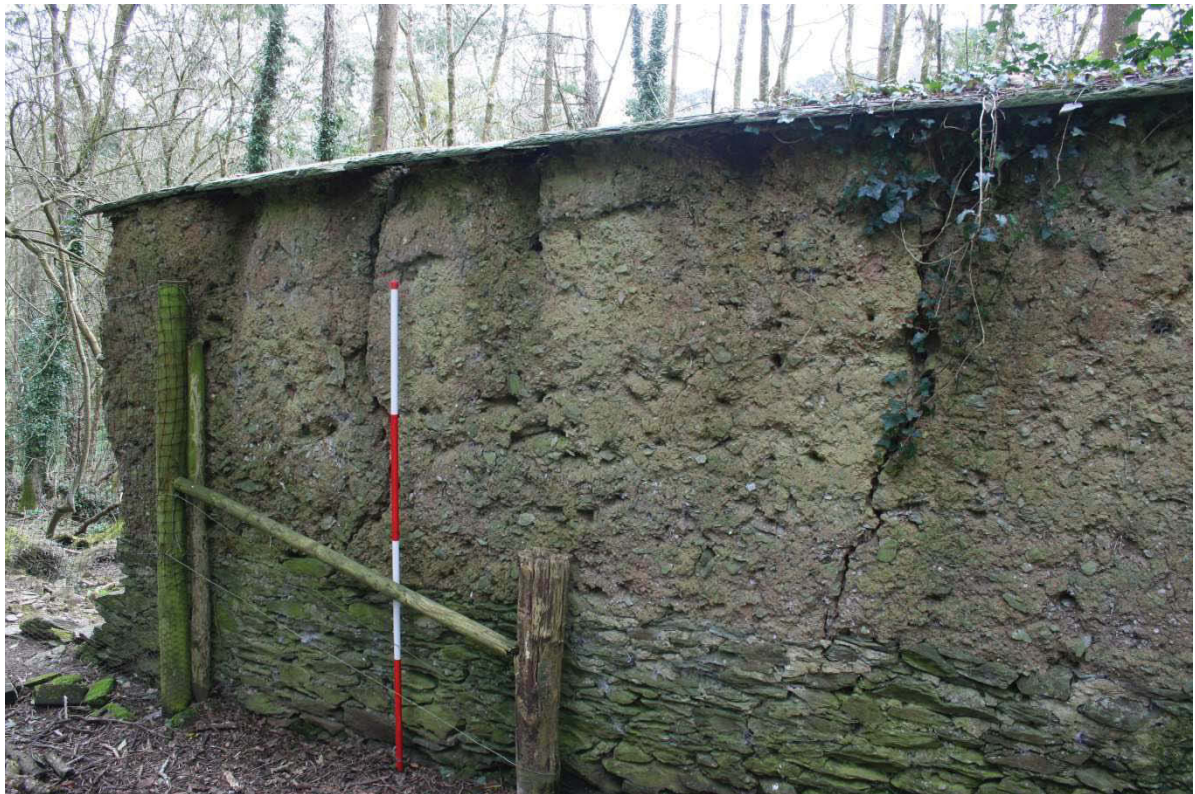
Figure 94 Original cob outer facing, eroded where there are gaps between slate coping stones.

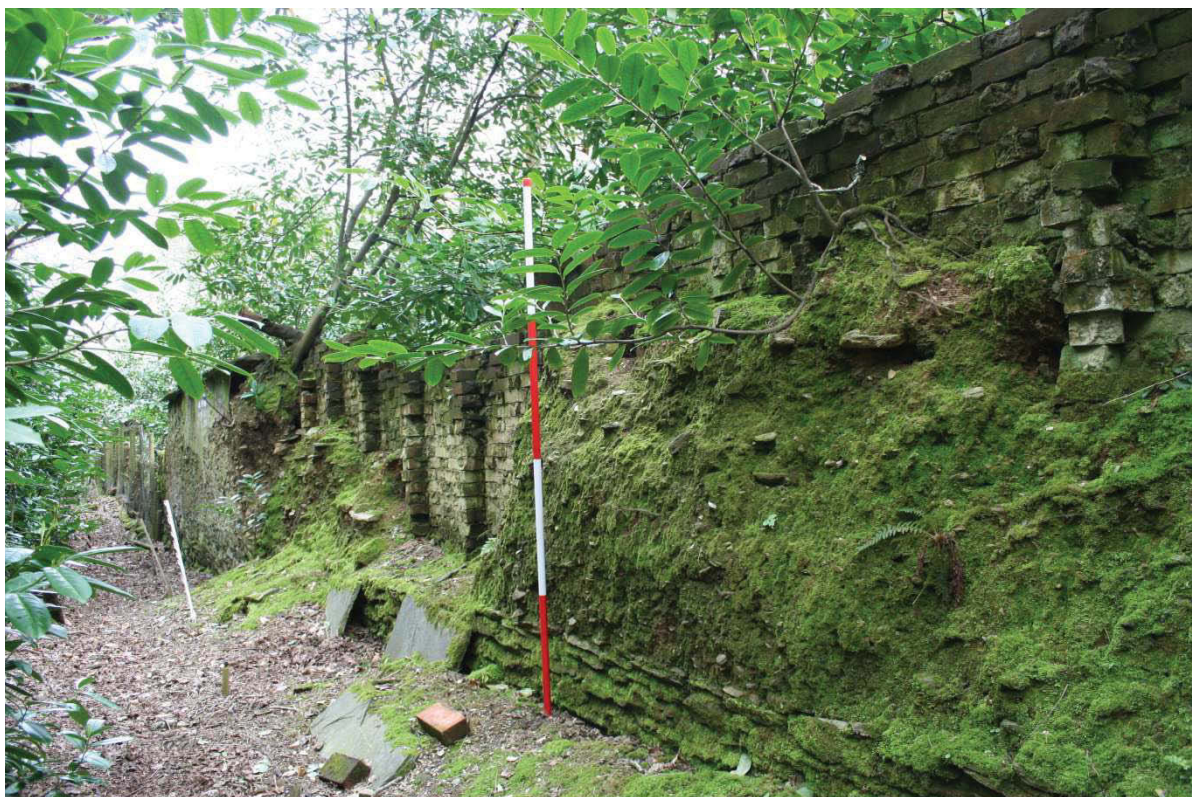
Figure 95 Part of the NW wall, showing tumbled coping stones and collapsed cob, with brick inner facing still standing.

- Remove engulfing vegetation. Spot repairs to cob walls, to try and arrest further collapses (Fig 95).
- Replace rotten lintels to Upper Greenhouse ventilators. Renew rotten timberwork in greenhouse shutters (Fig 91).
