Tintagel, Cornwall

Archaeological impact assessment of proposed new access arrangements to the Island

Client	English Heritage
Report Number	2016R064
Date	6 October 2016
Status	Final
Report author	Adam Sharpe BA MIfA
Checked by	Jacky Nowakowski FSA MIfA
Approved by	Andrew Young MIfA

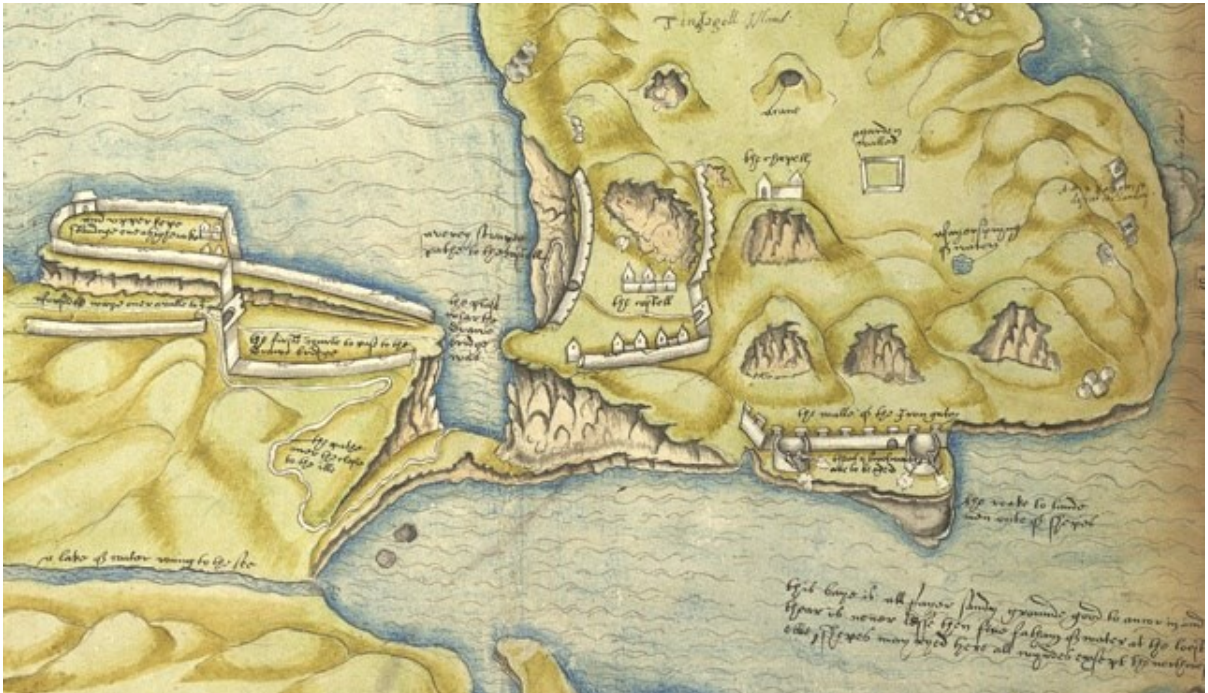
Fig 3. An extract from Grenville's 1583 map of Tintagel. The extensive stretch of curtain wall shown to the south-west (left) of the site of the Great Hall may have been one the works proposed by Grenville's to fortify the Island, rather than anything earlier which survived at the time. The Grenville map also shows that access to the Island was, at the time, more or less as it is today.

Grenville's 1583 map (Fig 3) clearly shows both the northern end of the Lower Ward and the southern end of the Inner Ward as being truncated, and not being closed off by walling, but it is almost impossible to identify from this image exactly to what point that process of truncation had advanced in 1583. The plan also shows a section of curtain walling to the north-west of the Great Hall, complete with an arched doorway, though this is possibly a proposal, part of his intended fortification of the Island. He does, however, show that the access to the Island from the Mainland was, by 1583, by means of a path leading from the Haven across a low isthmus and thence by means of a zig-zagging track to the Island (the upper section of which is visible in this plan). This strongly suggests that any previously relatively easy connection between the two elements of the castle had gone, this almost certainly taking place between 1540 and 1580. Carl Thorpe suggests (pers. comm.) that this might have been possible had there been a sea cave through the neck on one of the major fault lines which had collapsed around this time. It is noticeable that Grenville's map shows the path extending to the northern end of the Lower Ward terminating at a vertical cliff face.

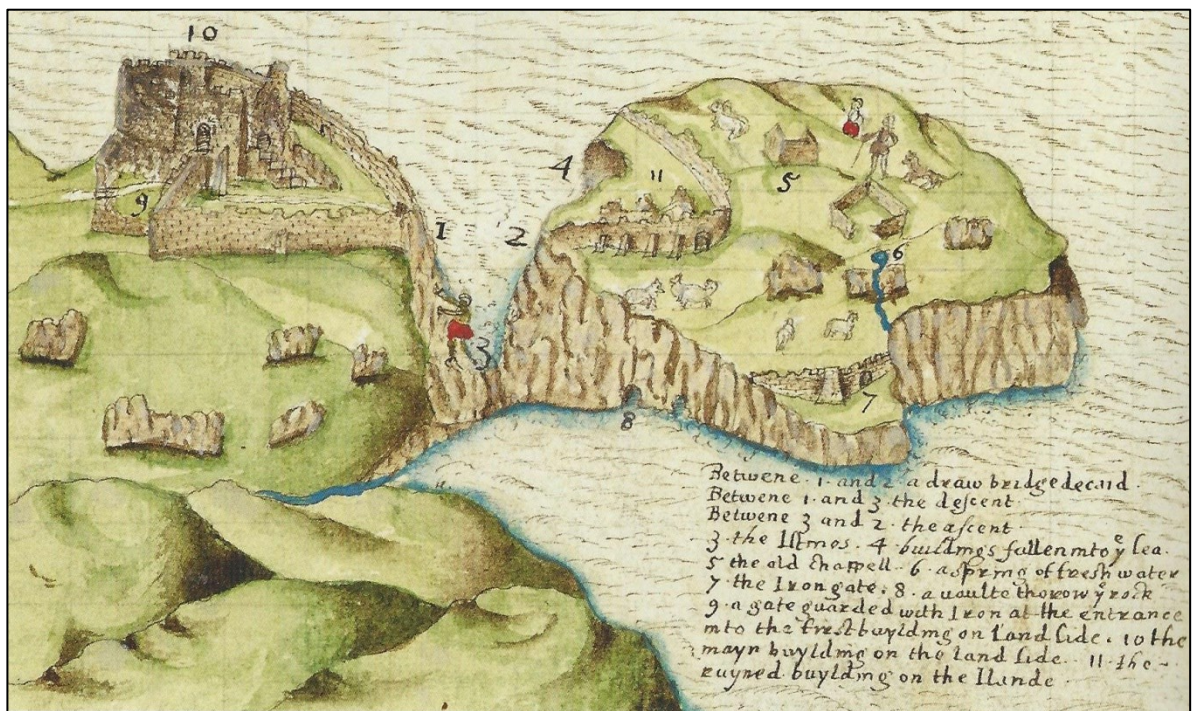
Fig 4. Norden's 1604 view of Tintagel Castle. He showed only the most vestigial of land bridges connecting the Mainland to the Island, labelling it 'Isthmos'. Note the figure in the red breeches clambering his way up the slope to the Lower Ward.

John Norden's 1604 drawing of '*Tintagell, a Borowe*' (Fig 4) is too stylised to be of much use, though he does mention in his key the area (4) where '*Buildings fallen into ye Sea*', suggesting that it was known at the time that buildings had collapsed within living memory – this statement may relate to the collapse of the bridge but also to the collapse of sections of the curtain wall and the southern wall of the Great Hall. Norden also explicitly mentions a descent from the Lower Ward, and isthmus and an ascent to the Inner Ward. He does, however mark the site of '*a drawbridge decayed*'. It is likely, therefore, that this bridge was a feature which had still been in existence during the 1540s, though which had gone by the 1580s. It should be noted, however that Norden depicted a northern wall closing off the Lower Ward, something which Grenville's map suggested had been lost to erosion twenty years previously.

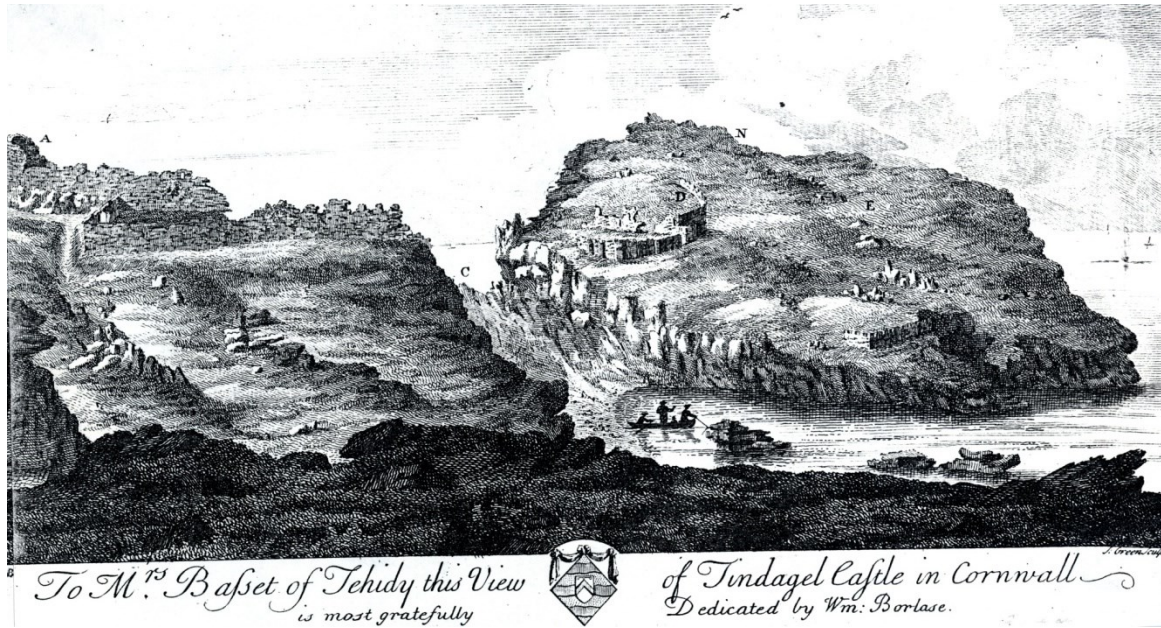
Fig 5. A rather poor quality reproduction of the 1754 Borlase engraving of Tintagel Castle; this shows the neck with an appearance very similar to that seen today.

The detail in Buck's 1734 engraving (Fig 6) is too fanciful to use as hard evidence in any assessment of archaeological loss; Borlase's 1754 engraving of '*Tindagel Castle*' suggests that, during his time, some additional parts of the south-eastern arc of the curtain wall around the Great Hall survived, but this may be misleading. Borlase's 1754 drawing of Tintagel Castle is also, unfortunately, of little use.

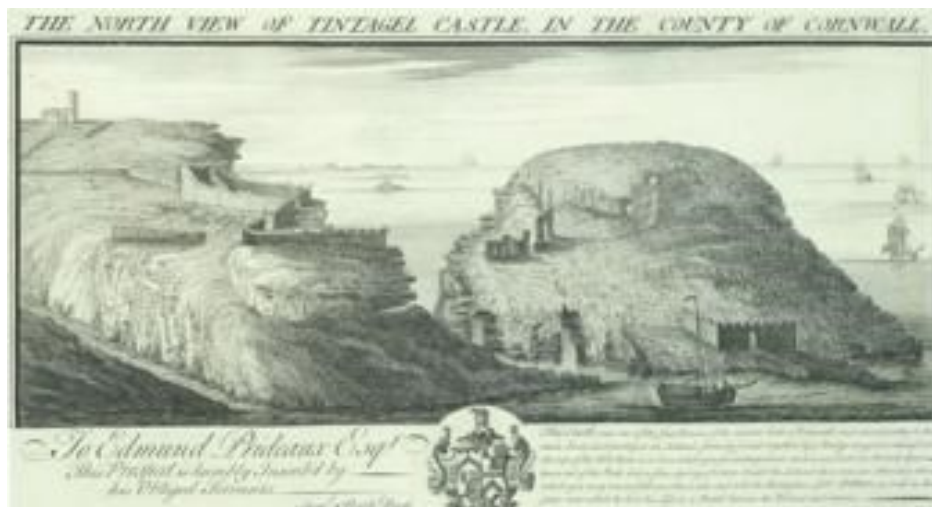
Fig 6. This low resolution copy of Nathaniel Buck's 1734 engraving of the north view of Tintagel Castle shows the ruinous state into which the castle had fallen by this date, but little other useful detail.

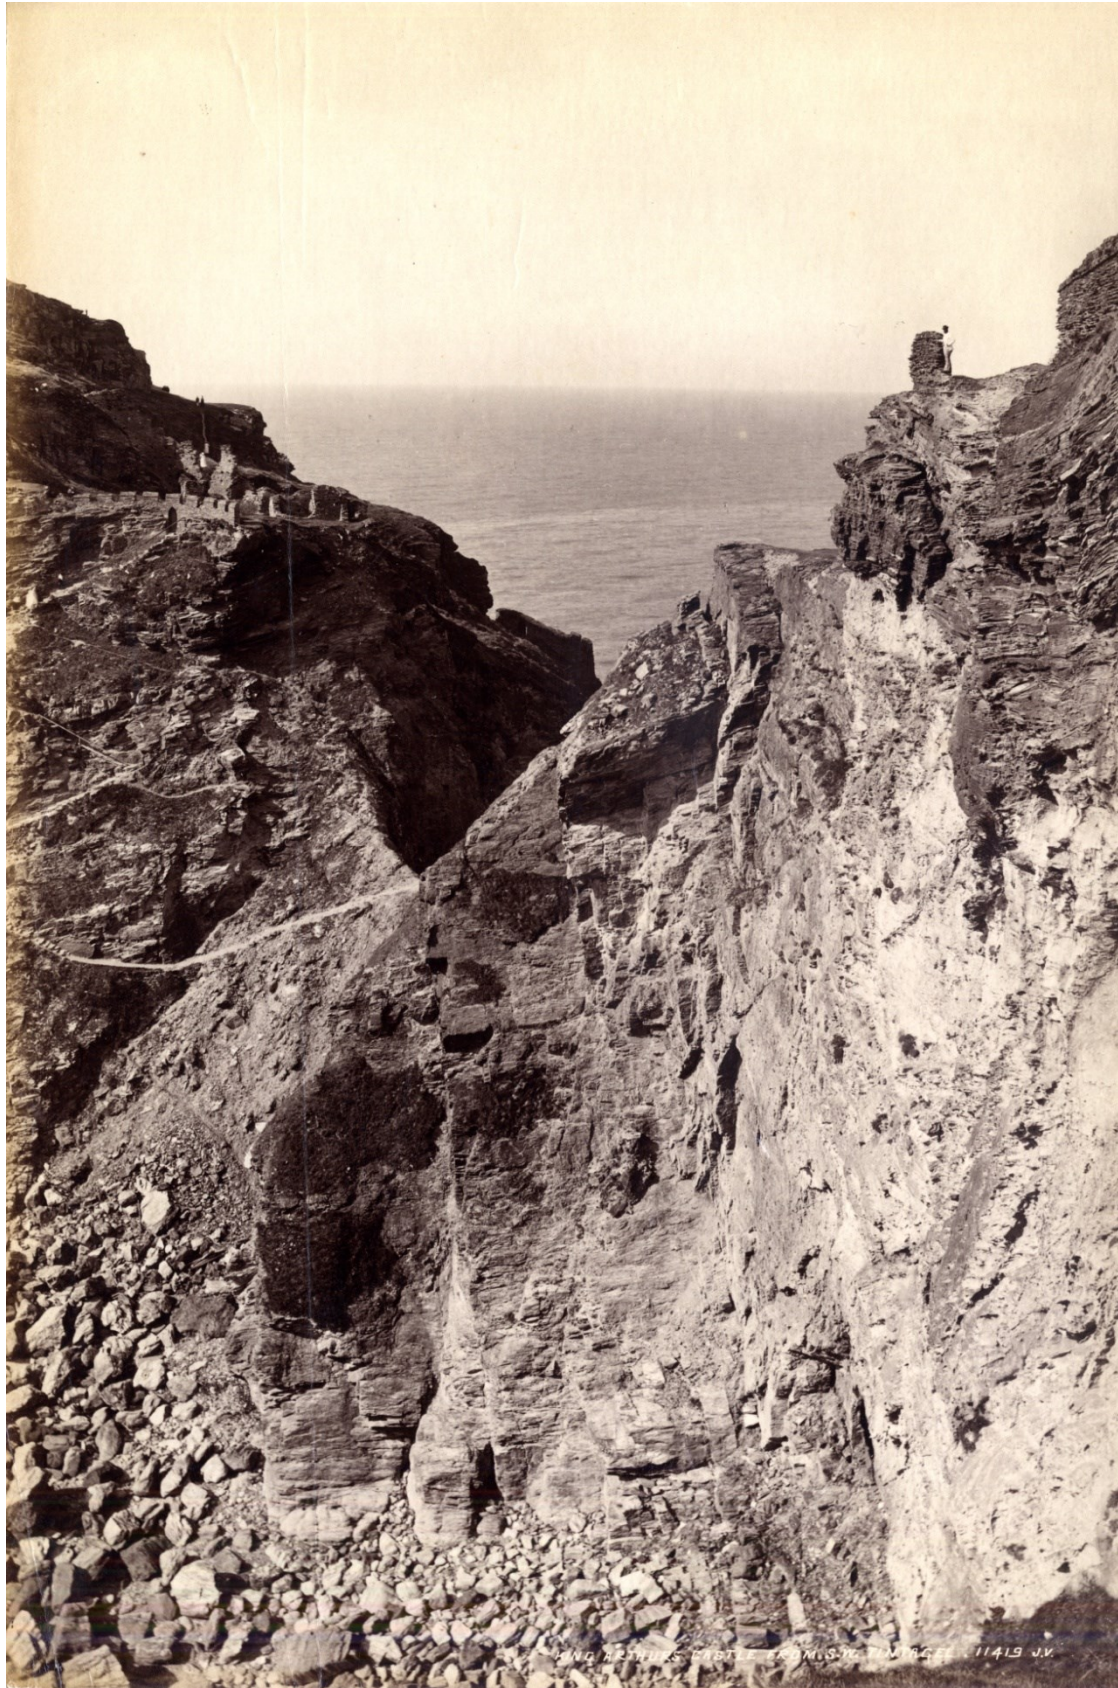
Fig 9. The 19th century path arrangement can be seen in this view can be seen to have consisted of a narrow zig-zag path, including a visibly dangerous lower section running up and over the neck. The length of Kinsman's wall visible in this image should be compared with that visible in later views.

One of earliest available images to show any useful detail (Fig 9) clearly depicts a crumbling, overhanging northern end to the eastern wall of the Lower Ward. Sections of this have gone. Two figures in white at the northern end of the Lower Ward appear to be sitting on the ground behind a low Cornish hedge – this feature has been replaced by the present wall closing off this part of the Castle. The topography suggests that perhaps five and possibly up to ten metres of the northern section of the Lower Ward have been lost since its construction during the C13th, the upper figure being a probable maximum given the tapering shape of this element of the Castle. However, the profile of the cliff slope to the north of the Lower Ward suggests that there have clearly been substantial landslips within this area, and considerable sections of the cliffs at this location have been lost to erosion over the centuries, as is witnessed by the size of some of the boulders on the beach below

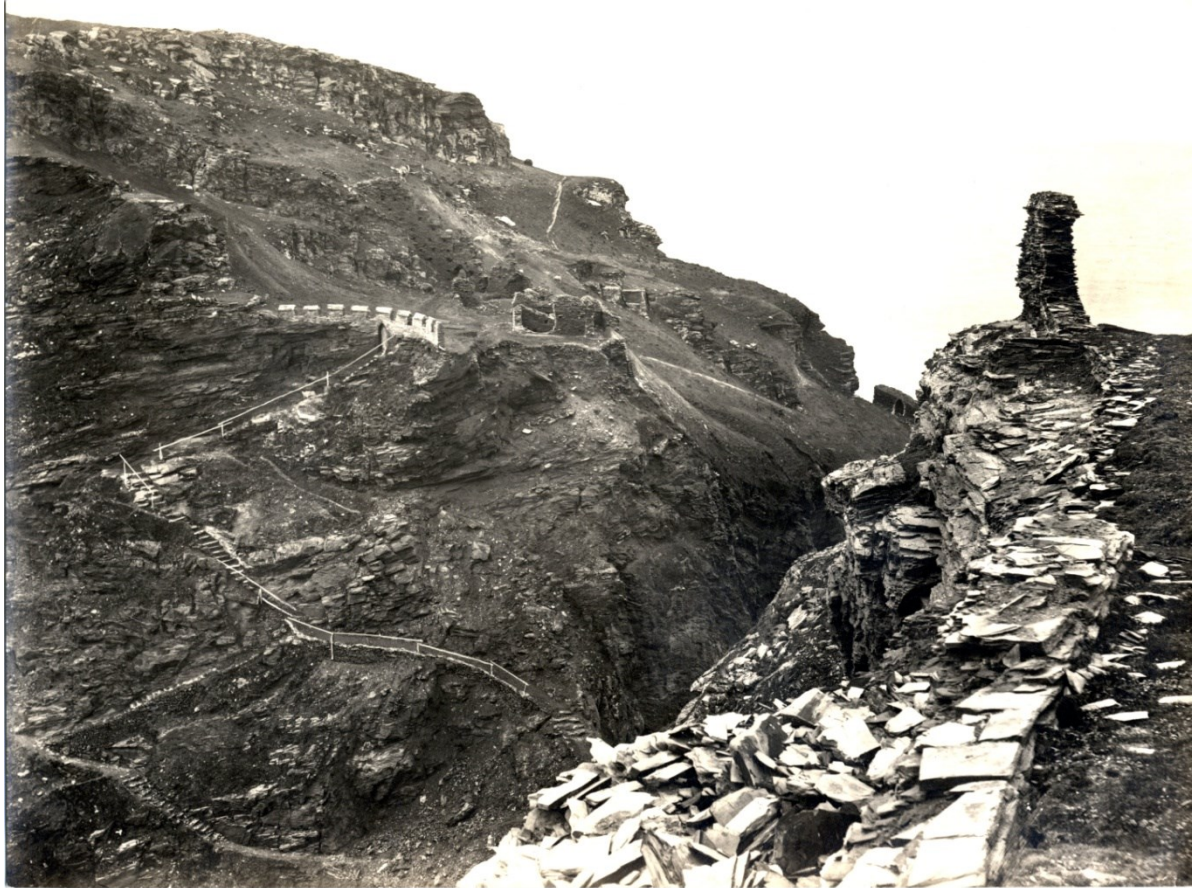
Fig 10. In this slightly later image, the lower section of the path can be seen to have been abandoned, and a new route had been cut down to and across the top of the neck.

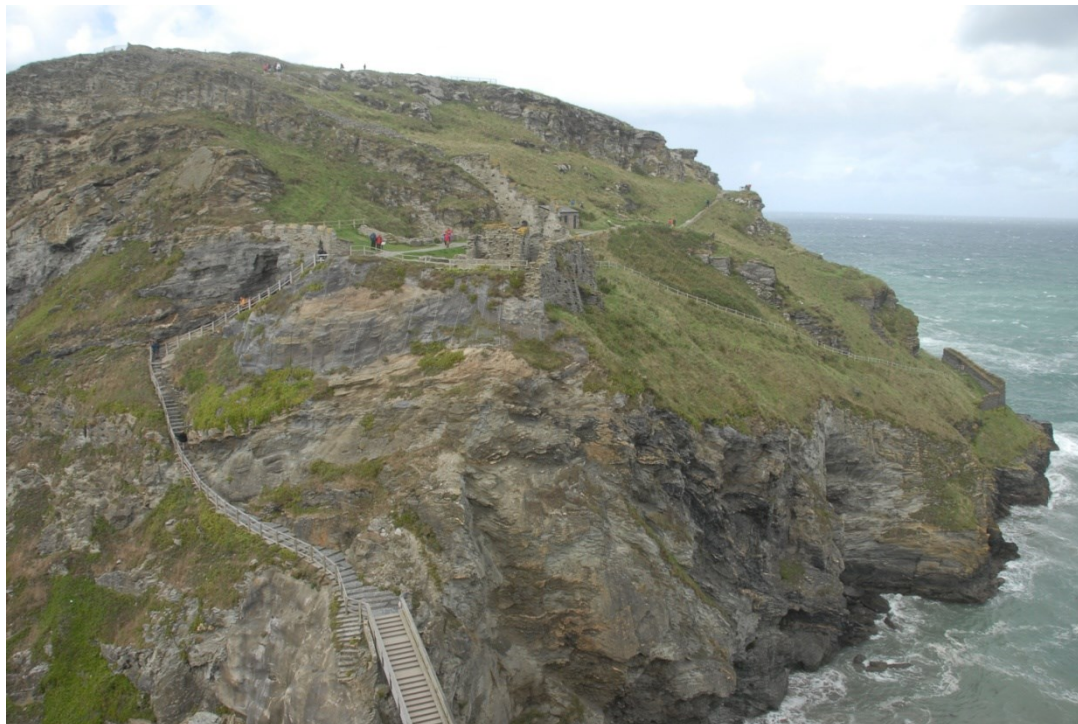
Fig 11. A modern view, showing the new bridge and the abandoned lower section of the steps which originally led to the path running along the top of the neck.

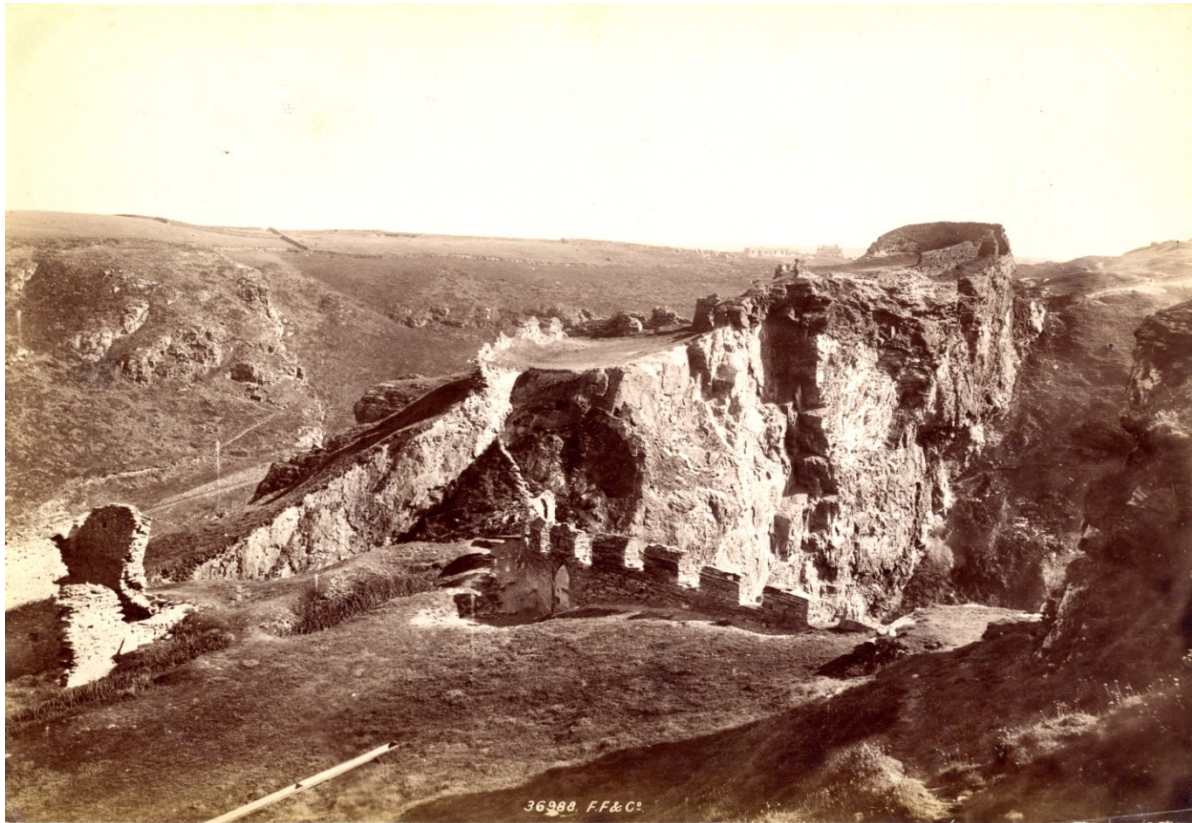
Fig 12. A Frith postcard showing that there was at the time clearly no access from the Lower Ward down to the neck, nor any form of walling across its northern end.

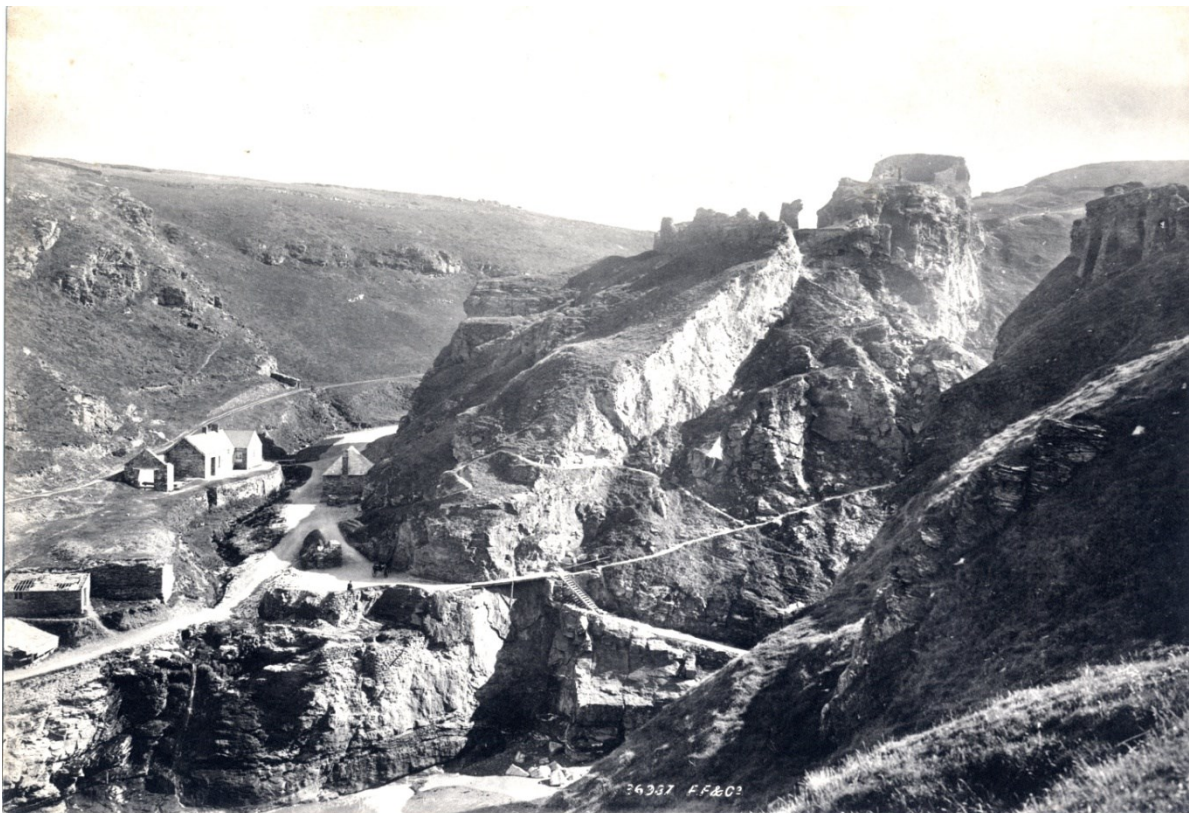
Fig 13. Another Frith postcard showing access arrangements from the valley base. The higher paths routes led to the neck and the cliff path up to the Island.

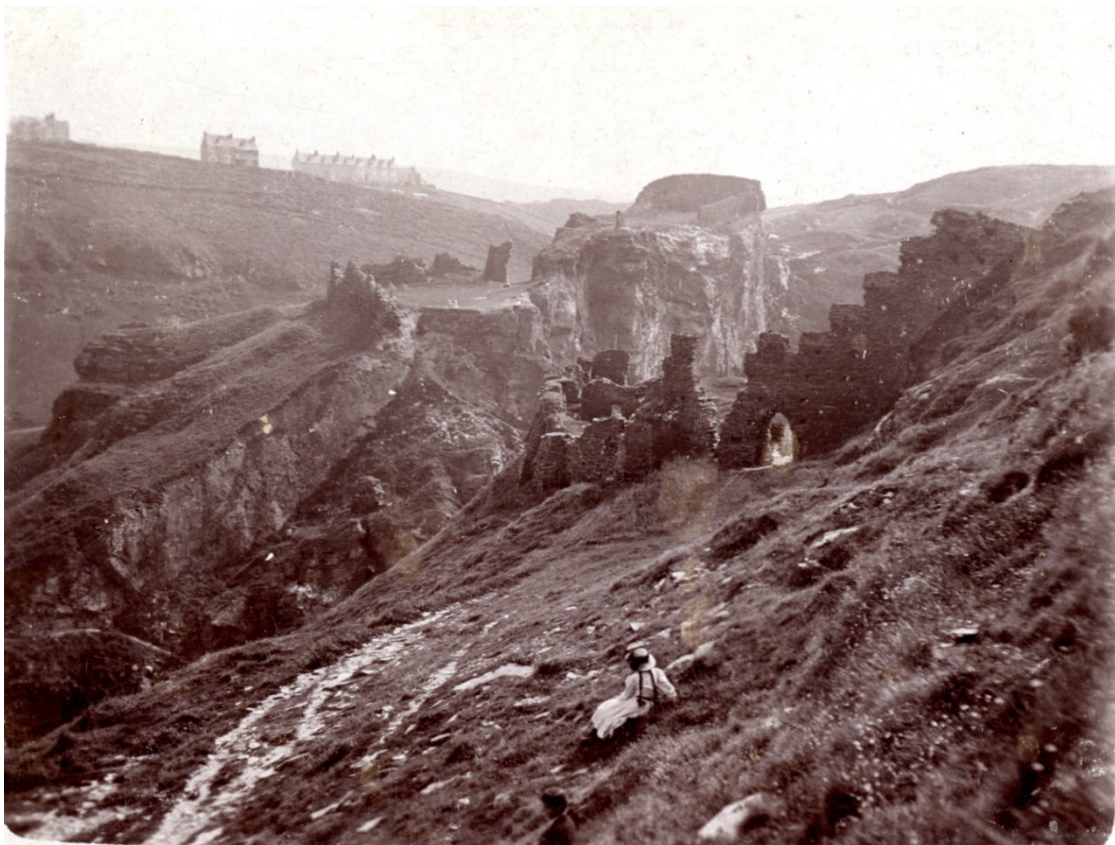
Fig 14. An early photograph which shows a low wall or bank across the northern end of the Lower Ward and hints of very steep paths running down the slope below towards the neck.

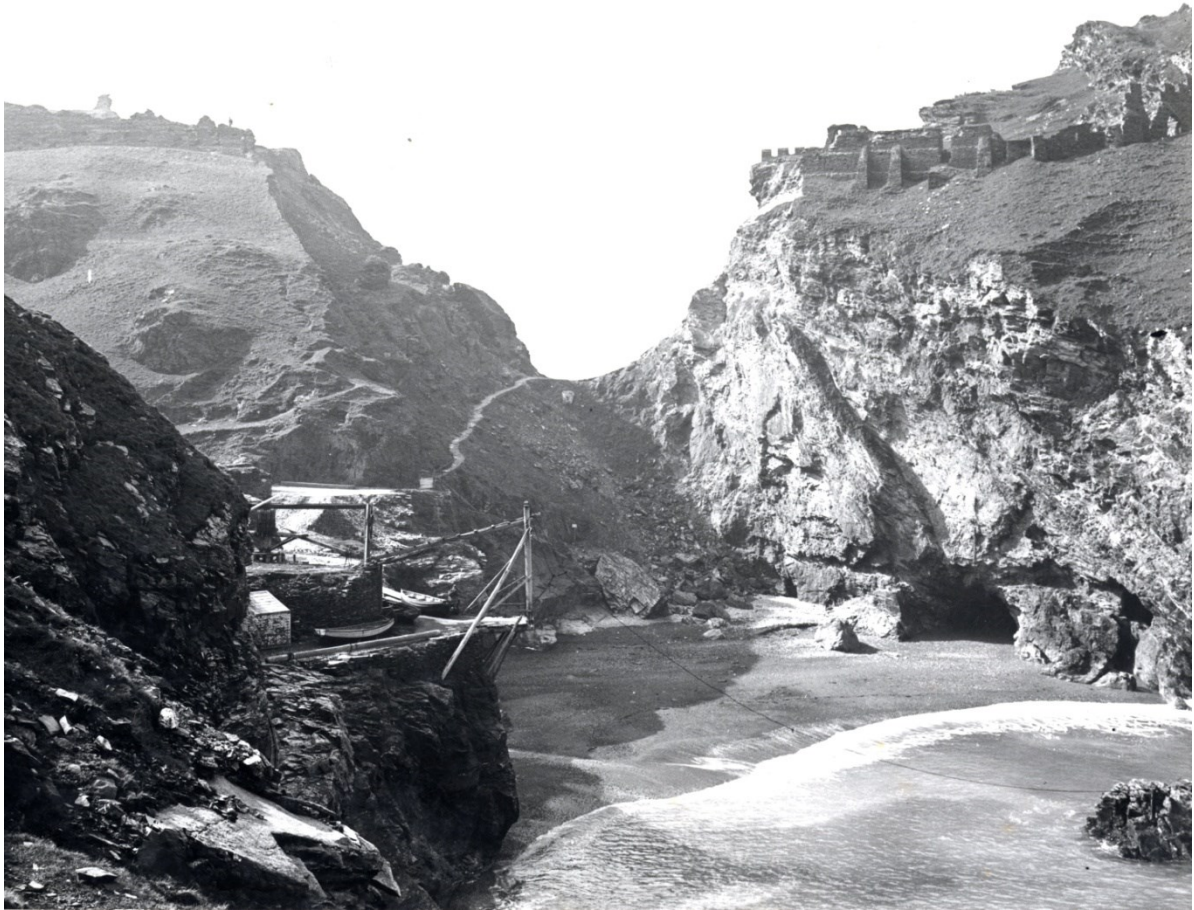
Fig 16. A good late 19th century view looking from the Haven showing the access track leading up the neck. Note the clear evidence for major landslips on the slope below the Lower Ward.

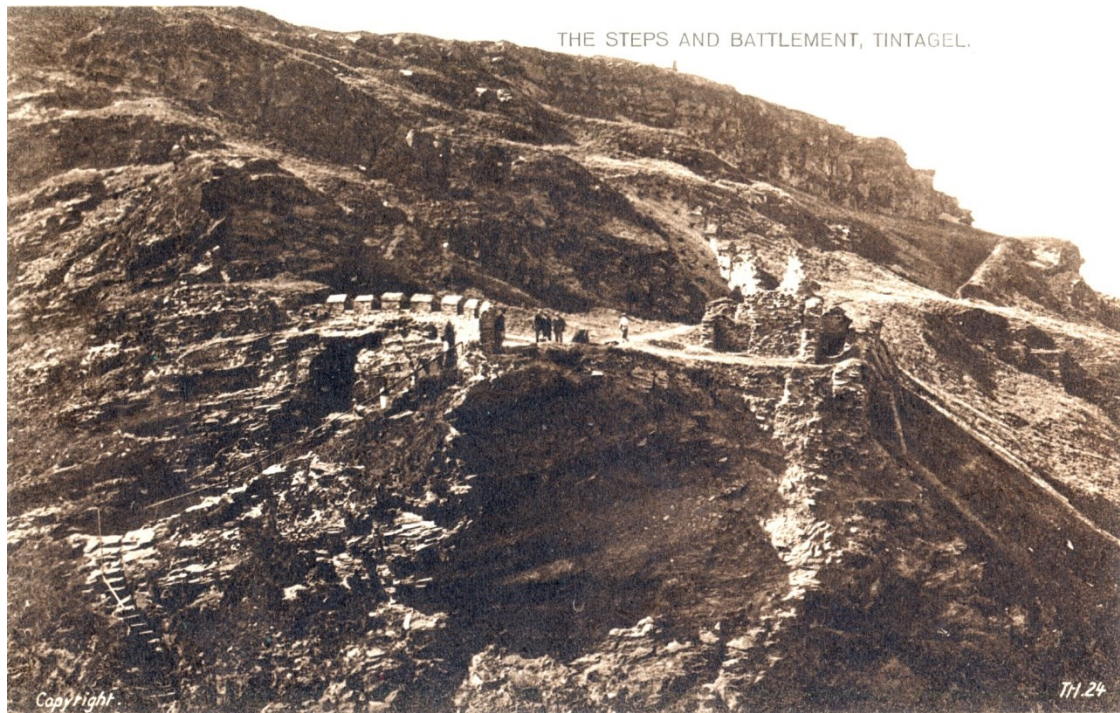
Fig 18. A relatively early (probably early C20th) view of the Inner Ward, showing the substantial erosion scar below and to the right of Kinsman's new walling, the right hand end of which had already collapsed.

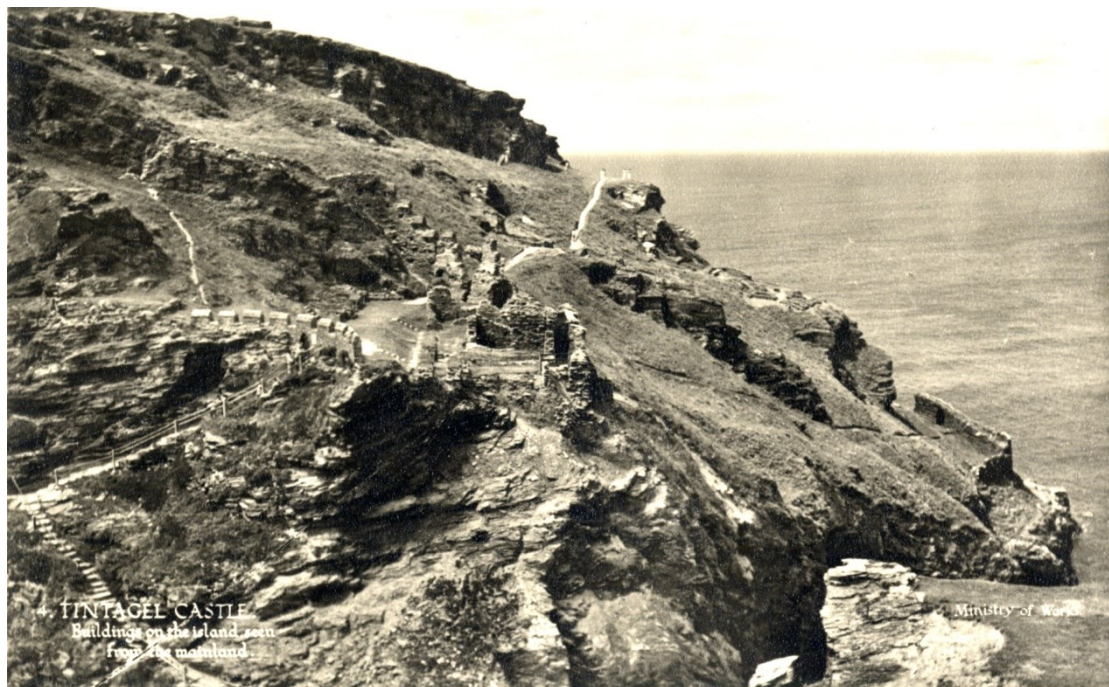
Fig 19. A Ministry of Works postcard probably dating to around 1930, showing evidence for some degree of additional erosion of the cliff face beneath the eastern end of the Great Hall.

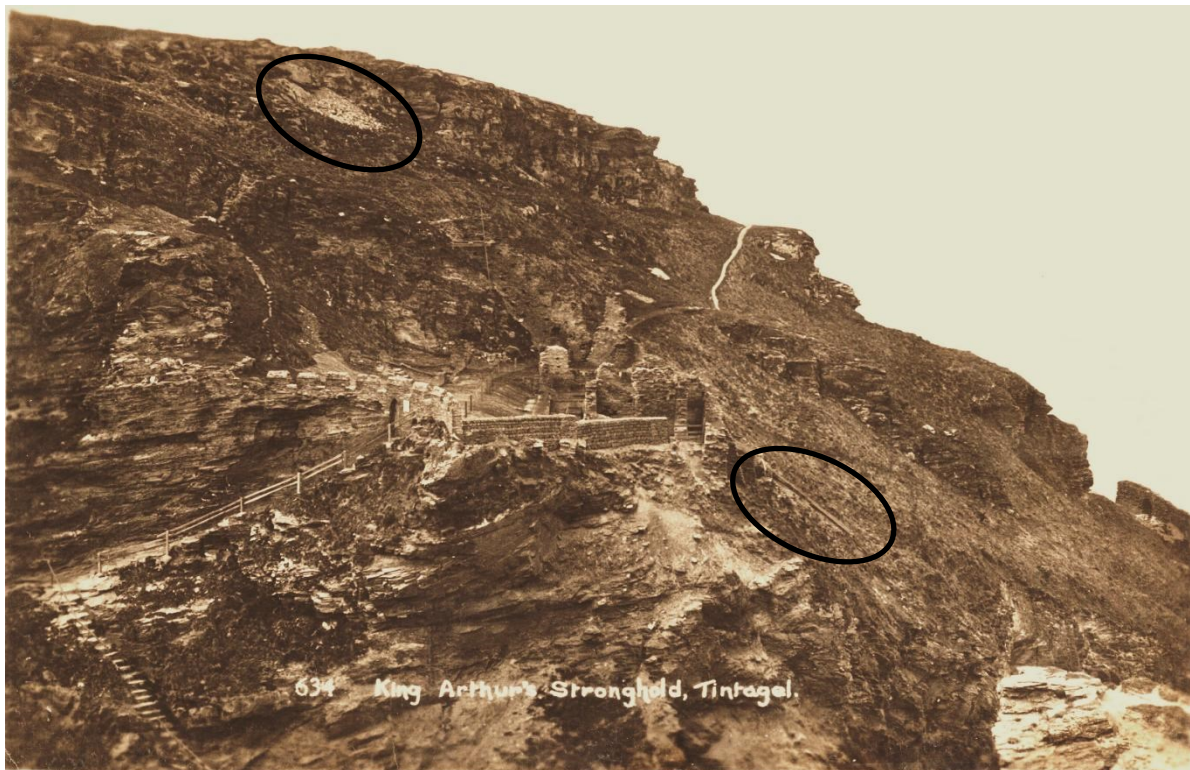
Fig 20. A postcard which is likely to date to the early 1930s showing the short-lived cliff-edge barrier constructed between Kinsman's wall and the eastern curtain wall, as well as excavation spoil from the chapel (circled, left of centre, top) and a wooden rubble chute (circled, on the slope to the right of the Great Hall).

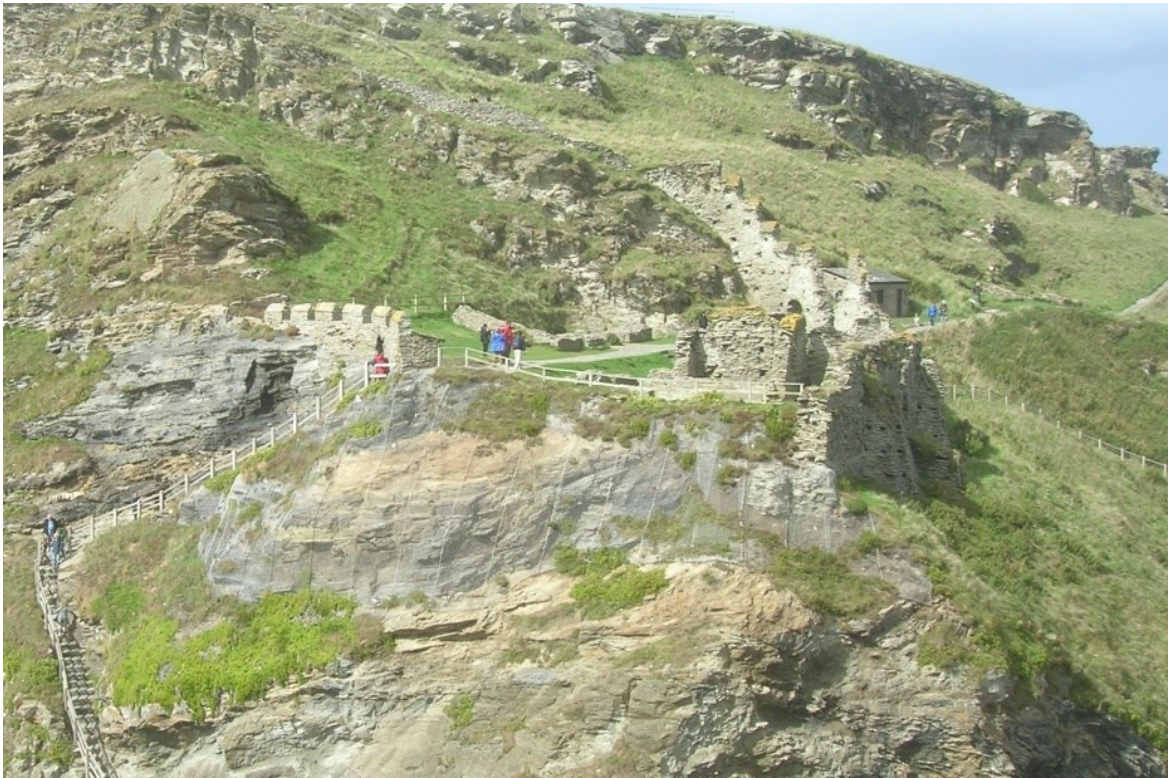
Fig 22. A broadly equivalent modern view to that shown in Fig 21. The cliff slope below the Great Hall has been meshed and rock bolted. A further metre of Kinsman's wall has collapsed since the earlier postcards were produced.

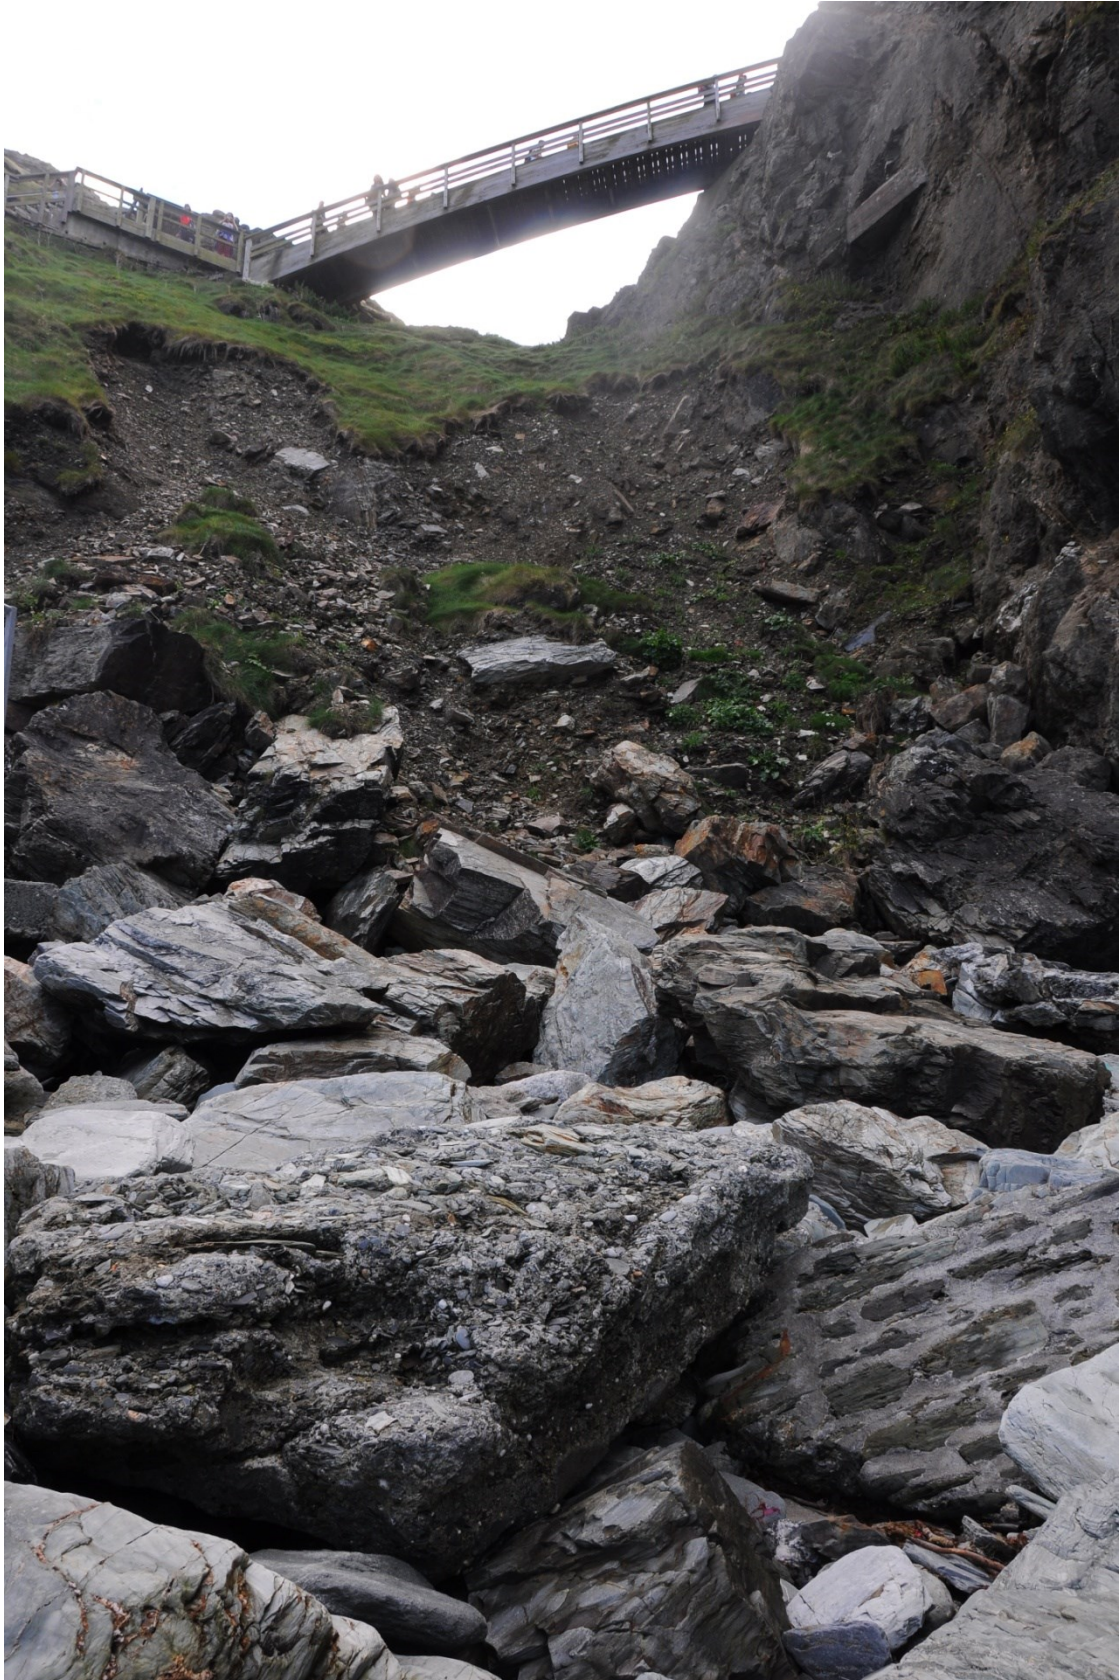
Fig 26. Looking up to the neck from the Haven, the instability of the land bridge is immediately evident, as is the absence of exposed solid rock within it on this side.

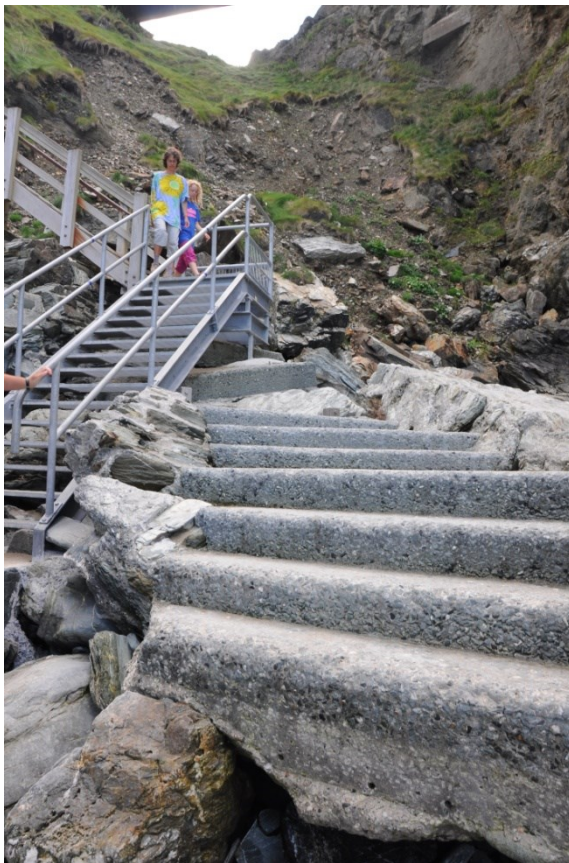
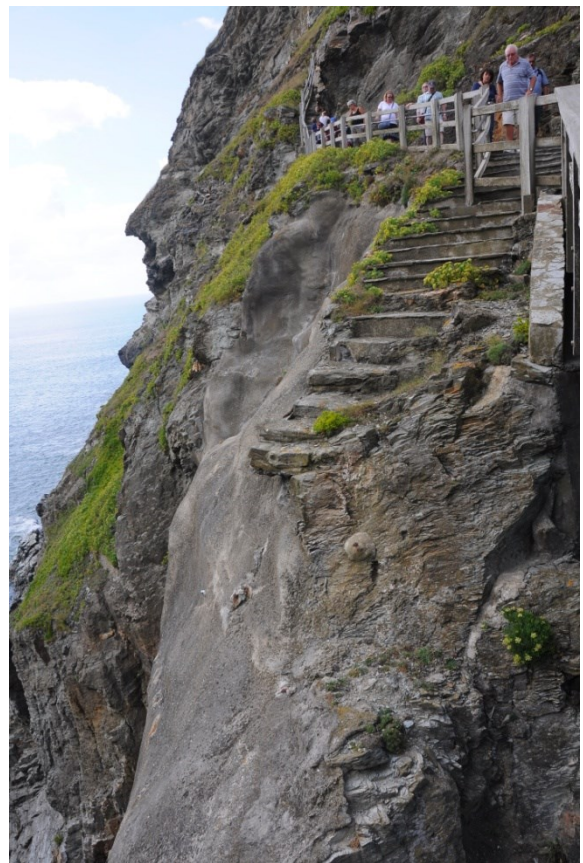
Fig 28. And the existing steps are also rather prone to being lost to erosional processes – whether maritime, or through the collapse of the rock on which they were built.

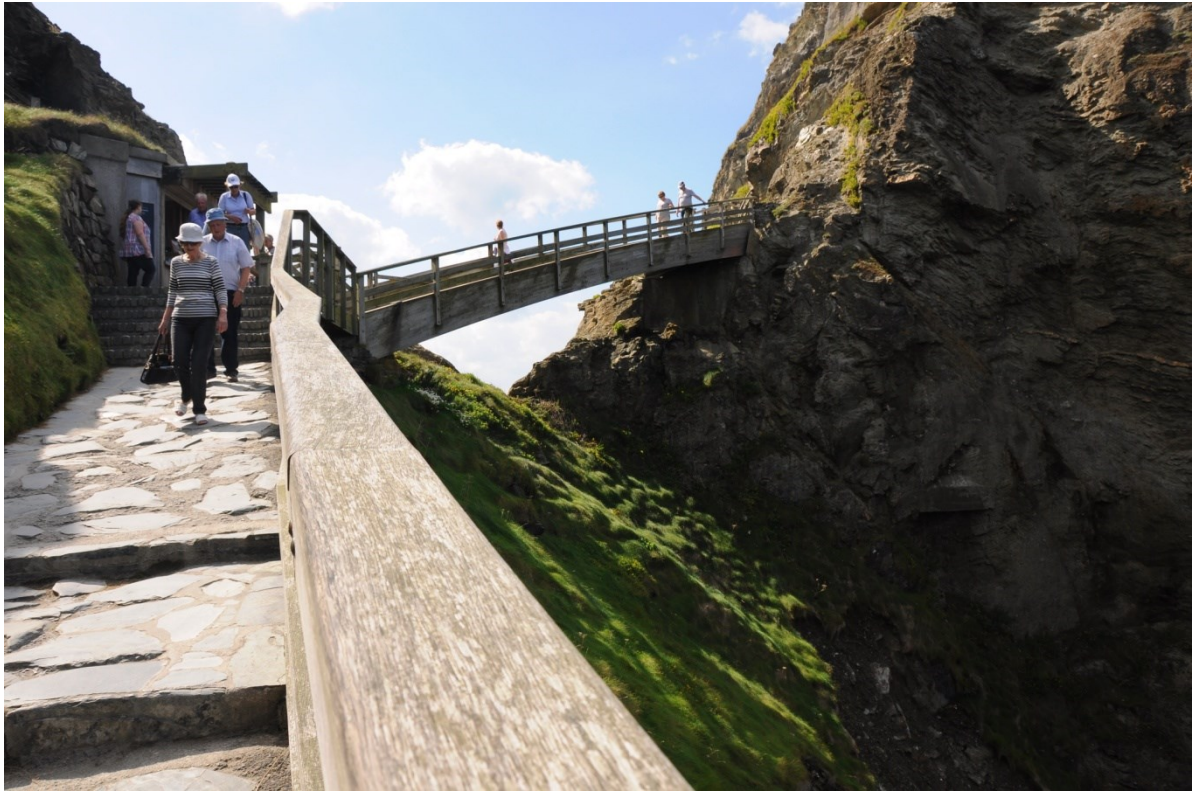
Fig 29. The path up from the Haven to the existing bridge, the route in the foreground being one which has been used since at least the 1580s.

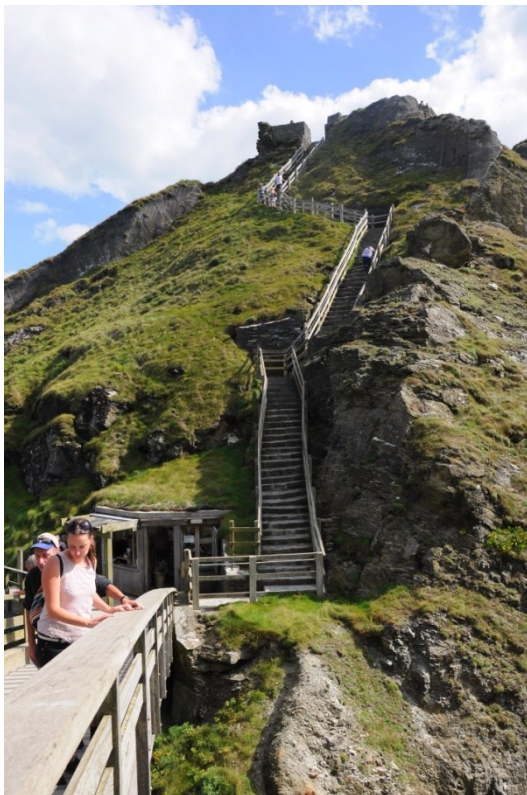
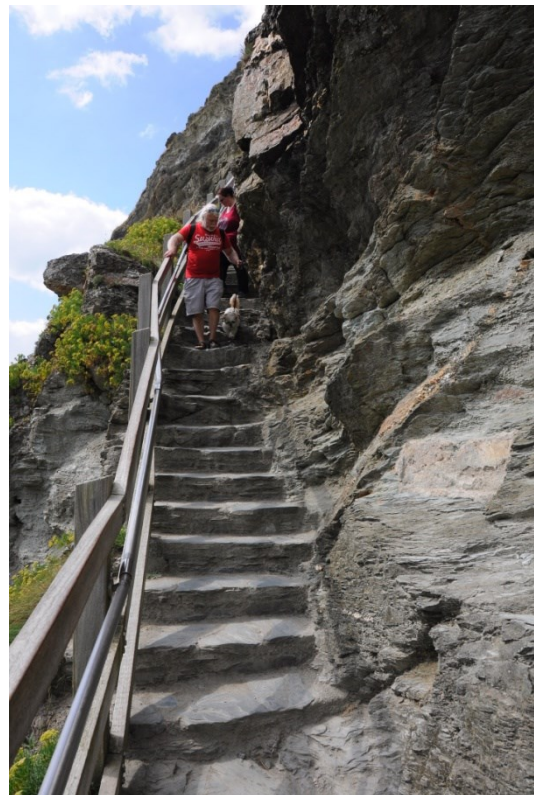
Fig 30. Whether it's getting down from the Lower Ward (left) or getting to the Inner Ward (right), the climb is a steep one, the steps are narrow, and there are few passing places.

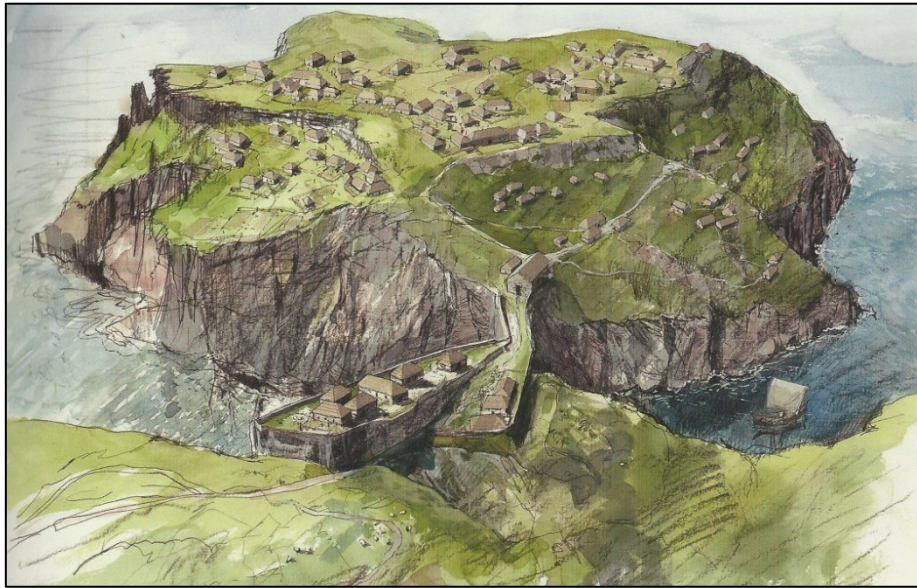
Fig 31. An English Heritage commissioned reconstruction of post-Roman Tintagel by Liam Wales. This assumes an almost level surface to the isthmus between the Mainland and the Island and contemporaneity of occupation of all of the house stances on the Island, as well as the sites of a number of structures on the Mainland for which there is currently no surface archaeological evidence.

Hypothetical reconstructions of the Castle including its appearance during the post-Roman and medieval periods have been included in the most recent version of the Tintagel Castle guidebook (Figures 31 & 32), as well as a possible development sequence for the medieval castle (Figure 33).

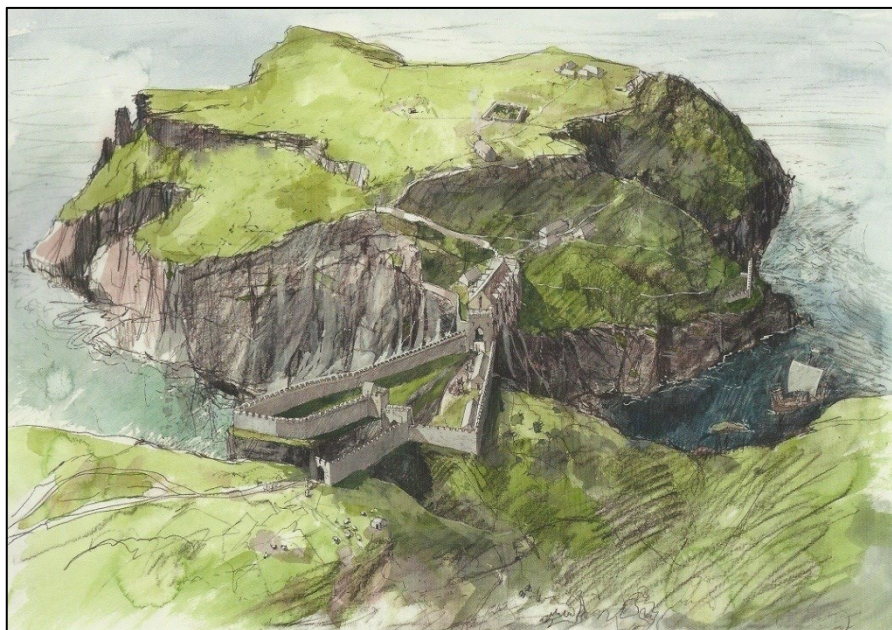
Fig 32. A companion reconstruction showing Tintagel during the 13th to 14th centuries, again commissioned from Liam Wales by English Heritage. This model again assumes a narrow, almost completely level upper surface to the isthmus and a drawbridge near the Great Hall.

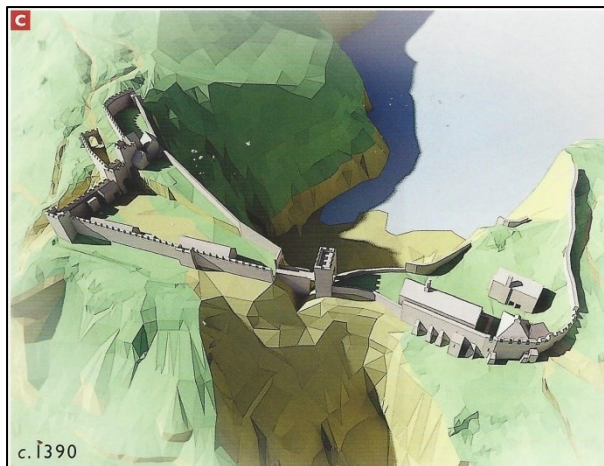
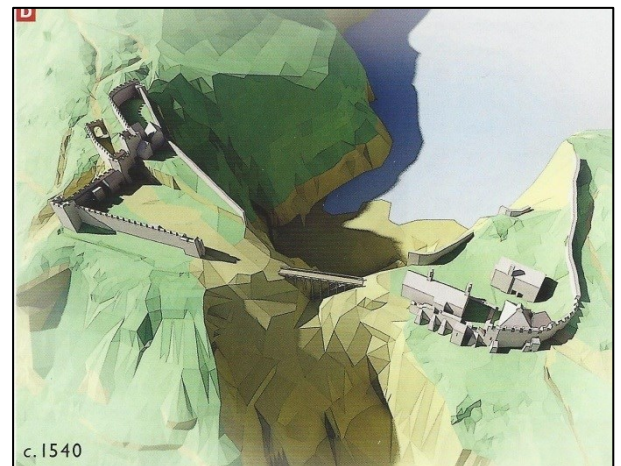
Figs 33 A-D. The development sequence for the Mainland and Island wards during the period from 1260 to 1540 proposed in the current English Heritage guidebook to Tintagel Castle. A – the initial appearance of the castle when constructed. B – parts of the Great Hall and the western wall of the Mainland wards had collapsed into the sea through cliff erosion. C – A new western wall had been constructed for the Mainland wards and lodgings had been built on the site of the Great Hall. D – The drawbridge had collapsed into the sea and the Island ward lodgings had been reduced in size.

The reconstruction assumes the presence of a gatehouse and drawbridge on the isthmus for which no archaeological evidence survives, as well as the very early loss of the southern section of curtain wall around the Great Hall.
