Tintagel, Cornwall

Archaeological impact assessment of proposed new access arrangements to the Island

Client	English Heritage
Report Number	2016R064
Date	6 October 2016
Status	Final
Report author	Adam Sharpe BA MIfA
Checked by	Jacky Nowakowski FSA MIfA
Approved by	Andrew Young MIfA

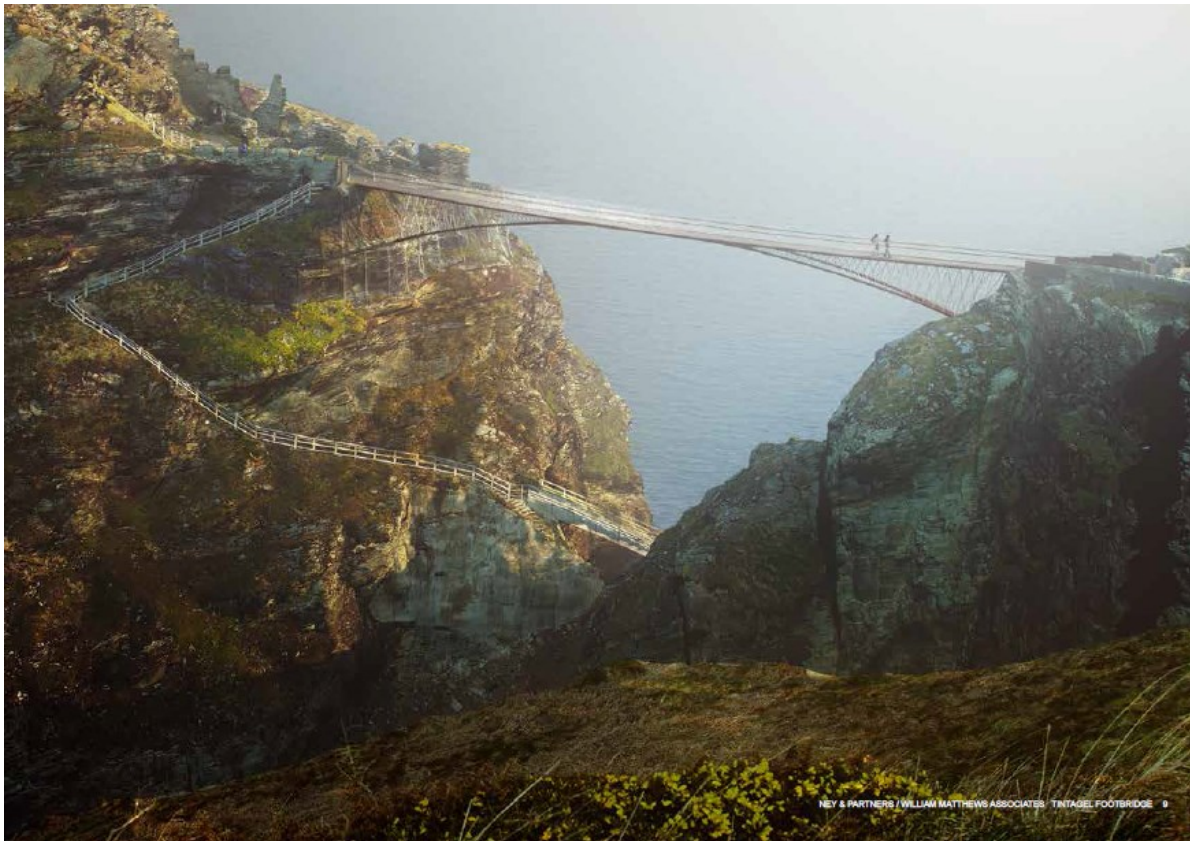
Fig 42. A 2016 Ney and Partners and William Matthews Associates visualisation of the new bridge linking the two halves of Tintagel Castle.

The principal physical impacts will result from the bridge construction activities. Two areas, in particular, will need to be excavated down to and into the bedrock to create the bridge landing points. Archaeological excavation in advance of construction will be required at these locations in order to mitigate unavoidable damage to *in situ* archaeological deposits (Figure 42).

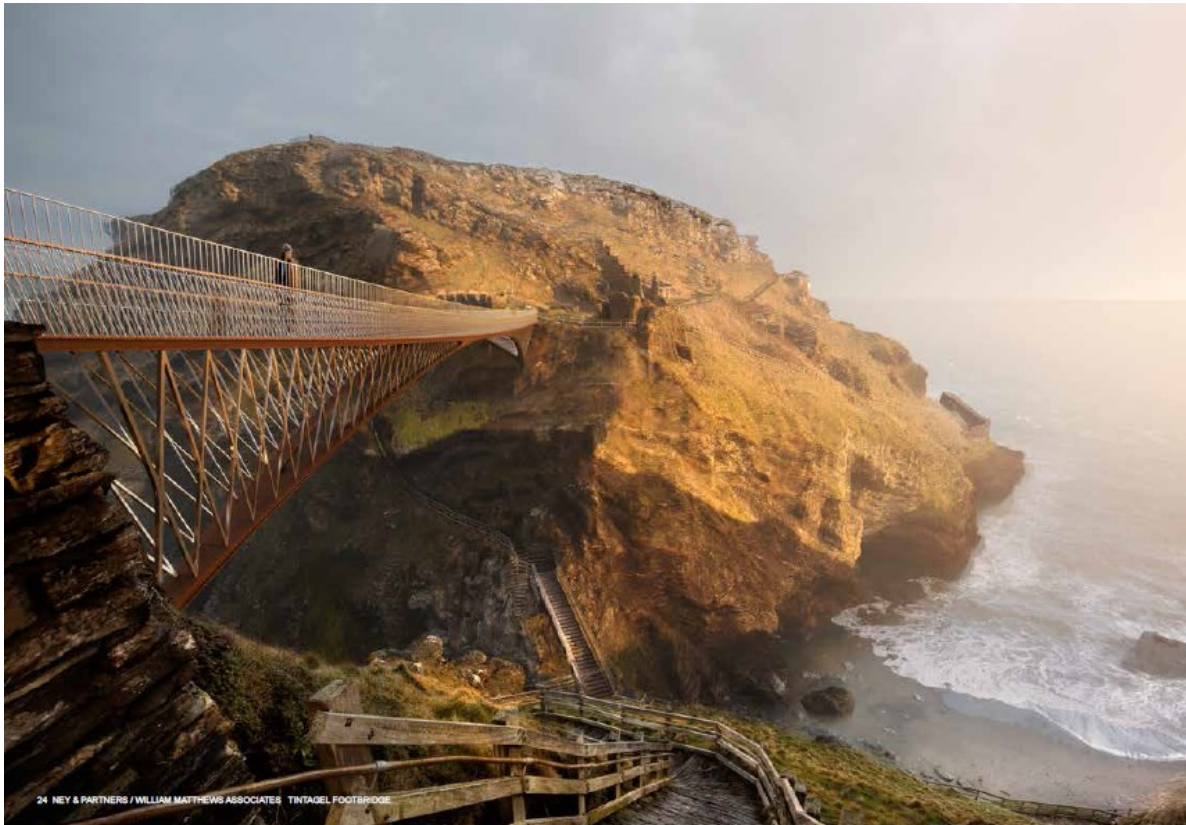
Fig 43. A second Ney and Partners and William Matthews Associates visualisation of the proposed bridge linking Lower and Inner Wards at Tintagel Castle.

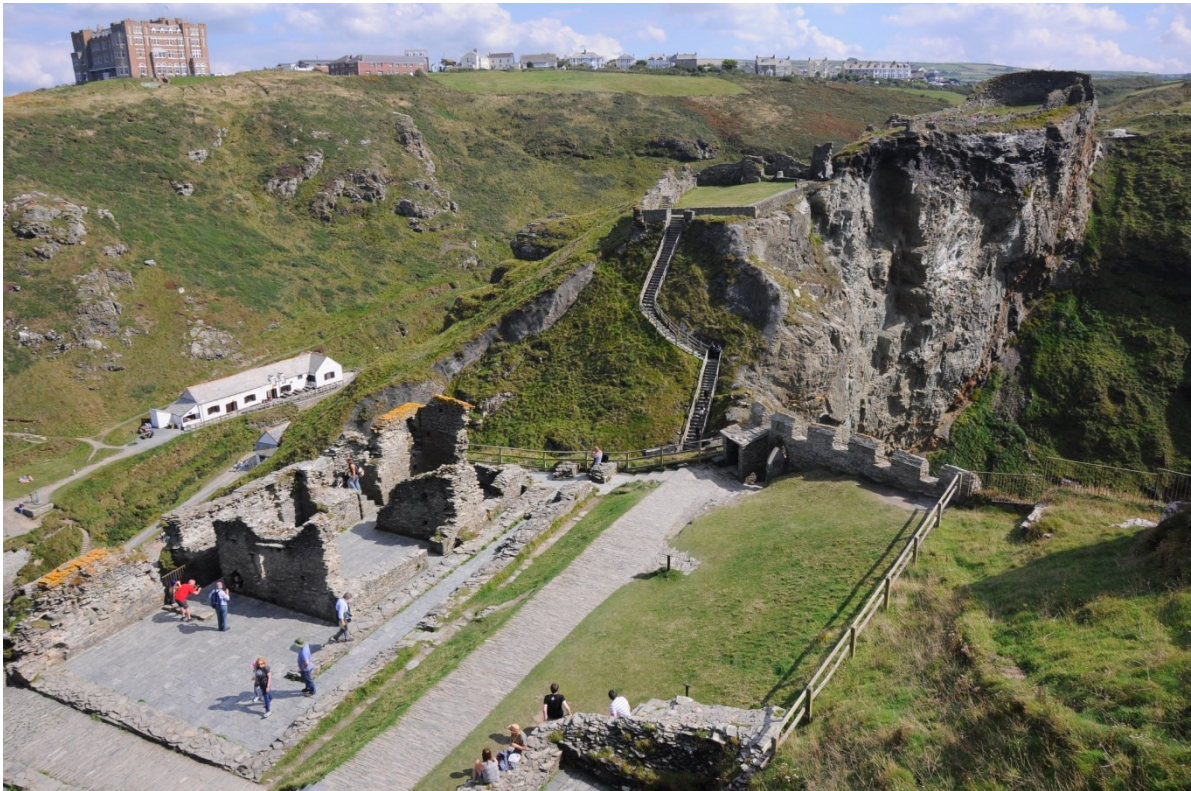
Fig 44. Looking from the Inner Ward to the Lower Ward along the line of the proposed bridge.

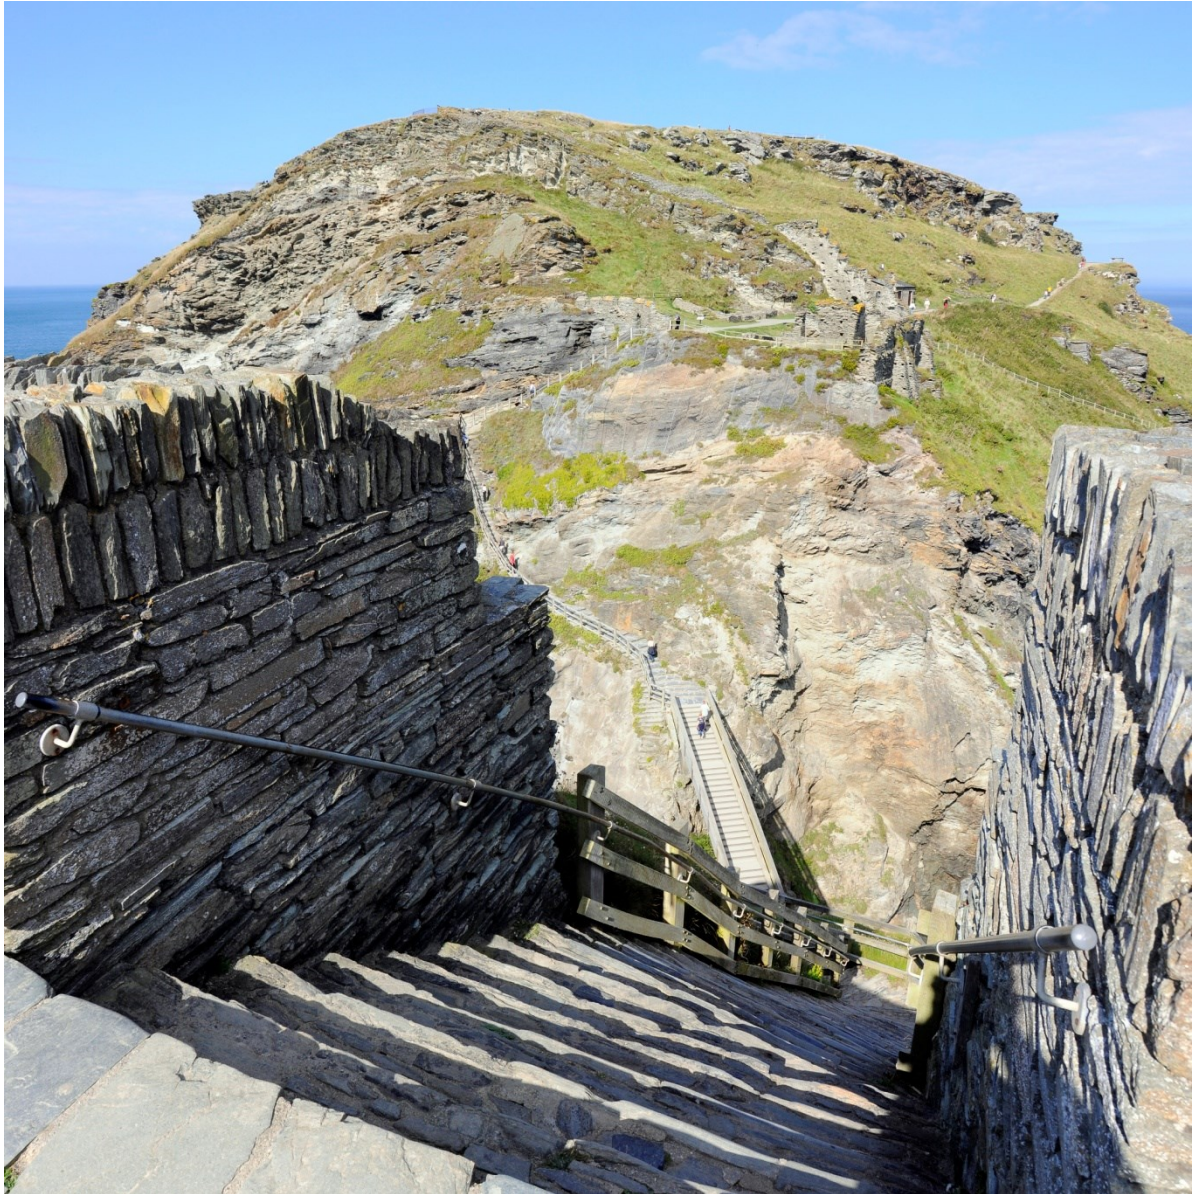
Fig 45. The view from a location close to the springing point of the proposed bridge at the northern end of the Lower Ward towards the Inner Ward.

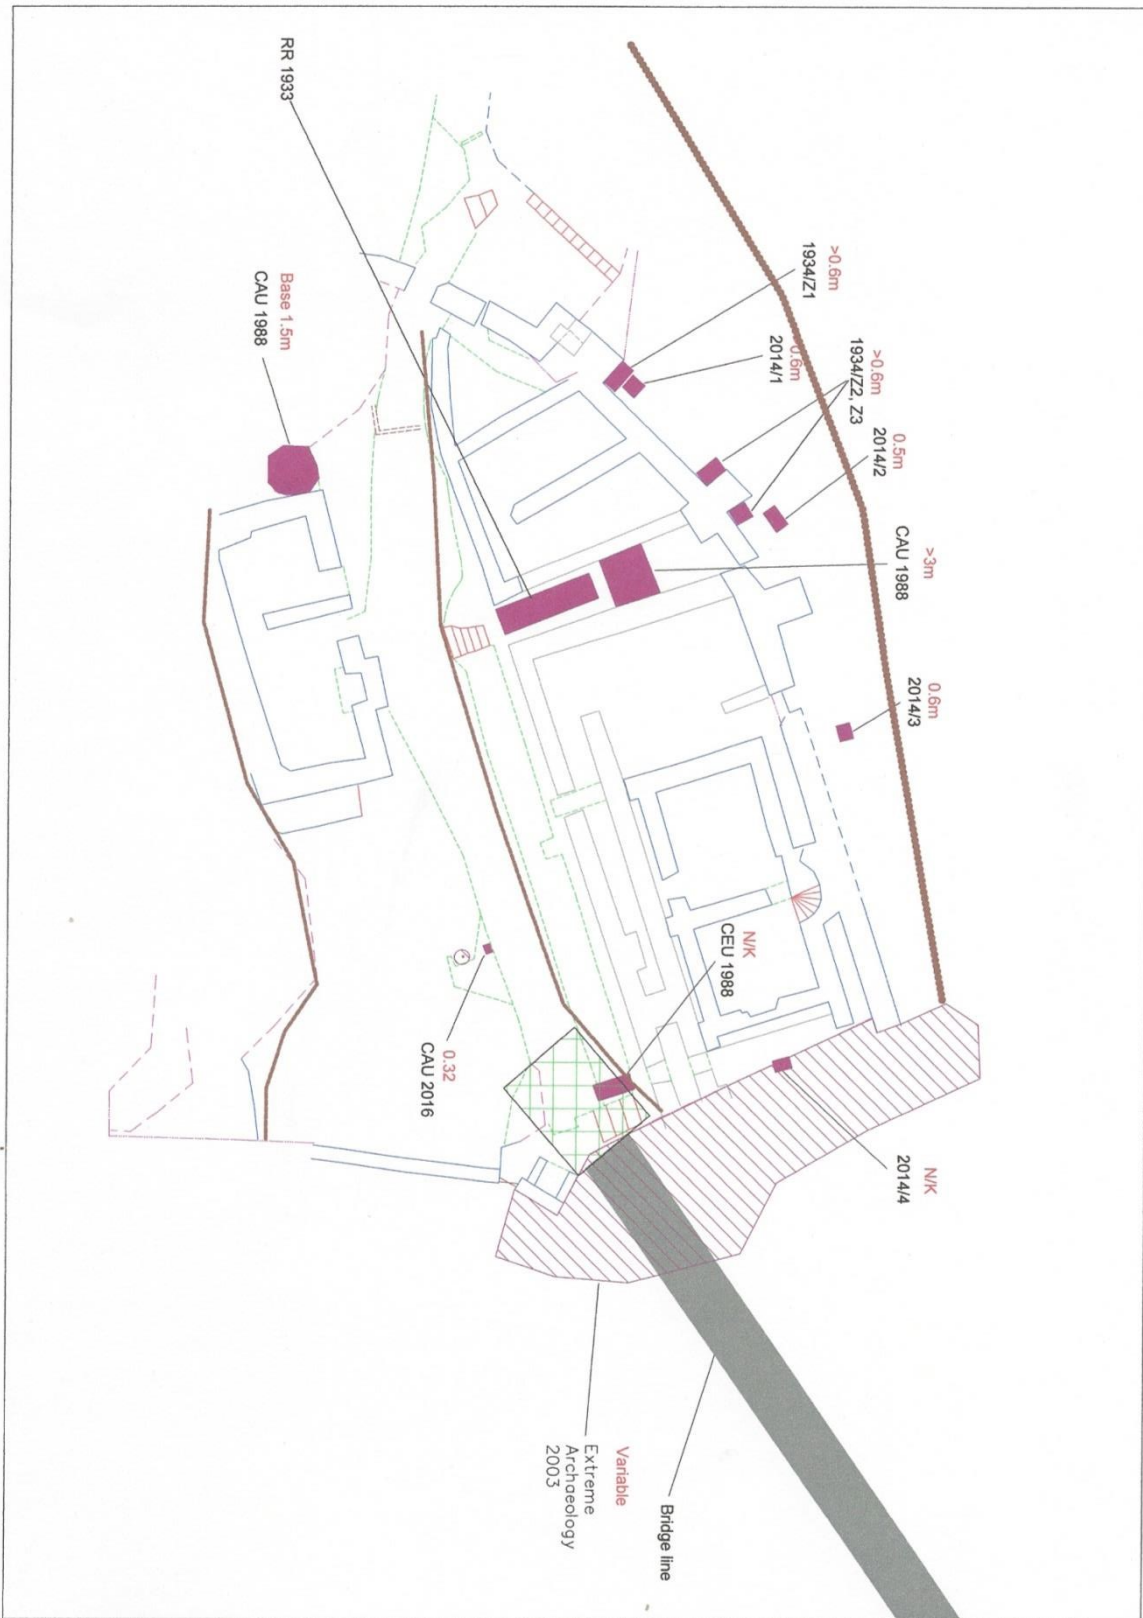
Fig 47. The locations of previous archaeological evaluation trenches (purple) in the Inner Ward together with dates and excavator information; additionally the approximate extent of the proposed bridge abutment (green hatch). Depths to bedrock are shown in red.

where bedrock was exposed at surface. Test pit 3 was excavated to the west of the path passing the Great Hall. Bedrock was found close to surface, though the southern edge of a rock cut feature of unknown extent and depth was clipped on the edge of the test pit (Smith 2016).
