Report No: 2016R018

The Dodman, St Goran, Cornwall

Archaeological survey, evaluation and watching briefs

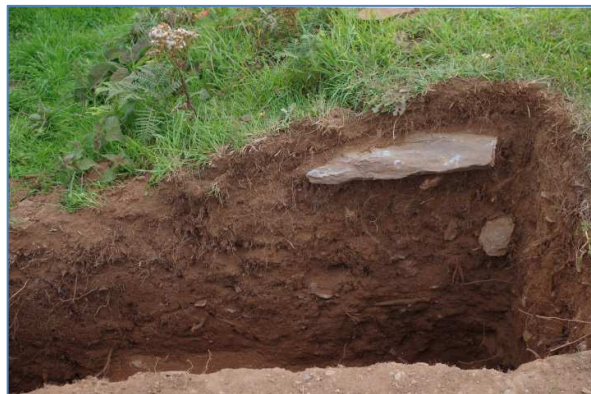
Figure 3 Trench 1, north facing section, with large capstone (102) in situ below the turf

Trench 1 (Figs 3, 4 and 9) was dug on the east side of boundary 4, which runs in a north-south direction down the centre of the plateau, dividing the medieval field system to the west from the open headland to the east. This boundary has areas of very poor repair, with stone facing surviving on its eastern side along some sections and other sections reduced to low earth banks on both sides, much affected by scrub and vegetation. There is a suggestion of stone facing on both sides along some sections but this was not evident in the vicinity of T1, which comprised a 1m wide trench inserted into a section of degraded earth bank, extending broadly eastwards from the centreline of the boundary to a length of 2.65m.

From top to bottom the trench revealed a thin turf line over topsoil (101), which comprised a slightly stony greyish brown silty loam between 0.05m in depth and 0.15-0.2m where it rose over the bank. A single sherd of post medieval cream glazed pottery was recovered from the topsoil to the east of the bank (not retained). Set just below the surface of (101) at the west end of T1 was a **large slate capstone (102)** about 0.55m in length and which extended out of the north facing section; a quartz stone was set directly below this. The form of the capstone was similar to those observed along the tops of some of the hedge boundaries in and around the headland. The height of the capstone was 0.6m above natural but, judging by the height of surrounding boundaries (averaging between 1m and 1.4m in height), it had probably slipped

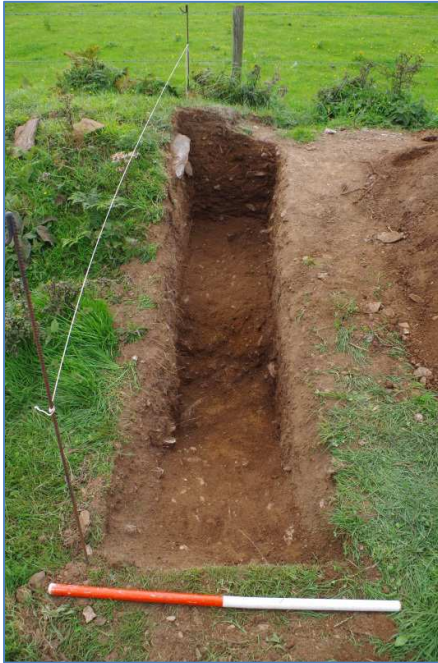
Figure 4 Trench 1, looking west

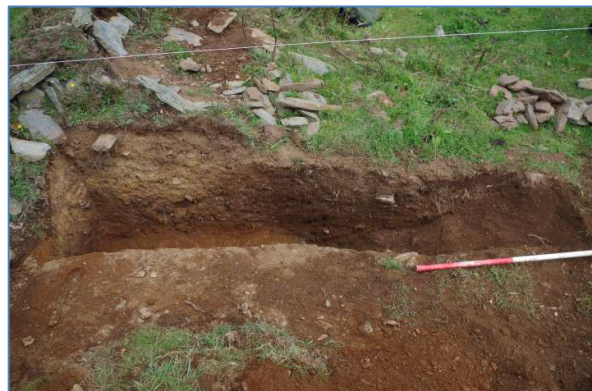
Figure 5 Trench 2, west facing section

Trench 2 (Figs 5, 6 and 9) was dug into boundary 13 towards the southern end of the surviving medieval field system and which may at one time have been within the medieval boundaries extent. The 1775-6 Mount Edgumbe map (Fig 47) indicates that by the late eighteenth century this boundary marked the southern edge of an area of unenclosed land, although the boundary itself appears present at this time. The boundary is stone faced on both sides along much of its length with lateral capstones along the tops and stands up to 1.2m. Some sections of this boundary are in poor condition, with much evidence for slumping. A 1m wide trench was inserted into the south side of the boundary, in a section retaining a stone facing on the north side, with the south side degraded and with some slumping. The trench extended broadly southwards from the centreline of the boundary to a length of 2.2m.

The top of the **stone wall (201)** facing the north side of boundary 13 was positioned above the north east corner of T2. This comprised large angular slate stones within a non-bonded earth matrix topped by a large capstone and under thin turf (not excavated). On the south side of the boundary were the remains of an earth bank topped by thin turf over light greyish brown silty loam topsoil (202) between 0.05m and 0.15m deep. There was much loose stone on the surface, predominantly large thin angular slate stones assumed to derive from a degraded stone facing on this side. (202) was deeper (0.3m) at its southern end over the bank edge. The southern end of T2 was also topped by a layer of thin turf and topsoil (203).

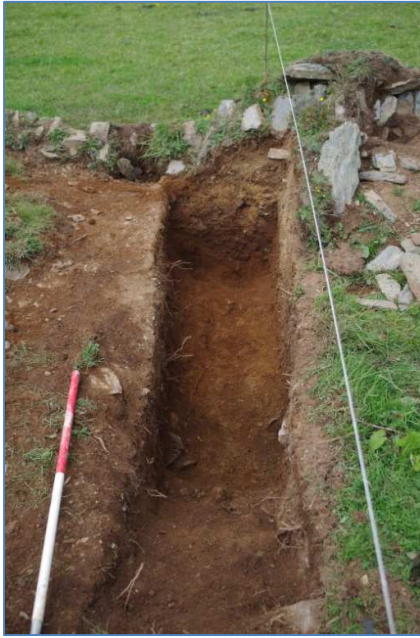
Figure 6 Trench 2, looking north

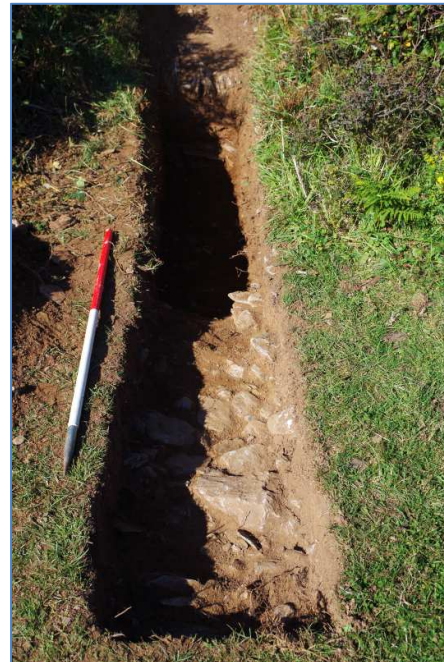
Figure 7 Trench 6, looking north

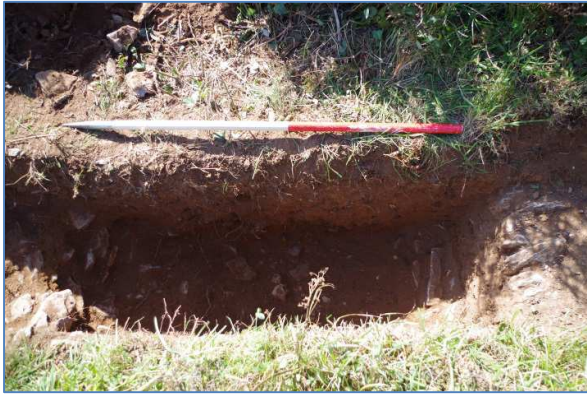
Figure 8 Trench 6, east facing section

Deposit (603) was the secondary fill of a **wide shallow ditch [606]**, which measured around 1.2m wide and around 0.2m deep. It had a wide flat base cut into natural and shallow sloping sides. At its northern end it terminated in a ledge of raised weathered bedrock abutting a vertical edge

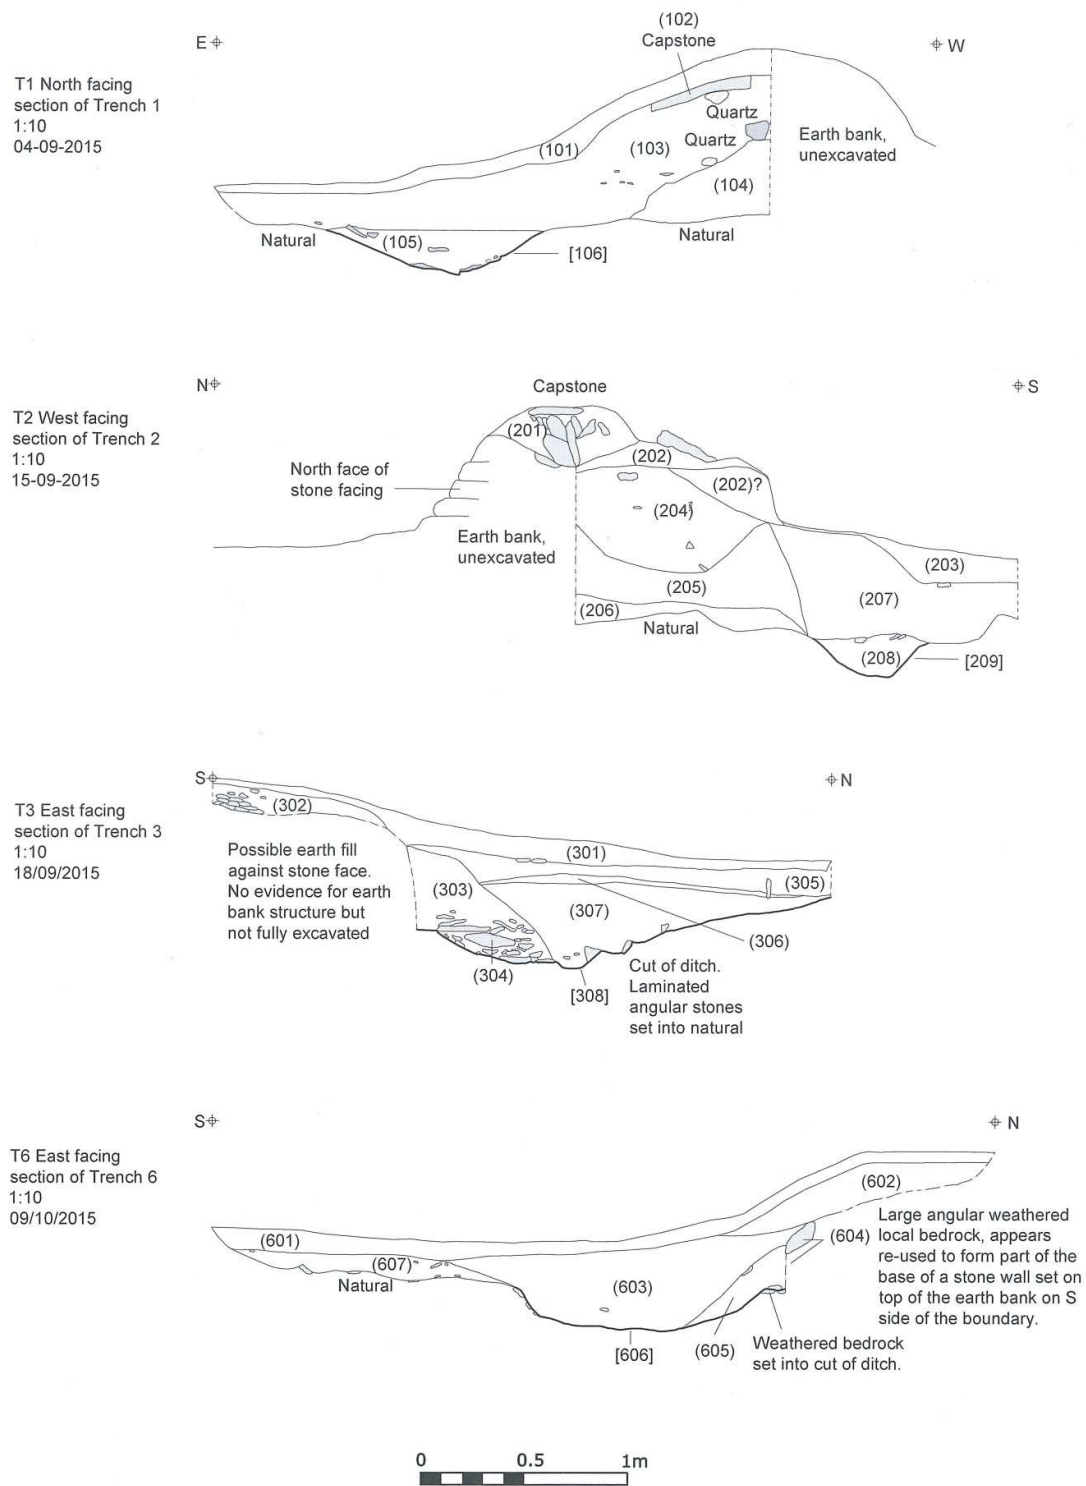
Figure 9 Section drawings of the field boundaries excavated in T1-T3 and T6

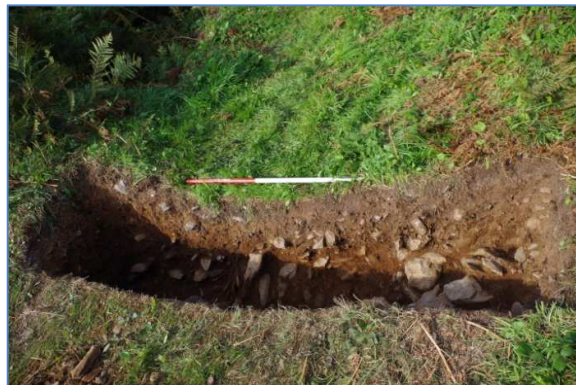
Below (404) and slightly overlain at its south end by (406) was a sloping layer of very stony and rooty dark greyish brown silty clay (407), averaging 0.18m in depth and containing some larger (0.18-0.25m) angular slate stones and quartz stones. A holed stone was recovered from the south end of this context. Deposit (407) was interpreted as a possible former land surface with some tumble from the rampart to the north towards its base and intermixing with it. At its south end (407) slightly overlay a deep layer of very dark blackish brown silty loam (408), around 0.2m to 0.3m deep and containing some large (0.18-0.25) slate stones, but with stone free pockets. There were many matted bracken rhizomes present within the looser soil, to a depth of around 0.7m below current ground level. Deposit (408) was interpreted as a possible former land surface pre-dating the construction of **structure 1** and possibly forming the upper fill of **ditch [415]**, *Figure 10 Trench 4, east facing section*

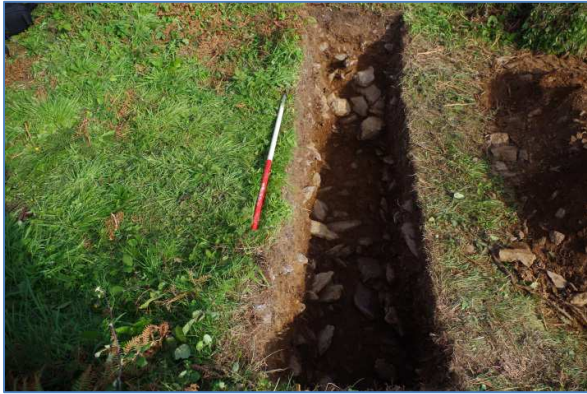
Figure 11 Trench 4, looking south

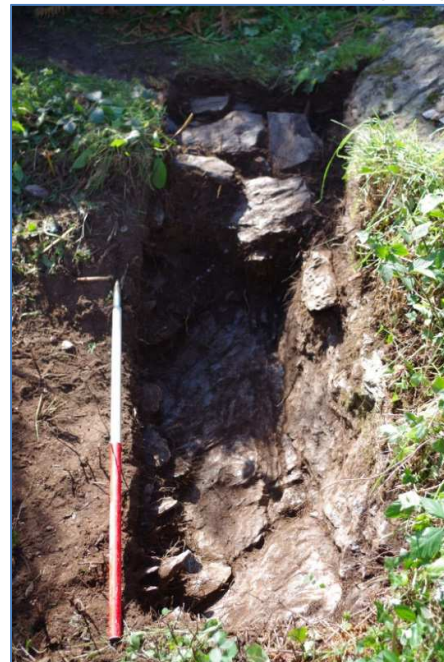
Figure 12 Trench 5, looking south

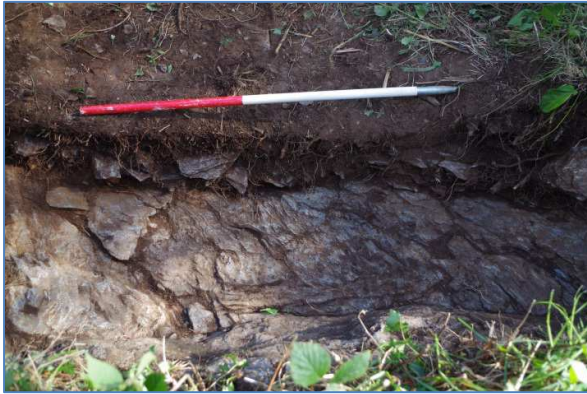
Figure 13 Trench 5, west facing section

The discussion of T5 refers to both the east facing and west facing sections, both of which were very different from each other. The east facing section of T5 from top to bottom revealed a rooty and heavily vegetated surface (501) above mid greyish brown silty loam topsoil (502), up to 0.2m deep. At the north end of T5 and below (502) was a 0.2m deep layer of **weathered bedrock stones (503)**, roughly coursed and following the plane of the bedrock. The stones abutted the **large slab of weathered bedrock (504)** on its northern edge and may have been part of the natural bedrock formation, although they had the appearance of rough walling. At around 0.6m depth the **slab of bedrock (504)** had been cut into. The **cut [505]**

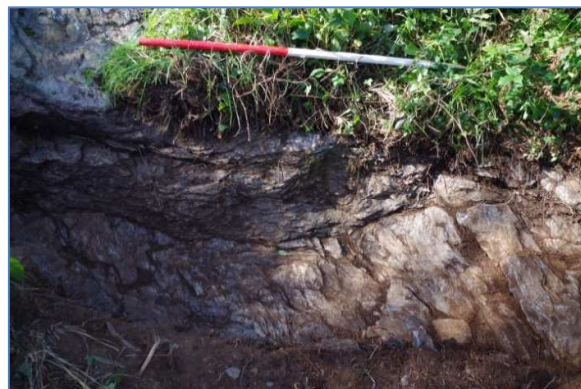
Figure 14 Trench 5, east facing section

The evidence from T5 appears to relate to a small 3m by 4m structure partly formed by the construction of earth and stone banks against a natural face of bedrock. The date of **structure 1** is not clear, but as the upper layers within T5 ((510) and (511)) appear to indicate loamy soils containing late nineteenth to early twentieth century pottery, it might be assumed that the structure was uncovered and possibly out of use by at least the late nineteenth century. The stone laid pathway running alongside the artificial terrace to the south of **structure 1** also remains undated and its association unclear; the topographic survey of the earthworks (see Section 9.3.3) suggests **structure 1** may once have extended as far as the artificial terrace to the south and that the pathway therefore cuts through **structure 1**, but further excavation would be required to confidently

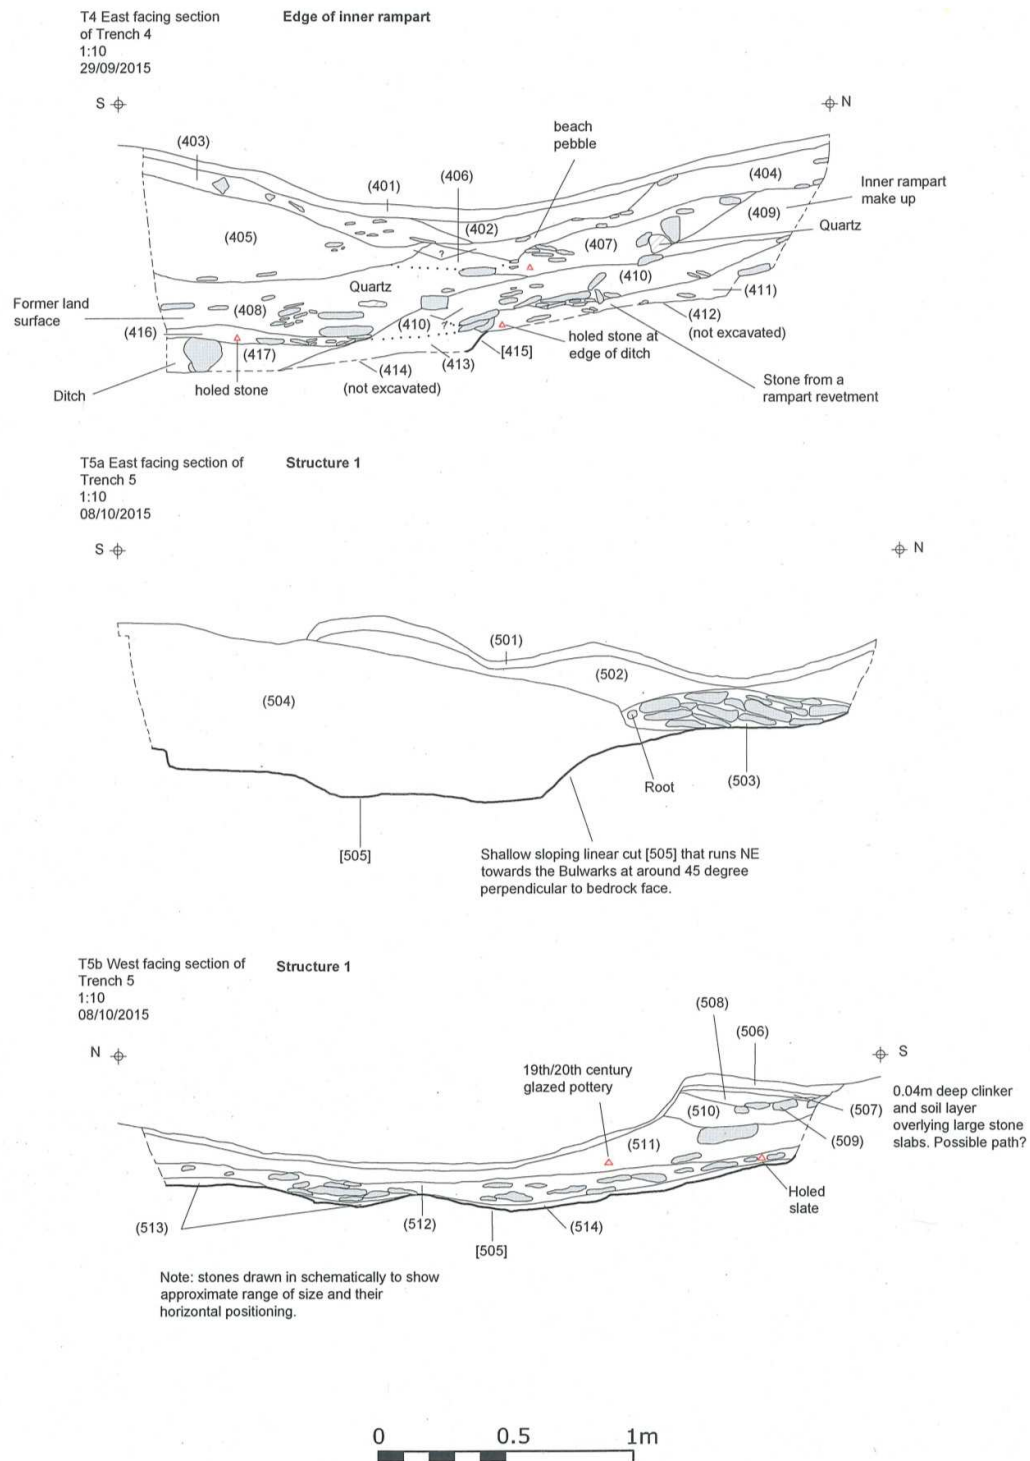
Figure 15 Sections across edge of inner (Bulwarks) rampart (T4) and Structure 1 (T5a and T5b)

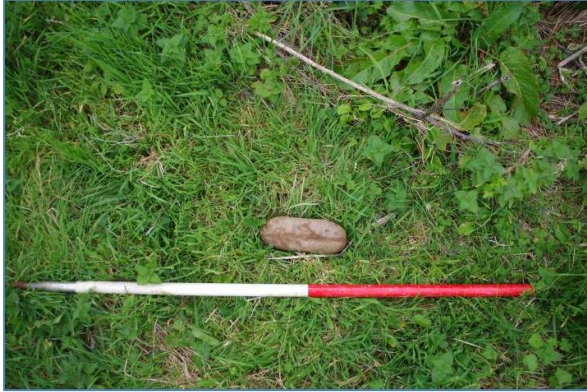
Figure 16 Beach cobble from Pit 5

- **Pit [5]** (SX 00202 39981): excavated depth around 0.6m. From top to bottom: mid to dark reddish brown silty loam (0.2m) below turf over quite stony mid yellowish red silty clay (0.4m) over a stony light brownish yellow silty clay. A large smooth beach cobble (Fig 16) was recovered from upper horizon of the middle layer, 0.2m below topsoil. The cobble shows signs of wear and polish that suggest various possible uses, perhaps as a whetstone or pestle.

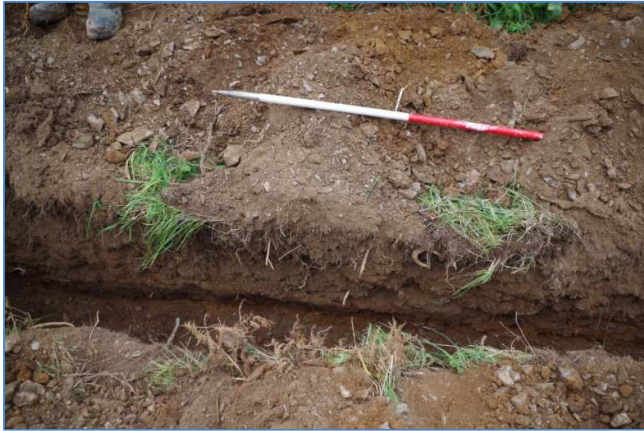
Figure 17 Trench 7, east facing section, across the central part of the inner rampart, showing possible buried soil surface (705)

Trench 7 was not fully excavated to natural but from top to bottom revealed stone free mid greyish brown silty loam topsoil (701) topped by turf, about 0.2m deep and extending across the length of the trench. Below (701) at the southern end of T7 and extending north for around 11m was a stony mid yellowish red silty clay layer, around 0.4m deep. Below (702) at the southern end of T7 was a deposit of very loose weathered bedrock fragments (703), possibly redeposited. This was interpreted as a possible secondary phase of rampart construction or modification.

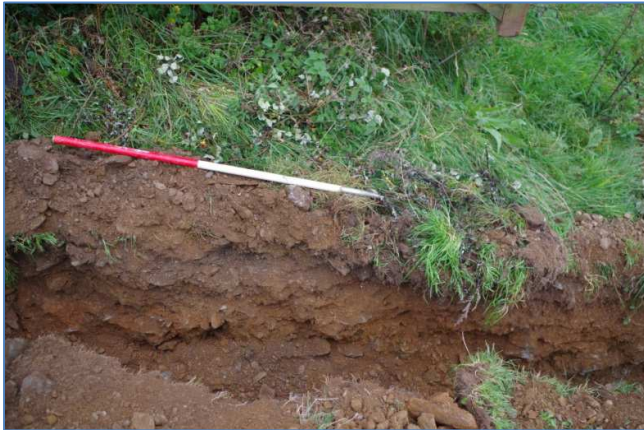
Figure 18 Trench 8, east facing section from south to north (above), showing the central section over the inner rampart, and the north end (right) where it meets Pit 7

Deposit (805) was intermixed with mid reddish brown silty clay that may have been partly mixed with (806) and (804). Together (805) and (806) appeared to face the lower section of the inner rampart, with (803) and (804) forming part of the inner bank material. The laminated stones in (805) and (806) have a slightly sloped alignment from north to south and abut (804). It was not clear, however, whether both deposits reflected *in-situ* natural bedrock, or whether (806) was natural bedrock cut to take the base of a bank, which was then filled by redeposited material (805). Alternatively it may be that both deposits reflect natural bedrock that has been cut into or shaped somehow to form a rampart facing. Underlying (803), (804), (805) and (806) was a stony light to mid yellowish brown silty clay (807) that was not fully excavated but which appeared to be the natural subsoil of this area. The presence, or otherwise, of the ditch to the north of the inner rampart at this point was not clarified.

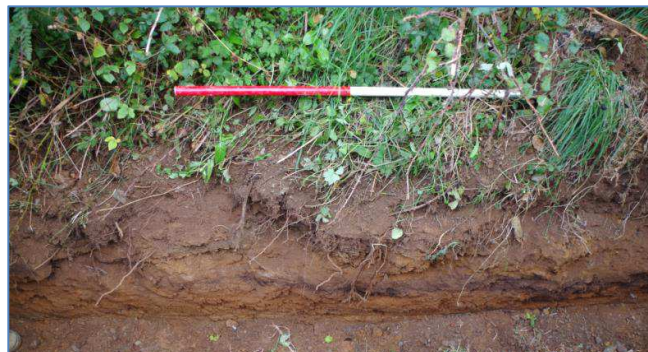
Figure 19 Trench 9, west facing section showing a buried soil surface (906), which appears to have formed over an earlier earth bank

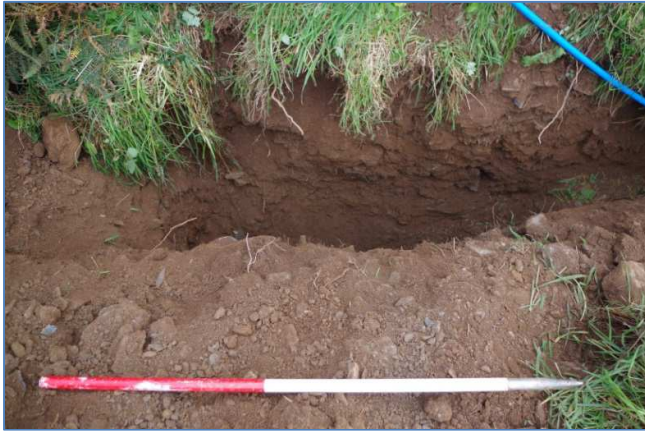
Figure 20 The edge of the interior ditch at the base of Trench 9

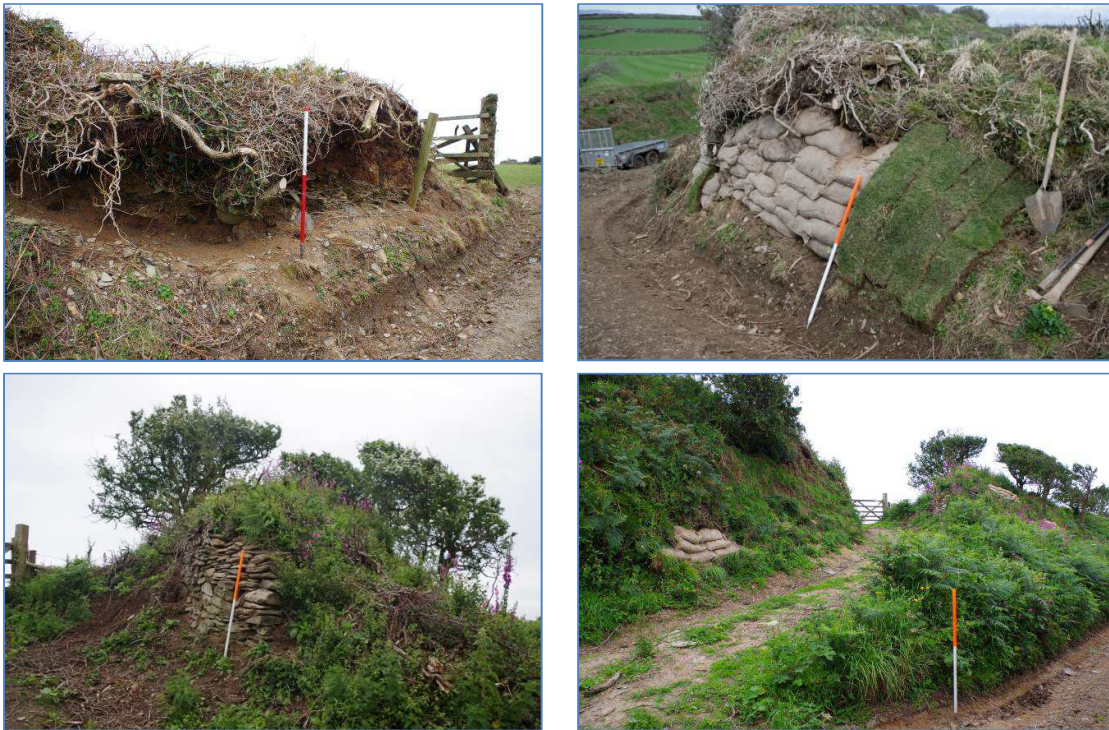
Figure 23 Clockwise, Erosion Area (E1) before, during and following repair in March, April and August 2016. The Cornish hedge adjacent to the gateway on the west side was also repaired

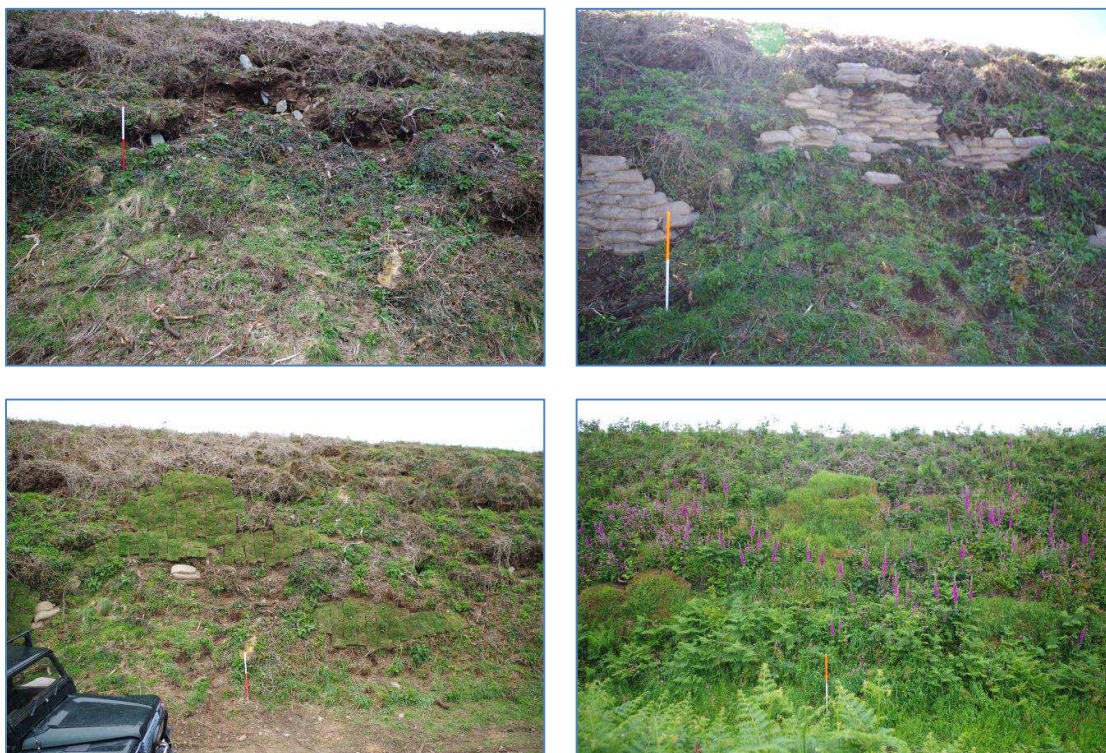
Figure 24 Clockwise, Erosion Area E2 before, during and after repair in March, April and June 2016

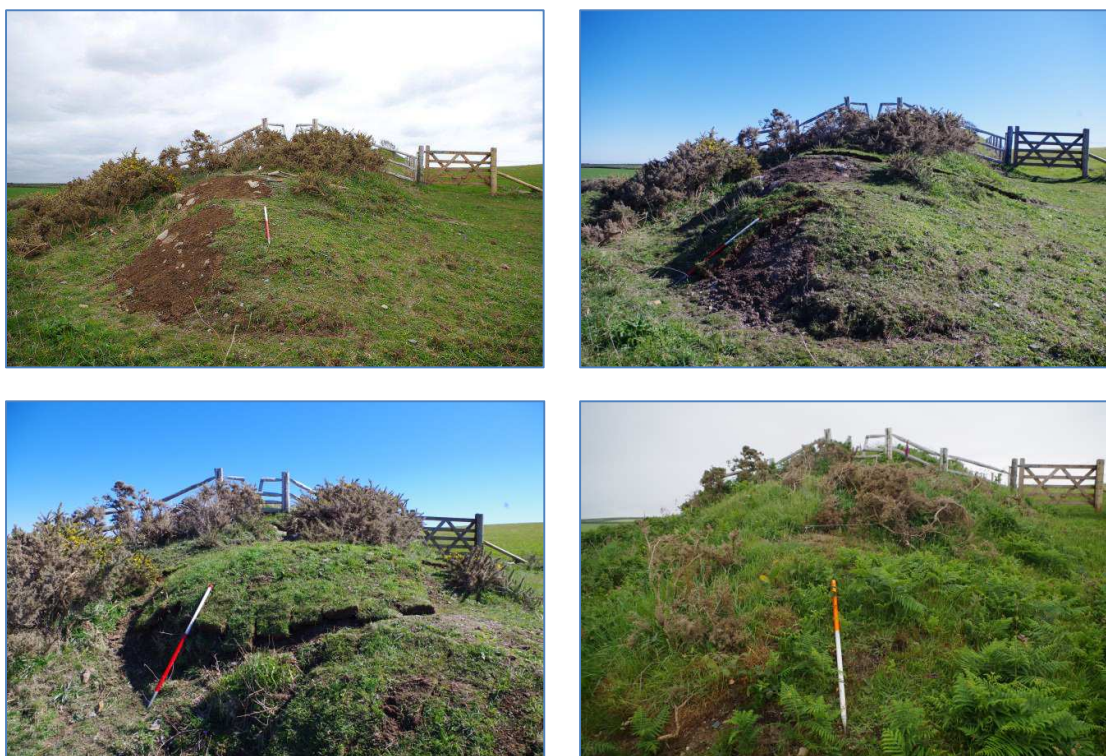
Figure 25 Clockwise, Erosion Area E3 before, during and after repair in March, April and August 2016

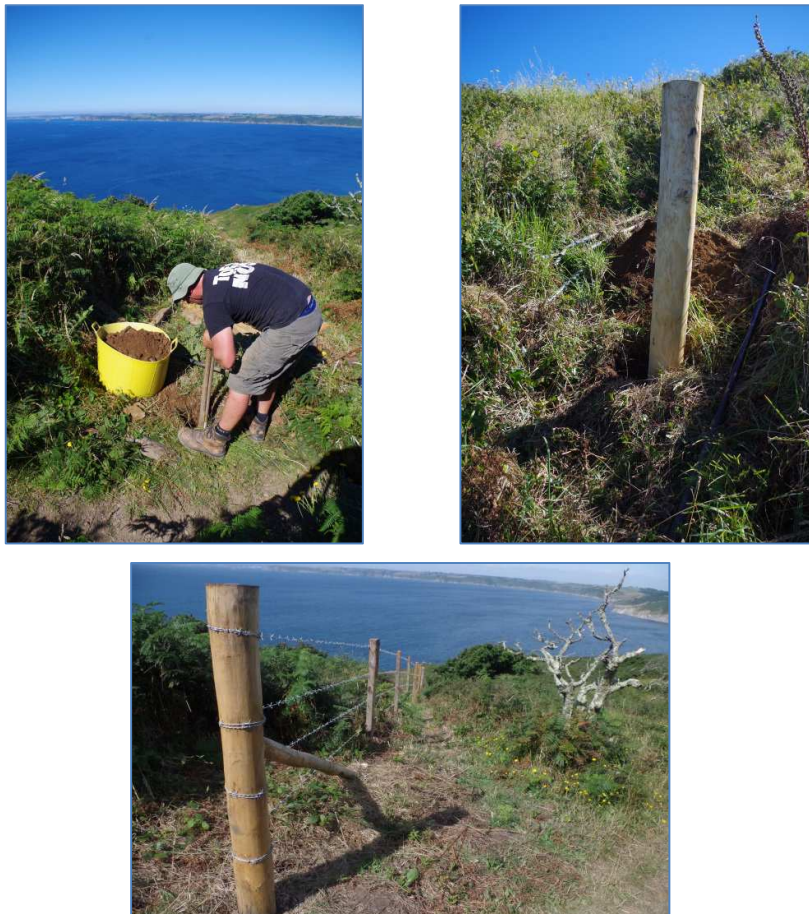
Figure 26 Digging postholes for the new line of fencing on the west side of Dodman Point

Four postholes (Fig 26) were monitored on the western slopes on July 18 2016 in preparation for a new line of fencing:

- **Posthole [1]** (SW 99908 39769): depth 0.92m, containing mid reddish brown friable silty clay with frequent small to medium stones.
- **Posthole [2]** (SW 99858 39740): depth 1.02m, containing mid reddish brown friable silty clay to 0.8m, slatey stones to 0.9m, mid reddish brown friable silty clay to base.
- **Posthole [3]** (SW 99821 39725): depth 1.07 and situated on top of a north to south break of slope (possible earth bank but difficult to see either side because of thick vegetation cover), containing mid reddish brown friable silty clay.
- **Posthole [4]** (SW 99789 39703): depth 0.92m and situated on cliff edge, containing light yellowish brown friable silty clay – probable head material.

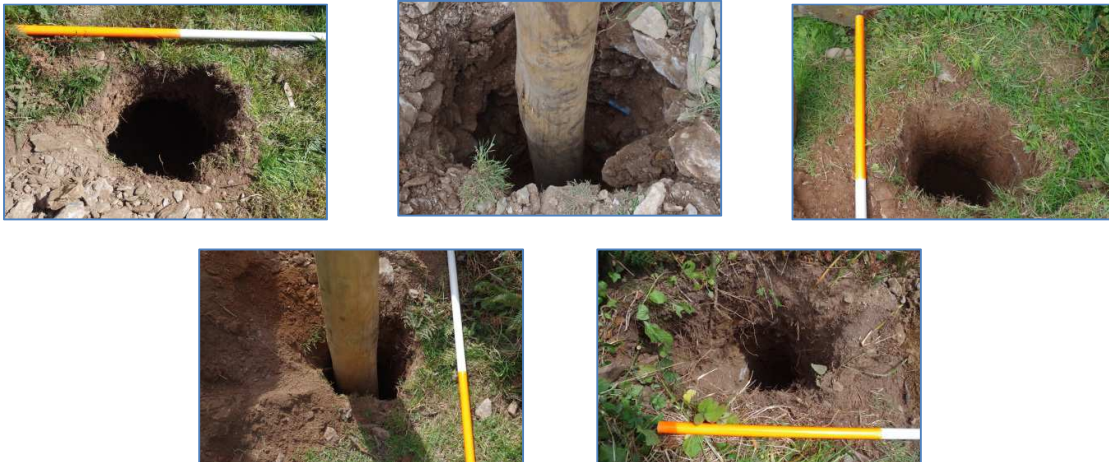
Figure 27 Postholes 1 to 5, dug to erect gateposts for two new gates and one existing gate leading on to the field lanes crossing the inner rampart

- **Posthole [5]** (SX 00212 39973): on east side of gateway, north side of inner rampart, depth 0.95m, containing slightly stony, dark brown silty loam topsoil and turf to 0.15m, stony mid reddish brown silty clay loam to 0.35m, very stony light reddish brown silty clay with greyish hue and containing frequent medium to large slate stones and crushed shillet fragments to 0.9m, soft dark reddish brown silty clay just exposing at base to 0.95m.

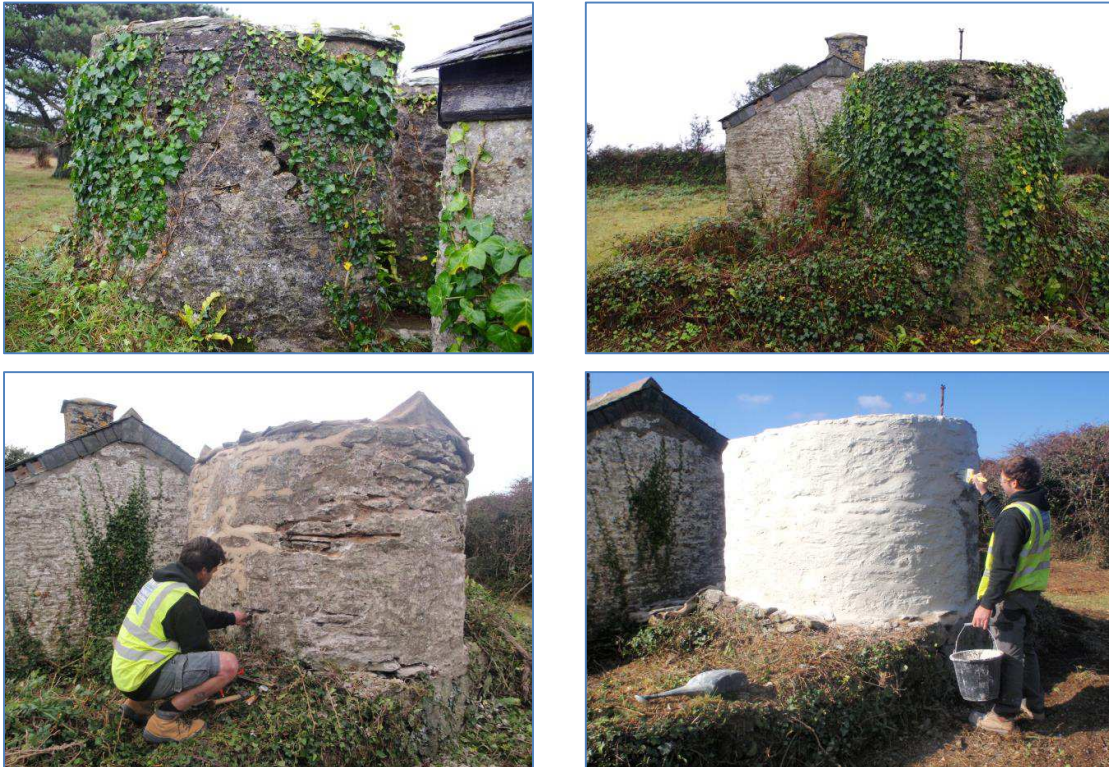
Figure 28 The watch house lookout platform before and during repair

NB: The lime wash finish to the lookout platform should be reapplied annually to maintain it, as this type of finish washes off very easily. Although the watch house could not be repaired under the current HLS scheme the repairs to the lookout platform highlight the need for this under future schemes, as there is now a very distinct contrast between the two structures.

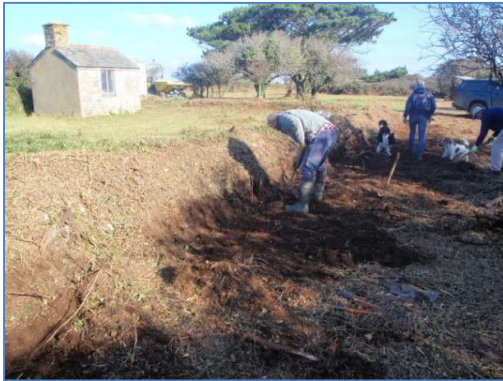
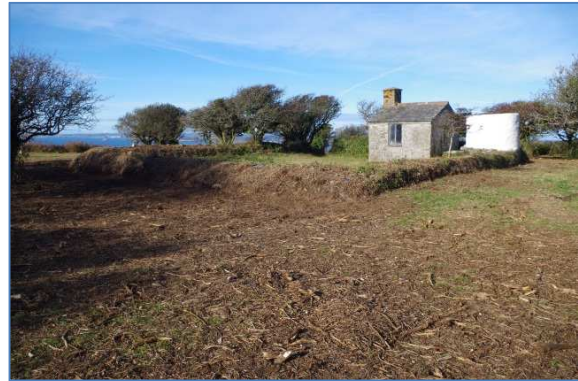
Figure 29 Clearance around the watch house enclosure

Clearance around the exterior of the watch house enclosure boundary was monitored during October 2016 ahead of the installation of park fencing to protect the enclosure once the Penare Dexter herd are introduced into that area. The work was carried out by the National Trust and volunteers (Fig 29).

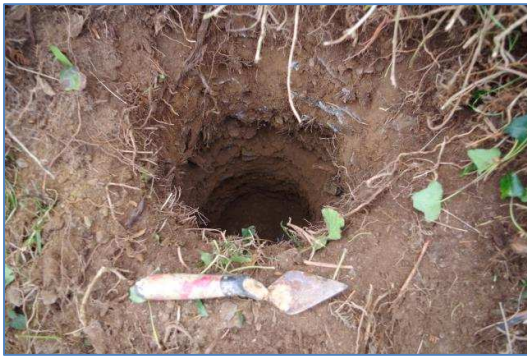
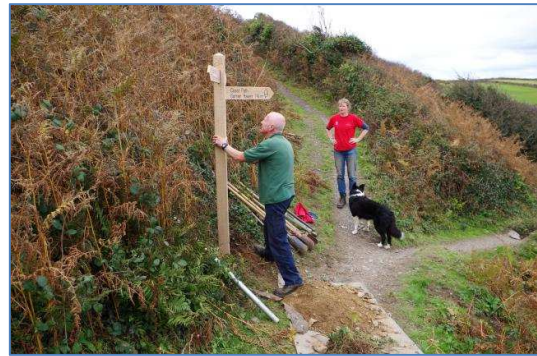
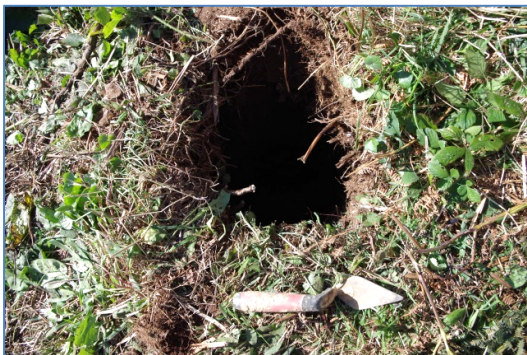
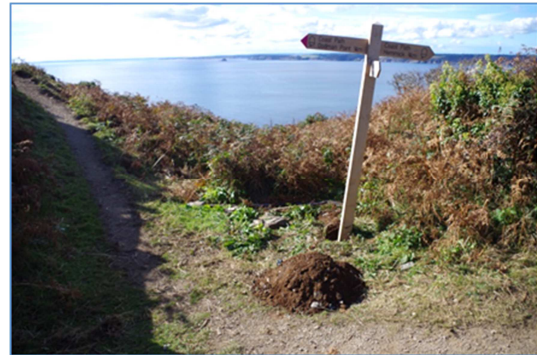
Figure 30 Postholes and new fingerposts installed along the coast path on the east and west sides of Dodman Point

New fingerposts were installed on Dodman Point by the National Trust during October 2016, on the east side of the headland on the coastal path between Dodman Point and

Gorran Haven, and on the west side of the headland on the coast path between Dodman Point and Hemmick Beach (Fig 30). Two postholes were dug to take the new posts. The posthole on the west side of the headland was placed in the inner ditch of the Bulwarks and hit bedrock at 0.7m.

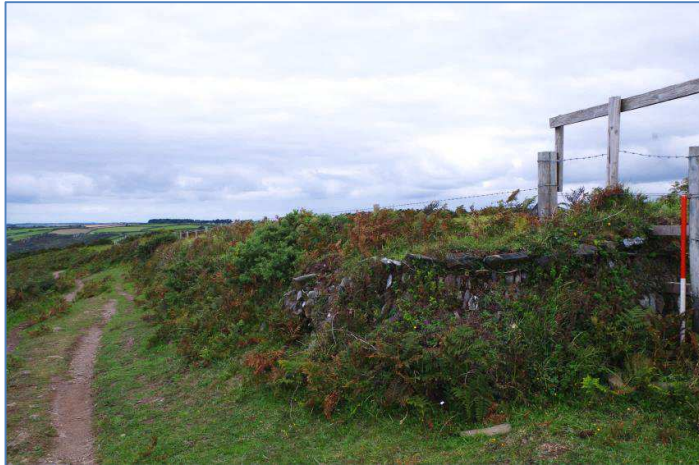
The northern section of boundary 3 is fenced between the Bulwarks and the junction with boundary 15, where a stone-faced retaining wall around 1.2m high is introduced against the break in slope, the fencing continuing above this. Between the ends of boundaries 14 and 15 the predominant style of stonework is Jack and Jill herringbone style, with some lateral capstones present along the top edge. The walling is generally in good condition. Between the ends of Boundaries 13 and 14 the stone walling varies in height between 1.3 and 1.75m and the style of stonework comprises coursed uprights with some piers of lateral slate stones present and placed lateral capstones along the top edges (Fig 31).

Figure 31 Looking north along Boundary 3

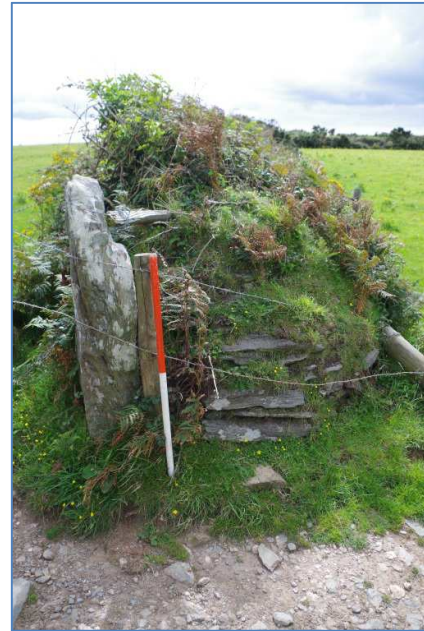
Figure 32 Gateway in Boundary 4 with moor stone gatepost

On the east side of field 1883 boundary 4 appears to have a stone facing of upright stones on both sides, with placed capstones visible along the top on some sections. There is dense vegetation obscuring much of this boundary. A gateway into field 1883 has rounded ends of lateral slate stones and a moor stone gatepost with iron hinges (Fig 32). The northern wall end is showing signs of erosion and there is some wall tumble generally along this section.

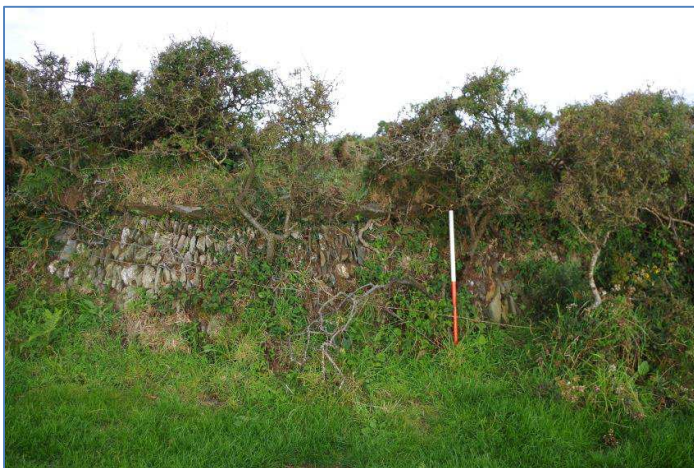
Figure 33 Rounded angle in Boundary 4 on the south side of field 2366

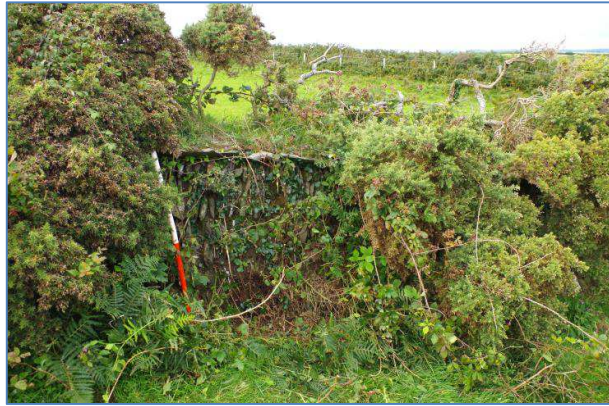
Boundary 5 extends along the south side of field 2694. It is shown on the 1775-6 Mount Edgecumbe estate map as the north side of two rectangular enclosures, now surviving as low lynchets to the south (Fig 47). It stands between 0.8m and 1m high and comprises stone facing of small upright slate stones on both sides with capstones along the top (Fig 34). There is much vegetation along both sides, largely gorse and bramble, and a break has been made in the centre to create stock access. There is some wall tumble and some erosion breaks at the eastern end.

Figure 34 Boundary 5, looking north

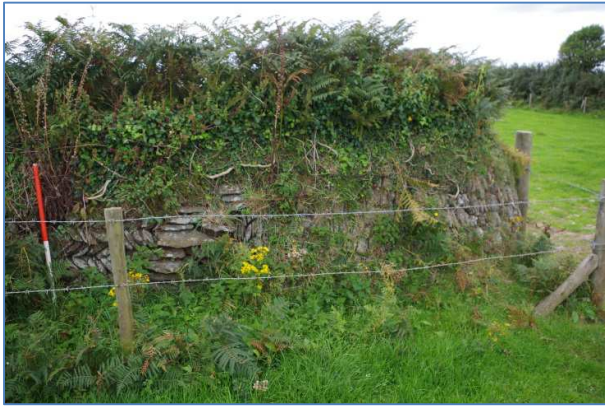
Figure 35 Boundary 6a, northern end looking west

Boundary 6a extends along the west side of field 1883, from the Bulwarks to the northern junction with boundary 4. The boundary may be shown on the 1775-6 Mount Edgecumbe estate map (Fig 47) and 1842 Gorran parish Tithe Award map (Fig 49), both of which suggest former strip field boundaries here. Boundary 6a stands 1.2m high and comprises stone walling on both sides. The style of stonework varies along its

length, alternating coursed slate uprights and Jack and Jill herringbone, with lateral piers of horizontal slate stones at intervals, particularly visible at the northern end (Fig 35). No capstones are visible. A gateway between fields 1883 and 1167 has rounded ends of narrow upright slate stones, with protruding stones on the southern gate end now supporting a wooden gatepost. There is dense vegetation, largely gorse and blackthorn, along much of the boundary, with evidence of animal burrowing.

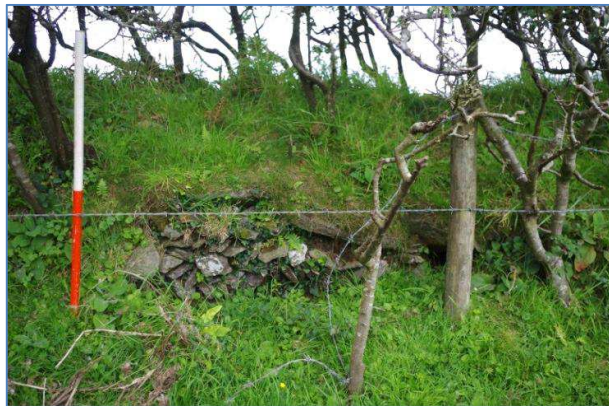
Boundary 6b extends along the east side of field 1883 as far as the northern junction with boundary 4 at the corner of field 2694. The boundary is shown on the 1775-6 Mount Edgecumbe estate Map (Fig 47). It currently stands to around 1.2m high and is stone faced on both sides. The style of stone walling is predominantly coursed uprights of varying size in the central section but with Jack and Jill herringbone at both ends, the northern end also having lateral capstones along the top edges. There is dense blackthorn along the northern section where the walling is showing demonstrating some collapse (Fig 36).

Figure 36 Boundary 6b, northern end, looking east

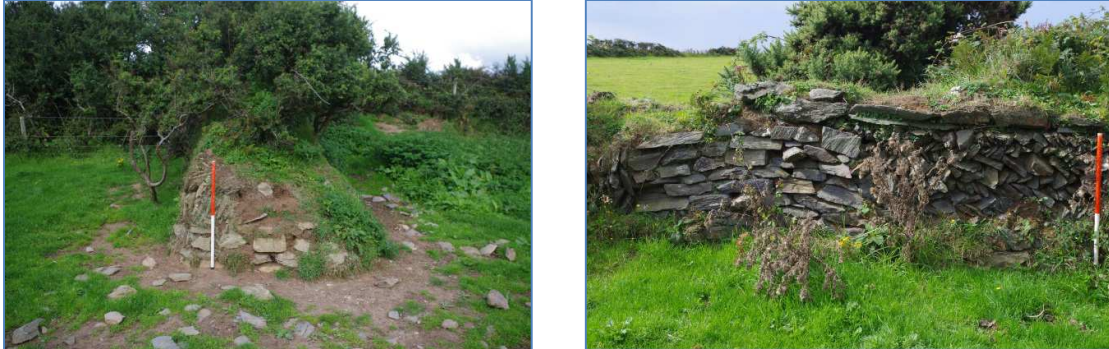
Figure 37 Boundary 7, the gateway looking north and the changes in stonework styles either side of Boundary 16, looking west

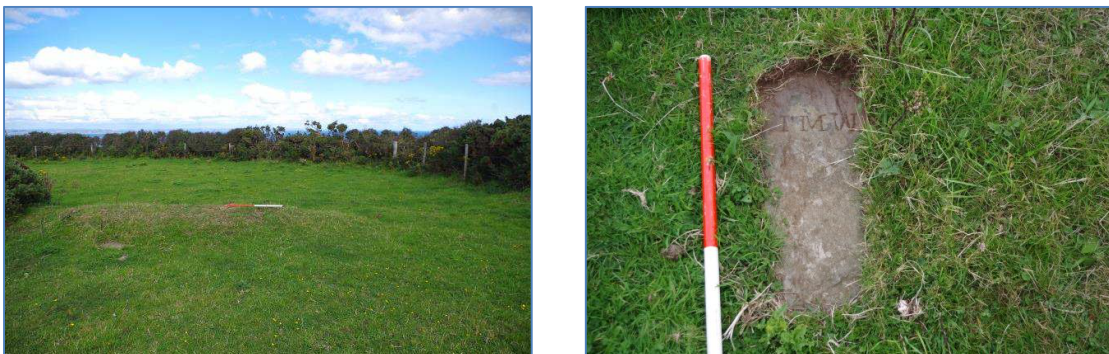
Figure 38 Boundary 8, southern end, with boundary stone and inscribed initials I.M.W.

Boundary 8 extends along the west side of field 2366. On the 1775-6 Mount Edgumbe estate map it appears to be pencilled in as a small rectangular enclosure to the north and is shown as having a less clear boundary line to the south (Fig 47). The boundary appears more solid on the 1842 Gorran parish Tithe Award map (Fig 49) but it has a different form in the south than the north, which may indicate its former division. At the north end boundary 8 is stone-faced on both sides, comprising coursed uprights 0.8m high, with some lateral stones along the base. The stonework shows evidence of much repair. Towards the southern end boundary 8 becomes a low earth bank, around 0.8m high but with several breaks and much vegetation cover. An opening at the south end allows access between fields 2366 and 1456. One of the recorded boundary stones (MCO45828) bearing the inscription I.M.W. lies against the west side of boundary 8 near this opening (Fig 38), although this is known not to be *in-situ*. A second large flat stone, of similar shape and size, lies on the opposite side of the opening but does not appear to bear any inscription.

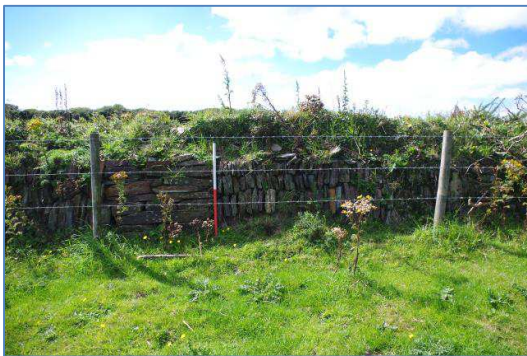
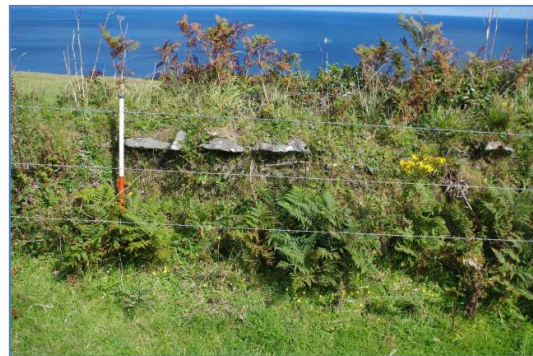
Figure 39 The east and west faces of boundary 10

Boundary 10 ranges between 1m and 1.4m in height and is stone-faced on both sides. The east and north faces are largely coursed upright slate stones, the style of which is different at the northeast end, looking older and rougher in design. There is some Jack and Jill herringbone sections along the north face and at intervals between the uprights on both the north and east faces are lateral piers of long horizontal stones (Fig 39), as seen periodically within other boundaries on Dodman but particularly evenly spaced here. In places they seem to coincide with the ends of the low curving lynchets to the east of boundary 10. This may be coincidence but an alternative theory is that these pillars somehow mark land division in some way; the pier in boundary 7 at the junction with boundary 16 (Fig 37), may also be an example of this.

The west and south faces of boundary 10 contain some sections of Jack and Jill herringbone stonework with some lateral capstones and both sides of the boundary have dense vegetation cover (Fig 39). Condition is generally very good, although there is some degradation of stonework at the southern end of boundary 10 at the point where the hollow way meets it.

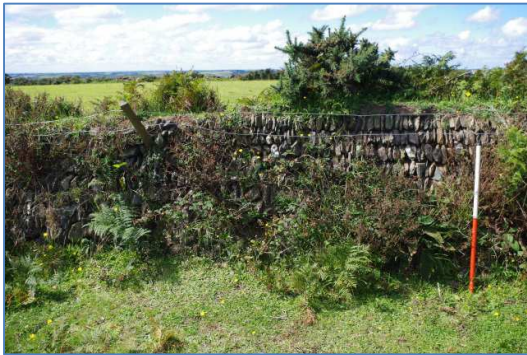
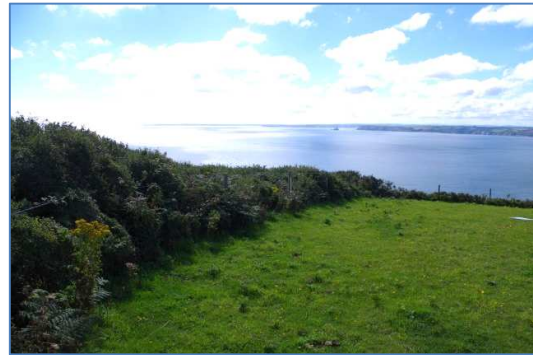
Figure 40 The south side of boundary 12 at its eastern end, and the fenced dogleg at its western end

Boundary 12 extends along the south side of field 2348. It appears to be shown on the 1775-6 Mount Edgecumbe estate map as forming the north side of the watch house enclosure (Fig 47) and is also shown on the Gorran parish Tithe Award map (Fig 49). The boundary is stone-faced on both sides and varies between 0.4m and 1.3m high, with some sections along the north face where the stonework has tumbled and the boundary is in very poor repair. The eastern end of boundary 12 comprises coursed upright slate stone on both sides (Fig 40), with signs of significant repair on the north face. Towards the western end the stonework on the north face of boundary 12 is Jack and Jill herringbone style. Dense vegetation along the south side of boundary 12 obscures the western end on this side. The western end of boundary 12 incorporates a short dogleg on its north side to meet boundary 3. The dogleg is fenced with dense vegetation behind (Fig 40). The dogleg is not shown on historic mapping and the reason for this is not clear.

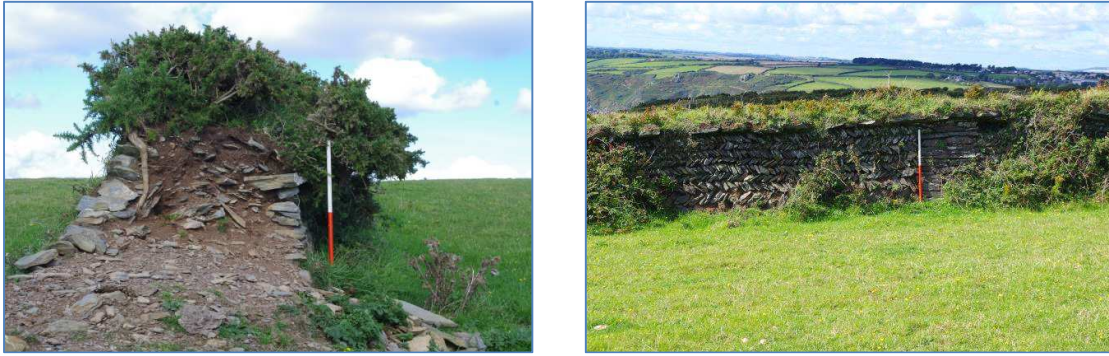
Figure 41 An eroded section across boundary 13 and a section of the south face showing coarse 'Jack and Jill' style stonework, capstones and one of the lateral piers
