Report No: 2016R018

The Dodman, St Goran, Cornwall

Archaeological survey, evaluation and watching briefs

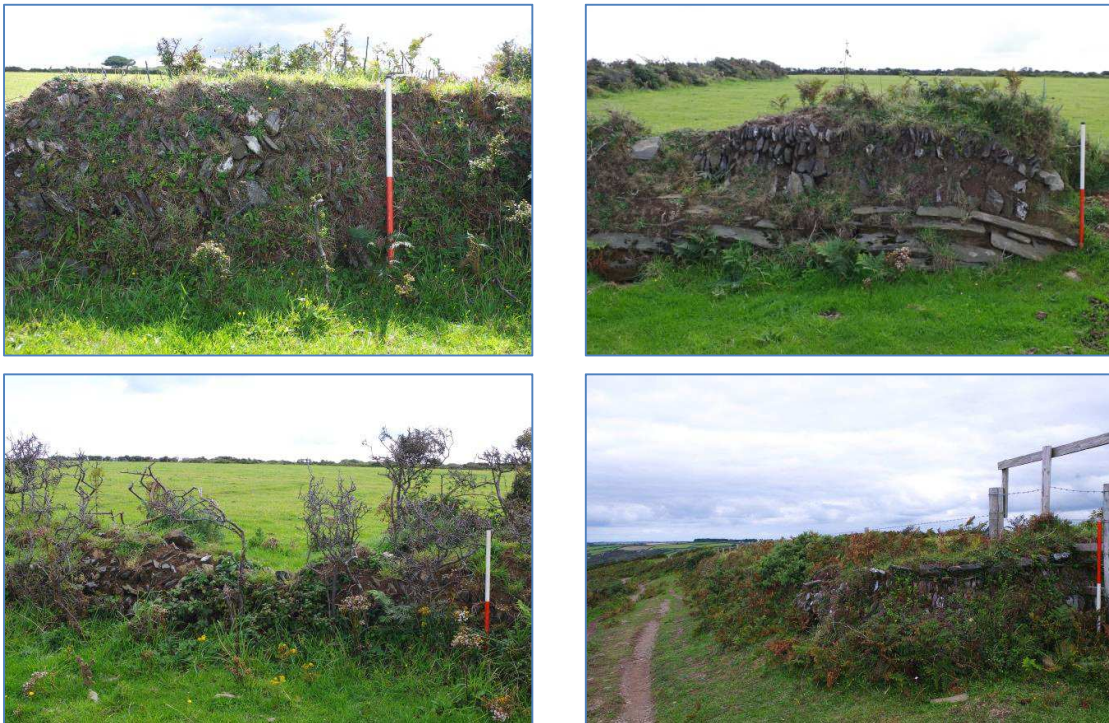
Figure 42 Boundary 14 showing different styles of stonework and evidence for repair. The west end of boundary 14 curves round to meet boundary 3

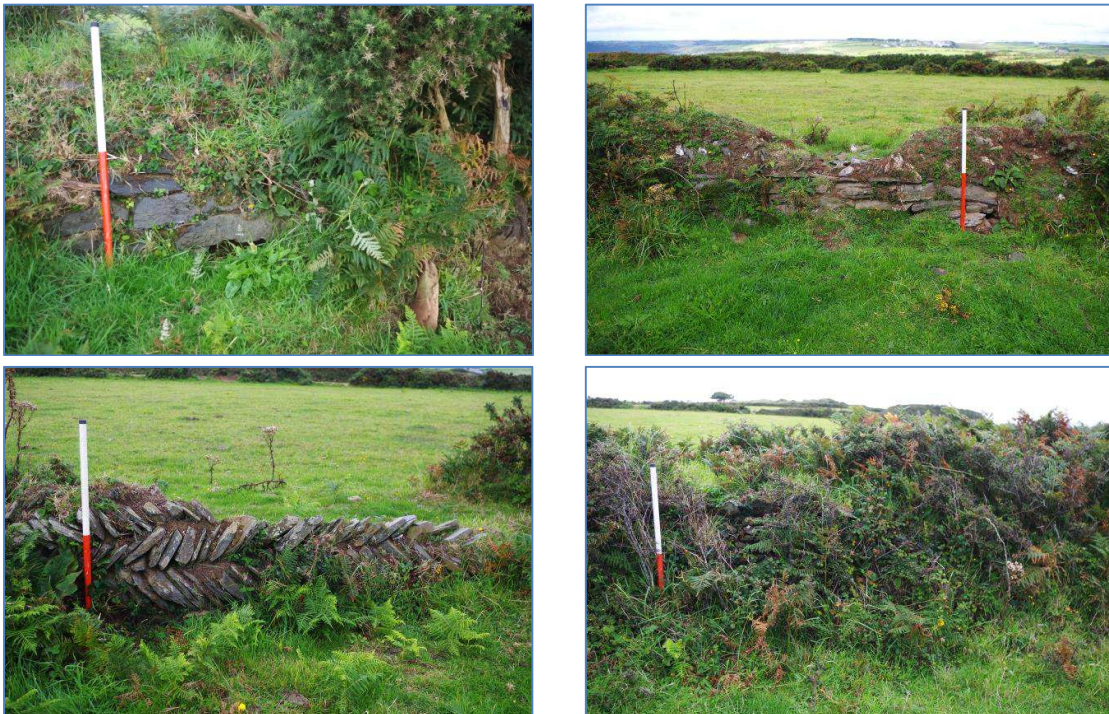
Figure 43 Boundary 15 showing different stonework styles and evidence of repair. A worked stone at the eastern end (top left) may have served as a drain

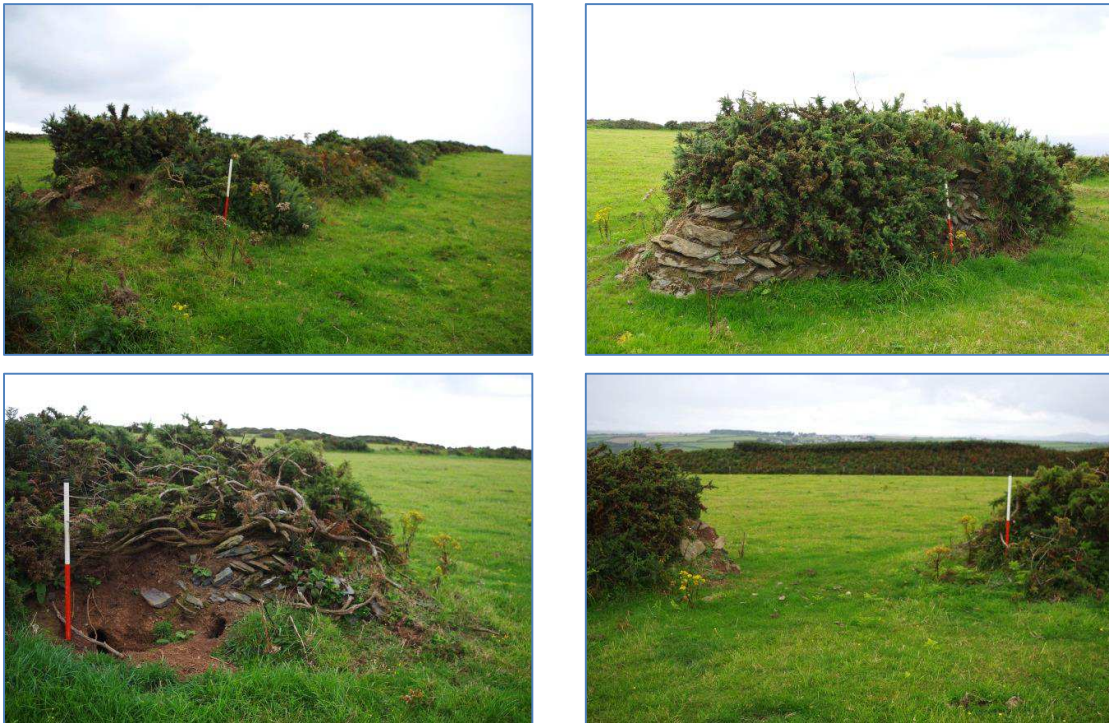
Figure 44 Boundary 16, now reduced to a low earth bank in places but with some sections of stone facing. There are several large stock breaks along its length

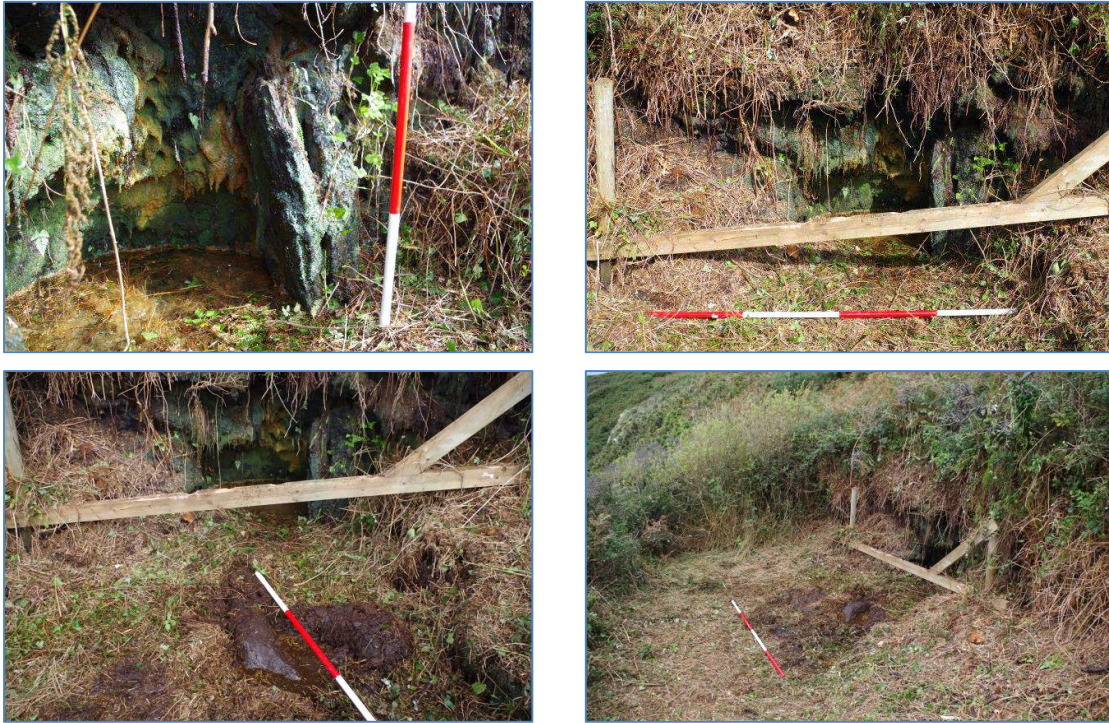
Figure 45 The spring on the west side of Dodman. A terrace in front of the spring is deep in boggy vegetation. A fallen jamb stone lies in front of the niche (bottom left).

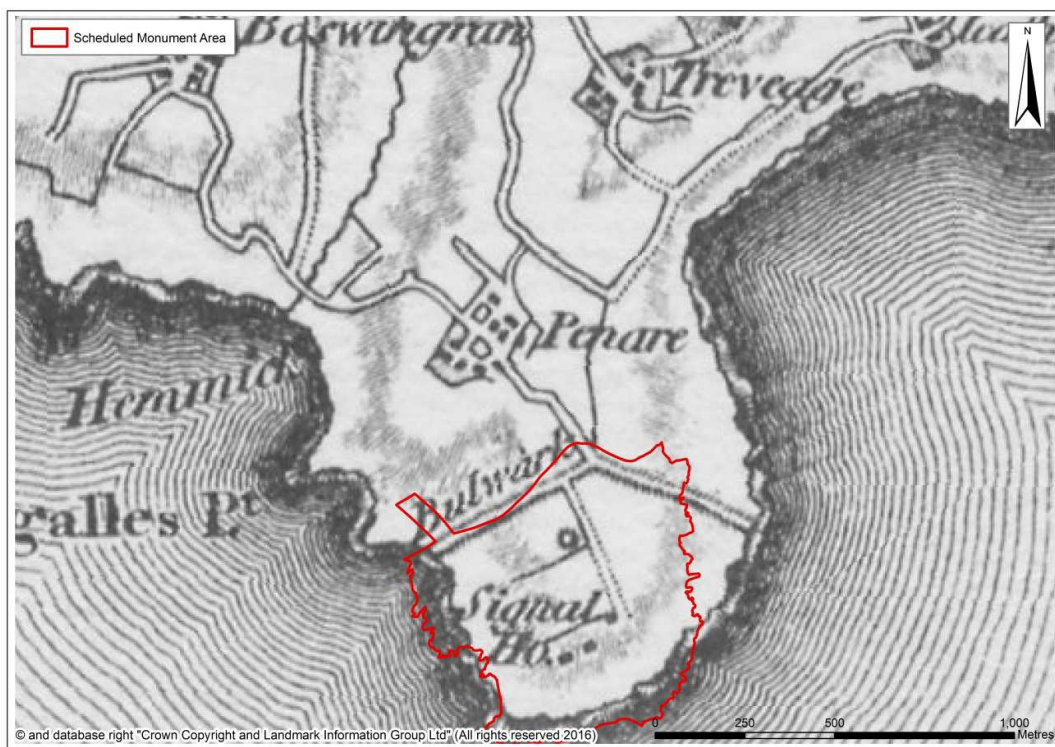
Figure 48 OS First Edition map c1809 showing three possible buildings on the site of the Watch House and Signal Station

The crew of the signal station is recorded as comprising an officer and assistant and four men (Whetter 1990, 108). There may have been more buildings associated with the signal station at one time: three possible buildings are shown at this location on the First Edition OS 1 inch 1809 map (Fig 48), one of which probably refers to the watch house itself. The remains of one of these buildings may survive as a hollow sub-rectangular earthwork (NT96909) to the south west of the signal station, abutting the west side of the enclosure bank. The signal station was re-used by the coastguard in the mid-1830s, and again in World War I. In her collection of wartime letters, Marjorie Williams of Lamledra recalls sitting on the locker in the watch house in front of the furze fire as the coast watcher showed her his semaphore flags (Williams 2007).

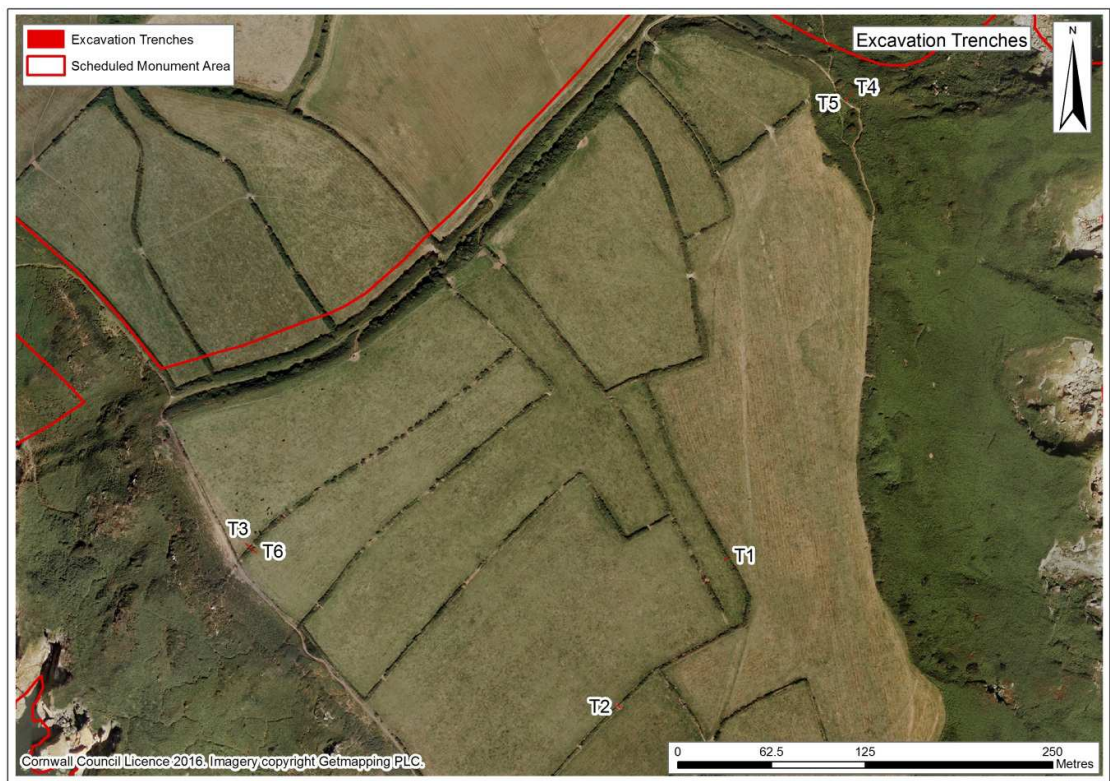
Figure 52 Location of excavation trenches 1-6.

Investigative trenches were located within two areas of the site (Fig 52) to inform their archaeological potential with a view to their future long-term management.

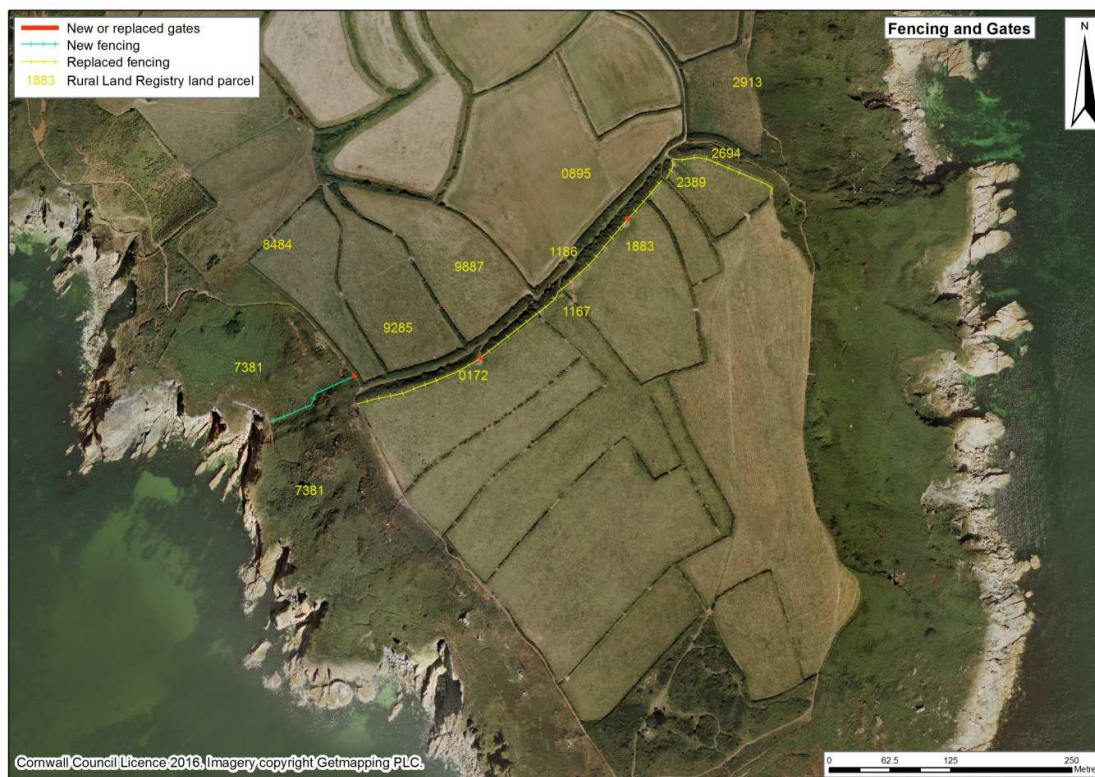
Figure 56 Location of new and replaced fencing and wooden field gates

Where postholes for fencing and gateposts were dug these were measured and recorded. Digital colour photographs were taken for illustrative use. The location of new or replaced fencing and gates were included on a base plan (Fig 56).

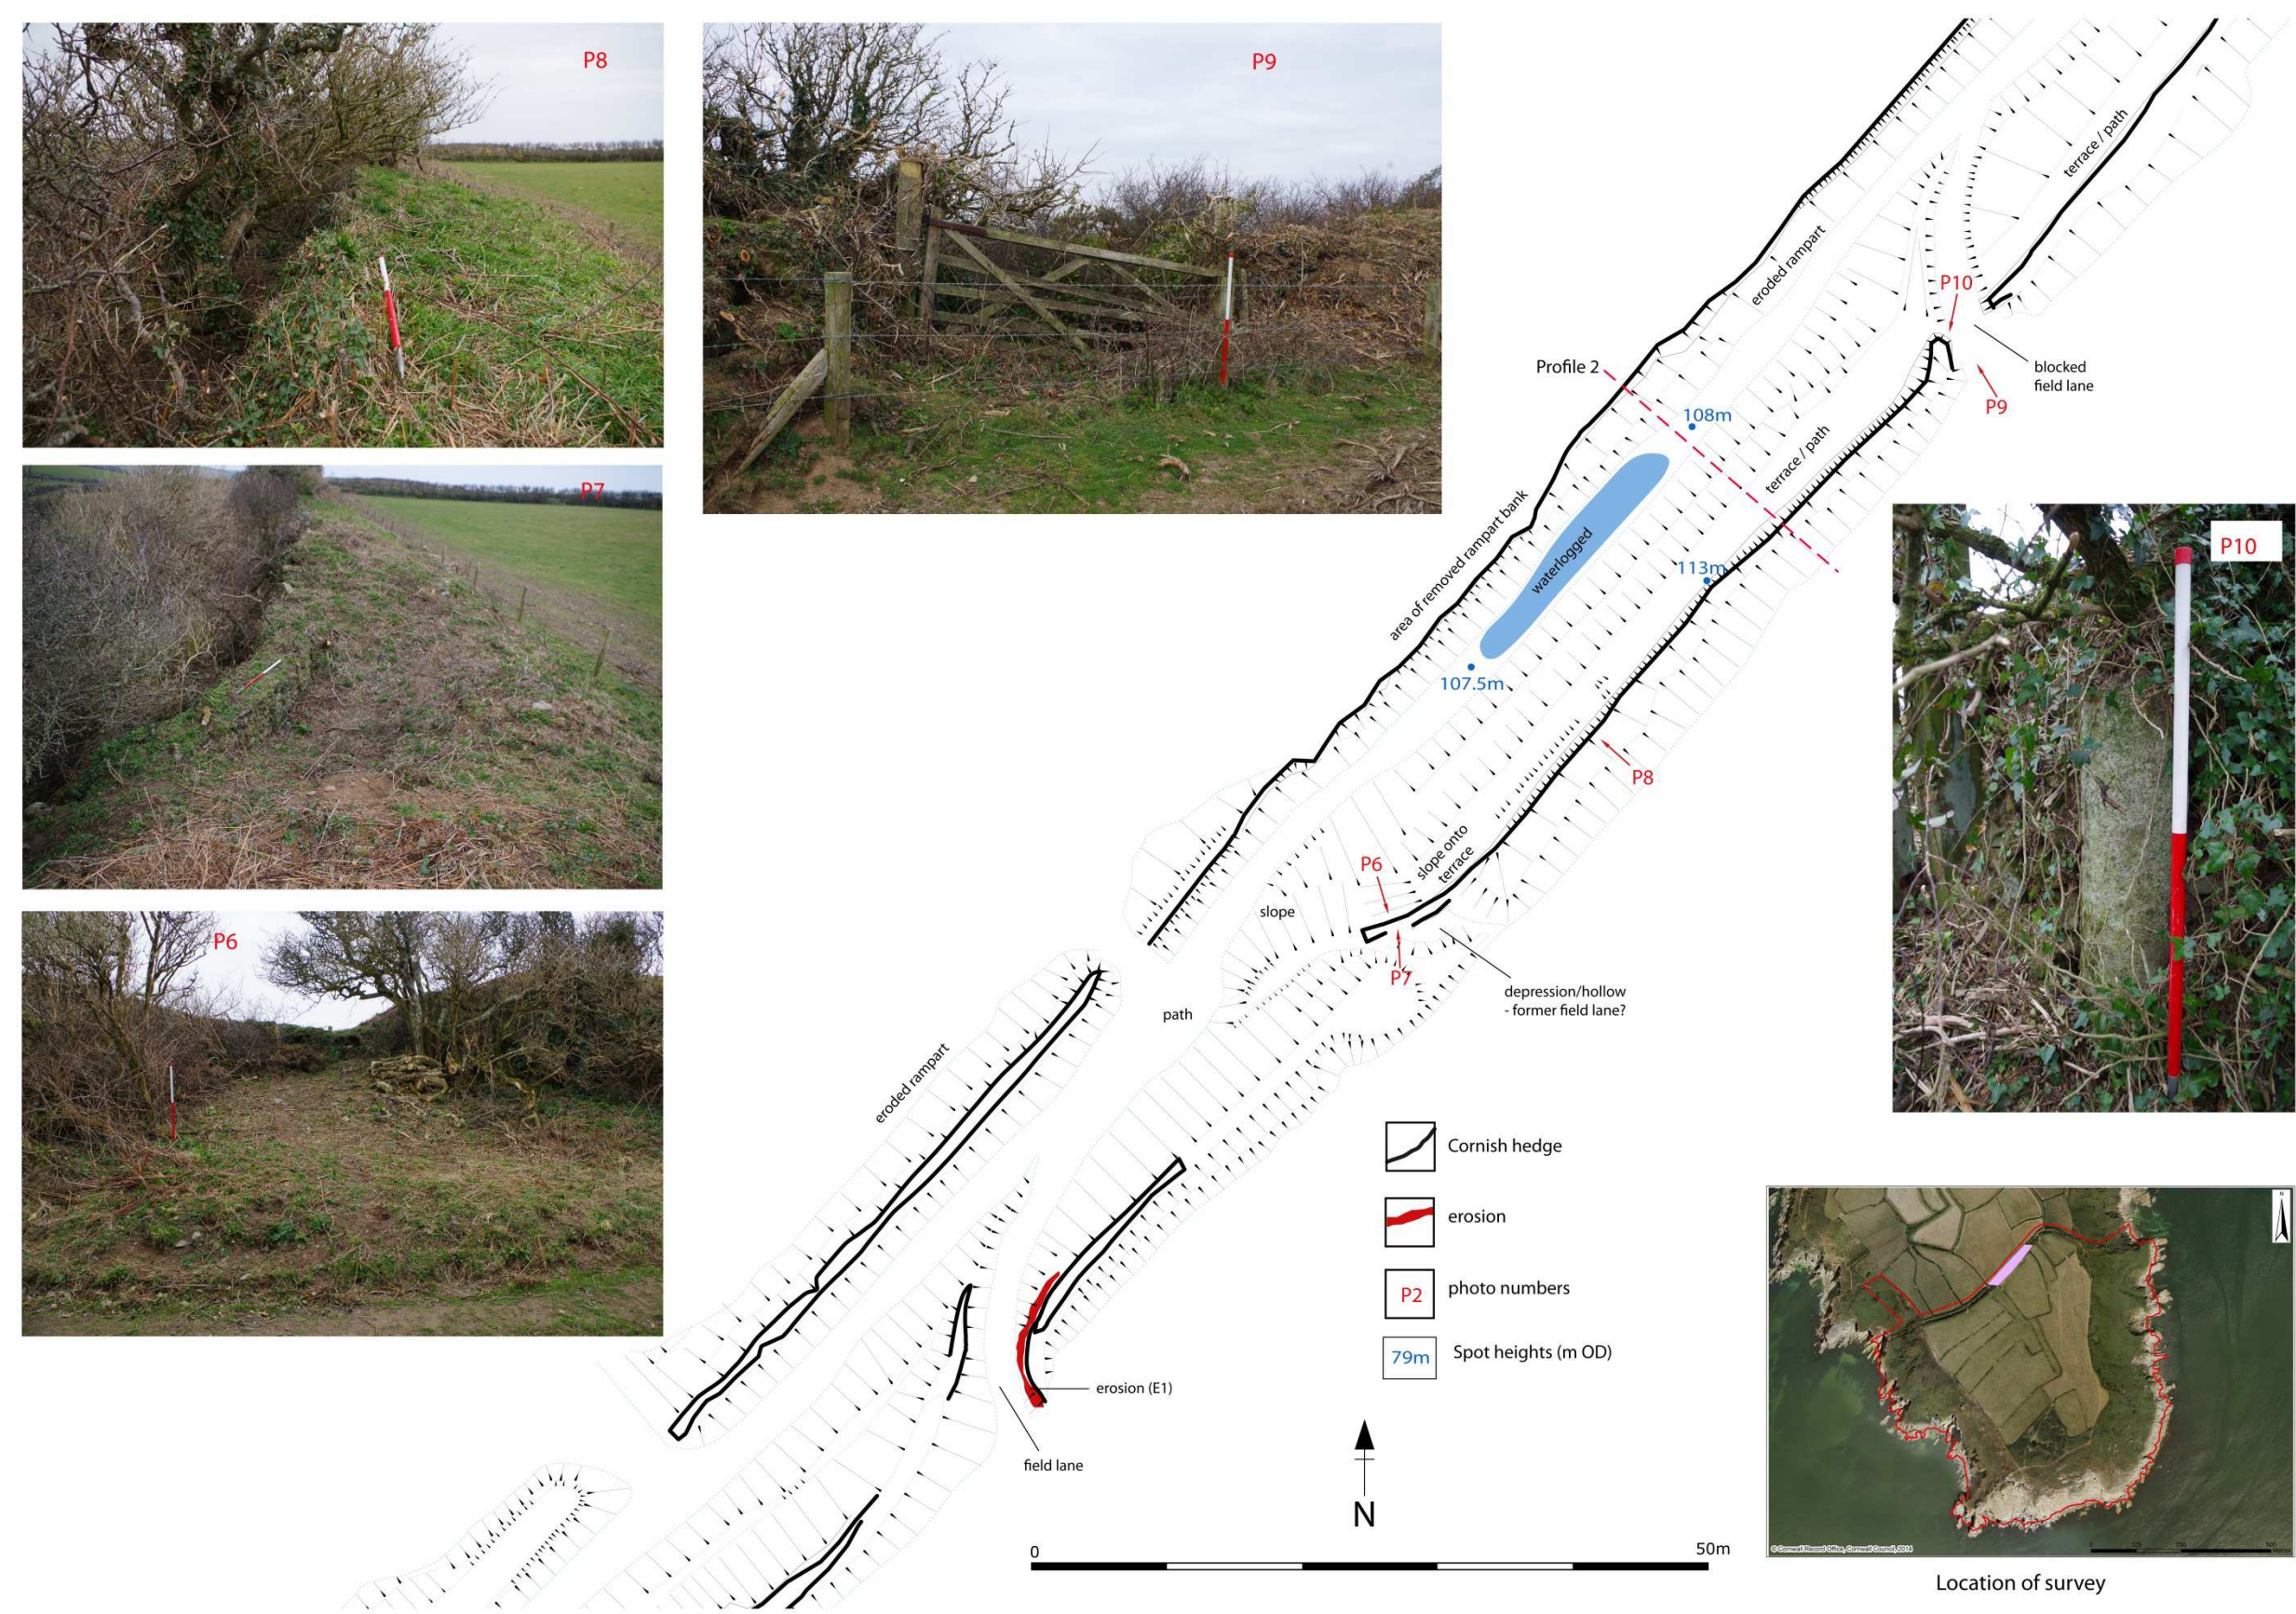
Figure 59 Survey drawing of the central section of the Bulwarks with attached images. Profile 2 is included as a separate drawing (Fig 61) below

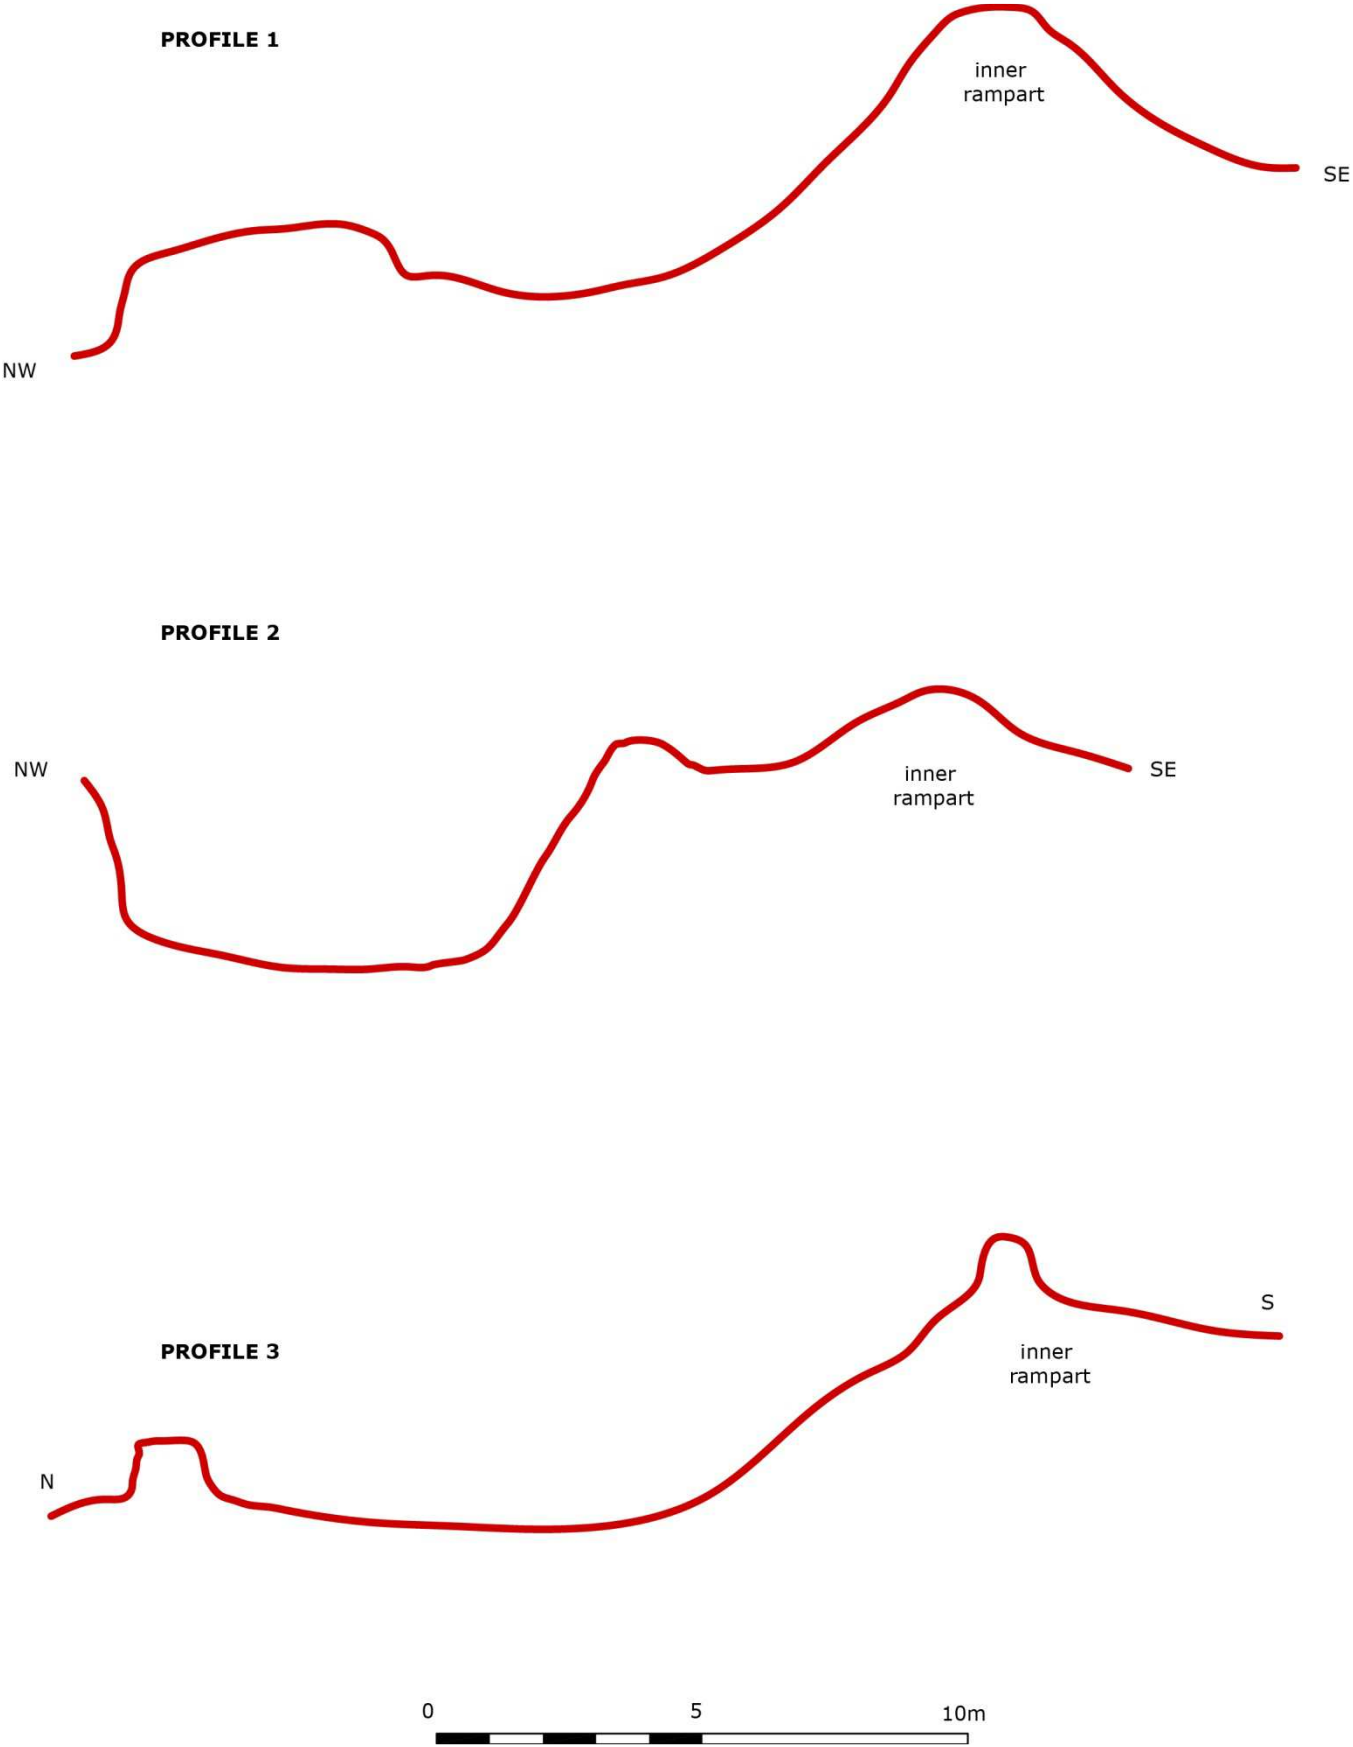
Figure 61 Profiles taken across the western, central and eastern sections of the Bulwarks
