Buckland Abbey, Devon  
Historic Building Recording and Rapid Archaeological  
Assessment

Report No: 2016R061

### **Historic Building Recording and Rapid Archaeological Assessment**

<b>Client</b>	The National Trust
<b>Report Number</b>	2016R061
<b>Date</b>	15 <sup>th</sup> November 2016
<b>Status</b>	Final
<b>Report author(s)</b>	Stuart Blaylock and Peter Dudley
<b>Checked by</b>	Jo Sturgess and Peter Dudley
<b>Approved by</b>	Andy Jones

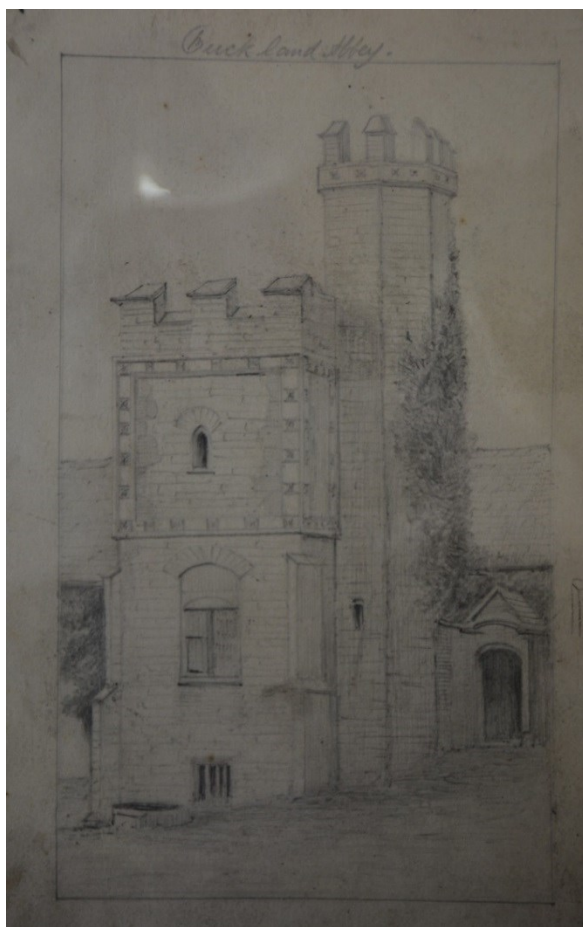
Fig 33 1875 drawing of the Tower House by J Brooking-Rowe, showing the building before insertion of new window. Reproduced with the kind permission of Devon Archives and Local Studies Service (DHC MD/P&D 08057; published as Brooking-Rowe 1875, pl 6) (ref: digital archive photo 6103)

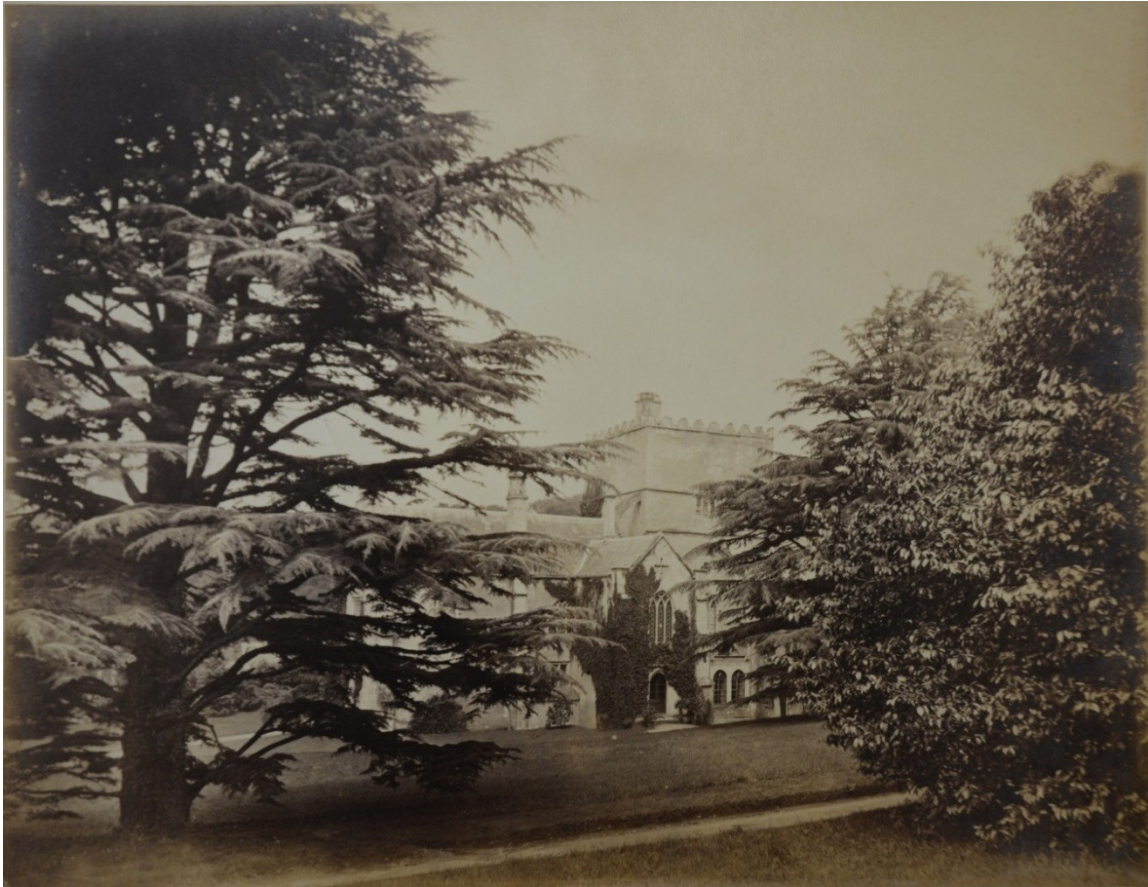
*Fig 34 Photograph of c1895 showing the south side of the Abbey church, looking north-east. Reproduced with the kind permission of Devon Archives and Local Studies Service (DHC MPh/P&D00758) (ref: digital archive photo 6134)*

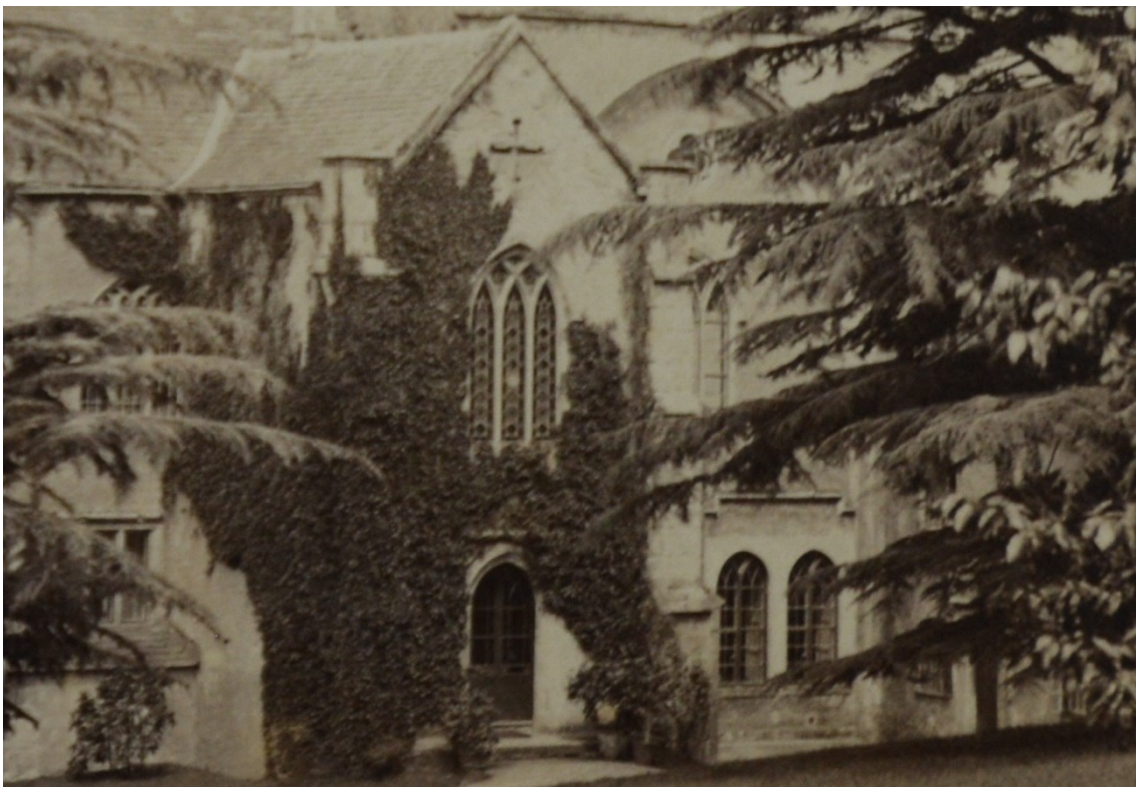
*Fig 35 Detail of Fig 34 enlarged to show the fenestration of the south-transept arch. Reproduced with the kind permission of Devon Archives and Local Studies Service*

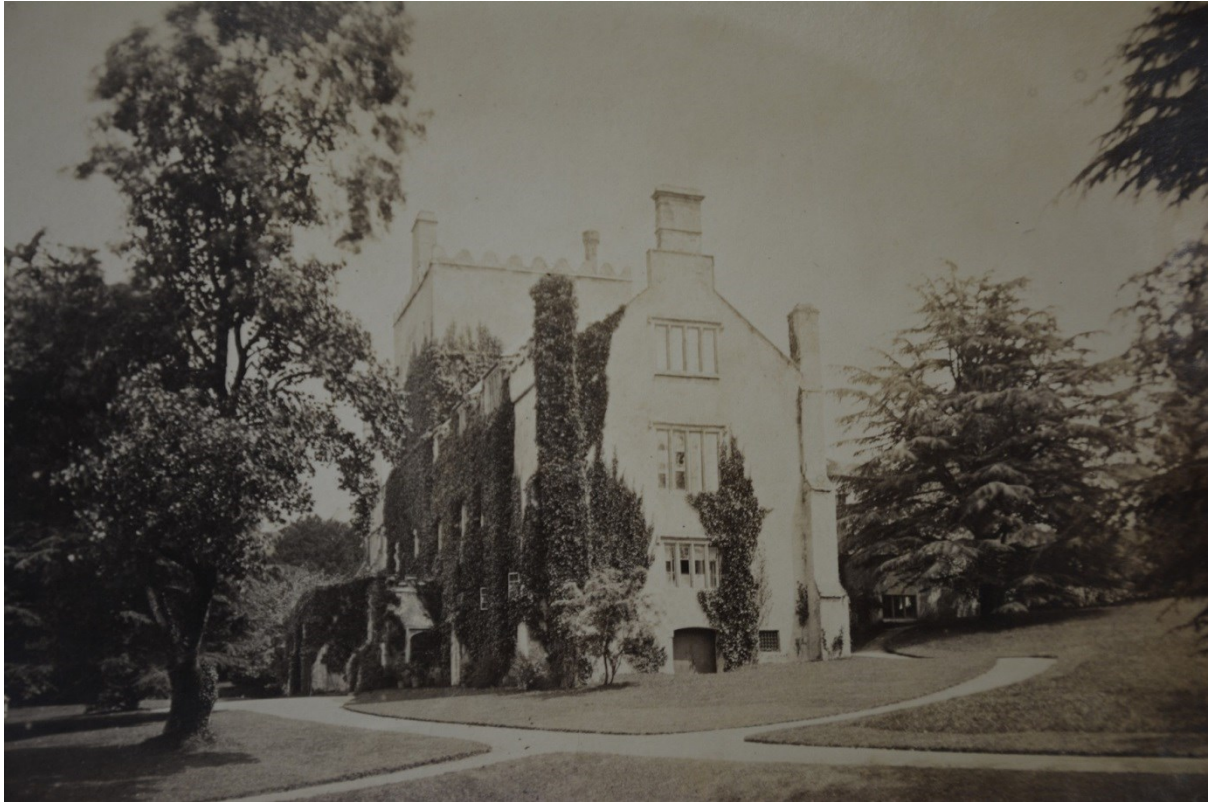
*Fig 36 Photograph of c1895 showing the west front of the Abbey church, looking south-east. Reproduced with the kind permission of Devon Archives and Local Studies Service (DHC MPh/P&D00759; published in Lambert 1993, 12, where it is dated 1893) (ref: digital archive photo 6137)*

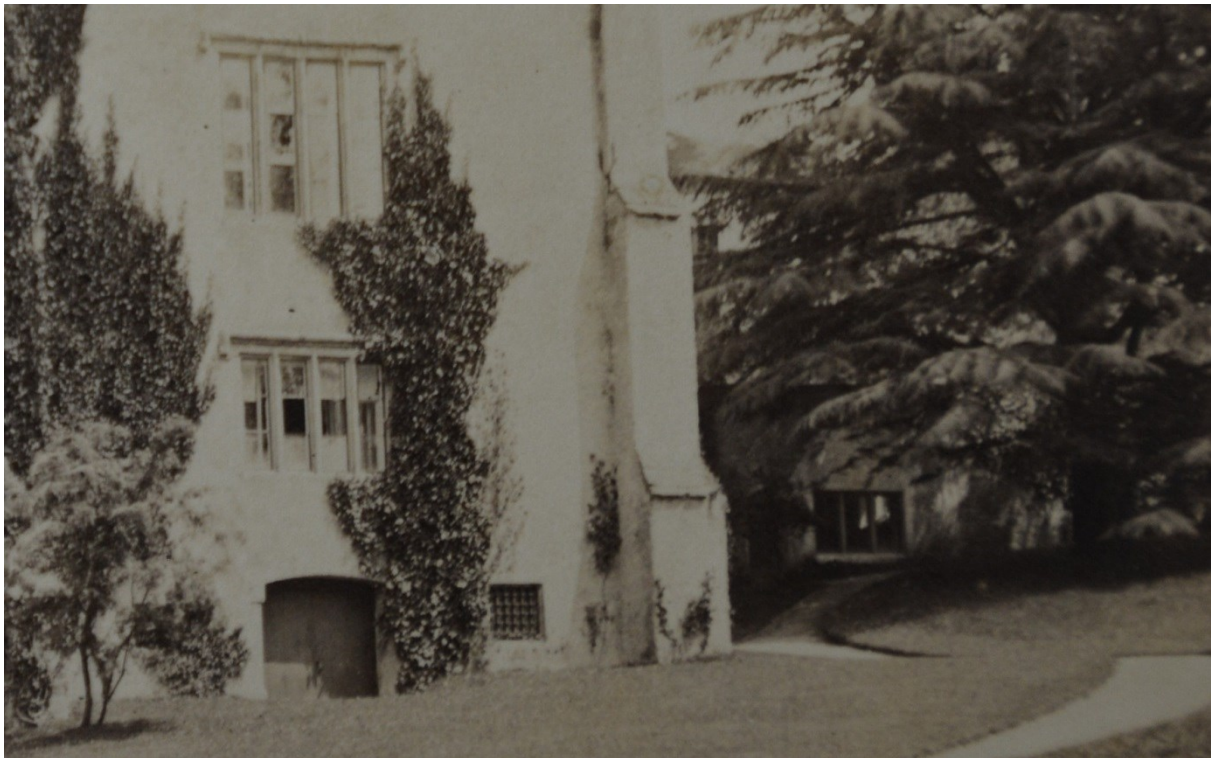
*Fig 37 Detail of Fig 36 enlarged to show a structure with a three-light window projecting south from the south-east range. Reproduced with the kind permission of Devon Archives and Local Studies Service*

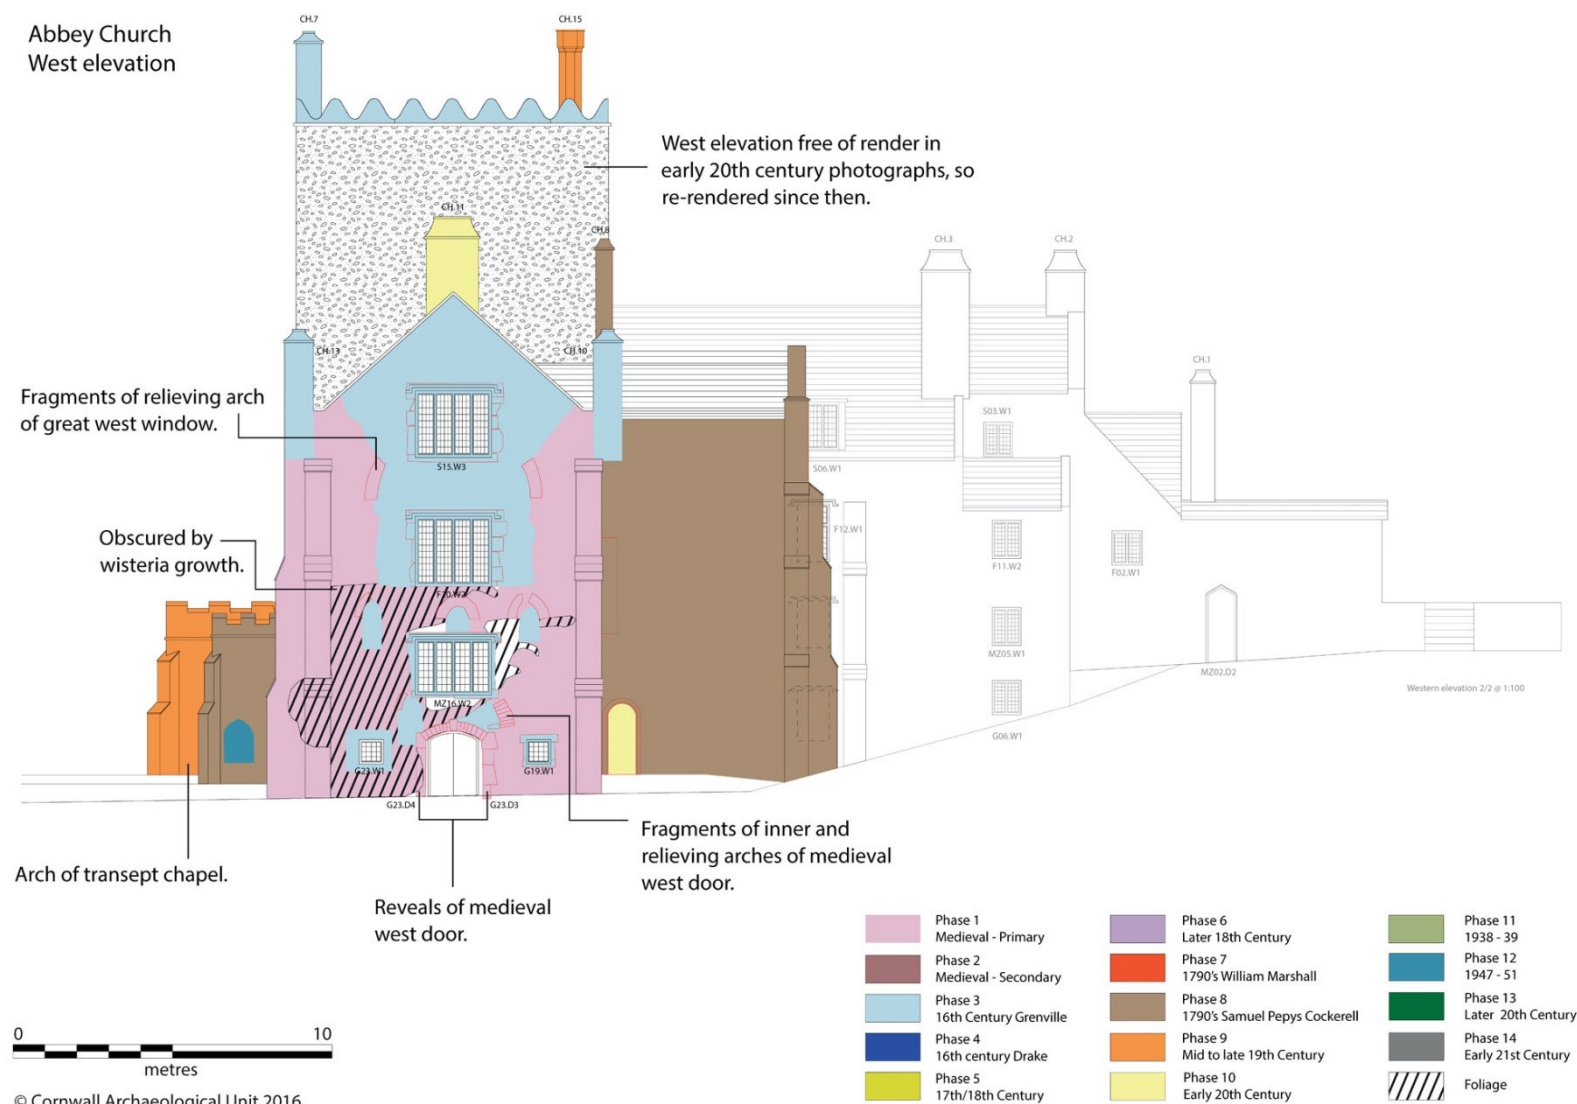
Fig 48 Abbey Church: West elevation.

The west elevation of the Abbey Church is relatively simple in its phasing, consisting of original medieval fabric of phase 1, mainly concentrated across the base of the elevation and to each side (ie north and south, including the corner buttresses), with a column of mid 16<sup>th</sup> century rebuilding through the centre, caused largely by the insertion of three floors' worth of windows, the filling in of the great west window of the medieval church, and the rebuilding of the gable and adjacent chimney stacks (Fig 48). The central chimney stack was rebuilt in the early 20<sup>th</sup> century (phase 10), since it appears in different form in a photograph dated to c1895 (DHC/WSL P&D00759; Fig 36). The medieval fenestration consisted of a large 'great' west window, from which the springing of the relieving arch and traces of the reveals and sill survive (in rather ragged form); below sill level were three narrow lancet windows, again represented by relieving arches, lower still was a central doorway, from which the jambs and voussoirs from inner and outer relieving arches survive above and to the south of the present doorway. The recording of part of the north side of this elevation was hampered by plant growth (wisteria) growing across the lower left hand side of the elevation. There is no particular reason for thinking that any of the medieval windows of the west elevation were anything other than of the primary phase. Lancet windows were certainly still part of the available armoury of fenestration to the later 13<sup>th</sup> century builder, and the building itself provides two examples of comparable tracery for larger windows: the intersecting tracery of the window re-used in the pseudo-transept, and the composite multi-foiled lights of the window in the east wall of the tower, above the chancel roof. Its width, at perhaps approximately 4.25m is significantly wider than the surviving side windows of the church, whether in nave or chancel (which average about 2.75m wide), but is still narrower than the great east window, which measures nearer 5m in width at the base of the arch. The west window is likely to have been of 5 lights, and intersecting tracery over these proportions is quite likely (see, for instance, the east windows of the parish churches of Bere Ferrers and Whitchurch, both have five lights).
