Enys Farm Buildings, Penryn, Cornwall  
Historic Building Record

Report No: 2016R066

# **Enys Farm Buildings, Penryn, Cornwall**

## **Historic Building Record**

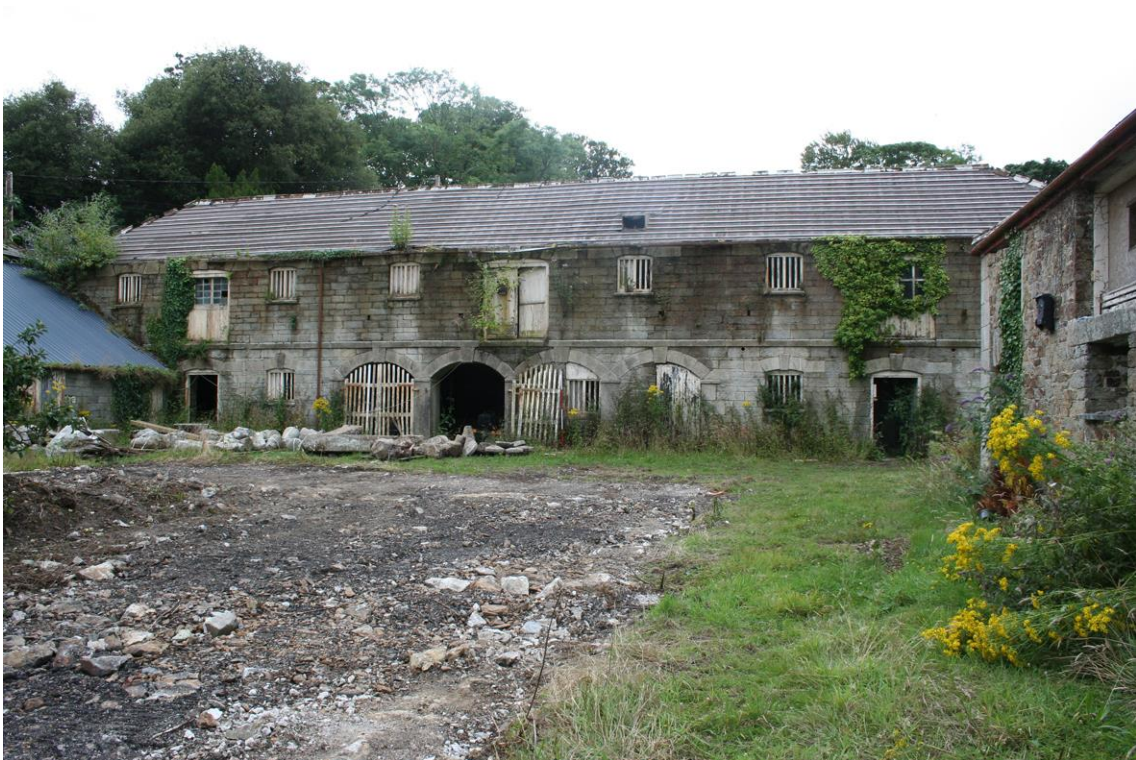
*Figure 10 South-west Range - farmyard elevation.*

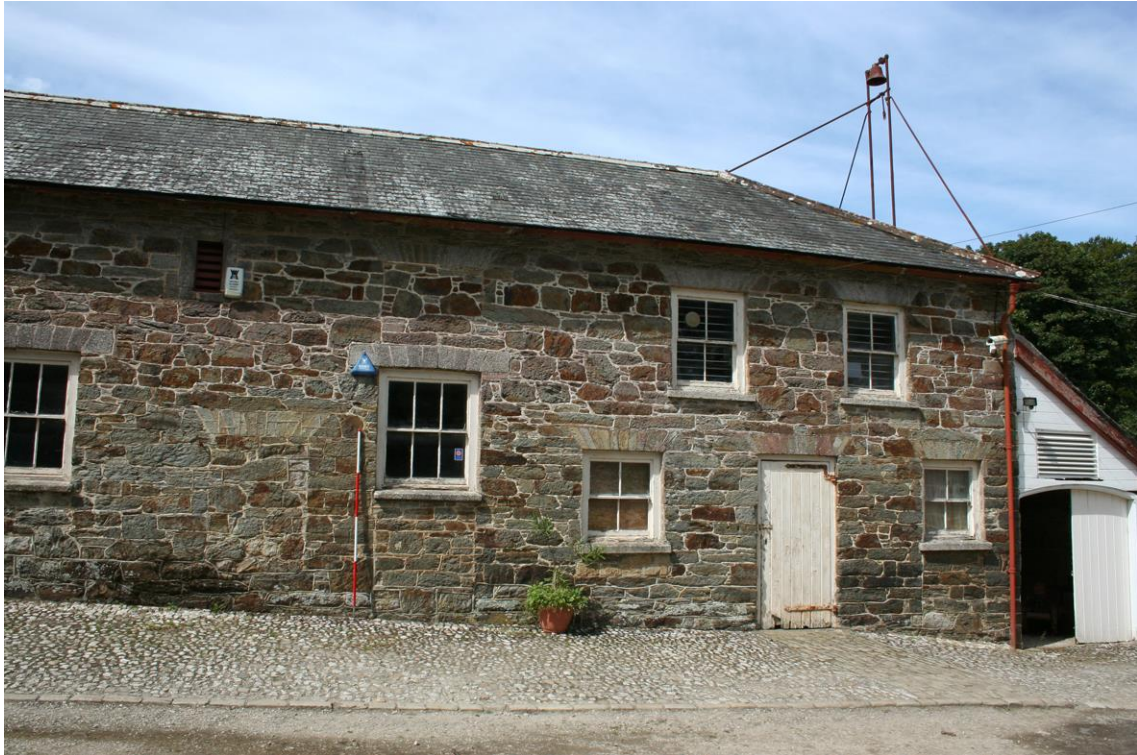
Figure 21 Stables Range - south-east elevation of the lower end of the stables with garage/game larder to right. Blocked ground floor and first floor windows indicate the upper floor once extended further left. Note also the bell on the roof of the range.

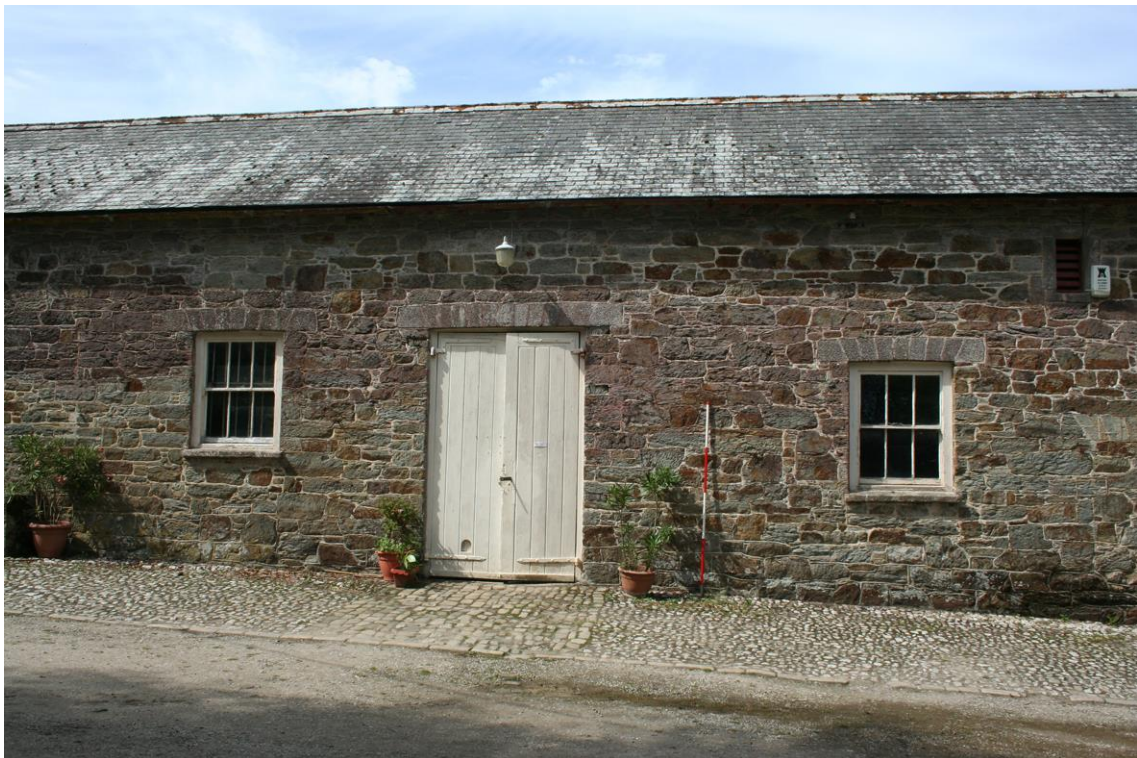
Figure 22 Stables Range - middle part of the range showing later principal doorway and windows. Note the blocked slit ventilator between the scale pole and the RH window.

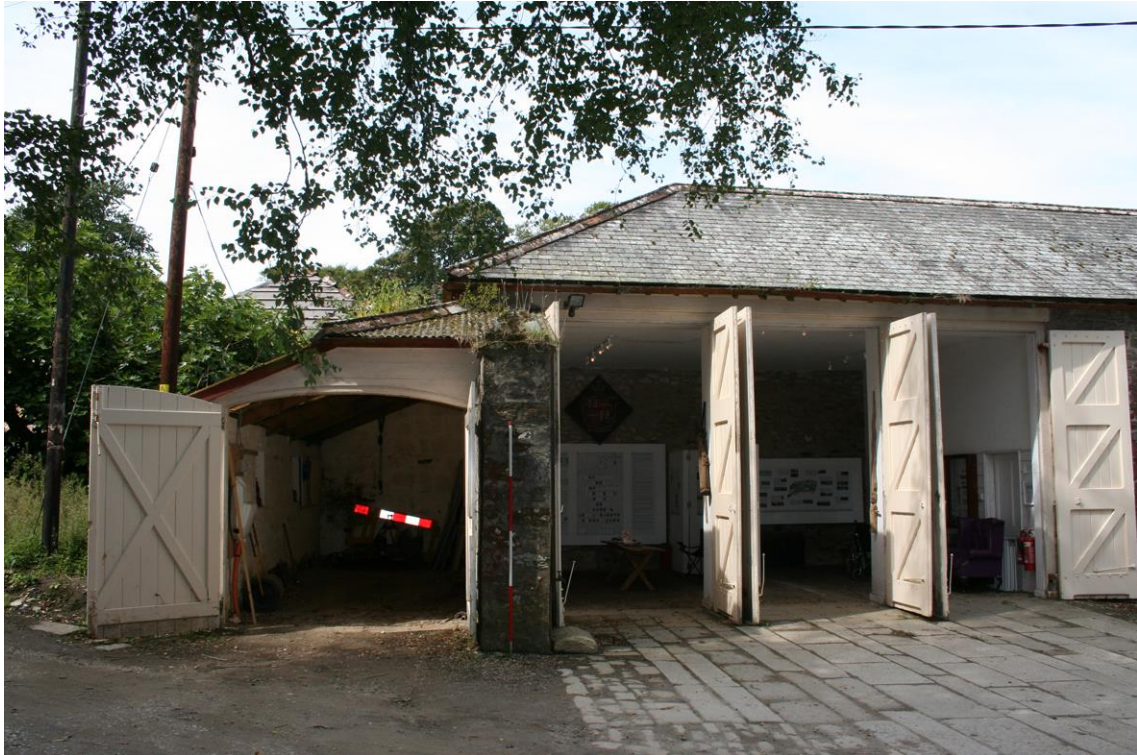
Figure 23 Stables Range – upper end of the south-east elevation of the stables, showing a later lean-to addition [1] to left of the coach house [2].

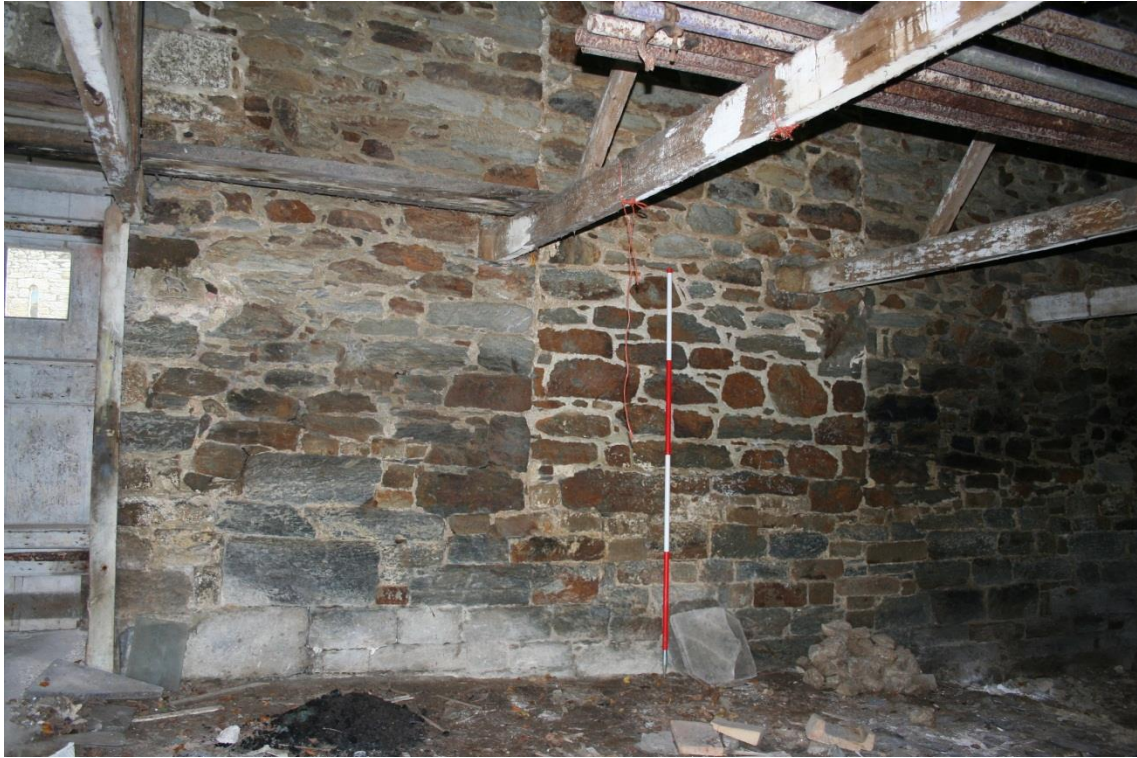
Figure 29 Rear wall of the Stables Range – viewed from inside room [10] of the Farmyard Range; old doorway blocked before lean-to roof of Farmyard Range was added, and masonry underpinning inserted at base of the wall to deal with change of level.

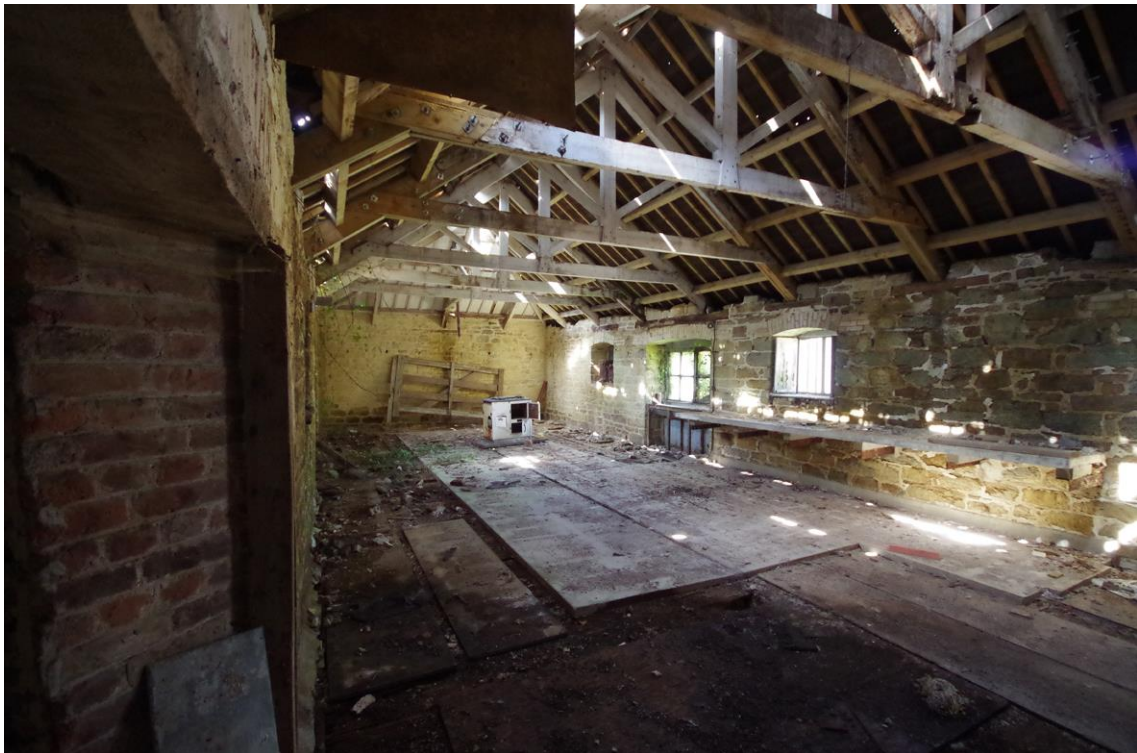
The roof structure is of king post trusses supporting purlins and rafters. The roof covering is of scantle slate (with some lime mortar 'torching' surviving beneath) although at the time of investigation the covering was heavily decayed and holed in several places. Attempts have been made to secure the roof trusses with additional bolted timbers, and considerable parts of the roof slopes have been re-raftered and covered with felt.

*Figure 44 South-west Range – first floor, north-west room space [31] with roof trusses showing recent repair and damage to roof covering visible.*

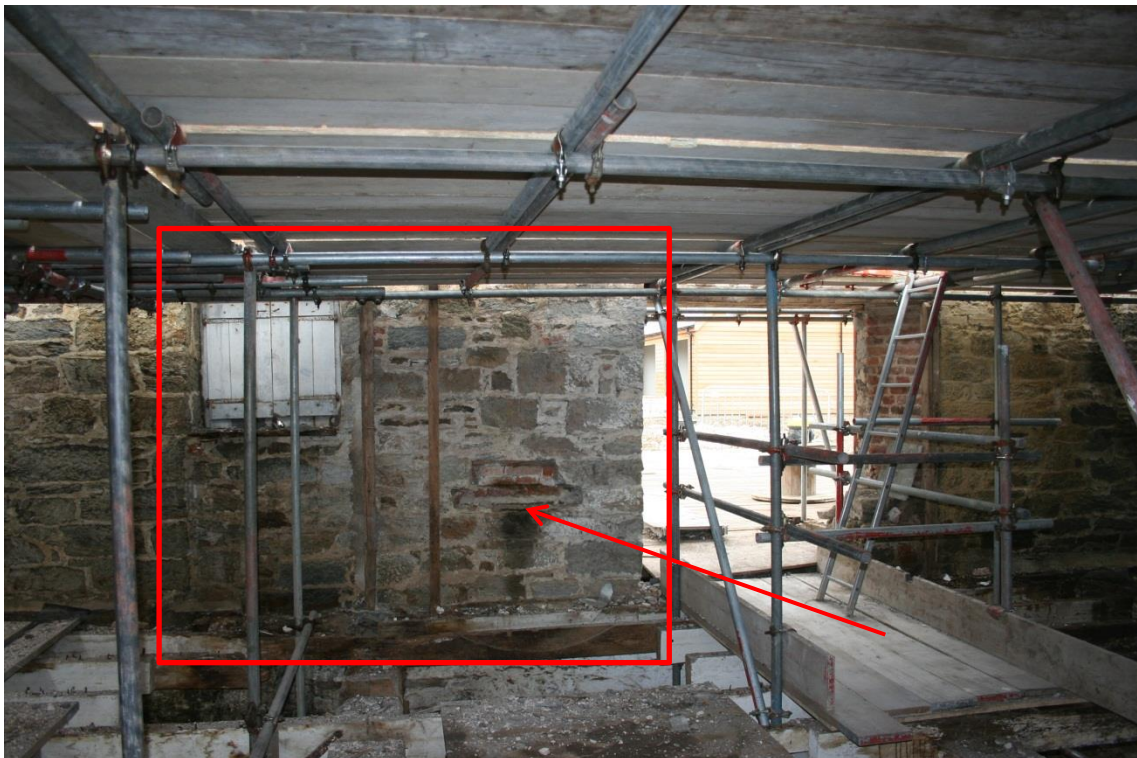
Figure 46 South-west Range - original threshing doorway (within red rectangle) blocked when horse-engine was added outside, new doorway to right, and machinery bearing support included in masonry (arrowed).

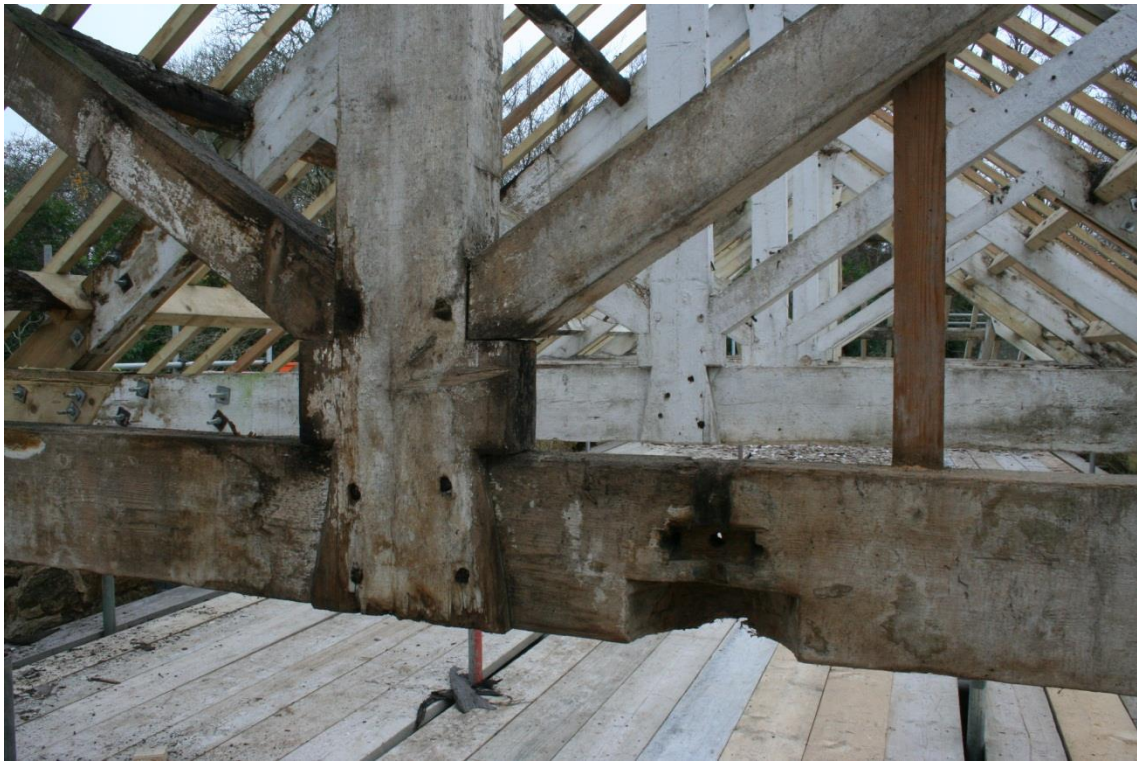
Figure 47 South-west Range - detail of a king post roof truss. Note also the cut-out for a machinery bearing to the right.

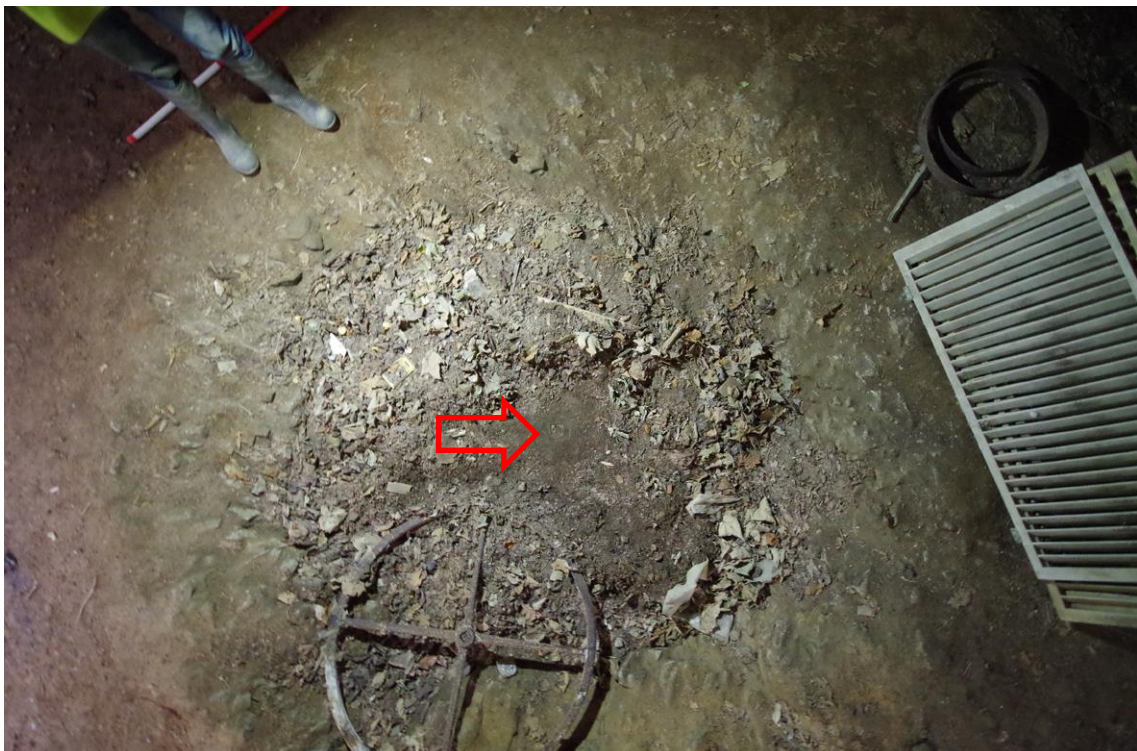
Figure 52 South-west Range - horse engine house [32]: looking down from first floor towards in situ lower bearing (arrowed).

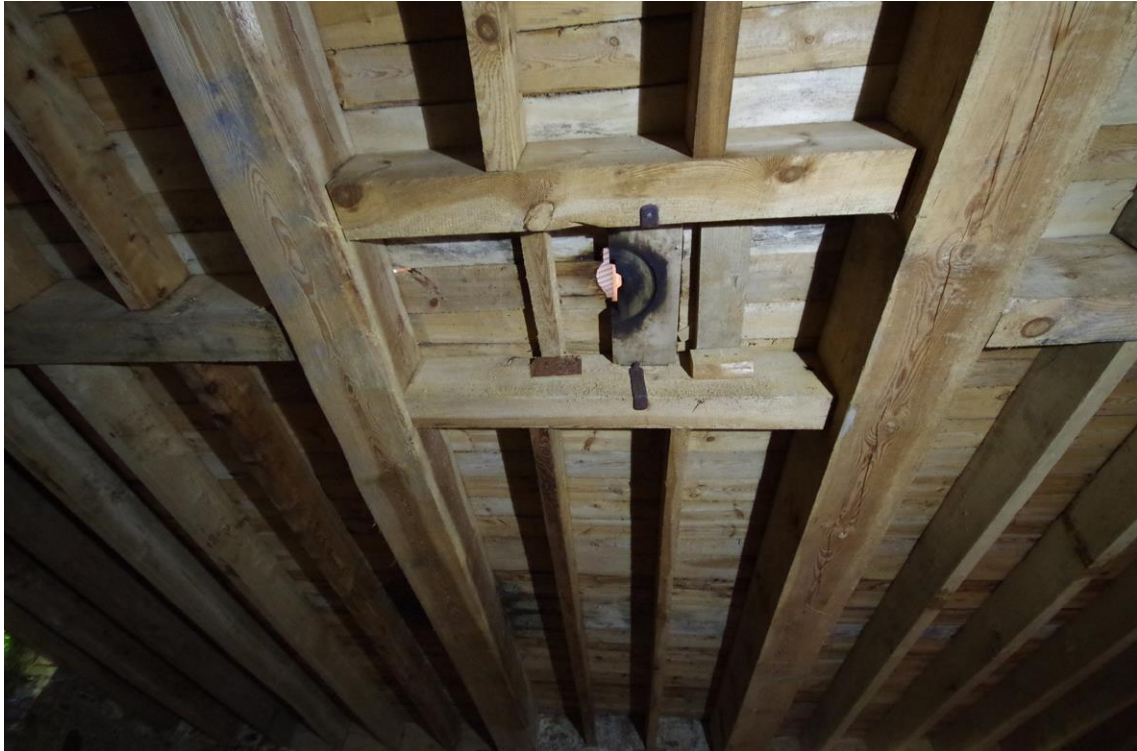
Figure 53 South-west Range - horse engine [32] upper bearing location, timberwork and added upper floor.

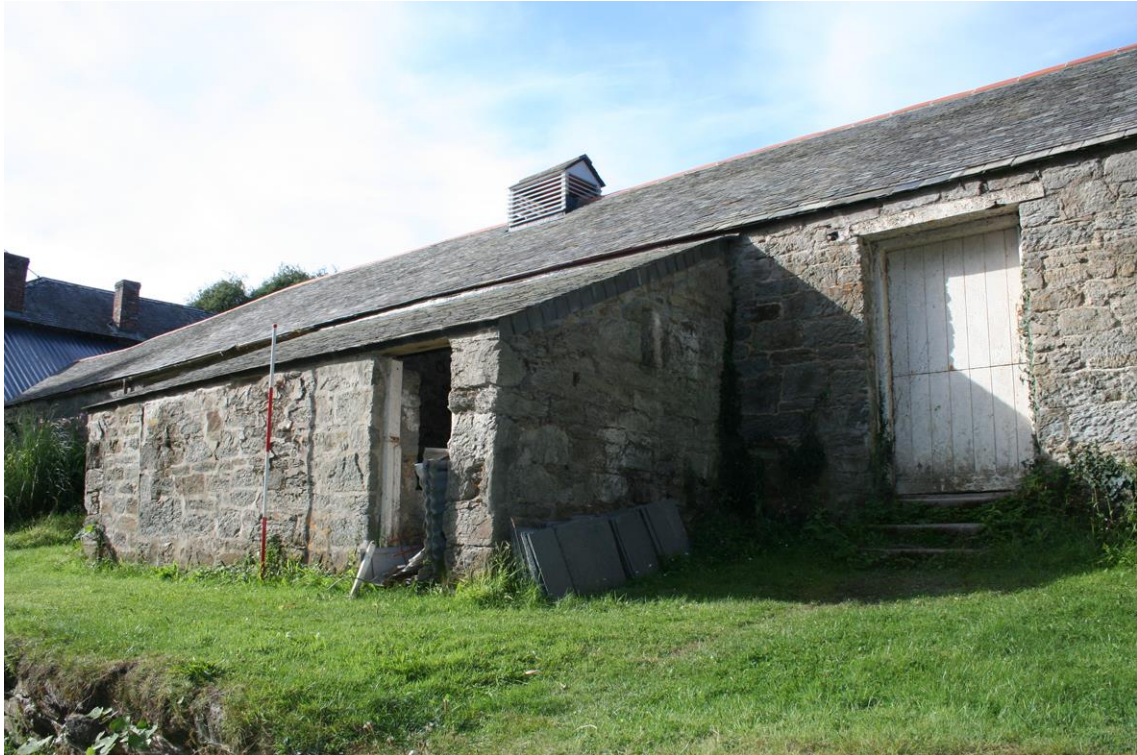
The main part of this single-storey range now contains four spaces. A pair of symmetrical plan lean-to outshuts is attached on the rear side (rooms [17] and [18]; Fig 59). These have original doorways facing outward to the lane; one is now blocked with stone masonry and replaced with a newer doorway on the side of the structure. It is not certain what functions these lean-tos originally served; they may have been tool sheds or perhaps small animal houses.

Figure 59 North-east Range - pair of later lean-to buildings (rooms [17] and 18]) added to the rear elevation.

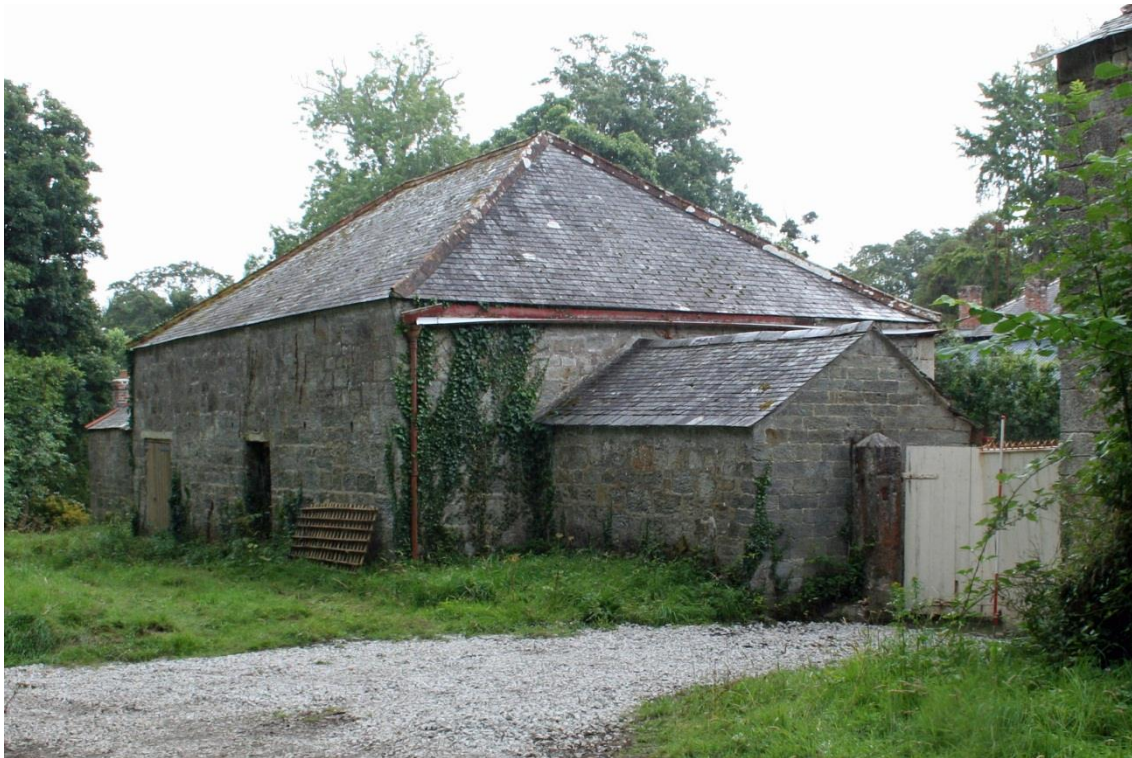
The south-westernmost pigsty, altered to insert a gateway before 1841, has a replacement gable wall built in slate ashlar (Fig 63) and a narrowed and angled run in front. The granite coping stones on its run have been reshaped and joined with iron cramps.

Figure 63 North-west Range – rear view, showing the inserted farmyard gateway and rebuilt gable of the adjoining pigsties.

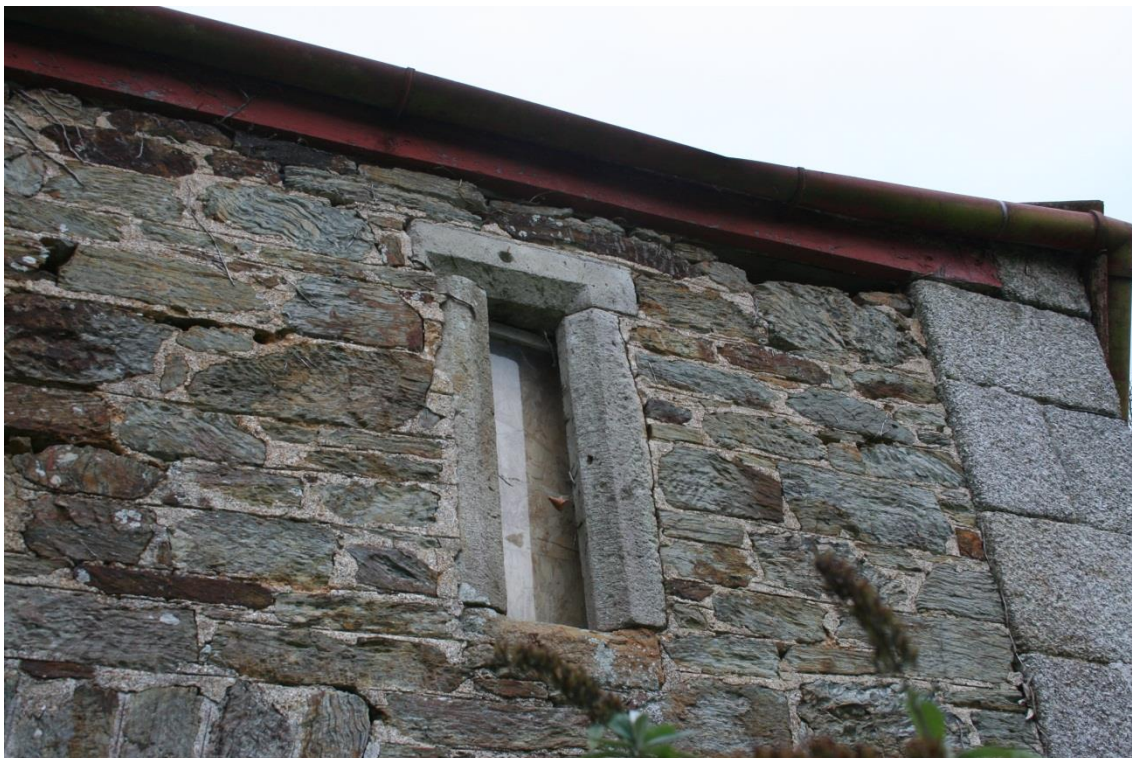
This building also has a shallow first floor space [23], partially within the roof (Fig 68), now reached by a steep ladder/stairway at the rear of the cow-house, and was likely a loft for fodder. The upper floor also has a loading doorway and three slit windows/vents in the front wall. Interestingly the vents are created from dressed masonry i.e. chamfered window elements reused from elsewhere, most likely after replacement of the Elizabethan main house in 1826 (Fig 64).

Figure 64 North-west Range - loft opening in central block, showing reused dressed masonry window parts.

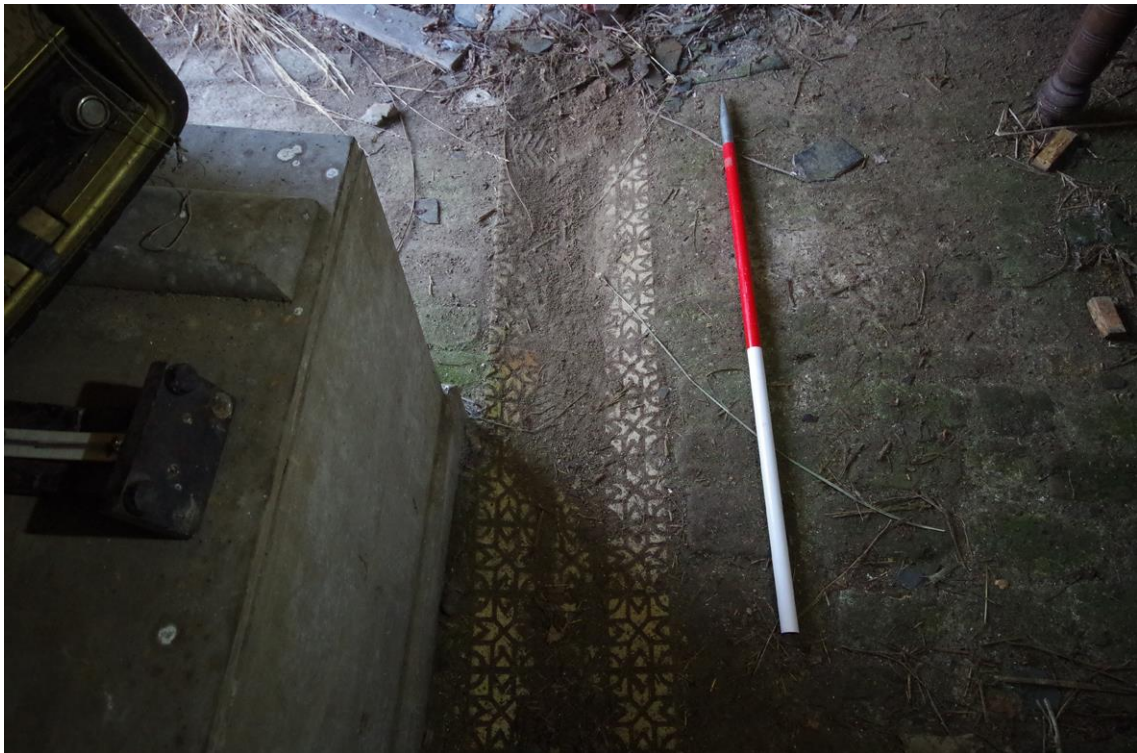
Inside room [21] the stalling was later changed with a new layout parallel to the front and rear walls (Fig 65). This comprised slate mangers, double stalls and a drain lined with distinctive decorative tiles (Fig 66). These tiles date to c1900 and are more usually found in town pavements (e.g. Truro terraces).

Figure 66 North-west Range - tiled drain within cow-house [21].
