Wheal Martyn, Cornwall. Asbestos Survey.
Archaeological Watching Brief.

Report No: 2016R079

Watching Brief.

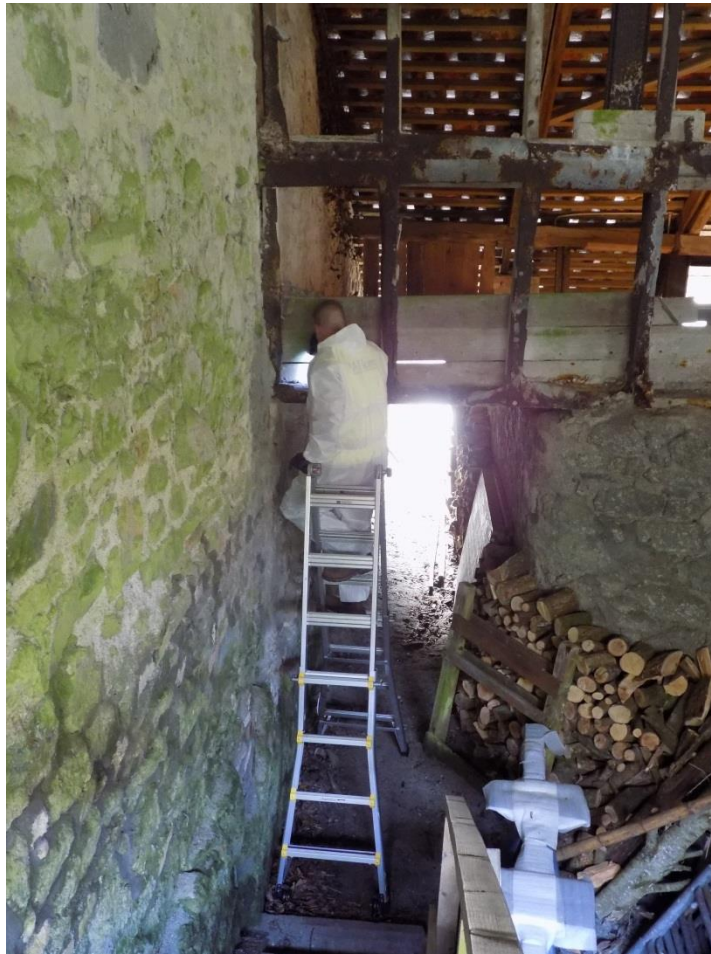
This structure lay at the northern end of the main block of buildings to be examined (Fig 4). The first area looked at was around the eastern side which was the room containing the furnaces for the mica dry pan kiln (Figs 5 and 6). No structural asbestos was located though there were a few loose fragments of corrugated asbestos sheeting on the floor. A small sample of this was taken for examination. No structural features or fittings were affected within this part of the building.

Figure 5. Building 17. Mica Dry. Furnace area at east end. Checking for asbestos.

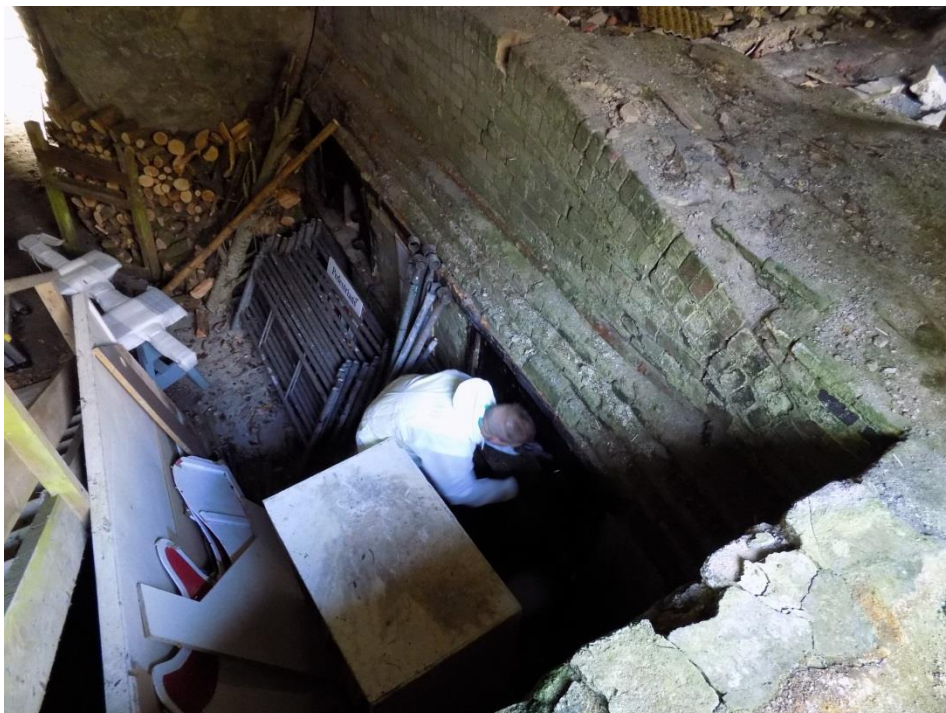
Figure 6. Building 17. Mica Dry. Furnace room, checking for asbestos.

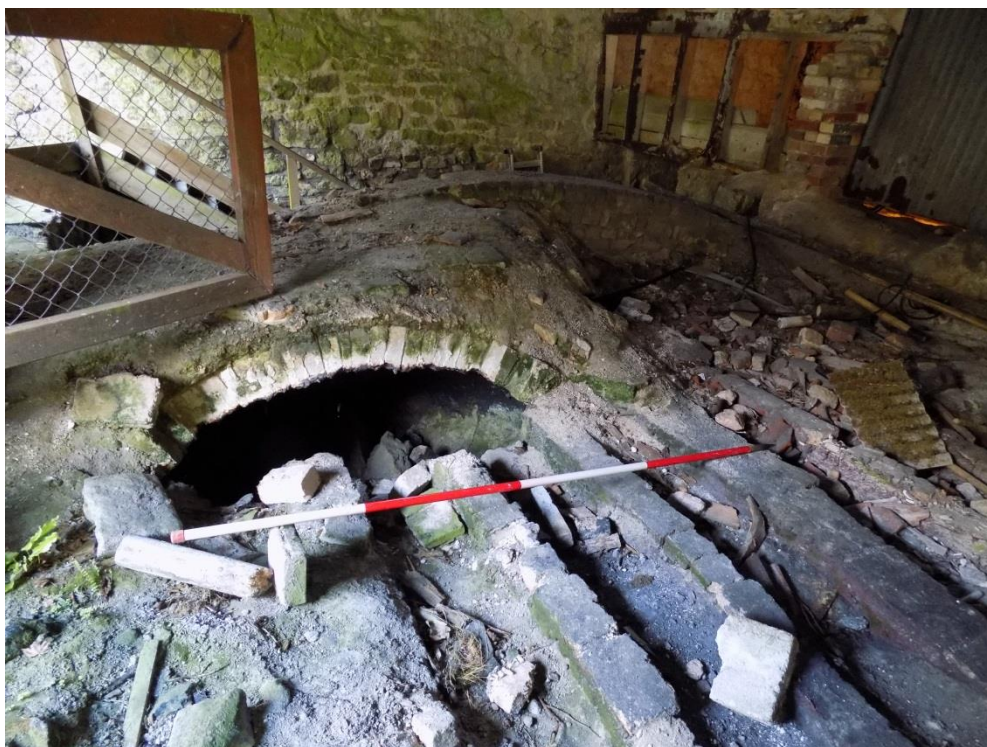
The second area examined was within the pan kiln area itself, and where possible where the original floor had collapsed into the flues below (Fig 7). Part of this area had had rubble tipped over it, probably to infill exposed holes. Again no structural asbestos was located though there were a few loose fragments of corrugated asbestos sheeting and asbestos slate fragments within the rubble on the floor. Small samples of these were taken for testing. No structural features or fittings were affected by the sampling within this part of the building (Fig 8).

Figure 7. Building 17. Mica Dry. Collapsed floor above furnace.

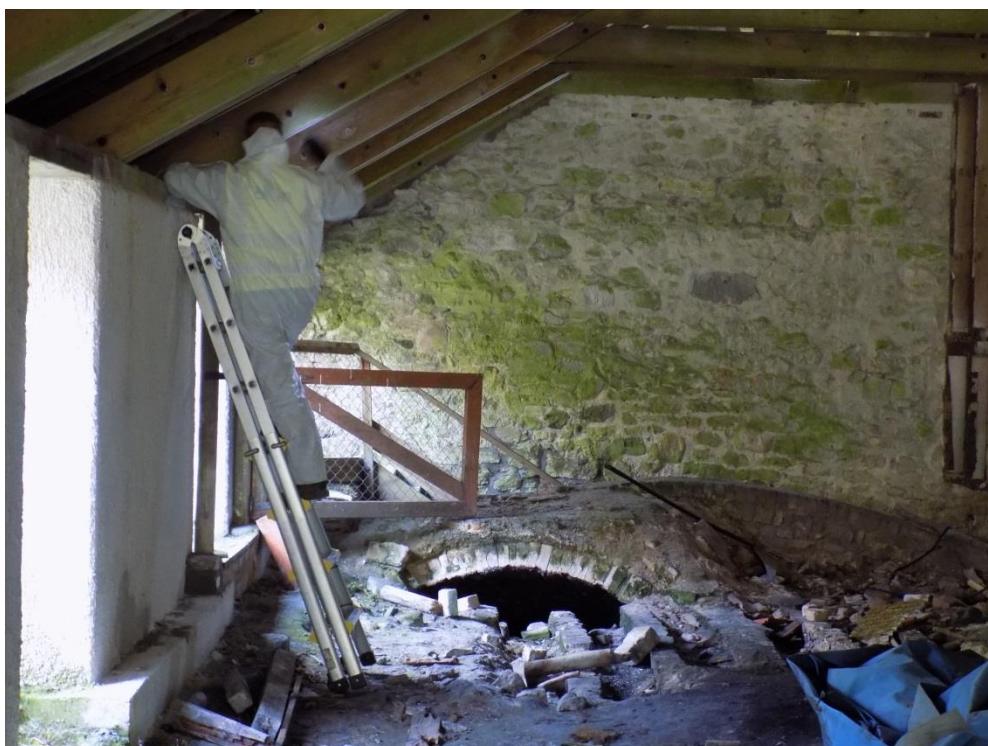
Figure 8. Building 17. Mica Dry. Looking NE. Searching for asbestos.

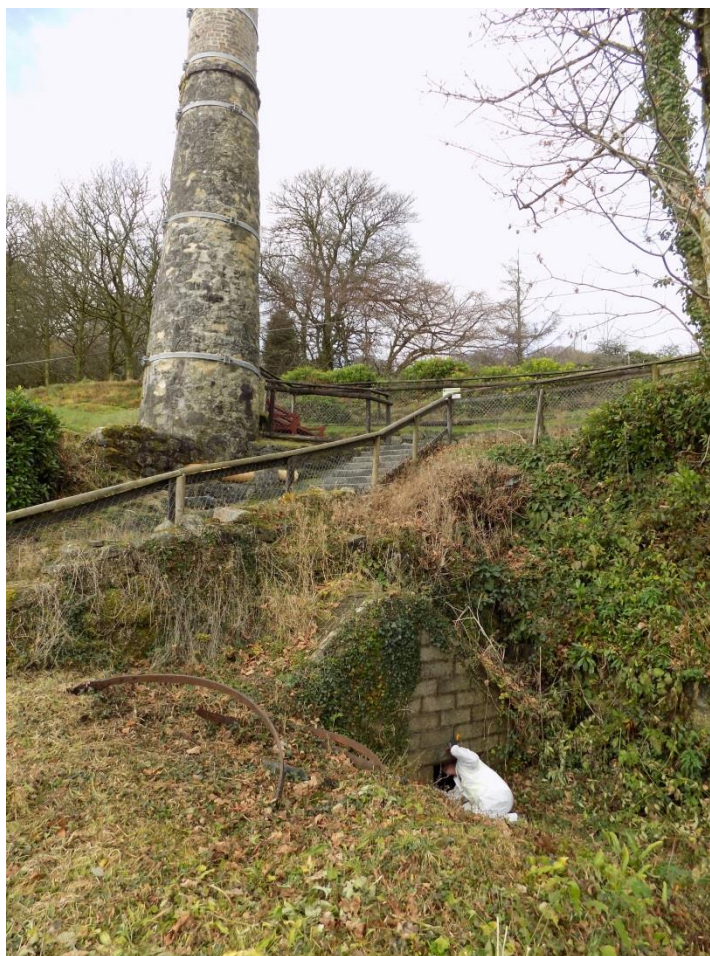
The westward extension to the Mica Dry (Structure 18) which was ruinous, with no roof and filled with debris from a collapsed stack was examined, as was the flue into chimney stack 15 as it was proposed to develop this area as part of the museum. No asbestos was located (Fig 9).

Figure 9. Examining flue of Stack 15.

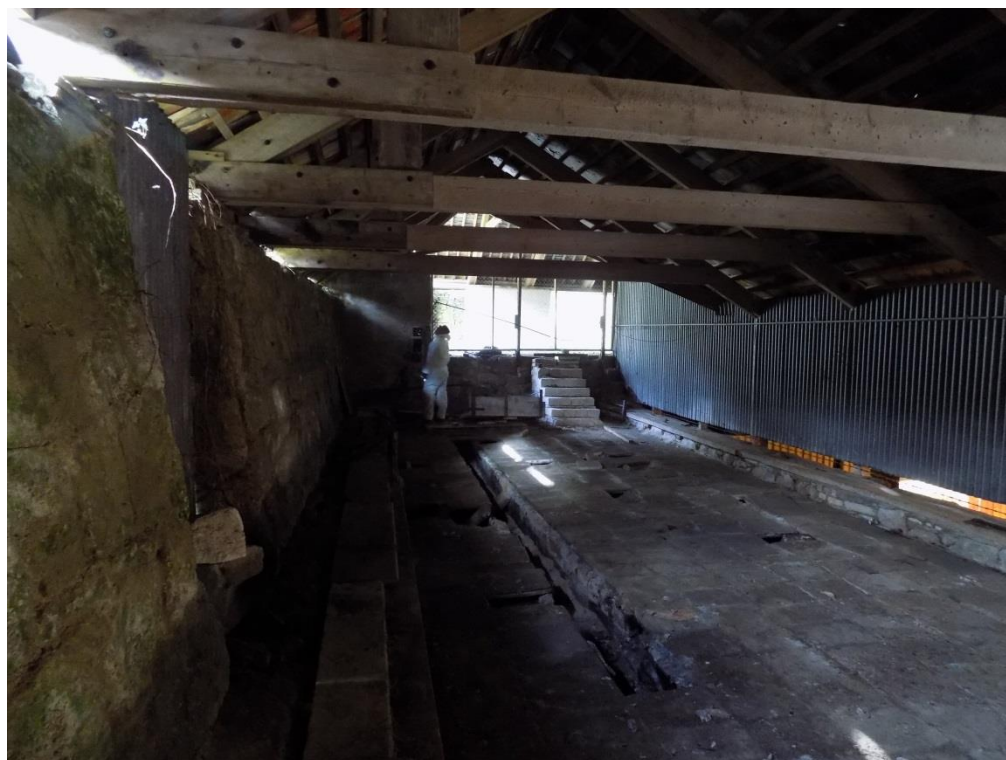
The first area examined was the pan kiln floor space itself, especially the northern 2/3rds of the building which has not as yet been opened up for public access (Fig 10). Some small broken fragments of corrugated asbestos sheeting and asbestos slate were located lying on the floor in the north-west corner of the structure, perhaps derived from material dumped within the Mica Dry. Small samples of these were taken, but as elsewhere no structural features or fittings were affected by the sampling within this part of the building.

Figure 10. Structure 13. Pan Kiln. NE end. Looking for asbestos.

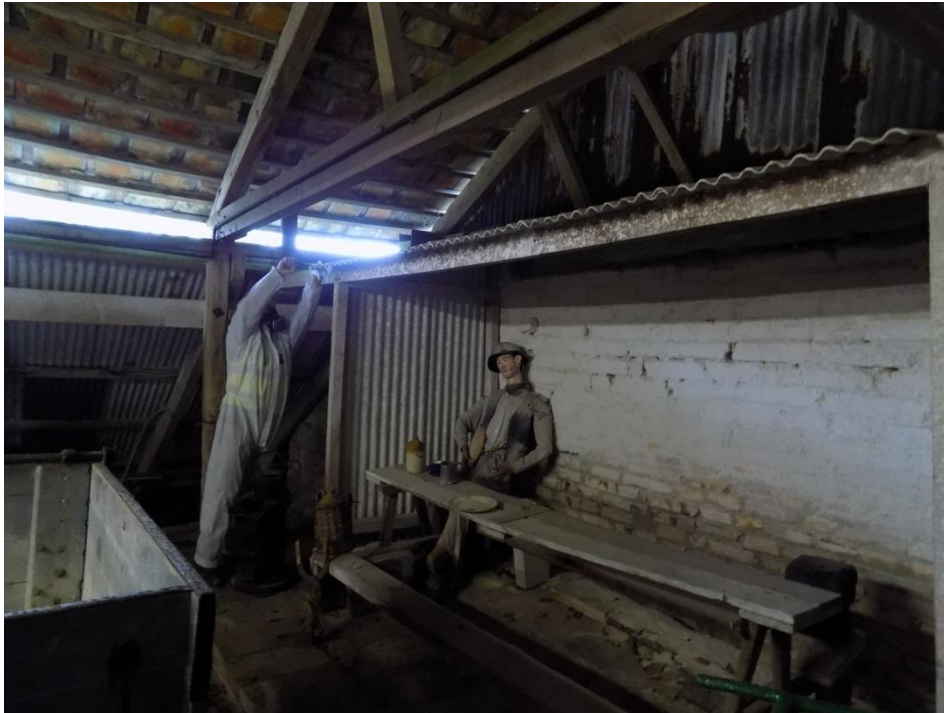
It was noted though that one of the displays at the southern end of the Pan Kiln illustrating a crib hut had been roofed with corrugated asbestos sheeting. A sample was taken of this material (Fig 11).

Figure 11. Sampling roof of reconstructed crib area within Structure 14 Pan Kiln.

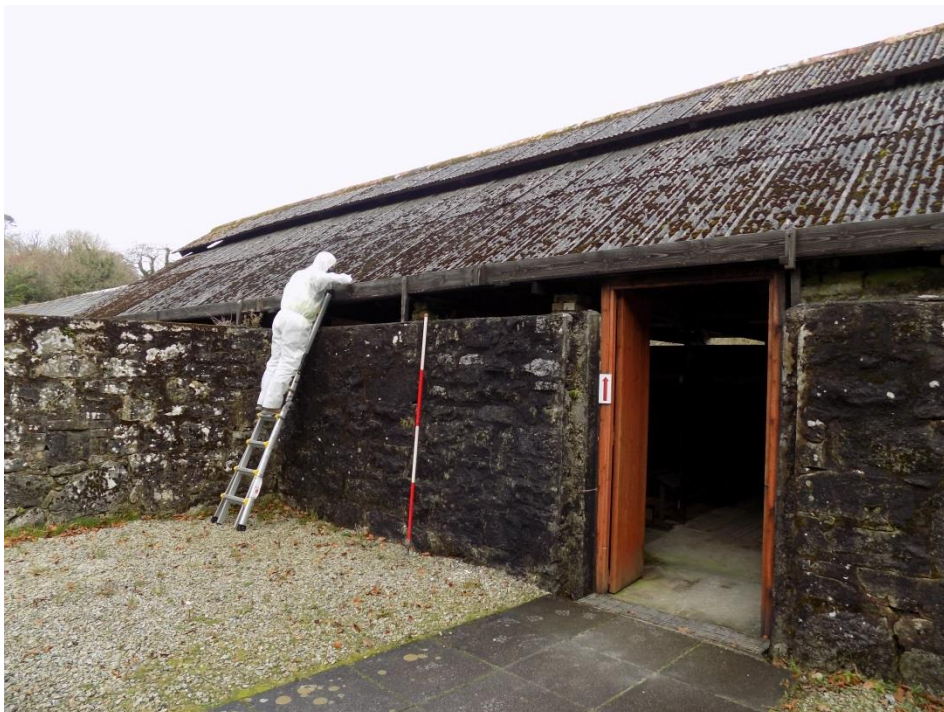
It was noted that the Pan Kiln building was covered in a roof made out of corrugated asbestos sheeting. A small sample was taken of this material adjacent to the western entrance to structure 14 (Fig 12). The sample measured less than 2cm x 2cm, was removed from the edge of a roofing sheet obscured from view by a wooden launder, so has no visual impact on the Scheduled structure.

The largest occurrence of asbestos was in the form of corrugated sheeting forming the roof of the Pan Kiln, along with gutter launders on the eastern side of the building. Small samples were taken of these from locations chosen to be obscured from view. The samples themselves (less than 2cm x 2cm) were of a size that would have no visual impact of the structure of the Scheduled building.

Figure 12. Sampling for asbestos Structure 14 Pan Kiln.

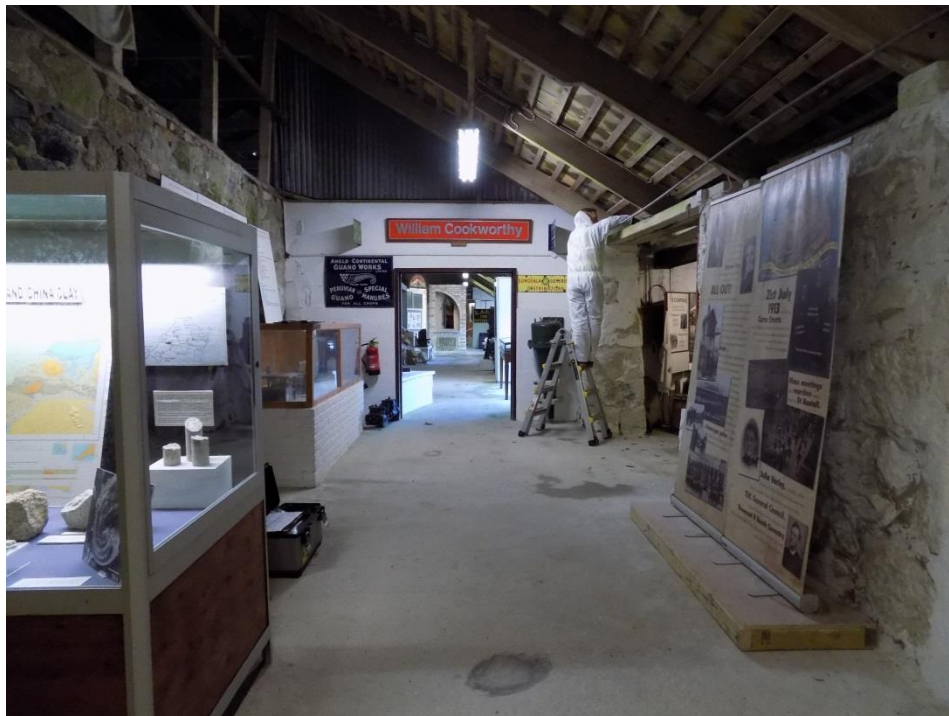
The Linhay (loading area) for the Mica Dry which formed the southern part of the building has been converted into a display area for the museum. No asbestos was located within this part of the building and no sampling was undertaken (Fig 13).

The linhay area of the Pan Kiln, which lies on the eastern side of the building, has been converted into display areas for the museum. Inspection of this area did not reveal any asbestos, so no sampling was undertaken (figs 13 and 14).

Figure 13. Looking for asbestos within Structure 13 the Pan kiln linhay.

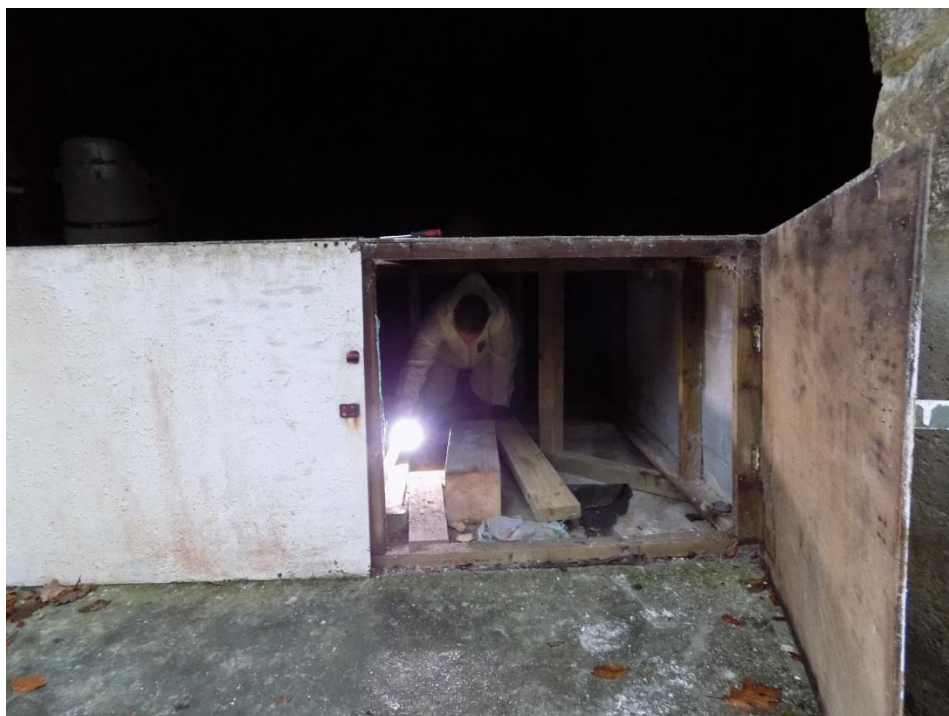
Figure 14. Structure 14. Pan Kiln linhay. Searching blocked loading bay.

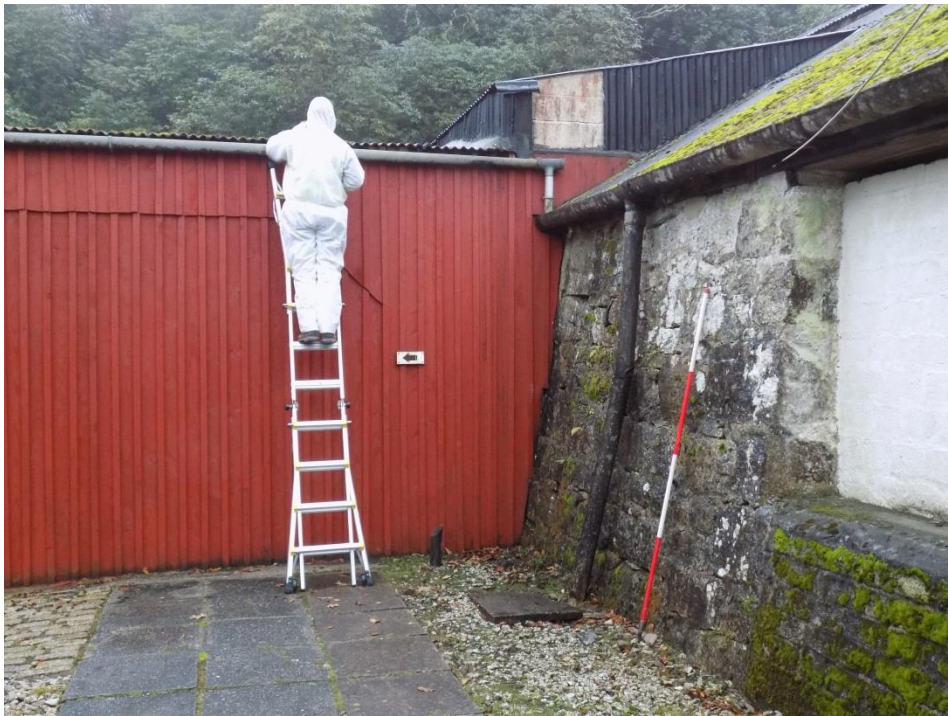
The eastern roof of the Pan Kiln linhay was again roofed in corrugated asbestos sheeting, and the gutter launder also appeared to be made out of the same material. Small samples were taken from the roof and launder at the south-east corner of the building. These samples, again very small, were from areas obscured from view and thus again had no visual impact on the Scheduled structure (Fig 15).

Figure 15. Sampling roof of Structure 14, Pan kiln linhay.

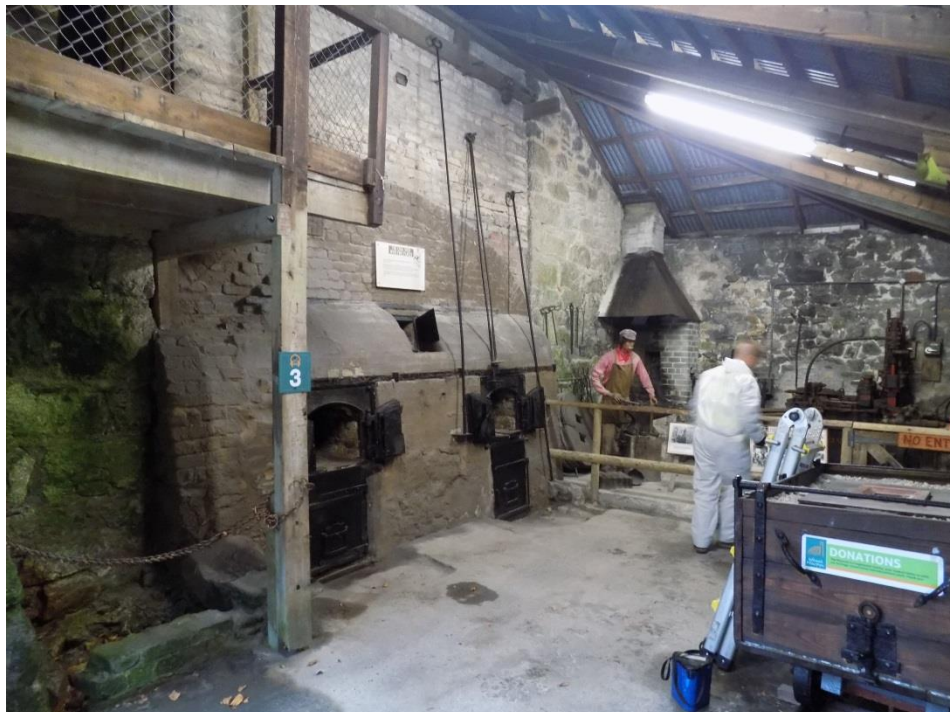
Finally the furnace area for the Pan Kiln, located at the southern end of the building was examined. This is now another display area, fitted out as a blacksmiths workshop. No asbestos was located and no samples were taken (Fig 16).

Figure 16. Structure 14 Pan kiln. Examining the furnace area.
