Tintagel Haven, Cornwall: Archaeological watching brief during cliff edge stabilisation works.

Report No: 2017R001

Archaeological Watching Brief

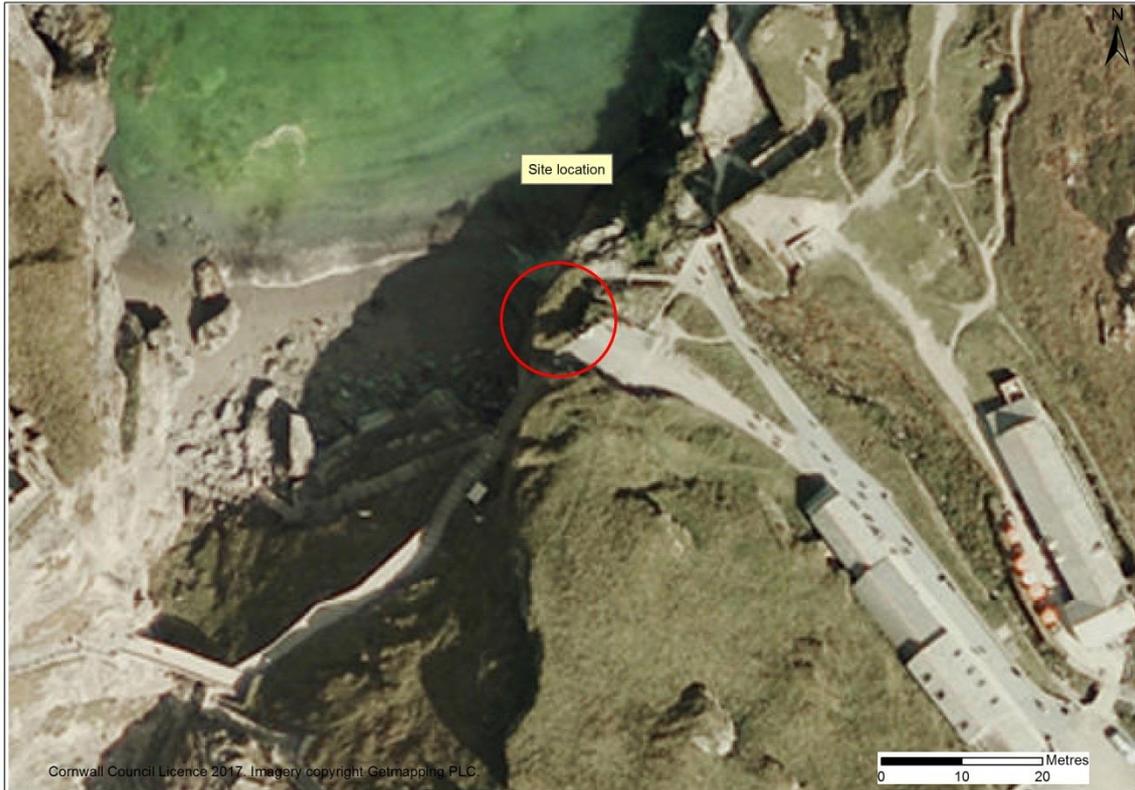
Fig 5. A 2005 aerial image showing the location of the site. The associated horse whim platform can be seen to have been obliterated during the 20th century.

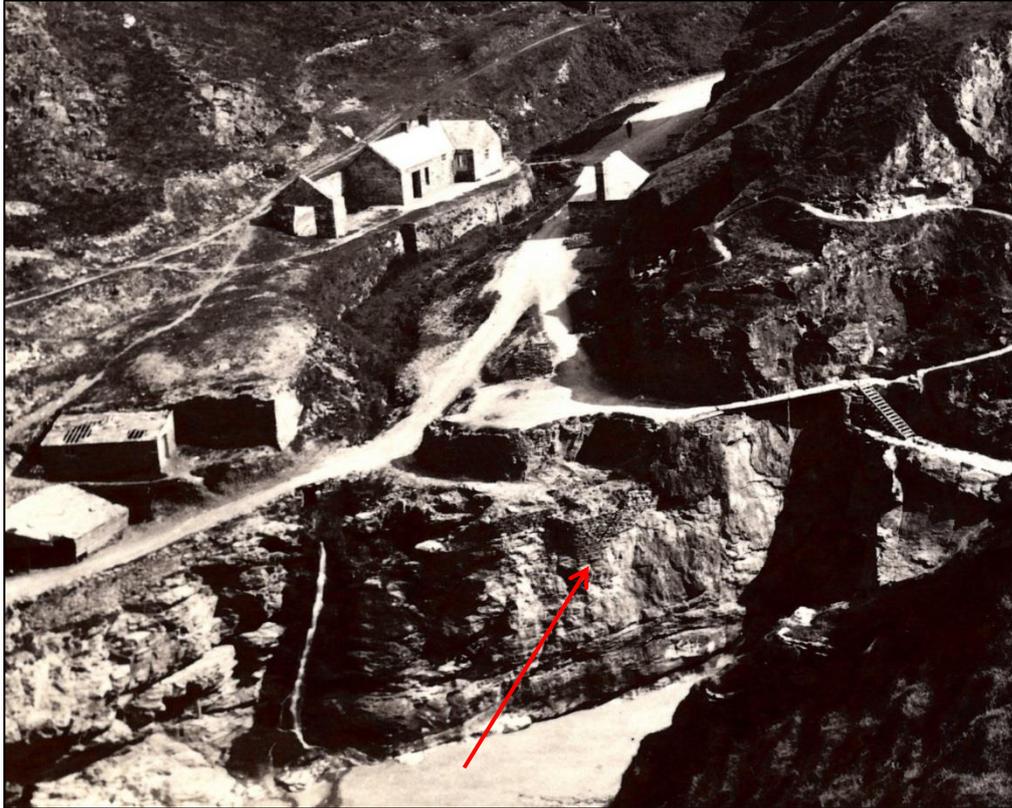
Fig 7. An extract from a late 19th century postcard of Tintagel Haven showing (arrowed) the cliff edge walling. © Charles Thomas Archive.

Archive mapping (Figs 3 & 4) indicates that the area immediately above the site investigated was the site of a horse whim platform, almost certainly serving a loading platform projecting over the cliffs from the cliff-edge strong point. Postcards and photographs dating to the later decades of the 19th century (for example Fig 7) show the remains of the strong point walling, one of several set up around the Haven to serve the slate trade. Unlike the other, larger equivalent to its north which continued in operation until the end of the 19th century, this example appears to have gone out of use before the end of the century, as postcards from this period show no timberwork or machinery sited on it and its strong point walling gradually deteriorating. Its associated horse whim platform seems to have been completely destroyed, its last remnants probably being removed when the area it occupied was levelled during the setting up of

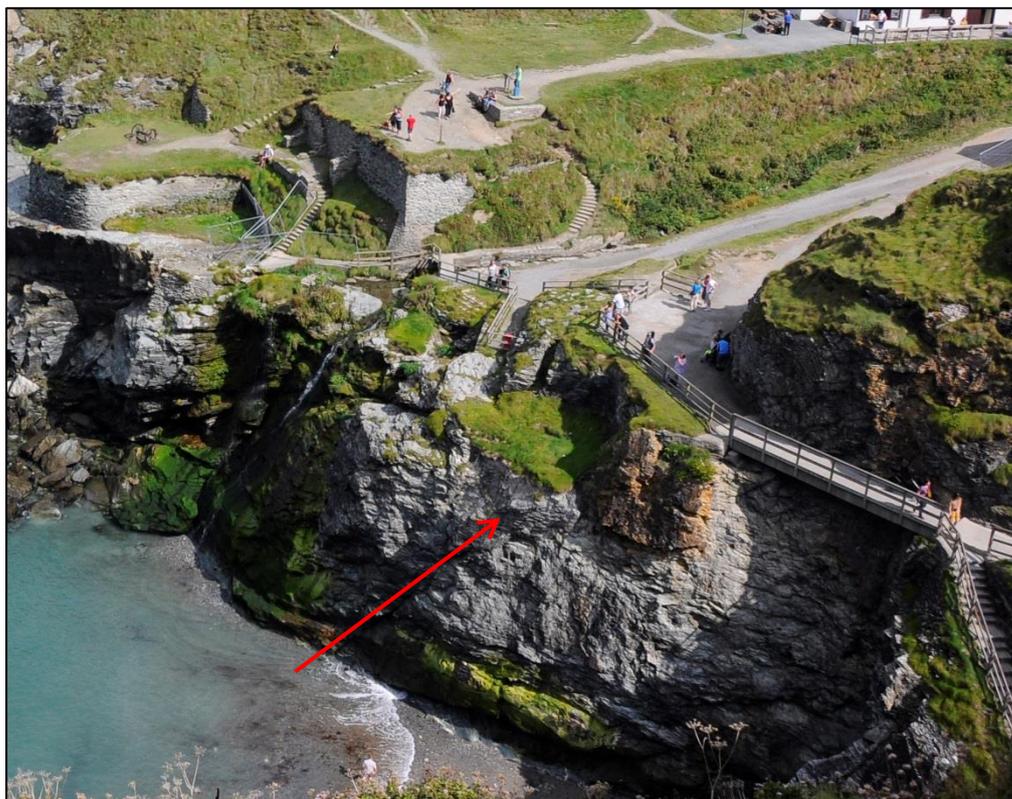
Fig 8. A 2004 CAU view of the remains of the cliff edge walling following its netting (arrowed). The other intact horse whim plat can clearly be seen on the left.

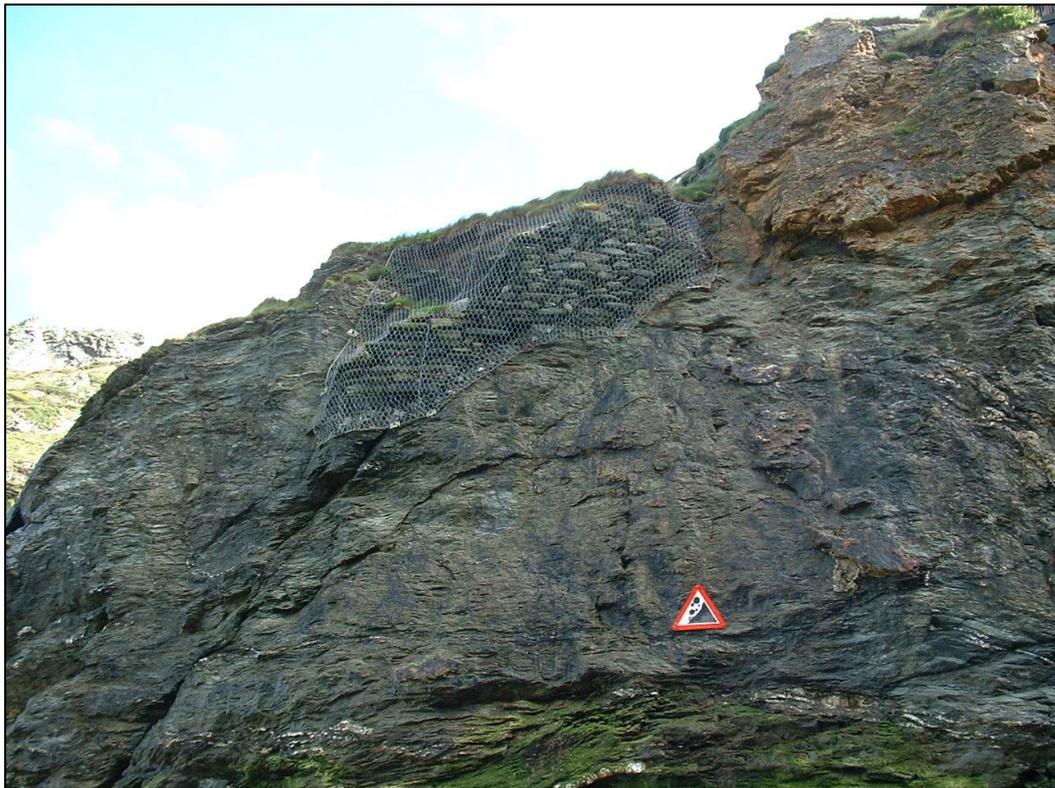
Fig 9. A 2004 image of the netted remains of the strong point walling taken from the beach below.

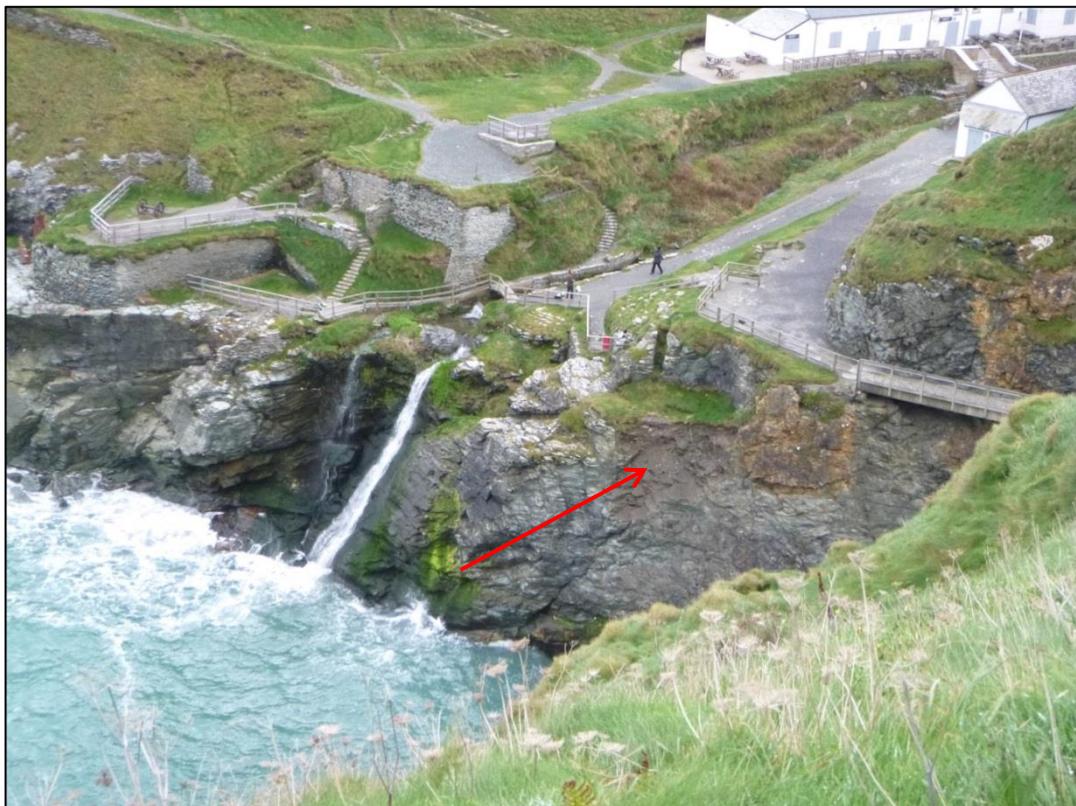
Fig 10. View looking north east from Tintagel Island showing the extent of the collapse (arrowed), this having removed all of the remaining sections of the former strong point.

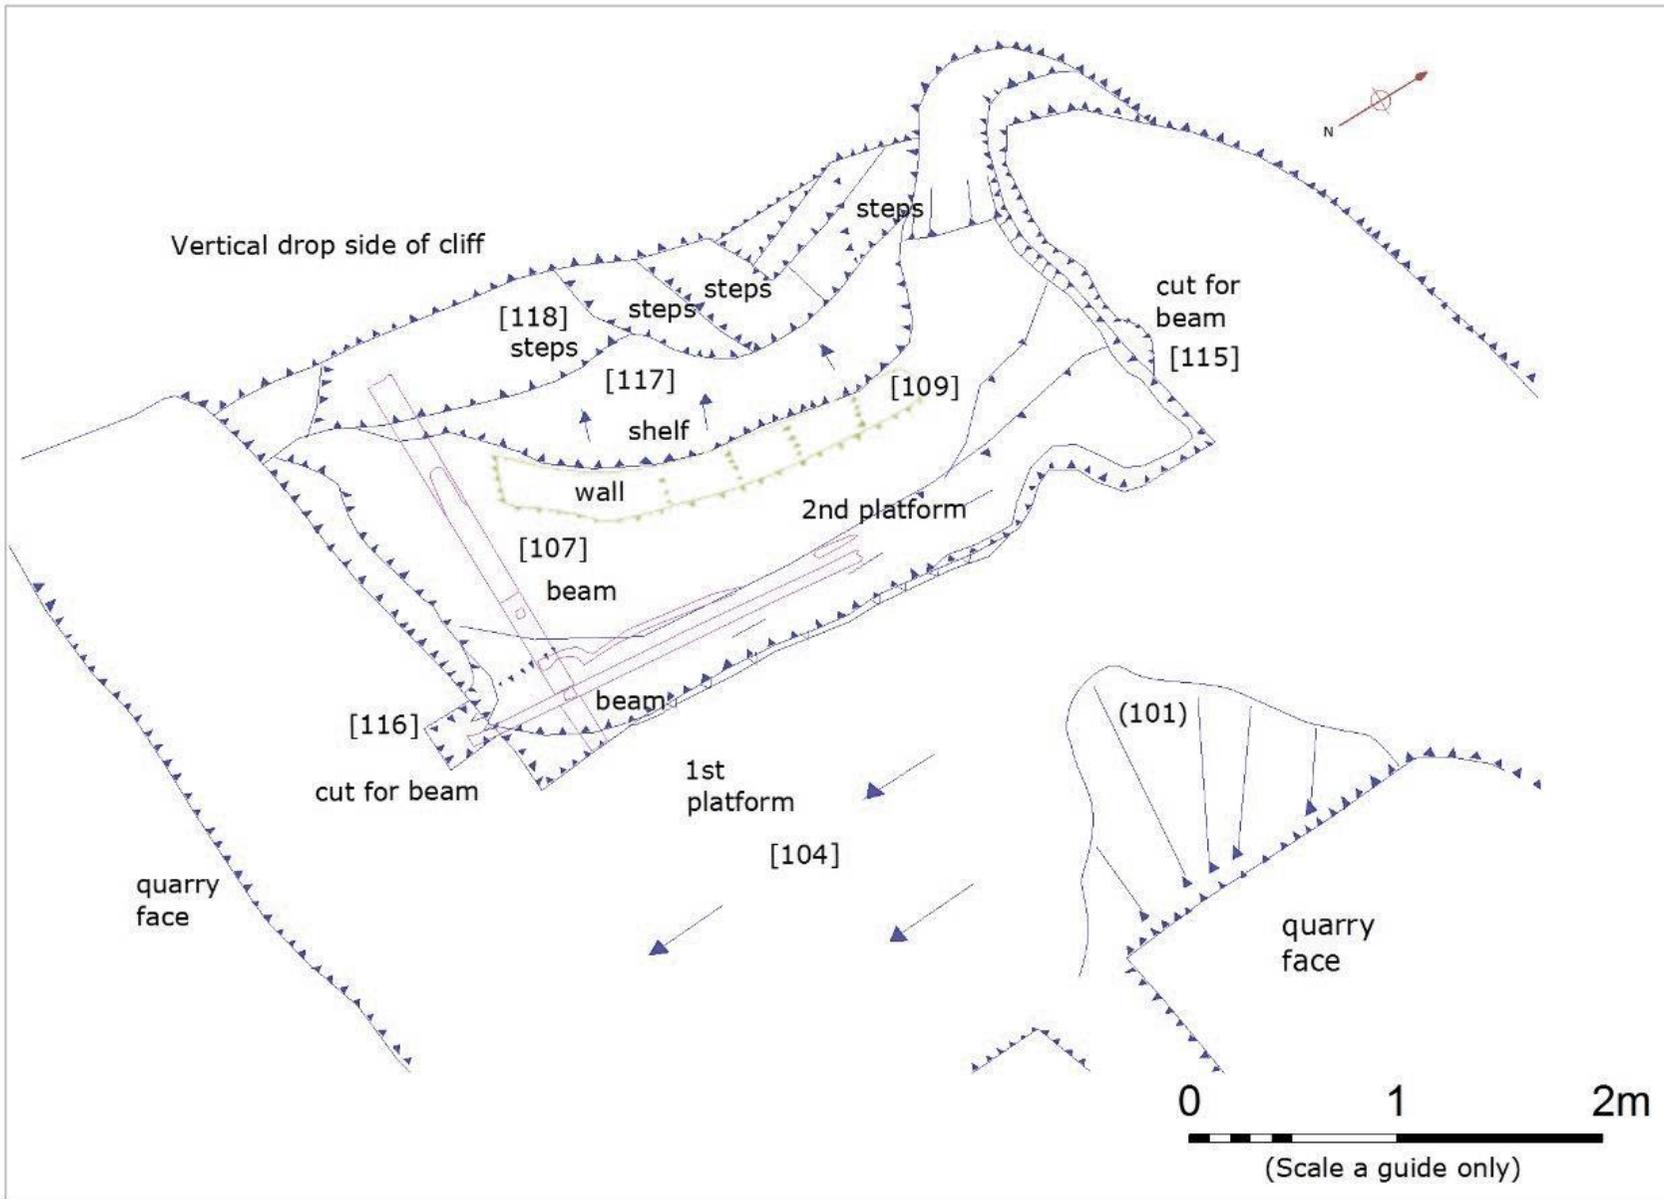
Fig 11. As excavated plan of site (scale as a guide only)

Rock cut platform No 1 [104] and low wall [102]

Prior to the removal of the turf an area at the centre of the site was noted as exhibiting a change in depth, apparently reflecting the position of a feature. The removal of the turf and further soil revealed a low wall [102], this comprising three courses of slate

This low wall did not appear to have a solid foundation or have any relevance to the working life of the platform, whilst material associated with it contained modern rubbish. The wall was probably a recent addition to the site, being surrounded by modern rubbish; it may well have been a small bench constructed for use by visitors to Tintagel and may be the feature just visible at the rear of the platform on a mid-20th century aerial photograph.

This second rock cut platform measured approximately 4.5m long; its south wall was 2.1m long, its north wall was 2.5m long and it was between 1.1m and 1.3m wide. The floor of the cut sloped to the south and was uneven, following natural fractures and bedding planes in the bedrock. The width of the platform at its northern end was 2.5m from the east wall, but to the south the floor area became narrower and irregular in plan, ranging from 1.1m to 1.8m in width from the east wall. Its seaward edge was formed by a vertical drop to a further smaller platform or shelf.

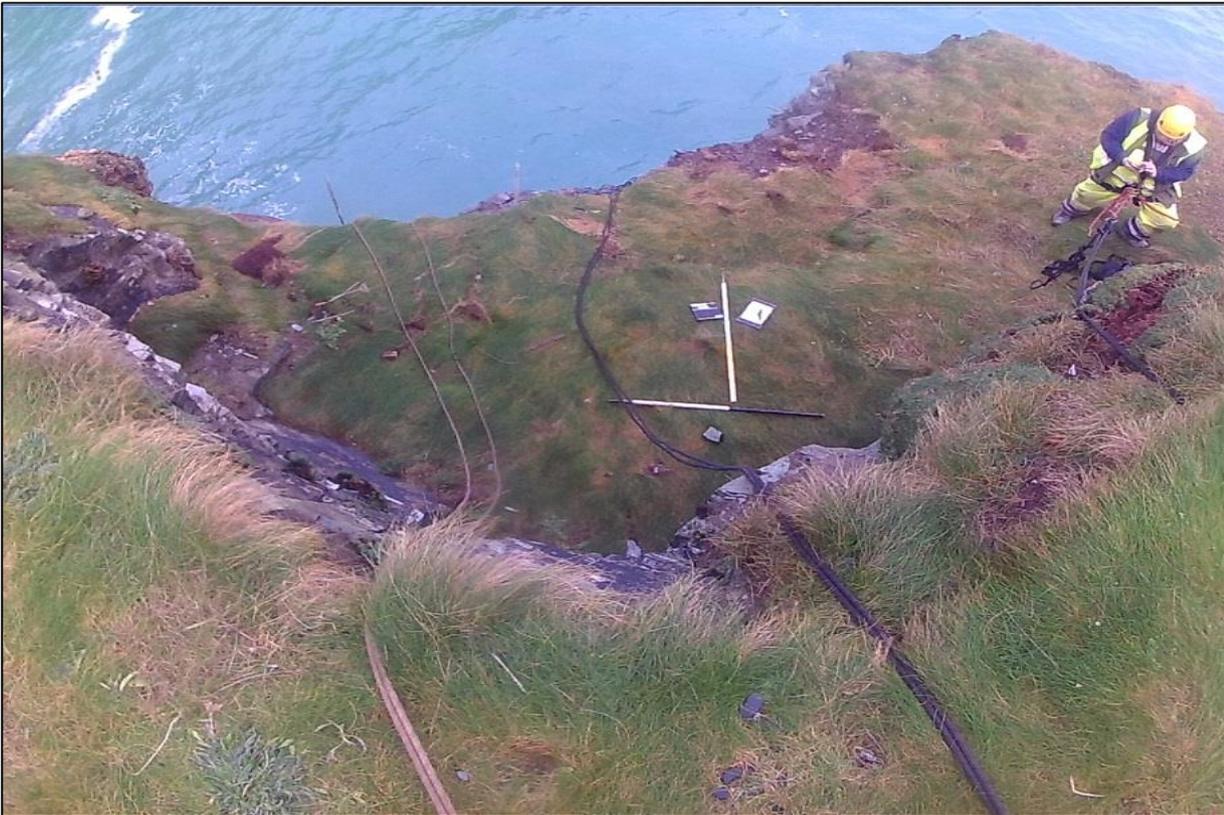
Fig 12. The site prior to its excavation, looking north west. The collapsed walling formerly revetted this (originally more extensive) platform on its seaward side.

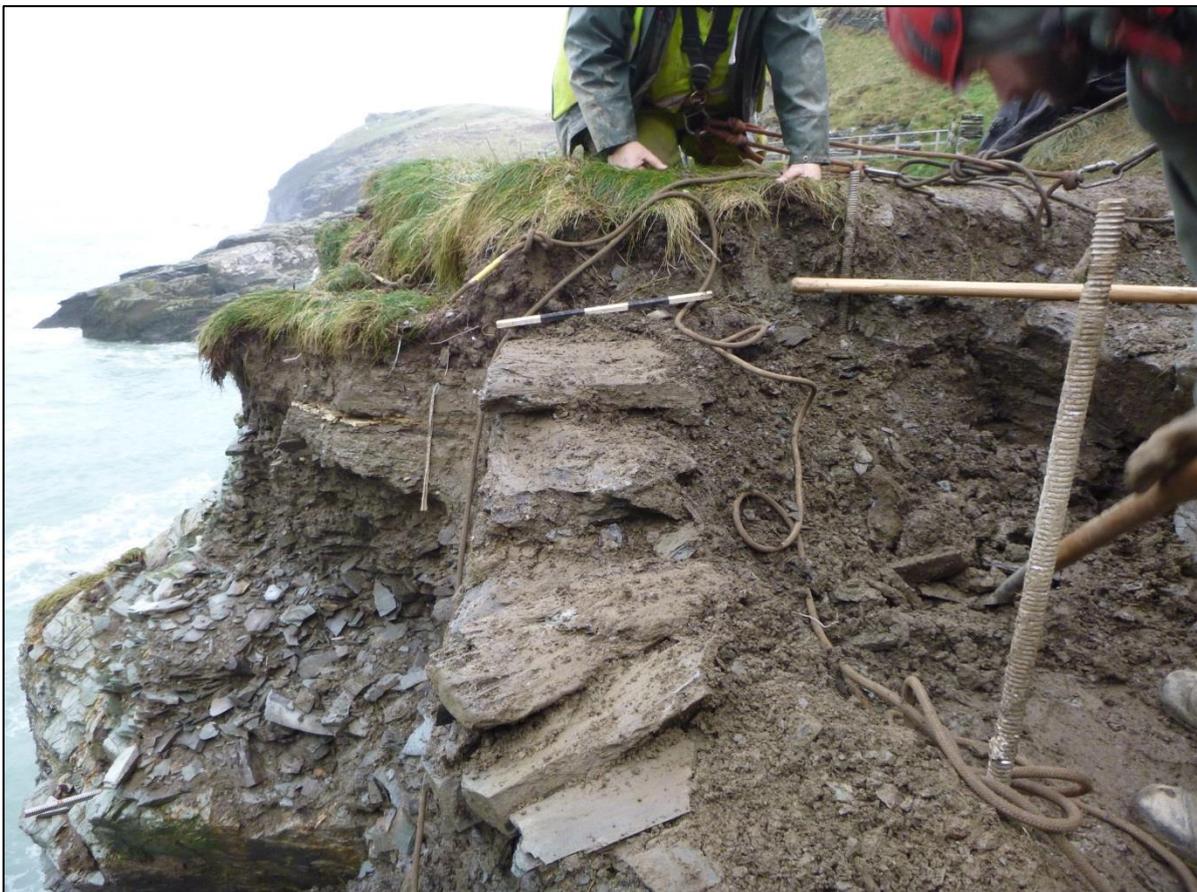
The remnants of a dwarf wall [109] were found running almost parallel to the eastern face of the lower rock cut platform; this was made up of at least four courses of laid stone and appeared to be sited on the outer edge of its floor. It continued along the edge of the platform to the south, but was clearly incomplete; the missing section is likely to have been lost during the late autumn 2016 collapse of the revetting stonework. The wall did not appear to be attached to the rock face. Some of its stones were quite large being 0.5m long, 0.3m - 0.4m wide, and 0.05m - 0.1m thick; all appeared to have been set in soil. The area in which the walling was found was particularly unstable; it was recorded photographically (Fig 13) before being dismantled. During its removal it was not possible to determine whether it was abutted by the shillet fills or had been backed by other material. Features recorded during the watching brief suggest that the outer revetting walling of the platform, founded off the rock steps cut into the cliff face, may have been backed by this inner wall, which may possibly have been constructed in order to reduce the pressure of the backfill on the outer walling.

Fig 13. Buried wall [109] near the cliff edge, 0.5m scale looking north.

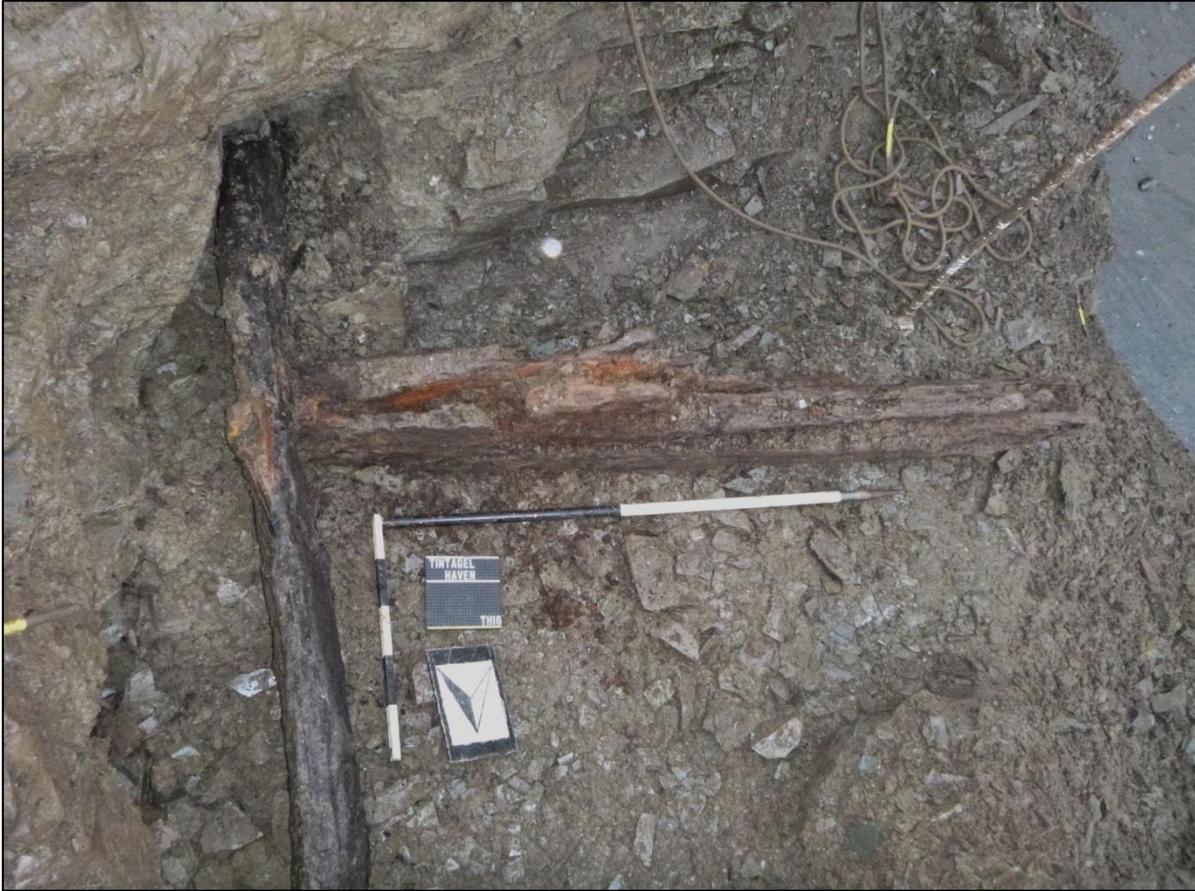
The composite timber had been neatly cut at its inner end, where it was joined to a further timber. This cross-beam was a rounded section timber 0.1m in diameter and 2.1m long; it was set perpendicular to the composite beam and was joined to it by an iron bolt; a cut had been made in the lower platform face to accommodate the cross-beam [116]. A second cross member of similar form was found running parallel to it and 0.5m from it on its seaward side. This was in very poor condition and was not recoverable. Metal artefacts found in close proximity to the main beam appeared to be the remains of further iron bolts.

Fig 14. Looking down onto the surviving wooden beam and cross member in situ (1m and 0.5m scales).

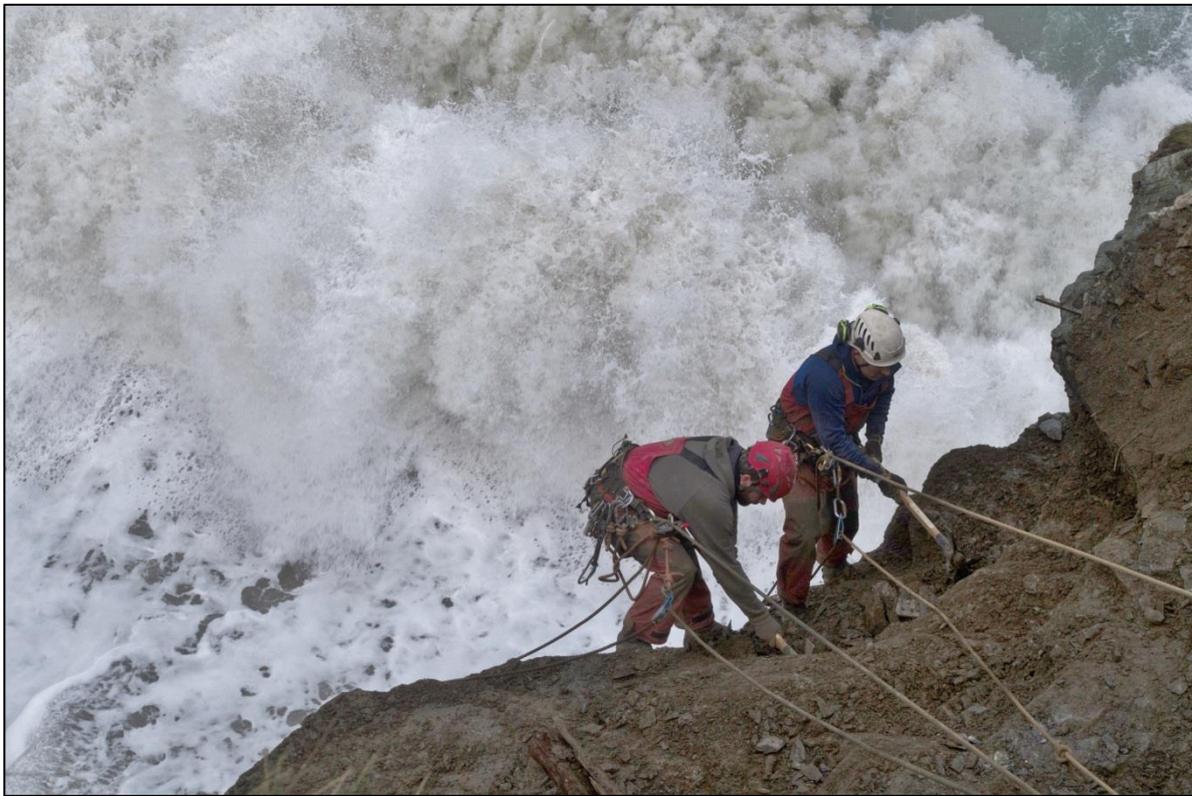
Below the second rock platform [107] a narrow ledge was revealed following the excavation of covering material, and below this was a series of what appeared to be steps cut into the cliff face. The southern end of this stepped section was about 1.5m wide, though the features narrowed further downwards and to the north; each step was less than 0.5m wide and each was between 0.1m and 0.2m below the one above. Archive photographs suggest that these were cut to site the foundation courses for the revetment wall.

Fig 15. Vertical Technology staff clearing steps cut into the cliff face.

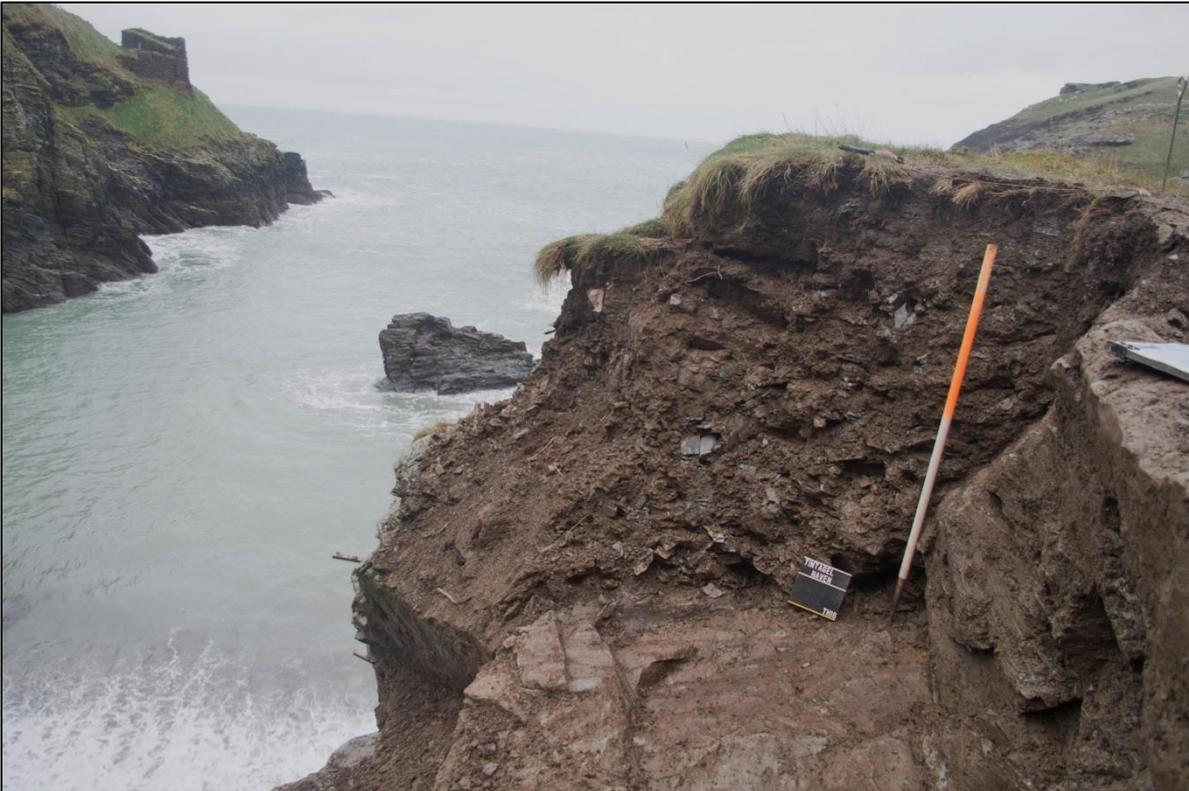
Fig 16.1 The south-facing section of the north end of the platform prior to the removal of the last part of the backfilled material, showing the remnants of a possible wall and quarried face (1m scale).

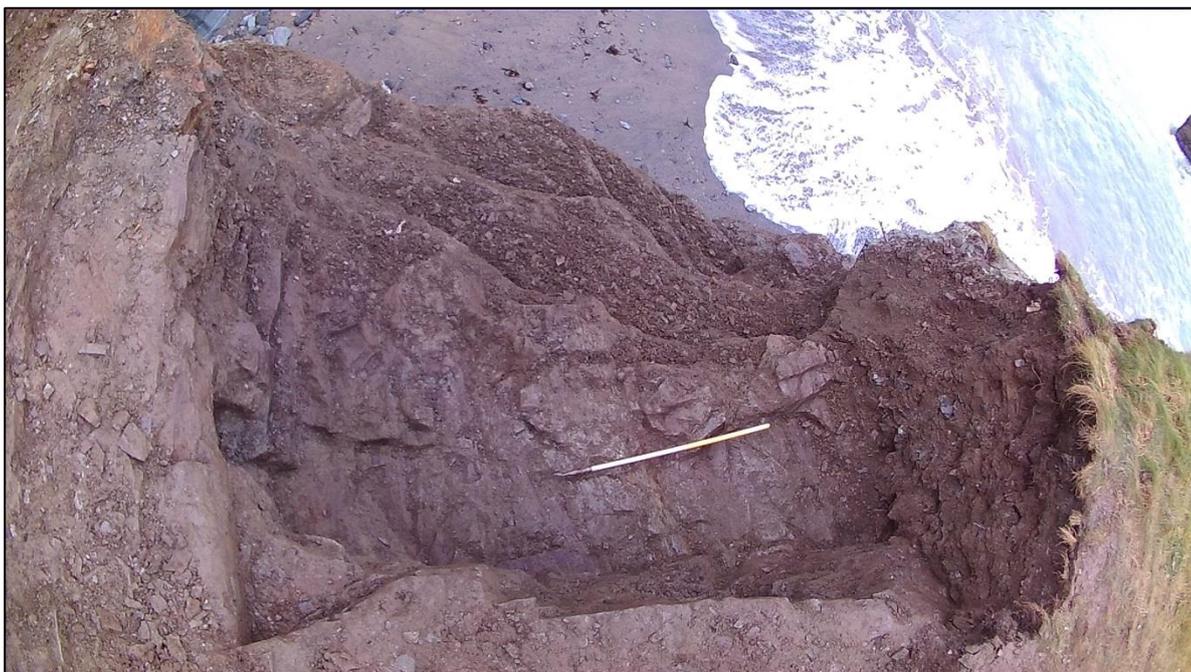
Fig 17. Mid excavation view prior to the removal of the material covering the north end of the platform (1m scale).

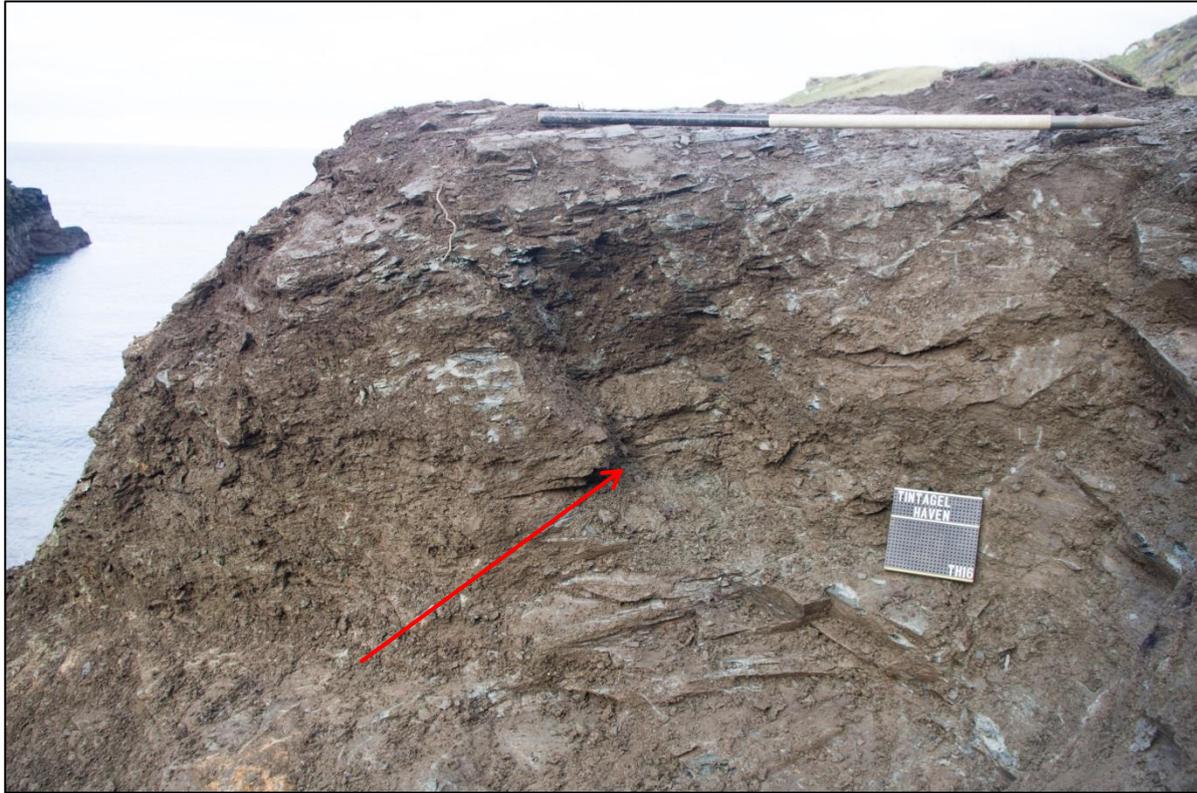
Fig 18. The north end of the platform cut after the removal of the backfill (1m scale). Note the possible notch in the face (centre).

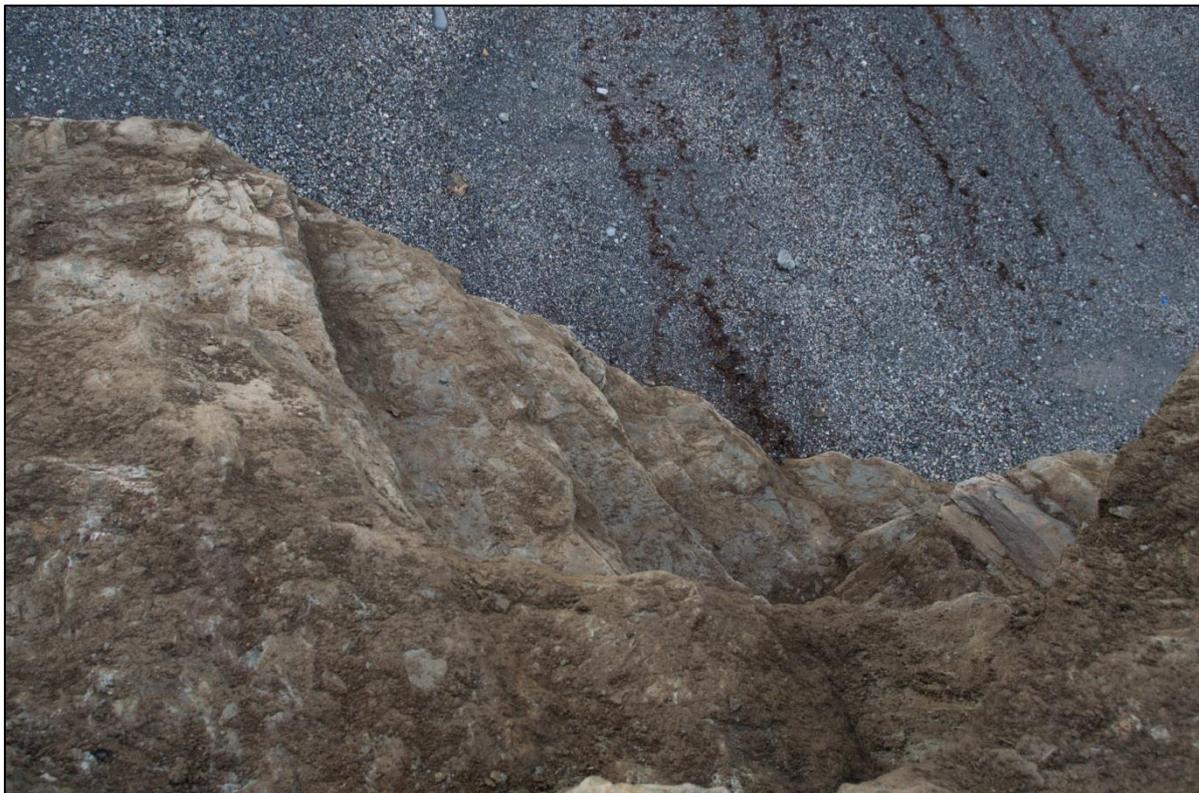
Fig 19. A vertical view of the stepped area after the final clean up.

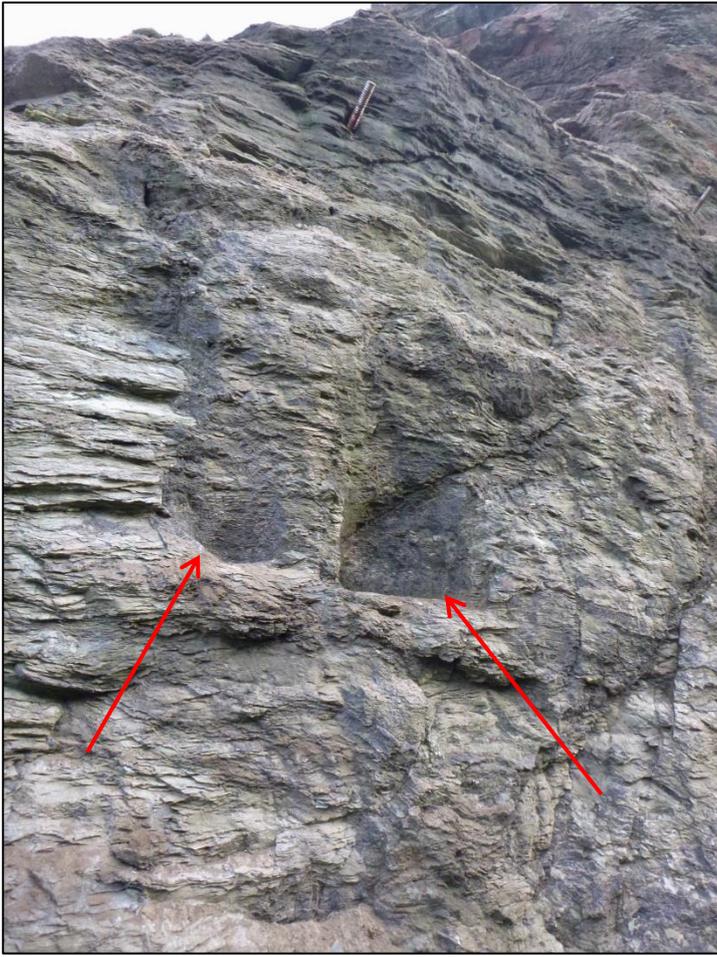
One of the VT staff noted two notches at least one metre below the middle of the stepped area, the notch to the south apparently being better defined. Archive images of a similar site on the eastern side of the Haven (Figs 21 and 22) suggest that these rock-cut hitches would have held timber struts supporting the outer end of a now-lost timber platform.

Fig 20. Two notches cut into the cliff face below the stepped area.

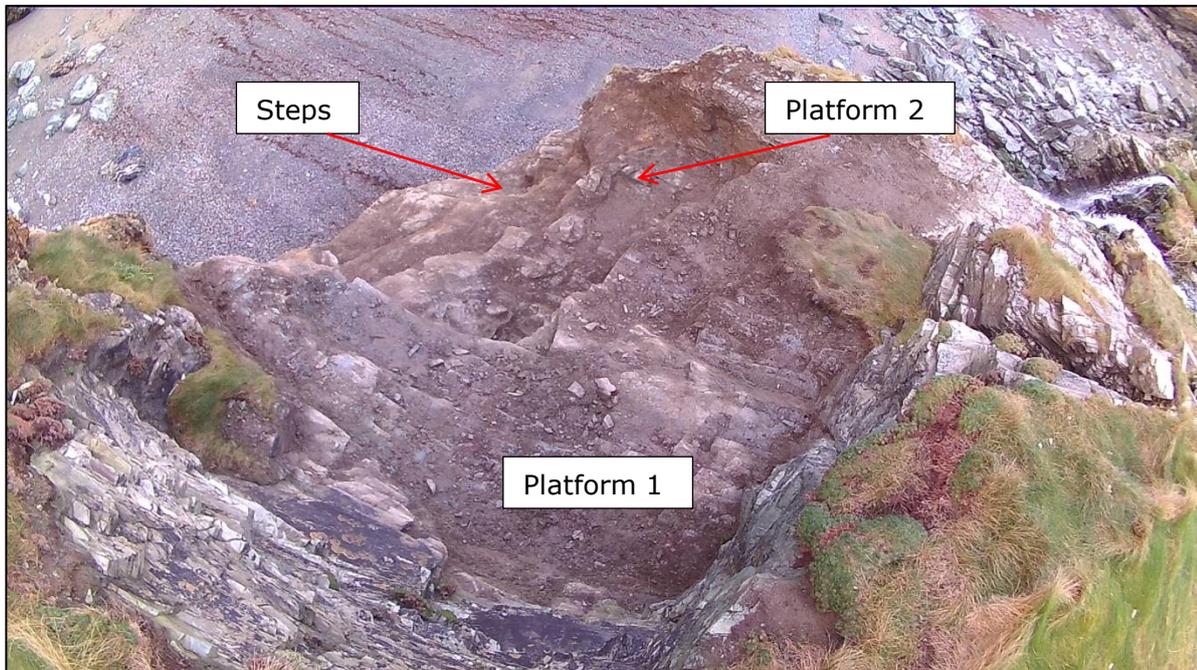
Fig 21. A vertical view of the platform following the final clear up of the site.

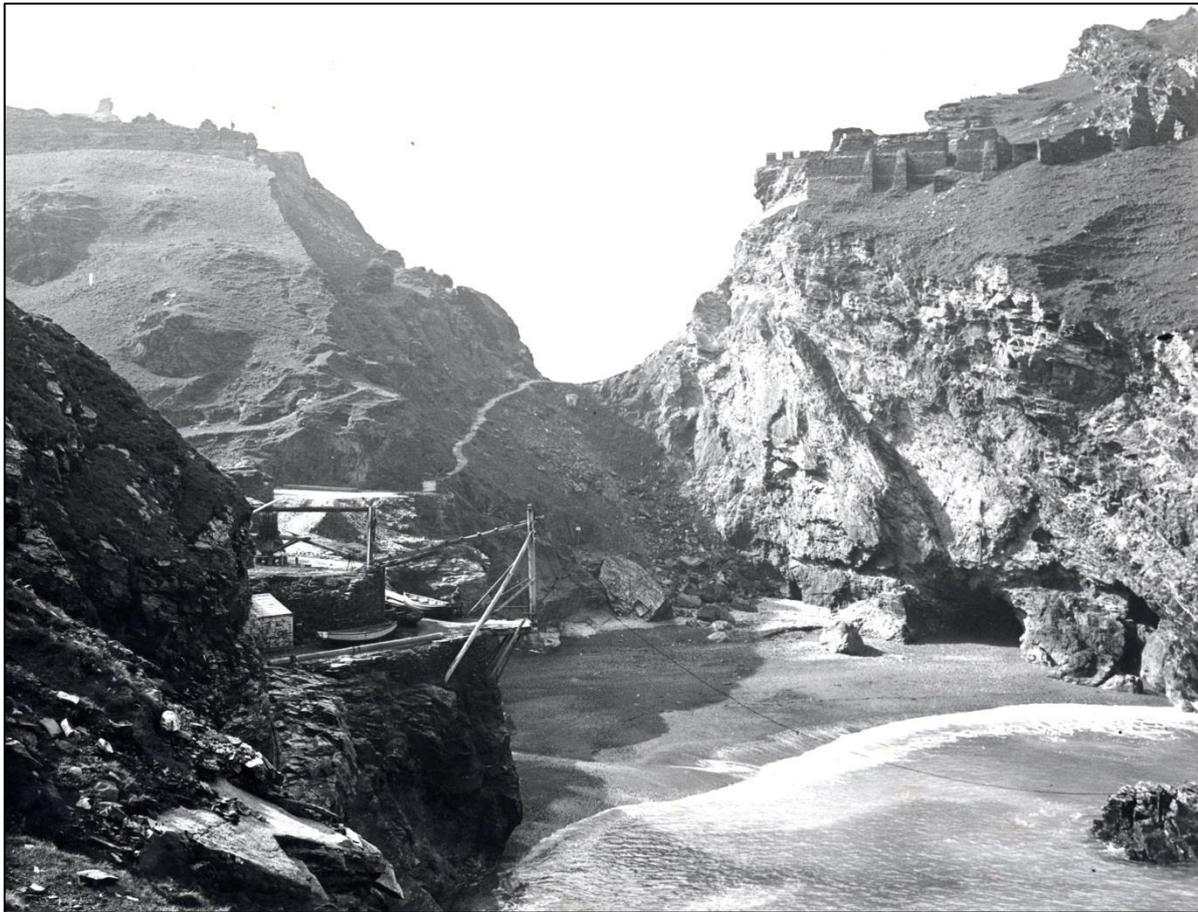
The archaeological evidence suggests that a substantial cut with a levelled base was made into a suitable section of vertical cliff face above the beach. A substantial horizontal frame protruding out well beyond the cliff face was installed on the floor of this lower platform; the outer arms of the frame would have been diagonally braced by timbers hitched into the cliff face below the platform (as is indicated by the notches found there). Revetment walling was constructed off steps cut into the cliff face, archive postcards indicating that this originally substantial feature included a right angled wall return to define a rectangular area. The lower cut was completely backfilled with a layer of soil and slate waste up to the level of the upper platform, pinning the frame in place. A rock-cut walkway was created from the north to access the platform. A horse whim was constructed on the clifftop immediately to the south, together with vertical framing to carry the winding rope from the whim drum to a pulley set up on a shearlegs on the protruding section of the frame (which would have been decked over, possibly incorporating an access hatch). This arrangement would allow slate carried down to the cliff edge platform to be lowered to boats beached underneath the frame at high tide. An arrangement closely matching the archaeological evidence is shown in several postcards of the Haven (for instance see Figs 22 and 23).

Fig 22. A late 19th century view of the Haven from the north showing the horse whim, strong point and timber gantry on the site to the north of that excavated in 2016/17. Its details are likely to have been very similar to that examined during this project. © Charles Thomas Archive.

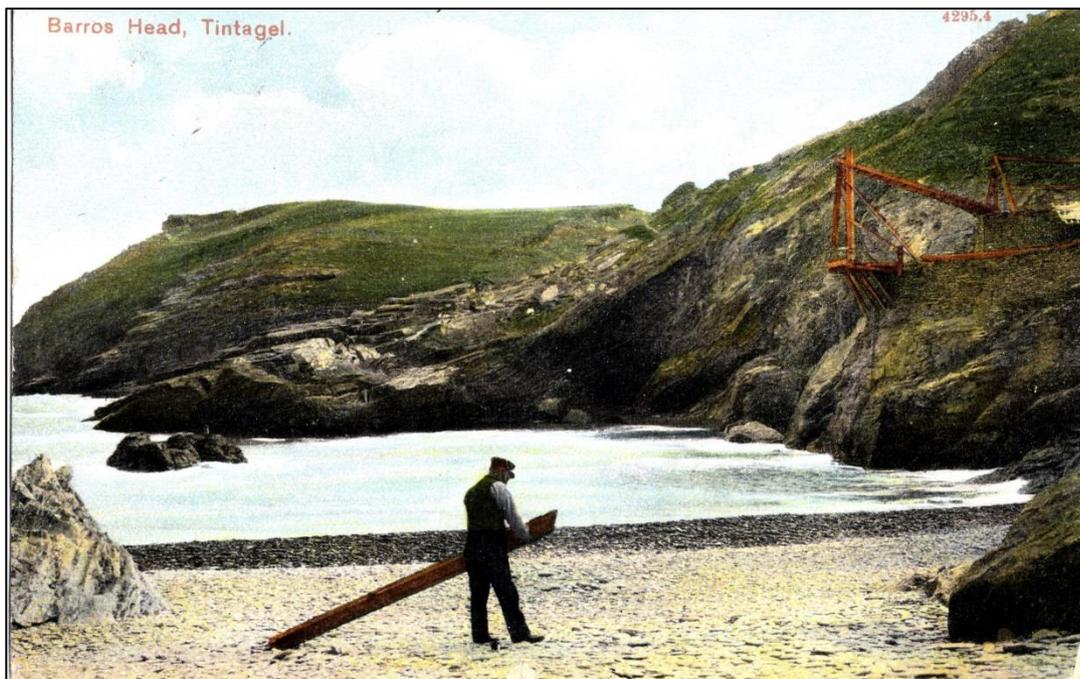
Fig 23. A hand-tinted late 19th century postcard showing the northern loading point. © Charles Thomas Archive.

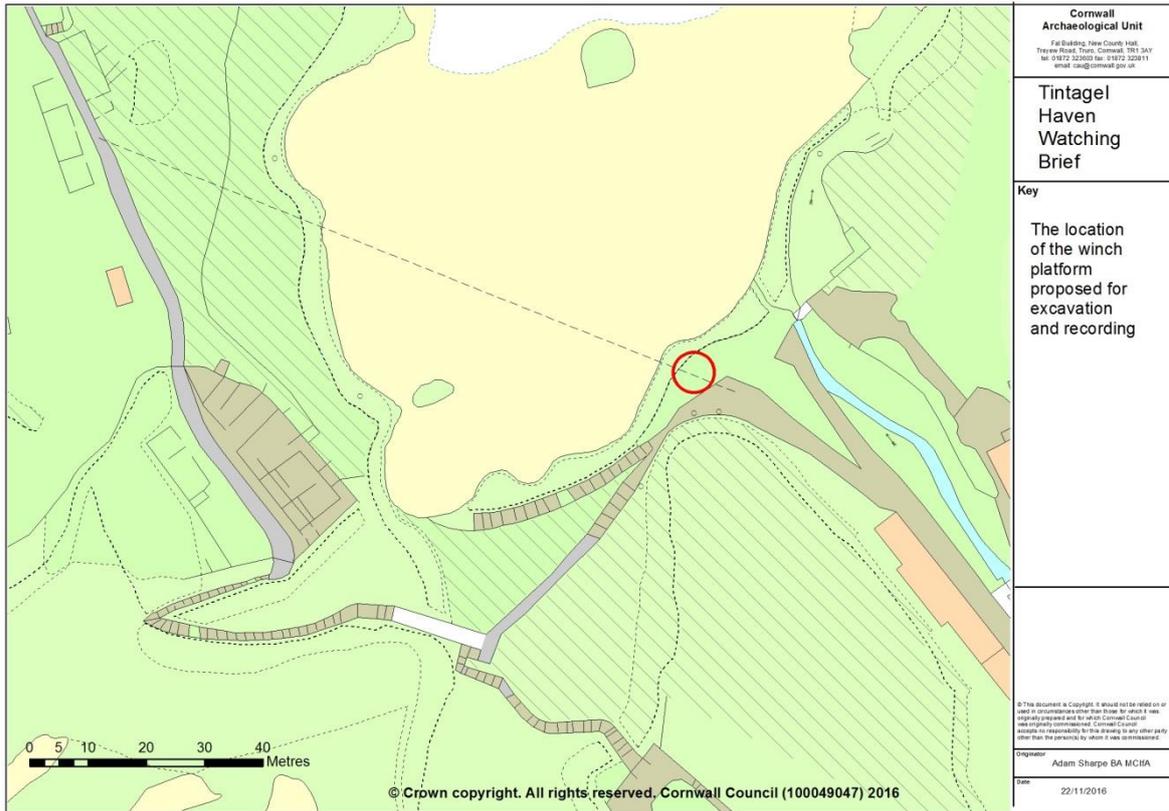
Fig 1. The location of the winch platform at Tintagel Haven.

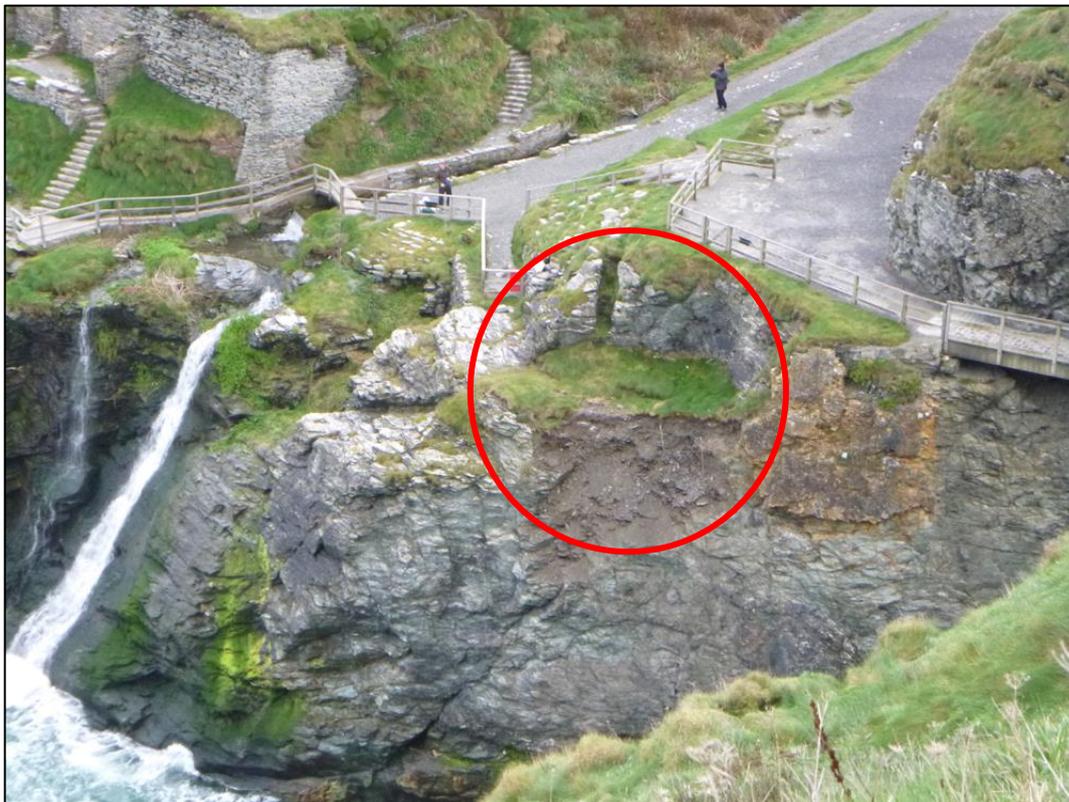
Fig 2. A view of the area to be excavated from the north-west.
