Wheal Martyn Mica Dry, Carthew, St Austell, Cornwall
Archaeological Evaluation trenching

Cornwall Archaeological Unit

Report No: 2017R003

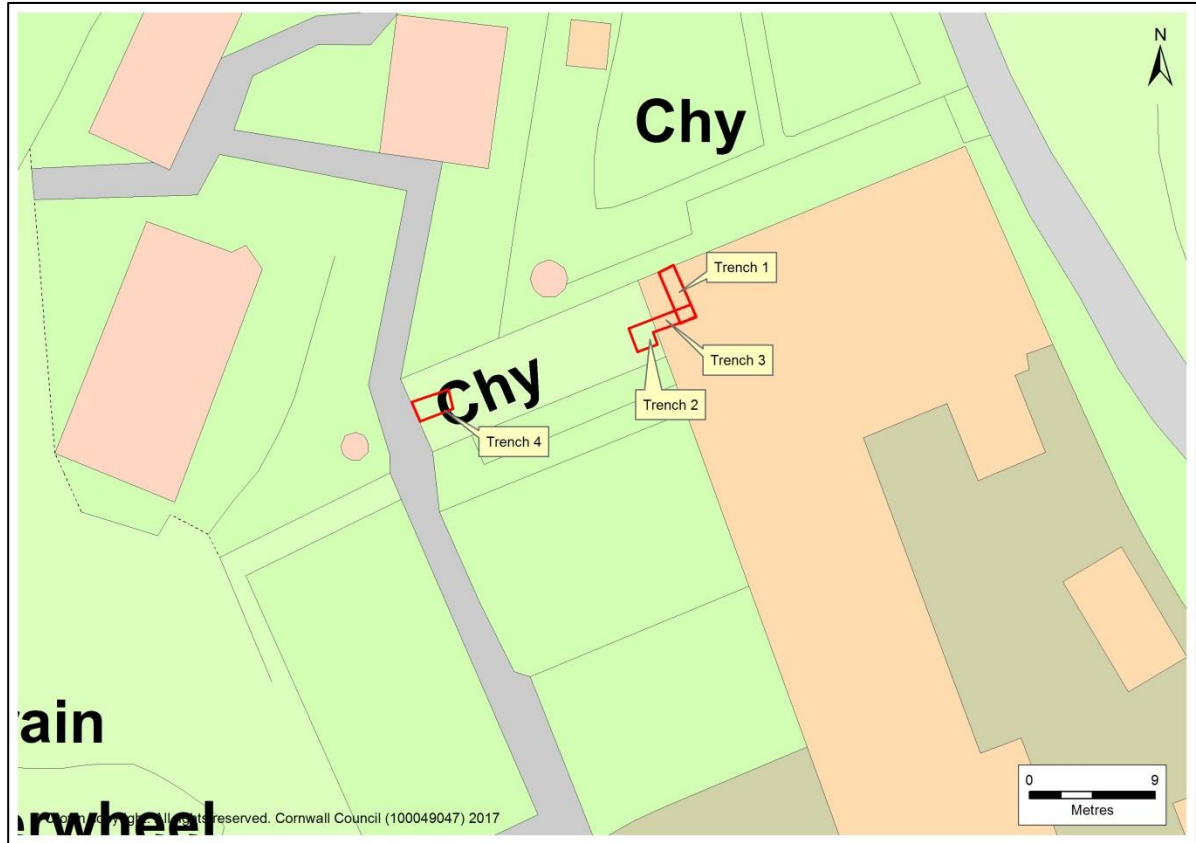
The initial excavations took place over three days (11th January to 13th January 2017) and were followed up later by the excavation of another trench (4) on 27th January 2017. To begin with three trenches (Fig 5) were excavated by hand; these measured 3m x 1m, 2m x 2m and a smaller linking trench (between trenches 1 and 2) measured 2m x 1m.

Trench 1 was intended to examine the character and degree of survival of the floor of the building; Trench 2 was positioned over the recorded western end of the building as shown on the *circa* 1877 OS mapping (Fig 3); Trench 3 – a linking trench see above was excavated to explore an anomalous, undocumented feature between the two trenches. An additional trench (Trench 4) was later opened up adjacent to the chimney and was intended to explore an area documented in 1908 (OS map) as siting the western wall of an extension to the original Mica Dry building (Figs 4 & 5).

Figure 5: Locations of trenches.

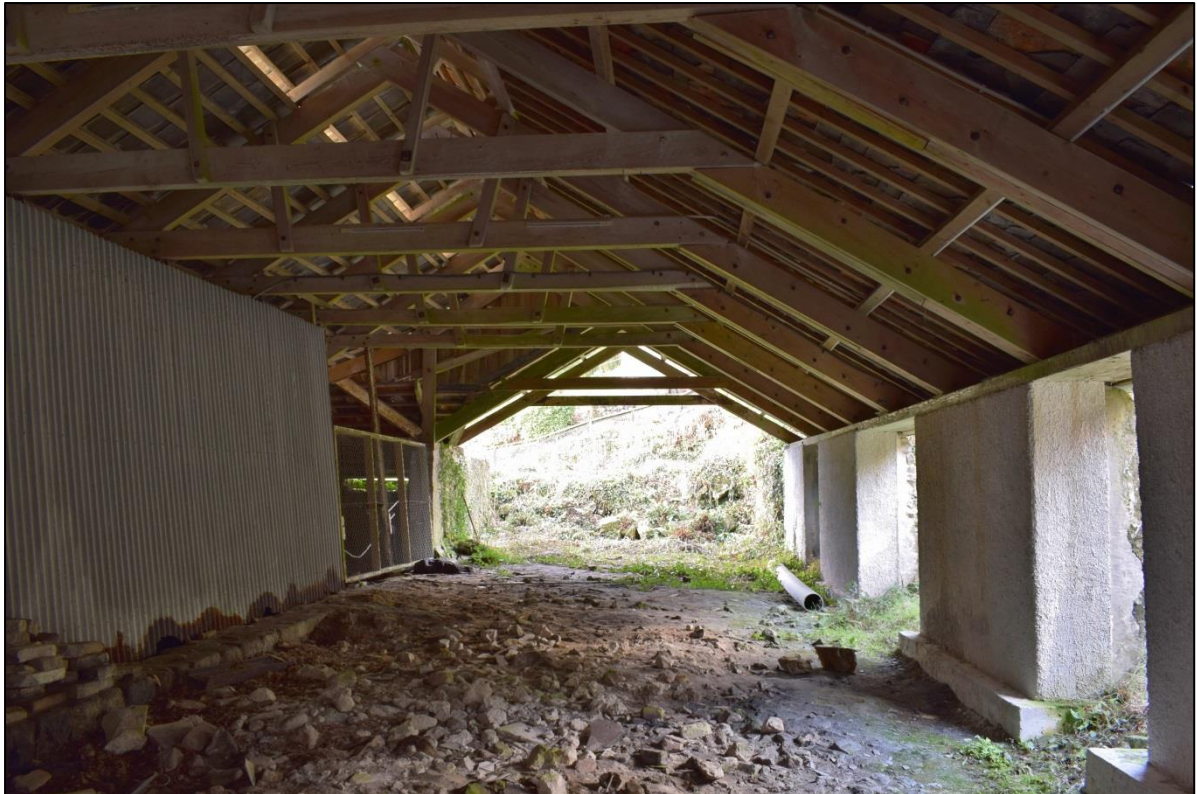
Figure 6: View through Mica Dry looking west-south-west, prior to excavation.

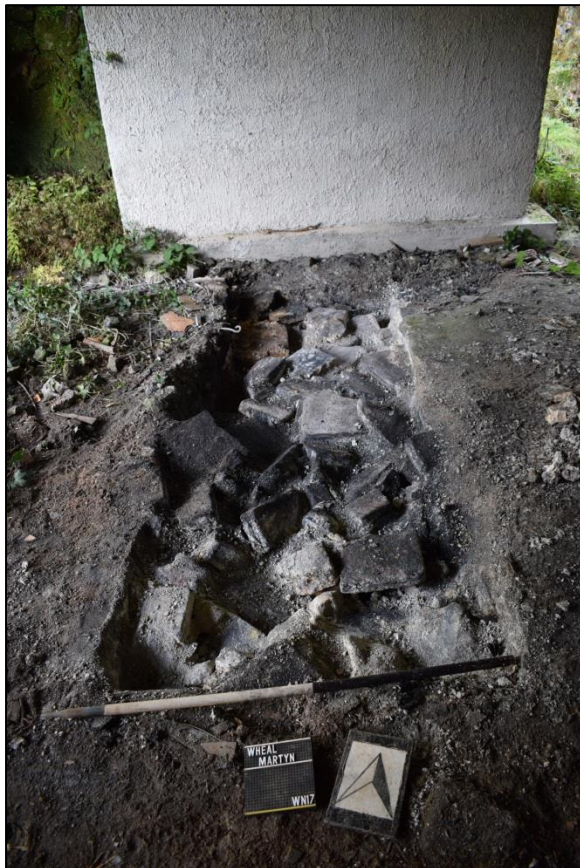
Prior to excavation the surface area of Trench 1 and the wider setting was found to be covered in a mass of demolition rubble (101) which overlaid a grey brown coloured silty loam (which was less than 0.05m deep). The rubble comprised pieces of flue brick, broken floor tiles, china clay slurry, burnt sandy ash and pieces of rusting metal, all mixed up and dumped in this area apparently during the 1980s when the museum was being developed. The material was compacted in places and very loose in others, cavities were present within the rubble. In one section of the trench there was a spread of clay slurry (102) which had seeped into the underlying material; this smothered larger pieces of rubble and reached a depth of at least 0.23m below the surface spread. This overlaid a mid-brown sandy earthy deposit (103) which appeared to be a mixture of (101) and (102). Below this deposit was another layer of clay slurry (104).

Figure 7: Mid excavation of trench 1 showing demolition rubble (101) in situ.

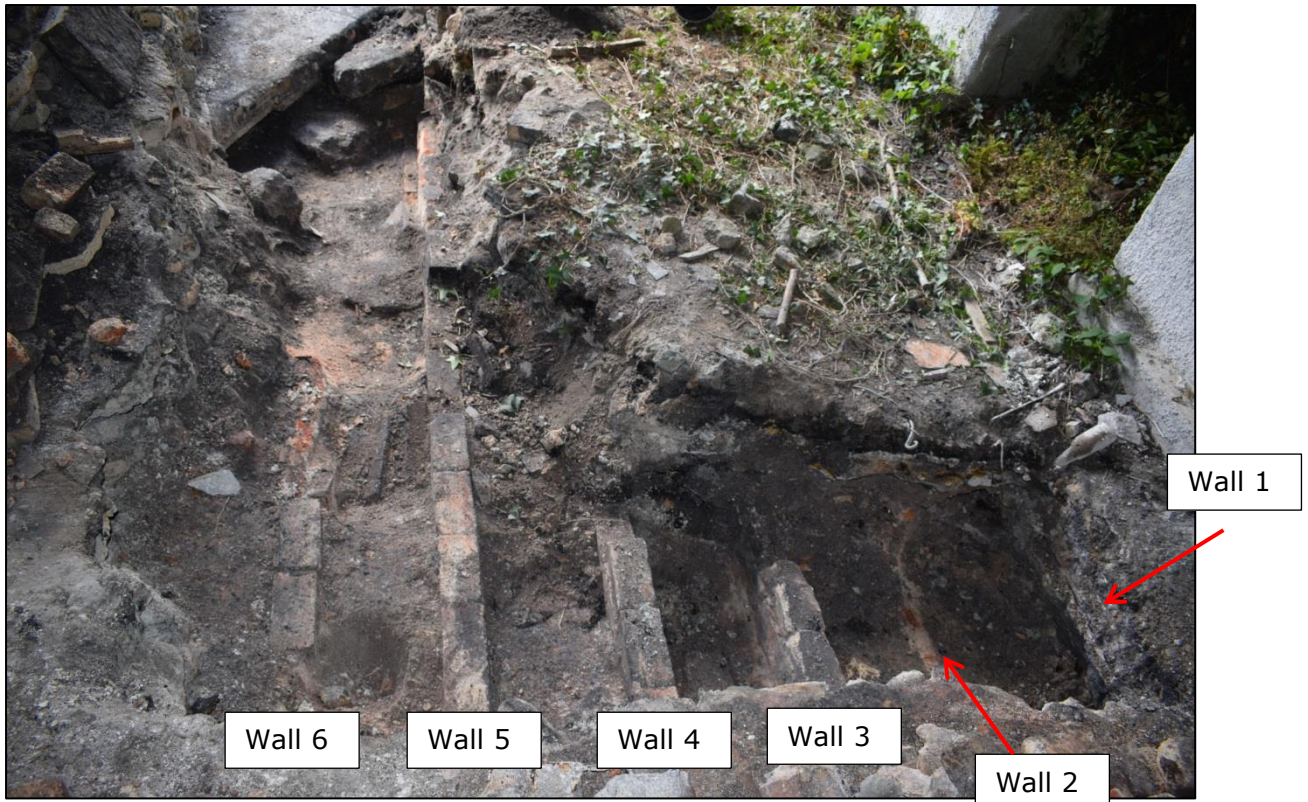
Within Trench 1 were the remains of a number of hypocaust walls [105] orientated along the length of the building; these were constructed of red and off-white coloured bricks. A single brick in thickness, the individual walls heights are not provided, only the number of courses revealed due to only walls four and five being bottomed. These walls were probably at least eight to nine courses of brick in height, over 0.6m from the original bedding surface. No sign of the former capping tiles was found.

The hypocaust walls revealed during the excavation were in various states of disrepair and decay. Some of the bricks had been significantly affected by heat and are in the process of reverting to sand. The bonding cement was still evident between the brick courses. These bricks were easily damaged during their cleaning up with a firm brush, and this made the bottoming of the trench impracticable because of the high potential of damage this could cause to the buried archaeology.

Figure 8: Trenches 1 and 2 showing remains of hypocaust system beneath rubble capping.

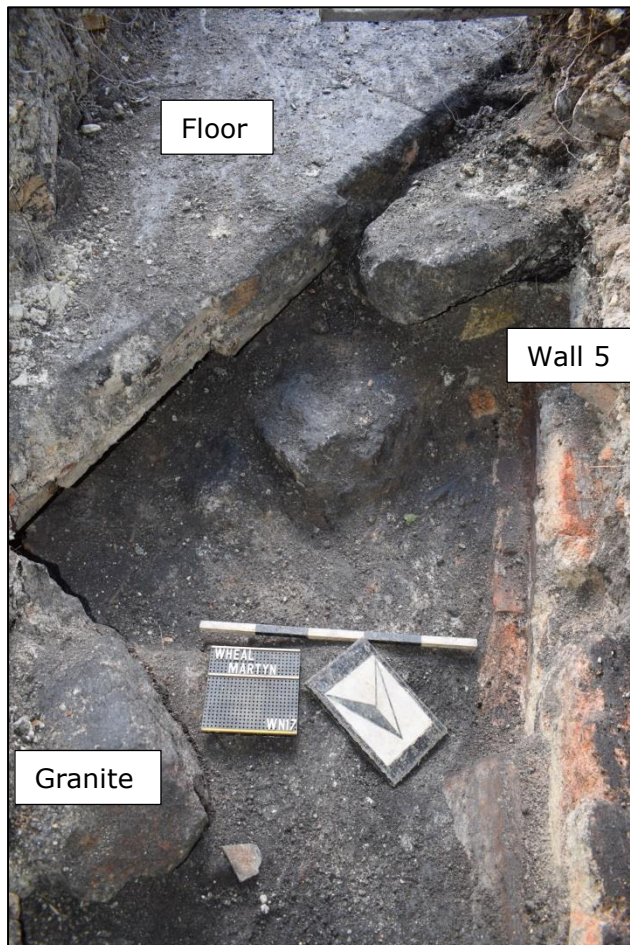
The feature (i.e. floor (106) see Fig 9) exposed in the trench ran diagonally to the line of the Mica Dry hypocaust. Approximately a 1m wide section was exposed in the trench and it consisted of two layers of hypocaust tiles bonded with clay. The combined tiles were 0.15m thick and they appeared to be set onto a concrete wall (108), which had a grey bubbly hard/compacted surface. Wall 5 appeared to run the length of the exposed section of this tiled surface (the possible end of the wall went under a large granite boulder which was too heavy to move but was in any case set into the ground surface and baulk, so whether the wall ended abruptly or continued further) remains unknown.

The feature capped with hypocaust tiles found in Trench 2 is not shown on any maps, and appears to head NNW in the direction of the pump house and former chimney on the northern side of the building. Its exit through this wall is indicated by the presence of modern brickwork in an otherwise granite-constructed structure. The exact nature of this feature cannot be confirmed without further excavation to reveal more of its course. It was not seen in the area on the southern side of the Mica Dry. The feature clearly cut through the brick hypocaust walls. Around one metre of the underlying feature was revealed (though not to any significant depth) but this had no indications of openings corresponding with the hypocaust channels. It seems likely therefore that this feature post-dates the abandonment of the Mica Dry and formed a levelled connection between features to the north and south of the Mica Dry. Without further excavation the function of this feature cannot be confirmed, though it may have been a dwarf wall carrying a pipe, a wooden launder or some other feature associated with the pump house to the north of the Mica Dry, carrying this across the voided floor of the Mica Dry.

Figure 9: Trench 2 showing feature surfaced with double layer of hypocaust tiles.

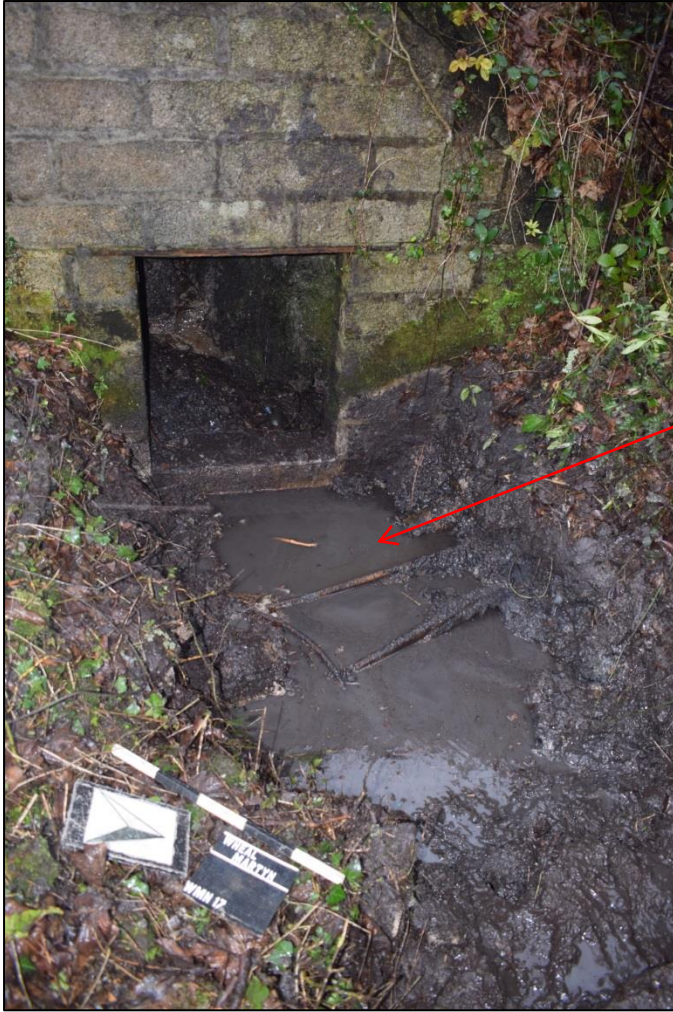
A 1.2m by 1.8m long trench was excavated against the flue chamber entrance to the west of the Mica Dry building. This was orientated along the area of the floor to the extension of the Mica Dry due to the density of overlying demolition rubble (110) within the building.

The rubble (110) was about 0.6m above the potential floor area and comprised an upper layer of dressed granite stone (each being in excess of 0.5m long and some showing signs of having been dressed for use as wall facing material). Lower layers comprised broken brick and smaller stones intermixed with cement; these had an earth covering. The foundations of the walls of the extension to the Mica Dry were revealed rapidly and were found to be intact although the interior of the flue area contained gritty material and rubbish. There was a fair amount of water ingress into the trench during the evaluation work which made excavation and recording difficult.

The exterior walls of the flue building were of breeze block-type construction incorporating a single flue opening which measured 0.73m wide and 0.93m high; the blocks making up the base of this feature were about 0.2m wide.

Figure 10: Trench 4 post excavation.

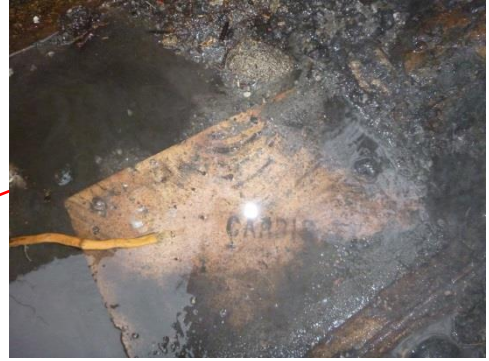
As the demolition layer was removed, the trench started to fill with water. Nonetheless a pinkish-coloured floor tile was found, apparently level and *in situ*. This was stamped 'CARBIS' (Fig 11). The tile was adjacent to a large iron pipe protruding from the baulk which lay at a downward angle into the water and went under the floor tile. Immediately to the north east were several larger similar pieces of tile; all were angled upwards and thus disturbed even though they were at the same level as the first. This suggests that they too had once been level and part of the same surface until rubble had been dumped onto the floor.

Figure 11: Floor tile CARBIS (111) in situ.

(111)	Trench 4 floor tile, <i>in situ</i> floor tile, pinkish red in colour, CARBIS imprinted in the surface.
(112)	Trench 1 an orangey red compacted gritty sand, very hard found between walls 4 and 5. 0.1m deep. Subjected to heat, no indication of direct burning.

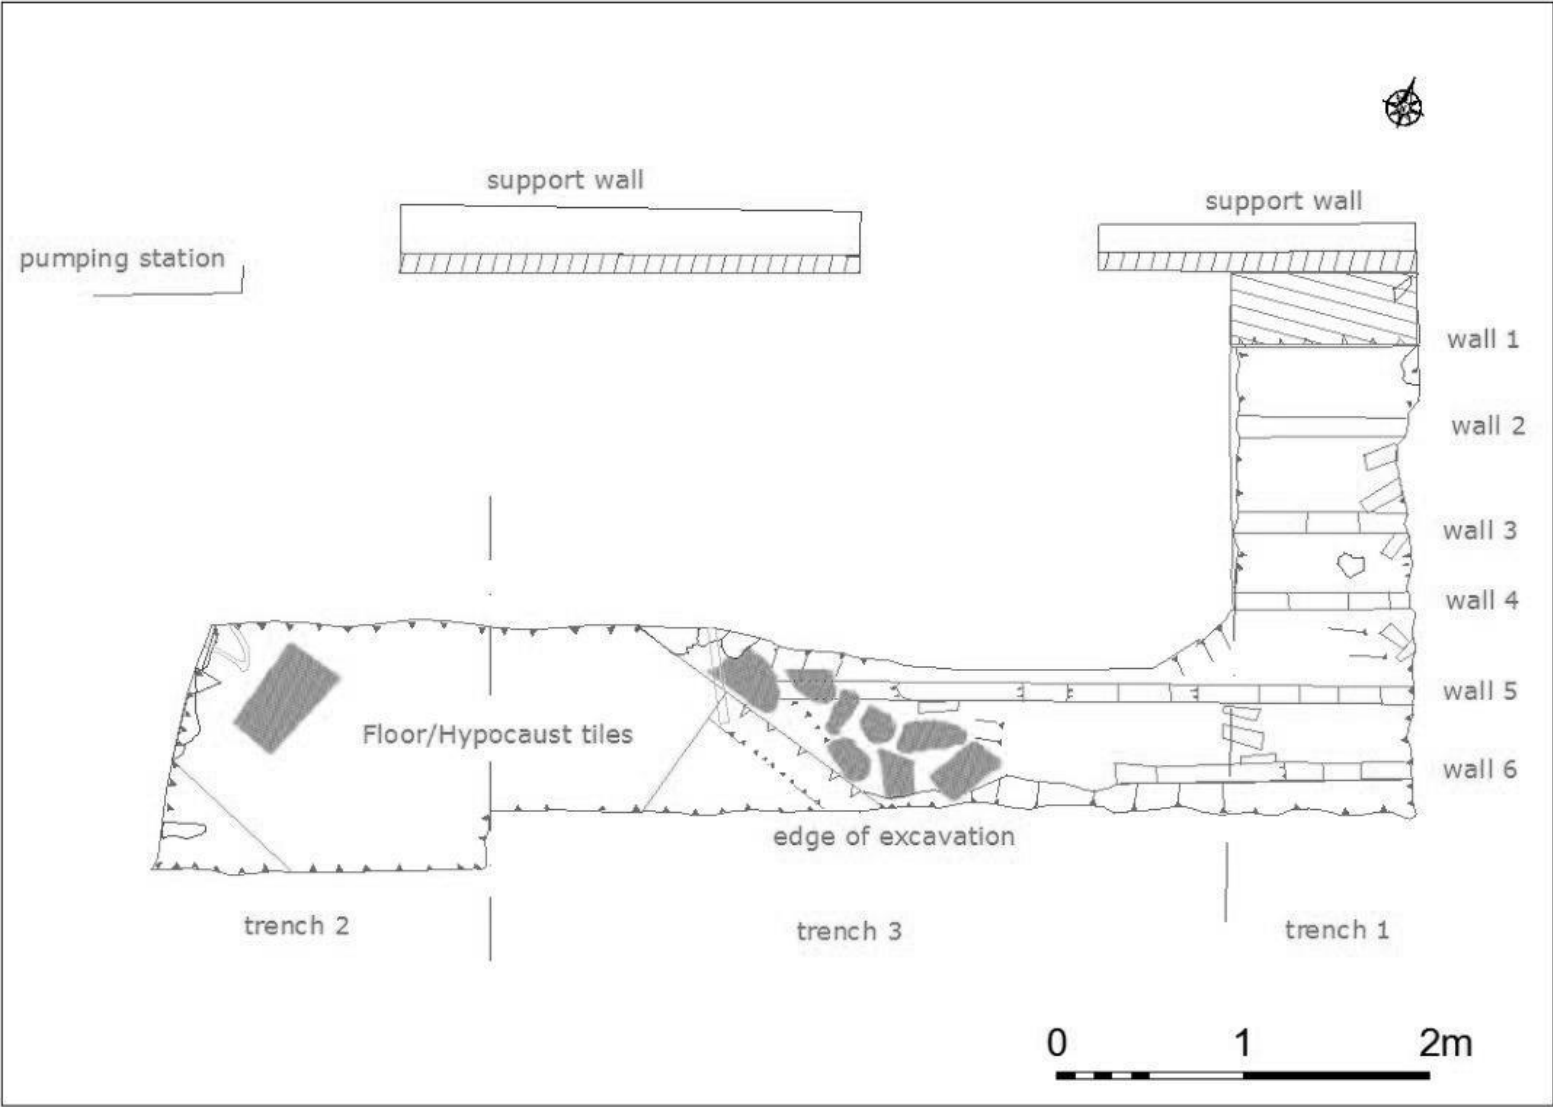
Situated at the north western end inside the building, Trench 1 (originally 3m x 1m) was aligned east-west. It was positioned here in order to investigate the condition of the original floor and underlying hypocaust system. The condition of this had been described by J R Smith as being poor in his assessment (Smith 1999).

Trench 3 (2m x 1m) was excavated to combine trenches 1 and 2 in order to find out more about the tiled floor and to work out how it related to the brick walls which formed the Mica Dry hypocaust.

It was decided to orientate the trench along two of the hypocaust walls. Wall 6, as described above, comprised mainly red bricks and continued along the line of Trench 3 from Trench 1 for approximately 1.2m before stopping. The base of the wall was not found because of its poor condition; much of the brickwork was in a state of decay and fell apart when touched, turning into sandy dust as recorded at wall 2 (see above).

Wall 5 was initially constructed of white bricks, though subsequently changed to red bricks; this feature continued along the trench line until it reached an area topped with what appeared to be large granite stones (107). These appeared to follow the line of the tile-floor (106). Several of these were removed in an attempt to determine their purpose. There was no bonding agent and they appeared to have been placed in a soil (109) and rubble mix. Wall 5 continued under the line of stones but its full length could not be determined. The granite stones on top of the wall were too large and heavy and projected from the trench section. The soil and rubble mix (109) material (soft to trowel) was also not bottomed.

Figure 12: Plan of trenches 1, 2 and 3.
