Bradley Manor
Historic building record and landscape assessment

Report No: 2017R017

Historic building record and landscape assessment

Client	National Trust
Report Number	2017R017
Date	February 2017
Status	Final
Report author(s)	Jo Sturgess and Graeme Kirkham
Checked by	Jo Sturgess
Approved by	Andy Jones

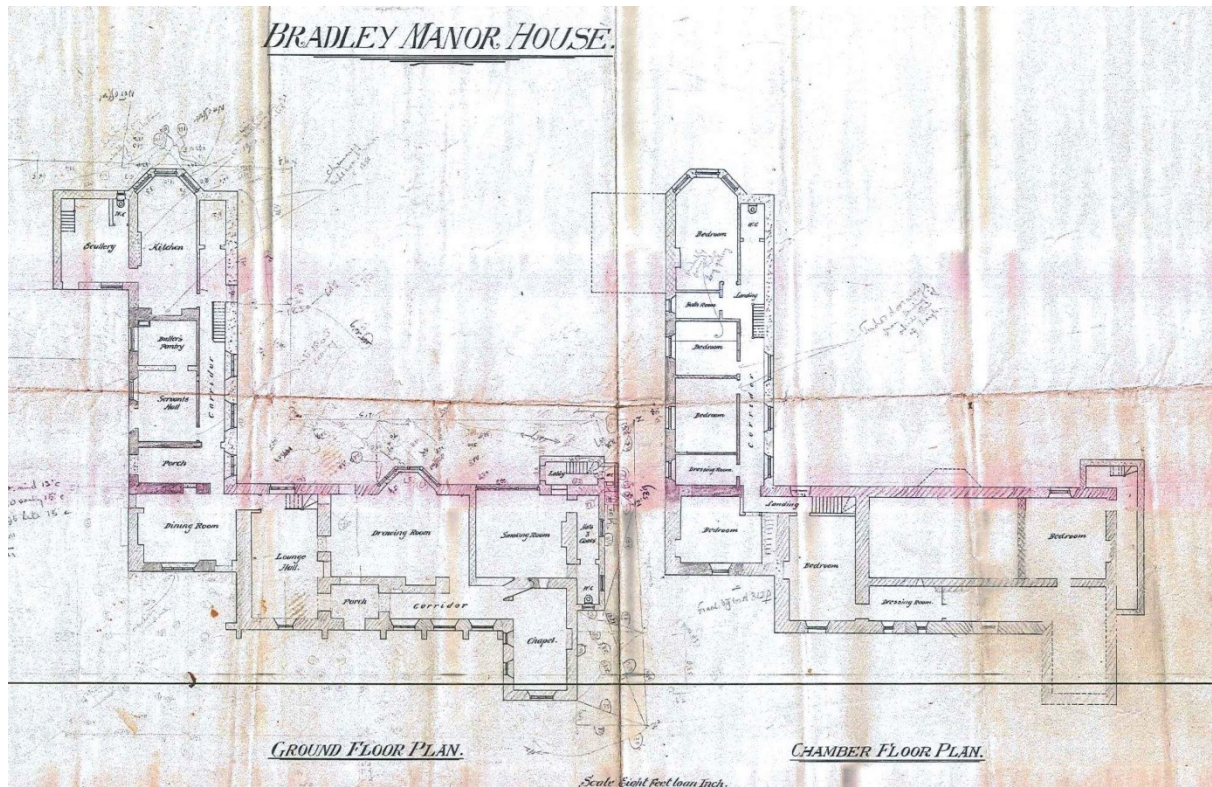
Fig 23 Early 20th century plan of Bradley Manor. (Bradley archive.)

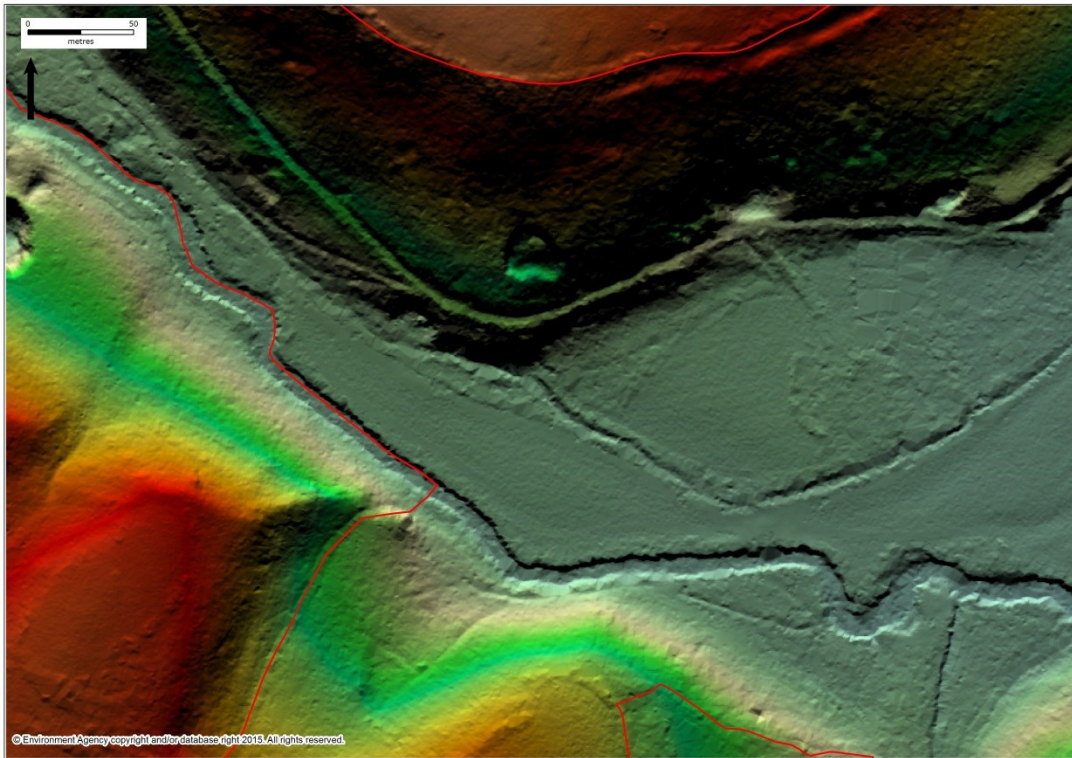
Fig 43 A Lidar image of the area around the house at Bradley, including possible cultivation ridges on The Lawn to the west, the hillfort ramparts to the north, two terraced tracks between the carriage drive and leat in woodland to the west and various quarrying sites. (Environment Agency.)

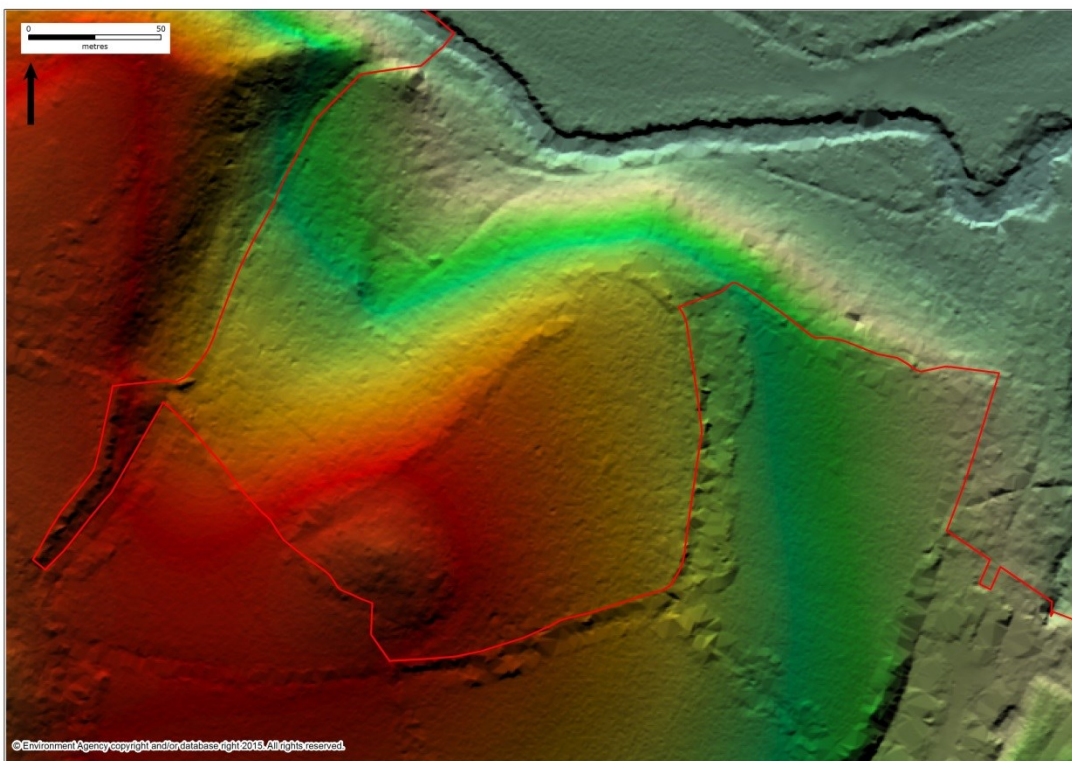
Fig 44 Lidar image of the woodland area to the south of the River Lemon, including (lower left) the possible barrow on a local summit surrounded by a plantation boundary. The apparent enclosure to the north is illusory, partly formed by a boundary bank and partly by a public footpath. (Environment Agency.)

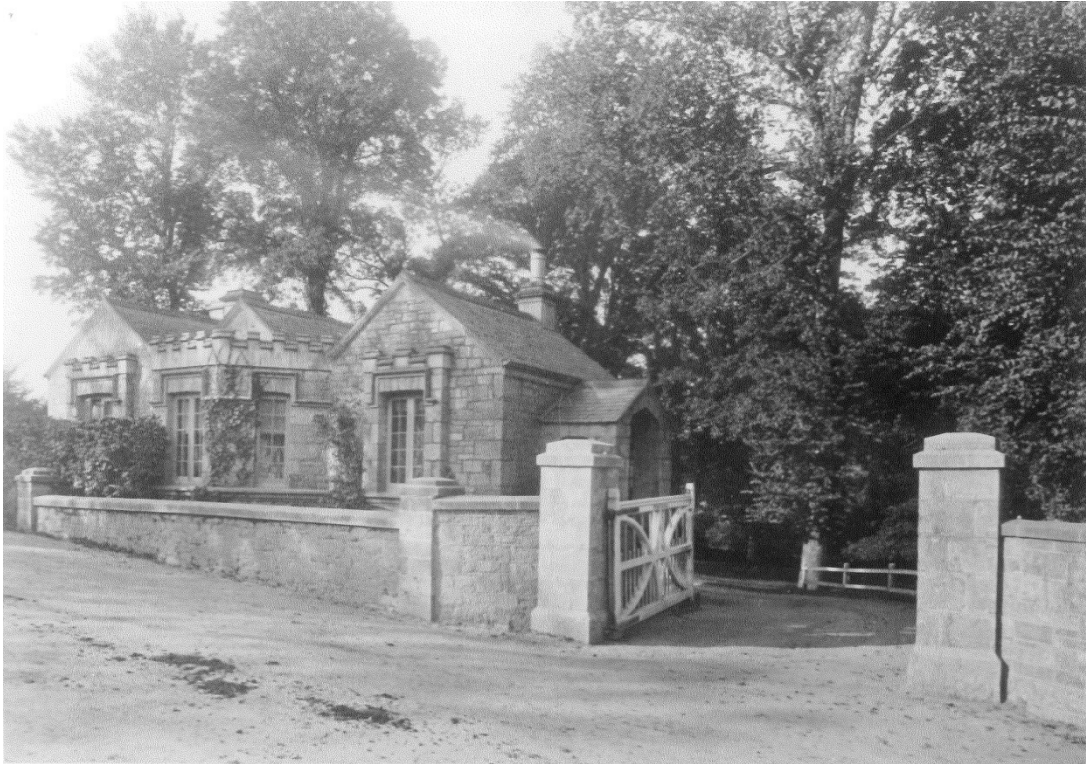
Fig 51 The Totnes Road lodge, probably built by the Reverend Wall in the mid 19th century. This early 20th century photograph (Bradley archive) shows a significantly different layout from that which exists at present. Much of the wall fronting the lodge has been lost to a rise in the level of the main road and the gate piers and gate have been moved and are now set back behind the porch and main door to the lodge.

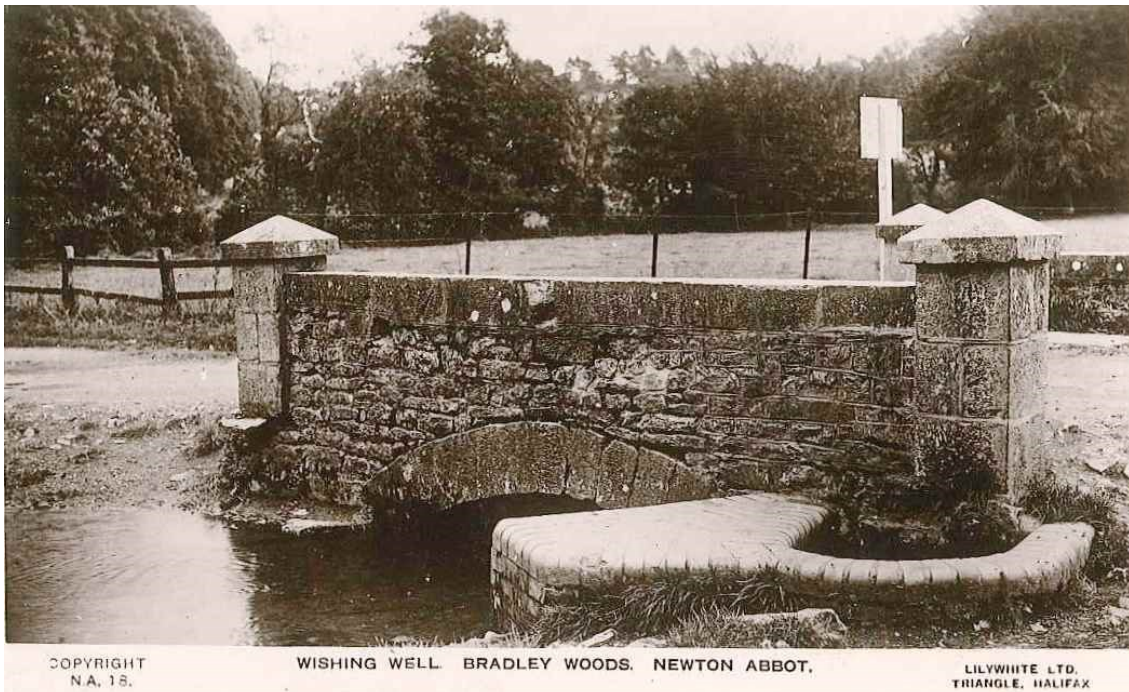
Fig 52 The leat bridge and 'wishing well' on a postcard probably dating to the 1920-30s. The well appears to have been neatly reconstructed in brick. (Bradley archive.)

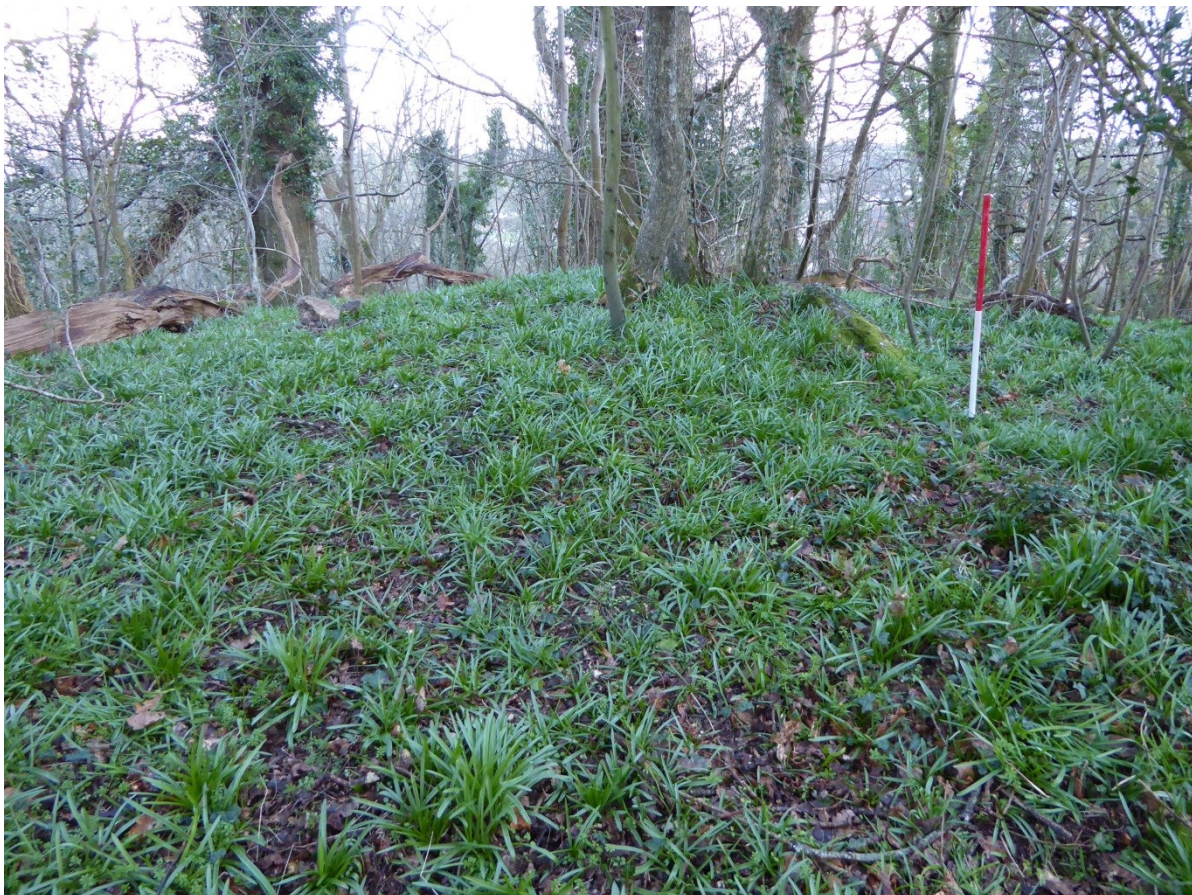
Fig 60 The possible barrow or cairn (NT 160045) on a local summit on the south side of the River Lemon valley.

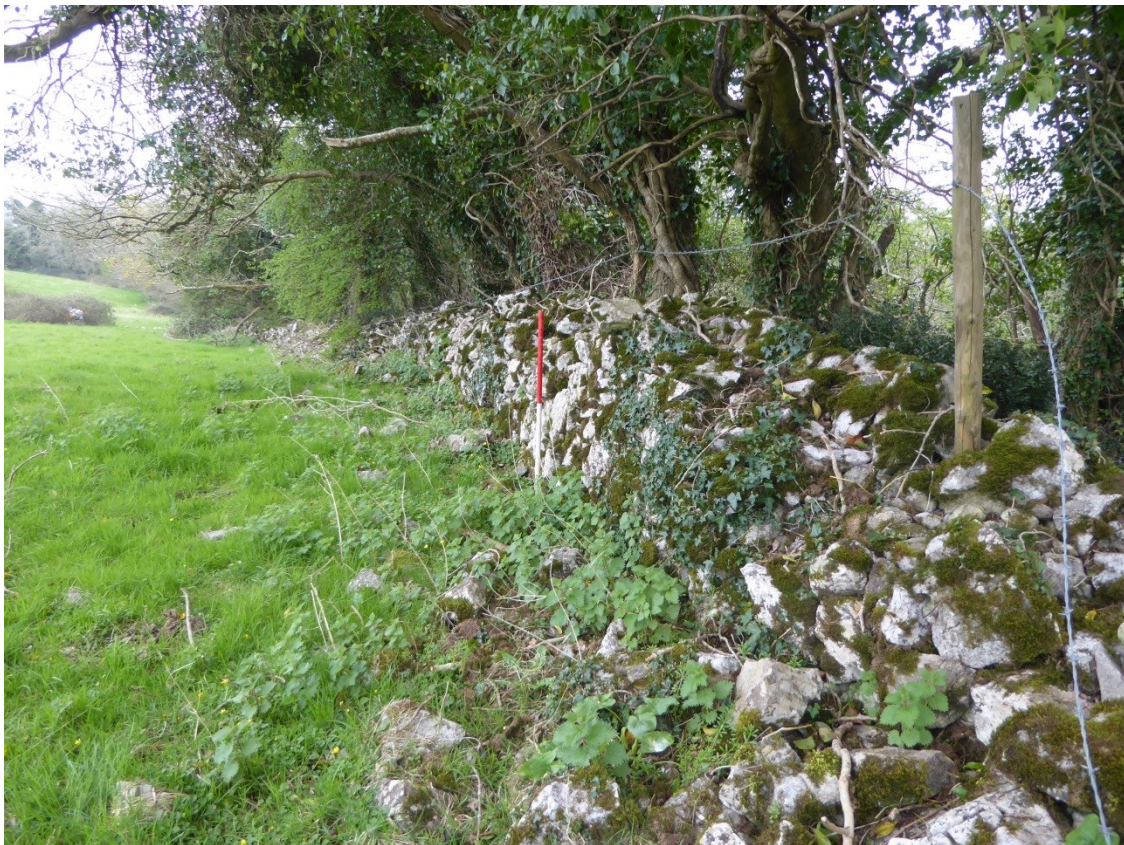
Fig 62 The warren boundary (NT 160109) which follows the inner face of the stony enclosing rampart of the hillfort on Berry Down.

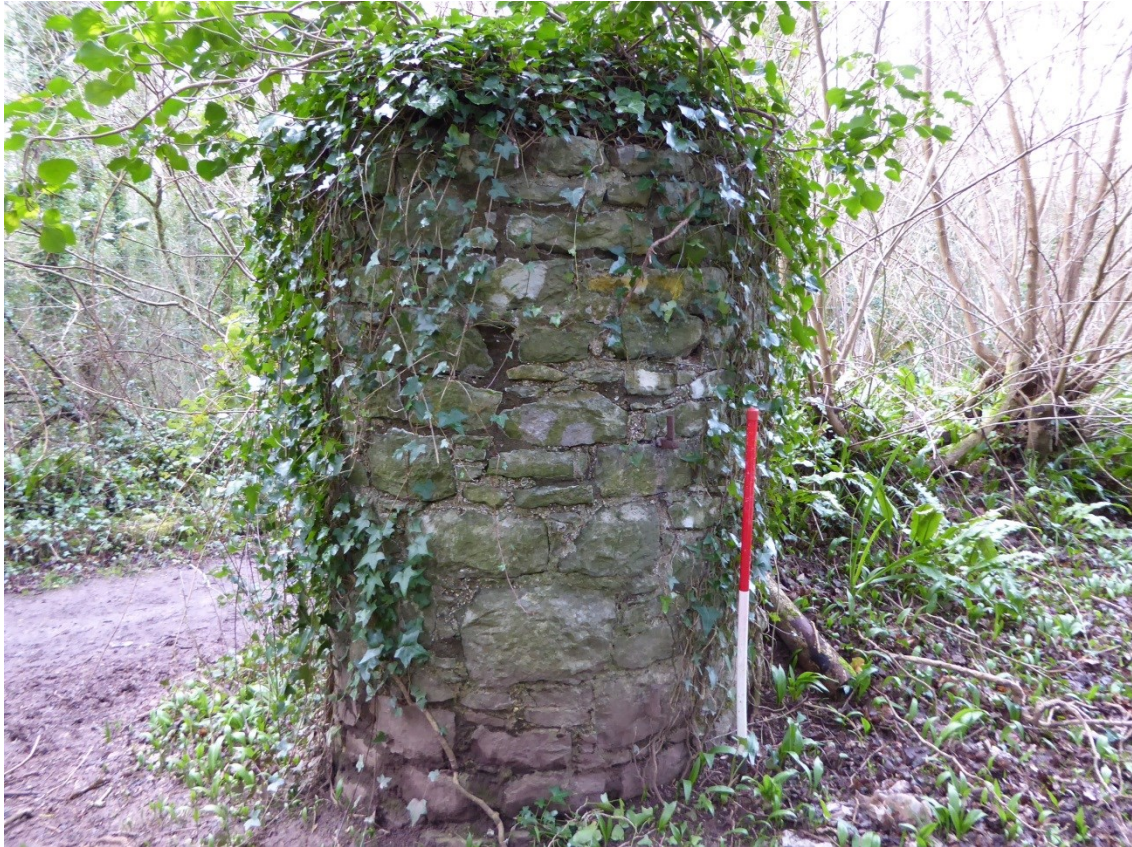
Fig 63 One of the two surviving gate piers (NT 1600095) to Culver Orchard.

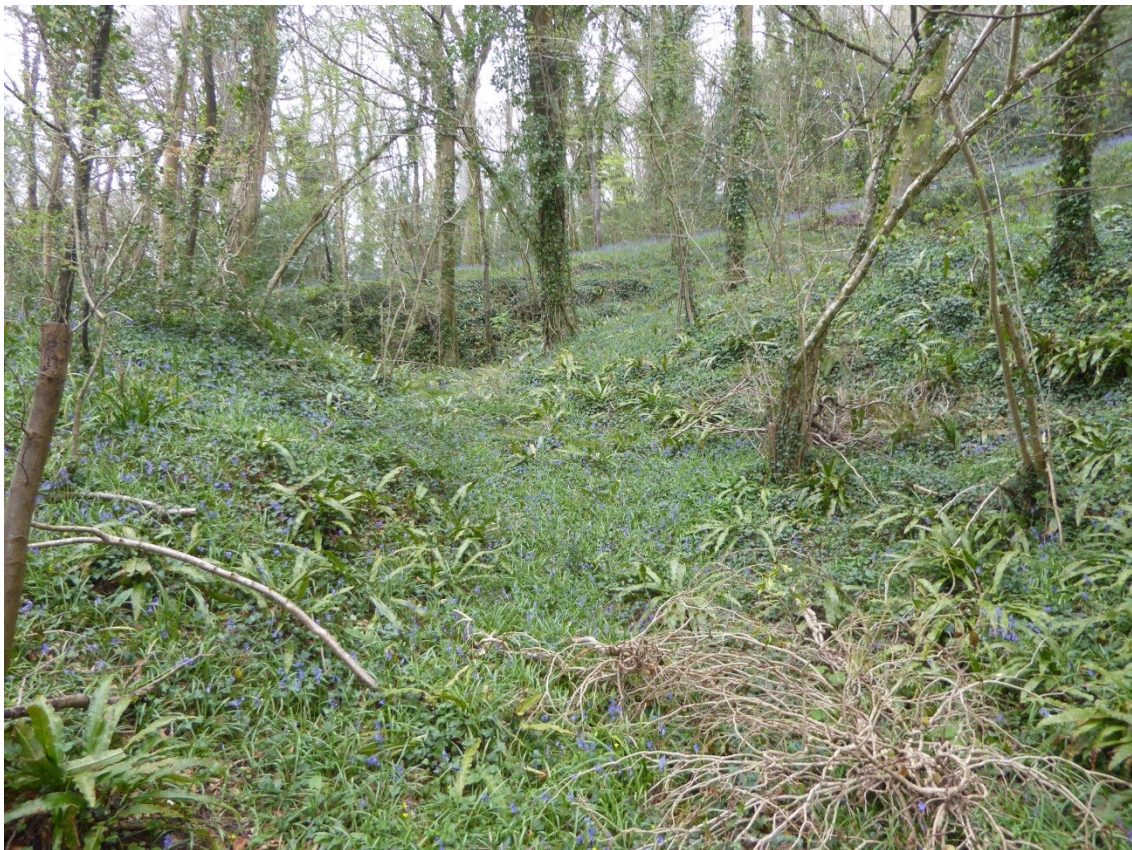
Fig 64 An area of former quarrying activity in Berry's Wood (NT 160135).

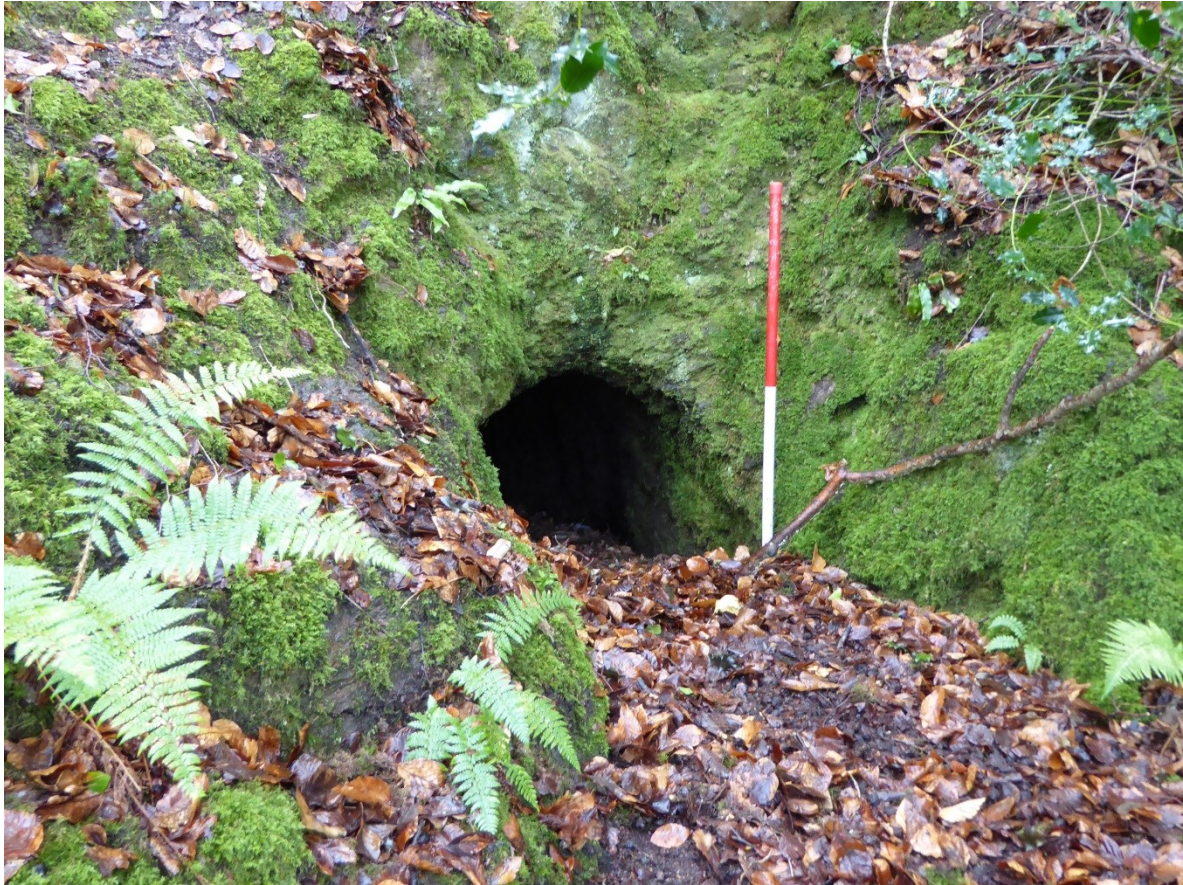
Fig 65 The historic mine working in Powsey Moor (NT 100028).

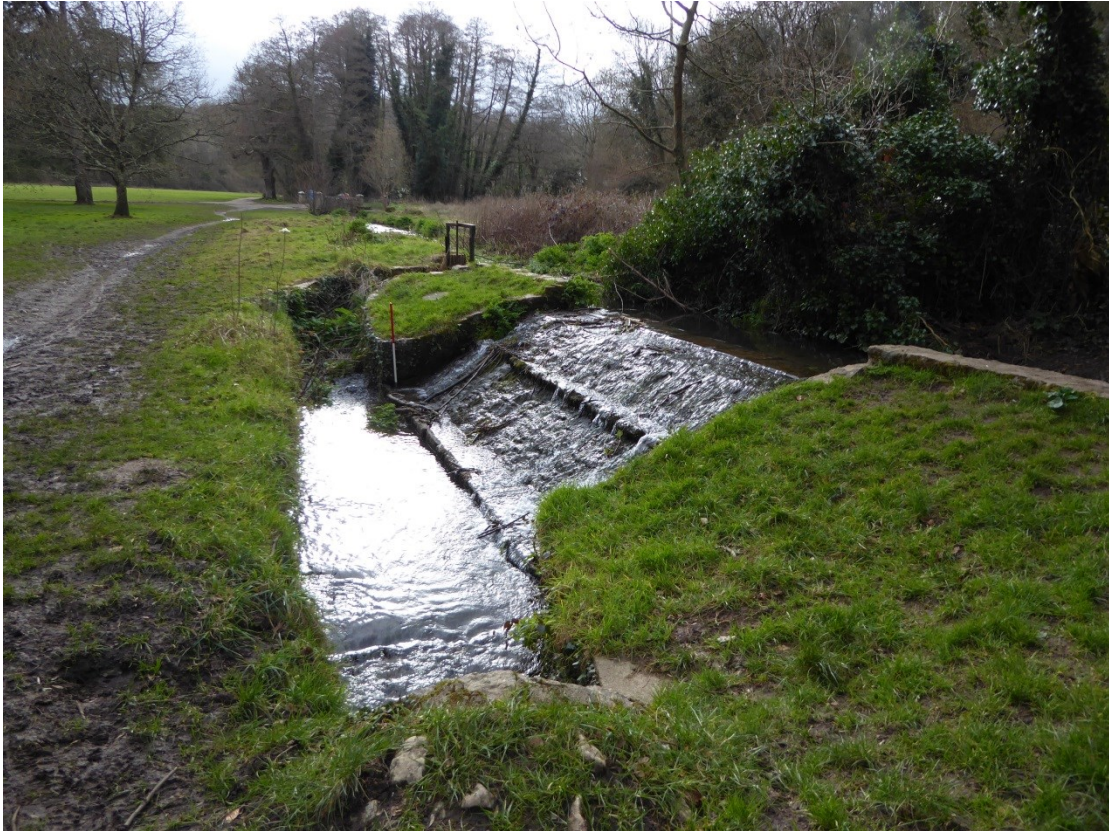
Fig 67 The cascade, spillway and sluice (NT 160070) on the leat below Bradley, looking west towards the leat bridge. This view can be compared with numerous images from a similar viewpoint which were produced in the late 19th and early 20th centuries.

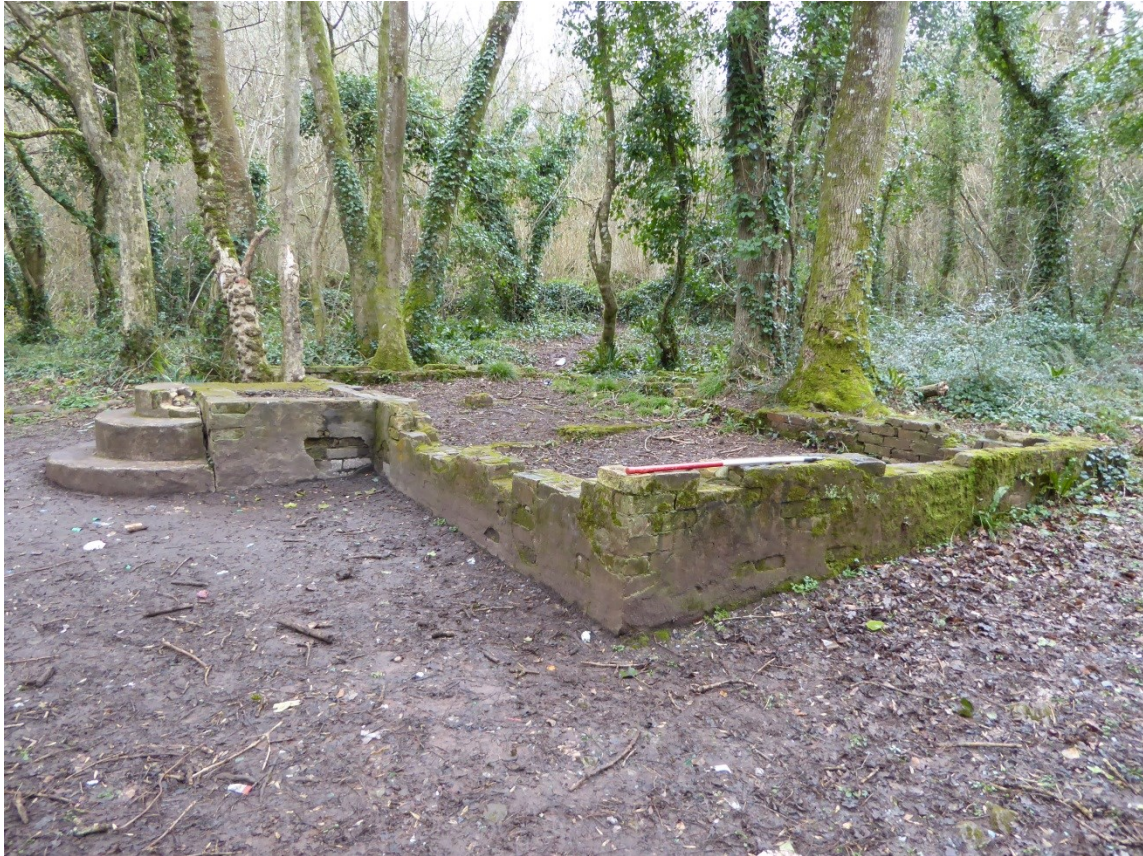
Fig 71 The brick base of the 1930s unemployed men's clubhouse (NT 160093) in Stray Park Orchard.
