Penzance Park and Ride, Cornwall
Archaeological Watching Brief

Report No: 2017R019

Archaeological watching brief

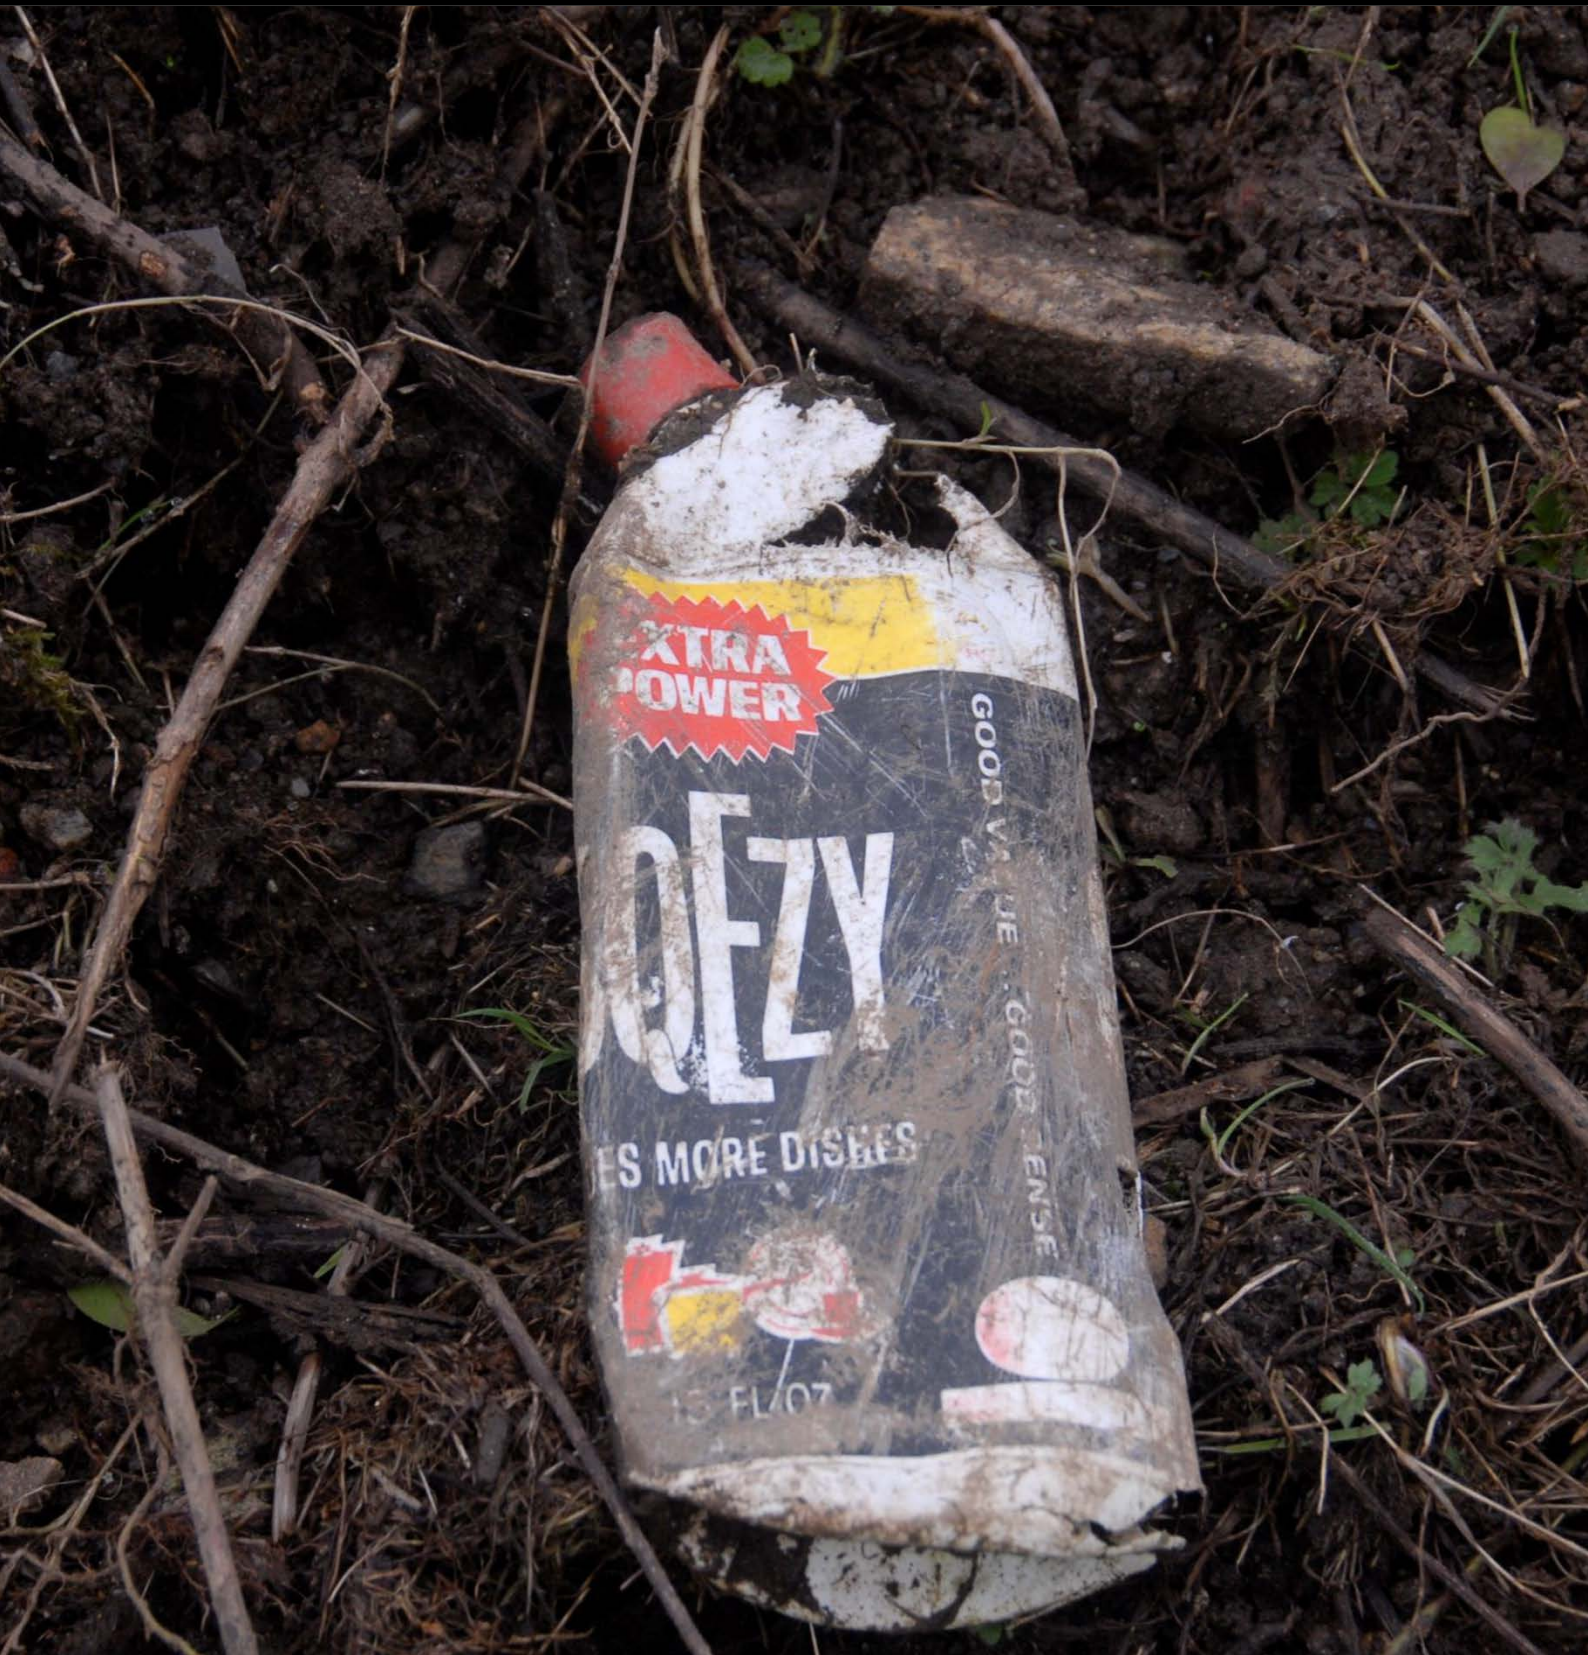
Cover illustration

A sample of the material within the landfill, indicating deposition of material in this area during the mid-1960s.

The landfill material exposed in the trench was wholly modern in date (see cover illustration), the inclusion of plastic bottles and similar material suggesting that it was dumped here during the 1960s, probably not long before the former heliport was established at this location in 1964. The landfill site is recorded as having been closed at the end of December 1969 (Environment Agency website), having accepted a mixture of material including inert, industrial, commercial, household and special waste. The Environment Agency mapping of disused landfill sites show an area extending from the Tesco fuel station at the western end of Eastern Green side to the roundabout at the intersection of the eastern end of Jelbert Way and the A30, bounded to its south by the line of the modern A30 and to the north by Jelbert Way. The date when waste was first deposited here is not recorded, though rubbish is likely to have been disposed here on a progressive basis, probably over several decades. As well as allowing for the disposal of all types of locally produced rubbish it also facilitated the reclamation of an area of low-lying boggy land for redevelopment for 20th century housing, light industry and retail developments. Although extensive, the landfill site seems to have been a shallow one along its northern edge, though deeper towards the south, reflecting the topography of the former land surface on which it was deposited.

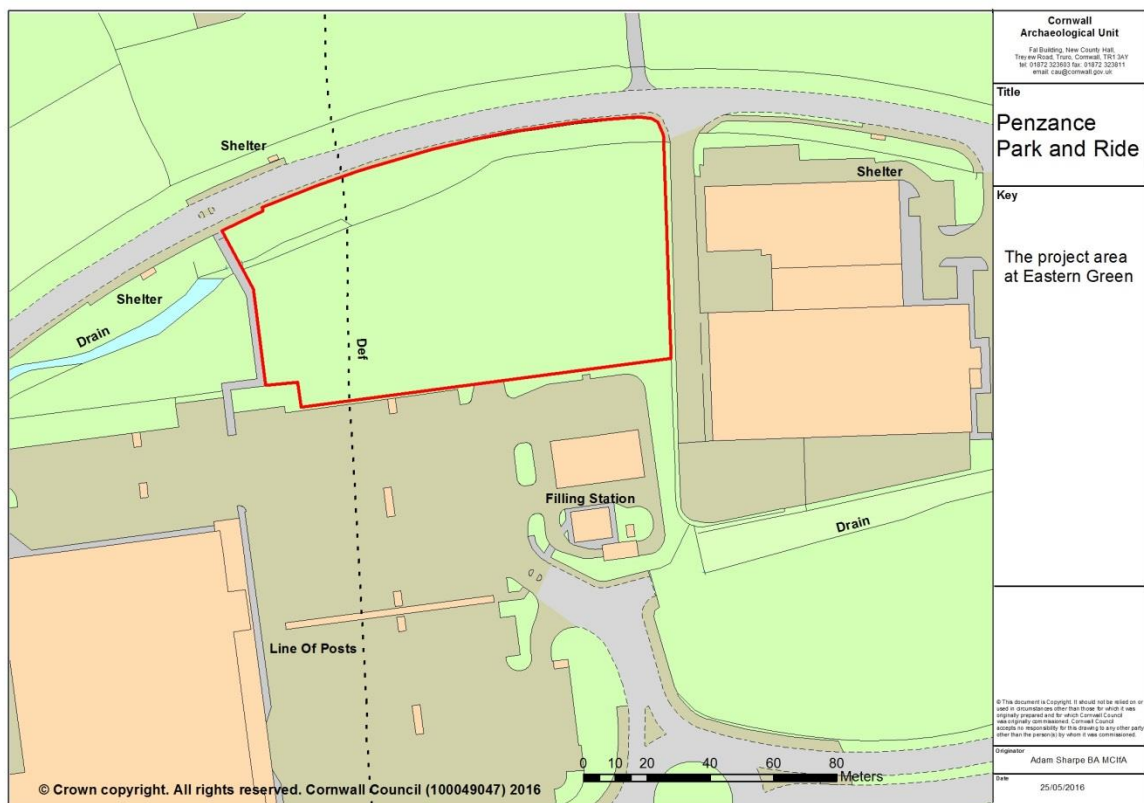
Fig 2. The extent of the area to be re-developed as the Penzance Park and Ride facility.

The project area has a rectangular outline, reflecting the shape of the former field in which it was developed, extends to approximately 0.8 Hectares and is centred at SW 48703 31401. The site is in the ecclesiastical parish of Gulval; its western section is in the civil parish of Penzance, whilst its eastern section falls within in the civil parish of Ludgvan. Prior to works the site was almost completely level and at an average elevation of 4.8m OD. The area proposed for the development for the Park and Ride facility (Figs 3 and 4) is bounded to the west and south by fencelines defining Sainsbury's carpark, to the east by a fenceline and service roadway to the rear of Halfords and the former B&Q store and to the north by an open service drain and Jelbert Way. The principal vehicle entrance to the Park and Ride was to be created at

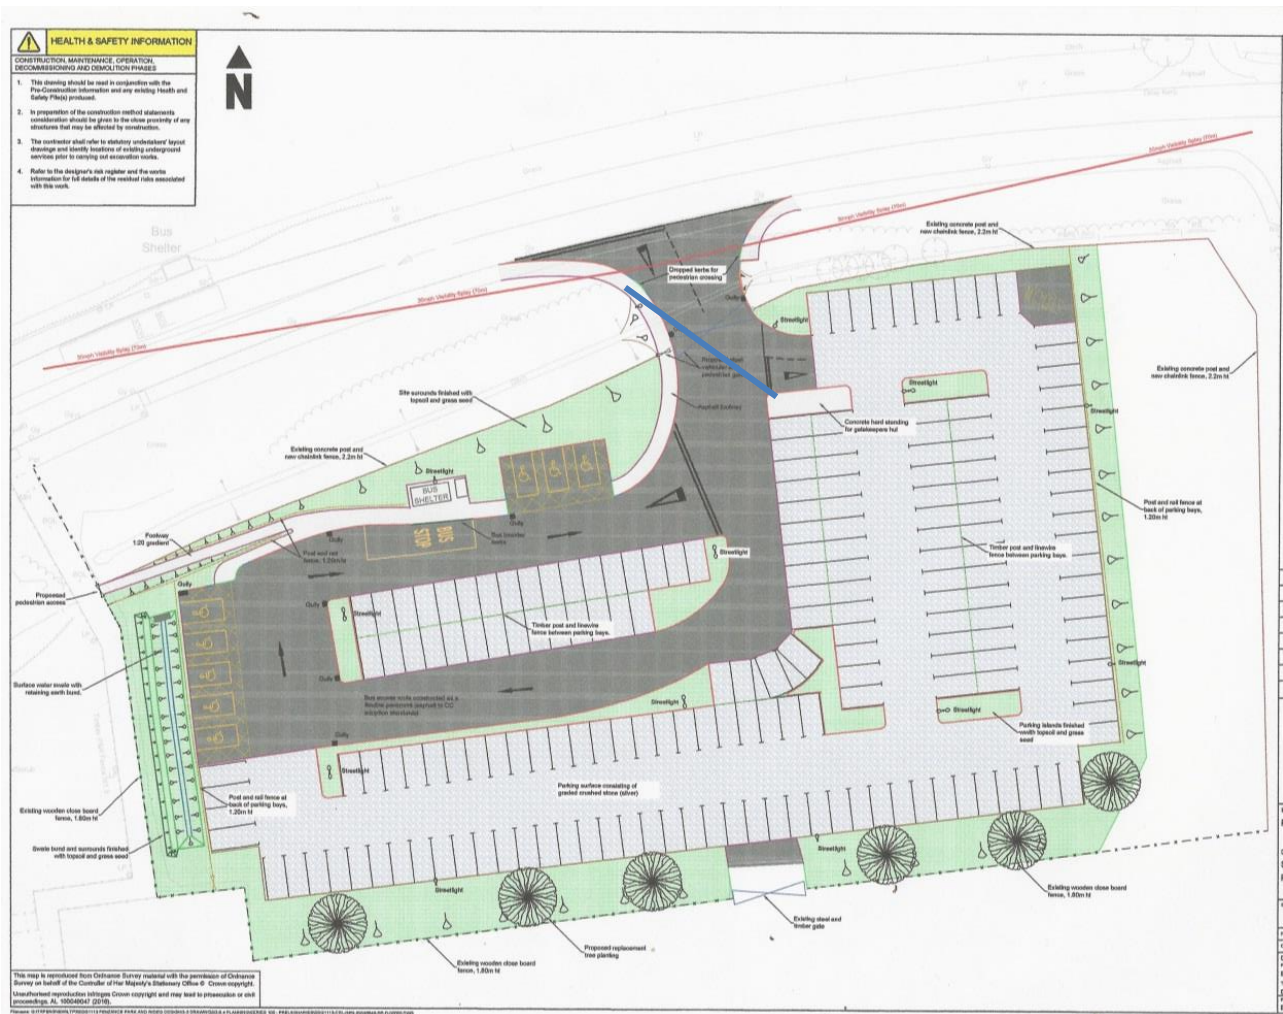
Fig 3. The proposed layout for the Penzance Park and Ride facility. The blue line indicates the approximate line of the new sewer trench.

The second area of excavation took the form of a narrow (600mm wide) trench excavated from the location of a proposed toilet facility at the location of the park and ride custodian's hut north-west to and across the drainage ditch to a new manhole chamber adjacent to the southern verge of Jelbert Way. The main section of the trench within the P&R site measured 22m in length and that on the northern side of the ditch was 5m in length. The excavation of an east-heading spur 4m long from the manhole at the south-eastern end of the trench to the site of the intended toilet was not observed. The main trench was 1.3m deep at its intersection with the south side of the ditch and just under 1.0m deep at its southern end. Beyond the ditch, a 4m extension of the trench led to the site of a further manhole chamber.

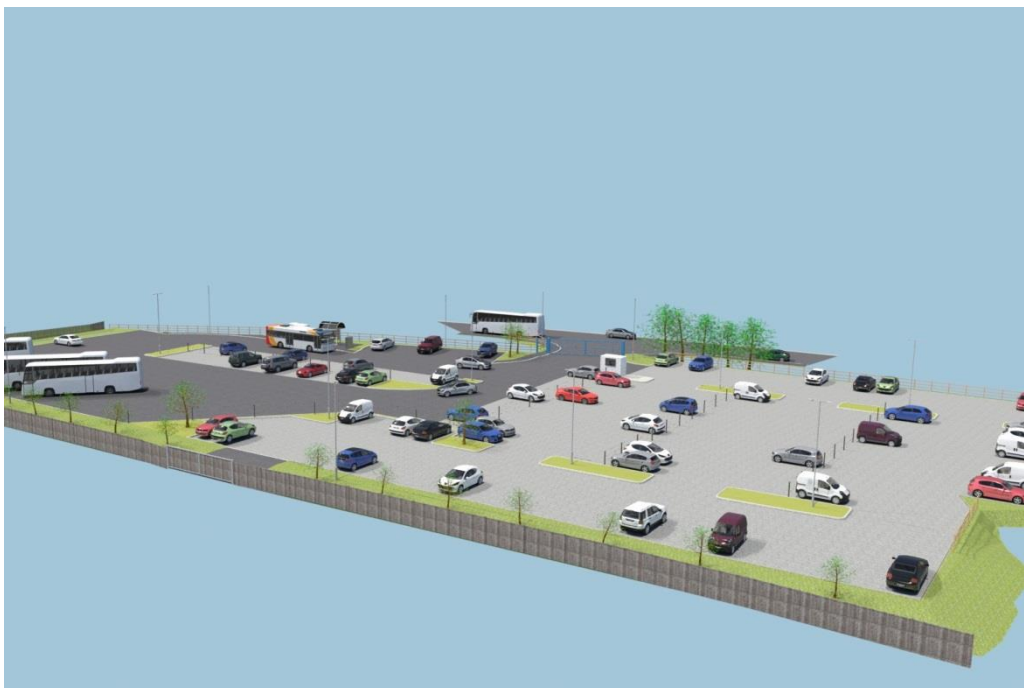
Fig 4. A CORMAC image showing the proposed park and ride facility, as viewed from the south-south-east.

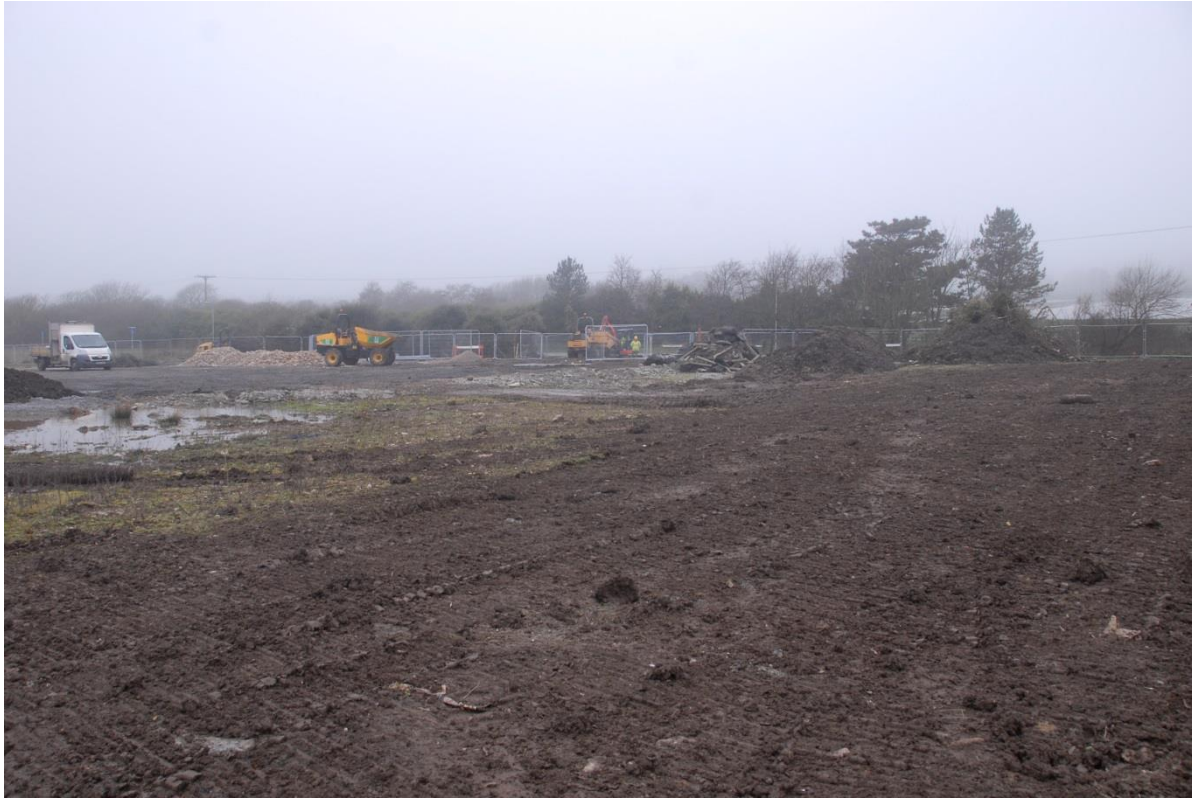
Fig 5. A general view looking north across the site during the early stages of the works. The area to the right had been skimmed of topsoil, whilst the new site entrance is in the background at the centre of the image.

The stripping of a layer of topsoil and vegetation from the eastern part of the area which will site the park and ride began on 8th March, and was undertaken by Morcom Construction. This material was stripped to between 100mm and 200mm depth only (Fig 5). These operations did not remove any more than the surface of the mixed topsoil and landfill material which formed the ground surface in this part of the site and no features of archaeological interest were revealed. This surface was compacted prior to the site being built up with a deep layer of 7000 cubic metres of clean stone sourced from Castle an Dinas Quarry, Ludgvan, topped with granular surfacing materials to create the park and ride facility.

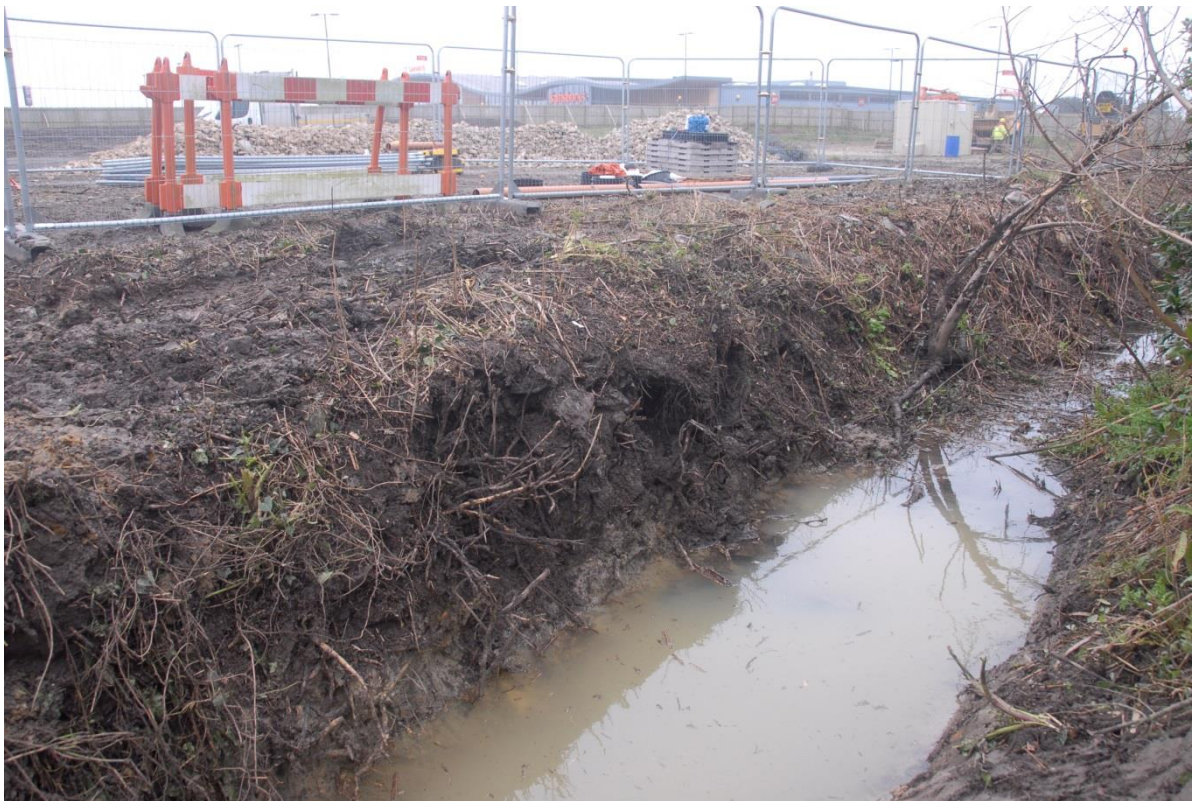
The surface deposits of topsoil and tree roots mixed with some modern rubbish were found to overlie a 0.75m depth of a dense pale blue-grey, yellow-mottled clay with some small granitic inclusions (Fig 6). This clay base was not bottomed during the ditch cleaning work. The section of the ditch at the location of the new site entrance off Jelbert Way was infilled with clean stone so that it could continue to carry water flows when the site entrance was constructed over it.

Fig 6. The drainage ditch along the northern side of the site, showing the mixed topsoil at surface overlying the upper parts of the clay into which the ditch had been excavated.
