# Enys Farm Buildings, Penryn, Cornwall Watching Brief

Cornwall Archaeological Unit

Report No: 2017R022

## Watching Brief

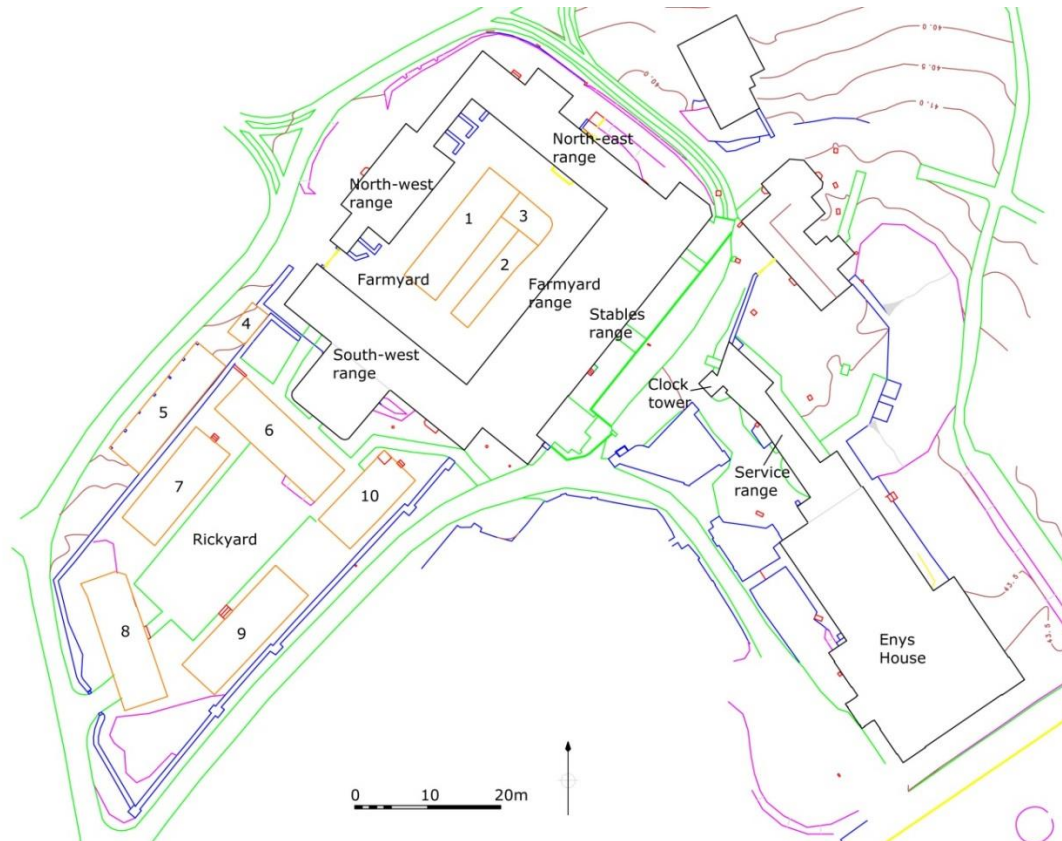
Figure 2 Detail of assessment area with main buildings and areas named.

*Based on fieldwork notes taken by Carl Thorpe. See Figure 2 for the locations of the building platforms.*

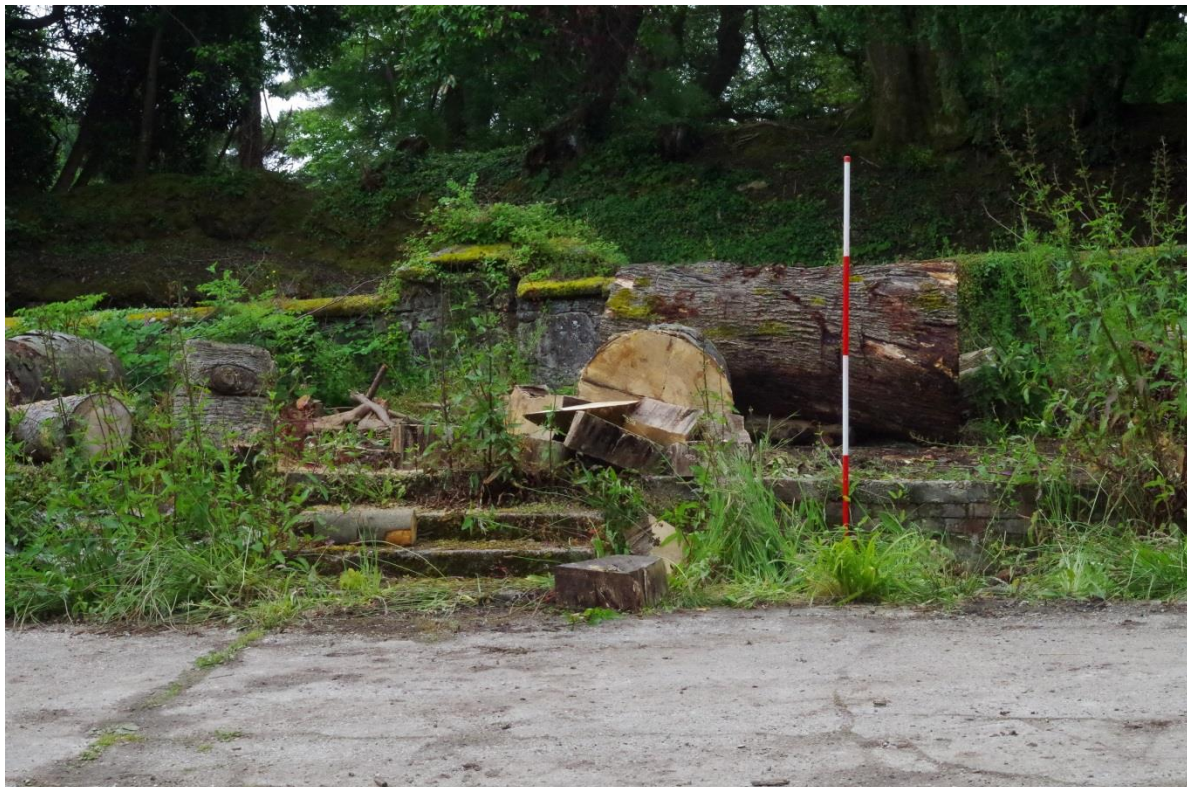
A set of three steps centrally placed on the north-western side of the platform marked the location of the entrance to the building (Fig 10).

Figure 10 Rickyard – Building platform 9 showing the steps on the north wall.

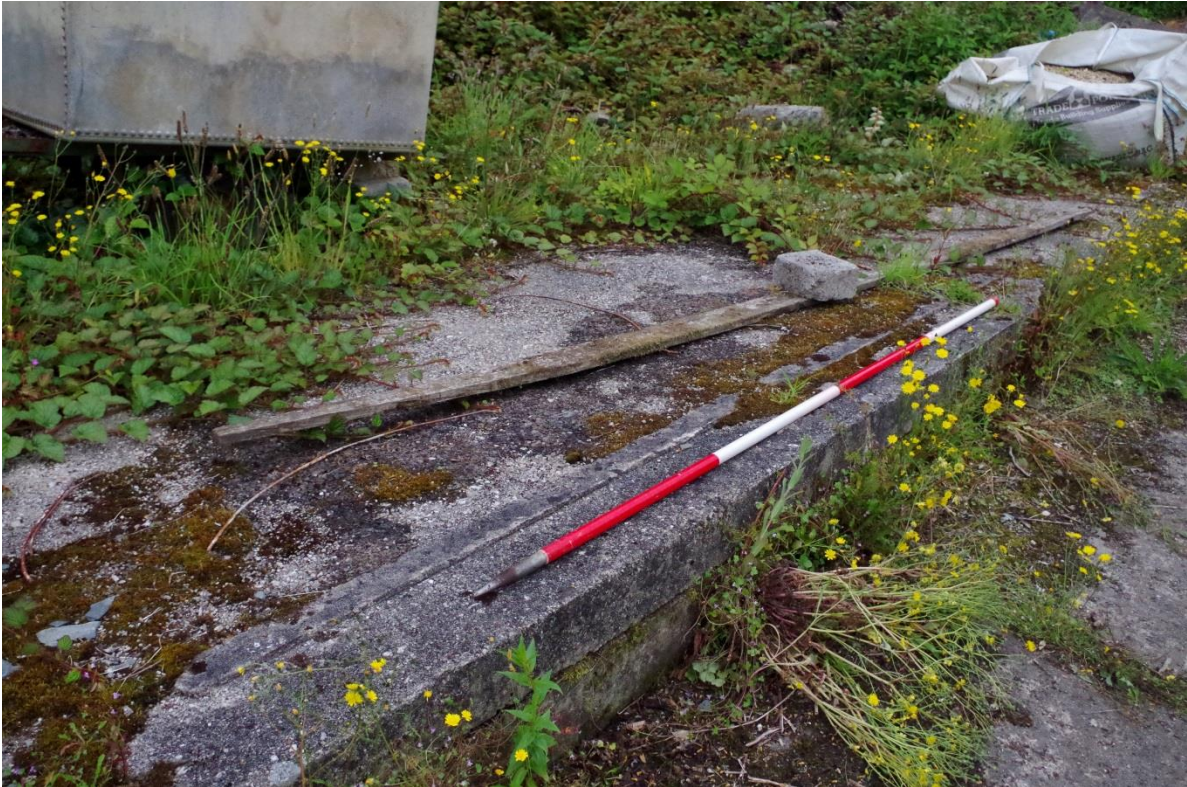
A level rectangular platform measuring 13m long and approximately 6m wide, edged by concrete blocks with cement render, and with a shuttered concrete floor. Due to the hillslope the eastern side of the platform varied between 0.02m and 0.6m high, increasing in height to the north. A 0.4m wide roughened edge to the southern edge of the platform marked the former location of a wall. Midway along the northern side of the platform was a raised flat-topped concrete ridge running parallel to and some 0.3m from the edge of the platform. This was 4m long, 0.04m wide, and 0.02m high with rounded ends. Though the function is uncertain, it is possible that this may have been a guide for sliding doors (Fig 11).

*Figure 11 Rickyard – Building platform 10, west side showing detail for the possible door.*

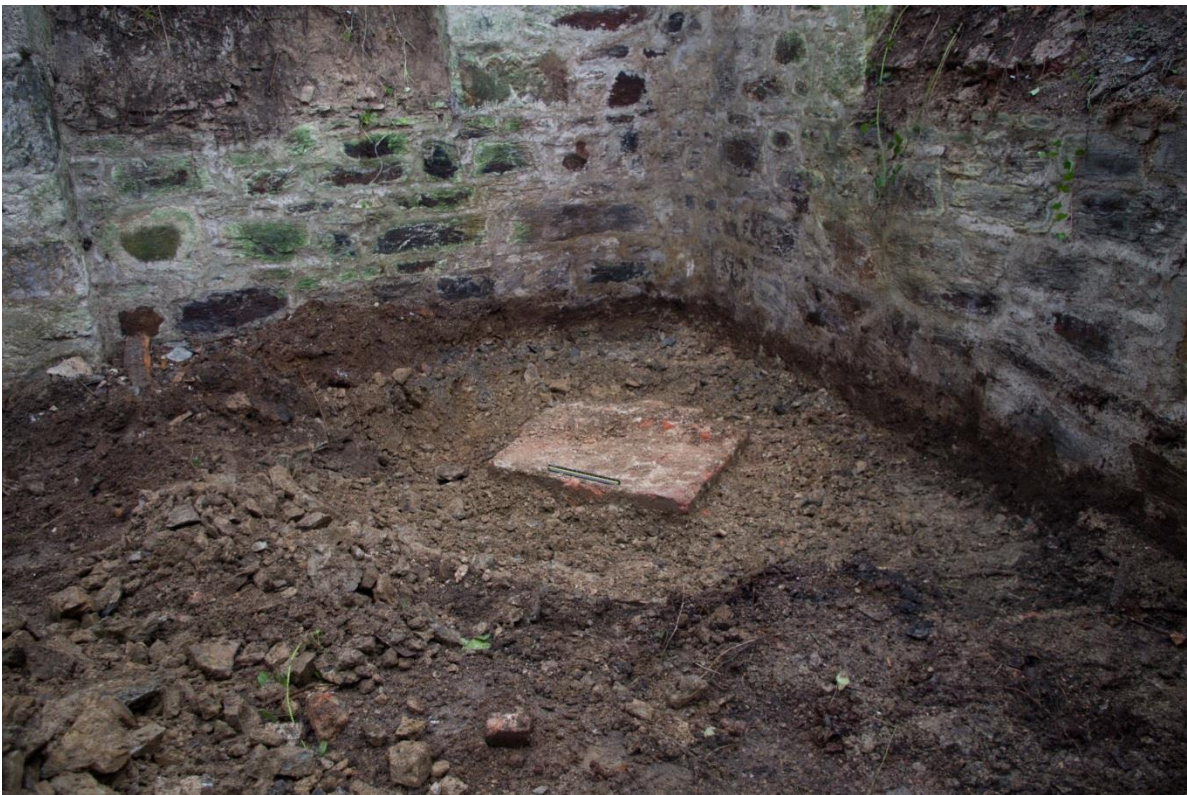
*Figure 12 Block D, Horse engine house (Room 32) – Looking north to the surviving footings of the brick-built pillar for the earlier horse-engine house.*

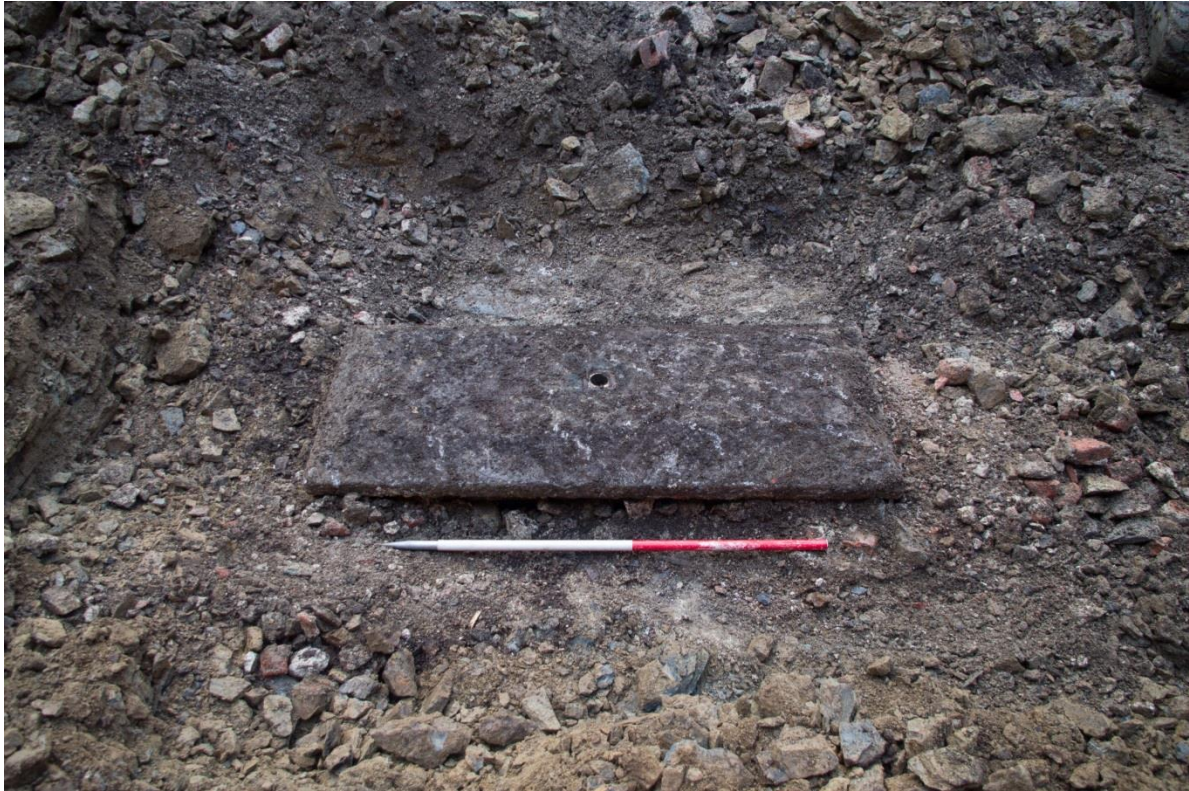
*Figure 13 Block D, Horse engine house (Room 32) – Looking north west to the centre of the room and the chamfered mellior stone in situ (with the central bearing visible).*

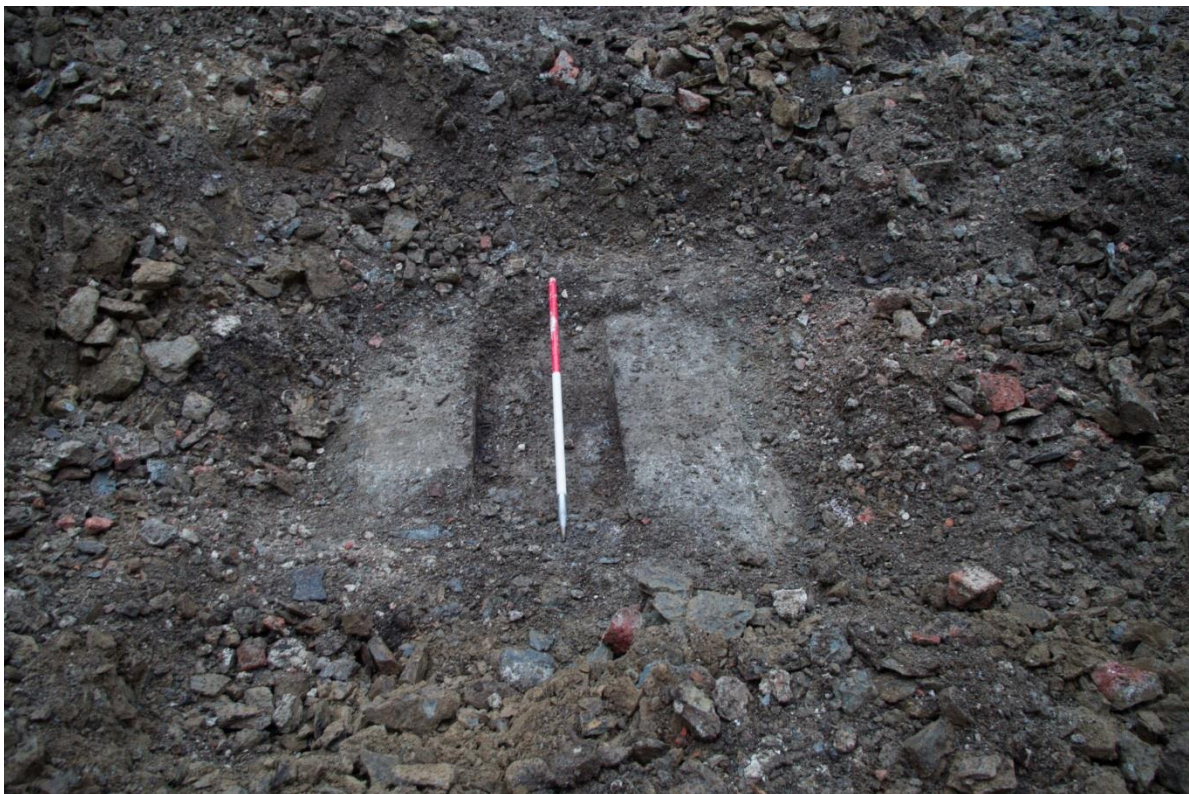
*Figure 14 Block D, Horse engine house (Room 32) – Looking north west to the footings beneath the removed mellior stone.*

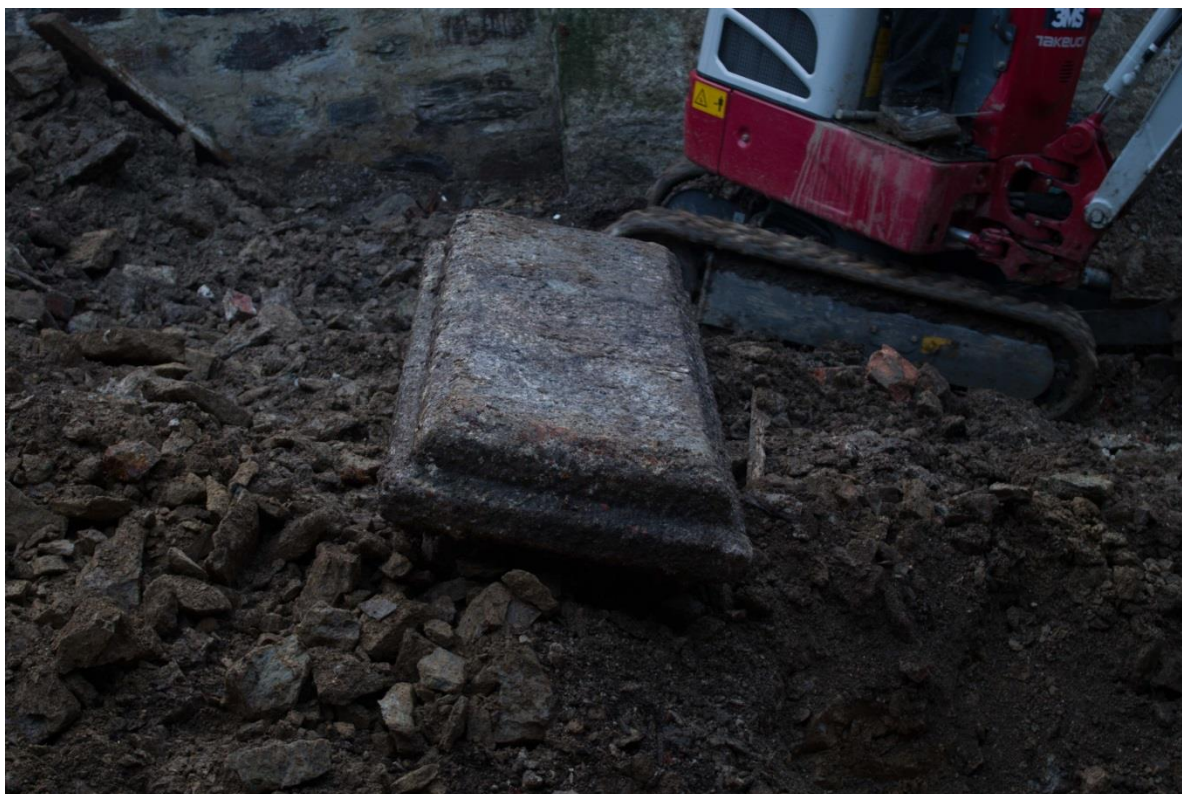
*Figure 15 Block D, Horse engine house (Room 32) – the underside of the mellior stone.*

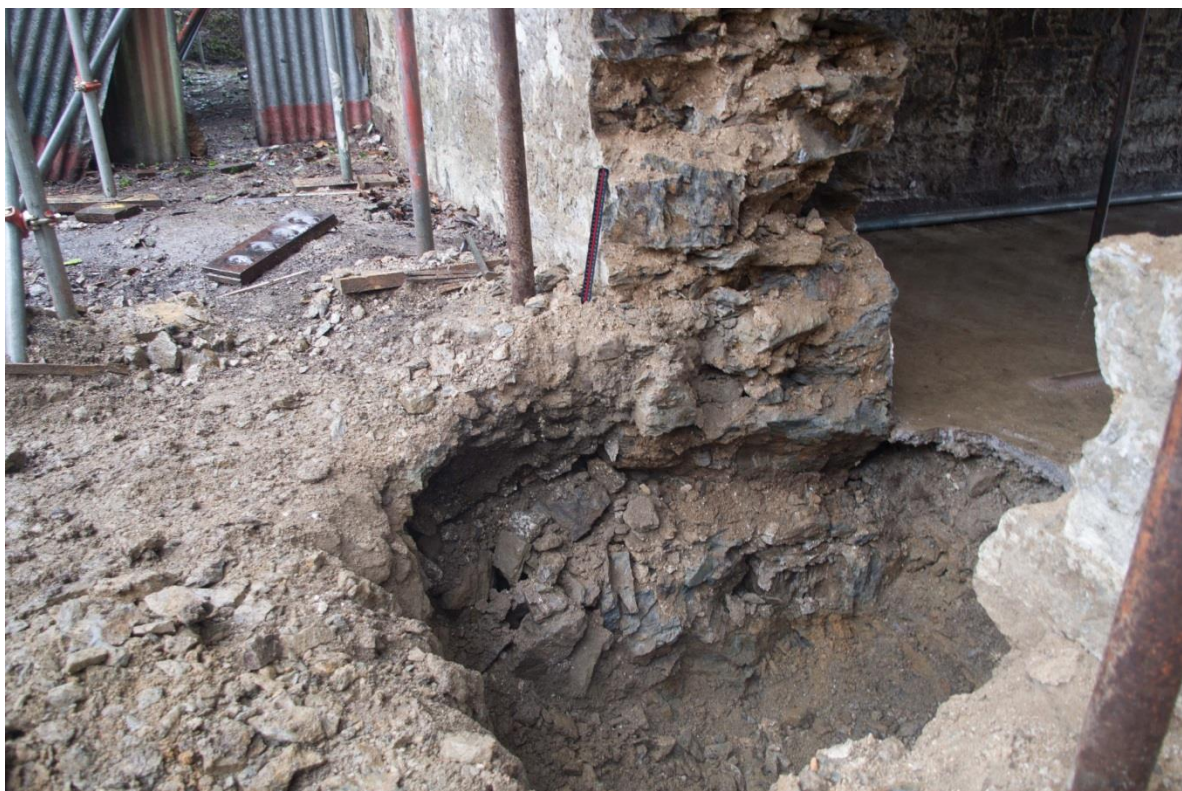
*Figure 16 Block D, Rooms 32 and 25 – test pit showing the depth of the rear wall of the main part of Block D.*
