Webber Hill, Falmouth, Cornwall - Archaeological watching Brief

Report No	Report Name	Report Author
2017R024	Webber Hill, Falmouth, Cornwall – Archaeological watching Brief	Peter Dudley
Event Type		
Watching Brief		
	L	
Client Organisat	tion Client Contact	
Cormac Solution	ns Ltd Will Buse	
Monuments (Mo	onUID)	
Fieldwork dates	(From) (To) (Created By)	(Create Date)
15/03/17	25/03/17 PD	30/03/2017
Location (posta	l address; or general location and parish)	
Webber Hill, Fal	mouth	
(Town – for urb (Postcod		
TR11 3PN		
(Easting) X co-d	ord (Northing) Y co-ord	
SW 80752	32924

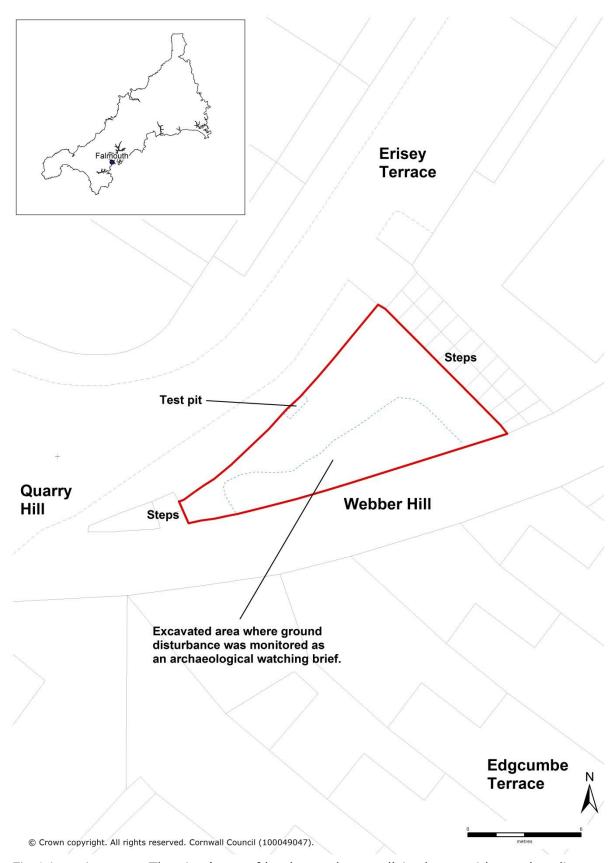
The archaeological watching brief covered a small test pit and an area of ground disturbance, the approximate extent of which is shown on Figure 1.

Fig 1 Location map. The site (area of landscaped ground) is shown with a red outline. The extent of the areas covered by the archaeological watching brief are shown with a blue dashed line.

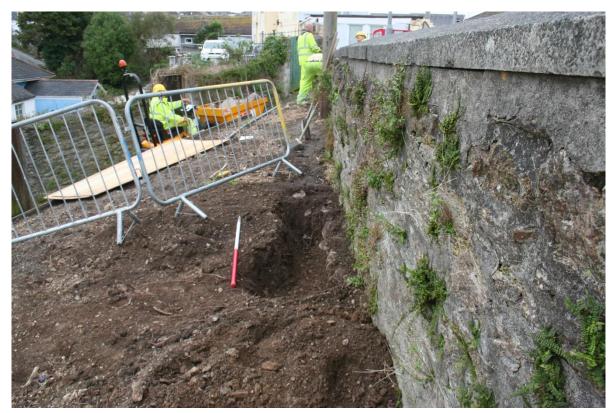
A 1.4m long, 0.4m wide and 0.4m deep test pit was dug at the top of the site to expose the footings of the revetment wall against Erisey Terrace (see Figs 1 and 2). This revealed a layer of topsoil 0.3m deep with shillet-rich subsoil beneath and the insubstantial footings of the wall. The footings were formed by a single layer of medium-sized slate fragments projecting 0.3m from the foot of the wall.

Fig 2 Looking to the test pit at the foot of the Erisey Terrace wall. Note the insubstantial footings to the wall projecting out into the test pit.

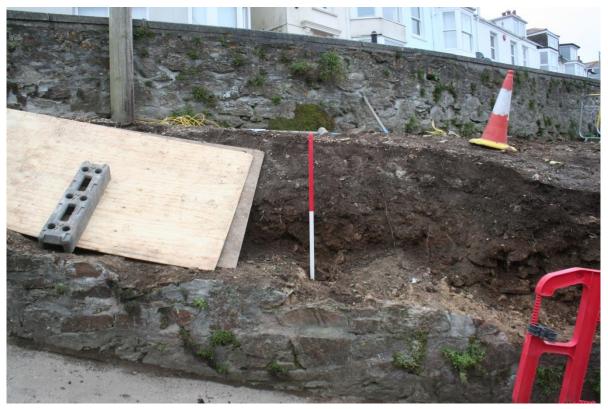
A small swing shovel with a grading bucket removed all topsoil from the lower, southern part of the site (Fig 1). This was dug down 0.2m at its upper level to provide a batter to the steep slope of the landscaped area. Lower down the excavation was between 0.6m to 0.8m deep. Here, a modern 0.6m deep layer of topsoil was revealed across the site. Beneath the topsoil was a mid orange brown layer with numerous small to large fragments of poor-grade slate or shillet (Fig 3). This was natural subsoil, most probably *in situ*.

Fig 3 Mid-excavation. The lower revetment wall has been lowered and the depth of the topsoil has been revealed.
