# **Bangor Cornish Quarry, Launceston, Cornwall**

## **Heritage assessment and impact assessment**

<b>Client</b>	<b>CORMAC Solutions</b>
<b>Report Number</b>	2017R021
<b>Date</b>	<b>April 2017</b>
<b>Status</b>	Final report
<b>Report authors</b>	<b>Catherine Parkes BA MCIfA and Adam Sharpe BA MCIfA</b>
<b>Checked by</b>	<b>Adam Sharpe BA MCIfA</b>
<b>Approved by</b>	<b>Andrew Young MCIfA</b>

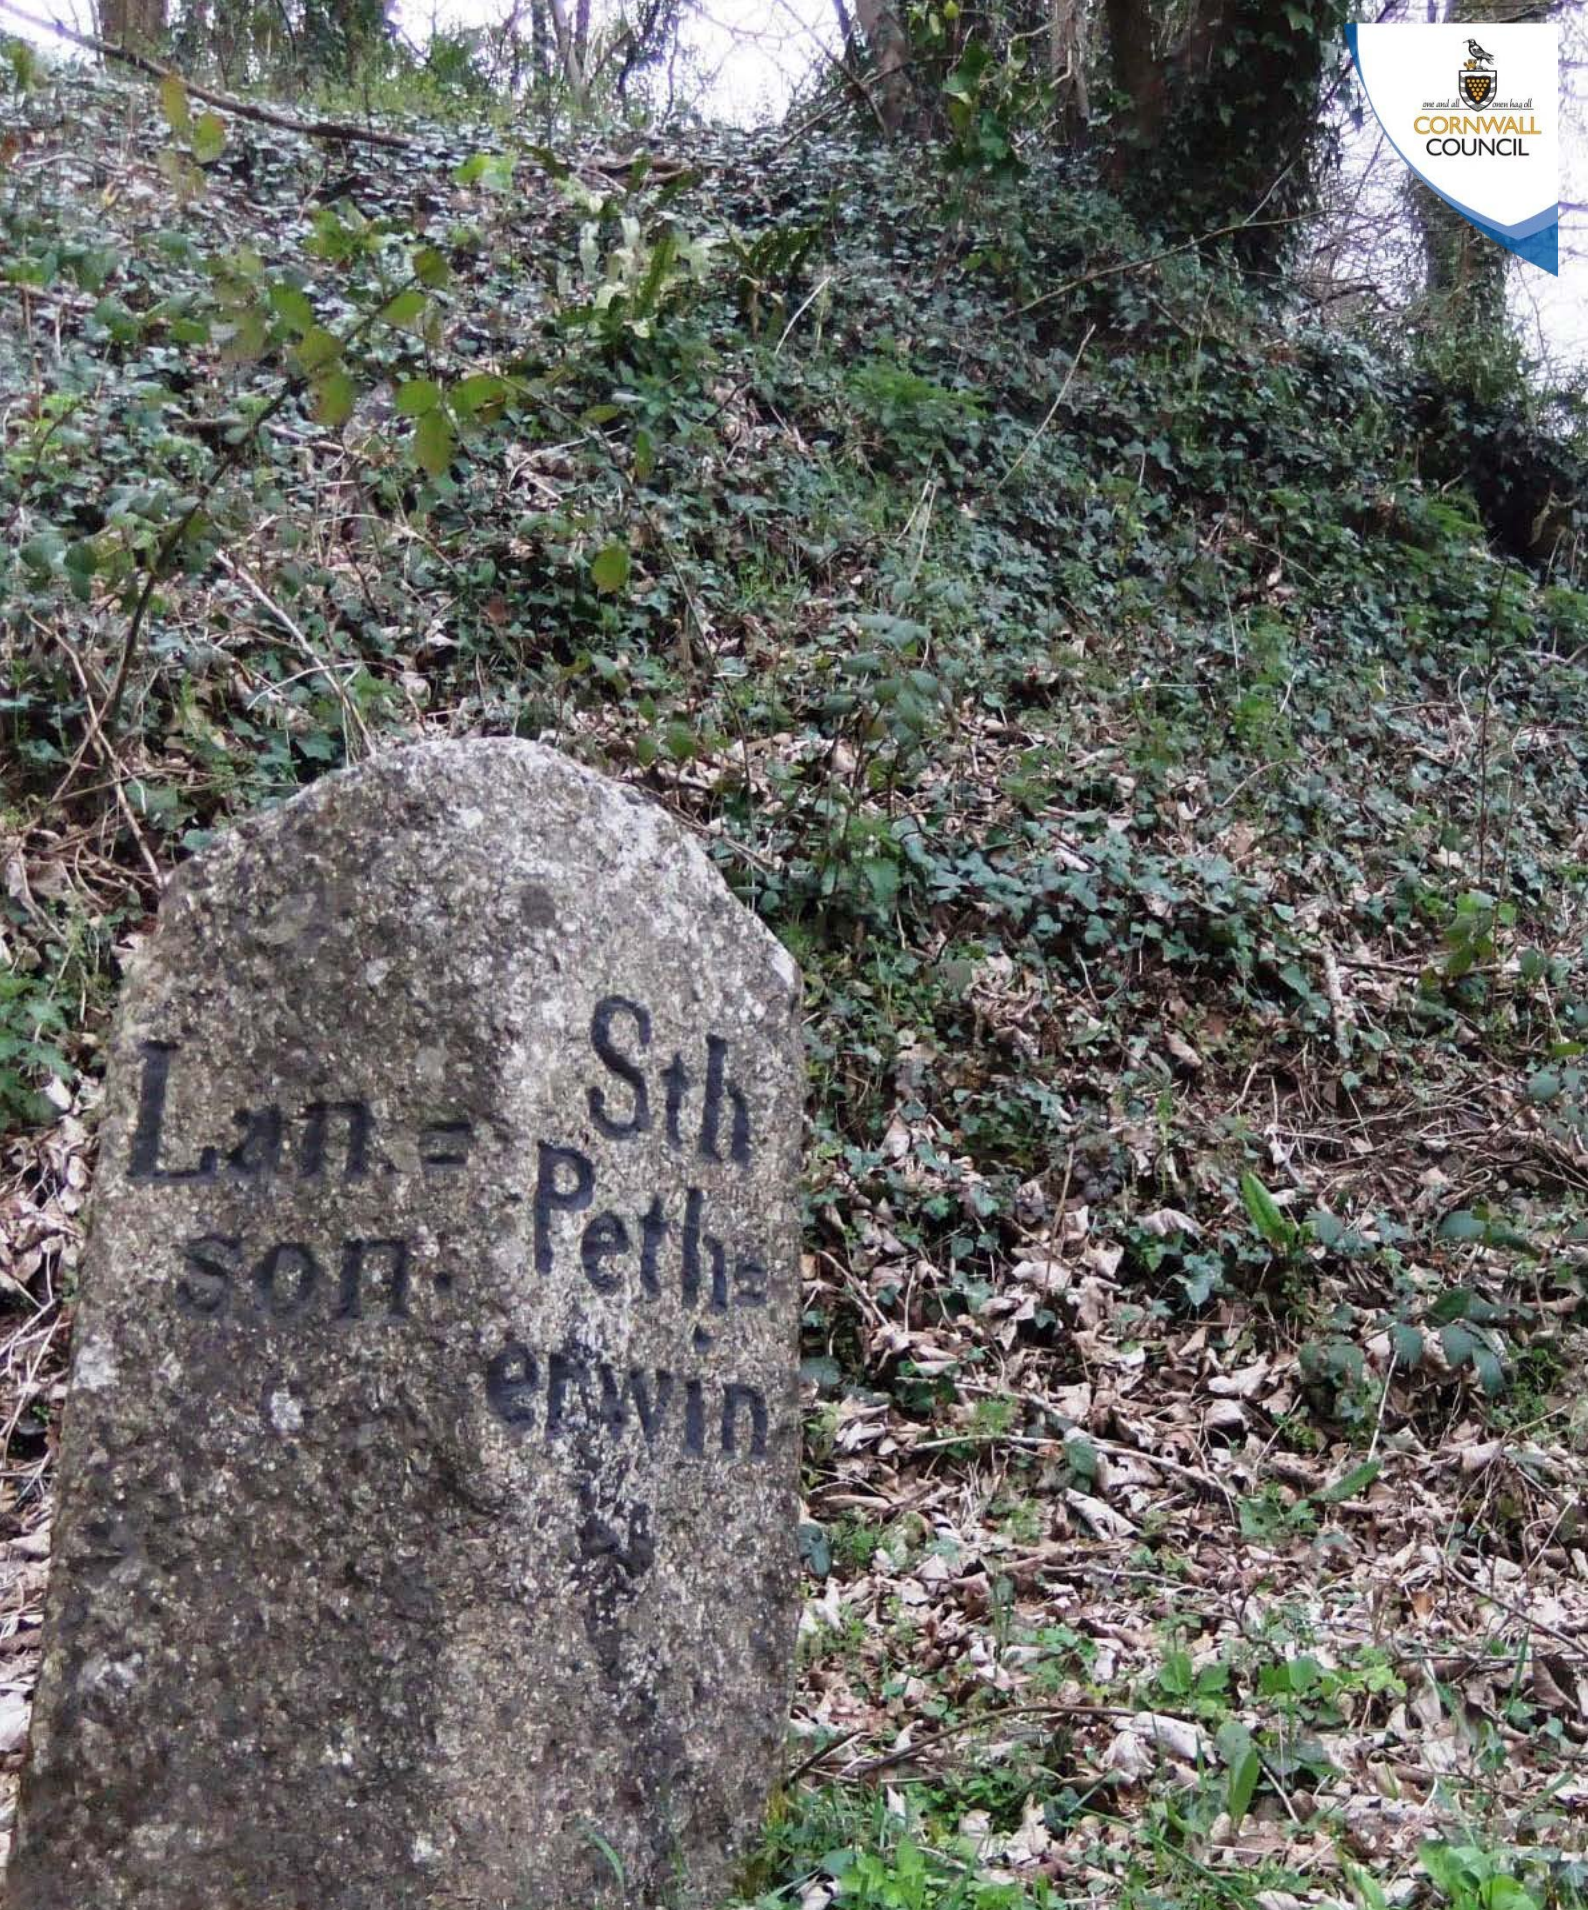
Cover illustration

*Boundstone on the south east of the quarry at location **10**, marking the medieval parish boundary following a small stream, covered by the old quarry dumps beyond.*

- **Area 10.** The site plans show no works impacting the parish boundstone which stands close to the former turnpike road at the south east margin of the property. The proposed shifting of the site entrance to the north west may have some beneficial effect on the preservation and appreciation of the stone, in that it could reduce the traffic hazards, and potential risk from vehicle damage, common to roadside monuments.

- Area **10**. No recommendations specific to the proposed works (though see the note below, and also the above suggestion for re-opening a way to the stone re-using the historic Quarry Lane in Area **9**).

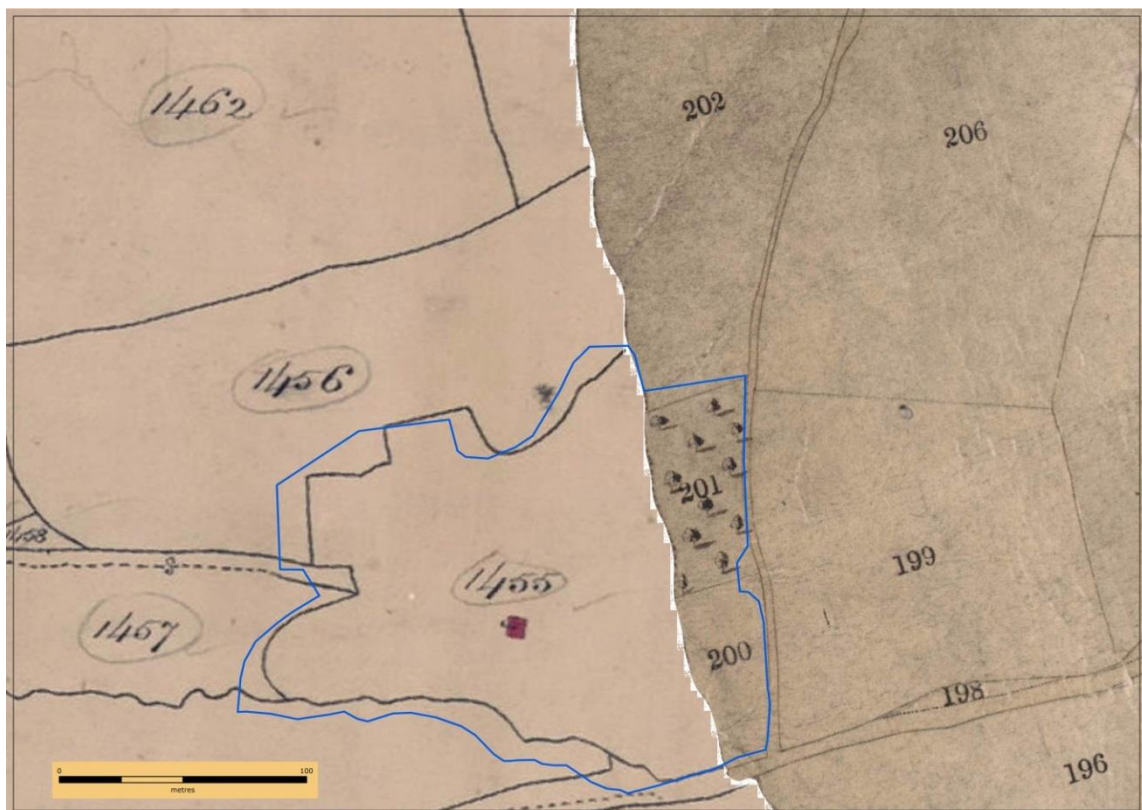
Fig 6 Tithe surveys of 1843, outlining the quarry with central building in South Petherwin parish (1455) and former quarry areas in Launceston (200, 201).  
(The study area and quarry edges are offset due to differences in map bases.)

The first of the more detailed county-wide maps is that produced by various surveyors as part of the Tithe Award survey, undertaken *circa* 1840 (here dated 1843). Each survey is accompanied by an Apportionment, which lists the owner and occupier of the land, its use, acreage and tithe value. The majority of the site lies within the ecclesiastical parish of South Petherwin, though its easternmost edge falls in the parish of Launceston St. Mary Magdalene (Fig 6).

Within the first parish, South Petherwin, the tithe mapping shows an enclosure broadly congruent with the project area as Plot 1455. The tithe apportionment schedule records this as 'Quarry & Plantg', extending to 5 acres, 1 rod and 0 perches, part of the tenement of Tresmarrow, owned by Isaac Dawe, named as Daw on the census returns, probably the 'gentleman farmer' Mr Down who had bought Tresmarrow some decades earlier (Lysons and Lysons 1814, 265). The reference to planting demonstrates that trees were already present on the site, perhaps screening its edges from Tresmarrow and the roads leading there.

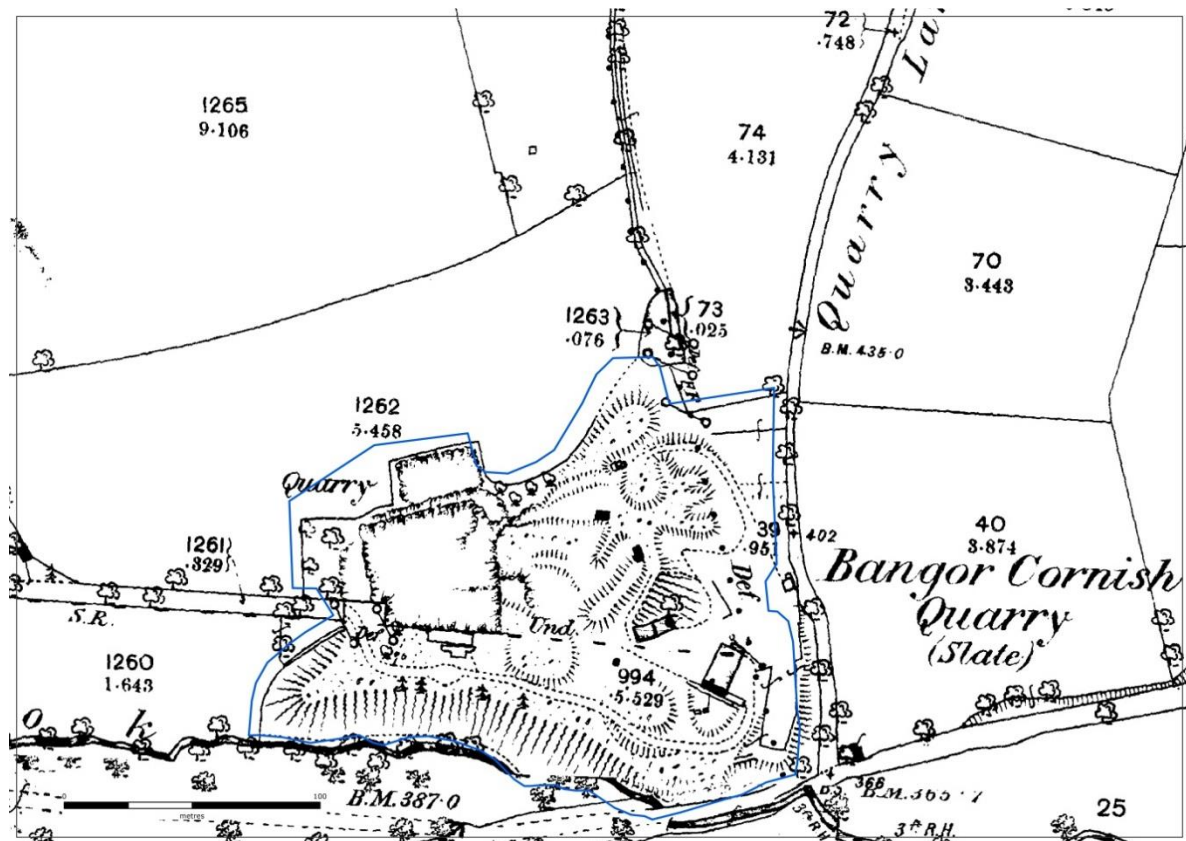
Fig 7 OS map of c1880 recording quarry pits, dumps, structures and trees.

As shown by the 1843 survey and especially by the more detailed OS map of c1880 (Fig 7), the east part of this early approach to Trebursye, incorporated in the quarry site, was formerly respected by some of the quarry dumps and buildings. This strongly suggests the track served as a cart track or tramway for the quarry before being dug away and buried by it. A notable feature of the east part of the approach (as indicated by the positions of these former quarry structures) is that it bent to the south towards its end; and the south end of Quarry Lane bent to the east in a similar area, before it was re-aligned.

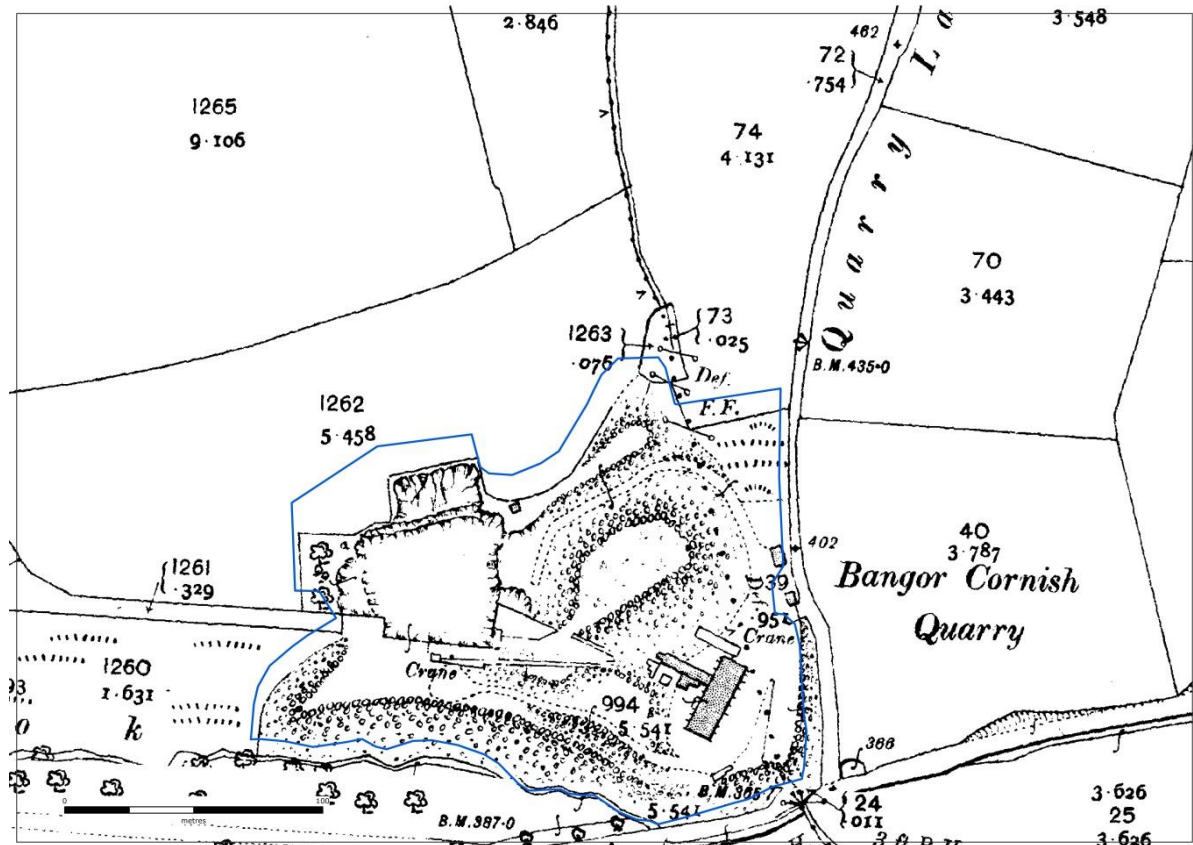
Fig 8 OS map, c1908, showing fewer, larger structures and dumps (individual trees are not plotted on this edition).

At the time of the *circa* 1908 OS revision of the 25" to a mile mapping (Fig 8), although the quarries centred in Area **2** retained almost the same footprints as those shown c1880, the planned deepening of the southern quarry had evidently been achieved, given that a substantial dump of material was depicted to its east. All of the small buildings shown on the c1880 mapping had been over-dumped. A small structure at the centre point of the northern boundary may well have been a replacement powder magazine; two new buildings had been constructed against the eastern site boundary. The structure to the south of the southern quarry was marked as 'crane'.

Little of this infrastructure surveyed c1908 is now upstanding. The more recent large concrete bay on the south east at Area **7** reuses part of the site of the largest shed of c1908 (itself representing a doubling of the area of a yard with buildings shown on the map of c1880), matching its footprint on the north west side. However the bay was probably formed by digging away the earlier structures (Fig 26). A small concrete or rendered masonry base near the north west corner of the site (outside the proposed development area), though not mapped, is probably of this period, as it stands beside the north west edge (now infilled) of quarry Area **2**, beside the western extension to this mapped c1880 and 1908. It measures c3m east-west by 2m, and is 0.4m high. It has a broad battered side facing the quarry, and was probably one of several winching strong points allowing one winding engine to work in several areas.

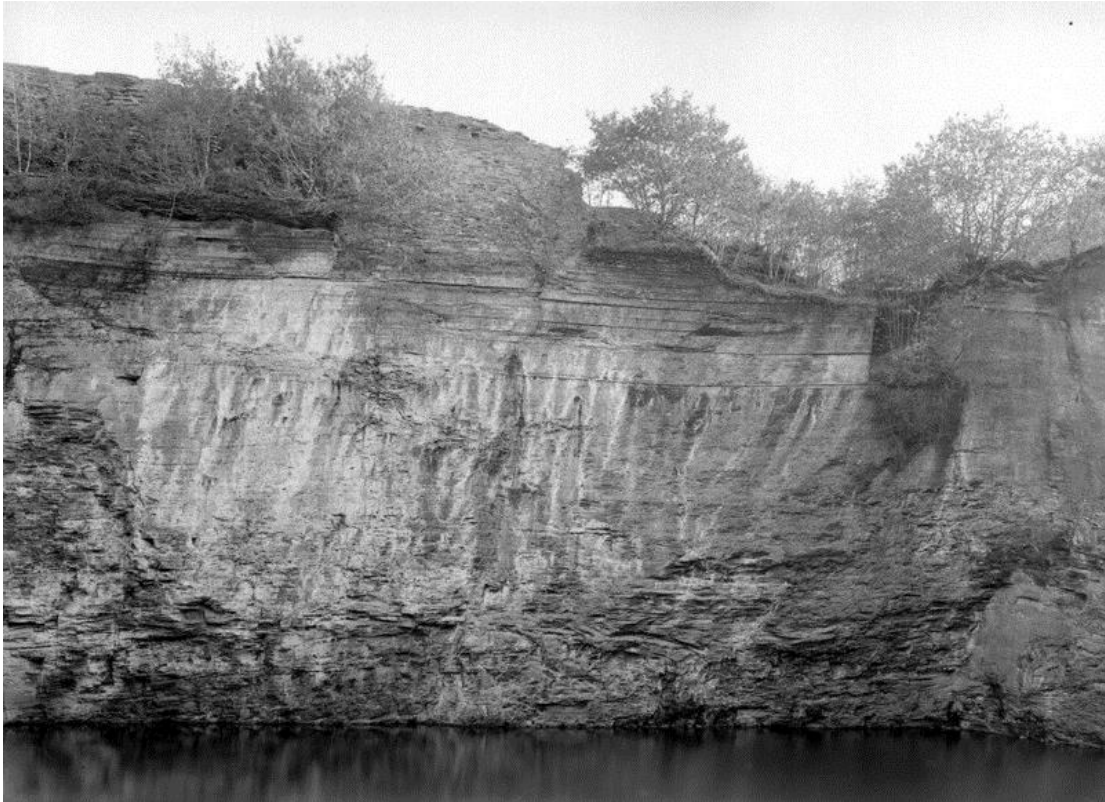
*Fig 9 Photograph by TC Hall, 1909, indicating the depth of the flooded quarry.  
© NERC; reproduced here for non-commercial use.*

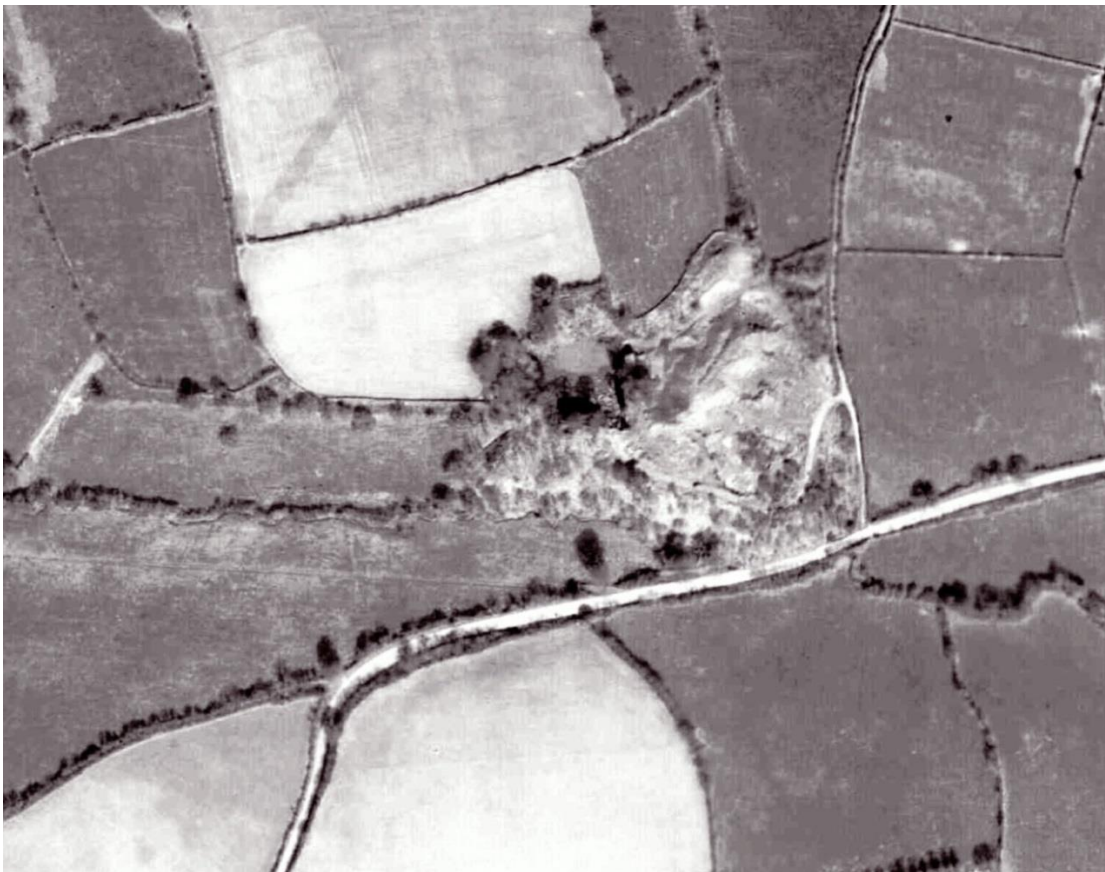
*Fig 10 Air photograph of 1946, RAF E54/5035, showing landfill and tree cover.*

By the 1950s the quarries were in the process of being infilled having been used for some time as landfill sites, presumably for domestic and other rubbish emanating from Launceston. Infilling continued in the following decades, before they were handed over to Cornwall County Council in the early 1980s. The landfill material had been capped over by the early 1990s. Cornwall County Council aerial mapping dating to 2000 shows the site was under scrub, with trees particularly to the south along the Lowley Brook and along the eastern edge. A small yard had been established in the north-eastern corner of the site, whilst a cleared area with a large loading pit (Fig 26), moderately sized buttressed concrete shed (Fig 30) and some smaller structures were located in its south-eastern corner at Area **7**. No traces of the quarry excavations could be seen, and the spoil dumps appear to have been landscaped. The site was re-photographed from the air for Cornwall County Council in 2005 (Fig 11), its use appears to have been as it was five years previously.

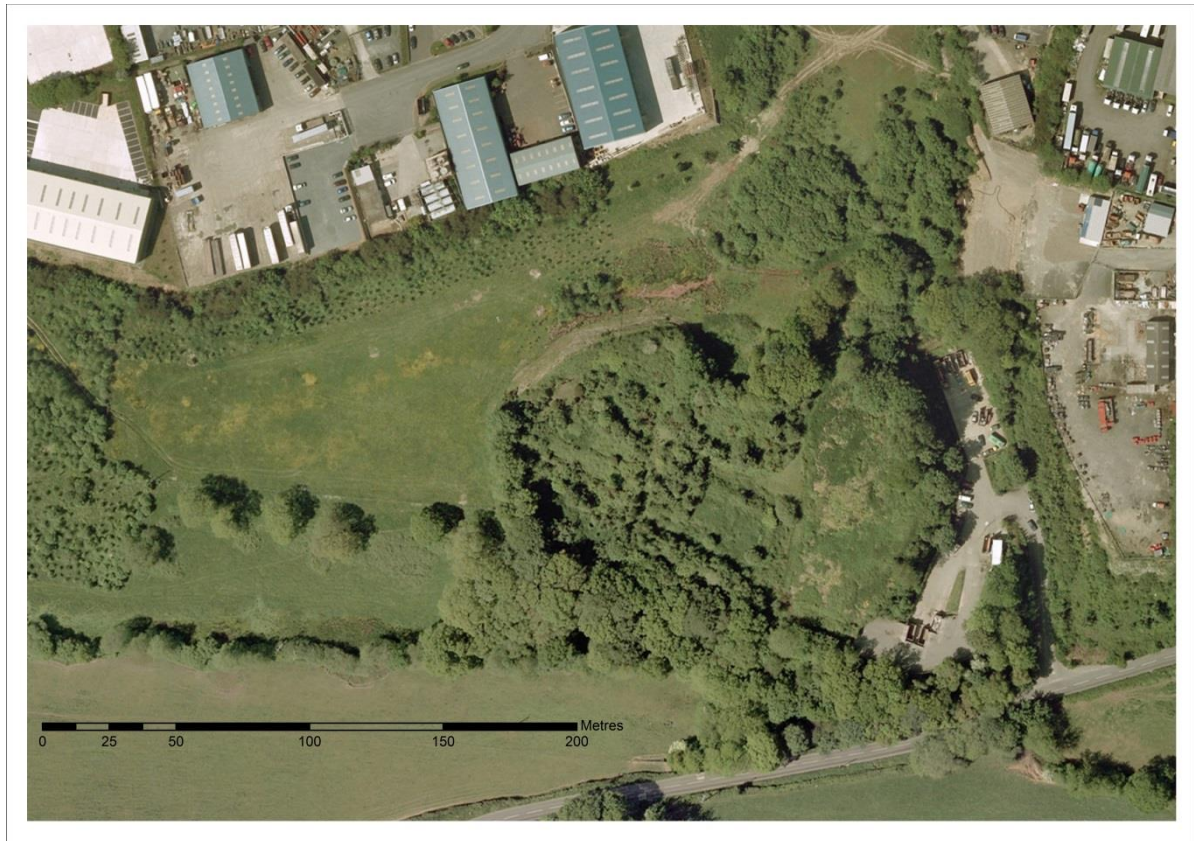
*Fig 11 CC aerial photograph of 2005, before the central working area was made.*

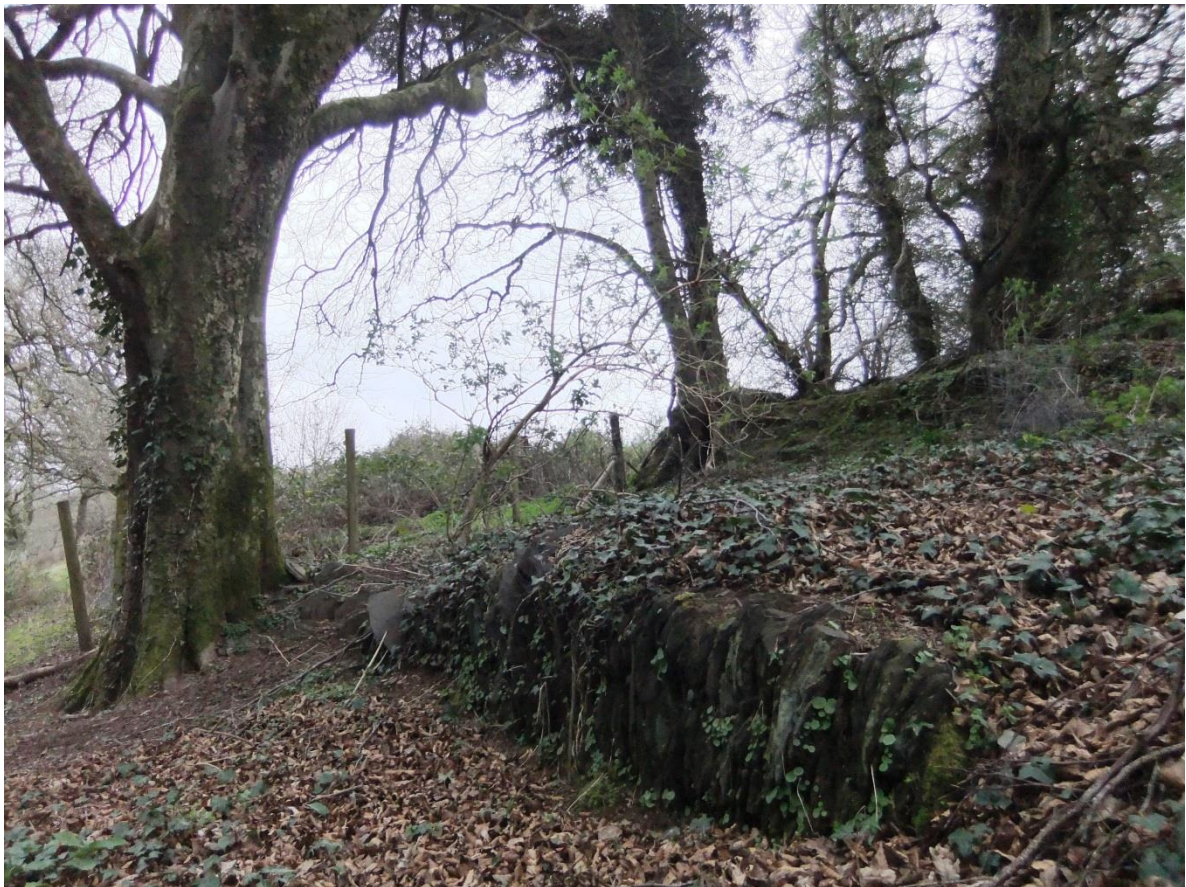
*Fig 12 Slate-faced and tree-lined way to Trebursye, running west from Area 1.*

Remains of the Trebursye approach survive on the shoulder of the valley immediately west of the quarry, partly within its modern fenced boundary, in Area 1 (Fig 12). It has a road platform 4m-5m wide, now mostly covered in leaf mould or grass, and stone-faced edges, lined with trees at intervals. The revetment on the north, cut into the valley side, rises to around 1.4m above the track, and that on the south, levelled out from the slope, is c0.7m high where better preserved. Large mature trees (or stumps, west of the quarry property) stand along the sides of the route. These include a beech inside the study area, measuring some 2.75m around the trunk at c1.4m from the ground. The revetments flanking the roadway are of rough slate slabs measuring c0.4m square and 4cm thick, set vertically in rough courses (unlike the quarry dump revetment walls, where the stones are laid). The colour and texture of these slates, matching others in the dumps, indicate they are from the locality, and they may have come from an early quarry on the site.

- Area **1**. Put measures in place to ensure there is no inadvertent direct impact or lateral damage to the remains of the former approach to Trebursye on the western edge of the site, including the associated flanking trees and their root systems. This might be achieved through attendance of an archaeologist during the laying out and/or execution of any works here, as part of the watching brief recommended for other areas of the site.

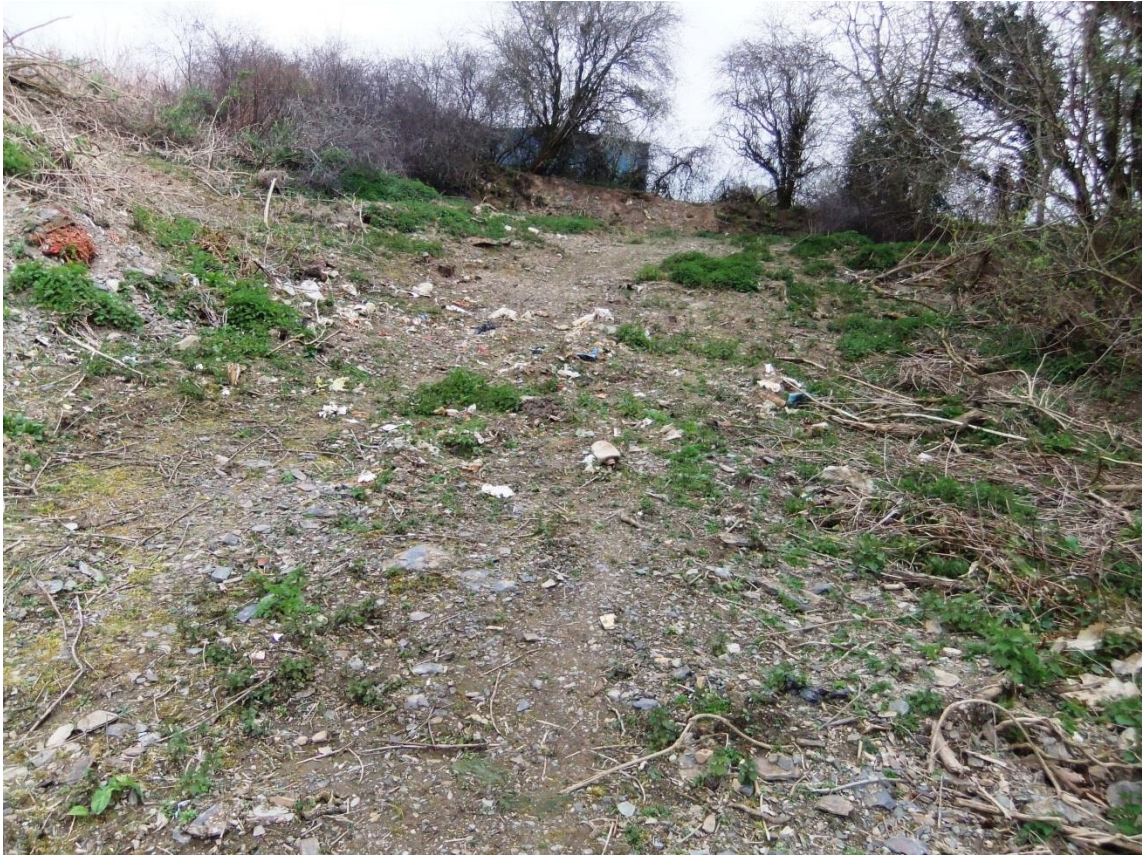
*Fig 13 Quarry dating from before 1843 under landfill in Area 2, looking north.*

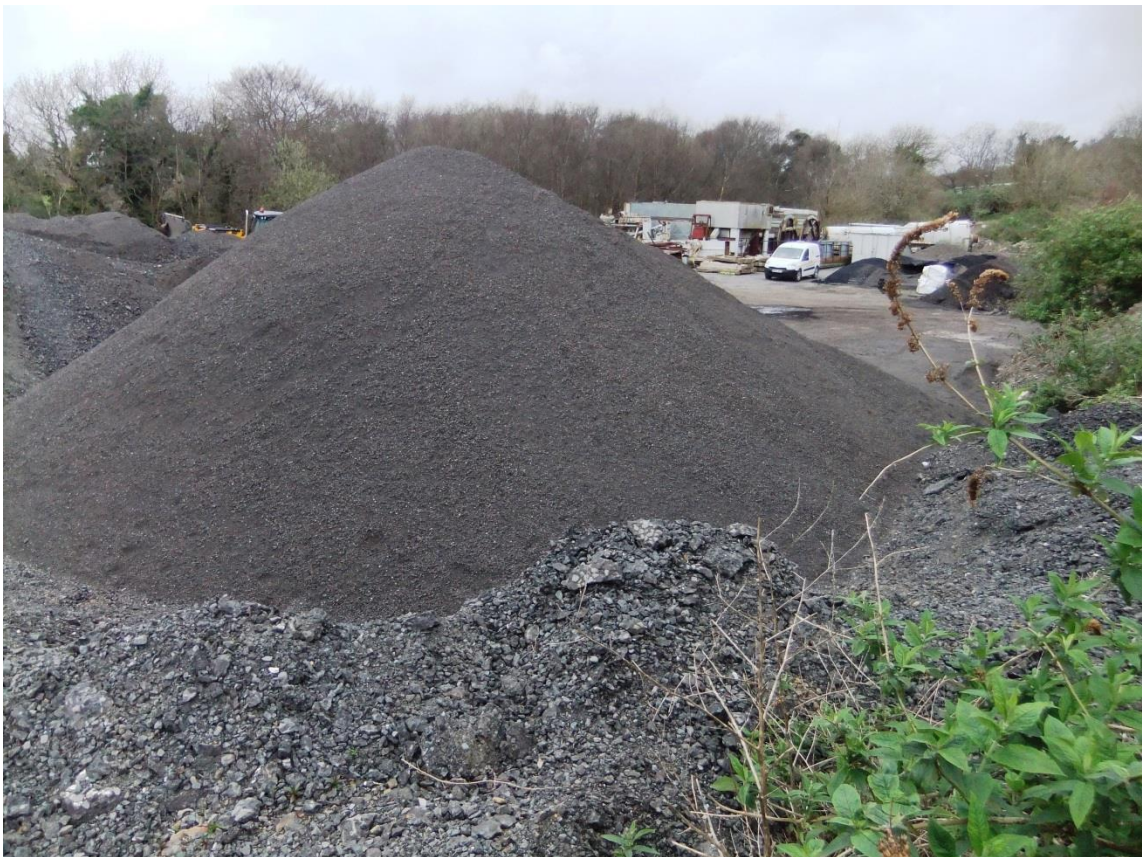
*Fig 14 Central working area extending west onto site of infilled quarry Area 2.*

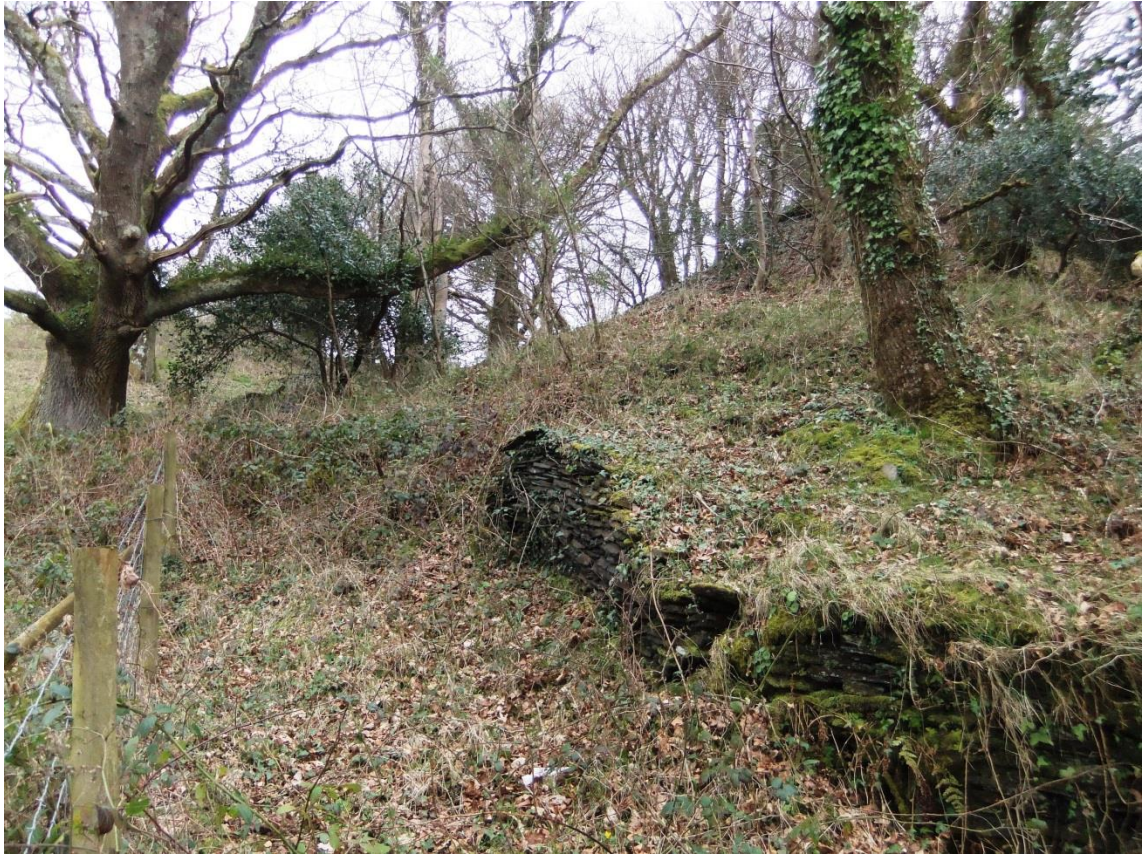
*Fig 15 West corner of spoil heap on south, Area **3**, with stone edging, and woodland.*

- Area **2**. No recommendations.
- Area **3**. Avoid any dumping, ground disturbance or tree damage on the scarps of spoil on the south and south west of the site; limiting any works to the area north or east of the modern bund on their tops. Retention of the woodland here is strongly recommended, both for its intrinsic semi-natural interest, and for its utility in screening views of the site from the rural landscape surrounding it on the south and west.

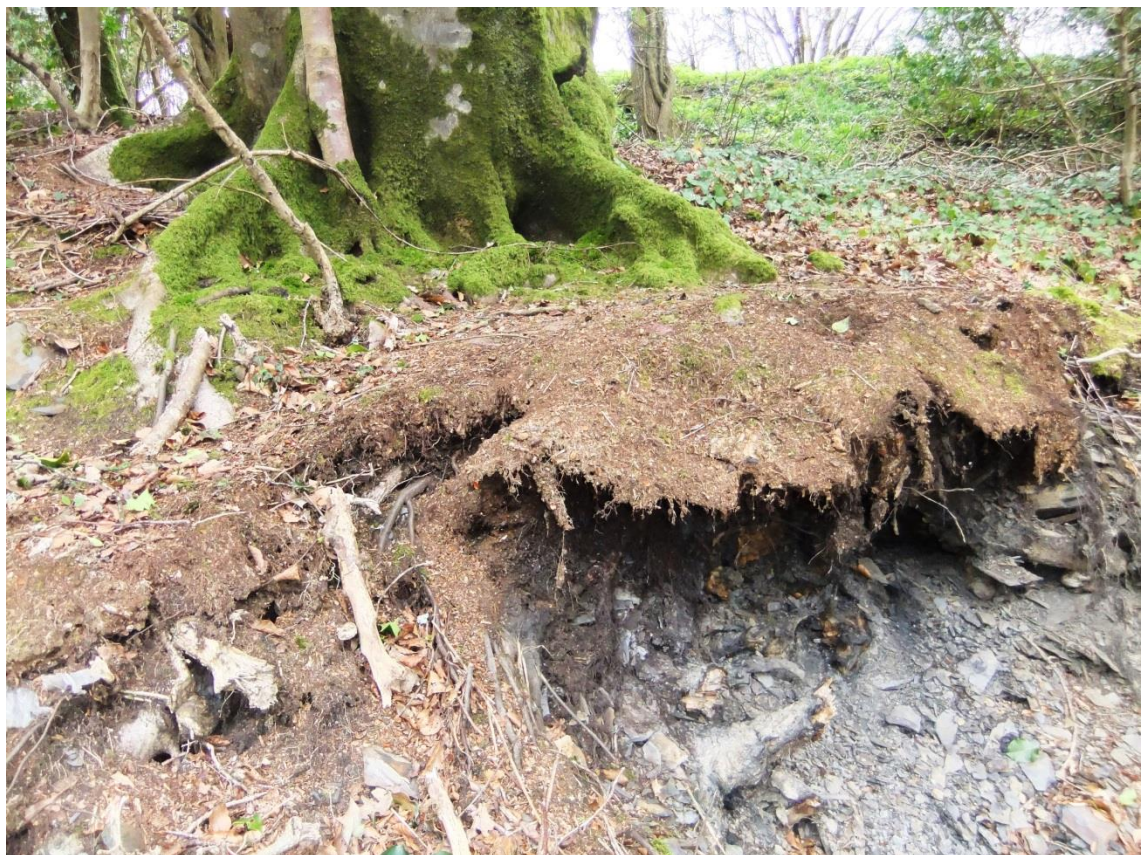
*Fig 16 Small exposure of blue-grey slate spoil fabric of dump on south forming Area **3**.*

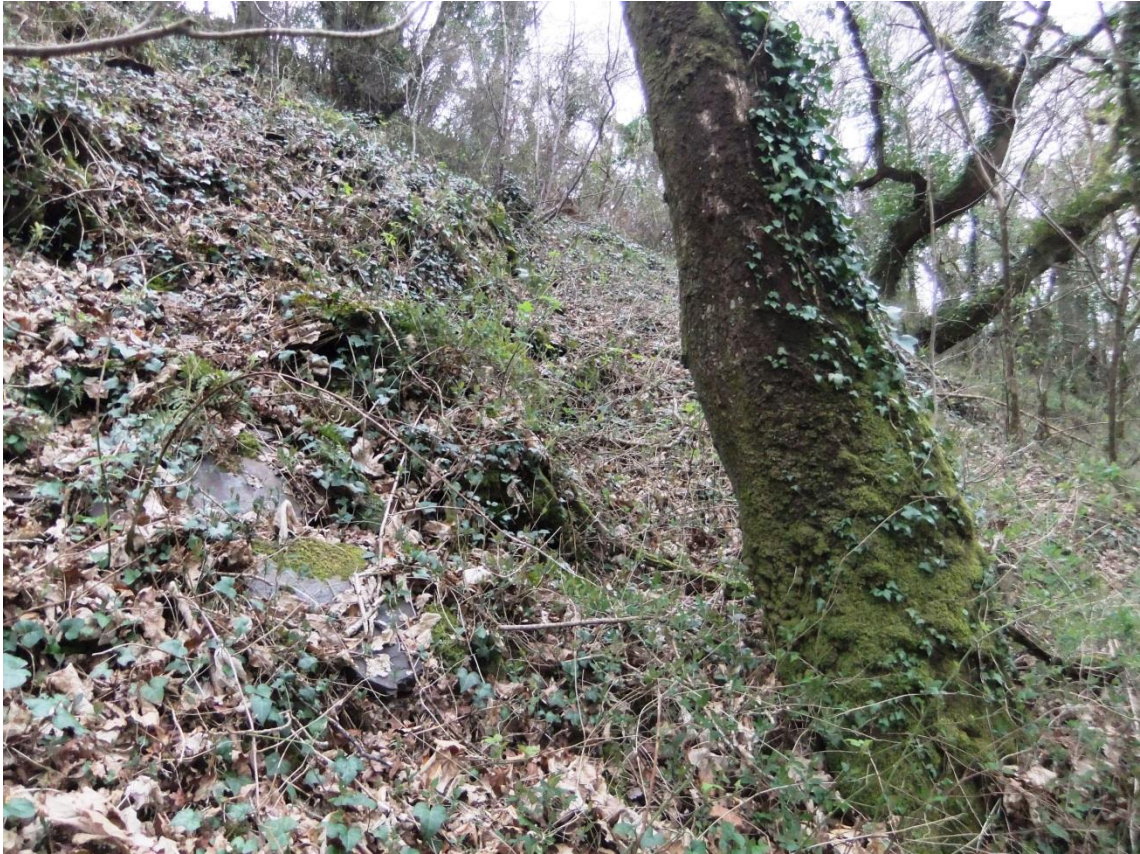
*Fig 17 One of a series of slanting runs formed in southern spoil heap Area 3.*

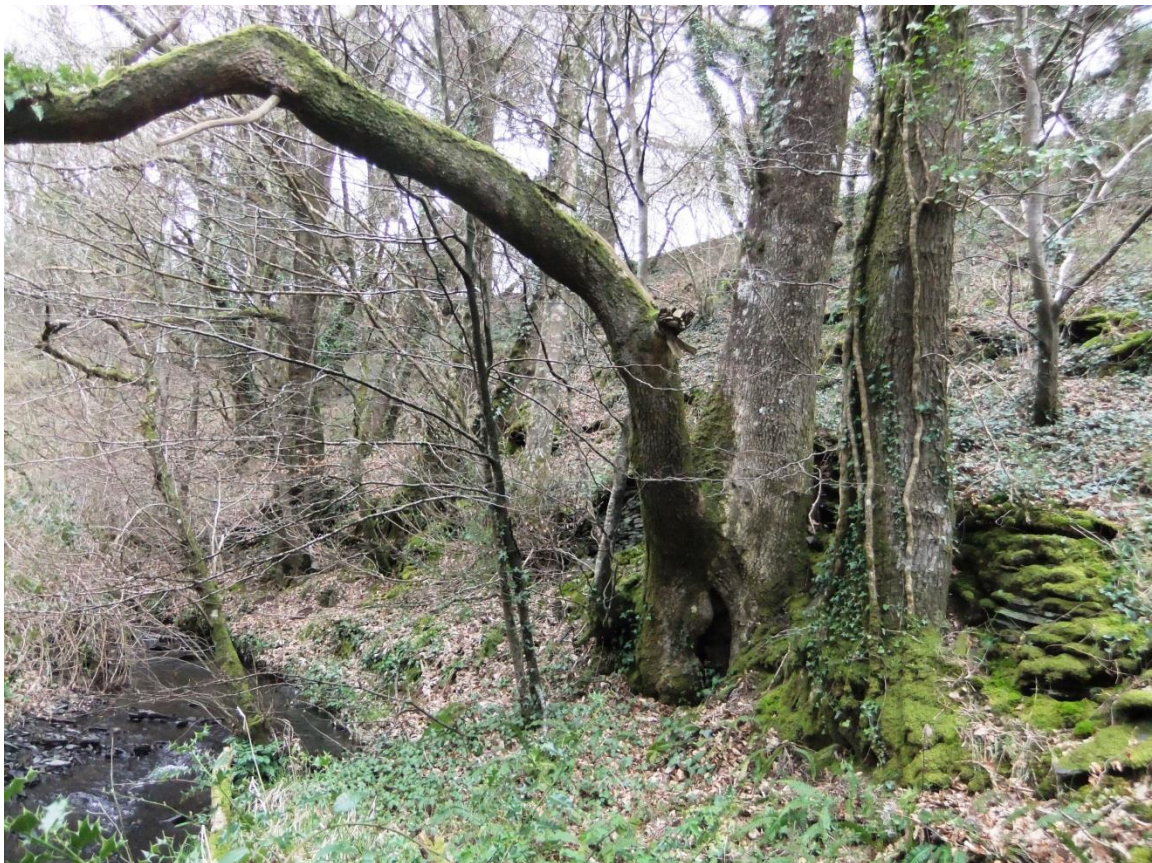
*Fig 18 South side of spoil in Area 3 by the stream, with semi-natural diversity.*

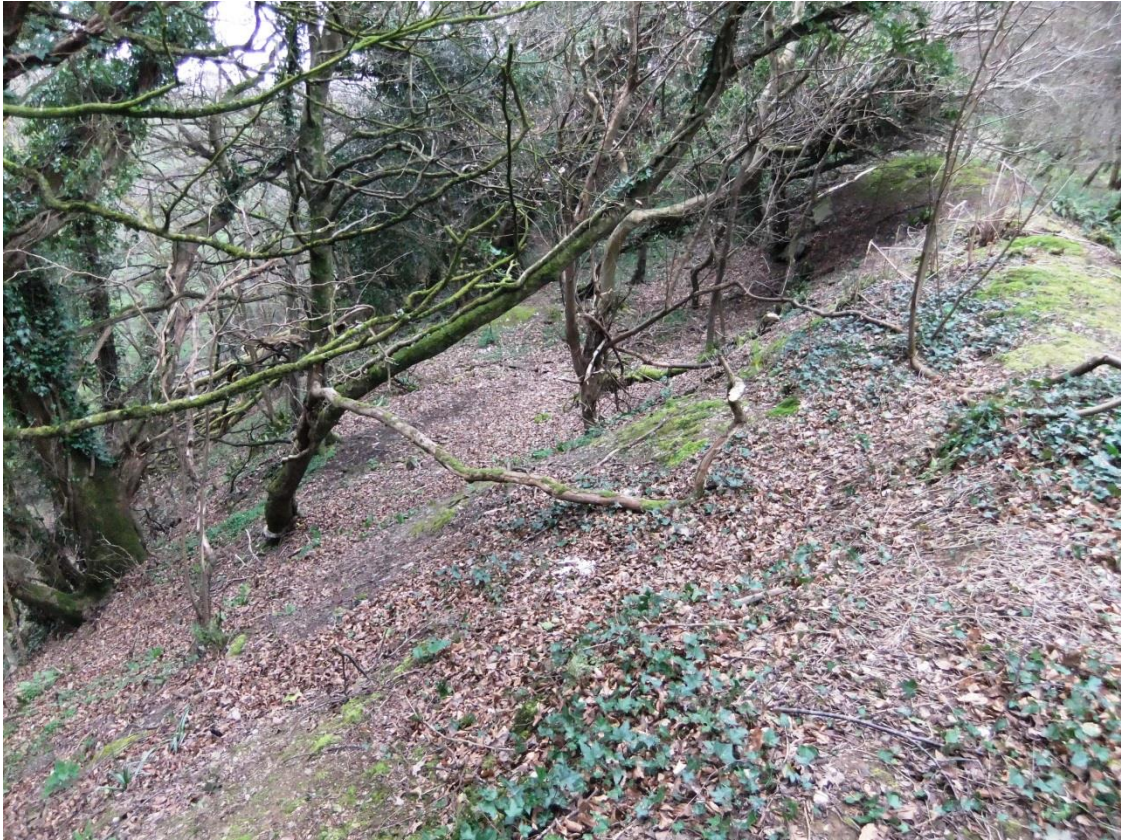
*Fig 19 North side of spoil Area **3** with part of a track along its shoulder mapped c1880 (centre), overlain by a bund bounding the recent central working area.*

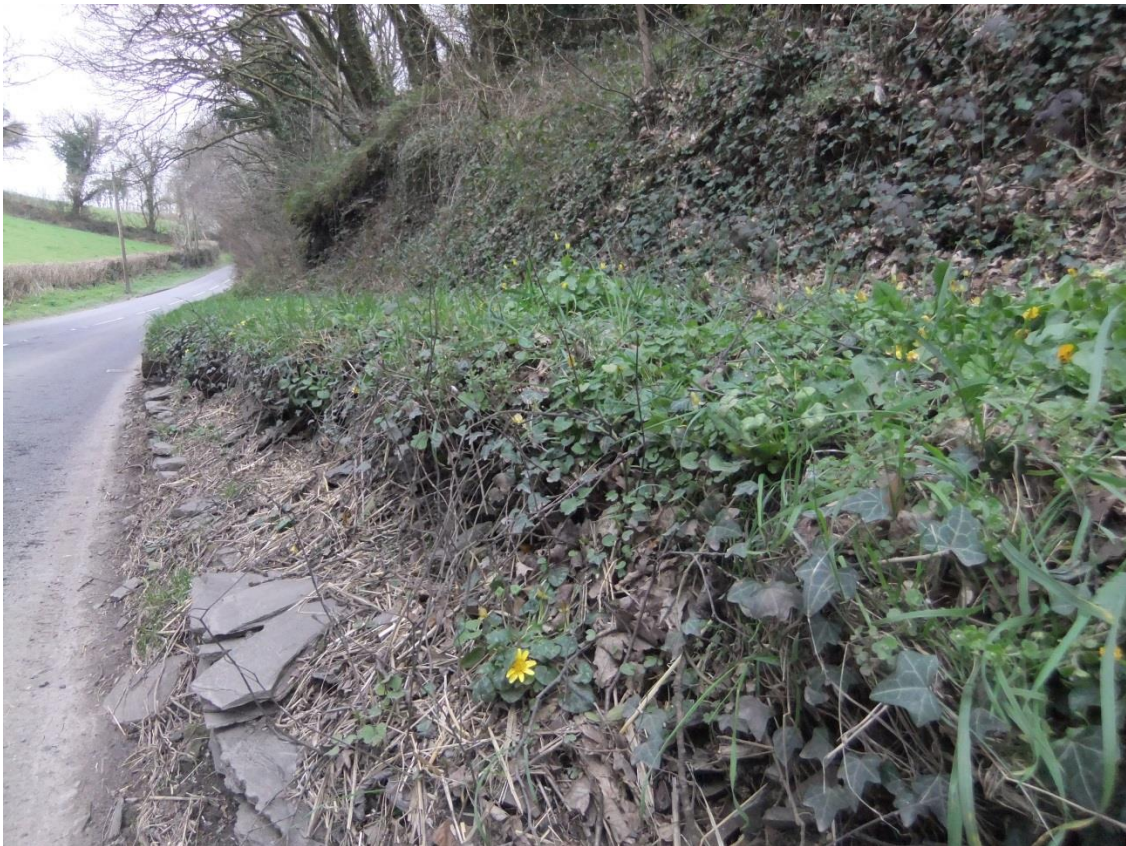
The quarry also generated large quantities of spoil in the early 19<sup>th</sup> century. The road on the south running to South Petherwin and on to Trekellearn Bridge, now the B3254, was among those improved by the Launceston Turnpike Trust (founded in 1760) in a phase of works enabled by an Act of Parliament of 1815 (turnpikes.org.uk website). The road is partly made up of and edged with quarry waste, visible in the sides of the roadway around 0.5m high (Fig 20).

*Fig 20 Turnpike below southern dump Area **3** showing formation in quarry spoil.*

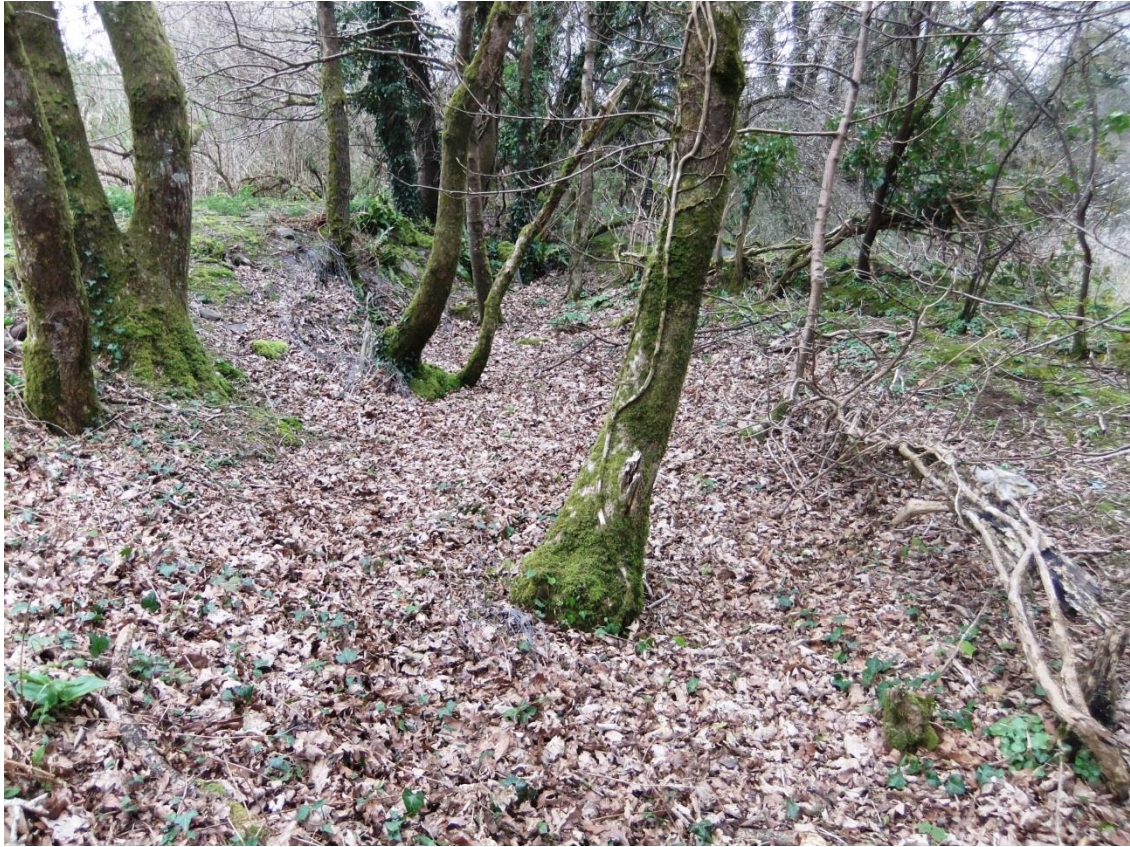
*Fig 21 Track in Area 5, part dumped over, running west towards quarry Area 2.*

- Area **5**. Ensure there is no direct impact or lateral damage to the early quarry spoil, associated earthworks and structural remains, and established tree cover in the centre of the north side of the site. As with the proposal for Area **1** this could involve attendance of an archaeologist, as part of the watching brief recommended elsewhere on the site.

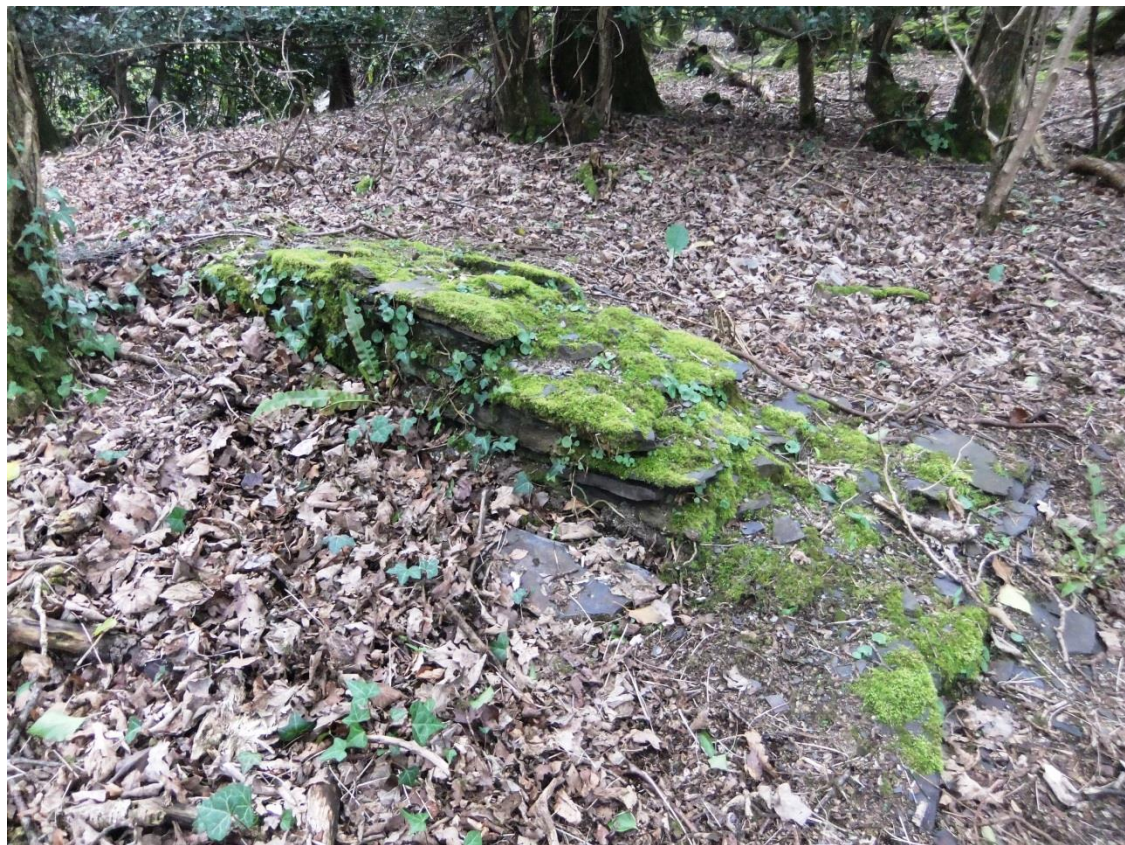
*Fig 22 Wall c2.5m long, 0.5m wide, 0.35m high, remains of a building, Area 5.*
