# **Bangor Cornish Quarry, Launceston, Cornwall**

## **Heritage assessment and impact assessment**

<b>Client</b>	<b>CORMAC Solutions</b>
<b>Report Number</b>	2017R021
<b>Date</b>	<b>April 2017</b>
<b>Status</b>	Final report
<b>Report authors</b>	<b>Catherine Parkes BA MCIfA and Adam Sharpe BA MCIfA</b>
<b>Checked by</b>	<b>Adam Sharpe BA MCIfA</b>
<b>Approved by</b>	<b>Andrew Young MCIfA</b>

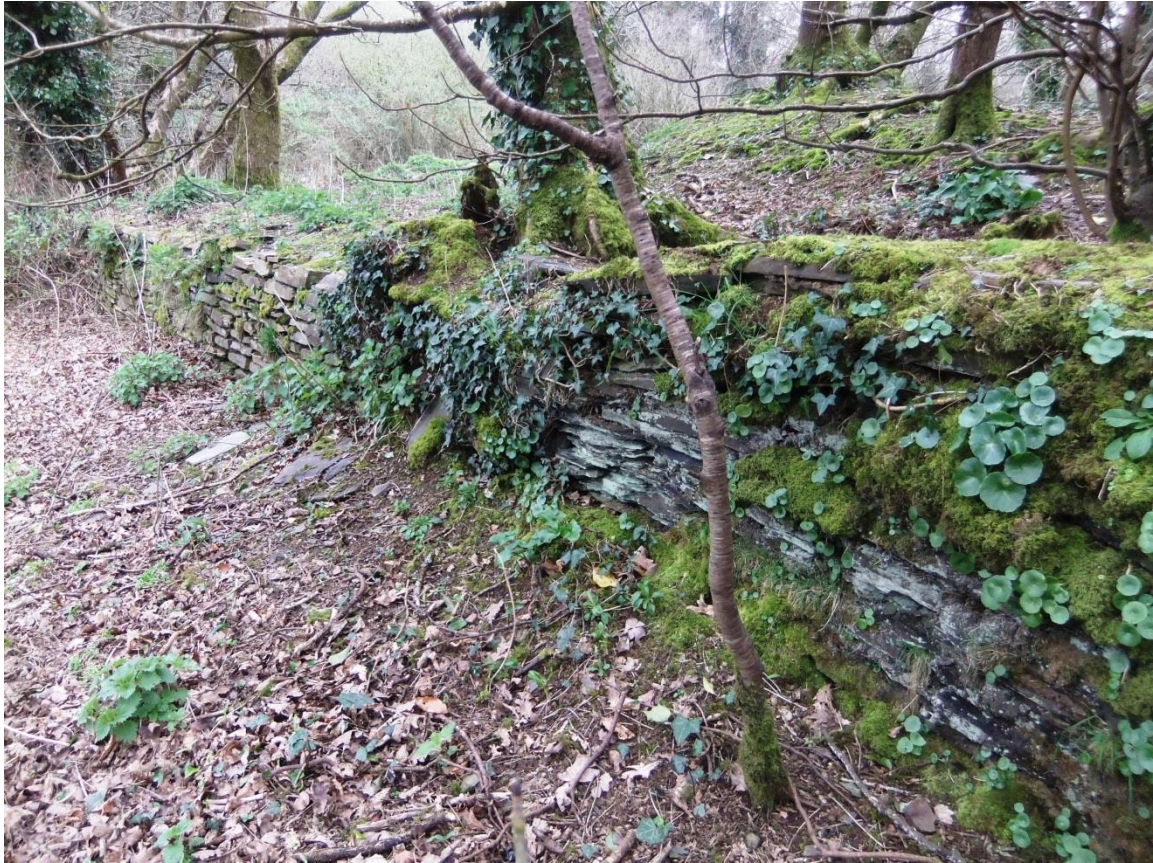
*Fig 23 Centre of outer, north edge of Area 5, edged with laid slates, looking south east.*

- Area **5**. Ensure there is no direct impact or lateral damage to the early quarry spoil, associated earthworks and structural remains, and established tree cover in the centre of the north side of the site. As with the proposal for Area **1** this could involve attendance of an archaeologist, as part of the watching brief recommended elsewhere on the site.

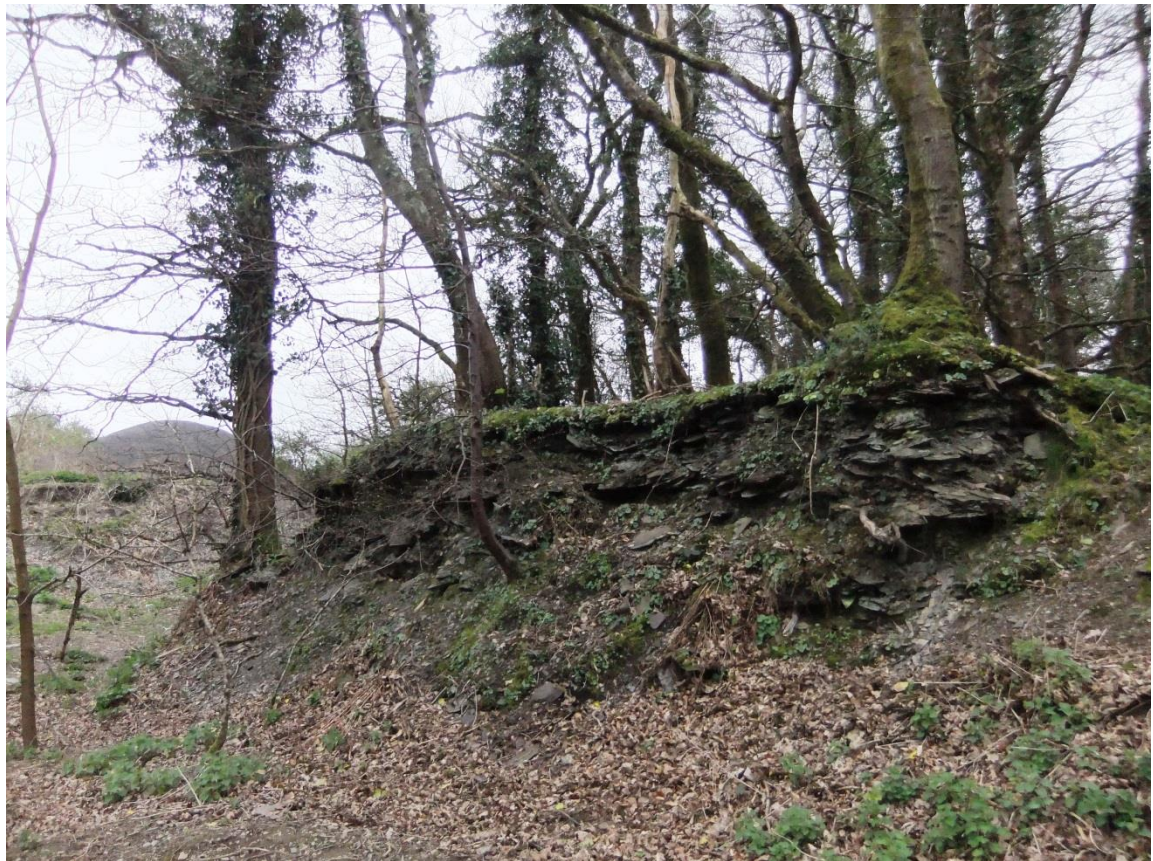
*Fig 24 Cut east edge, Area 5, exposing the 2.5m-3m depth of early spoil there.*

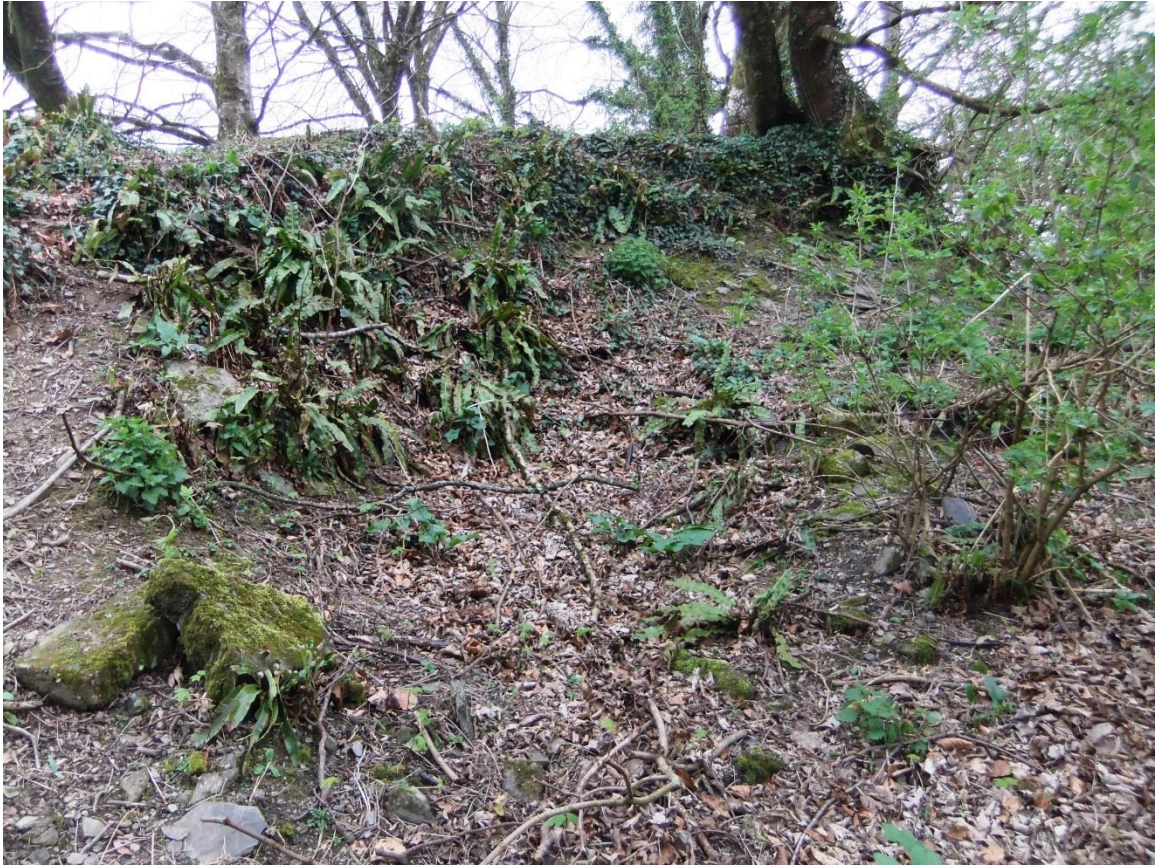
*Fig 25 Edge of tip mapped c1880 in Area 6, with possible site of small building.*

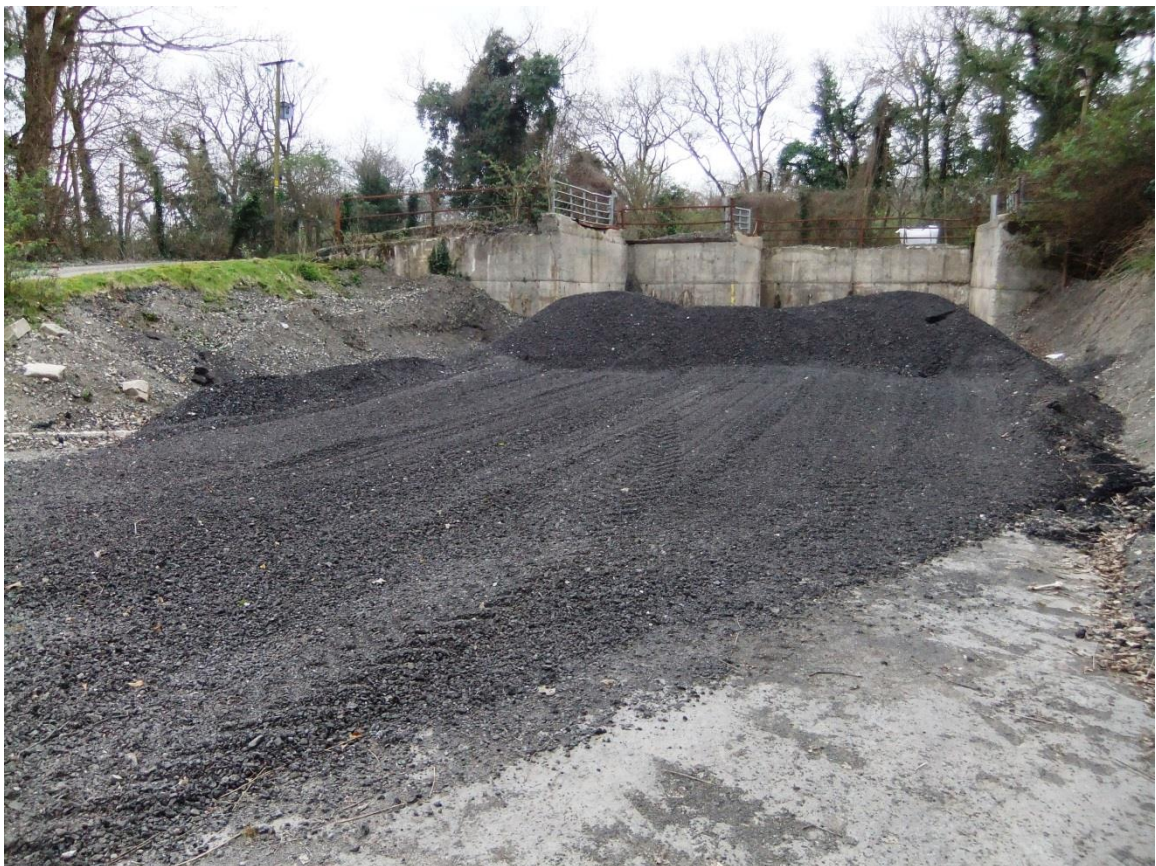
*Fig 26 Large sunken loading bay on site of quarry buildings in Area 7, looking south.*

Little of this infrastructure surveyed c1908 is now upstanding. The more recent large concrete bay on the south east at Area **7** reuses part of the site of the largest shed of c1908 (itself representing a doubling of the area of a yard with buildings shown on the map of c1880), matching its footprint on the north west side. However the bay was probably formed by digging away the earlier structures (Fig 26). A small concrete or rendered masonry base near the north west corner of the site (outside the proposed development area), though not mapped, is probably of this period, as it stands beside the north west edge (now infilled) of quarry Area **2**, beside the western extension to this mapped c1880 and 1908. It measures c3m east-west by 2m, and is 0.4m high. It has a broad battered side facing the quarry, and was probably one of several winching strong points allowing one winding engine to work in several areas.

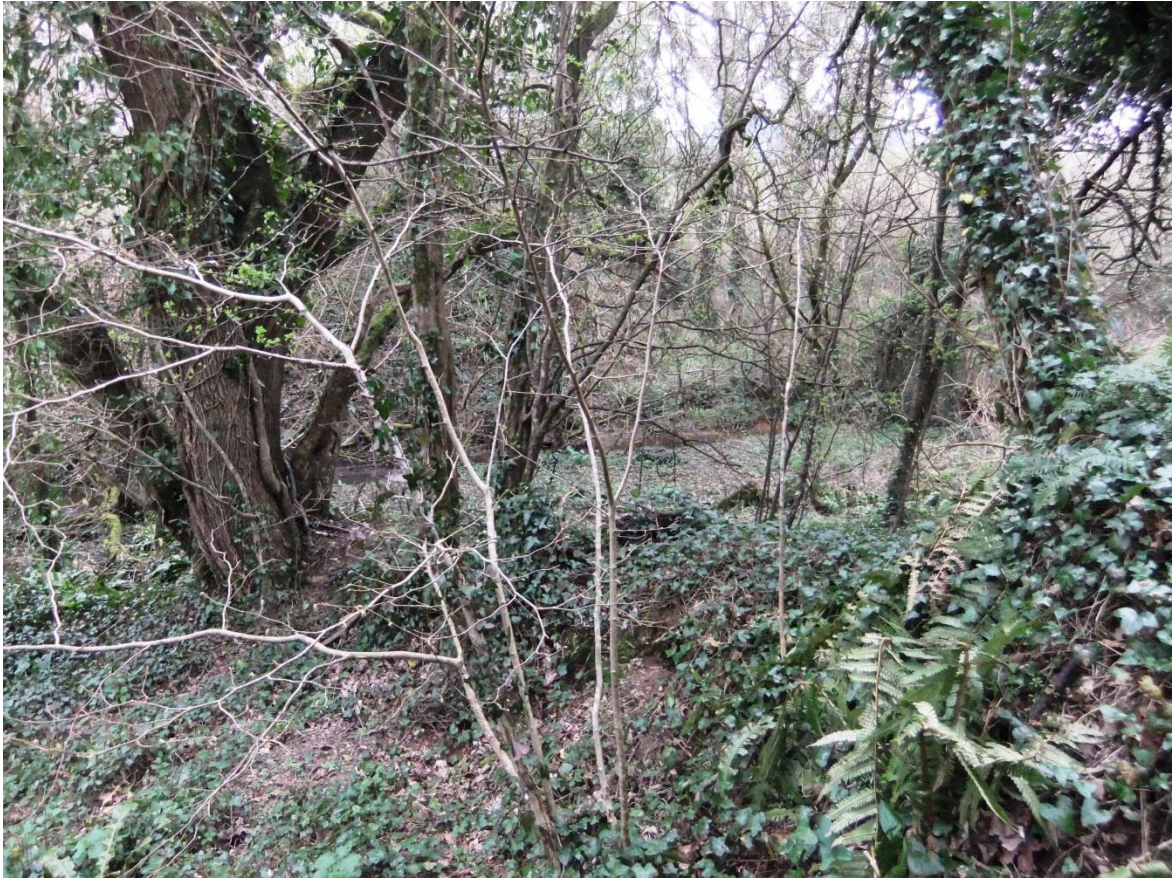
*Fig 27 Large trees on a hedge bounding former eastern quarry ground, Area 8.*

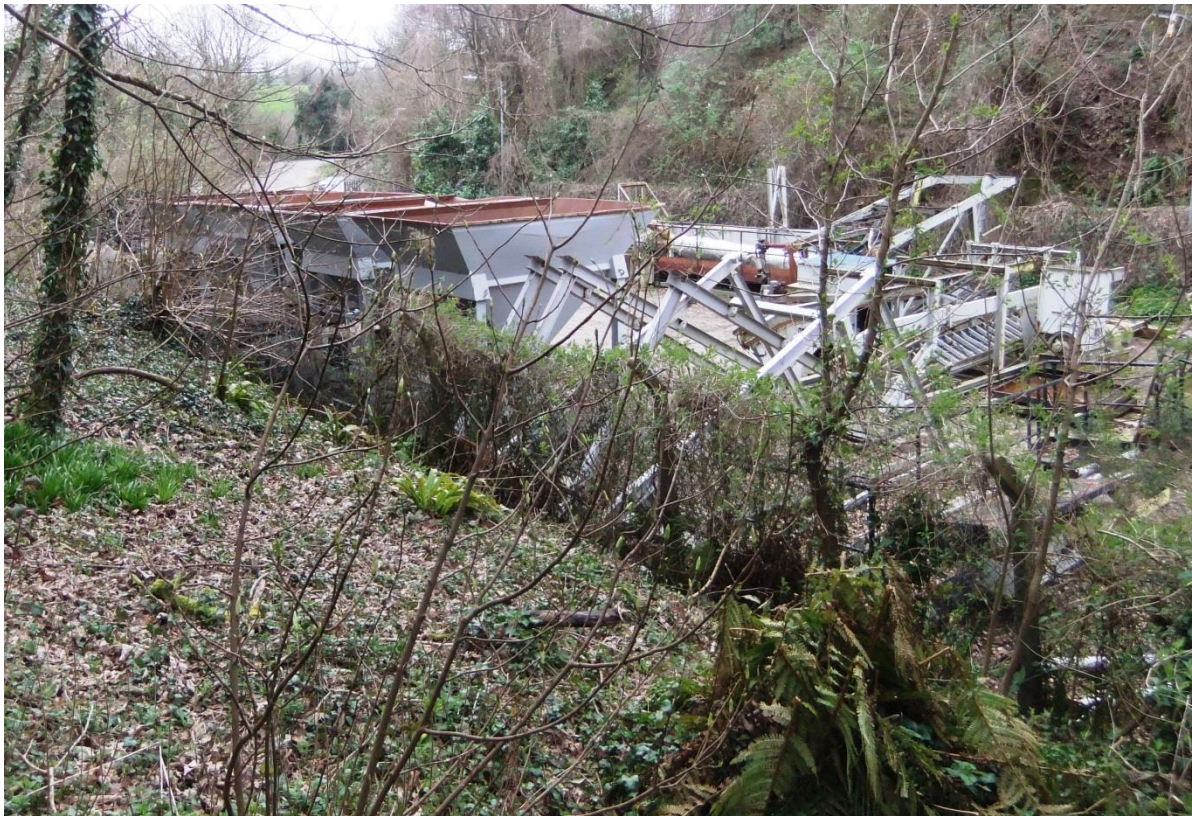
*Fig 28 Early quarry spoil in eastern Area 8, with modern levelled yard below.*

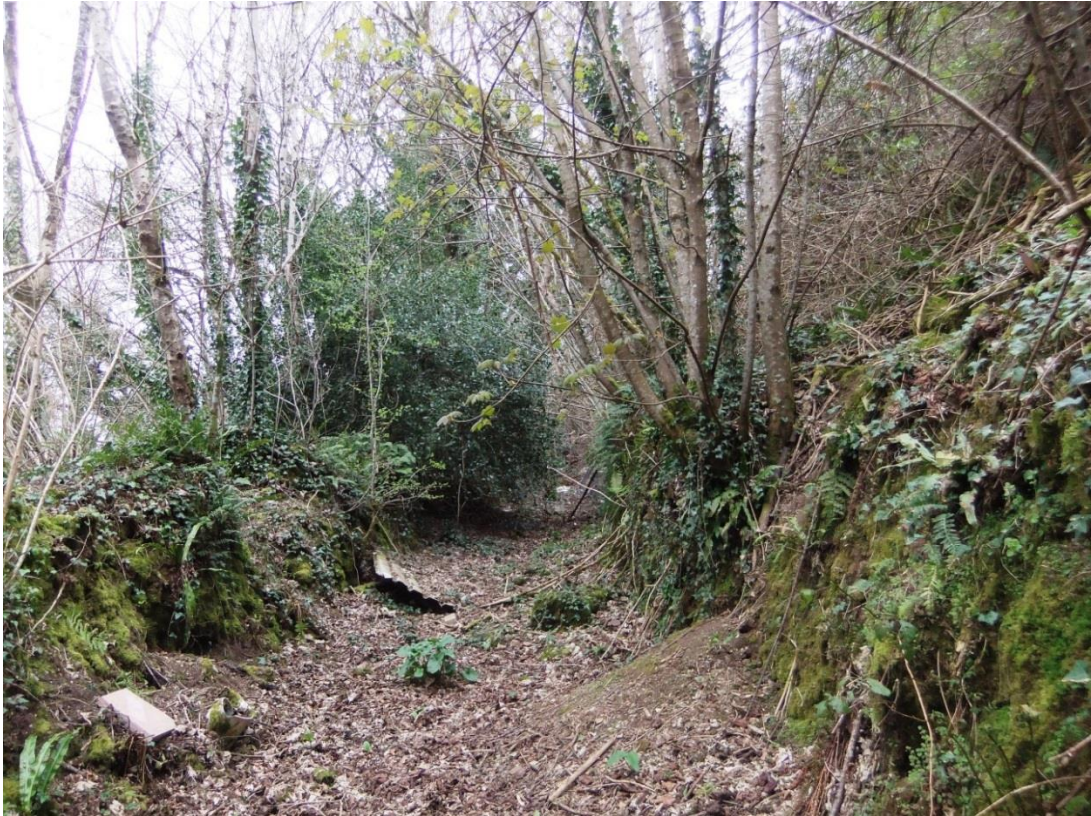
*Fig 29 A well-preserved part of Quarry Lane in Area 9. The lane is cut into rock and only c2m wide. The quarry site shares its western boundary bank (left).*

- Area **8**. No recommendations.
- Area **9**. Ensure the development works, including any associated groundworks such as dumping, perimeter fencing, or tree felling, do not disturb or obscure the remains of the historic Quarry Lane. Again this could be achieved as part of the watching brief recommended elsewhere on the site. Ideally, consider the feasibility re-opening the lane as a footpath, as a historic route on the Launceston borough boundary, giving access to the boundstone in Area **10**; this would involve re-routing the way to the north of here, where it is overlain by the made-up ground below the Pennygillam Industrial Estate.

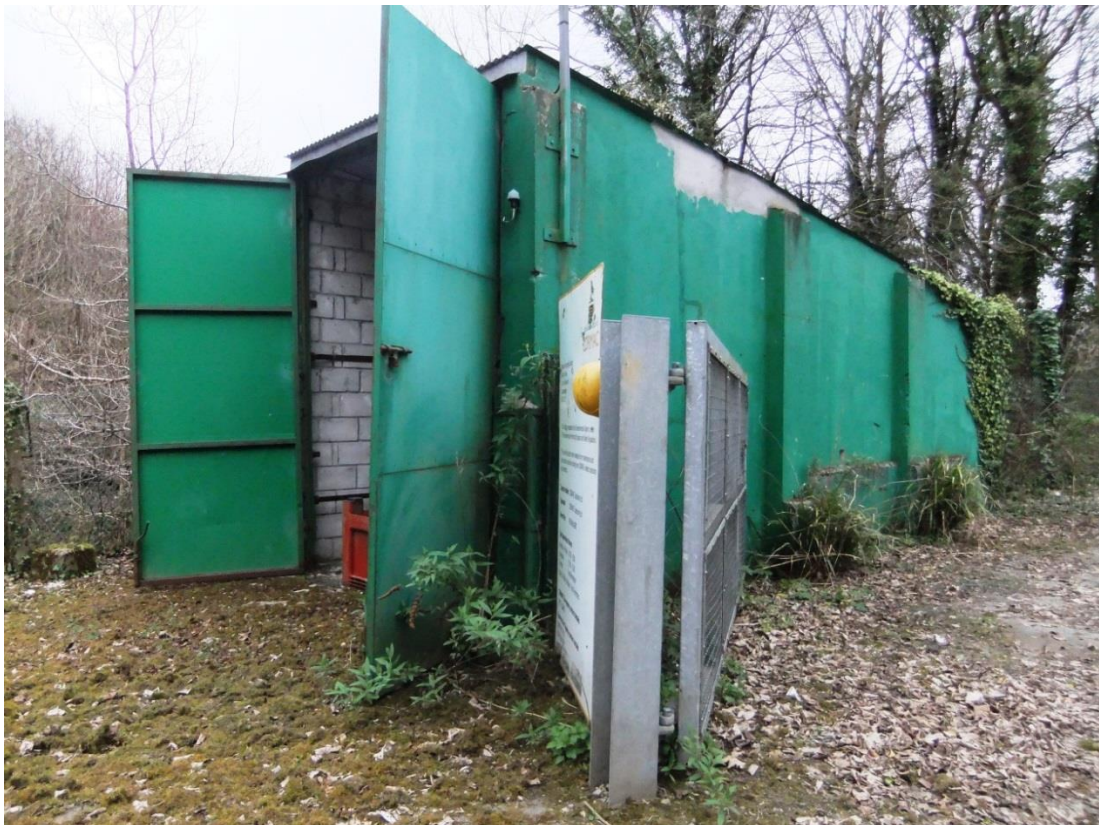
*Fig 30 Present quarry building south of the eastern entrance, probably 20th century.*
