Land at Tolvaddon Energy Park, Pool, Cornwall;
Heritage Impact Assessment

Report No: 2017R025

Client	Hydrock
Report Number	2017R025
Date	May 2017
Status	Final report
Report author(s)	Catherine Parkes BA MCIfA
Checked by	Andy Jones
Approved by	Andrew Young

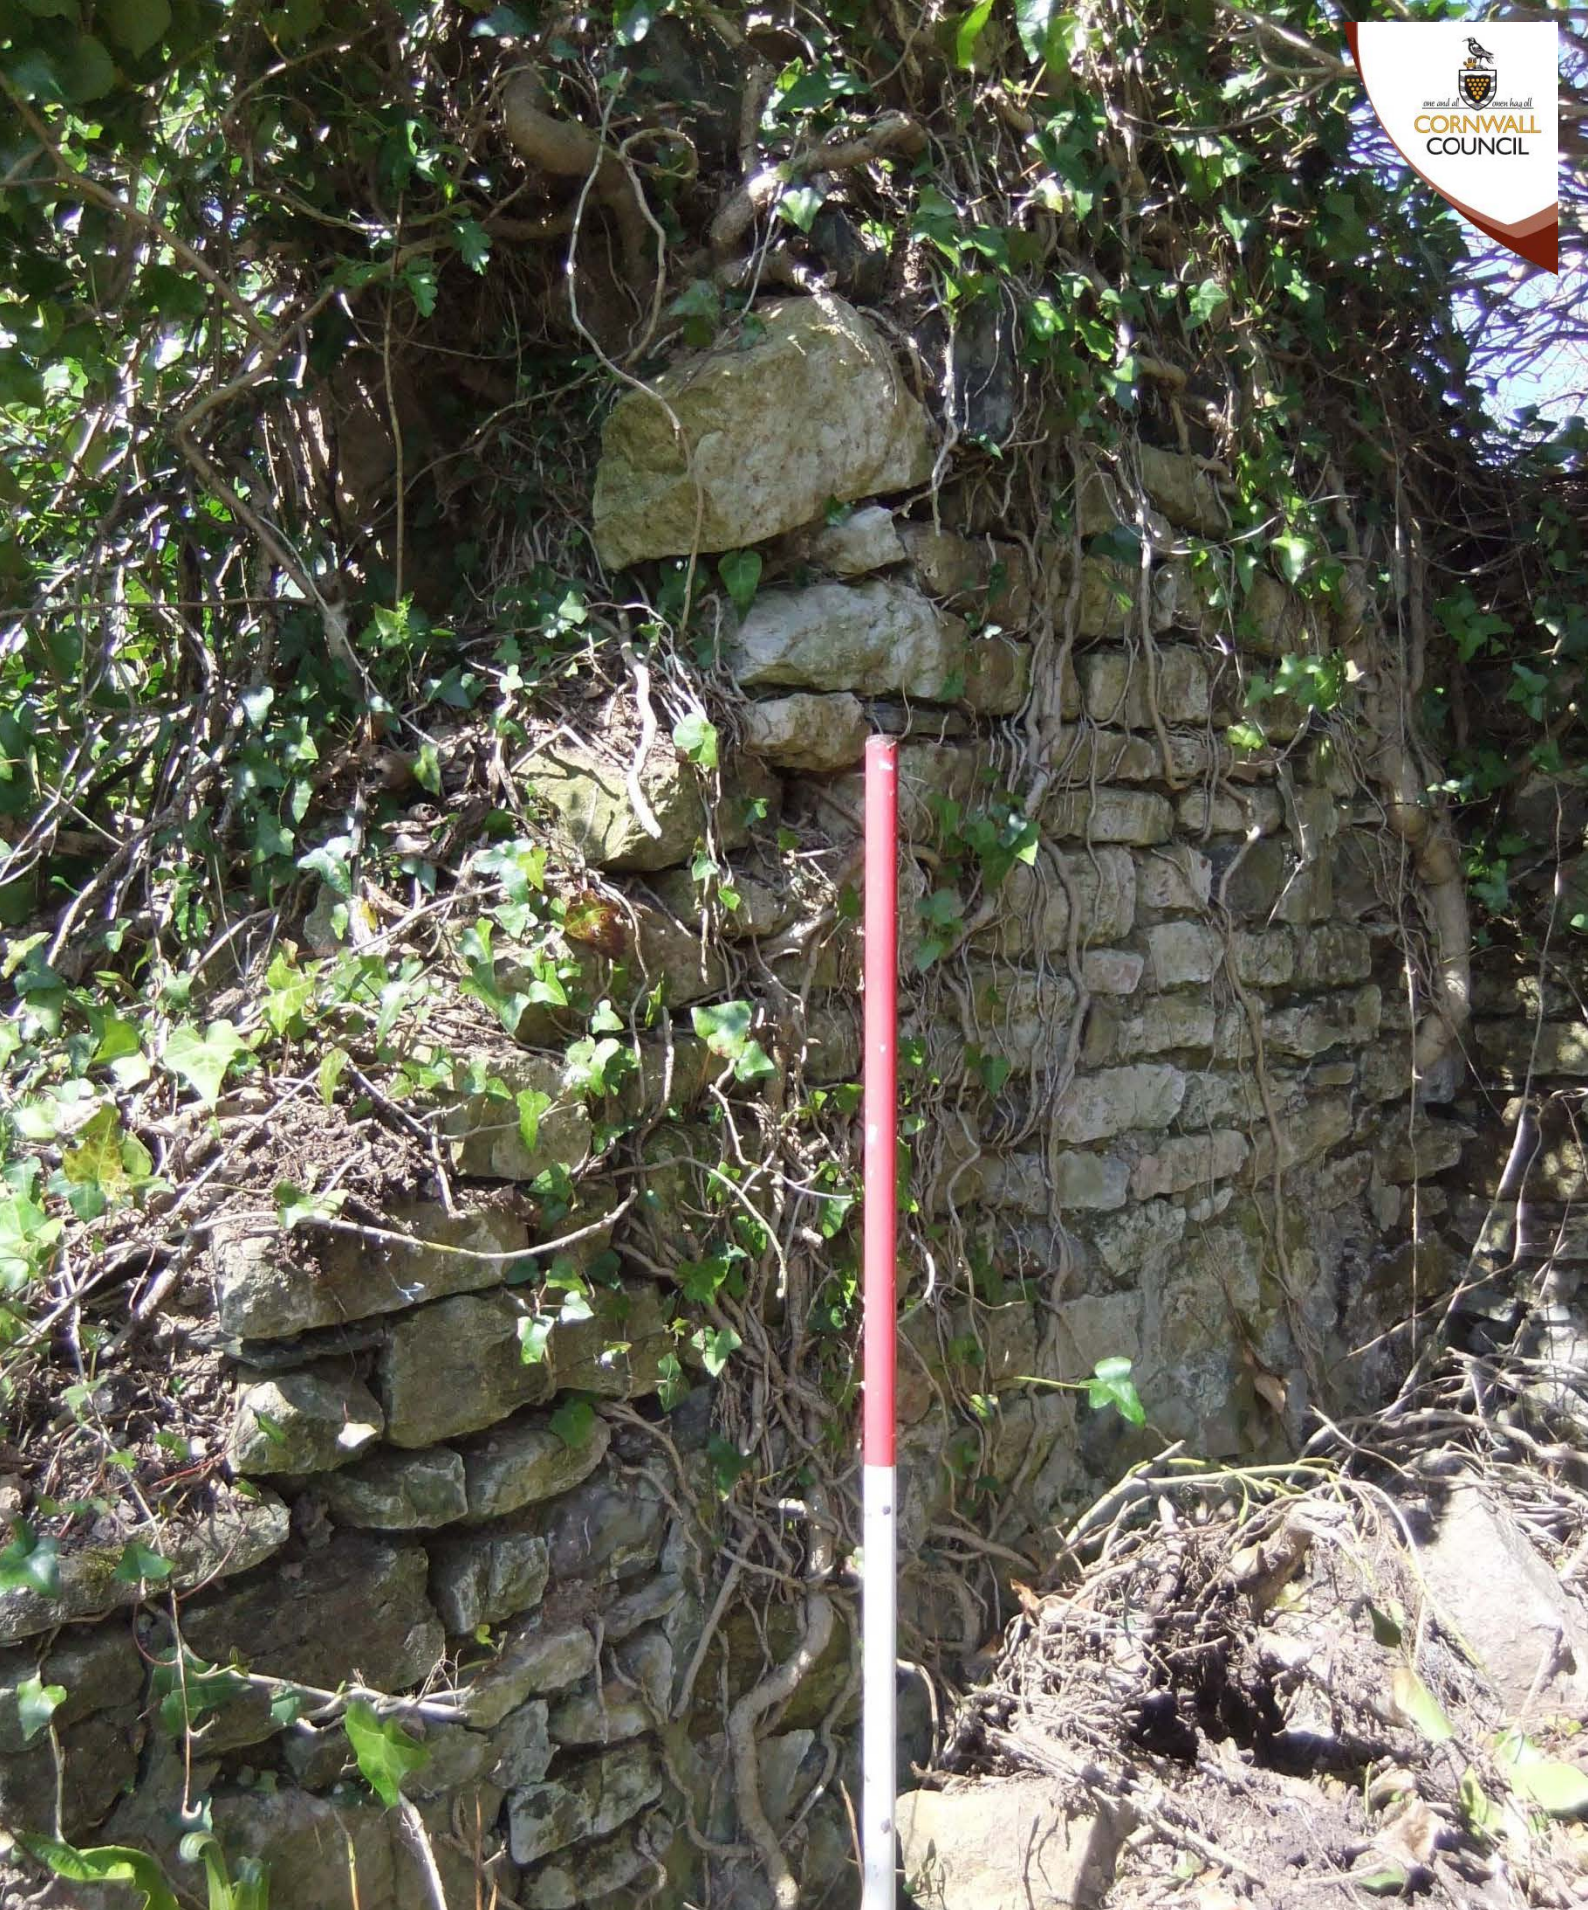
Cover illustration

Interior of west gable end of westernmost of two roofless farm buildings near the north west corner of the abandoned settlement within the proposed development area. Note the distinctive rubble used for the wall fabric, potentially a rare, very local freestone.

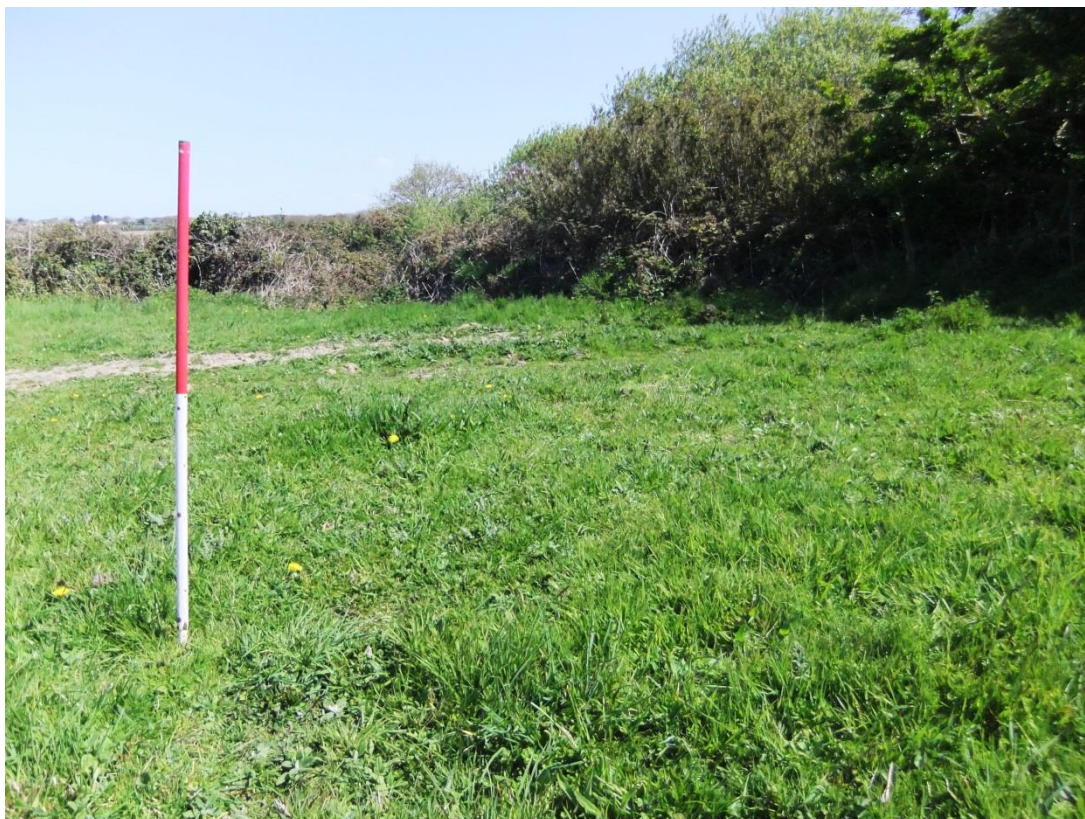
Fig 3 View across a low earthwork west of the abandoned settlement, in one of the fields forming Site 1, looking NNE. The 1m scale marks the edge of the feature.

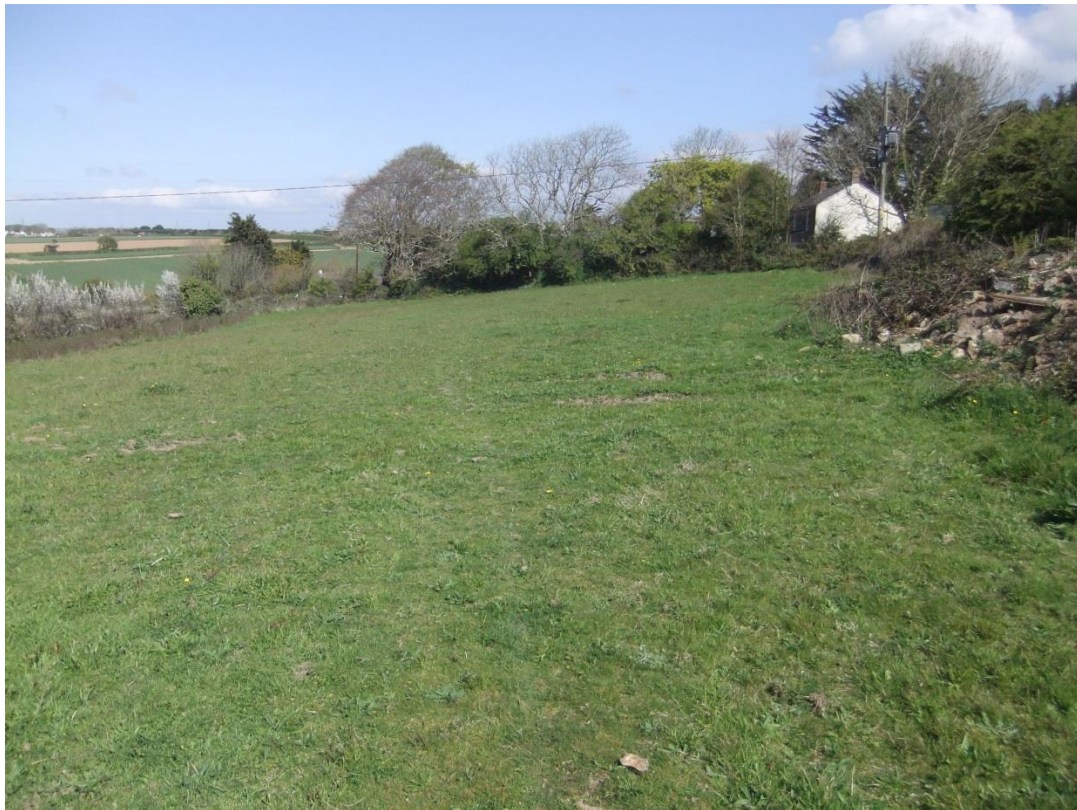
Fig 4 Eastern field showing the typical character of the study area, with dump Site 10 on the south (right), and the neighbouring smallholding of Mount Pleasant beyond.

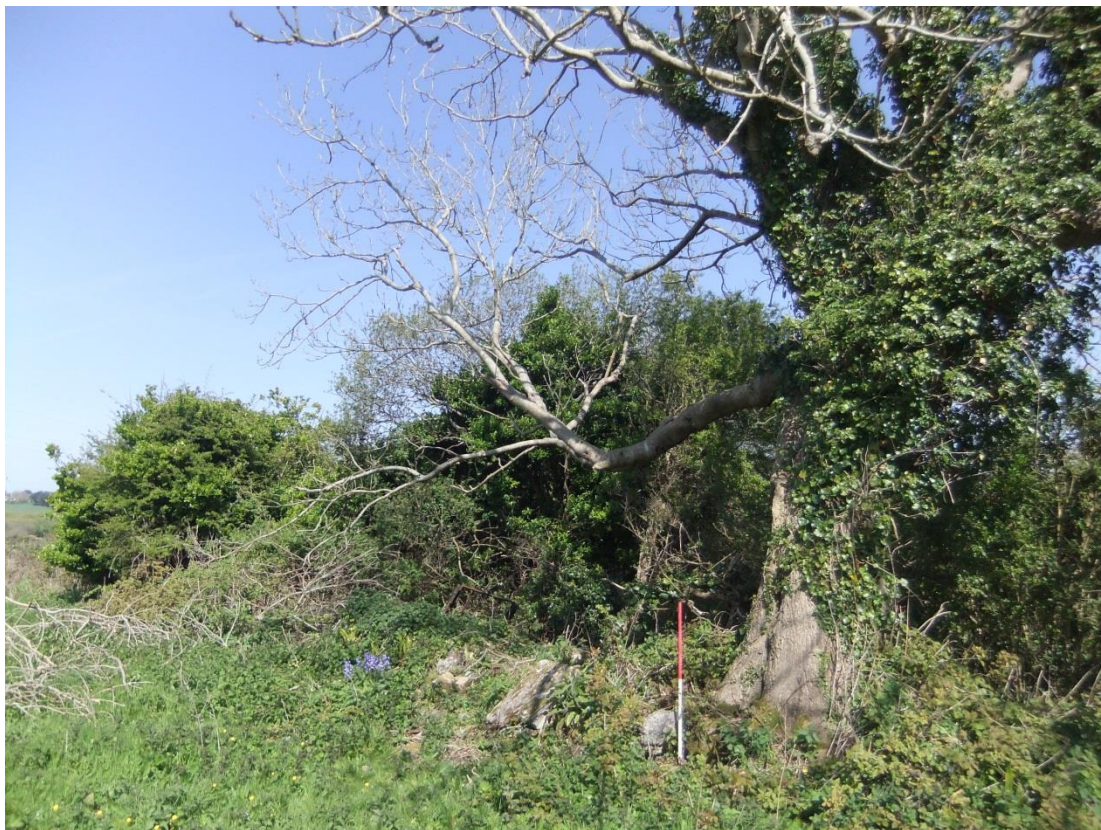
The field boundaries are typically hedge banks c1m-2m wide and 1m high (Fig 5), with earthy cores, and battered faces of vertically set local rubble stone including slate, granite and quartz. (Herringbone facing to the hedge on the north west reflects the realignment of the boundary there associated with road improvements.) A recess in the roadside boundary on the north marks the gateway to the settlement, blocked with hedging. Many original granite gateposts survive, both *in situ* and displaced. They have generous proportions and are shaped irregularly but well with square or rectangular sections, and sometimes with rounded heads, and have features including wedge-splitting and iron gate fixings in broad drill holes, consistent with a date before c1800.

Fig 5 Bank west of cottage Site 3, with old ash tree, and possible well cover left of this.

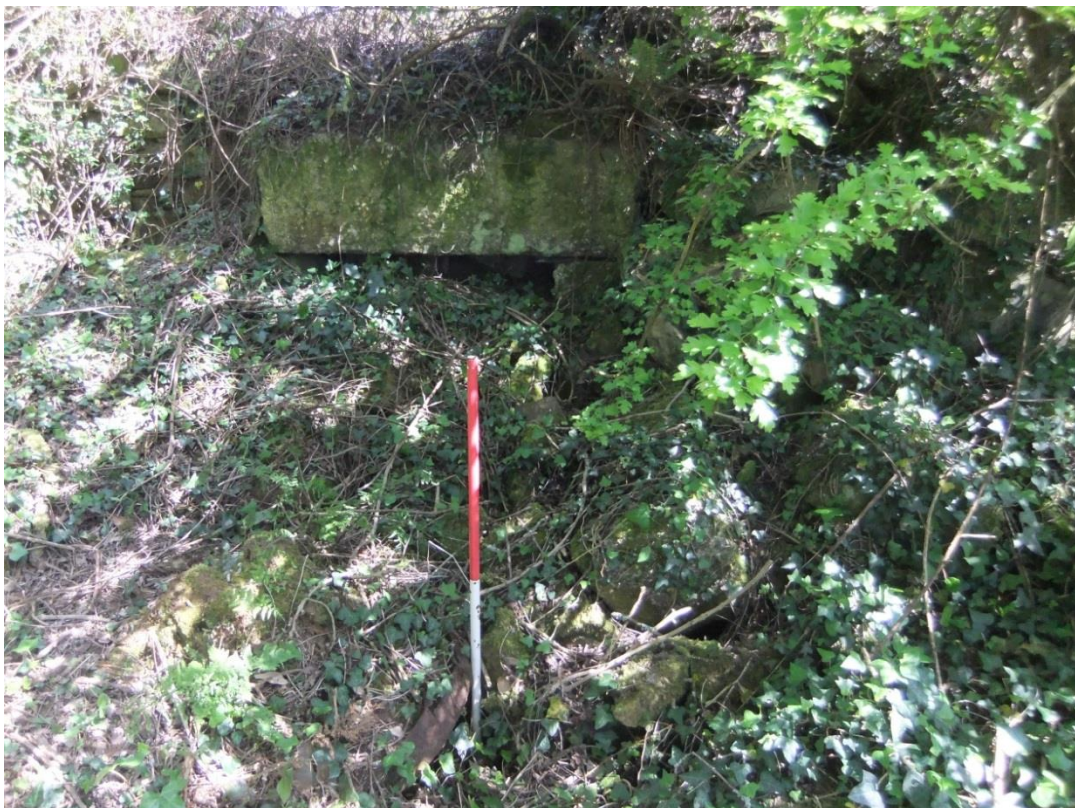
The cottage at **Site 3** is approximately 8m square. It has lost its roof and much of it is concealed by tumbled fabric and by vegetation, but it has substantial survival of walling around 1m wide to a height of c1.3m or more and may retain features relatively undisturbed under rubble. Large worked granite blocks survive both *in situ*, notably at the east end where they form a fireplace, and in tumble (Fig 6). Other masonry includes roughly shaped blocks of pale freestone. This may be the 'free-stone raised on Illogan downs, of which the eastern front of Tehidy House....is mostly built' recorded in the mid-18th century (Borlase 1758, 95).

Fig 6 East end of cottage Site 3 with massive granite blocks probably forming the fireplace.

Note the depth of rubble sealing the base of the building, indicated by the 1m scale.

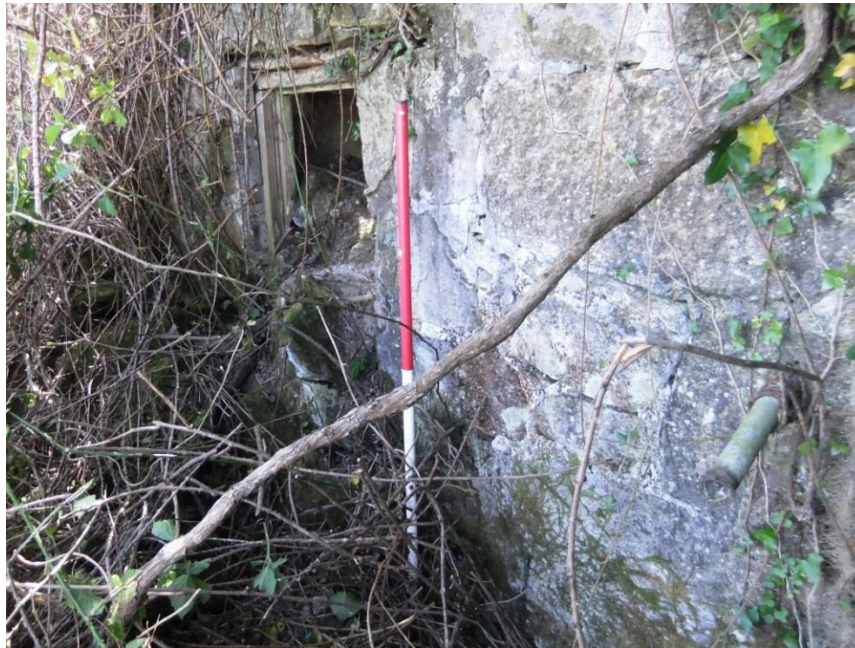
The adjoining **Site 4** was obscured and inaccessible at the time of the walkover due to dense scrub. Part of the exterior of the east gable was visible, with walling rising to c3m high, featuring a window opening, and signs of extension to the north (Fig 7).

Fig 7 East end of the overgrown dwelling at Site 4, showing potential for recording.

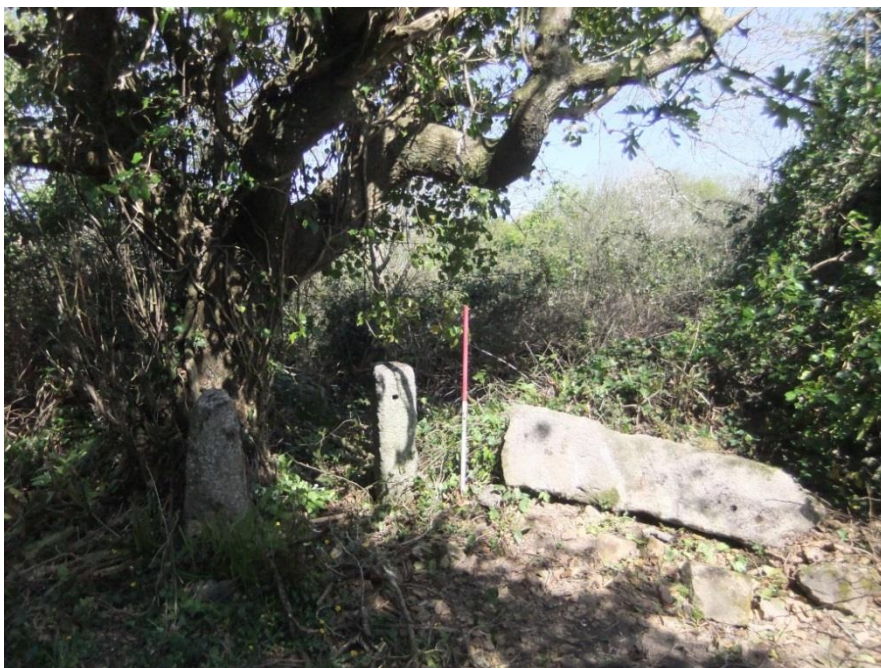
The 1806 plan also depicts an enclosure on the north of the settlement, subdivided between the mapping of 1840 and that of 1880 to form plots at **Site 5** and **Site 8** and a farmyard with outbuildings at **Site 6** and **Site 7**. The two small outbuildings are reduced in places but largely survive to roof height showing they were single-storey structures made of the pale freestone used in the cottage at **Site 2** (cover photo). The plots around them have generally well-preserved boundaries with facing of local rubble stone and substantial granite posts similar to those in the adjoining fields noted above.

Fig 8 Granite posts, in situ and displaced, between yard Site 6 and plot Site 8 (from south).

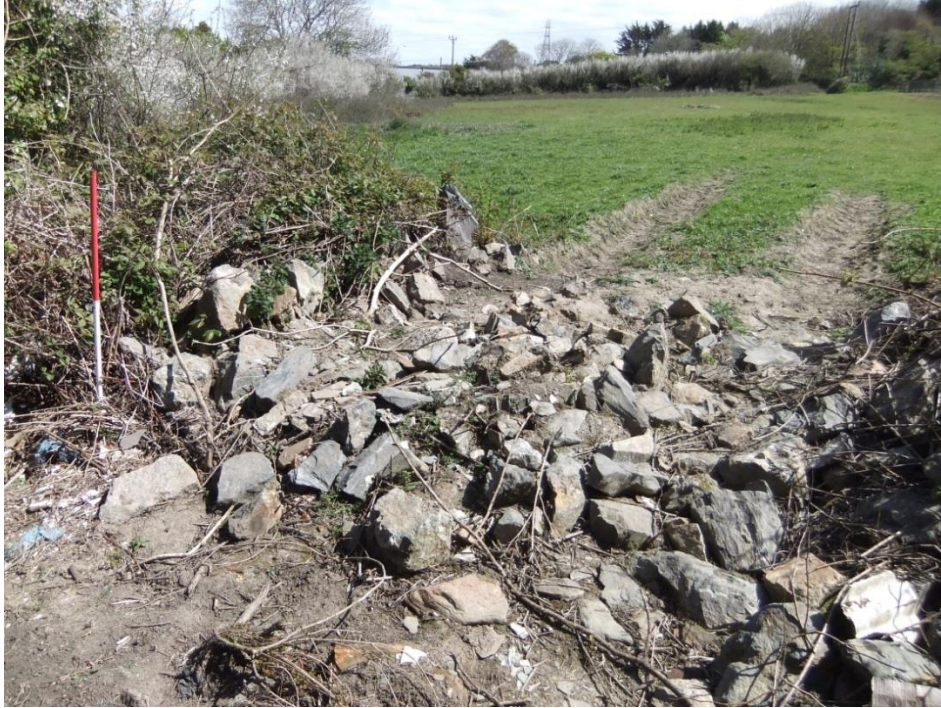
Some stones are displaced, and the east side of yard **Site 6** has been recently reduced and breached by machine (Figs 8 and 9). Spreads of fallen or disturbed stone here may conceal paving or other features. The plan as recorded by the 1880 map (Fig 22) indicates that the western farm building was built onto the east one, and other indications of chronology are likely to be recoverable in this overgrown and rubble-strewn area.

Fig 9 Recent damage on east of yard Site 6, with tracks aligned towards dump Site 10.

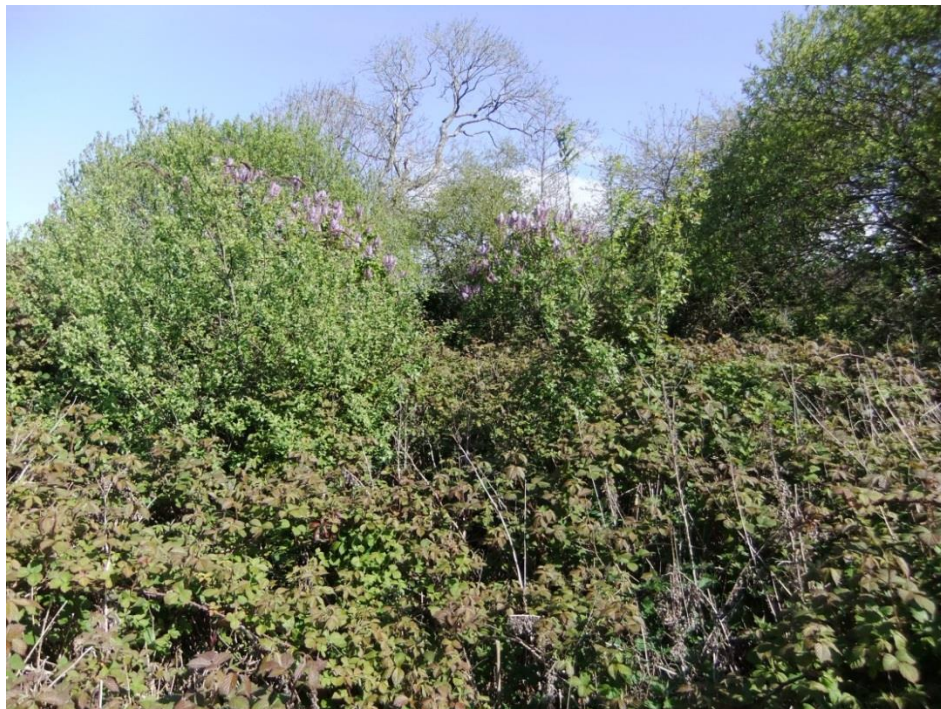
A lane from the road on the north is blocked by a hedge bank. The enclosures to either side at **Site 5** and **Site 8** are overgrown, but **Site 5** is clearly a garden (Fig 10).

Fig 10 Front garden Site 5 from the west, showing mature shrubs as well as brambles.

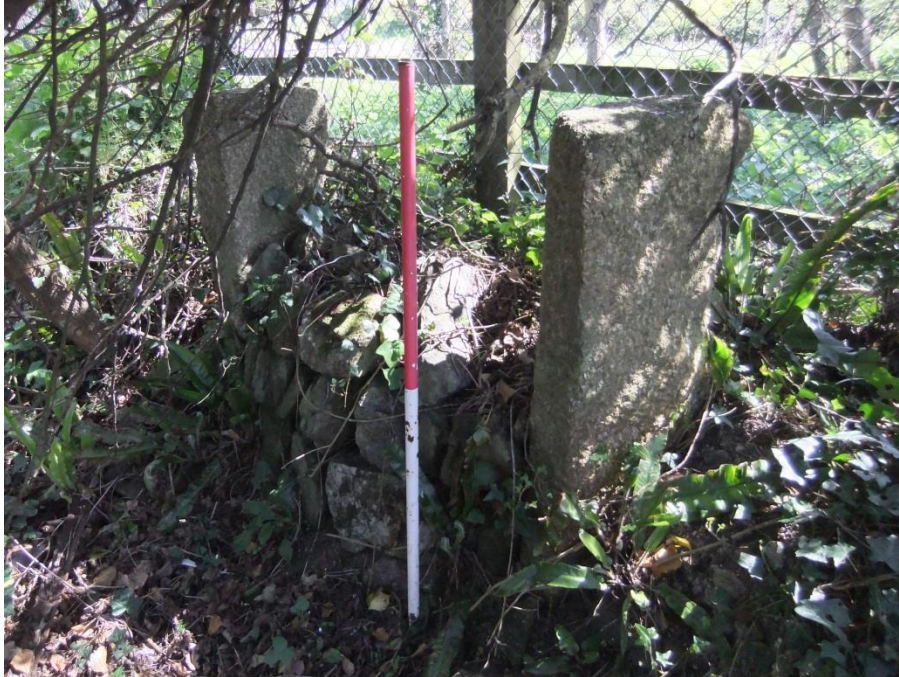
The 1840 plan records a secondary enclosure south of the settlement. By the time of the 1880 map this was split into two gardens running north-south (**Site 2**), with a pair of privies, and a pigsty or other shed in the far corner on the east side. This area is overgrown and partly obscured by small-scale but quite numerous modern deposits of garden waste, plastic, corrugated iron and the like. However, most of its external boundary bank survives, including a small gateway with granite posts at the east side of the south end of the western garden (Fig 11). The posts are slighter and more regular than those used for the earlier cottage enclosures, reflecting a later date.

Fig 11 Inner, north side of gateway at south end of subdivided south garden, Site 2.

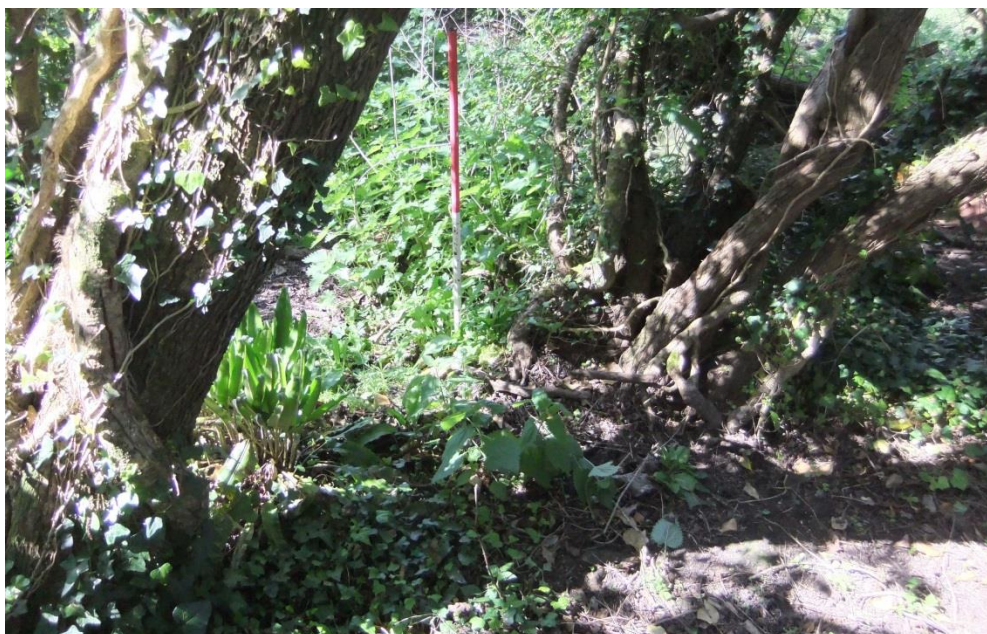
The garden interiors have overgrown shrubs marking a living hedge between them (Fig 12), a spread of rubble up to c3m across and 0.7m high representing the site of the privies, and traces of the base of the corner shed, overgrown and breached on the east.

Fig 12 Living hedge and associated earthwork dividing garden Site 2, looking NNW.

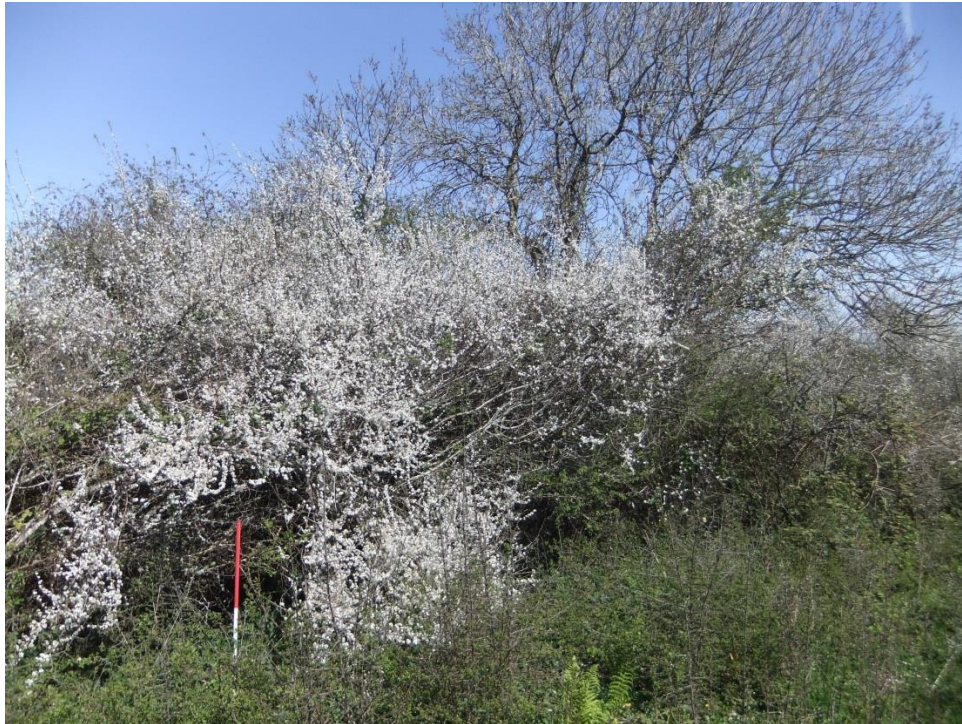
A little building on the north side of the central field at **Site 9**, shown on the 1806 map, may have been another cottage, having its own curtilage fronting the road on the north. It was removed after the first OS mapping of the district dated 1813, before the time of the tithe survey of 1840. Its site is now overgrown with dense scrub (Fig 13).

Fig 13 Site 9, with potential for remains of smallholding structures, seen from south.

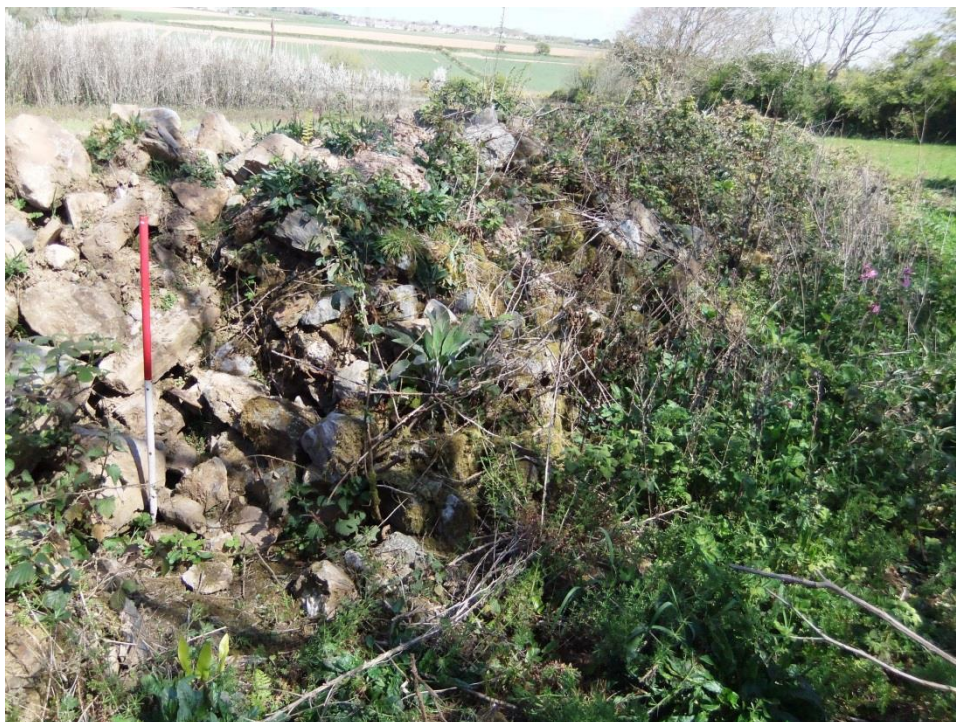
In the eastern field at **Site 10** is a linear dump running roughly east-west. It is c14m long by 3m wide and over 1m high and consists of local stone and other material including wrought iron hinges, apparently from the abandoned settlement (Fig 14).

Fig 14 Dump at Site 10; note iron hinge protruding to the right of the scale bar division.

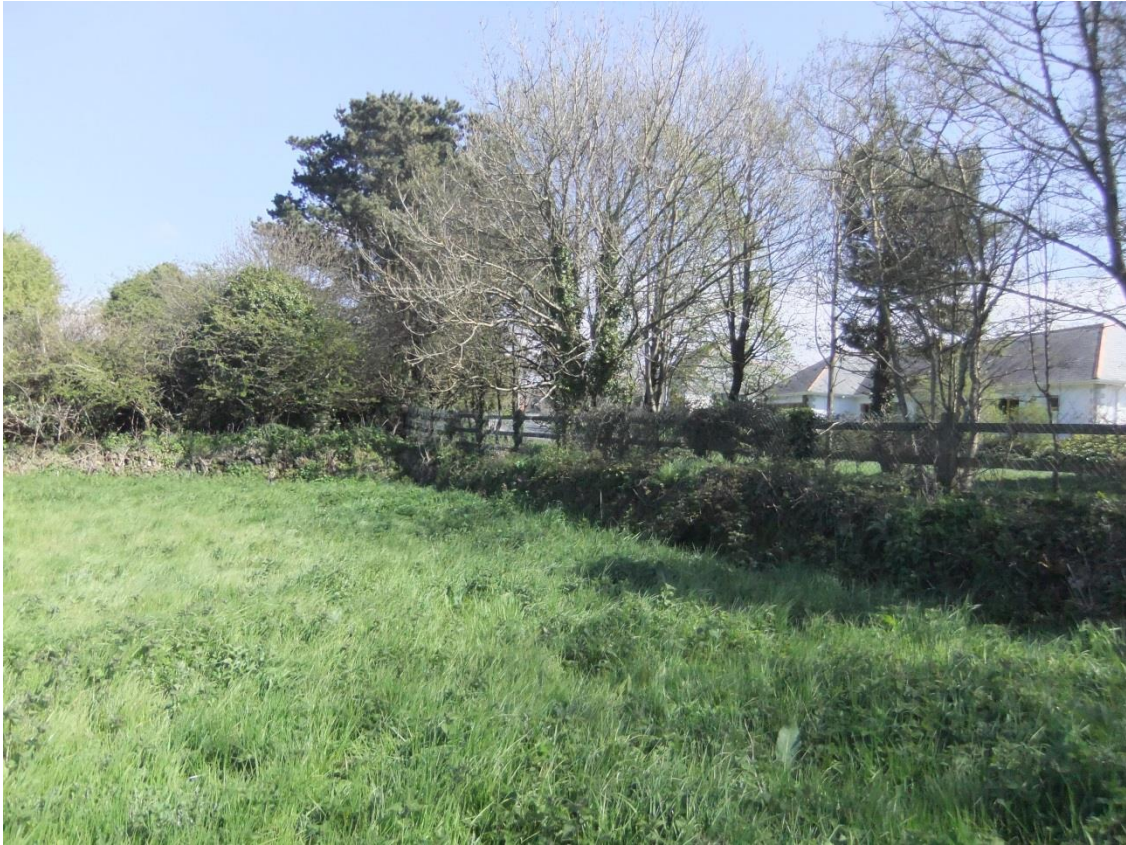
Fig 15 Limited view towards the south west from the western field (part of Site 1).

The proposed development area at Tolvaddon has no heritage designations within it. It is considered a significant element of the settings of both the WHS of international importance (containing numerous designated mines and related sites) on the south, and the nationally important Grade II Listed mansion and gardens of the Tehidy estate to the north west. It lies near, between, and on approaches to, both mining landscape and estate core, and has historic relationships with both. Miners' smallholdings are noted components of historic mining landscape (WHS nomination, Anon 2005, 148). Unusual, specific documentation records their promotion during the 18th century to house miners in this locality by the lords of Tehidy, who improved the estate with funds from mines partly now in the WHS. Connections with Tehidy may be legible at the site itself, through the use of building stone similar to that used in the Georgian mansion there. The location, on a fairly flat-topped ridge, means there are no clear lines of sight between the study area and those designated complexes. However, much of the ground here offers rural views to the north, framed on the skyline by extensive 18th century and later plantations marking the vast ornamental park of Tehidy (Figs 15 and 16).

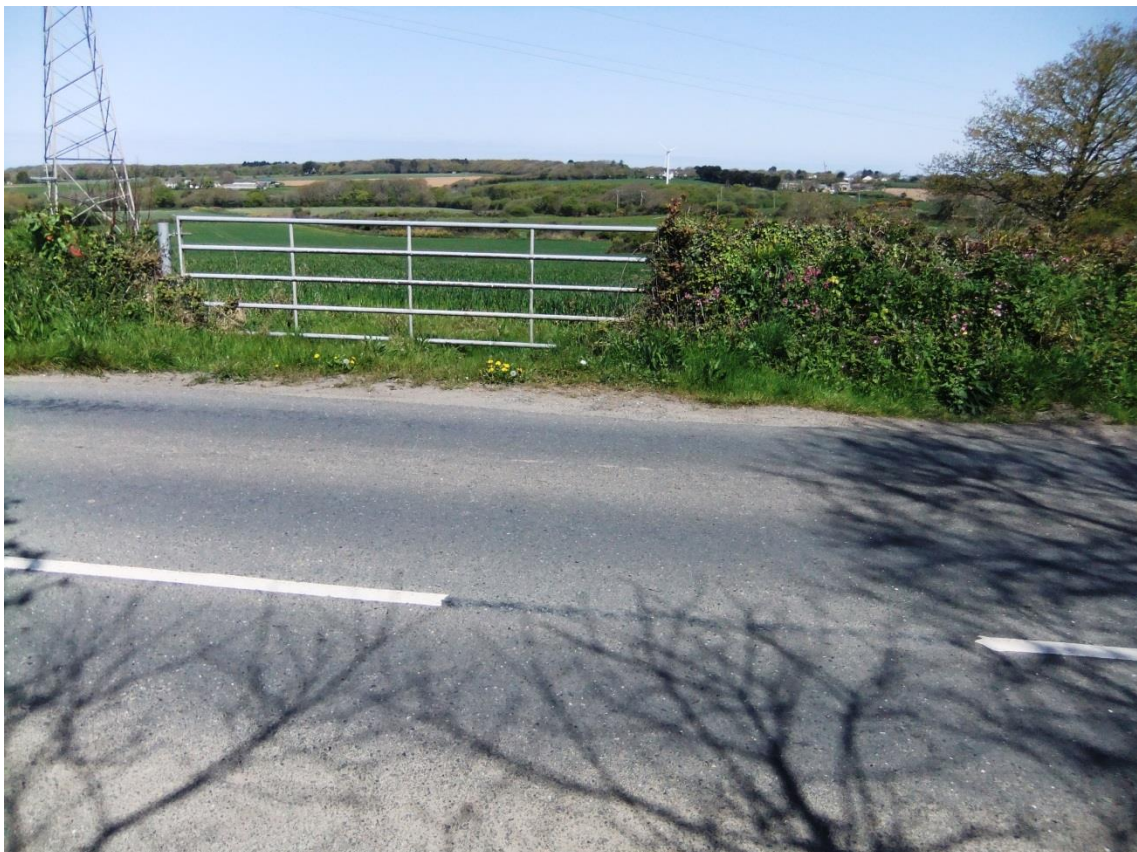
Fig 16 Wider view north from the hedge of the western field, framed by Tehidy woods.

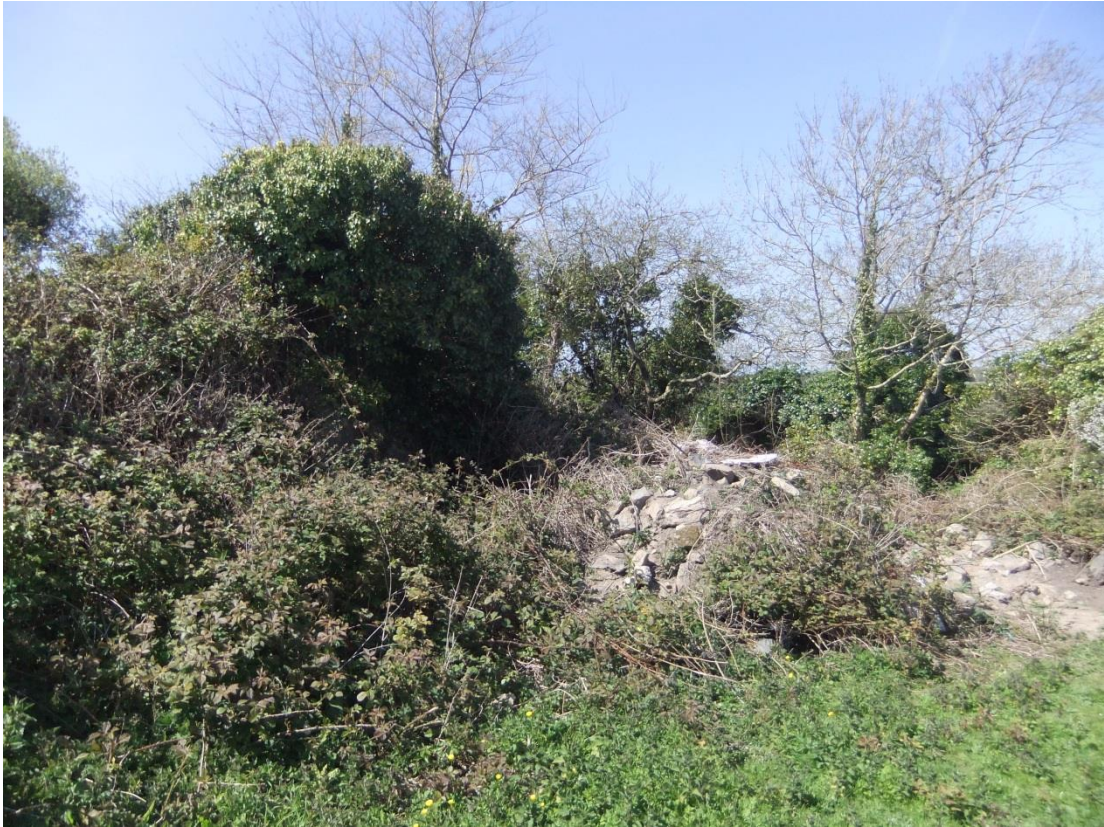
Fig 17 View from the south of the east sides of cottage Site 4 (under the tall growth of ivy) and yard Site 6 (right of this), indicating their poor condition, and potential.

The proposed development would have an adverse potential impact on the principal heritage resource of the area, that is, the abandoned smallholding. This is considered significant as an element of both the setting of Area A5i, the Camborne and Redruth Mining District, of the Cornwall and West Devon WHS, and the setting of the Grade II LBs of Tehidy House. Impacts would include loss of the open land of the smallholding with its sub-divisions (**Site 1**), and removal, truncation, disturbance or levelling of the upstanding and buried remains of its cottages and related buildings, enclosures and associated route-ways (**Site 2 – Site 9**). It should be noted, though, that the remains of the settlement are in poor condition; the standing buildings are roofless and most of their walling is reduced.

- Full recording at appropriate levels of detail for the remains of the settlement, through building survey. This work should involve research on potential documentation for the site, in the Tehidy archives at CRO, for example (**Site 2–Site 9**). (In the event that the settlement remains or components are preserved or restored as recommended in Section 8.1 above, the results of the building survey should be used to inform this process with archaeological guidance; see further below.)

- Archaeological guidance and watching brief for restoration of the main settlement site to stable condition or appropriate new use, should this be undertaken as recommended in Section 8.1 above (**Site 2–Site 8**).

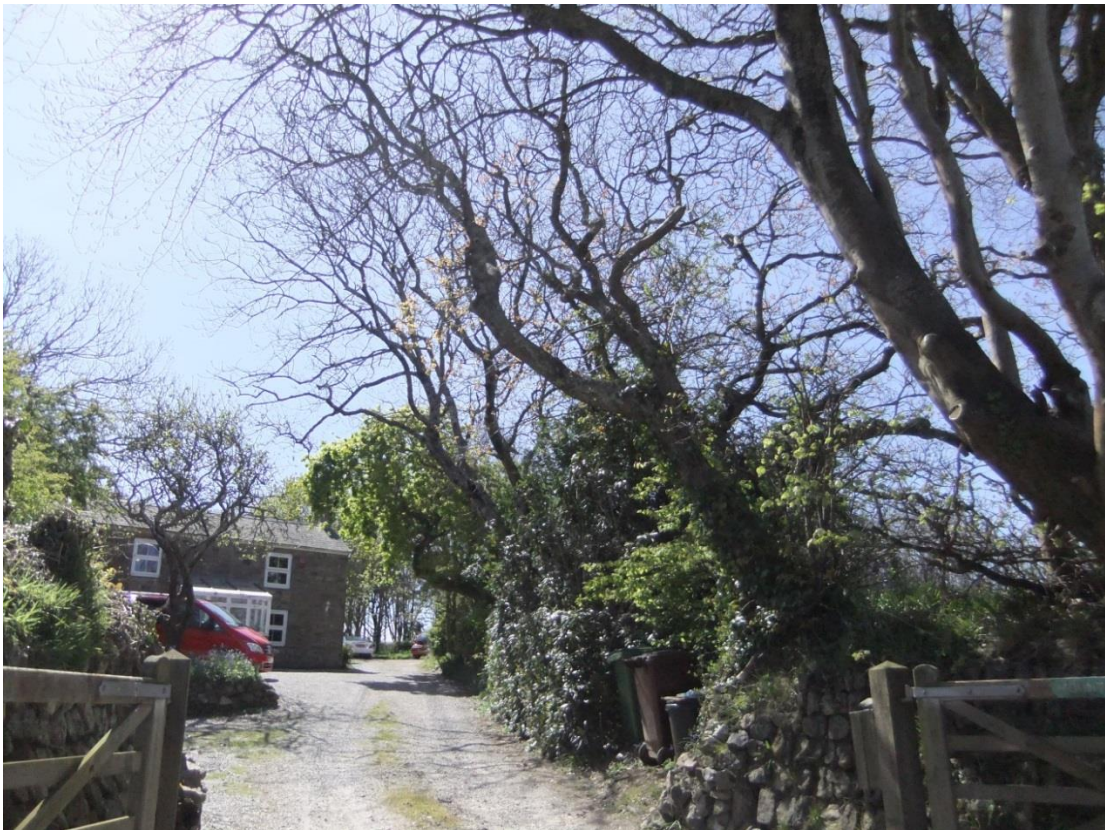
Fig 18 Mount Pleasant on the west, showing the character of a smallholding still in use.

Hedgerow trees include a large mature ash growing from the base of the bank bounding the settlement on the west, on the farmland/downland edge of the turn of the 19th century (Fig 5). Mature oak and beech, marked as individual trees on the highly detailed 1880 OS map, survive on the eastern boundary against Mount Pleasant, which also has long-established hedgerow flora including primrose and bluebell (Fig 18).

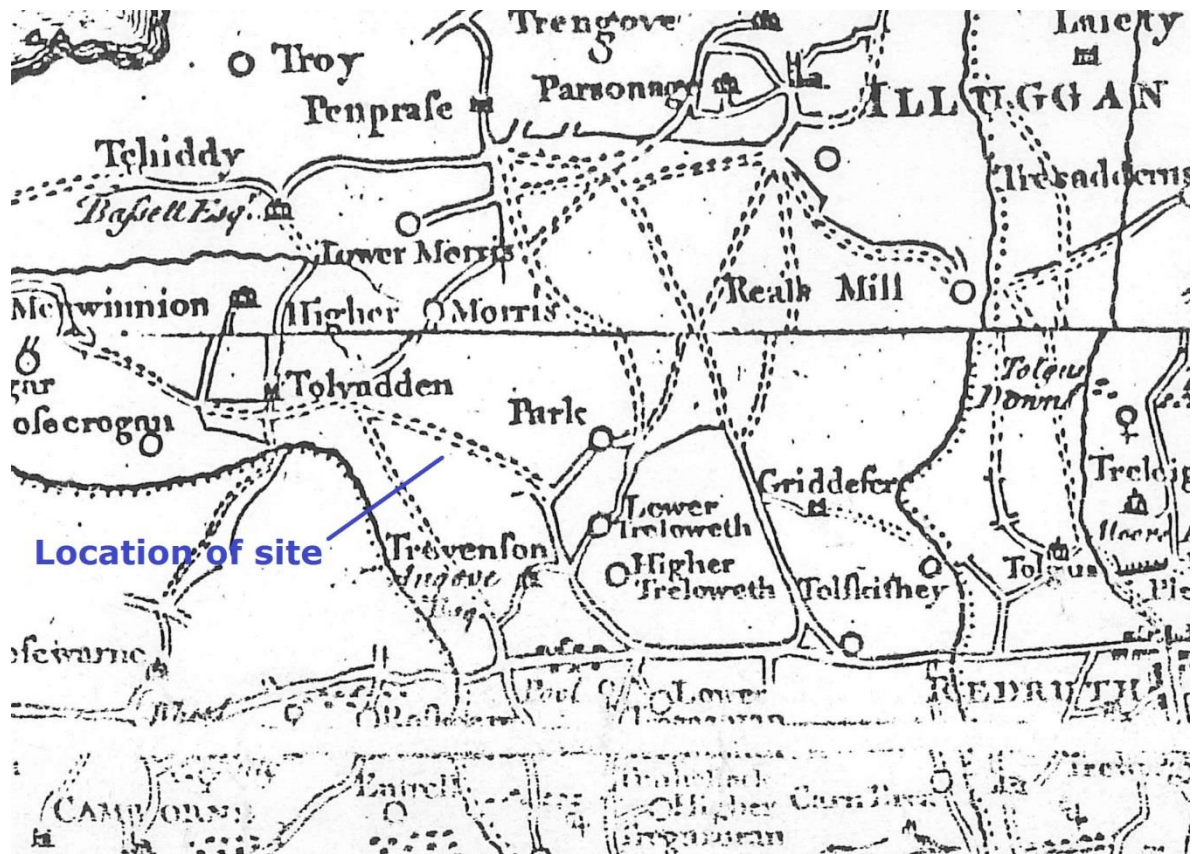
Fig 19 The area as it appears on Martyn's map of 1748. The road bounding the study area on the north is marked with broken lines, showing it lay in open downland.

In more recent centuries the downland is recorded as part of the manor of Great Nancecuke, part of the greater estate of Tehidy. The down is clearly indicated, on Martyn's map of 1748, through the use of dashed lines denoting open tracks leading through the rough ground (Fig 19). These tracks included the route running along the ridge which became the road now defining the north side of the study area. The down was a common, used as rough pasture, as documented in a lease of Tolvaddon dated 9 Nov 1700 (CRO B/1/21/123). By the middle of the 18th century parts of the common were rented out for small enclosures and associated new dwellings. Leases of Little Tolvaddon with rights to a croft or rough field of around five acres survive from 1721 (CRO B/1/21/124); further study could establish where such tenements lay.

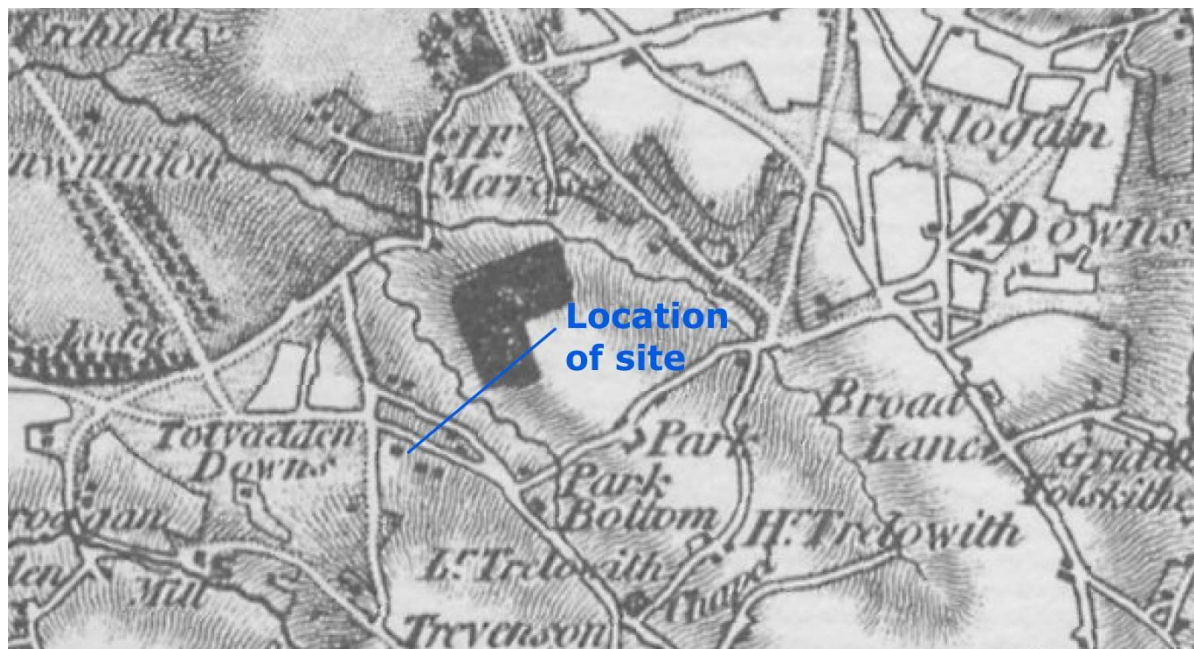
Fig 20 First edition OS map, 1813, recording the two cottages on the site, later abandoned, together with a third immediately east at Mount Pleasant, still occupied.

Note also the depiction of Tolvaddon Downs, west of the site; the tree-lined approach to Tehidy House running north from there; and Illogan Downs to the east, possible source of the stone used in construction of the cottage settlement at the site.

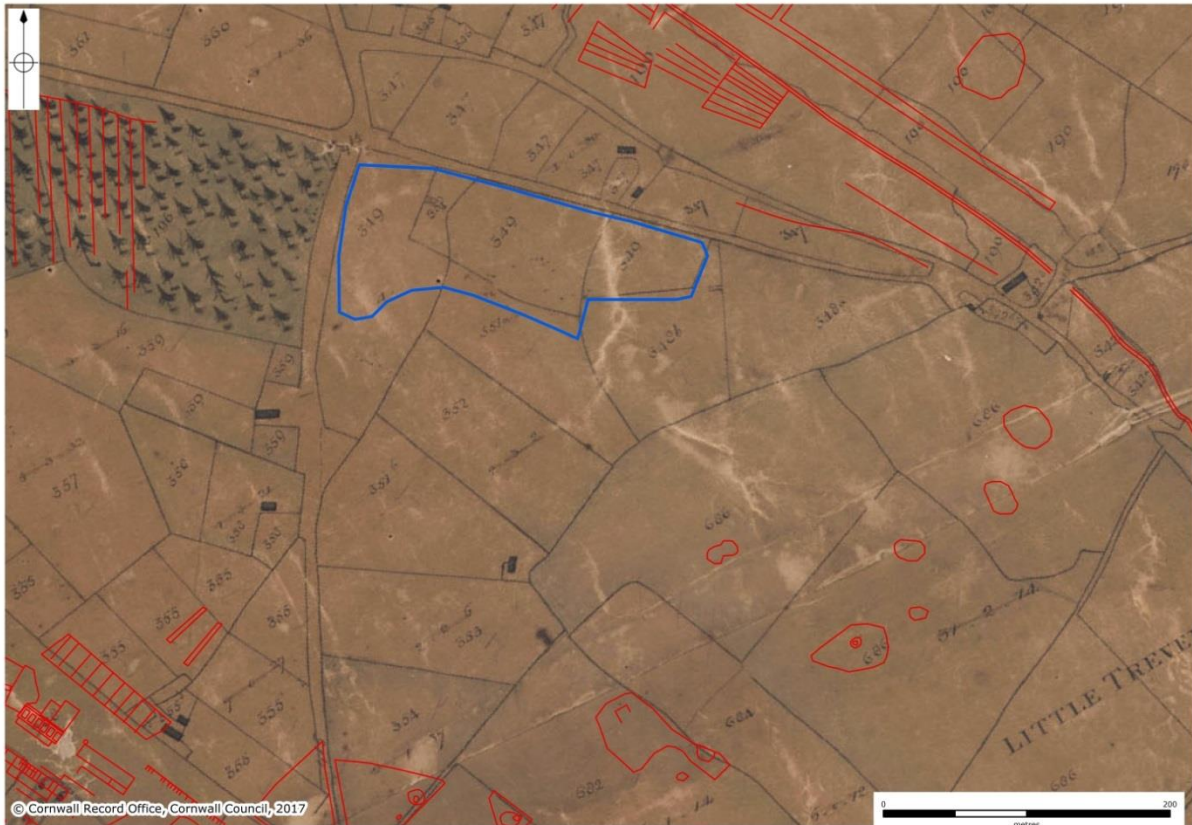
Fig 21 Tithe map, 1840, with NMP plot in red. Site 9 has gone, while Site 2 is enclosed.

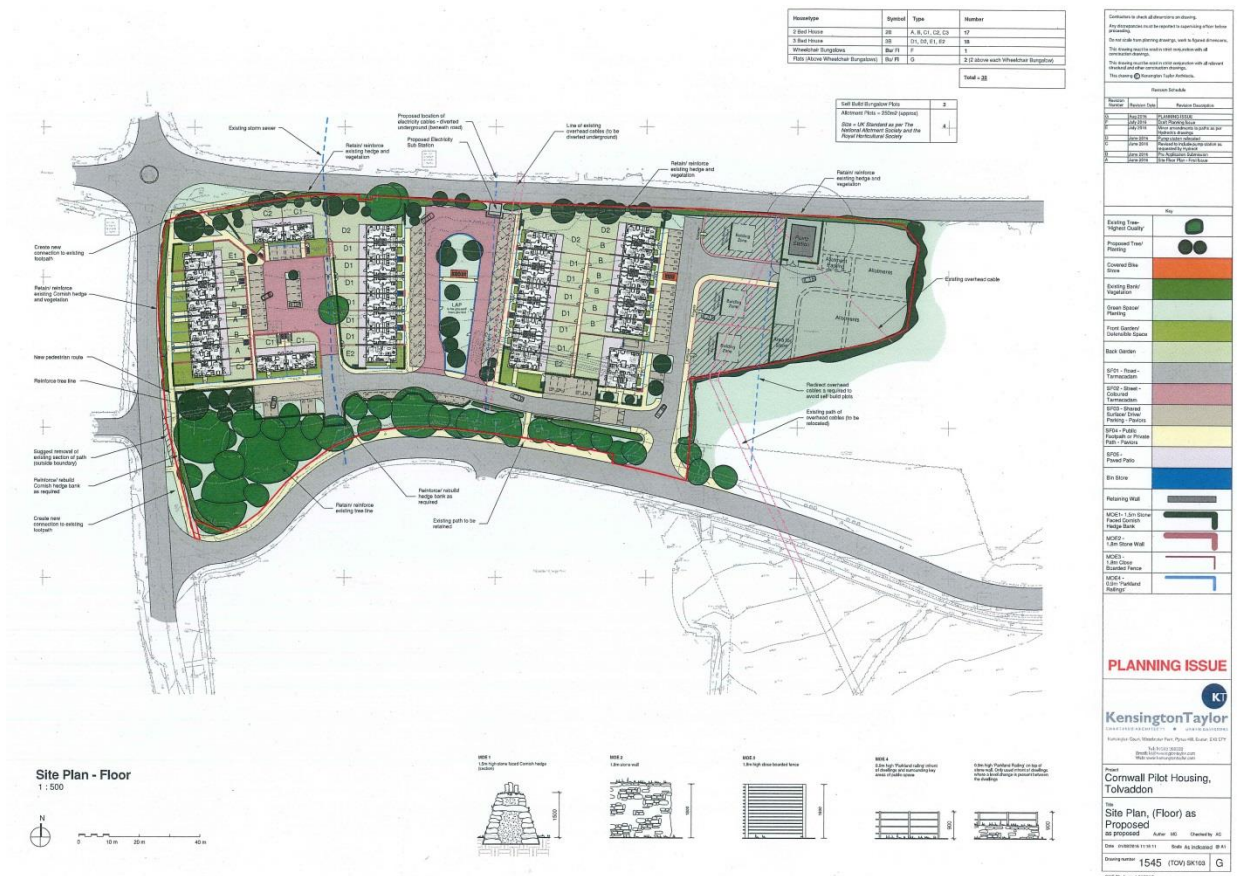
Fig 26 Plan of proposed development

The planning proposal is for a residential development of approximately 40 units largely in linear arrangements running north-south; together with related small plots, larger parking areas, access ways, services and other infrastructure including pumping station and electricity substation, and allotments at the east end of the property covering around half of the existing small eastern field (Fig 26).

The works would entail ground disturbance across most of the area. The proposed plan does not indicate retention or respecting of historic structures or earthworks within the area. The plan does show a large tree near the centre of the existing boundary dividing the central and western fields; this would appear to be the existing, old ash in that position, but this is not specified. Plan labels indicate 'retention/reinforcement of existing hedges and vegetation' on the external boundaries to the north, south and west sides; the proposed outer hedgerow on the east appears to be the existing one, judging from its line on the plan, but this is not labelled as such.
