Bude Holiday Resort, Maer, Bude-Stratton, Cornwall
Archaeological Watching Brief

Report No: 2017R026

Archaeological Watching Brief

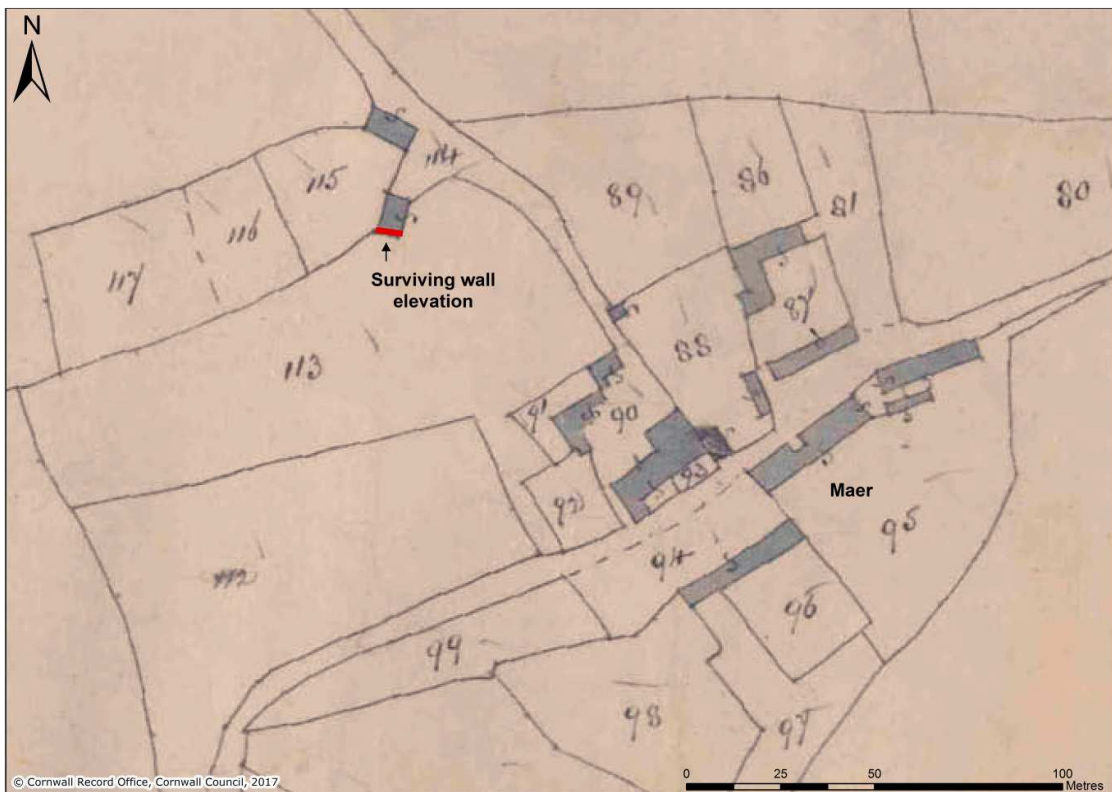
Figure 4 Poughill Tithe Map, c1840 (with Structure 1 walling shown in red).

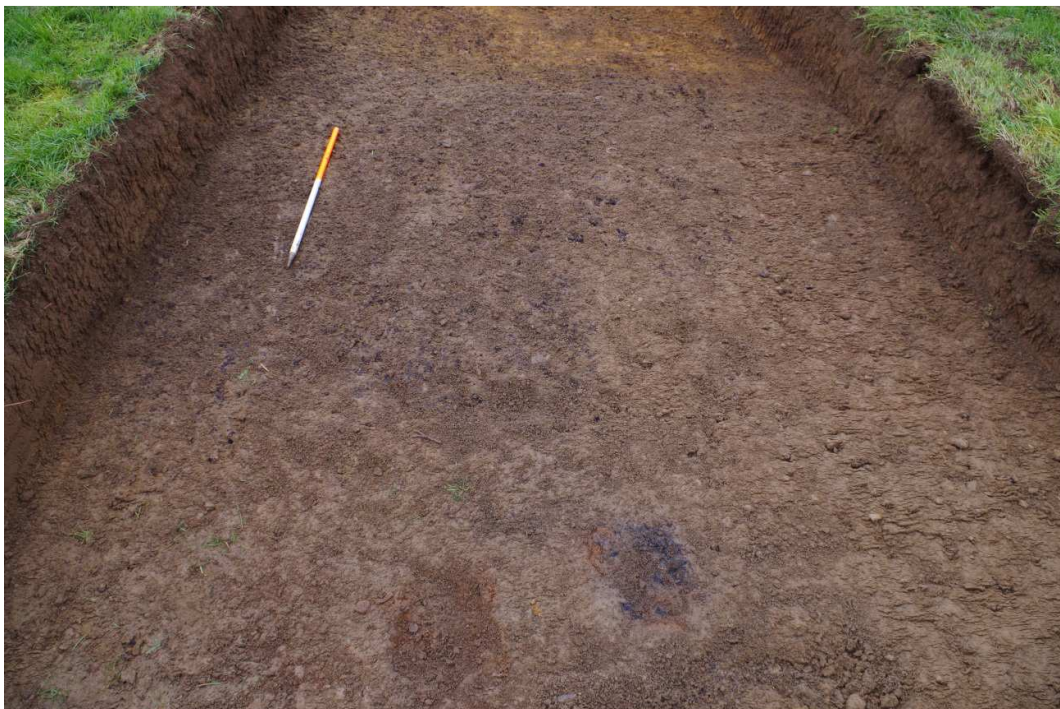
Across Field 1 the digging out for the access roads revealed charcoal scatters alongside two concentrated areas of possible burning (**Burnt Areas 1 and 2**). The burnt areas and charcoal were located above the upper horizon of the subsoil and within the base of the topsoil, often combined with a halo of burnt soil (Figs 9 and 10). Two small burnt pits to the south of **Burnt Area 1**, Field 1, were found to contain unidentified ironwork and part of a modern carbide battery. No other features or finds were recorded in association with **Burnt Areas 1 and 2** (Fig 15) and it is unclear what activity these relate to, although an agricultural origin seems most likely.

Figure 9 Burnt Area 1, Field 1, looking north.

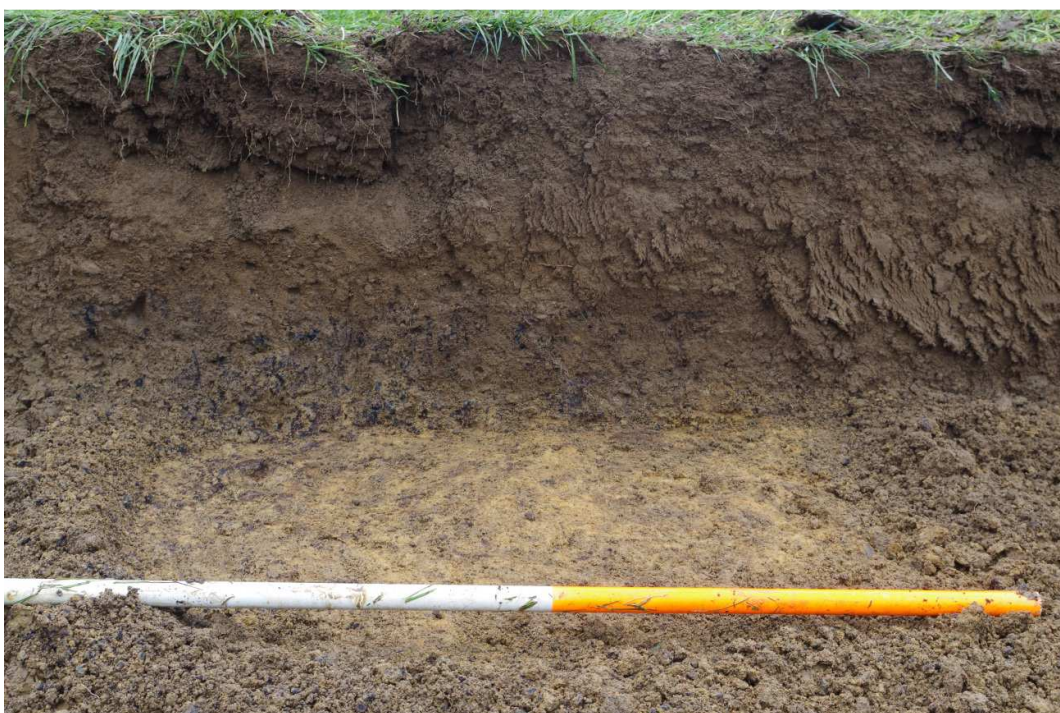
Figure 10 Burnt Area 1, Field 1, seen in section, looking west.

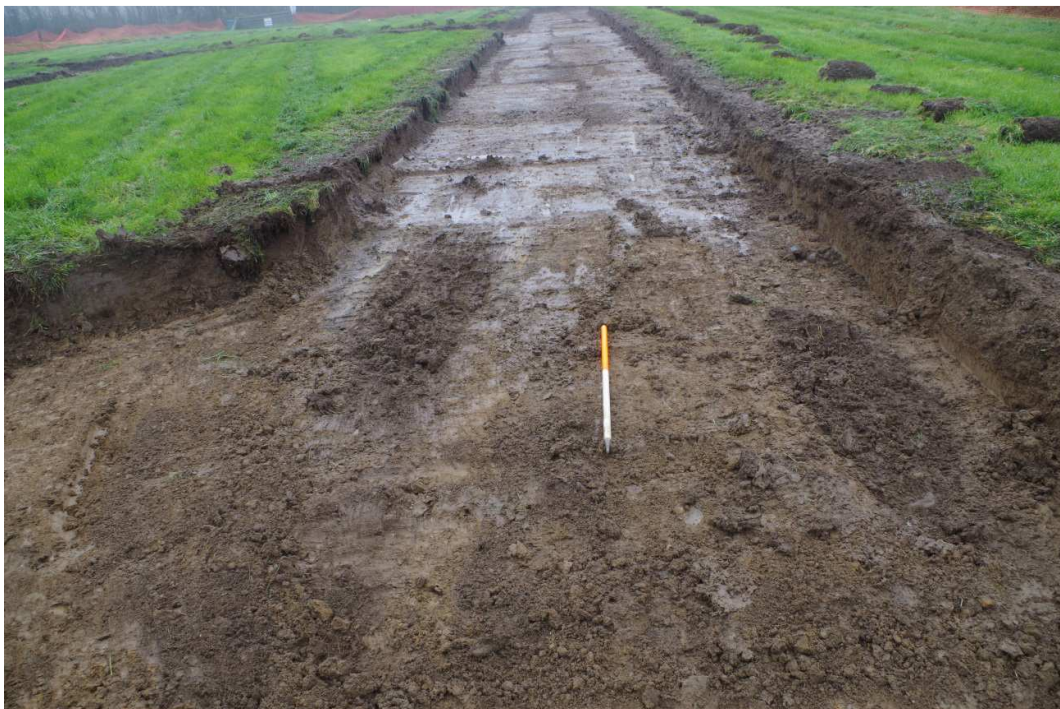
A series of parallel linear features were recorded along the length of the main east to west running access road (Fig 11). These were most clearly visible in the central section and were considered to be wheel ruts. The linears were located at a depth of around 0.35m, set around 0.2m into the subsoil. They were between 0.4m and 0.6m wide and set around 1.5m apart. The linear features were not excavated but finds from these features included several large sherds of glazed red earthenware and several smooth rounded beach pebbles. The rounded pebbles may have been brought in with sand for sweetening the heavy clay soil. Other finds from these linear features included slate, fragments of butchered animal bone and a sherd of red Barnstaple Ware thought to date to the late 18th century.

Figure 11 Linear wheel ruts, Field 1, looking west.

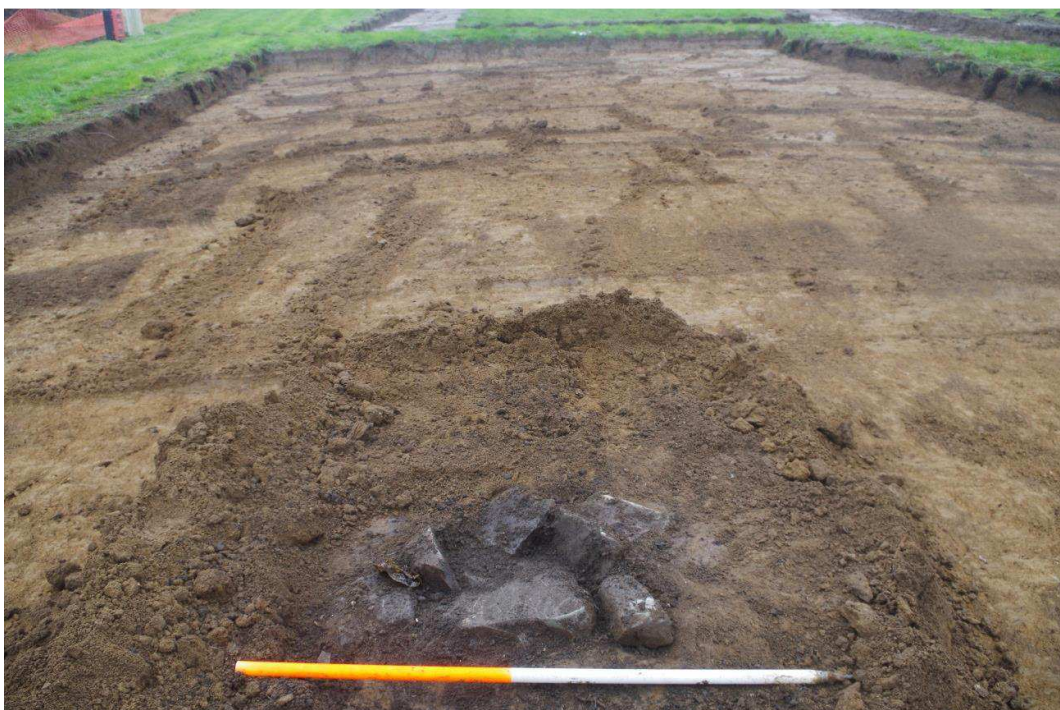
Figure 12 20th century campfire, Field 1, looking west.

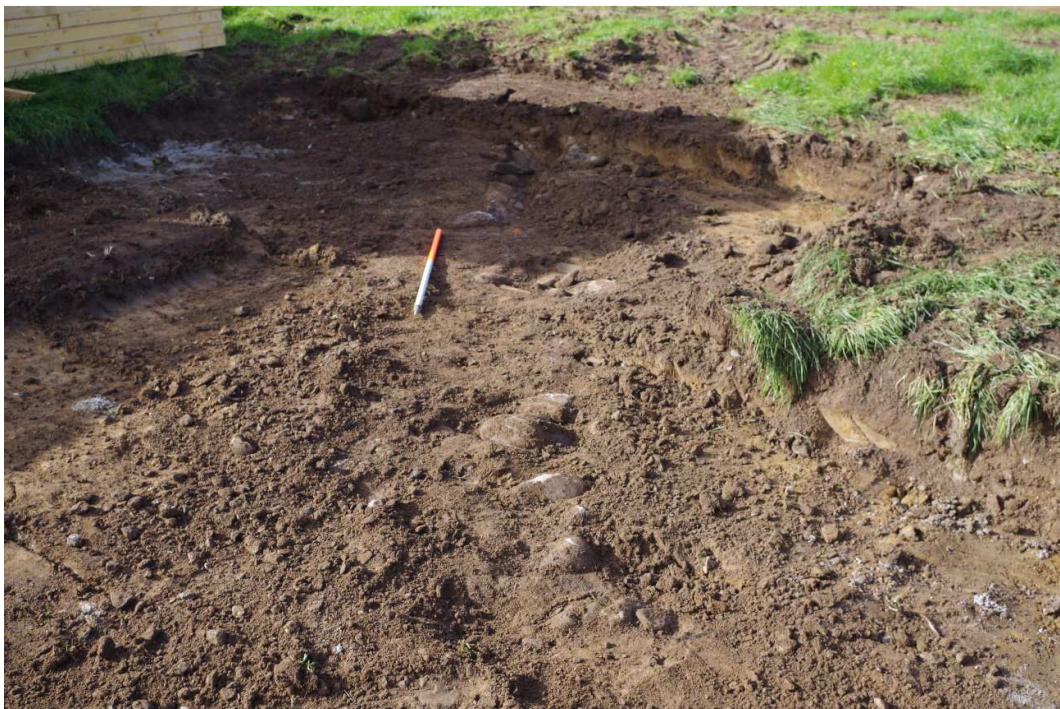
The excavation of a caravan base on the south side of Field 1, and at its eastern edge, revealed a 12m long row of large angular and rounded stones, embedded in places with unidentified ironwork (Fig 13). The central section of stones appeared to have a burnt surface (Fig 14). No other features were recorded in association with this row of stones, which are considered likely to comprise the base of an exterior wall adjoining the two historic buildings shown on the 1842 Poughill Tithe Map (Fig 4) and OS 1st and 2nd Edition Maps (Figs 5 and 6). The stones extend in the direction of and perpendicular to the section of historic wall (**Structure 1**) that still survives above ground straddling the boundary between Fields 1 and 2 (see Fig 18). The wall base may extend to form part of the north elevation of **Structure 1**, although no further wall foundations were recorded so this is not certain.

Figure 13 Base of historic wall, Field 2, looking southwest.

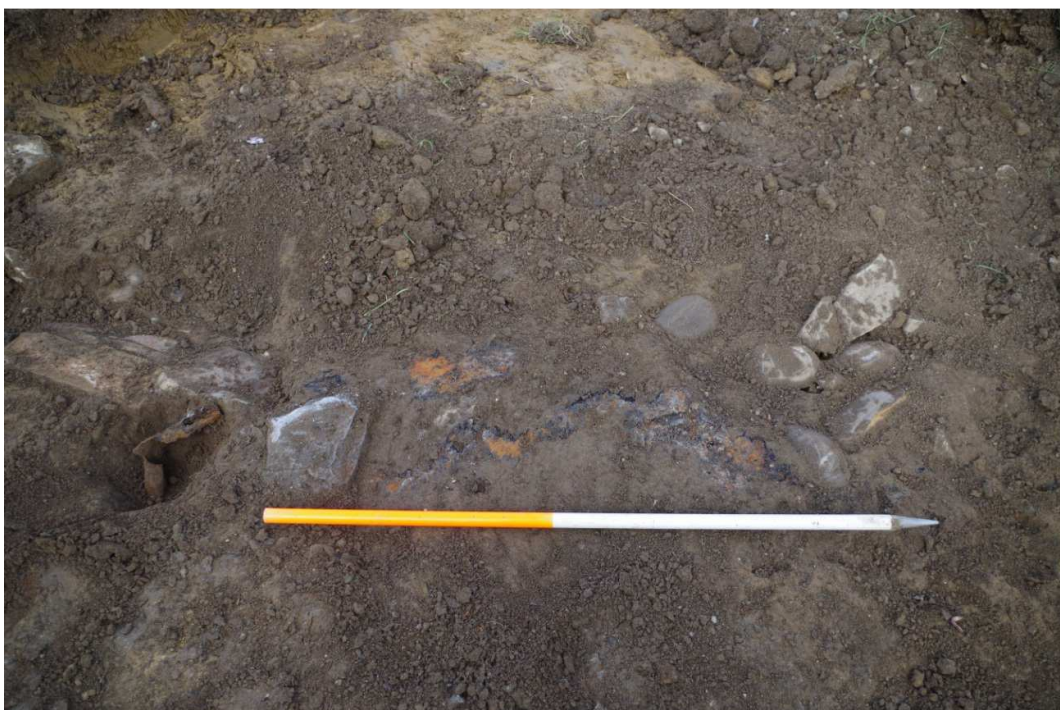
Figure 14 Burnt deposit overlying wall base, Field 1.

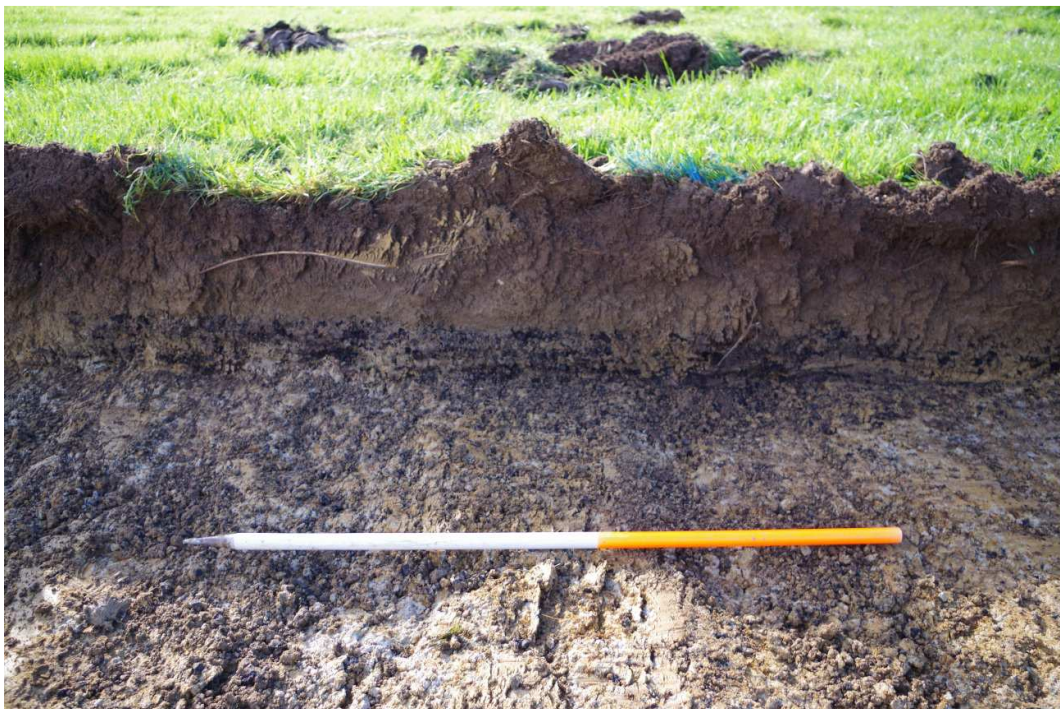
Figure 15 Burnt Area 2, Field 2, seen in section, looking south.

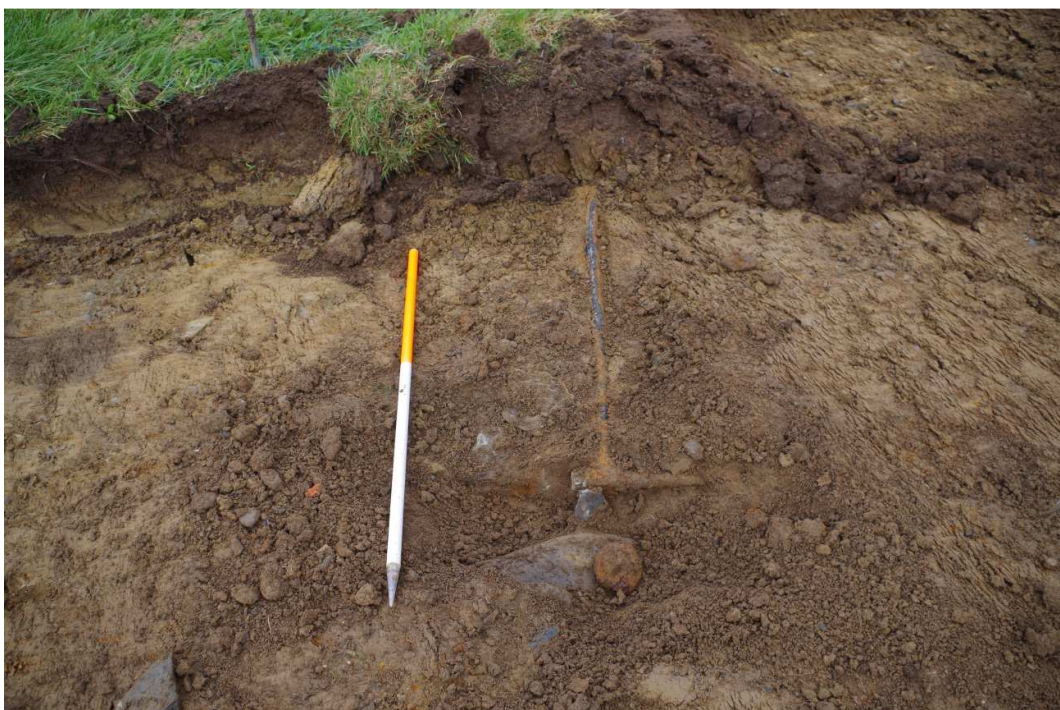
The only features recorded by the digging out for the access roads in Field 2 were sections of galvanised iron water pipe connecting to a brick inspection chamber and a land drain filled with large rounded cobbles (see Fig 8 and Figs 16 and 17). Removal of some of the cobbles revealed fresh water rising below. Issues are shown on Ordnance Survey mapping in fields to the east and west of Field 2 and the rising water may indicate an underlying natural spring in this area.

Figure 16 Iron water pipe, Field 2, looking north.

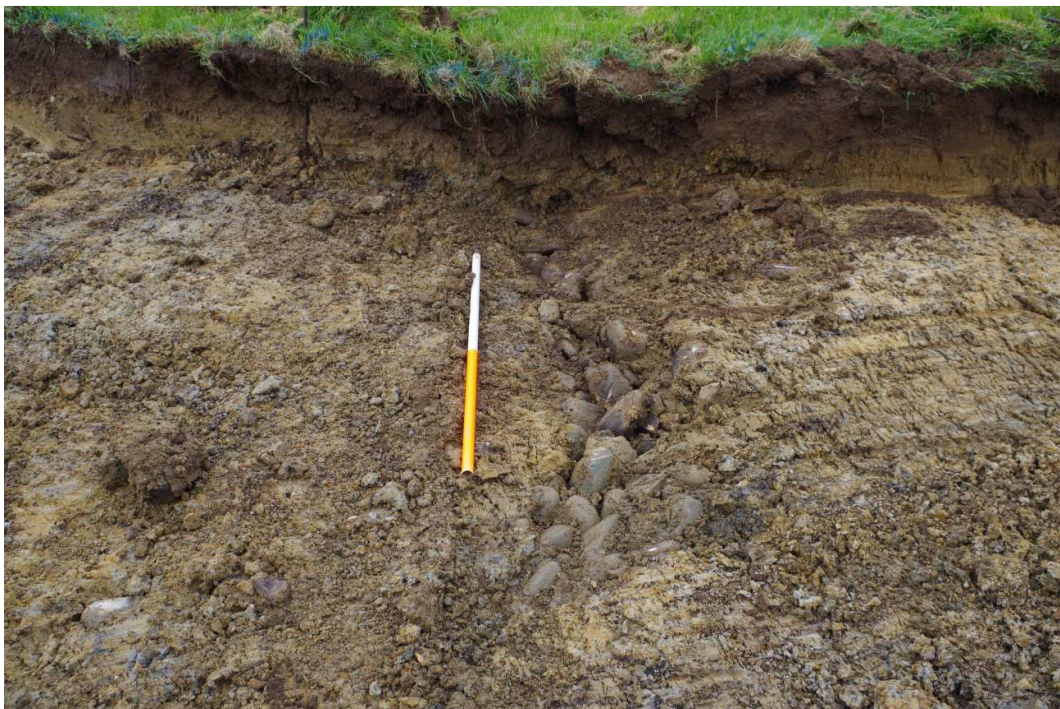
Figure 17 Land drain with cobbles, Field 2, Looking west.

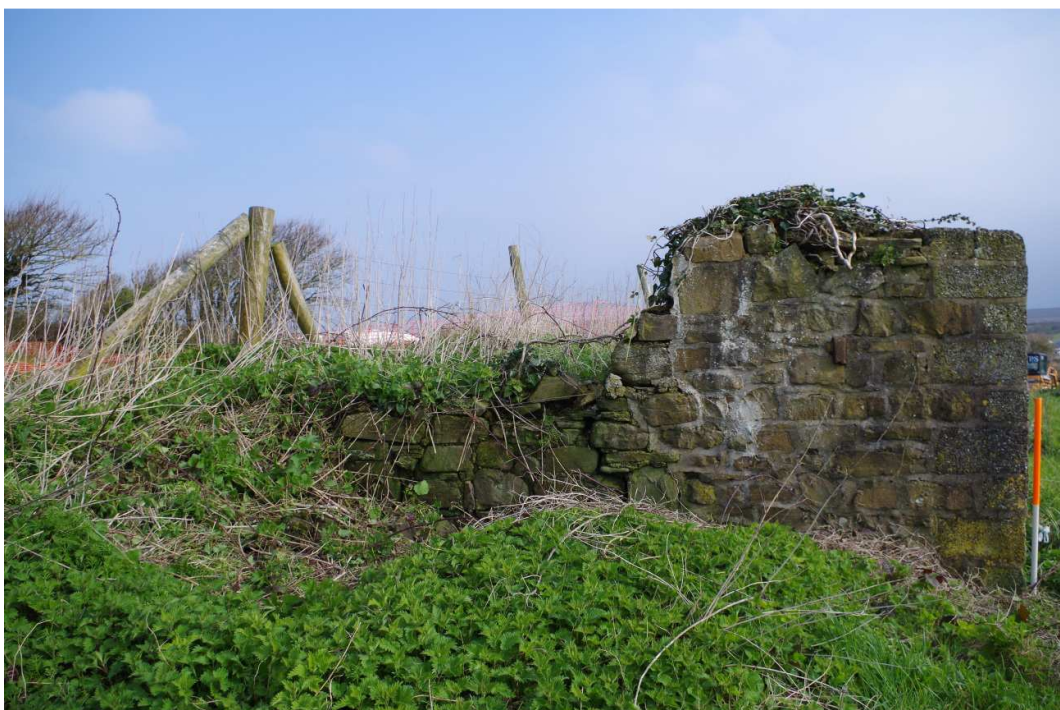
The surviving section of historic wall (**Structure 1**) from the building shown on the 1842 Poughill Tithe Map (Fig 4) was recorded and photographed (Figs 2 and 18). Around 4.2m of visible wall is upstanding, although the wall may extend slightly further into the hedge line where it is currently very overgrown. The wall is constructed of large angular rubble stone (Killas) with intermittent cobbles. The wall has seen much repair and replacement of loose stone and there was no clear evidence for any window or door openings.

The south end of the wall has been stabilised with modern concrete block and there is much wall tumble on both sides. The ground level on both sides of the wall is also raised and now forms part of the field boundary. An aerial photograph of 2000 shows an access road running to the west of the wall and there is still a slight dip in the hedge line here.

Figure 18 West facing elevation of Structure 1, Field 2, looking east.

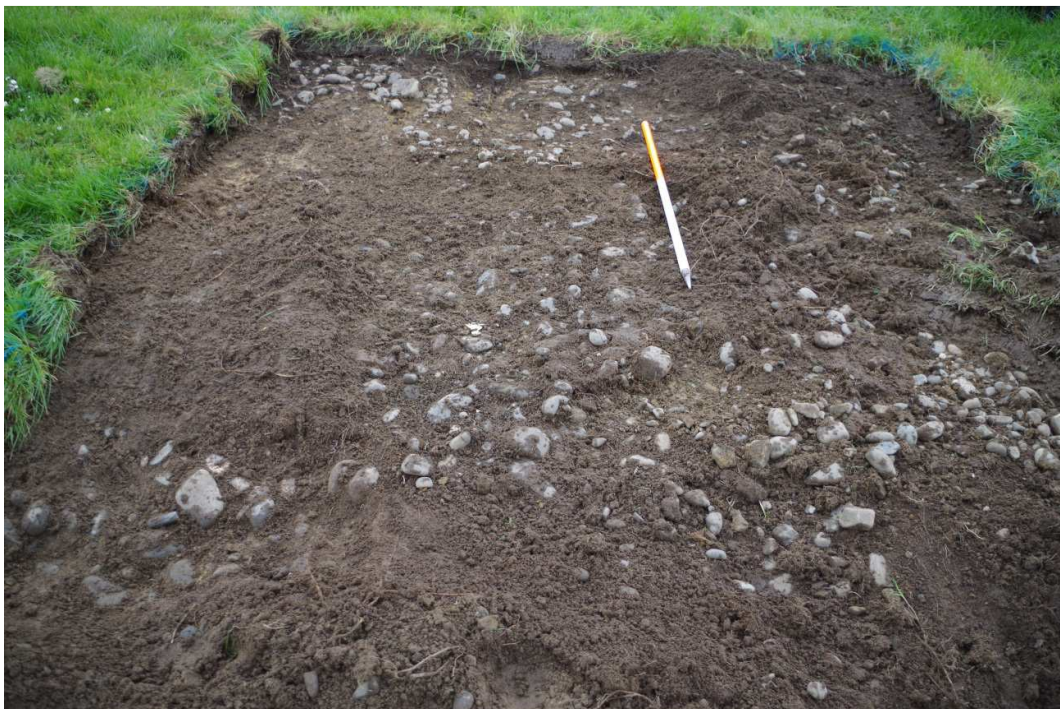
The second caravan base lay closer to the surviving section of historic walling (**Structure 1**) straddling the boundary hedge between Fields 1 and 2. At shallow depth below the turf were a large number of large angular stones and cobbles (Fig 19) and

other materials including brick, coal, ironwork and pottery, including some post medieval green-glazed earthenware (possibly Barnstaple Ware), which potentially dates anywhere from the late 18th to late 19th century (Appendix 1). One large piece of ironwork may have been a large door-latch. The material clearly derives from the demolition of the nearby historic building although no associated structures were recorded in this area.

Figure 19 Cobble spread within caravan base to southeast of Structure 1, looking north.

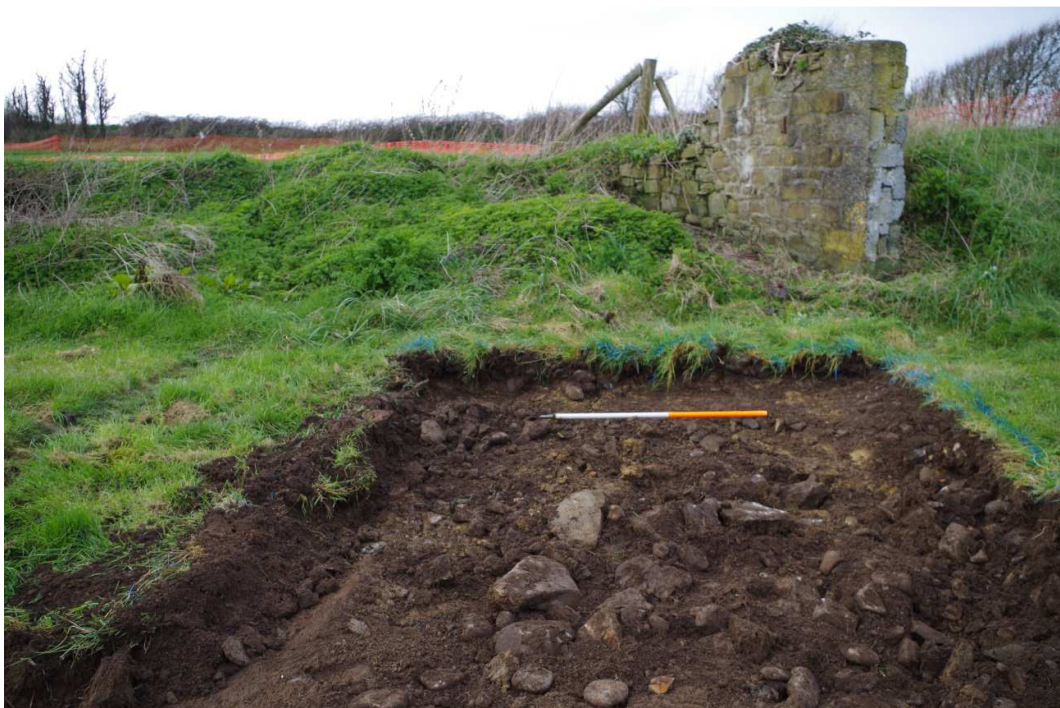
The excavation of the first two caravan bases on the north side of Field 2 revealed demolition material (Fig 20) associated with the historic building (**Structure 1**) shown in this vicinity on the 1842 Poughill Tithe Map (Fig 4). The easternmost caravan base contained many small cobbles that looked at first to be part of a laid surface. The cobbles lay on top of the subsoil at very shallow depth, however, and were easily disturbed; they are more likely to be redeposited material, possibly from an external yard surface. Two coins were found amongst the cobbles; a Queen Victoria farthing (dated 1896) and a King George V halfpenny (dated 1921).

Figure 20 Demolition layer within caravan base to south of Structure 1, looking north.
