Par River Railway Embankment, Cornwall Archaeological Watching Brief

Cornwall Archaeological Unit

Report No: 2017R034

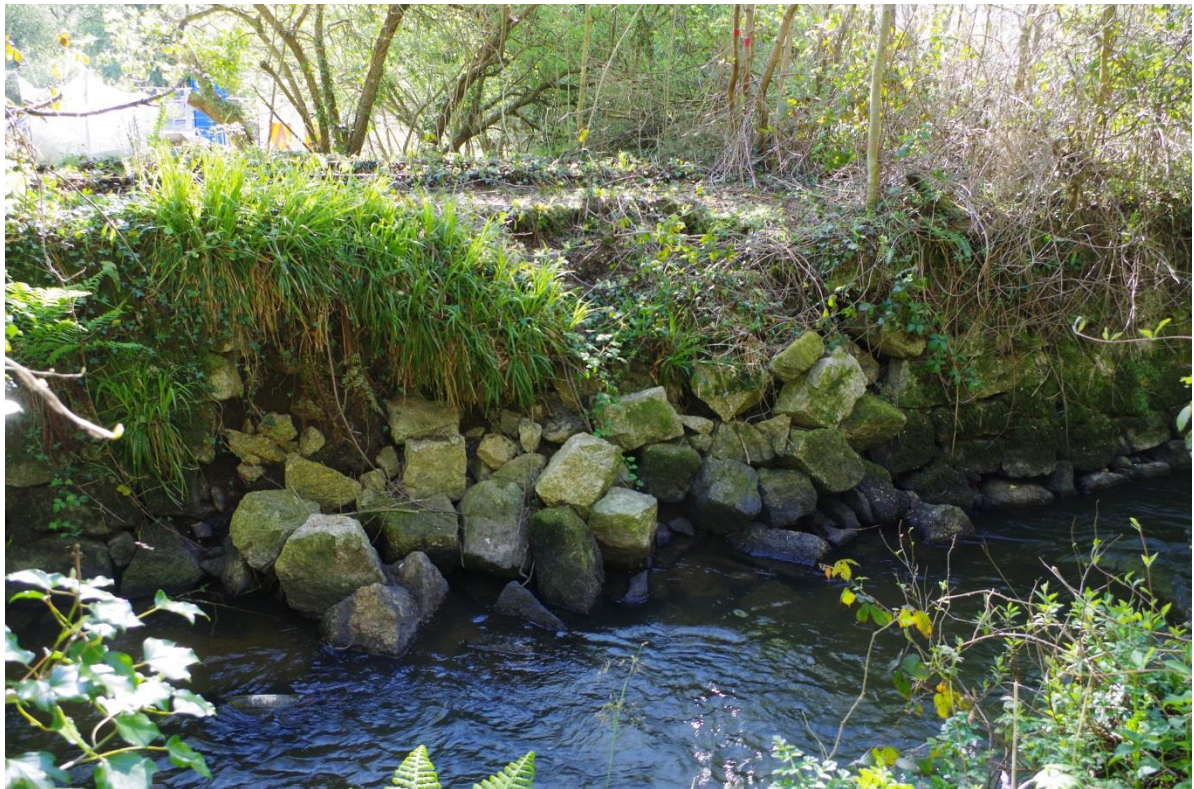
Figure 4. Collapsed embankment prior to work commencing.

Cornwall Archaeological Unit (CAU) was commissioned by Ben Mason of Mott Macdonald on behalf of the Environment Agency to undertake archaeological recording during groundworks required for the repair of a collapsed revetment wall (Fig 4) to a railway embankment running alongside the Par River at SX 07339 55702 (Figs 1 and 2).

The stone rubble from the collapsed revetment wall (Fig 4) was to be removed by a machine operating from the top of the embankment (the rails being protected by timber boarding) reaching down into the stream bed. Once the stone had been removed, a section was to be cut into the collapsed fill of the embankment, to provide seating for a new revetment wall to be constructed. As part of this work, a gabion dam was erected within part of the stream bed. This allowed dry access to the base of the embankment, so that a small section of the stream bed could be cut away and levelled to provide a platform onto which a concrete foundation could be laid. The new revetment wall was built upon the platform.

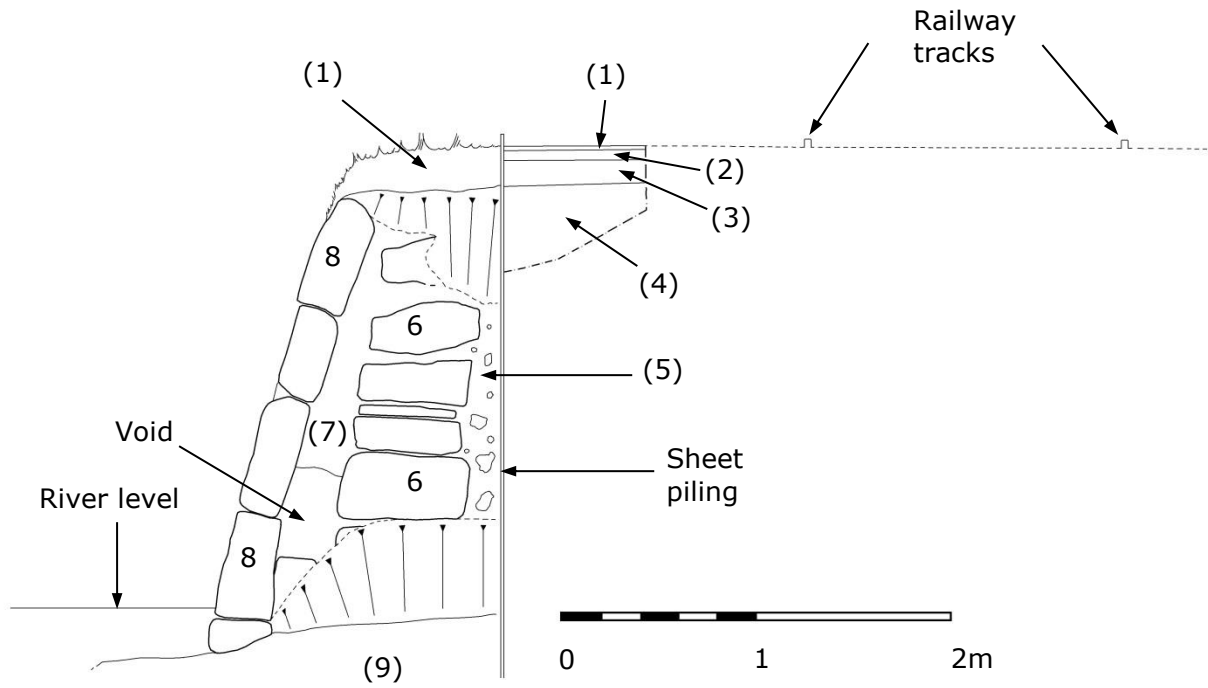
Figure 6. Sketch section through exposed part of the railway embankment.

Two vertical stone walls (mostly of large granite blocks) running parallel with each other and set roughly 6m apart (wall, context 6 on the west side of the embankment, and the wall forming the eastern side) had been constructed. The space between them had been infilled by tightly packed light grey-brown friable sandy clay with stone rubble fragments (5). This filled the gap to roughly 0.8m below the level of the top of the embankment. The layer was overlain by white, grey-brown sand (possibly derived from china clay working) up to 0.5m thick (4). It was in turn sealed by layer (3), a deposit of orange-brown granitic 'rab' clay, which was up to 0.1m thick. This layer was immediately below the level of the base of the rails. It was not visible where the sleepers were actually sitting upon it. The structural engineers working on the site (pers comm) suggested that the sand (4) may have acted as a cushioning layer to protect the rails from the effects of heavy loads allowing them to flex a little, while the 'rab' clay (3) above was a weatherproofing layer (Fig 6).

On the western (river) side of the embankment a further chamfered wall (8) was constructed to deflect the river away from the base of the main core of the embankment to prevent it from being undermined. It was this part of the railway embankment construction that had failed, resulting in the collapse into the river and the necessity for this current scheme of repair (Fig 6).

The length of the trench was approximately 10m. It reached a maximum width of 1.5m, and roughly a depth of 2.6m (Figs 3 and 6).
