Bodmin SEP Schemes 5 and 9, Cornwall Archaeological Watching Brief

Report No: 2017R048

Client	CORMAC Solutions
Report Number	2017R048
Date	September 2017
Status	Final
Report author(s)	C. M. Thorpe
Checked by	Charles Johns
Approved by	Andrew Young

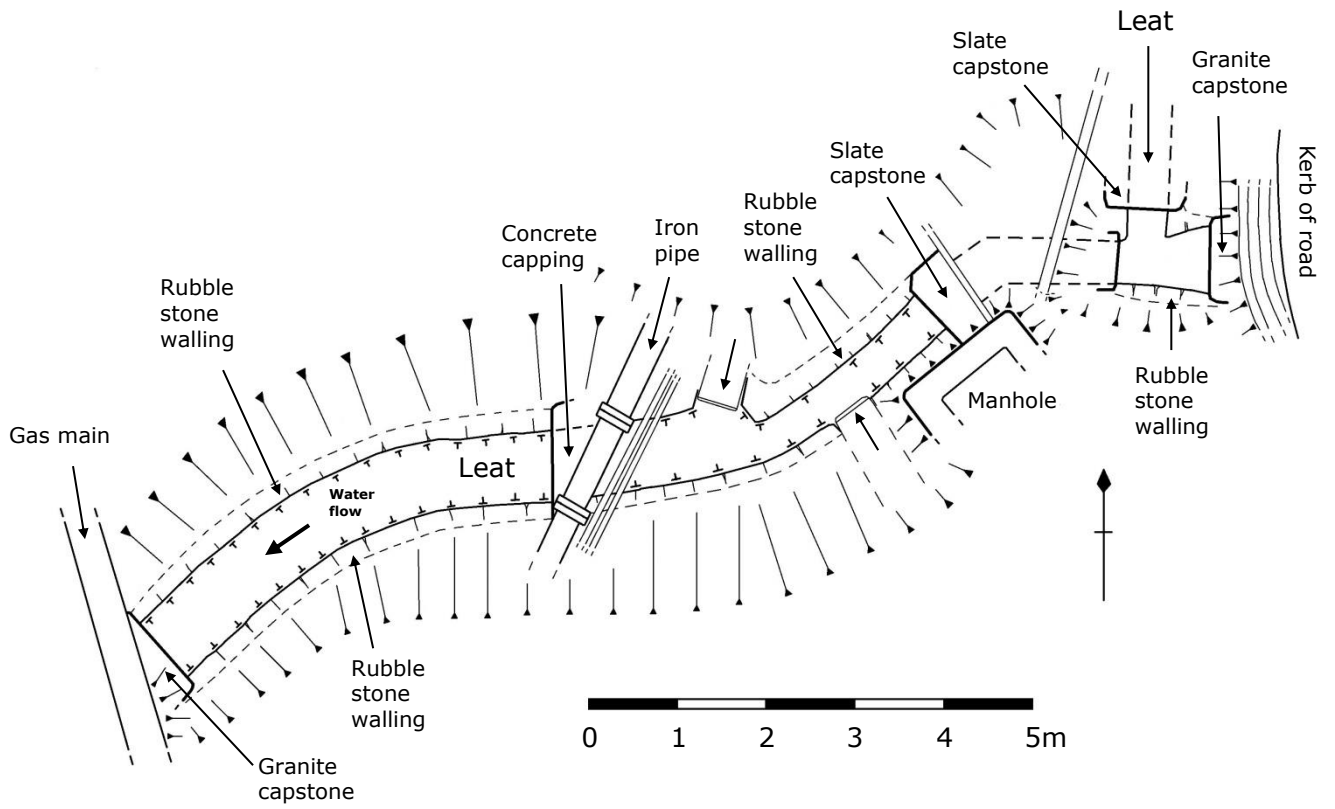
Figure 9. Plan of St Guron's Well Leat.

This was recorded on the northern side of Church Square (Figs 7 and 9). It was a sinuous feature trending roughly from north east to south west across Turf Street. A length of some 14m was recorded running from SX07249 67033 in the north east to SX 07249 67033 in the south west.

At a point close to the north eastern end (1.5m) there was a junction with a second leat on the northern side (at SX 07263 67037). This leat (trending north to south) was similar in nature being some 0.45m wide, 0.25m deep, and flat bottomed. It was capped with slate. This leat also had an active flow of water. No further details could be recorded as only the junction was exposed (Fig 9).

Two ceramic pipes emptied into St Guron's Well leat. These appeared to be storm water drains clearing water from the road. Roughly 4m from the north eastern end of the leat, the southern wall had been disrupted and the side rebuilt by the construction of a large manhole at SX 07262 67035. Several other modern services (gas, electric, and water) over lay the leat at various points (Fig 9).

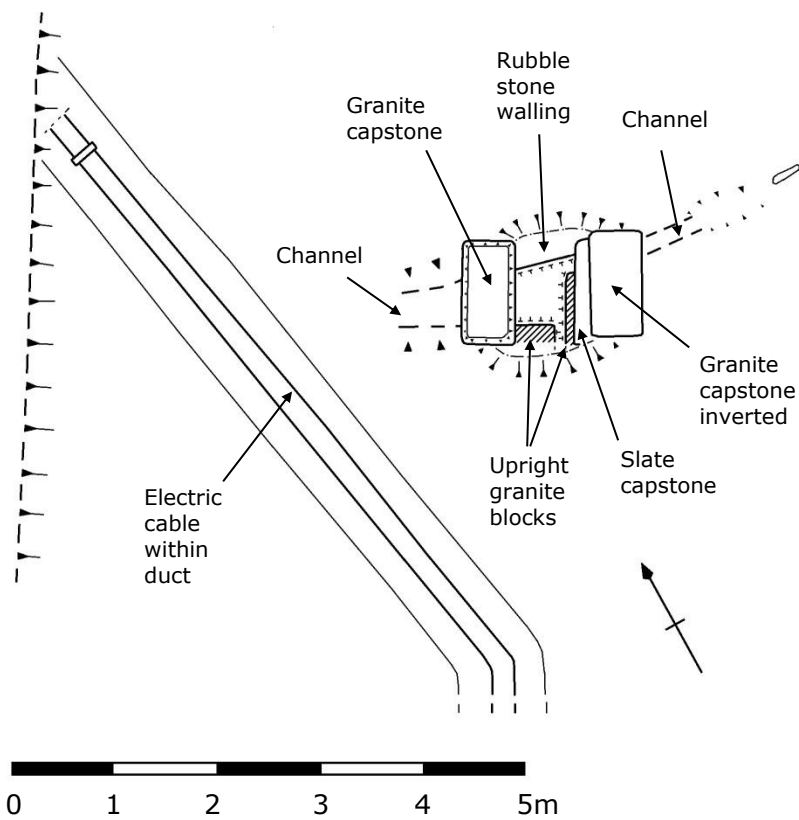
Figure 10. Plan of the Church Square Culvert

The very fragmentary remnants of a culvert were found close to the centre of Church Square at SX 07254 67028 (Figs 7, 10, and 17). The part of the culvert exposed formed a rough T junction with the main channel trending roughly west to east, with a smaller branch heading southwards. The channels at the centre of the junction opened out into a rough square shape measuring about 0.5m x 0.5m. This square part was capped by two neatly cut and dressed granite blocks, each measuring 1m x 0.5m and 0.18m thick (Fig 17). The top surface of the slabs had neatly chamfered edges. The capping for the rest of the channels (where present) were a mixture of slate and granite slabs.

The eastern arm of the T junction survived for a length of 0.8m, though its possible continuation marked by a hollow in the ground, and an upright slate could be traced for a further 1.5m. This branch of the culvert was about 0.2m wide. It had vertical sides constructed of slate blocks some four courses high (0.3m) unfortunately as the base was choked by debris the full depth, and nature of the base could not be determined (Fig 10).

The central square area of the junction (0.5m x 0.5m) had walls consisting of coursed slate rubble and single upright blocks of granite. The base was choked by debris so the full depth could not be determined though a depth of 0.3m was recorded (Fig 10).

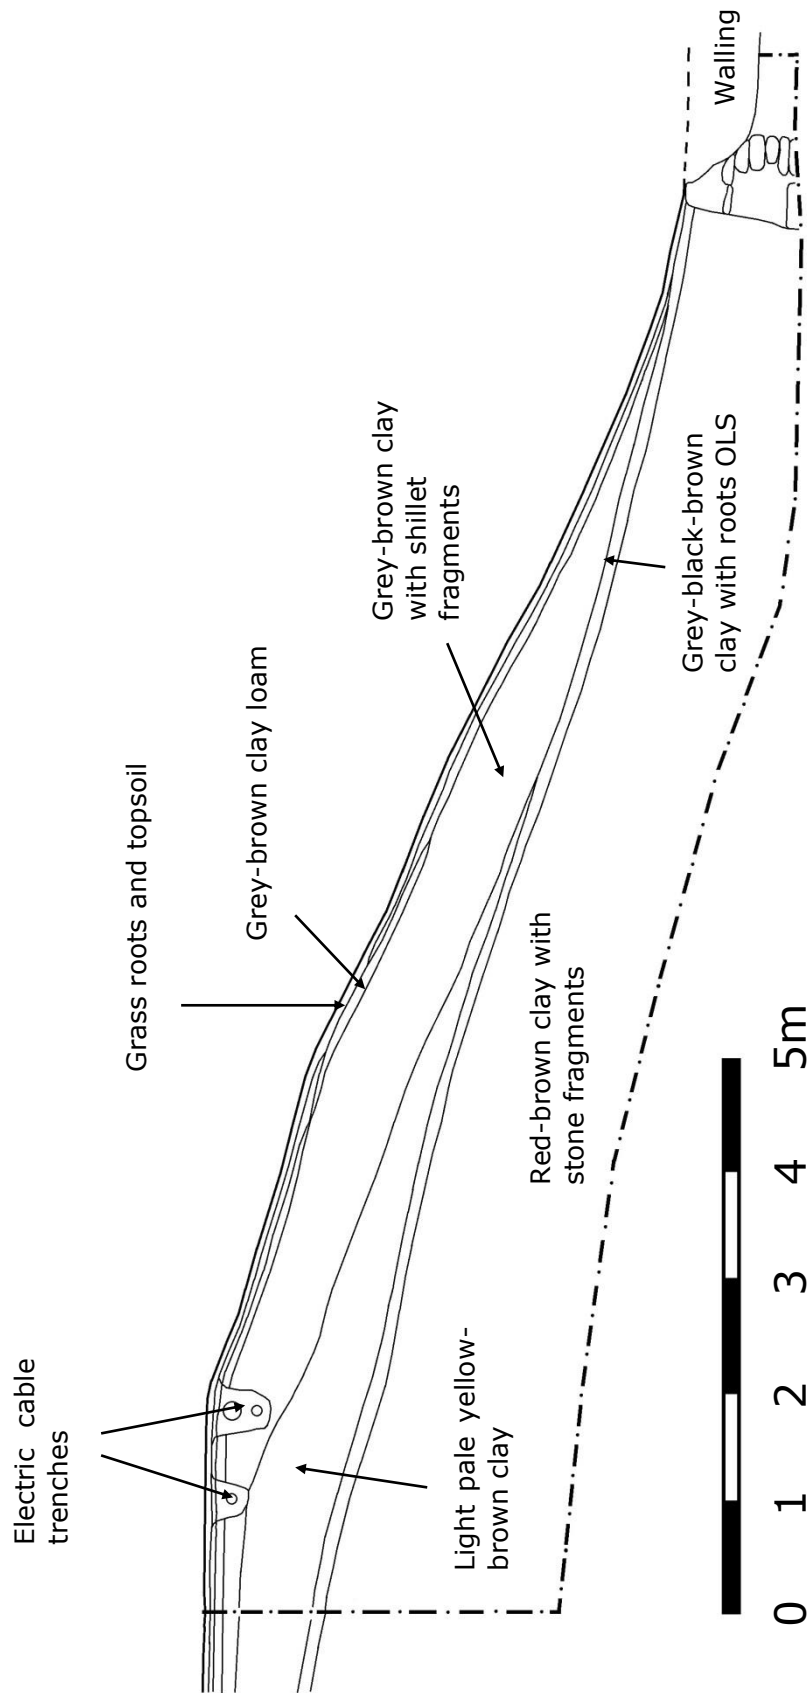
Figure 13. Scheme 9. Sketch section through Storm drain trench on hillside immediately above St Petroc's Well.

The work within the areas immediately around St Petroc's Well (Grade II listed Monument) was done with the archaeologist in attendance, the rest of the area was examined on an intermittent basis. A site plan was made of this area at a scale of 1:200, and a sketch section was made of the trench above the well at a scale of 1:50 (Figs 12 and 13).

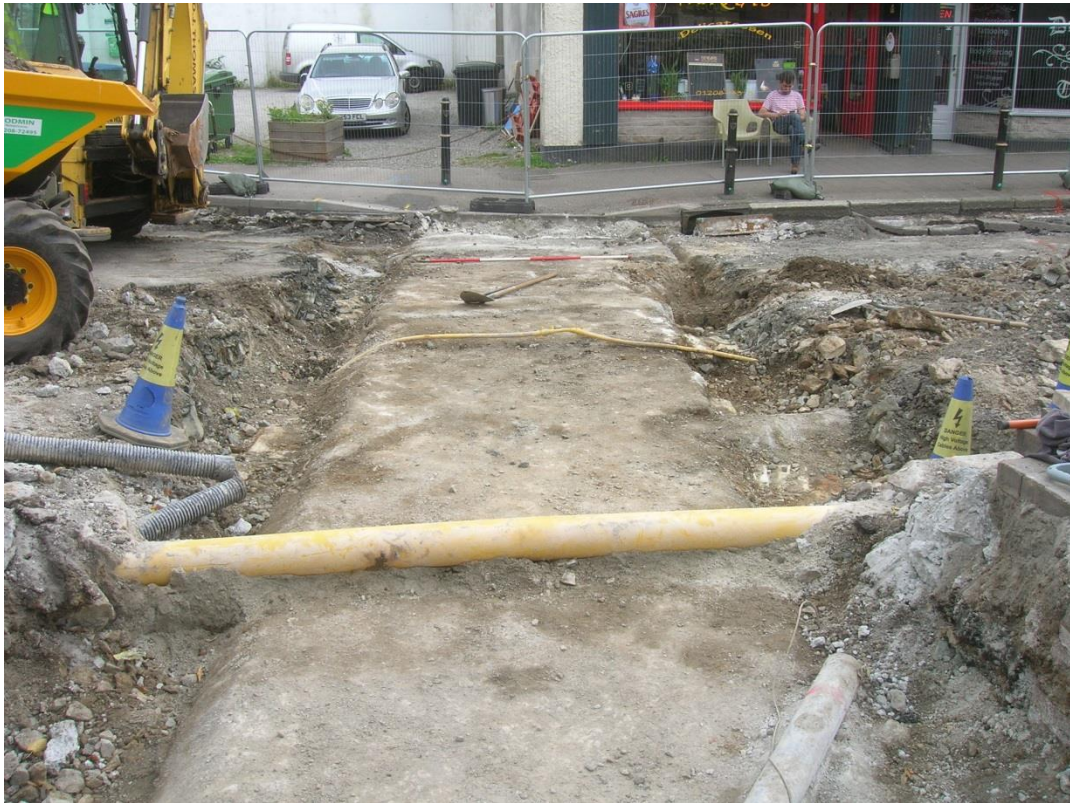
It was found that the leat was covered by a cap of re-enforced concrete roughly 3.5m wide, and approximately 0.2m thick (Fig 14). The top of this capping was roughly 0.3m below the road surface being overlain by 0.1m of tarmac (the road surface), 0.1m of grey-brown clay and gravel, and 0.1m of grey-green, brown clay with greenstone fragments.

Figure 14. Scheme 5. Church Square. Bodmin Town Leat looking south east showing concrete capping.

Unfortunately when uncovered it was found that the original structure of the leat had been rebuilt with concrete block sides and a re-enforced concrete cover probably during rehabilitation work carried out by the Environment Agency between 1999 and 2001 (Exeter Archaeology 2002) in order to reduce the risk of flooding in the area. This was achieved in part by widening and deepening of the leat which here appears to have involved the complete removal and replacement of the older structure (Figs 14 and 15).

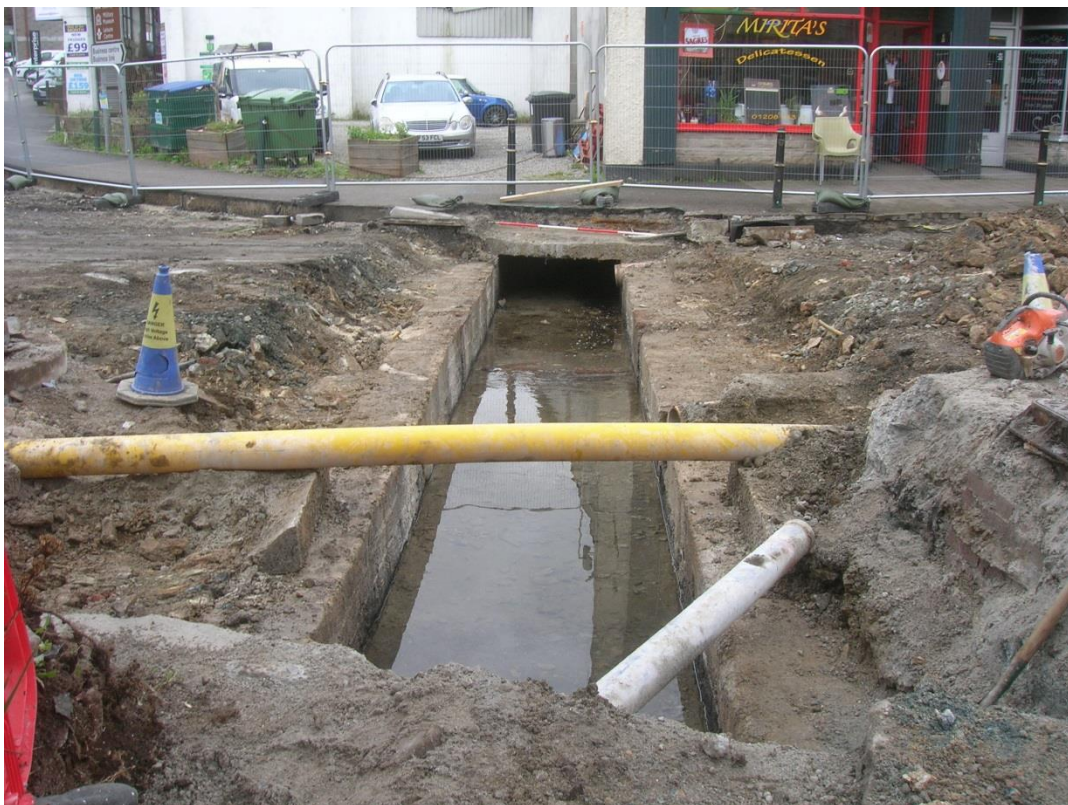
Beneath the capping the leat was seen to be 1.5m wide and 0.6m deep. It was flat bottomed (this being covered in silt and gravel) with vertical sides. There was a constant flow of water within the leat flowing from south east to north west. The depth of the water at the time of the project averaged roughly 0.1m (Fig 15).

Figure 15. Scheme 5. Church Square. Town Leat looking south east.

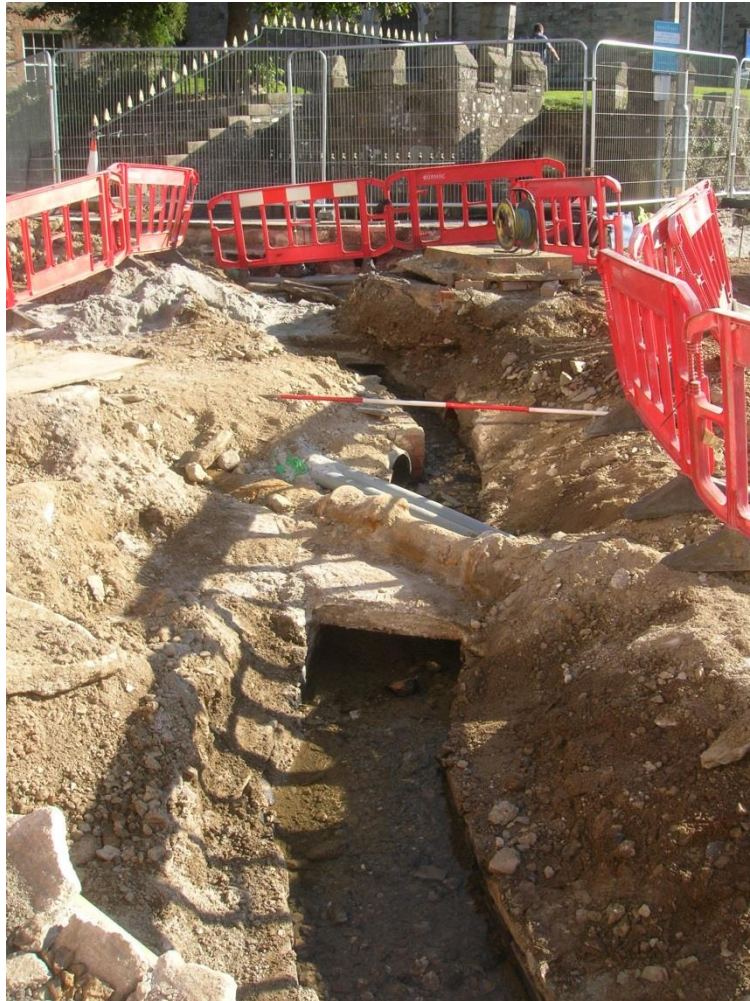
The leat varied in width, at its north-east end it was some 0.5m wide while some 6m from the north east end it increased in width to 0.8m. Where survival of the leat was best a depth of 0.3m was noted. It was flat bottomed (this being covered in silt and gravel) with vertical sides. There was a constant flow of water within the leat flowing from north east to south west. The depth of the water at the time of the project averaged roughly 0.05m (Fig 16).

This leat appears to act as an overflow/drainage channel connecting the fountain and water trough of St Guron's Well (centred at SX 207266 67036) with the Bodmin Town Leat (Fig 16).

Figure 16. Scheme 5. Church Square. St Guron's Well leat looking east.

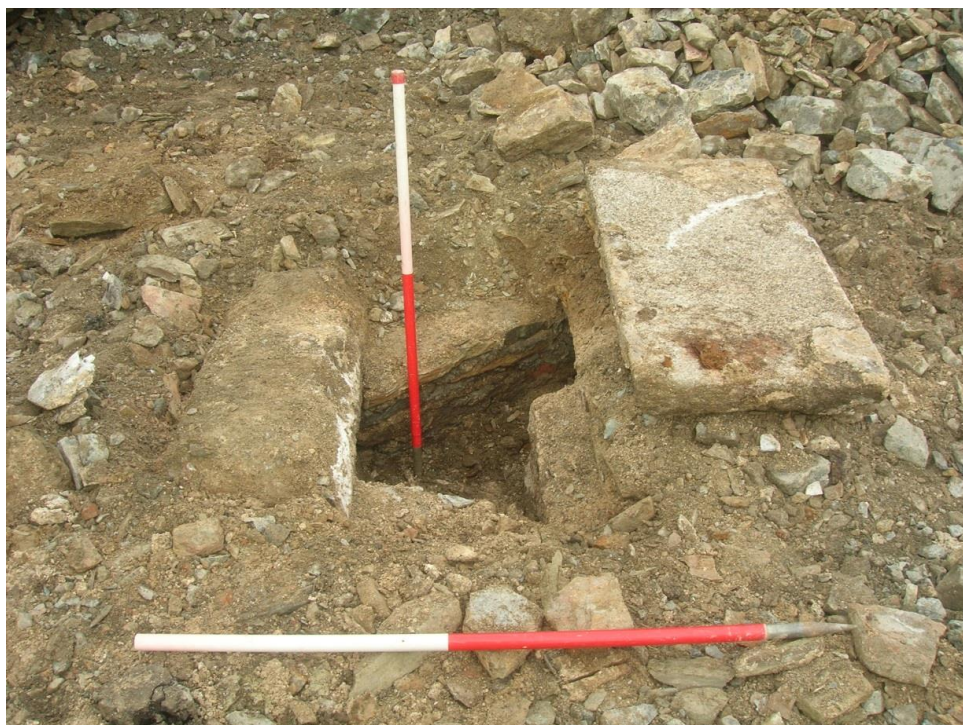
The two neatly dressed cover slabs that overlay the square shaped area of the culvert area suggest that this part was meant to be readily identifiable from the surface when originally constructed, which may mean that this could have been a silt trap built within the culvert that could be found and emptied on a regular basis, or an access point to allow the culvert to be rodded out (Fig 17).

The fragmentary remnants of a culvert found close to the centre of Church Square at SX 07254 67028 may have been part of a similar overflow system to that seen for St Guron's Well that drained the watering place built into the churchyard wall at SX 07281 67021, or it could have been part of a scheme to help drain the area, as Church Square was a site prone to flooding (Environment Agency 2002). The neatly cut and dressed granite capstones suggest a nineteenth century date (Fig 17).

Figure 17. Scheme 5. Church Square culvert looking north.

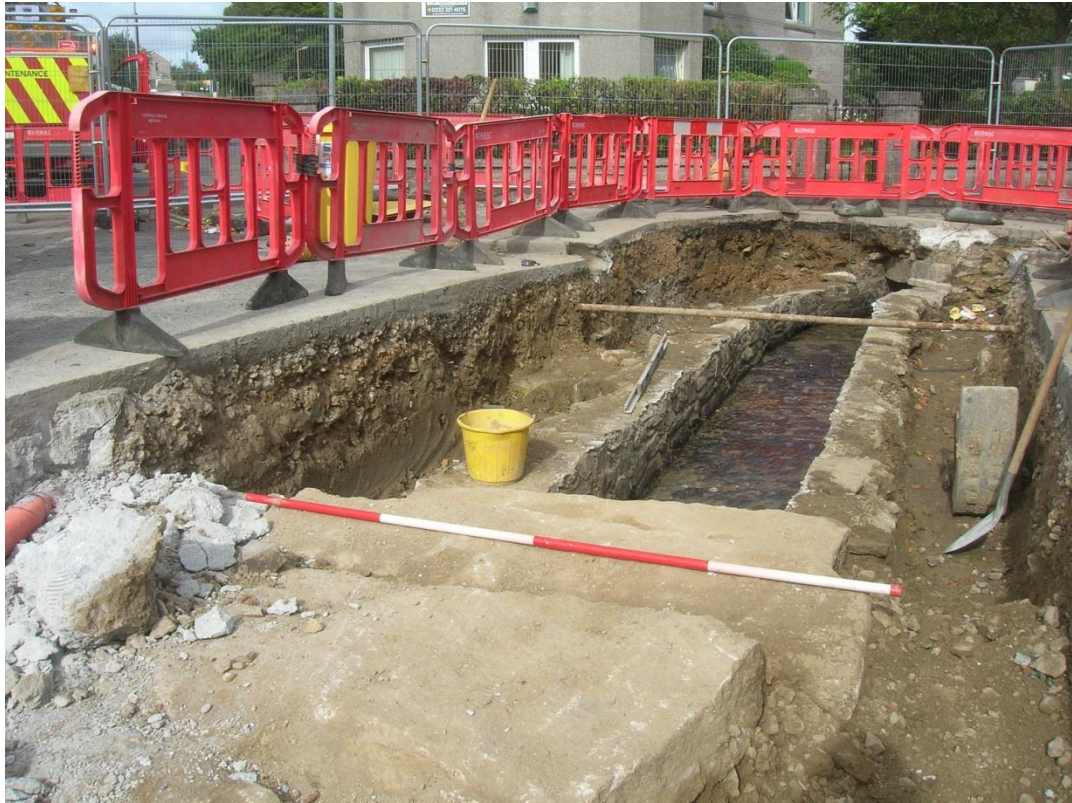
Figure 18. Scheme 5. Bodmin Town leat in Dennison Road, looking north west.

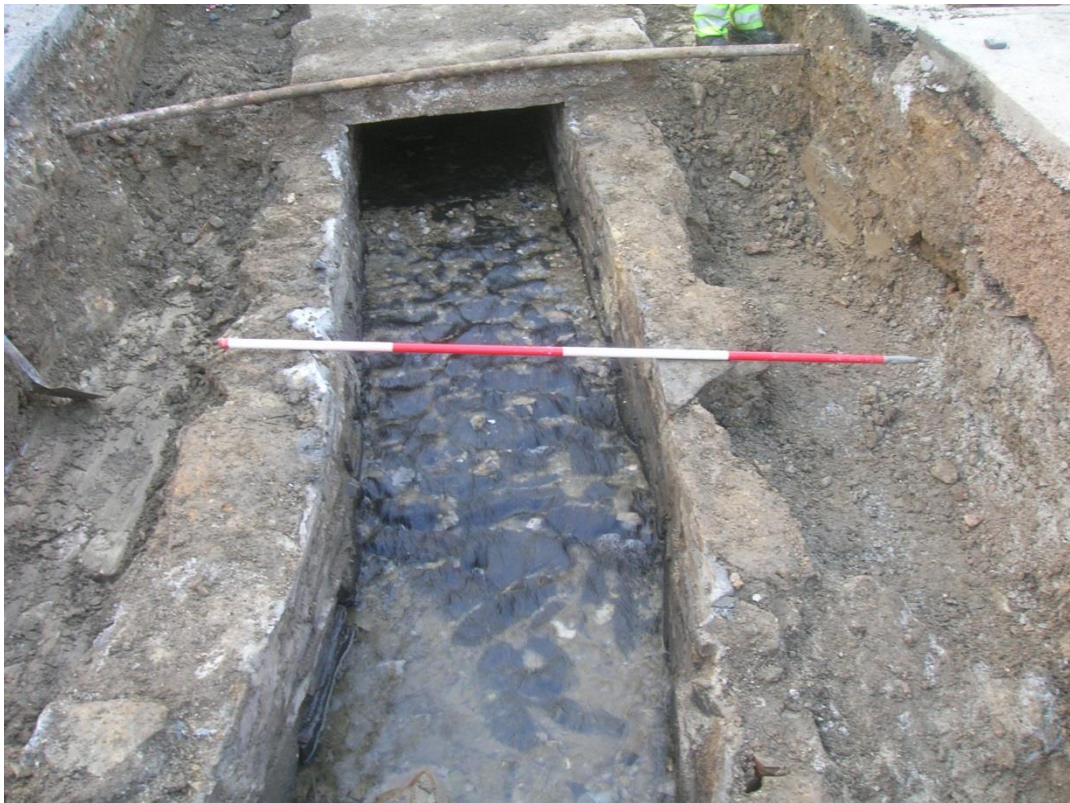
The walls of the leat were constructed from slate rubble blocks with up to five courses being visible. The walling was on average 0.3m wide. In places it was noted that some of the stonework had been bonded, or repointed in modern cement, suggesting that the leat at this point had been accessed, and repaired at some time in the recent past (Fig 19).

Figure 19. Scheme 5. Bodmin Town leat in Dennison Road, looking south east showing cobbled floor.

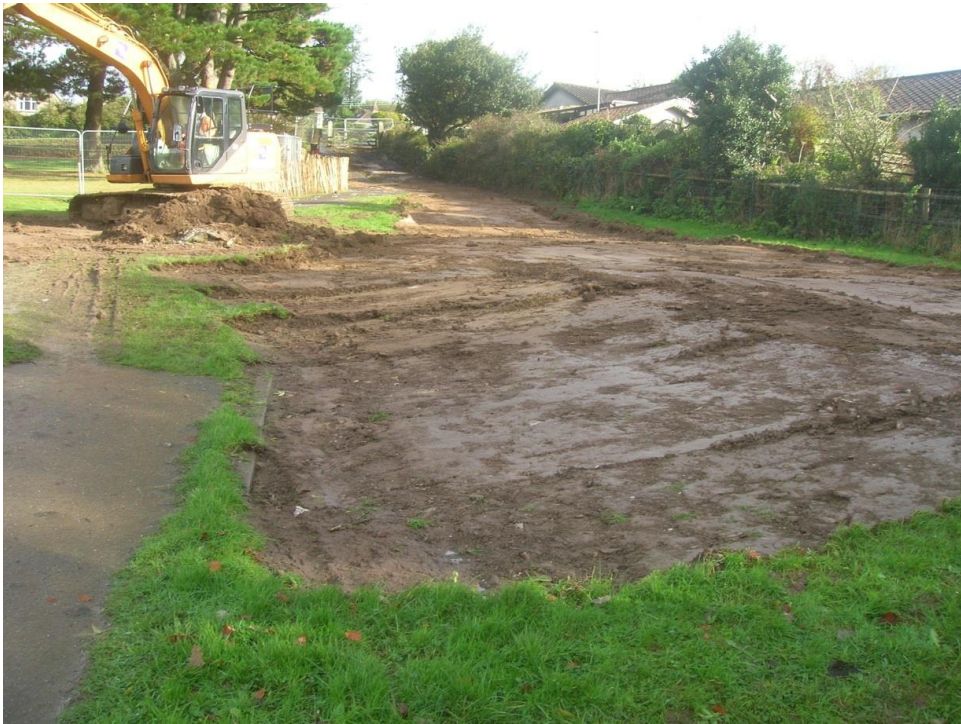
This was done using a machine fitted with a toothless grading bucket which reduced the ground to a depth of approximately 0.25m (Fig 20).

Figure 20. Scheme 9. Priory Park. The area topsoil stripped for cycle path looking north east.

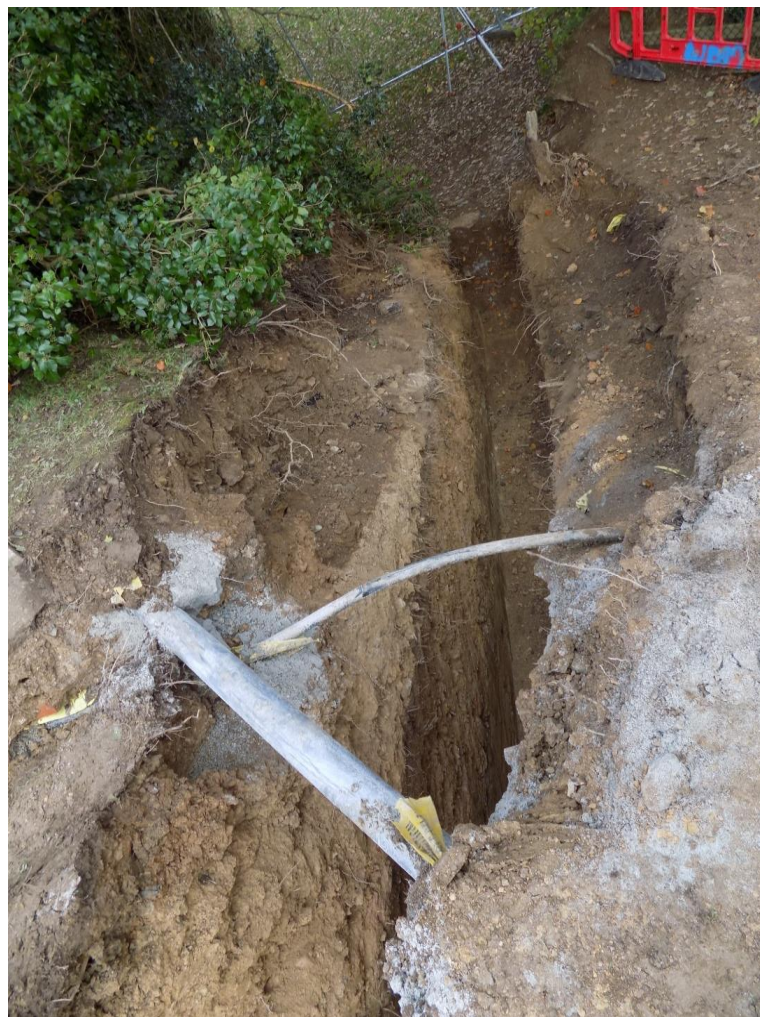
Figure 21. Scheme 9. Priory Park. Storm drain trench. Section on hillside immediately above St Petroc's Well looking south east.

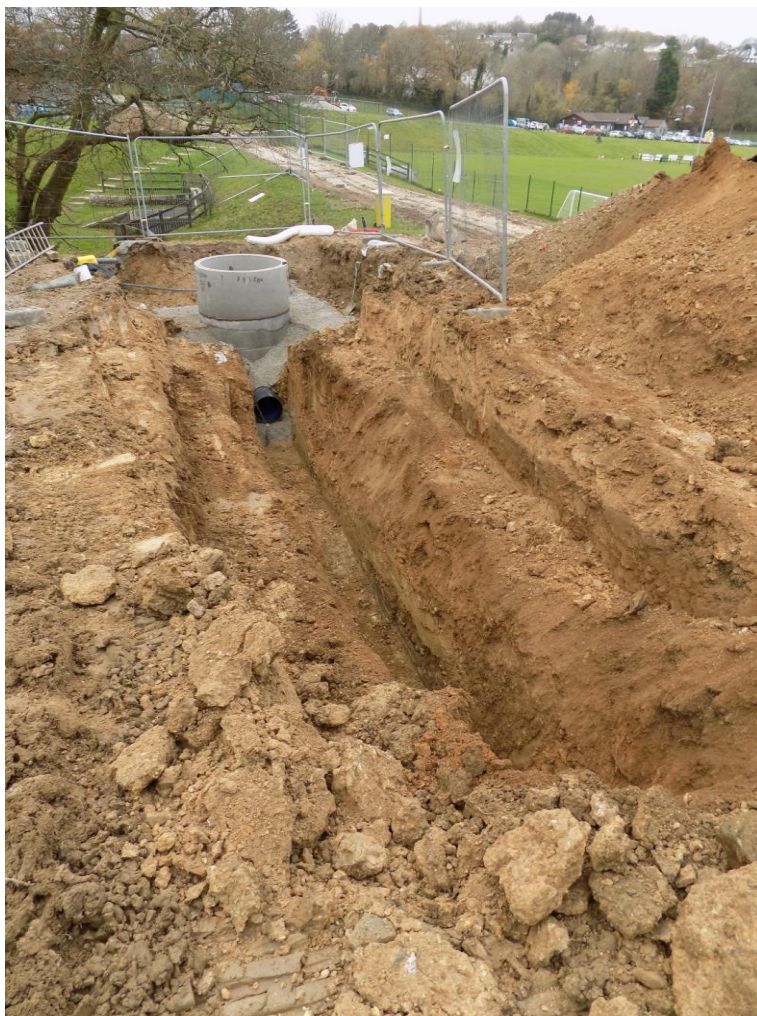
Similar profiles to that seen within the manholes was recorded along the length of the trench dug for the storm drain though with the rising ground, and reduction in trench depth towards the north, less of the profile was seen, with the lower OLS being lost from view at a point some 18m north of manhole A. Even at the northern end of the trench it was found that the ground into which it had been dug was entirely made ground.

Figure 22. Scheme 9. Priory Park. Storm drain trench. Section to north of manhole A showing nature of ground encountered.
