CHYSAUSTER ANCIENT VILLAGE GULVAL, CORNWALL CONSERVATION MANAGEMENT PLAN

Cornwall Archaeological Unit 2016

ENGLISH
HERITAGE

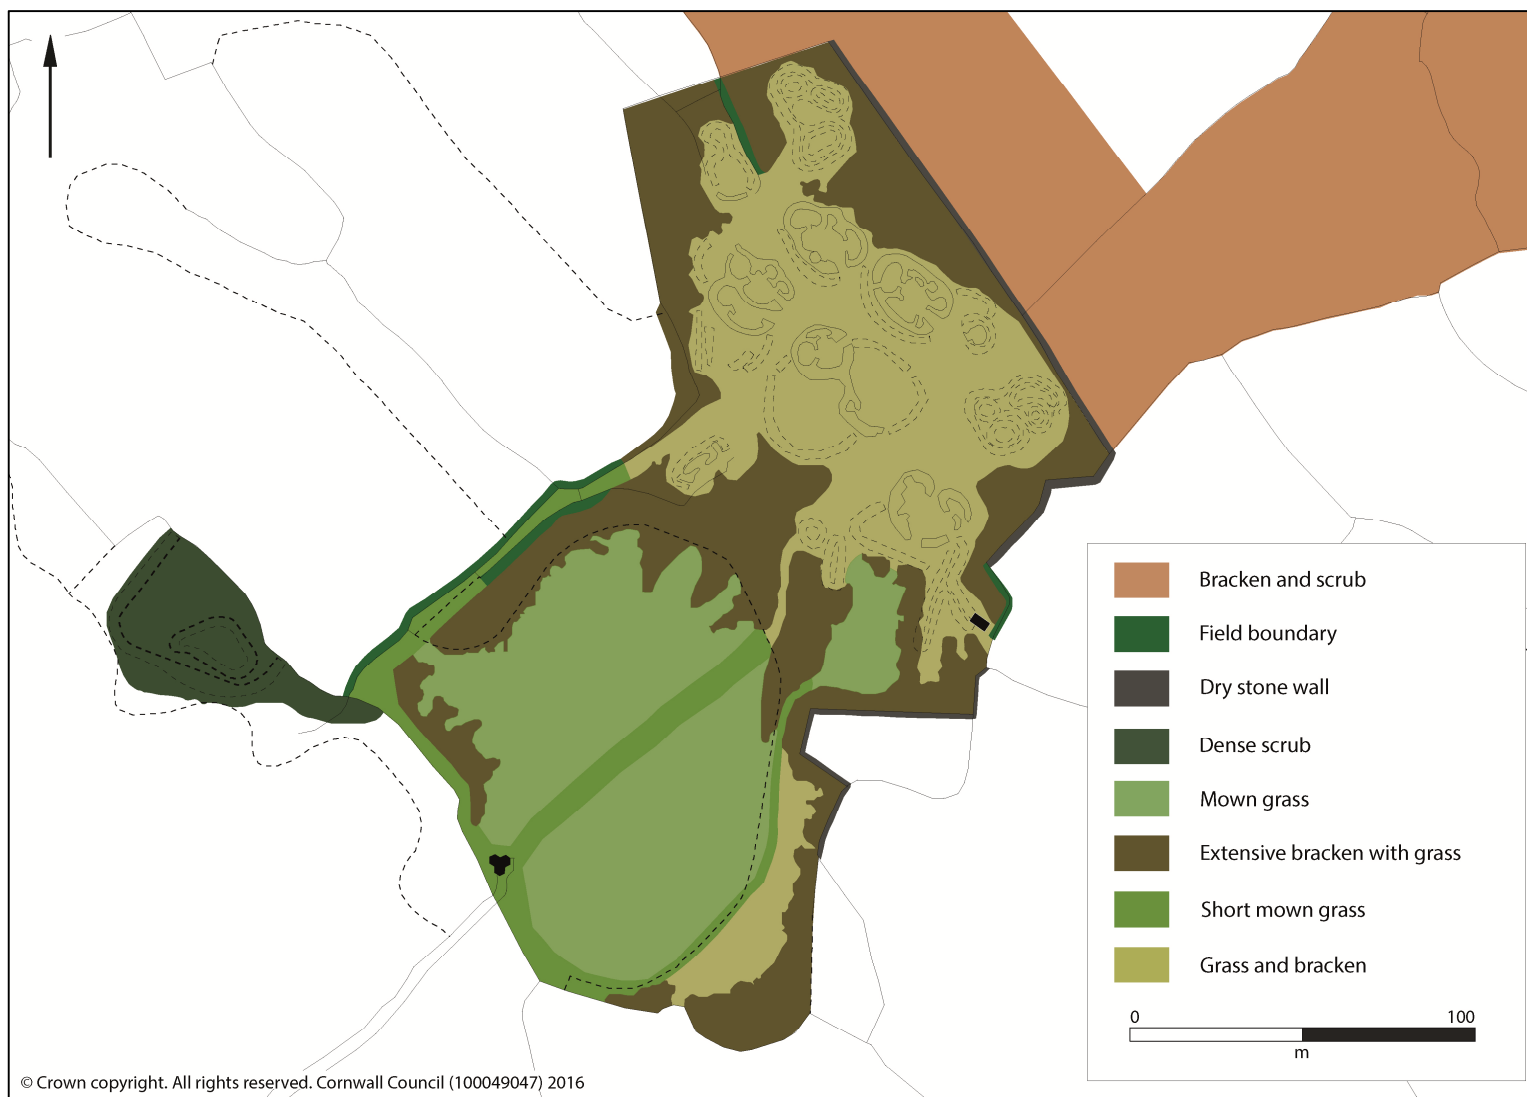
Figure 9: Broadly mapped areas of vegetation cover within the Chysauster Guardianship site

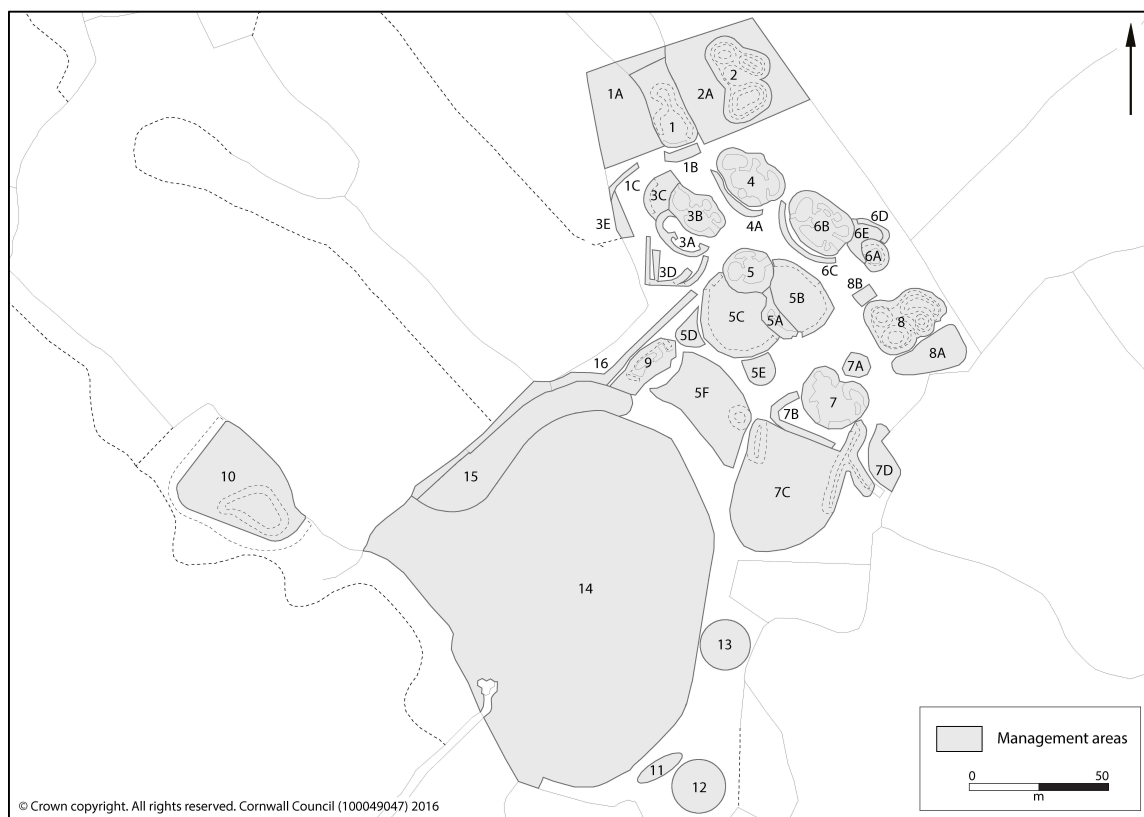
Figure 10: Gazetteer Map for Chysauster Ancient Village showing the location of numbered sites

The numbering for the gazetteer follows the current numbering of the courtyard houses. Where extra features associated with these houses are identified, the adopted system has been to use the house number and an alphabetic sequence. New features follow on using the numbering sequence. Descriptions of historic intervention are extracted from Nowakowski and Gould 2010.

A gazetteer of the principal components of the Chysauster courtyard house settlement within the guardianship site is included below. Sites that may survive within the wider scheduled monument area have not been included as this area is currently significantly overgrown and proper assessment could not be made during the site survey. This was carried out on 1 December 2015 and was by necessity summary rather than detailed. Site conditions were relatively dry underfoot and the weather was overcast and breezy. The grounds had been recently mown and the bracken cut back, but it was still possible to see how far the bracken is encroaching across the peripheral areas of the site, now significantly impacting on the condition of Houses 1, 2 and 8 and the possible courtyard house adjoining the fogou.

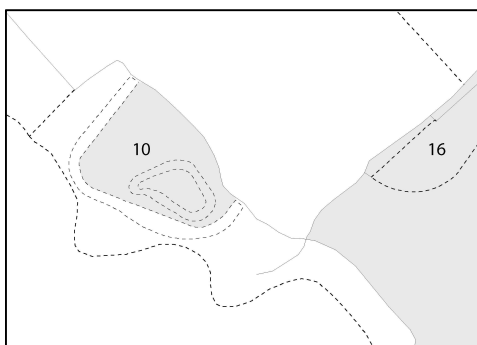
12.23 Courtyard House 10

Location: SW 47051 34934

It is recommended that House 10 is cleared of vegetation and a condition assessment made to determine any repair needs. The recent survey of this area should be referred to in order to assess its current survival, as compared with the survey of 1986. To define the area occupied by House 10 and to prevent farming impacts, such as stock trample, for example, a suitable stock-proof enclosure fence should be erected. It would be beneficial to the overall visitor experience to reintroduce this courtyard house to the visitor area although issues of access may impede this. If future plans include extending the site into the neighbouring field, however, these may open up this opportunity.
