Frythens Farm, St. Erth, Cornwall
Archaeological excavation of a WW2 Spitfire crash site

Report No: 2017R051

Archaeological investigation of a WW2 Spitfire crash site

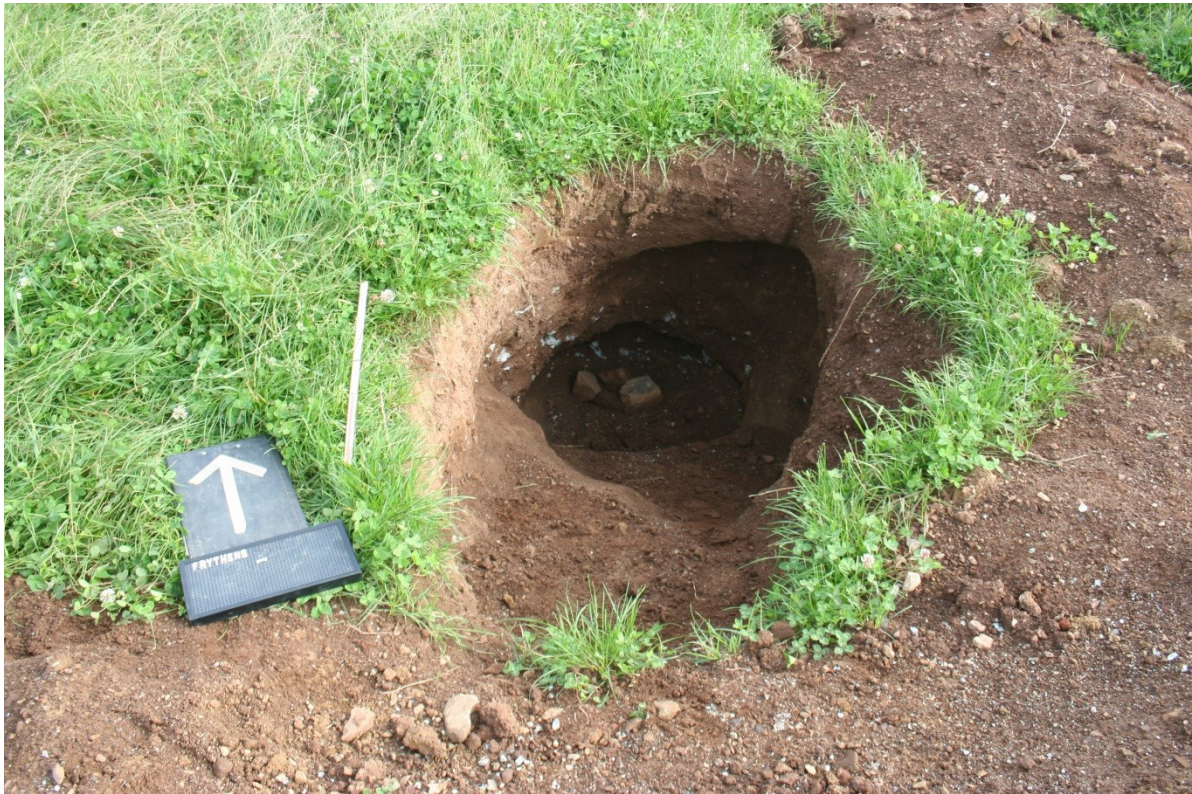
Fig 3. Looking north-east into the hole excavated by Mr. Palmer on the site of the Frythens Farm Spitfire crash site. Note the white-coloured corroded aluminium fragments in the side of the trench. The stones at the base of the pit had been placed there to temporarily protect the human bones which had been revealed at its base.

Prior to its controlled excavation the crash site at Frythens Farm was marked by the sub-triangular hole thought to have been excavated earlier in 2017 by Mr. Palmer. The hole was a maximum of 1.25m deep, having a shallow sloping face to the south-west and vertical to overhanging edges to the north-west, north-east and south-east. It is assumed to have been excavated over an area showing significant responses on a metal detector. A low spoil heap containing corroded aluminium fragments was located to the west of the hole. The topsoil could be seen to slope down to the north-east at an angle of around 30 degrees from the horizontal, overlying a compact, tan-coloured clay-sand subsoil with almost no stony inclusions. The topsoil also contained abundant fragments of corroded aluminium. At the base of the hole, a piece of small-bore copper pipe protruded from the unexcavated material; adjacent to this was the ball joint of a human femur. During a preliminary site visit on 27th June 2017 by ADI Green of the Devon and Cornwall Police, Laura Ratcliffe of CAU and Mr Palmer the presence of human remains bone had been confirmed; the exposed femur had been temporarily covered over with large stones to prevent further interference to it.

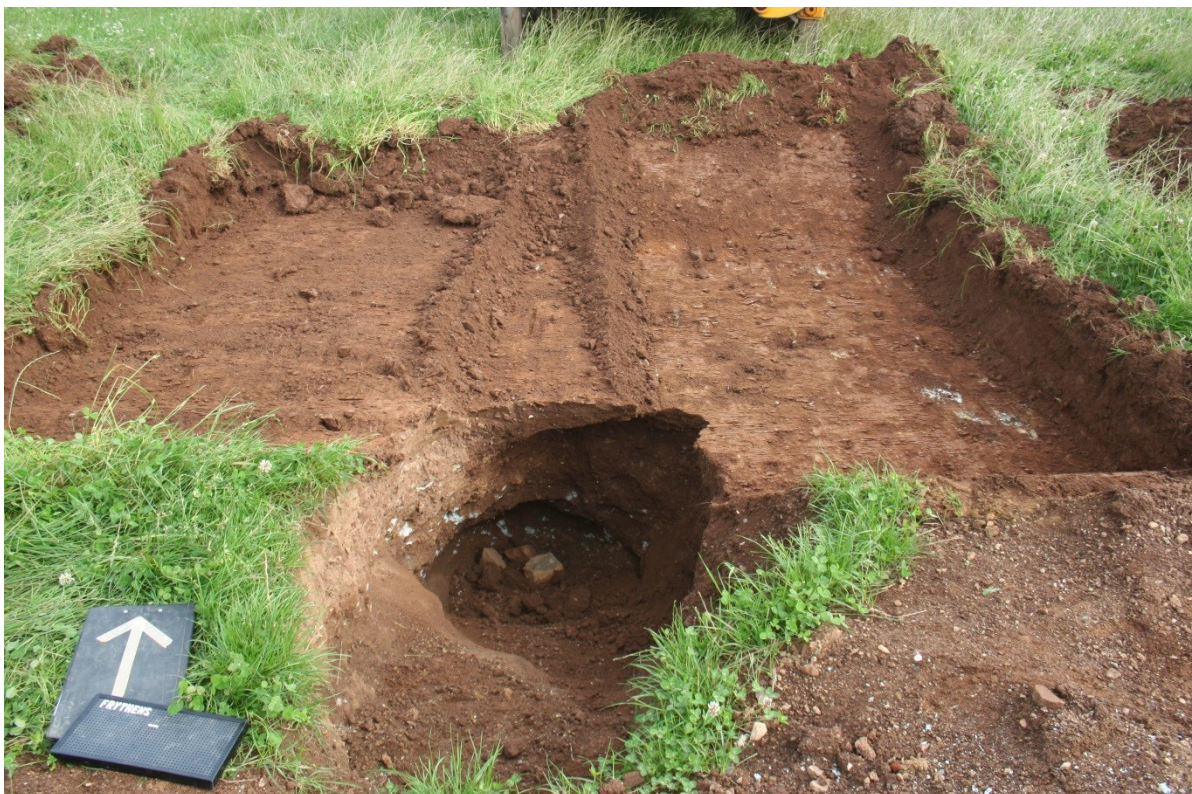
Fig 4. The early stages of topsoil stripping over the crash site at a depth of 300mm from surface. The exposed corroded aluminium (right) is in an area corresponding to the southern edge of the crater at this elevation.

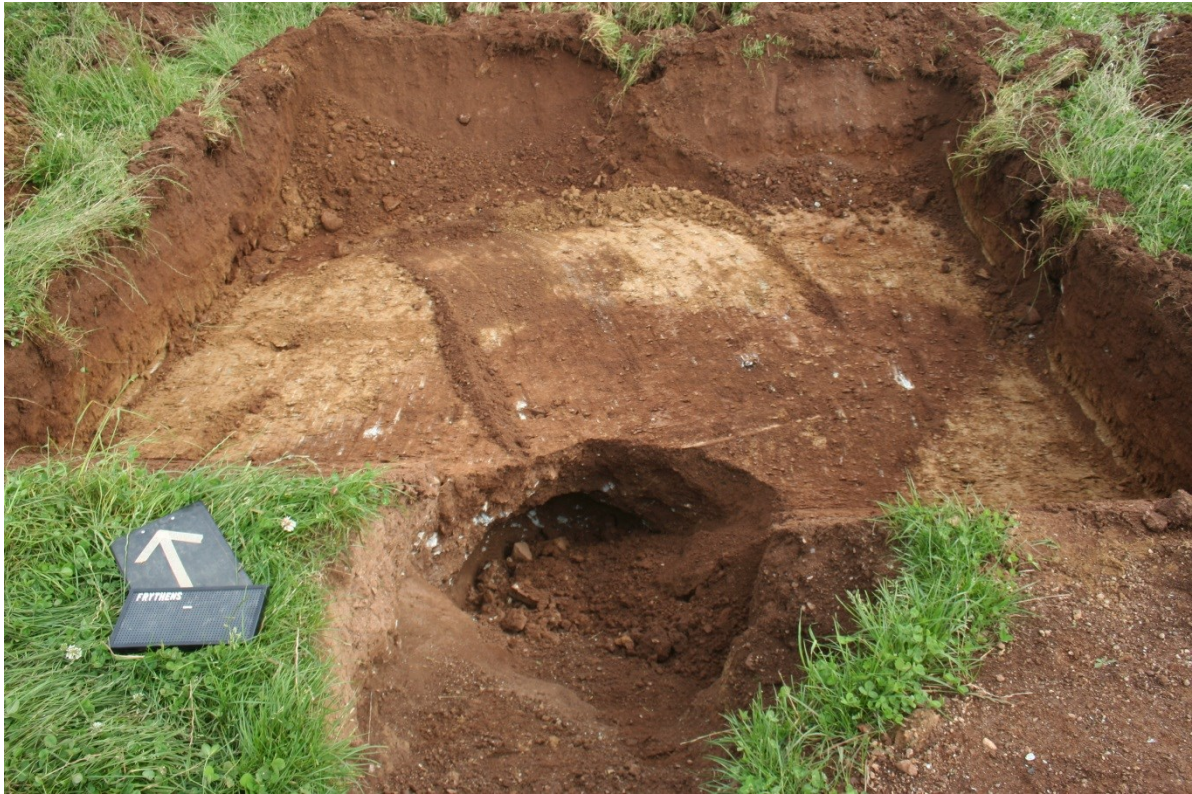
Fig 5. The excavation trench at 700mm from surface. The edges of the eastern section of the backfilled impact crater in the subsoil are clearly evident in this image.

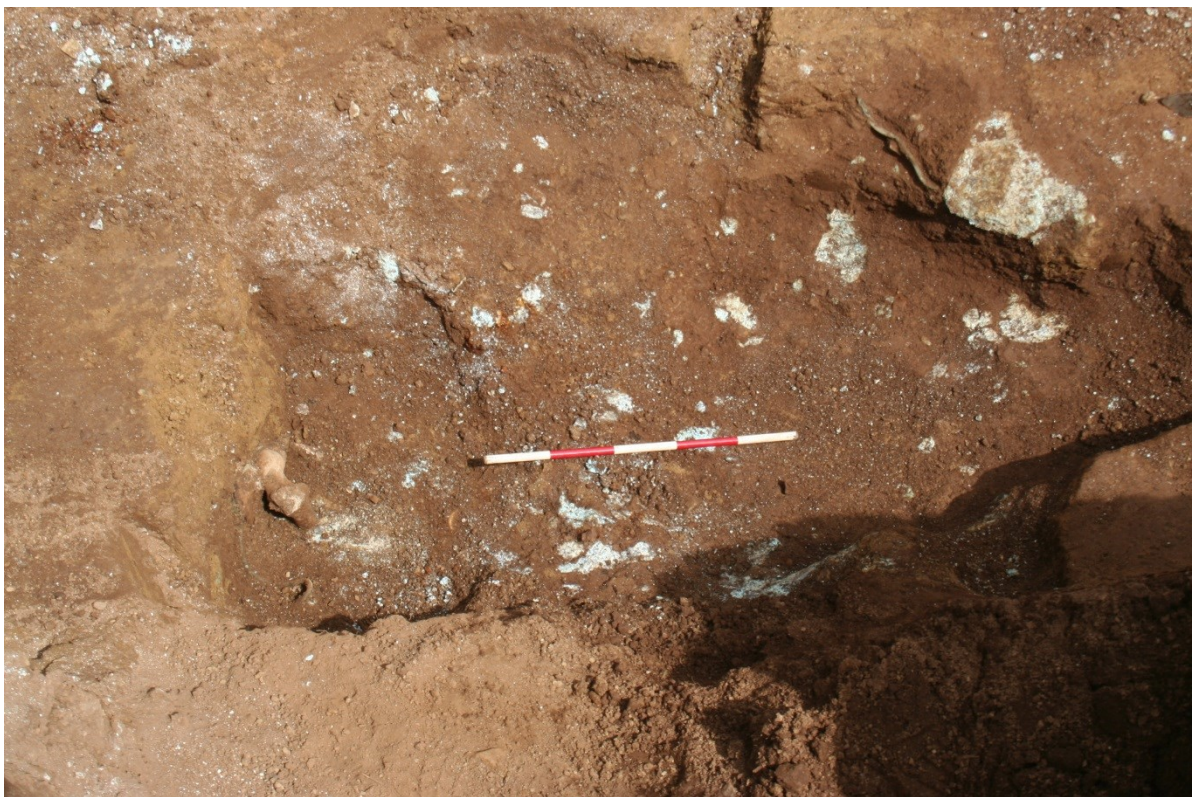
Fig 6. The head of a human femur (left) exposed at 1.0m from surface in the eastern part of the excavation trench. Note also the abundant corroded aluminium fragments in the crater backfill and the section of copper alloy hydraulic pipe exposed in the section (top right, just to the left of the large aluminium fragment).

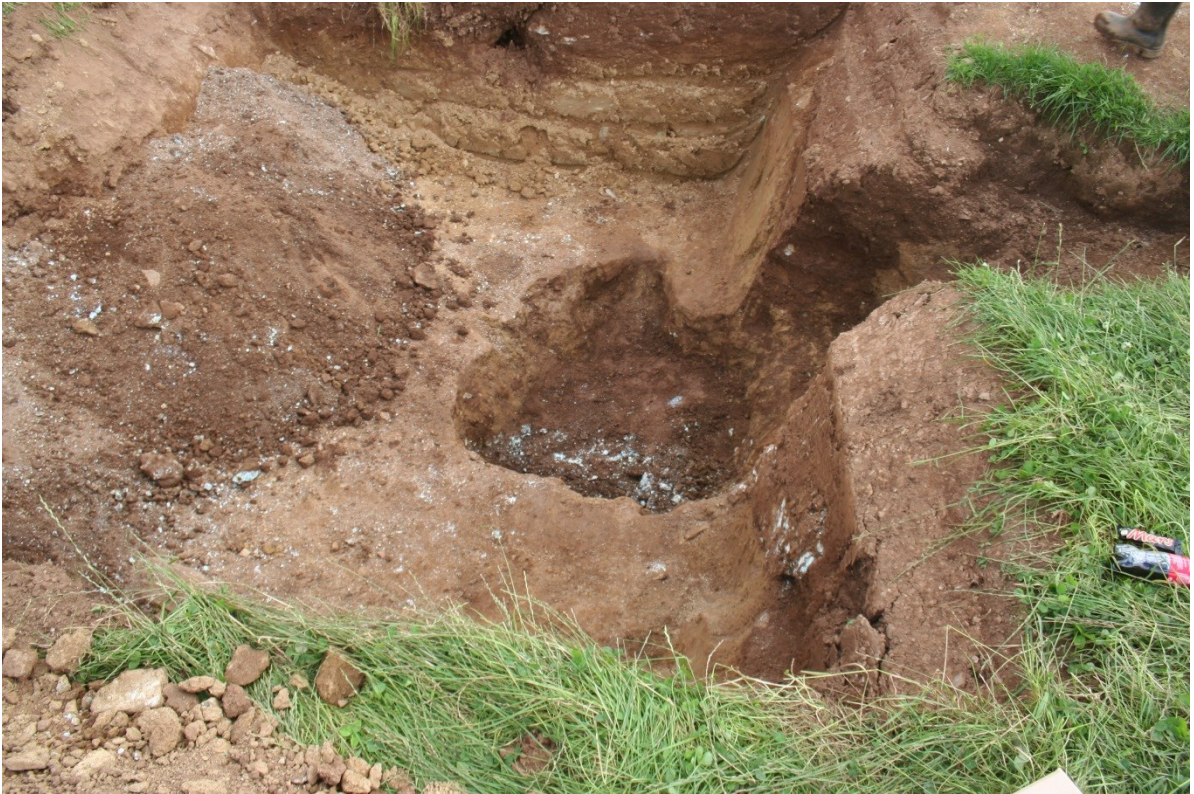
Fig 7. Looking south-east across the trench when its base was 1.4m from surface. Note how small the impact crater was at this depth. The edges of the crater on its south-western edge extended to the edges of the excavation trench.

The impact crater found at Frythens Farm had a distinctive asymmetric profile, and indicates that the aircraft struck the ground when travelling from the south-west. The upper section of the south-western side of the crater was at an angle of 30 degrees from the horizontal and was cut down through the topsoil and subsoil to a depth of 700mm for just under 2.0m from the crater's western lip. At this point the south-western crater edge steepened to 60 degrees from the horizontal and remained at this angle to its base at 1.7m from surface. The north-western, north-eastern and south-eastern edges of the crater were more or less vertical.

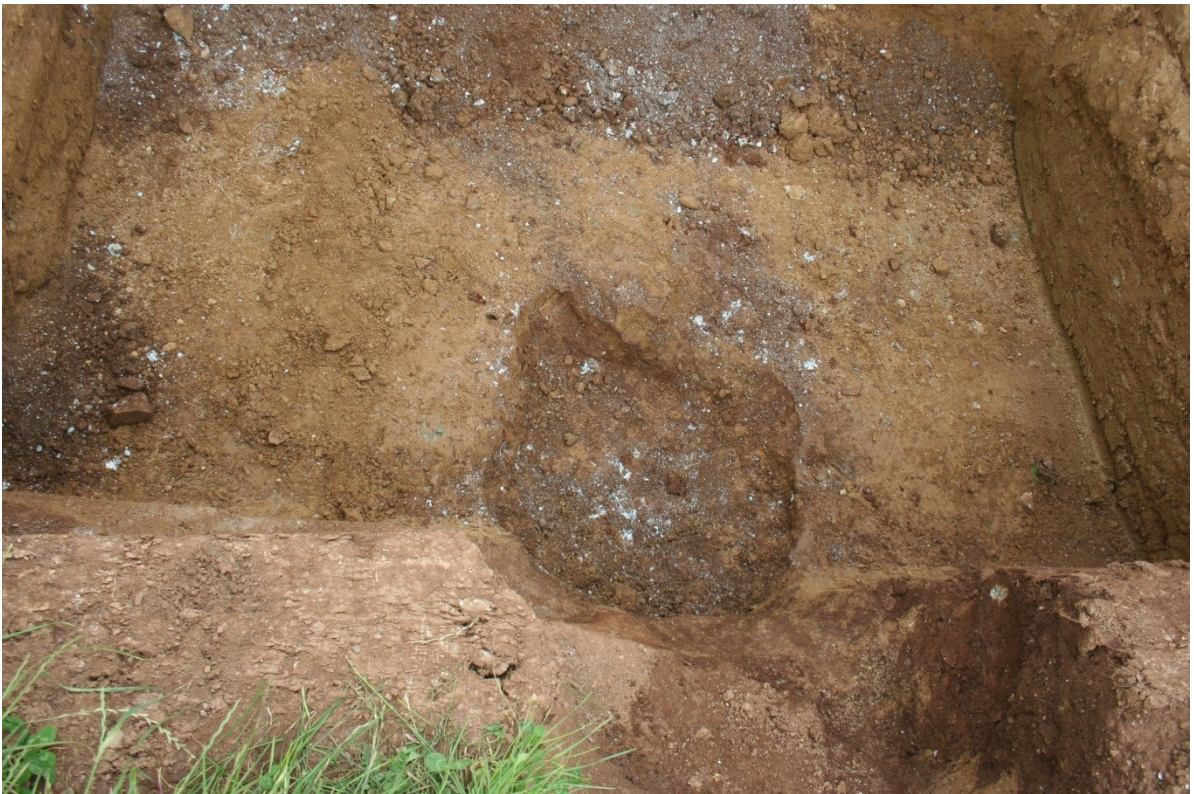
Fig 8. The fully excavated impact crater. The trench was lowered by a further 300mm from surface to expose clean subsoil across the whole of the trench base.

The area at the western end of the original trench was machine excavated to test the extent and profile of this edge of the impact crater; this proved the overall crater to have been approximately 3.0m in diameter; no additional artefacts were recovered during this exercise. Once excavation was complete the excavation trench was backfilled in layers, each being machine compacted before the next was replaced. The backfill within the excavated area was left slightly proud to allow for settlement.

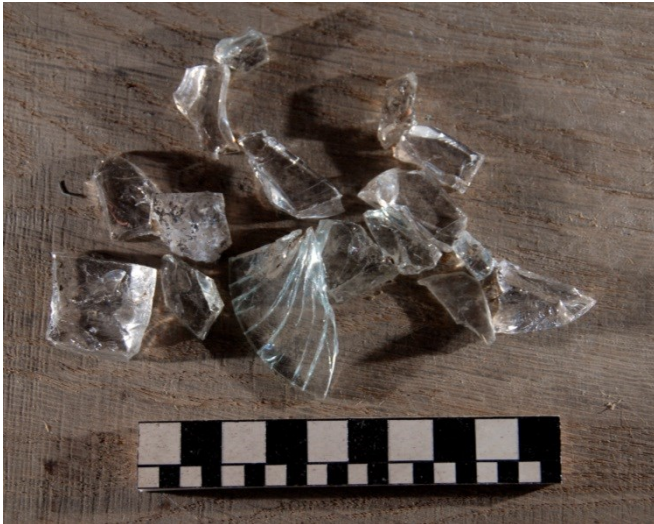
Fig 9. Fragments of the armoured glass cockpit windscreen.

- Small fragments of armoured glass from the front screen (Fig 9). Again, only a small proportion of the front window of the cockpit was found on site.

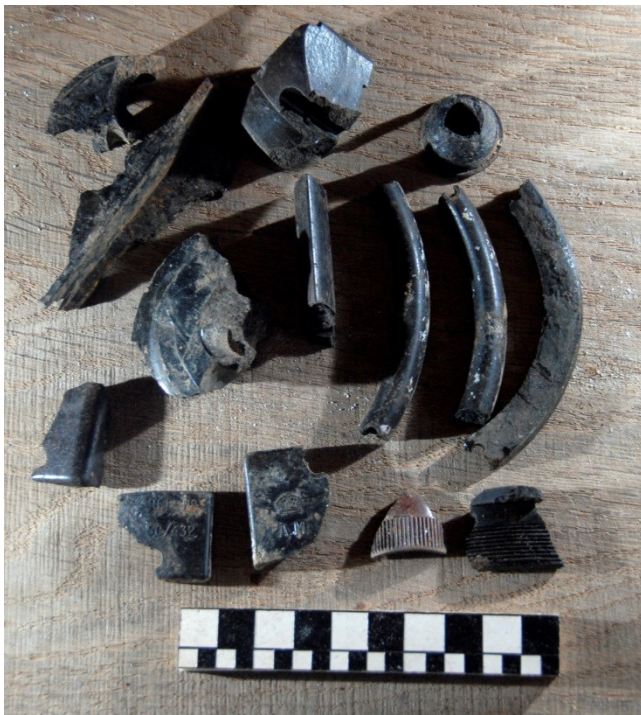
Fig 11. Broken Bakelite components, including parts of at least two control wheels.

- Broken parts of various Bakelite control knobs and wheels (Fig 11).
- A small electrical coil.
- The probable remains of the IFF Destructor button unit (Fig 28).

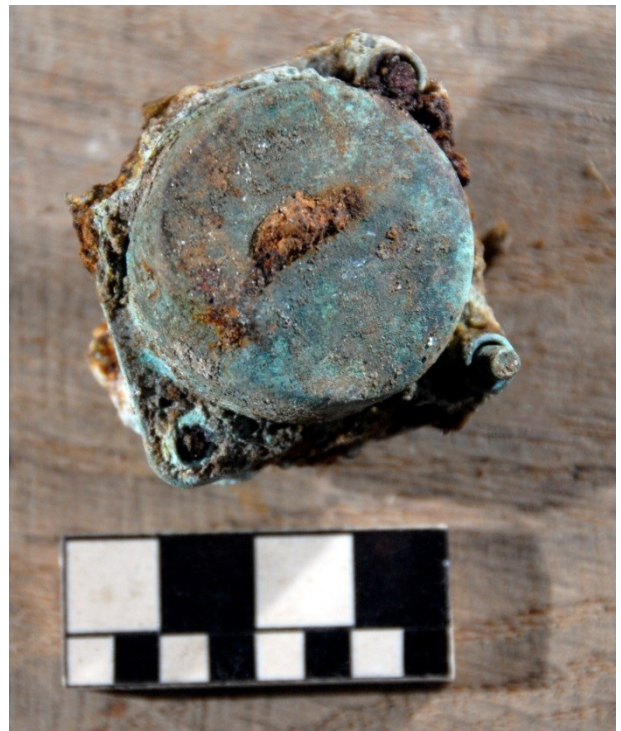
Fig 12. An unidentifiable, probably electrical component.

- Some badly damaged electrical components (for example Figs 12 and 23).
- Sections of woven copper tubing originally the sheaths of armoured cables (Figs 16).

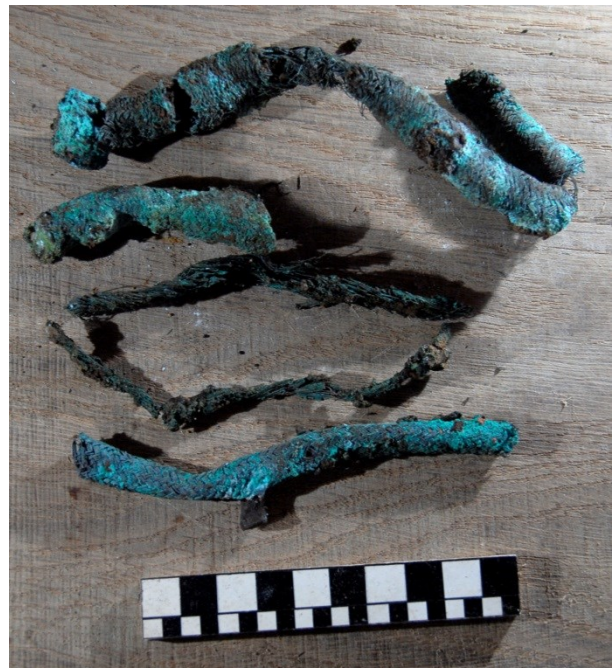
Fig 16. Smaller diameter sections of woven armoured cable sheathing.

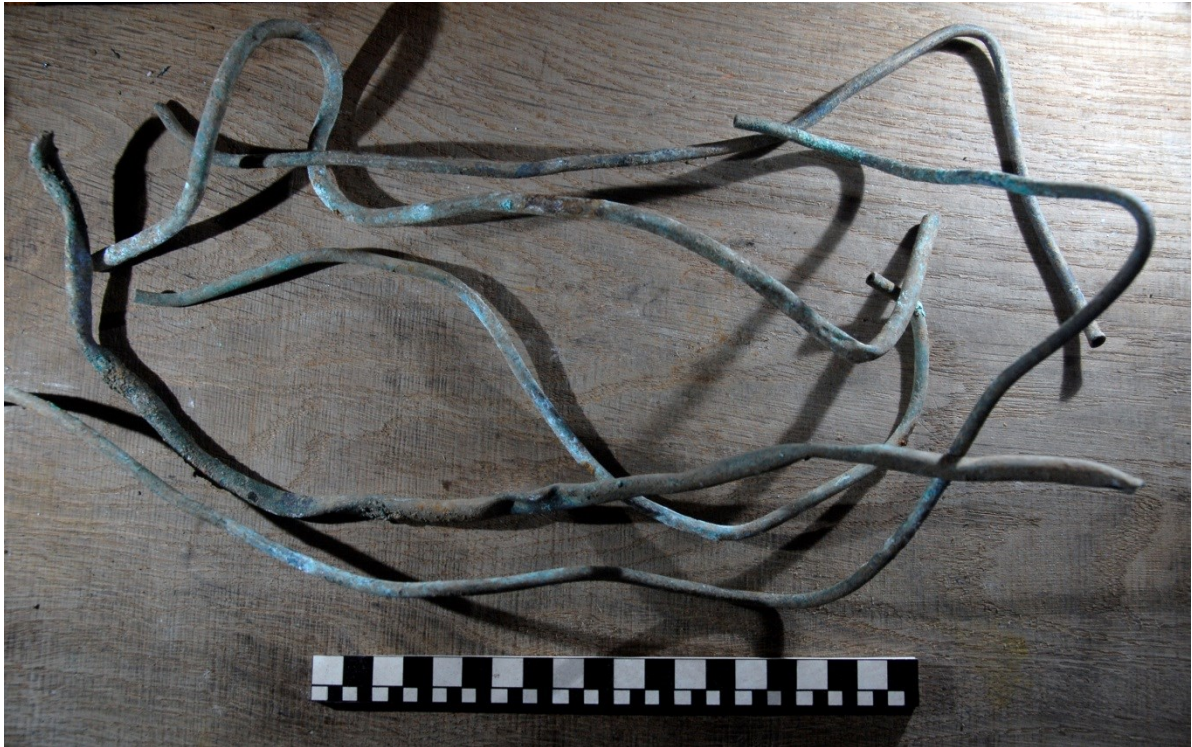
Fig 19. Sections of copper alloy hydraulic pipes associated with the undercarriage control system.

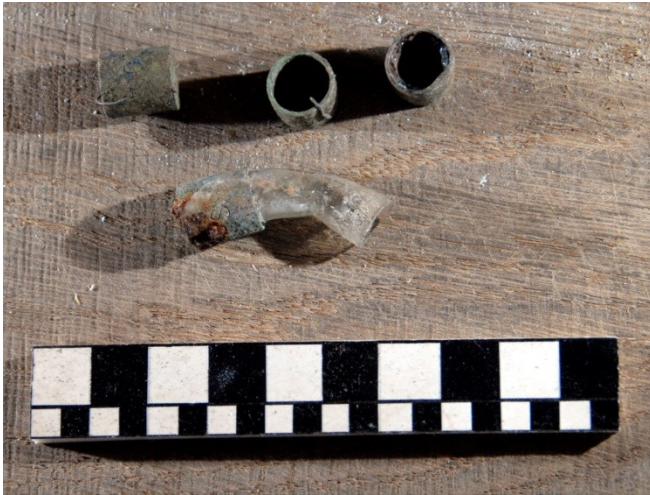
Fig 21. The remain of electrical fuses, the surviving glass in one being severely heat affected.

- A few sections of small-bore steel pipe (Fig 40), function unknown, though possibly sections of oil lines.
- A number of glass-bodied electrical fuses, most badly heat-damaged (Fig 21). The fuse box was low down beside the pilot's seat on the port side.

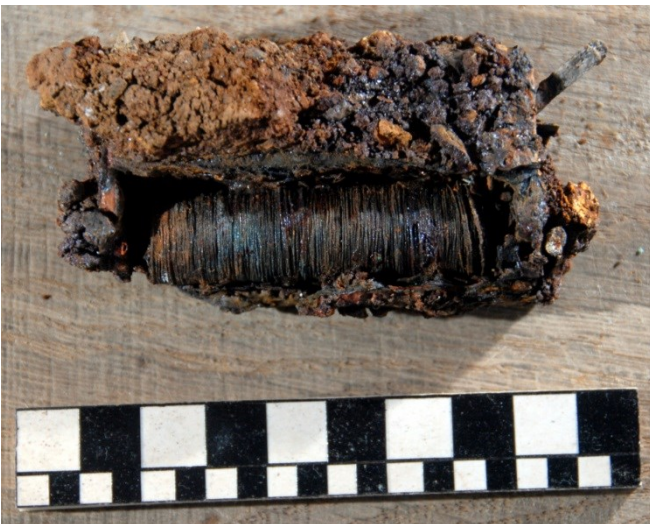
Fig 23. An electrical component consisting of two coils in a thin metal box.

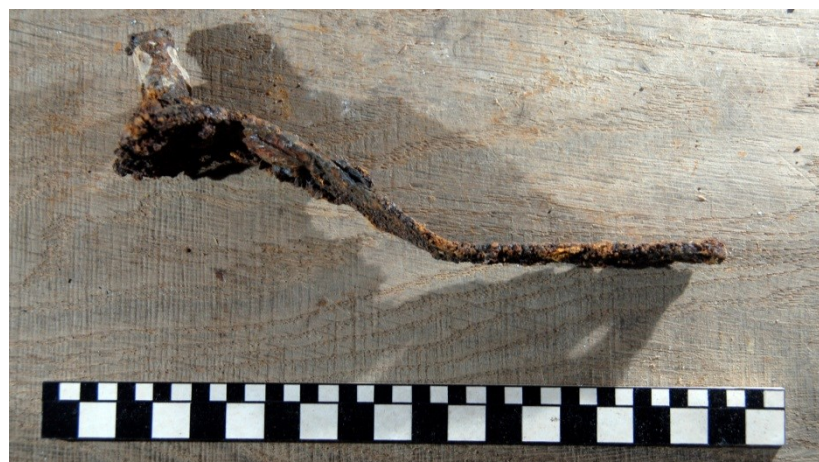
Fig 25. Probably the badly corroded throttle lever.

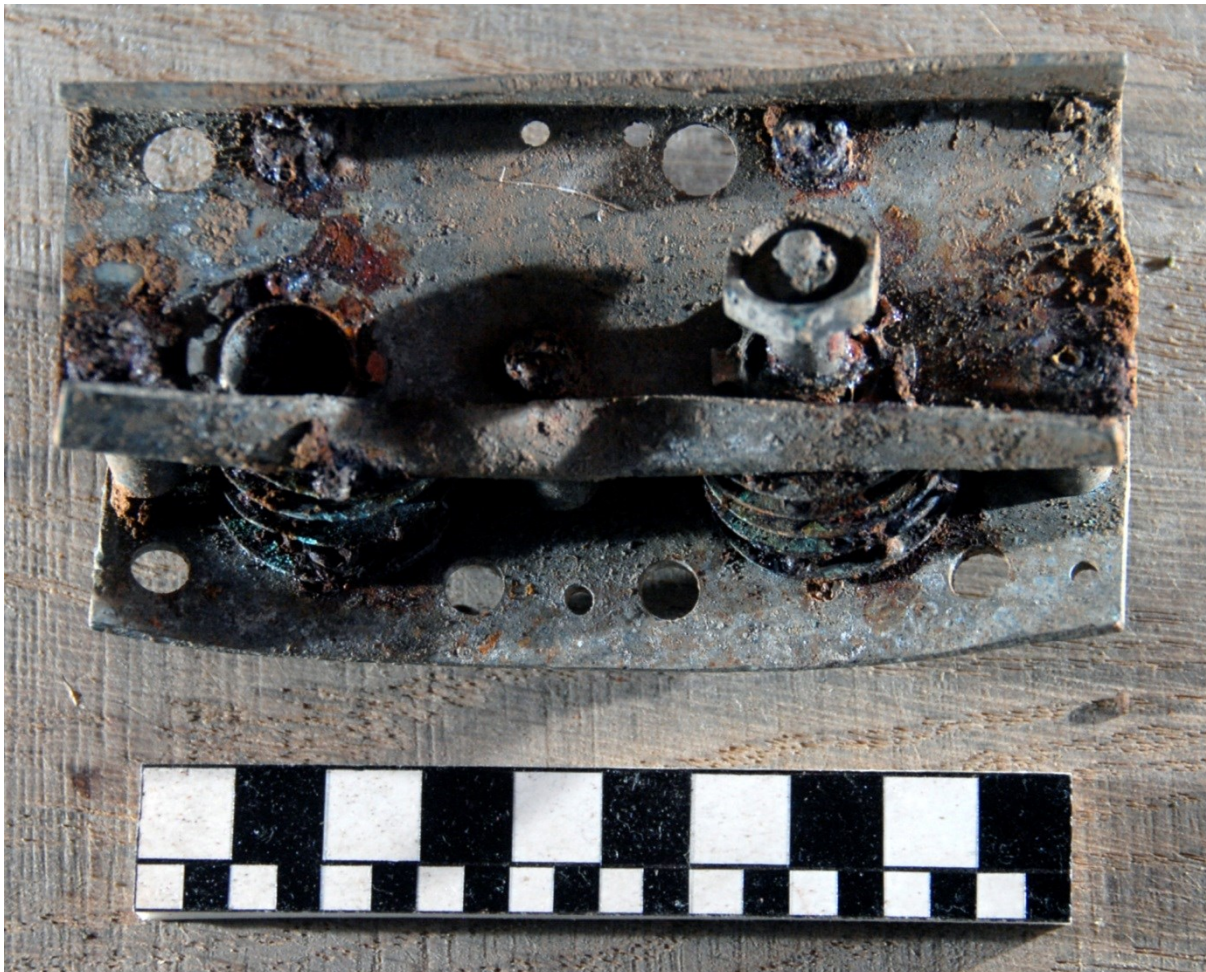
Fig 28. Possibly the remains of the twin button Identification Friend or Foe (IFF) destructor unit.

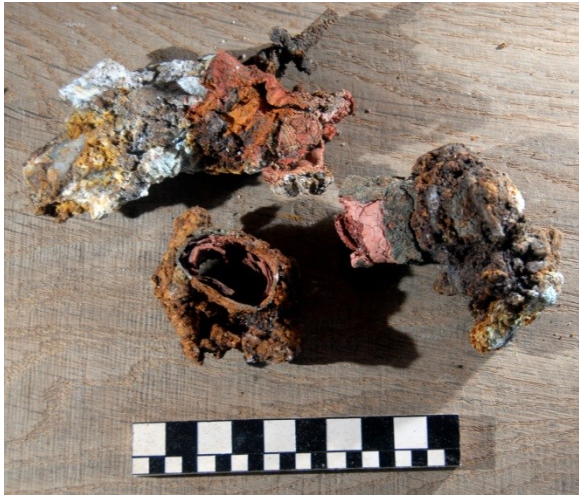
Fig 29. Badly decayed rubber pipe connectors.

- Miscellaneous and currently unidentifiable corroded ferrous objects (Fig 41, 42), including two pieces of probable former steel pipe incorporating woven copper alloy filters (Fig 31) and four pieces incorporating rubber hose connectors (Fig 29). Some of these might be better understood following X-raying.

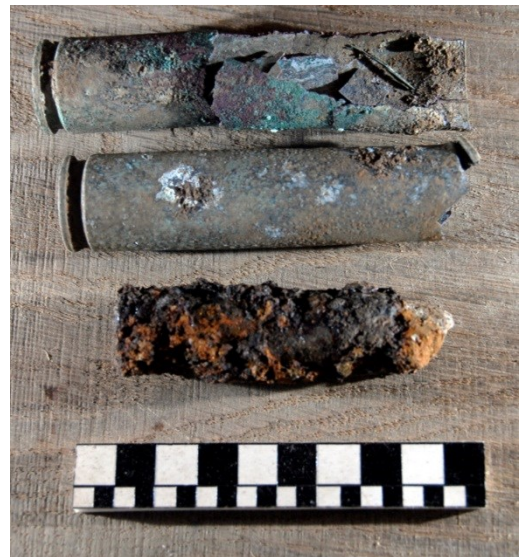
Fig 32. Two fire damaged 20mm cannon cartridge cases and a corroded possibly HE cannon shell projectile.

- Two fire-damaged cannon shell cartridges and one corroded 20mm cannon shell projectile, probably High Explosive (Fig 32).

at least one was certainly affected by the ensuing fire, as is evidenced by the heat-affected cannon shell cases found on the edges of the crater.

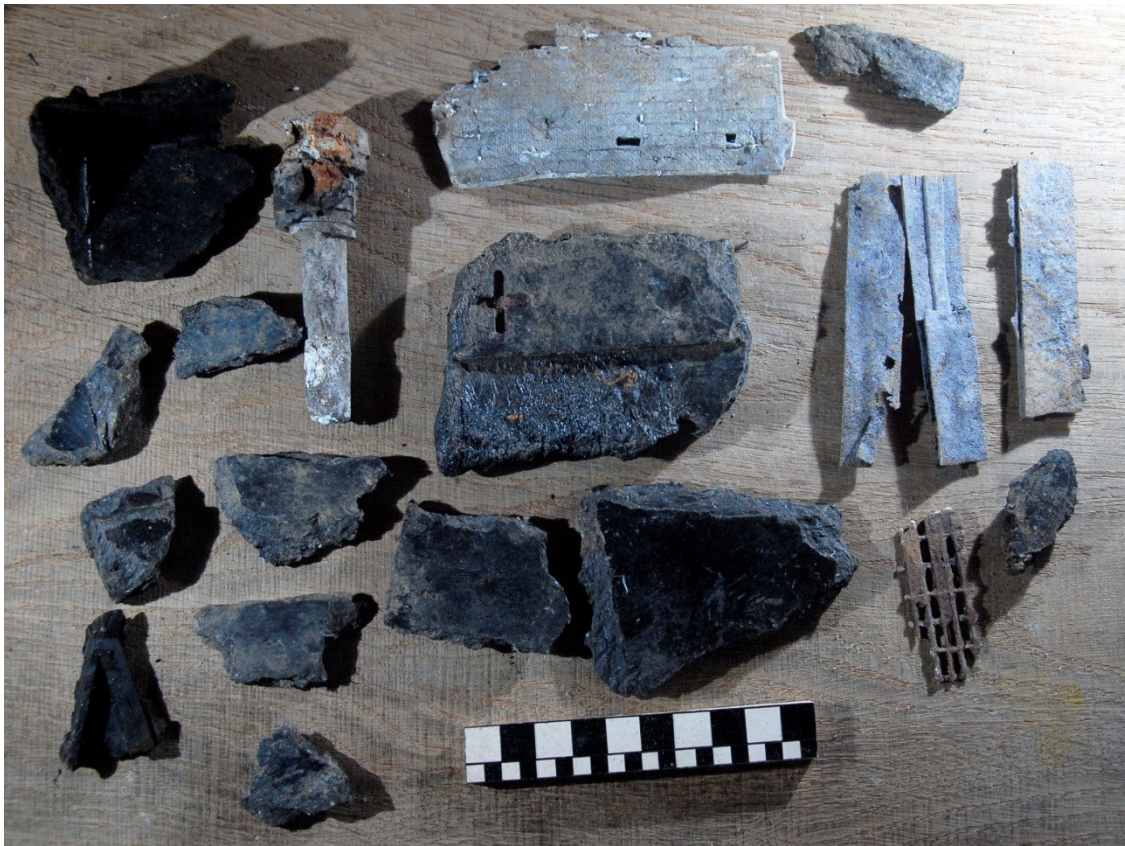
Fig 34. Fragments of the aircraft battery, including its casing, a terminal post, lead plates and separators.

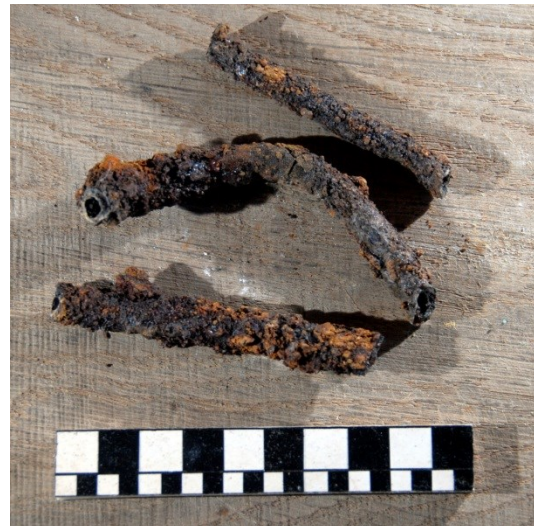
Fig 40. Short sections of small-bore steel pipe.

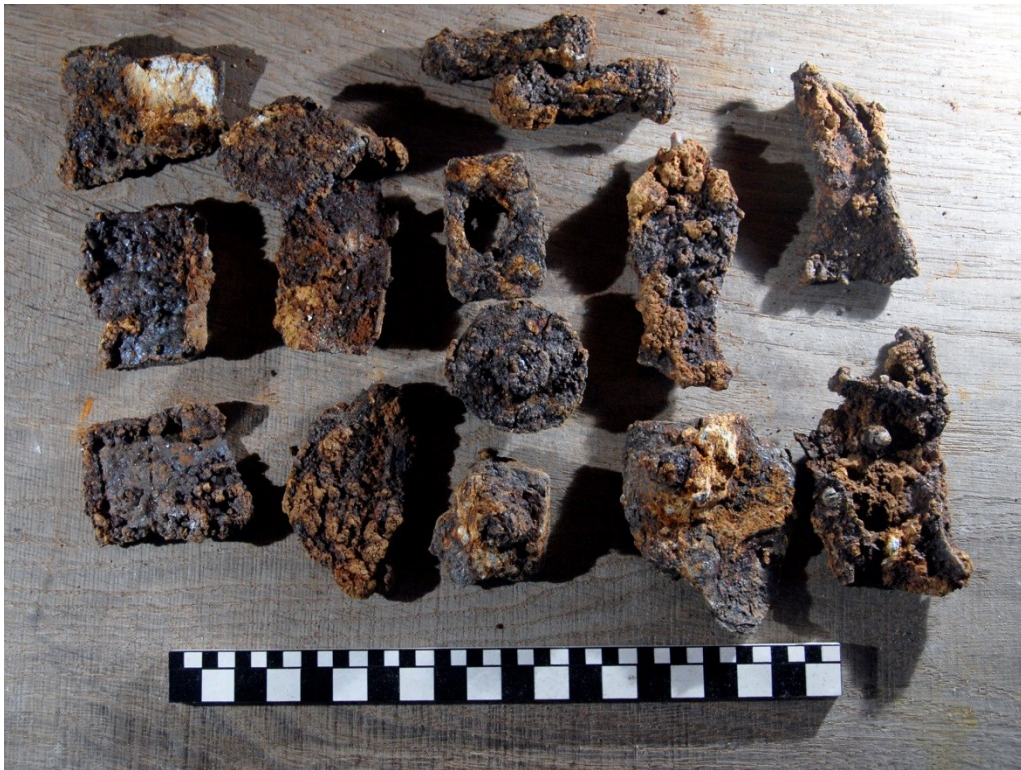
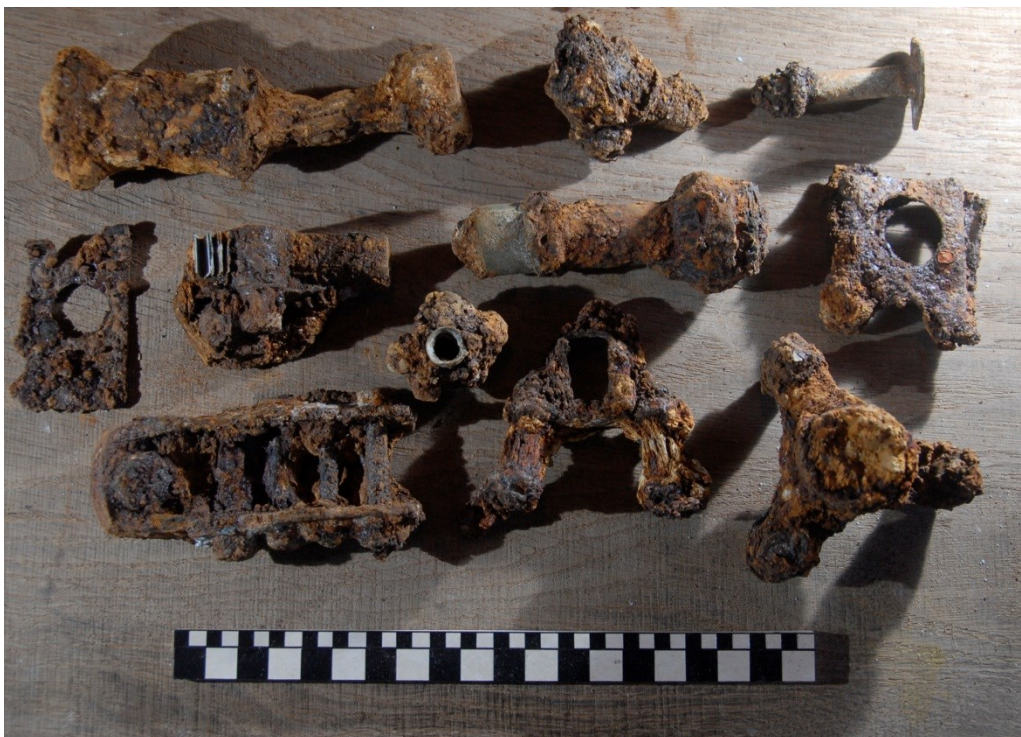
Fig 41. Pieces of corroded ferrous components.

Fig 42. Various corroded ferrous components, some of distinctive form.

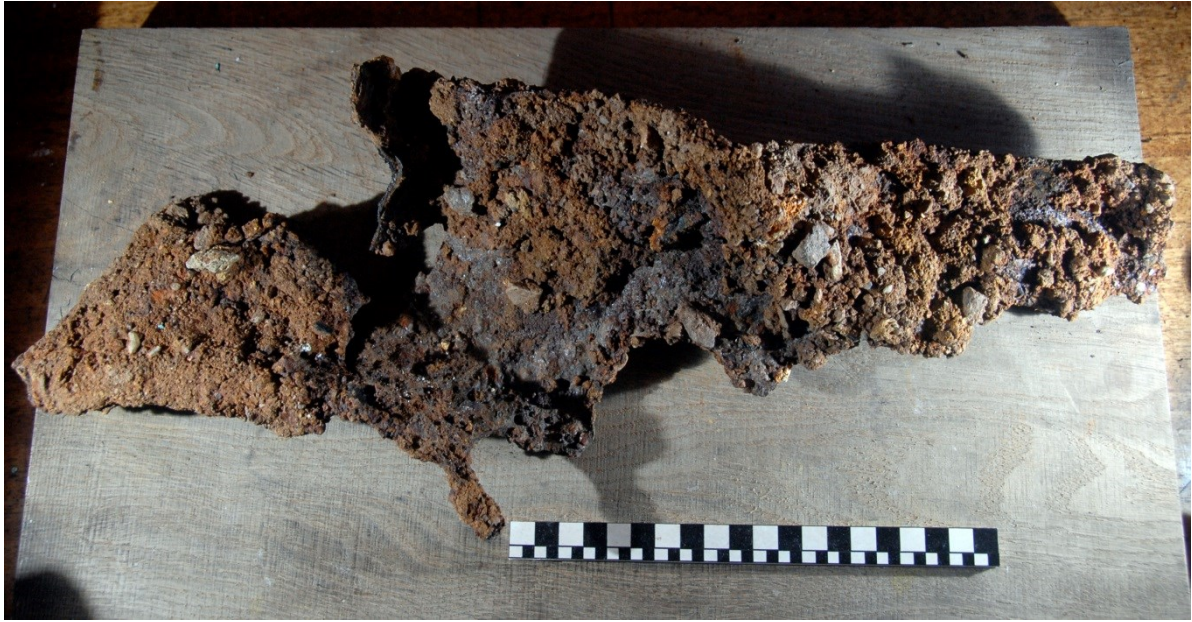
Fig 43. A large piece of badly corroded ferrous sheet, found at the base of the impact crater.

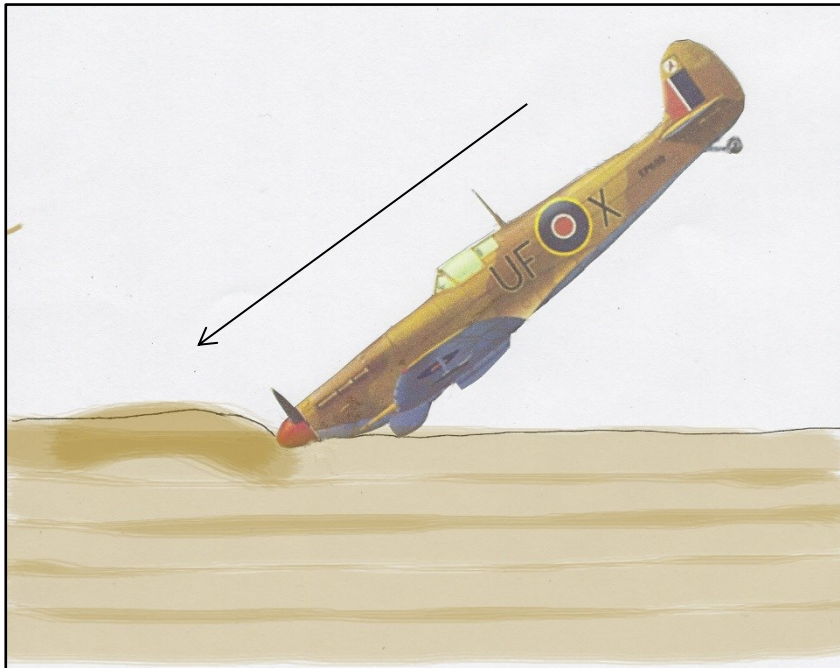
Fig 45. Crash stage 1. The Spitfire hits the ground at an angle of 30° , its wings shear off and the body begins to telescope into the rear of the engine block.

The forward end of the aircraft containing the engine as far back as the cockpit firewall (frame 5) almost certainly sheared off on impact, whilst the forward fuel tank and cockpit instrument panel (back to frame 8) probably also became detached at the time. This part of the impact event probably also destroyed substantial parts of the forward section of the cockpit, as none of its components were found in the impact crater. The archaeological evidence suggests that the engine did not become buried in the impact crater, and is thus likely to have stayed at or close the surface, possibly ploughing on eastwards at surface for some distance, something documented in other crash incidents where the angle of impact was not acute.

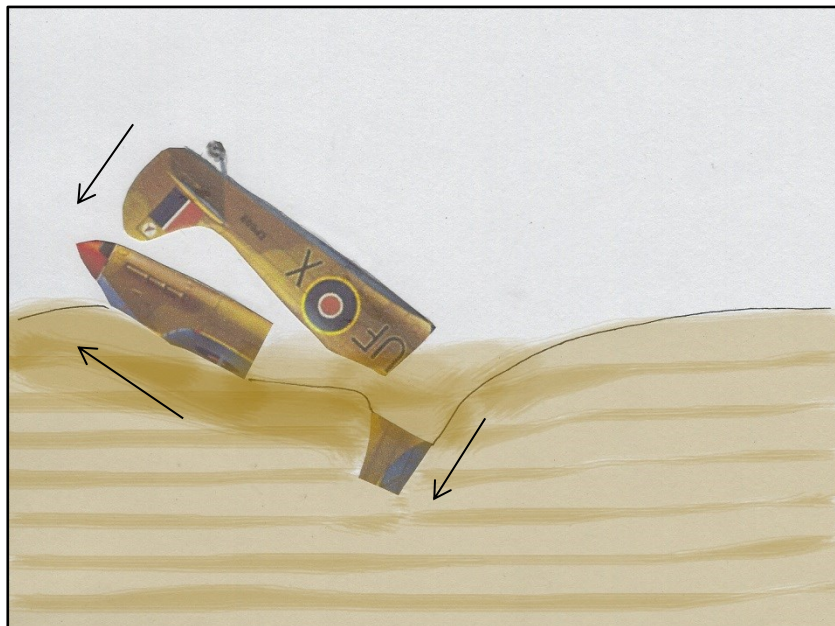
Fig 48. Crash stage 4. The engine block comes to rest (probably further on than shown here); the mid and tail section of fuselage may have ended up ahead of the impact crater as shown here, or standing more or less vertically on top of the crater as shown above; the fragmented remains of the mid cockpit area become buried at the base of the crater. Some above-ground parts of the aircraft wreckage are affected by fire. Above ground wreckage subsequently salvaged by the RAF maintenance unit team. The crater is partly backfilled.

The impact site would have been a chaotic mess following the crash, with partially burnt debris likely to have been scattered over a fairly large area on top of and to the east of the impact crater. The impact crater itself was not very large or deep, and following little more than a cursory examination by the recovery team may have been backfilled. From what remained at surface it would have been evident that there was relatively little of the aircraft buried there, and it is unlikely that anyone would have suspected that some parts of the pilot's body remained within the buried debris.
