Tintagel Castle, Cornwall
Archaeological desk-based assessment of an area
near the visitor facilities

Report No: 2017R054

Tintagel Castle, Cornwall: archaeological desk-based assessment of an area near the visitor facilities

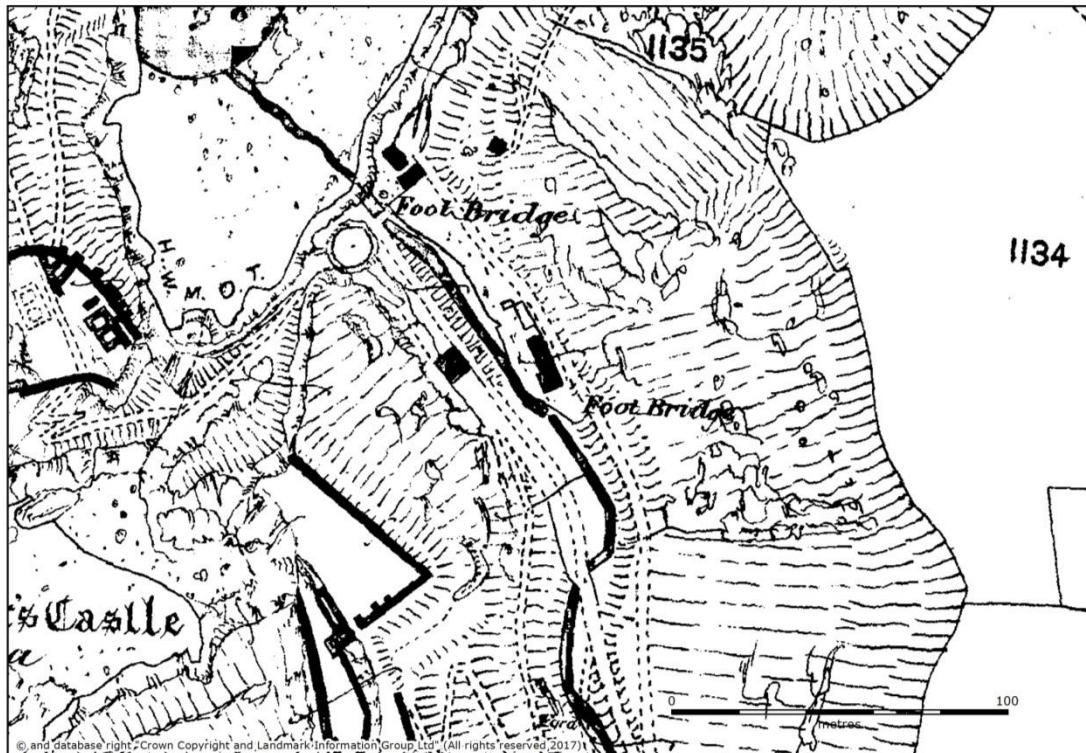
Fig 3. The area backing Tintagel Haven circa 1880.

Fig 4. The area backing Tintagel Haven circa 1908.

The *circa* 1878 and 1908 OS 1:2,500 mapping for Tintagel (Figs 3 and 4) showed buildings on both sides of the footbridge over the stream, the easternmost now converted into the café, the westernmost subsequently very considerably extended to form the modern visitor centre. A further building shown on the 1878 mapping to the north-west of the café on the eastern side of the stream appears to have been incorporated into the building to its south, when this was labelled 'Castle Cottage'. No indications of other structures, yards or walling which might have been associated with the mine or slate works were shown in the area covered by the DBA on these maps. This part of the site is now partly occupied by the north-western end of the carpark and partly by the modern footbridge and pathways associated with the café and visitor centre (Fig 5).

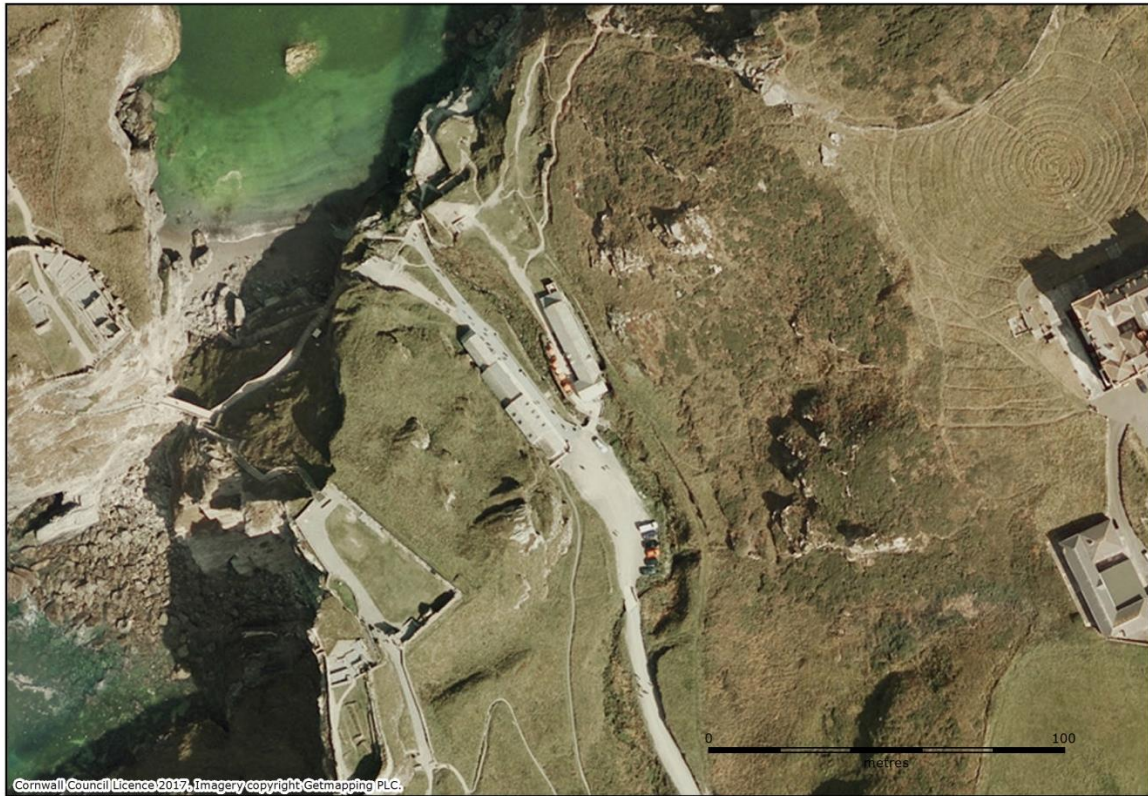
Fig 5. The area backing Tintagel Haven in 2005.

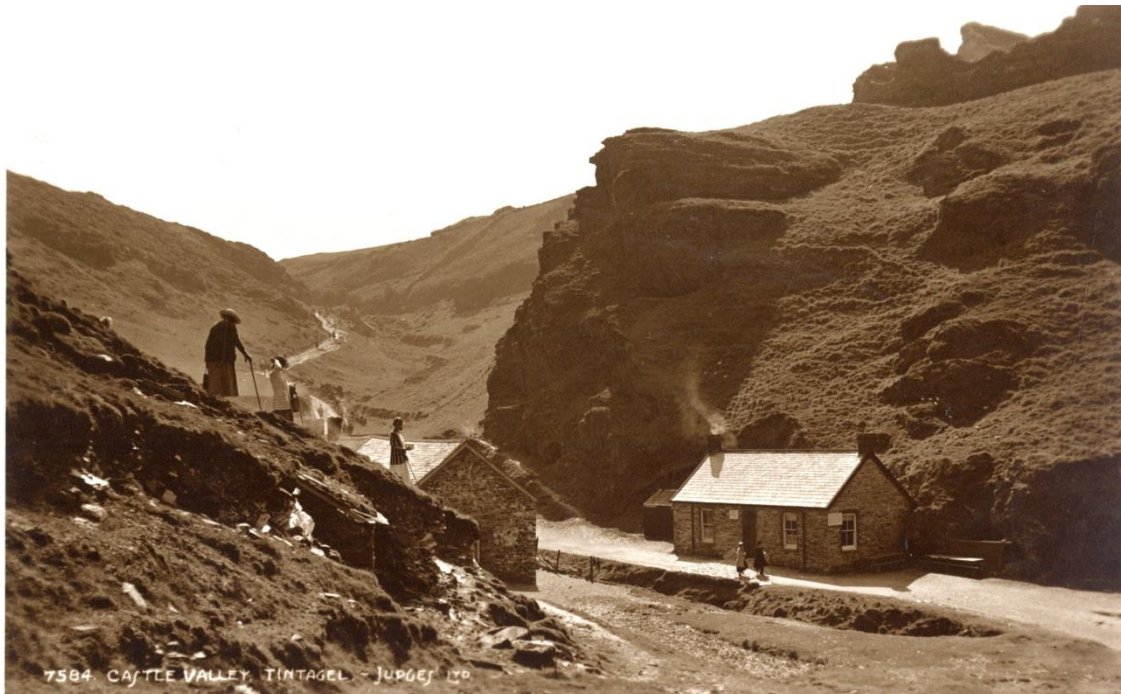
Fig 6. The buildings at the lower end of Castle Drive in the early 20th century following their conversion from industrial uses. Postcard image courtesy of the Charles Thomas Archive.

A number of late 19th century/early 20th century photographs of the valley running down to the Haven show distant views of the buildings on the eastern side of the stream, but the detail in the majority of these views is insufficiently clear to identify whether any other smaller features were sited near the buildings within the area considered by this DBA. Two early postcards have been reproduced in this report (Figs 6 and 7) and an extract from a further example has been used as the report cover. All three were sourced from the Charles Thomas Archive.

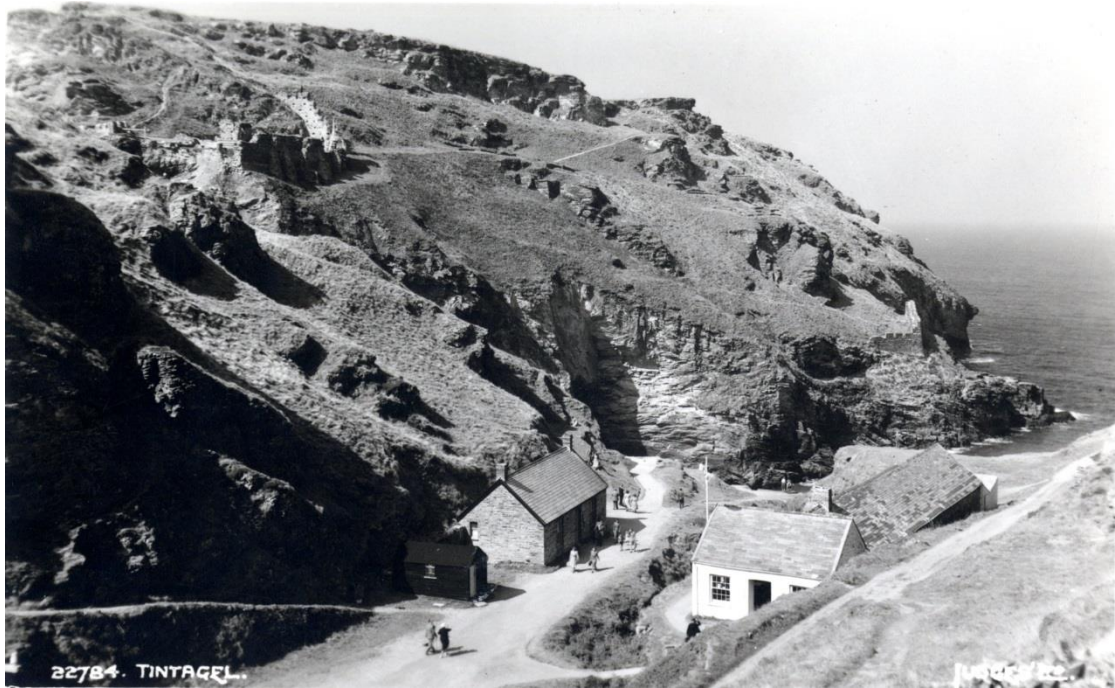
Fig 7. A further view of the buildings at the lower end of Castle Drive in the early 20th century. Postcard image courtesy of the Charles Thomas Archive.

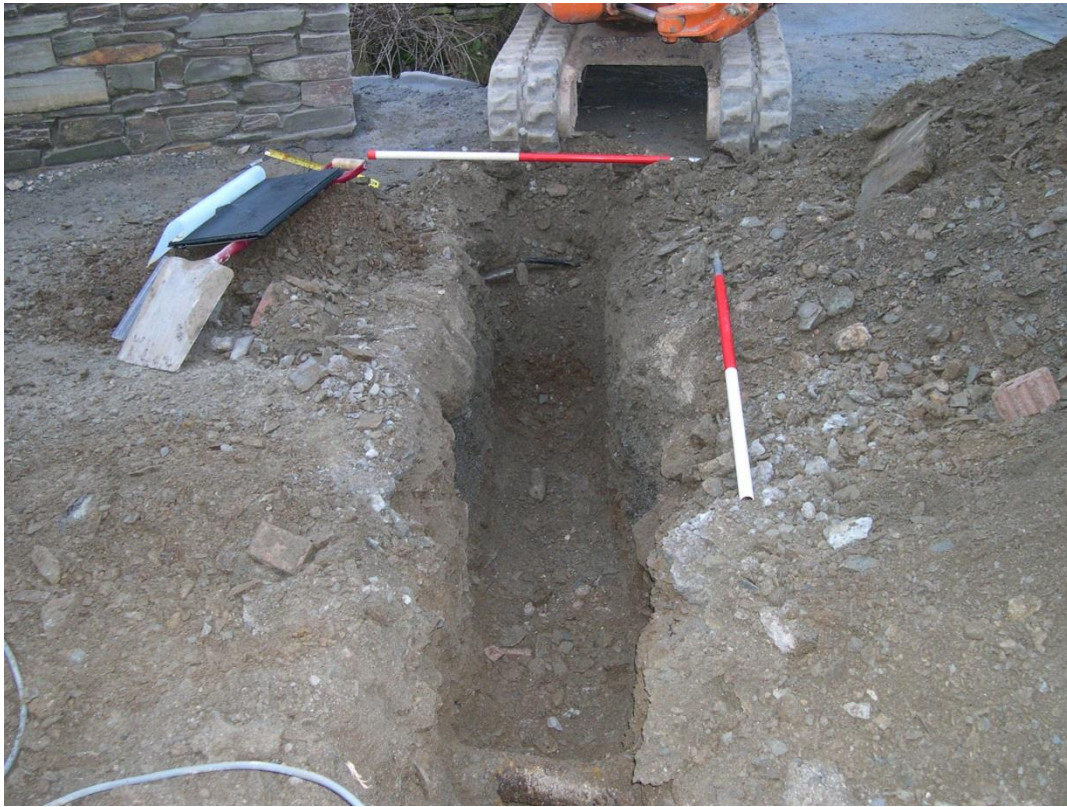
Fig 9. The services trench excavated in Area 4 in 2003 (Dudley 2004) showing the built up material interpreted as a slate processing yard and the iron pipe (bottom centre).

The service trench through Dudley's 2003 Area 4 (Dudley 2004) was excavated through the northern end of the present car park surface and underlying layers of made ground from the western end of the southern footbridge to the southern end of the concrete walkway running past the visitor centre (Figs 8 and 9). The area was found to have been cut by the installation trench for a 100mm diameter cast iron pipe running down

the valley. The service trench measured 0.74m deep. Another trench (Area 1) opened up immediately to the south-east of the visitor centre revealed the footings of a former wall.

The only intervention within this specific area which has been archaeologically recorded consists of the trench cut through Dudley's Area 4 in 2003 at the southern edge of the area with which this DBA is concerned (see Figs 8 and 9) This may well have been the trench for the currently failed water pipe. It is probable that other surviving levelling spreads in the adjacent area will be of similar character and origin, and that there is a possibility that this 18th and 19th century material will also incorporate post-Roman/early and later medieval artefacts.
