Bartinney Nature Reserve, St Buryan, Cornwall;
Archaeological Watching Brief for stiles and gateway

Cornwall Archaeological Unit

Report No: 2017R057

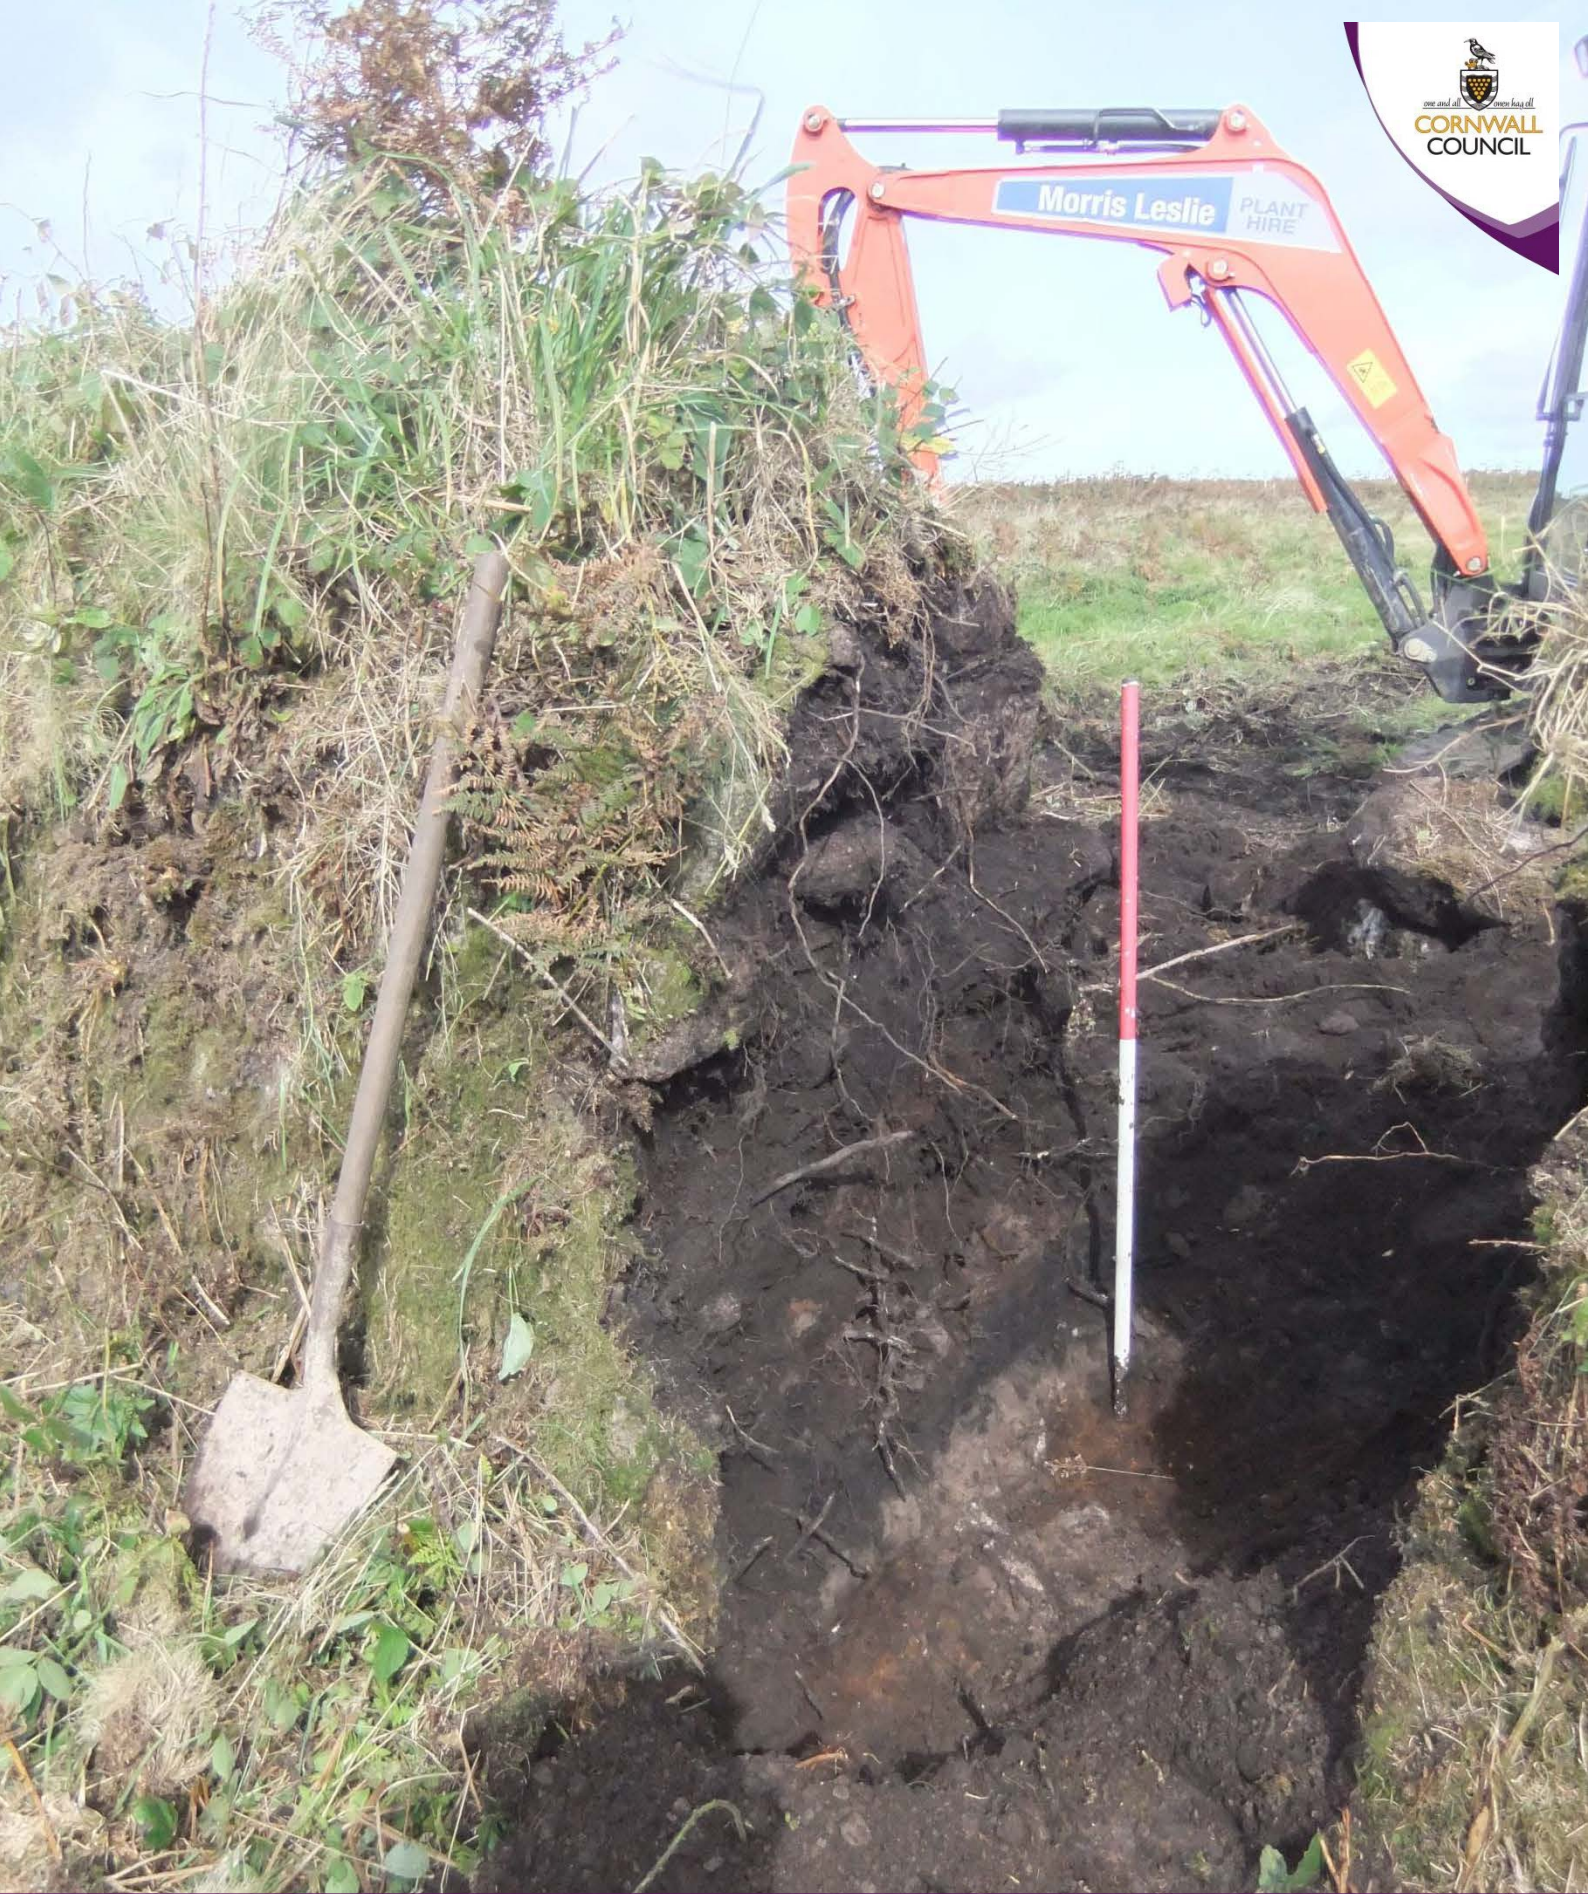
Cover West side of opening for stile and gateway in hedge at Site 2, looking north west. An earlier phase of the boundary can be seen, marked by a differently-coloured core to the bank, with associated dark buried ditch fill in front (see also section, Fig 25a).

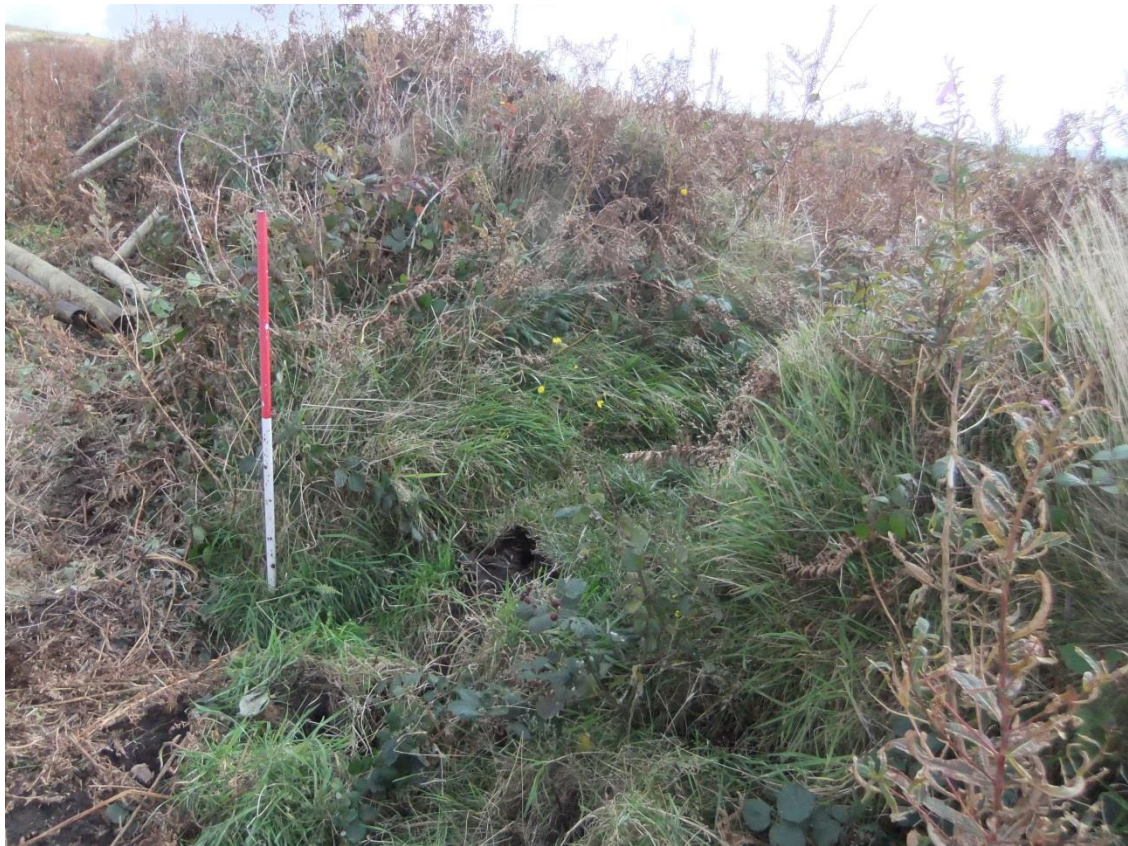
Fig 8 Bank at Site 1, bounding SM (foreground), after removal of old stile, looking SSW. The truncated end of the bank at the stile, visible here, is shown in section in Fig 24.

The hedge bank here was up to 2m wide and 1.1m high, worn down c0.5m at the stile, with battered sides faced with medium sized rubble granite, laid and pitched, and north side ditch appearing c2m wide and 15cm deep. The works revealed the following fabric:

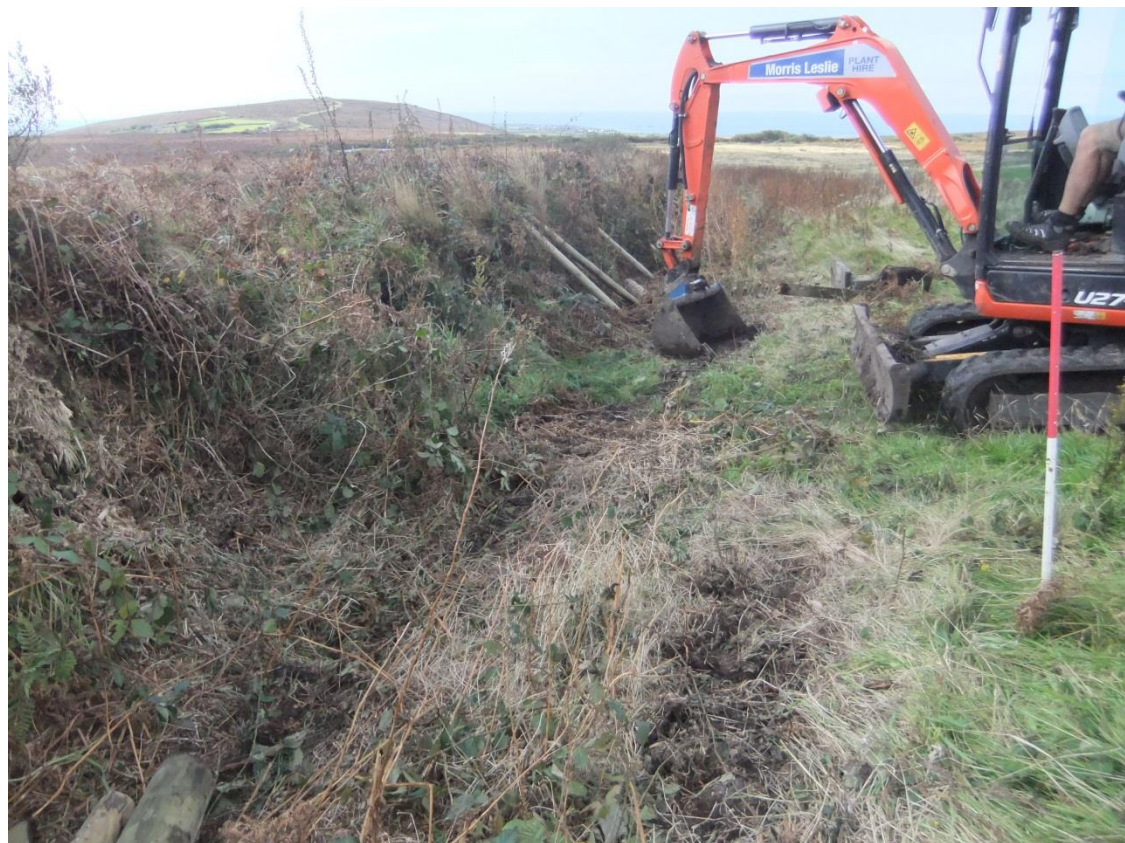
Fig 9 Site 1 cleared of scrub, looking WSW, showing bank's external ditch, and setting.

The hedge bank at Site 1 lies at the corner of a group of strip fields, and also forms part of a long arcing boundary – delimiting Tredinney Common and the medieval parish of St Buryan (Figs 4 and 9). Site 3 lies on the same medieval boundary: and, like Site 2 (Fig 12), is on the margin of the surviving prehistoric fields. As a result the boundaries at the 3 sites define part of the edge of a Scheduled Monument (SM) area protecting these important survivals on the common. This can be seen from Figure 3, where the NMP plot is reproduced in green and the SM outlined in red.

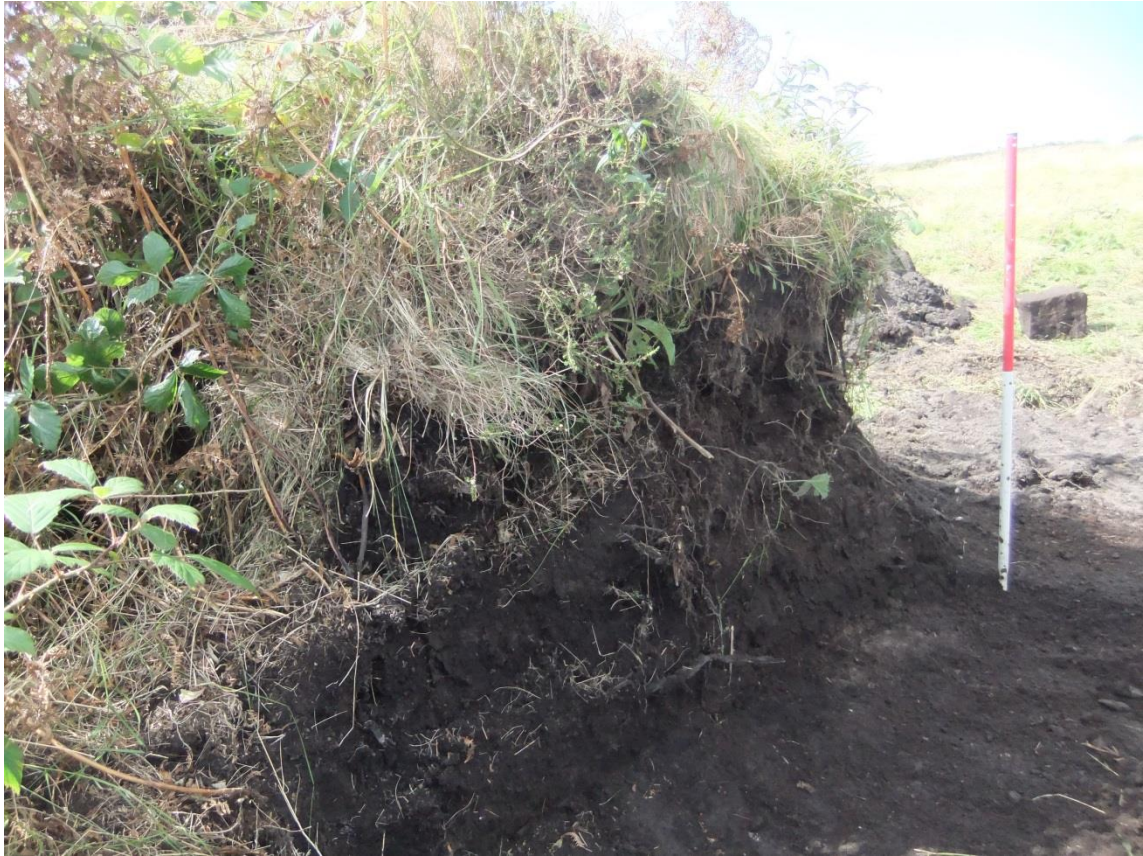
Fig 10 New opening at Site 1, looking WNW, showing side modified for 20C stile.

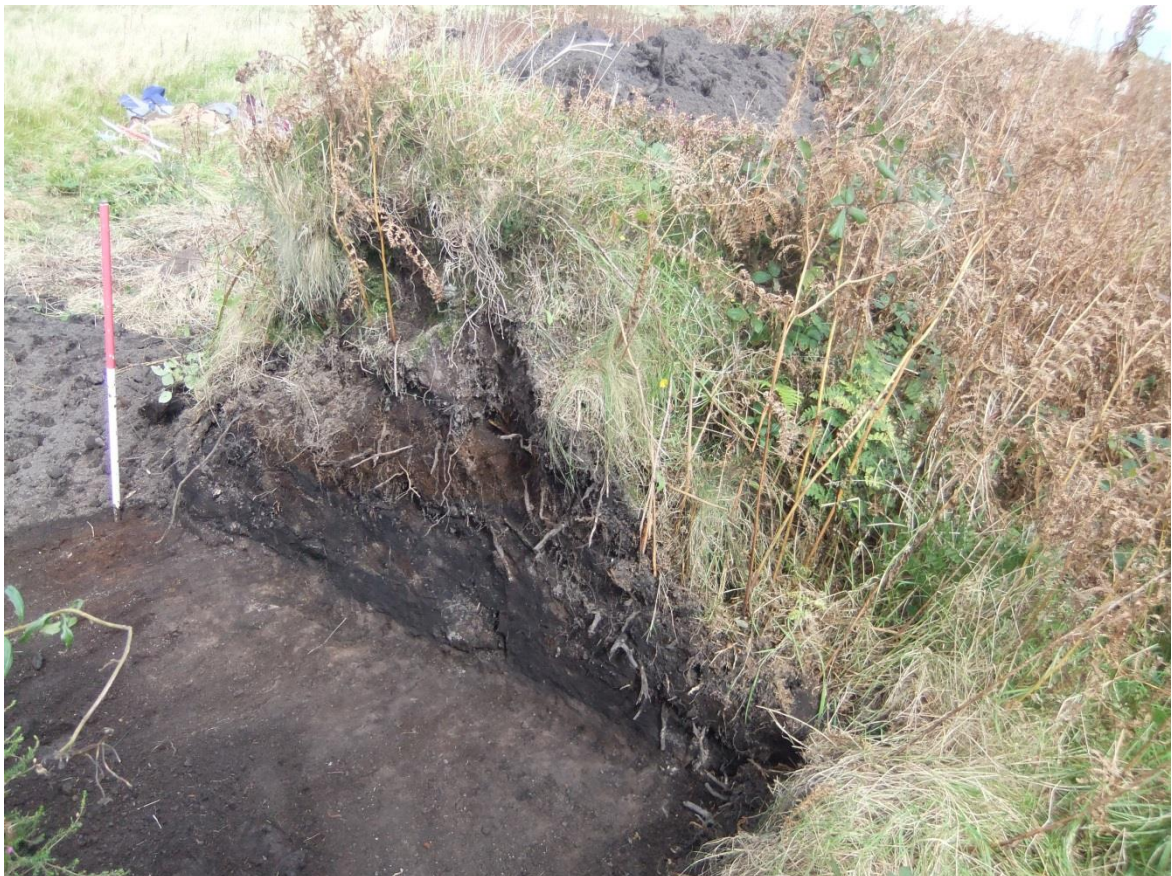
Fig 11 Site 1 opening, looking north east, with stratigraphy seen in section in Fig 24.

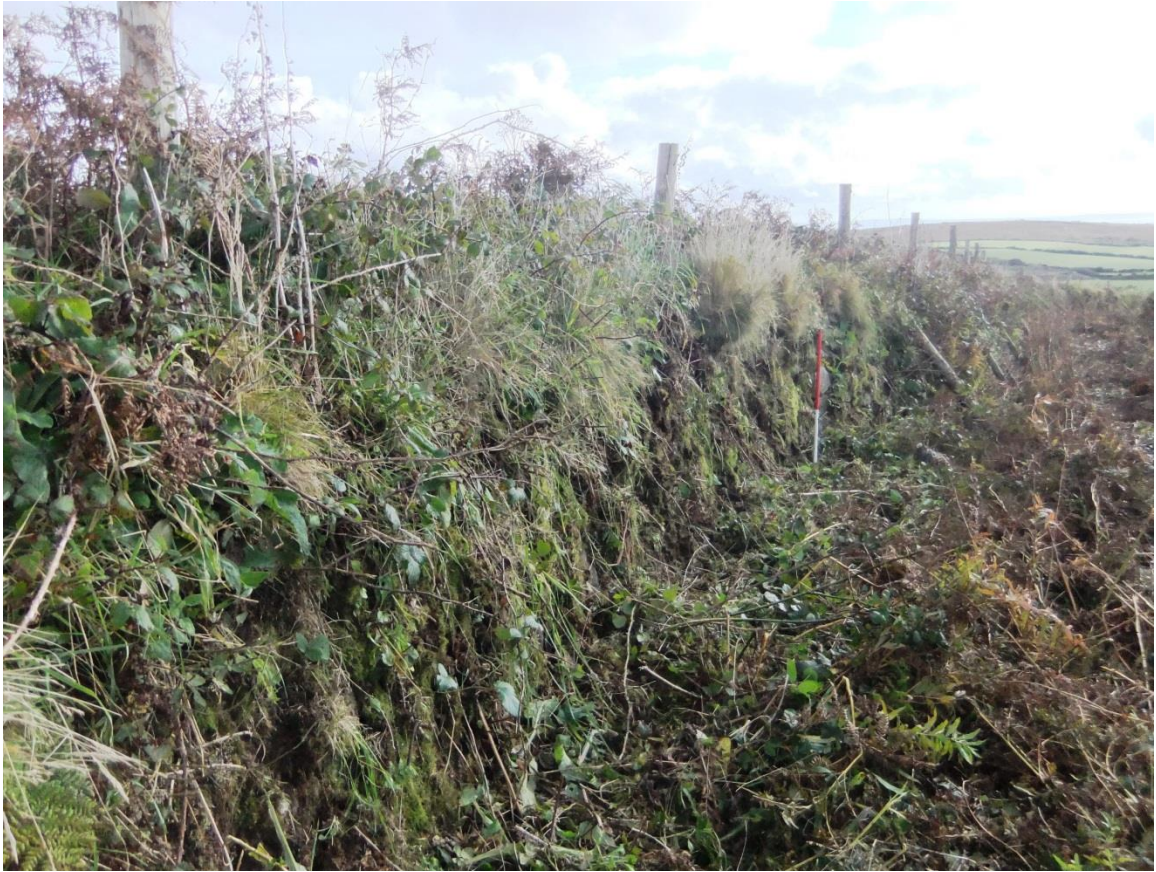
Fig 12 Site 2 before works, showing south side of bank bounding SM, looking east.

The bank here was c1.2m wide and 1.1m high, and had steeply battered sides faced in rubble granite, with medium stones laid over pitched slabs, and flat top. No ditch was evident at surface (but see 9, below). Fabrics and fills revealed are as follows:

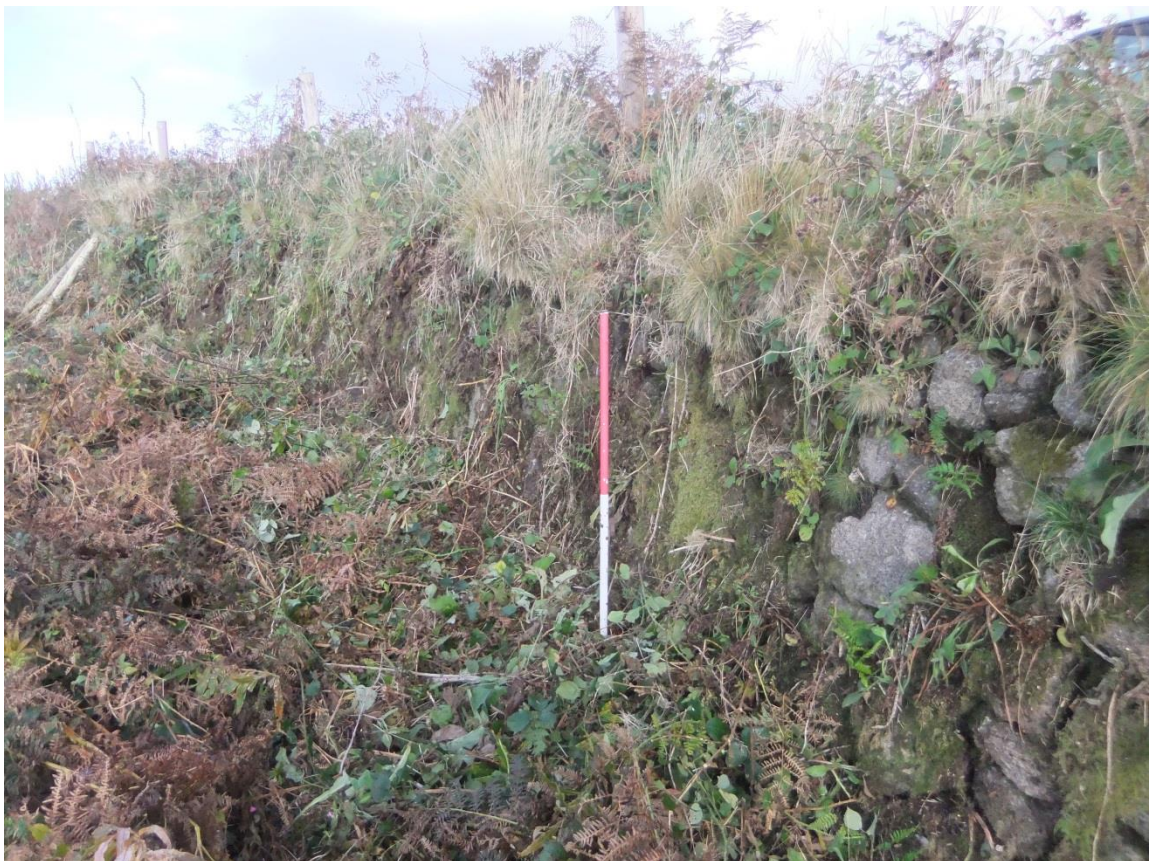
Fig 13 Site 2 cleared of bramble, showing stone facing to south side, looking west.

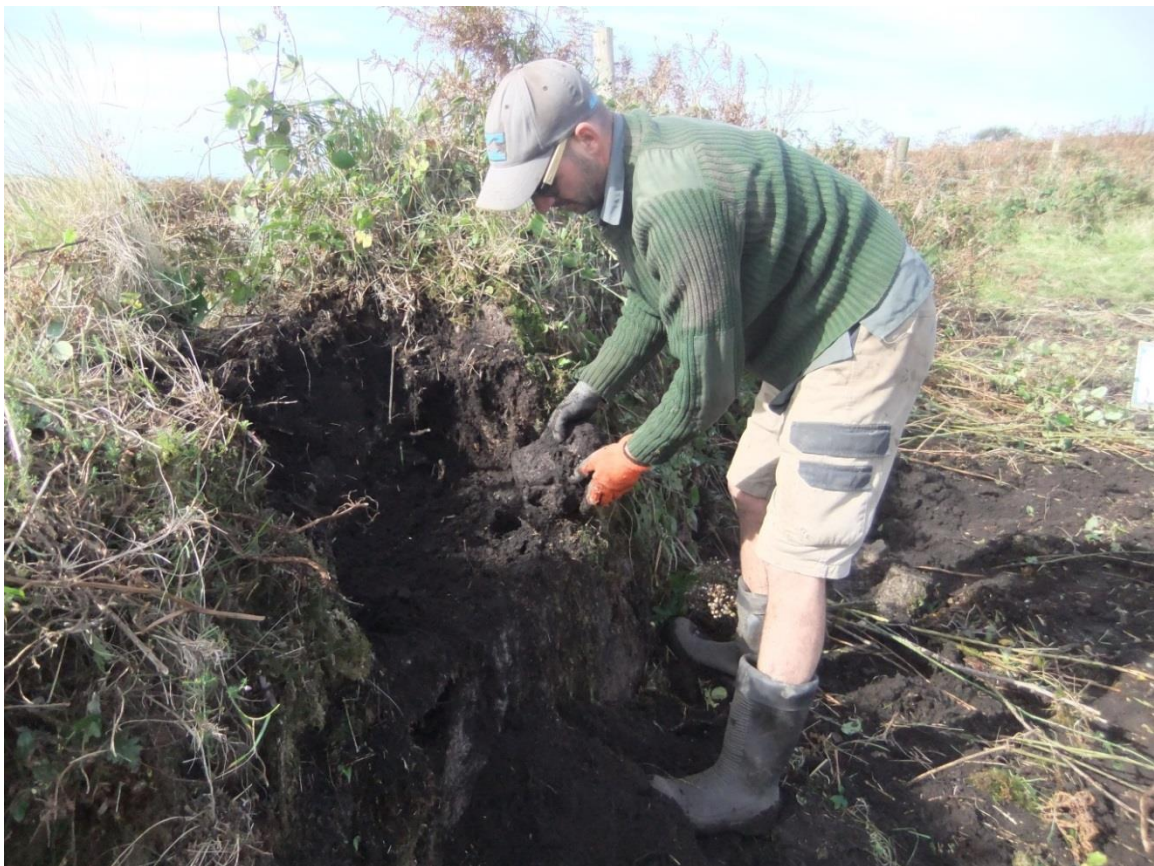
Fig 15 Dismantling facing stones on north side of hedge bank at Site 2, looking west.

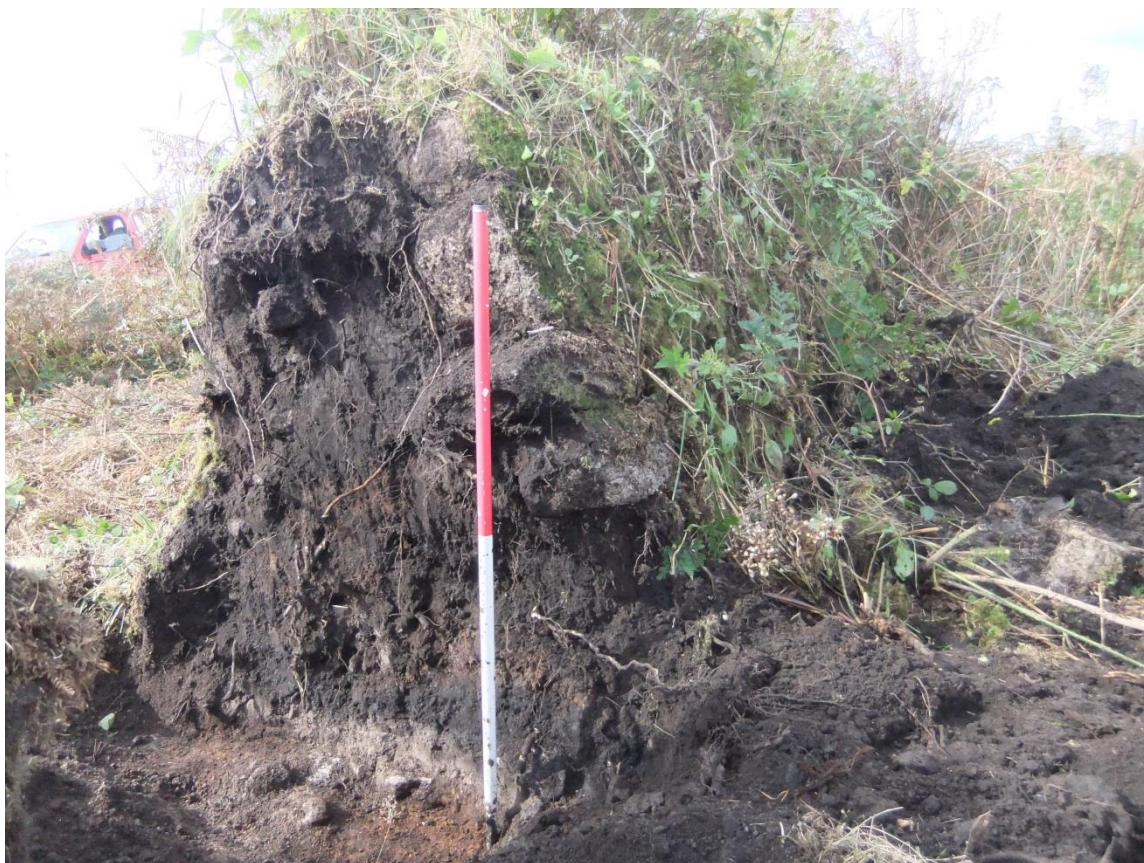
Fig 16 Site 2, west side, with evidence of earlier phase bank seen in Section 2, Fig 25a.

Section 2, at Site 2, again reveals a distinct hedge bank core (Layers 3-7, and 8). This may represent an early boundary, being associated, through proximity and profile, with a buried ditch in front (south) of it (context 9), partly overlain by the present, post-medieval style hedge facing, so pre-dating that. This core's texture and colour indicates it was made of turf or peaty soil, with several differently coloured, clayey patches, perhaps added along with turves when the hedger's shovel bit into the subsoil before casting up. It resembles Layer 4 in Section 1, potentially similarly made of turves.

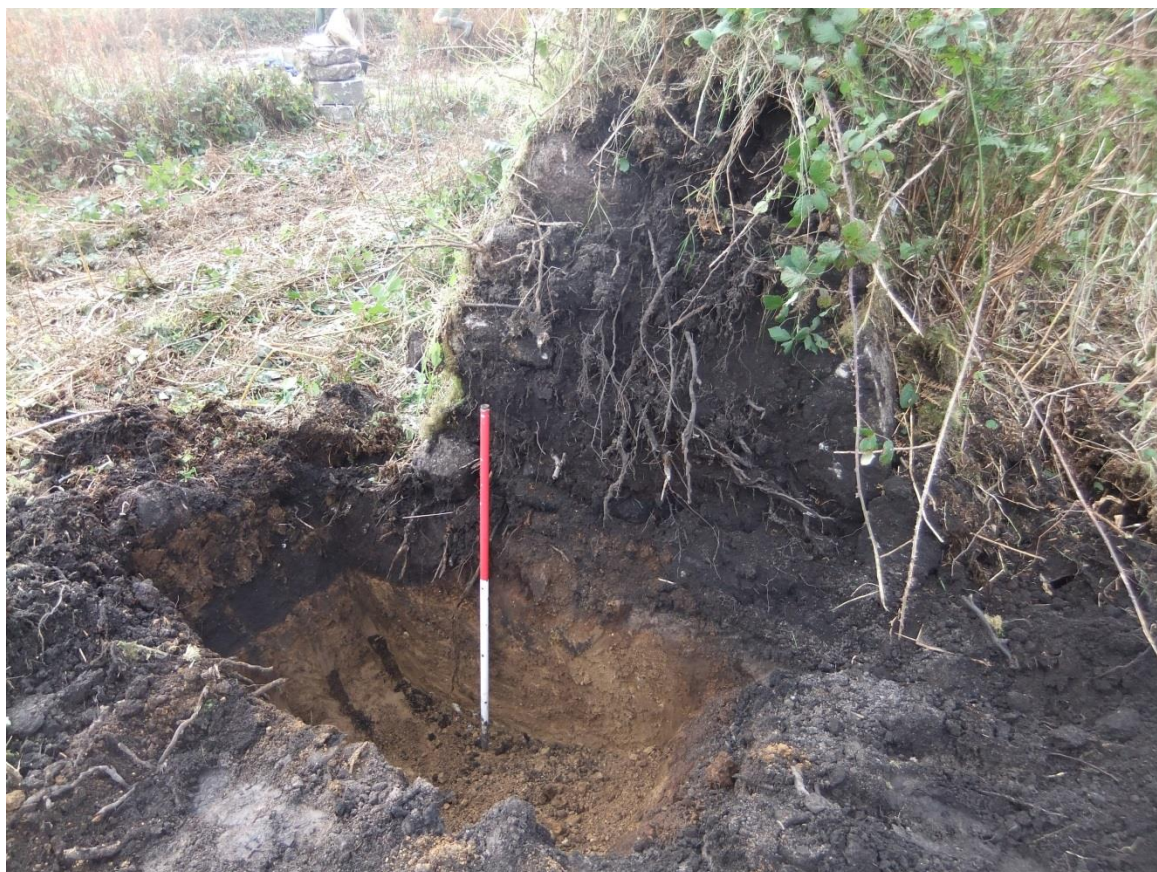
Fig 17 Site 2, with buried ditch exposed in western post pit, seen in Section 2, Fig 25a.

Notes Context 9 in Section 2 was exposed to view in section not in the cut for the access opening, as such; but rather, in a pit immediately alongside the sectioned bank, on the front (south) side of its cut. This new post-pit (together with a similar one on the other, east side of the gateway) was dug to take the base of the gatepost required for the new gate. It measured c1.45m by 0.65m north-south and was 0.8m deep.

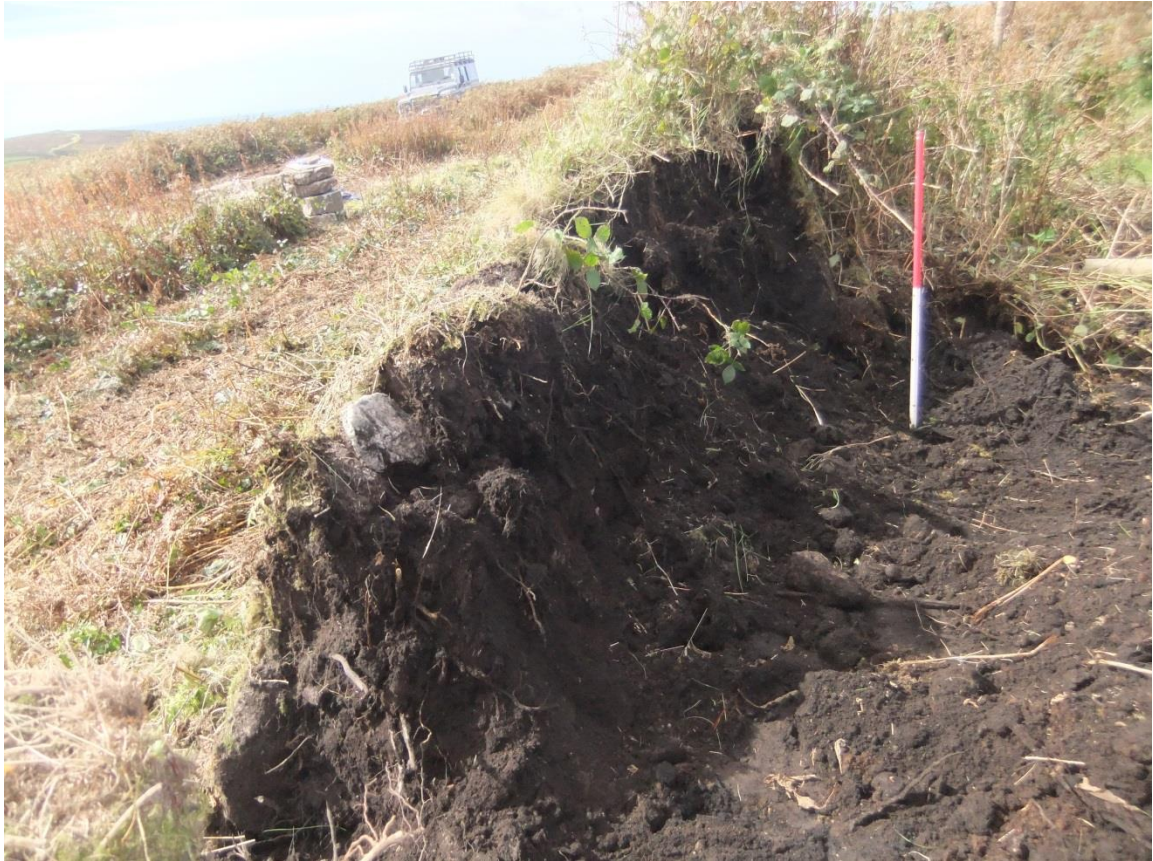
Fig 18 Cut north side of bank at Site 2 exposing peaty earth fabric, looking south west.

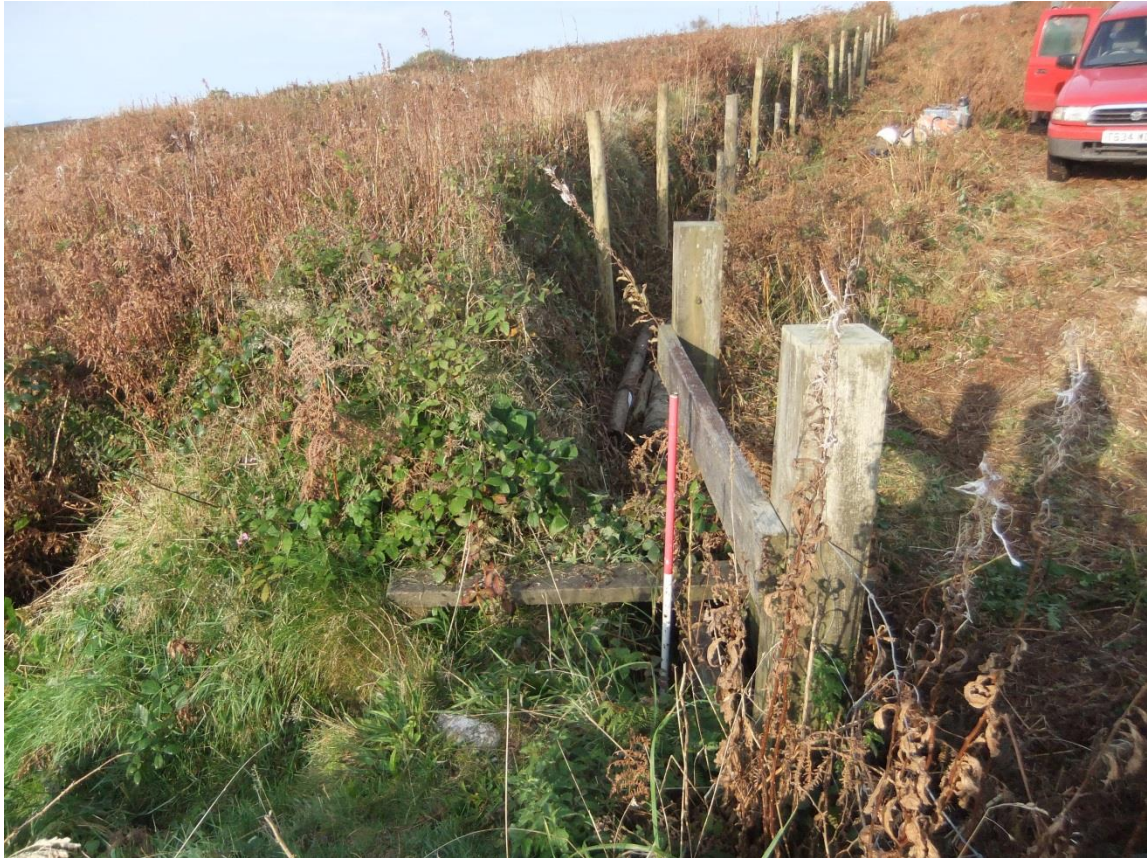
Fig 20 Bank at Site 3, forming the edge of the SM (left), before works; looking WNW.

On the same boundary as Site 1, the bank here was c1.8m wide, and c1m high though only 0.7m high where sectioned. Its steep sides were faced with laid medium rubble.

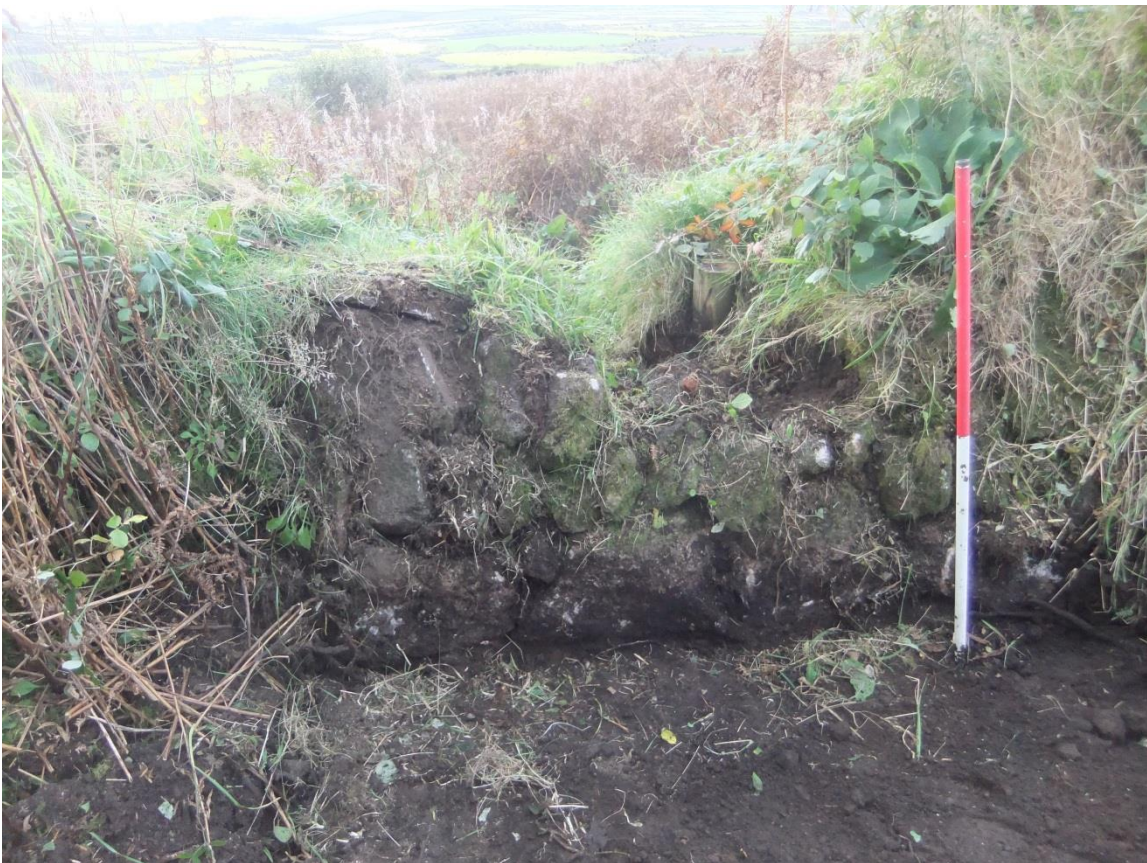
Fig 21 North side of hedge at Site 3 after trimming of vegetation, with worn pathway.

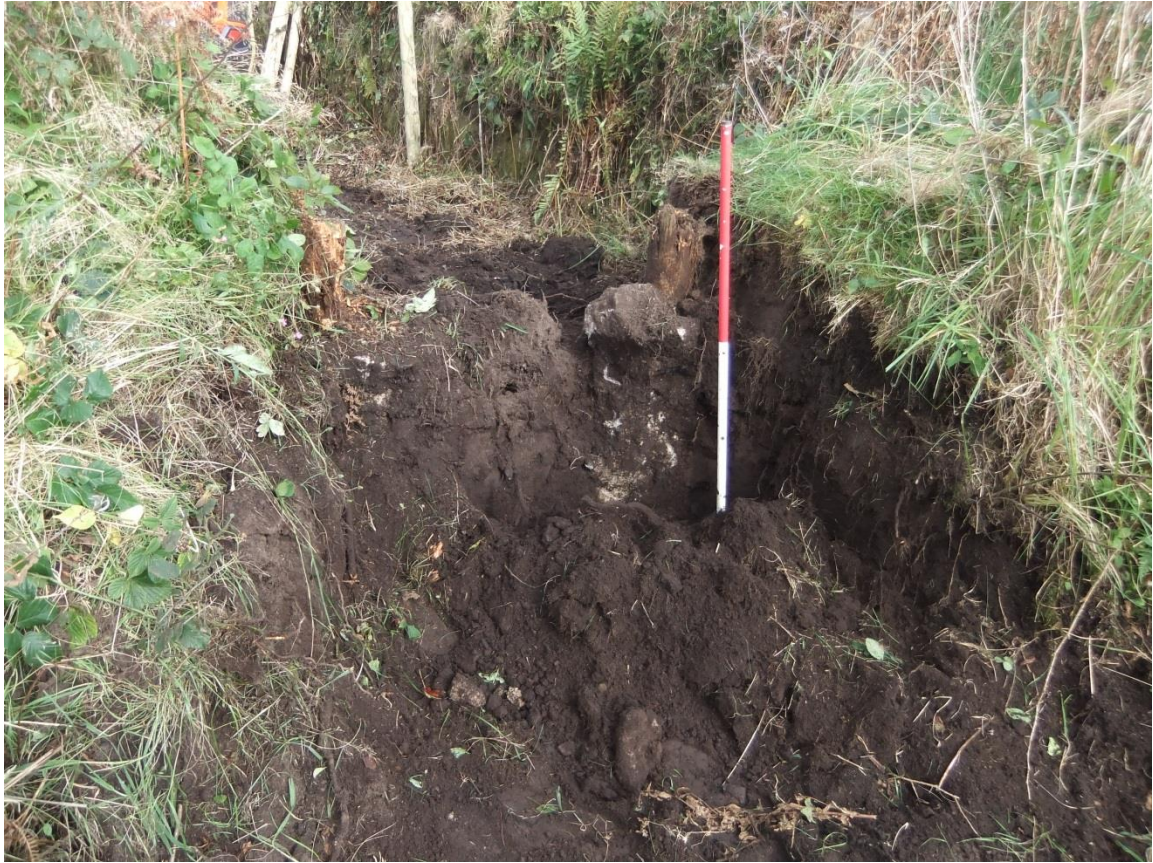
Fig 22 Site 3, south side, showing concrete post base in core of bank (left of 1m scale).

In Section 3, at Site 3, the same boundary did not have a distinct core, but was essentially of one phase; probably because here the 'gurgo' was worn or taken down before 1778, as the plan of that date suggests. Alternatively, aurgo may have been removed here when the boundary was rebuilt to admit the previous modern stile; the timbers of this were fixed in large concrete plugs, necessitating cutting away the bank.

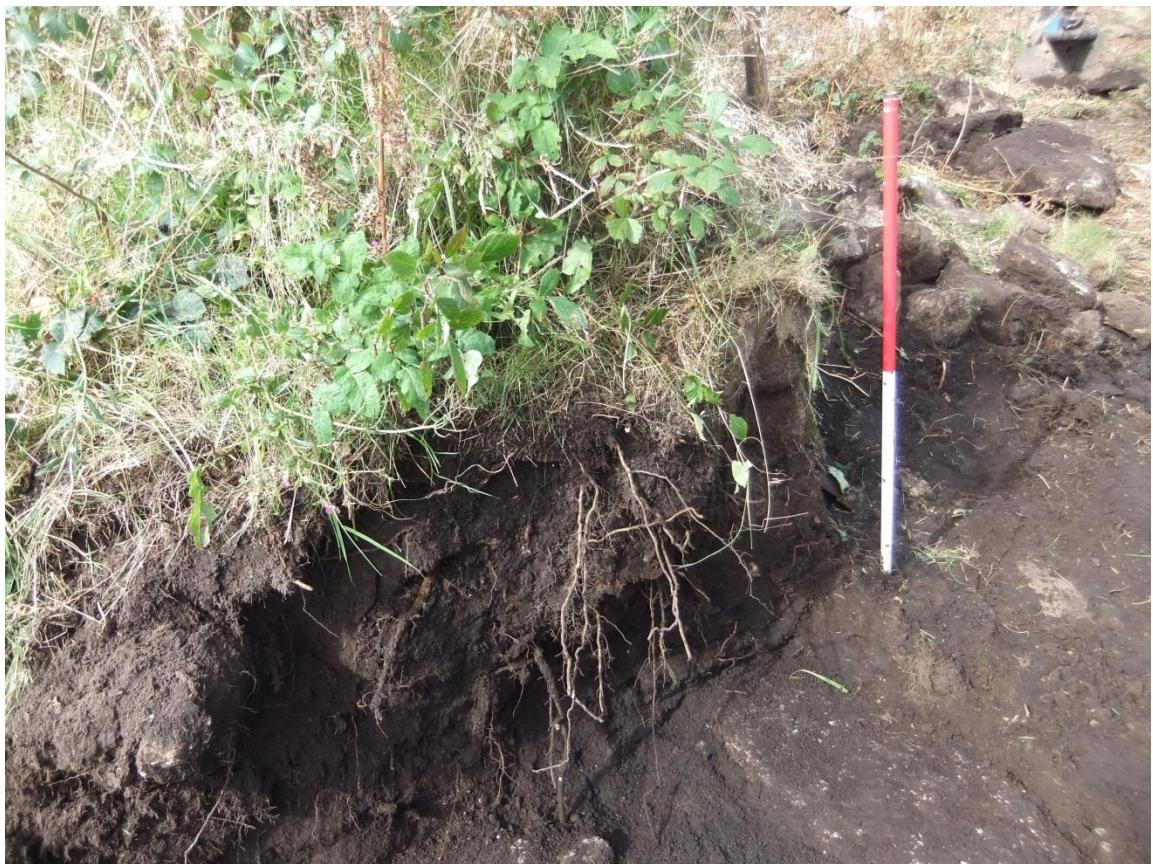
Fig 23 West side of opening, Site 3, largely of one phase; see also section, Fig 25b.

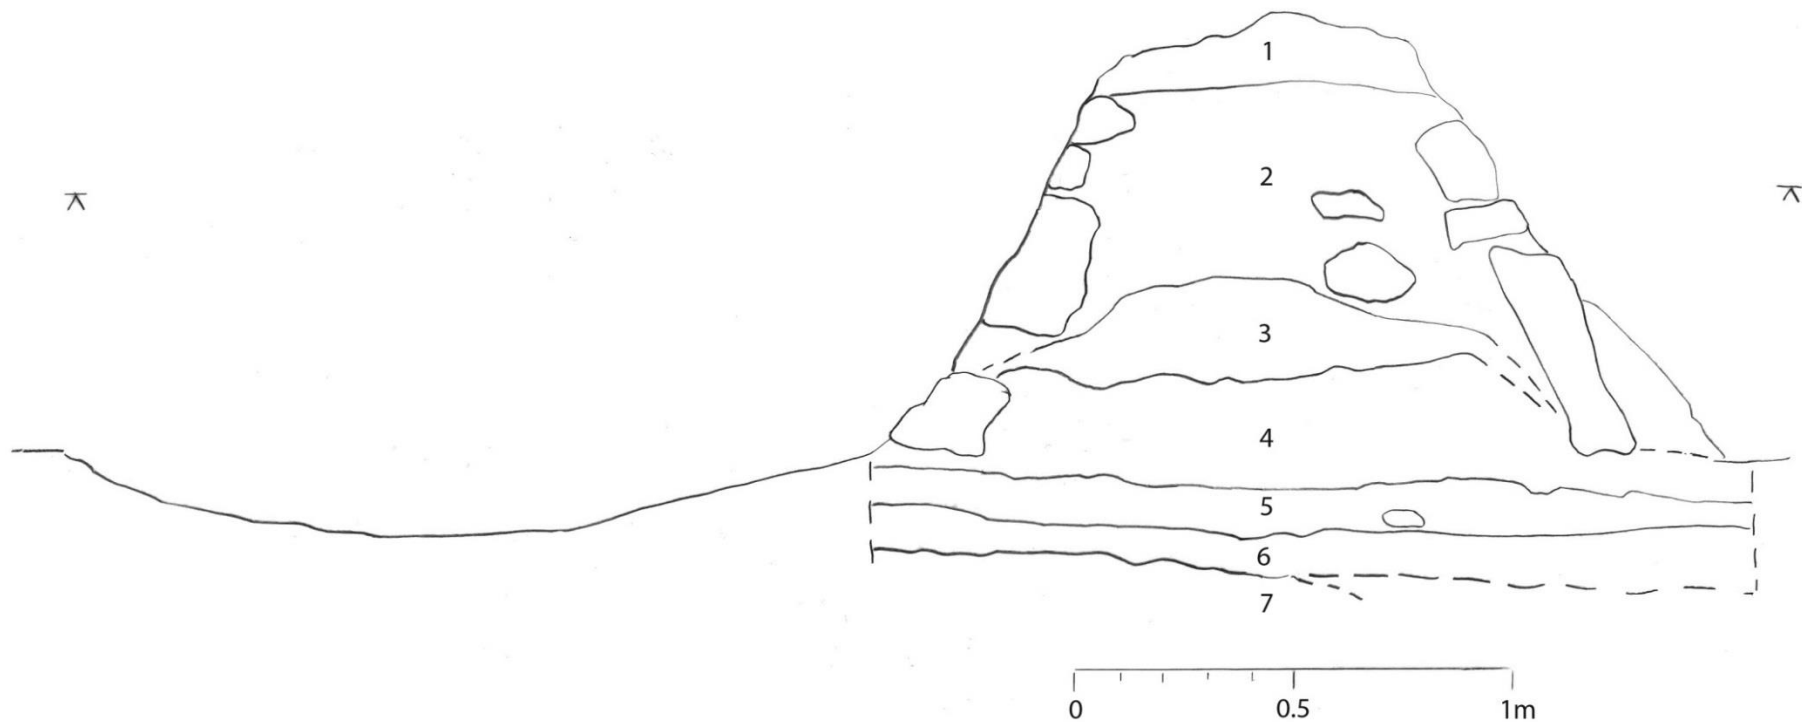
1. Turf, loose dark brown peaty soil, and roots (hedge bank capping and topsoil).
2. Dark brown-grey silty clay with occasional small grit (hedge bank fabric).
3. Orange-brown friable silty clay (hedge bank fabric).
4. Dark brown-black peaty soil, with thin streaks of grey clay, lenses of orange-brown clay, a few small granite stones, and occasional grit (hedge bank fabric).
5. Pale grey clay, dense but friable, gritty (top of natural subsoil).
6. Orange-reddish brown clay with yellow-grey granite gravel (natural subsoil).

Fig 24 Section 1; ENE side of opening for stile, Site 1. The ground SSE of the boundary – to its right, in the drawing – lies within the SM. See main text (part 4.2.1) for contexts exposed in the hedge bank, numbered 1-7. Note the linear depression on the NNW (left), a hedge quarry-ditch. (This feature was not affected by the works, so does not appear in the section. No doubt it is part filled as a result of natural silting, stock trampling, and perhaps short-lived cultivation, and is substantially deeper than its profile here might suggest.)

Section 1 at Site 1 (Fig 24) did reveal a possible early core preserved within the later, extant form of the hedge (Layers 3 and 4). This lies in the position of a 'gurgo' or derelict ancient bank marked on part of the boundary line on an estate plan of 1778 (Herring 1995, 3), and so the watching brief possibly provides rare evidence, if not definitive dating, of such a feature. It would have been c0.5m high, a height typical of medieval outfield boundaries here and in other parts of the county. The fabric was earthy, containing – at least at the section – none of the clearance stone, thrown out of the way of cultivation, often found in strip boundaries elsewhere. Nevertheless, the boundary may still be medieval (earthy strip banks are known elsewhere in Cornwall, for example at Forrabury, Boscastle, and Lamlavery, Davidstow; Peter Herring, HE, pers comm). The two layers within the putative early bank here (3 and 4) may mark separate phases, or simply construction by first throwing up some adjoining peaty soil (Layer 4) and then topping this with subsoil originally lying beneath it (Layer 3).

The present form of the bank at Site 1 shows the fabric, style and scale typical of post-medieval Cornish hedges, with battered sides of local rubble stone revetting an earthy body, and a flattish top. The boundary probably took this form after 1778 – when the estate surveyor recorded its line as being marked largely with boundstones (not affected by the 2017 works) and partly with the remnant 'gurgo' – and before 1840 when Tithe surveyors indicated it as having a solid, built line (Herring 1995, 9, 11, 67).
