King Edward Mine Trench Recording, Cornwall
Archaeological Recording

Report No: 2017R088

Cornwall Archaeological Unit was commissioned by King Edward Mine to carry out a record of structures uncovered during excavations carried out by KEM volunteers in two areas at the mine: at a small Brunton arsenic calciner, and a wall of the boiler house associated with the South Condurrow stamps engine house.

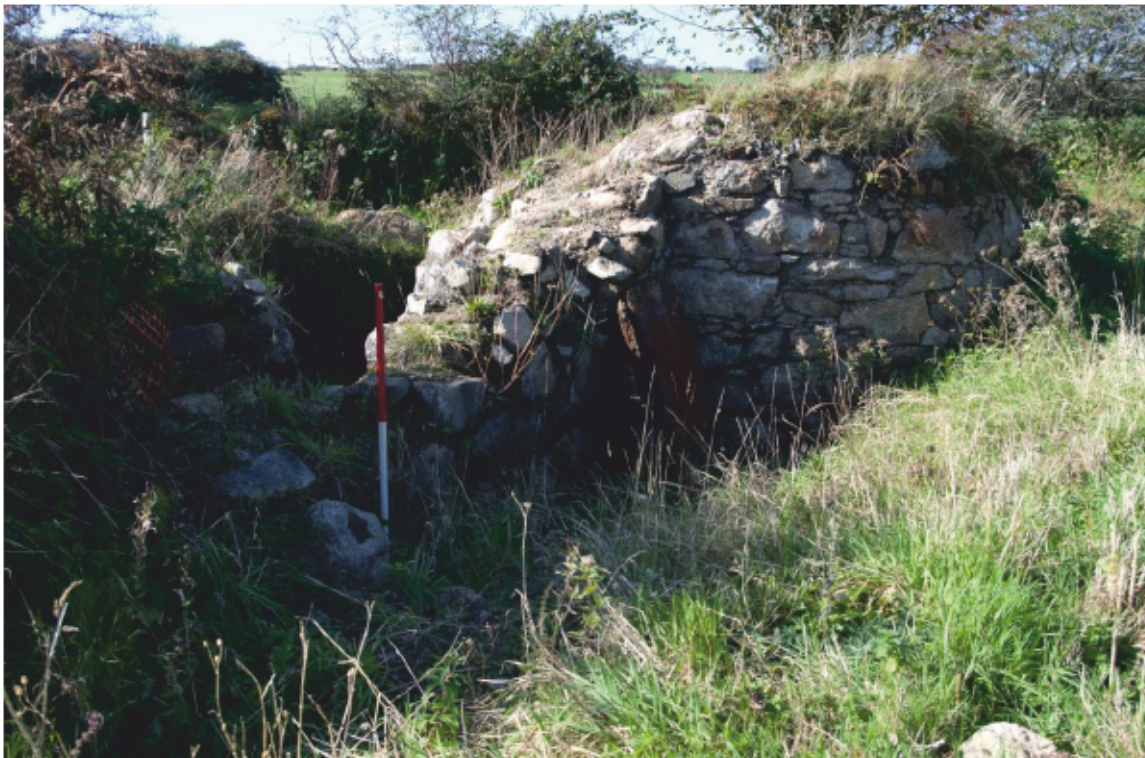
The flue runs for a distance of 40m between the Brunton arsenic calciner and its adjacent small labyrinth and the chimney to the NNW (Fig 5). For much of the distance only the eastern external bank flanking the flue is visible, the other side being obscured by thick scrub. For the most part this bank is around 0.5m high and 0.6m wide at the top. Much of the bank is obscured by vegetation but where the construction was visible it was of uncoursed killas rubble at the southern end. At the northern end where it emerged from the vegetation it is built exclusively of uncoursed granite rubble, as is the opposite wall, the eastern face of which is visible at this point.

The chimney, of which only the base survives, is built of granite rubble, roughly coursed, and survives to a height of 2m where it joins to the eastern flue wall. It is roughly oval, 3.85m long northeast to southwest, 3.65m northwest to southeast. The walls are around 1.25m thick and surround a flue 1.25m in diameter. This is currently covered with a loose metal grille and a tarpaulin.

The eastern flue wall has been built on to the southeast side of the chimney. The flue leads up to the southwestern side of the chimney, where it enters it through a small opening around 0.5m square.

Fig 5 The chimney, right, flue wall, left.

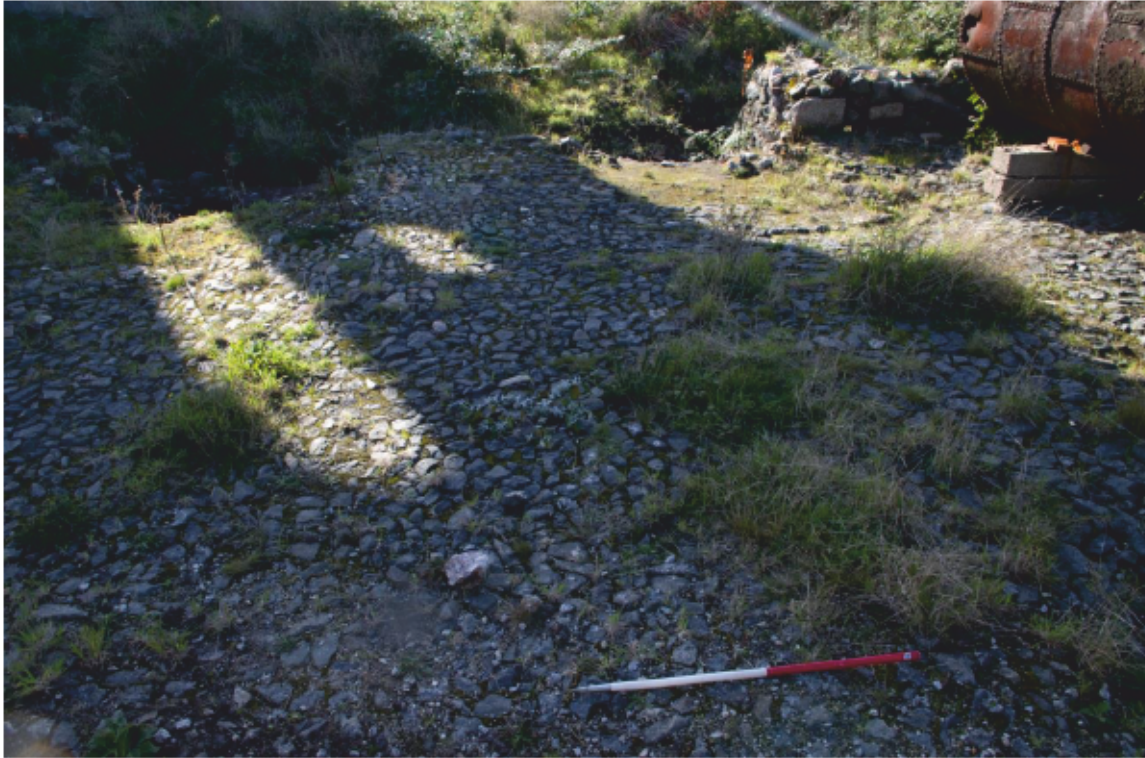
An area of cobbled surface around 11m by 7.7m lies exposed to the north of the stamps engine house (Fig 6). The surface is composed of lightly worn rubble, predominately killas but with some granite. Two semi-circular cobble-free areas are located where the floor is butted by a large wall along its southwestern edge. One of these is in the area of an excavation to uncover a flue running under the floor and through the wall; it is unclear whether the floor was removed at this point or whether it never existed. There is some hint of an edging kerb lining the other cobble-free area and it may be that both areas are deliberately cobble-free.

Fig 6 The cobbled yard, wall to rear (facing west).

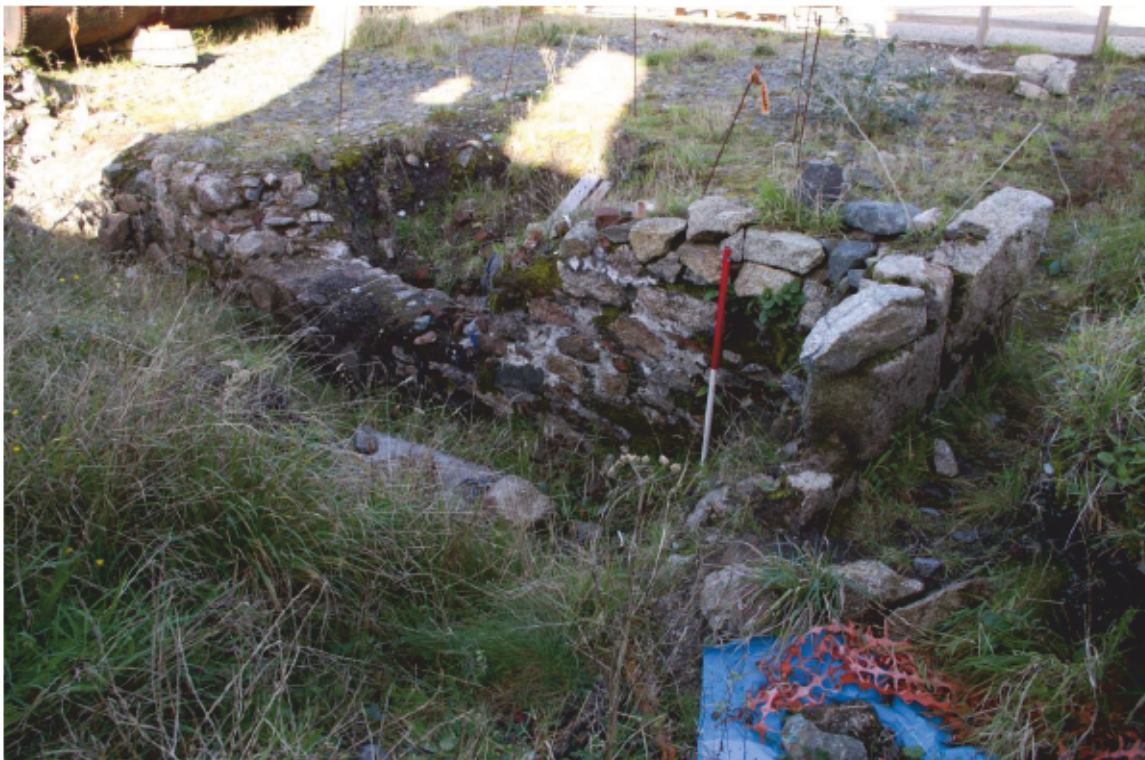
Fig 7 Wall to the southwest of the cobbled yard (facing northeast).

The wall (Fig 7) is of uncoursed killas and granite rubble, in places bonded with what looks like relatively recent cement-based mortar at its southeastern end. Here the wall appears to have been heightened with dry stone granite. The wall is around 13m long and up to 1.15m high to the southeast, lower in the middle, and rising again to 0.7m to the northwest. Another wall, largely uncoursed killas rubble, runs off to the southwest perpendicular to it at the northwestern end. At the southeastern end another wall, composed of large dressed drystone granite, runs off to the southwest.

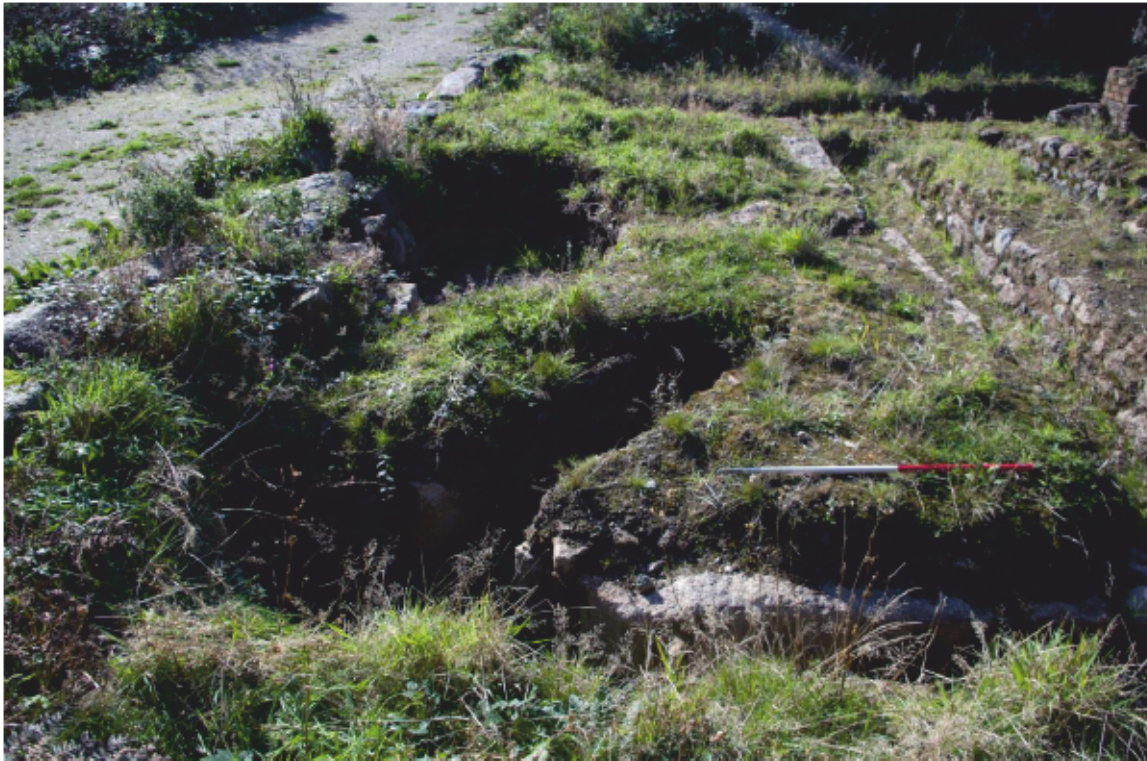
Fig 8 Calciner, left, leading to labyrinth, right (facing southwest).

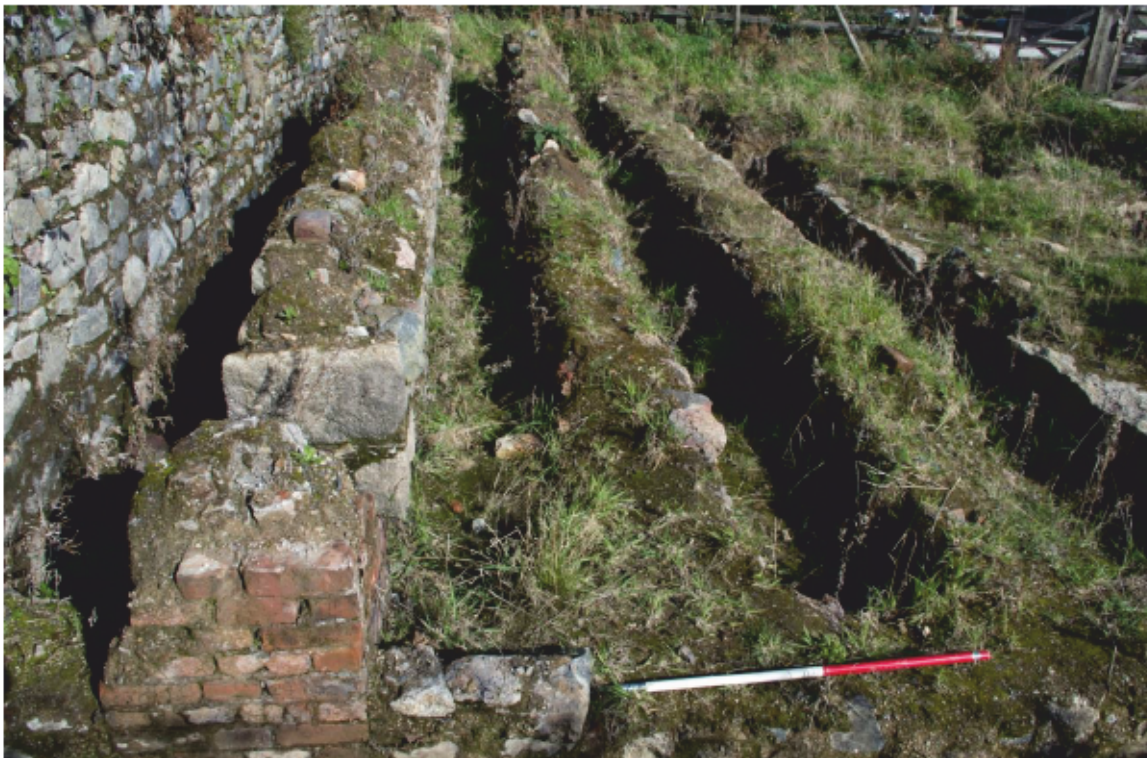
Fig 9 The retaining wall, left, and labyrinth (facing northeast).

This structure covers an area of around 10m northeast to southwest and 8m northwest to southeast. The northwestern retaining wall (Fig 9) is the largest, over 2m high, and composed of uncoursed mostly killas rubble. It runs for 10m along the edge of the labyrinth, beyond which it is much lower and disappears into thick vegetation. The taller section of walling fills a gap shown on the 1907 map, whilst the lower wall may

The labyrinth (Fig 9) consists of three parallel walls of uncoursed rubble to a height of up to 0.5m and 0.6m wide. These form a labyrinth of flues 0.5m wide leading from the semi-circular cement-surfaced platform of the calciner at the southeastern end of the complex to the flue leading to the chimney at its northeastern corner. The calciner would have been set within a small square building.

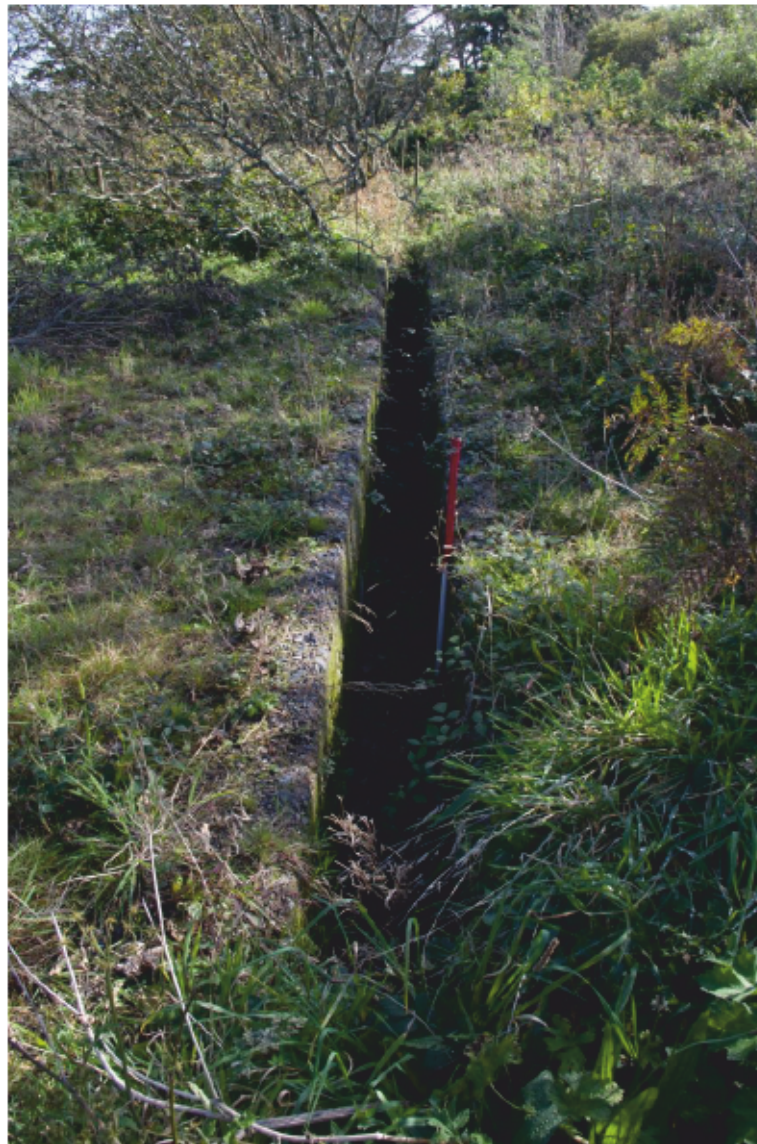
The edge of the calciner is marked by a path. Beyond this to the southeast is a narrow water channel or flue 0.4m wide (Fig 10), running northwest to southeast for 14m to a path, beyond which it continues. The channel is concrete-block lined and is 0.6m deep. Two partly excavated spurs run off to the northeast and west.

Fig 10 The water channel, or flue (facing SSE).
