Service trenching at St Pol De Leon Church, Paul, Cornwall
Archaeological Watching Brief

Report No: 2017R084

Client	St Pol de Leon PCC
Report Number	2017R084
Date	November 2017
Status	Final
Report author(s)	C.M.Thorpe
Checked by	Andy Jones
Approved by	Andrew Young

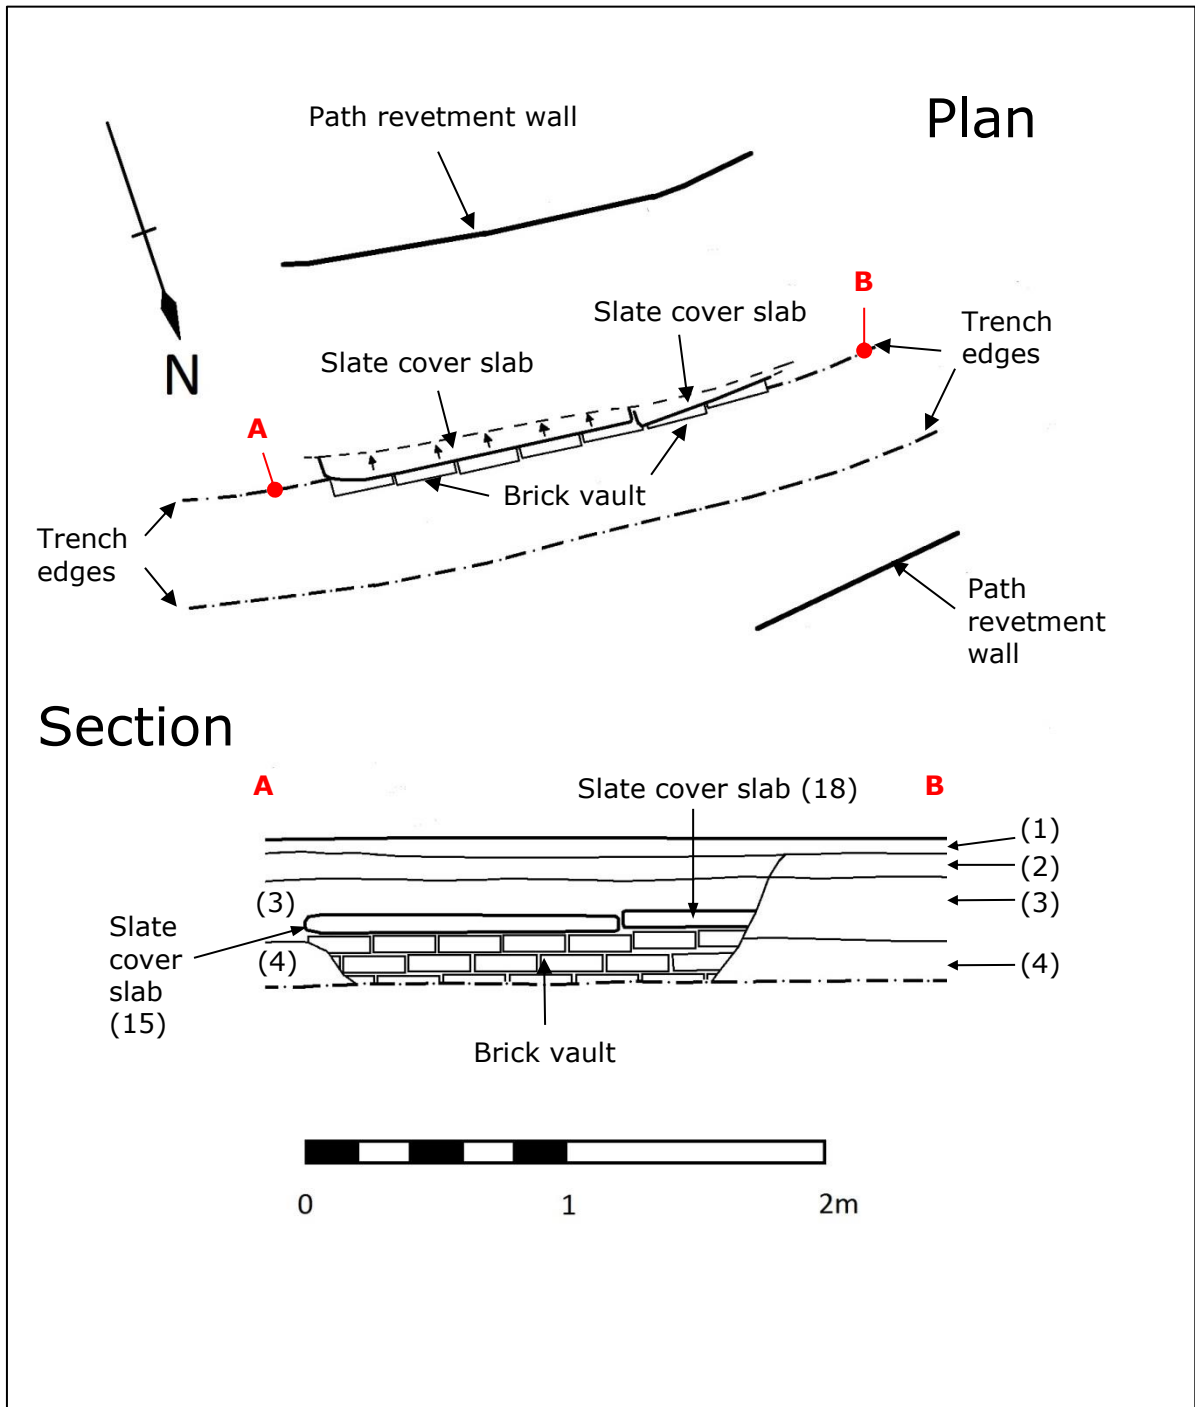
Figure 8. Plan and section of Grave II uncovered within the pathway trench showing 19th century vault.

II	Pipe trench	0.2m	<p>A slate covered brick built vault (See Fig 8).</p>	<p>Adult Burial within a Brick vault.</p>
JJ	Pipe trench	0.5m	<p>A grave cut that was <i>circa</i> 1.2m long, 0.3m wide, orientated west to east.</p> <p>The cut was scarcely wider than the body, had rounded ends with an uneven bottom.</p> <p>Infilled with dark grey-brown clay. Full skeleton of a child exposed, head at west end. The arms appeared to be alongside the body.</p>	<p>Childs burial.</p> <p>The grave shape suggests a shroud burial; there was certainly no evidence for a coffin recorded.</p> <p>Bones lifted, then reburied in area after the pipe was laid.</p>

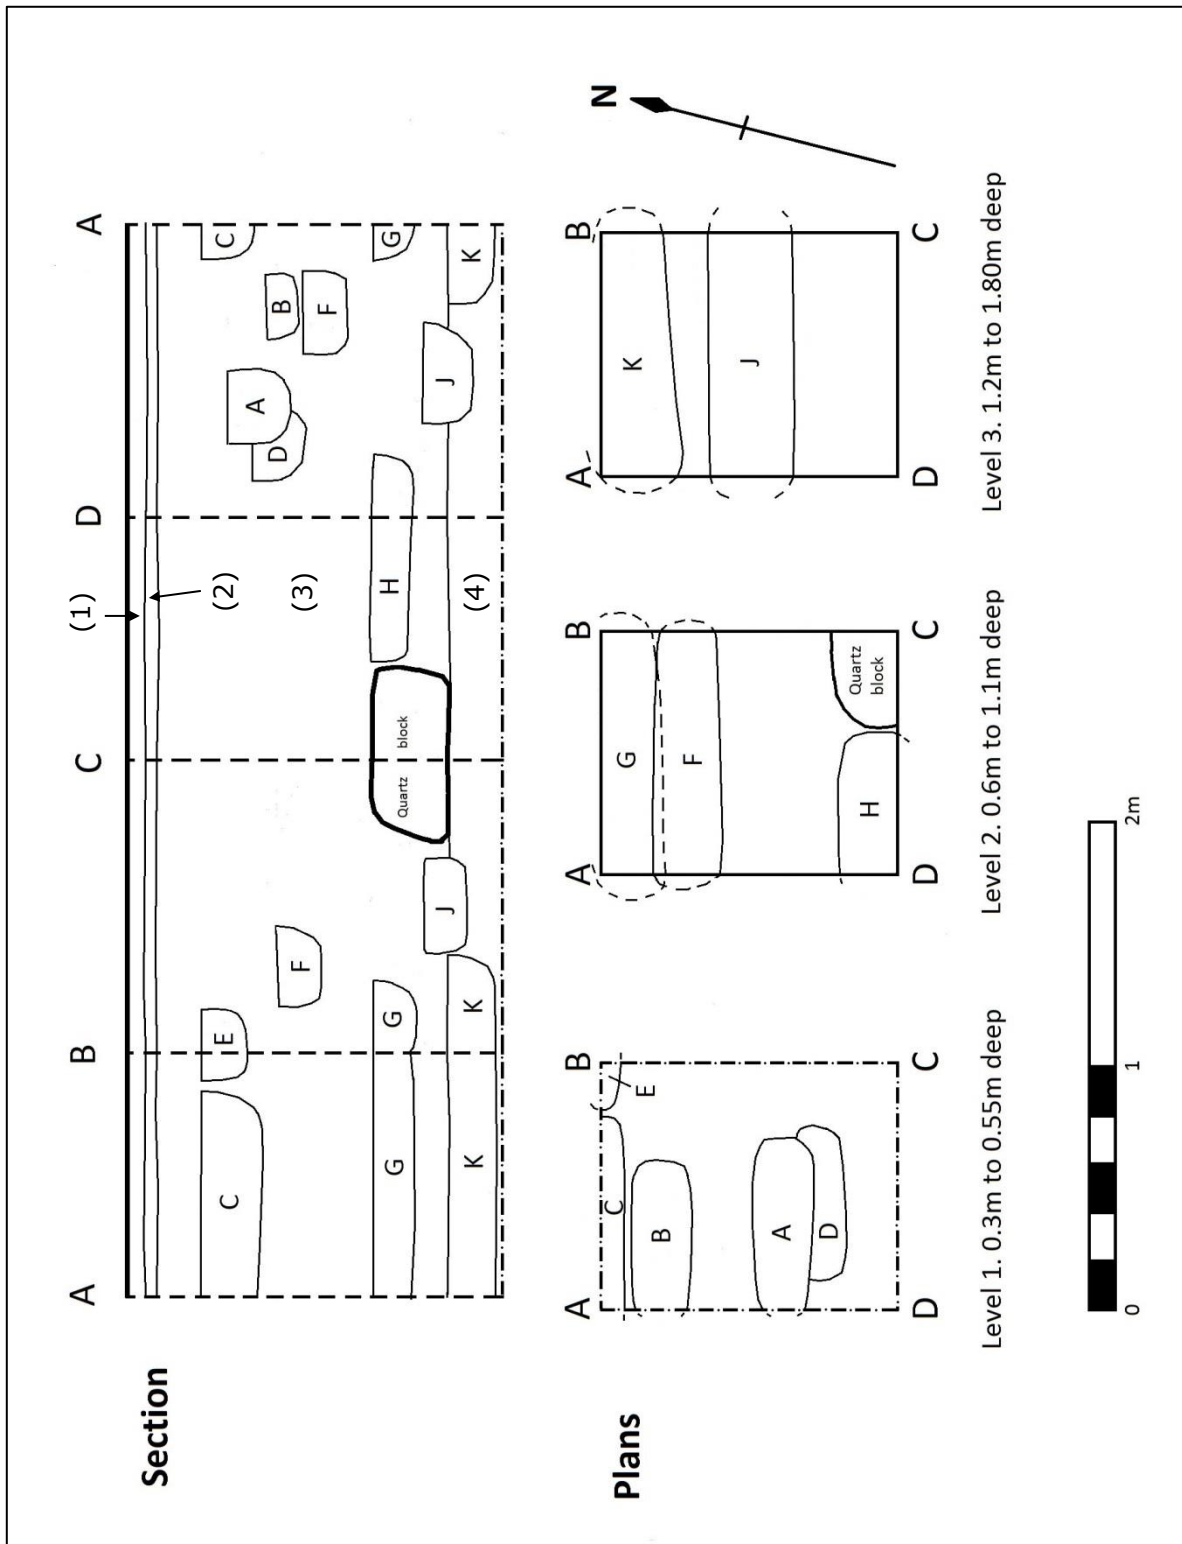
Figure 9. Pumping station pit. Plans and sections showing recorded graves.

A total of ten graves were recorded during the excavation of the pit. The dimensions for the grave cuts were difficult to record as the majority had been dug into the same material that they had been backfilled with, which made identification difficult.

The same procedure was followed for the pumping station pit. Due to the depth required for this pit and the unstable nature of the trench sides, it was excavated utilising a digging box to shore up the sides (Fig 14). This meant that no complete section was visible at any one time, but had to be recorded in spits roughly 0.3m deep at a time. Once the required depth was reached the box was left *in situ* as shoring for protecting the pump. A composite section was compiled at a scale of 1:20 of the sides of the pit (Fig 9).

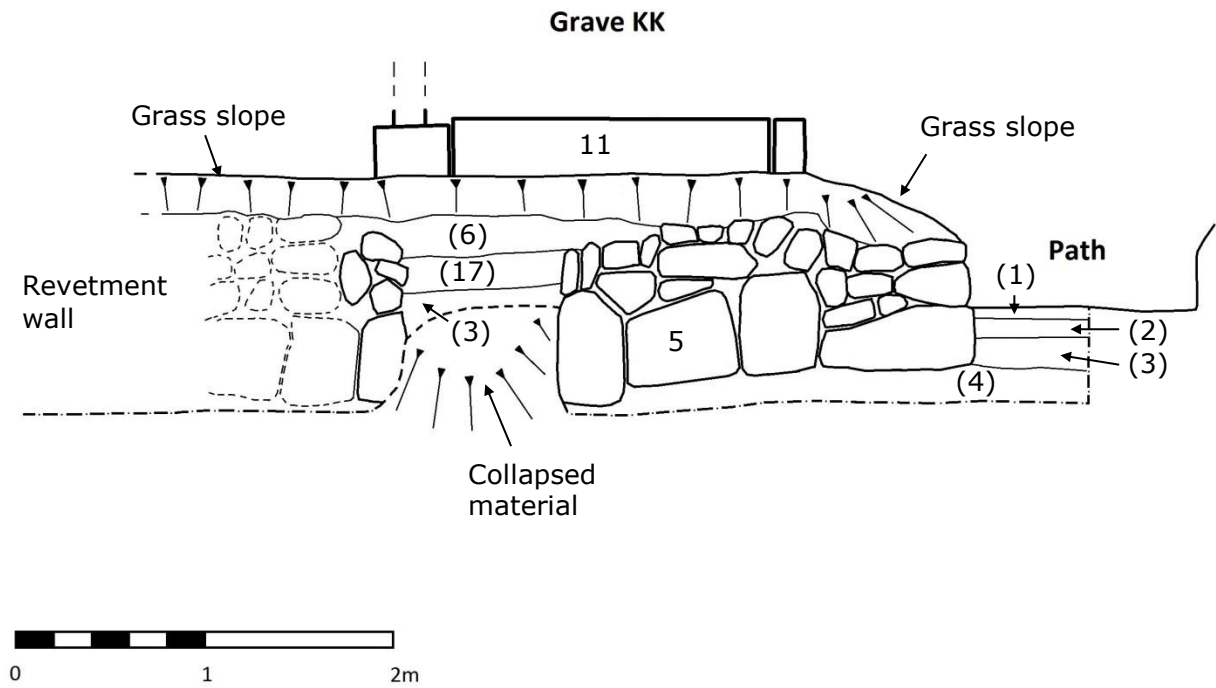
Figure 10. French drain section after revetment wall section (structure 5) collapse.

The retaining wall (structure 5) of the churchyard was constructed of granite rubble stone blocks with slightly larger ones at the base with smaller ones above. It stood to a maximum height of roughly 0.8m, above which was a grass slope to the granite kerb marking the base of Grave KK, the memorial to Charles Harvey who died in 1898.

Unfortunately the trenching for the pipeline connecting the WC and kitchenette facilities to the pumping station running along the line of the existing French Drain adjacent to the northern side of the church wall caused the collapse of a retaining wall supporting the churchyard. Two sketch section drawings were made at a scale of 1:20 of this area recording the initial collapse, and after the area had been cut back and stabilised (Figs 10 and 11).

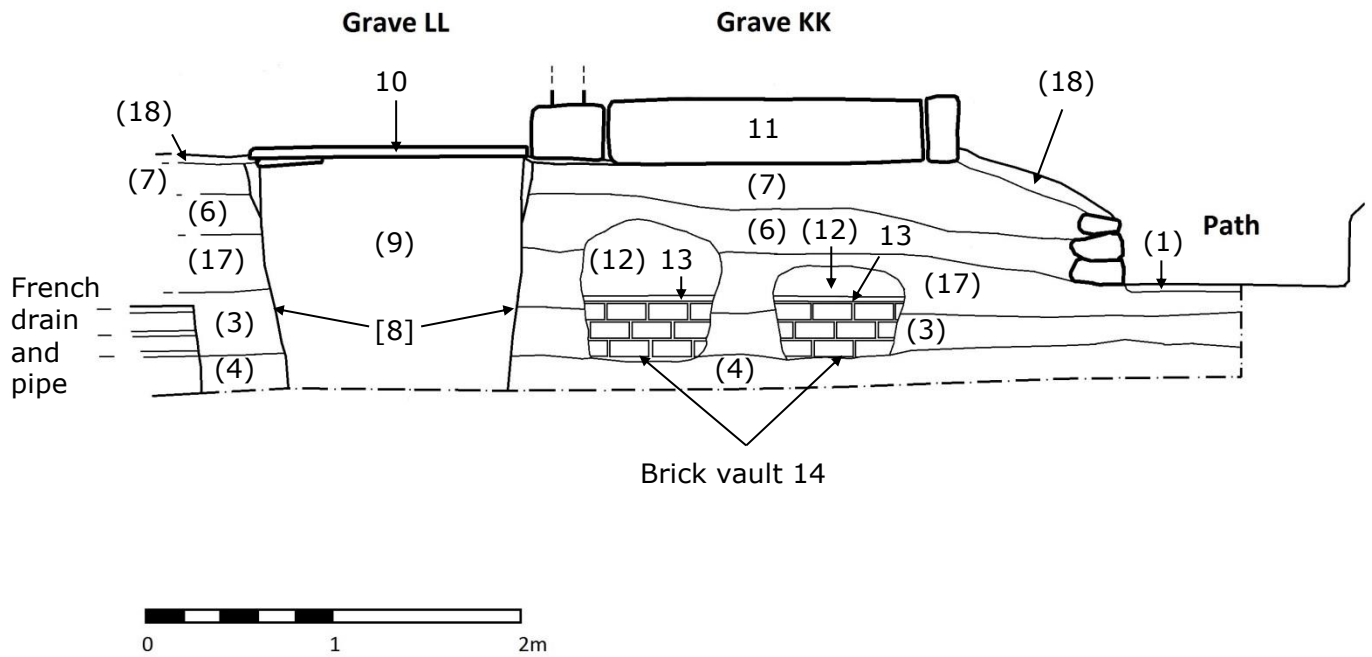
Figure 11. French drain section after cleaning back of collapsed material showing details of Graves KK and LL.

This grave was marked at the surface by a rectangular granite kerbed memorial, (structure 11), which measured 2.2m long and 1.8m wide the long axis orientated west to east. At the west end was a large slate headstone dedicated to the memories of Charles Harvey- 30 Mar 1898, Grace - 6 Mar 1901, Grace K. – 6 Sep 1839, and Agnes - 20 Feb 1902.

At a depth of 0.7m below the memorial, the collapse revealed evidence for a vault (Figs 11 and 13) consisting of a brick built structure 14 (presumably rectangular in shape) covered by a large slate slab 13. As this structure was only partially revealed by the collapse its dimensions could not be determined. The vault lay in a cut which had been back filled with loose friable grey-brown clay mixed with building debris such a roofing slate fragments and mortar (12).

Lying to the west of Grave KK, and butting up against its western kerb stone was a large slate memorial slab lying flush with the ground some 1.5m long, 0.8m wide, and that proved to be 0.05m thick. Unfortunately the inscription upon its surface was illegible.

This memorial stone overlay a near vertical grave cut [8] that was some 1.4m wide. This cut was noted running the whole depth of the section (1.2m) and it was not bottomed. The cut was infilled with loose friable grey-brown clay with stone, roofing slate fragments, mortar fragments and re-deposited bone (Fig 11). No evidence for the nature of the burial (for example, within a vault, coffin or shroud) was recorded.

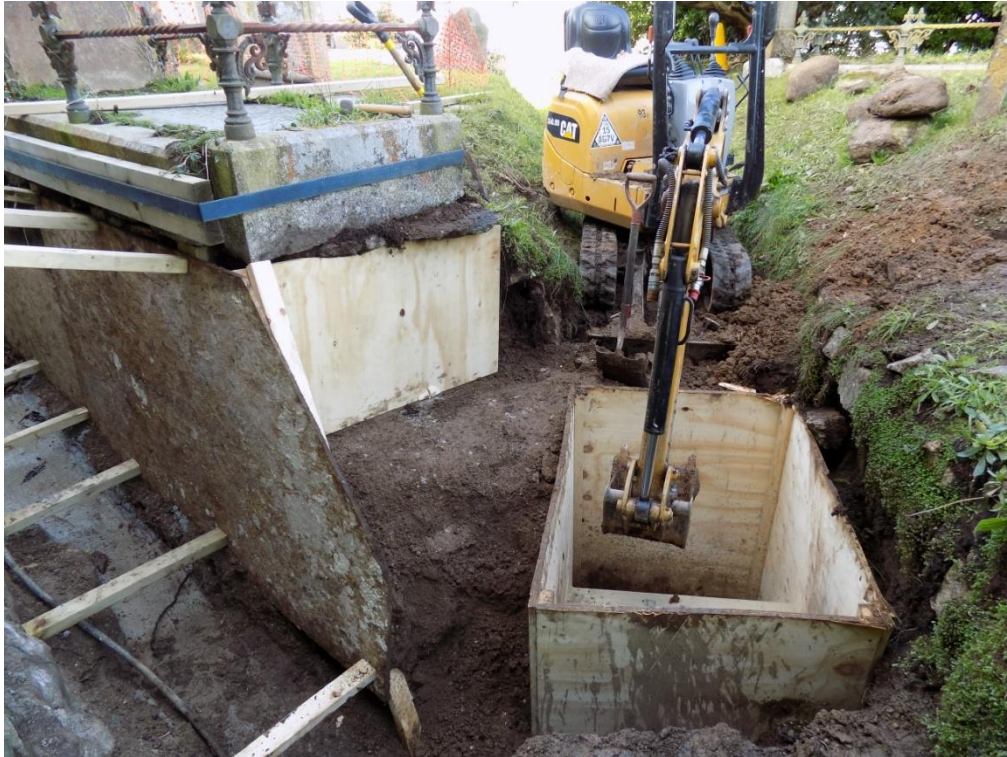
Figure 14. Pumping station pit outside north door of church showing digging box, and shoring around the French drain section.

This pit was excavated within the pathway immediate outside the north door of the church (centred at SW 46443 27089). It measured 1.2m by 1m with its long axis being roughly north-north-west by south-south-east and reached a depth of roughly 1.4m.
