Millpond, Hayle, Cornwall
Archaeological Watching Brief

Report No: 2018R008

Millpond, Hayle, Cornwall: Archaeological Watching Brief

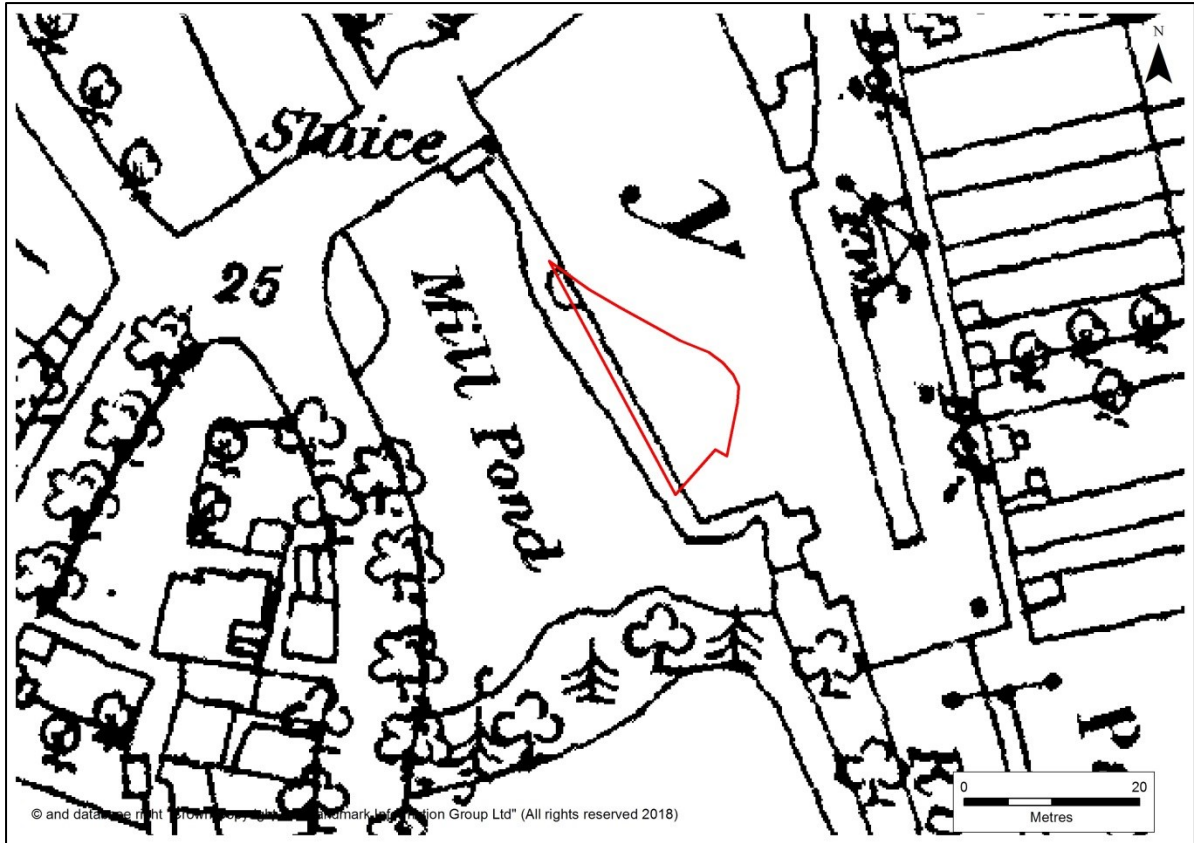
The reservoir, known as the millpond, remains largely water-filled, though partly silted at the south end. It measures about 200m NNW-SSE by up to 55m wide; its slender northern third is sub-divided as an inner pool by a bank. On the east it is defined by a strip of raised ground, broad on the north but narrow further south, separating the millpond from a leat which allowed the Penpol stream to bypass the millpond as required. The leat, part of the Harvey's original water management at the site, powered the wheel of a metal-boring mill (Figures 3 and 4).

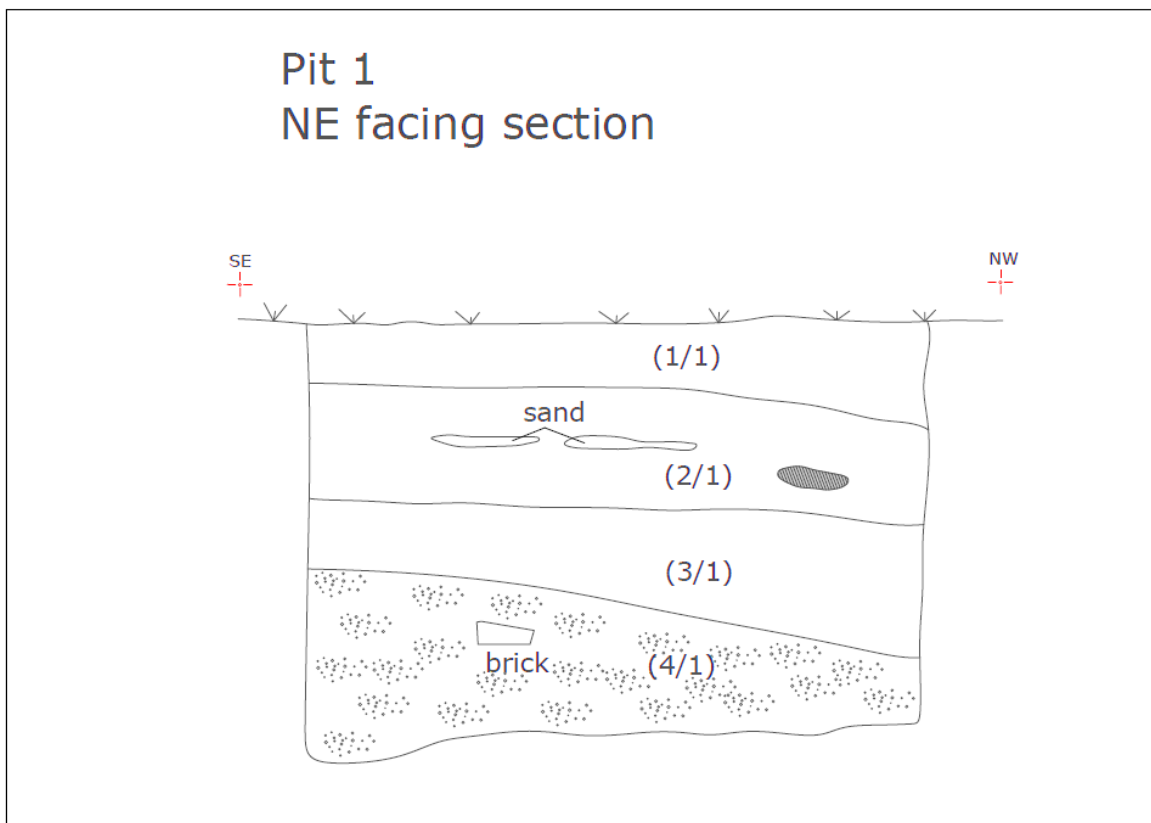
Figure 6: NE facing section of pit 1. This was typical of the majority of the pits excavated.

Pit 1

See Figures 5 and 6.

Measuring 1m x 0.4m x 0.6m deep, this contained four deposits. The topsoil (1/1) was a dark brown plastic clay silt, <0.2m deep containing small stone inclusions, unsorted; this was topped with a layer of low cut grass. This covered (2/1): a dark grey/blackish/brown friable sandy deposit, a very gritty mixture which appeared to be redeposited waste material <0.15m deep. Below this was a similar deposit (3/1): a grey/brown friable sandy gritty deposit <0.2m deep which appeared to be a mixture of (2/1) and (4/1). The basal layer (4/1) was a dark grey/black friable gritty sand deposit containing a piece of broken red brick.

It was clearly evident that other red brick fragments had been removed during the excavation of this pit and the other three pits associated with this piece of play equipment. None carried any markings and they were in poor condition; they had not been *in situ* as part of a structure.

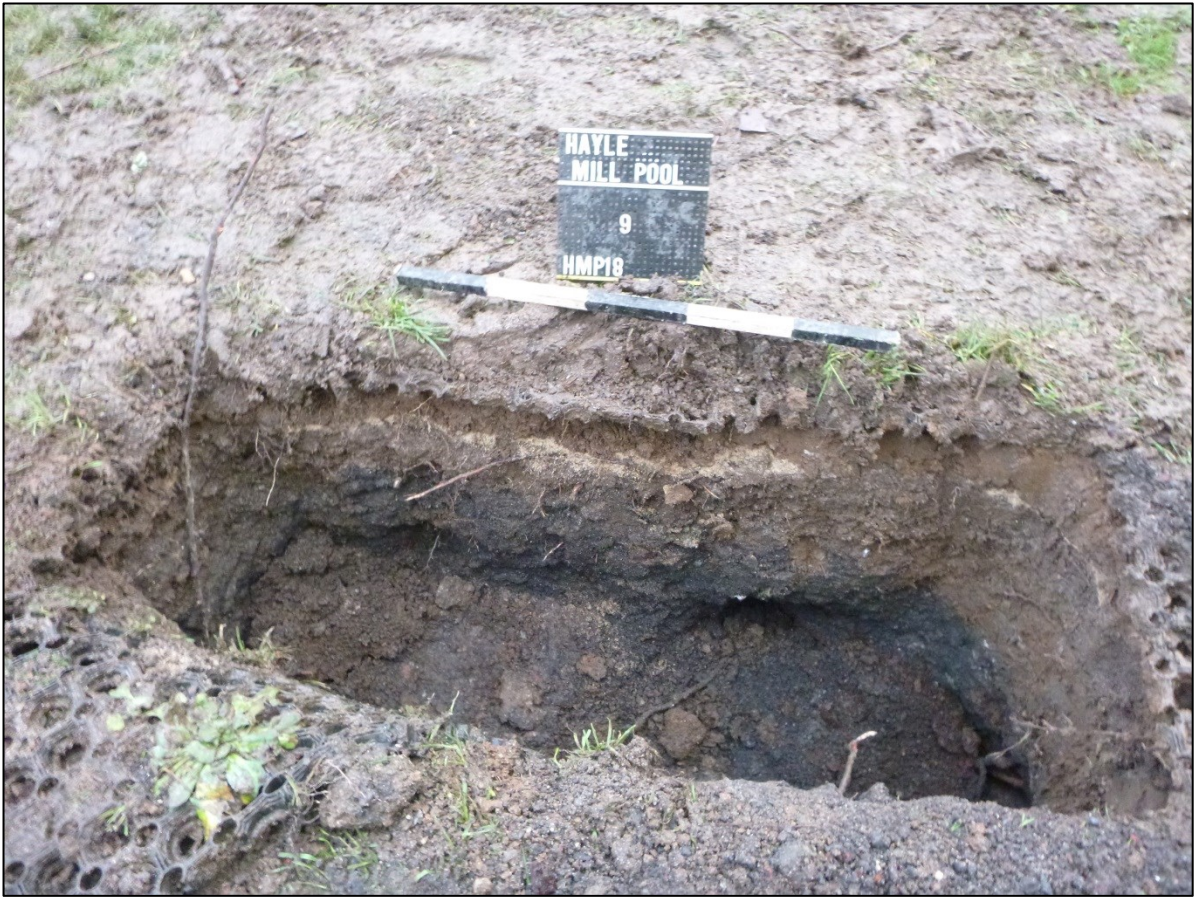
Figure 9: NE facing section of pit 9.

Pit 9

See Figures 5 and 9.

Measuring 0.95m x 0.35m x 0.6m deep, this contained four deposits: topsoil (1/9), a shallow layer of yellow sand (2/9), a mid-grey plastic clay/sand mixture (3/9) and a dark grey/black friable sandy grit (4/9).

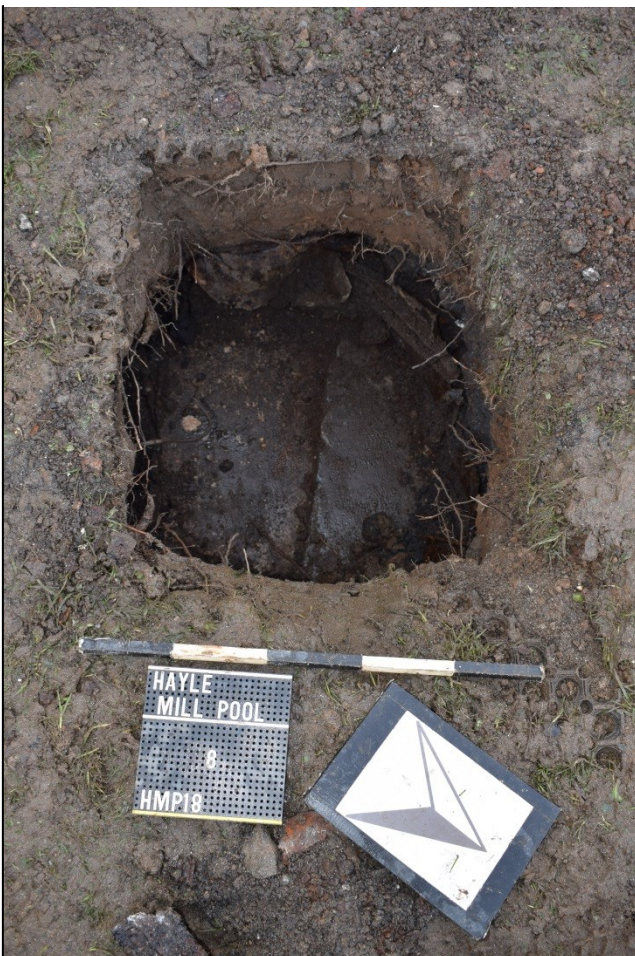
Figure 10: Plan image of possible floor surface at the base of pit 8.

Pit 8

See Figures 5 and 10.

Measuring 0.6m x 0.5m x 0.6m deep, this contained two deposits; topsoil (1/8) and a dark grey friable sandy grit, which covered a solid grey piece of stone which appeared to have a flat upper surface (3/8) and was interpreted as part of a possible floor surface.

The results from the watching brief suggest that at least in the area within which pits 7, 8, 11 and 12 were excavated, parts of an original stone floor survive at around 0.6m below the modern land surface. It seems likely that it will survive beyond the locations of these pits, but its full extent is currently unknown. It is suggested that, should the opportunity arise, a geophysical survey of the documented footprint of the buildings formerly occupying this site is undertaken to determine the extent of the sub-surface survival of this floor and any other features. The results of such a survey would inform the appropriate future management of this Scheduled Monument and, in conjunction
