St Michael's Mount, Cornwall
Archaeological watching brief and recording
Cornwall Archaeological Unit

Archaeological watching brief and recording

Client	Mr Jim Parry (National Trust)
Report Number	2018R006
Date	February 2018
Status	Final
Report author	Anna Lawson-Jones
Checked by	Andy Jones
Approved by	Andrew Young

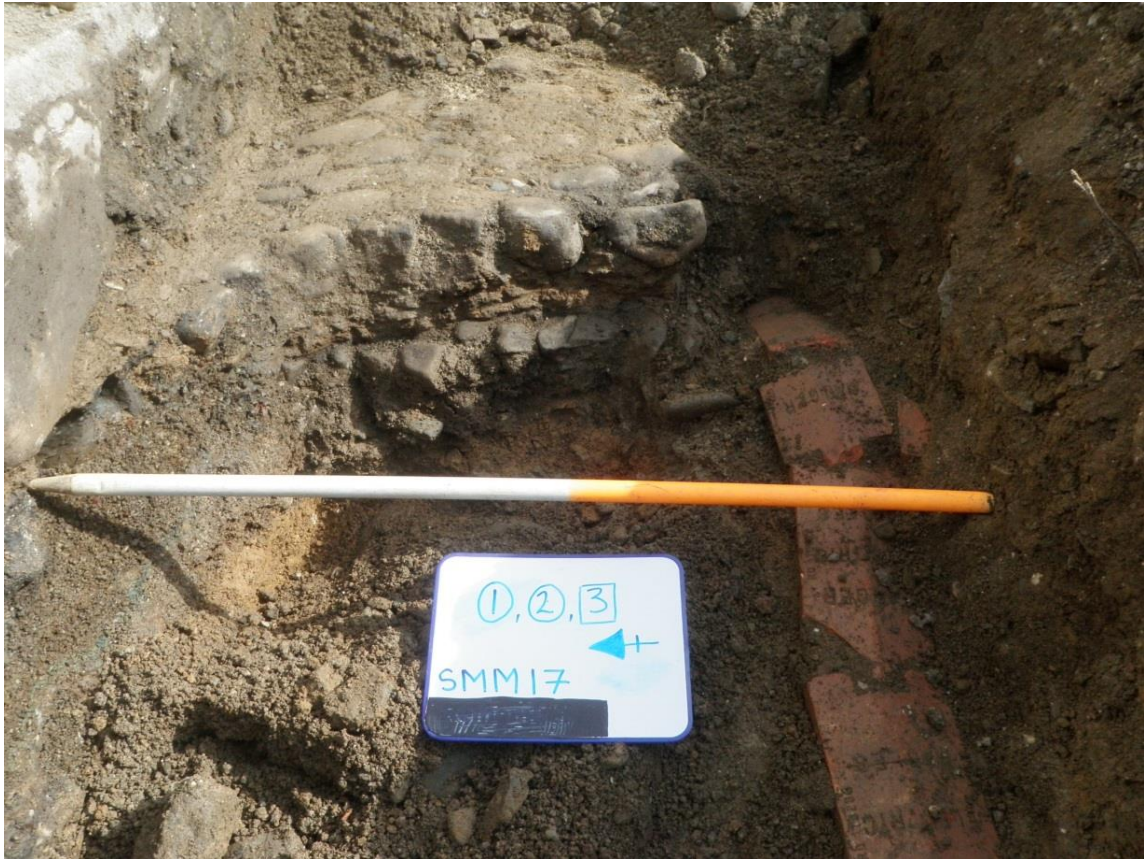
Fig 12 Looking east at upper cobbling (1), lower cobbling (2) and electrical cable tiles [3], with granite path sets (14) on upper left of photograph.

The large uneven cobbles of surface (1) were designed to raise the stacked and salted pilchards above the underlying channels between the cobbles. The oil was then funnelled across the slightly concave floor (beneath the present Elizabeth Terrace no. 1 and 2) towards the sunken vats behind them (found in 2016). The oil was then collected and graded. Similar cobbled features were recorded in 2016 on the northern side of the terrace, as were two sunken, timber lined vats (one with its press stone).

At the eastern end of the cobbling was north to south running granite cobble defined drain [4] with its silty fill (16). It clearly worked as an open surface drain when cobbled surface (1) was in use. When the silts were removed an underlying cobbled surface (2) was seen to extend 3m east from (1). Like (1) it was overlain by (12), but was set into compacted sticky clay layer (13), which contained occasional shell, bone and small stones. Cobbled surface (2) was very different from (1), consisting of patchy, small (up to 0.1m) cobbles and pebbles which were much more crushed and worn. These had initially been laid down to form a flat probable yard surface, which may have been in use for some time prior to the 1830s.

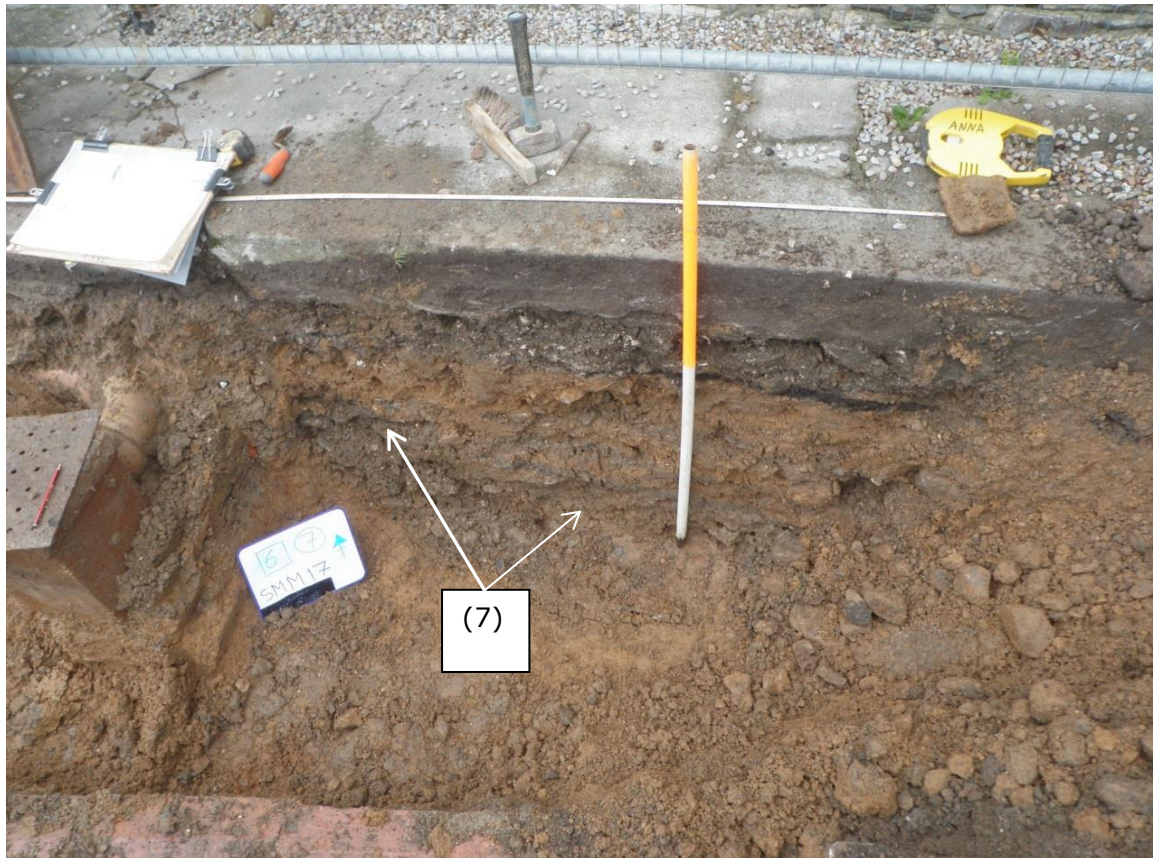
Fig 13 Working shot, looking north showing probable former understorey cut [6] and fill (7) with overlying deposits.

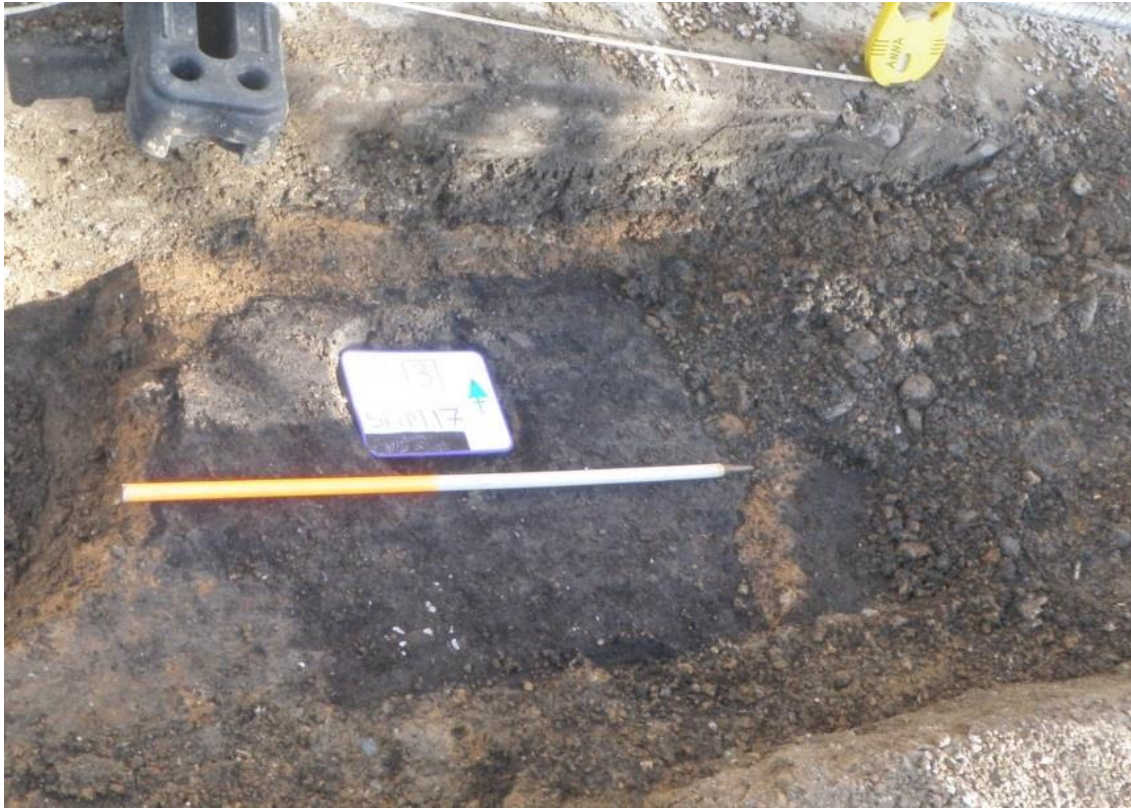
Fig 14 Looking down towards the northeast showing probable pilchard processing floors (17), cut by [3] in the foreground.

Pilchard processing/yard surface (17) was located on the southern side of Elizabeth Terrace no. 5 (Fig 14). It was recorded as one distinct area of very dark, compact, fine-grained silt over clay representing pilchard pressing/processing in the yard of the former terrace house underlying the present no. 5. It extended for approximately 6m east to west, and 0.35m south of path (15). The western end was found to overlie a second smaller spread of residual pilchard processing waste. Between these two layers was a very clearly visible thin, cream flecked layer of lime (possibly lime mortar), which may have been used to sweeten or cleanse the earlier layer. These two floors lay beneath layer (9) and above (10).

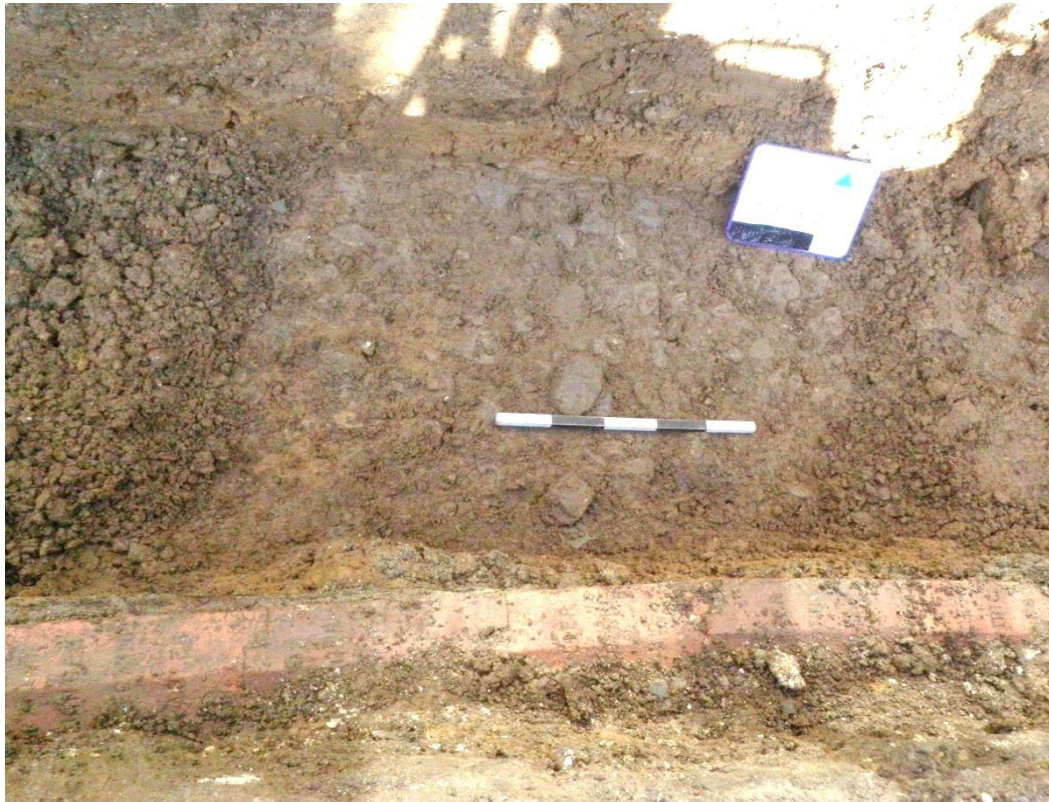
Fig 15 Looking down vertically on to part of stone floor (20), with [3] in the southern foreground.

Stone floors (20) and (31). Floor (20) (see Fig 15), was located in front of Elizabeth Terrace no. 5, pre-dating surface (17) and layer (10). It was 0.9m deep and consisted of a compacted sticky silty clay loam with many flattened abraded stones and crushed charcoal smears and animal bone, suggesting a worn surface with associated contemporary debris. It overlay basal trench layer (26), which was redeposited dirty, silty clay and probably represents the base of a cellar given its depth. Alternating sandy clay layer (23) also overlay (26) elsewhere.

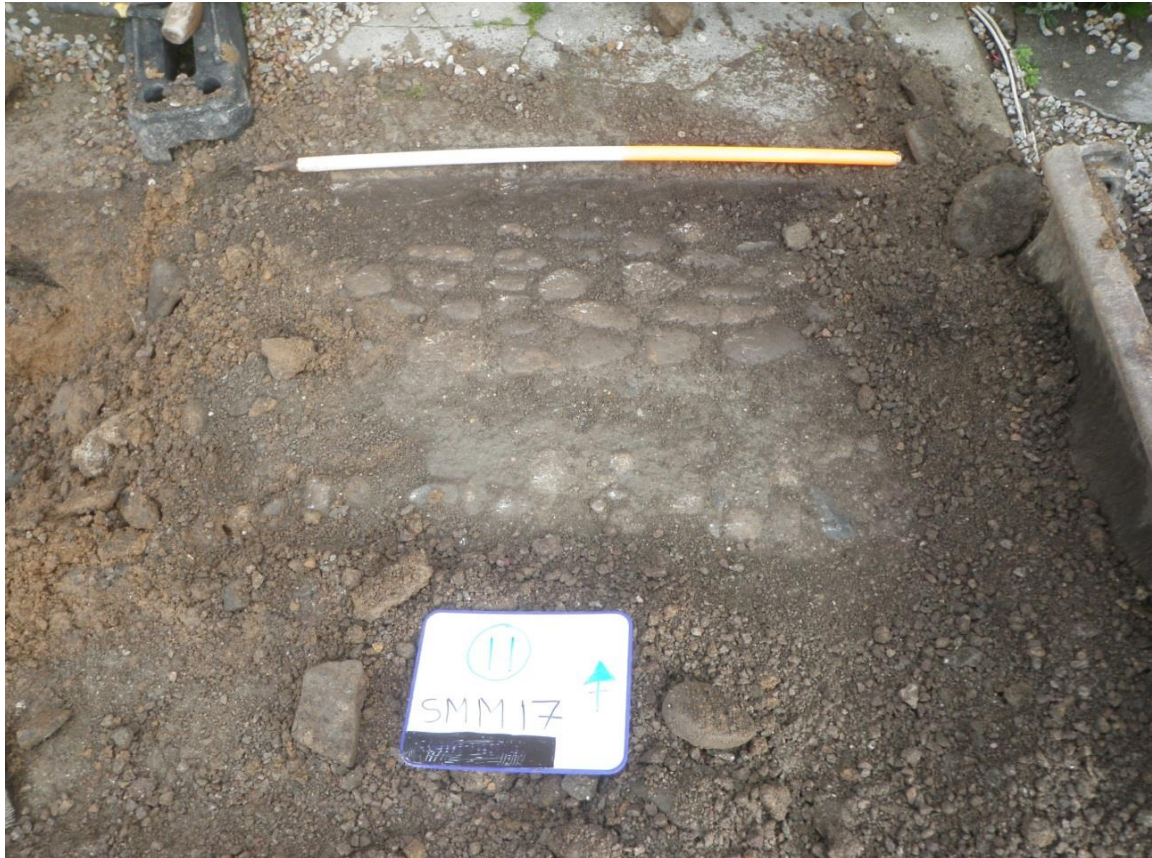
Fig 16 Looking north across shallow former cobbled lane surface (11).

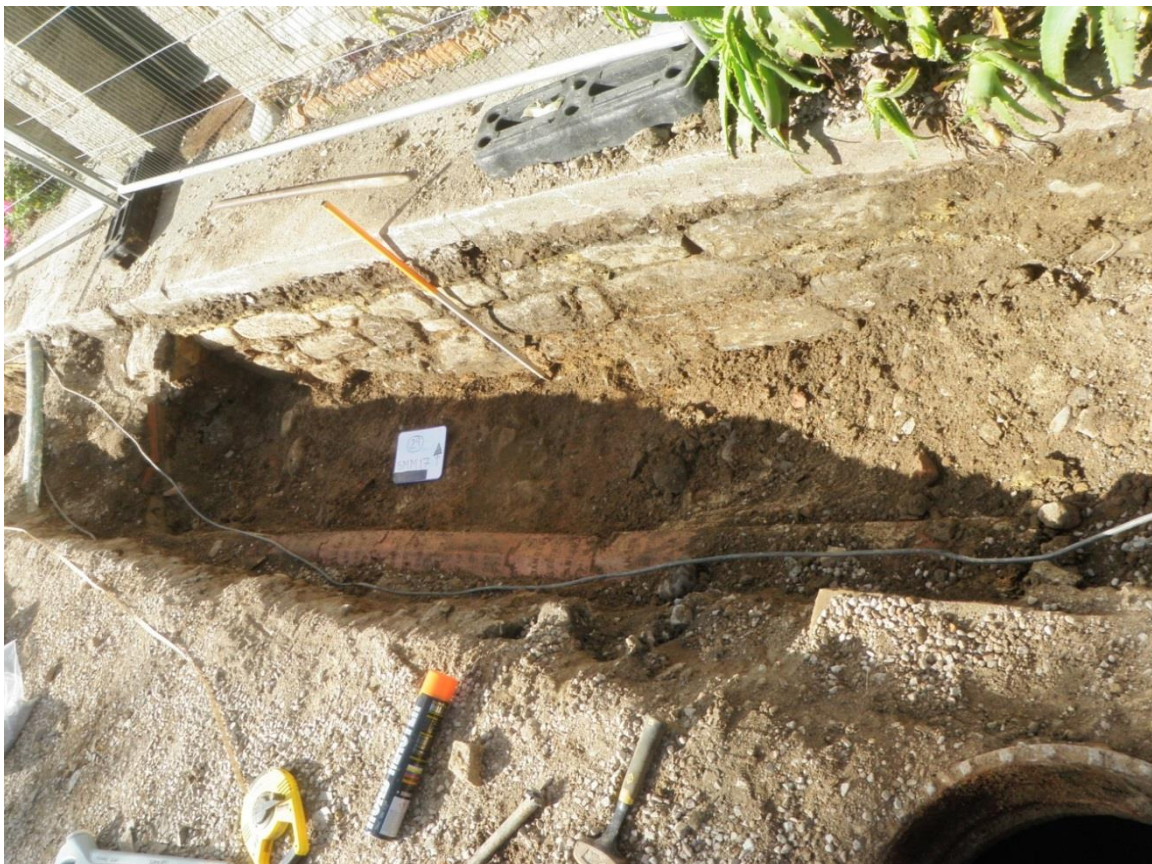
Fig 17 Looking down to the northwest from the eastern end of trench E showing part of wall 25 and an open service hatch on the right.

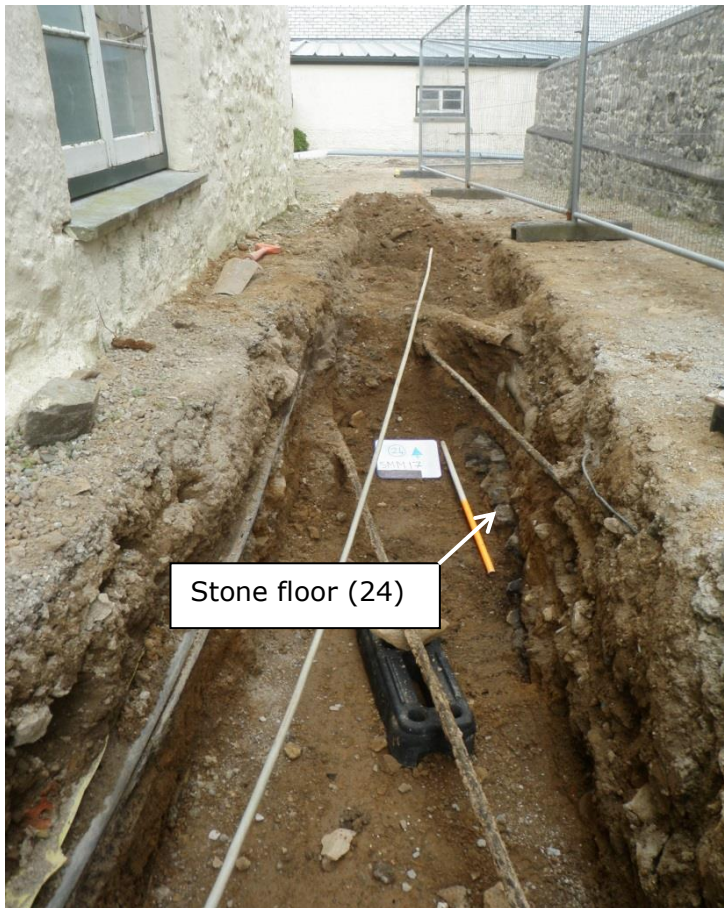
Fig 18 Looking north along trench E/N showing intercutting services overlying floor (24), which can be seen projecting from beneath the extreme lower right section.

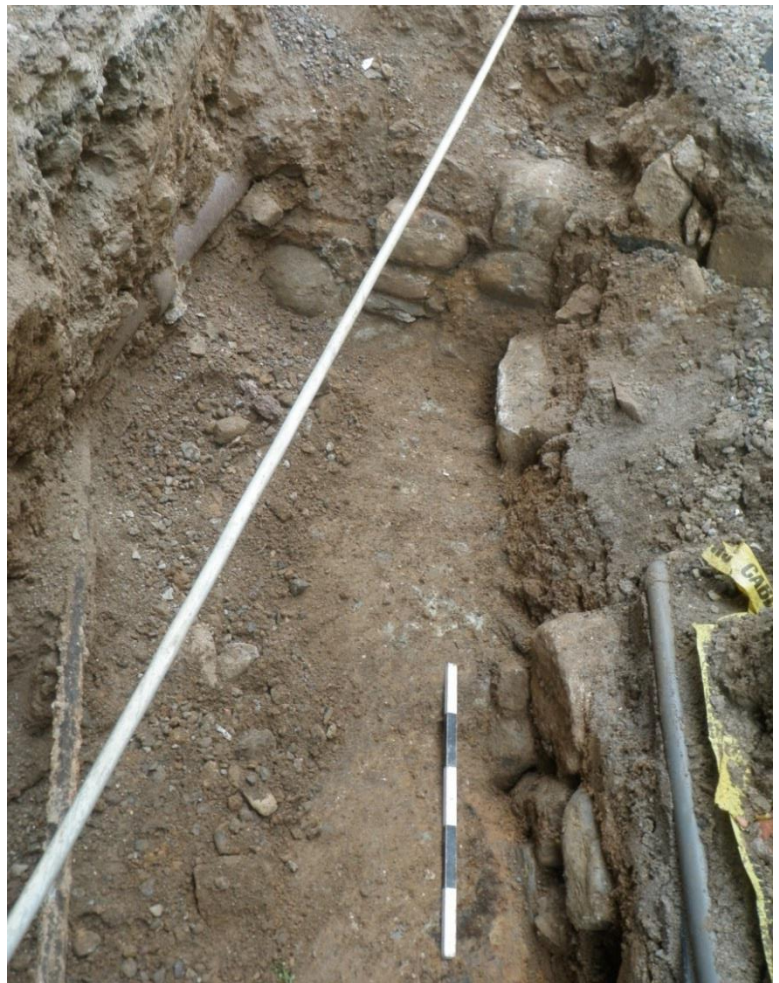
Fig 19 Looking south at the southern end of trench E/N showing wall 19 at the end and wall stones 32 on the right side of the trench section.

Wall 32 ran north to south and was seen in the western face of the southern end of the trench. It was abutted by wall 19, and was quite loose, suggesting perhaps wall foundations for a pre-1875 mapped structure. It appeared to be set on underlying natural clay (5).

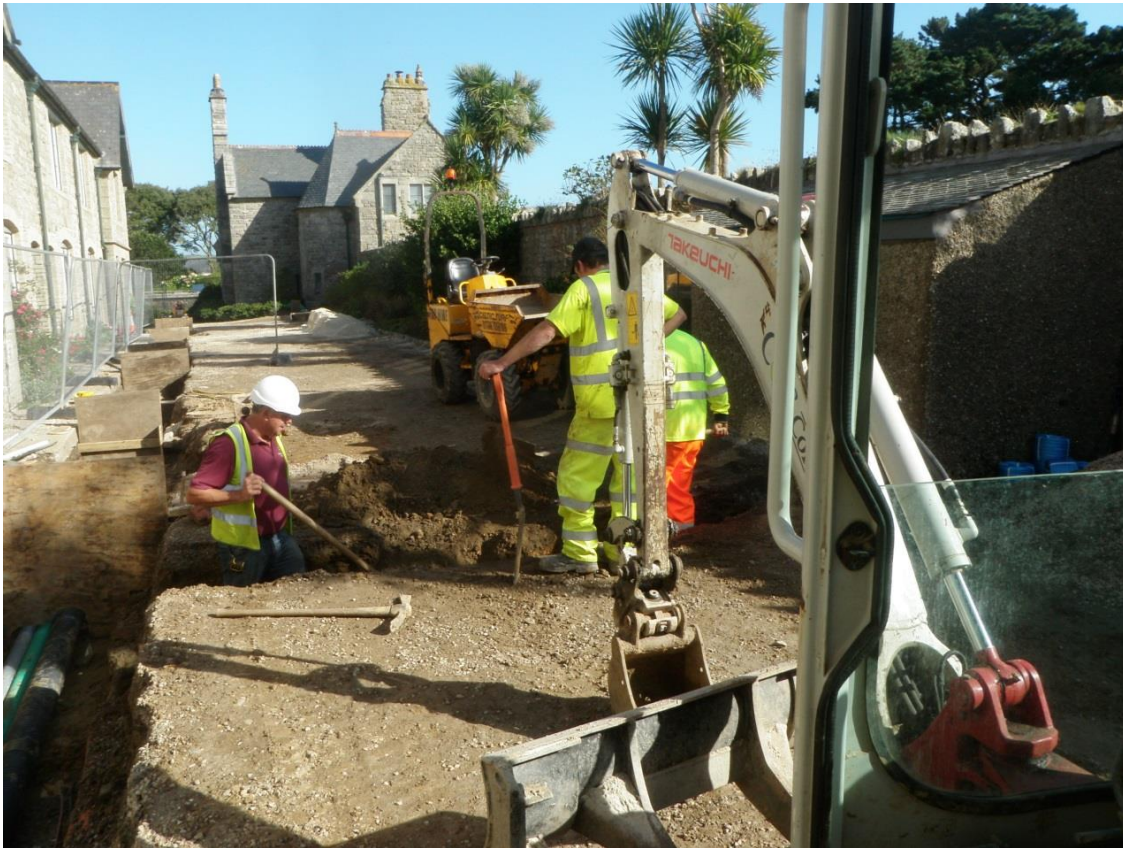
Fig 20 Working shot looking east along trench E showing trench E/S in the process of excavation.

Floor (61) was visible as a 0.6m wide, east to west running band of small, flat uncut stones with overlying thin, fine-grained, reddish black soft, almost oily silt (Fig 20). It lay 0.75m below current ground level and was approximately 0.3m north of wall 60 (with intervening sand (18)). Tiled electrical cable trench [3] ran above both the floor and the wall. To the north of floor 61 were loose, mixed stony ginger coloured, gritty deposits of uncertain date or origin. There were no associated finds.

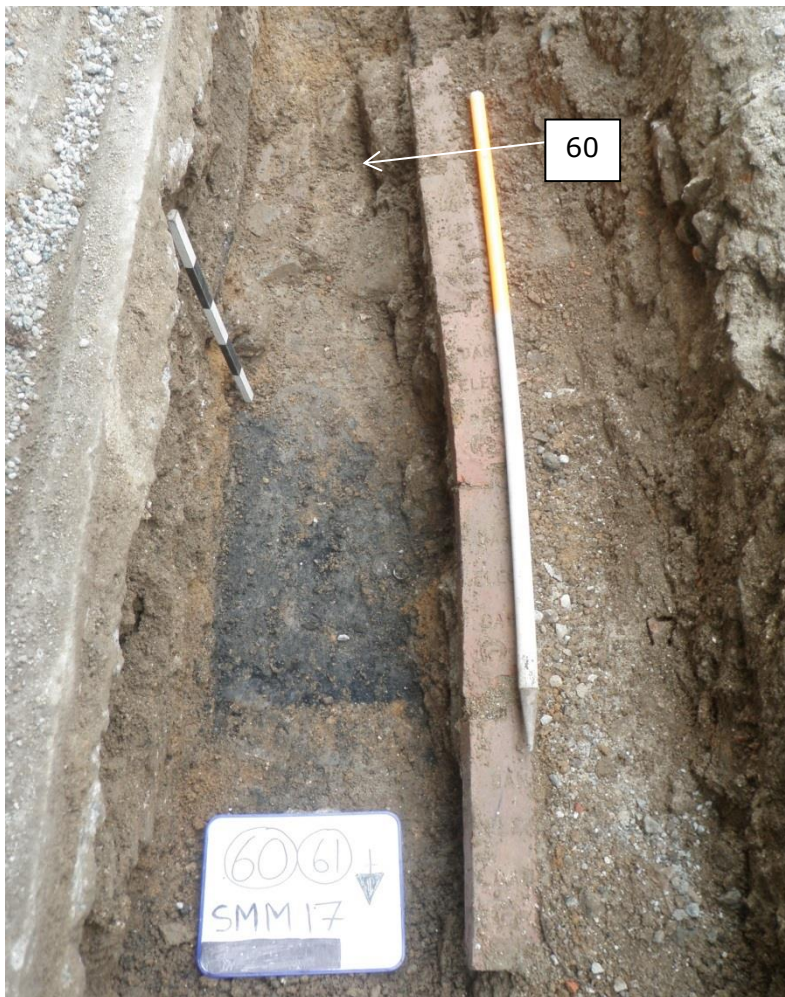
Fig 21 Looking south across E/N2 showing floor (61) with its dark surface silts towards wall 60 with overlying [3] on the right of the photograph.

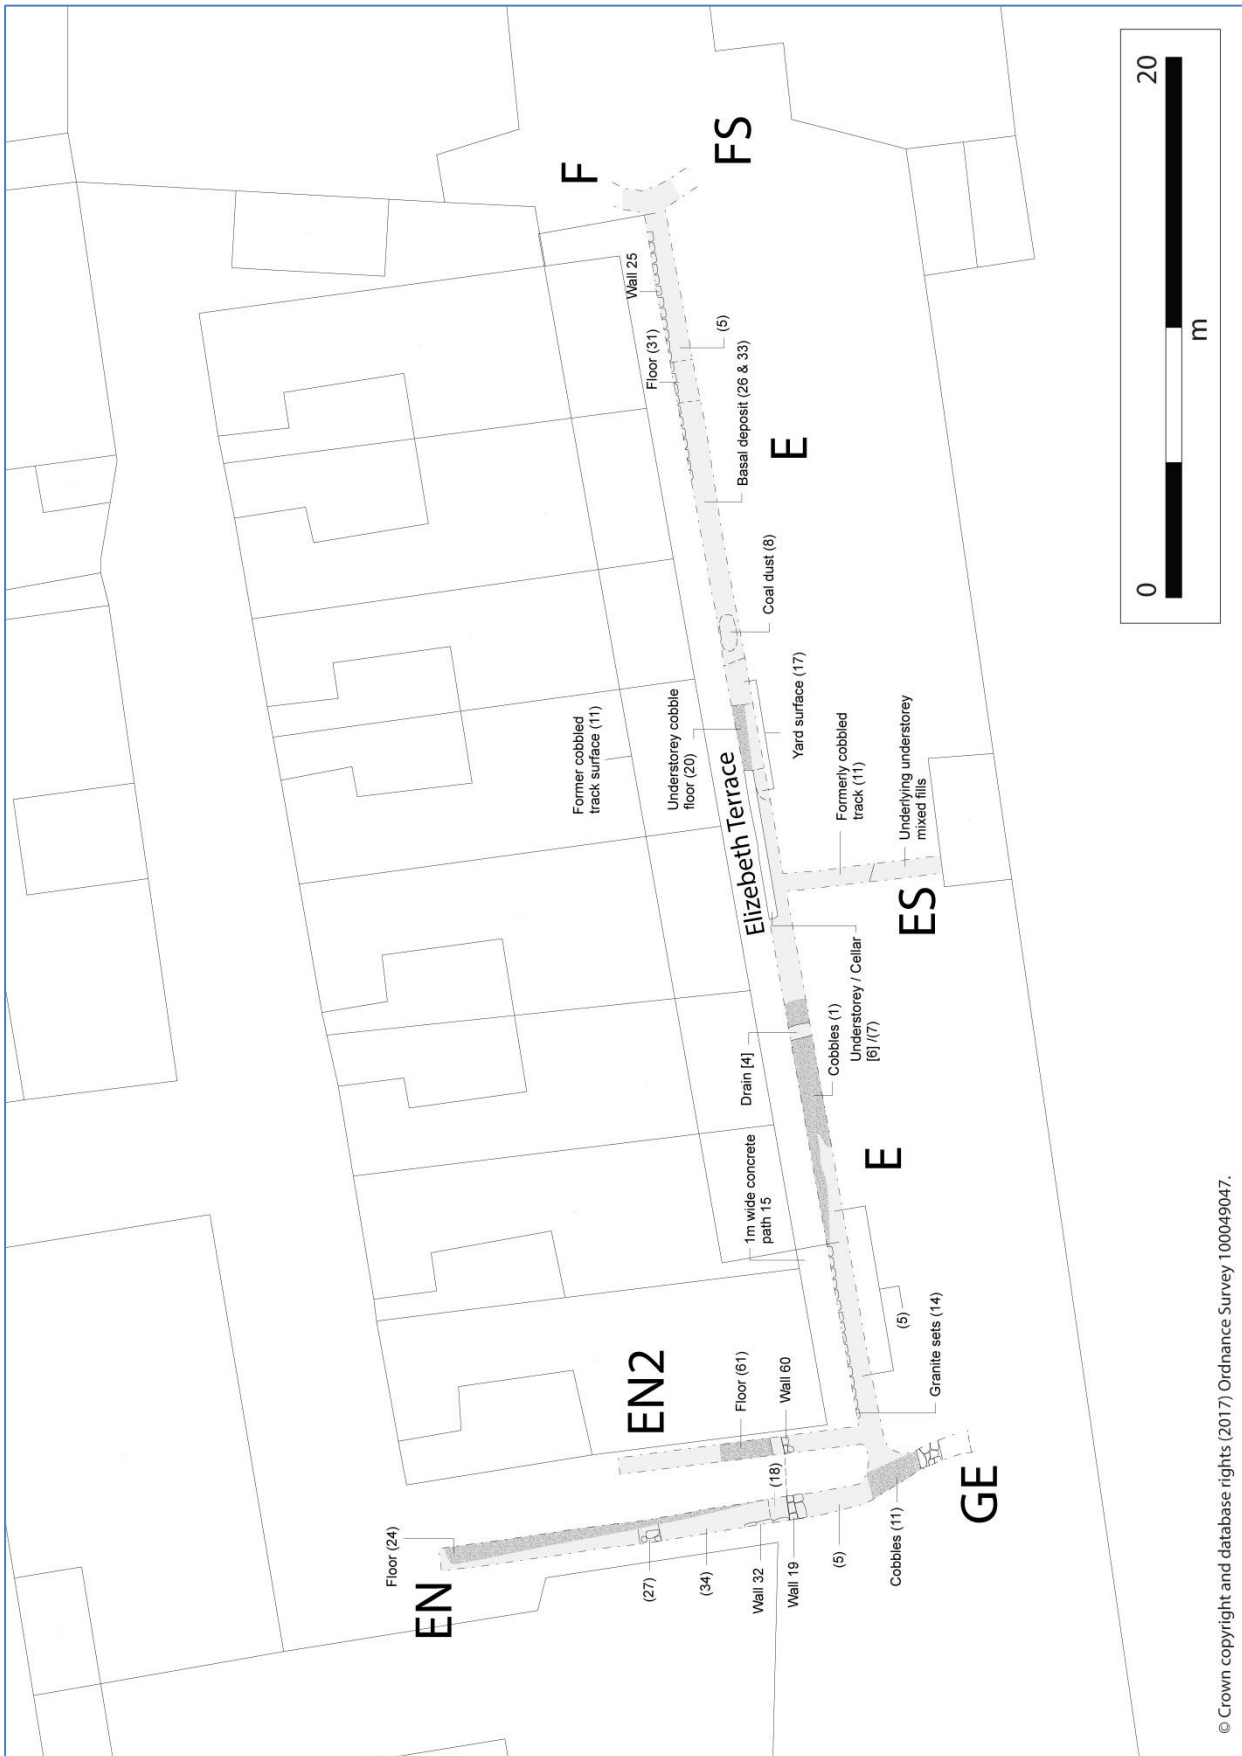
Fig 22 Plan of all area E related trenches, plus main feature groups discussed in the text.

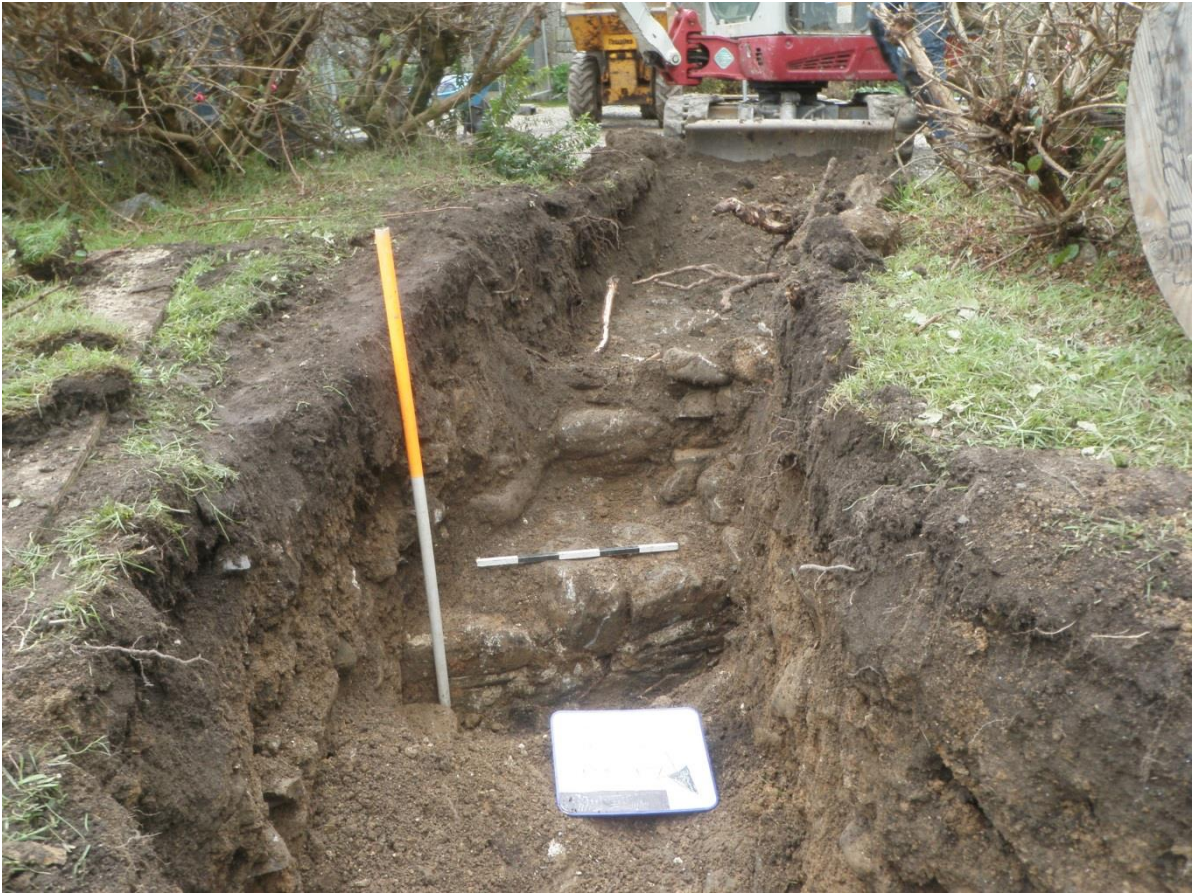
Fig 23 Looking south along trench F showing wall 42 in the foreground and stones/wall 43 beyond.

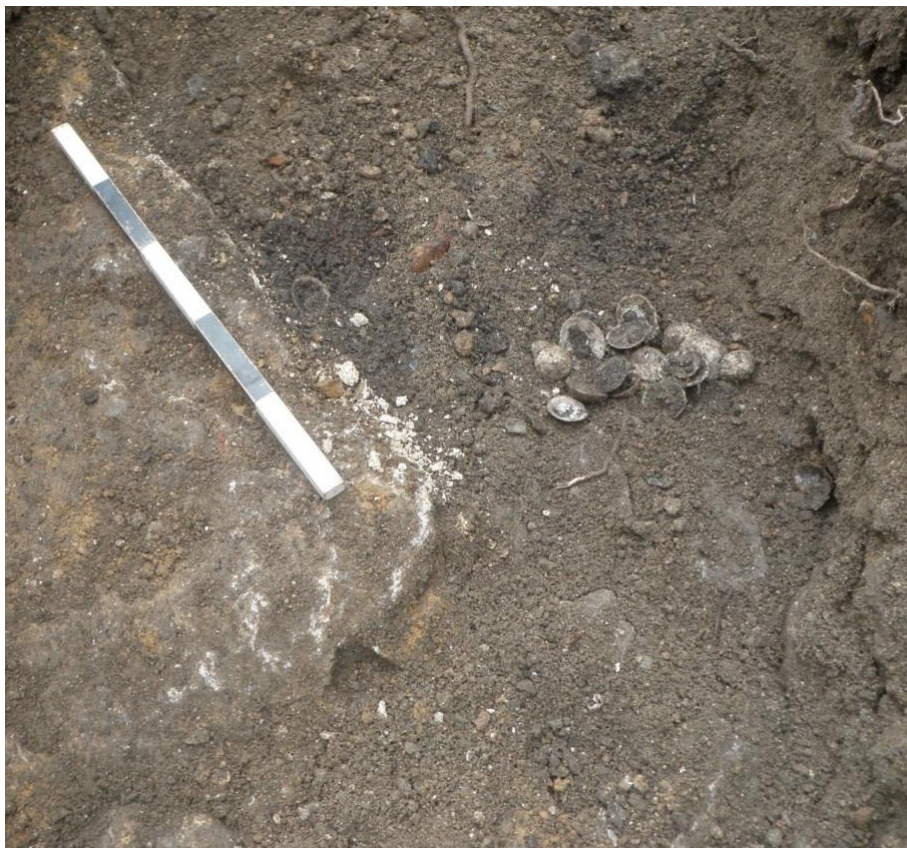
Fig 24 Looking down at wall stub 44 and showing part of adjacent shell midden (45).

Abutting the western side of wall 44 was a tiny, well-defined deposit of shells (45) (Fig 24), which consisted of 80% mussel shells and beach sand. Beneath (45) was loose rubbly infill layer (48). This butted up against walls 44 and 47 and appeared to represent deliberate infilling between remaining wall bases following demolition from the ground level upwards.

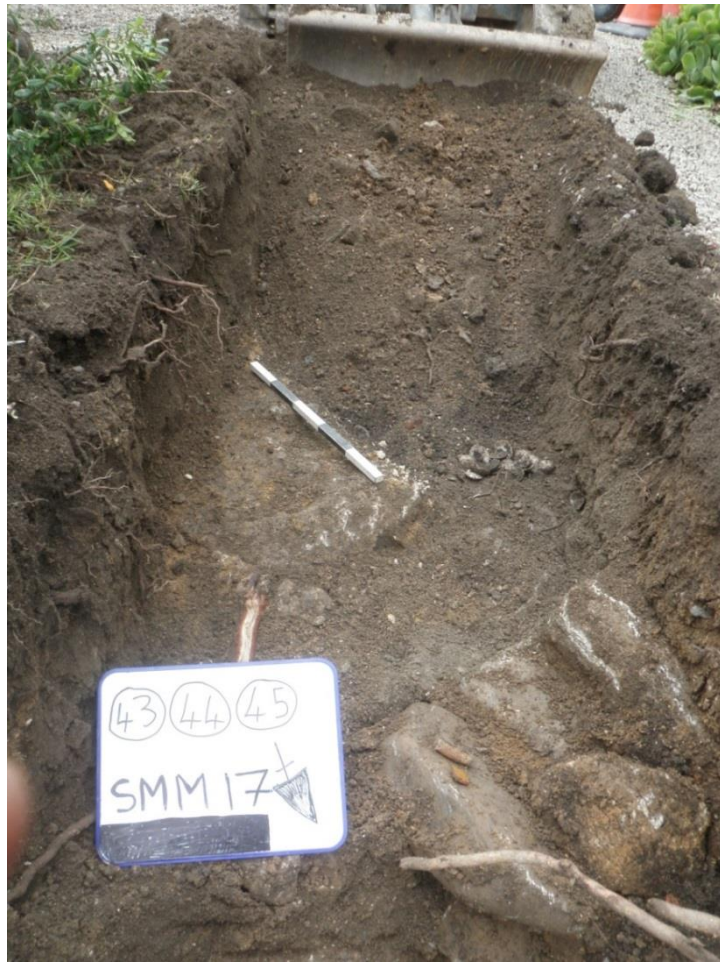
*Fig 25 Looking south
across southern side of
stones/wall 43, wall 44
and shell midden (45).*

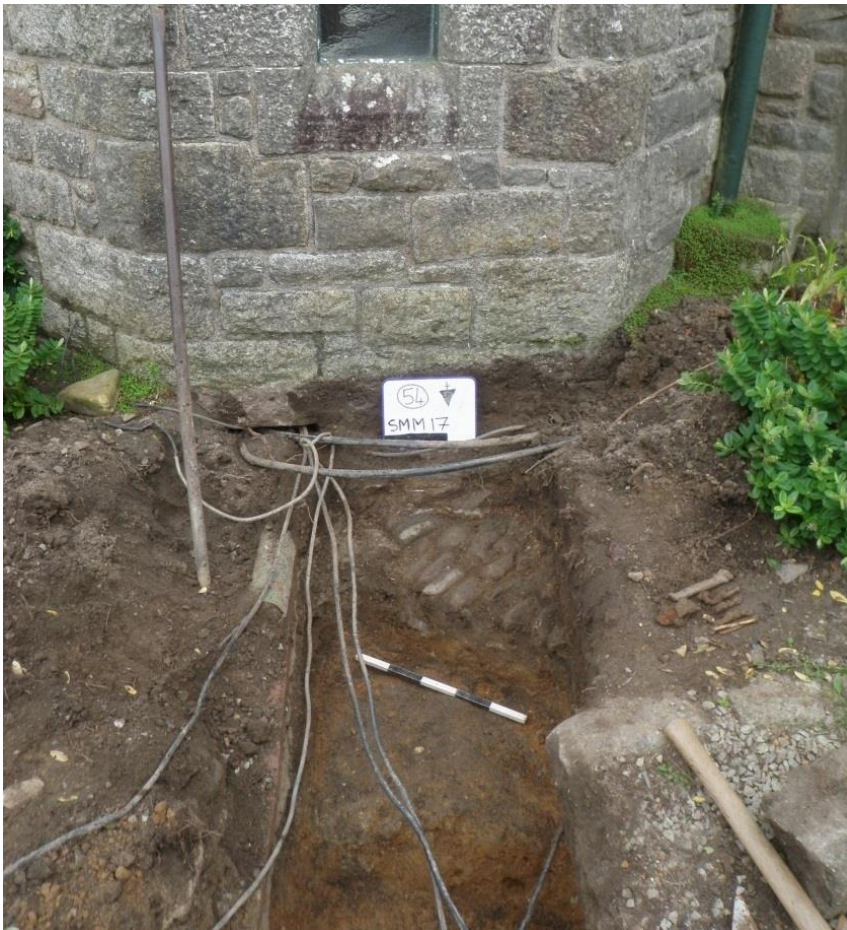
*Fig 26 Looking south
at the southern
end of trench F/S
showing cobbling
(54).*

Cobbling (54) ran diagonally east-south-east to west-north-west, with a very straight northern edge. They appeared to have been cut across by The Lodge, and was located 0.24m below ground level. The cobbles were markedly small and arranged lengthways, on their sides, in a diagonal north to south aligned pattern. Their small size and decorative appearance was strongly reminiscent of the internal cobbled floors seen beneath the current 17th century Stewards House floors. However, the position and relative height of (54) suggests a probable much later date. Cobbles (54) were probably designed to accentuate The Lodge's appearance at the main entrance in to the grounds of St Michael's Mount.

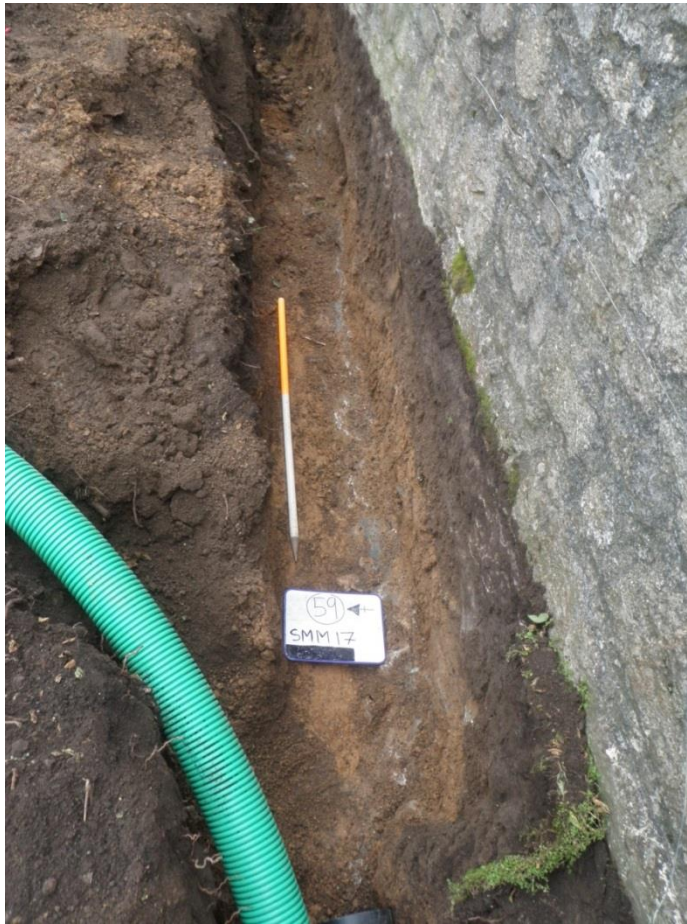
Fig 28 Looking east along trench G/E showing wall 59 at the base of the trench beneath the current standing garden wall.

Beneath the current garden wall and visible as distinctly different in build (and slightly in alignment) was 7m long basal wall foundation 59 (Fig 28). It was east to west aligned, 0.7m below ground level and extended north from the base of the current wall by up to 0.3m. The current garden wall probably includes much of wall 59's dismantled stonework. The eastern end extended beyond the trench and the western end suddenly petered out as it started to run in diagonally beneath the garden wall. Foundation 59 certainly predates the overlying garden wall, and relates to the run of buildings (with apparently intermittent cellars) known to have existed in this area.

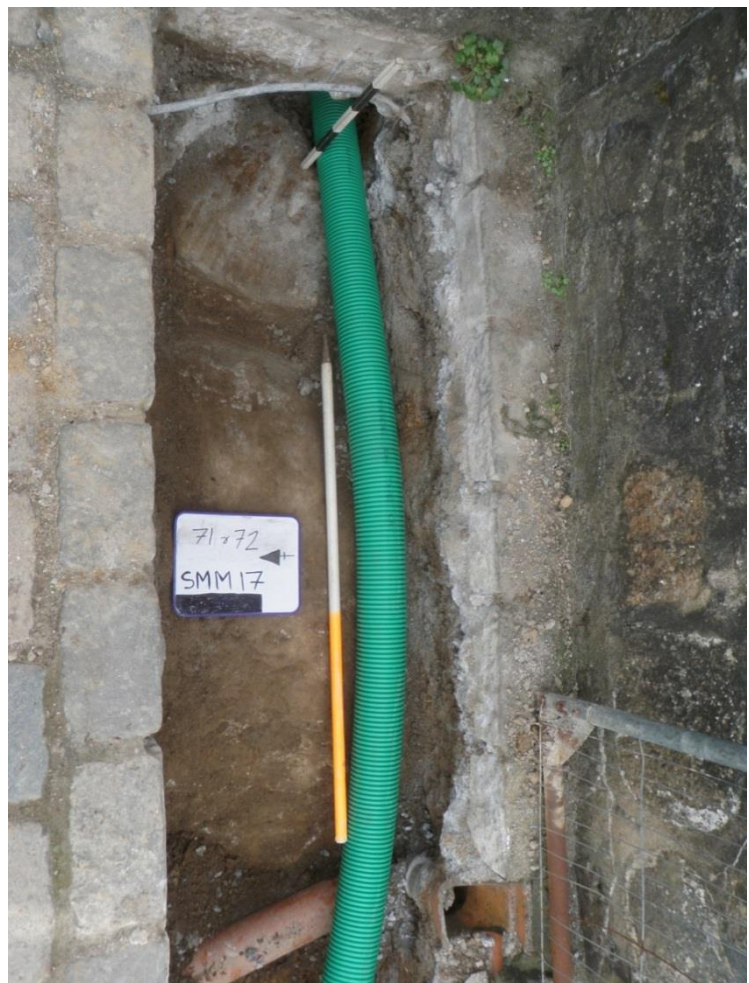
Fig 29 Looking down across the roof of the tunnel 72, showing wall 71 at the top of the photograph beneath the current wall. The green pipe running beneath the wall and over the tunnel roof has just been laid.

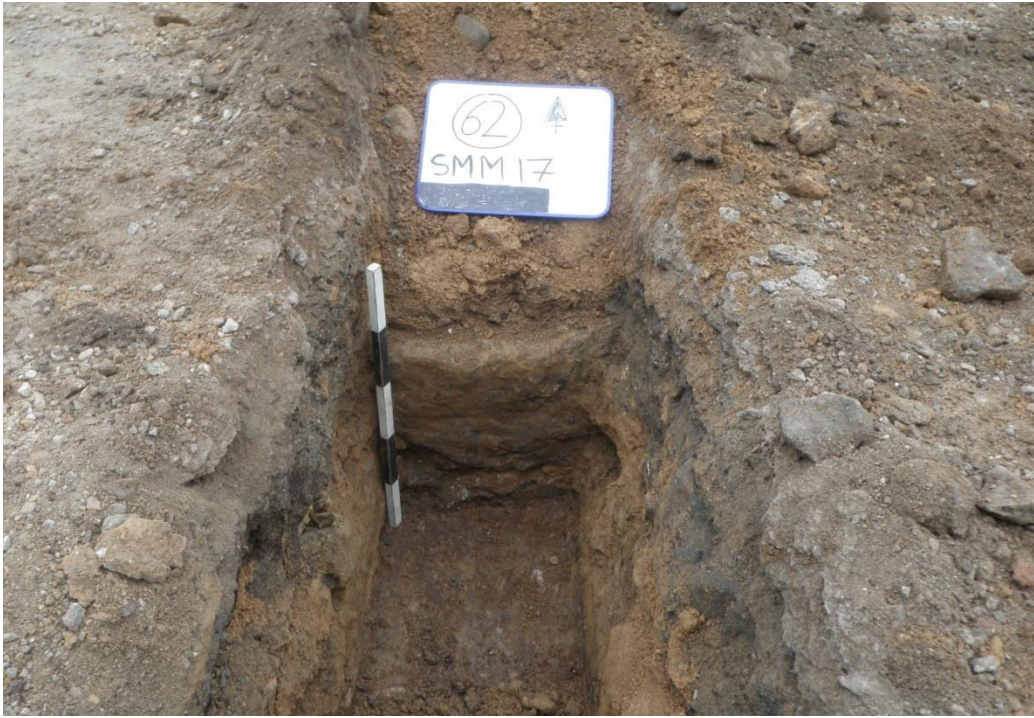
Fig 30 Looking north at wall 62.

Wall 62 and cobbled floor (70). This set of features mark the presence of a former ground floor room. The northern side is defined by basal wall foundations 62 (Fig 30), which ran east to west across the trench and had a 0.65m width and 0.4m surviving height. The top of the wall was 0.3m below ground level. It consisted of variably sized, cut and uncut granite blocks (at least one large one of which had been re-used) and a roughly shaped elvan block. The wall was overlain by (11). Clean redeposited clay/possible landscaping layer (65) was recorded on the northern side of the wall as lying on natural clay, and on the southern side of the wall on compacted clay (64). Layer (64) contained charcoal, bone, shell, clay pipe and slate. Above (65), and abutting the southern side of the wall was cobbled surface (70).

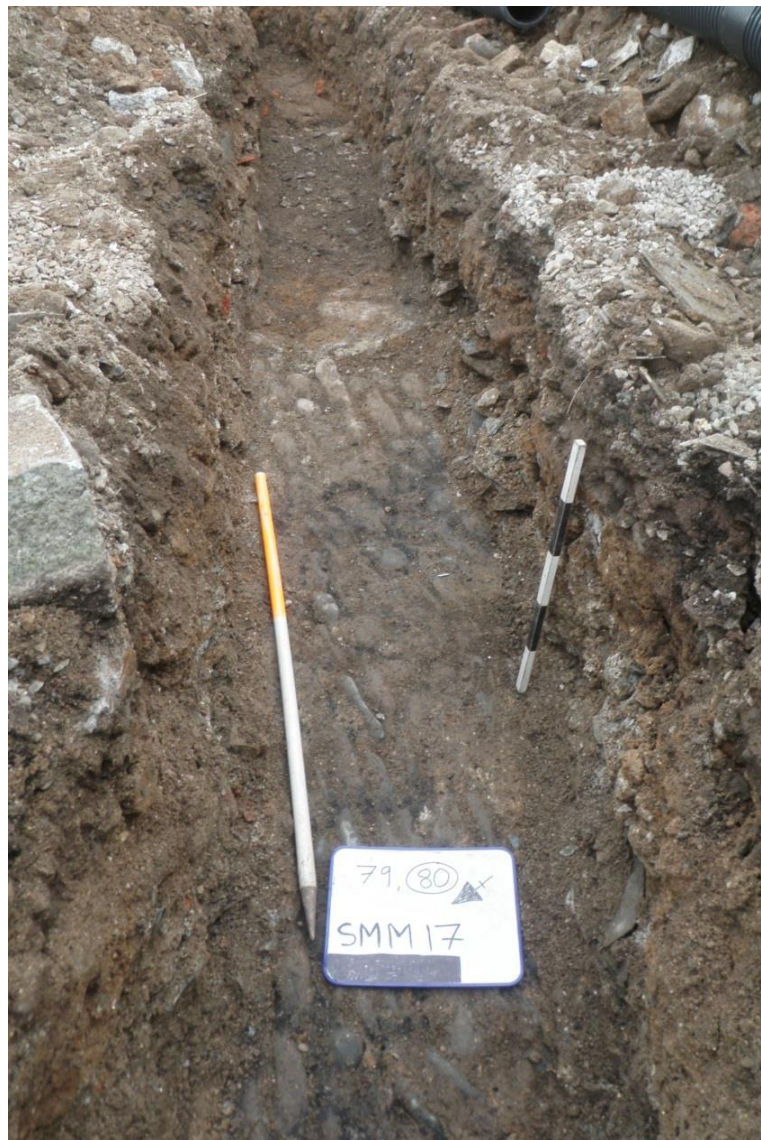
*Fig 31 Looking east across
cobbling (80), with
diagonal top of wall 79 just
beyond.*

Wall 79 was aligned north-south, was only 0.4m wide and 0.6m below ground level. It was very clear and partially overlain by demolished pale, decaying slate layer (81), which was in turn overlain by rubble (107). Its narrowness and rough stone facing suggested an internal plastered wall division, although the surviving plaster was minimal. Interestingly clay floor (82) and black (108) overlay the eastern top of this demolished wall, suggesting internal re-arrangement of possibly quite long-lived housing. An alternative interpretation might be that the 'wall' in fact supported a plaster and timber framework internal wall, which could account for the overlapping floor surface. It would also mean that the clay floor and western cobbling (80) (see below) were contemporary.

Cobbles (80) and wall 85. To the immediate west of wall 79 was the probably internal, 7m long stretch of cobbling (80) (Fig 31). It consisted of neat, tight fitting cobbles set on their long edges, covered with compacted, fine-grained dark silt reflecting the floor surface's final use. It was one of several contexts overlain by decayed slate layer (81). The western edge of (81) merged with mixed, weathered red brick and gravel demolition deposit (83). To the west of (83) was probable levelling layer (84). Both overlay cobbles (80). The western edge of cobbling (80) was marked by north to south running remnant wall 85.

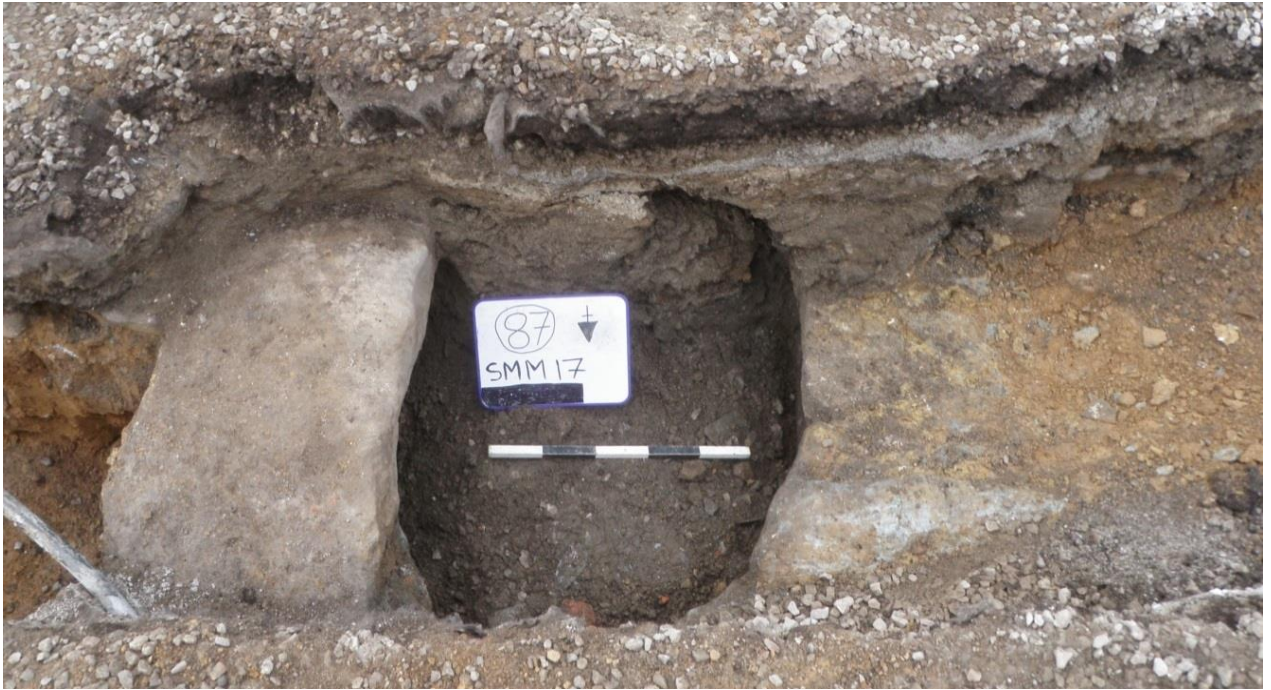
Fig 32 Looking down and south at well 87 in the early stages of excavation.

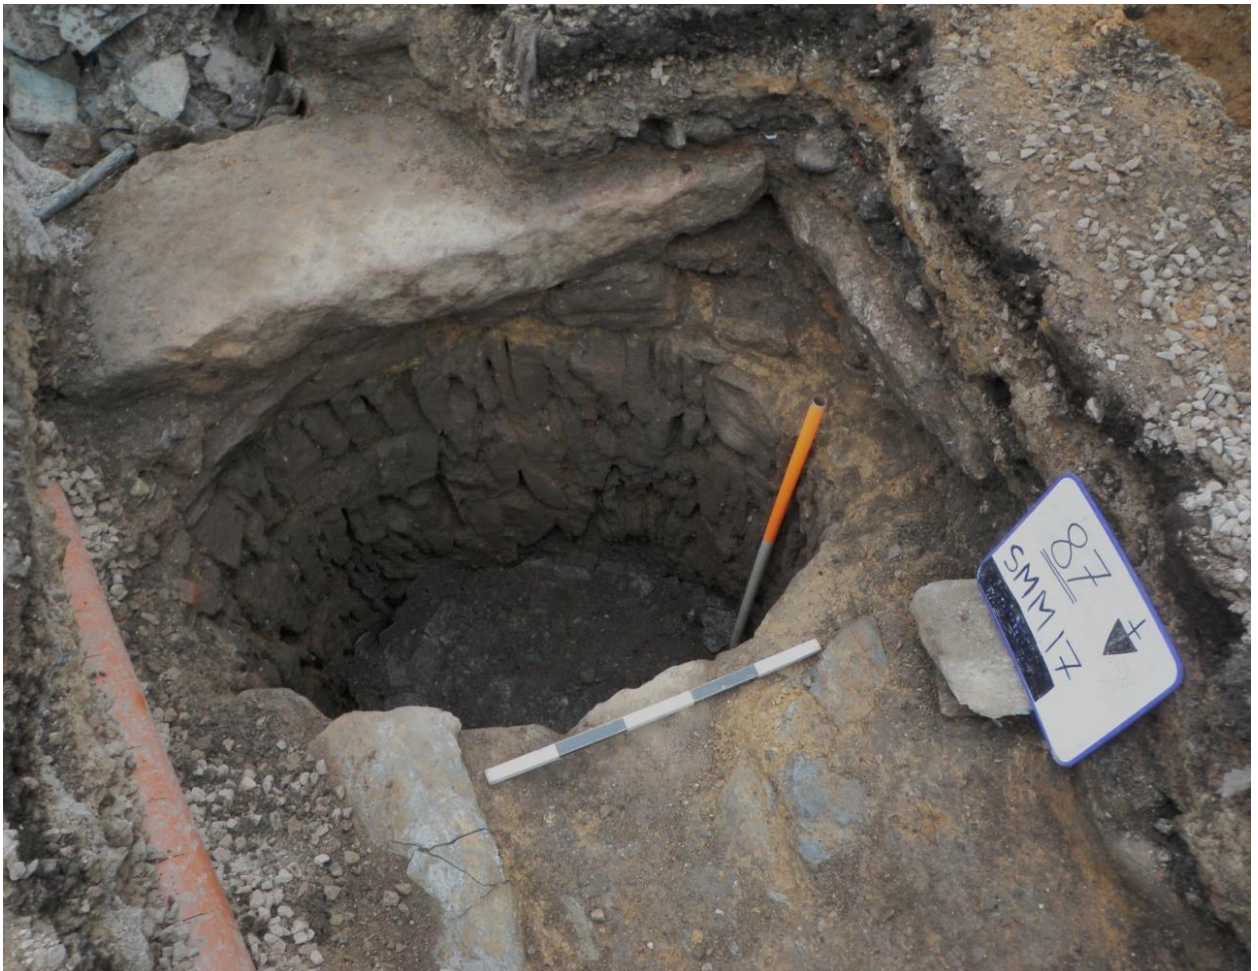
Fig 33 Looking down and east on well 87. The long eastern and shorter southern lintels (106) can clearly be seen, as can the internal stone-lining (109). Remnant cobbles (86) can be seen overlying the southern lintel.

The well was lined with stones (109). These were set vertically, on end into the surrounding clay and bonded with silty sandy clay. The stones were neatly arranged, and clearly selected and trimmed, but not cut. The stones were hard, blue-grey and locally derived, though few appeared to have been collected from the beach, since none had an abraded surface. They came from a very local source, possibly from the well excavation itself? No granite was noted in its build.

Two of the probable original four granite lintels (106) defined the eastern and the southern sides. These formalised and stabilised the upper edges of the well and were overlain very clearly on the shorter southern side by cobbles (86). The longer eastern granite was in excess of 1m long, 0.4m wide and 0.25m thick. On its upper northern surface a 2cm sized, circular drill hole was recorded. This would have supported a well-head attachment in the form of a bucket pulley or possibly associated superstructure. The northern and western granites were missing, almost certainly as a result of recent land drain works (the blue pipe for which is visible on the northern upper side of the well). Due to the removal of the western lintel, prepared underlying compacted silty clay (101) with horizontally placed killas slabs could be seen clearly. It provided a stable bedding context, on which the lintels were bedded.
