St Michael's Mount, Cornwall
Archaeological watching brief and recording
Cornwall Archaeological Unit

Archaeological watching brief and recording

Client	Mr Jim Parry (National Trust)
Report Number	2018R006
Date	February 2018
Status	Final
Report author	Anna Lawson-Jones
Checked by	Andy Jones
Approved by	Andrew Young

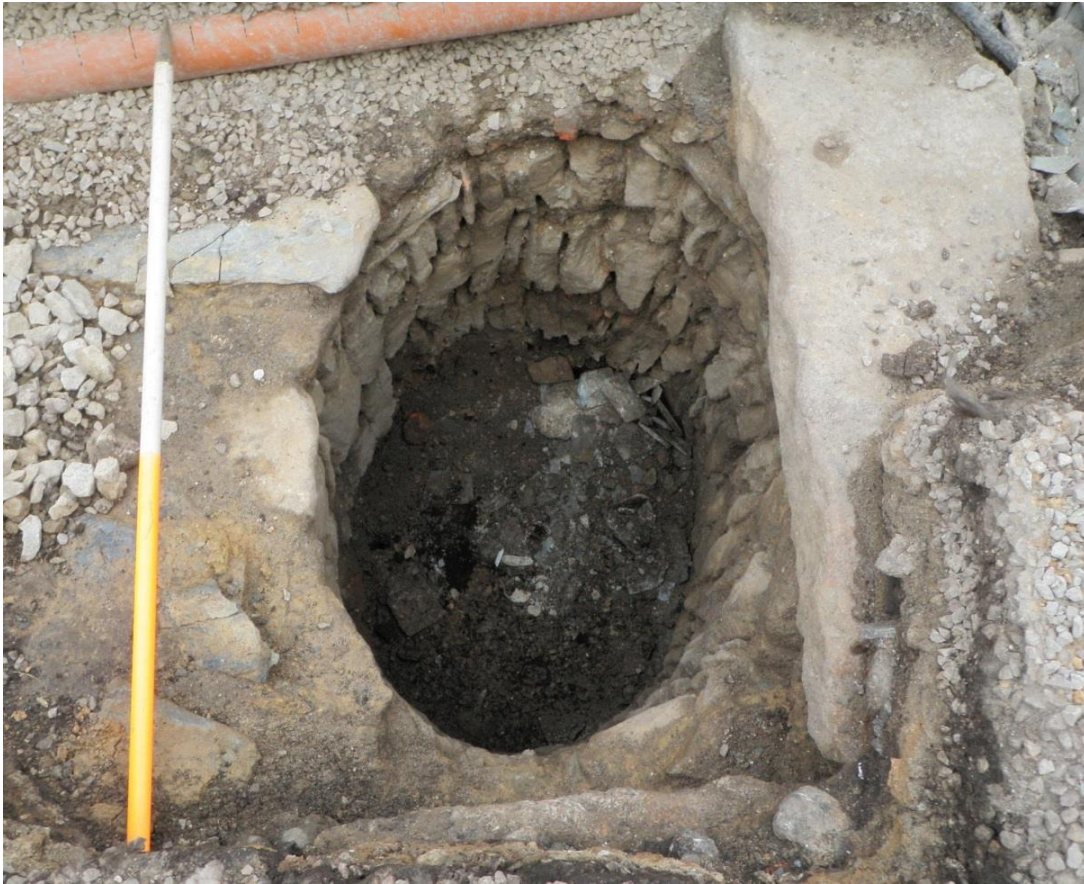
Fig 34 Looking down and north on well 87 showing the land drain responsible for the probable removal of the northern and western lintels. See also redeposited clay and slate layer (101) on the left hand side of the photograph.

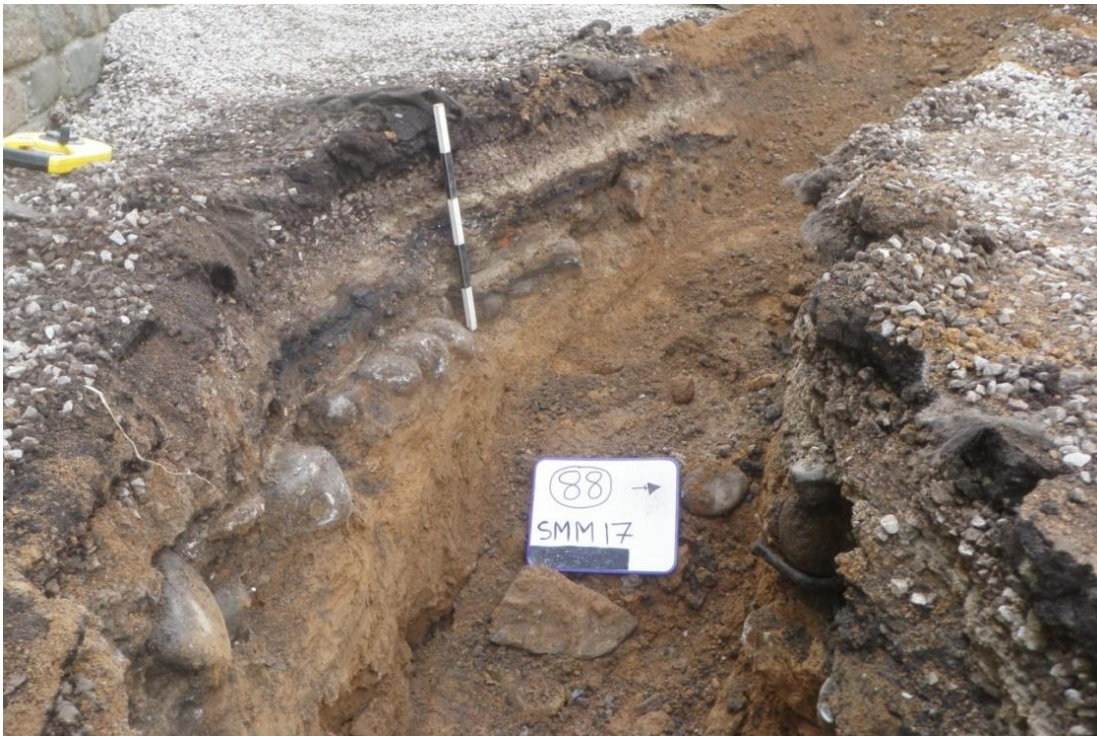
Fig 35 Looking west along trench G/W showing cobbling (88), underlying natural clay (5) and colourful overlying layers including (90).

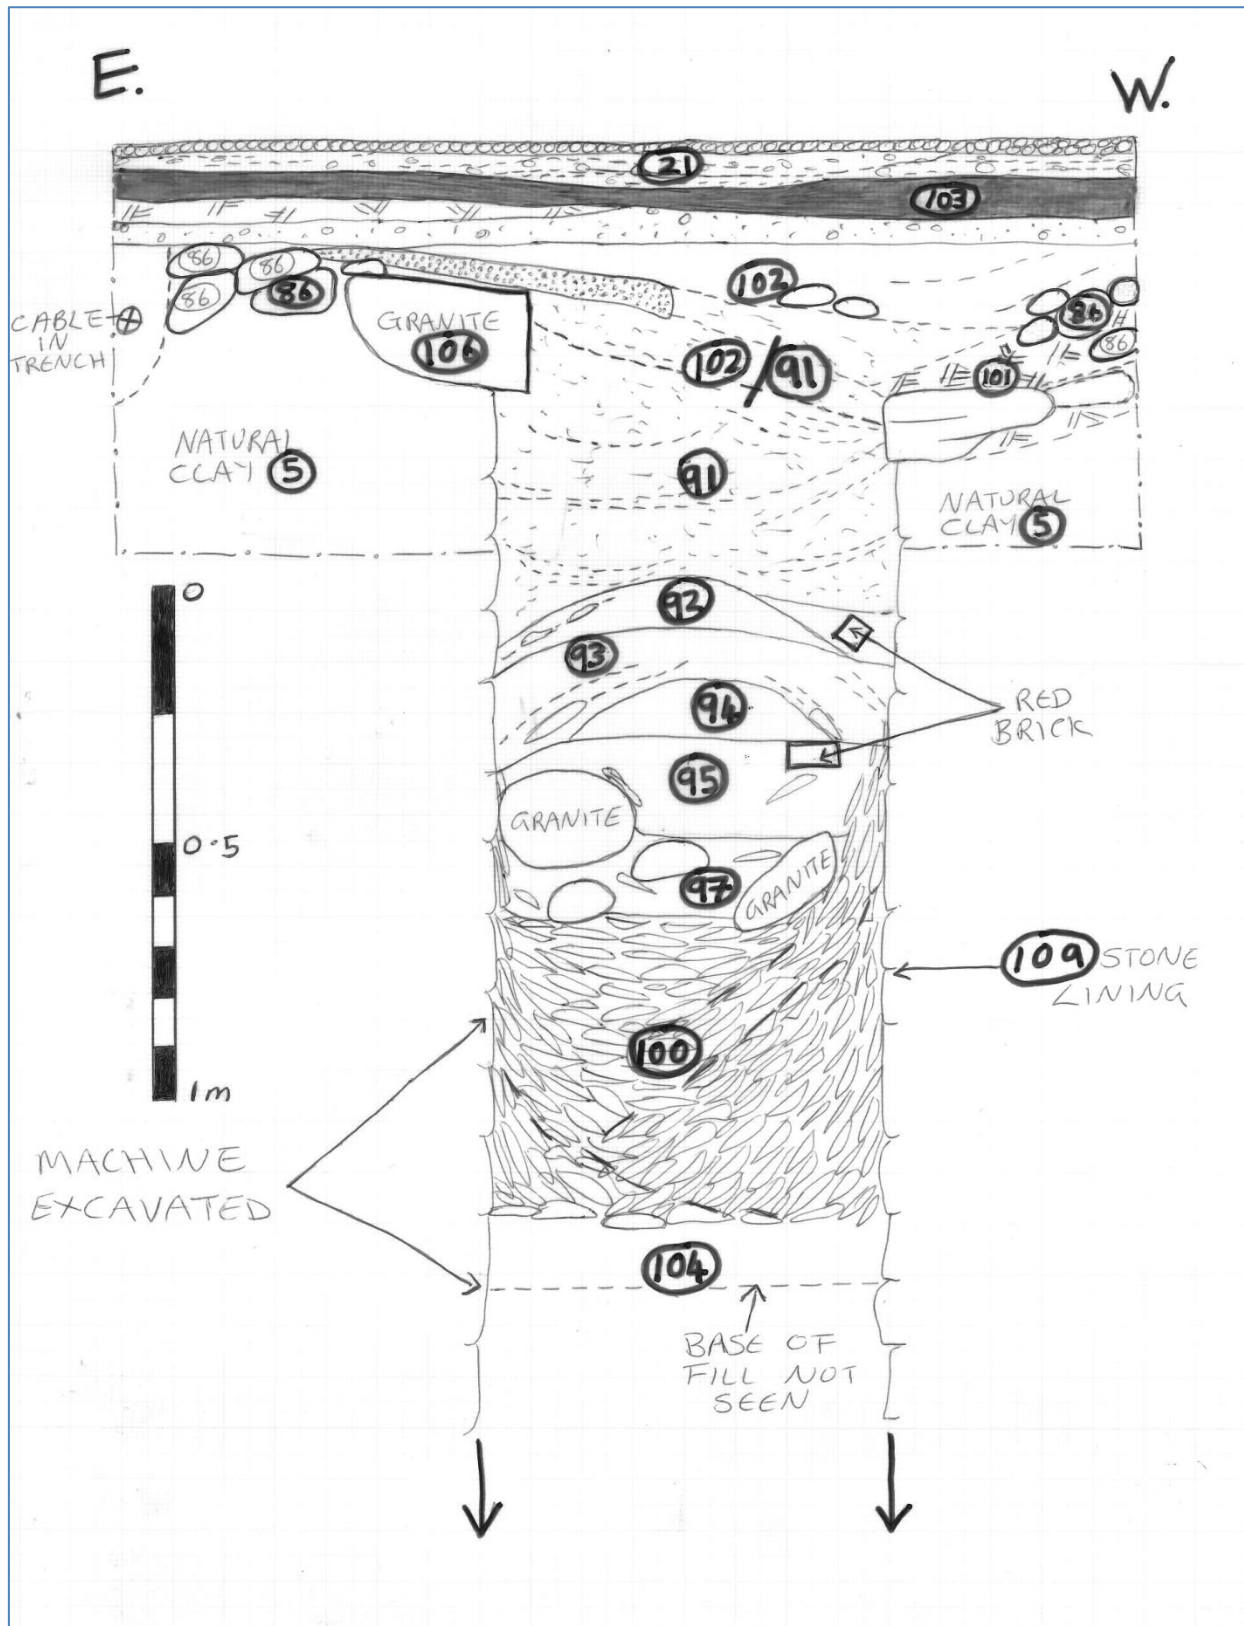
Fig 37 Looking south at a composite section through well 87, showing infill deposits and well profile and upper/sealing layers.

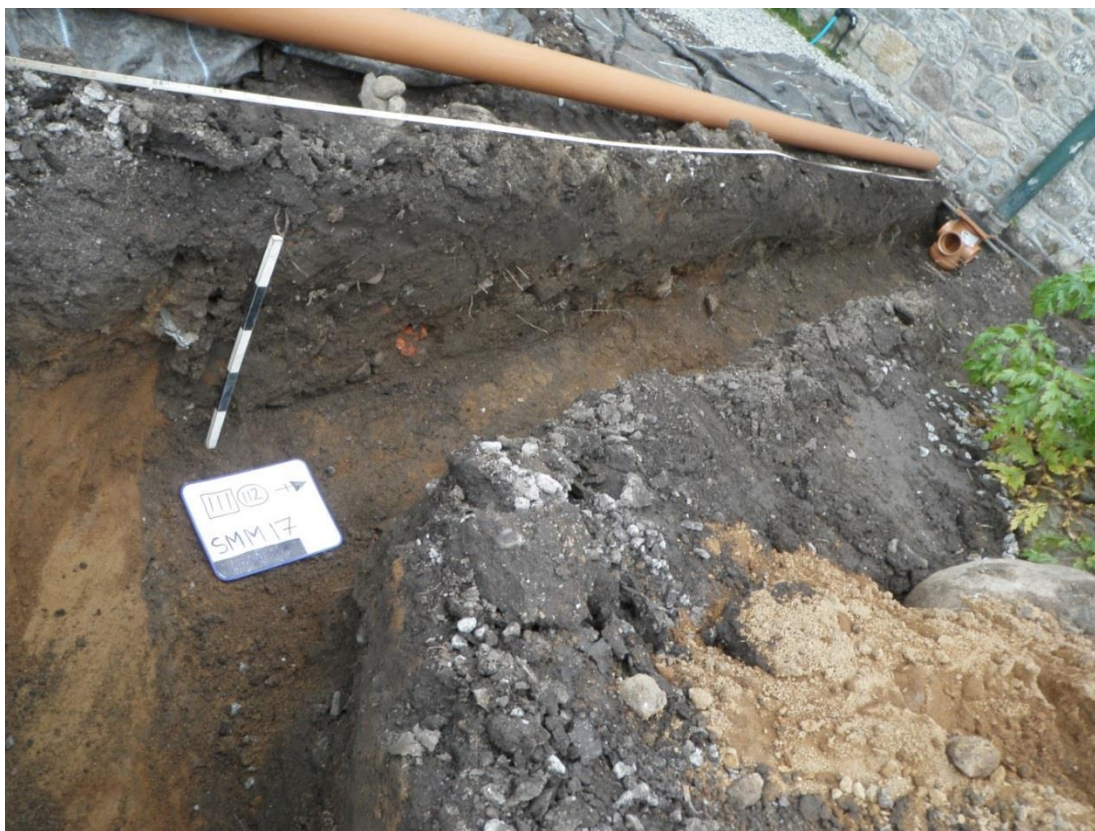
Fig 40 Looking down and west at the southern edge of understorey [111] cutting through natural (5). Fill (112) is to its north.

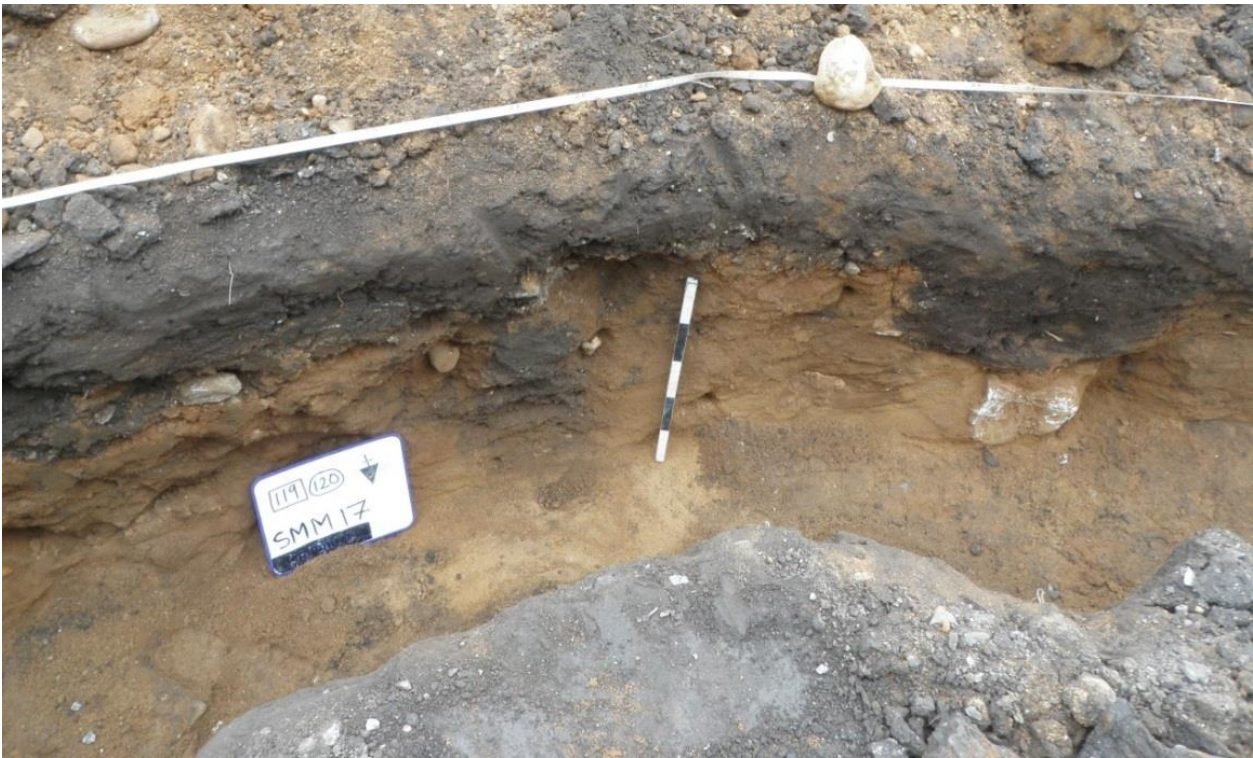
Fig 41 Looking down and south at posthole [119]/(120) (left) and basal wall stone 116 with upper robber trench [117]/(118).

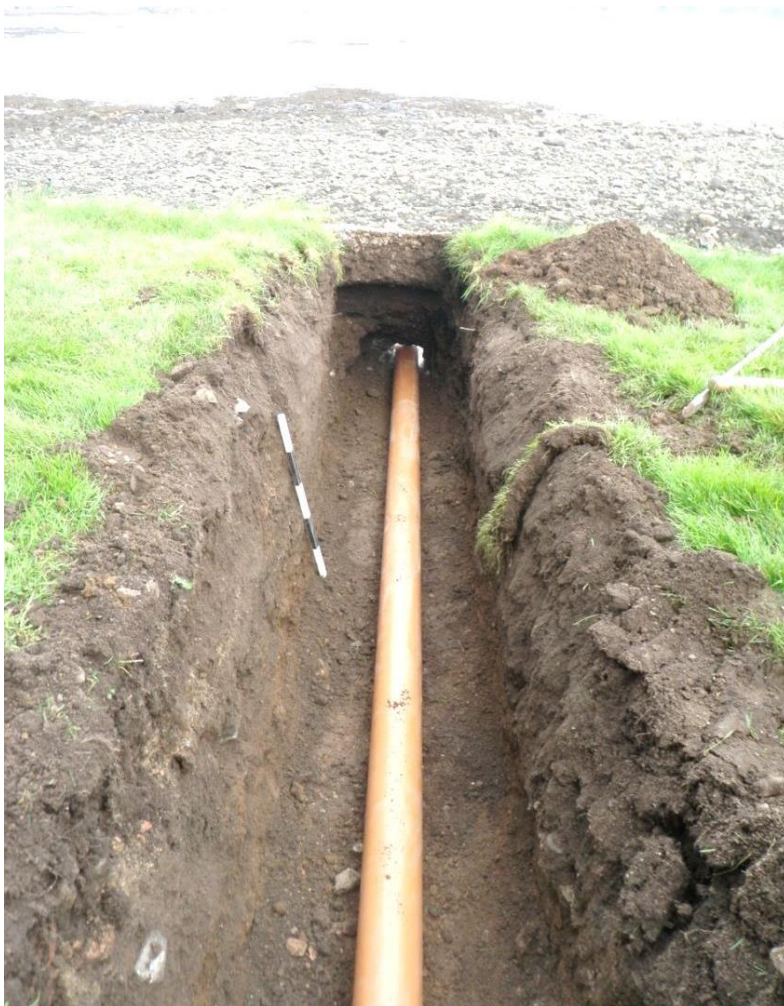
Fig 42 Looking north along the northern end of trench H, showing lower layer (126), etc and breached sea wall with new pipe feeding through it.

Sea wall context (127) and related landscaping layers. At the far northern end of the trench was the sea wall (Fig 42). This consisted of a 45° sloped granite and concrete wall. Running along its immediate southern edge was 0.5m high, 1m wide (127), which consisted of a stagnant organic loam infilling, which abuts the northern end of (126). To the immediate north of (127), a series of layers were recorded filling a shallow dip in the top of (126). The lowest was sticky brown, 0.3m thick clay layer (125). It contained occasional bone, and was sealed by 0.08m thick windblown sand deposit (124). Above was probable recent landscaping layer (123), which had a 0.2m thickness and contained domestic midden and possible demolition-related waste in a soft silty sandy loam. Turf layer (122) overlay (123) and (127).

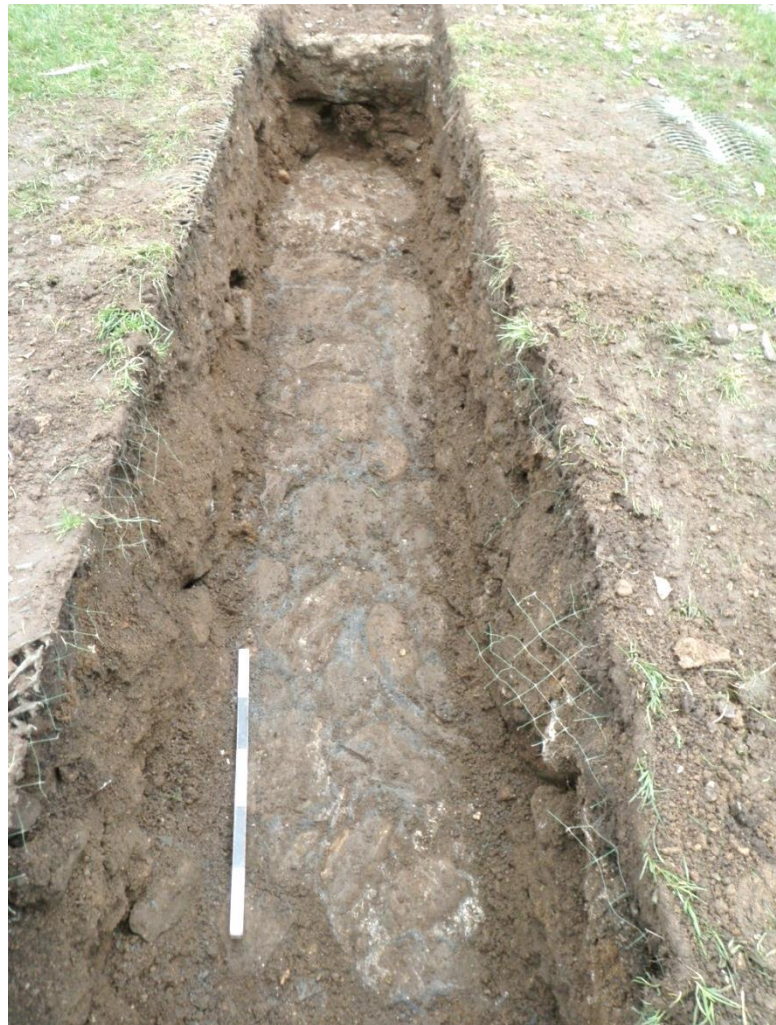
Fig 45 Looking south across trench I/1 showing the surface of floor (138). Note as yet unexcavated service pipe at southern end, just beyond the paler raised end of the floor

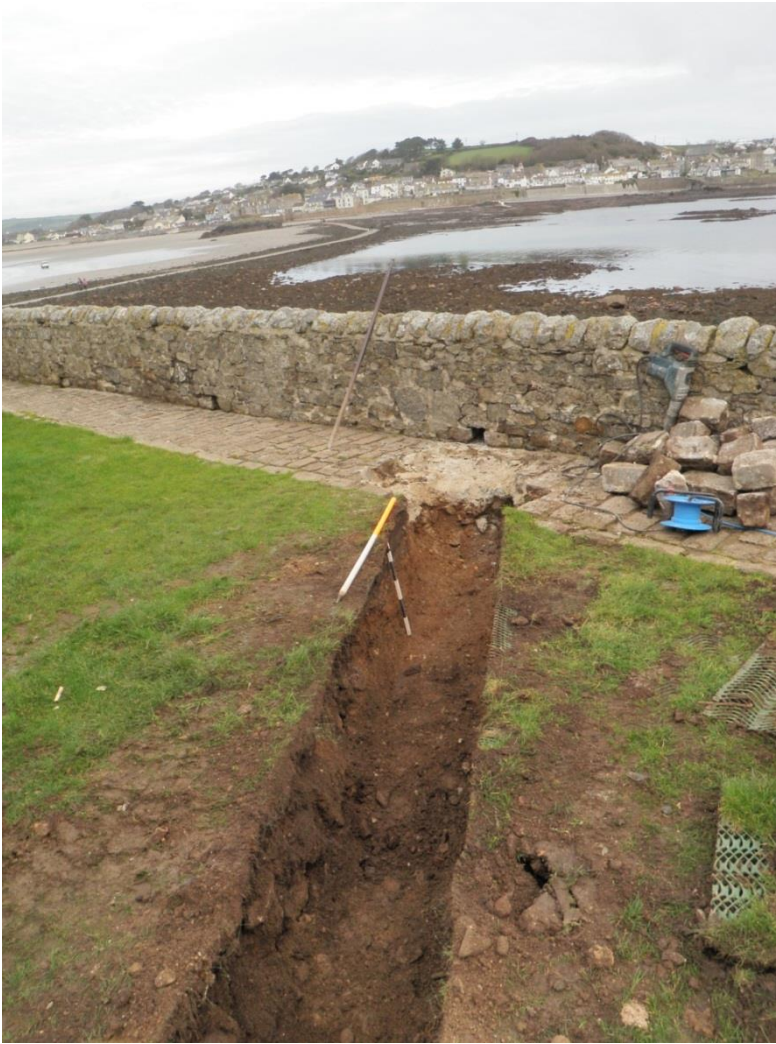
Fig 46 Looking north along the northern end of trench I/2 showing trenching running up to the path and sea wall.

Sea wall associated context (151) was located at the extreme northern end of trench I/2 (Figs 46 and 47). To its south, seen on the base of the trench was an un-numbered limey/mortar-like deposit overlying pale sandy clay. Context (151) consisted of 1.6m long, 0.5m thick mounded beach sand, pebbles and shells in loose sandy clay. This deposit equates with sea wall associated deposit (143) in trench I/1.

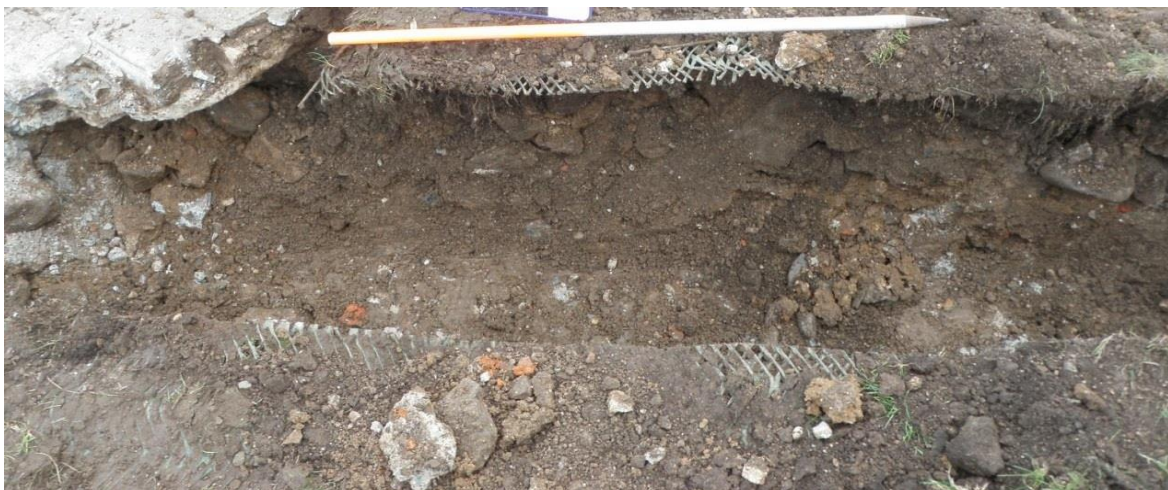
Fig 47 Looking east at stone and beach rubble deposit (143). Which supports the path and seas wall at the northern end of trench I/1. Note the protective plastic webbing and turf layer (136).

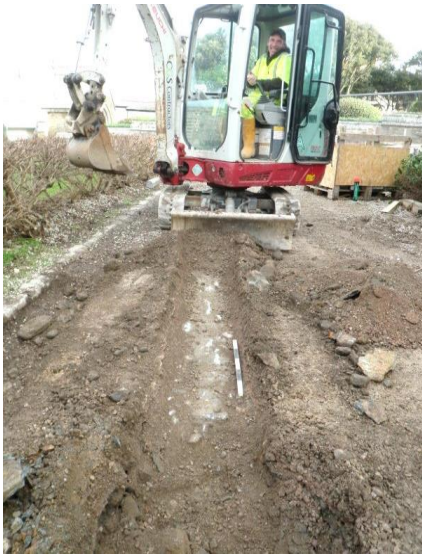
Fig 49 Looking east across the stone slab roof of culvert 155 (left) and along the emptied culvert (note fill (163) at the far end of the 0.5m scale).

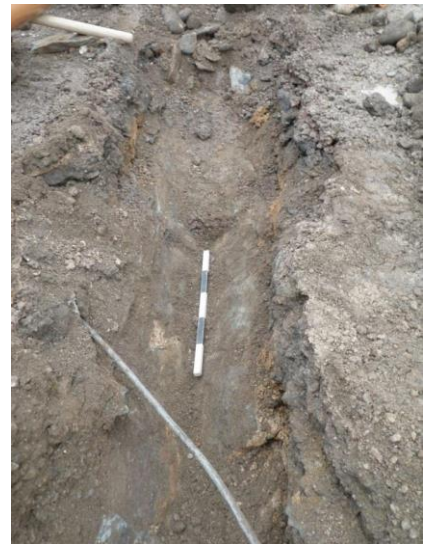
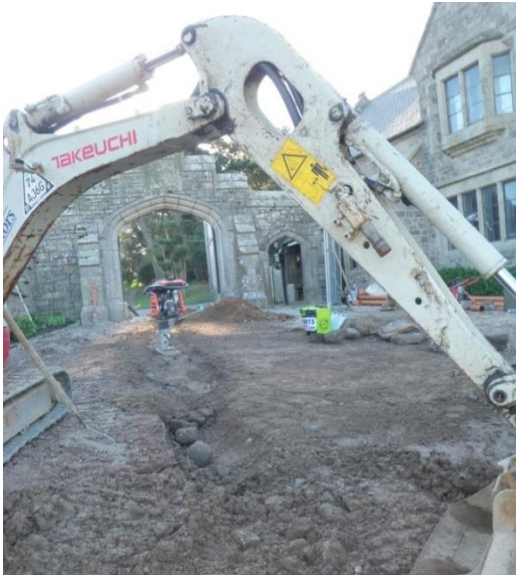
Fig 50 Looking south up largely backfilled trench J as it runs through the main gateway in to the gardens. Note the occasional cobbles in the back fill and the line of larger boulders beneath the arm of the digger, which come from wall 161.

A further 14m length of wall 156 (Fig 50) was partly seen (following partial backfilling), running south to the main gate (attached to The Lodge). On the basis of what was seen and information gleaned from the digger driver the following three contexts were identified. At the northern and southern ends of this arm of the trench was stony layer (160). This, like many of the rubble layers, represents landscaping beneath the trackway. It extended below the base of the shallow trench and was overlain by (21). Located running east to west through the centre of this deposit was wall 61 and associated (162). The wall consisted of two large granite boulders, placed side by side and aligned east to west, giving an approximate 1.3m width. Overlying these were a series of slightly disturbed and tumbled remnant upper courses of uncut granite and boulders. On both sides of the wall was a dark, probably organic loamy deposit with a noticeable number of limpet shells. This deposit represents a former midden deposit which had built up against wall 61 when it was still extant.

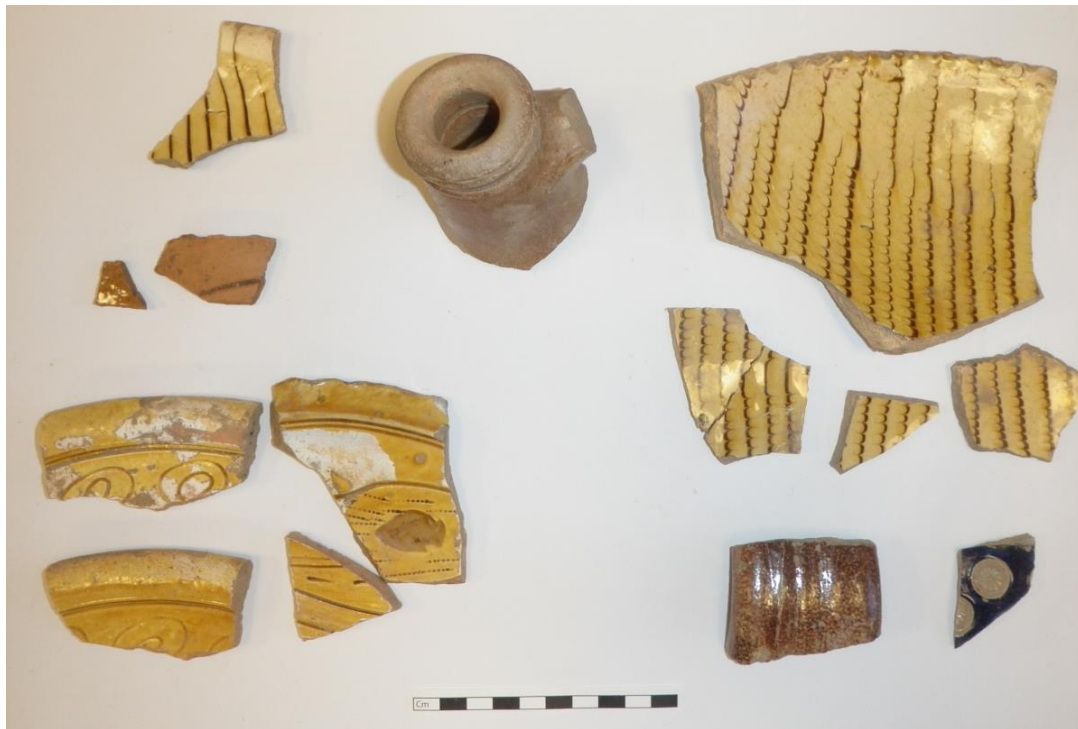
Fig 52 Selected 17th and 18th century pottery. Clockwise from top left: Bristol/Staffordshire ware- C18th rim sherd (E); Bristol stoneware- late C17th top of Bellarmine-like vessel (E); Bristol/Somerset ware- C18th rim sherd (E); Westerwald ware (stein fragment) of C17th-C19th (E); Bristol stoneware handle segment- C18th (E/N); Barnstaple ware with sgraffito decoration- C18th (E).

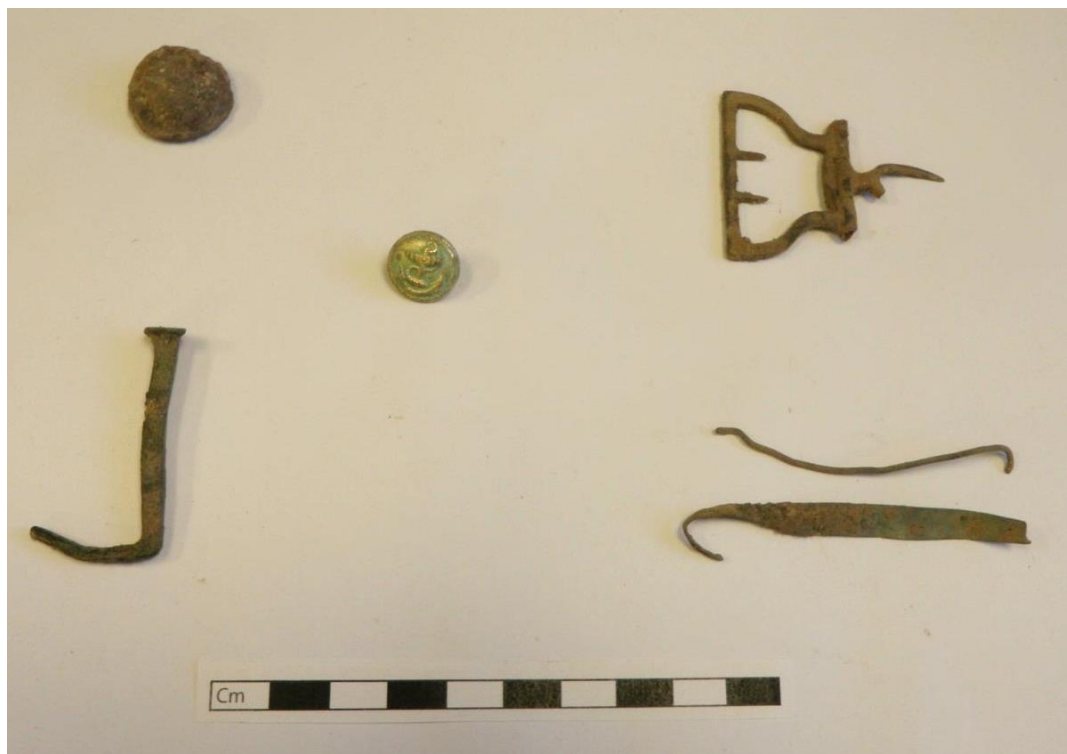
Fig 53 Miscellaneous metalwork. Clockwise from top left: Civil war musket ball flattened through impact- C17th (E); button with back attachment loop and anchor decoration, undated part of a seaman's uniform (E); Buckle of 1720-1790 style, found in deposit (95) near wall 25 (E); broken fine metal strap-like piece, undated from well 87 fill (95) (G); deliberately bent and hammered nail (E/N).

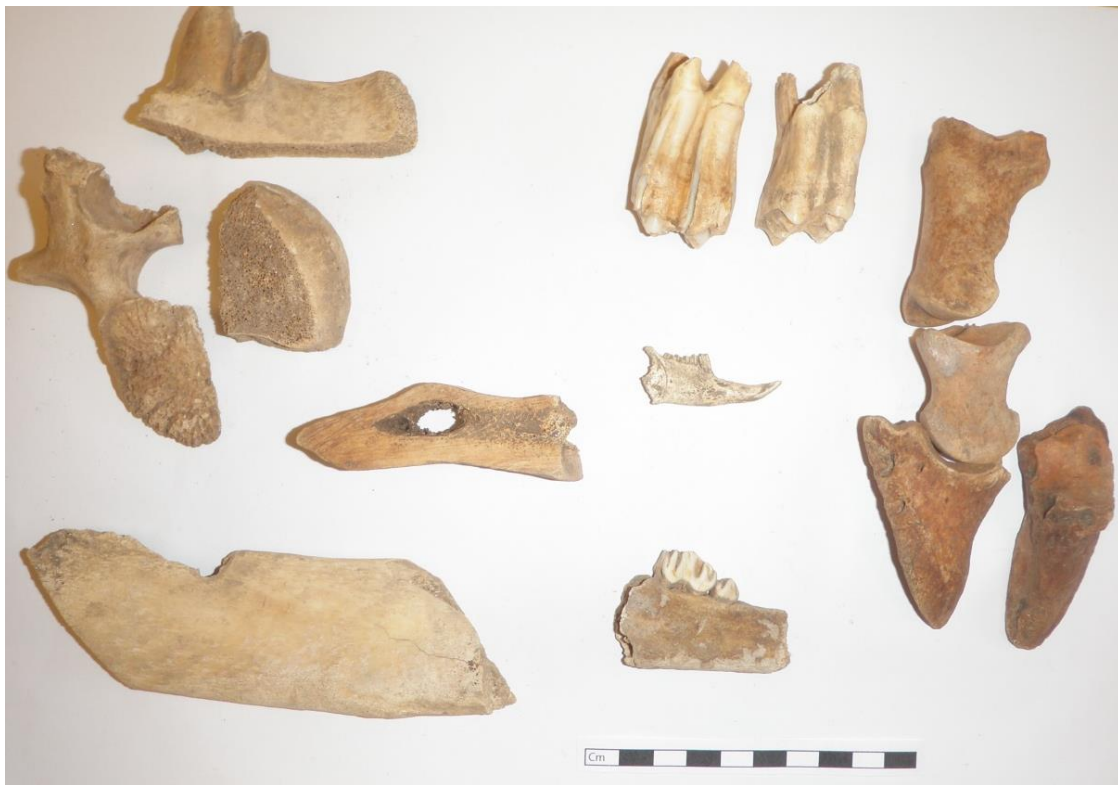
Fig 54 Domestic animals – a meaty menu. Clockwise from top left: miscellaneous butchered cattle bone (G), well 87 (92); two loose cattle teeth (E); articulated pigs trotter (E); part of lower rabbit jaw (E/N); part of lower sheep jaw (E); broad, cut cattle rib bone (F) (38)/(39); sawn/worked cattle shoulder blade (F).

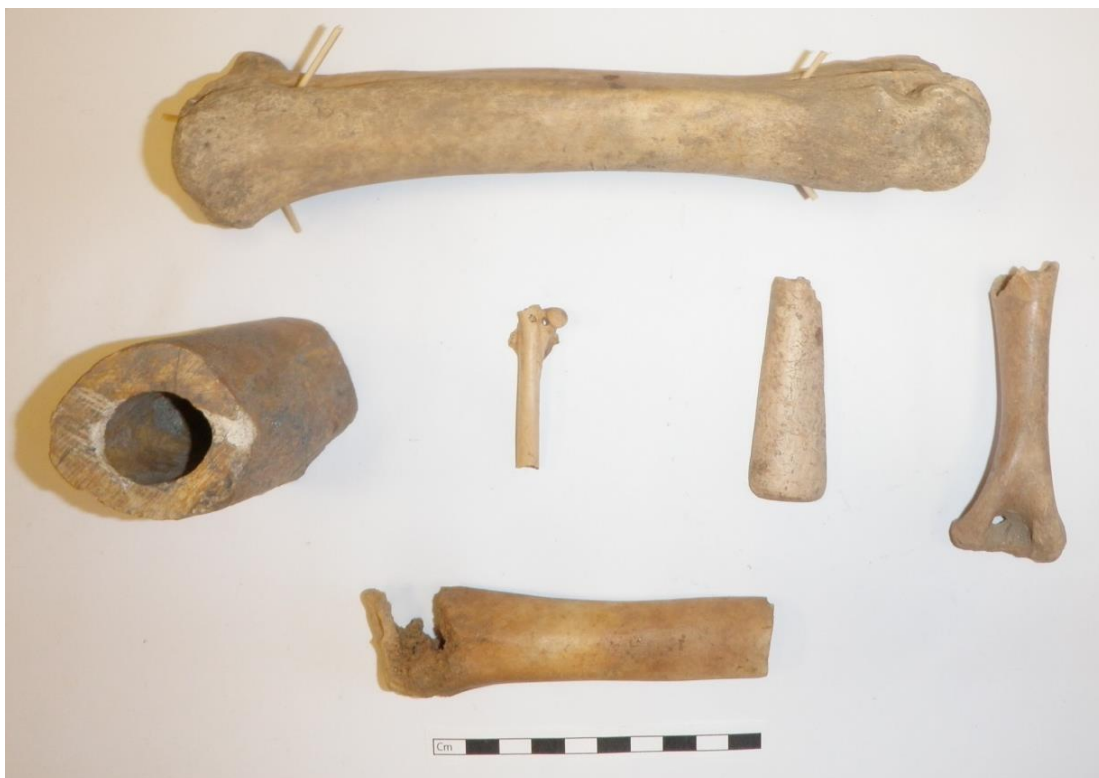
Fig 55 Domestic animal – worked bone implements. From the top down, left to right: cattle long bone with five drilled holes (cocktail sticks denote angle of each) (E), near shell midden (45); sawn cattle long bone (J); broken bird/ chicken? bone with two drilled holes (F) (41); worked bone tool/knife? handle (E); a 'less finished' bone handle?/simple tool with drill-hole (F) (48); bone handle with break where drilled.

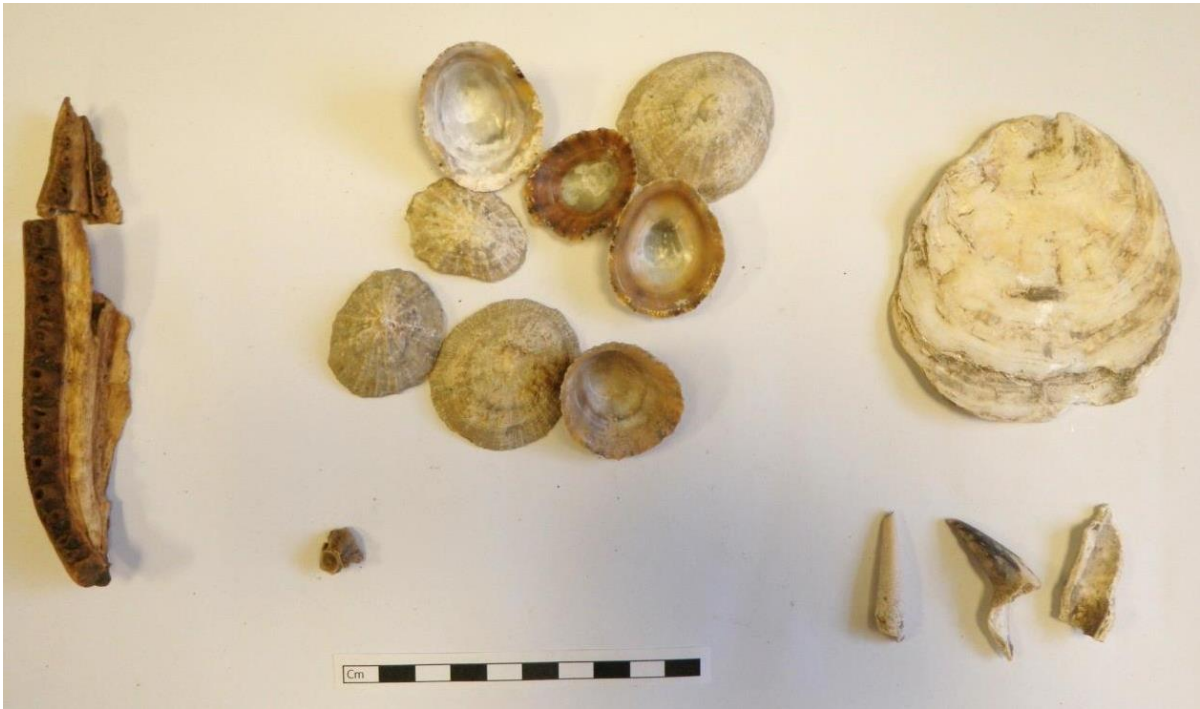
Fig 56 Maritime resources – a seafood menu. Clockwise from top left: one side of large eel lower jaw bone (F); hand full of limpet shells from (F) midden (45); oyster shell (F) (48); miscellaneous crab claws (F/S); a single miscellaneous fish vertebrae (E).

Coastal resources (see Fig 56) – the coastal location of the site allowed for maritime resources to be used on a regular basis. A range of shells including winkles, limpets and oysters, plus less commonly crab claws, fish vertebrae and a surprisingly large eel's lower jaw bone were collected during the works. The majority would originally have been deposited as kitchen midden waste. In addition, some small notably concentrated pockets of crushed shells associated with small-scale lime production for use in white washing walls, or possibly sterilizing of pilchard processing surfaces? were identified. Seals and gulls may well have been included within the list of maritime resources (although none have been identified). The collection of seaweed for improving or fertilising cultivated soils was identified – see trenches I/1 and I/2. Sea weed (along with samphire, etc.) could also have provided an easy to obtain and reliable food source.

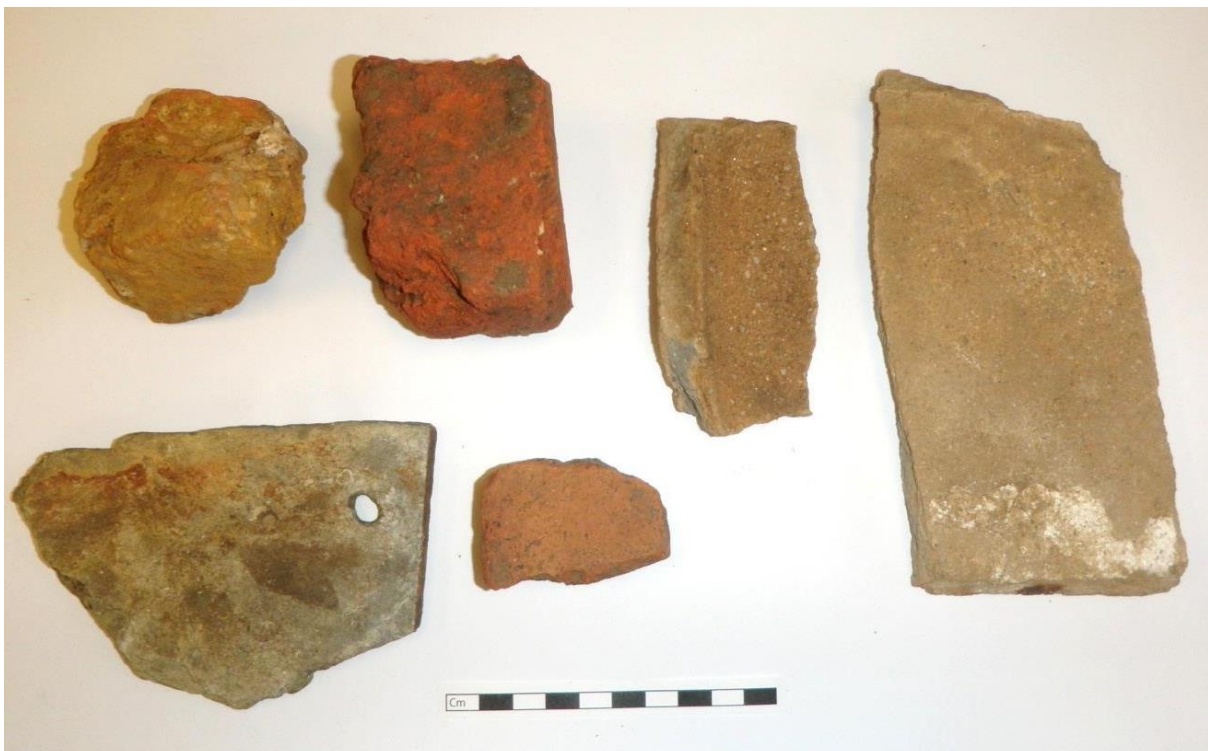
Fig 57 Selected building materials. Clockwise from top left: severely weathered, probable locally handmade orange brick (E/N) near wall 18; part of small handmade red brick (E); two different Cornish fabric C17th-C18th ridge tile parts (I) (137)/(142); small, undated red floor tile fragment (F/S); part of a roofing slate with nail hole.
