St Martins Church, Liskeard, Cornwall, Archaeological Watching Brief

Report No: 2018R021

St Martins Church, Liskeard, Cornwall

Archaeological Watching Brief

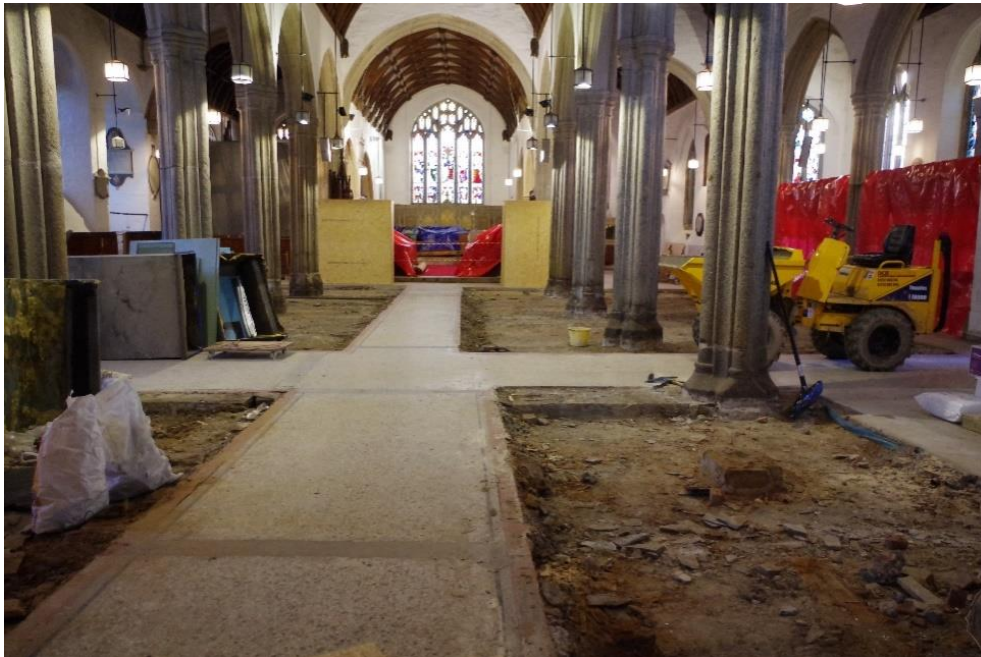
Figure 2 below shows a wider shot of the church floor to be removed with the terrazzo visible as a system of walk ways left after the wooden pews were removed and Figure 3 is a plan which shows the extent of the terrazzo.

Figure 2: General overview of the floor to be removed, looking east down the centre of the Nave.

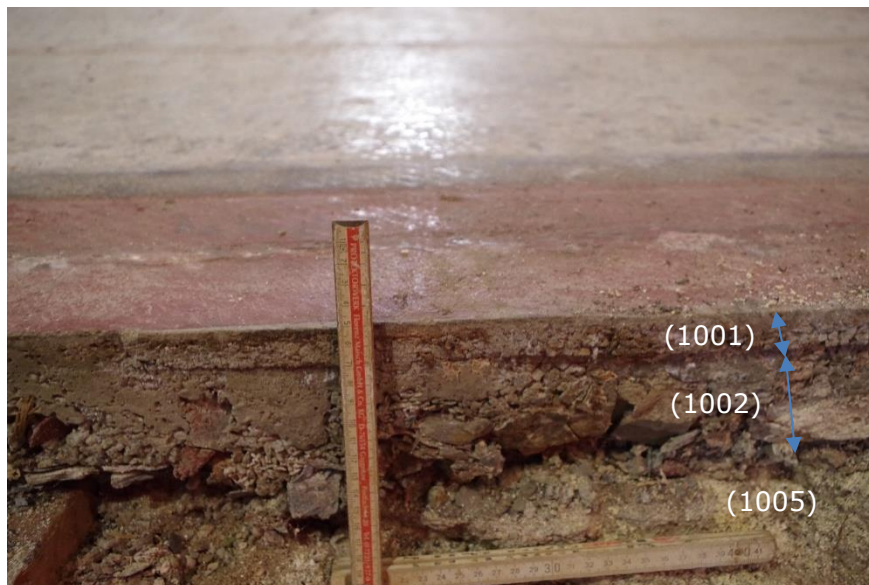
Figure 4 below shows a cross section of the terrazzo (1001), 0.03m thick, a coloured (red, black and white) concrete and marble chip polished surface and its underlying grey concrete and fine gravel bedding layer of approximately 0.09, thick (1002).

Figure 4: Terrazzo floor profile.

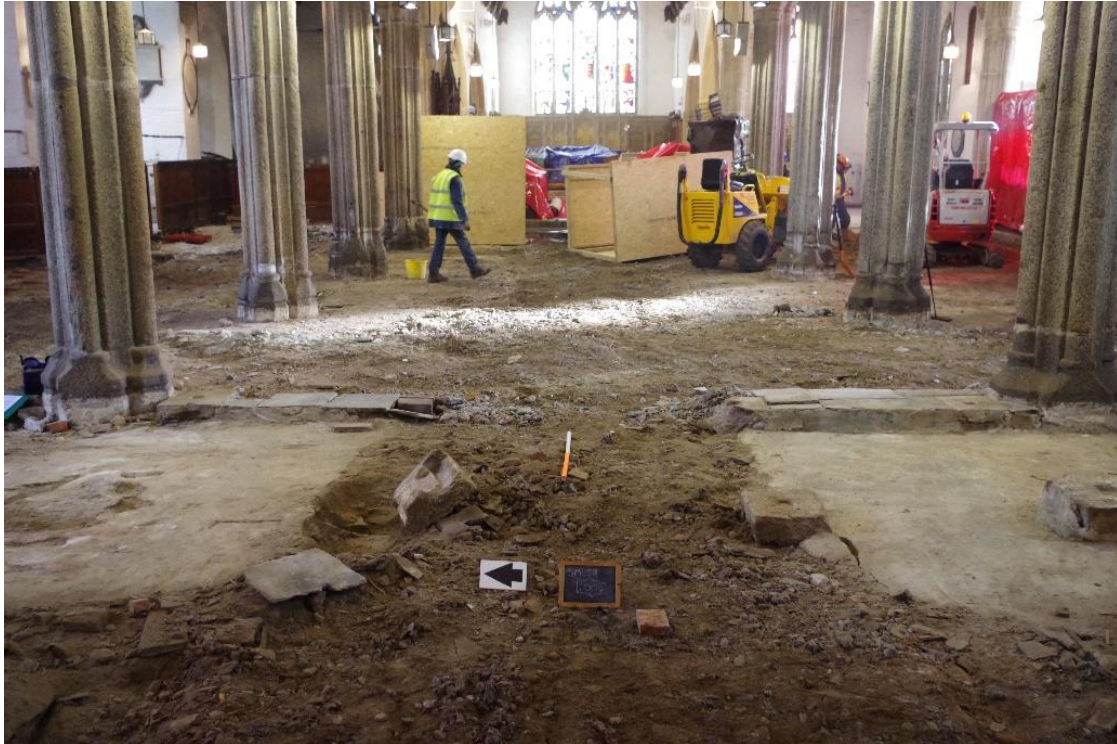
Figure 6 (below) shows a general shot of the nave looking east with the top of soil layer (1003) exposed and the lime screed (1005) in the foreground around feature [1004].

Figure 6: Soil layer (1003) looking east towards the chancel. Feature [1004] in the foreground.

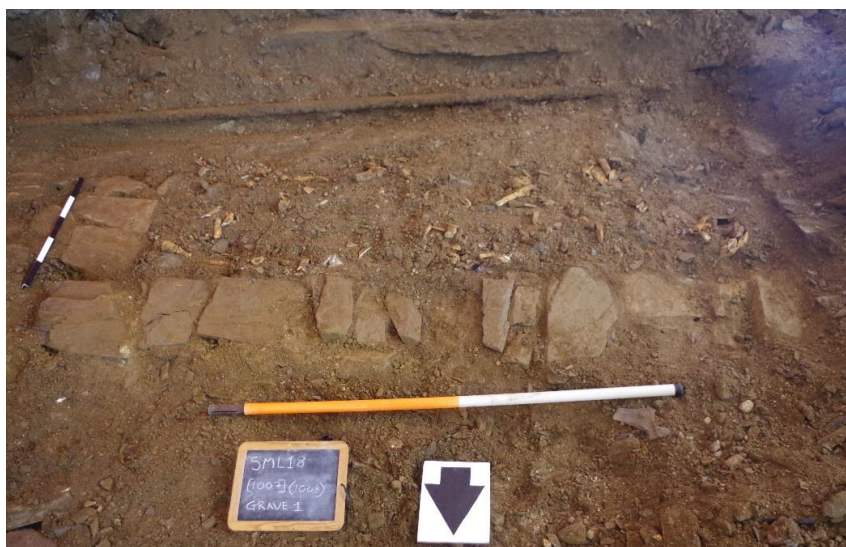
Grave 1 [1107]/(1008) was located in the south aisle just inside and to the east of the south door. This grave cut can be clearly seen and has a surrounding edge of a single layer of flat irregular shaped slates pressed into the earth round the cut. The *in situ* bones of two individuals were seen in this grave (Fig 8). A small bone toggle was found on the surface of this grave, which is likely to be a cloth fastening of some sort.

Figure 8: Grave 1 looking south.

The stones along the south side of the grave cut had been removed previously, most likely to accommodate the iron gas pipe running along the southern side of the south aisle (visible in Fig 8). The grave interior, fill (1008), measured 1.83m by 0.7m and was similar in appearance to the surrounding soil layer (1003). The depth is unknown as only the top was exposed and it was not excavated. This grave is clearly intact, having not been disturbed by previous floor works and the bones within appear to be undisturbed. A bone pin was found in the fill. There is no evidence of a coffin or staining from such. It is possible these graves are medieval or late medieval, no other cuts noted have the stone edging. A drawing of the upper grave can be seen in Appendix 3.

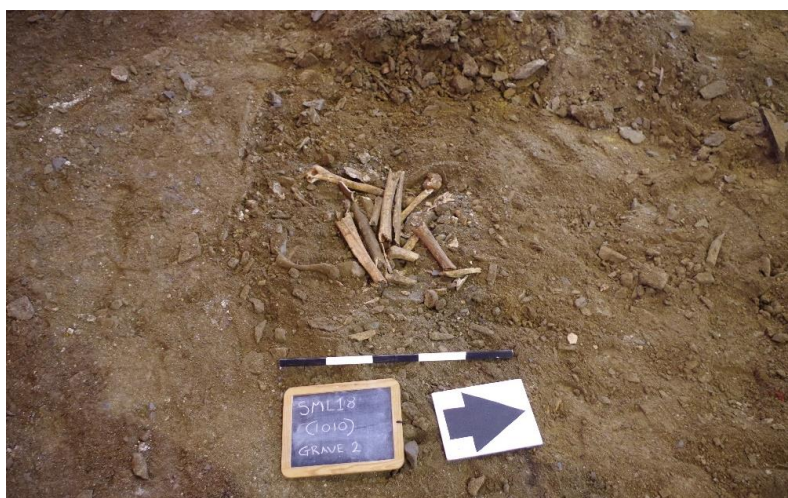
Grave 2 (1010) comprised a jumbled and dense deposit of bones approximately 0.6m in diameter within a poorly defined fill in the south aisle, the top of which is of a level with the base of excavations. Deeper digging was not carried out to define a clear cut as this would have disturbed deliberately deposited remains unnecessarily. The fill was largely bones mixed in with what appeared to be (1003), and sitting within layer (1003), it is possible this hole relates to a deposit of bones reinterred during previous floor works when layer (1003) was created as there are an odd collection of long bones, more than would be found within a single skeleton (Fig 9).

Figure 9: Grave 2 looking west.

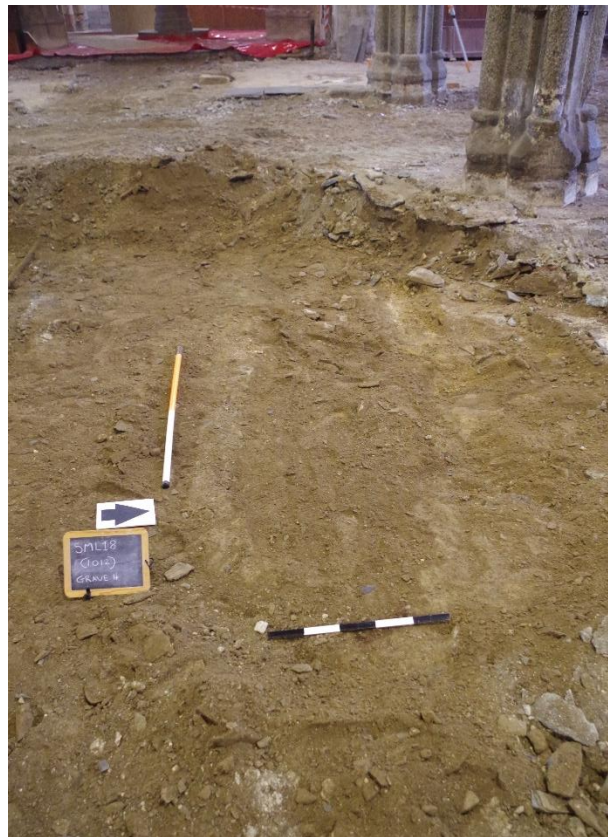
Grave 4 was located in the nave. Its fill (1012) was exposed at base of excavations so it was not excavated to define a clear cut. The fill does, however, appear to be a sub-rectangular coffin shape (Fig 10), of similar but slightly darker hue to the wider floor surface (1003), a mid greyish brown gritty silt with small fragments of slate. This grave appears to be undisturbed and is 2.5m long by 0.85m wide at the 'shoulder'. It looks to be cut into natural (1009). No bones were visible within the upper surface of the fill. It is likely this is a post-medieval coffin burial with the head end pointing east.

Figure 10: Grave 4, looking west.

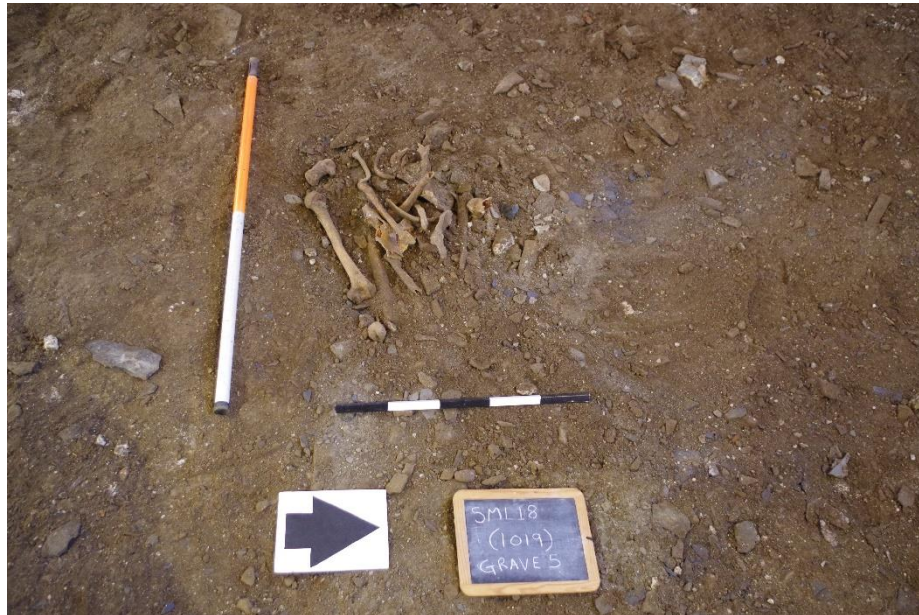
Grave 5, comprised layer (1019) a small collection of bones in the northern aisle exposed at base of excavations (Fig 11). No clear cut was evident and (1019) is very close in appearance to the surrounding layer (1003) within which it resides. No clear cut can be identified at this depth but the area of bone and looser soil is roughly 0.6m wide by 0.8m long, and aligned east-west. Bones could be seen within this fill and are likely *in situ* although a little jumbled. It is likely that this is a post-medieval grave.

Figure 11: Grave 5 looking west.

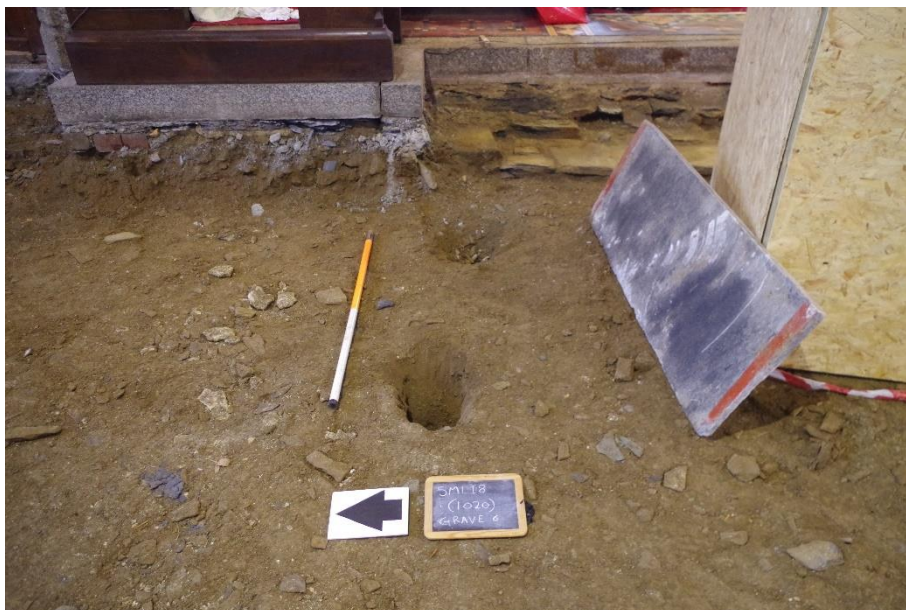
Grave 6 is located within the main aisle of the nave, where it abutted the northern side of the step to the chancel (Fig 12). Layer (1020) which was in the top of this feature was exposed at full depth of excavations for the new floor but voids were present. In order to ensure structural stability for the new floor, these had to be excavated and filled. A small number of post-medieval finds were recovered from layer (1020).

Figure 12: Grave 6 voids looking east towards chancel, pre excavation.

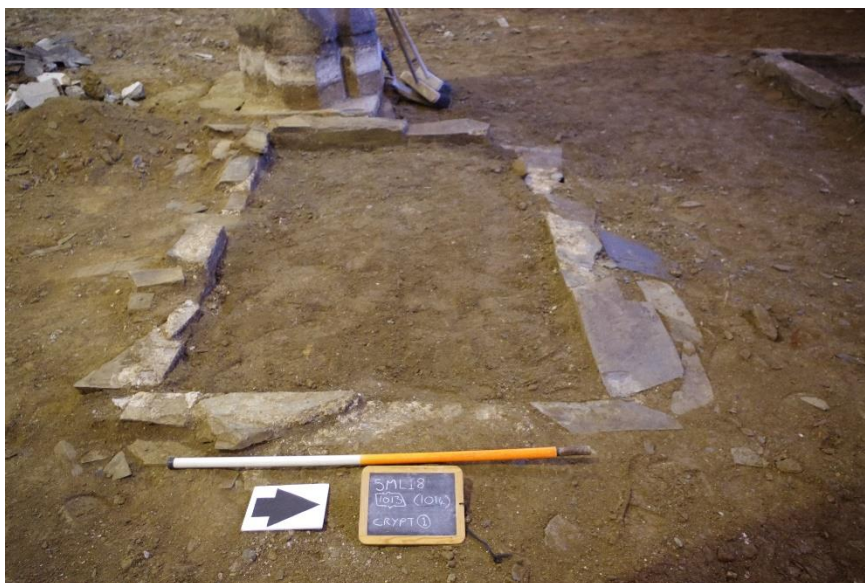
Crypt 1 [1013] / (1014) is located on the nave side of the north aisle and is a rectangular feature, aligned east-west (Fig 14). It is defined by a narrow wall of irregularly sized roughly rectangular pieces of mid blueish yellow slate joined with coarse granite sand lime mortar. The walling is a single thickness of stones, approximately 0.12m-0.2m wide, depth unknown but presumably the full depth of the cut for the crypt. The crypt is 1.85m wide by 2.45m long. The fill (1014) is a mid brown loose sandy silt, no bones are visible, quite similar to layer (1003) but less stone and fine rubble. This whole feature was overlain by lime screed layer (1005) which had sunk down over the feature. The upper layer of stones had to be removed down to 0.5m for engineering purposes, some 0.15m below the general depth of excavations. The upper course was recorded in plan (Appendix 3).

Figure 14: Crypt 1 looking west.

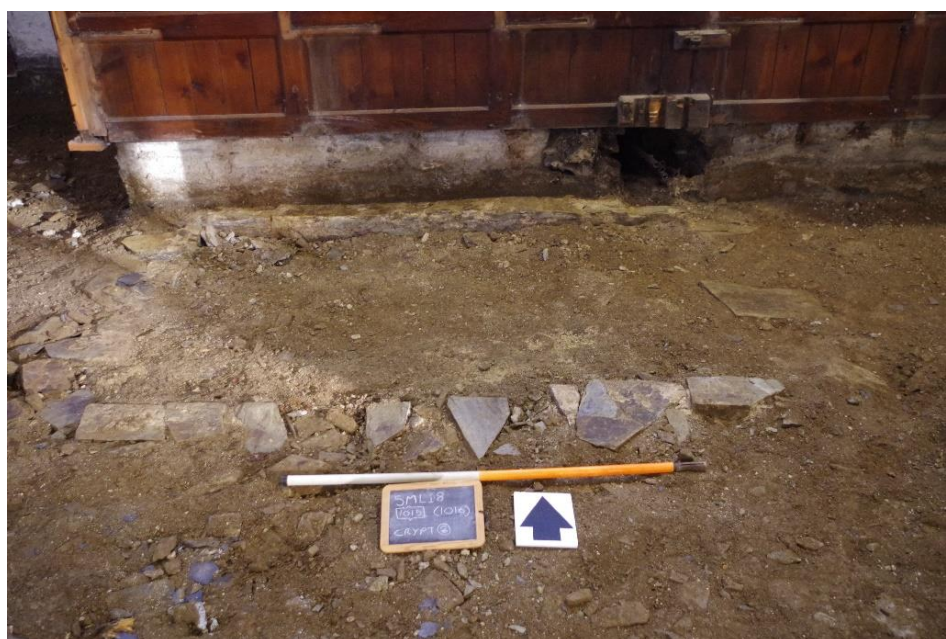
Crypt 2 [1015] / (1016) was very similar in appearance to crypt 1 and 3. It abuts the north wall of the north aisle and lies between two chantry chapels within this wall (Fig 15). Measuring 2.7m long by 1.83m wide this feature comprises a slate wall 0.15m–0.2m wide, a single course wide, and is likely to be the full depth of the crypt cut. The slate is blueish yellow and roughly cut into rectangular pieces of varying depths between 0.03m and 0.1m thick. Coarse lime mortar bonds the pieces of slate together.

The fill (1016) is similar to that in crypts 1 and 3; a finer version of floor layer (1003), a mid brown loose dry sandy silt with less slate and rubble and more lime mortar crumbs. No bones were noted and the top of the fill is of a level with the full depth of excavations (0.35m). This whole feature was overlain by lime screed layer (1005) which had sunk down over the feature.

The upper layer of stones had to be removed down to 0.5m for engineering purposes, approximately 0.15m below the general depth of excavations. The upper course was recorded in plan (see Appendix 3).

Figure 15: Crypt 2, looking north.

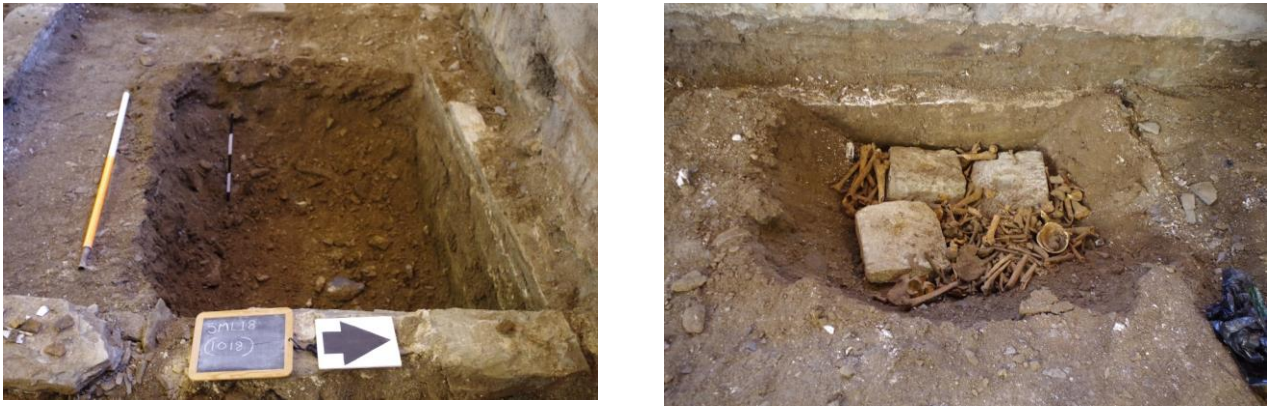
Crypt 3 [1017] / (1018) was a rectangular, east-west aligned crypt with a narrow yellow slate wall with coarse lime mortar lining it. As with crypt 2, it was located against the north wall of the northern aisle, just inside and to the east of the north door. The cut measured 2.7m long by 2.1m wide, making it the largest crypt. The depth is unknown but presumably it reached the bottom of the cut. The top of the fill, (1018), is similar to those found in crypts 1 and 2; a mid brown dry, loose sandy silt with few inclusions. This fill had a void in it which had to be excavated to depth for structural engineering reasons, this reached 0.64m below the general depth of excavations for the church floor works. No soil change or bones were noted. This void was used to reinter some of the bones found throughout layer (1003) during excavation works and three of the stones from feature [1004], stones 2, 4 and 6. Post-medieval pottery and shards of medieval/post-medieval glass were recovered (Appendix 2).

The excavated void and reinterred remains can be seen in Figure 16, a drawing of the upper course of stones was also made (Appendix 3).

Figure 16: Excavated void in crypt 3 (left) and reinterred stones [1004/2/4/6] and bones before reburial (right).

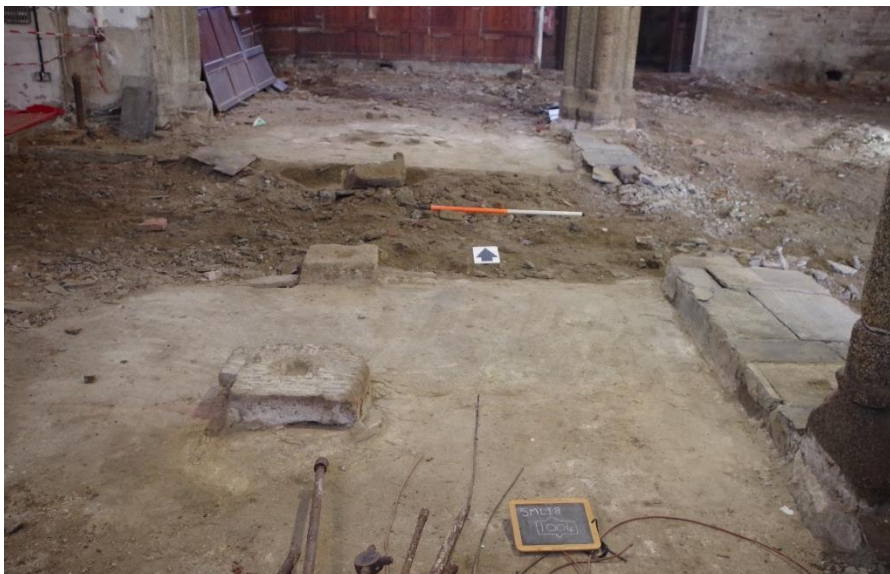
The granite blocks also seem to have been reused, having in all likelihood served another function and then been reworked to a small degree to serve this secondary purpose. The granite type and workmanship is very dissimilar from the smooth pale ashlar granite of the current medieval church, being a darker, and is more yellowish brown and rougher surface finished material. The blocks are possibly associated with an earlier phase of church building or maybe the local castle (Tony Piper, pers comm.). All the blocks are roughly square in plan and have a square or circular depression carved into the centre of the upper face (Table 1). Some of these depressions have iron staining in the base. The stone blocks were laid out in a double row of eight, although two were missing, the settings for the two absent stones could still be seen. The stones were parallel to each other within the double row configuration. A plan showing the layout of these stones and the feature can be seen in Appendix 3. The stones within this feature sit within the lime screed layer (1005) which seems to have been applied around it, the feature itself having been left in place during previous floor works.

Figure 17: Feature [1004] overview looking north.

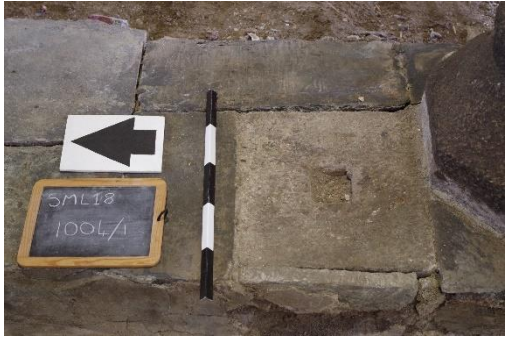
Stone number	Description	Image
[1004/1]	<p>0.37m by 0.34m and 0.2m deep, faced granite with a rough surface and a square hole on the uppermost surface in the centre 9cm by 8cm and 3cm deep. Abuts stone pillar and sits within the slate surface. This stone is about 1.6m north of stone 3 and east of stone 2. Buried in grave 6.</p>

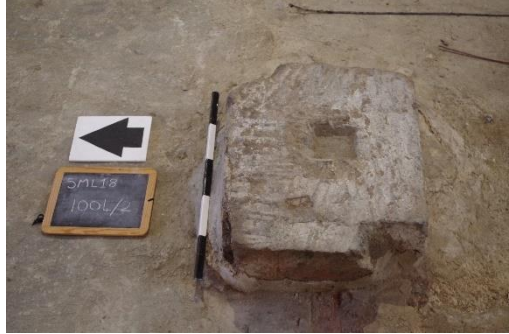
[1004/2]	<p>0.43m by 0.42m and 0.12m deep, this stone sits within the floor screed layer (1005). A square hole is in the centre of the upper surface and is 9cm by 10cm and 3cm deep. This stone sits 1.6m west of stone 1 and south of stone 4.</p> <p>The shape of this stone suggests a previous use in a doorway. It is the only stone to have a surface dressed to take mortar. Buried in crypt 3.</p>

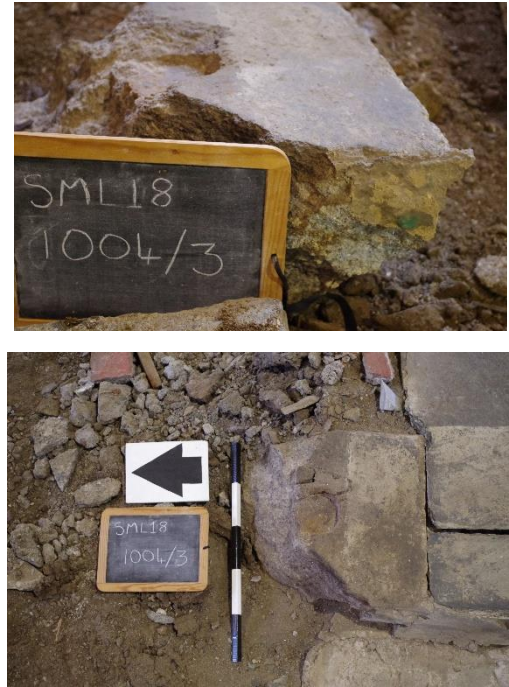
[1004/3]	<p>This stone is broken along the line of the terrazzo, probably to accommodate this floor surface when it was installed. 0.37m by 0.41m and 0.22m deep, a granite stone cut into a square shape with a circular hole in the centre of the upper face, 9cm in diameter and 2cm deep. This stone is about 1.6m north of stone 1 and east of stone 4.</p> <p>Once lifted, a trace of lime plaster was noted on the underside and some green pigment. Buried in grave 6.</p>

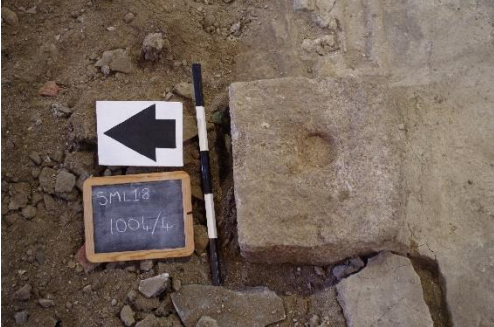
<p>[1004/4]</p>	<p>0.36m by 0.38m and 0.12m deep, faced granite square with a round hole in the centre of the upper surface 8cm in diameter and 2cm deep. This stone sits on the southern side of the terrazzo central aisle and about 1.6m west of stone 3 and north of stone 2. Buried in crypt 3.</p>

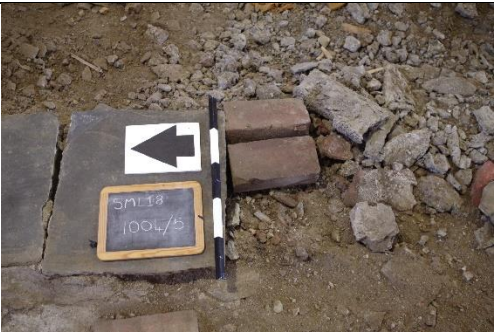
<p>[1004/5]</p>	<p>This stone is missing, probably removed to accommodate the terrazzo floor surface when it was installed as it would have been in the way of this. This stone would have been sitting within the line of slates at the east end of this feature.</p>

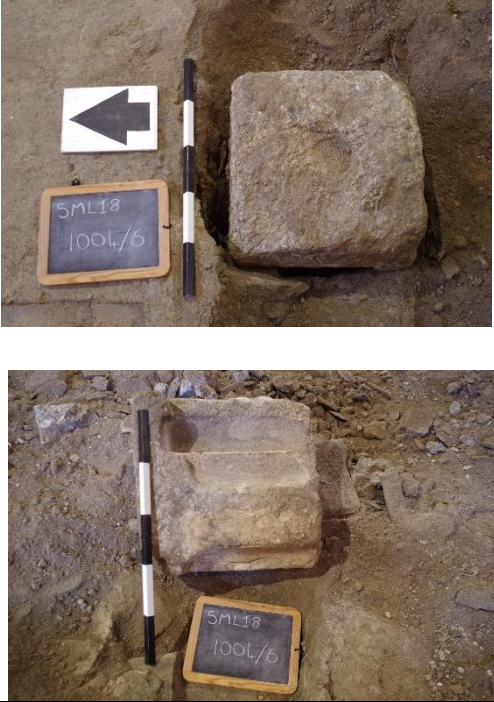
<p>[1004/6]</p>	<p>0.37m by 0.37m by 0.2m deep with a round hole in the centre of the upper surface 8cm in diameter by 2cm deep. This stone is about 1.6m south of stone 8, north of stone 3 and west of stone 5. The underside of this stone is carved as for a window interior or mouldings.</p> <p>This stone was knocked loose during initial excavations. Buried in grave 6.</p>

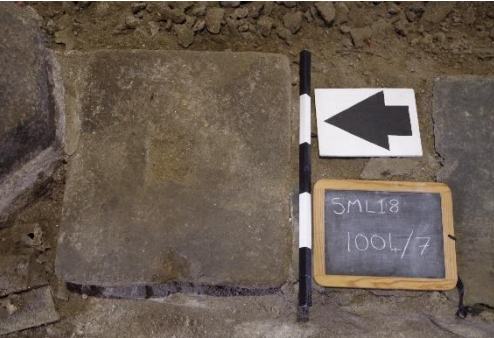
<p>[1004/7]</p>	<p>0.44m by 0.41m and 0.1m deep faced granite stone with a square hole in the centre of the upper surface 8cm by 9cm and 2cm deep.</p> <p>Buried in crypt 3.</p>

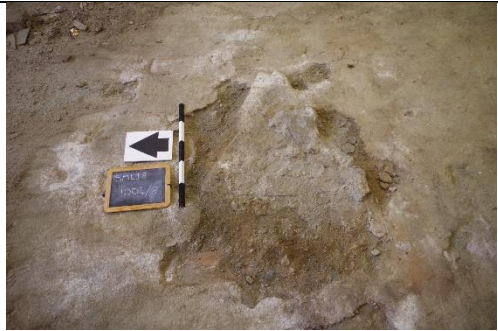
<p>[1004/8]</p>	<p>This stone is missing although the setting within lime screed layer (1005) can be seen and beneath this were stones that it had been mounted on. This location is 1.6m west of stone 7 and the same distance to the north of stone 6.</p>

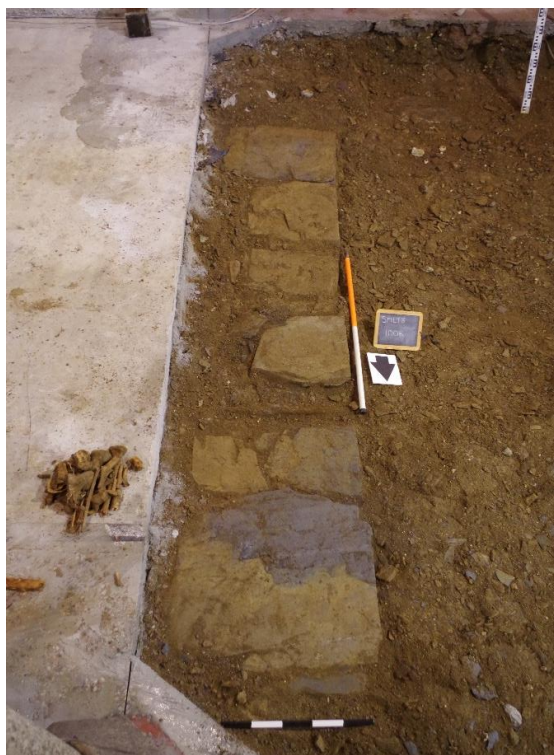
Exposed at a depth of about 0.15m and abutting the step into the war memorial chapel to the south of the chancel was a line of large flat slate paving slabs (Fig 18). The line of stones is 3.35m long by 0.76m wide. It is undated but it is possible that they are part of an earlier medieval church floor. The stones had to be removed in order for the new floor to be laid but were planned first.

Figure 18: Old floor surface [1006]. Looking south, war memorial floor to the east.

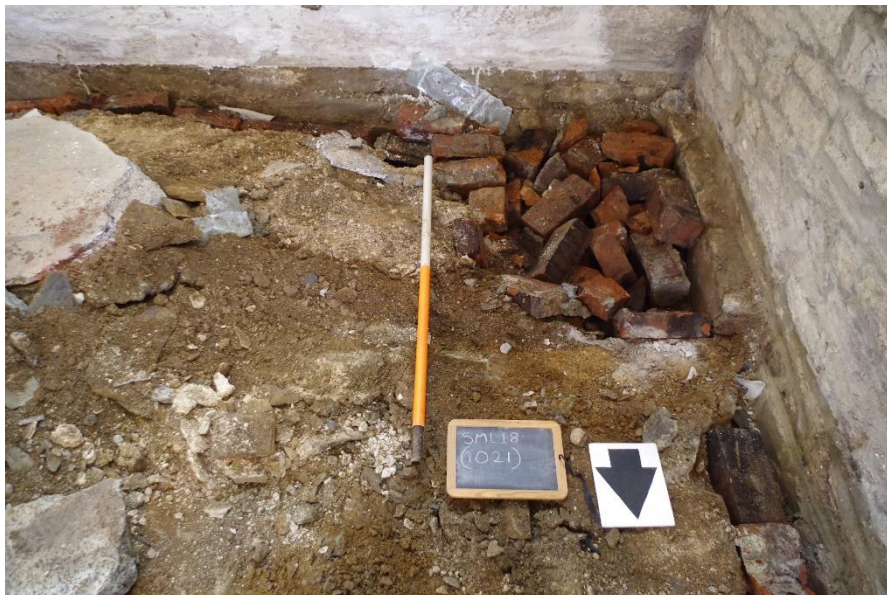
In addition to the features noted above, a lot of rusted iron pipes (which criss-crossed the floor) were identified. These are likely to be the remains of a previous heating system and be old gas pipes. In the far south west corner of the southern aisle under an area of recently poured concrete (apparently by parishioners some ten years previously), same as the floor in the war memorial chapel (Tony Piper, pers comm.), there was a void filled with fairly modern brick. Again, this is likely to relate to a previous heating system and was filled with brick to close the void prior to concrete pouring. This was numbered (1021) but not formally recorded (see Fig, 19 below).

Figure 19: Brick filled void (1021).

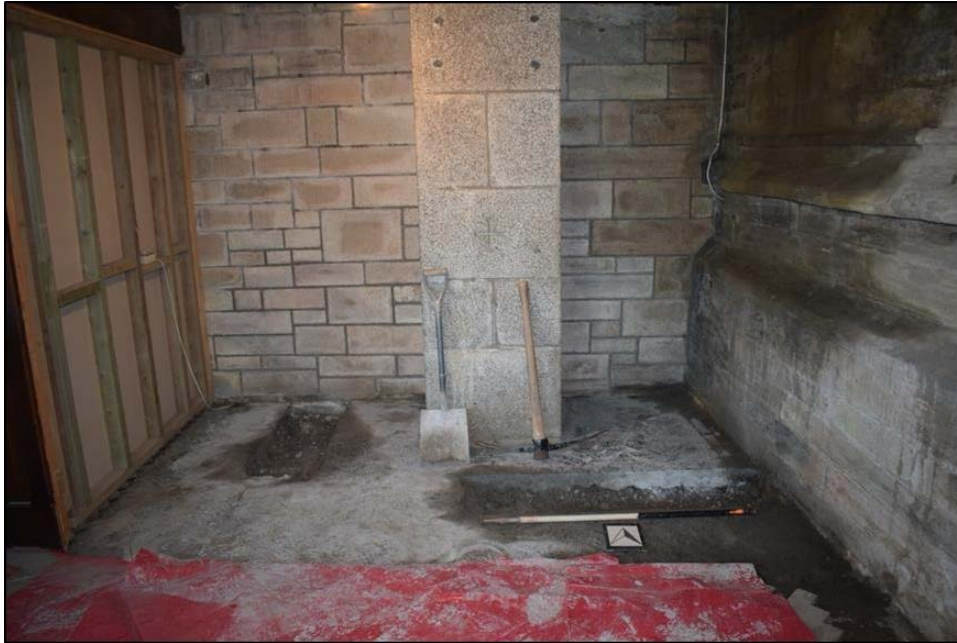
Figure 22: Trenches 2 and 1 prior to excavation. Looking north.

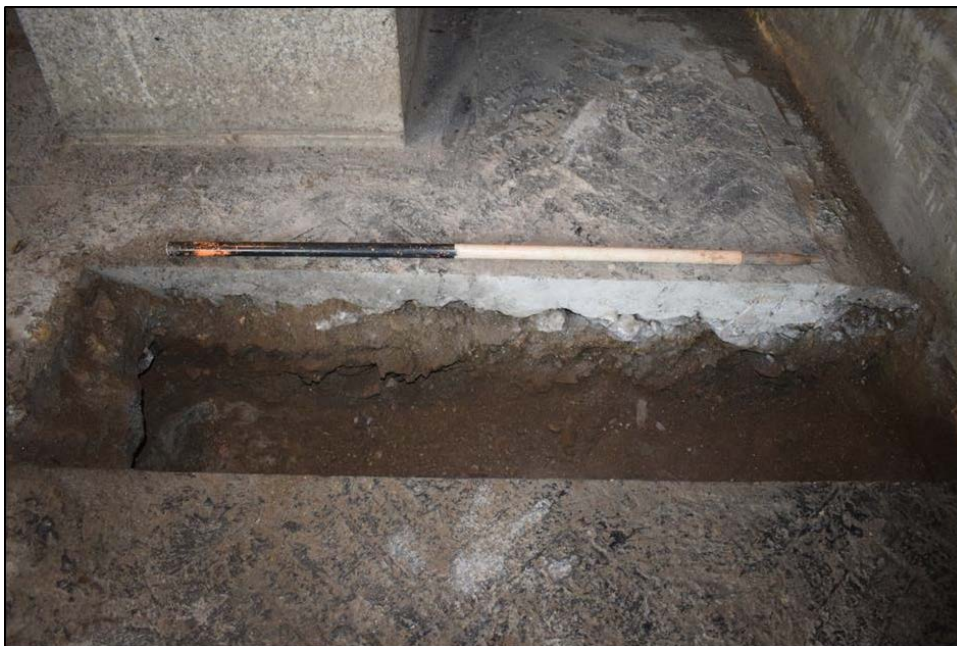
Layer (2002) was 0.11m thick and consisted of a loose dark brownish black loose soil containing building rubble and appeared to be bedding for the cement floor. The demolition rubble comprised fragments of slate and granite intermixed with sedimentary stone.

Layer (2003) consisted of dark reddish brown soil containing large amounts of demolition material, which included pieces of roofing slate, granite and other stone, a clay pipe fragment, and a sherd of modern pottery. At the west end of the trench was a length of rough slate (not floor slates) which may have been part of the foundation course of a nearby wall.

Figure 23: Trench 1, south facing section.

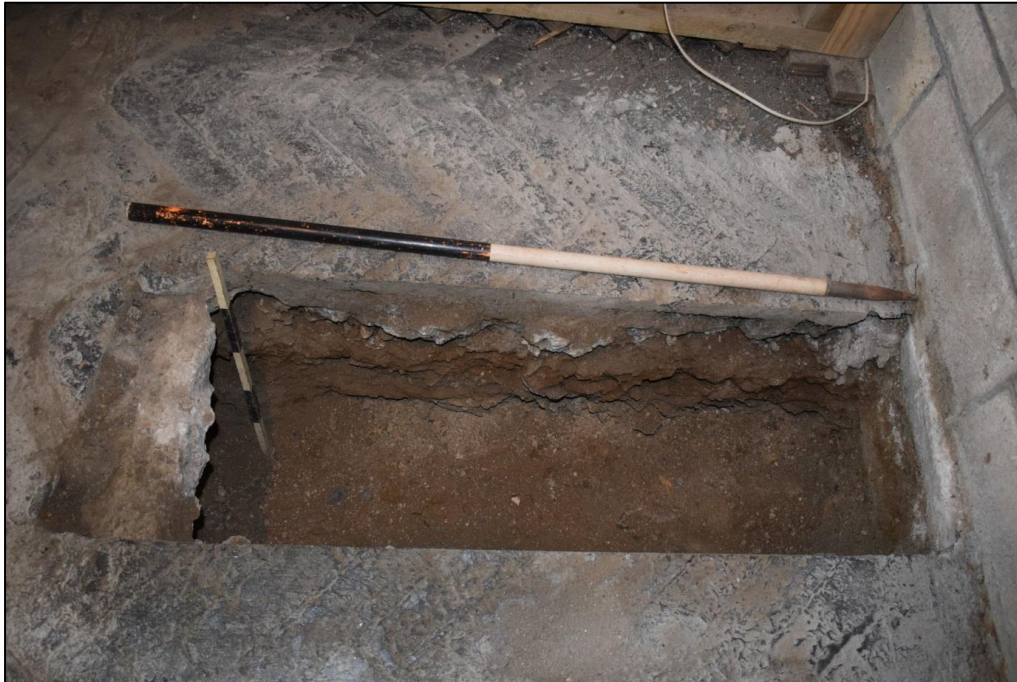
Layer (2004) was 0.1m deep and similar to (2002) in Trench 1. It comprised a mixture of larger stones and fragments of slate and broken granite. The layer was intermixed

A third possible layer (2006) was a mixture of mid greyish soil and grit, again containing some larger pieces of stone and demolition rubble. It may not really be distinct from (2005), and could have resulted from foundation material being dumped into this area of the trench (note the close proximity of the column and new annexe walls).

Figure 24: Trench 2, east facing section.

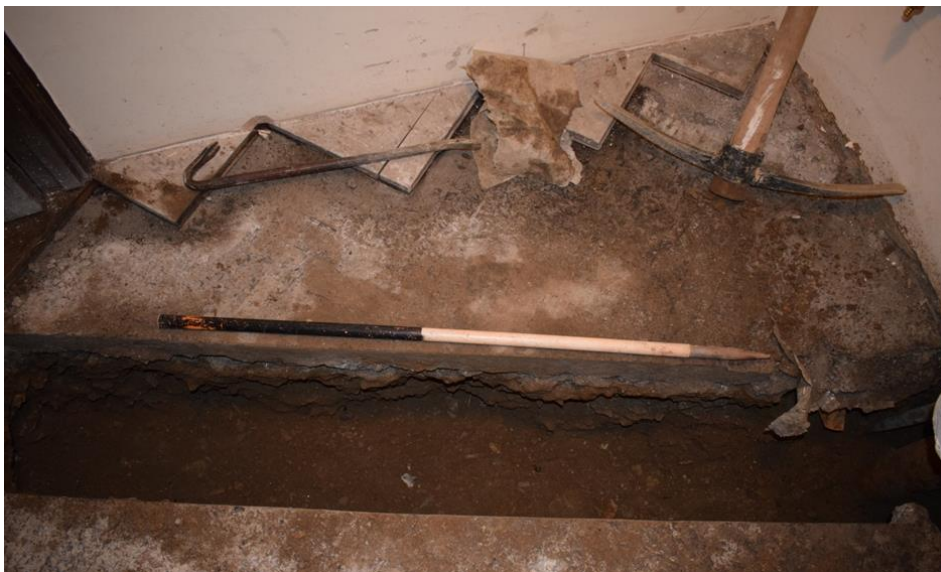
Layer (2007) was a loose dark reddish brown soil and stone mixture with demolition rubble, which was similar to layers (2005) and (2006) in Trench 2. The north west end of the trench produced fragments of bone, again however, these appeared to be scattered and did not form any recognisable pattern.

The pipe at the north west end of the trench was plastic and descended into the ground along with a water pipe, implying this area has already been disturbed at least once in recent history.

Figure 25: Trench 3, northeast facing section.
