Cook's Kitchen, Pool, Redruth, Cornwall: Archaeological Excavation of the Man-Engine House

Report No: 2018R023

Client	Western United Mines
Report Number	2018R23
Date	27 June 2018
Status	Final
Report authors	Ryan Smith and Adam Sharpe
Checked by	Dr Andy Jones
Approved by	Andrew Young

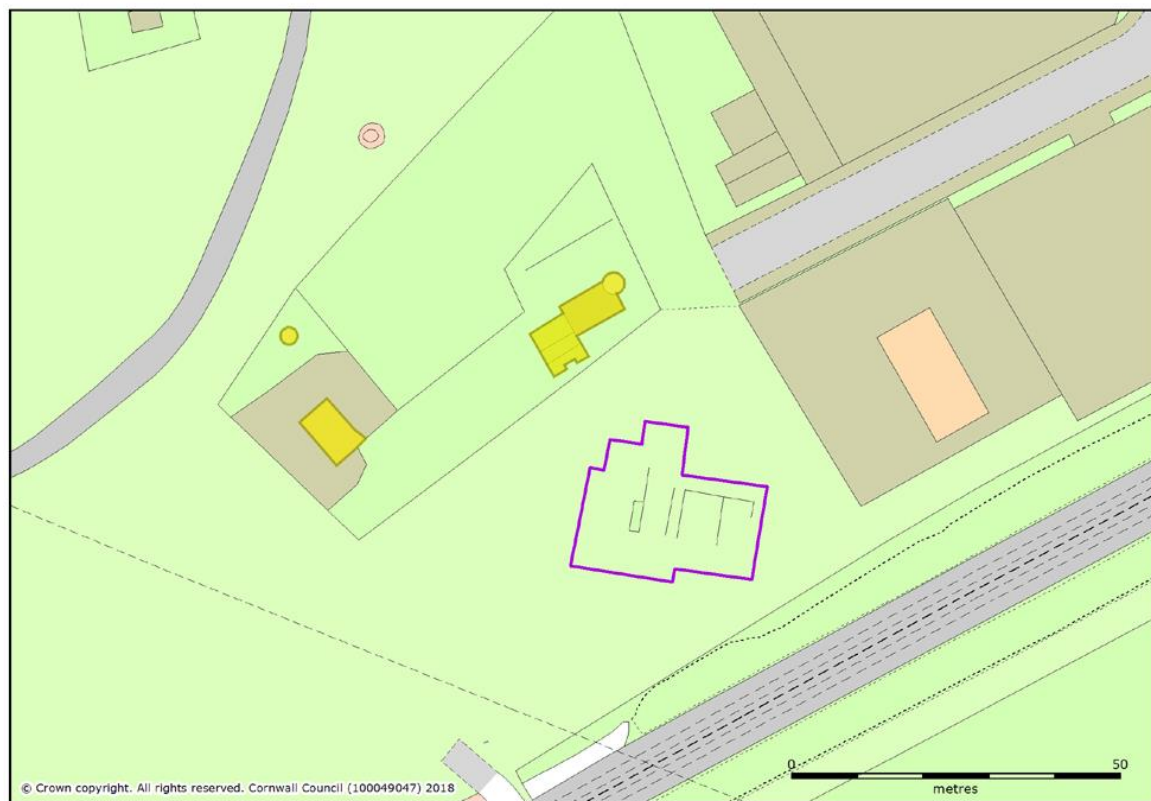
Figure 2: Extent of excavated area (within purple line).

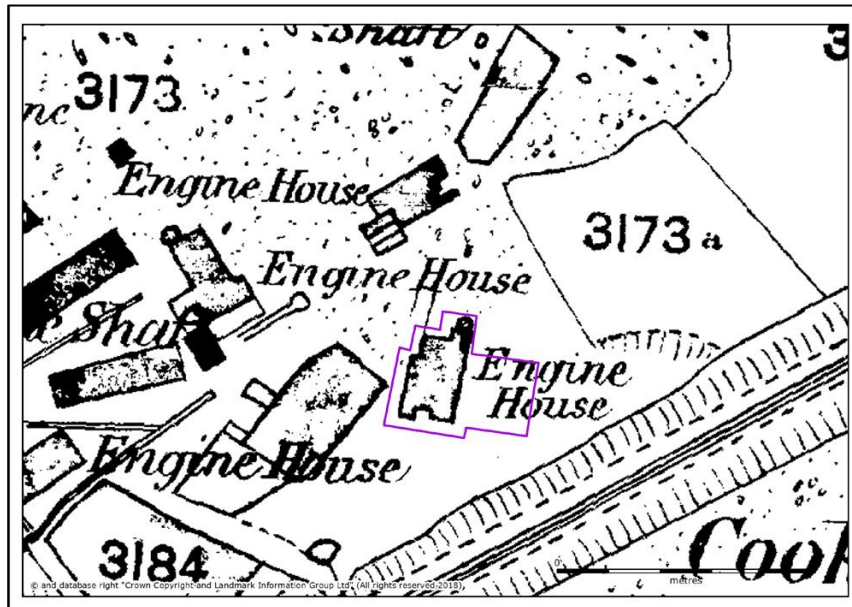
Figure 3: Ordnance Survey 25" mapping c1878 showing the roofed man-engine house and attached boiler house; purple line indicates extent of excavation.

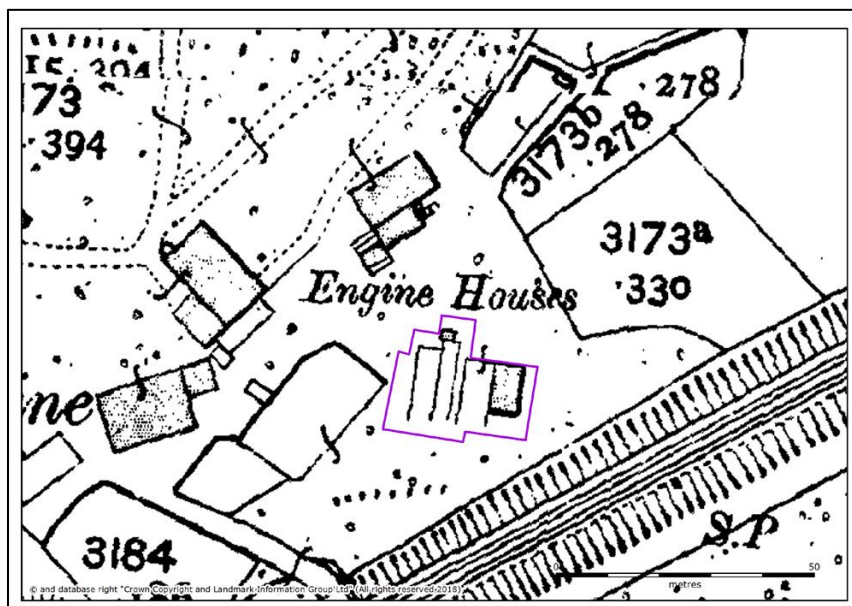
Figure 4: Ordnance Survey c1908 showing the man-engine house and boiler houses disused and un-roofed; the eastern building was still roofed.

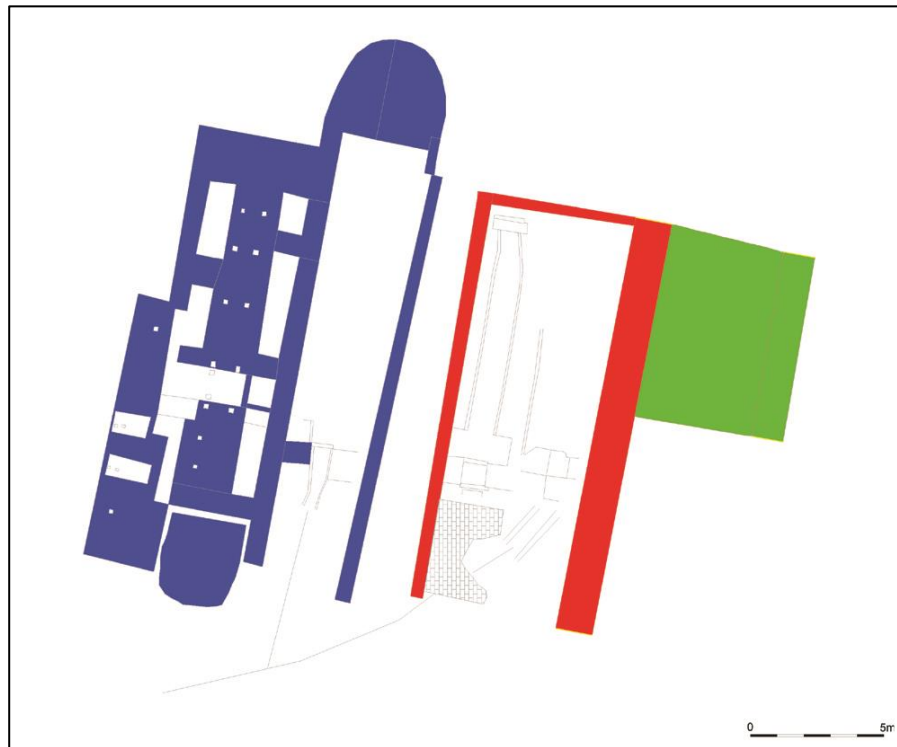
Figure 5: Phases of development derived from map regression. Blue denotes original building from 1871, red – boiler house constructed post 1878, green – possible compressor house surviving until at least 1938.

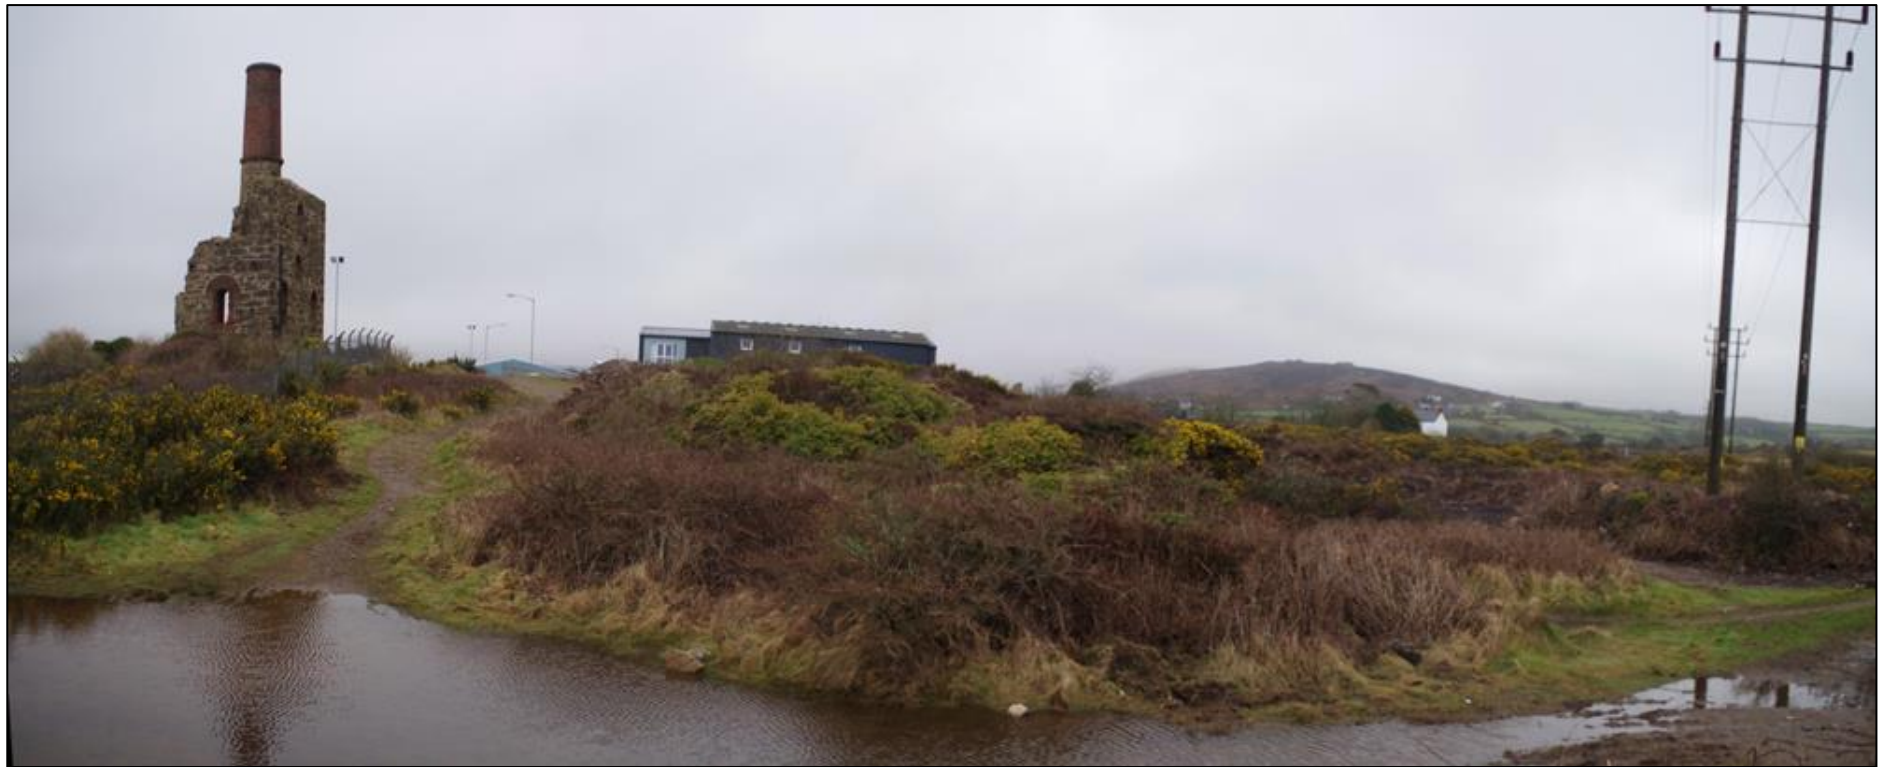
Figure 6: View of site prior to excavation, looking east.

The groundworks commenced with the removal of the overburden believed to cover the engine house remains (Fig 6). The various components of the site are described below. A list of detailed context descriptions can be found in Appendix 1 and finds recovered in Appendix 2 of this report.

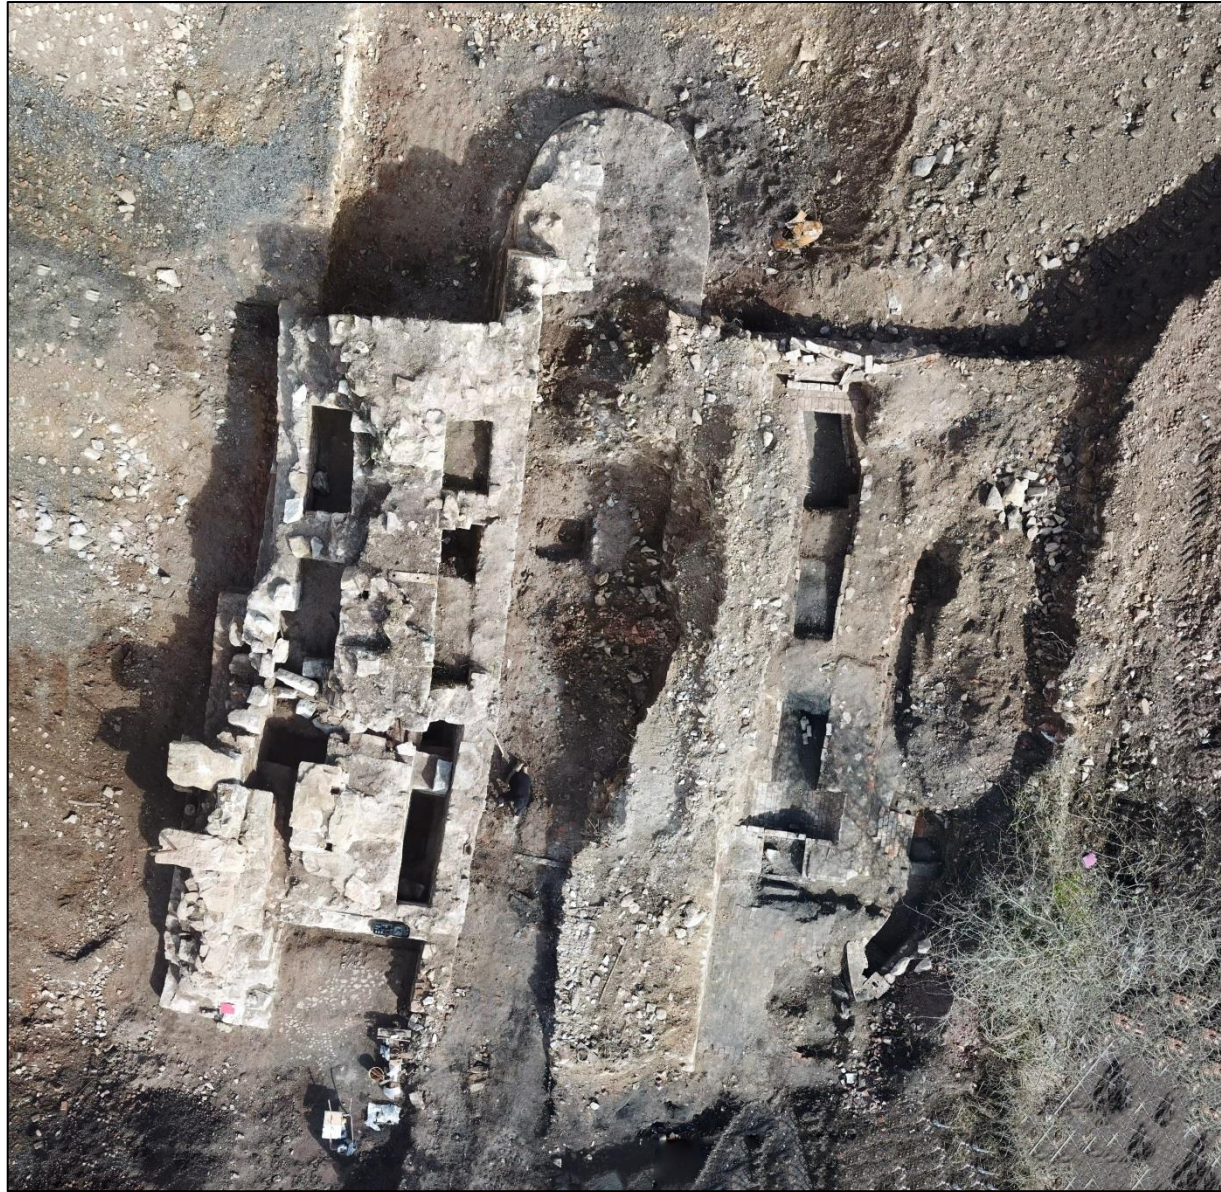
Figure 7: Post-excavation aerial view of site.

On the completion of the bulk excavation about 3.5m depth of overburden had been removed from the immediate environs of the engine house and at least 2m from over the area of the adjacent boiler houses to the east, revealing an engine house 23m long and 6.5m wide; the cleared area of the site measured 25m by 20m in plan (Fig 7).

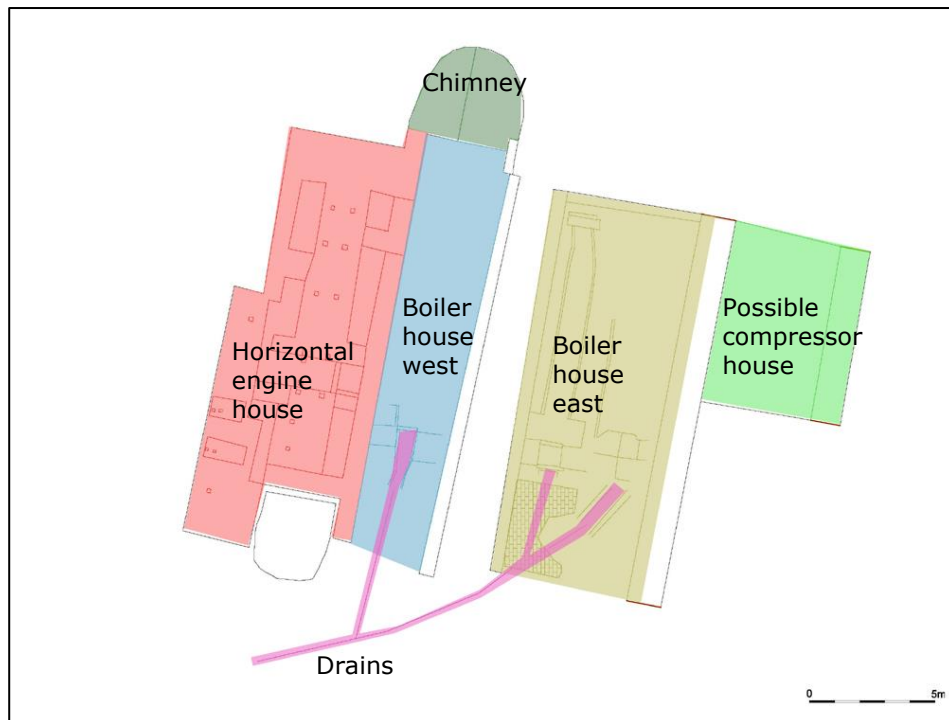
Figure 8: Cook's Kitchen man-engine house and associated buildings. Colours have been used to assist in the delineation of the extents of each structure.

The remains of a boiler house with the low foundations of an attached northern chimney lay immediately to its south-east. Abutting this to the south-east again was the detached house for a further pair of boilers, and to the south-east of this were the truncated remains of a smaller rectangular structure, interpreted as a possible compressor house (see Fig 8).

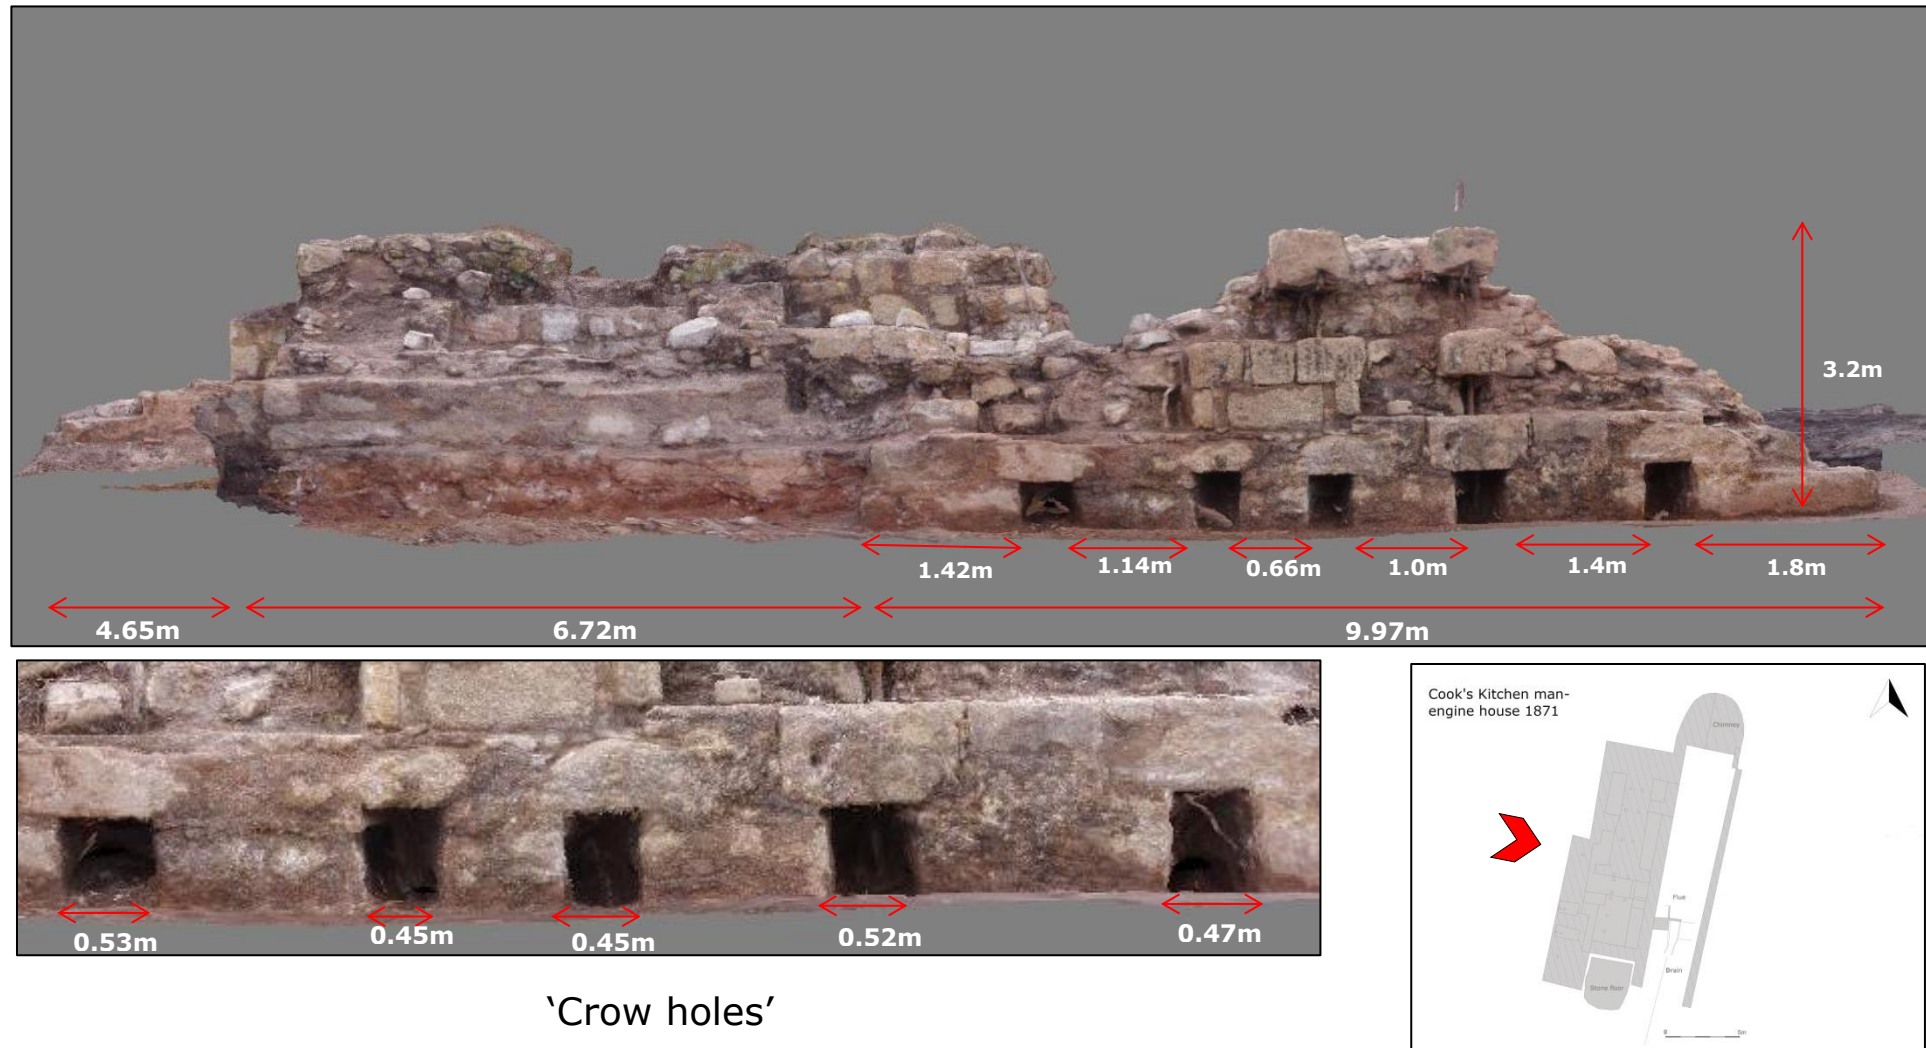
Cook's Kitchen man-engine house - west elevation

The engine house outer wall elevations on all sides [105] (Figs 9–14) were primarily constructed from large granite blocks, many of which appeared to have been dressed (faced up and squared), mixed with smaller pieces of granite, killas and mine waste, all of which had been bonded with lime mortar. The majority of the larger stones had been used as lintels above the crow holes found on the west side of the building and those within the lower parts of the structure within the interiors of Pits 5 and 6. Large pieces of dressed granite had also been used on the upper parts of the loadings which had supported the engine bed and the power train. The stonework at the northern end of the north-west facing wall retained remnants of scribed pointing – thin, regularly arranged horizontal and vertical lines of lime mortar intended to give the impression that the building had been constructed throughout of squared blocks of stonework, rather than largely of randomly-coursed rubble masonry.

Figure 9: West elevation of man-engine building showing measurements.

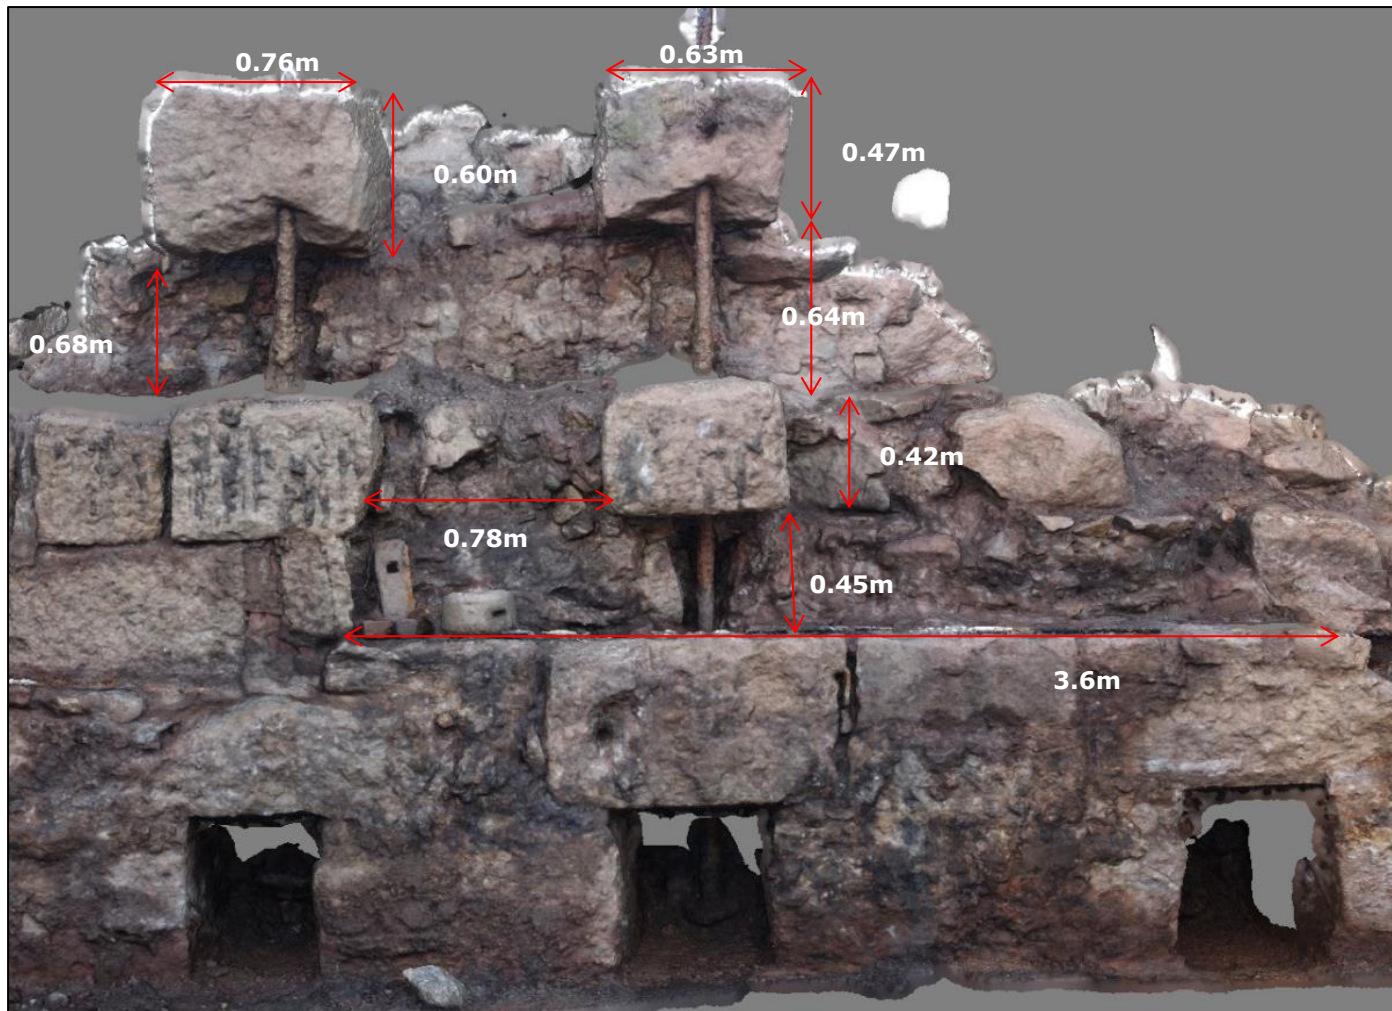
Cook's Kitchen man-engine house - west elevation

Incorporated into the loadings were a series of vertical bolt tunnels, some with surviving hold down bolts, whilst at the base of the western wall were 'crow holes' – horizontal tunnels giving access to the lower ends of the bolts. A series of rectangular pits were set within the structure's upper surface; further crow holes were found in some of these. It was clear that the side walls of the building had formerly been taller – the pits were universally infilled with substantial pieces of granite masonry mixed with smaller stones, decayed lime mortar and pieces of lime-rendered wall plaster. There were also abundant scattle roofing slates in this mix, together with some corroded ferrous artefacts. A similar mix of material covered most of the structure and was found around it, in places to considerable depths.

Figure 10: West elevation of man-engine building: close up of 'crow holes' and power train loadings.

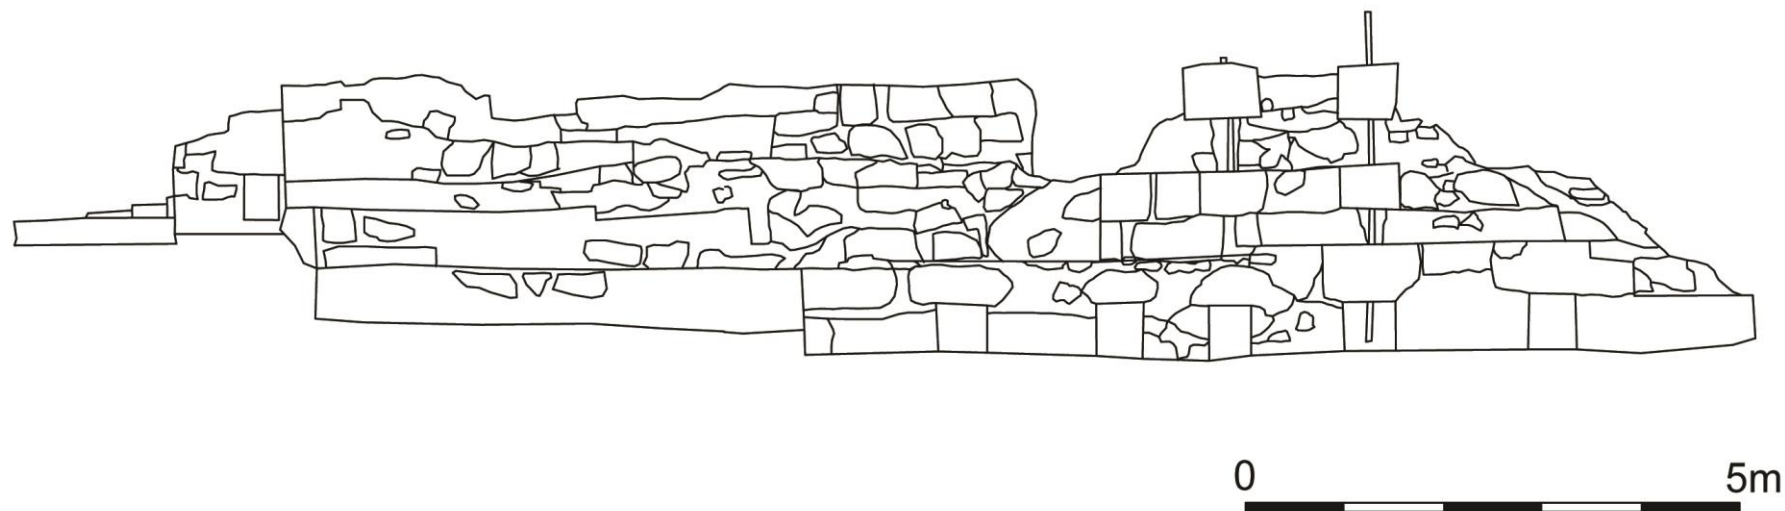
Cook's Kitchen man-engine house
west elevation

Figure 11: Section drawing using photogrammetry of west elevation of man-engine house.

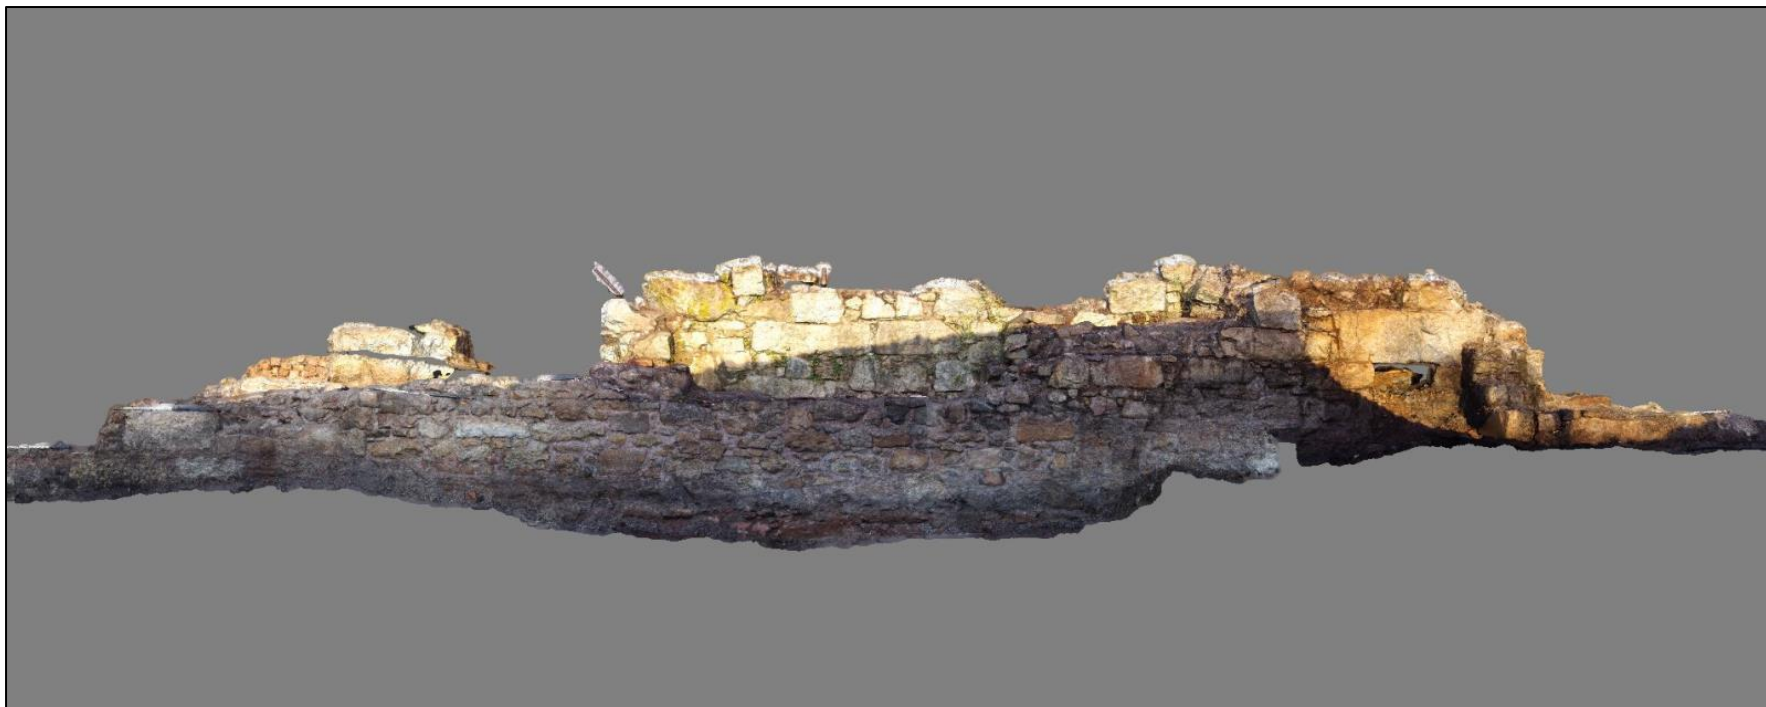
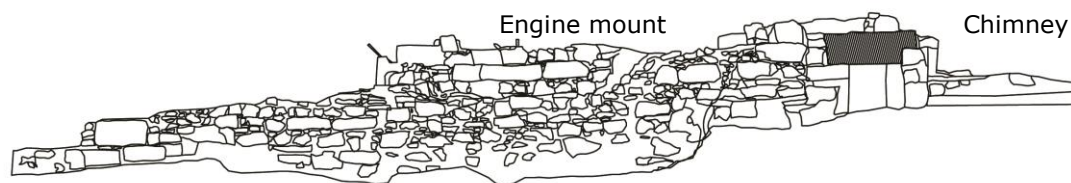
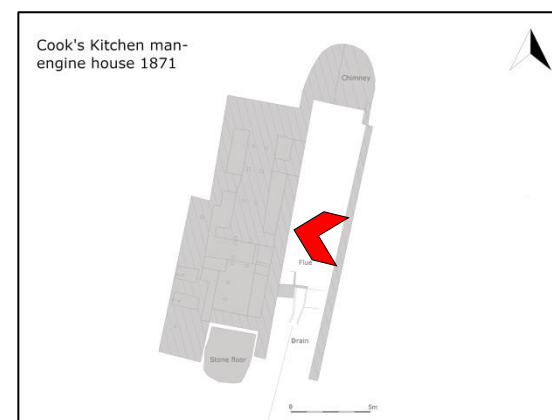
Cook's Kitchen man-engine house east elevation

Figure 12: East elevation of man-engine house, photogrammetric image and section image.

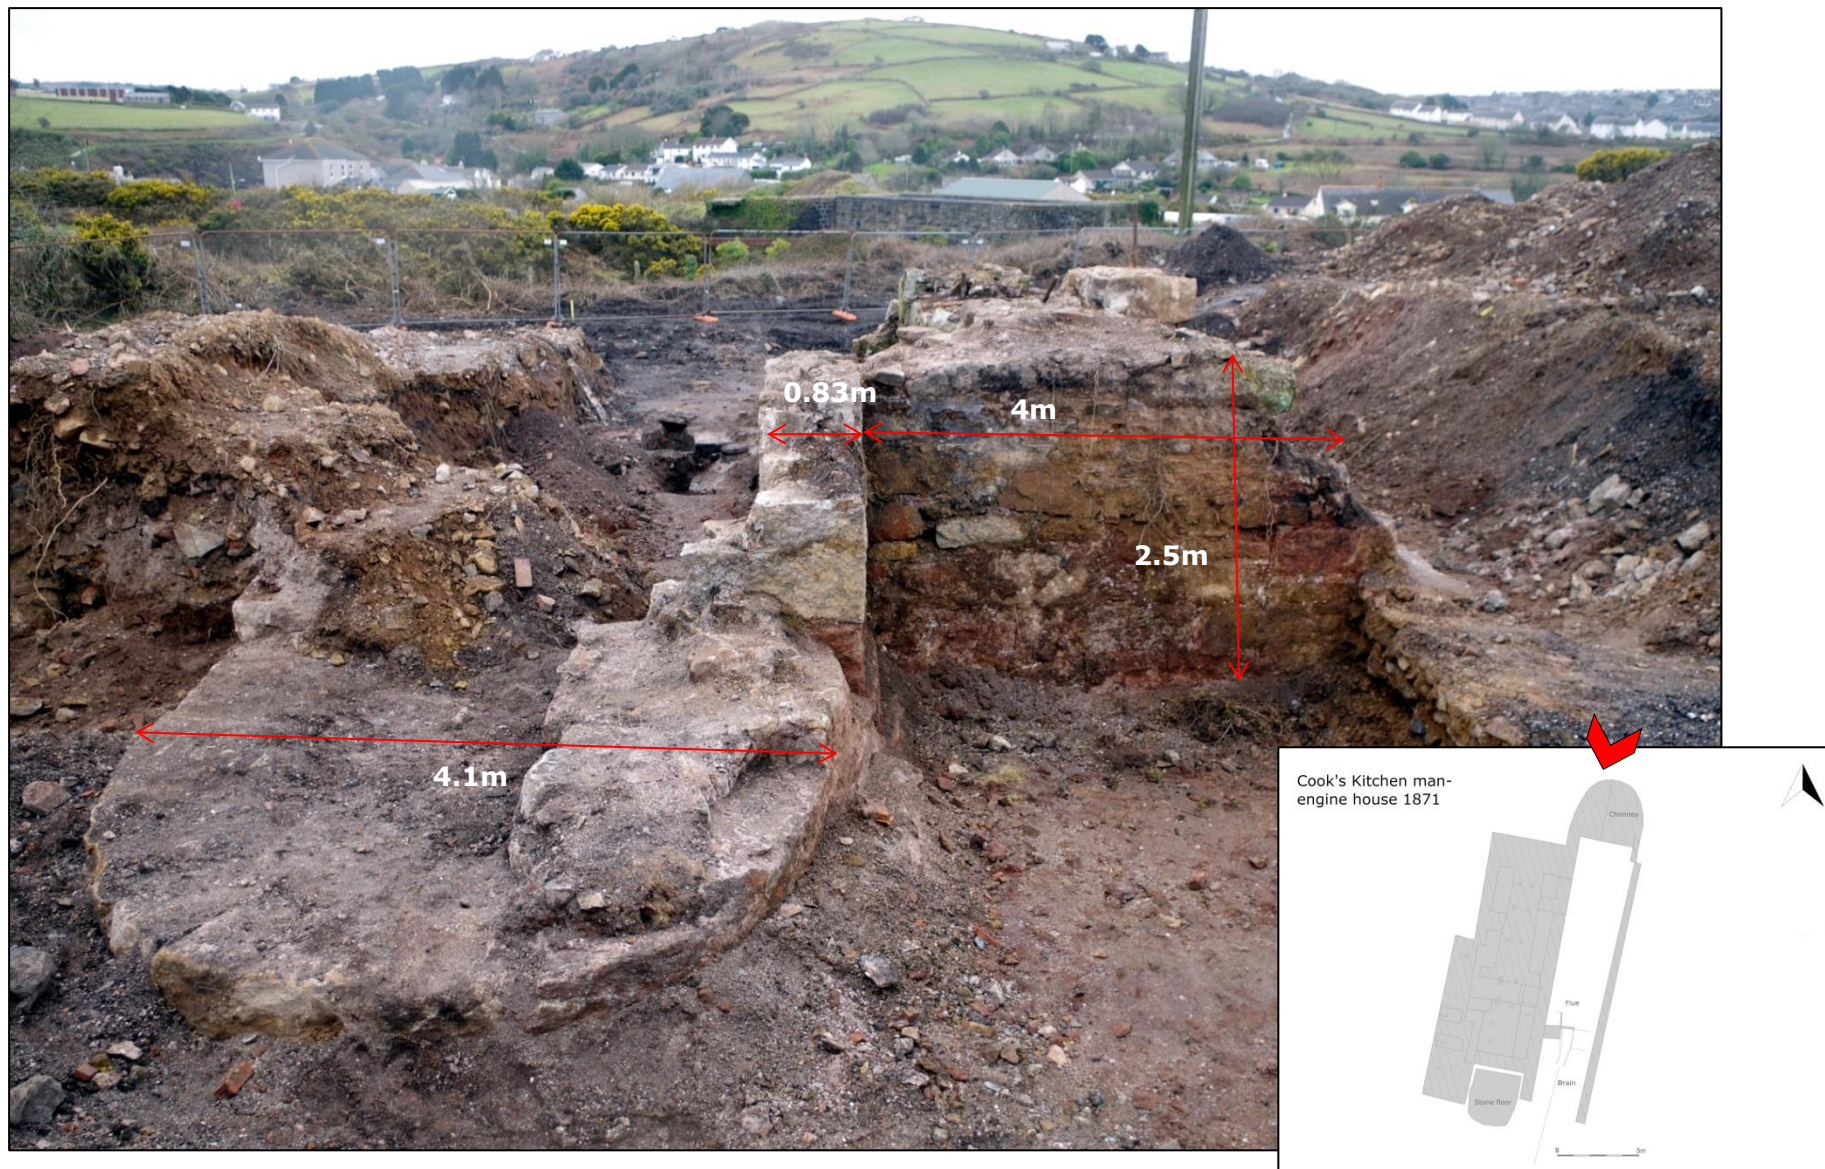
Cook's Kitchen man-engine house north elevation and chimney foundation

Figure 13: North elevation of man-engine house showing measurements. 30

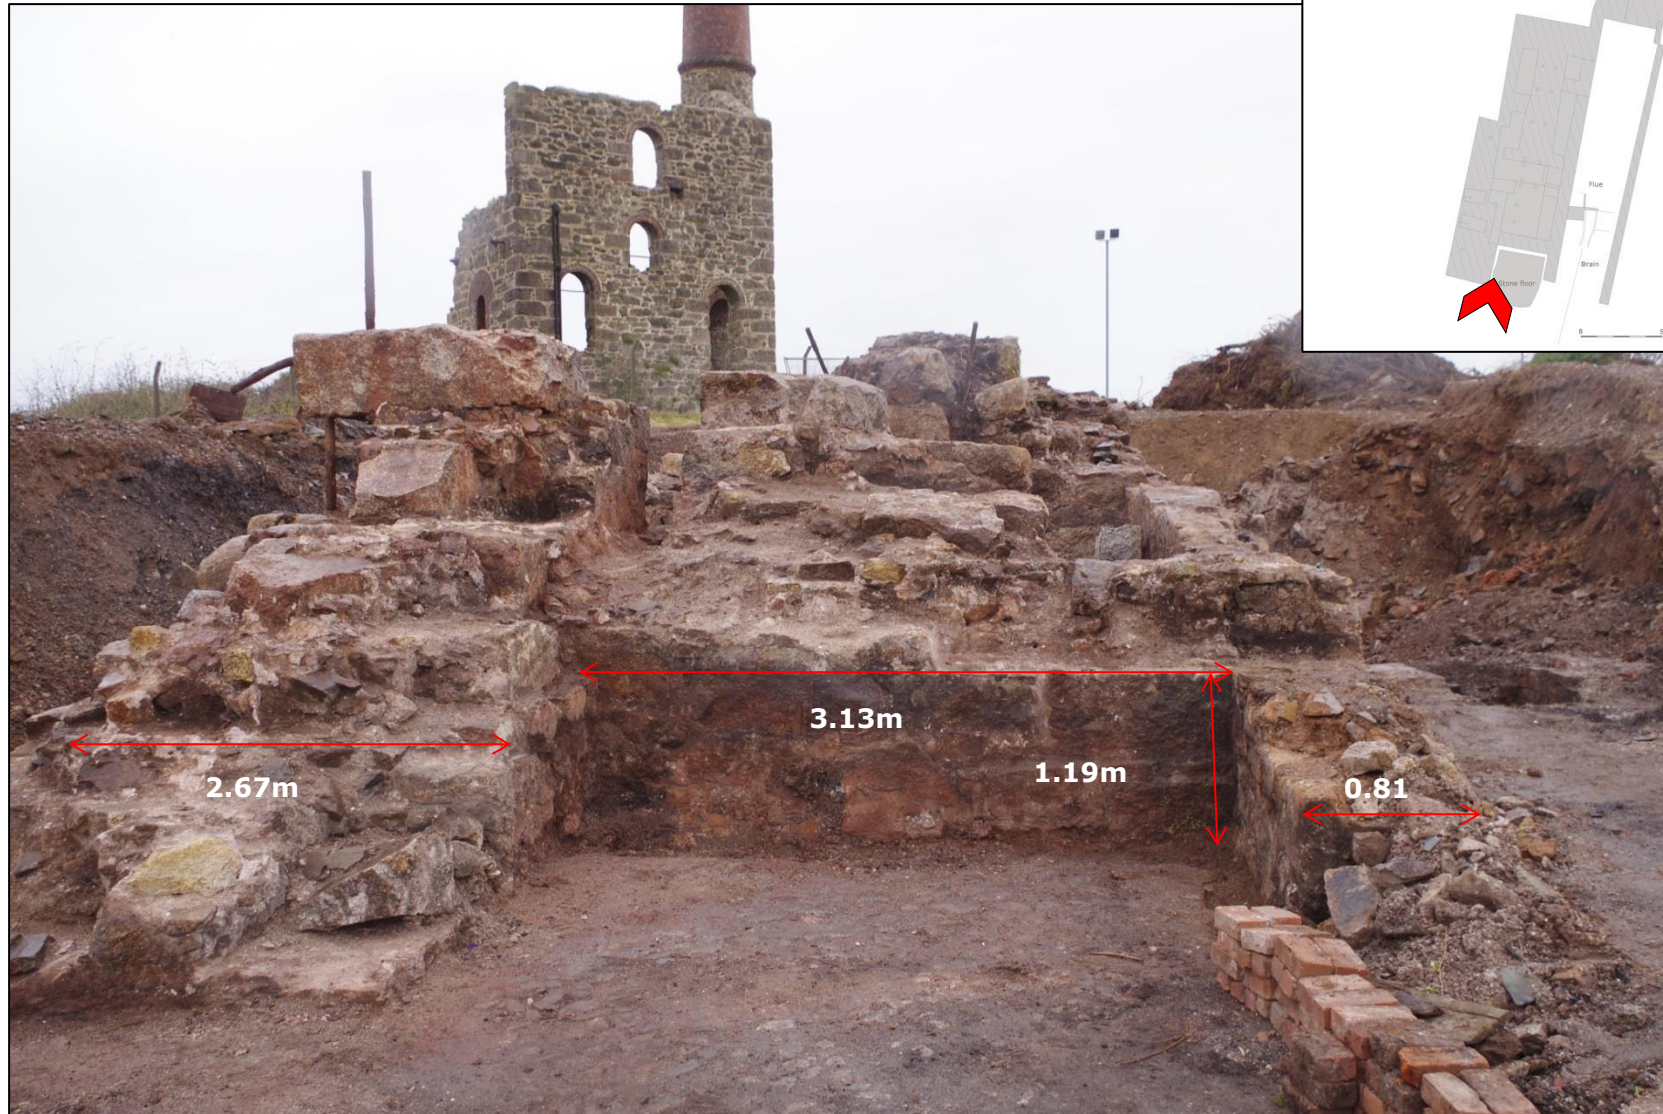
Cook's Kitchen man-engine house south elevation

Figure 14: South elevation of man-engine house showing measurements.

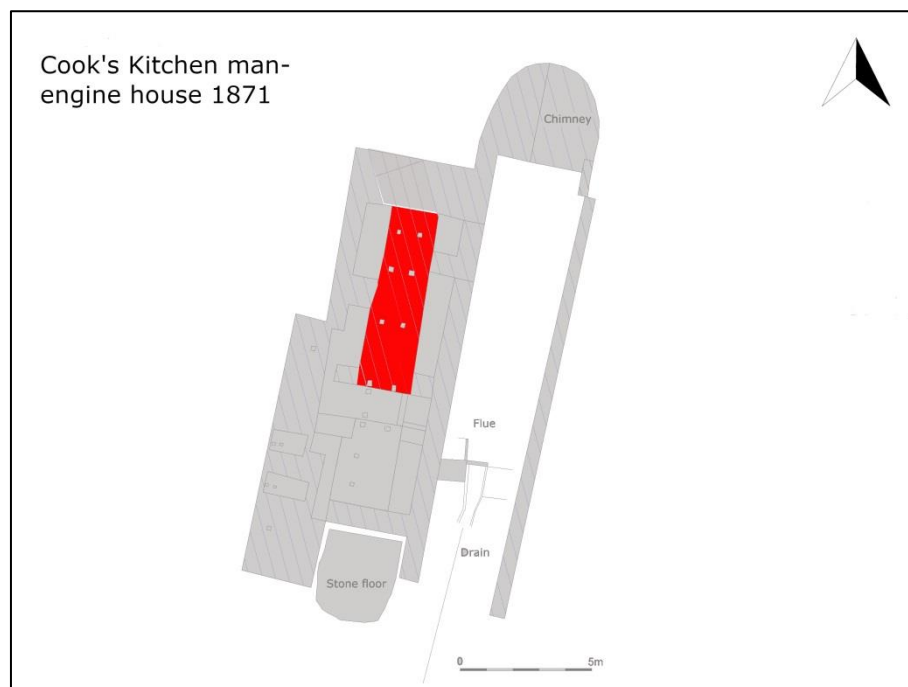
Figure 15: Engine bed loadings.

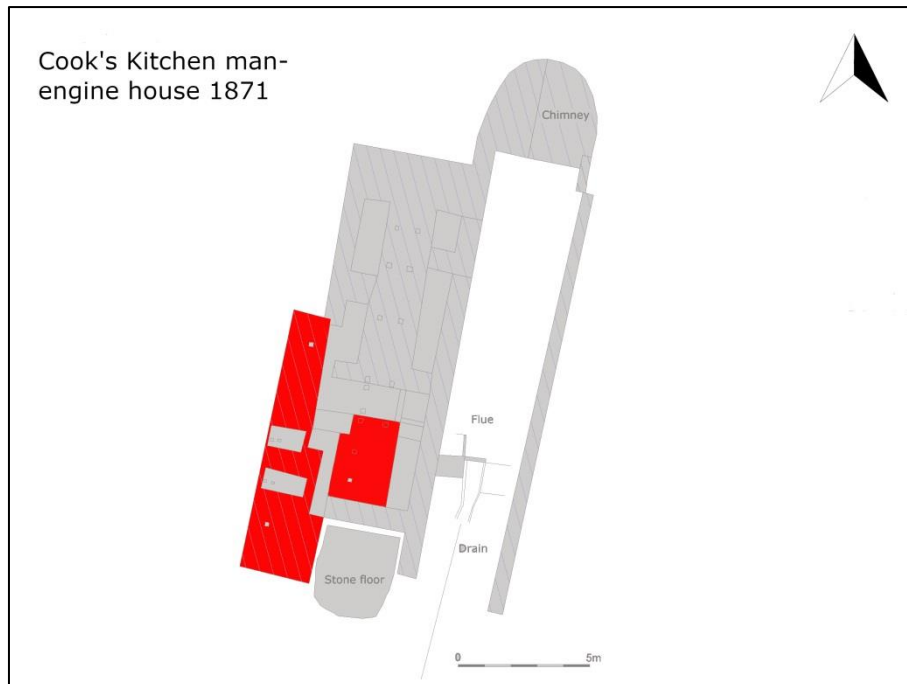
Figure 16: Power train loadings.

These were sited towards the southwestern end of the building, and consisted of two substantial masses of mortared masonry (Fig 16).

The evidence suggests that this area sited the power train where the engine speed was geared down and where the drive for the flat-rods leading to the man-engine was attached.

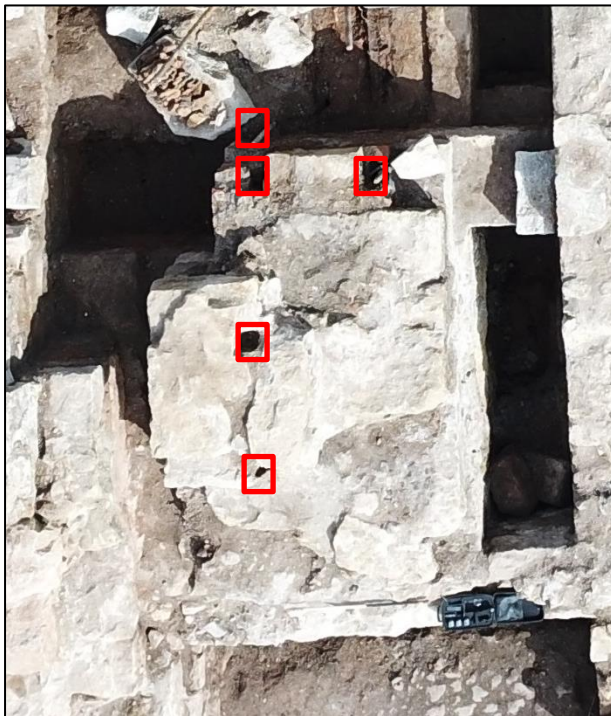
Figure 17: Eastern section of the power train loadings (red boxes indicate locations of holding down bolts).

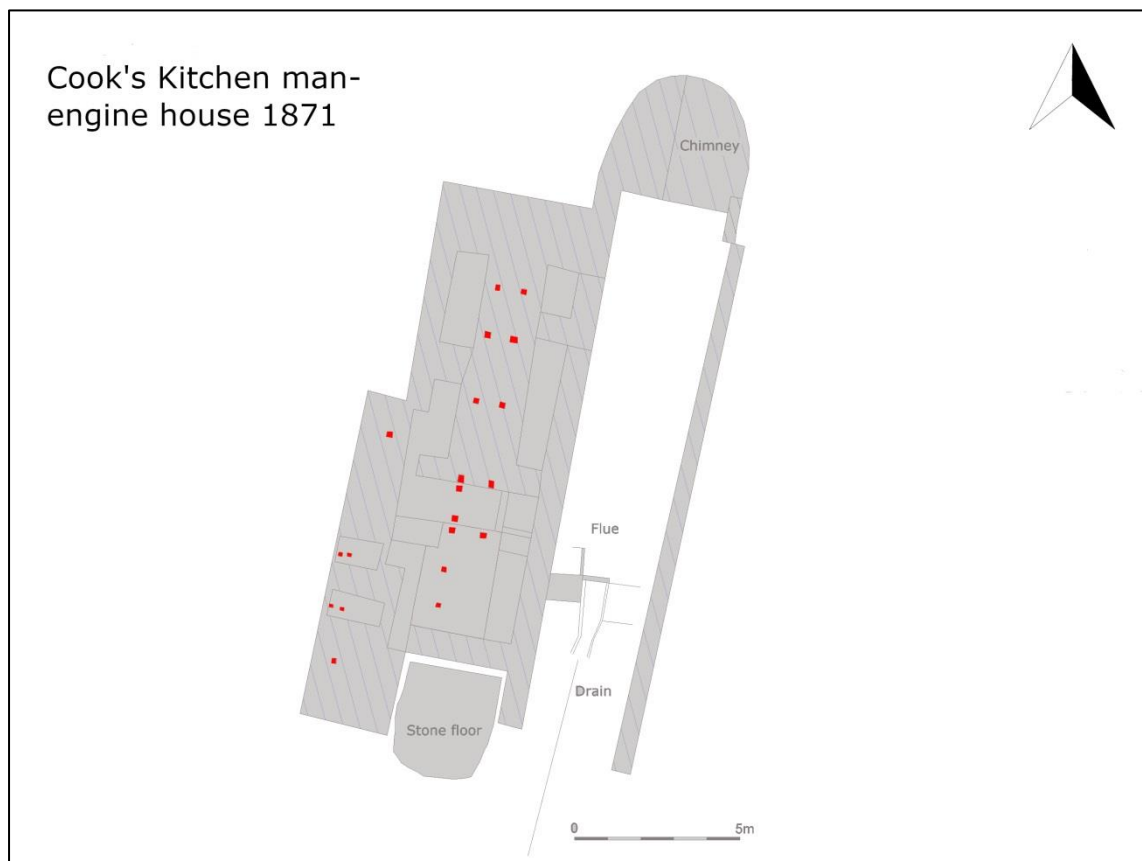
Figure 18: Locations of visible hold down bolt locations within the man-engine house.

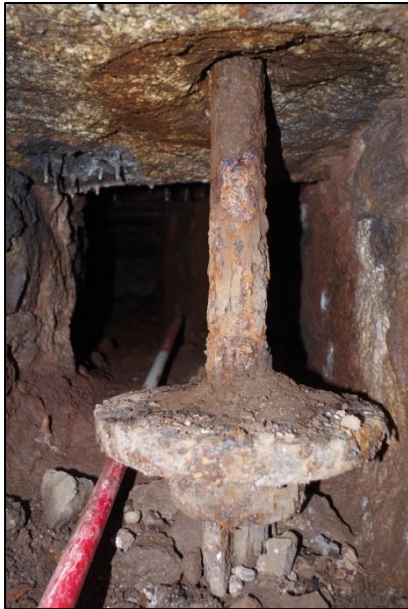
Figure 19: Bottom end of hold down bolt within crow hole.

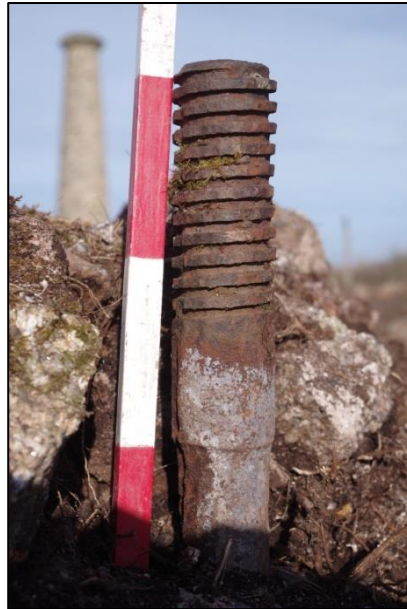
Figure 20: Threaded top of hold down bolt.

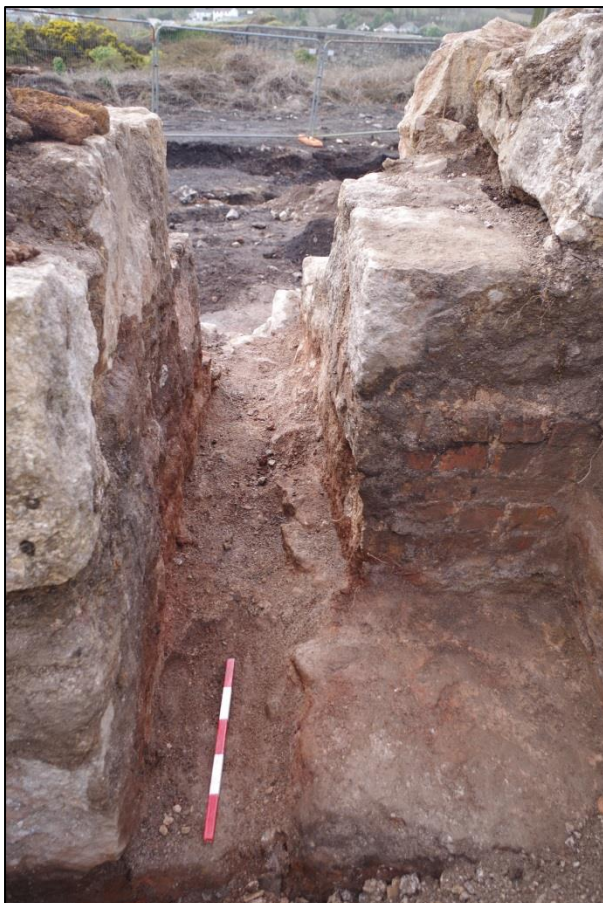
Figure 21: Looking south showing a large horizontal low-level slab of granite adjacent to the slot between the power train loadings (scale 0.5m).

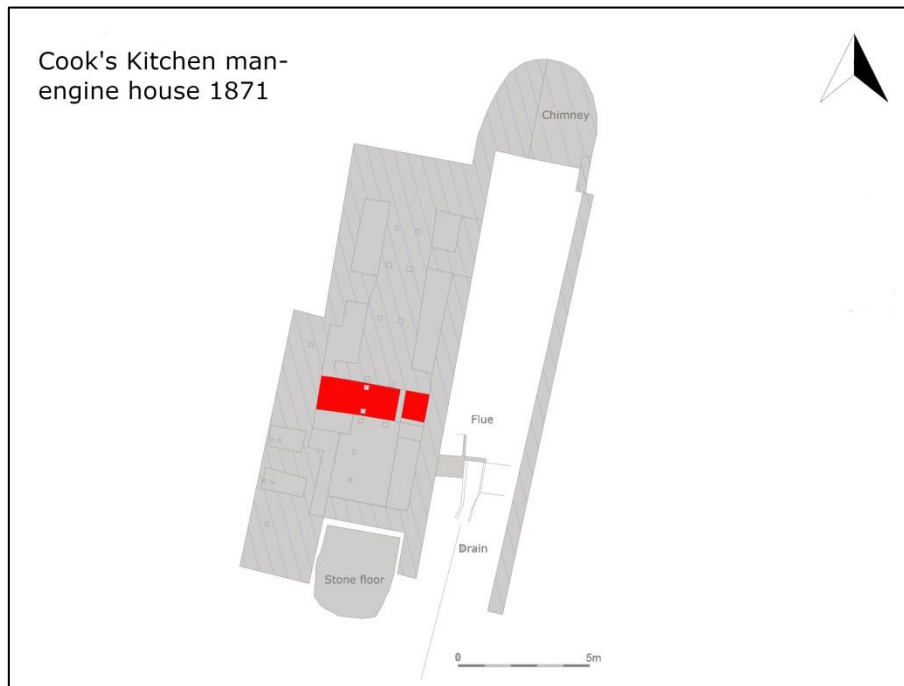
Figure 22: Location of Area 3.

Area 3 [111] extended across the width of the engine house (Fig 22), dividing the northern engine bed loadings from the southern power train loadings and containing several features (see Figs 15 and 16). Most of its floor consisted of the granite lintels covering a wide crow hole extending across the building from the base of its western wall.

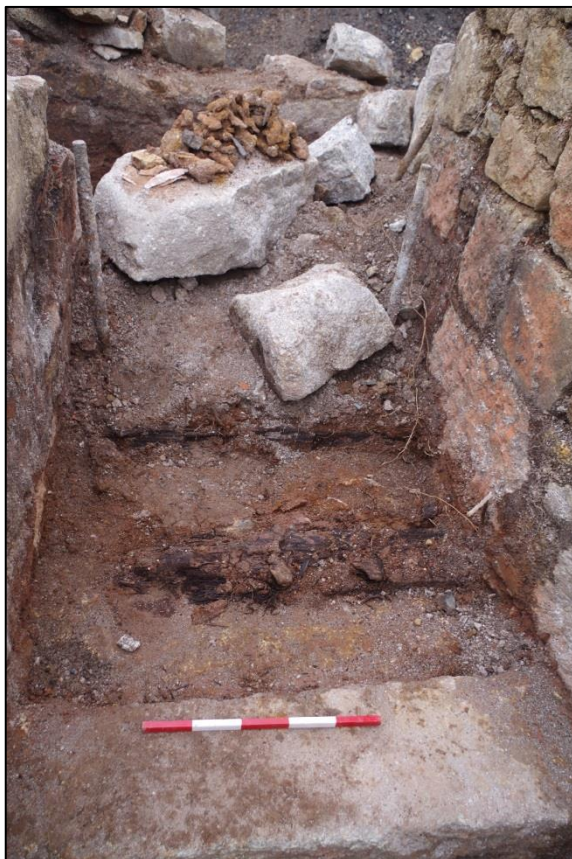
Figure 23: Decayed timbers within Area 3, looking west (scale 0.5m).

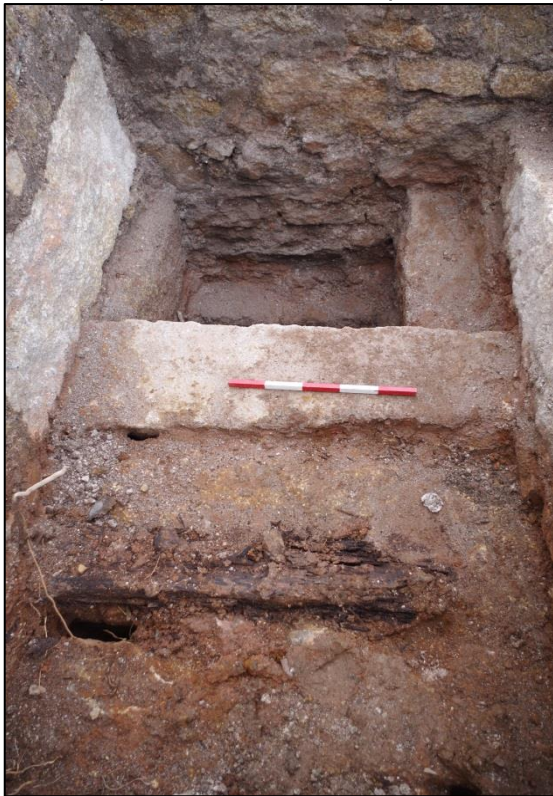
hole. Removal of the upper fills revealed recessed ledges on the north and south sides of the pit, as well as a step in the external wall (see Fig 24). These appear to be construction features rather than those designed to support machinery.

Figure 24: Recessed ledges on the northern and southern sides of the pit at the eastern end of Area 3 (scale 0.5m), looking east.
