Cook's Kitchen, Pool, Redruth, Cornwall: Archaeological Excavation of the Man-Engine House

Report No: 2018R023

Client	Western United Mines
Report Number	2018R23
Date	27 June 2018
Status	Final
Report authors	Ryan Smith and Adam Sharpe
Checked by	Dr Andy Jones
Approved by	Andrew Young

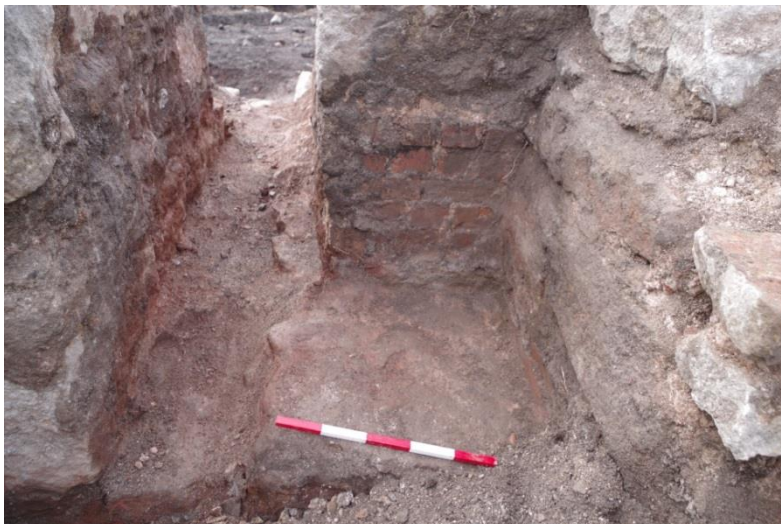
probable water tank [136]. The walling to the south of the slab was constructed of six courses of red brick bonded with lime mortar topped with a level-topped slab of granite.

Figure 25: Large horizontally-set square slab of granite (scale 0.5m), looking south-west.

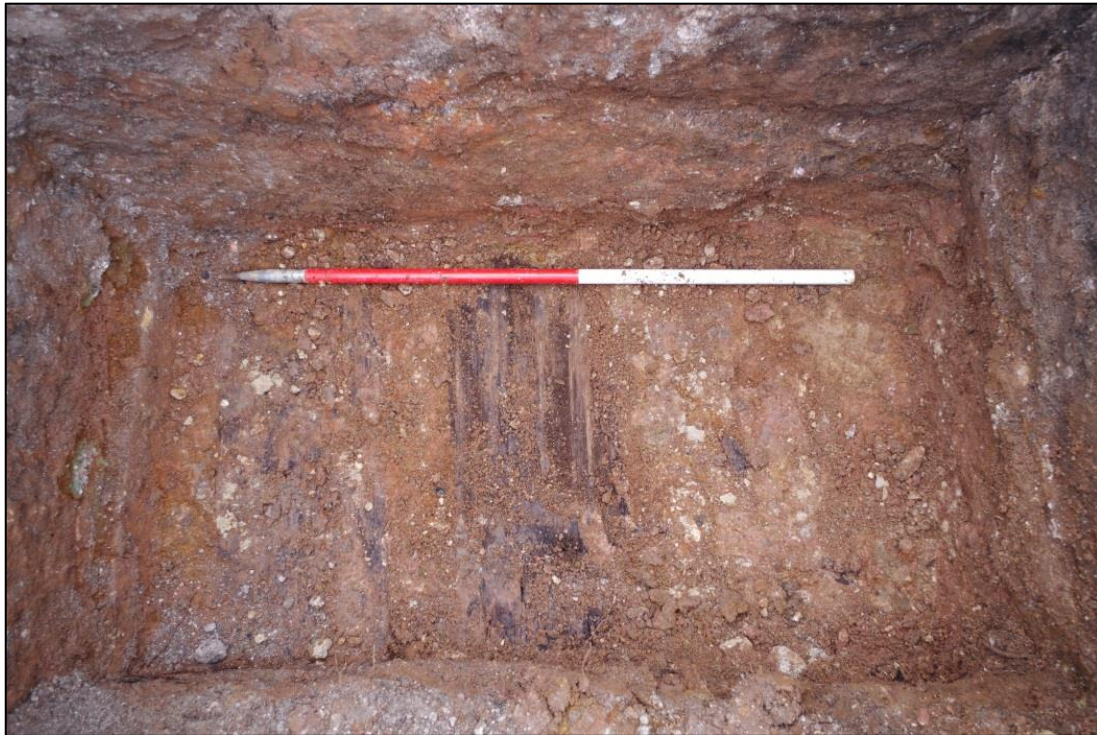
consisted of a sticky dark red clay (137) incorporating numerous corroded ferrous objects. Its base was partly lined with the remains of wooden boards – others might

Figure 26: Possible water tank [136] looking south-west (scale 1m).

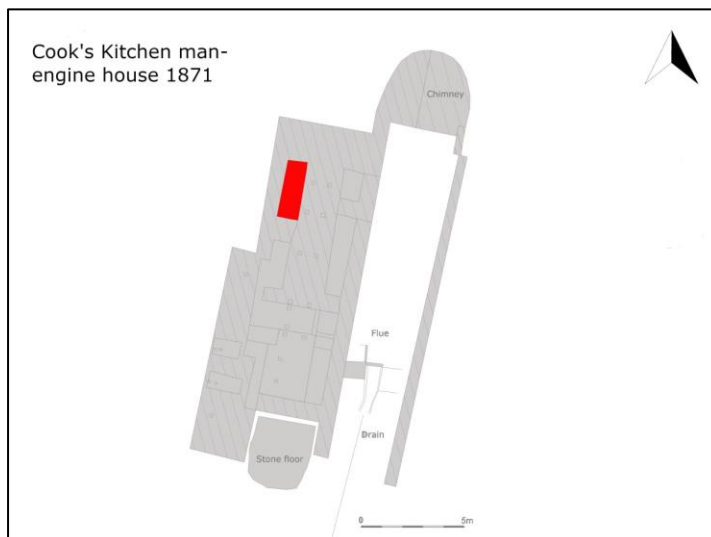
Figure 27: Location of Pit 1.

A rectangular shaped pit [107], this measured 2.63m long by 1.07m wide and reached a depth of 1.67m from the top of the central engine loadings (Figs 27 and 28). The north end of the pit was 1.67m from the northern end of the building. To the west was the external wall of the engine house, this being 0.72m wide; a dividing wall between Pit 1 and Pit 2 was 0.97m wide. All of the internal wall faces were vertical, and were integral with the fabric of the engine house.

This feature was filled with demolition rubble (108) comprising large blocks of displaced granite, fragmented lime mortar and pieces of lime-rendered wall plaster. This material was soft and partly voided in some areas and compacted in others. Some corroded

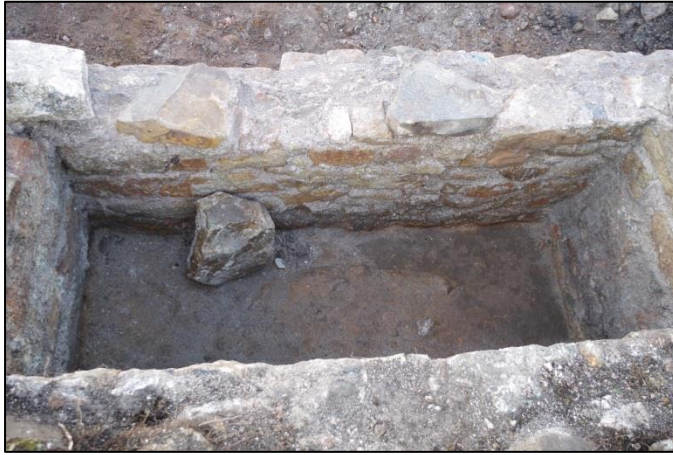
pieces of iron were recovered from within this fill, particularly towards its base. The floor of the pit consisted of a generally level compact reddish-brown sandy/gritty deposit (135). This was not excavated, so it cannot be confirmed whether it represented the original base of the feature.

Figure 28: Pit 1 as excavated looking west.

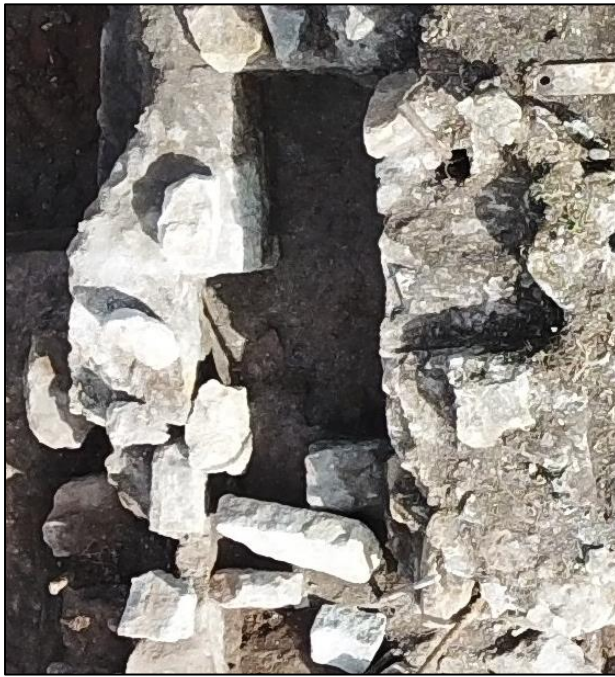
A rectangular shaped pit [109], with a dog leg on its outer wall and a narrowed extension to the south where it joins Area 3 (Figs 29 and 30). The northern end of the pit was 1m wide. 1.08m from the pit's northern end it widened by 0.33m on its western side; at 2.05m from its northern end, a 0.76 long by 0.84m long stub wall attached to the engine bed loadings formed a partial southern end to the pit; the pit continued 0.45m beyond this wall, where it joined Area 3 [111].

Figure 30: View of Pit 2 showing collapsed stones in situ.

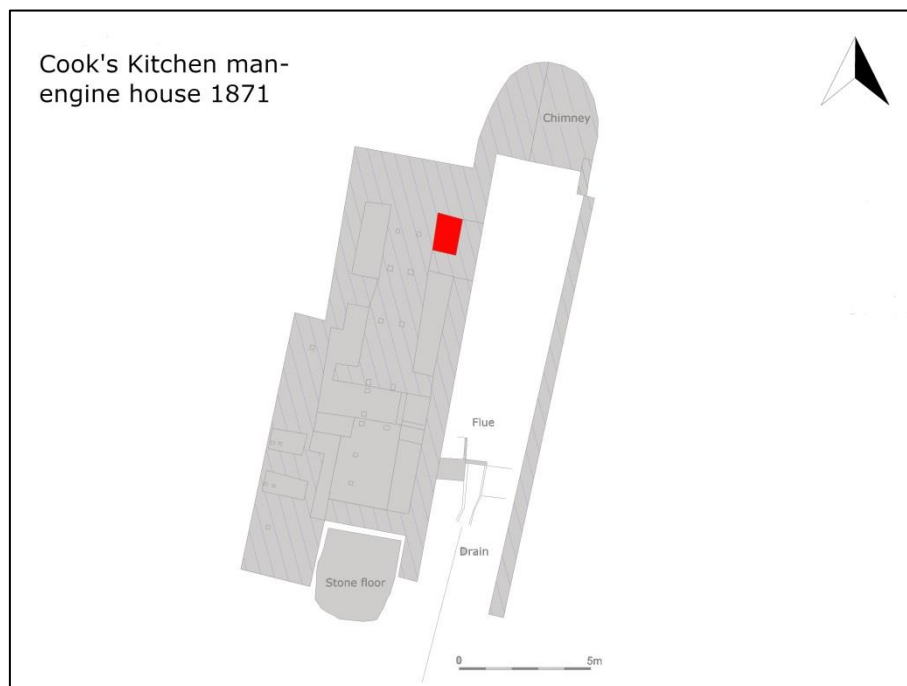
Figure 31: Location of Pit 4.

This relatively small rectangular feature was the one of the only components of the engine house which was still visible prior to excavation. Pit 4 [113] was located at the northern end of the engine house on its eastern side, adjacent to the cylinder loadings and mirroring Pit 1, though shorter in length; it measured 1.35m long, 0.9m wide and 1.3m deep (depth measured from the top of the wall to the top of the fill within the pit) (Figs 31 and 32); this feature was not wholly emptied of its fills. The north wall of this

The function of this pit is unclear, and its full depth is uncertain. It may well have given access to a crow hole accessing one or more of the engine bed hold down bolts.

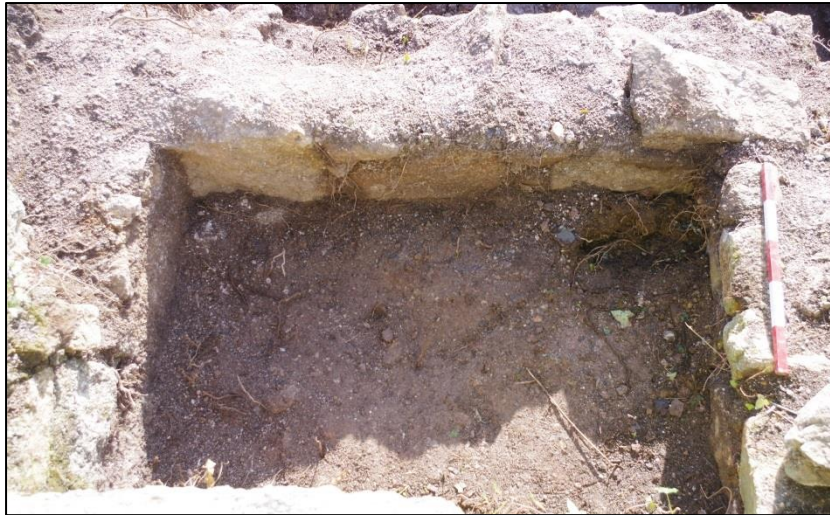
Figure 32: Pit 4 un-excavated (scale 0.5m), looking east.

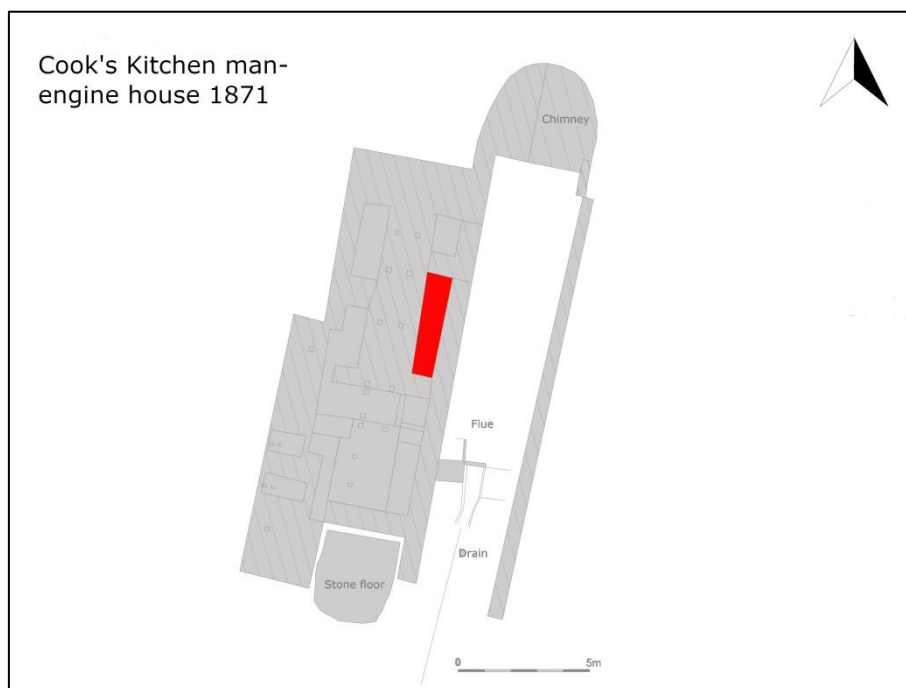
Figure 33: Location of Pit 5.

A long rectangular pit [115] located on the east side of the engine house, partly mirroring Pit 2 to the west (Figs 33 and 34). It abutted the loadings for the cylinder and cross head and measured 3.8m long and 1.5m wide. It did not prove possible to excavate the full extent of Pit 5 given time constraints, but its northern end was excavated down to 1.5m below the surviving head of the eastern wall. It was estimated that a maximum of 0.5m of material remained unexcavated in the base of the pit. The top of a crow hole accessing a pair of cylinder hold down bolts was revealed at the northern end of the pit; it is likely that a second crow hole exists towards the southern end of the pit, given the presence of further hold down bolts above this part of the feature.

A line of granite coursing (Fig 33) protruded from the western wall face 1m below the height of the upper edge of the eastern wall and immediately above the top of the exposed crow hole.

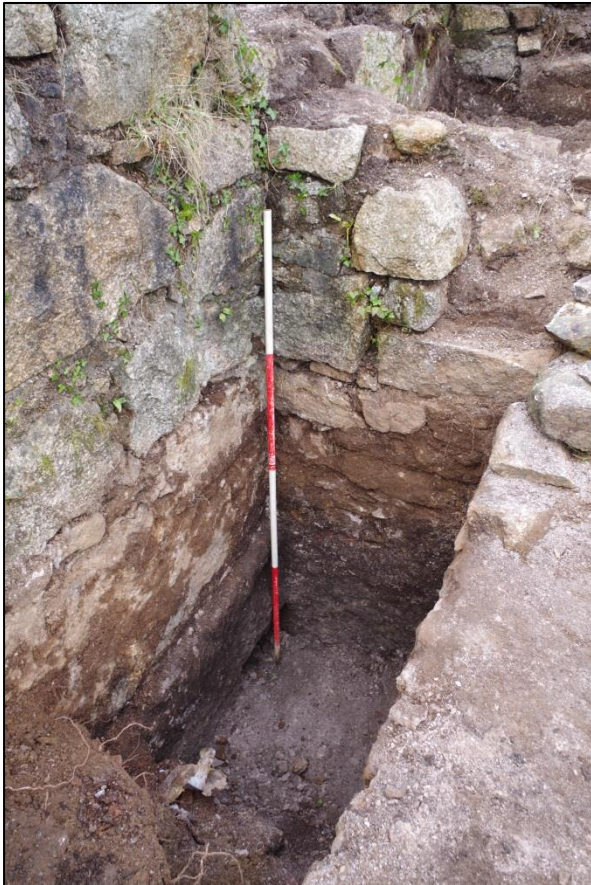
Figure 34: Pit 5 looking north, (scale 2m).

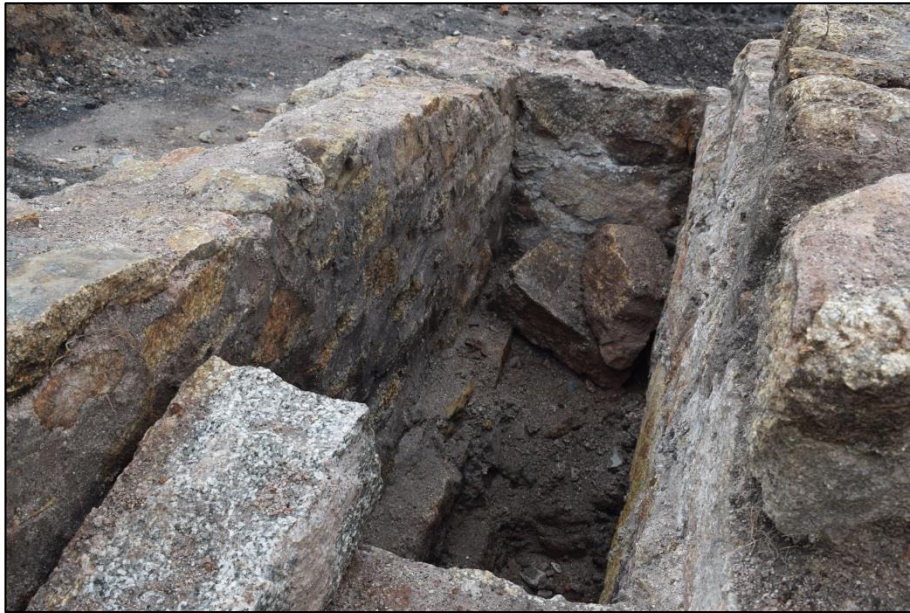
A rectangular pit [119] measuring 2.54m long, 0.84m wide, and about 1.7m deep (Figs 35 and 36). Its eastern and southern walls were formed by the outer walls of the engine house, its western wall was formed by the eastern edge of the power train loading and the northern end of the pit was divided by walling from the access into the crow hole tunnel at the eastern end of Pit 3. The eastern and northern walls exhibited steps in their construction.

Figure 36: Pit 6 post excavation looking south.

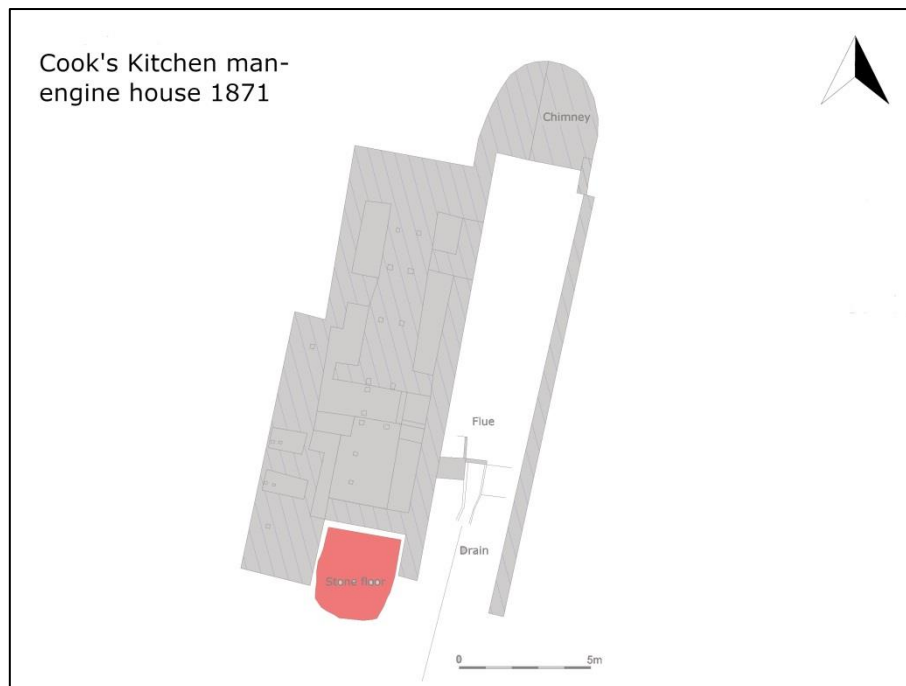
Figure 38: Location of cobbled surface.

At the southern end of the engine house, its western and eastern walls extended to enclose a small rectangular area. The western wall extension was 2.67m wide and 2.61m long, whilst the eastern wall extension measured 1.47m long and 0.81m wide (Figs 38 and 39). The space between the walls measured 3.13m and was occupied by a small area of cobbling (126). These did not abut the engine house to the north and east, but were separated from it by a linear gap 0.35m wide between the cobbles and the southern end of the engine house and a 0.24m wide gap between them and the eastern wall. These had the appearance of two timber beam slots, possibly the foundation timbers for a small structure of unknown function. At the northern edge of the cobbled area, the surfacing became a layer of generally level compacted coal dust and fine cinders (160) which extended at least as far north as drain [140]. The full extent of this coal dust and cinder surface was not revealed. Removal of (160) revealed a smooth compacted surface (159).

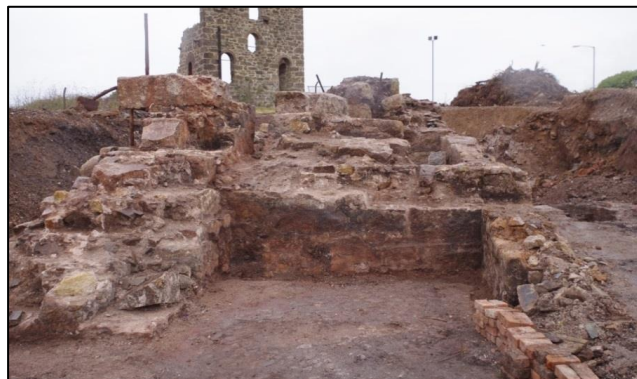
Figure 39: View of southern end of the man-engine house, cobbled surface located in the foreground.

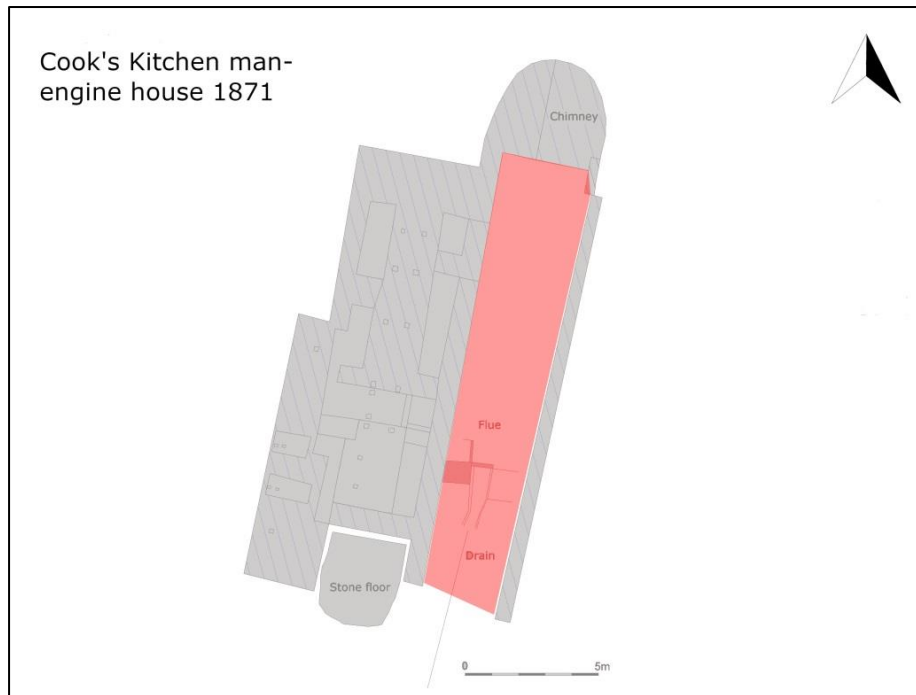
Figure 40: Location of western boiler house.

The original western boiler house [134] measured 16.5m long and 3m wide. It had been constructed up against the eastern wall of the engine house, was abutted by the chimney to the north; a poorly-constructed wall divided off the northern section of the building (Fig 40); it had incorporated an originally free-standing western wall. Its southern wall had been completely demolished, presumably when its boiler was being scrapped and had left no archaeological trace; it might well have been entirely of timber construction.

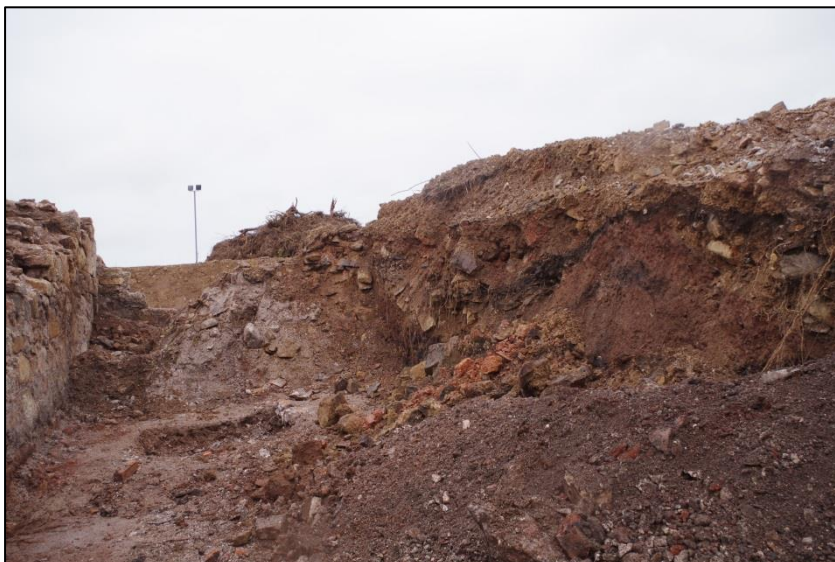
The western wall of the original western boiler house was shared with that of the engine house and was well-constructed (see Section 7.2 for the description of the engine house); in contrast the eastern wall of this boiler house comprised loosely-stacked killas and mine waste; this wall was not bonded by any mortar except at its southern end (where it would have been exposed next to the firing area). As a result it was unstable to the extent that it progressively collapsed as the excavation progressed.(Fig 41).

Figure 41: The eastern and northern walls of the western boiler house, looking north.

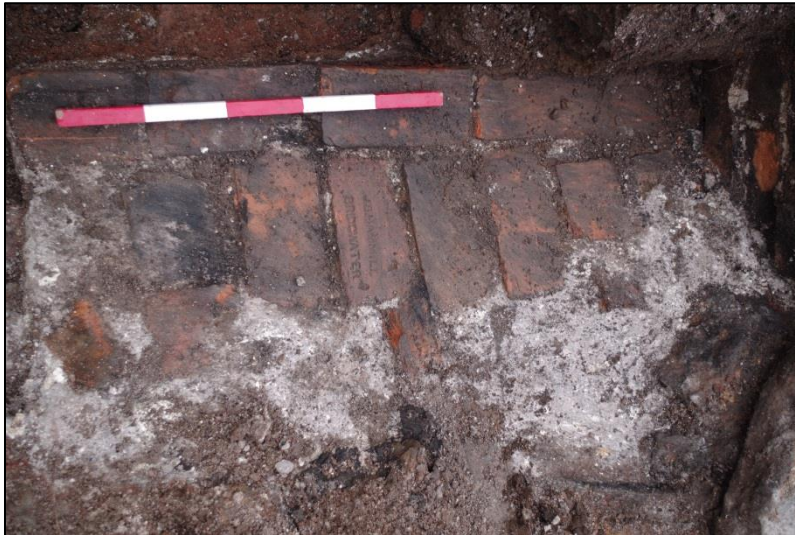
The brick feature is likely to represent the truncated remains of the feature where the side flues connected with the under-flue (Fig 42).

Figure 42: Section of the under-flue in the western boiler house (scale 0.5m), looking south-east.

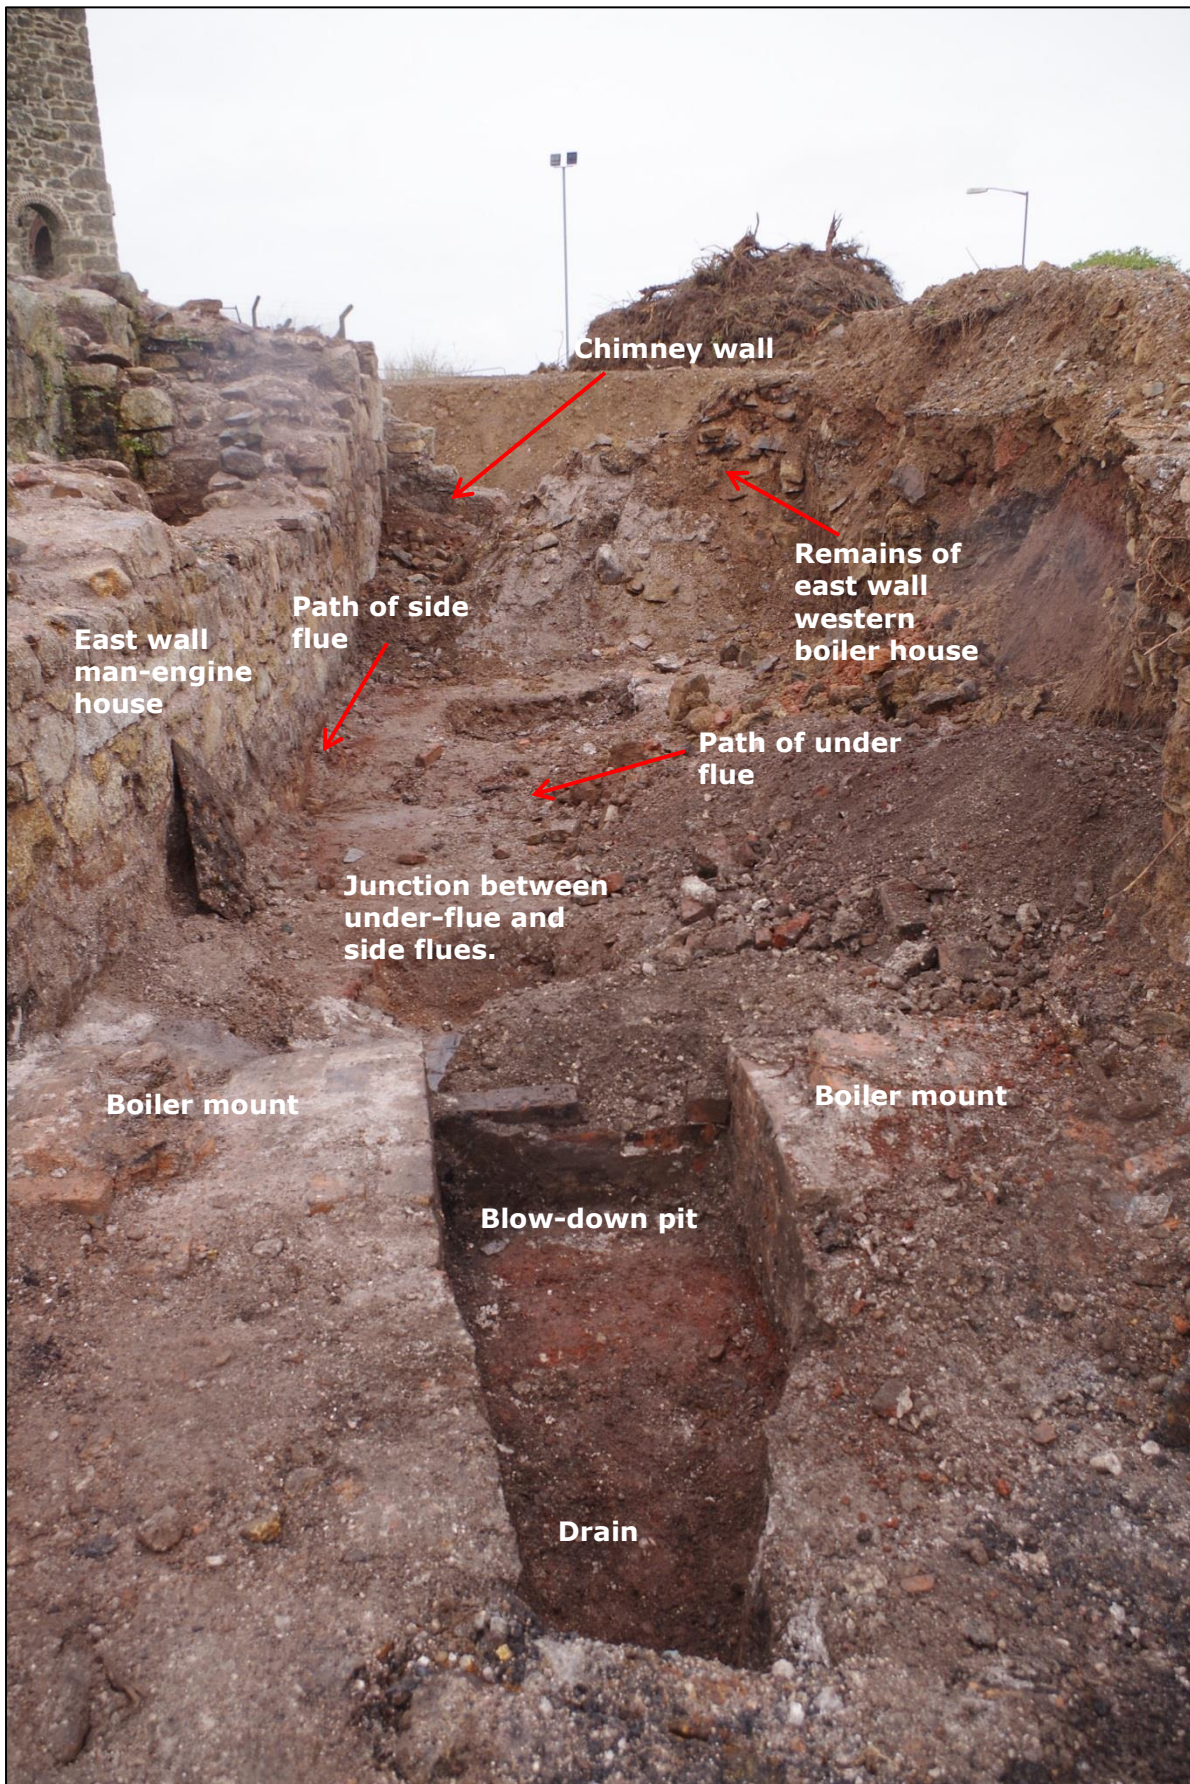
Figure 43: Interior of western boiler house looking north.

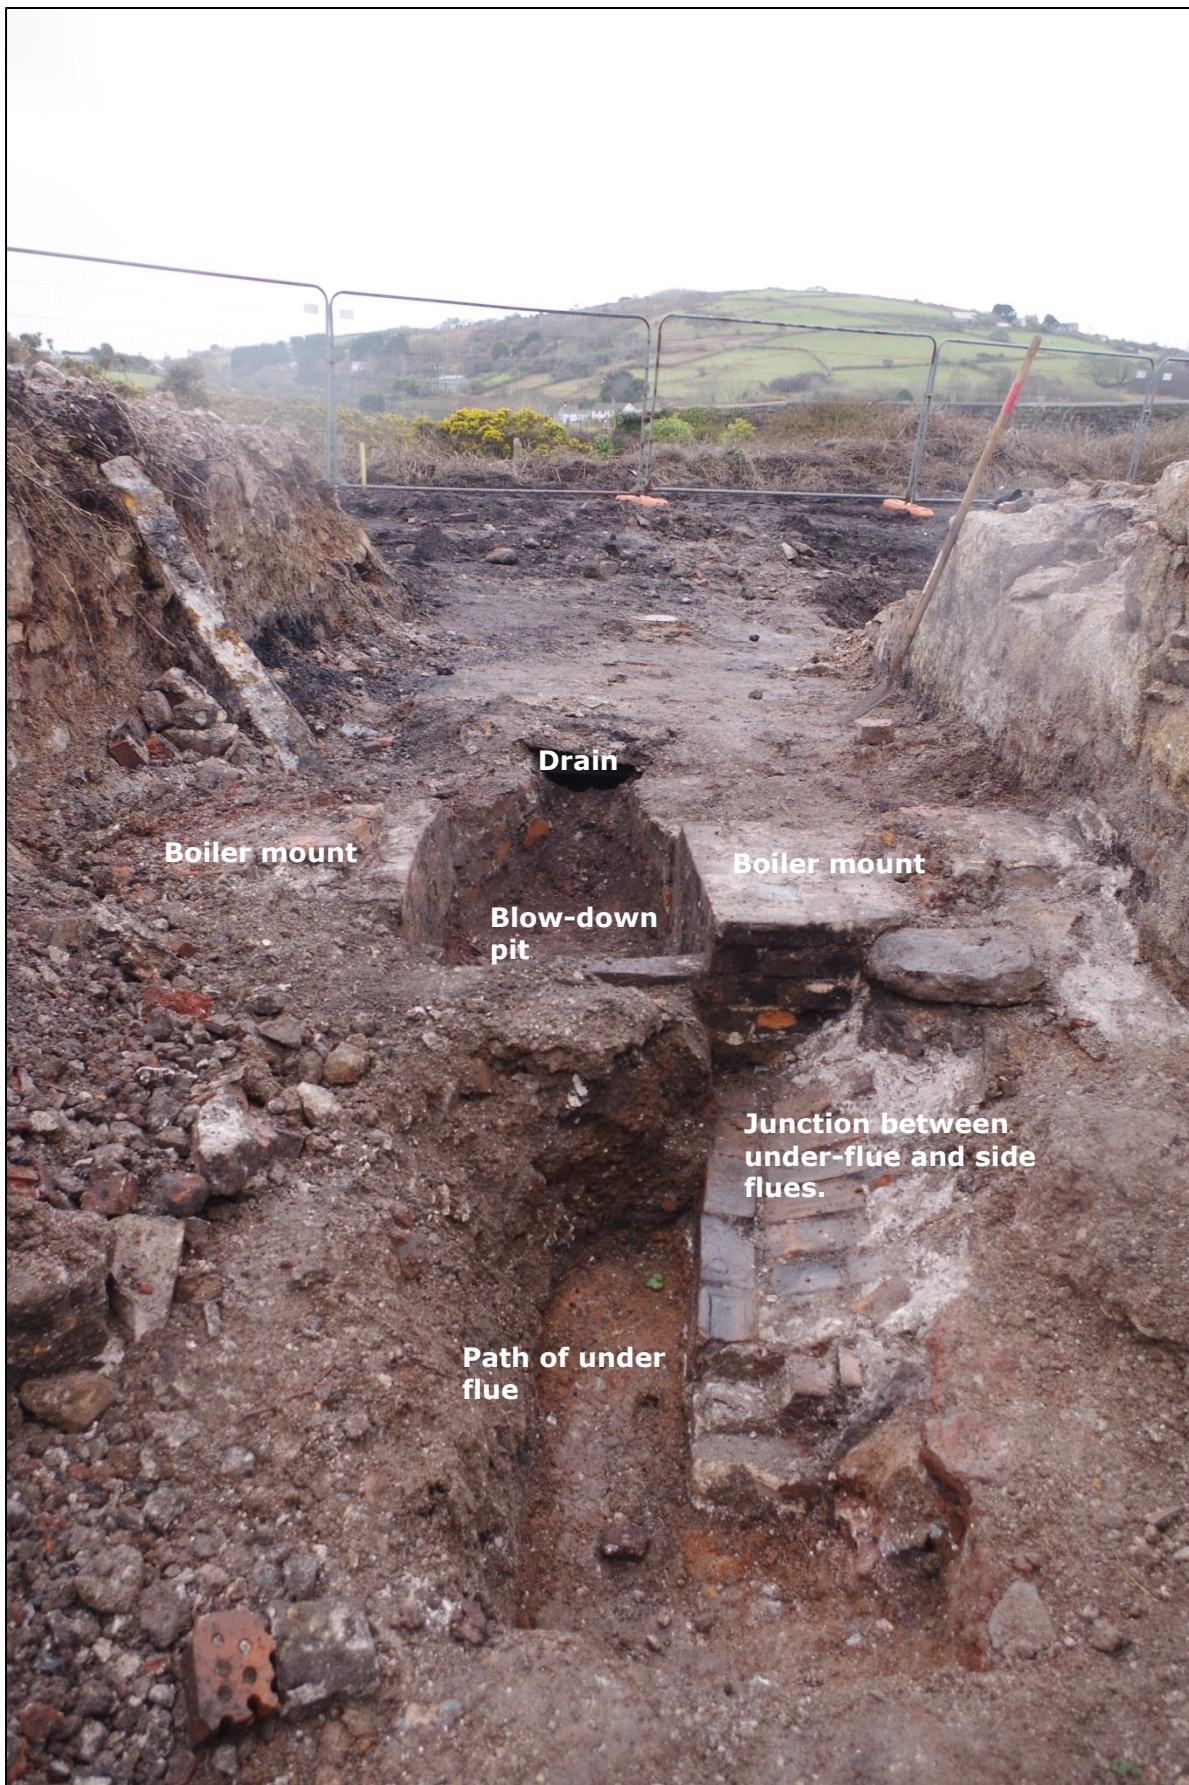
Figure 44: Interior of western boiler house looking south.

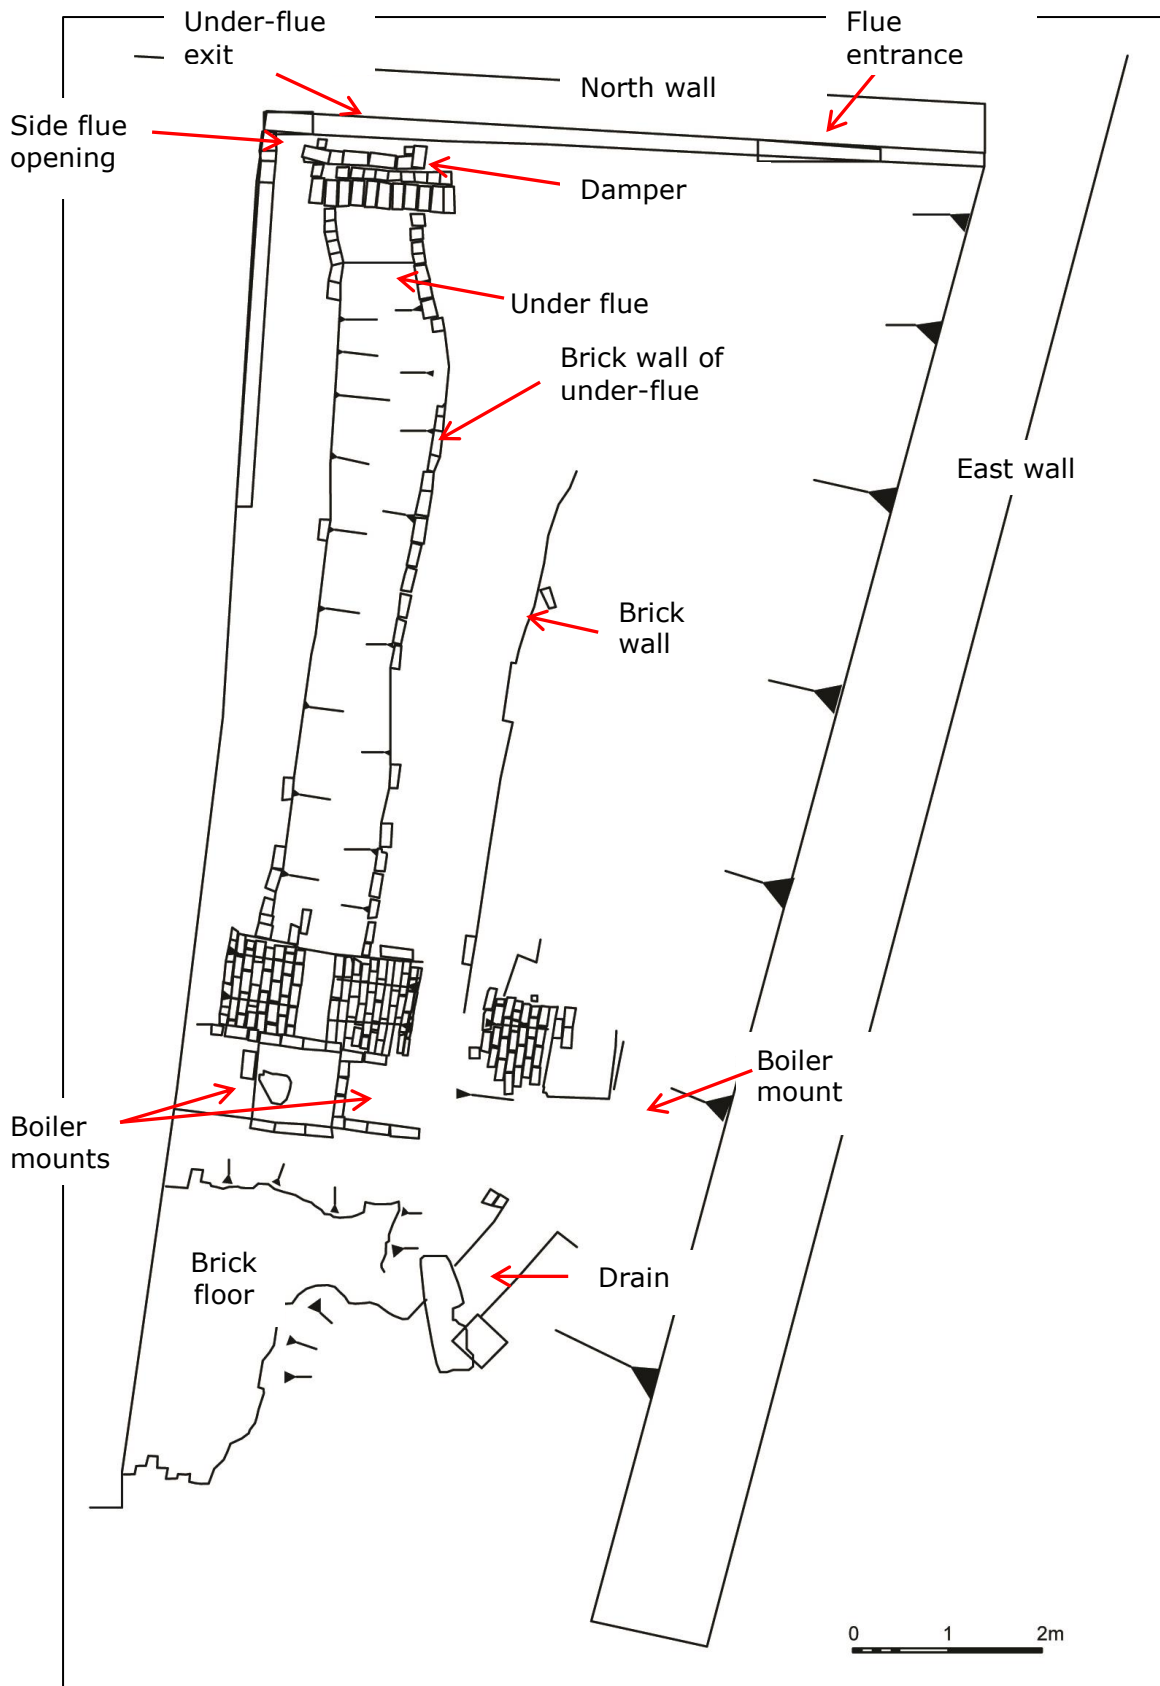
Figure 46: Layout of eastern boiler house.

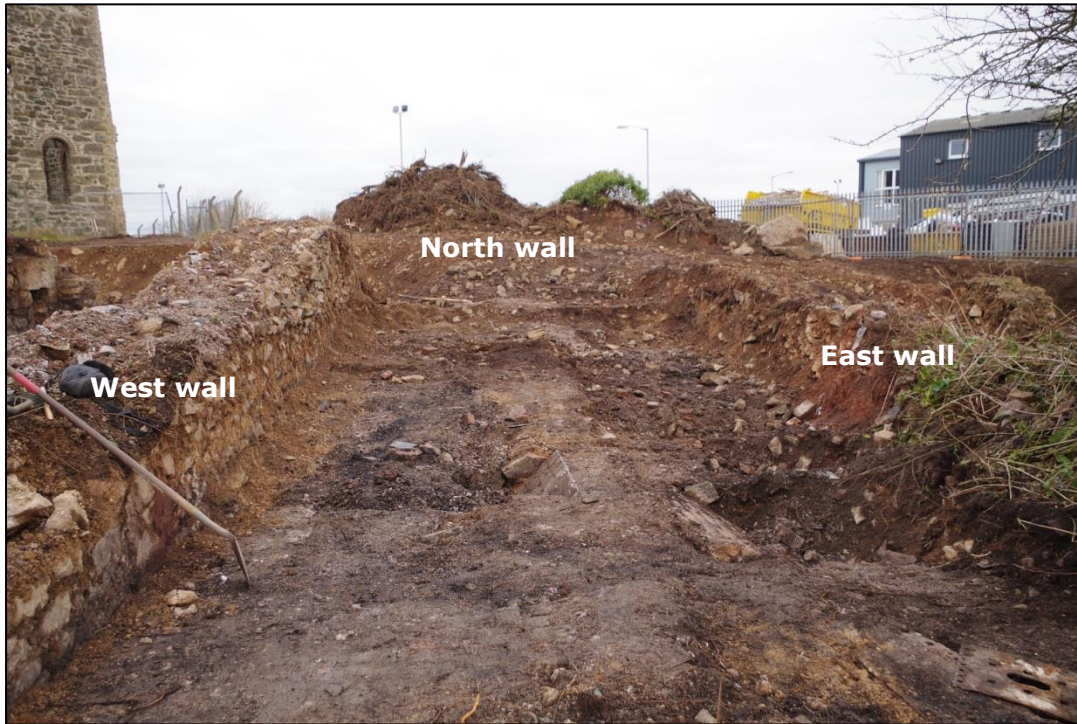
The features associated with the eastern boiler appeared to be less intact than those associated with the western boiler, in part because the eastern wall of the boiler house appeared to have partially collapsed into the building.

Figure 47: Pre-excavation view of eastern boiler house, looking north.

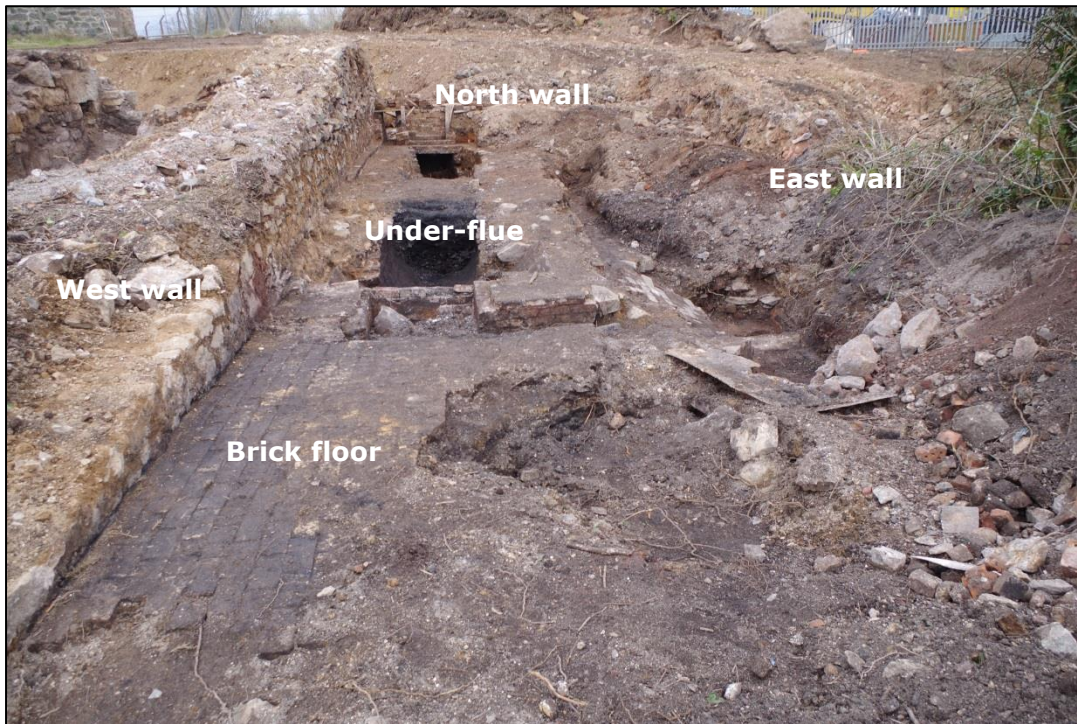
Figure 48: Post-excavation view of eastern boiler house, looking north.

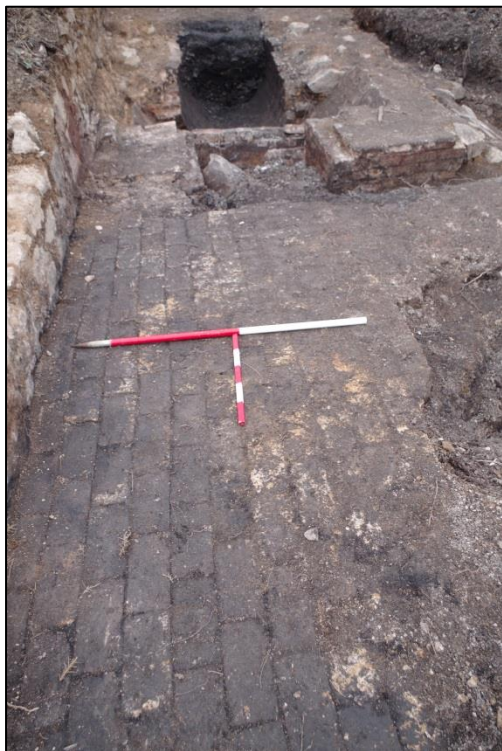
Figure 49: Brick floor in eastern boiler house looking north (scale 1m x 0.5m).

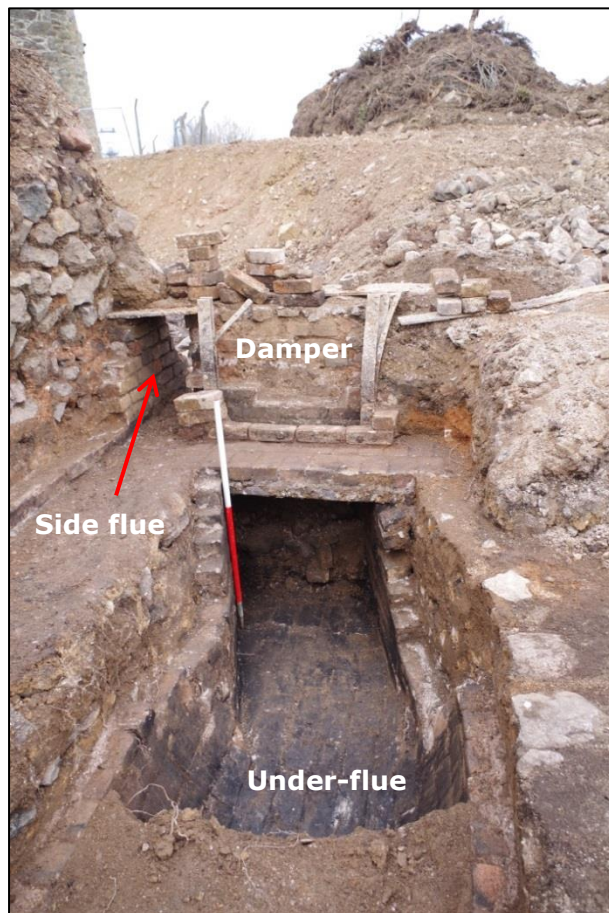
The under flue walls were made up of at least nine courses of white brick bonded together using lime mortar. At their southern end

Figure 50: Western boiler under-flue and side flue (scale 1m) looking north.

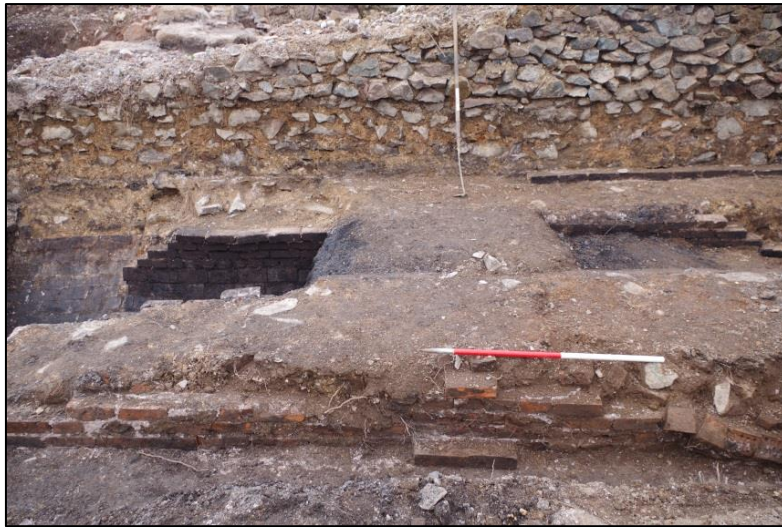
Dividing the eastern boiler house into two sections and aligned north-east to south-west was wall [152] (Figs 46 and 51). This was not fully excavated, though

Figure 51: Central wall dividing the eastern boiler house, (scale 1m) looking west.

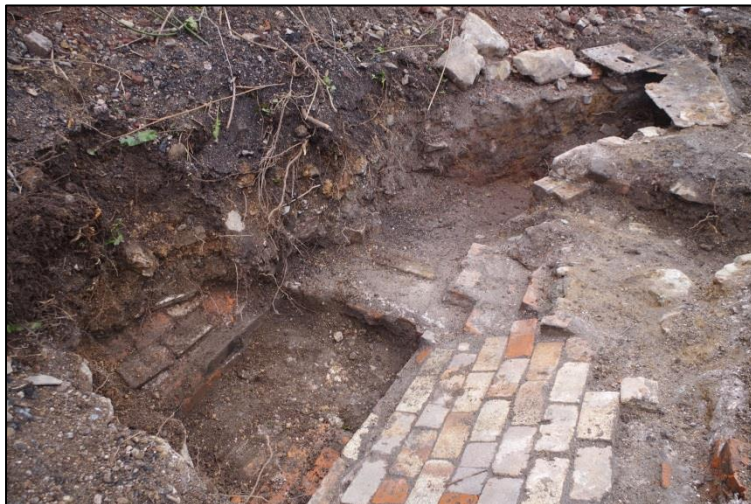
The only substantial evidence for the eastern boiler in this boiler house which was exposed by excavation was a brick-built curving depression [156] which would have

Figure 52: Brick curved depression belonging to the easternmost boiler, looking south.

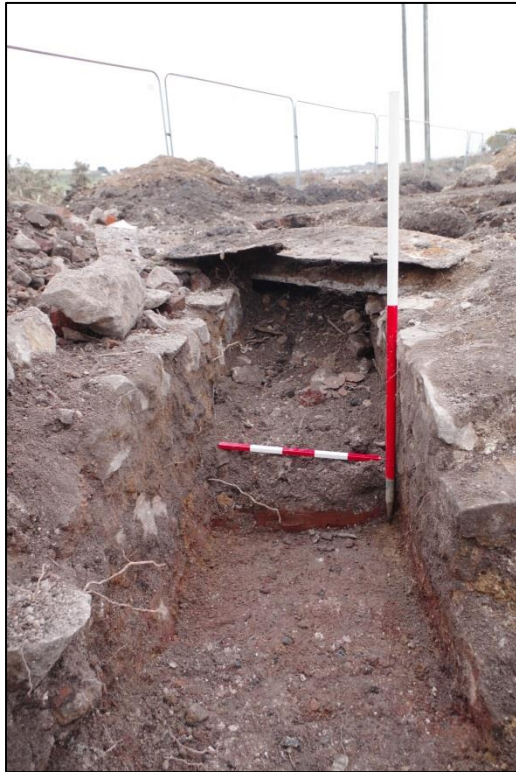
The northern end [153] of one of the drains from the eastern boiler house was initially revealed through excavation near the location of the firing end of the eastern boiler (Figs 46, 52 and 53). Here, it consisted of two vertical sections of parallel brickwork 0.63m apart and 0.4m high sloping gently away to the south-west. The base of the drain was rendered in lime mortar.

Figure 53: Eastern boiler house drain on the east side (scale 1m x 0.5m) looking south.

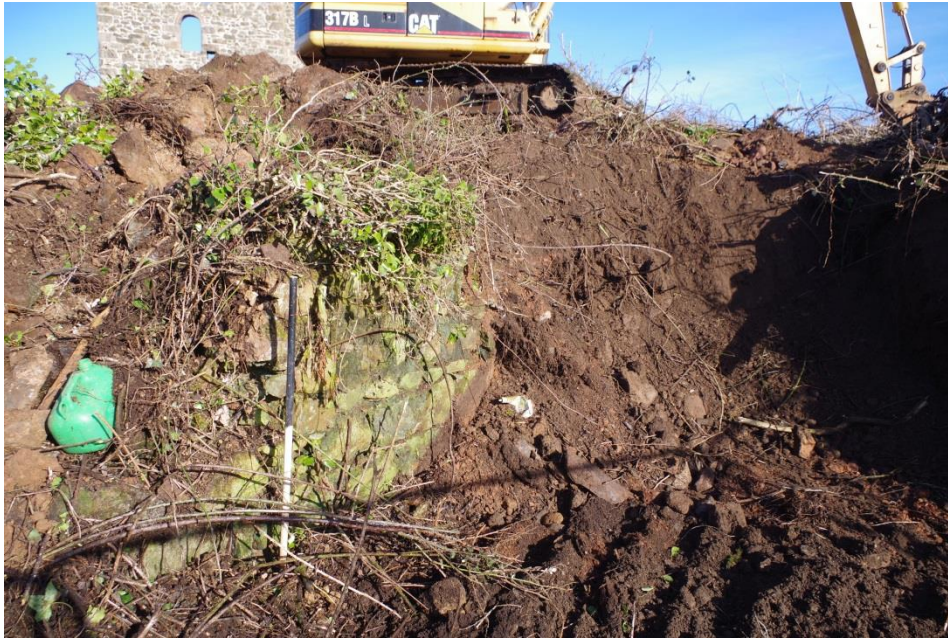
Time constraints precluded investigative excavation of this building, but the preliminary lowering of ground levels within its interior revealed no evidence for machine bases, or for a floor.

Figure 54: View looking north of the possible compressor house east wall.

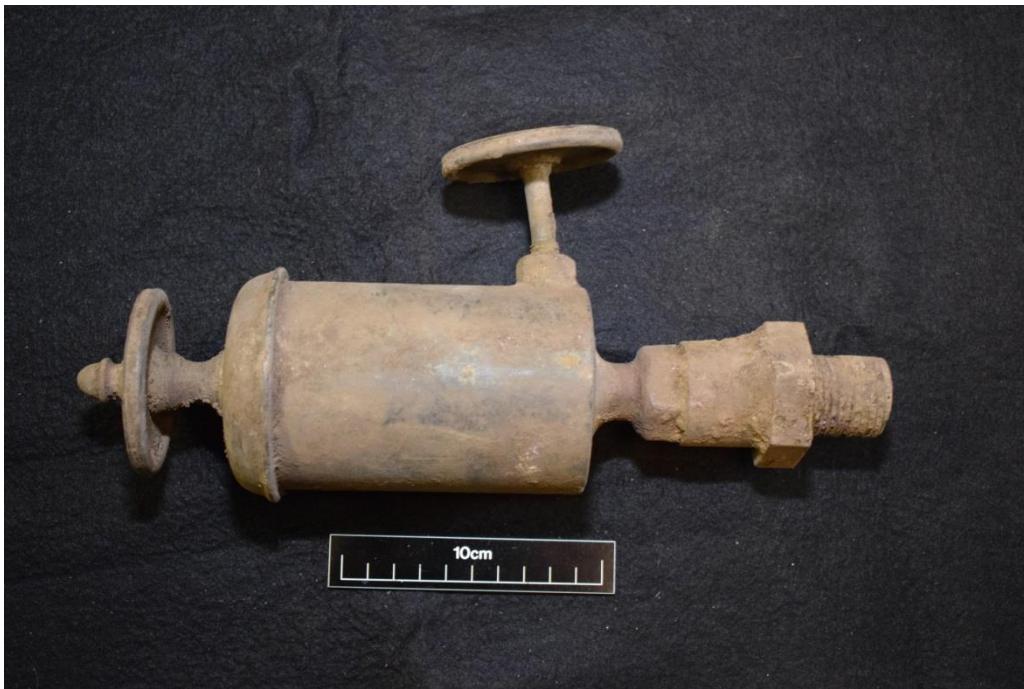
Figure 55: Lubricator from demolition rubble within the eastern boiler house.

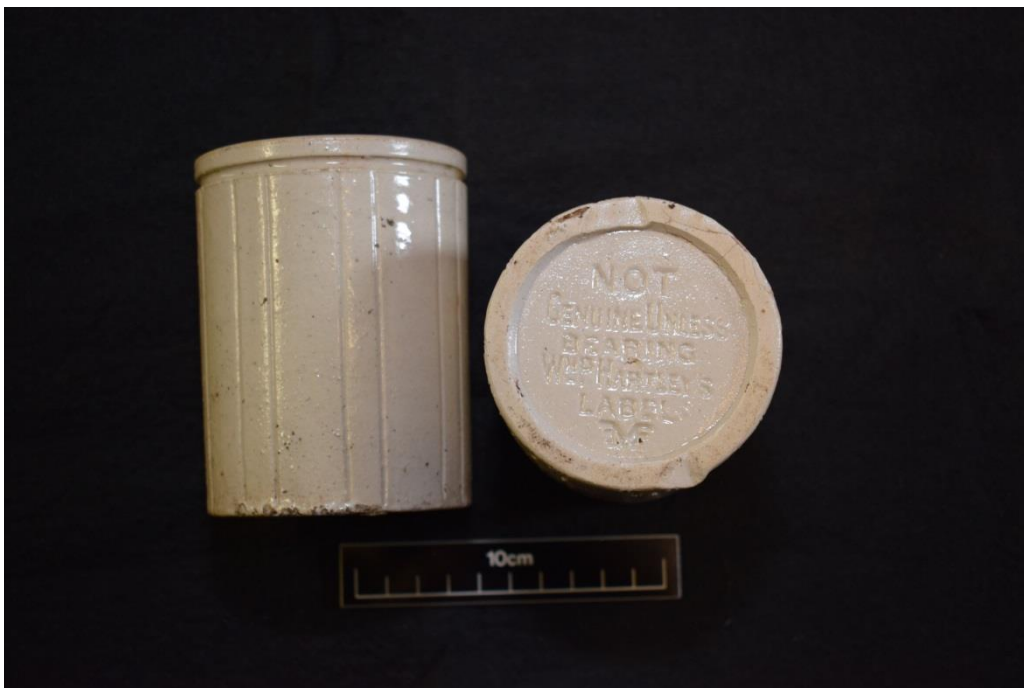
This covered deposit (117) which incorporated glass bottles, jam jars (Fig 56), pottery (Fig 58), corrugated iron and other metal rubbish, mixed with decayed

wood and what appeared to be broken window glass (see Fig 56). The material was notably voided. This mostly represents mid- to late-20th century rubbish, dumped on the site before the engine house was buried, though also incorporates some 19th century ceramics.

Figure 56: Hartley's jam jars (late 19th century) from Pit 5.

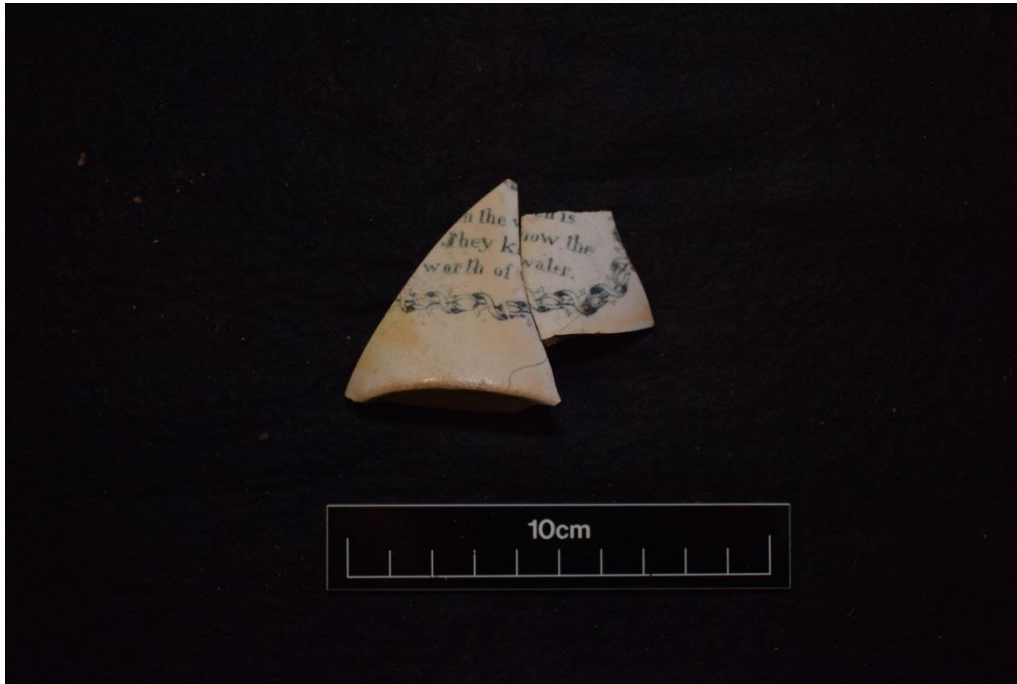
Excavation of this area produced substantial amounts of corroded ferrous material, some strips of lead sheet which appeared to have been used as pipe connectors, together with some copper-alloy objects, glass bottles and domestic china (Figs 57 and 60).

Figure 57: Pottery sherds from Area 3. This included one of Benjamin Franklin's popular 'Poor Richard' maxims: 'When the well runs dry they shall know the value of water'.
