Cook's Kitchen, Pool, Redruth, Cornwall: Archaeological Excavation of the Man-Engine House

Report No: 2018R023

Client	Western United Mines
Report Number	2018R23
Date	27 June 2018
Status	Final
Report authors	Ryan Smith and Adam Sharpe
Checked by	Dr Andy Jones
Approved by	Andrew Young

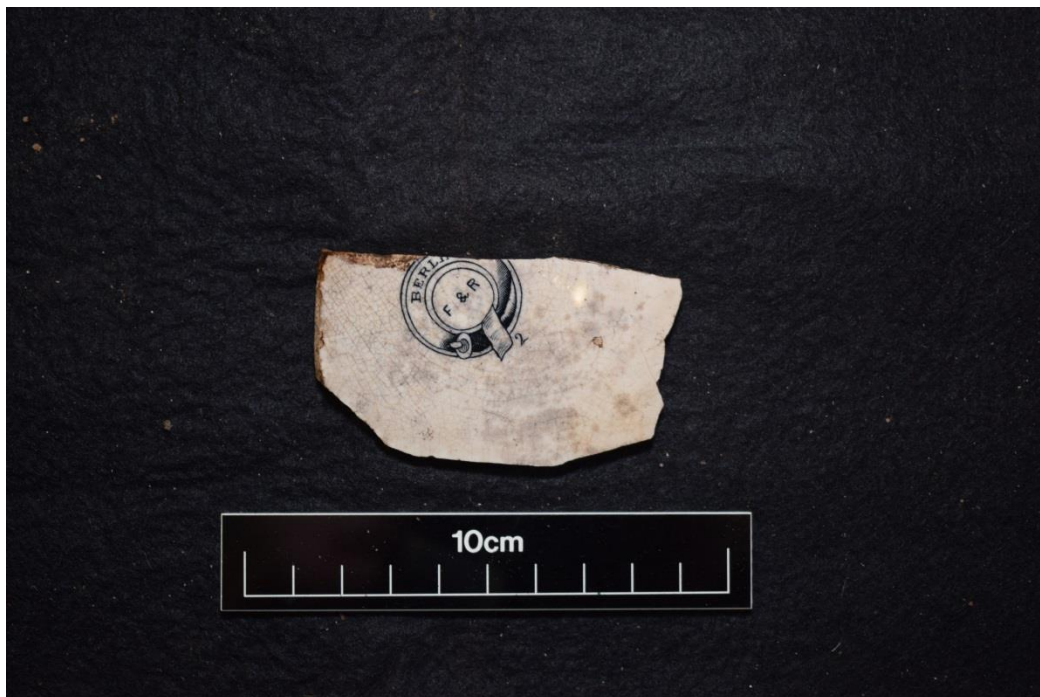
This covered deposit (117) which incorporated glass bottles, jam jars (Fig 56), pottery (Fig 58), corrugated iron and other metal rubbish, mixed with decayed

Figure 58: Pottery sherd from Pit 5. This was made at the Ford and Riley Pottery in Burslem, Staffordshire, between 1882 and 1893.

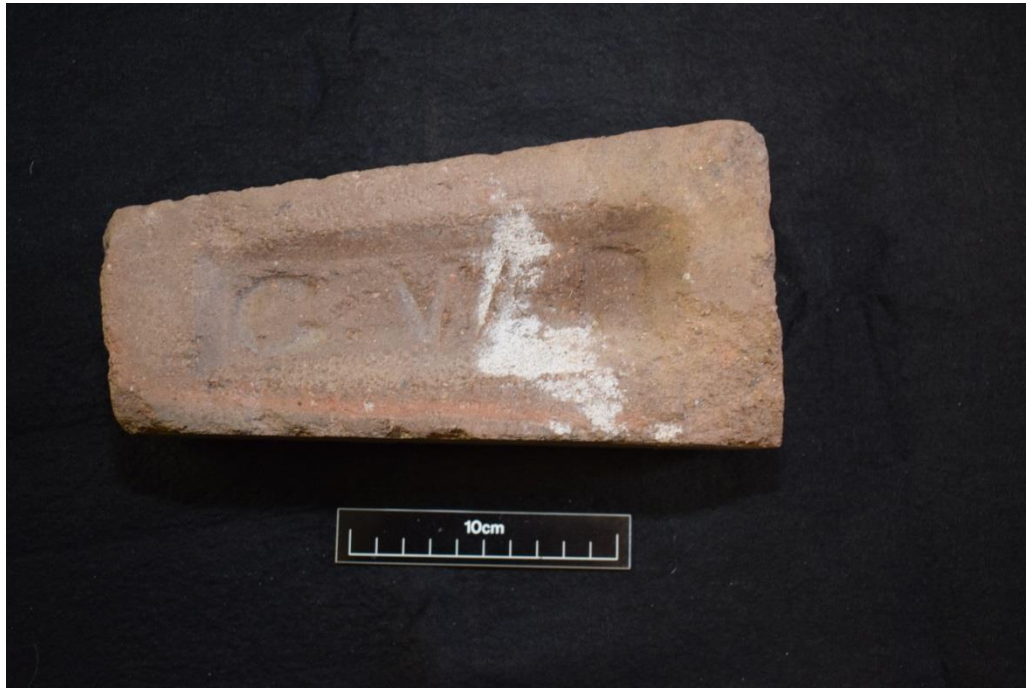
Figure 59: Chimney or side flue arch brick with 'GWR' stamp from the demolition rubble on the west side of the engine house.

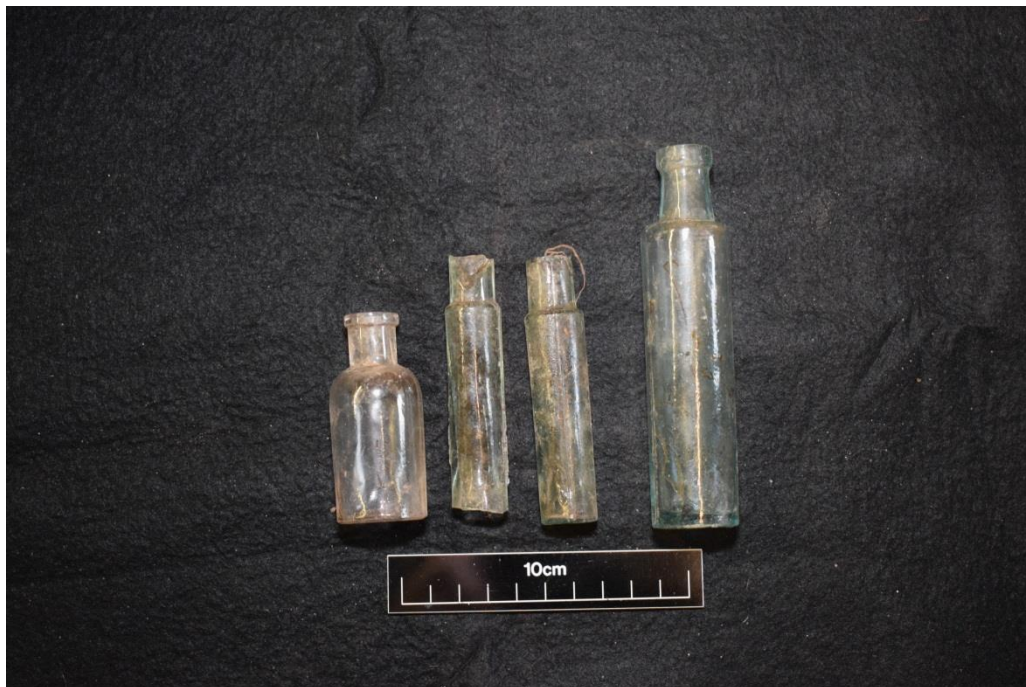
Excavation of this area produced substantial amounts of corroded ferrous material, some strips of lead sheet which appeared to have been used as pipe connectors, together with some copper-alloy objects, glass bottles and domestic china (Figs 57 and 60).

Figure 60: Selection of small bottles from the central part of Area 3.

(137)	Man-engine Upper fill of Area 3	The central and eastern part of Area 3 was infilled with (137) the demolition material found elsewhere within the engine house, for example (108). This incorporated pieces of corroded metal and a number of small glass bottles (Fig 60). It was mixed with (112).
