Pendennis Castle Signage, Falmouth, Cornwall Archaeological Watching brief

Client	English Heritage
Report Number	2018R030
Date	May 2018
Status	Final
Report author(s)	Carl Thorpe
Checked by	Charles Johns
Approved by	Andy Jones

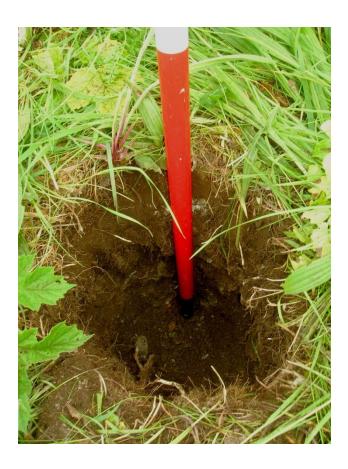
Figure 7. Sign 33, posthole after removal of old sign.

The profile recorded within the posthole consisted of 0.05m of grass, roots, and humic topsoil overlying 0.1m of grey-brown clay with a few stone fragments, and 0.45m of grey-brown clay with numerous stone fragments. This latter deposit was not bottomed.

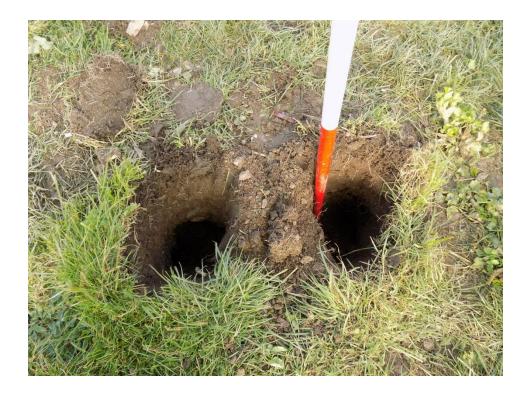
Figure 10. Panel 5, the postholes dug for the new panel.

Two postholes were dug to support this panel; each had a diameter of 0.2m and was 0.5m deep.

The recorded soil profile consisted of 0.05m of grass, roots and topsoil that overlay 0.15m of grey-brown clay loam, and 0.2m of yellow, grey-brown clay with stone fragments, and 0.1m of fragmented slate shillet bedrock, which was not bottomed. No archaeological features or finds were recorded.
