St Pinnock Churchyard wall,  
Cornwall  
Archaeological recording

# **St Pinnock Churchyard wall, Cornwall**

## **Archaeological recording**

<b>Client</b>	<b>CORMAC Consultancy</b>
<b>Report Number</b>	<b>2018R049</b>
<b>Date</b>	<b>August 2018</b>
<b>Status</b>	<b>Draft</b>
<b>Report authors</b>	<b>Ryan Smith PIfA and Adam Sharpe MIfA</b>
<b>Checked by</b>	<b>Dr. Andy Jones MIfA</b>
<b>Approved by</b>	<b>Andrew Young MIfA</b>
<b>Project number</b>	<b>146800</b>
<b>Site code</b>	<b>SP18</b>
<b>Data location</b>	<b>\\CAU\Archive\Sites\S\St Pinnock churchyard wall WB 146800</b>
<b>Historic England / ADS OASIS online reference</b>	<b>cornwall2-326221</b>

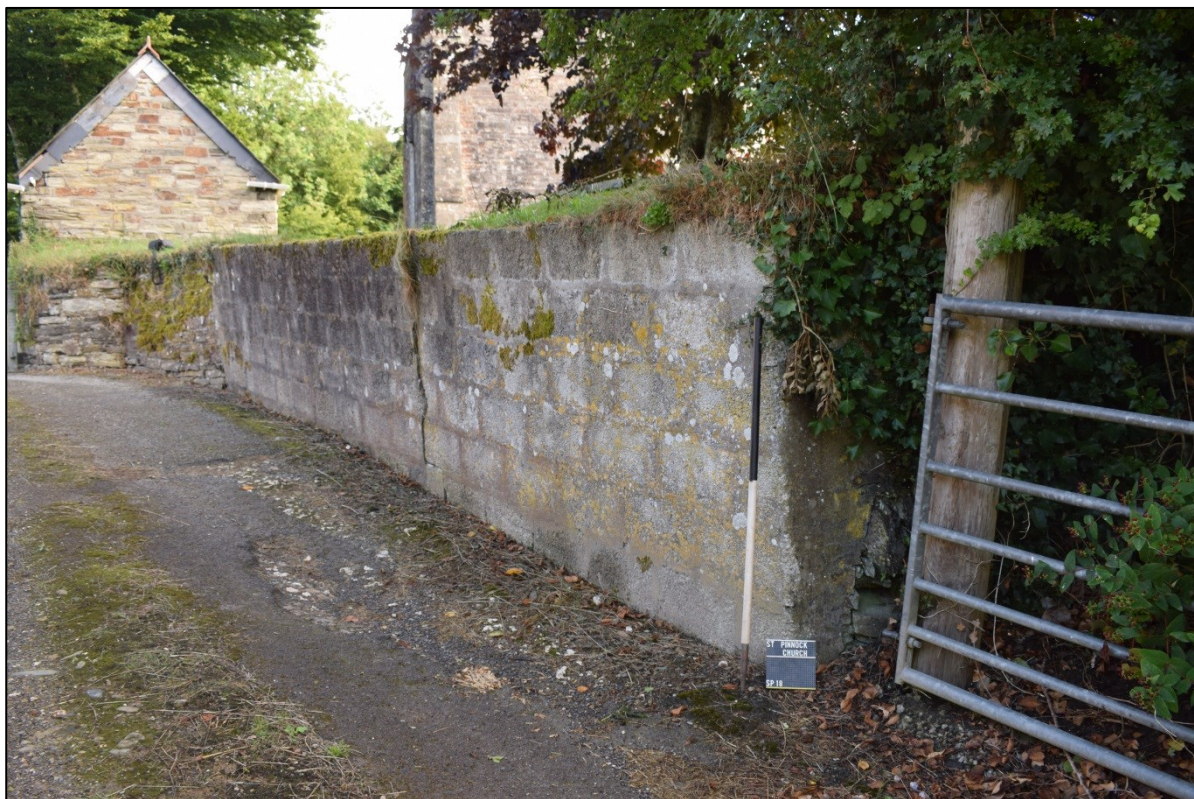
Figure 3: Pre-works view of the section of wall to be re-built. (1m scale looking north).

The removal of the blockwork wall **111** proceeded towards the southern end of the churchyard from the wall's north-western junction with the earlier stone walling **115** (Figs 10 and 11). After the removal of the blockwork, a 0.4m thick vertical slice of the material backing it was removed; this material was checked for artefacts and human remains. The top 0.4m of the standing section was then chamfered back at a 45 degree angle to ensure that this material remained stable during the construction of the replacement blockwork wall.

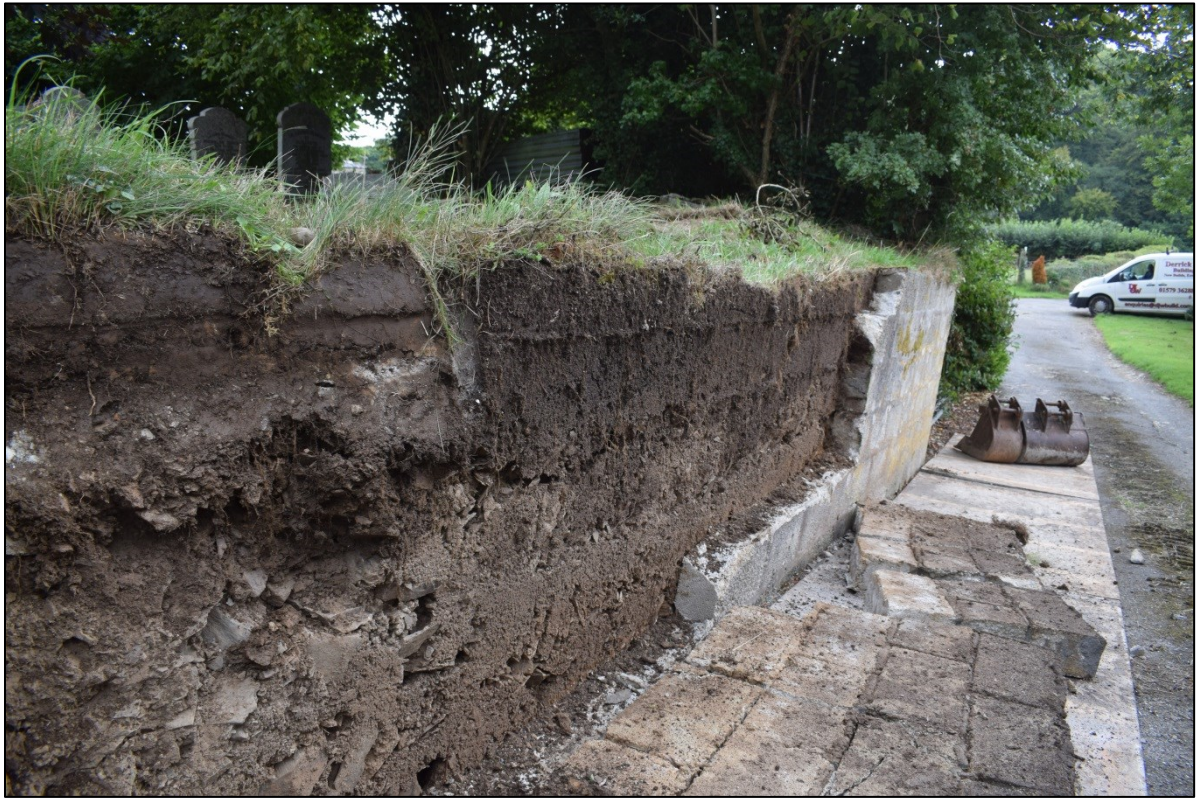
Figure11: Looking south-east after the removal of the north-western section of the wall.

The results of the watching brief are presented below north-west to south-east. See Figures 10 to 12 for views of the exposed section following the demolition of the blockwork wall and Figure 17 for the locations and extents of the archaeological contexts described below.

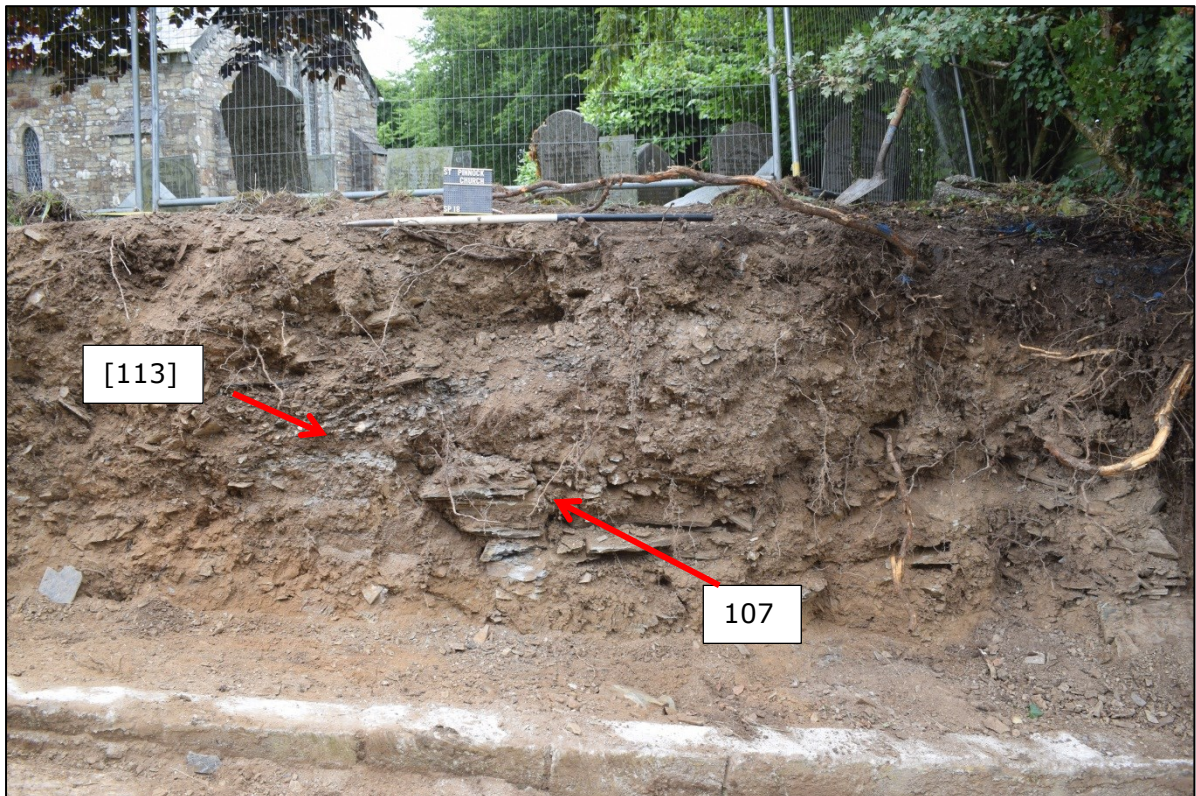
Figure12: Section showing cut [113] and possible wall 107. (1m scale).

Towards the south-eastern end of the standing section the exposed material changed to a greyish-brown, loose, very fragmented soil/shillet mix (**110**). This deposit might have been within a possible hollow [**113**] or reflect dumped material, as within the deposit there were three bands or tip lines of a greyish stony material comprising broken slate and gravel (**104**), (**105**) and (**106**). These were individually about 0.4m long and 0.1m deep, and each line sloped down toward the north-west. They overlaid a probable wall 0.4m high and 0.35m wide, **107** (see Fig 12) which was made up of eight pieces of flat stone. This mass of stone had a curving face to the north-west and a vertical edge to the south-east. To the south-east of this feature were two flat stones which appeared to have been laid randomly; the largest was 0.4m long and <0.05m thick.

Low wall **107** is likely to be the basal remains of a wall shown at this location on the 1840 and 1880 mapping (Figs 4 and 5), this being the southern wall of a small square enclosure abutting the churchyard. The wall had been demolished by 1908.

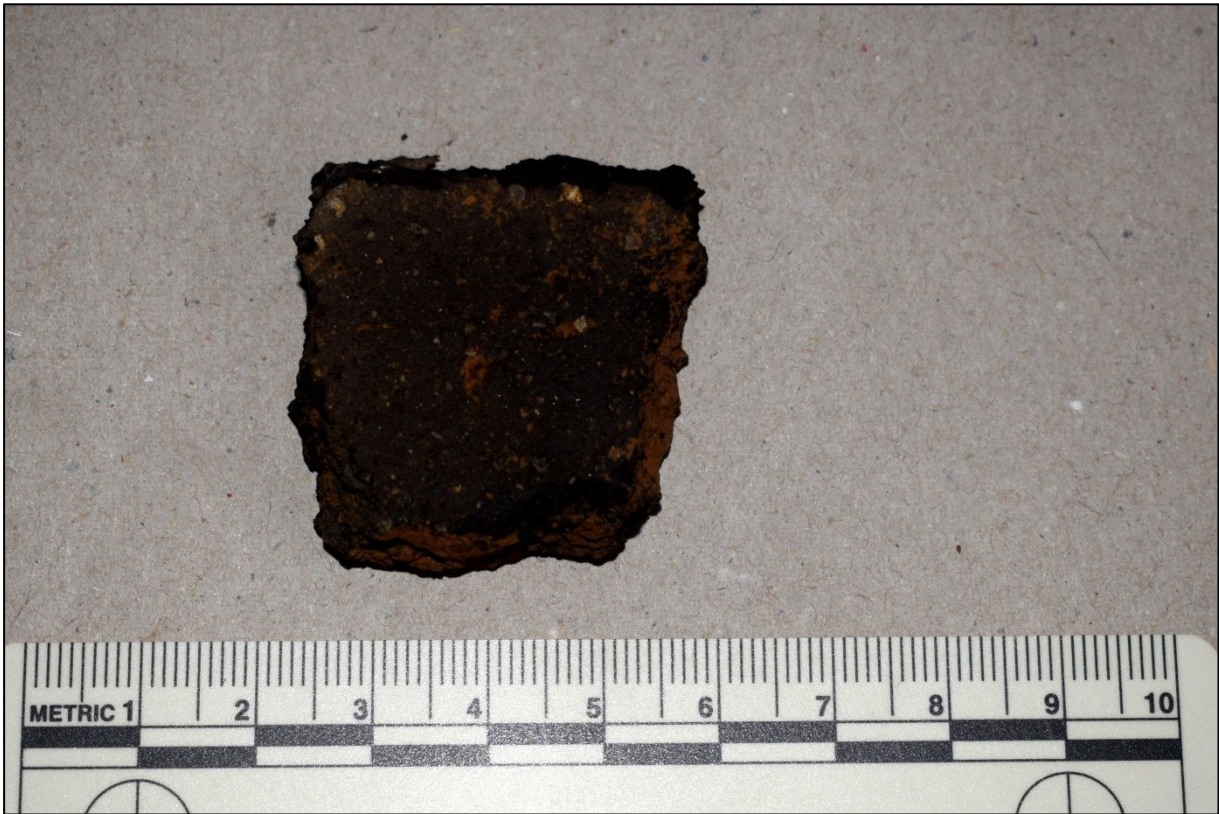
Figure13: Undiagnostic body sherd of medieval pottery (probably 11th -12th century).

The medieval period is represented by domestic pottery of 11<sup>th</sup> to 12<sup>th</sup> century and 13<sup>th</sup> to 14<sup>th</sup> century date (Figs 13 and 14), the earlier material apparently predating the construction of the first documented church on this site. Of broadly similar date are the pieces of 13<sup>th</sup> to 14<sup>th</sup> century ridge tile of which probably originate from the original church. Dating to the late medieval period is a ridge tile fragment of 15<sup>th</sup> to 16<sup>th</sup> century date which might have been part of the roof of the church which was rebuilt during that period. The post-medieval period is represented by domestic pottery dating to the 16<sup>th</sup>, 16<sup>th</sup>/17<sup>th</sup> century (Fig 15) and 17<sup>th</sup>/18<sup>th</sup> century, as well as four ridge tile fragments of 16<sup>th</sup>/17<sup>th</sup> century date which might indicate a phase of roof repairs during that period. The later material includes pottery of 18<sup>th</sup>/19<sup>th</sup> century date, glassware of 18<sup>th</sup>/19<sup>th</sup> and 19<sup>th</sup>/20<sup>th</sup> century date and a late 18<sup>th</sup> century clay pipe stem. The most modern material consisted of the base of a pre-1908 whisky bottle and a meat paste jar.

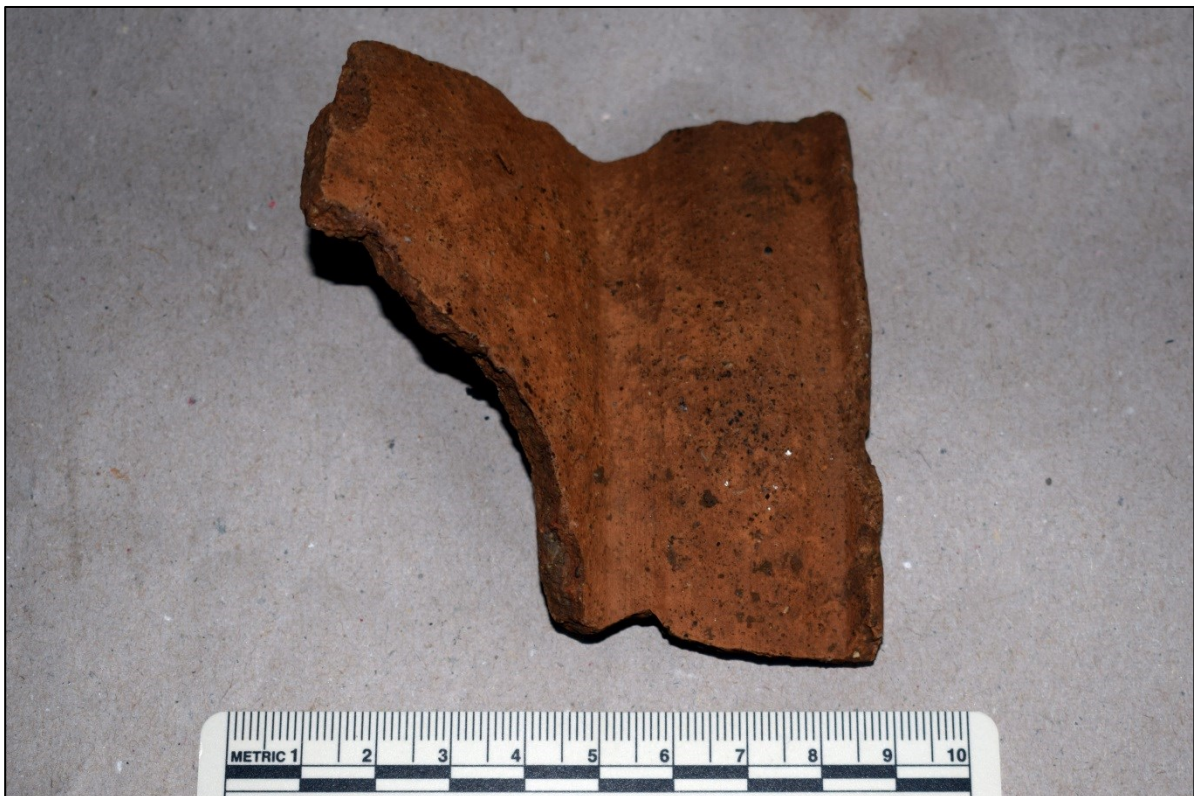
Figure 14: Rim sherd from a medieval coarseware cooking vessel 13<sup>th</sup> - 14<sup>th</sup> century.

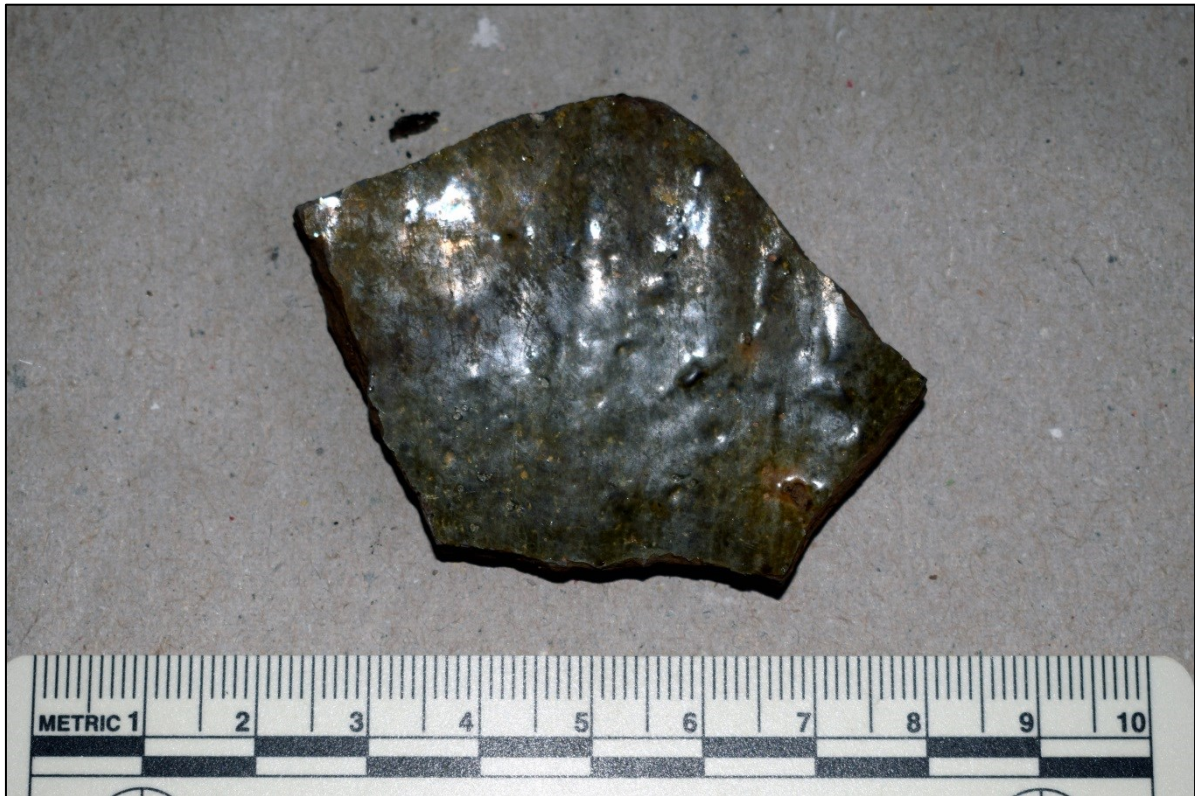
Figure 5: Undiagnostic body sherd Cornish Post-Medieval Coarseware (Lostwithiel Ware) 16<sup>th</sup> century).

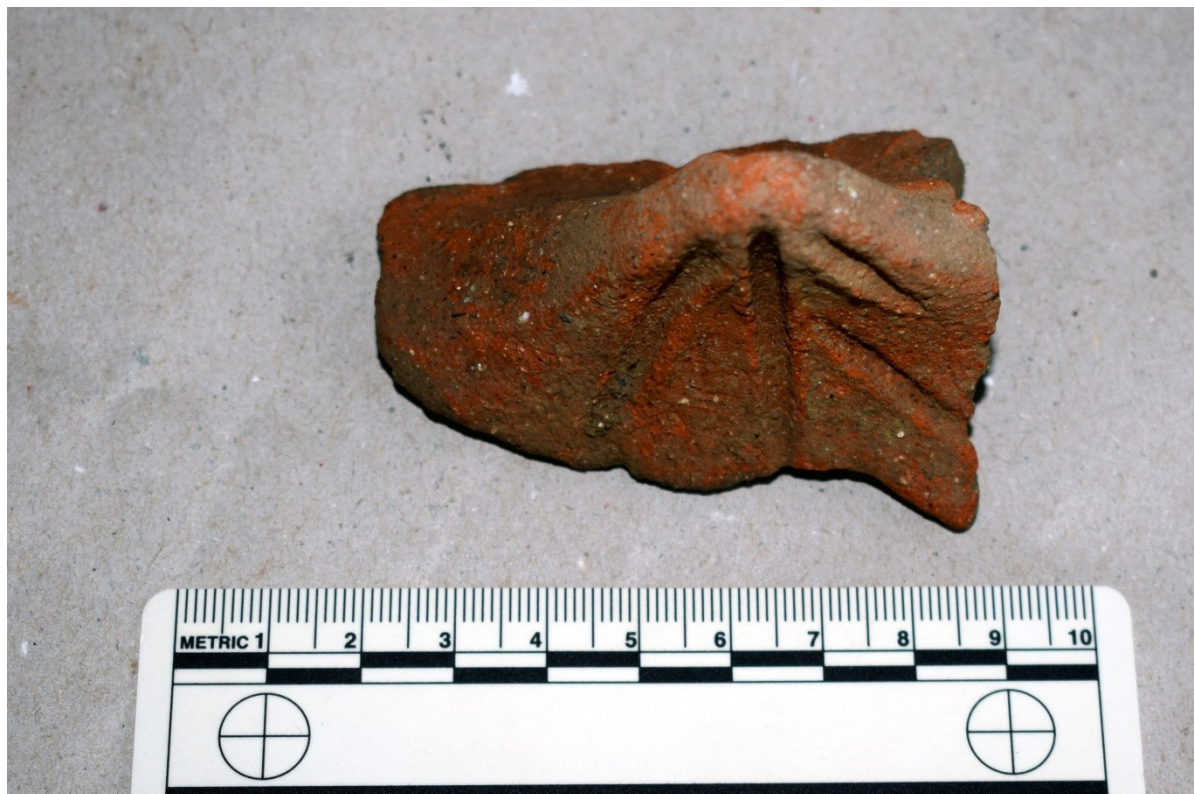
Figure 6: Ridge tile fragment. Prominent crest present with 'Christmas tree' decoration. 13<sup>th</sup> - 14<sup>th</sup> century.

Of particular interest are the ridge tile fragments which have been dated to the 13<sup>th</sup>/14<sup>th</sup> centuries (Fig 16), the 15<sup>th</sup>/16<sup>th</sup> centuries and the 16<sup>th</sup>/17<sup>th</sup> centuries. These suggest
