Barn Range at West Penstroda, Waterloo, Bodmin, Cornwall

Historic Building Record

Client	Tim Baker
Report Number	2018R055
Date	September 2018
Status	Final
Report author(s)	Jo Sturgess
Checked by	Andy Jones
Approved by	Andrew Young
Project number	146829
Data location	\\CAU\Archive\Sites\W\West Penstroda Barn Waterloo HBR 146829
Historic England / ADS OASIS online reference	cornwall2-328449
Planning reference	PA18 /01039

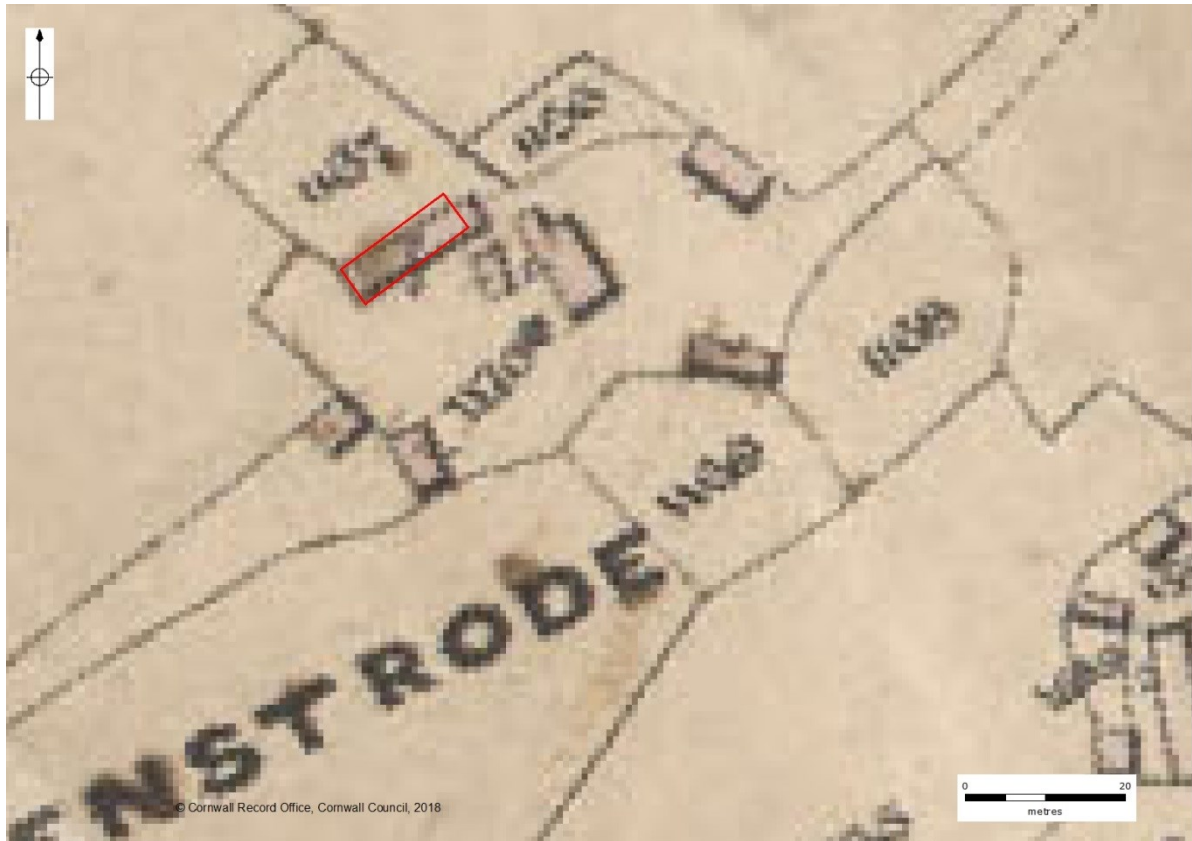
Fig 3 Blisland Tithe Map, 1839.

The Tithe map for the parish of Blisland dated 1839 (Fig 3) shows that two separate farmsteads within 'Penstrode' had been established by this date (the present West Penstroda and Penstroda Barn). The corresponding Tithe Apportionment shows that John Wallis still owned West Penstroda at this date, but that it was leased to William Axworthy and occupied by Richard Thomas. The Tithe map (Fig 3) shows that the shippon and threshing barn and adjoining store/calf house and pens had been constructed by 1839 and the Apportionment names the enclosed plot of land to the north-west of the buildings as a 'mowhay'. Both the design of shippon and threshing

barn and store/calf house and the quarry drill marks seen on some of the granite masonry indicate that these buildings date to the early 19th century and were probably built during the ownership of John Wallis. Interestingly the Tithe map shows the farmhouse on a north-south alignment with a separate building to the west. However, the farmhouse is now aligned east-west. This may suggest that a former south wing was removed and the original eastern part of the building extended westward to join the small western building shown on the Tithe map.

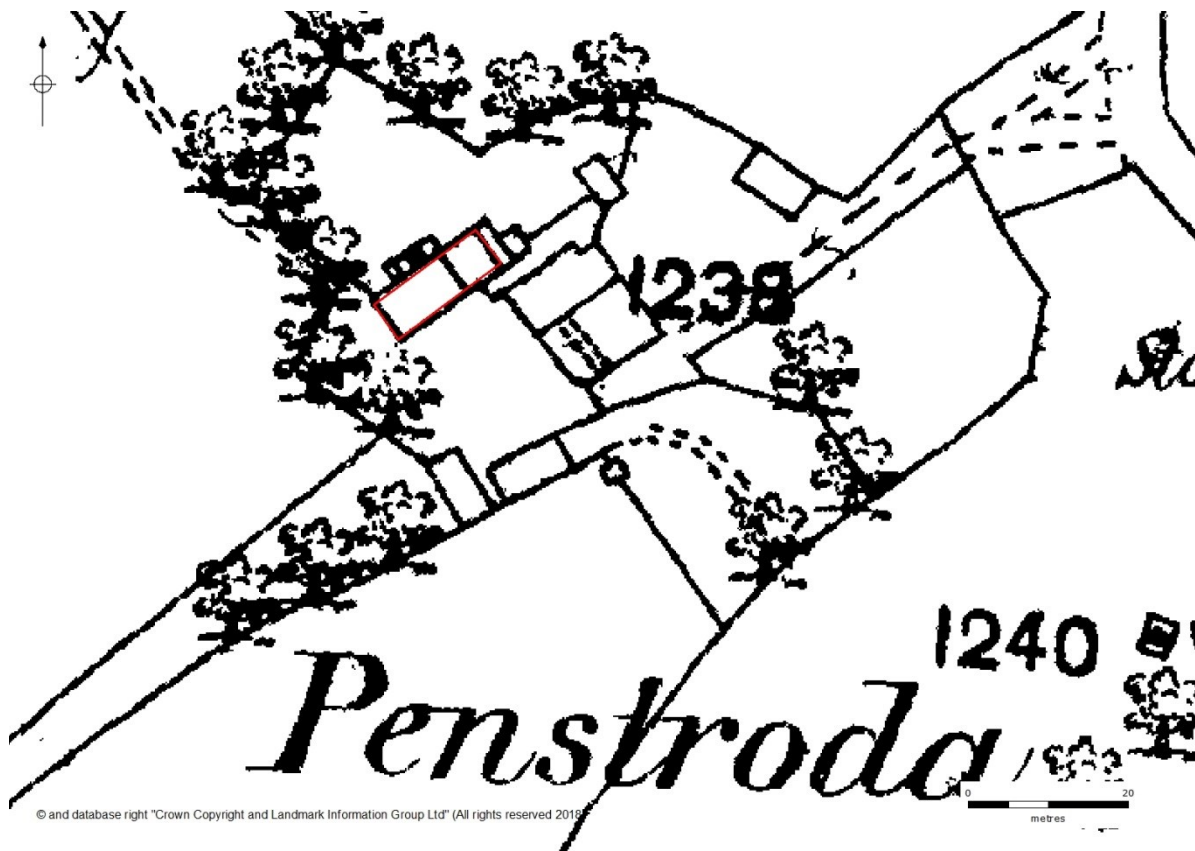
Fig 4 First Edition of the Ordnance Survey 25 Inch Map, c1880.

By the time of the first edition Ordnance Survey map of c1880 (Fig 4) the farmhouse existed on its present footprint. This map shows the barn range as two adjoining buildings with a narrow building attached to the north-east of the store/calf house and a small, yard on the north-east side of it. On the north-west side of the shippon and threshing barn the ramp is shown as a flight of steps. Symons' Gazetteer of 1884 lists 'Penstroda' as containing three tenements and a common (Symons' Gazetteer 1884 in Bond 2007).

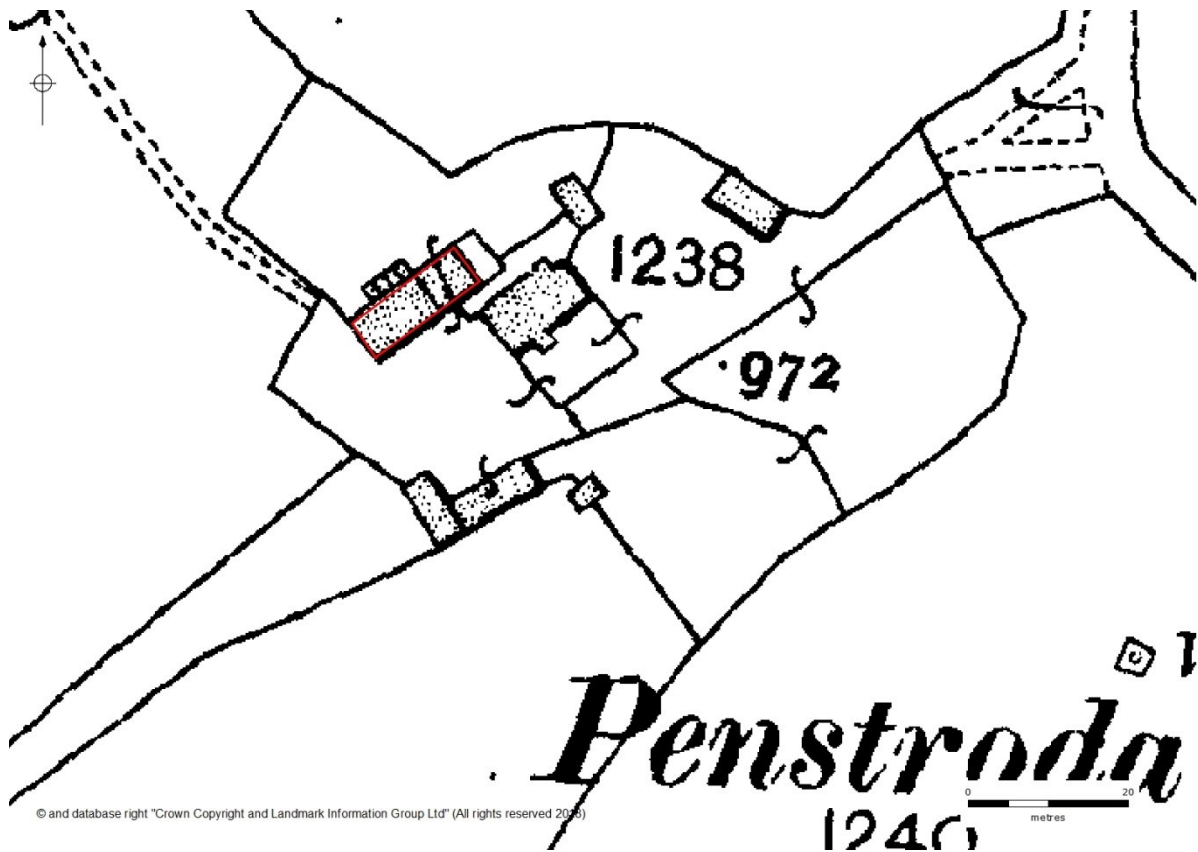
Fig 5 Second Edition of the Ordnance Survey 25 Inch Map, c1907.

The Second Edition OS map of c1907 (Fig 5) shows that little change had been made to the barn range since c1880. The shippon and threshing barn with its external steps and adjoining store/calf house appear unchanged, but at the north-east end a small, open yard is shown.

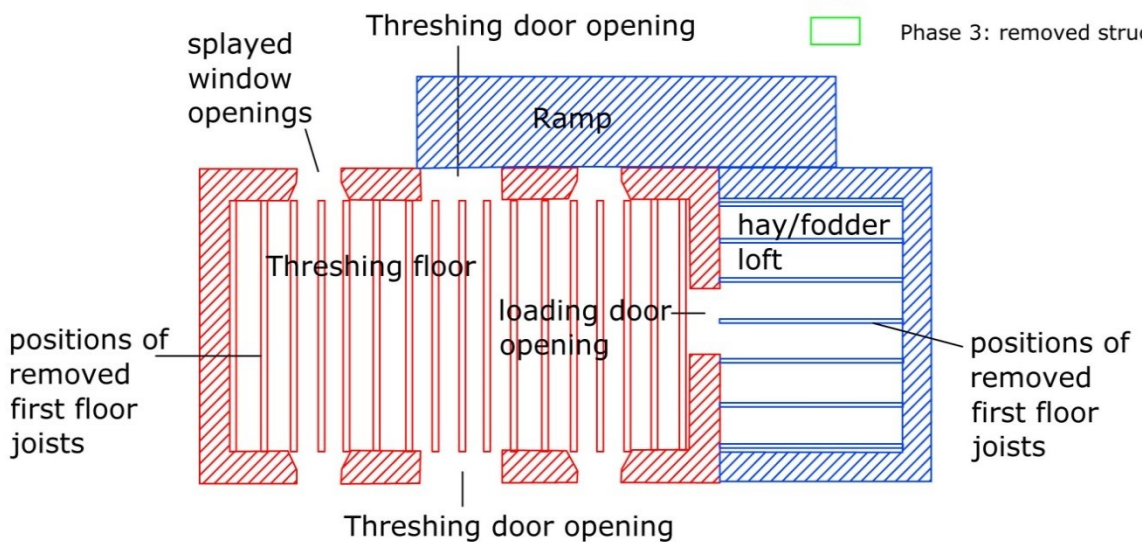
Fig 7 Ground and first floor annotated phase plans.

The interior of the shippon and threshing barn now stands as an open shell with no roof or first floor. The ground floor surface is now obscured by earth and grass and no evidence for the location of cattle stall divisions could be seen.

The ground floor, designed originally as a shippon, has splayed, slit ventilators in the rear (north-west) wall and three door openings in the front (south-east) wall, all with granite thresholds and iron pintles hinges on which the doors were hung. The internal timber lintels of the door openings do not survive. There are two drill holes either side of the double central door opening which presumably once held iron hooks for keeping the doors open. Between the north-eastern and central door openings there is a square recess approximately 0.15m² of unknown function. In the rear (north-west) wall and the north-east wall small iron hoops survive for tethering animals or hanging hay. In the two end walls (north-east and south-west) there are three stones that protrude from the wall surface (one to the north-east and two to the south-west). These may have been associated with securing the ends of the timber stalls.

The first floor was originally designed as a threshing floor with two opposing threshing doors in the front and rear elevations, and lit by two splayed window openings either side of the doors in both elevations. The rear threshing door was accessed via the stone ramp (formerly steps). The north-eastern window openings in both elevations retain their internal timber lintels. In the north-east end wall there is an original loading door/hatch, enlarged at during phase 2 to create a door opening when the store/calf house was added to the north-east so that access could be gained to its loft. Either side of this door opening there are two square recesses/sockets approximately 0.15m² of

unknown function. Although the threshing floor has been removed, sockets in the front and rear walls show that it was supported by 17 closely set joists, and a border of render approximately 0.25cm high in the walling immediately above indicates where the threshing skirting boards were fixed. No evidence could be seen at the tops of the walls for the location of trusses associated with the former hipped roof.

The interior of the store/calf house now stands as an open shell with no roof or first floor. The ground floor surface is now obscured by earth and grass and no evidence for the location internal divisions could be seen.

The ground floor, possibly designed originally as a calf house, has two opposing door openings which indicate that a feeding passage along the south-west side of the room may have existed. The door opening to the front (south-east) has a granite threshold and that to the rear (north-west) also has a granite threshold which steps up from the internal ground surface by 0.25m. The rear door opening has been blocked with granite rubble bonded with cream/beige earth mortar and also has remnants of cement pointing. The internal timber lintel of the rear door opening does not survive but the timber lintel in the front door opening does. In the rear (north-west) wall to the north-east of the blocked door opening a small iron hoop survives (possibly for tethering animals). In the two side walls (north-east and south-west) there are joist sockets showing that the loft floor above was supported by seven joists.

The first floor was originally designed in phase 2 as a hay/fodder loft. When it was added as an extension to the shippon and threshing barn, the existing phase 1 loading hatch/door in the north-east wall of the threshing barn was extended downwards to create a doorway which gave access directly from the phase 1 threshing floor into the phase 2 loft space. The enlargement of the lower section of the opening is clearly identifiable by its lack of dressed granite jambs. Either side of this door opening the former, pitched roof line of the store/calf house is visible as two lines of cement, with the apex reaching the top of the lintel of the loading hatch/door. On the south-east pitch line some lead flashing survives.

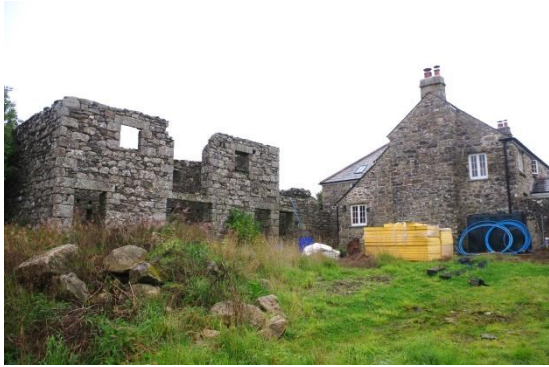
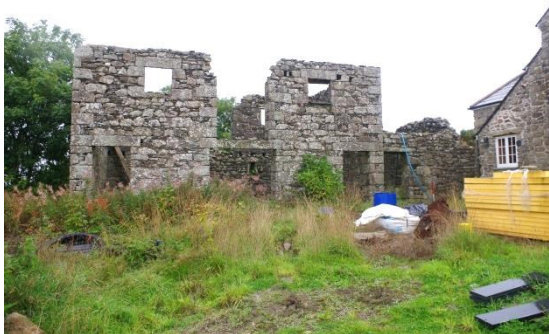
Fig 9 South-east (front) elevation of barn range.

The front elevation has three original door openings at ground floor level giving access to the shippon. The two door openings at either end are standard in size but the central opening is double width and once held double doors evidenced by the surviving iron pintles hinges on both jambs. Iron pintles hinges also survive on the south-west jamb of the south-west door opening and the north-east jamb of the north-east door opening. Each of the door openings has a large, dressed granite lintel and that over the central double door opening contains quarry drill marks of c2.5cm diameter.

At first floor level there are two window openings either side of a central, wide threshing door opening. Granite lintels survive over the two window openings but the lintel and walling above the door does not. Two square recesses are located high up, to the south-west of the north-eastern window opening and another two to the north-east of it. It seems likely that these are pigeon holes.

At the north-east end of the wall the granite quoins survive from the ground up to the top of the wall, and a straight joint is visible where the top of the store/calf house wall has been built up against them. Only the granite lintel of the store/calf house door opening has been tied into the quoin of the shippon and threshing barn.

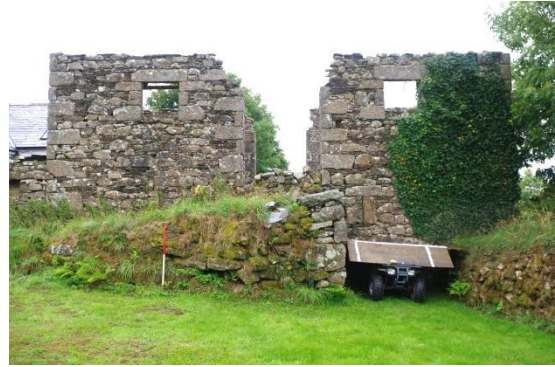
Fig 13 North-west (rear) elevation of shippon and threshing barn.

The rear elevation of the shippon and threshing barn now has a granite rubble ramp built up against its lower half. As indicated by the c1880 and c1907 OS maps this was probably once steps, but now the top surface is overgrown it is difficult to say if the steps survive below the earth and vegetation. It seems possible that this feature added

at a later date since it now appears to partially cover an original slit ventilator in the shippon wall.

At ground floor level in the rear wall there are two slit ventilators, airing and lighting the shippon. That to the north-east (as described above) is partially obscured by the rubble-built ramp. At first floor level there are two window openings either side of a central, wide threshing door opening. Granite lintels survive over the two window openings but the lintel and walling above the door does not survive.

The south-west end of the wall is now obscured by ivy and the quoin here is abutted by a Cornish hedge which encloses the mowhay to the north-west.

At the north-east end of the wall the granite quoins survive from the ground up to the top of the wall, and a straight joint is visible where the top of the store/calf house wall has been built up against them. Only the granite lintel of the store/calf house door opening has been tied into the quoin of the shippon and threshing barn.

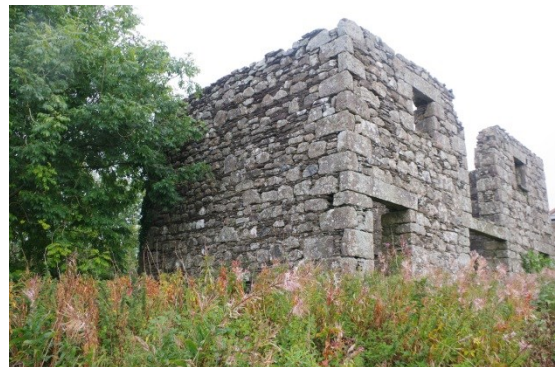
Fig 14 South-west elevation of shippon and threshing barn.

There are no features or openings in the south-west, end elevation, but the walling survives to full height.

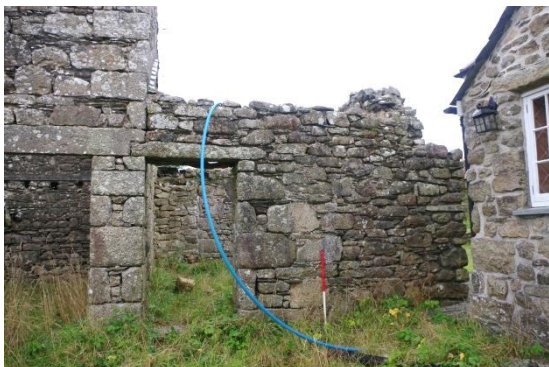
Fig 11 South-east (front) elevation of shed/calf house.

The front elevation has an original door opening at ground floor level giving access to the store/calf house. The fact there is a blocked door opening directly opposite in the rear wall suggests that both doors may have given access to a feeding passage along the south-west side of the ground floor, which indicates its possible use as a calf house. The granite lintel over the door opening has been cut into the quoin of the shippon and threshing barn and contains quarry drill marks of c2.5cm diameter, which indicate an early 19th century date. The walling above the lintel abuts the quoin of the shippon and threshing barn and has not been tied in. There are no other openings in this wall, but a scar to the north-east of the door opening shows the location of a removed section of walling which once abutted the building. The quoin at the north-east end of the wall is constructed from random rubble.

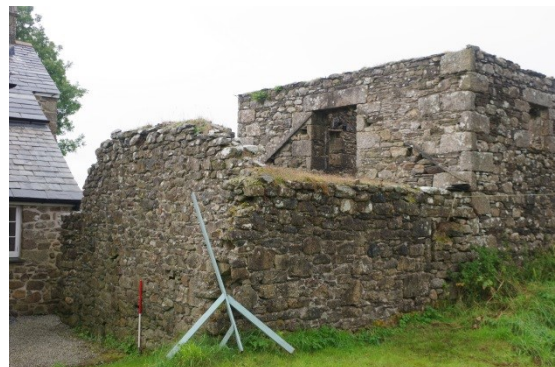
Fig 15 North-west and north-east elevations of threshing barn and shed/calf house.

This elevation was constructed originally as an external elevation. There are no openings at ground floor level, but at first floor level there is an original loading hatch/door opening with dressed granite lintel and jambs. The granite jambs reach down to approximately 1.5m below the lintel, but the opening was extended downwards by another 0.5m when the store/calf house building was added to the north-east to give access from the threshing barn to the store/calf house loft. The location of pitched roof line of the store/calf house is now visible as a cement scar on the north-east elevation of the threshing barn, with its apex located at the top of lintel over the loading door/hatch. Attached to the top of the wall there are three iron brackets that once supported the guttering.

This is the gable end of the store/calf house. There are no features or openings in this elevation and the apex of the gable has collapsed. At the north-west end a section of walling which once formed the north-west wall of the lean-to extends at right angles from the gable for a distance of 1.6m, where it has been truncated.

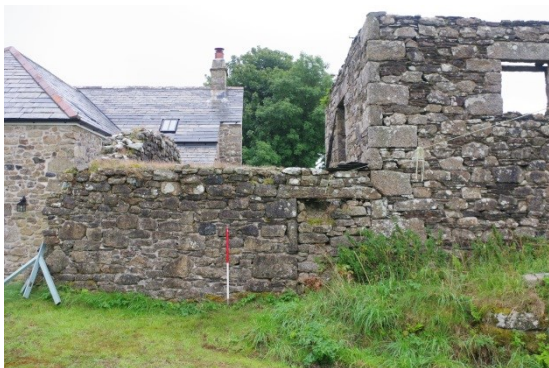
Fig 12 North-west (rear) elevation of shed/calf house.

The rear elevation of the store/calf house contains a blocked door opening directly opposite that in the front wall (possibly originally giving access to a feeding passage). The granite lintel over the door opening has been cut into the quoin of the shippon and threshing barn, and the walling above the lintel abuts it. There are no other openings in this wall, but at the north-east end the walling continues as a single build beyond the gable end of the store/calf house where it has been truncated. This indicates that the former lean-to structure (possibly a piggery) beyond was part of the same construction phase.

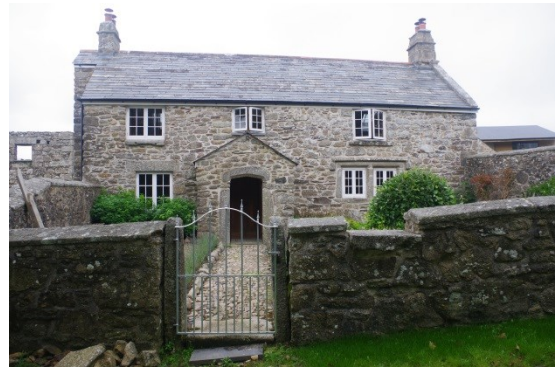
Fig 26 South-east elevation of farmhouse with barn range to rear left.

The farmhouse at West Penstroda is a Grade II Listed Building and the barn range which lies immediately to the west is within its curtilage (Fig 26).
