# **Weir at Allansford, Advent, Cornwall**

## **Historic Building Record and Watching Brief**

<b>Client</b>	Westcountry Rivers Trust
<b>Report Number</b>	2018R060
<b>Date</b>	December 2018
<b>Status</b>	Final
<b>Report author(s)</b>	Jo Sturgess
<b>Checked by</b>	Adam Sharpe/ Andy Jones
<b>Approved by</b>	Andrew Young
<b>Project number</b>	146827
<b>Data location</b>	\\CAU\Archive\Sites\A\Allensford Weir record and WB 146827
<b>Historic England / ADS OASIS online reference</b>	cornwall2-336231

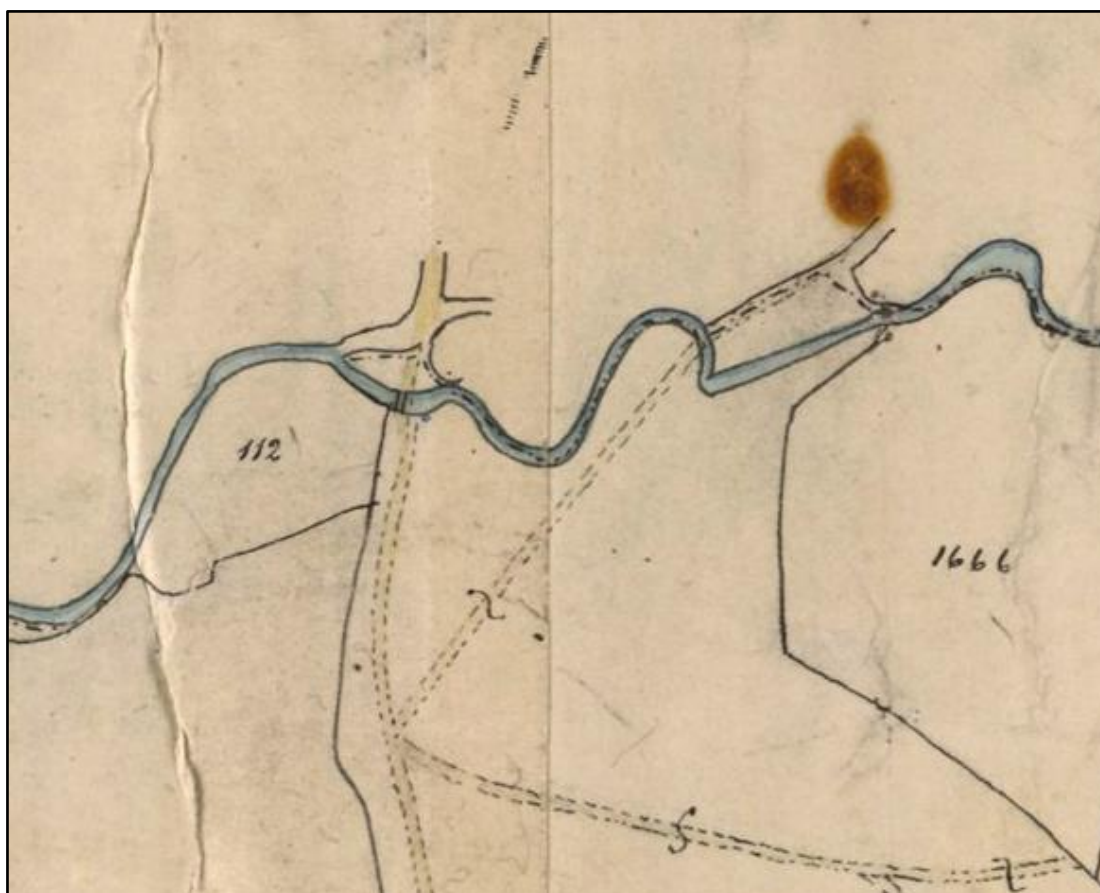
Fig 4 Tithe Map for the parish of St Breward, c1840.

Martyn's map of 1748 indicates that the settlement of Allansford existed at this date and also shows the road crossing the river here, suggesting the presence of at least a ford in the 18<sup>th</sup> century. It is possible that a weir had also been constructed by this date to enable a safer ford crossing. Martyn's map also shows the river marked as the 'River Allan'. The OS map (1 inch to 1 mile scale) surveyed in 1805 is not very detailed but also shows the road crossing the river at this date. By c1840 the settlement had become known as Allansford, and it is shown as such on the Tithe Map in the parish of Advent (Fig 3). The Tithe Map for the parish of St Breward c1840 (Fig 4) depicts what is probably a footbridge crossing the river alongside a ford crossing at this time.

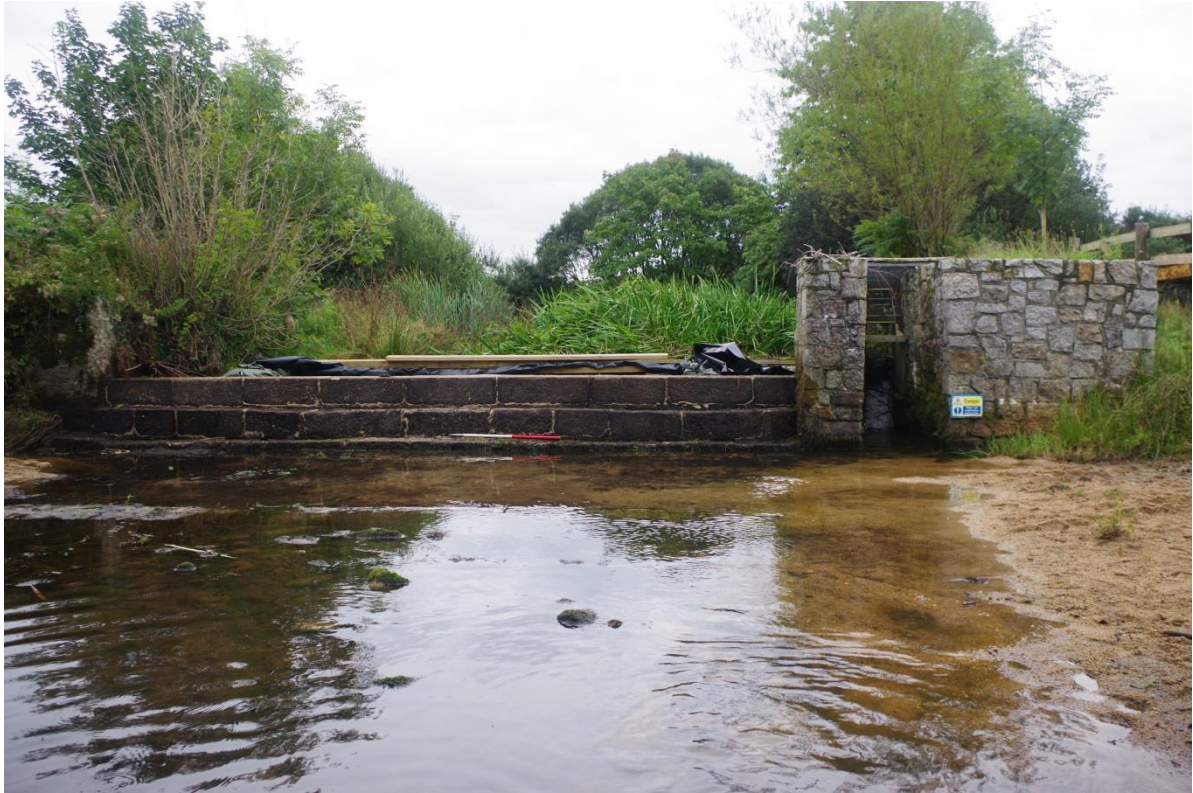
*Fig 7 View of the weir and fish pass looking east.*

The present weir is aligned north-south across the river and demonstrates clear evidence for its complete reconstruction during the 1960s. Adjoining the left hand side (south end) of the weir and adjoining the southern bank of the river a modern (c1991) Alaskan A fish pass has been inserted (see Figs 7, 8, 10, 12 and 19).

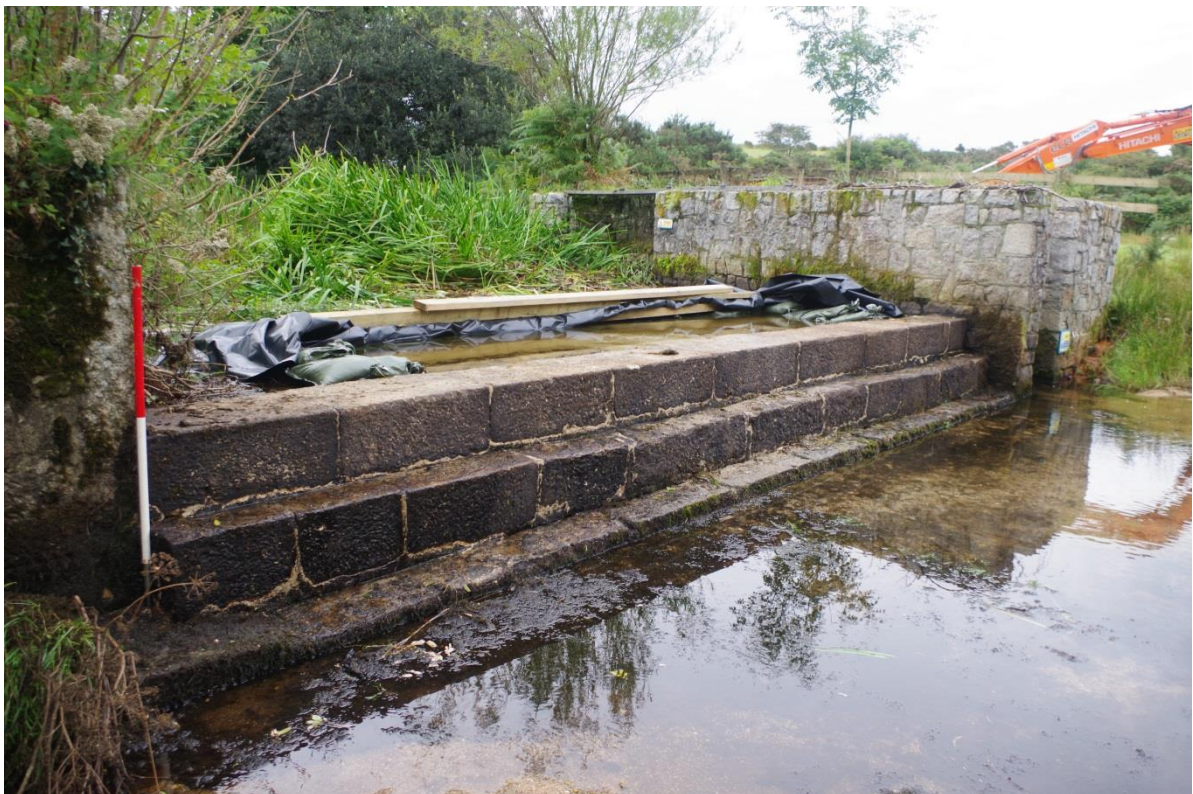
*Fig 8 View of the weir and fish pass looking south-east.*

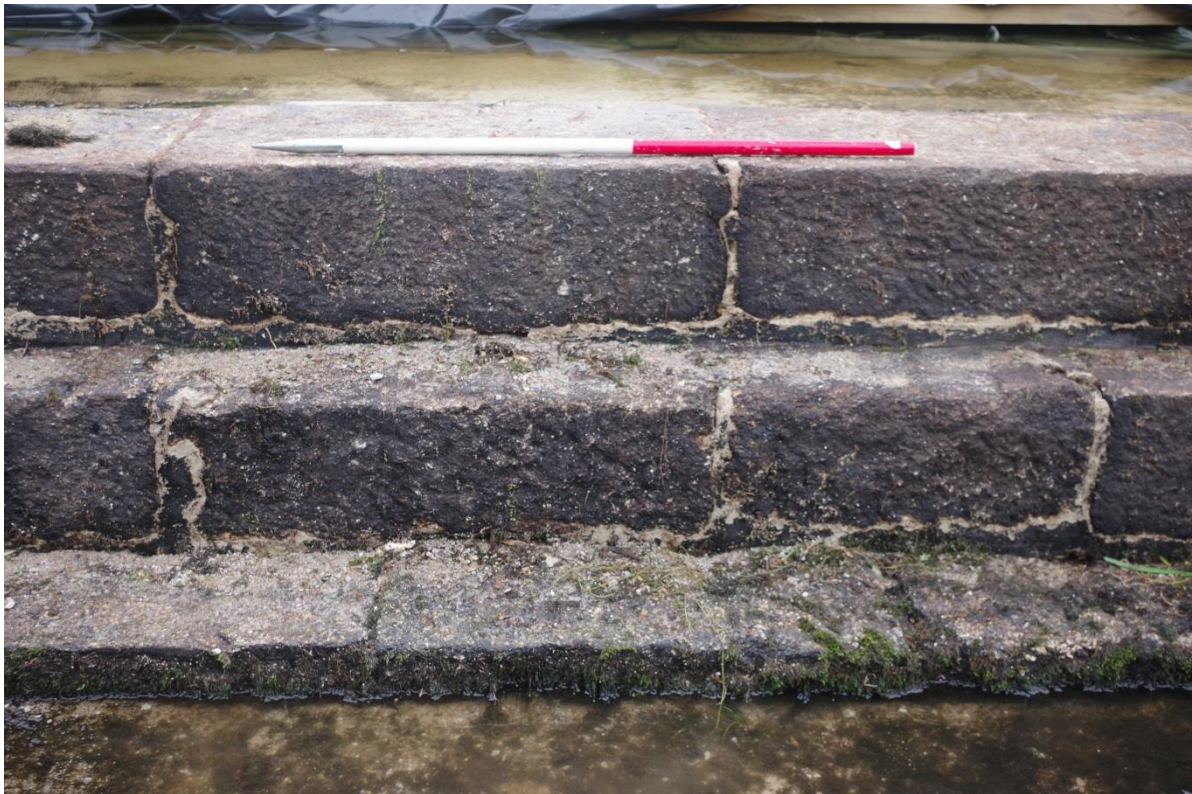
*Fig 9 Detail of stepped, reused granite blocks.*

The weir is constructed in three stepped courses of granite blocks with the steps facing west, downstream. Abutting the west (downstream) side of the lowest course a poured concrete slab approximately 0.2m deep and 3m wide has been laid to create a solid surface for a ford crossing the river on the weir's downstream side. Forming the western edge of the concrete surface is a single course of long, roughly faced, granite blocks which have been laid to create an edge for the poured concrete. These blocks bear early or mid 19<sup>th</sup> century drill marks (approximately 2.5cm wide) which were created when they were first quarried; the stones' original use is unknown. Abutting the east (upstream) side of the weir is another area of poured concrete which extends the full height of the structure and for a distance of approximately 2m the east (upstream). The total height of the weir is approximately 0.8m and the top of the structure is just slightly higher than the riverbed upstream to the east. The weir is constructed from reused, later 19<sup>th</sup> century, squared granite blocks dressed on their outer faces with a pecked surface. Quarry drill marks identified on a couple of the blocks were approximately 1.5cm wide, indicating that they were quarried in the later part of the 19<sup>th</sup> century. The fact that the granite blocks had been reused was evidenced by the fact that they were bonded with concrete and some of the dressed faces were set against the poured concrete retaining slab to the east (upstream). In the upper two courses the granite blocks measured on average 0.5m deep by 0.35m high with varying lengths. In the lowest course the granite blocks were of much the same dimensions as those in the upper courses, measuring on average 0.5m deep by 0.31m high.

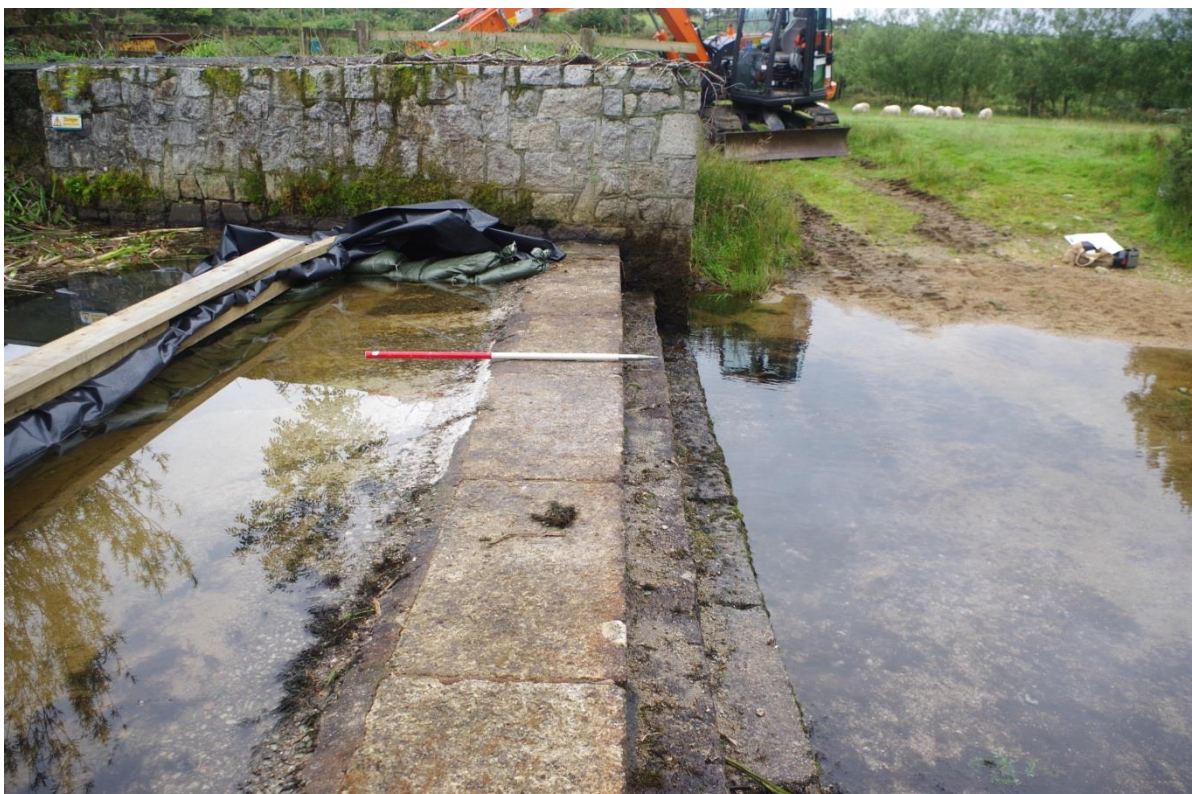
*Fig 10 View of the weir and fish pass looking south.*

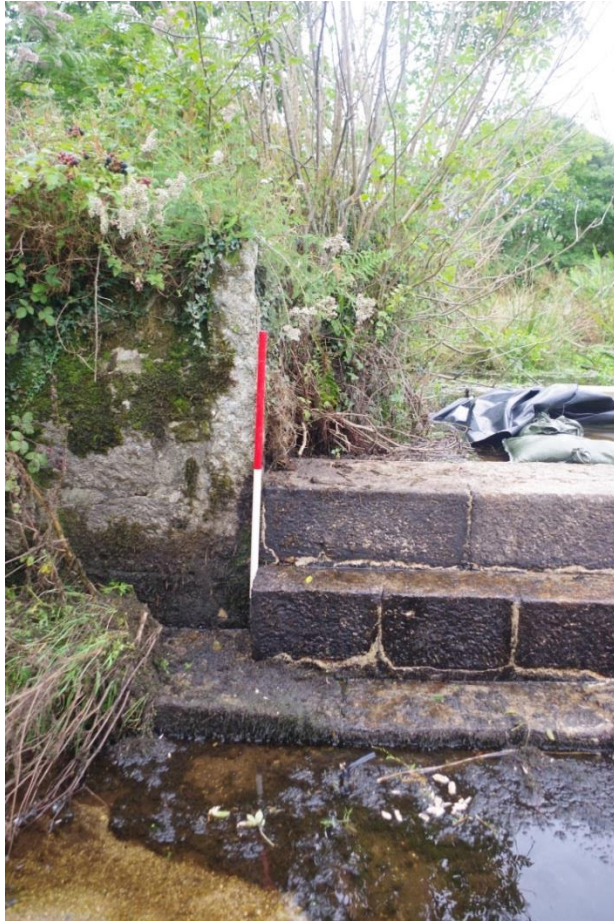
Fig 11 North end of the weir adjoining short length of wall.

At the right hand side (north end) of the weir a short section of walling extends approximately 1.5m up the river bank in line with the weir (see Fig 16). It is built from granite rubble and has been repointed with a cement mortar. At its south end, where it adjoins the weir, there is an upright granite post which has wide quarry drill marks indicative of an early to mid 19<sup>th</sup> century date.

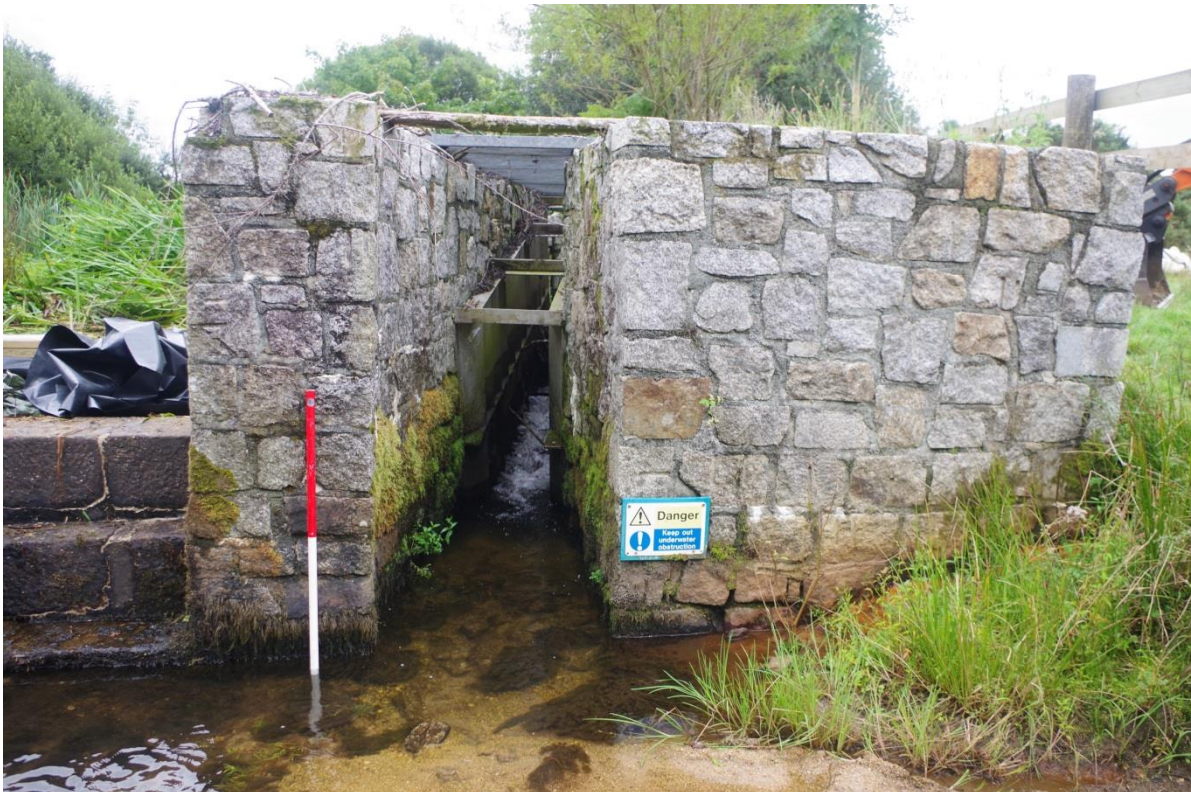
Fig 12 View of the fish pass looking east.

At the left hand side (south end) of the structure and adjoining the southern bank of the river a modern Alaskan A fish pass has been inserted (see Figs 9, 11, 14 and 15). This walled structure is built from granite blocks bonded with a modern cement mortar.

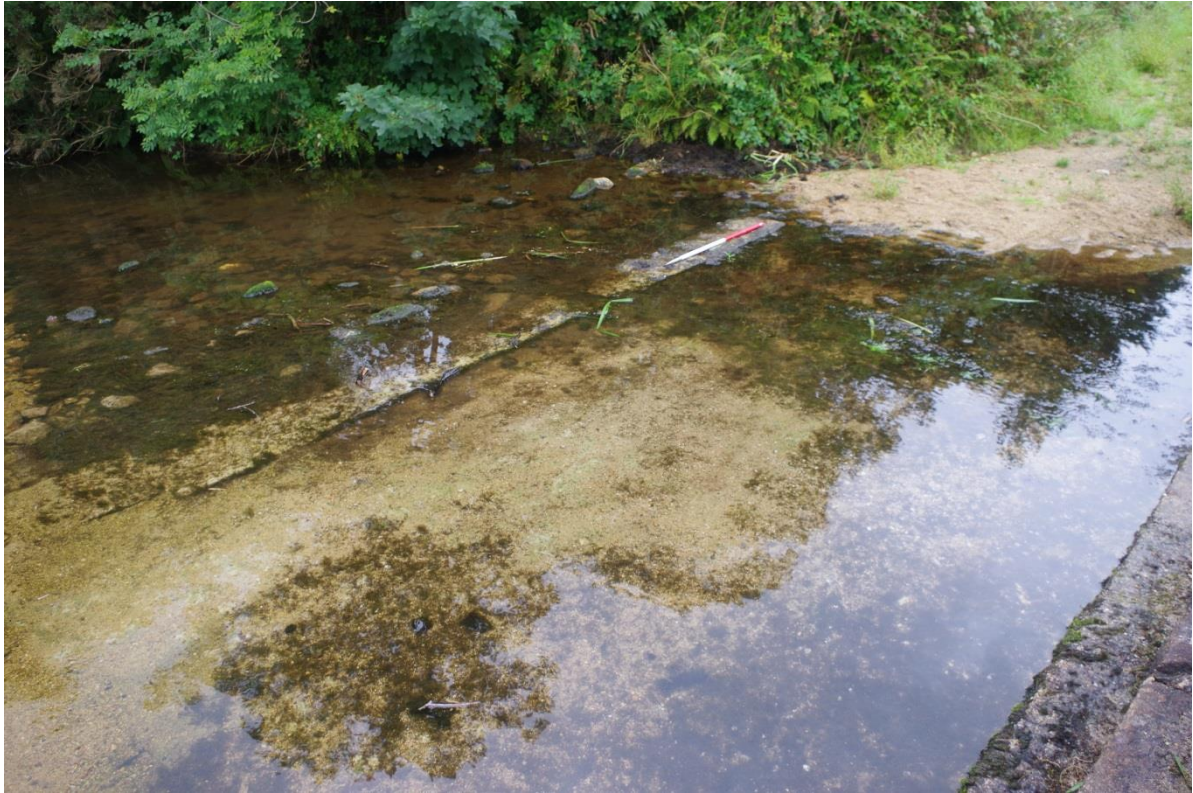
Fig 13 View of the ford looking north-west.

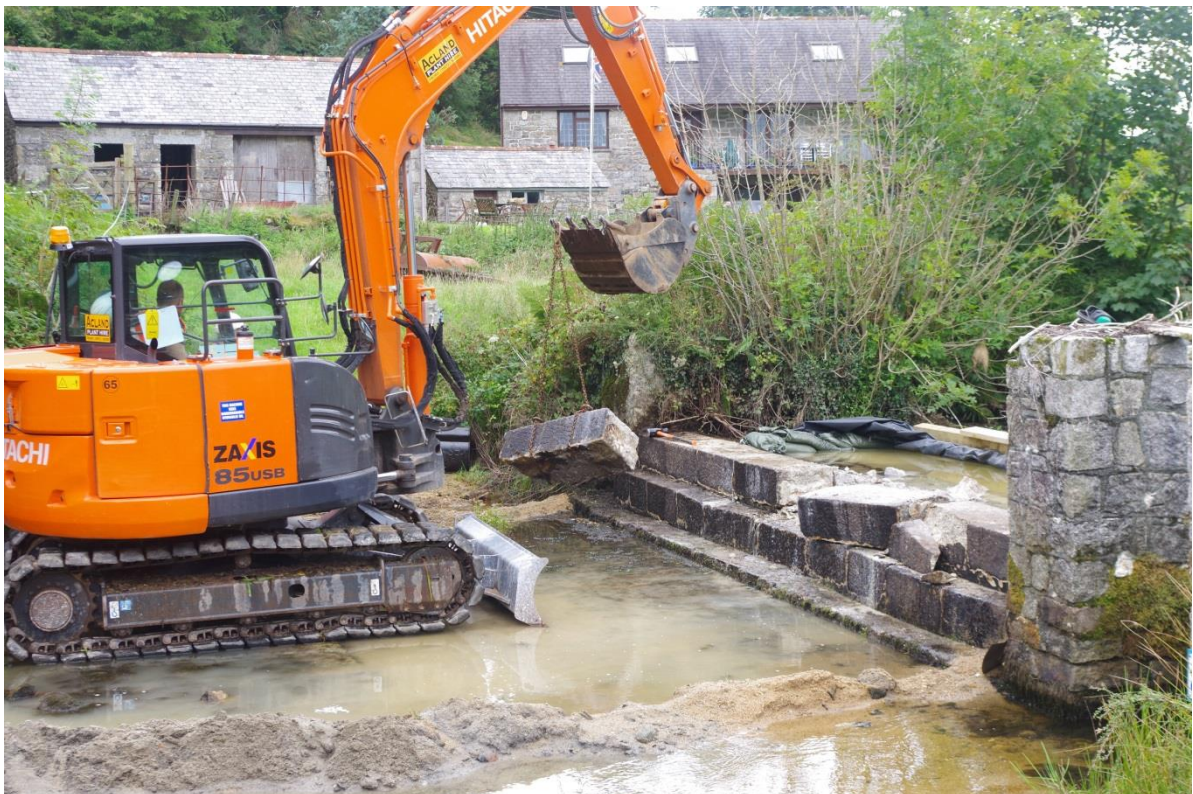
Fig 14 View of the weir during partial demolition looking north.

- The removal of the top stone course of the weir besides a couple of blocks left at both ends.
- The removal of the central section of the lower two courses of the weir to form a central notch to act as a fish pass, this notch was continued to both the east and west, through the concrete slabs on either side. The slab to the east (upstream) was stepped down from its outer edges towards the deeper central notch and the slab to the west was taken down 0.2m in a dish shaped profile.

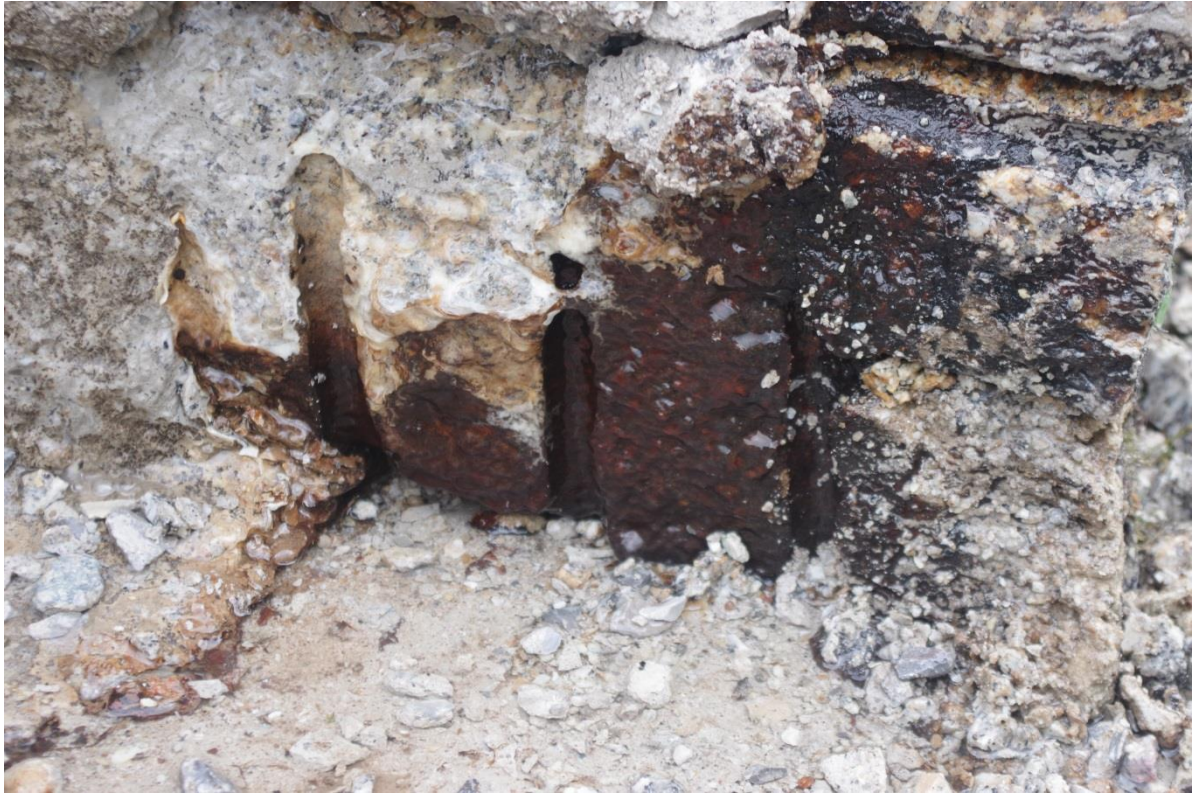
Fig 15 Narrow, late 19<sup>th</sup> century drill marks in a reused granite block of the weir.

Quarry drill marks on some of the granite blocks, which were taken from the earlier weir and reused to construct the present weir, indicate a late 19<sup>th</sup> century construction date for the original weir. The first historic map to show a weir at this location is the 1<sup>st</sup> edition OS 25 inch map of 1881-2 (Fig 5), so it seems likely that the original weir was built just a few years before the OS map was produced.

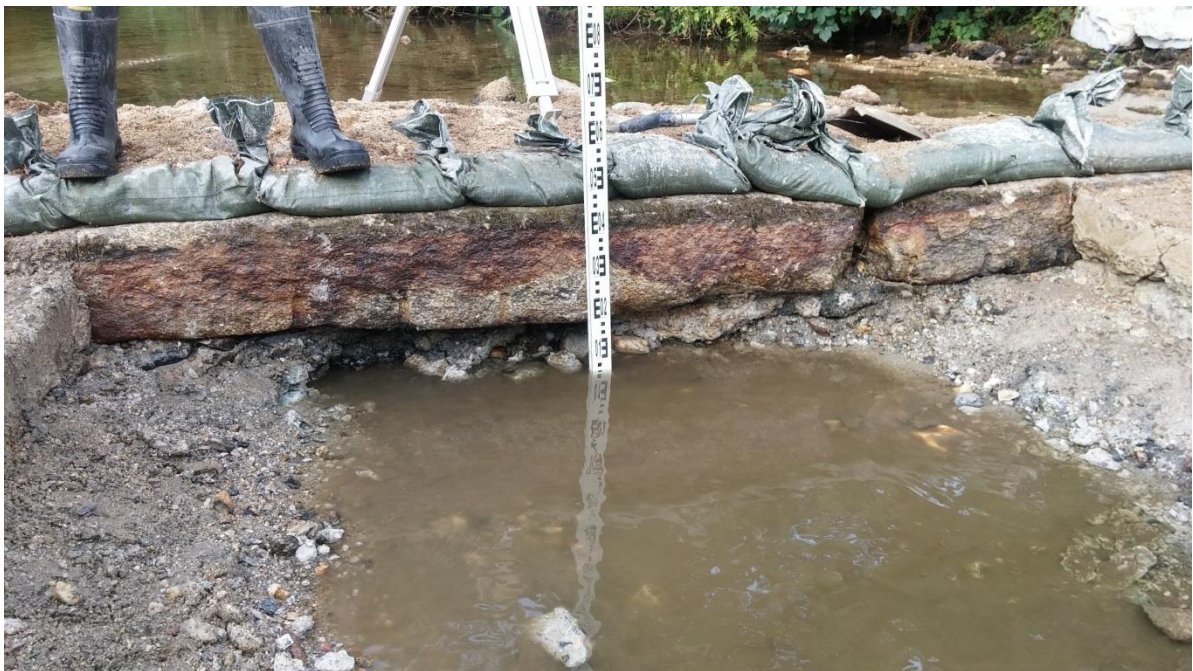
Fig 16 Reused granite edging blocks of ford with early/mid 19<sup>th</sup> century drill marks.
