Hayle Millpond, Cornwall

Archaeological watching brief during repairs to the Scheduled Monument

Client	CORMAC Ltd
Report Number	2019R030
Date	22/05/2019
Status	Final
Report author(s)	Adam Sharpe BA MCIfA
Checked by	Dr. Andy Jones MCIfA
Approved by	Tamsin Daniel
Project number	146853
Data location	\\CAU\Archive\Sites\H\Hayle Millpond building repairs WB 146853
England / ADS OASIS online reference	cornwall2-360386

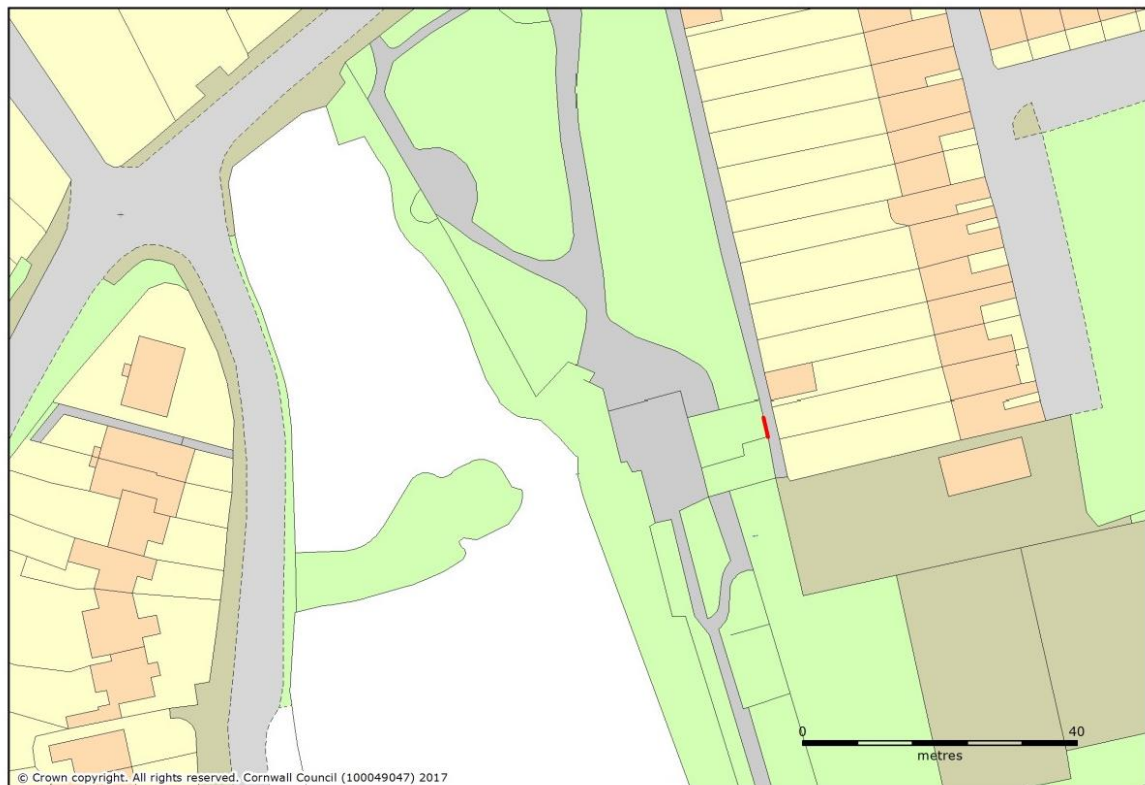
Fig 2. The extent (in red) of the walling to be repaired at Hayle Millpond. © Crown copyright. All rights reserved. Cornwall Council (100049047).

All of the upper section of walling over a length of 6.6m at its head was taken down in a controlled fashion and reconstructed (see Fig 2 for the extent of this work). The timber lintel over the doorway was removed and replaced using a recycled weathered granite lintel. All significant stones within the repaired section were replaced in their original positions, this process being guided by a series of pre-works photographs taken by the contractors.

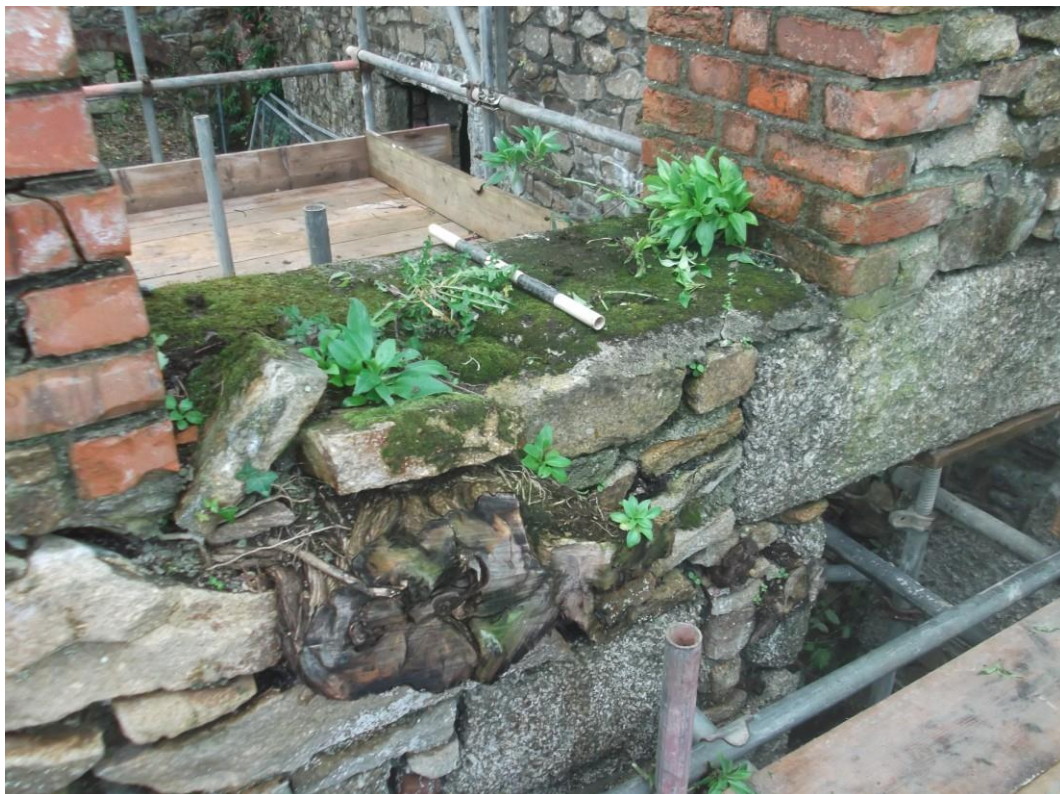
Fig 9. A view of the area around the upper floor window following the cutting back and stump treating of the Buddleia, showing the size of some of the destabilising root growth.

The buddleia which had taken root in the wall had, in some areas, become well-established and of a substantial trunk size, locally deforming the walling, causing distortion of its profile, partially dislodging some stonework and thus creating a potential hazard to users of the adjacent footpath. This vegetation was cut back to stumps, which were chemically treated prior to the main work programme. Once these had died back and shrunk to a degree, they were removed from the wall structure without causing any significant further stone loss. This initial work was undertaken prior to the watching brief being commissioned.

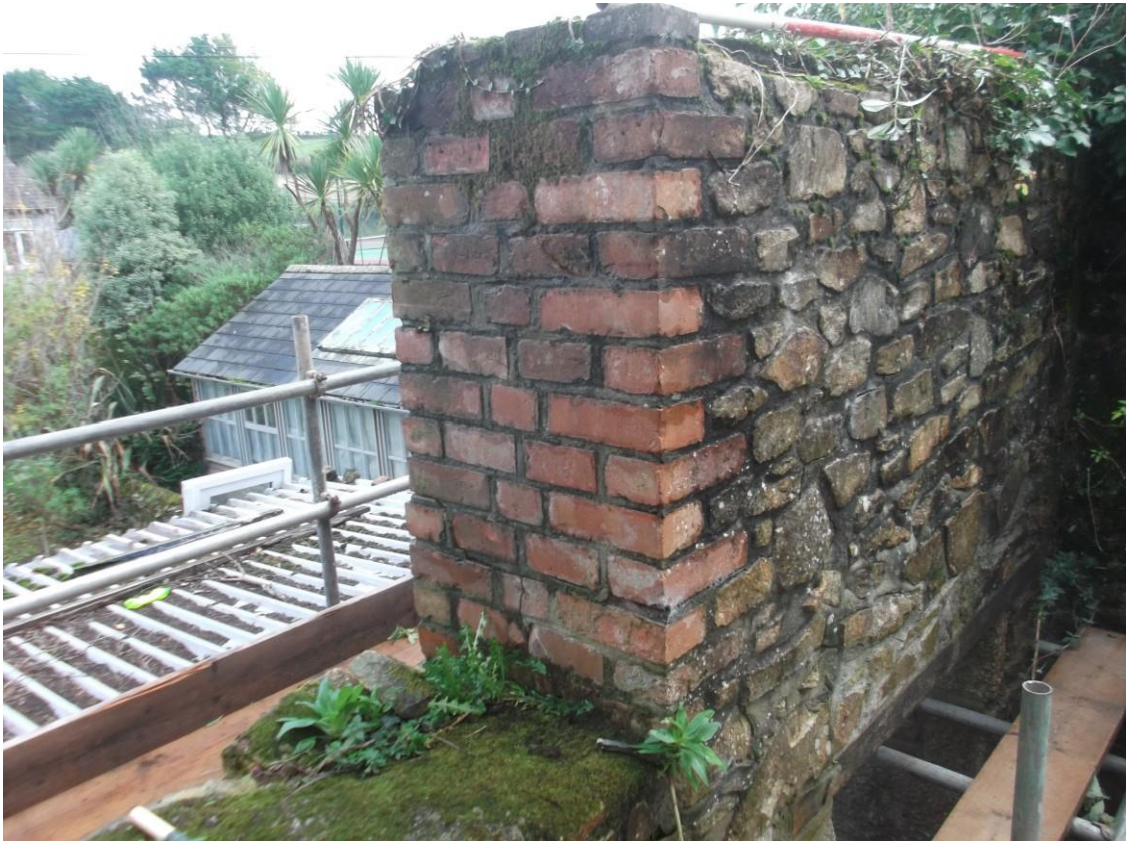
Fig 10. The southern reveal of the upper floor opening, showing the vegetation growth on the cill and wall capping.

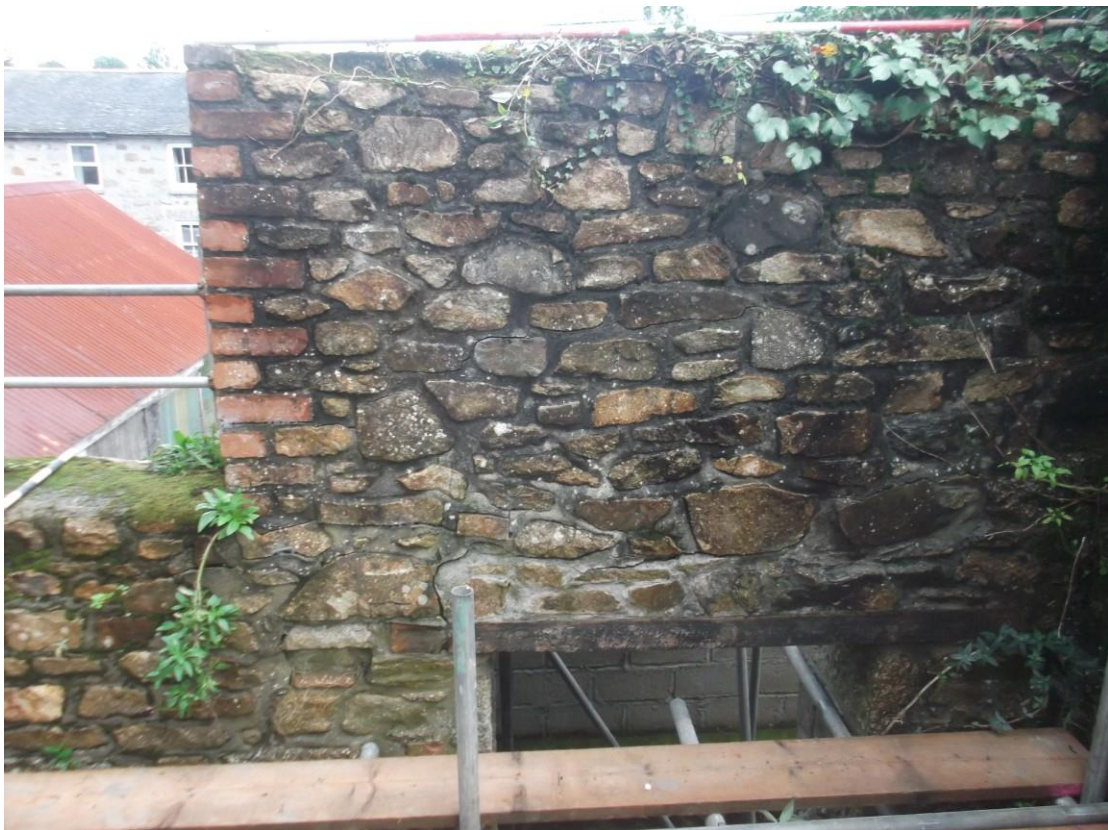
Fig 11. The original (replacement) timber lintel to the ground floor wall opening. As can be seen in this view, this had begun to fail and cracking had appeared within the pointing of the walling it supported.

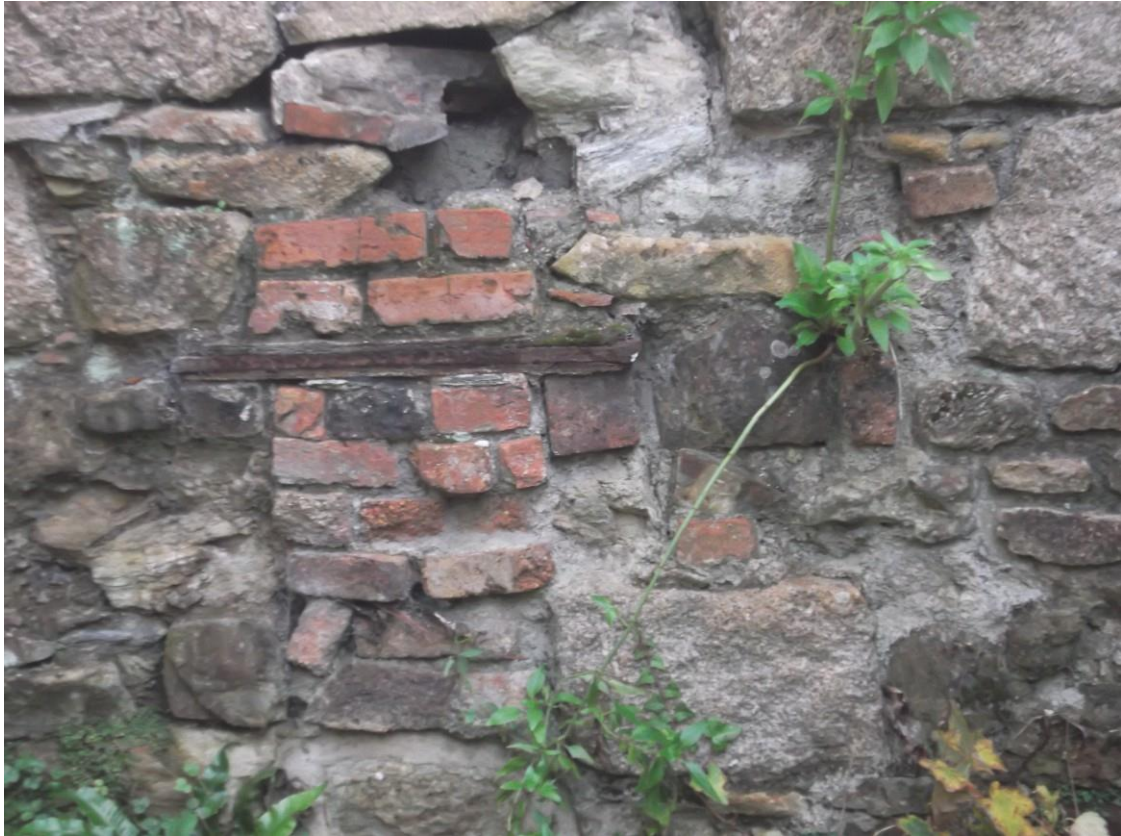
A small flue opening runs through the thickness of the wall, the location of the hearth being exposed in the internal elevation of the wall, where it had been blocked in using six courses of red brick (600mm high); the hearth opening measured two brick stretchers wide (400mm wide). The head of the hearth had been formed using an iron flat bar lintel, though this had suffered some degree of corrosion. Two courses of probably original brickwork overlaid this lintel, but some stonework had been lost above these, and cracking was evident at the sides of the flue-line up through the internal wall face. The interior of the flue had an irregular sub-circular form measuring an average of 300mm in diameter, and had been partly infilled with stone, brick and mortar, probably following the removal of the roof of the building. Given its dimensions and location it is probable that it was originally fronted by a small cast-iron fireplace of domestic type, and that the interior of the building had been lime plastered, though the flue opening seems to have been bricked in at some point when the fireplace became disused. The original function of the building, and of this room, could not be determined, and may well have changed over the lifespan of the building.

Fig 12. The blocked flue opening on the internal elevation of the section of wall which was repaired.

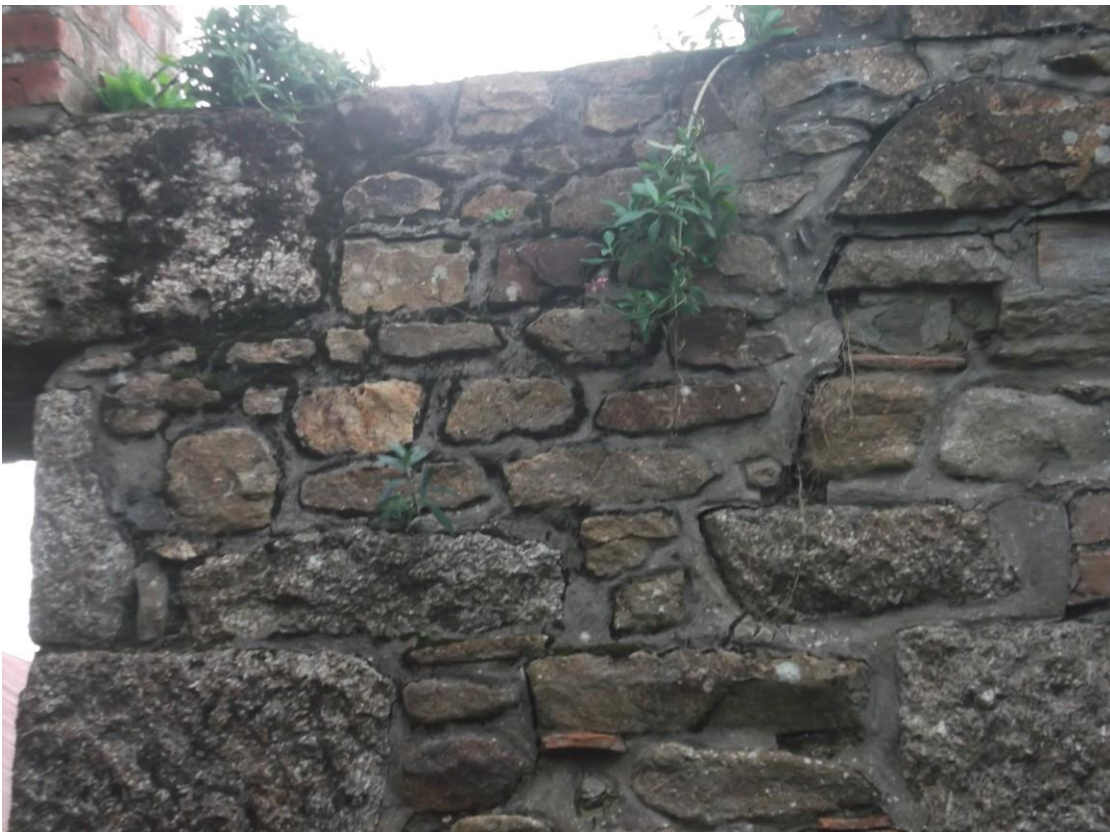
Fig 13. A view of the section of walling between the wall openings showing its cementitious pointing, Buddleia growth and eroded or cracked wall joints.

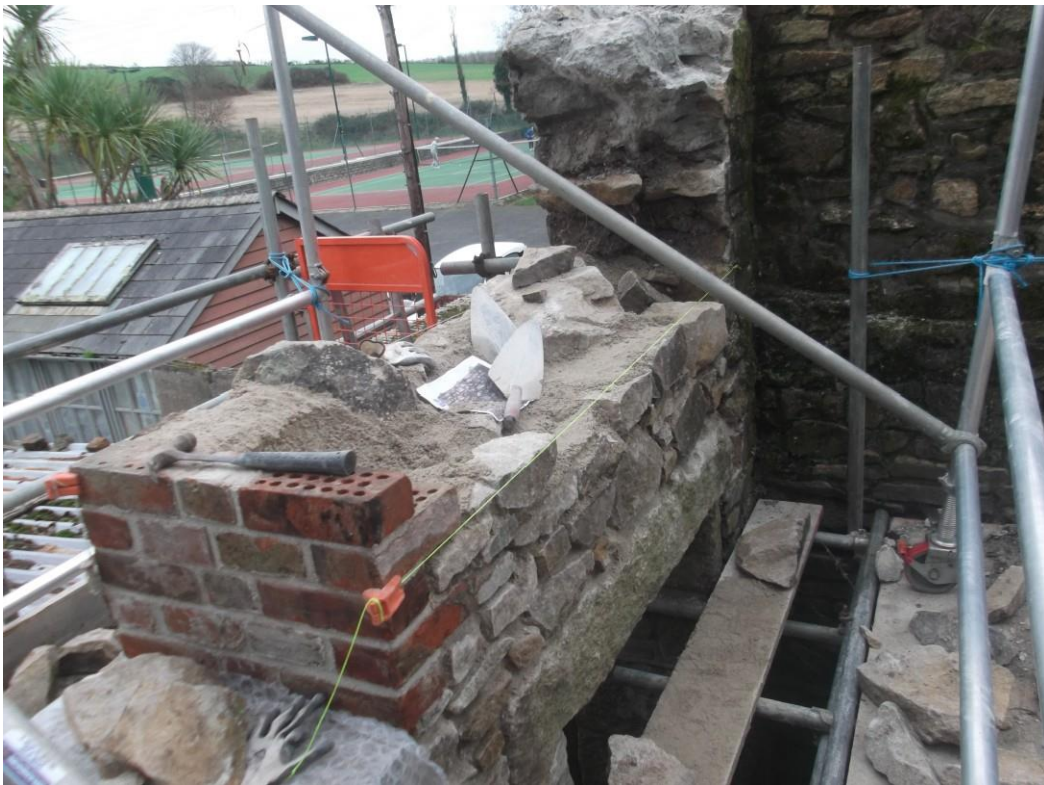
Fig 14. Reconstruction work in progress on the southern side of the upper floor wall opening.

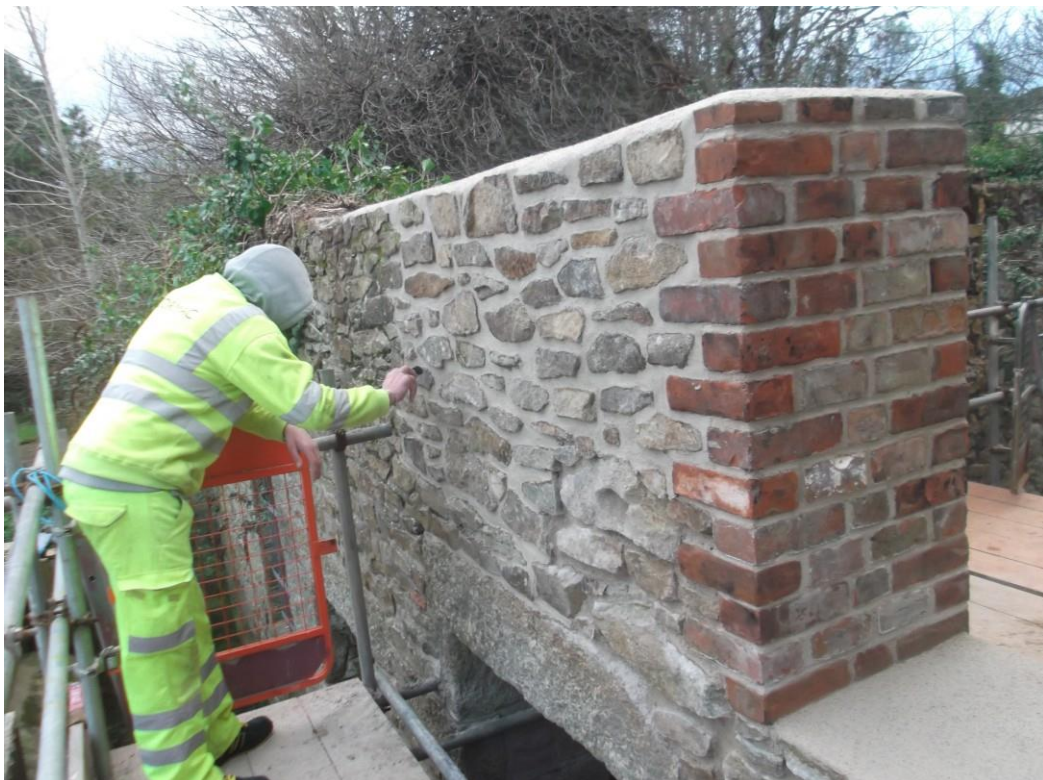
Fig 15. Repointing the external face of the walling using a lime pointing mortar.

The mortar used for both gauging and pointing repair work consisted of pre-mixed bagged Cornerstone NHL3.5 dry mix, which was batched as required on site. The pointing mortar was brushed back to achieve good contact with the wall stonework, and to bring up the required surface texture. Most of the finished pointing was slightly recessed from the faces of the stonework, though in some areas it was finished flush with them. Some closely-matching replacement brick was utilised where the originals were found to be in poor condition and not capable of reuse, whilst the decaying timber lintel over the doorway was replaced using a locally-sourced granite item. The original wall capping, which had largely been lost, was replaced using a slightly flanchéd profile in lime mortar. No gallets were incorporated into this, and it may, in the future, therefore prove somewhat vulnerable to thermally-induced cracking. The absence of any rust treatment to the iron lintel over the blocked flue opening may, in the future, result in damage to the overlying masonry and brickwork through expansion of the lintel as it rusts.

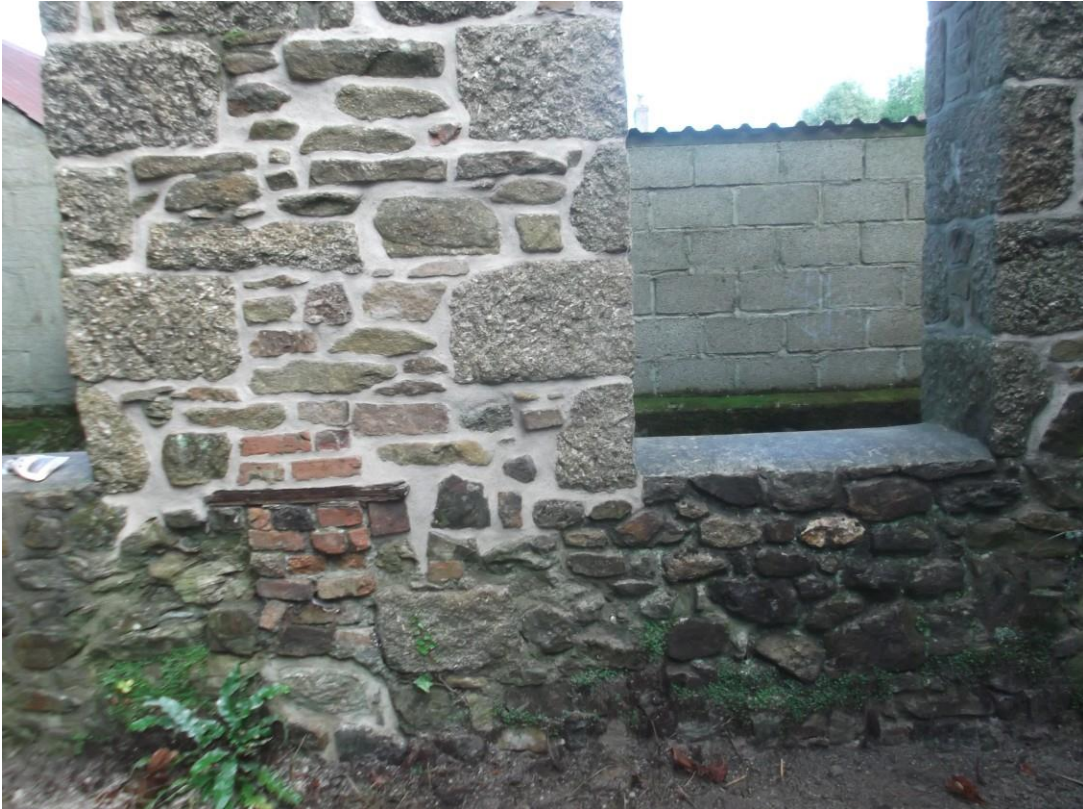
Fig 16. Repointed and partially rebuilt stonework adjacent to the flue opening on the internal wall face.

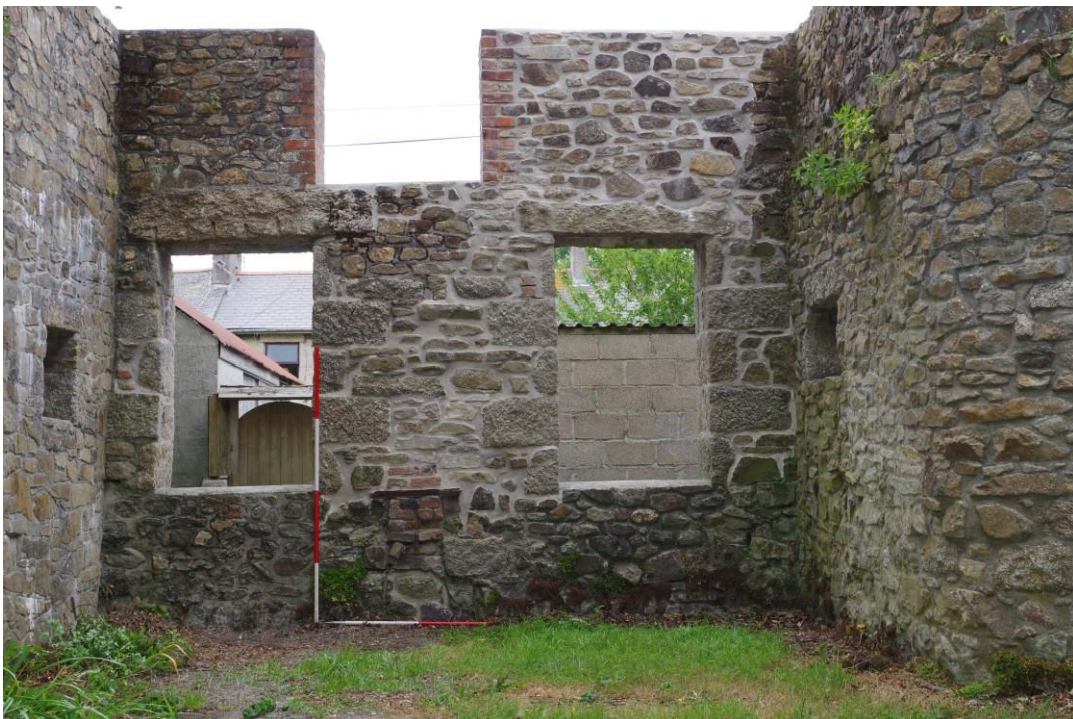
Fig 17. A view of the reconstructed and repointed section of the eastern wall of the building, including (right) the replacement granite lintel.

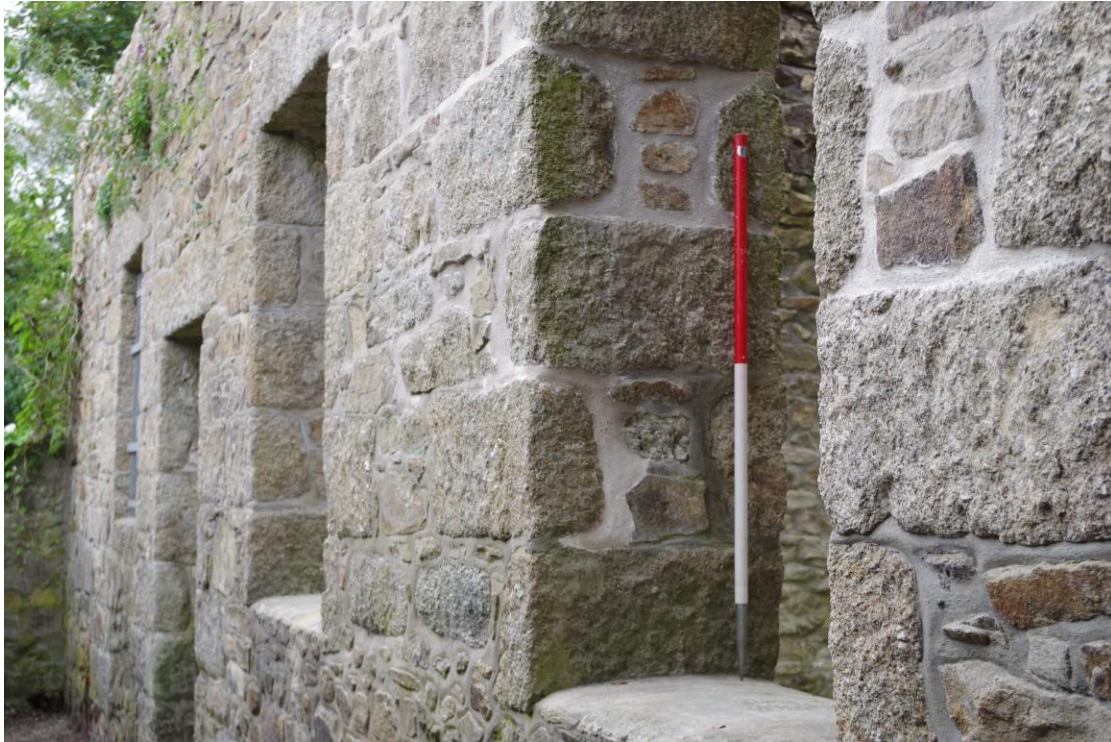
Fig 18. A view of the repair works to the exterior of the building and a window reveal, showing the appearance of the replacement pointing.

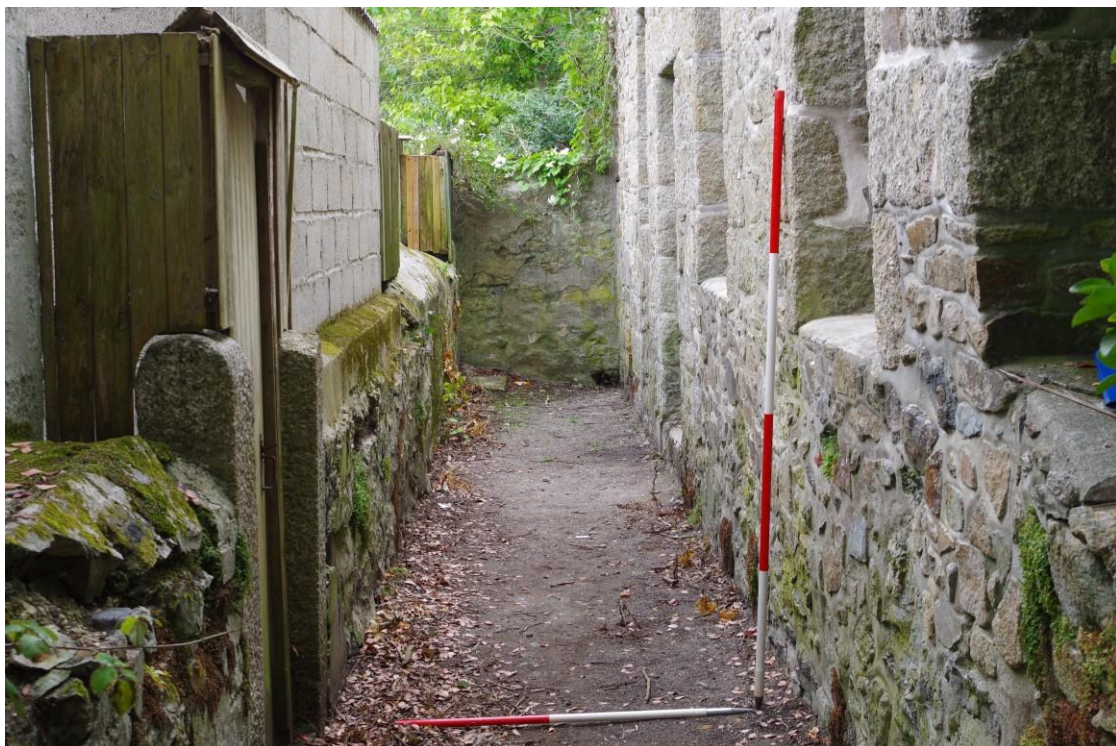
Fig 19. A view of the repair works from the footpath to the east of the building.

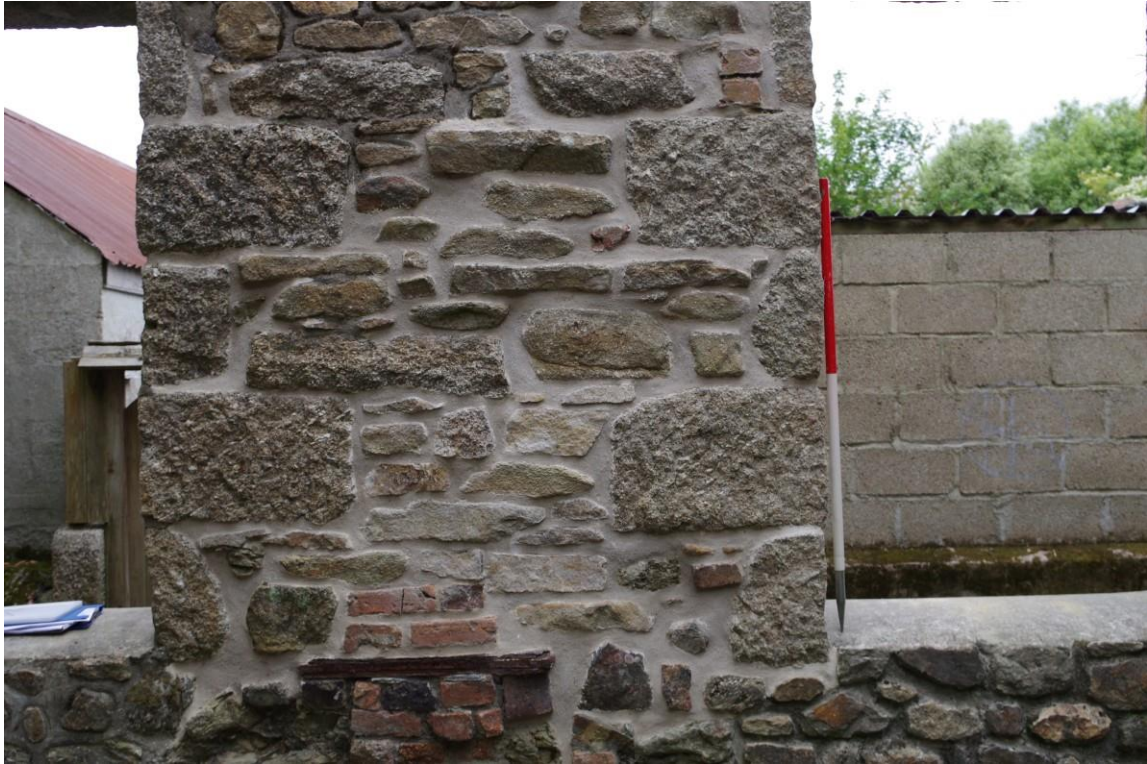
Fig 20. Detail of the partially reconstructed and fully repointed stonework forming the wall panel between the two windows, this incorporating the integral flue.

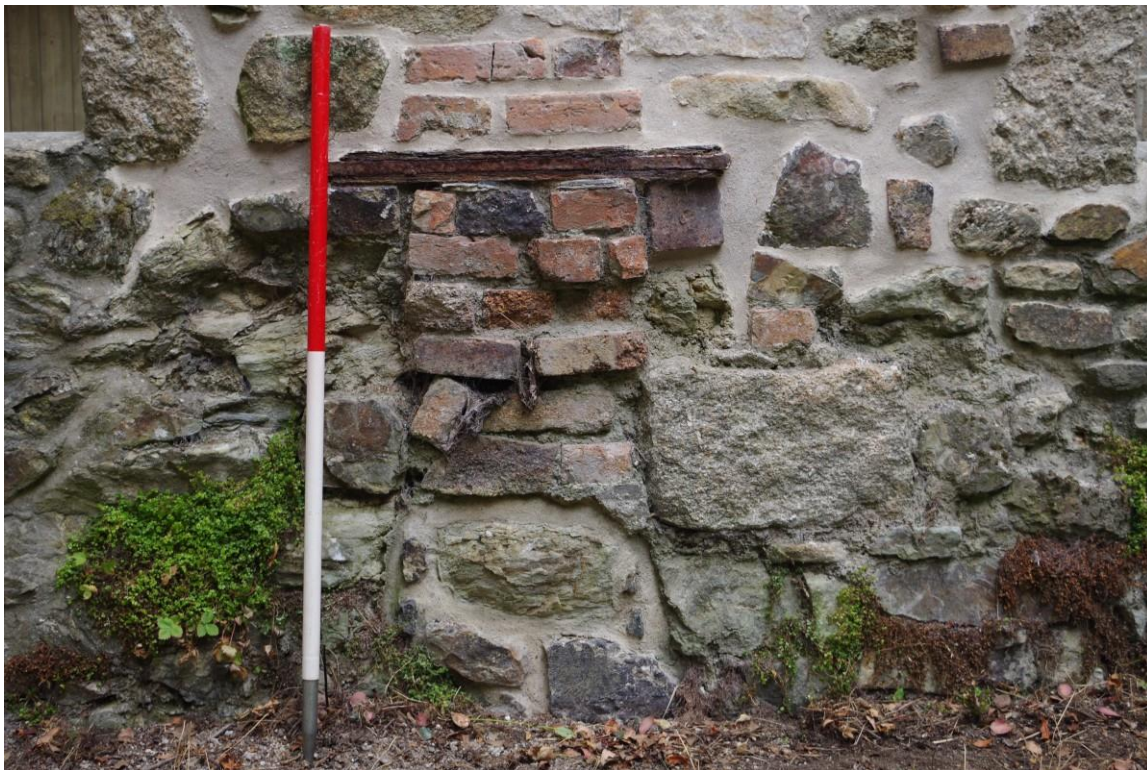
Fig 21. Detail of the repair works surrounding the flue opening near the base of the wall. The joints between the blocking bricks have not been repointed, and no stabilisation treatment has been applied to the iron lintel.

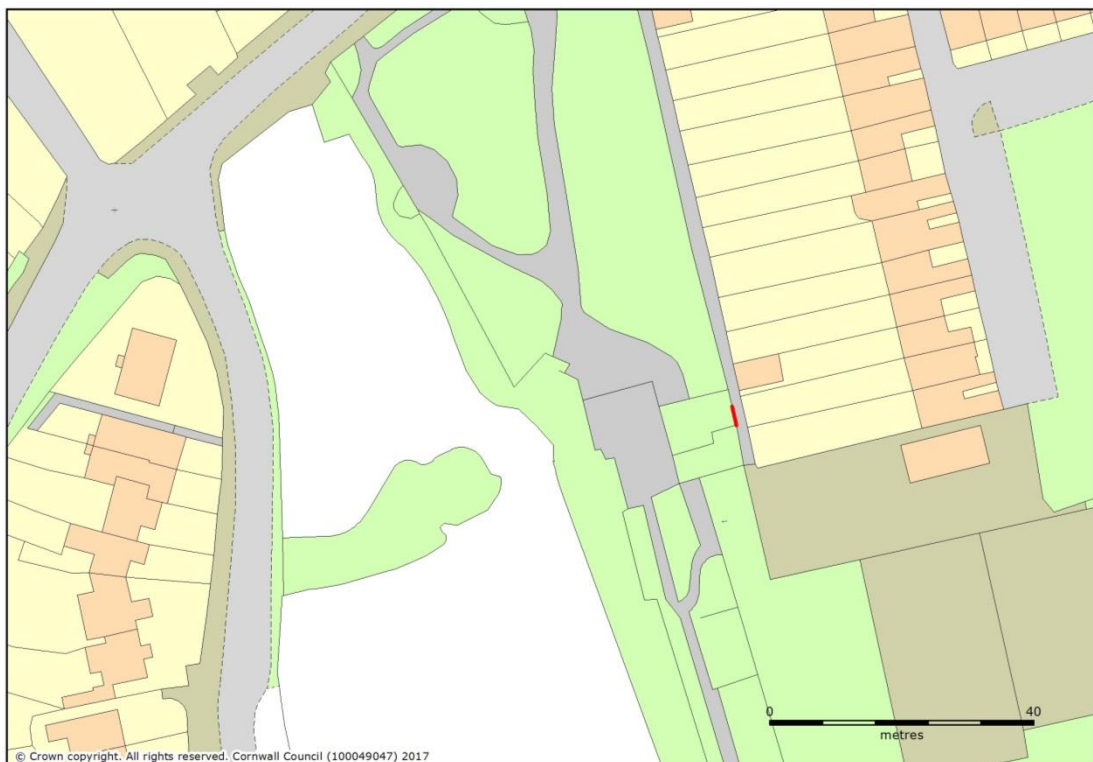
Figure 1: Hayle Millpond. The area where the repairs are to take place is

indicated in red.

The project area is confined to the area indicated by a redline on Figure 1 in this document, which indicates the area where the wall repairs are to be undertaken.
