St Michael's Mount,
Stewards House Floors,
Cornwall
Archaeological recording

Archaeological recording

Client	Cornish Heritage Builders
Report Number	2019R071
Date	February 2020
Status	Final
Report author	Anna Lawson-Jones
Checked by	Dr Andy Jones
Approved by	Tamsin Daniel
Project number	146897
Site code	SMM SHF19
Data location	X:\Live Projects\St M's Mt-Stewards House floors 146897\Report
Historic England / ADS OASIS online reference	cornwall2-383797
Planning reference	-

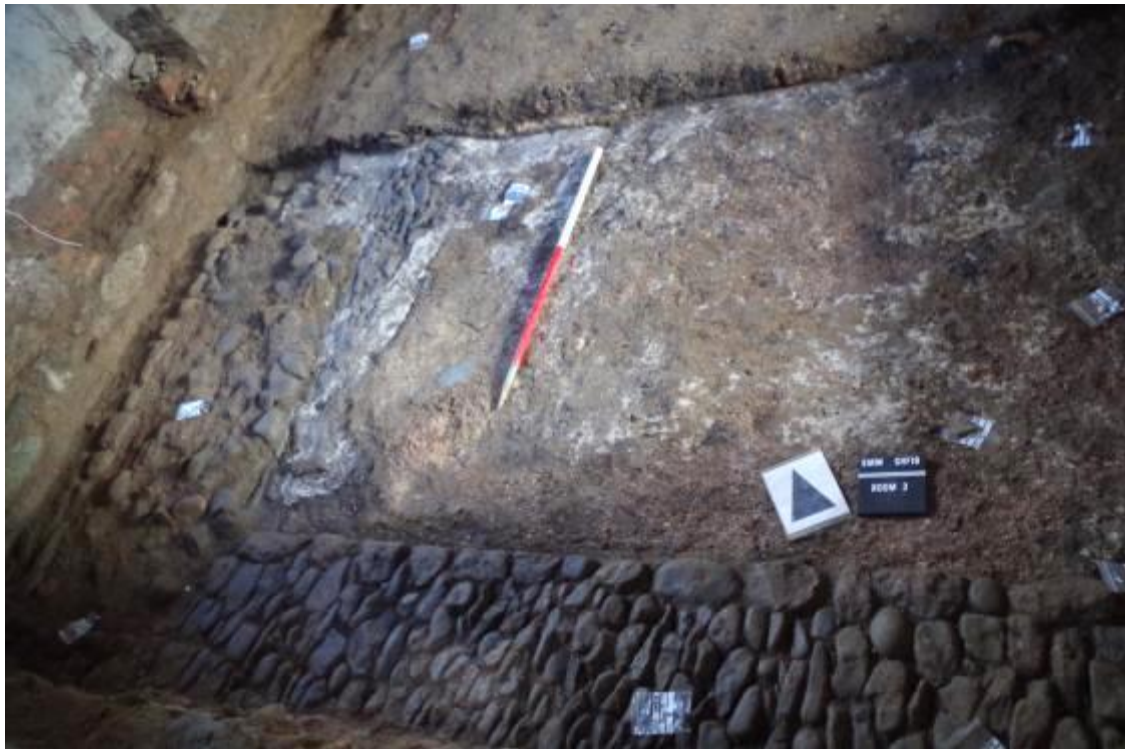
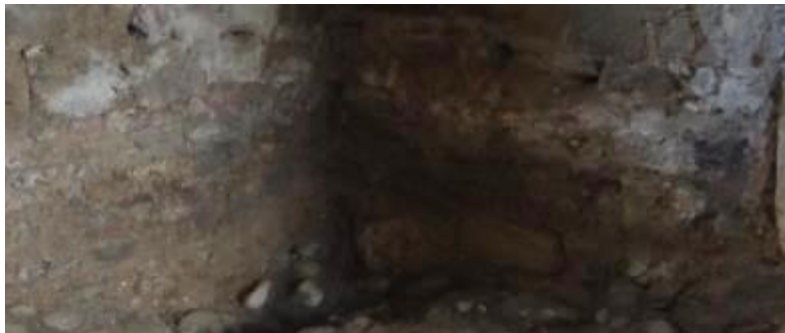
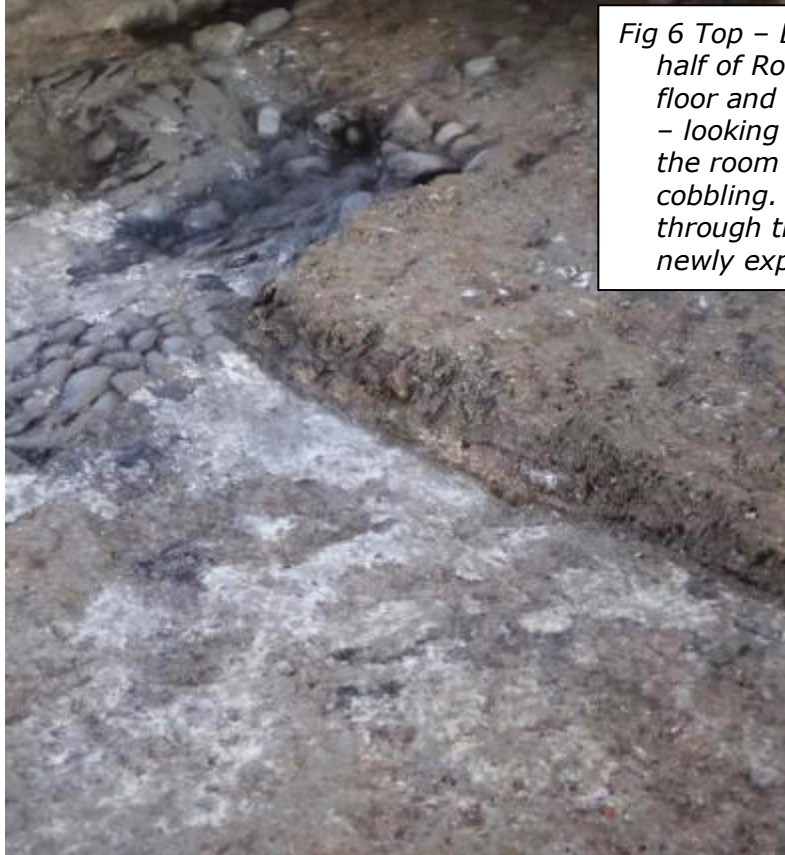
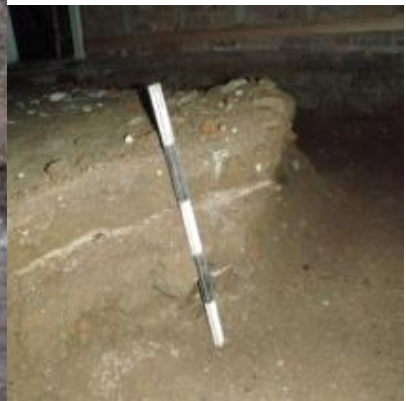
Fig 6 Top - Looking across the southern half of Room 3 showing the cobbled floor and earth and mortar floor. Left - looking at the northwest corner of the room showing earlier phases of cobbling. Bottom right - section through the deposits overlying these newly exposed floors.

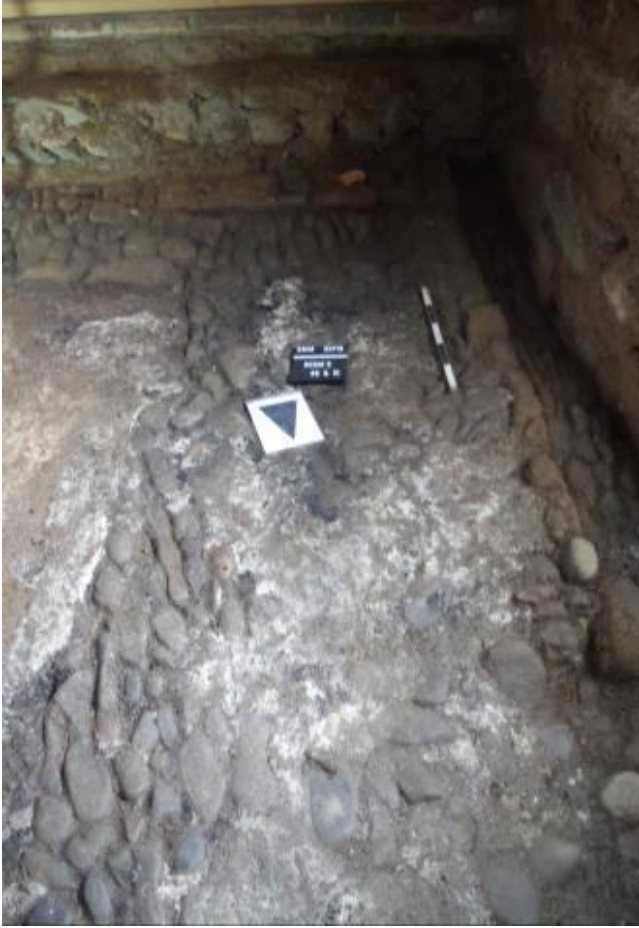
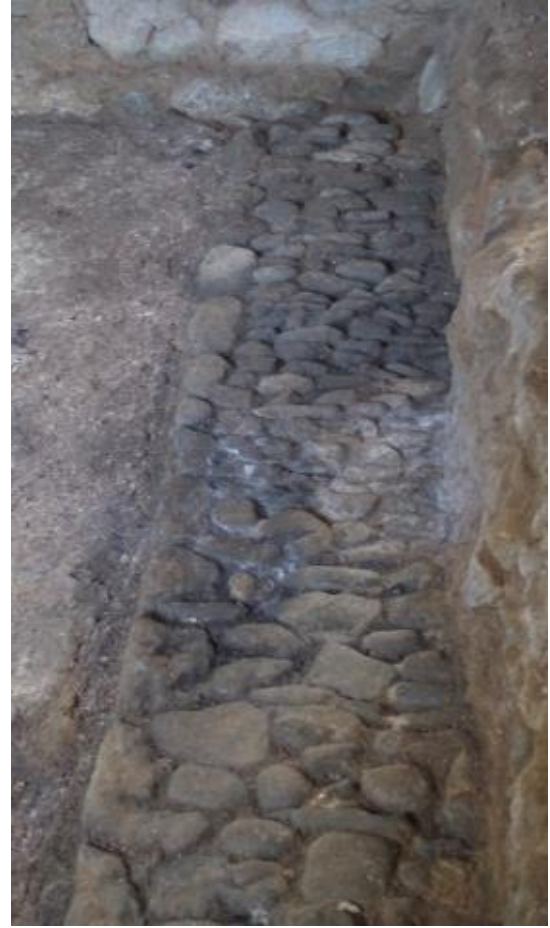
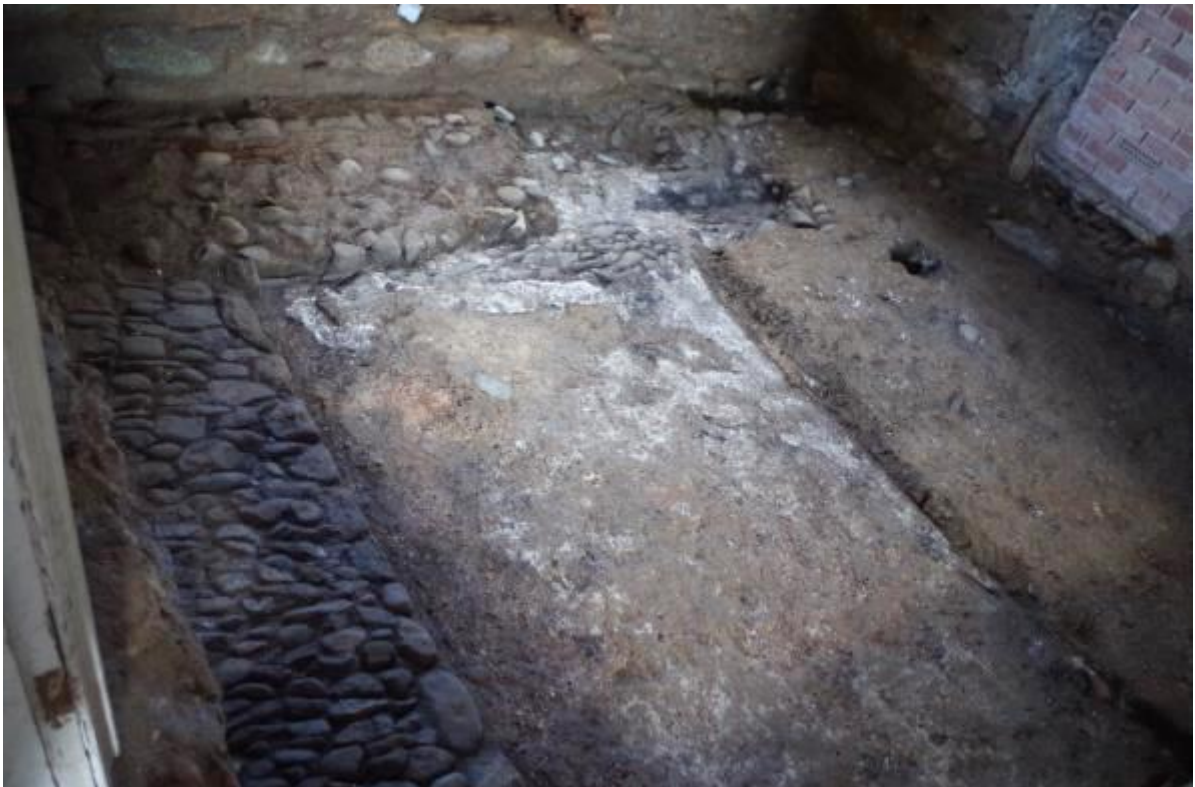
Fig 7 Top left – Looking south along the western side of Room 3; Top right – Looking east along cobbling (50); Bottom – Looking west across Room 3 showing cobbling, earth and lime flooring, the unexcavated step of material overlying the earthen floor (right) and the not yet fully excavated western side of the room (top of photo).

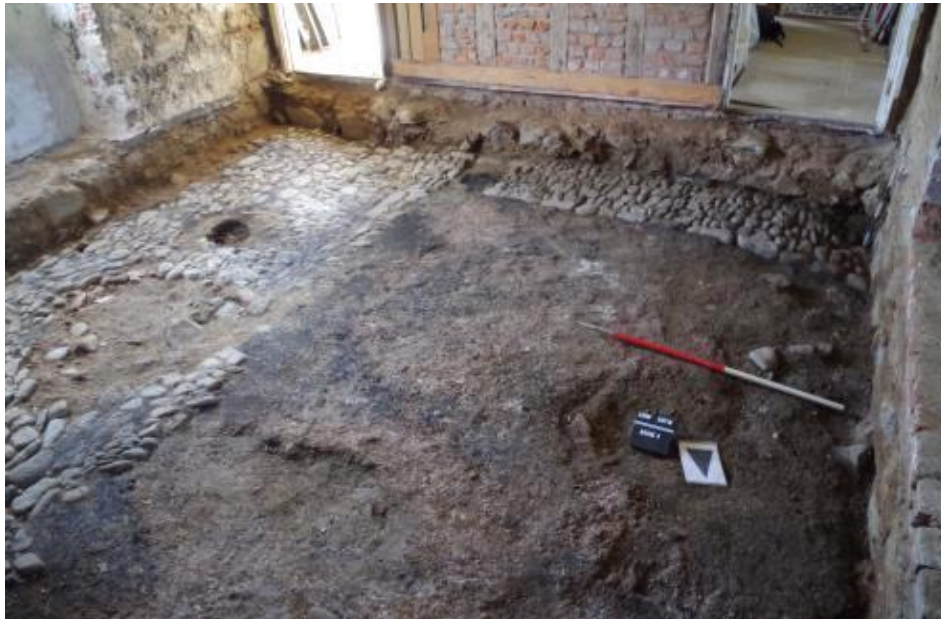
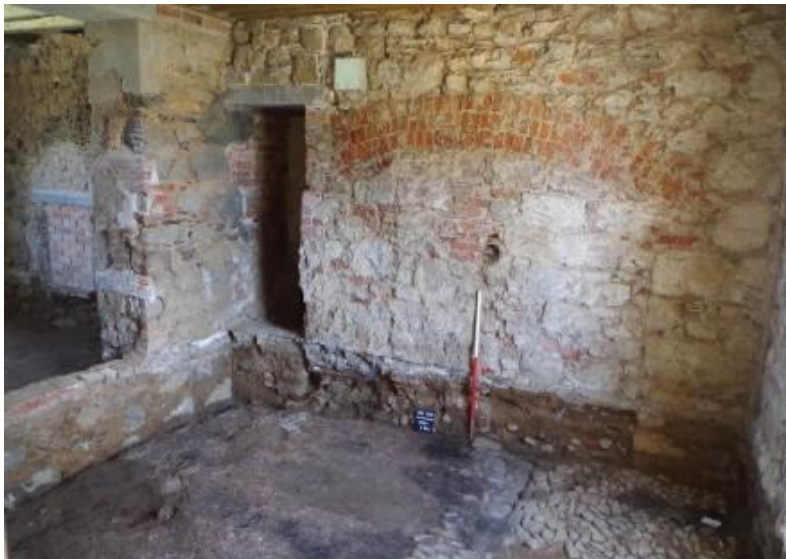
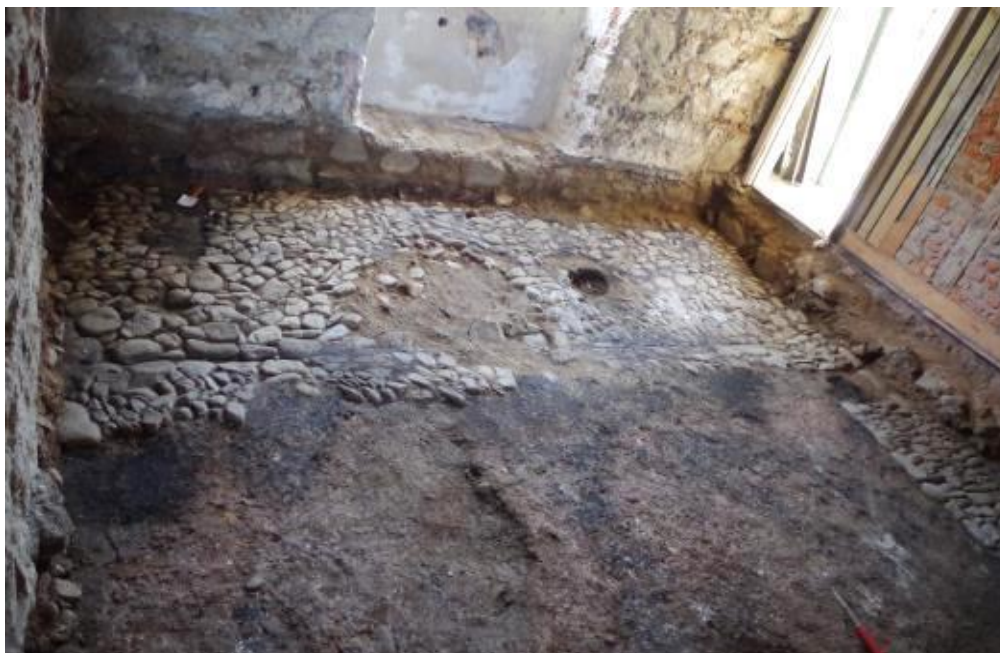
Fig 9 Top – Looking south across Room 4 floors – note the cobbled surface and earthen floor dropping down to the right; Middle – Looking north towards the fireplace showing adjacent Room 3 (left) and layers overlying the cobbled and earth floors (beneath the fireplace); Bottom – Looking east across Room 4 showing the floors.

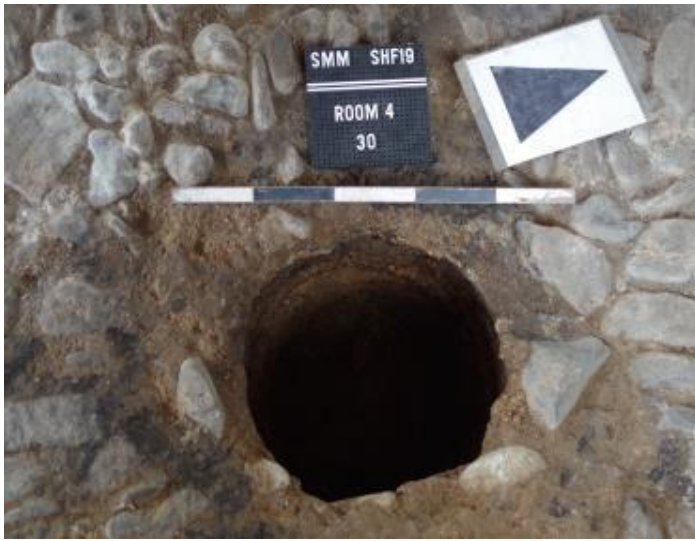
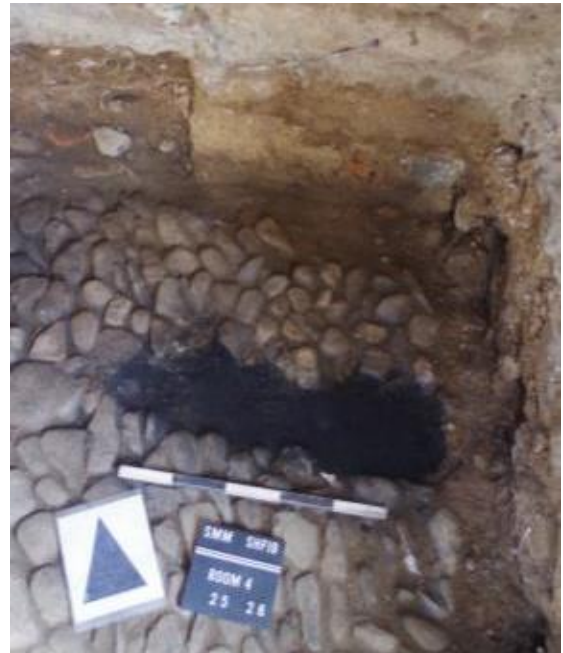
Fig 10 Top left – fully excavated barrel [30] with cobbles (27); Top right – magazine box [26] with unexcavated gunpowder deposit (25) spilling north in to cobbles (27); Left - post socket [32] and cobbles (65); Bottom – sections through barrel [30] and box [26].

Circular cut [30] appeared contemporary with cobbling (27) (Fig 10). The top would originally have been near flush with the top of the cobbling. On excavation the cut was found to open into a wooden barrel, which had been sunk into the floor. The barrel wood (36) was slightly better preserved than nearby magazine box [26], and as a result the internal upper rim marking the original lid support could still be seen, as were at least two very thin iron rings encompassing the outer girth of the barrel. The barrel had a 0.35m diameter and a 0.45m depth.

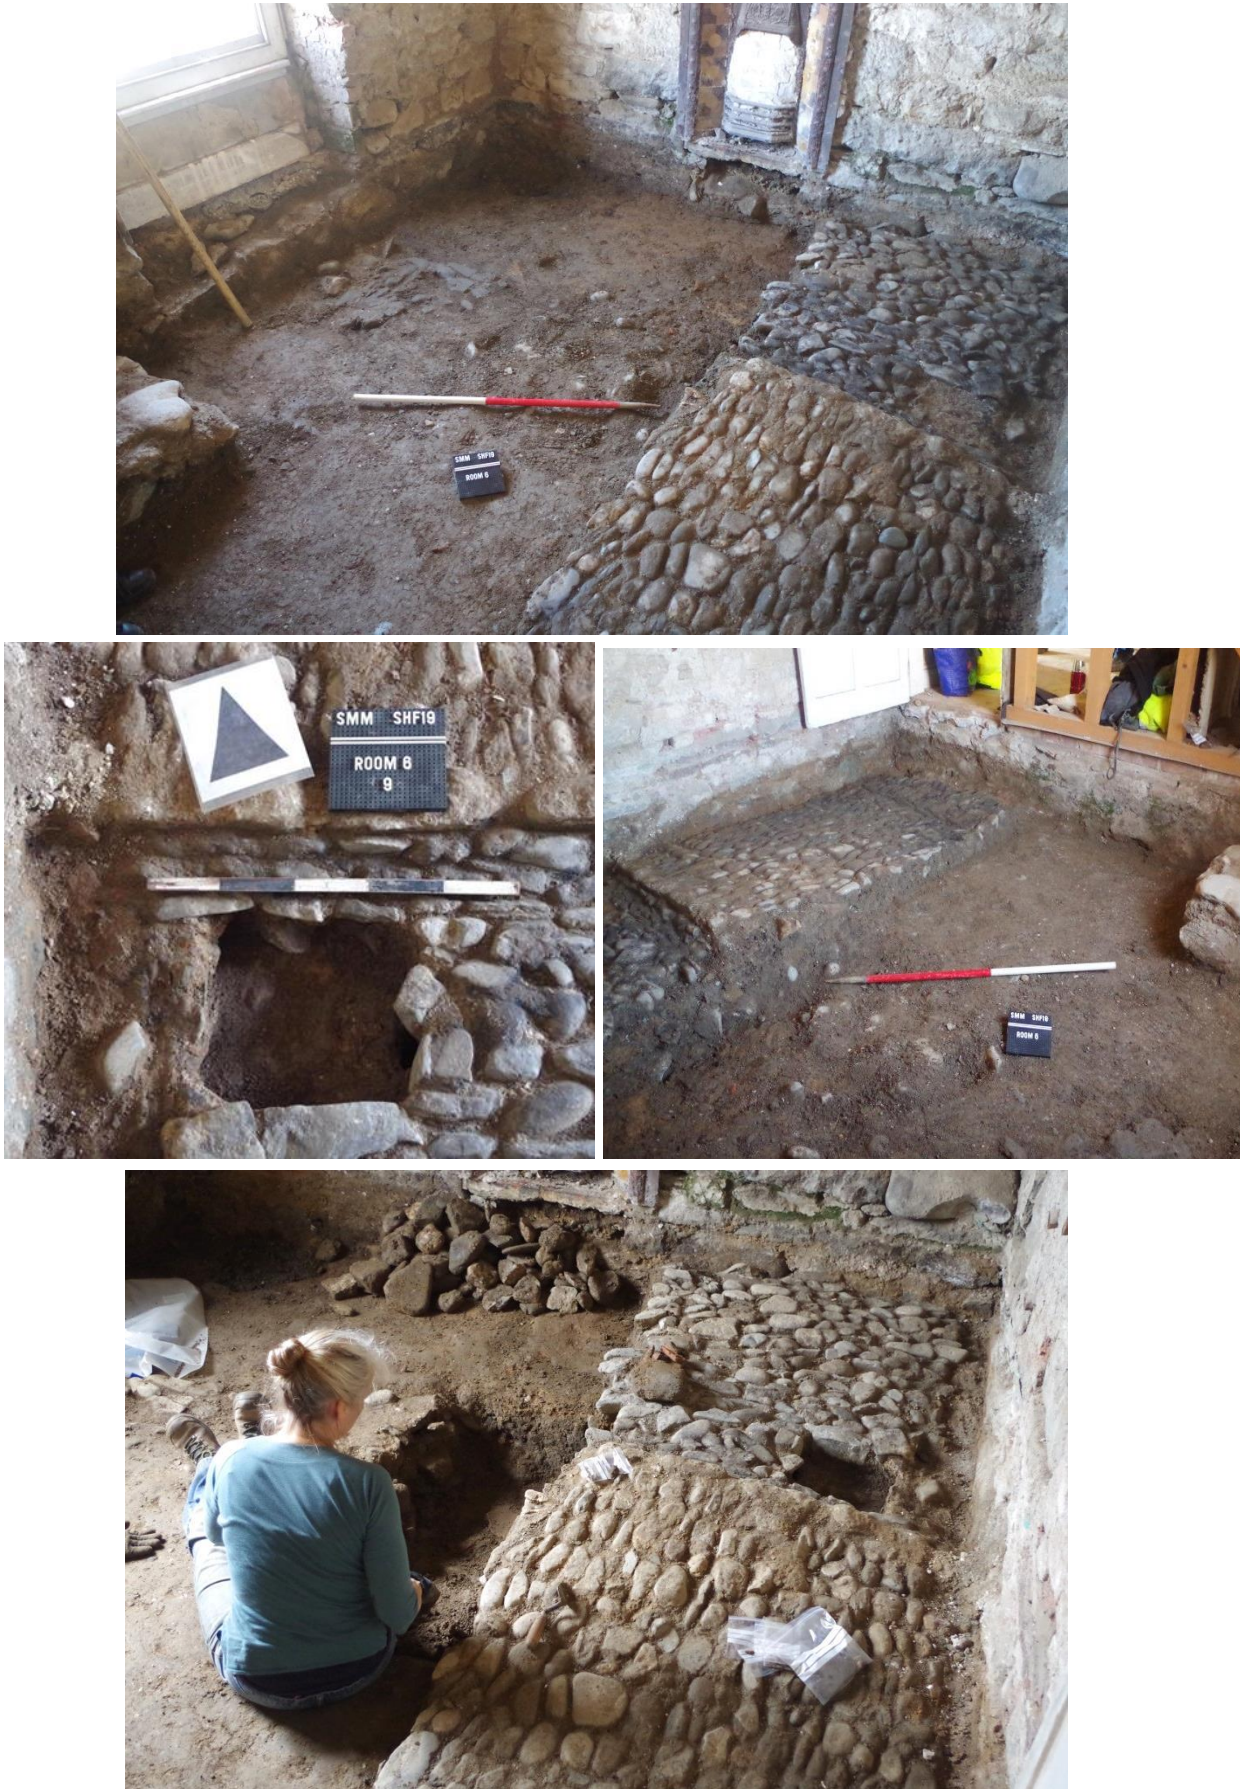
Fig 12 Top – looking southeast across Room 6 showing internal, external and remnant cobbling and fireplace; Middle left – looking down on post support [9] with void in upper edge; Middle right – looking northwest across cobbles and showing masonry block; Bottom – showing test pit during excavation and post slot [9].

A 0.9m by 0.8m by 0.3cm high, freestanding block of lime-like mortar and uncut stone and a soft broken brick was recorded in the north-east corner of the room (mid Fig 12). It sat on layer (4) and had a rotted-out timber upright against its western edge, close to the northern wall of the room. This masonry block was not bonded with either the northern or the eastern walls of Room 6, although they all touched. It could not be ascertained whether the walls or the block came first. The purpose of this block was not determined.

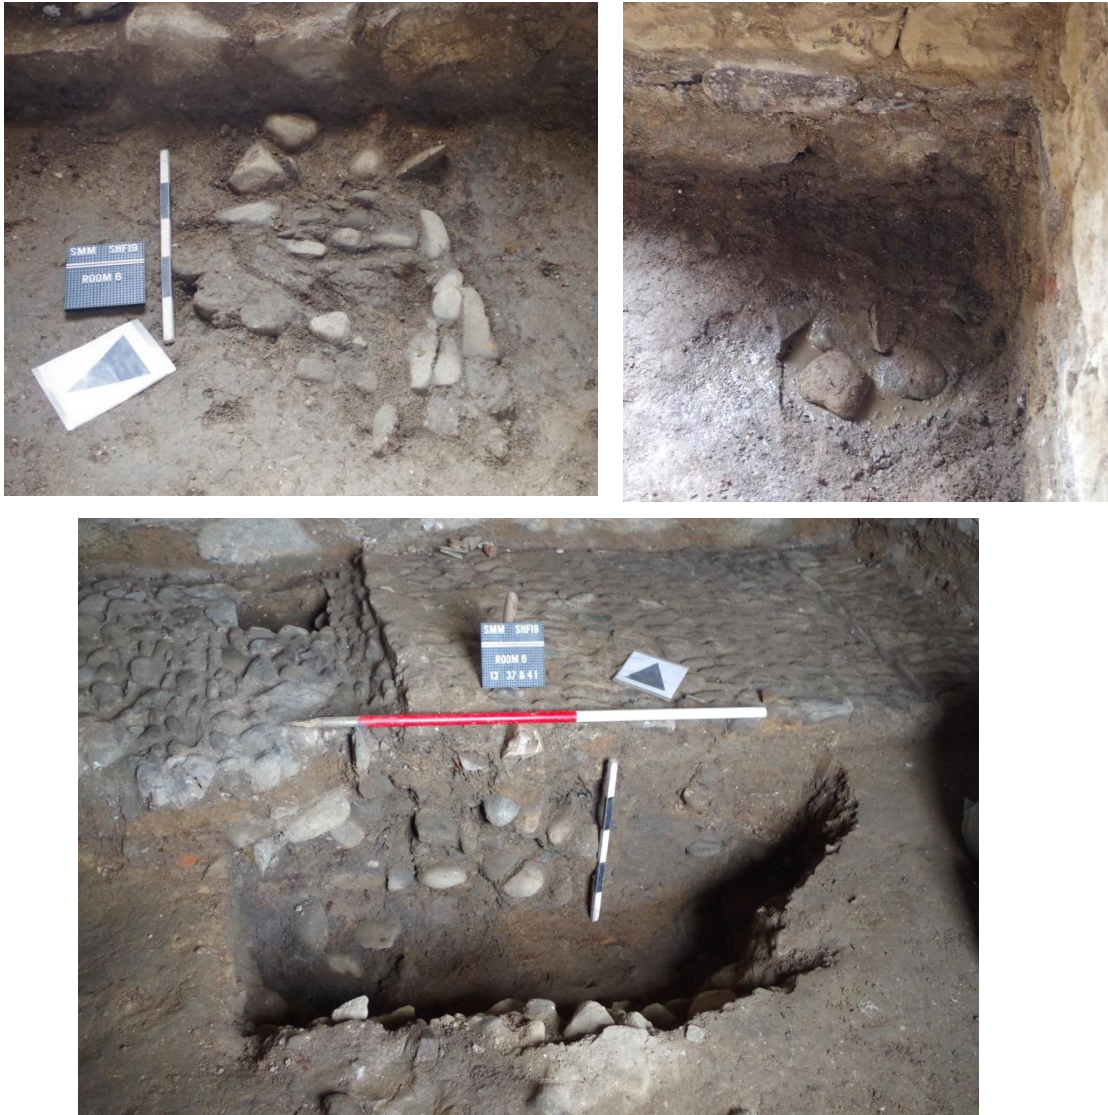
Fig 13 Top left – early cobbles (15); top right – waterlogged context (7); middle – looking west towards the excavated test pit in Room 6.

Layer (4), into which cobbling (15) appeared to have been set included charcoal flecks and fragments of soft, worn, handmade redbrick. This layer was not excavated and can be seen in Figs 12 and 13). Metal detecting identified a bronze nail and part of a bronze buckle within this layer (see Fig 11).

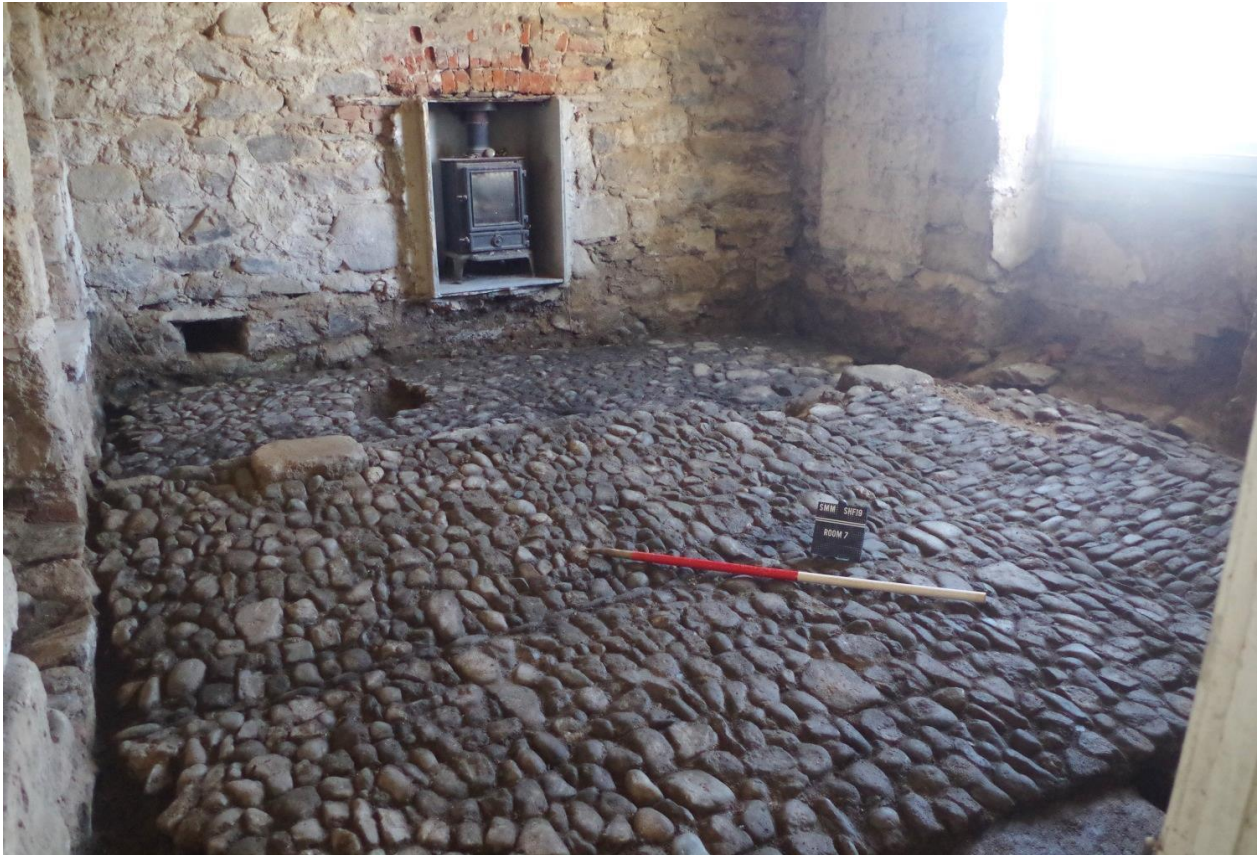
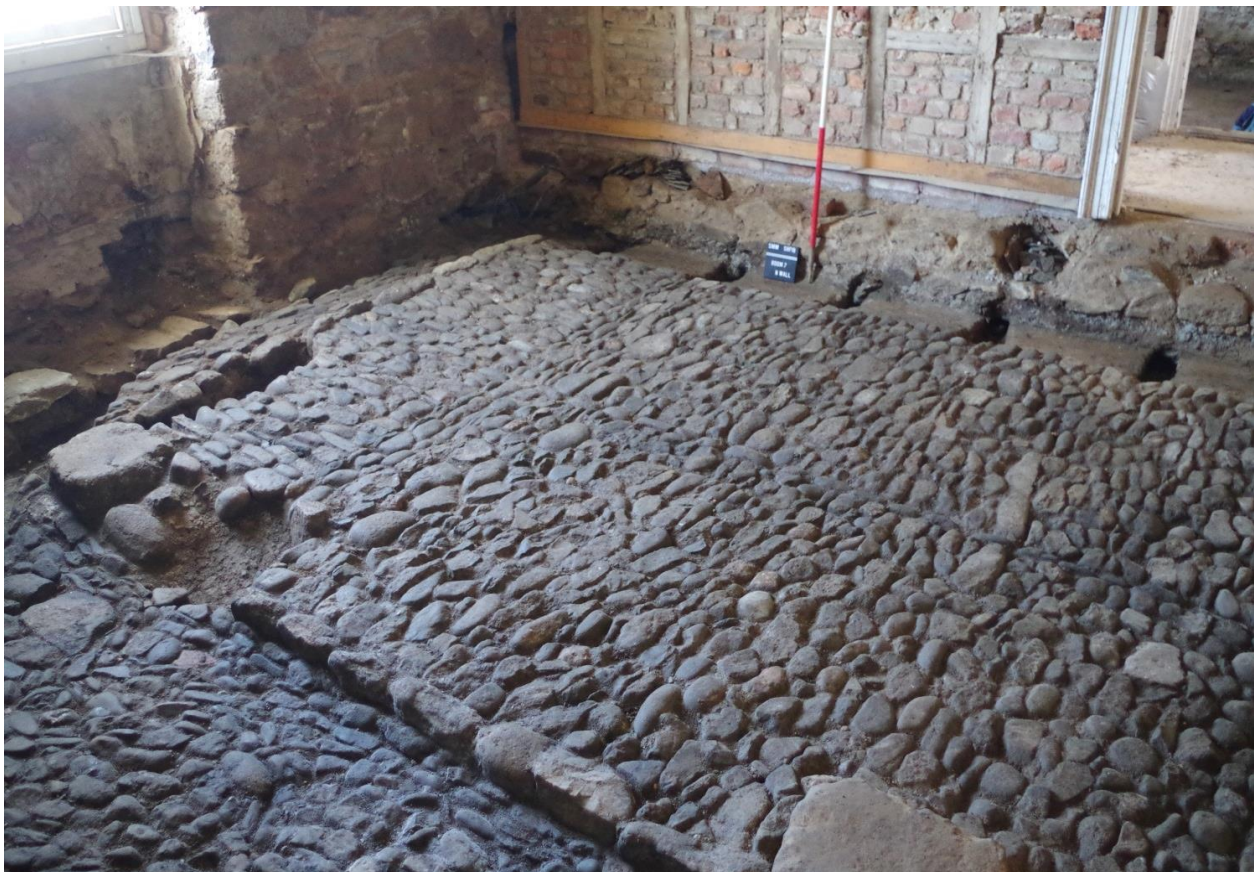
Fig 16 Top – Looking south across Room 7 from the door, showing the internal cobbling in the foreground, two post-pads and the culvert (?) opening in the south wall. Bottom – Looking northwest across Room 7 showing part of the external cobbling and post-pad 70 in the foreground, [19], [20] and 69 on the left, patterning of the internal cobbled surface and beam slots [2] to the upper right.

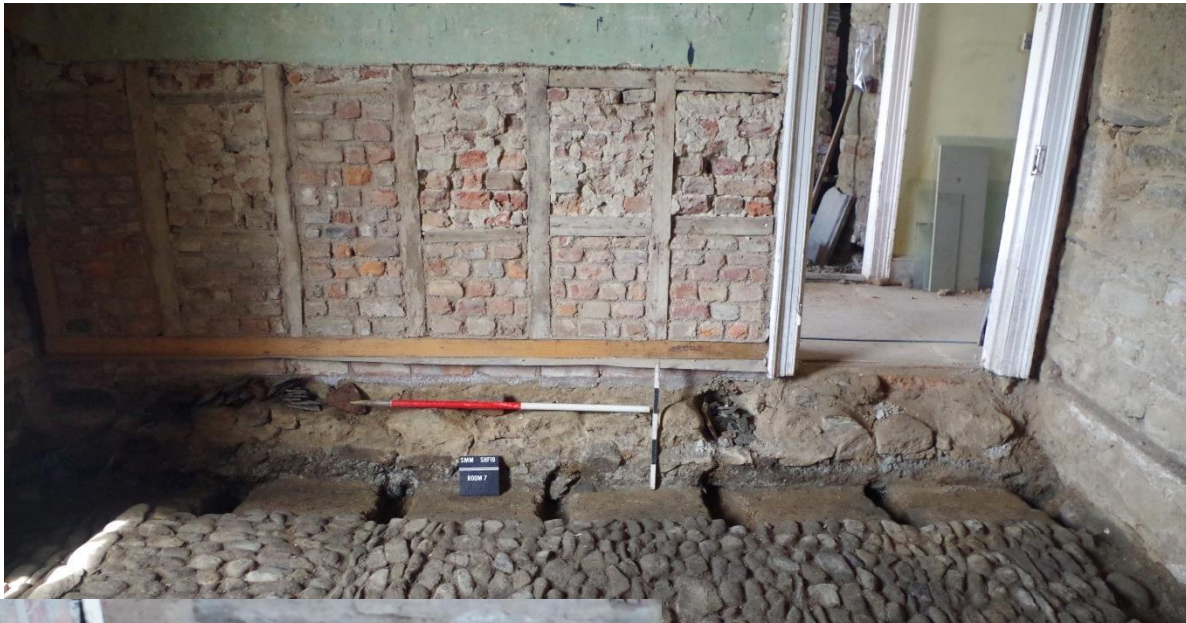
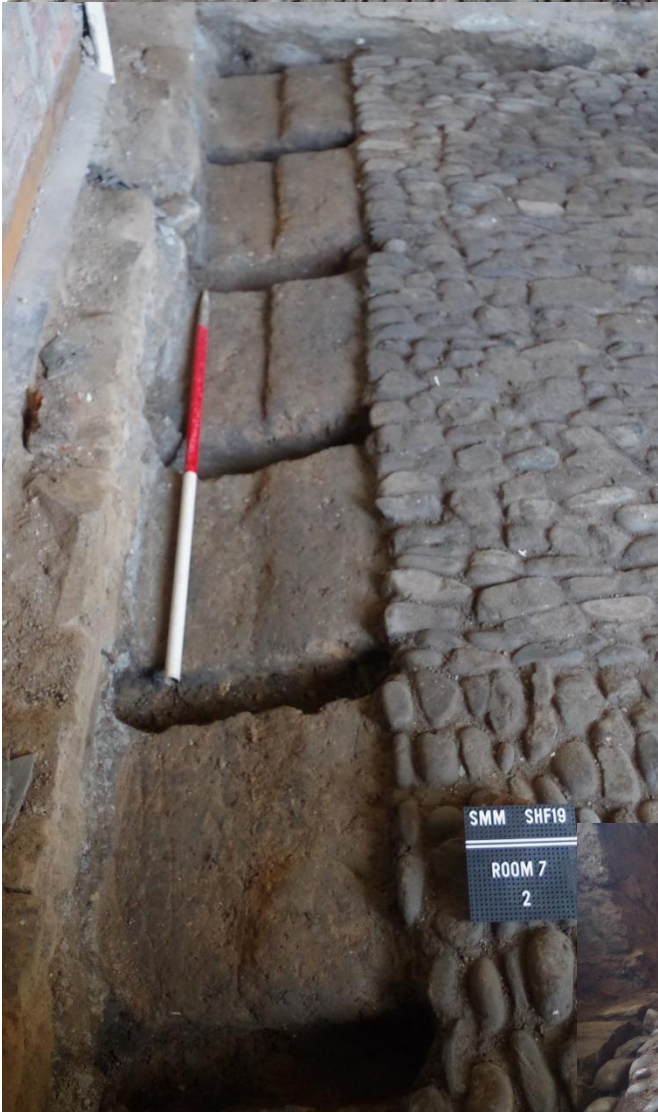
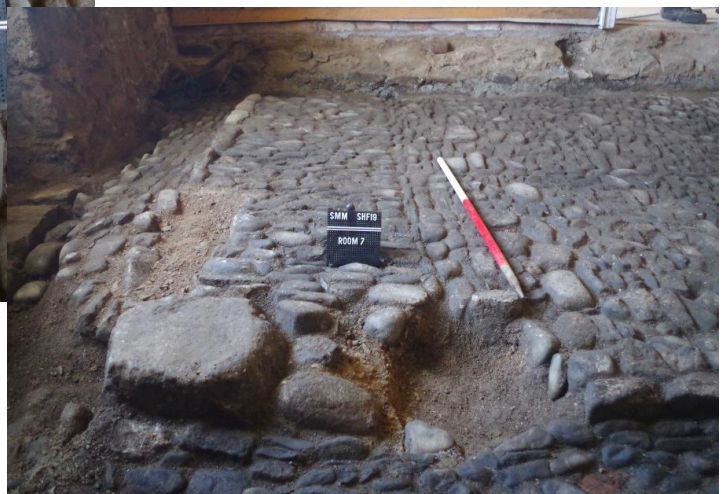
Fig 17 Top – Looking north towards the clay and beam slots [2] (note the piecemeal wall repairs and overlying wall foundations). Left – Looking east along clay, beam slots [2] and plank impression. Bottom – Looking north from the southwestern corner of the room, showing post-pad 69, adjacent posthole (20), slot [19] and sloped surface drain on the left.

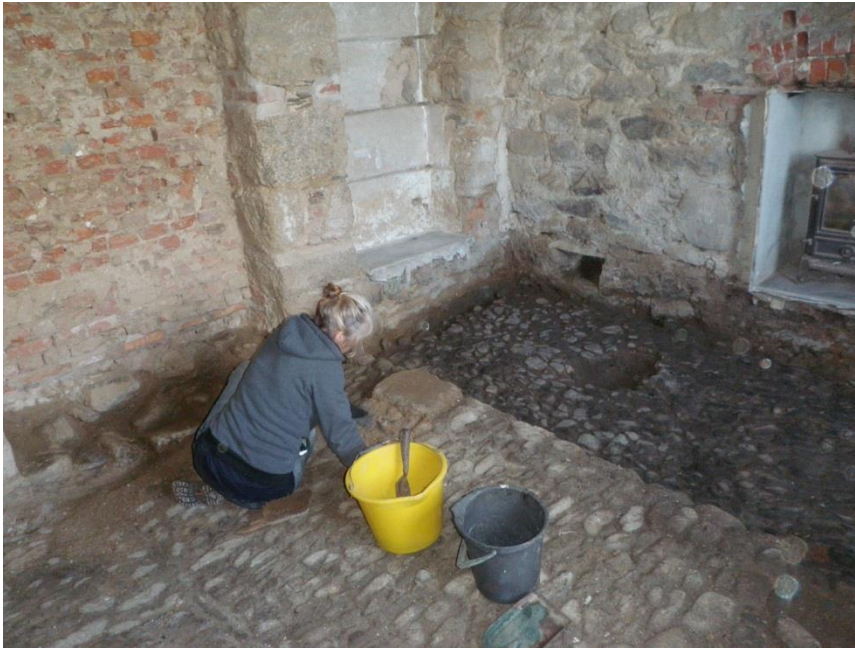
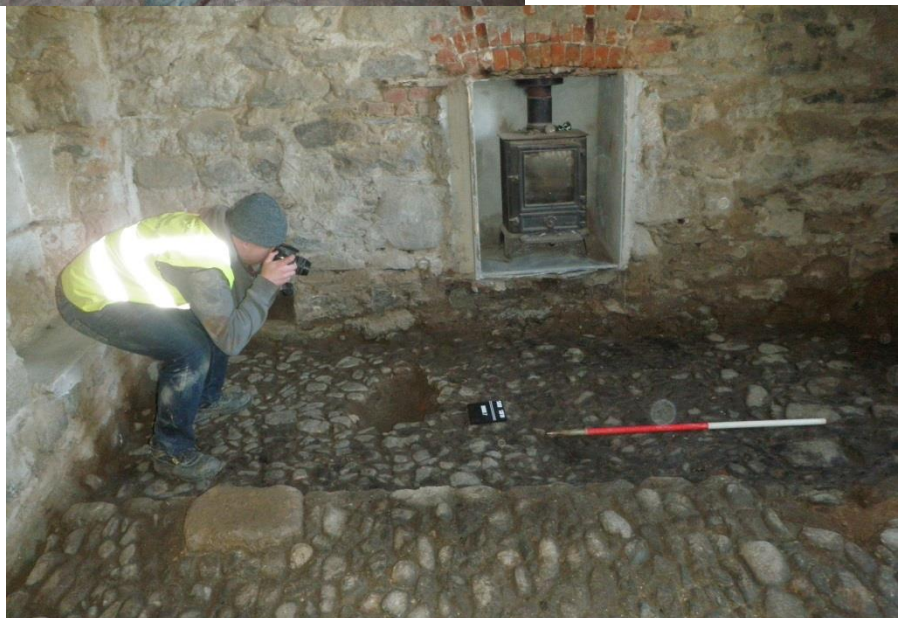
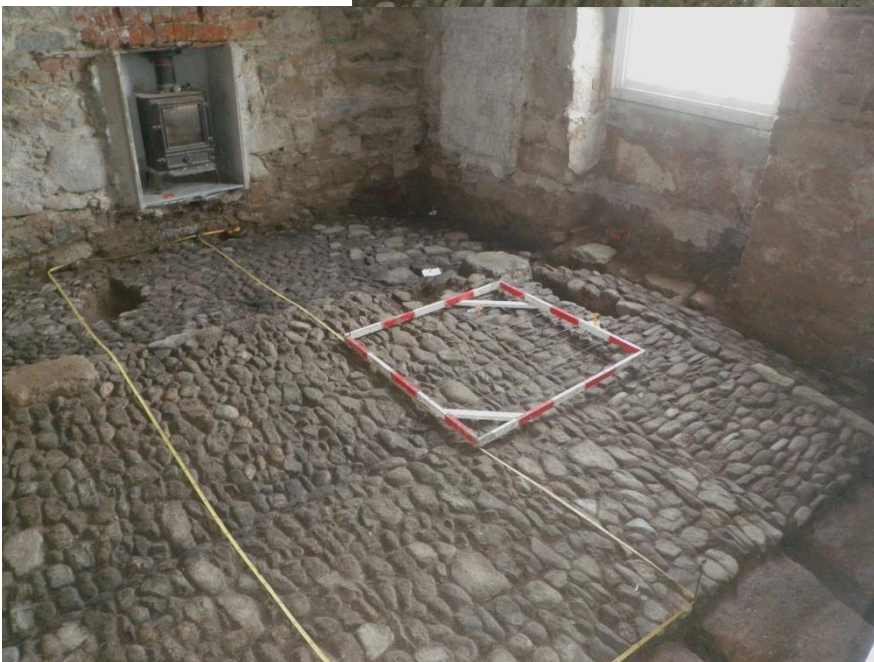
Fig 18 Three working shots taken during; Top - clearance and cleaning, Middle - photographing, and Bottom - planning of Room 7.

The heat-discoloured cobbles do not relate to the former hearth/current wood burner (shown in upper Fig 16 and Fig 18). It appears to be directly associated with a number of small splats of molten iron (two of which are shown as two black dots on one of the cobbles northeast of the void, and as five dots southeast of posthole (20)). It is possible that the heated cobbles and the iron droplets reflect the position of a former smithy.
