# Stowe's Hill, Linkinhorne, Cornwall Condition Survey

<b>Client</b>	Historic England
<b>Report Number</b>	2020R073
<b>Date</b>	20/10/20
<b>Status</b>	Final
<b>Report author</b>	James Gossip
<b>Approved by</b>	Andy Jones
<b>Project number</b>	147004
<b>Site code</b>	n/a
<b>Data location</b>	<a href="#">\\CAU\Archive\Sites\Stowe's Hill Condition Survey 147004</a>
<b>OASIS online reference</b>	cornwall2-405903

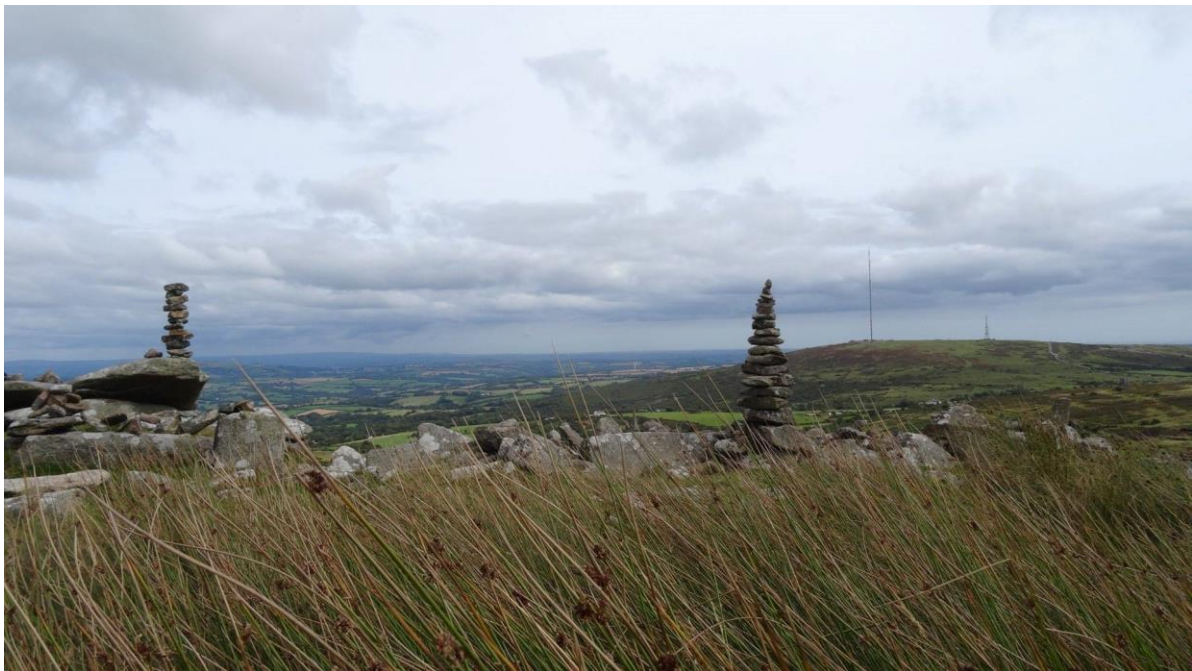
Fig 3 Stone stacks on the ramparts of the southern enclosure, 2017 (photo Stuart Dow).

In recent years the walls of the enclosures have suffered from vandalism, mostly in the form of the construction of stone stacks, or 'Fairy Castles' (Figs 3-5). Sections of original rampart face and core are being robbed-out to create these stacks, and the shifting of collapsed or loosened stones reveals more *in situ* rampart which is then accessible to further robbing. The project focusses on providing a record of condition and form of the main enclosures and internal features with an emphasis on volunteer engagement, damage recording and enhanced interpretation by means of signage and newer technological solutions. It is envisaged that through enhanced interpretation and education visitors will be deterred from vandalism in the future.

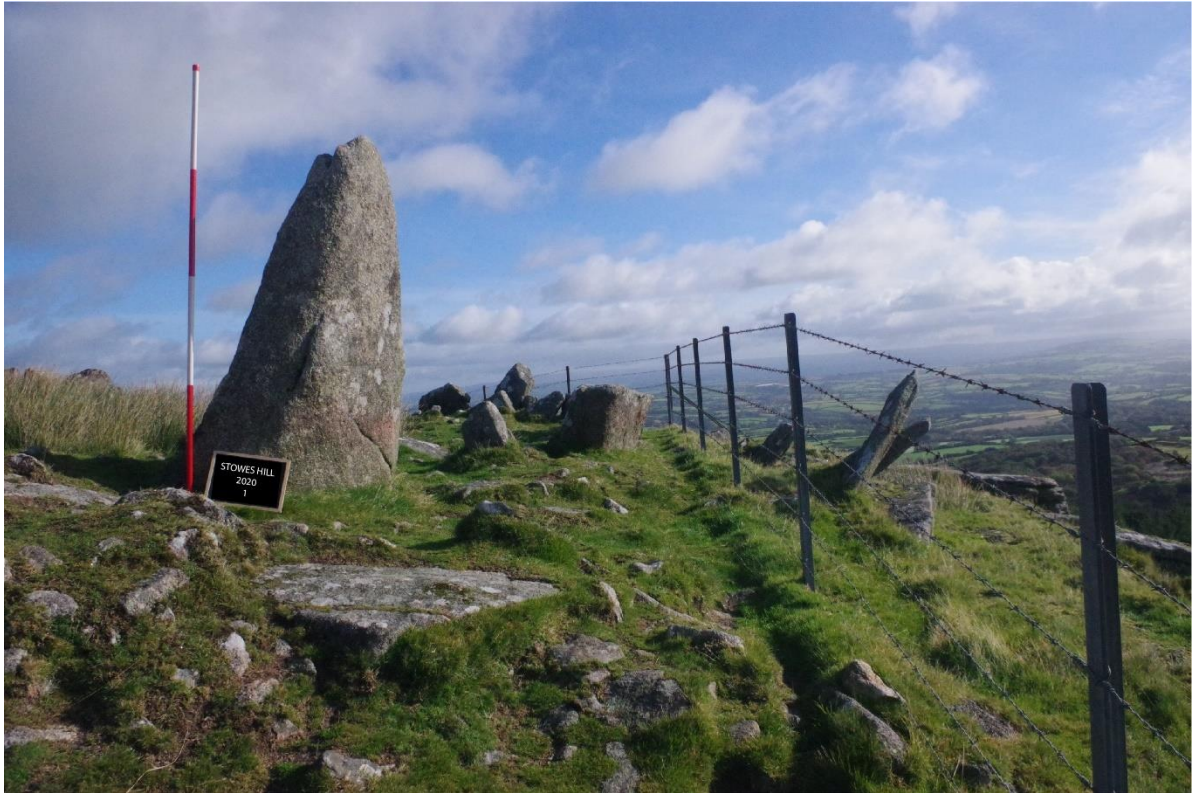
<b>Feature</b>	<b>Description</b>	<b>Current condition</b>
<b>Southern Enclosure</b>		
1	Orthostatic boulders on the southern edge of the smaller southern enclosure, just inside the fence line. A prominent feature, presumed to be facing stones to a rampart now removed.	Stable. Relatively high footfall.
2	Orthostats perhaps indicating outer edge facing stones or part of rampart core, close to the edge of the quarry and on the outside of the fence line.	Stable.
3	Areas of reed growth within the smaller enclosure.	Ground stable, not boggy.
4	Facing stones along the inside edge of the rampart at its south-eastern end.	Stable and earth-fast, visible.
5	Top of the rampart south-eastern end.	All stones are loose and easily mobile. No evidence of recent vandalism, but stones do move when the ramparts are walked on. There is evidence that many visitors do this.
6	Remains of hut or shelter built into the top of the southern enclosure rampart, eastern side.	Stones very loose and unstable.

Fig 14 Feature 1 – orthostats, southern tip of southern enclosure.

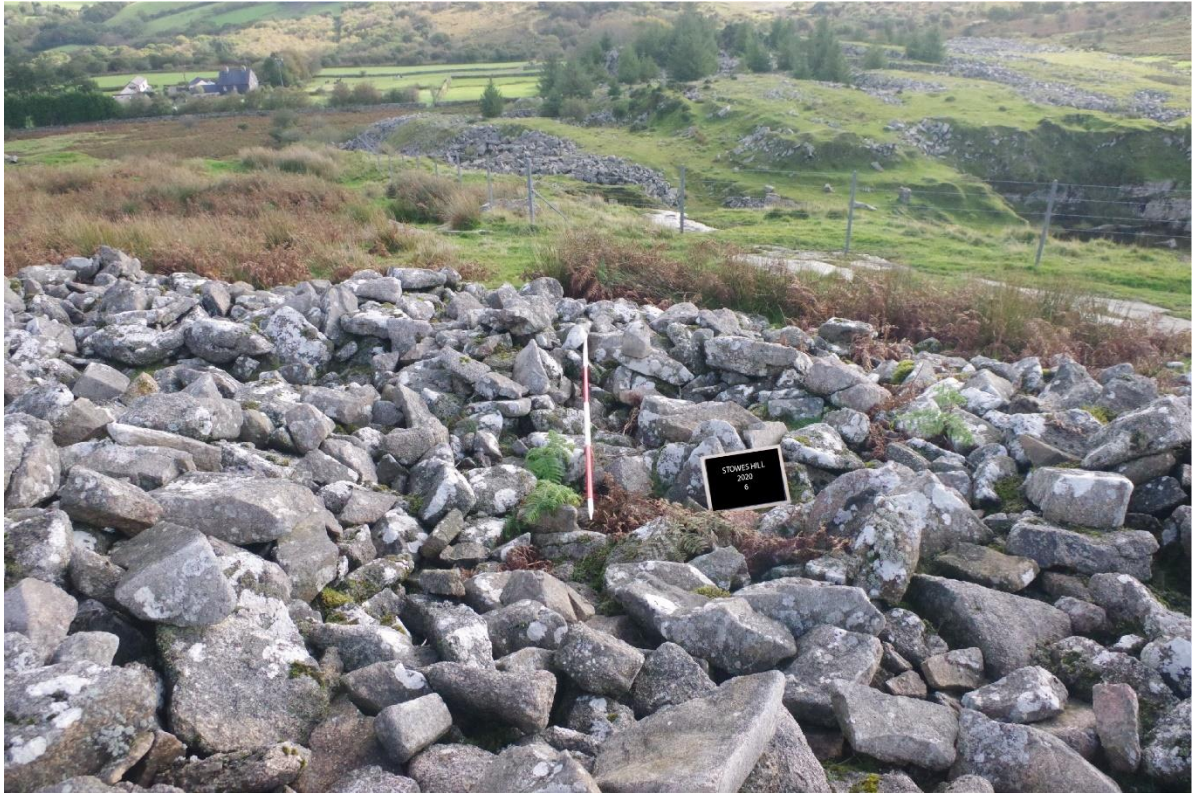
Fig 20 Feature 6 – quarry or shelter, eastern rampart, southern enclosure.

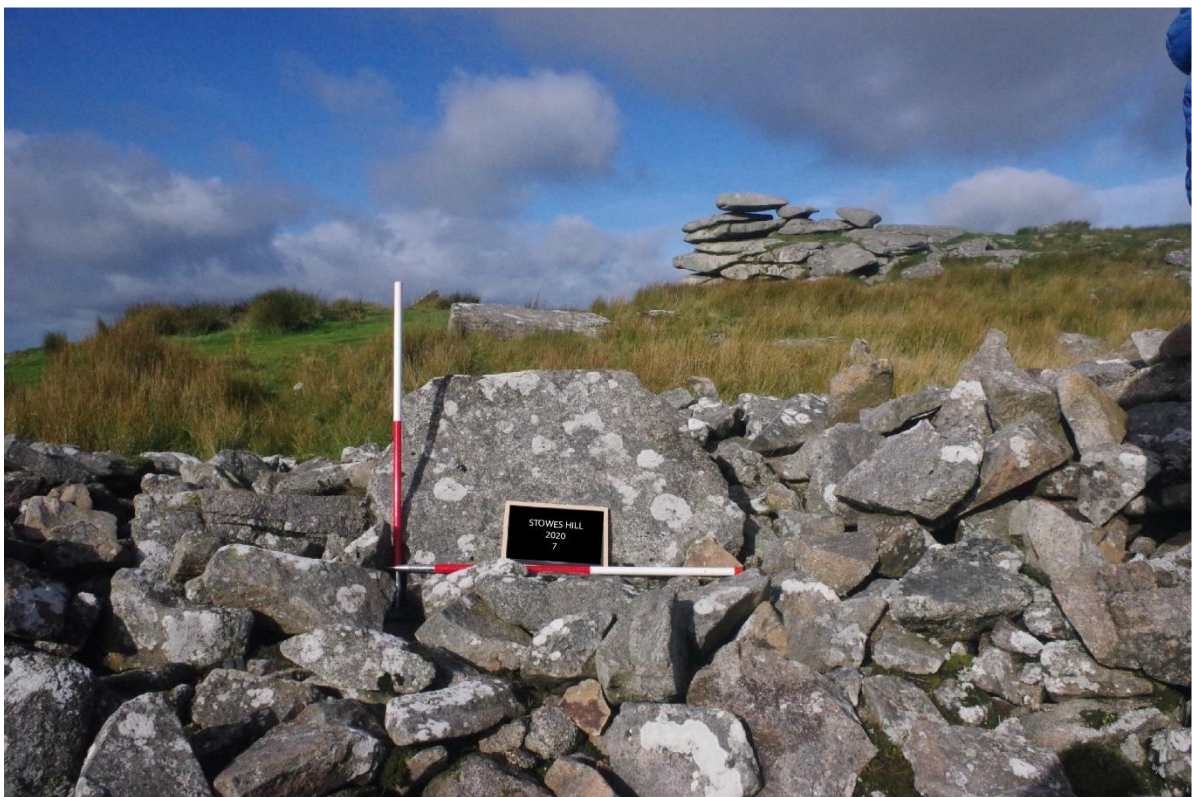
7	A large boulder, possibly part of rampart core, eastern side.	Boulder earth-fast, surrounded by loose stone.
8	Well-preserved remains of oval hut or shelter built into the top of the southern enclosure rampart, eastern side. Coursed stone walling on western side, orthostats form the south-eastern curved wall.	A long stone has been toppled into the centre of the structure, presumably from nearby. All stones making up the structure and those surrounding are very loose.
9	Coursed stone forming the west wall of site 8 shelter or hut.	
10	Orthostats forming the south-eastern wall of site 8 shelter or hut and showing dumped stone.

Fig 21 Feature 7 – exposed wall core, eastern rampart, southern enclosure.

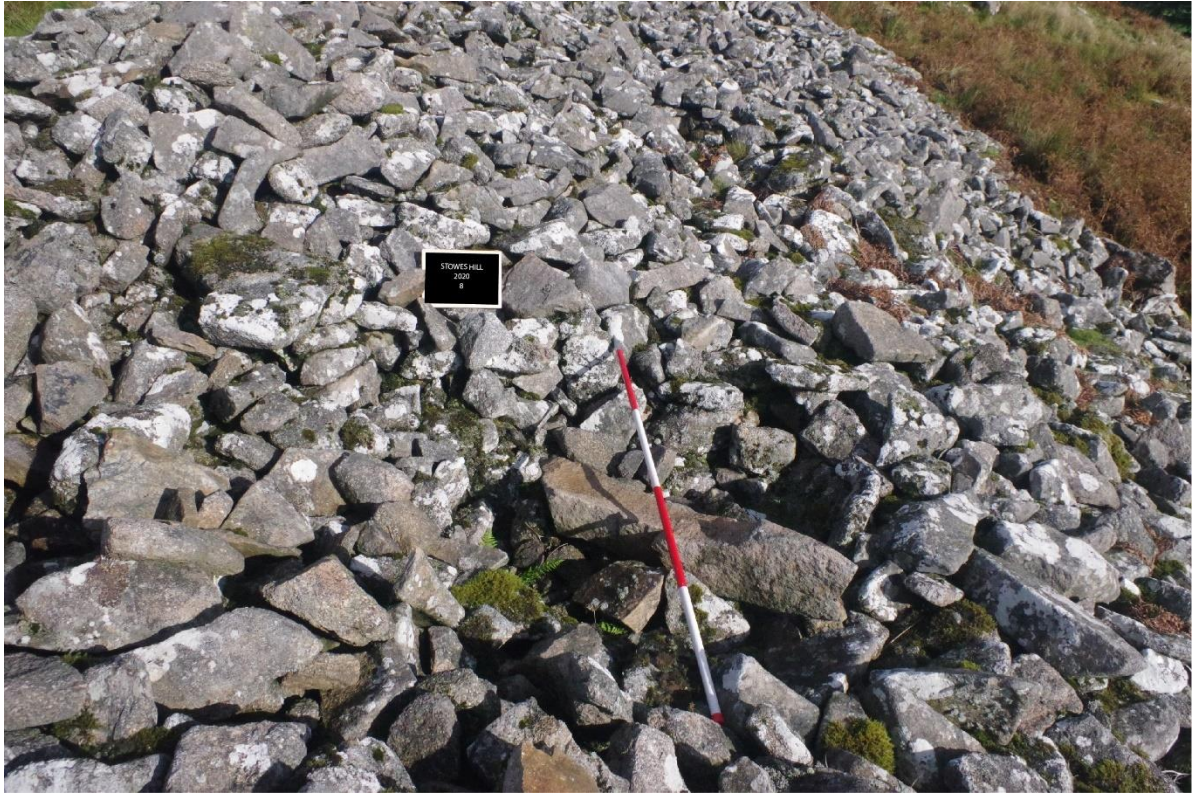
Fig 22 Feature 8 – shelter/hut, eastern rampart, southern enclosure.

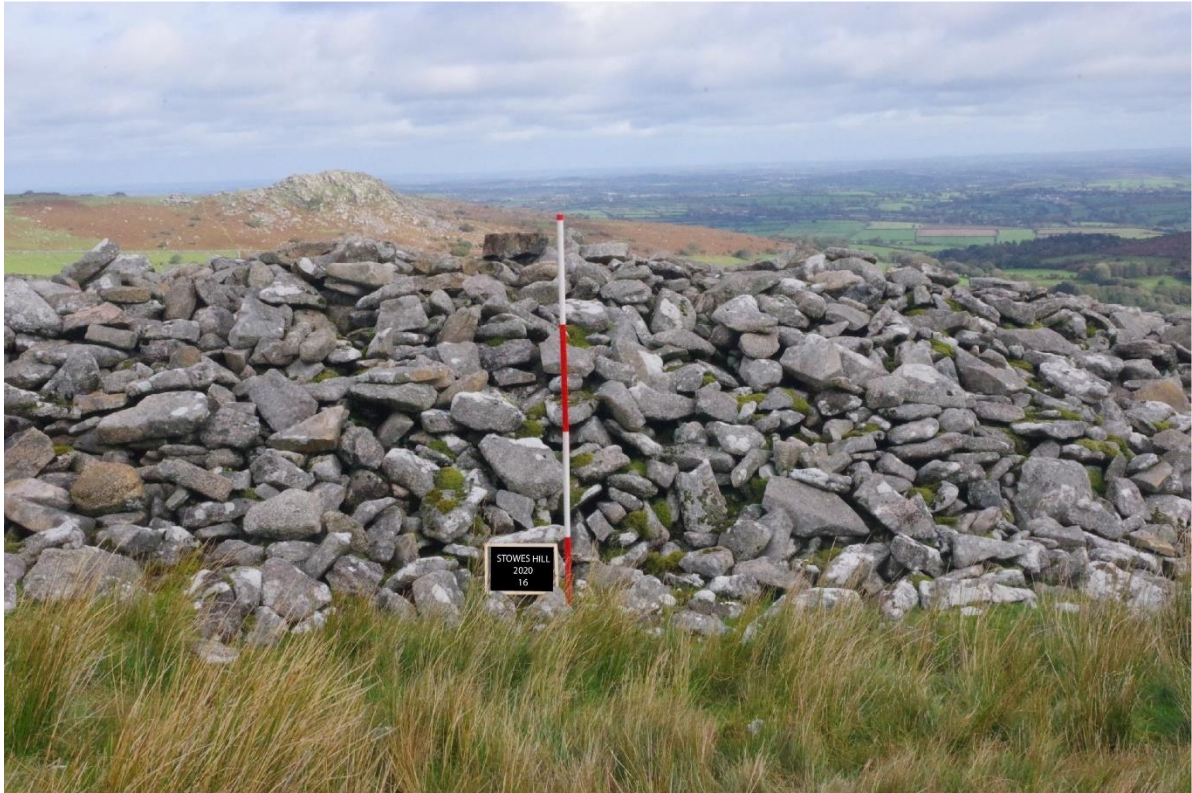
<b>Feature</b>	<b>Description</b>	<b>Current condition</b>
11	Possibly buried facing stone covered by rampart tumble.	All stones very unstable surrounding the facing stone.
12	Facing stone, inside edge of enclosure rampart, east side.	Evidence of recent tumble of stone into the interior of the enclosure. Possible collapsed stone stack
13	Facing stones along the inside edge of the rampart on its eastern side to the west of large outcropping boulder (14).	Stable and earth-fast, visible
14	Large outcrop 'slab', covered with 'Merriment' or 'Midsummer' holes.	Stable
15	Leaning boulder, probable facing stone, inside edge of rampart, north-east side. Rampart falls away steeply on eastern side.	Very unstable stone either side of boulder with an accumulation of stones collapsed into interior of enclosure on the north-west side of the stone.
16	Tumble of stone along inside face of rampart, north-east corner.	Moss covered, no recent movement.

Fig 30 Feature 16 – tumble from rampart face, north-east corner, southern enclosure.

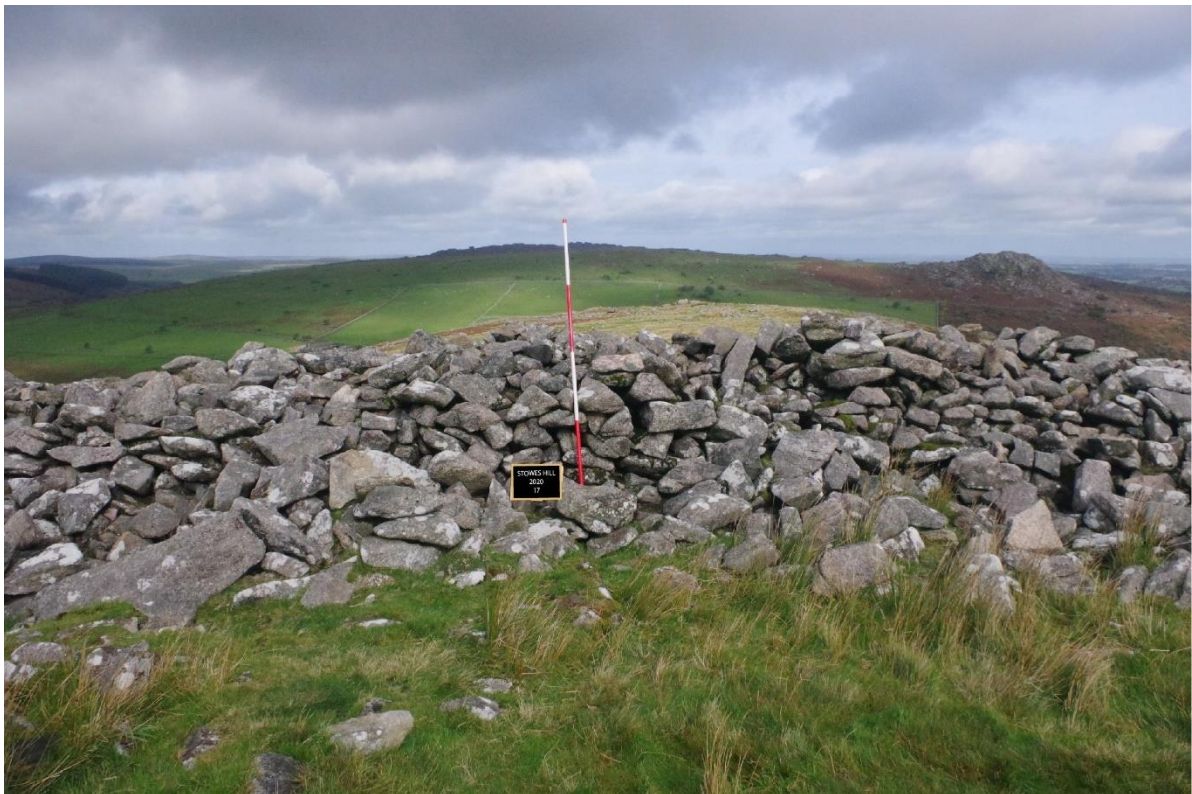
17	Coursed stone wall 0.70m high indicating exposed rampart core, inside face of rampart north side of enclosure.	Stones are unstable and could be damaged by climbing. Close to the most often used access point into the northern enclosure.
18	Large boulder: possibly rampart core visible on inner face of rampart north side of enclosure. May have become visible after tumble of smaller stones.	Surrounding stones very unstable.
19	Broken granite cider press inside enclosure adjacent to natural outcrop stack – probably an unfinished piece, later split by drilling.	Stable.
20	Western rampart south of outcrop. Hawthorn growing from outside edge.	Unstable stone. Tree not causing any visible damage.
21	Western rampart, collapsed inner face, outside tumbled down slope making the rampart low but wide at this point.	Loose, unstable stones.
22	Orthostatic facing stones along the inside edge of the rampart, western side of enclosure.	Facing stones stable, loose surrounding material.

Fig 31 Feature 17 – exposed wall core, northern rampart, southern enclosure.

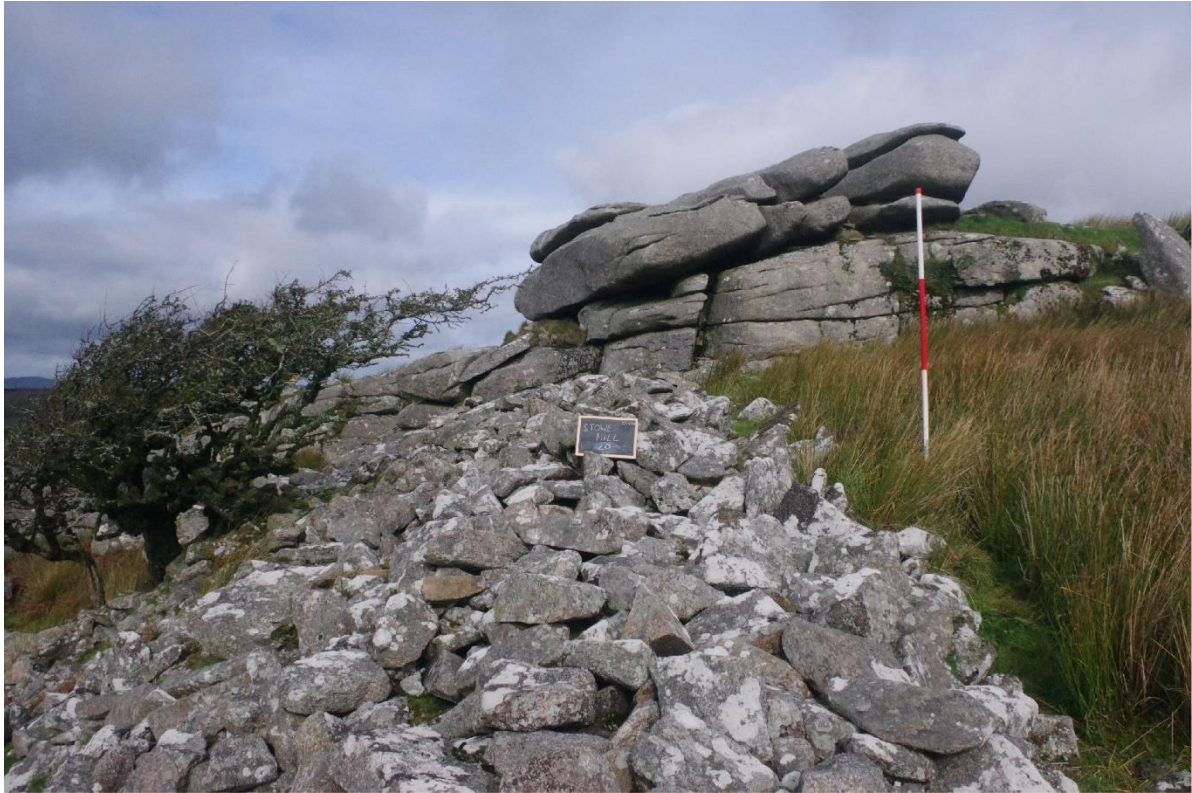
*Fig 34 Feature 20 - collapsed western rampart southern enclosure showing tree growing from rampart, facing north.*

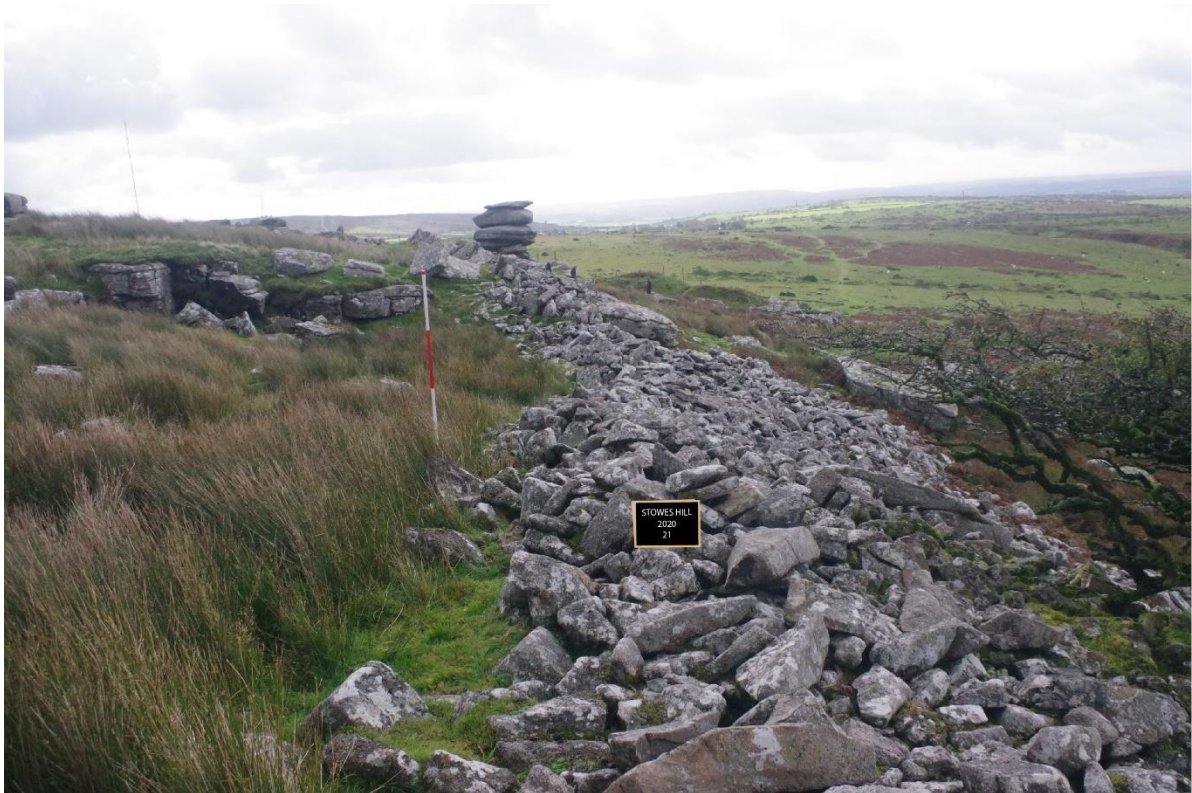
*Fig 35 Feature 21 - collapsed western rampart southern enclosure showing facing stones, facing south.*

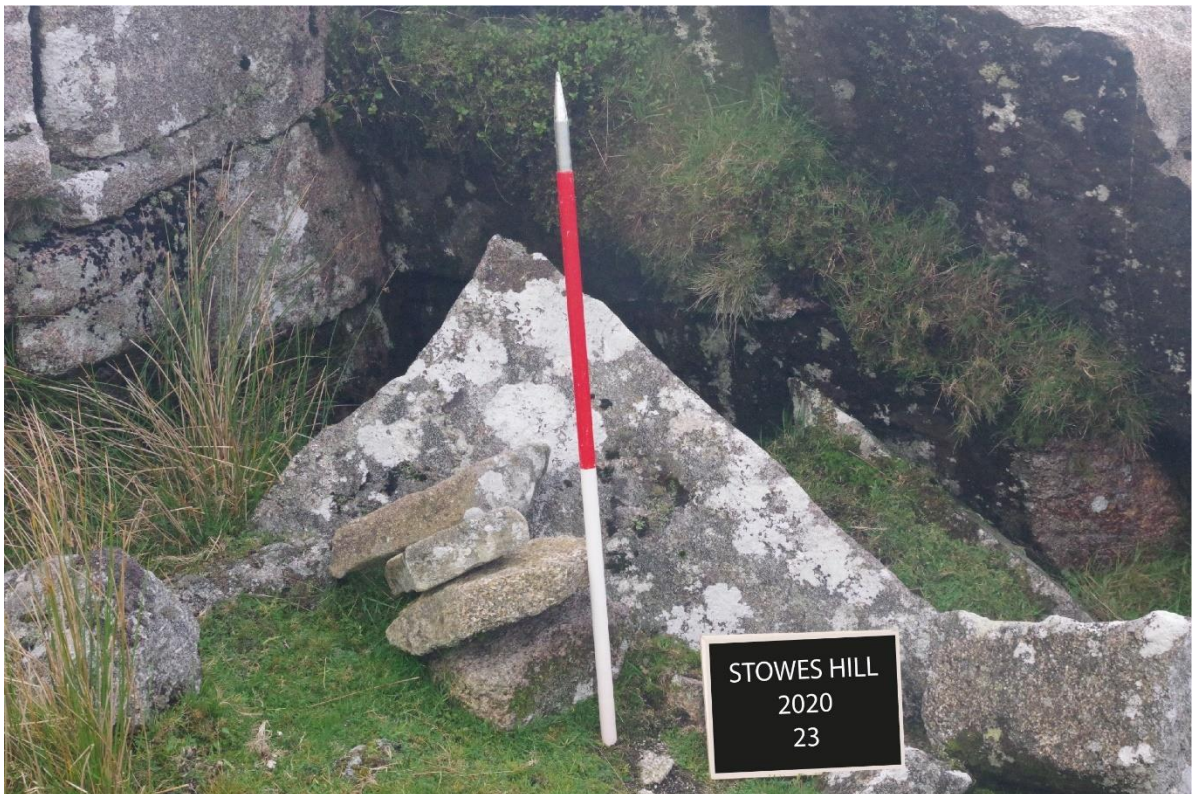
23	Small stack of stones, probably a collapsed stone stack at base of outcrop.	Currently left in place.
24	Orthostatic facing stones along the inside edge of the rampart, western side of enclosure.	Facing stones stable, loose rampart material on western side of facing stones.
25	Orthostatic facing stones along the inside edge of the rampart, many leaning westwards into the rampart core, western	Facing stones stable, loose rampart material on western side of facing

Fig 37 Feature 23 - collapsed stone stack.

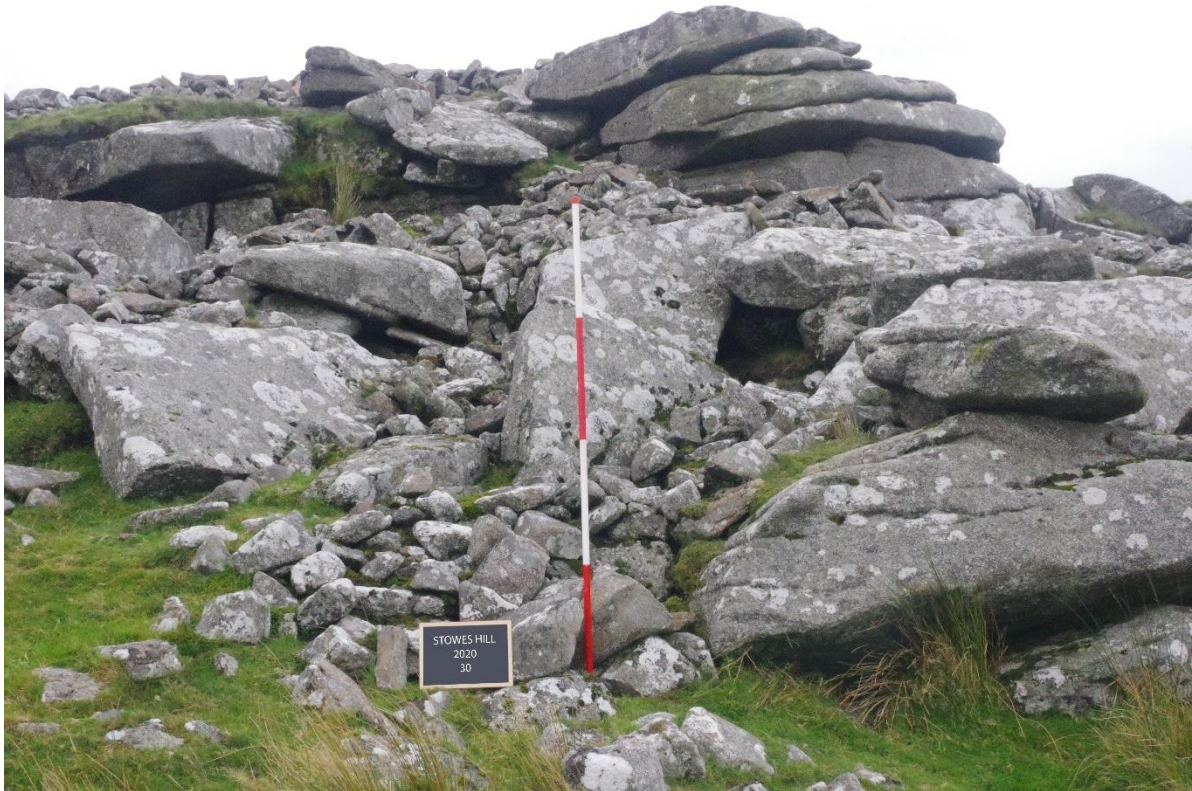
*Fig 44 Feature 30 – northern enclosure, tumble of small stones on the outer face of the rampart.*

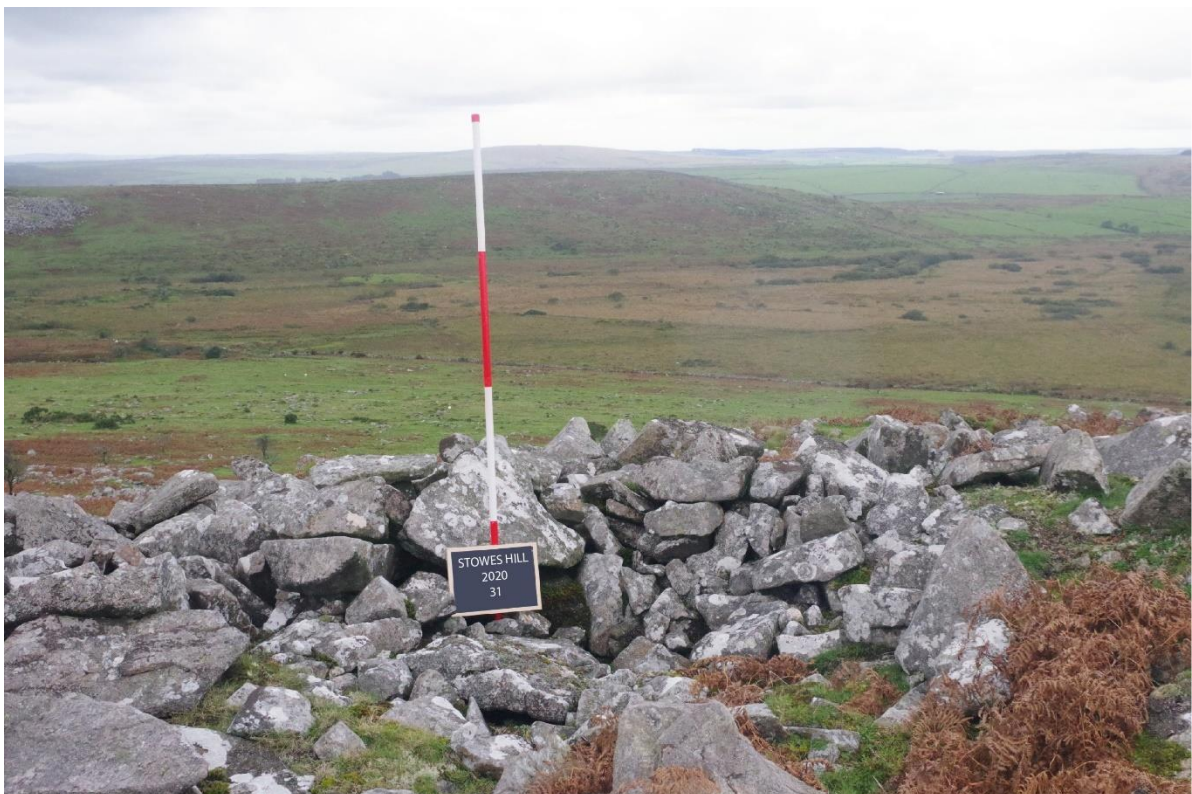
*Fig 45 Feature 31 - northern enclosure, area of exposed wall core comprising irregularly coursed stone, northern end of enclosure.*

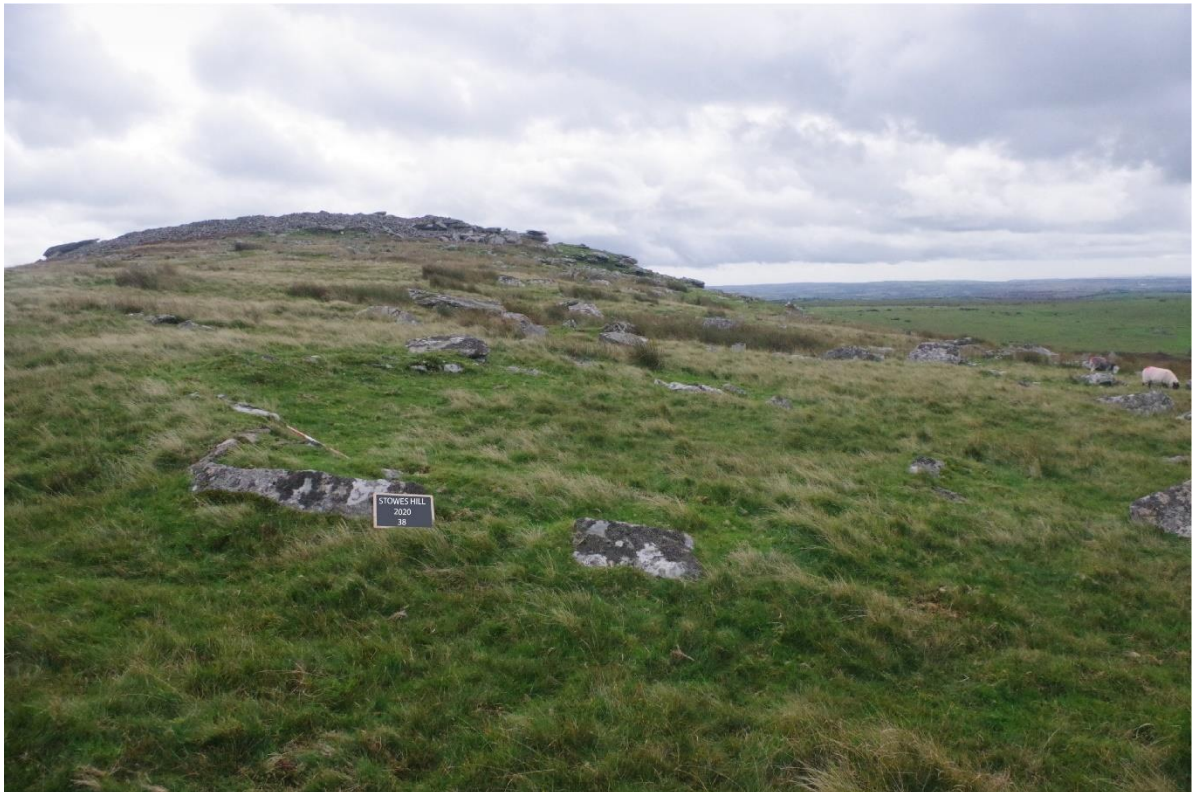
38	Hut platform with partially visible stone kerb. Grass, grazed.	Stable.
39	Denuded rampart at northern extent of enclosure.	Stable.
40	West hollow way entrance into enclosure. Bracken growth on north side.	Stable.
41	Extensive bracken growth obscuring eastern rampart on the slopes as it runs southwards towards the southern enclosure.	Obscured by vegetation.

Fig 53 Feature 38 - northern enclosure, hut platform with partially visible stone kerb.

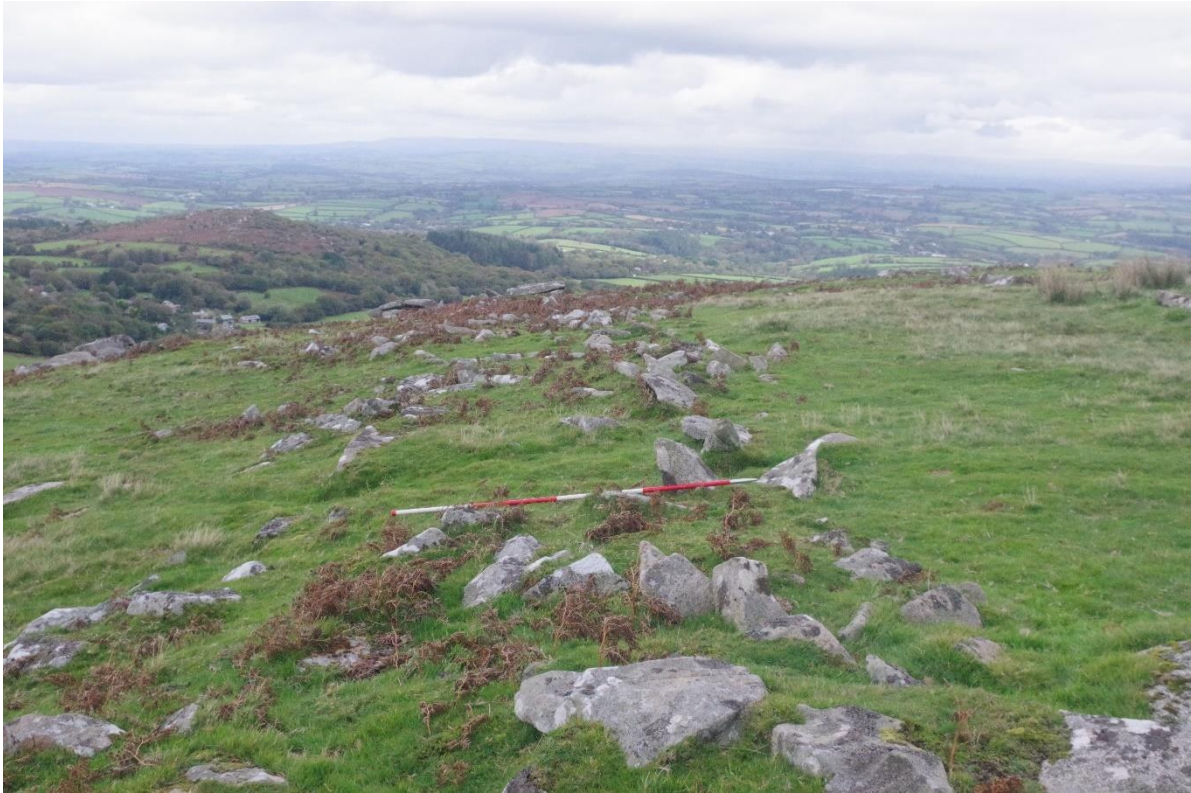
*Fig 54 Feature 39 - northern enclosure, denuded rampart at north-eastern extent of enclosure.*

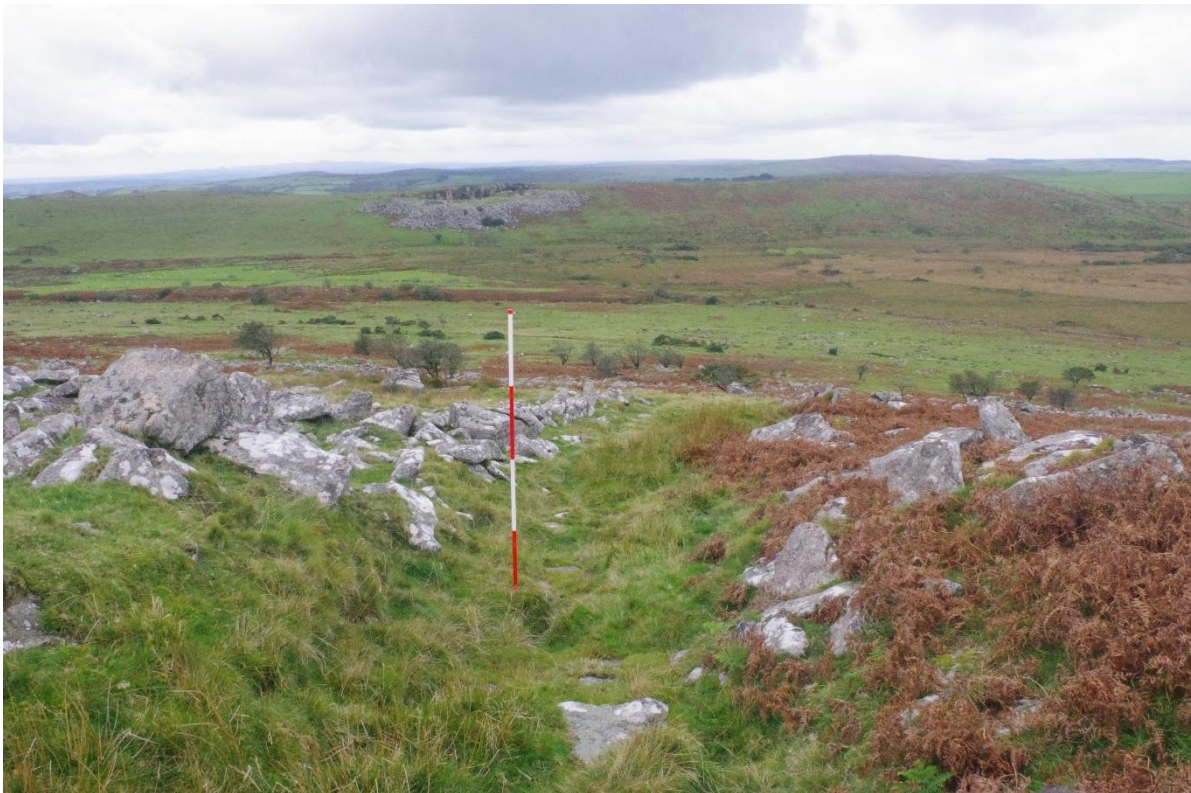
*Fig 55 Feature 40 - northern enclosure, west hollow way entrance into enclosure. Bracken growth on north side.*

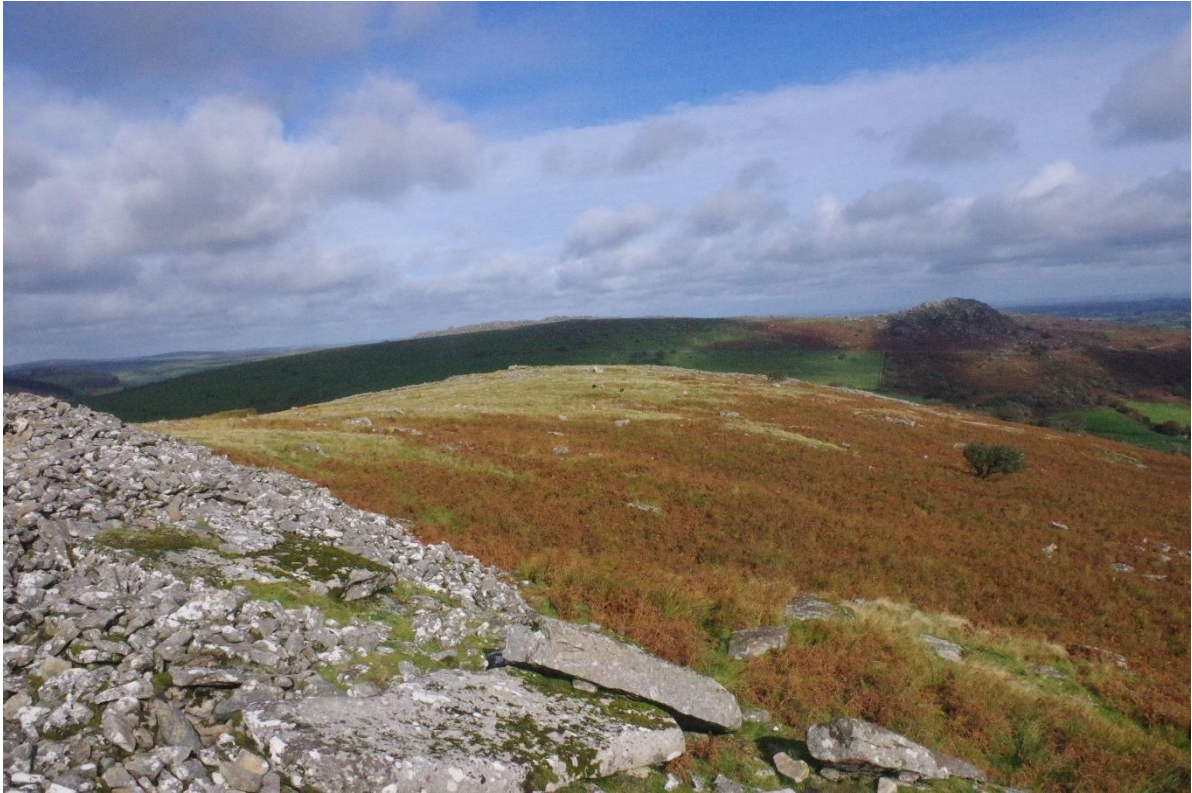
*Fig 56 Feature 41 - northern enclosure, extensive bracken growth obscuring eastern rampart.*

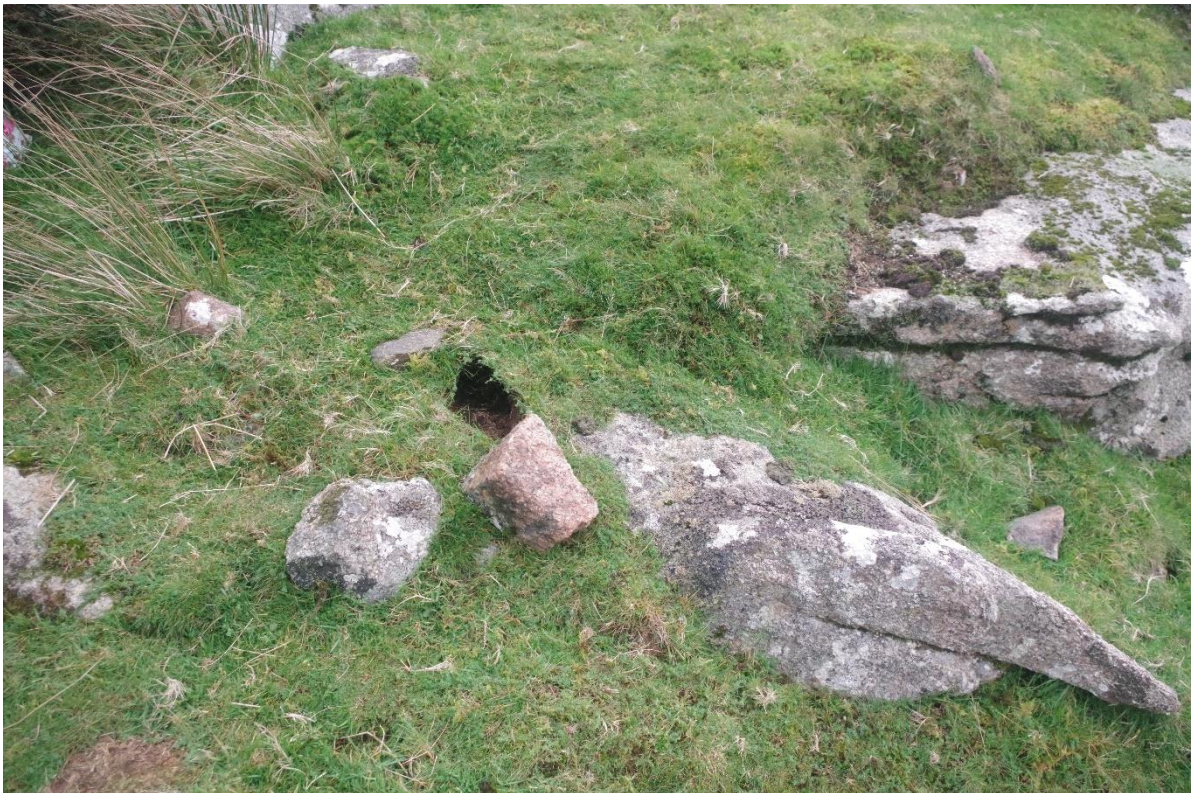
<b>Feature</b>	<b>Description</b>	<b>Current condition</b>
42	Stones displaced from base of southern enclosure rampart.	Easily displaced.
43	Fractured stones thrown from the high ramparts of the southern enclosure into the larger enclosure.	Scatters of stone indicate this is a fairly common practice.
Additional records		
44	A small fairy castle at the base of the rampart of the southern enclosure.	Dismantled and stones placed on rampart adjacent. No indication where the stones had derived from.
45	A circle of stones built from rampart stones, close to the base of the rampart of the southern enclosure.	Dismantled and stones placed on rampart adjacent. No indication where the stones had derived from.
46	Bracken growth at the north-western end of the northern enclosure.	Obscures features such as site 32 and outer walls.

*Fig 57 Feature 42 - northern enclosure, stones displaced from base of smaller enclosure rampart.*

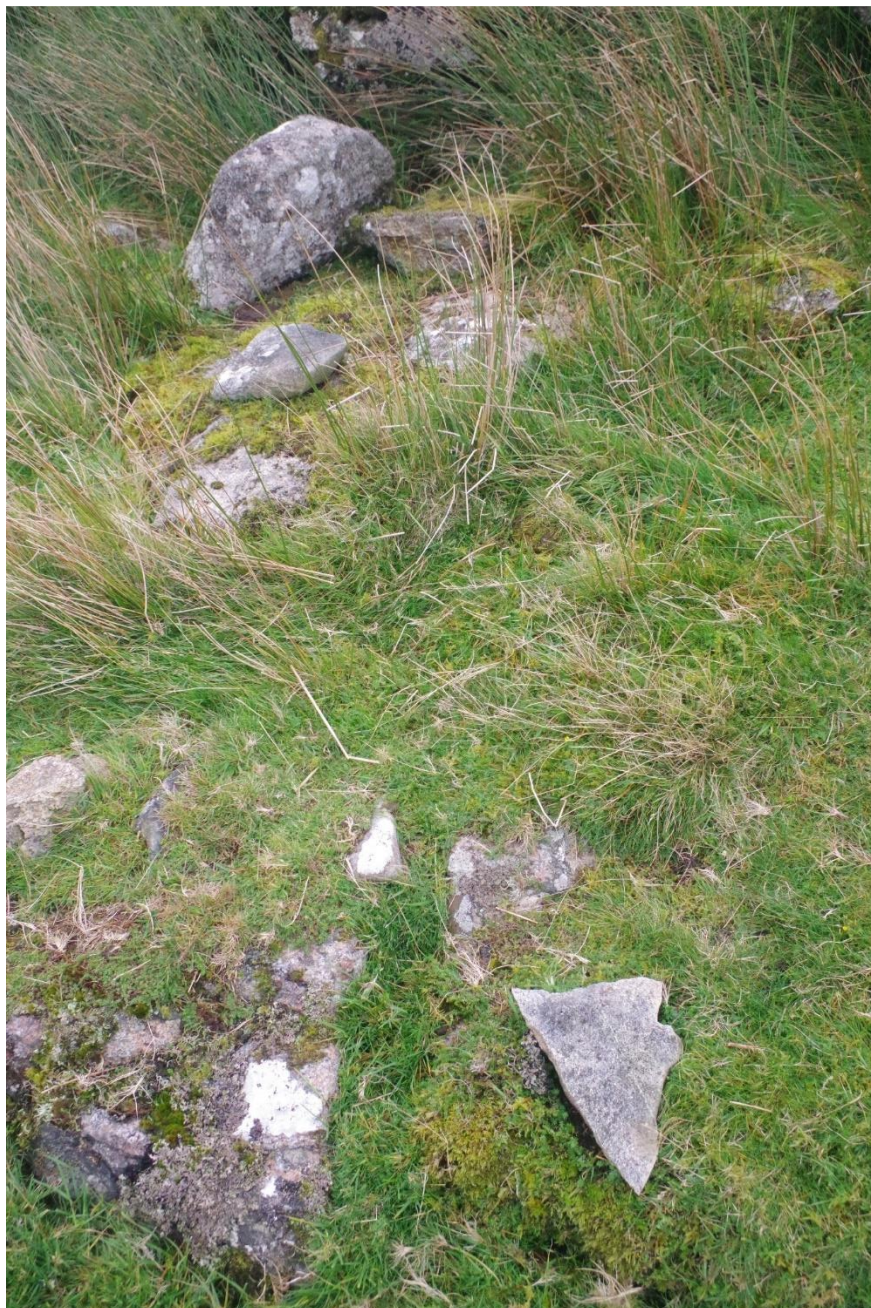
*Fig 58 Feature 43 – broken stones thrown from the high ramparts of the small enclosure into the larger enclosure.*

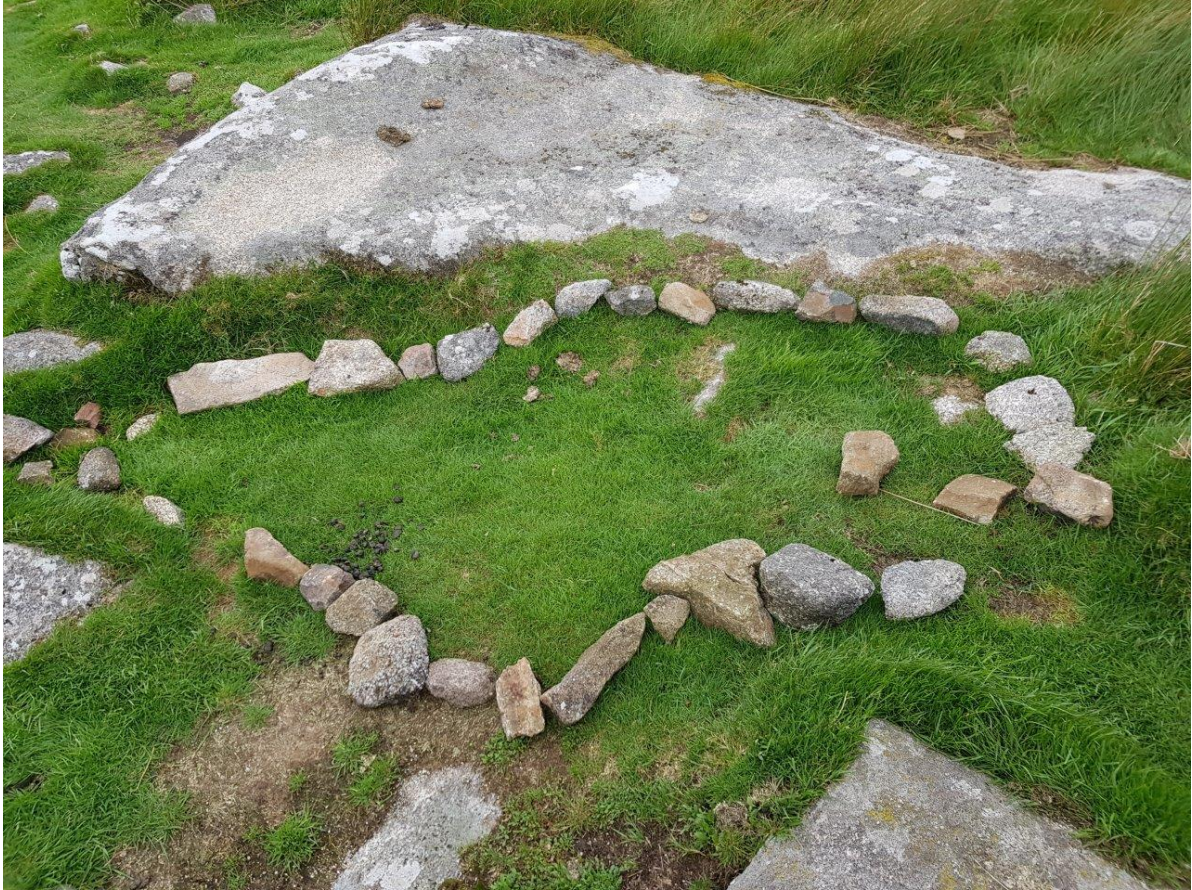
Fig 59 Feature 45 - southern enclosure, small ring of displaced stones.

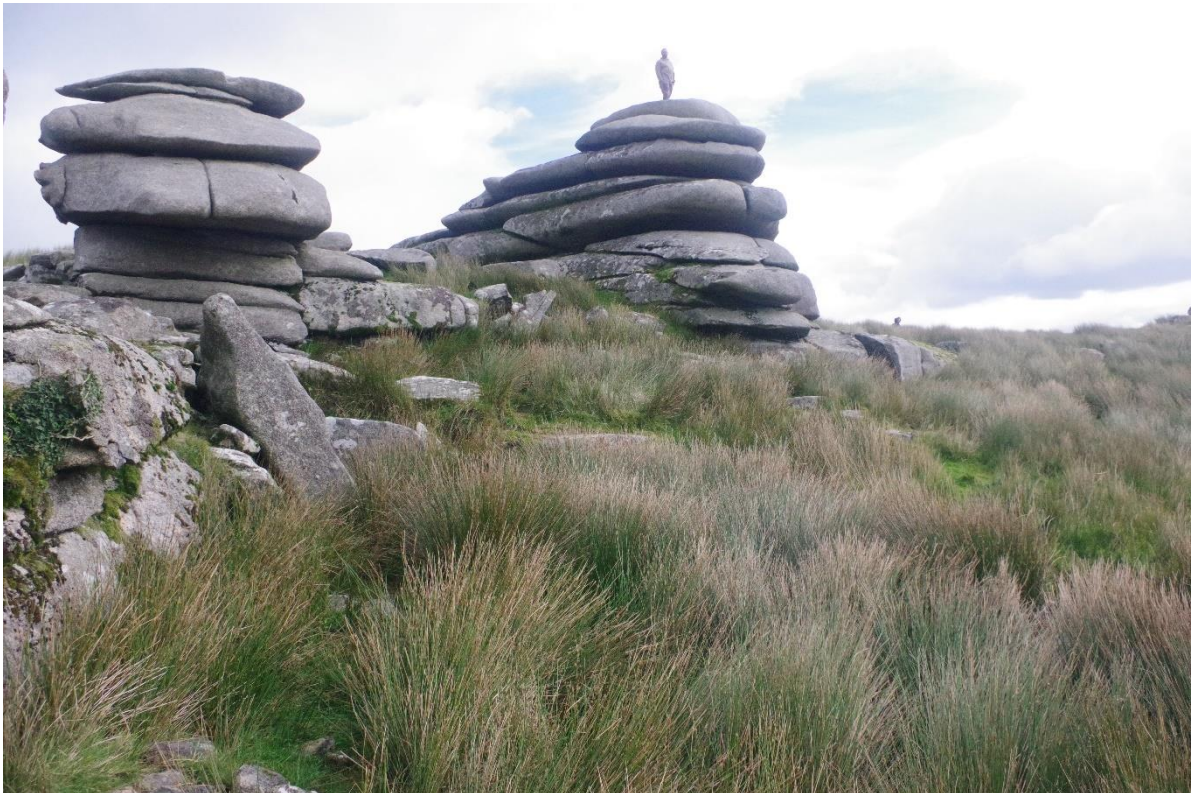
Fig 60 Feature 46 - extensive reed growth on the western side of the small enclosure.

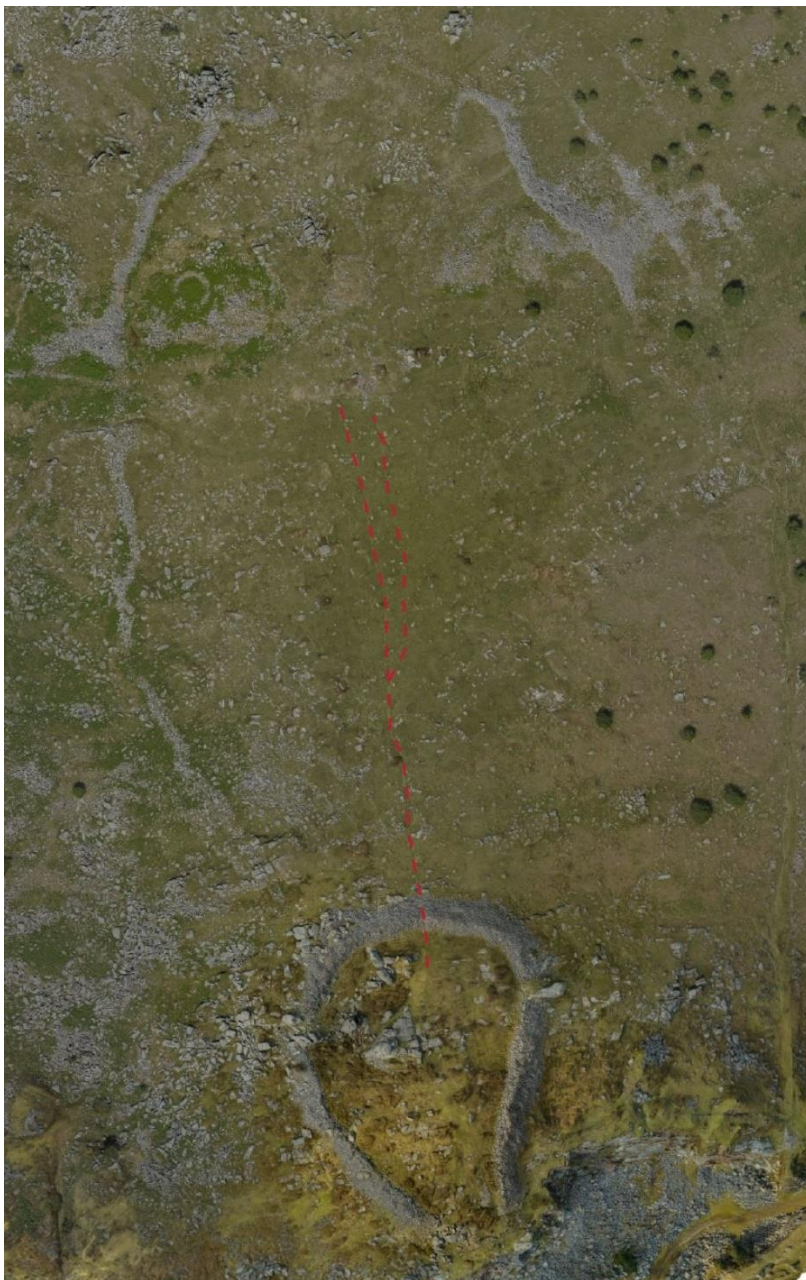
The orthographic aerial imagery shows low impact desire lines leading through both enclosures. Two worn paths run from the southern enclosure extending into the centre and around the eastern internal perimeter along the base of the rampart (Fig 61). Within the enclosure most visitors are drawn to the large rocky outcrops. For those visitors wishing to explore the northern enclosure a section of rampart in the centre of the northern stretch is most often used, to join the desire line extending south to north across the enclosure. This splits in two with desire lines running parallel as far as the central area where they partly fade out or connect with the hollow trackway leading through the western entrance. An additional worn path runs around the base of the eastern wall to the enclosure entrance on its eastern side.

No erosion is apparent on any of the desire lines and they are fully grassed over. There appears to be no significant damage caused by the desire lines. However, the rampart section most frequently crossed shows a marked deterioration (Fig 62). This area should be focussed on for comparison following the 2021 drone survey.

Fig 61 Desire lines from the southern enclosure across the northern enclosure.
