# Stowe's Hill, Linkinhorne, Cornwall Condition Survey

<b>Client</b>	Historic England
<b>Report Number</b>	2020R073
<b>Date</b>	20/10/20
<b>Status</b>	Final
<b>Report author</b>	James Gossip
<b>Approved by</b>	Andy Jones
<b>Project number</b>	147004
<b>Site code</b>	n/a
<b>Data location</b>	<a href="#">\\CAU\Archive\Sites\Stowe's Hill Condition Survey 147004</a>
<b>OASIS online reference</b>	cornwall2-405903

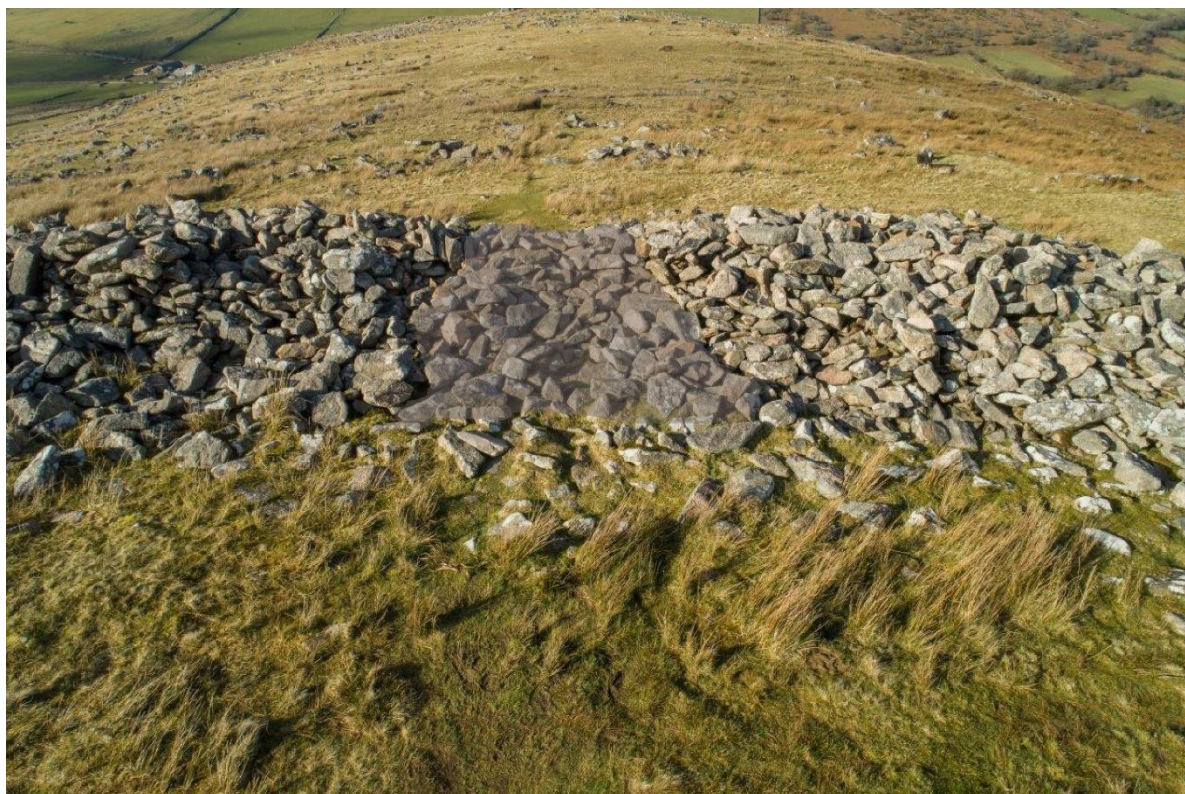
No erosion is apparent on any of the desire lines and they are fully grassed over. There appears to be no significant damage caused by the desire lines. However, the rampart section most frequently crossed shows a marked deterioration (Fig 62). This area should be focussed on for comparison following the 2021 drone survey.

*Fig 62 Common route across rampart, shaded, showing reduced height of rampart as a result of dislodged stones.*

The ramparts of the southern enclosure comprise largely loose, stones, many of a size that can be easily dislodged. 2020 is likely to have seen the largest number of visitors to Stowe's Pound for some time. Despite this, footfall appears to cause very little damage and not all visitors are compelled to climb due to the unstable nature of the stones. However, it is clear that any movement across the ramparts has the potential to dislodge stones and foot traffic will continue to dislodge stones over time. The most frequently used route across the ramparts of the southern enclosure mid-way along its northern edge (Fig 62) where it is clear that stones have been dislodged. The conclusion is that although access at this point does not appear to be an immediate concern it should be monitored. Comparison of the 2020 and 2021 aerial surveys will indicate whether any disturbance has occurred at this point.

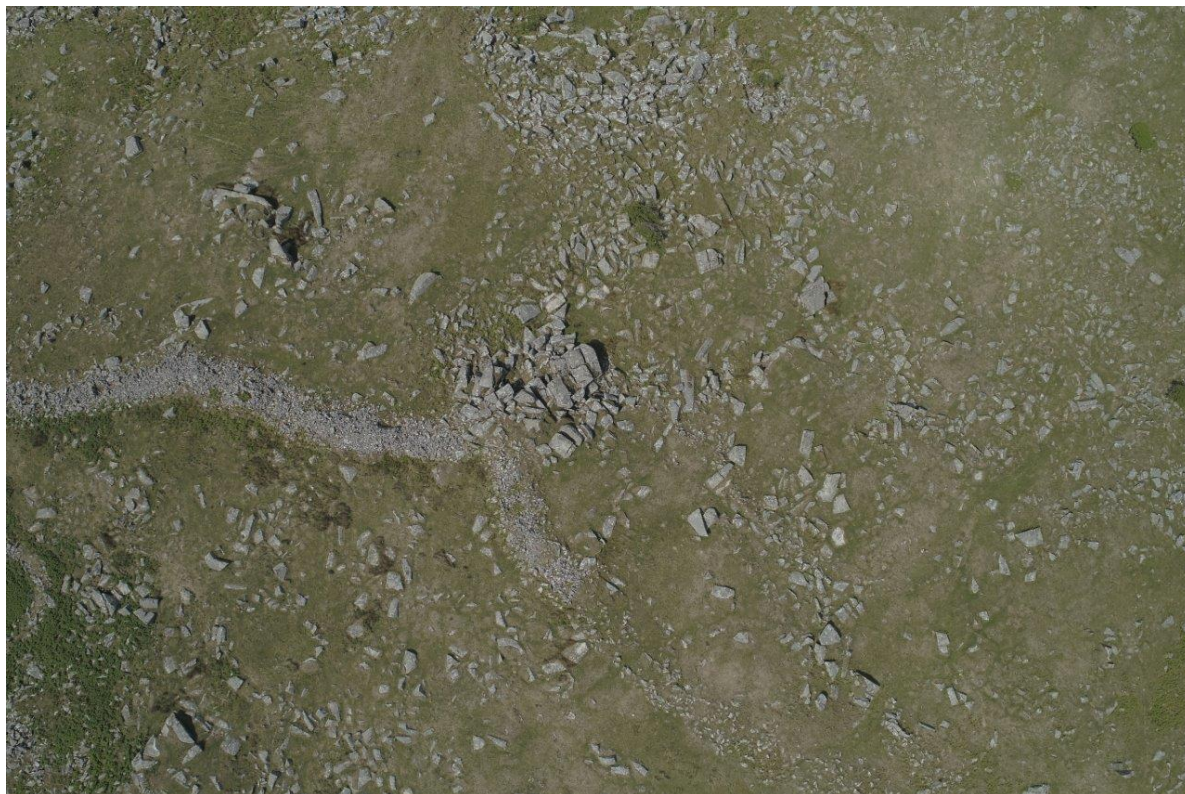
*Fig 70 denuded rampart at the northern end of the northern enclosure.*
