Noss on Dart Marina, Kingswear, Devon;
Archaeological Monitoring, Car Park Site

Client	Devon Contractors Ltd
Report Number	2020R057
Date	November 2020
Status	Final Report
Report author(s)	Cathy Parkes BA MCIfA
Checked by	Andy Jones
Approved by	Andy Jones
Project number	147064
Site code	N/A
Data location	\\CAU\Archive\Sites\Devon\Noss on Dart Marina Watching brief 147064
Historic England / ADS OASIS online reference	cornwall2-407045
Planning reference	2161/17/FUL

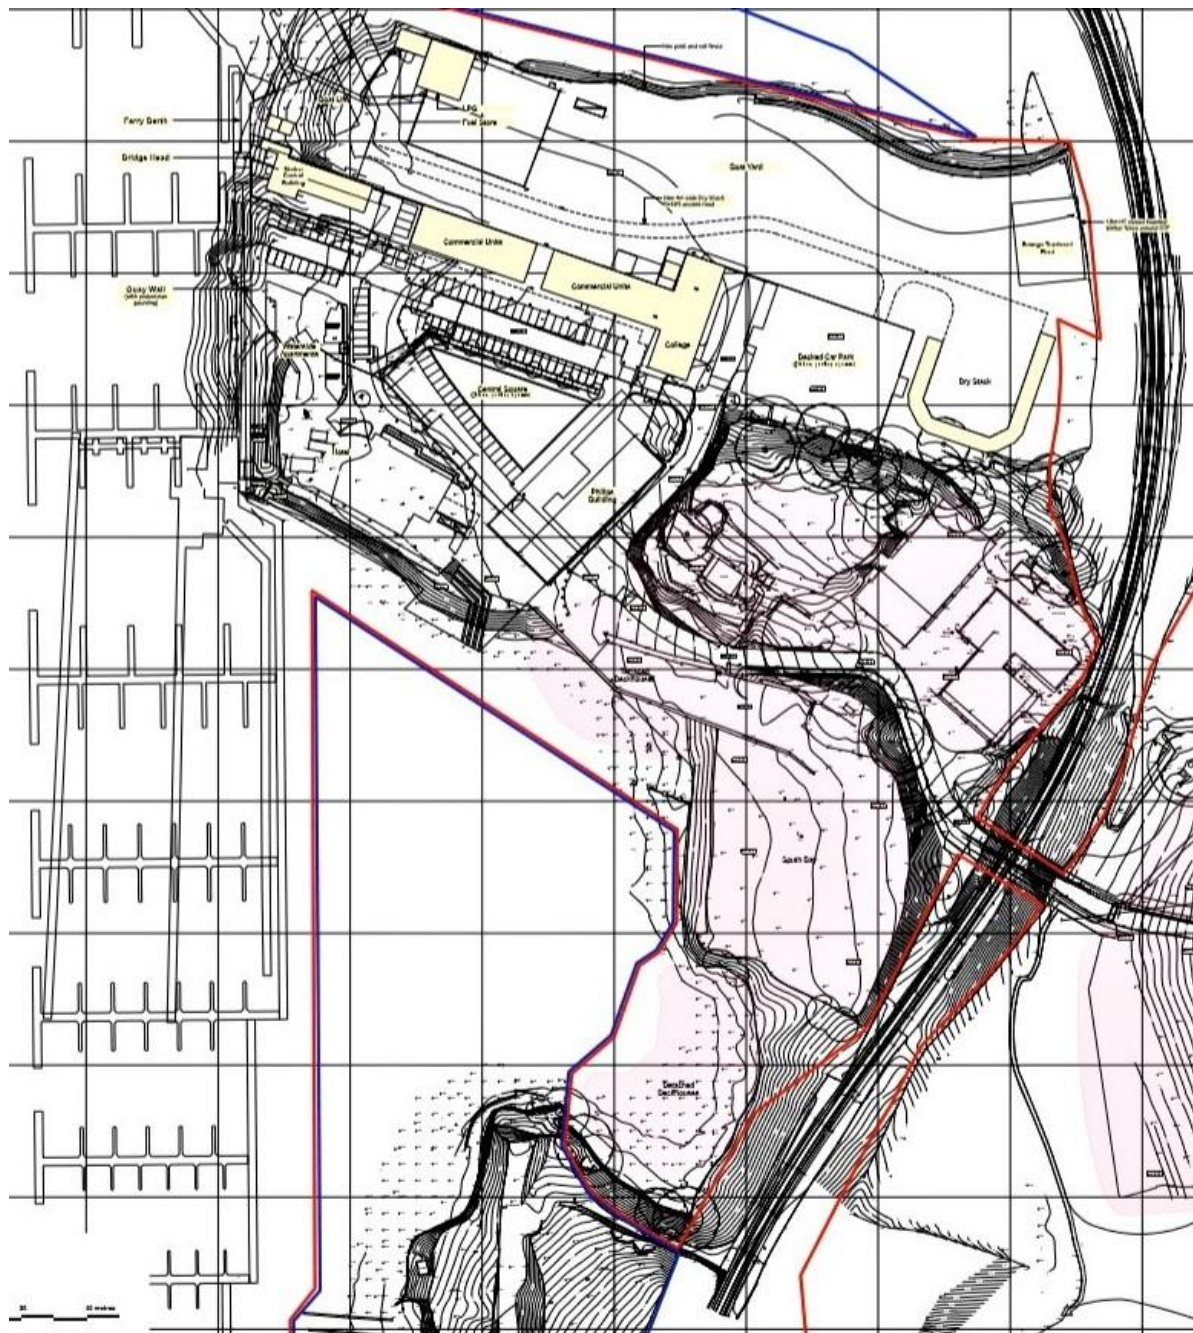
Fig 3 Client's plan of development scheme showing the car park towards the top right.

The area excavated for the new car park was rectangular in plan (Fig 3). It measured c45m WNW-ESE by 35m and was c4m deep at the end of the monitoring. On the south the works took in a strip up to c3.5m wide along the base of the steep north slope of the ridge of the Point, on the historic shoreline. The remainder of the works affected built up or 'made ground' extending north from there to reclaim a substantial part of the former tidal mud flats of Noss Creek. This made ground had been used previously as an open working area for the shipyard and as a boat storage and parking site for the marina. Along the old shoreline on the south a c2m wide grading bucket was used for parts of the machine excavation, with a toothed bucket used to remove stumps, masonry, concrete rafts and bedrock.

The topography and land reclamation can be appreciated from the client's survey showing the steep north side of the Point falling to the former shoreline on the south edge of the car park area (Fig 3). An even steeper scarp to the south west is a cutting for the railway line on the east side of the Dart Valley, which ran across the Point here and over viaducts to either side before being re-routed further east (Fig 29).

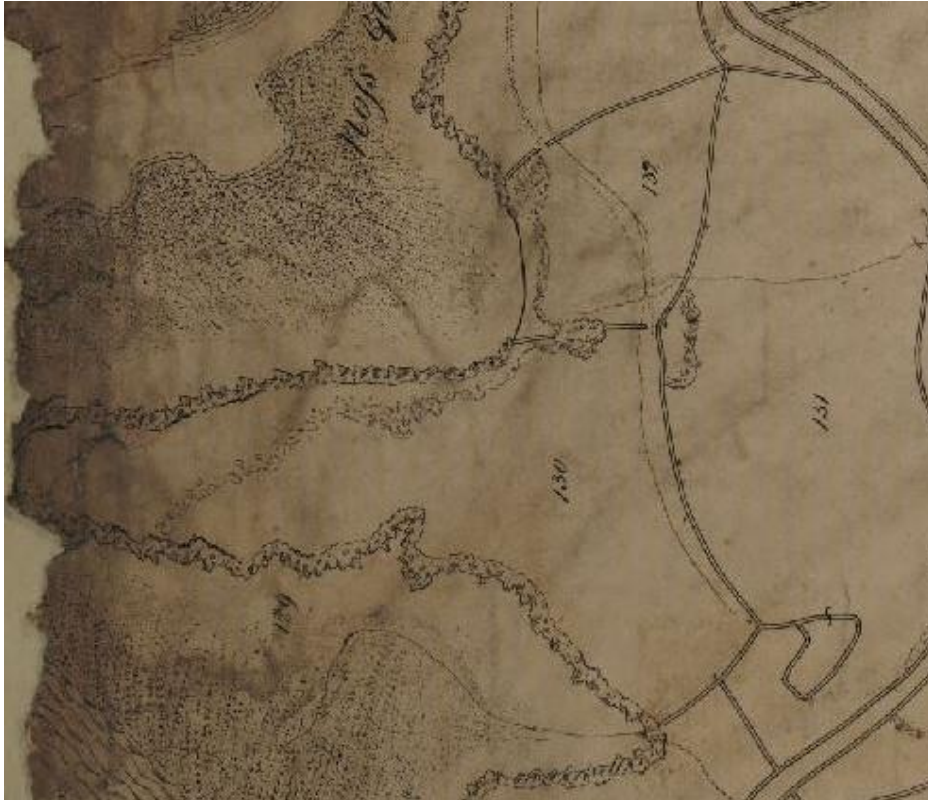
Fig 4 Kingswear Tithe survey of 1838 showing the natural shoreline with no structures.

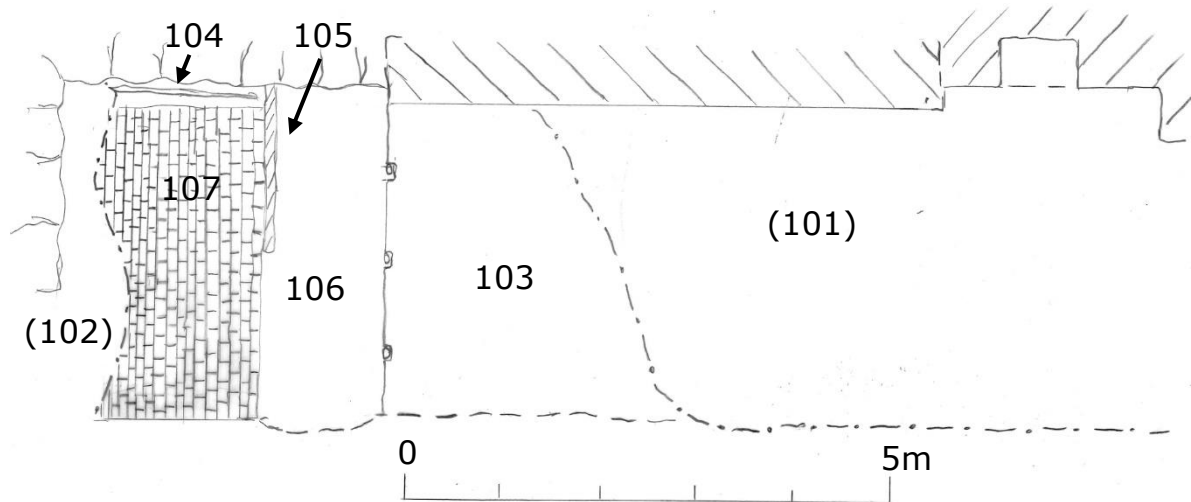
Fig 9 Schematic plan of exposed floors with context numbers (see Appendix 2) inside building at site 5 on south east of car park area.

(102)	Deposit	Dark brown soft humic silt, few small stones, up to c0.1m deep, on floor 103.	
	103	Build	Concrete poured slab 7.9m east-west by up to 3.5m (north side broken away), c10cm thick. Along east side at intervals of c0.8m (where concrete adjoins floor 103) 3 small rectangular holes (each c13cm north-south by 8cm) left by decayed inbuilt timber uprights.	
	104	Build	Concrete strip along south side of brick floor, 2.14m long, c25cm wide, with irregular runnel 7cm wide and 2cm deep made roughly along its centre.	
	105	Build	Mortar scar, possibly lime based, 1.65m long, 13cm-15cm wide, at south end of east side of lime ash floor.	
	106	Build	West part (1.22m across) of floor extending 3.36m east-west by 3.35m (north edge broken away). Lime ash c8cm-10cm thick (with some sizeable rubble stones in its base).	
	107	Build	East part (eastern 2.14m) of floor, extending 3.36m east-west by 3.35m (north edge broken away). Bricks laid in rows north-south (each c22cm by 8cm and 10cm deep).

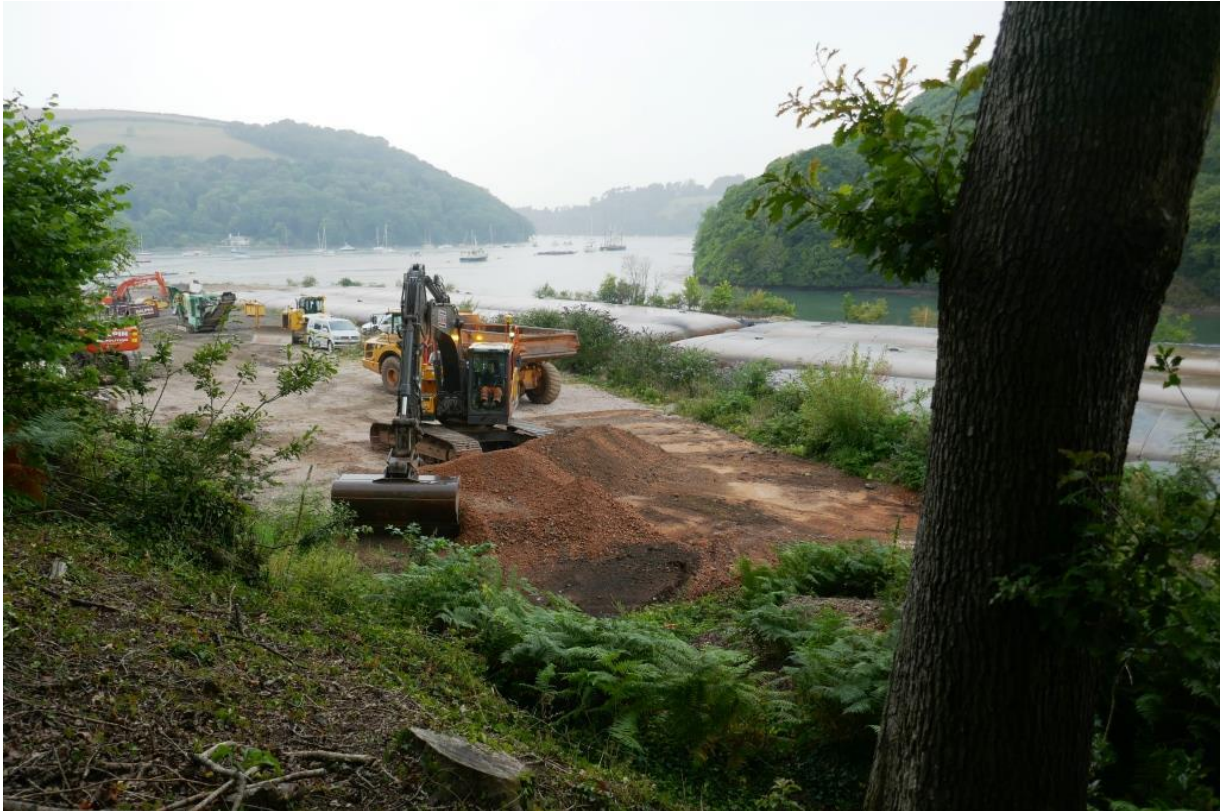
Fig 10 Looking north west across area from Higher Noss Point during stripping of gravel surface (112); beyond are the River Dart (centre) and Noss Creek (right).

Higher Noss Point, the operational centre of a historic shipyard and of the modern marina, is a small, distinctive, ridged promontory running out into the east side of the estuary of the River Dart in south Devon. Alongside the Point on the north is a small side branch of the estuary, Noss Creek (Fig 10). The historic port and town of Dartmouth lies on the other side of the main river. The area monitored was that excavated into bedrock to provide a sunken base for a new decked car park on the north side of the Point (Figs 1 and 2). The bedrocks in the vicinity are the slates and sandstones of the Lower Devonian (Devon RIGS Group website) and soils are the Denbigh 1 series of typical brown earths (Soil Survey of England and Wales 1983).

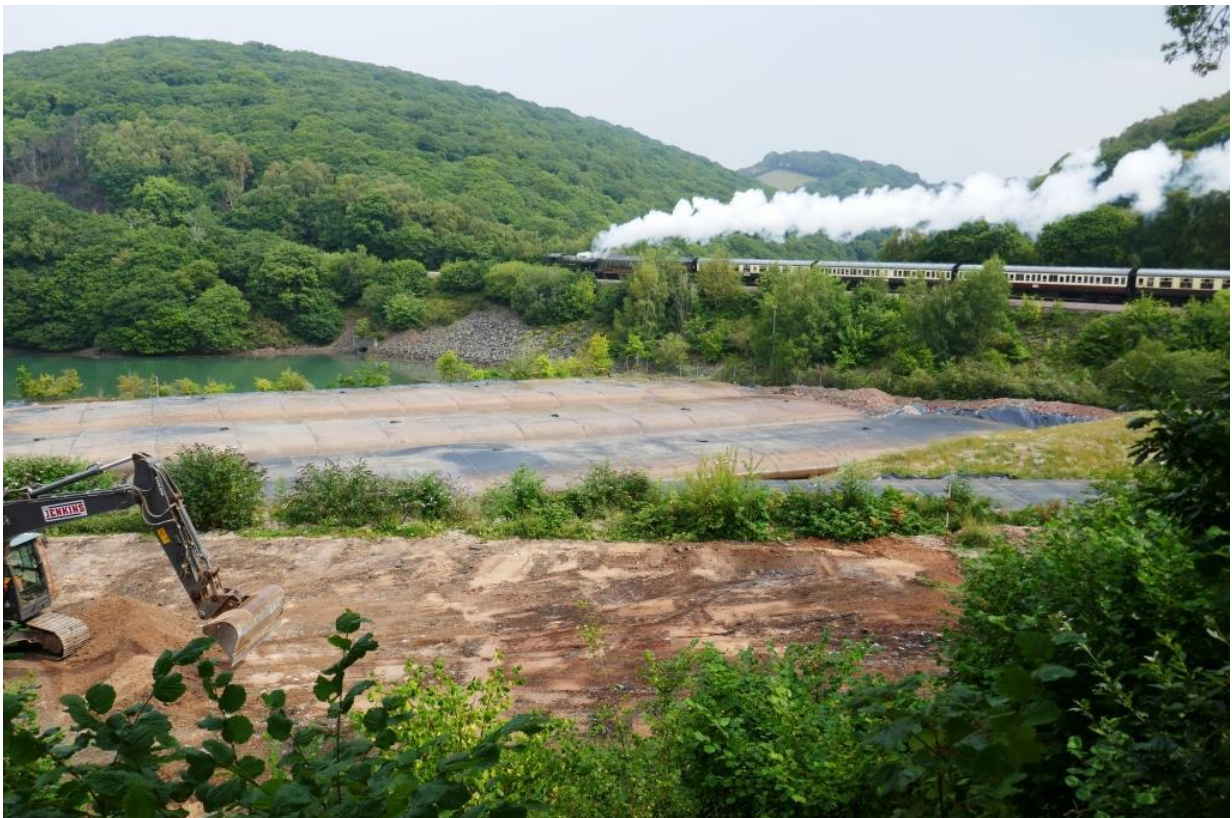
Fig 11 Looking north east during stripping of gravel (112), showing railway (formerly carried across Point and creeks), wooded spur with barrow to left, and hillfort right of centre. The large modern holders at the creek are stores for dredged silt.

The flint, if from the Point, would be of interest particularly since as noted in a previous Heritage Assessment of the site (Service and Clifford 2017, 13) there is a Scheduled bowl barrow (1020159) on the shoulder of a spur above the Dart Valley, across Noss Creek, around 0.5km to the NNE (Fig 11). It is very likely that Noss Creek was used as a natural landing place in prehistory, and it is possible that the top of Higher Noss Point, above the monitoring site, also attracted Bronze Age activity as it overlooked both the side creek and the main estuary.

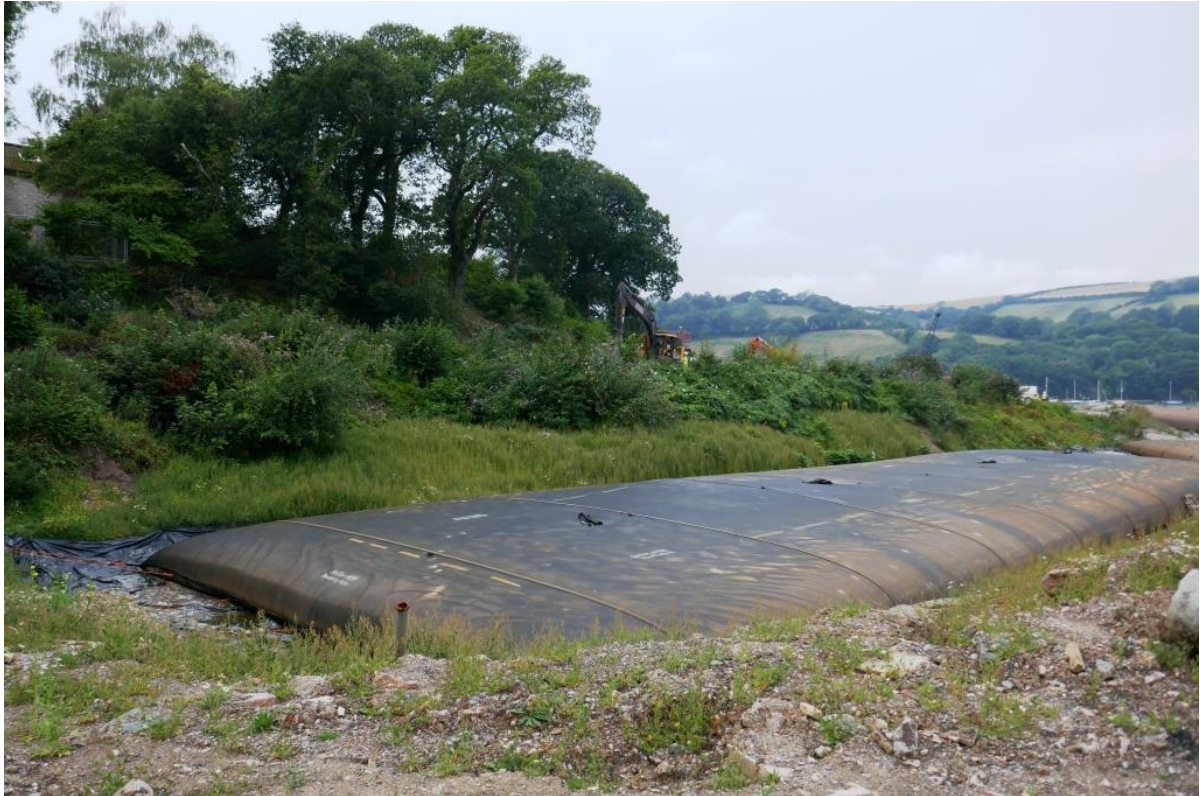
Fig 12 Storage for silt from creek, with site above, looking south west. A flint core from the disturbed ground (front left of photo) may have come from the Point above.

A large knapped flint was found in re-deposited stony clay east of the monitored car park area, at site **1** where silt storage had recently been installed (Figs 12 and 13). This is a core of good quality grey flint measuring up to c7cm, probably Bronze Age in date, perhaps Middle rather than Early Bronze Age (Anna Lawson-Jones, pers comm). It may have come originally from the north east corner of the Point adjoining, where the access to the silt storage area has been cut down from the level of the monitoring area prior to the excavation of this, although it is also possible it was brought in by chance with material from somewhere other than Higher Noss Point.

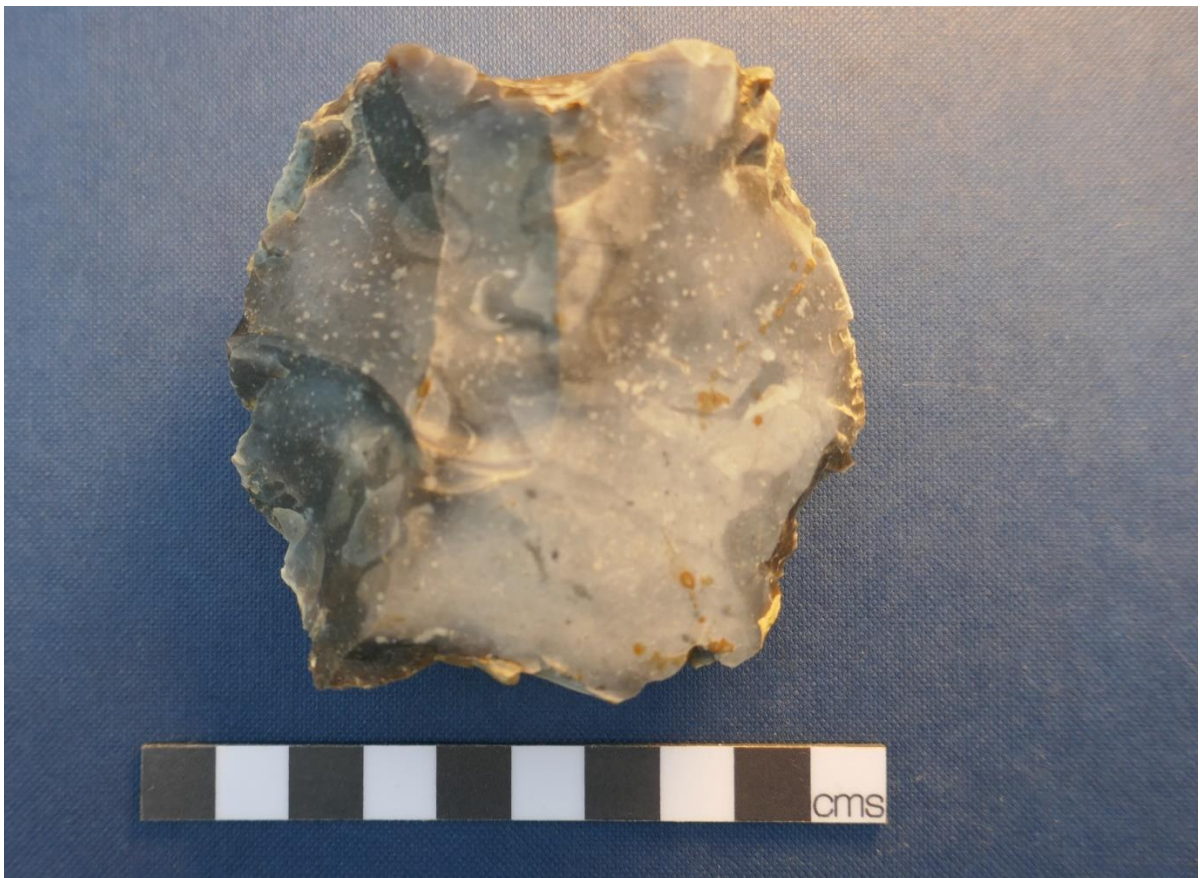
*Fig 13 Large flint core, from site **1** near silt store in creek north east of car park site.*

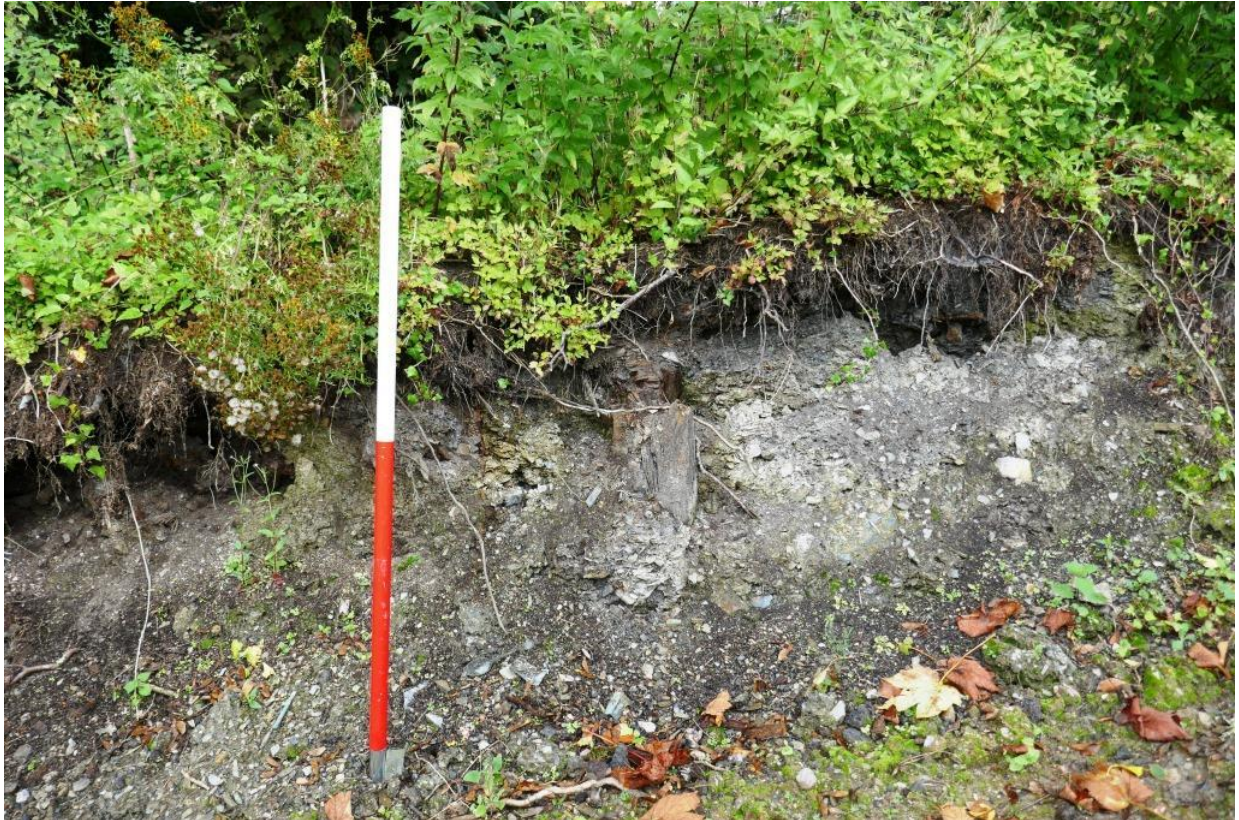
Fig 14 South side of recent track to east side of silt store in creek (ESE of car park), cut through debris making up earlier track, at site 2; note spoon, right of 1m scale.

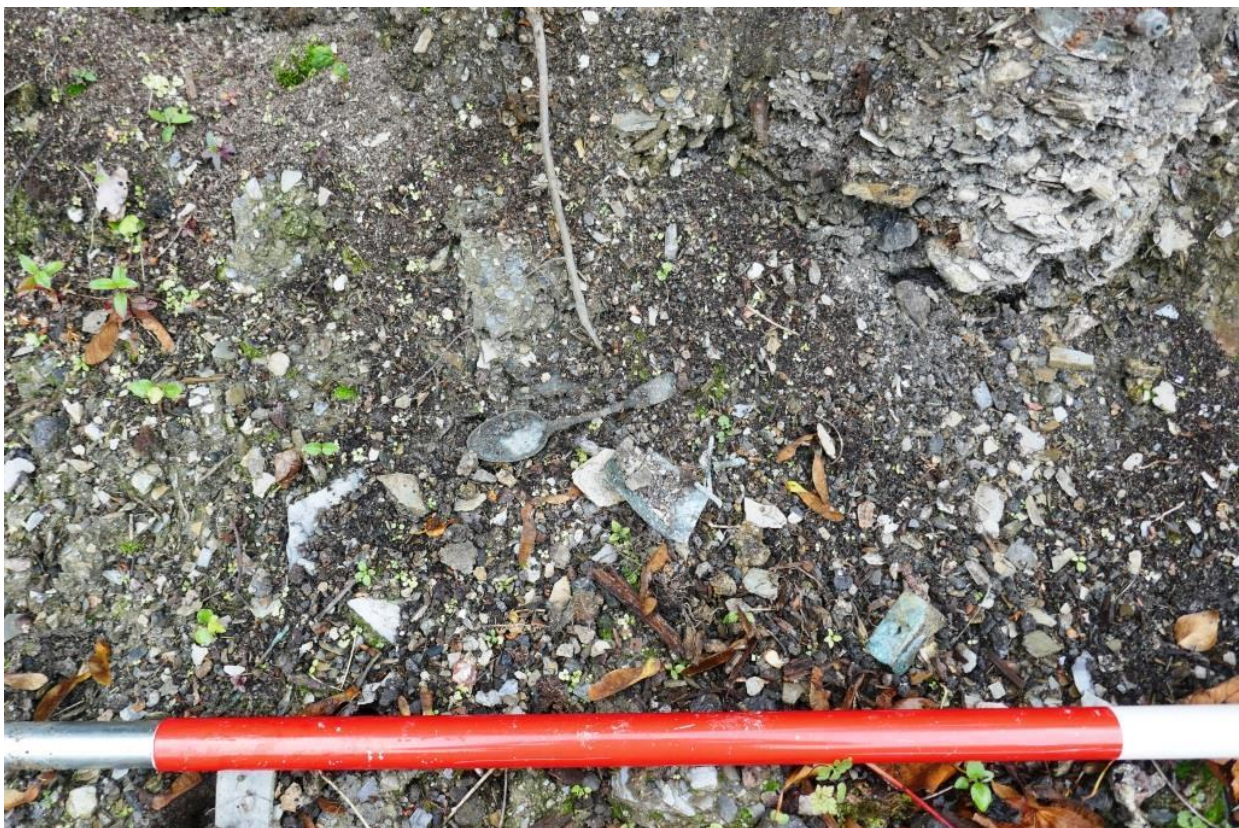
Fig 15 Spoon and small copper plates and nails in cut section of track at site 2, ESE of car park site (0.5m scale bar division).

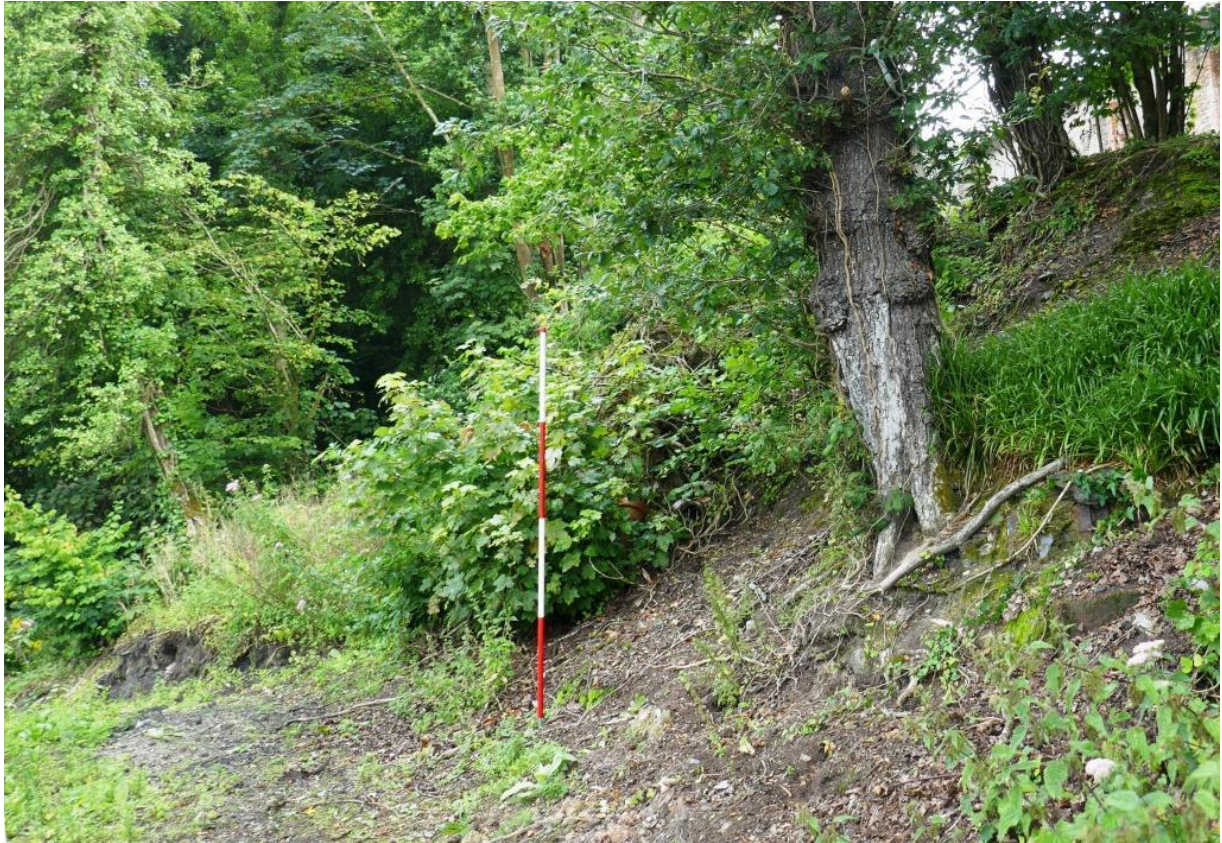
Fig 16 Slope of Point reaching down to old shoreline on south east of area (2m scale).

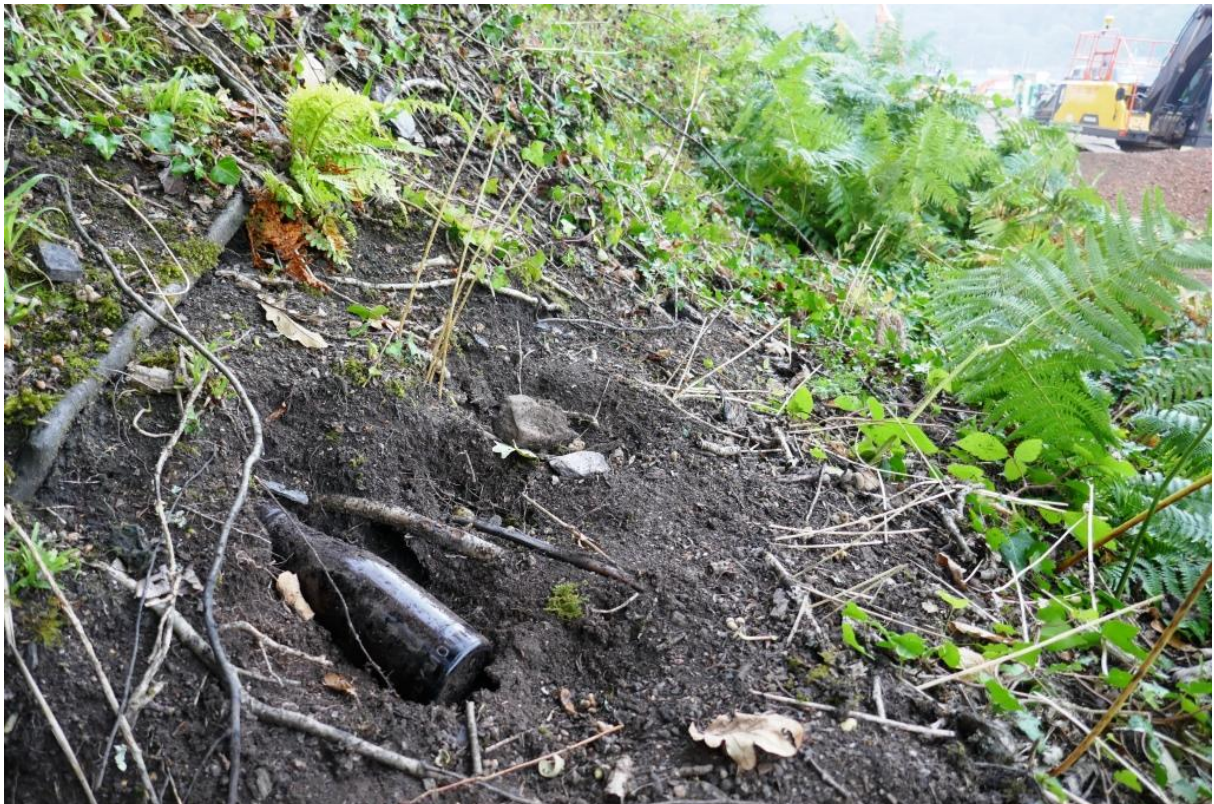
Fig 17 Plymouth Breweries bottle ESE of car park area at site 3, part of a wide spread of material dumped from above extending from here across much of the north slope of the Point, looking north west.

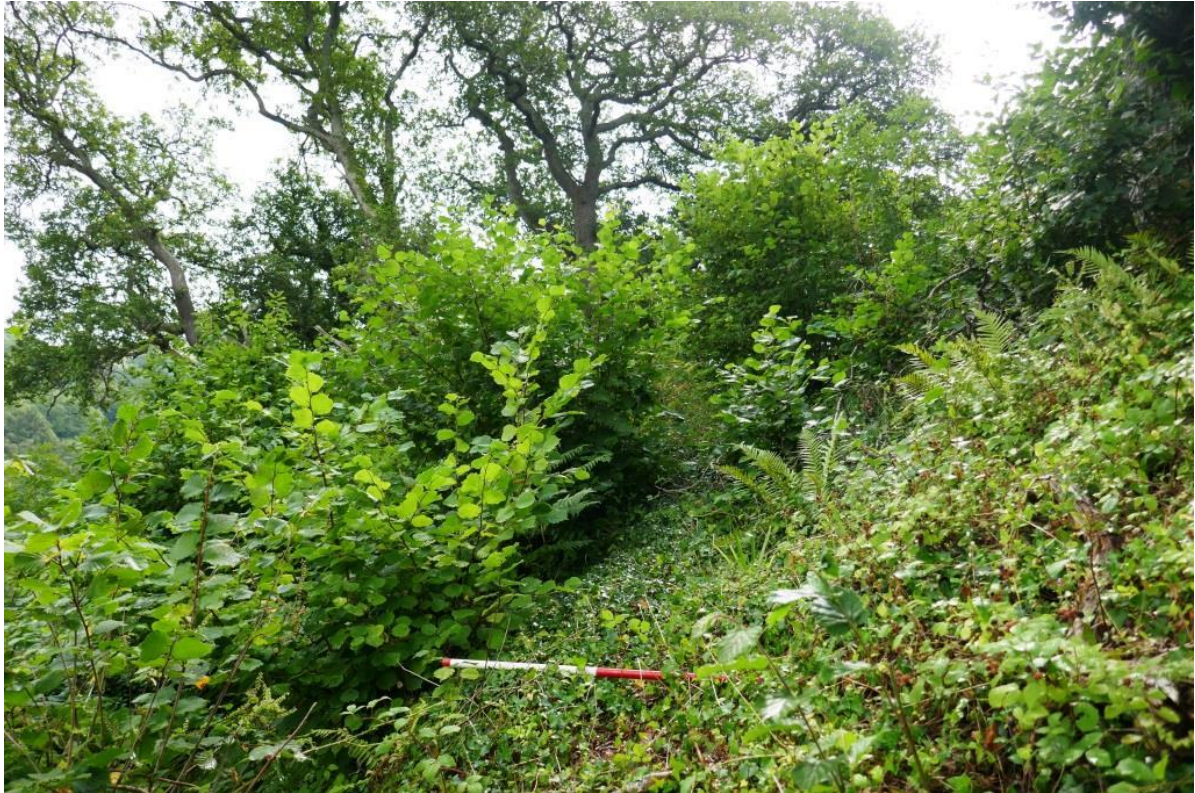
Fig 18 Disused track running south east up slope of Point from old shoreline at site 4, passing above a ruined building on south east of car park site 5; the platform for the later ruined building on the south west of the car park site 7 cuts the lower end of the track (1m scale).

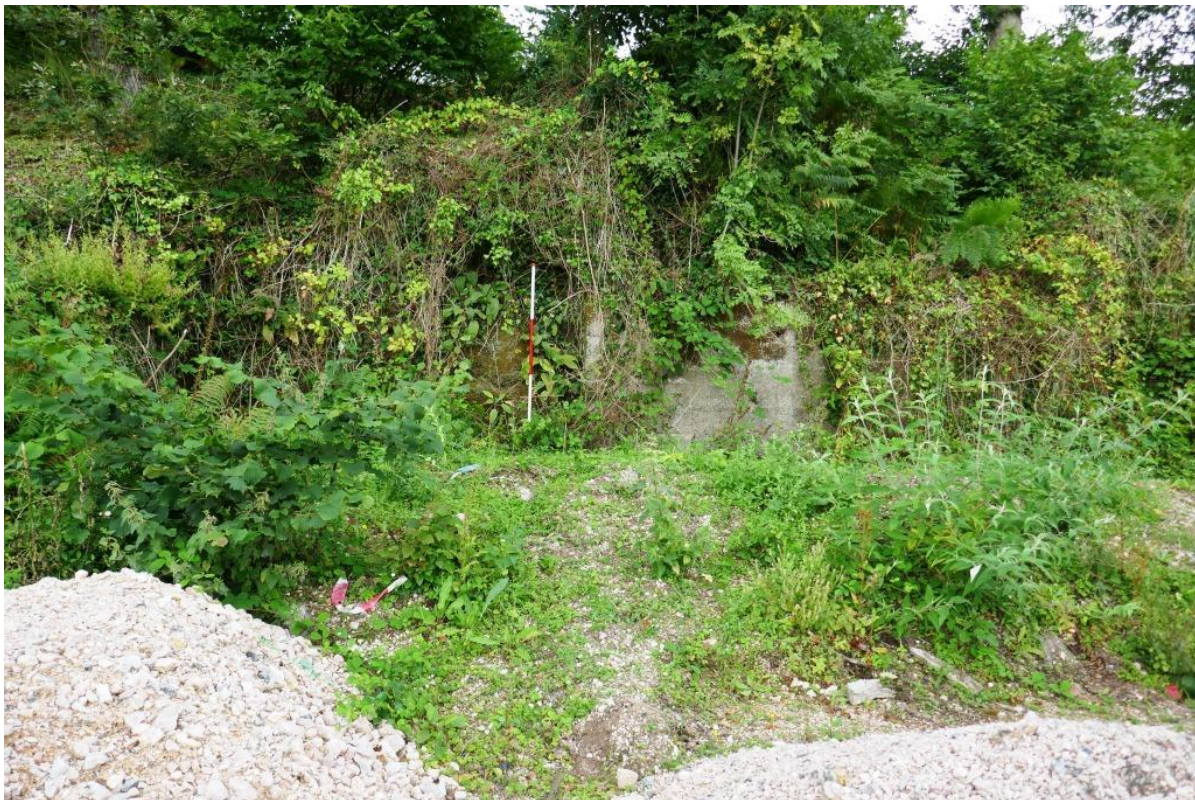
Fig 19 South east building at site 5 before works, looking south, showing rock cut on east (left), and overgrown concrete and stone rear wall (2m scale).

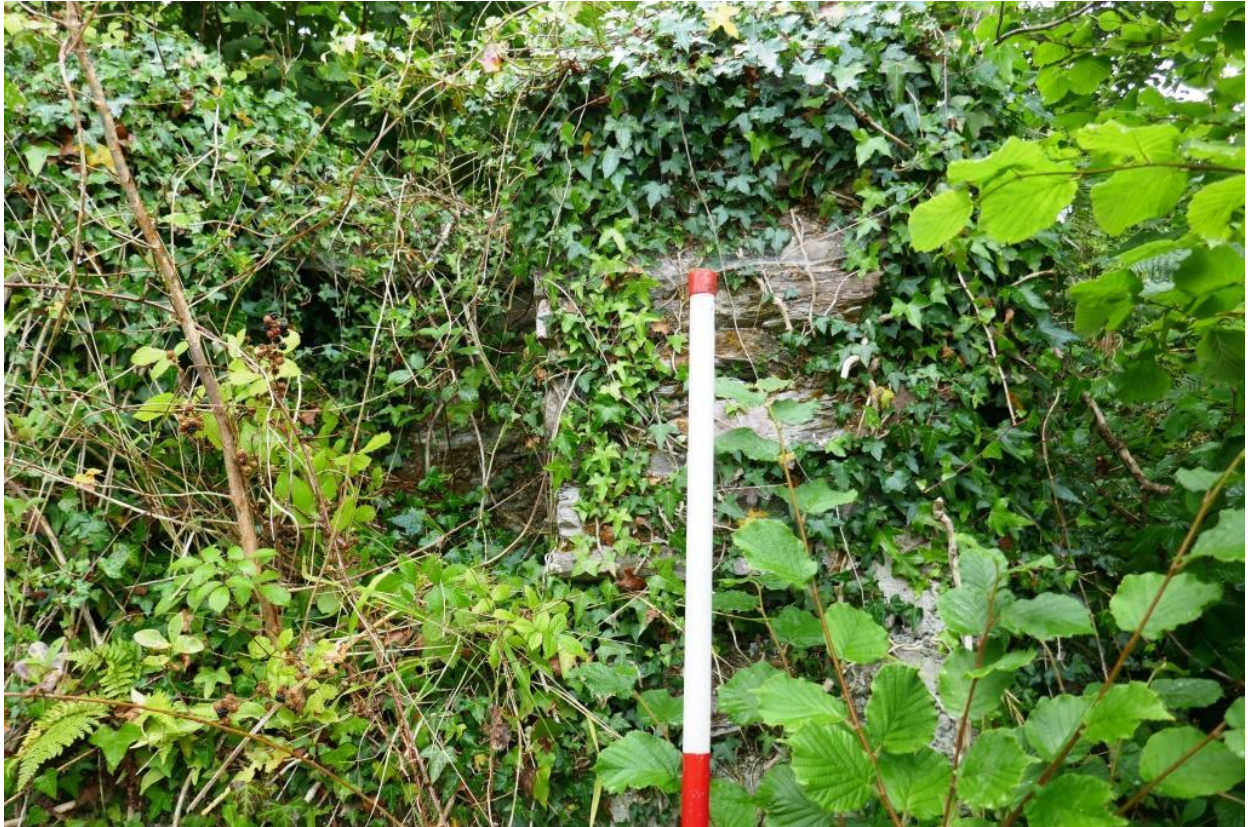
Fig 20 Possible opening and return wall in upper storey inside west end of building 5 on south east.

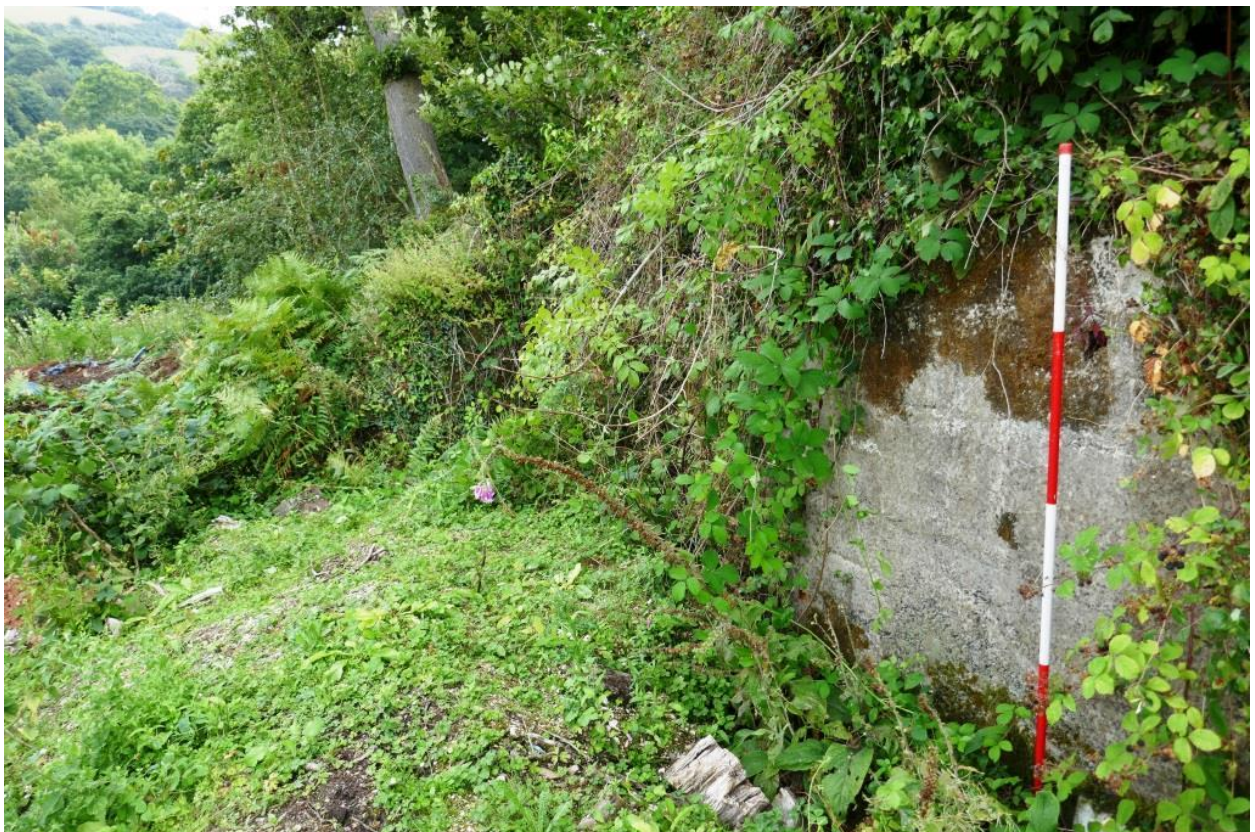
Fig 21 Building at site 5, looking east from centre prior to works, showing fill (101) (2m scale).

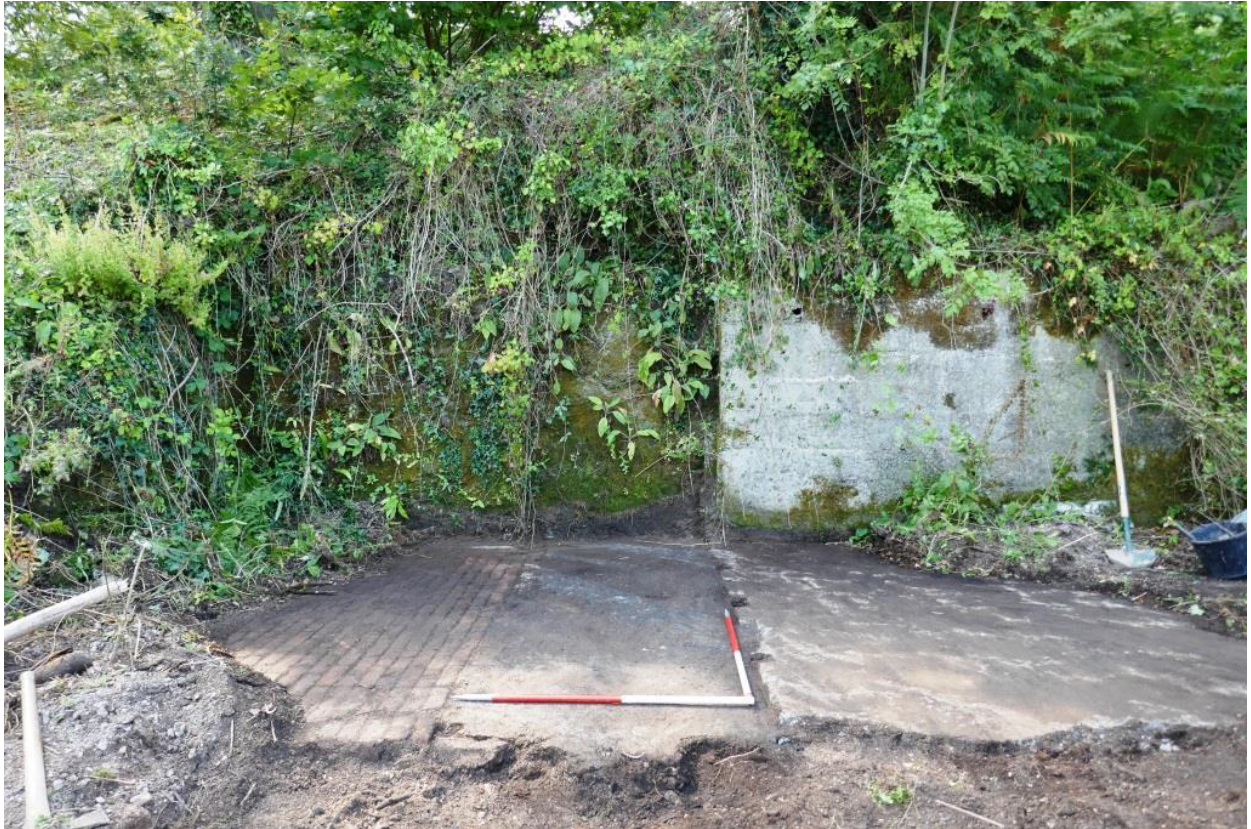
Fig 22 South east building 5, with floor features 103-107 partly exposed (1m scales). Removal of fill (101) and (102) was not all monitored as asbestos was present.

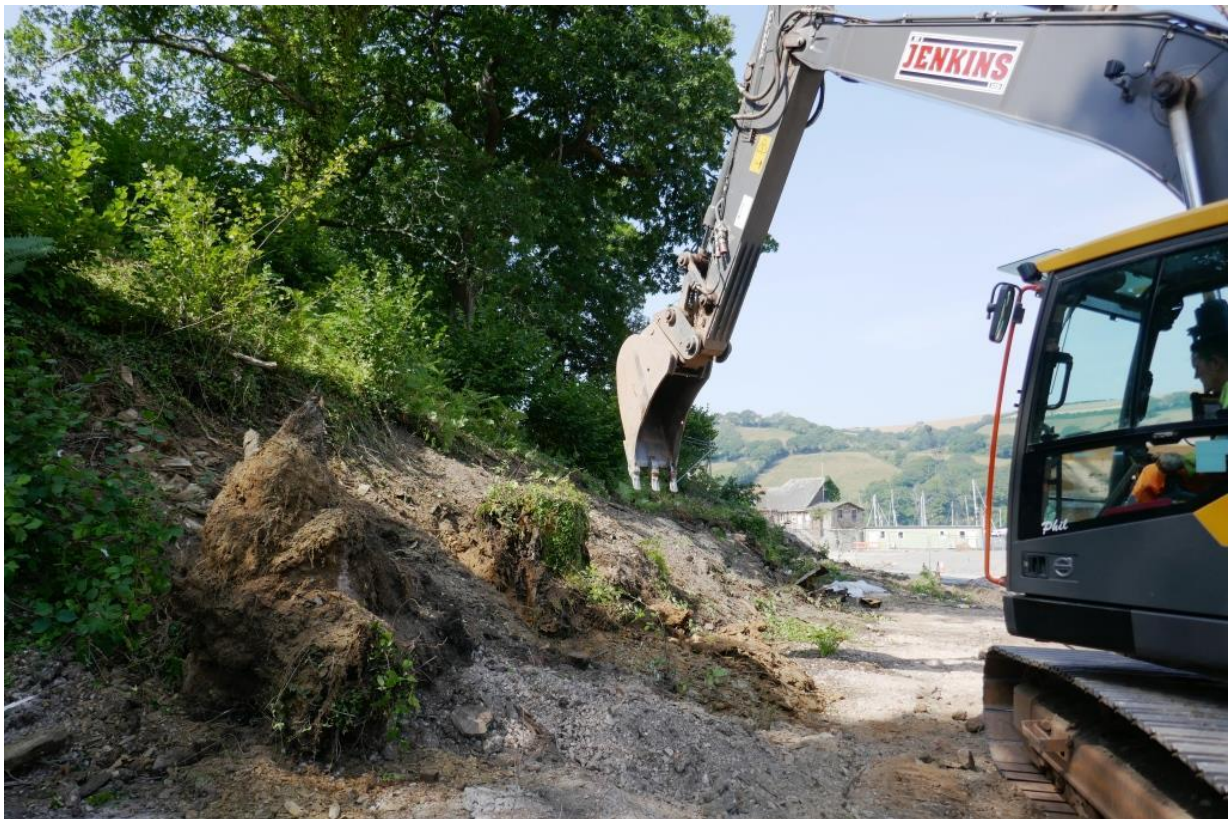
Fig 23 Grading the scarp on the south revealed several large tree stumps. Under topsoil much of the scarp was cloaked in debris tipped from above including asbestos.

The asbestos and other debris which had been redeposited in the past on the slope on the south of the car park site (109) probably came from other 20th century shipyard buildings above on top of Higher Noss Point. Some redeposited material from the shipyard was also noted at two points outside the monitoring area, south east of the car park works, at sites 2 and 3.

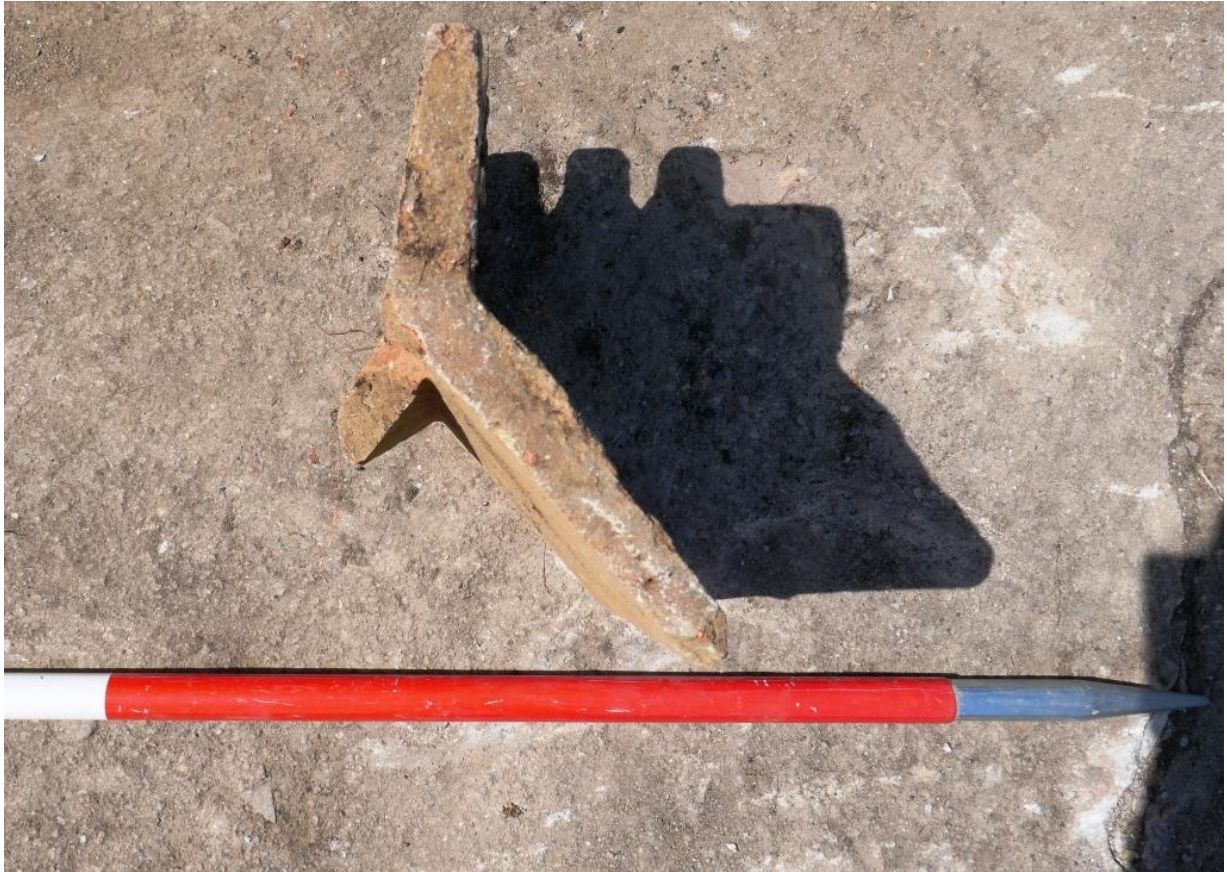
Fig 24 Ridge tile from beside stump on scarp on south at site 6 (0.5m scale division).

A broken ridge tile was found in debris accumulated behind one of the tree stumps on the slope just to the west at location 6. The tile was red clay and was 32cm long and 28cm high overall, and had a ridge standing 15cm (6") high with four indentations 2.5cm apart, 5cm wide and 4cm deep (one of which was broken off) giving a decorative profile (Fig 24). This may suggest that the building at site 5 originally had a roof resembling that of the standing shipyard building further to the west, beyond the car park site, of roughly the same date (also shown on the 1904 map), which has similar tiles although with dark slip or glaze (Fig 25). Alternatively, the ridge tile may have been dumped down to this site from the top of the Point.

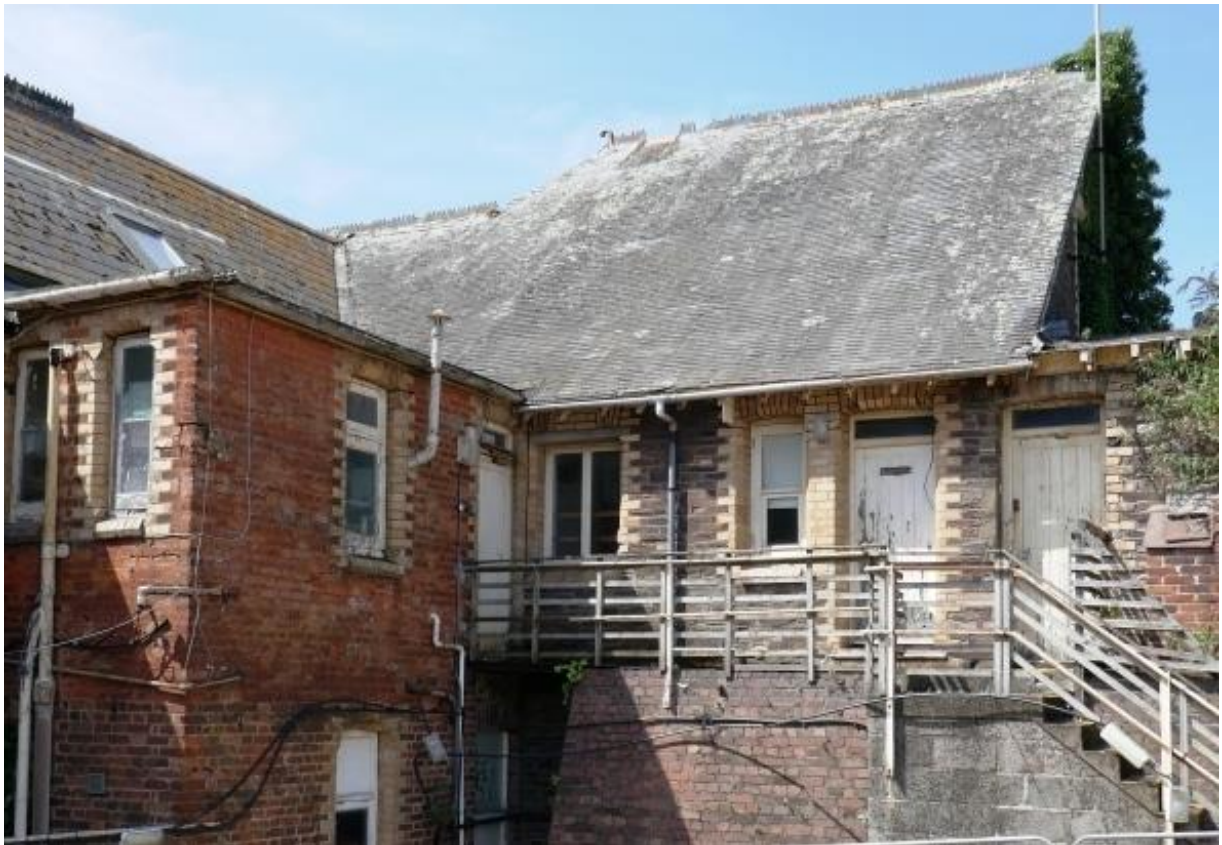
Fig 25 Buildings west of car park site, recorded on the 1904 OS map, with ridge tiles.

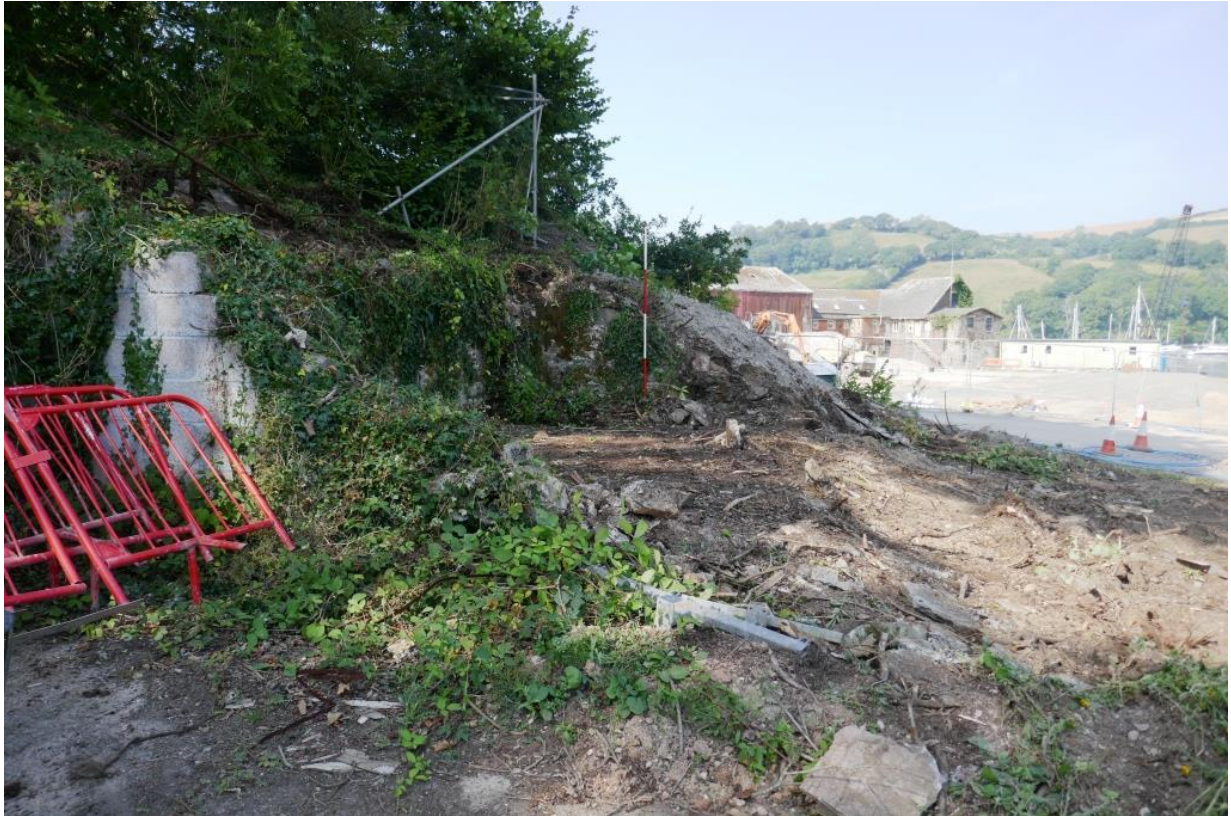
Fig 26 South west building at site 7 at start of works. Of its two roughly equal-sized parts, the nearer one appears relatively recent with concrete walls and floor 111; the further part appears modern though primary with narrow stone walls (2m scale).
