Noss on Dart Marina, Kingswear, Devon;
Archaeological Monitoring, Car Park Site

Client	Devon Contractors Ltd
Report Number	2020R057
Date	November 2020
Status	Final Report
Report author(s)	Cathy Parkes BA MCIfA
Checked by	Andy Jones
Approved by	Andy Jones
Project number	147064
Site code	N/A
Data location	\\CAU\Archive\Sites\Devon\Noss on Dart Marina Watching brief 147064
Historic England / ADS OASIS online reference	cornwall2-407045
Planning reference	2161/17/FUL

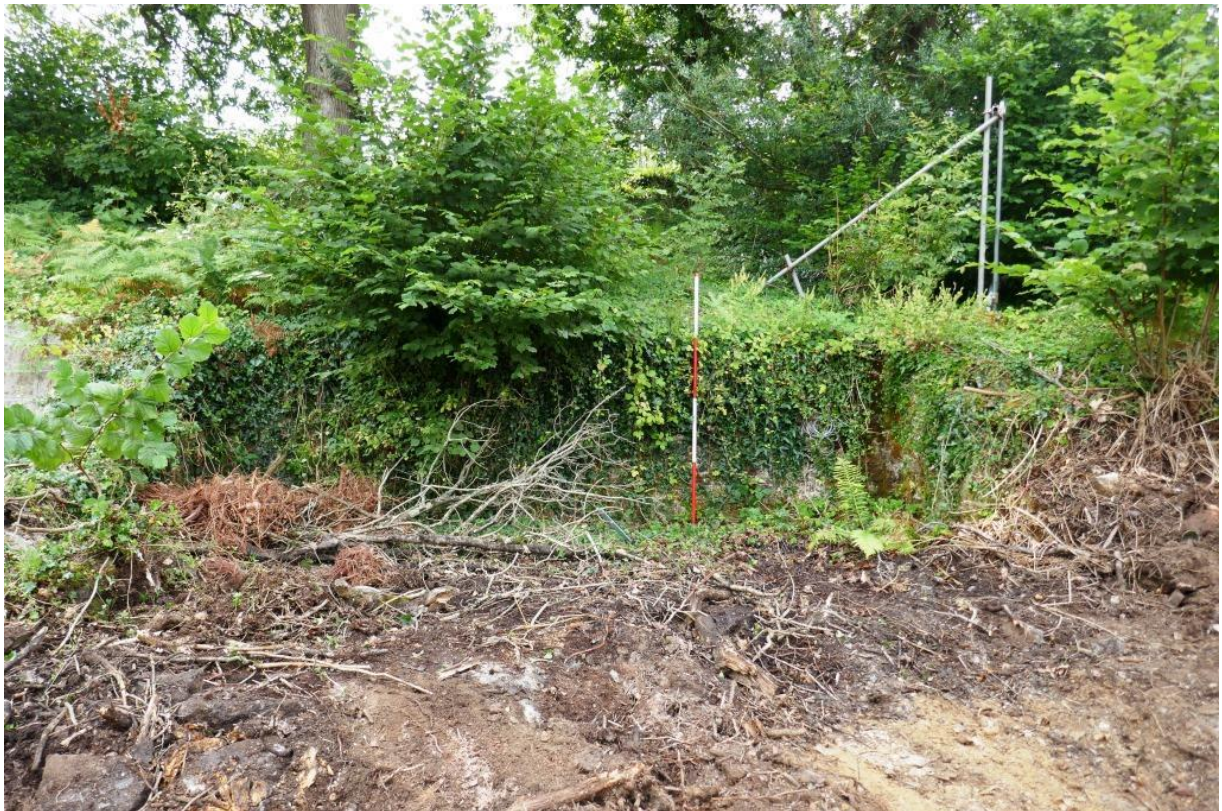
Fig 27 West part of south west building at site 7 at start of works with overgrown walling and mixed loose fill (110) which proved to contain asbestos (2m scale).

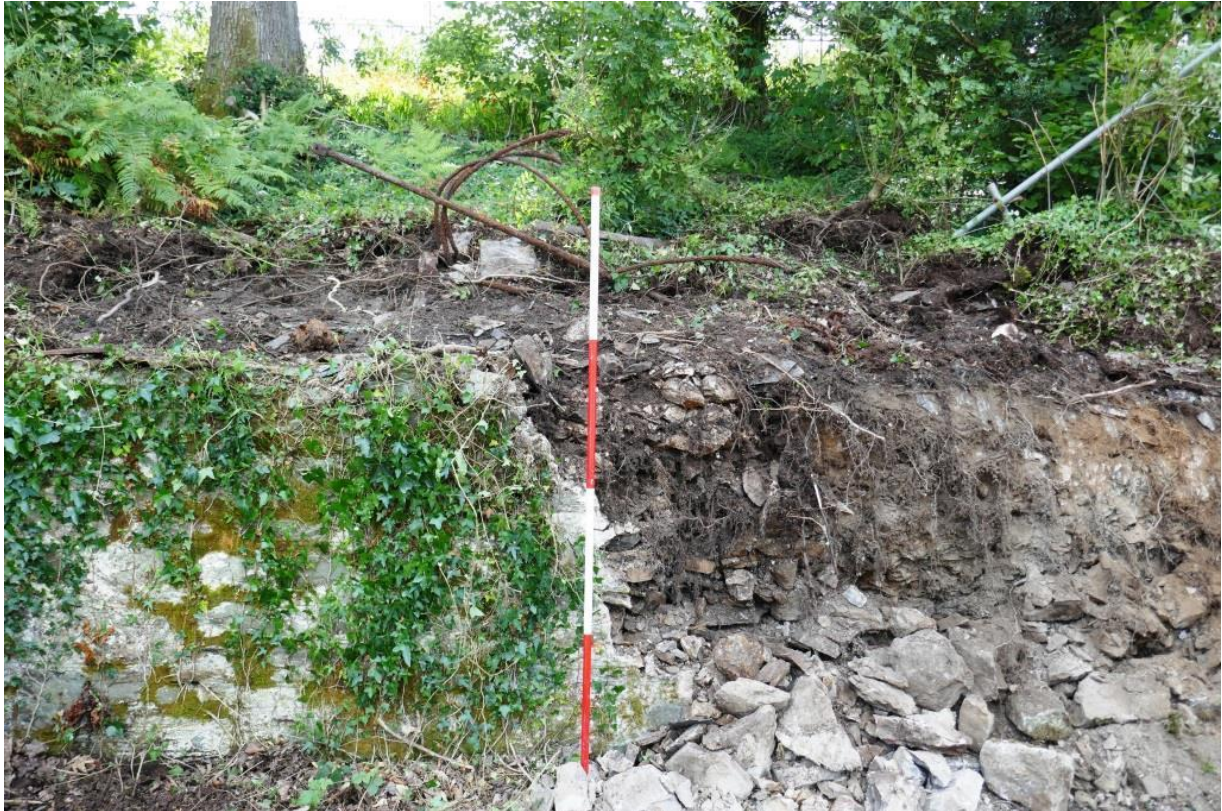
Fig 28 West part of south west building at site 7 during removal of its south wall where the building platform had been cut into the bedrock and the space between wall and cut later filled with debris dumped down the scarp including asbestos (2m scale).

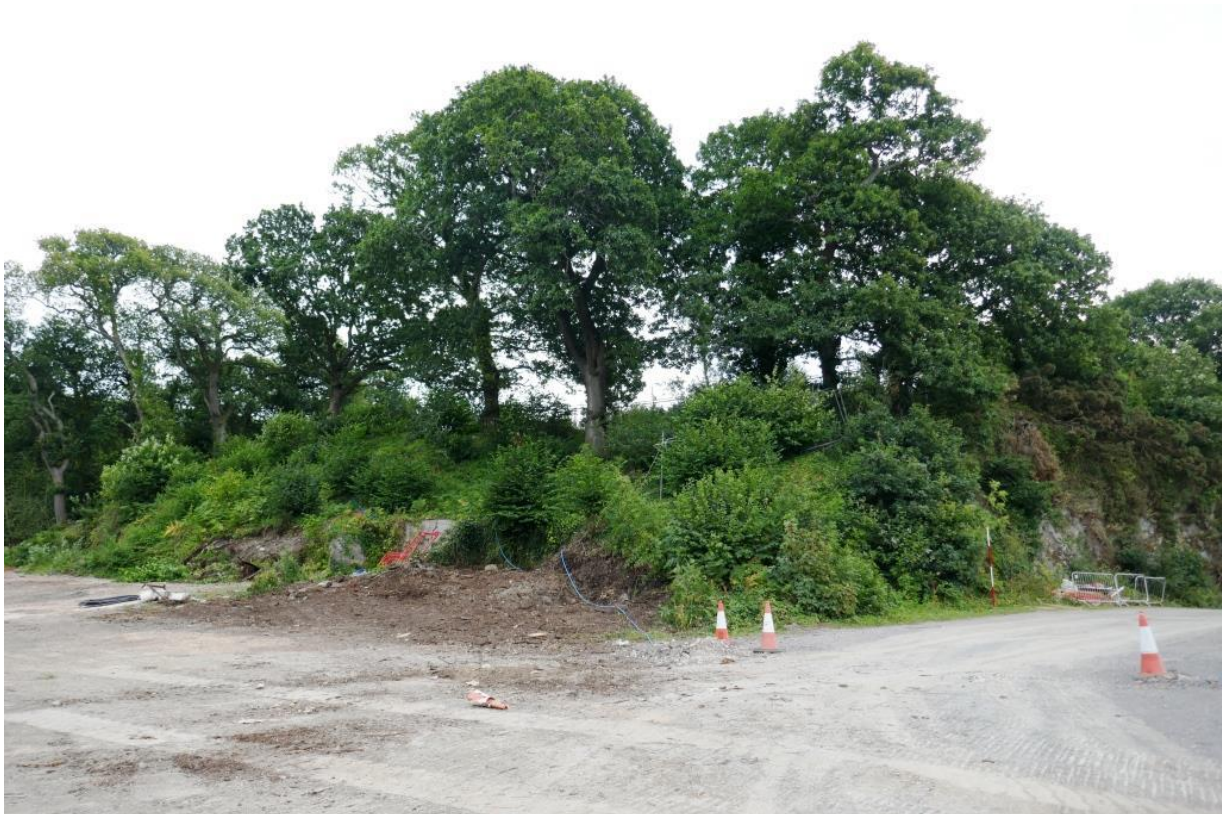
Fig 29 Old railway cutting west of new car park area (right) with trees on the ridge above mapped in 1895 and possibly indicated also in 1838 (2m scale).

The topography and land reclamation can be appreciated from the client's survey showing the steep north side of the Point falling to the former shoreline on the south edge of the car park area (Fig 3). An even steeper scarp to the south west is a cutting for the railway line on the east side of the Dart Valley, which ran across the Point here and over viaducts to either side before being re-routed further east (Fig 29).

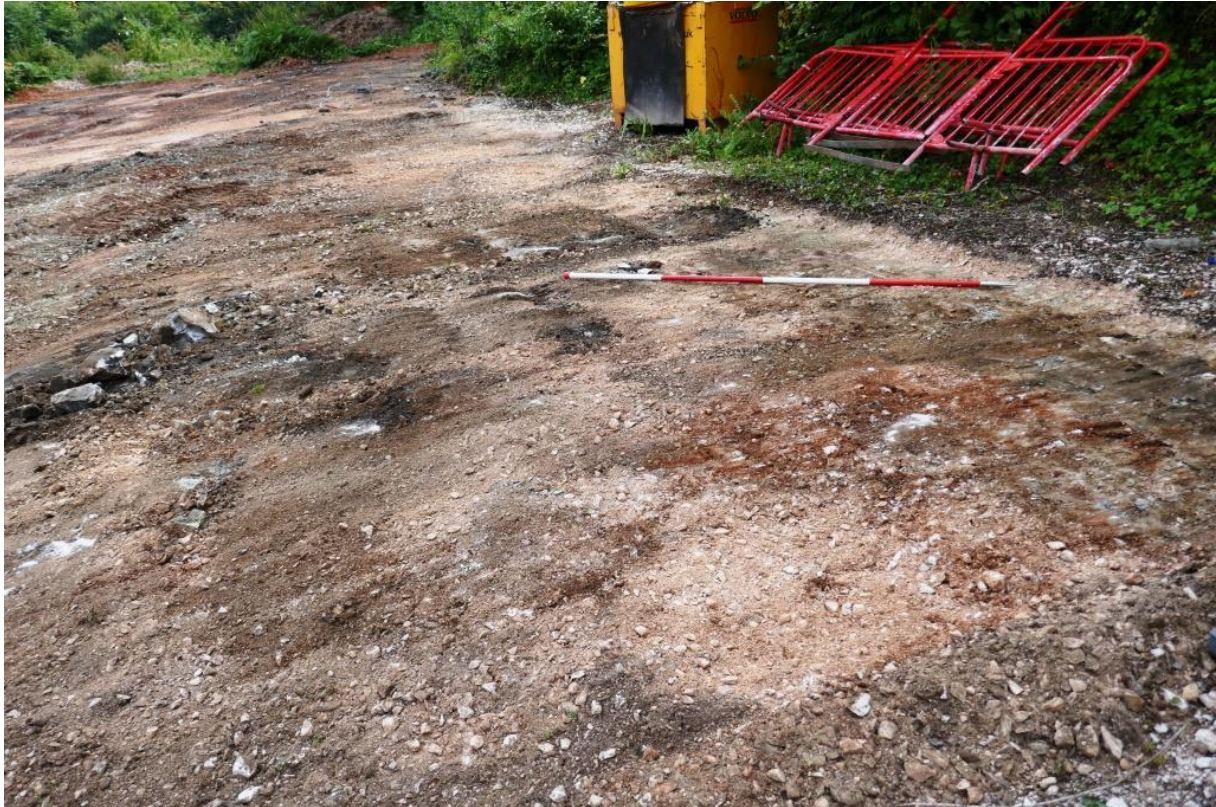
Fig 30 View from north west of south side of made ground stripped of gravel (112), showing infill (113), very stony clay with coal (2m scale).

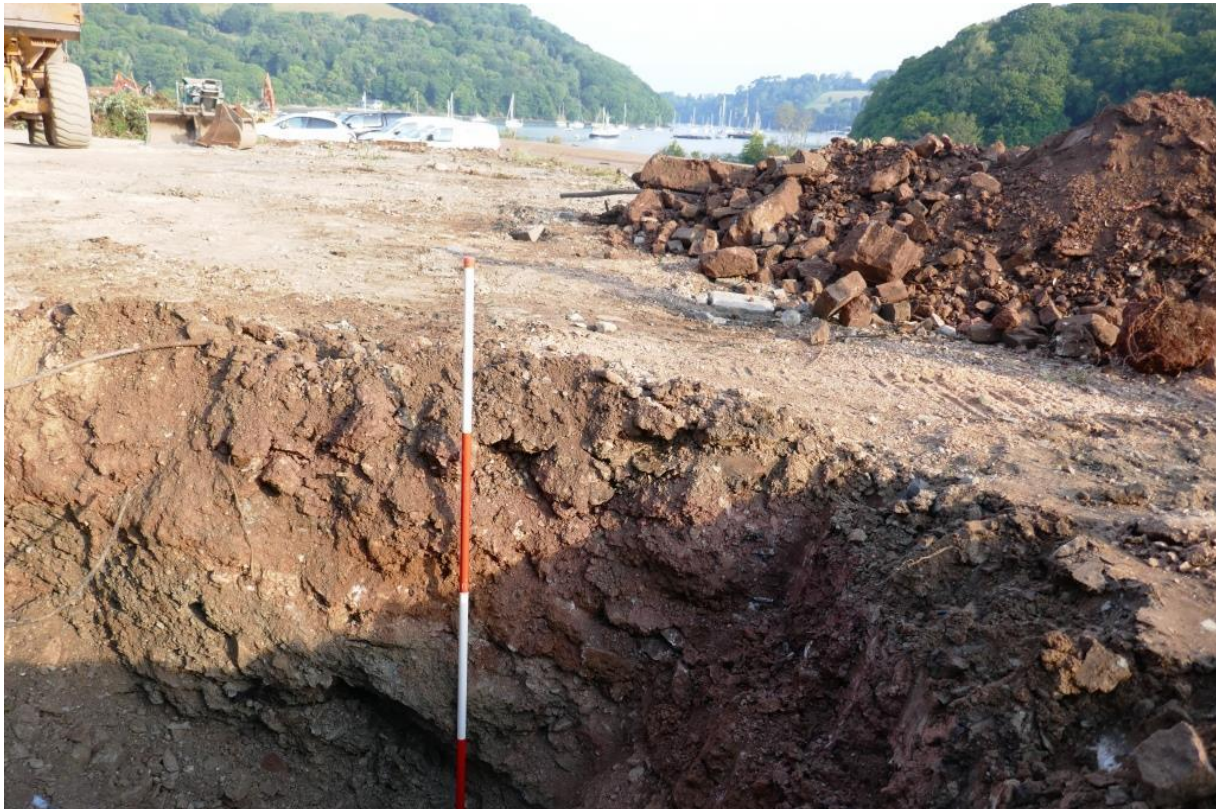
Fig 31 South facing section exposed by test pit east of centre of car park area, with layers of very stony infill (113) and (115) deposited from the south side in the 20th century to reclaim the ground from the creek beyond (2m scale).

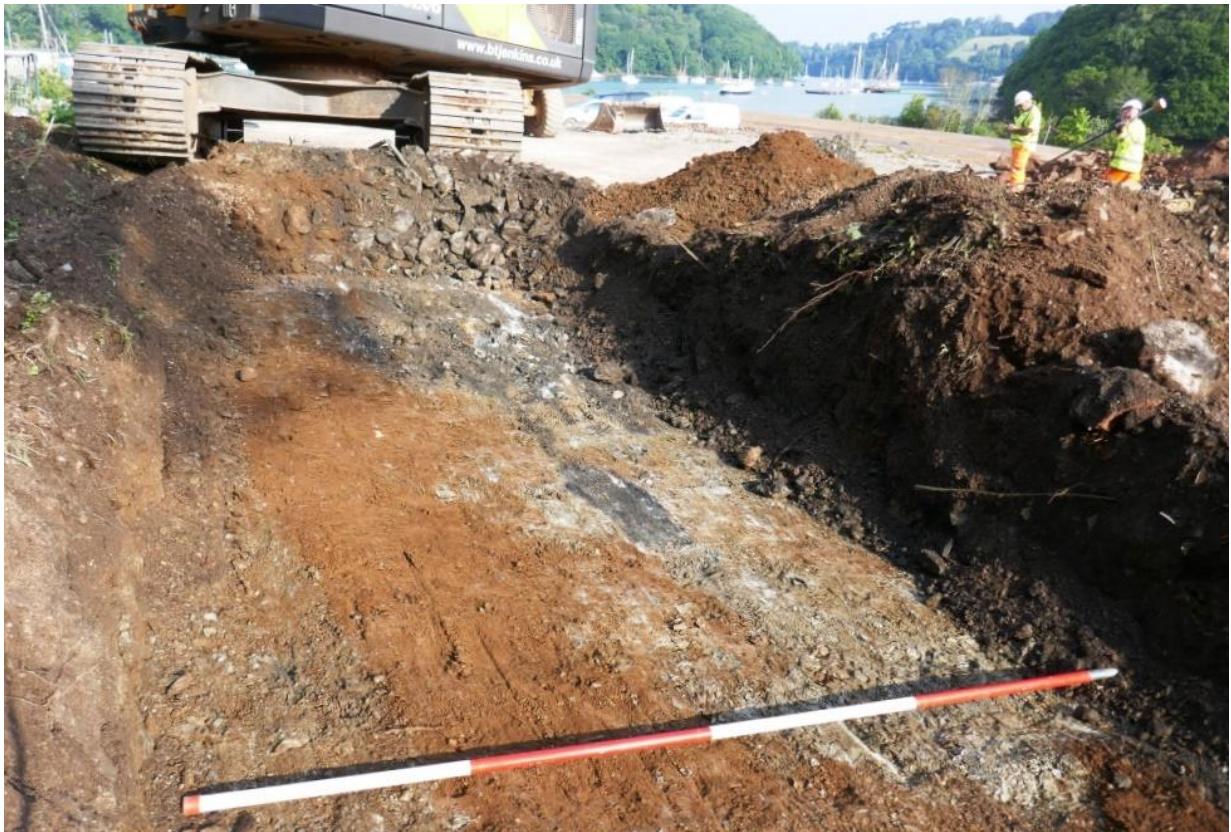
Fig 32 Stripping of modern fill on south east quarter of site in progress (looking north west). The base of the trench shows the thick stony coally pinkish layer (113), the most recent apart from the surface gravel, right; orangey clay (114), centre; and greyish stony layer (115), left; all spread successively into the creek (2m scale).

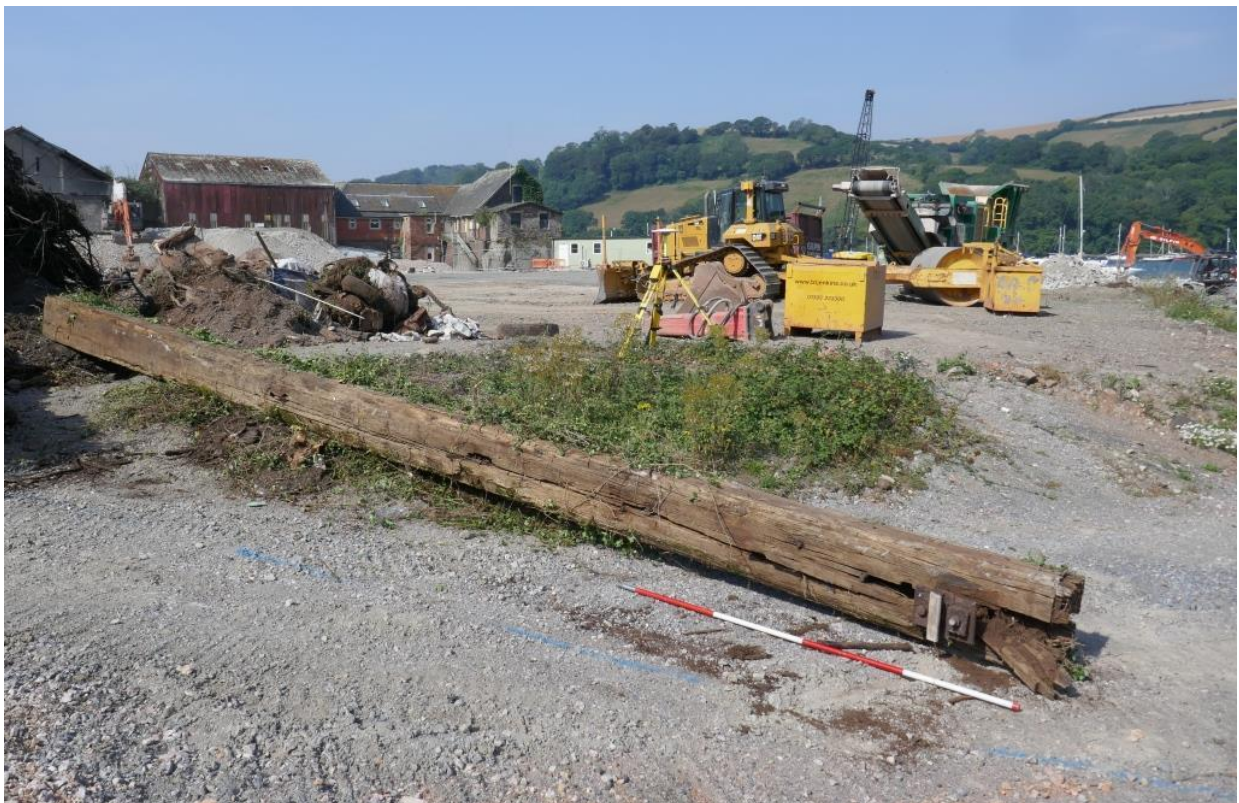
Fig 33 Large timber, possibly from crane, used to face modern creek infill (2m scale).

A large timber found in the later reclaimed ground on the outer, north part of the car park site (not during the archaeological monitoring) may be from a shipyard structure, potentially one of the Simpson and Strickland phase such as a crane marked at the west end of the Point on the 1904 map (Fig 6). The timber was 9.25m long and 0.4m square and had remains, and marks, of iron bolts and fittings (Fig 33).

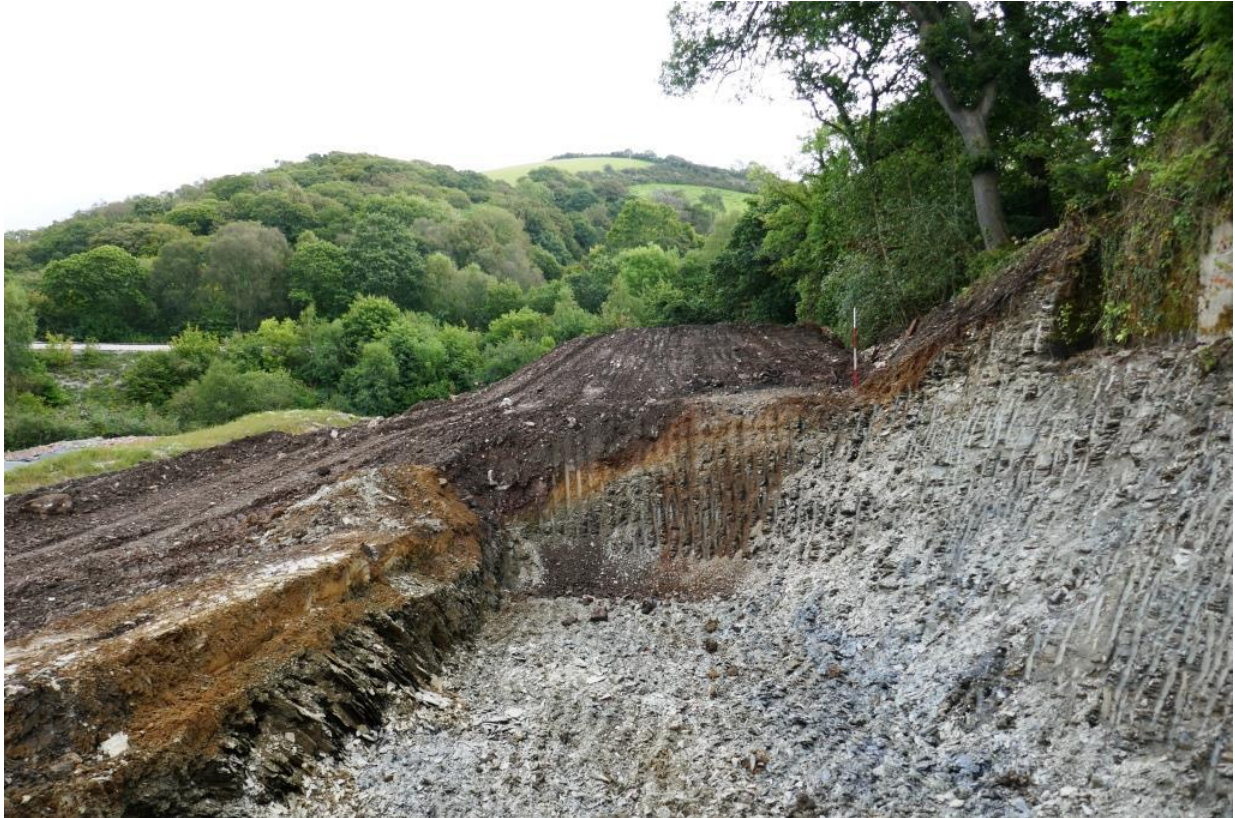
*Fig 34 Site after cutting into bedrock, looking east, showing infill (113) and clay (114), and, right, backs of buildings sites **5** and **7** by former shoreline (2m scale).*

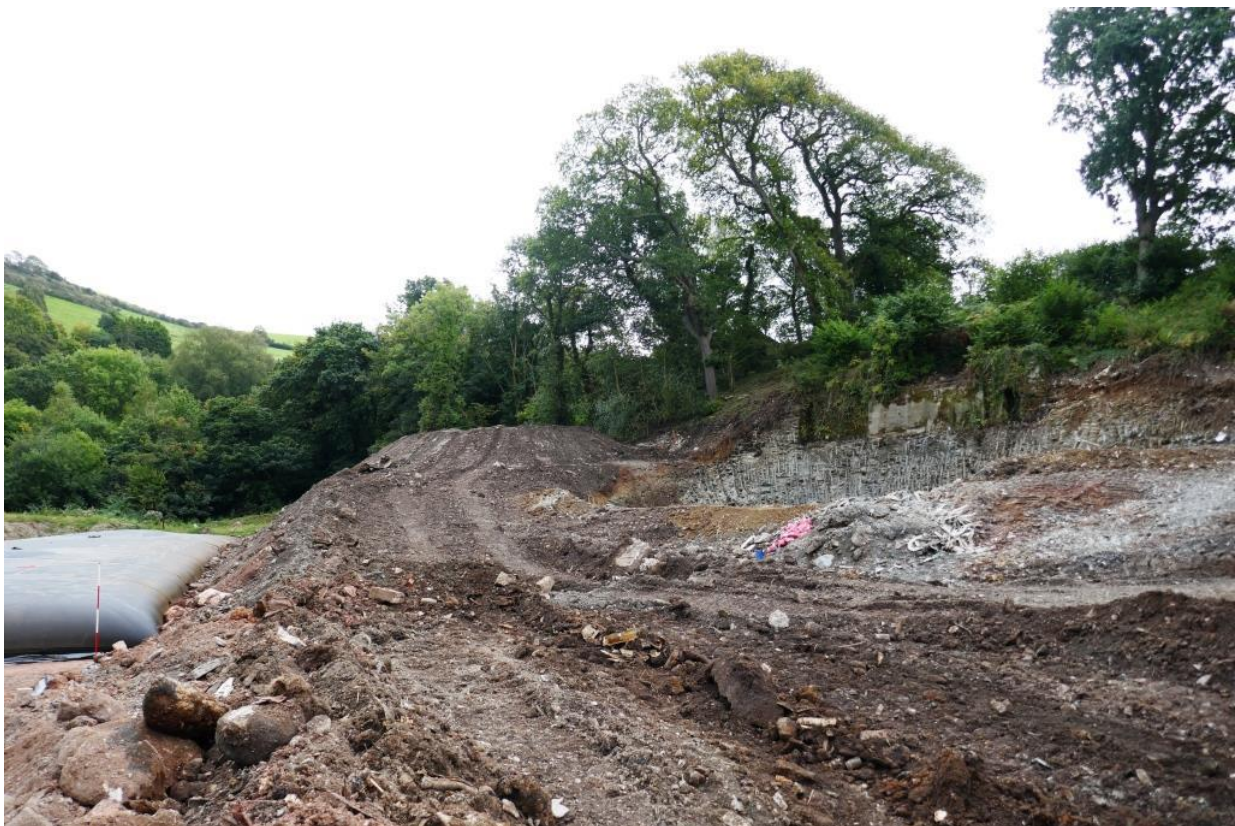
Fig 35 Site looking south east from silt storage area beside creek below, at conclusion of monitoring (2m scale).

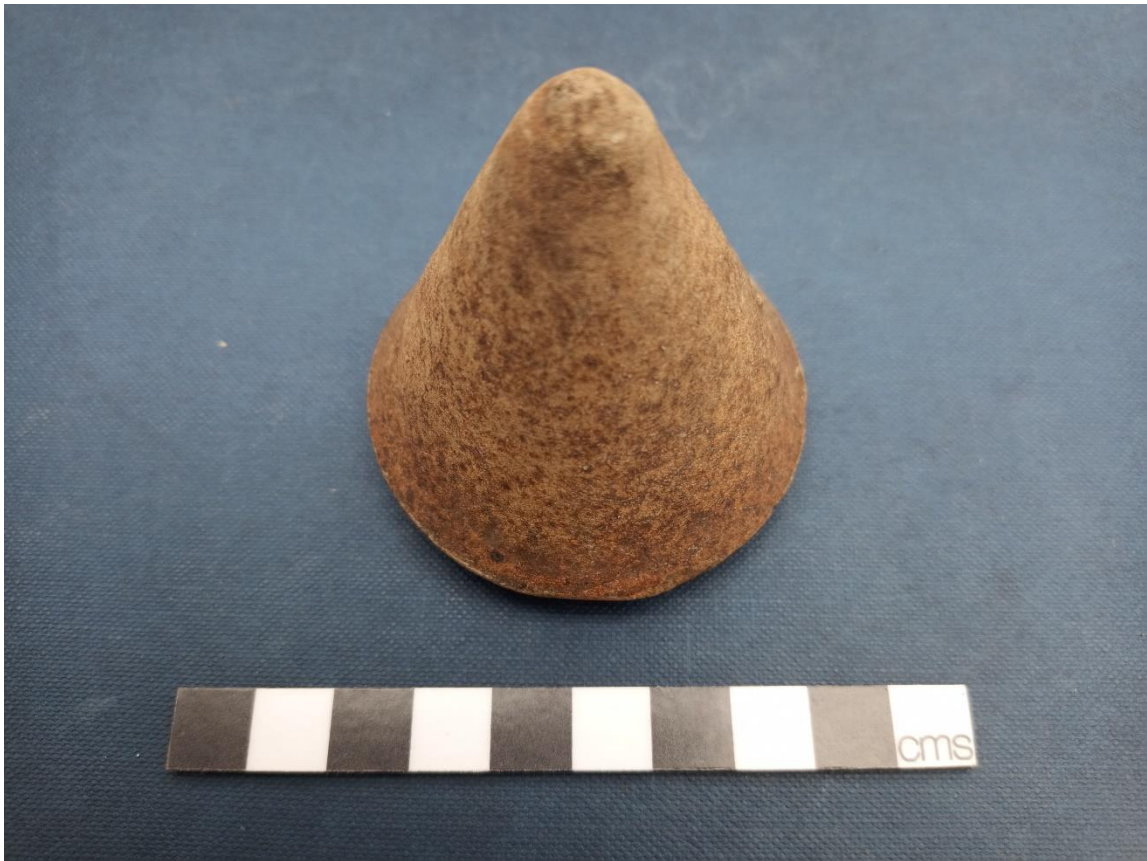
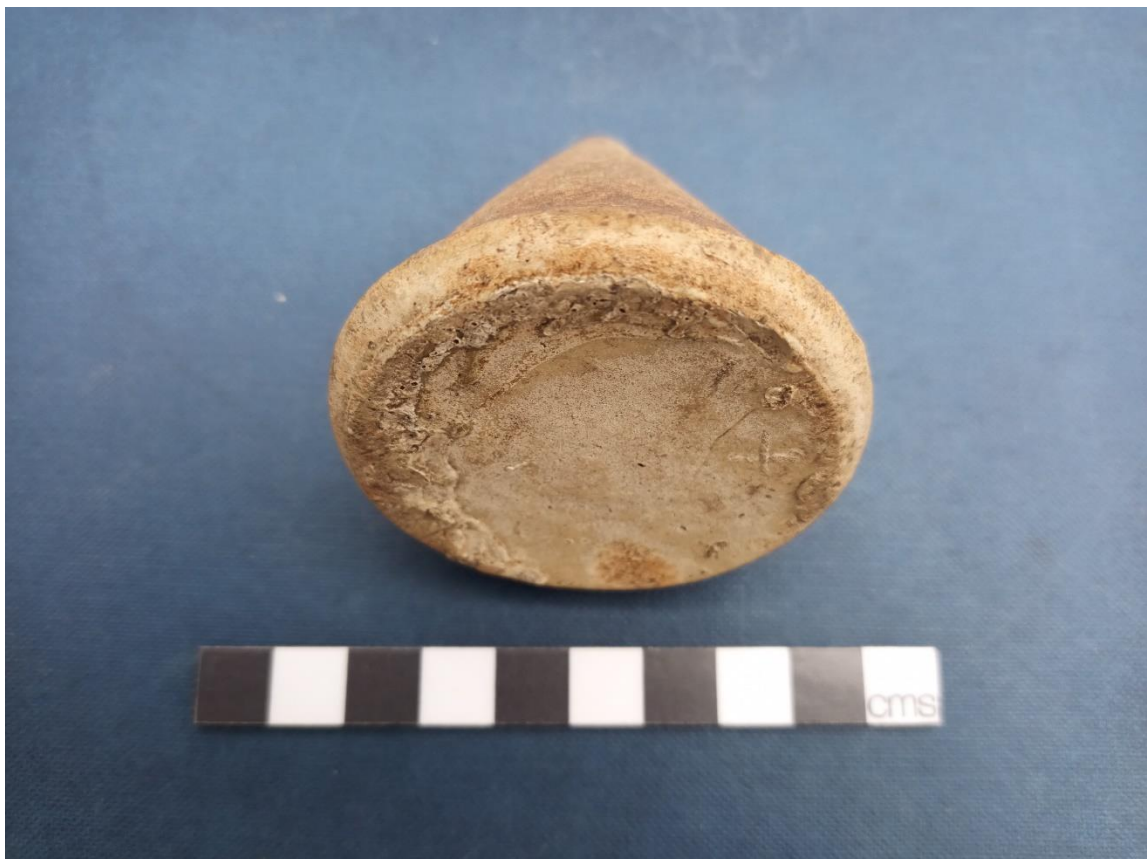
Fig 36 Ceramic cone uncovered by grading of slope behind Site 7 (unstratified).

Fig 37 Base of ceramic cone from grading of slope behind Site 7 (unstratified).

A small, regular, ceramic cone, with thin brown glaze, concave base and slightly worn top, was uncovered during the grading of the slope just above site 7 (unstratified). This is unidentified but its general character may suggest it could date from around the later 19th century so it may be related to the earlier years of the shipyard (Figs 36 and 37).
